**Environmental Monitor Construction Site Inspection Report
MassDOT Project #608164 Construction Contract # 119678
EM Report #13**

Project Description: Bruce Freeman Rail Trail Right-of-Way
Permit Description(s): Order of Conditions (MGL Chapter 131, Section 40 and 310 CMR 10.00, Mass DEP File No. 301-1362); 2022 EPA NPDES General Permit for Discharges from Construction Areas; U.S. Army Corps of Engineers Permit No NAE-2021-01975.

Project Name:	Bruce Freeman Rail Trail - Phase 2d - Sudbury
Date of Inspections:	7/22/2024
Bi Weekly/ Monthly Period Covered:	July Weekly Inspection #3
Inspector's Name(s):	Anna Haznar
Inspectors' Contact Information:	ahaznar@beta-inc.com

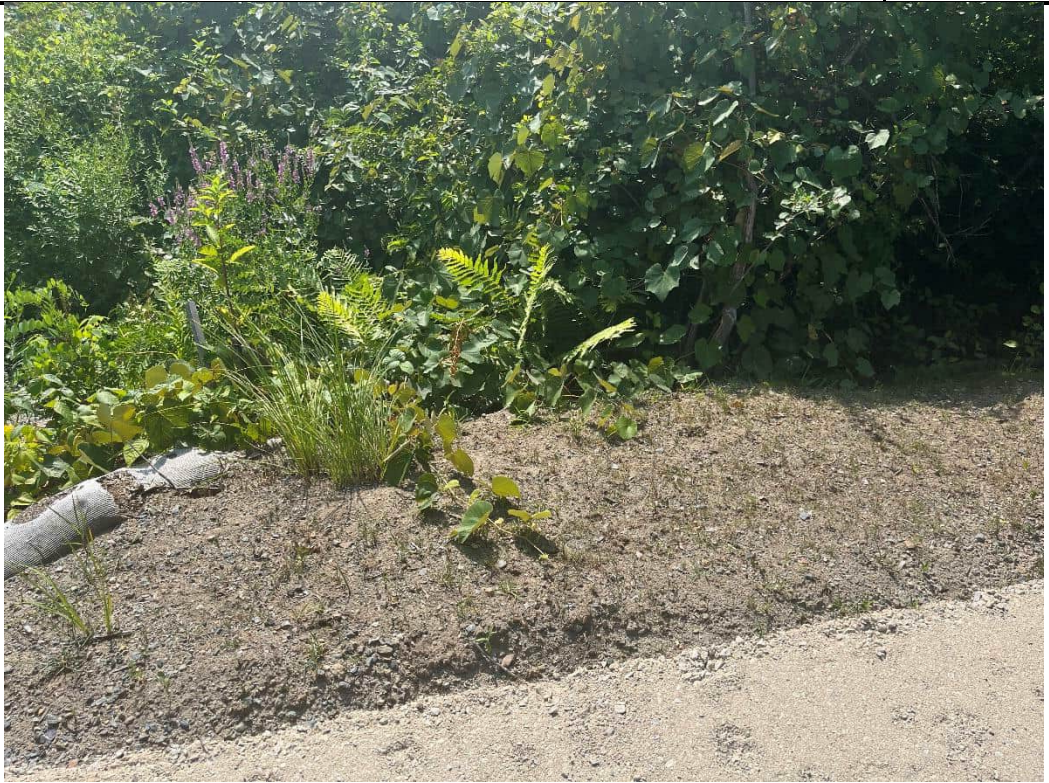
Photo No. 1 **Date:**
7/22/2024

Typical view of slopes requiring stabilization and removal of gravel/sediment accumulation along compost filter tubes at Station 105+00 to 106+00 per Compliance Action Items 43 and 44.

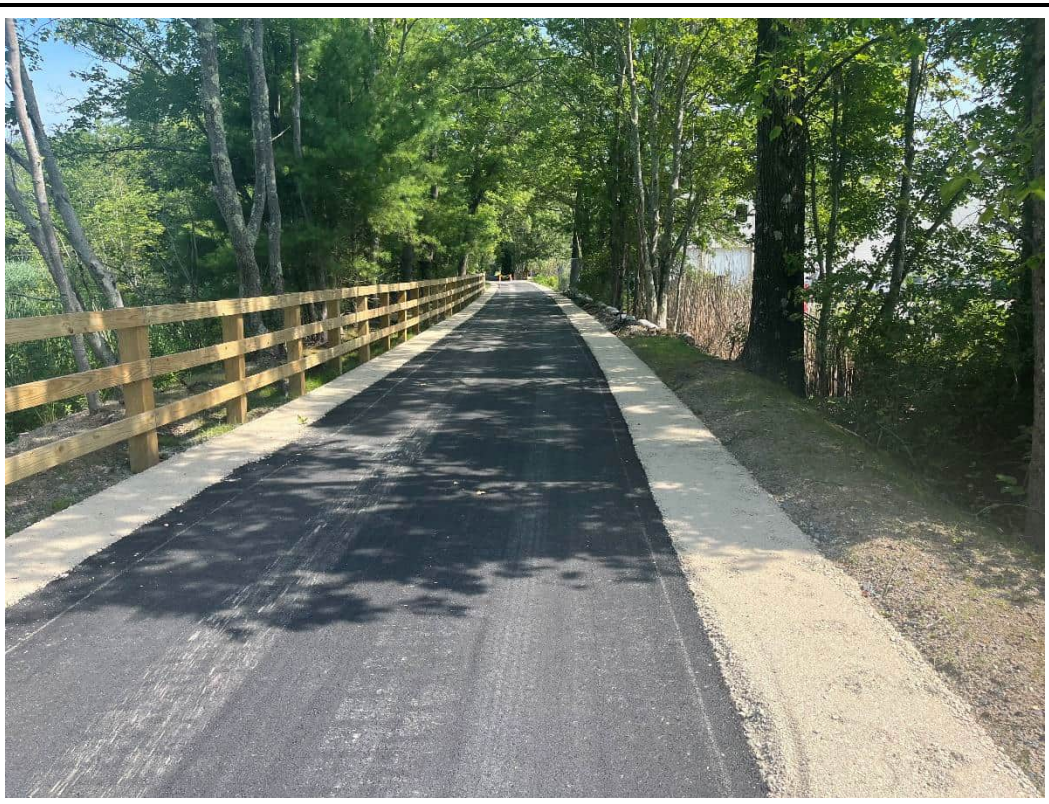
Photo No. 2 **Date:**
7/22/2024

Typical view of crushed stone that has been placed and compacted on the sides of the path.

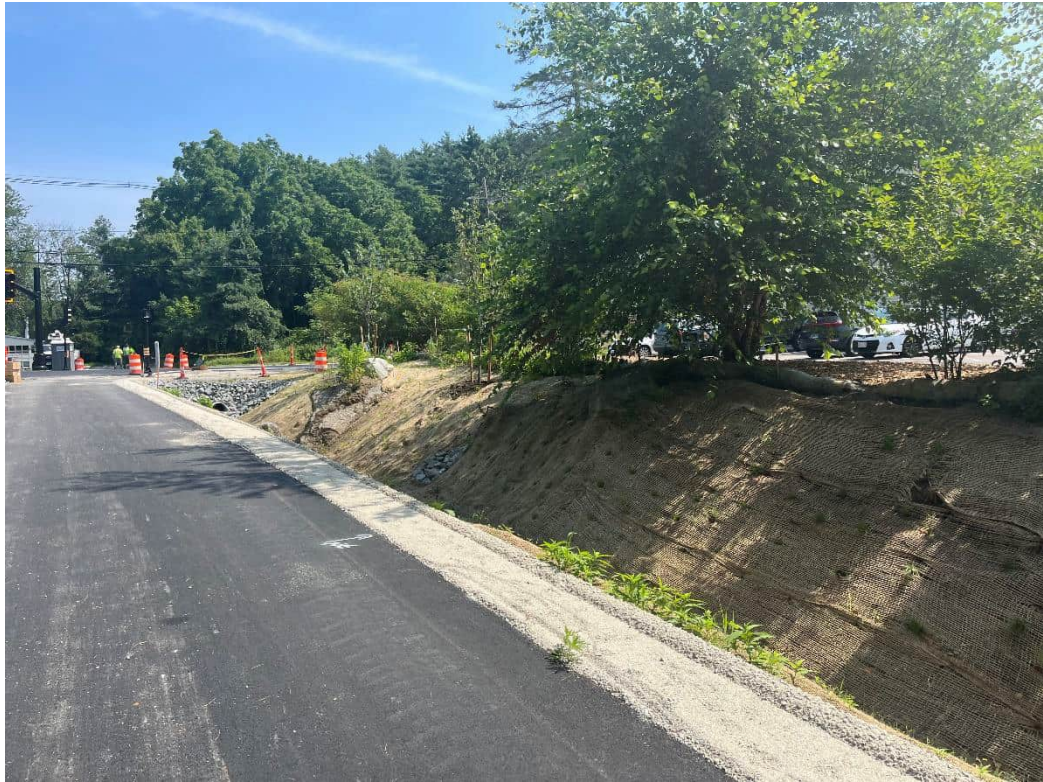
Photo No. 3 **Date:**
7/22/2024

View of the slopes near Station 173+00 per Compliance Action Item 6.

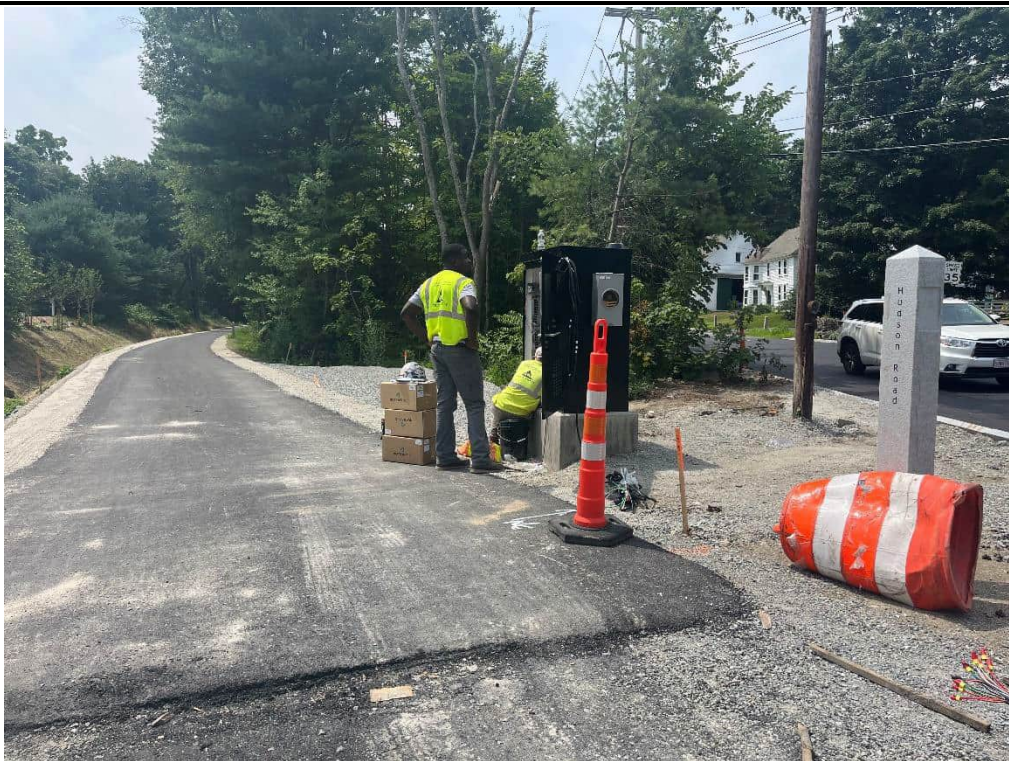
Photo No. 4 **Date:**
7/22/2024

View of ongoing utility work at the Husdon Road intersection.

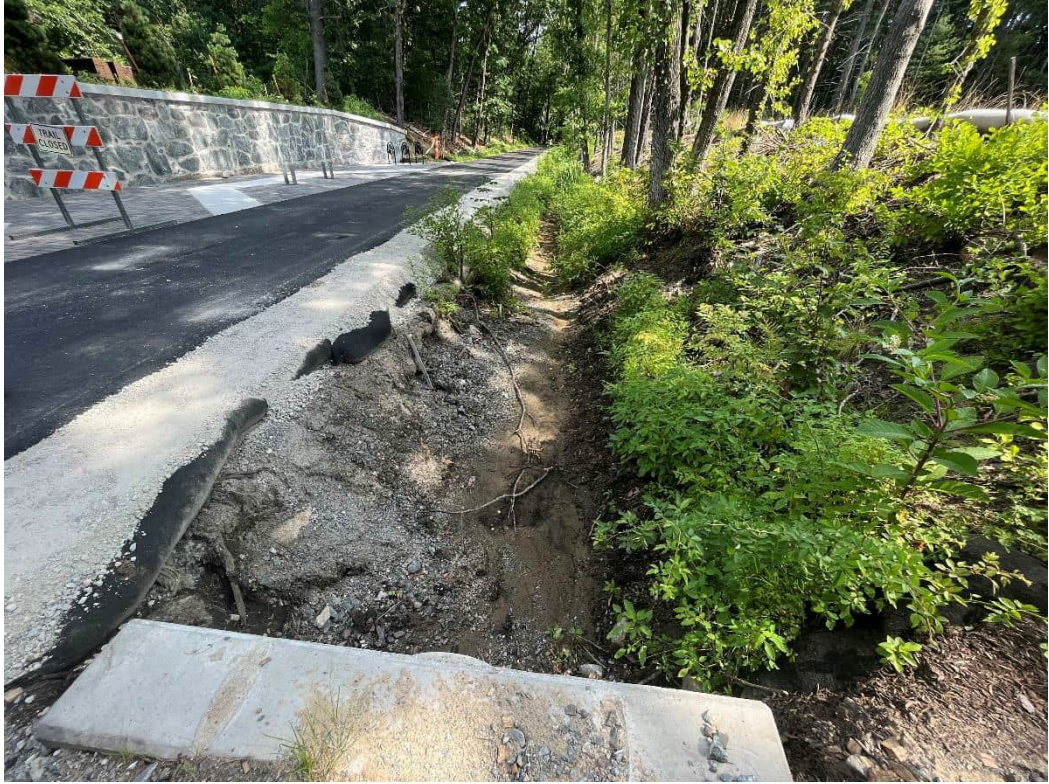
Photo No. 7 **Date:**
7/22/2024

If yes, please describe:			Sediment was observed within the streambed east of the path between Stations 215+00 and Station 217+00.

41	Stream Bank has been regraded beyond the limit of work at Station 216+00 Priority: High	5/28/2024	6/4/2024	The Contractor should confirm if this work was permitted by the Conservation Commission, as it does not appear to be a part of the approved plans/impacts. MassDOT should be consulted on next steps regarding notification and potential restoration.	<p>5/31/2024 - Observation remains.</p> <p>6/7/2024 - Observation remains.</p> <p>6/14/2024 - Observation remains.</p> <p>6/17/2024 - Observation remains.</p> <p>6/24/2024 - Observation remains.</p> <p>6/27/2024 - Observation remains.</p> <p>7/8/2024 - Observation remains.</p> <p>7/15/2024 - This area could not be assessed due to paving operations ongoing during the inspection.</p> <p>7/22/2024 - Crushed stone and sediment continue to be discharged to the stream between Stations 215+00 and 217+00 due to overtopped and undermined compost filter tubes.</p>

View of where crushed stone was observed as overtopping the compost filter tubes and entering the streambed at Station 216+50 to 217 per Compliance Action Item 41.

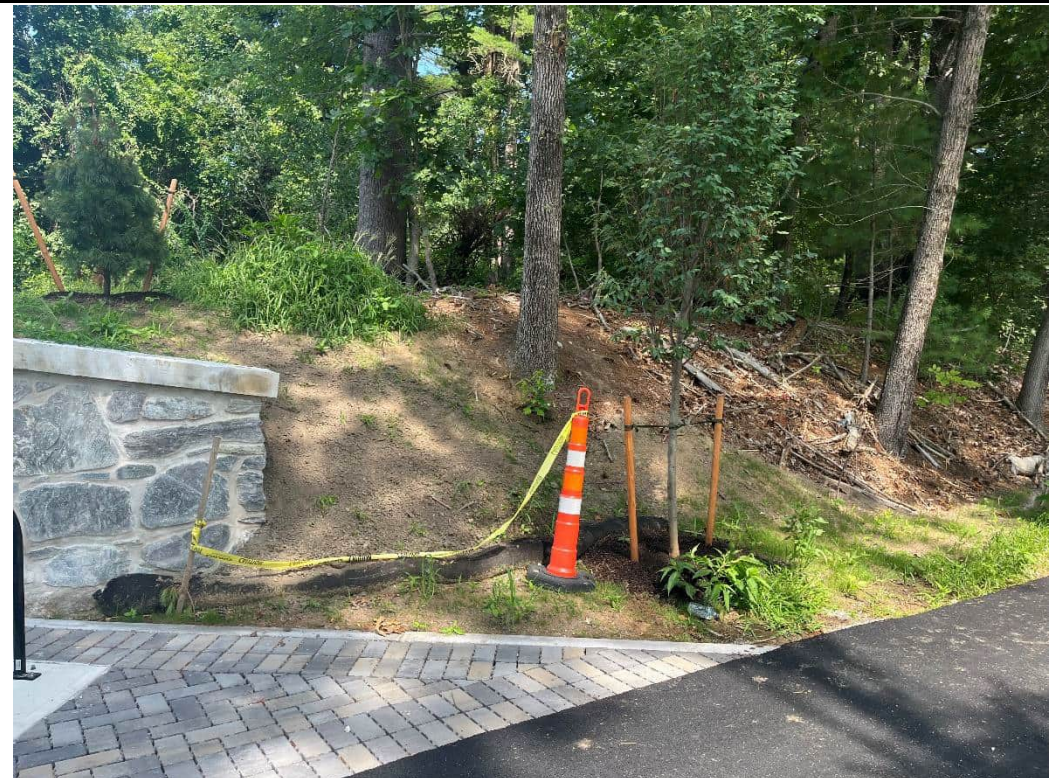
Photo No. 8 **Date:**
7/22/2024

View of an area requiring additional seed along the masonry wall at Station 217+45 per Compliance Action Item 34.

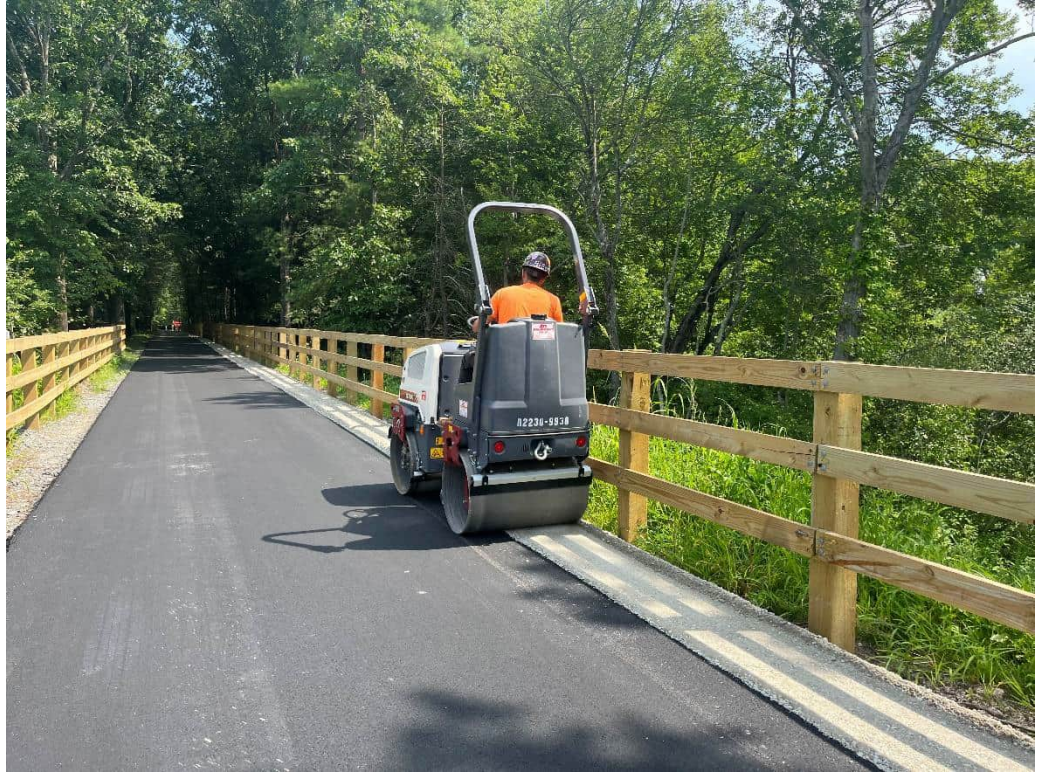
Photo No. 9 **Date:**
7/22/2024

View of active compaction of the crushed stone on the sides of the path.

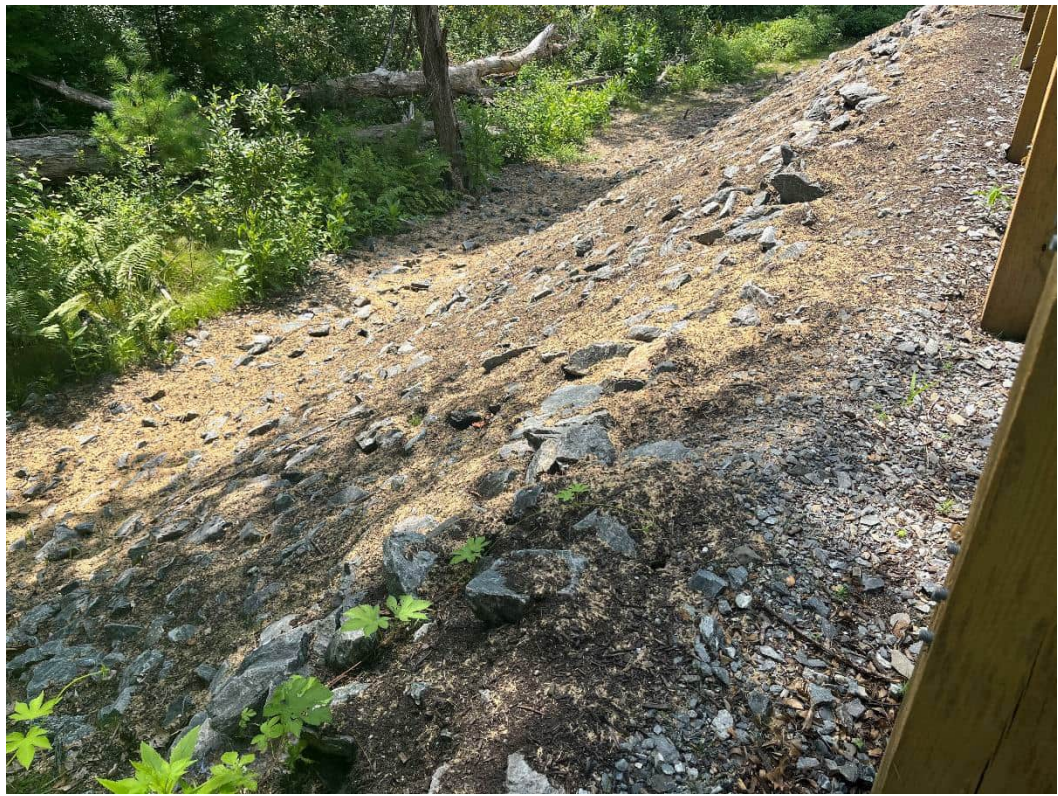
Photo No. 10 **Date:**
7/22/2024

View of hydroseed that was applied on a slope at Station 282+00.
