**Environmental Monitor Construction Site Inspection Report  
MassDOT Project #608164 Construction Contract # 119678  
EM Report #14**

Project Description: Bruce Freeman Rail Trail Right-of-Way  
Permit Description(s): Order of Conditions (MGL Chapter 131, Section 40 and 310 CMR 10.00, Mass DEP File No. 301-1362); 2022 EPA NPDES General Permit for Discharges from Construction Areas; U.S. Army Corps of Engineers Permit No. NAE-2021-01975.

Project Name:	Bruce Freeman Rail Trail - Phase 2d - Sudbury
Date of Inspections:	7/29/2024
Bi Weekly/ Monthly Period Covered:	July Weekly Inspection #4
Inspector's Name(s):	Anna Haznar
Inspectors' Contact Information:	<a href="mailto:ahaznar@beta-inc.com">ahaznar@beta-inc.com</a>

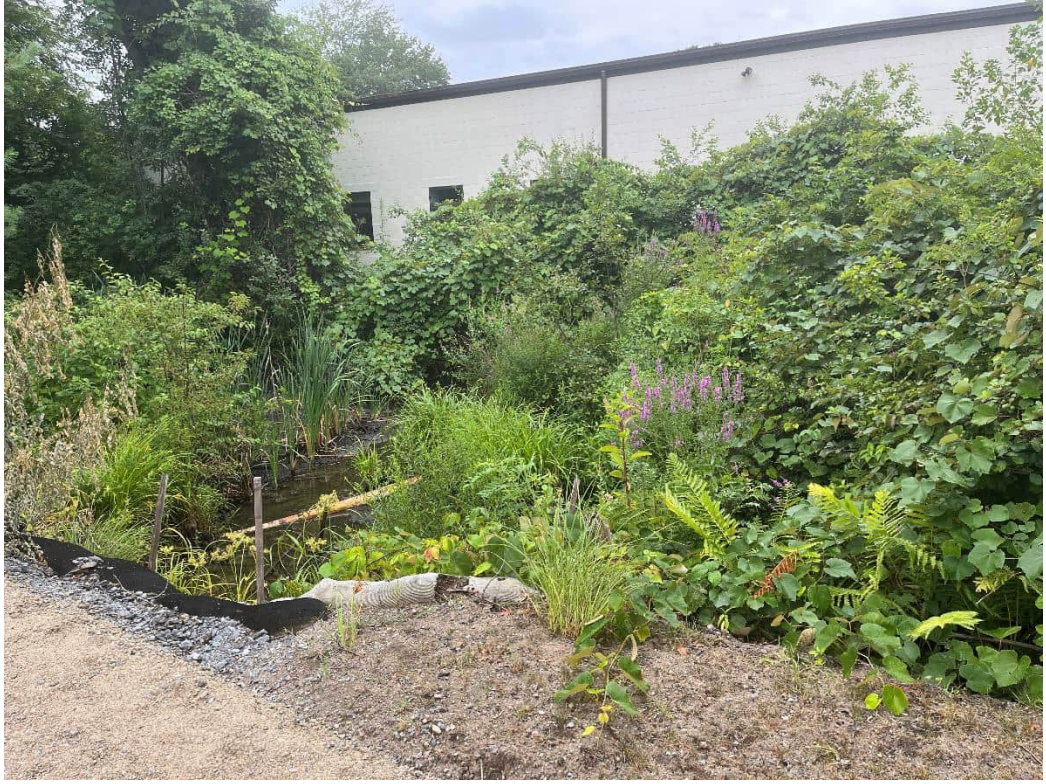
**Photo No. 1**     **Date:**  
7/29/2024

44	Slopes require stabilization / additional seed due to lack of compost filter tubes at 105+00 and 106+00 <b>Priority: High</b>	6/7/2024	6/14/2024	Stabilize the slope with the approved seed mixture and provide interim stabilization such as straw mulch.	6/14/2024 - Observation remains. 6/17/2024 - Observation remains. 6/24/2024 - Observation remains. 6/27/2024 - Observation remains. 7/8/2024 - Observation remains. 7/15/2024 - Observation remains. 7/22/2024 - Observation remains. 7/29/2024 - Regrowth of vegetation has been observed in this area. This item will remain open until the area is fully stabilized.
45	Erosion observed along east side of trail at Station 225+50 <b>Priority: Medium</b>	6/7/2024	6/14/2024	Stabilize the slope with the approved seed mixture and provide interim stabilization such as straw mulch.	6/14/2024 - Observation remains. 6/17/2024 - Observation remains. 6/24/2024 - Observation remains. 6/27/2024 - Vegetation has become established; however, migrated material requires removal. 7/8/2024 - Observation remains. 7/15/2024 - Observation remains. 7/22/2024 - Observation remains. 7/29/2024 - Observation remains.

Typical view of slopes requiring stabilization and removal of gravel/sediment accumulation along compost filter tubes at Station 105+00 to 106+00 per Compliance Action Items 43 and 44.

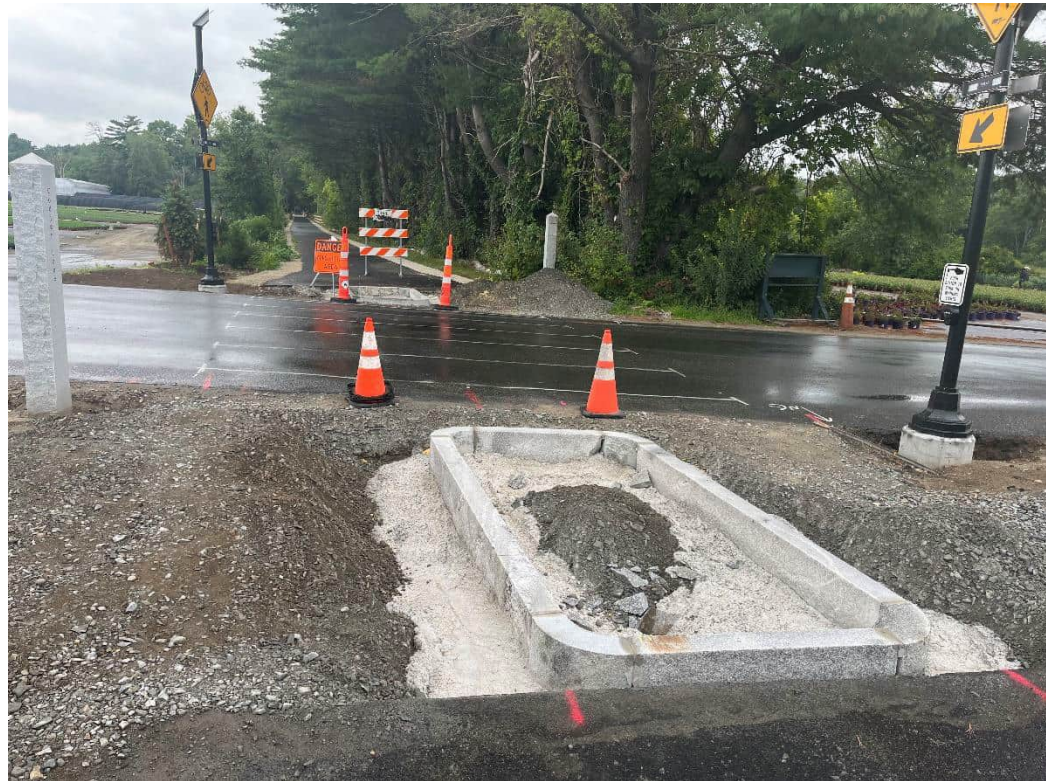
**Photo No. 2**     **Date:**  
7/29/2024

Typical view of a concrete splitter island that has been installed at every intersection along the path.

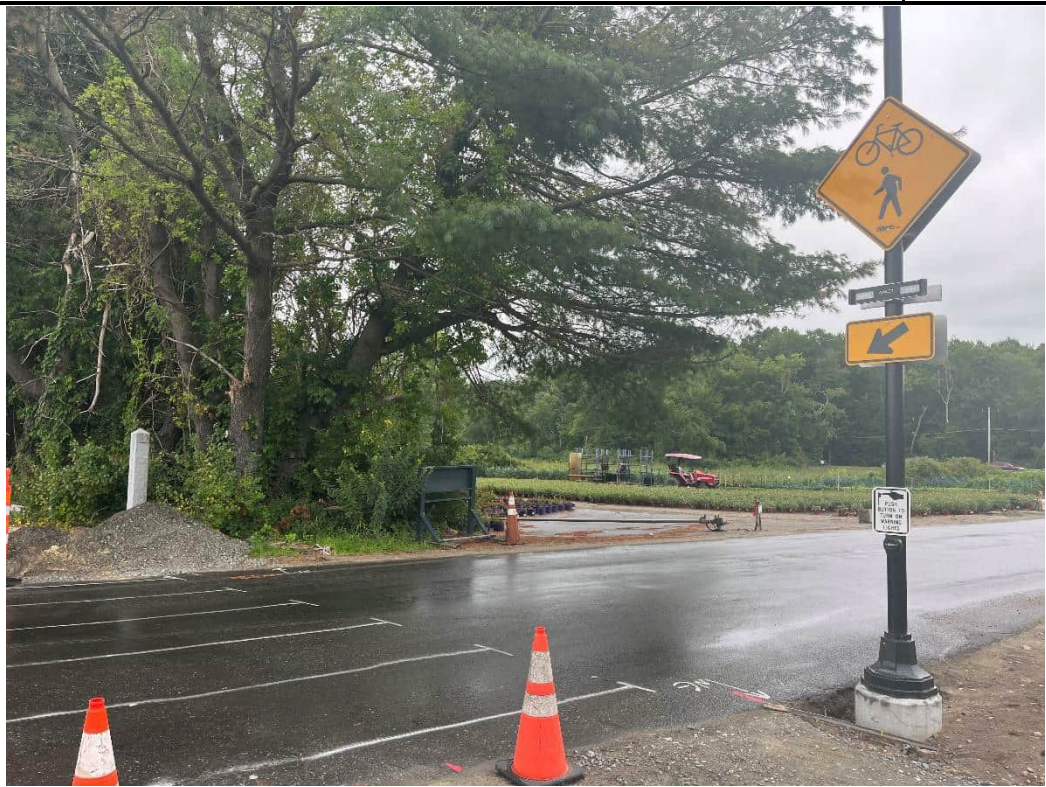
**Photo No. 3**    **Date:** 7/29/2024

Typical view of the rapid flashing beacon that has been installed at every intersection along the path.

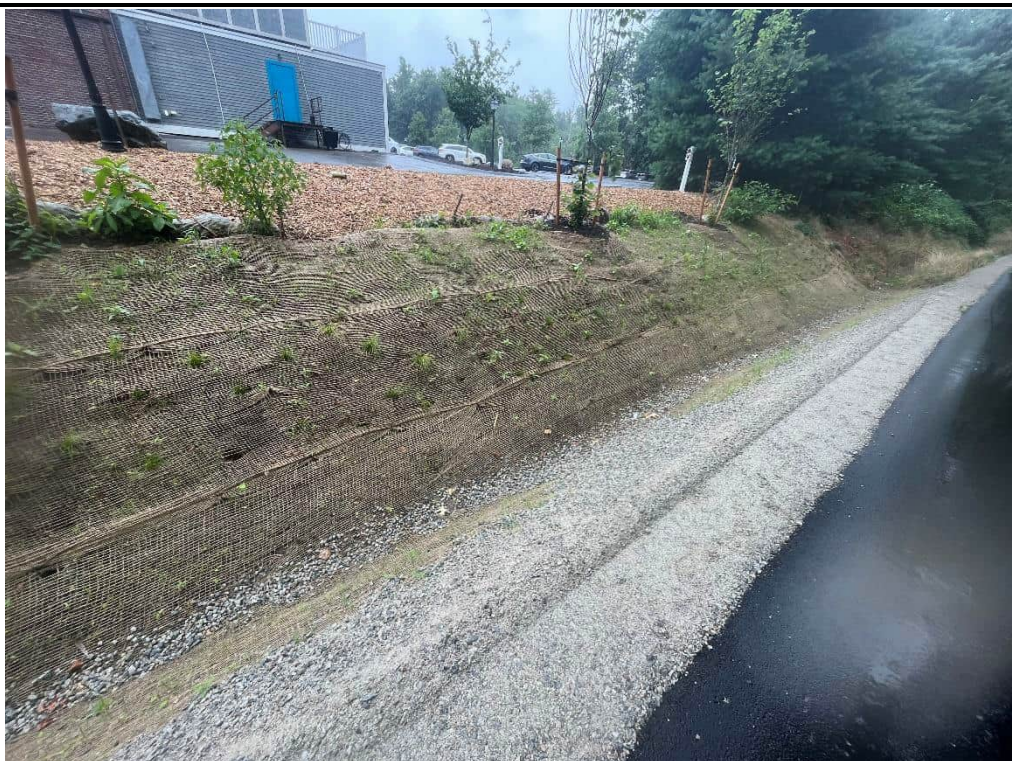
**Photo No. 4**    **Date:** 7/29/2024

Item	Location/ Description	Observation Date	Resolution Due Date	Recommended Resolution / Resolution Date	Comments/Updates
53	Stone was observed requiring removal from the swale on the east side of the trail at Station 172+00 to 173+00 Priority: High	7/29/2024	8/6/2024	Remove stone from the swale.	
52	Slope along the driveway to the parking lot at Station 216+50 requires stabilization Priority: Medium	7/29/2024	8/6/2024	Install erosion control blanket and place seed.	
51	Stone dust requiring sweeping was observed within and to the east of the trail at Station 297+00 to 298+00 Priority: High	7/29/2024	8/6/2024	Sweep stone dust from trail and sides of trail.	
50	Catch basin requiring inlet protection at the Hudson Road intersection Priority: Medium	7/15/2024	7/22/2024	Install inlet protection within the catch basin.	7/22/2024 - Observation remains. 7/29/2024 - Observation remains.
43	Overtopped compost filter tubes and exposed soils beyond the limits of work at Station 105+00 Priority: High	6/7/2024	6/14/2024	Stabilize the area with the approved seed mixture and provide interim stabilization such as straw mulch.	6/14/2024 - Observation remains. 6/17/2024 - Observation remains. 6/24/2024 - Observation remains. 6/27/2024 - Observation remains. 7/8/2024 - Observation remains. 7/15/2024 - Observation remains. 7/22/2024 - Observation remains. 7/29/2024 - Observation remains.

View of stone requiring removal from the swale at Station 172+00 to 173+00 per Compliance Action Item 53.

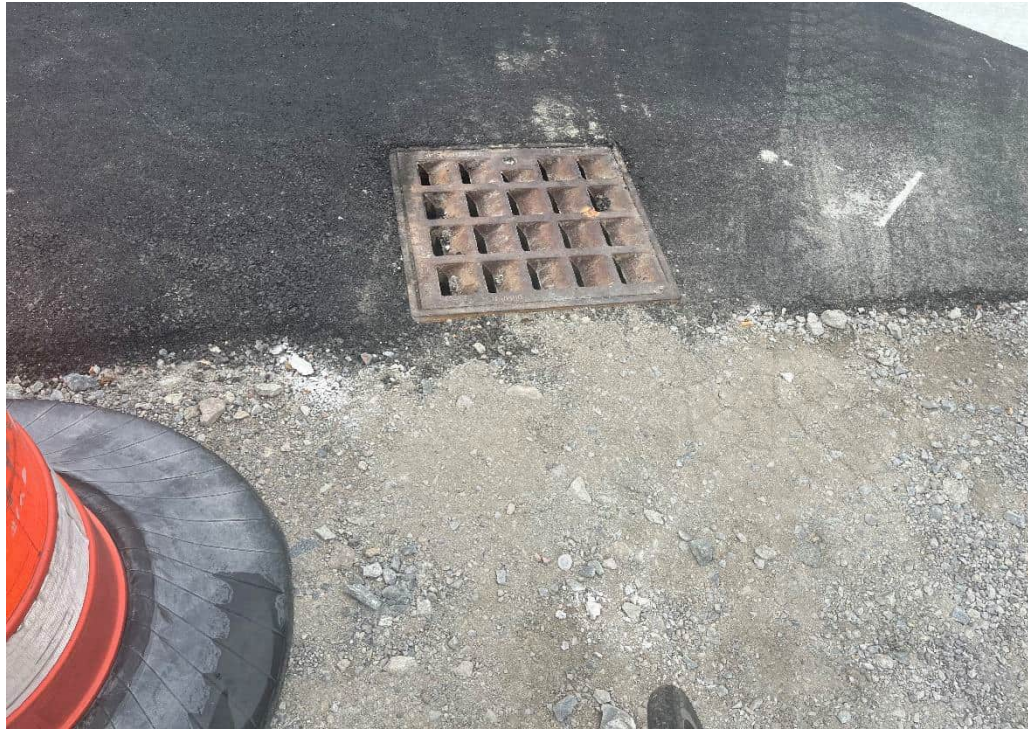
**Photo No. 5**    **Date:**  
7/29/2024

Inlet Protection Measures	Yes	Catch basins in the vicinity of active work at the Hudson Road intersection require the installation of inlet protection.
Stabilized Construction Entrances	No	
Stockpile Protections	No	
Dust Control	No	
Street Sweeping	No	Sweeping of stone dust is required on the path at Station 297+00 to 298+00.
Dewatering Controls	No	
Construction Equipment and Material Storage	No	
Construction and Domestic Waste Storage and Collection	No	
Location of Sanitary Waste Facilities	No	
Washout Areas	No	
Fertilizers, Herbicides, and Landscape Material	N/A	
Stabilization of Exposed Soil	Yes	Varying degrees of stabilization are present within areas that were constructed/graded as part of the Project. Stabilization efforts are required at Station 105+00 to 106+00, Stations 172+00 to 175+00, Station 217+45, Station 225+50, Station 265+50 to 273+00, Stations 313+00 to 316+00 and along the driveway to the parking lot near Station 216+50. Stabilization has commenced via application of hydroseed at the majority of these locations and should be monitored for successful establishment.

View of a catch basin requiring inlet protection at the Hudson Road intersection per Compliance Action Item 50.

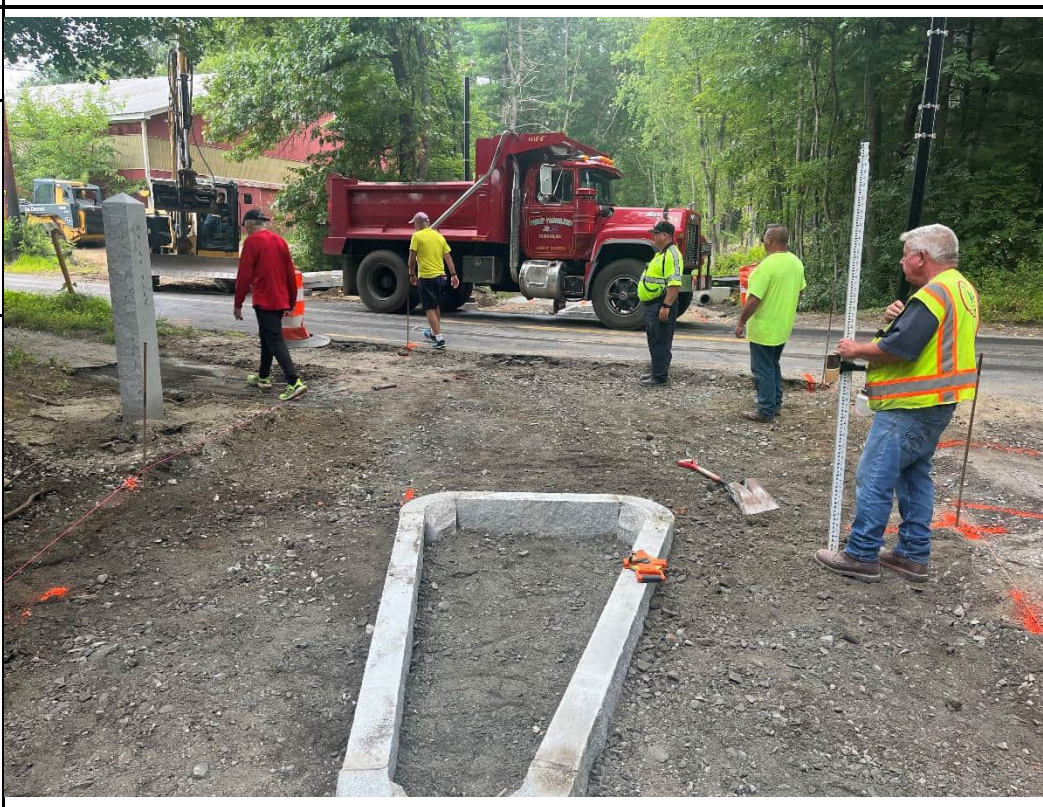
**Photo No. 6**    **Date:**  
7/29/2024

View of the grading work being performed at the Morse Street intersection.

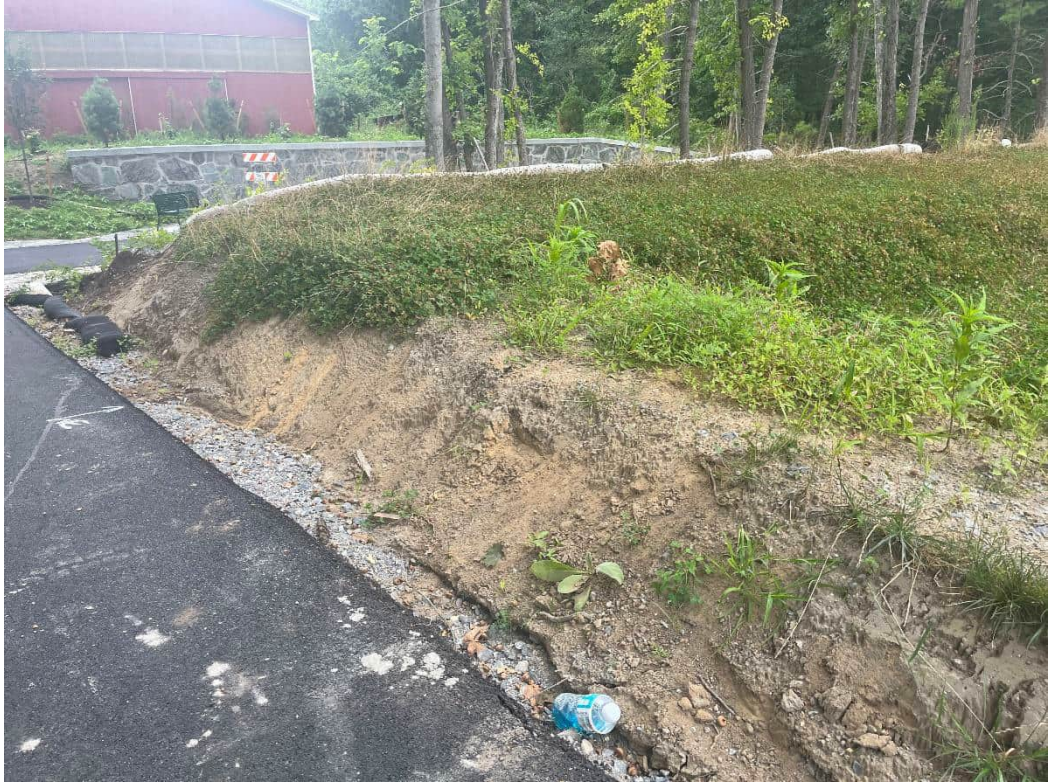
**Photo No. 7**    **Date:**  
7/29/2024

View of a slope requiring stabilization along the driveway to the parking lot near Station 216+50 per Compliance Action Item 52.

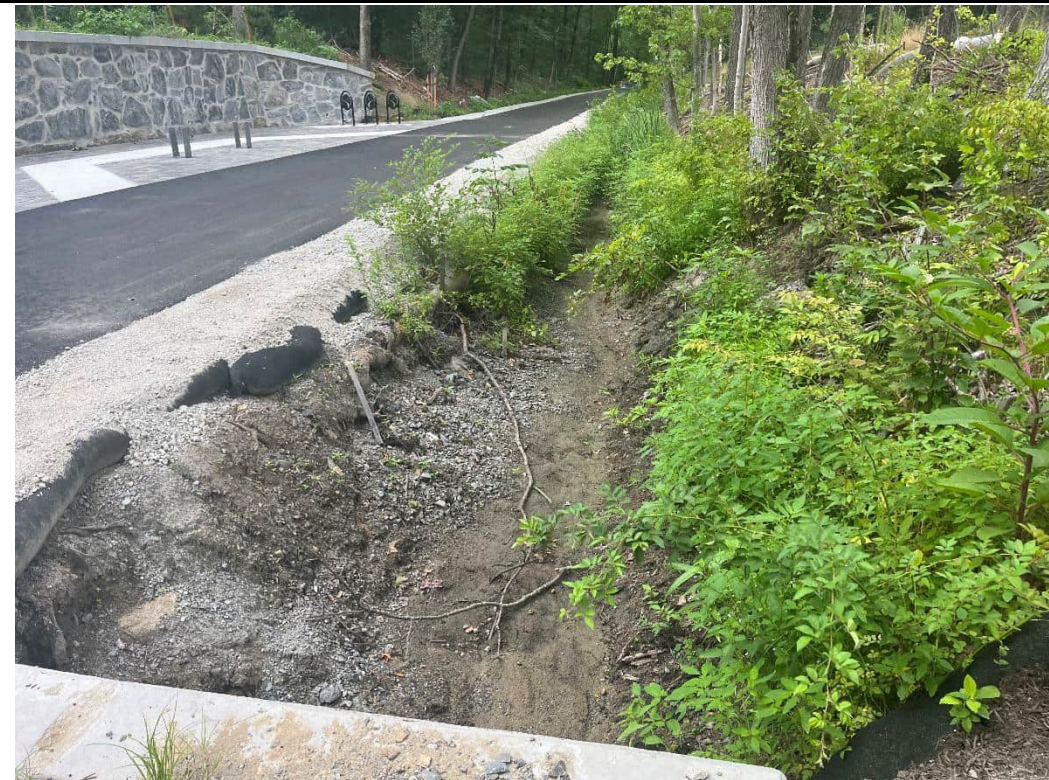
**Photo No. 8**    **Date:**  
7/29/2024

41	Stream Bank has been regraded beyond the limit of work at Station 216+00 <b>Priority: High</b>	5/28/2024	6/4/2024	The Contractor should confirm if this work was permitted by the Conservation Commission, as it does not appear to be a part of the approved plans/impacts. MassDOT should be consulted on next steps regarding notification and potential restoration.	5/31/2024 - Observation remains. 6/7/2024 - Observation remains. 6/14/2024 - Observation remains. 6/17/2024 - Observation remains. 6/24/2024 - Observation remains. 6/27/2024 - Observation remains. 7/8/2024 - Observation remains. 7/15/2024 - This area could not be assessed due to paving operations ongoing during the inspection. 7/22/2024 - Crushed stone and sediment continue to be discharged to the stream between Stations 215+00 and 217+00 due to overtopped and undermined compost filter tubes. 7/29/2024 - Observation remains.
VI. Agency Submittals (Note: only filled out for monthly report)

View of where crushed stone was observed as overtopping the compost filter tubes and entering the streambed at Station 216+50 to 217 per Compliance Action Item 41.
