**Environmental Monitor Construction Site Inspection Report  
MassDOT Project #608164 Construction Contract # 119678  
EM Report #15**

Project Description: Bruce Freeman Rail Trail Right-of-Way  
Permit Description(s): Order of Conditions (MGL Chapter 131, Section 40 and 310 CMR 10.00, Mass DEP File No. 301-1362); 2022 EPA NPDES General Permit for Discharges from Construction Areas; U.S. Army Corps of Engineers Permit No NAE-2021-01975

Project Name:	Bruce Freeman Rail Trail - Phase 2d - Sudbury
Date of Inspections:	8/5/2024
Bi Weekly/ Monthly Period Covered:	August Weekly Inspection #1
Inspector's Name(s):	Anna Haznar
Inspectors' Contact Information:	<a href="mailto:ahaznar@beta-inc.com">ahaznar@beta-inc.com</a>

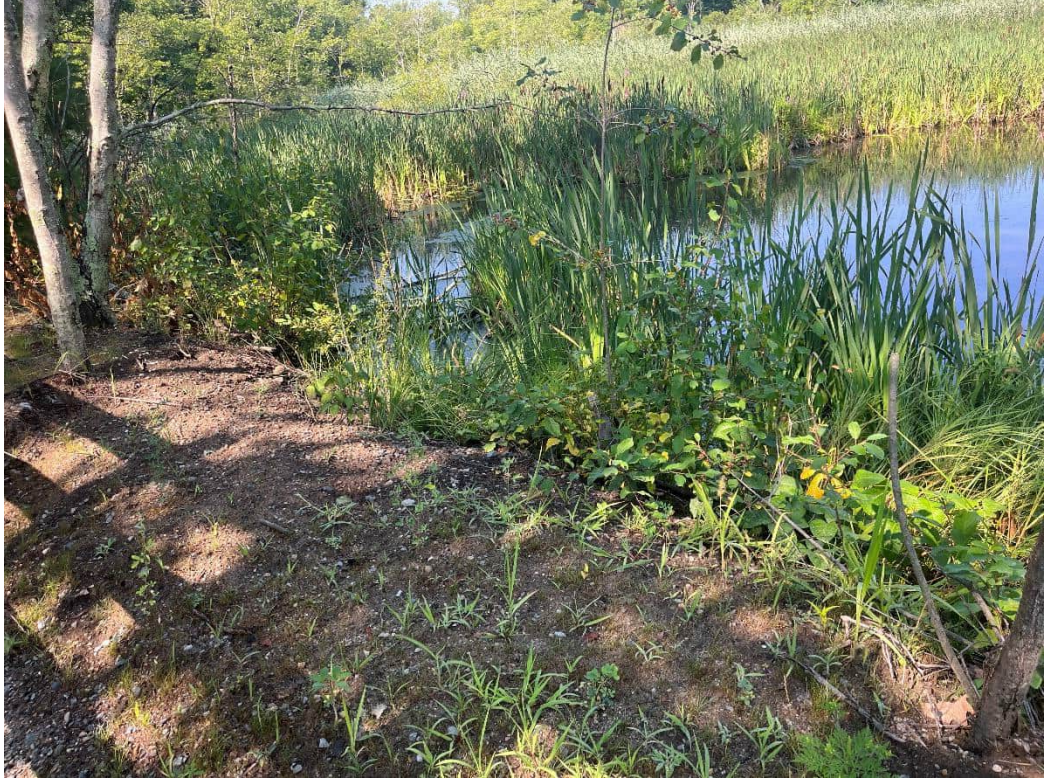
**Photo No. 1**    **Date:**  
8/5/2024

44	Slopes require stabilization / additional seed due to lack of compost filter tubes at 105+00 and 106+00 <b>Priority: High</b>	6/7/2024	6/14/2024	Stabilize the slope with the approved seed mixture and provide interim stabilization such as straw mulch.	6/14/2024 - Observation remains. 6/17/2024 - Observation remains. 6/24/2024 - Observation remains. 6/27/2024 - Observation remains. 7/8/2024 - Observation remains. 7/15/2024 - Observation remains. 7/22/2024 - Observation remains. 7/29/2024 - Regrowth of vegetation has been observed in this area. This item will remain open until the area is fully stabilized. 8/5/2024 - Observation remains.

Typical view of slopes requiring stabilization and removal of gravel/sediment accumulation along compost filter tubes at Station 105+00 to 106+00 per Compliance Action Items 43 and 44.

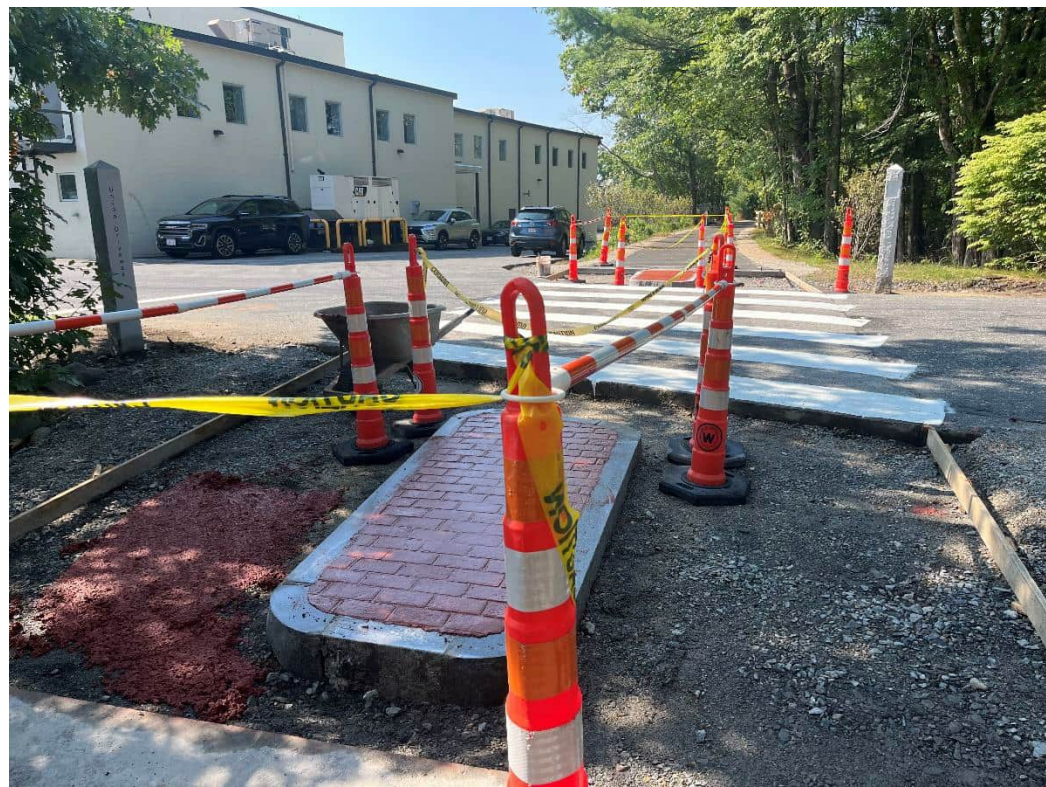
**Photo No. 2**    **Date:**  
8/5/2024

Typical view of a stamped concrete splitter island that has been installed at every intersection along the path.

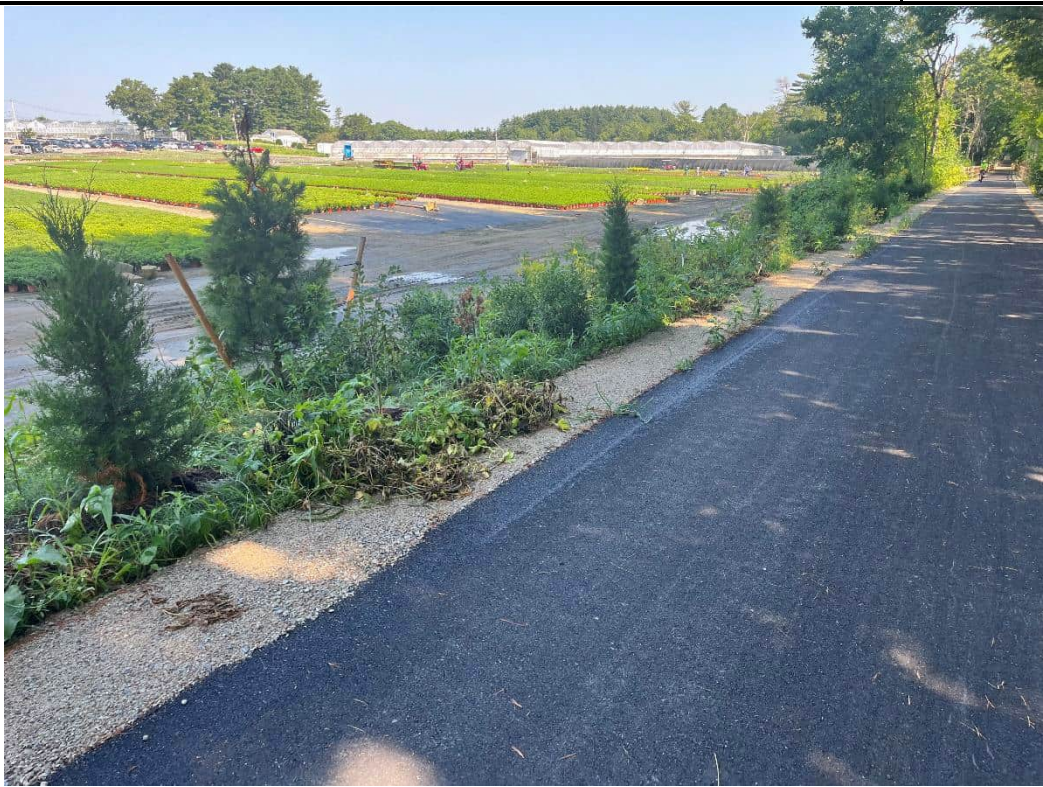
**Photo No. 3**     **Date:**  
8/5/2024

View of an area where Japanese hops (*Humulus japonicus*) have been hand pulled away from plantings at Station 117 per Compliance Action item 67.

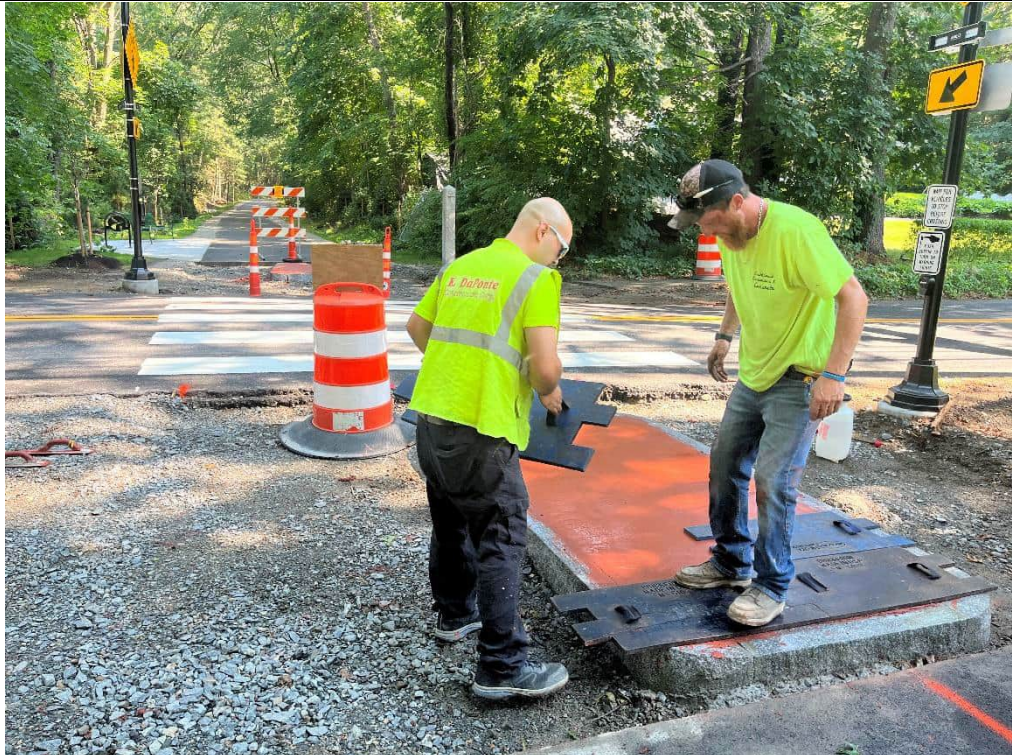
**Photo No. 4**     **Date:**  
8/5/2024

View of the crew “stamping” the concrete splitter islands.

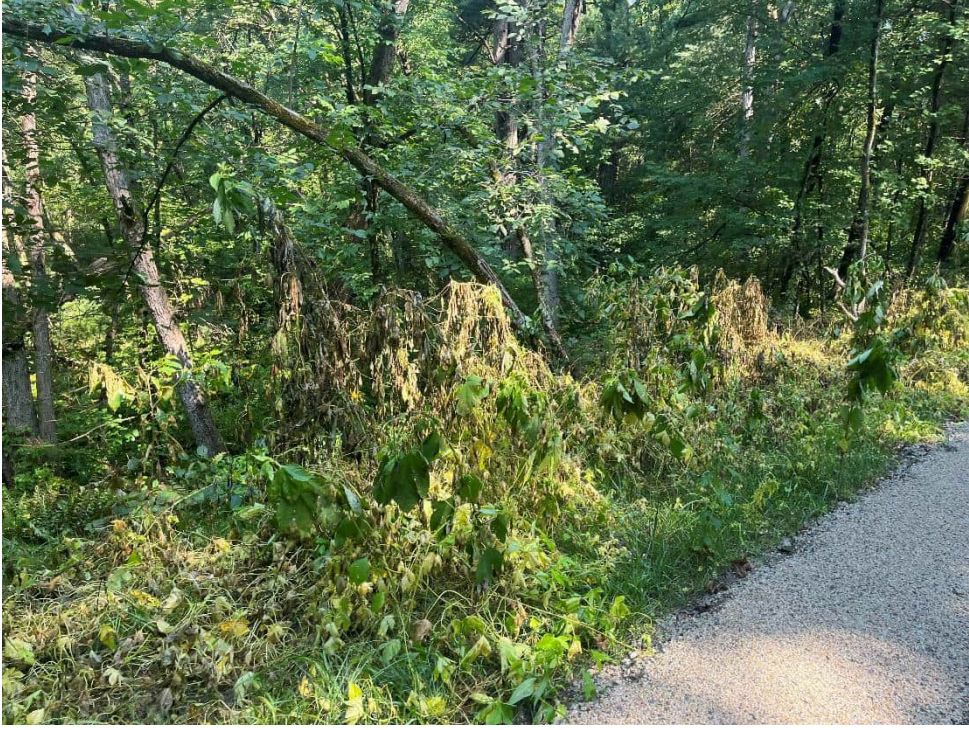
<b>Site Location</b> Bruce Freeman Rail Trail Right-of-Way		<b>BETA Project No.</b> 24.10326.23
<b>Photo No. 5</b>	<b>Date:</b> 8/5/2024

<b>Direction Photo Taken:</b>  Toward the Northeast		
<b>Description:</b>  Typical view of a location where Japanese hops and invasive species have been treated with herbicide at Station 145+50 per Compliance Action item 67.		
<b>Photo No. 6</b>	<b>Date:</b> 8/5/2024

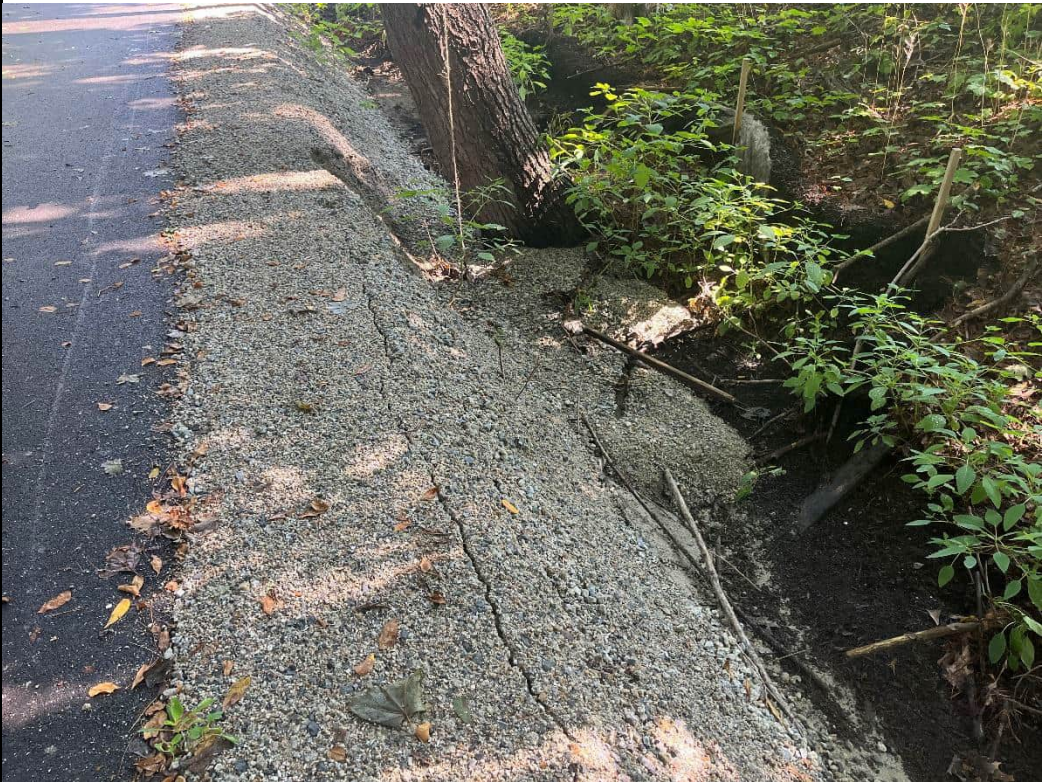
Item	Location/ Description	Observation Date	Resolution Due Date	Recommended Resolution / Resolution Date	Comments/Updates
56	Crushed stone discharged to the stream at Station 170+00 Priority: High	8/5/2024	8/12/2024	Remove crushed stone from streambed and provide more robust erosion and sediment controls	
55	Crushed stone dust was observed requiring removal from the streambed on the west side of the path at Station 215+00 to 217+50 Priority: High	8/5/2024	8/12/2024	Remove crushed stone from streambed and provide more robust erosion controls	
54	Runoff/debris associated with the stamped concrete splitter island was observed to be requiring removal from the streambed on the west side of the path at Station 216+00 Priority: High	8/5/2024	8/12/2024	Remove debris from streambed and provide more robust erosion controls	
53	Stone was observed requiring removal from the swale on the east side of the trail at Station 172+00 to 173+00 Priority: High	7/29/2024	8/6/2024	Remove stone from the swale.	8/5/2024 - Observation remains.

<b>Direction Photo Taken:</b>  Toward the North		
<b>Description:</b>  View of crushed stone that requires removal from the streambed at Station 170+00 per Compliance Action Item 56.

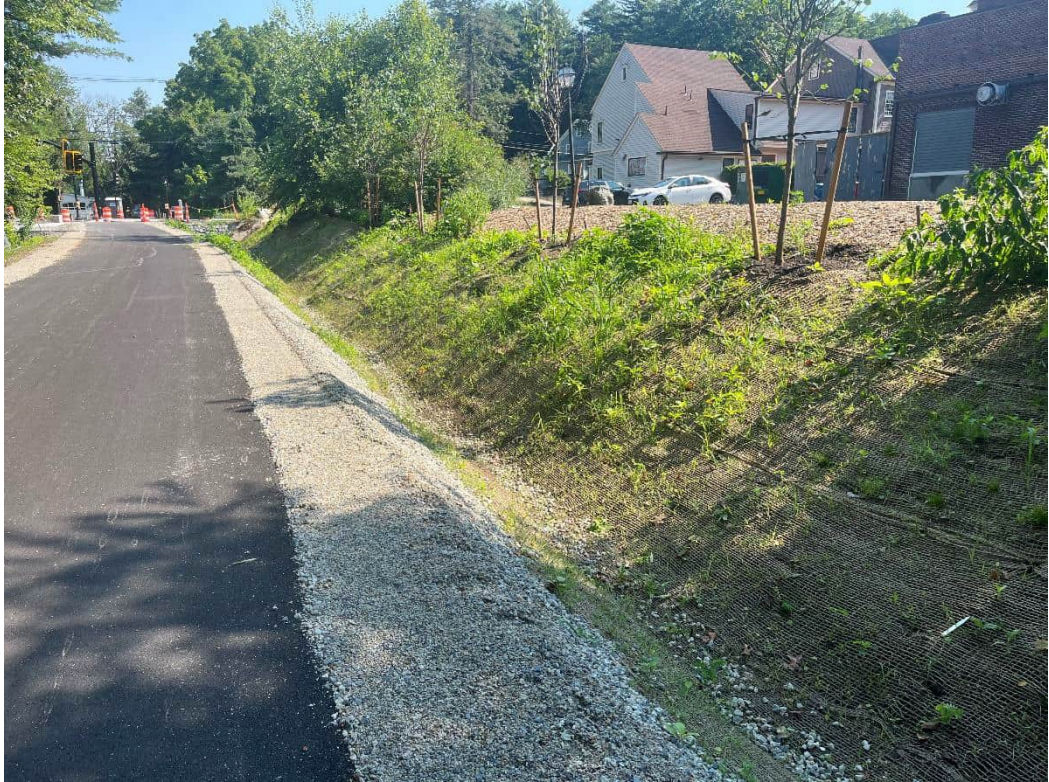
**Photo No. 7**    **Date:** 8/5/2024

View of stone requiring removal from the swale at Station 172+00 to 173+00 per Compliance Action Item 53.

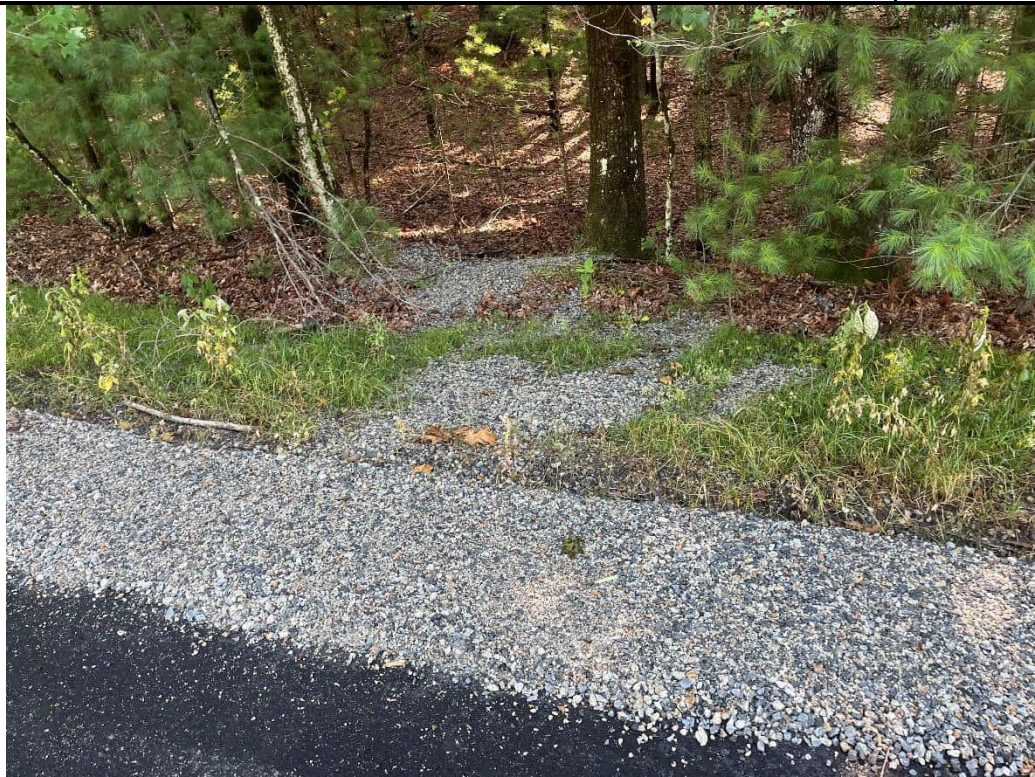
**Photo No. 9**     **Date:**  
8/5/2024

Typical view of a location where crushed stone has migrated from where it was placed but is still within the limit of work. This photo was taken at Station 178+00; however, this condition was observed in multiple areas across the Project.

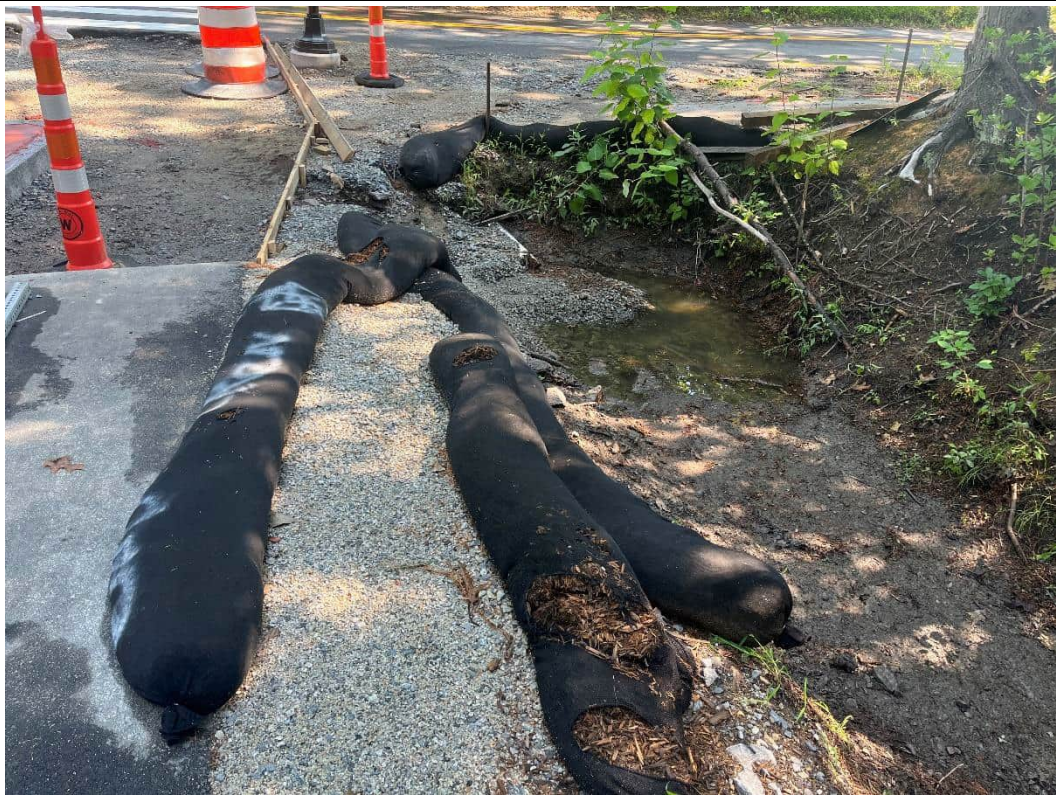
**Photo No. 10**     **Date:**  
8/5/2024

View of a location where crushed stone requires removal from the streambed at Station 215+50 per Compliance Action Item 55.

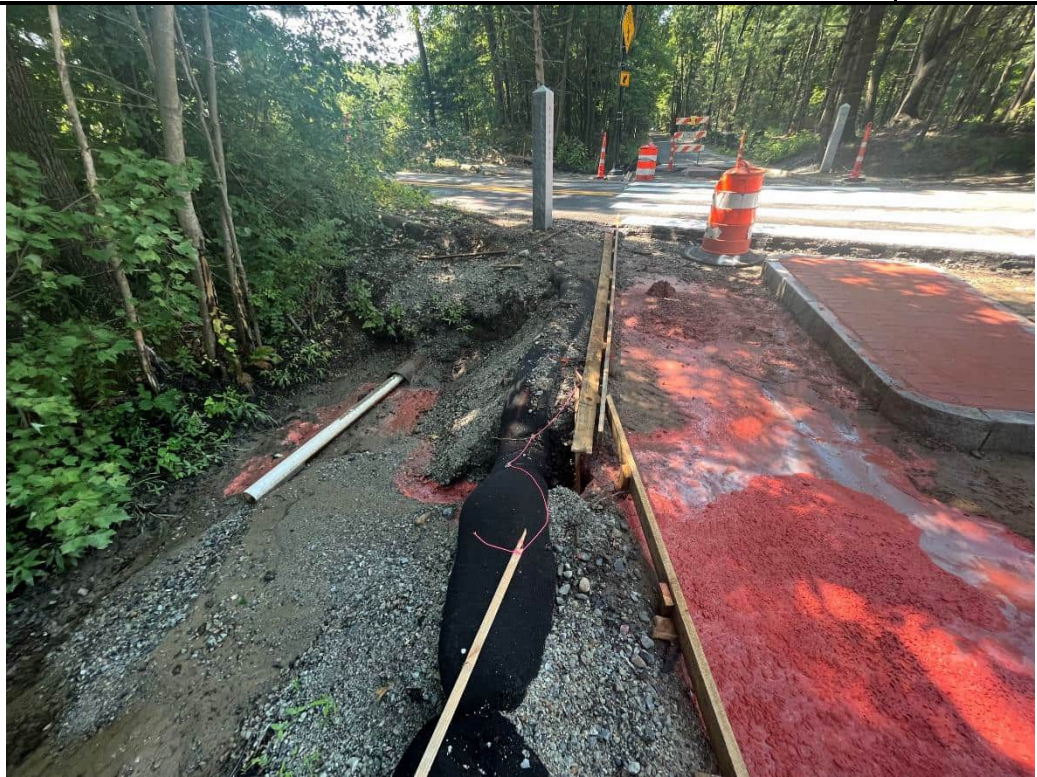
**Photo No. 11**    **Date:**  
8/5/2024

View of the location where runoff from the stamped concrete splitter island requires removal from the streambed at Station 216+00 per Compliance Action Item 54.

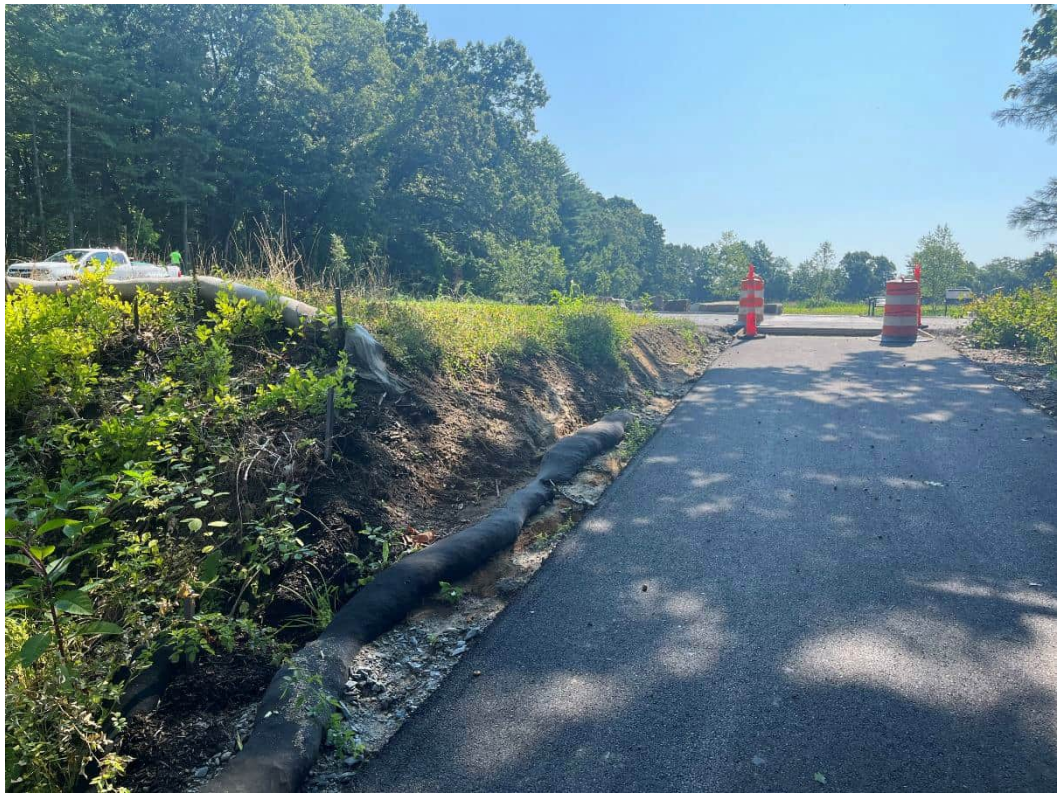
**Photo No. 12**    **Date:**  
8/5/2024

52	Slope along the driveway to the parking lot at Station 216+50 requires stabilization Priority: Medium	7/29/2024	8/6/2024	Install erosion control blanket and place seed.	8/5/2024 - Observation remains.

View of a slope requiring stabilization along the driveway to the parking lot near Station 216+50 per Compliance Action Item 52.

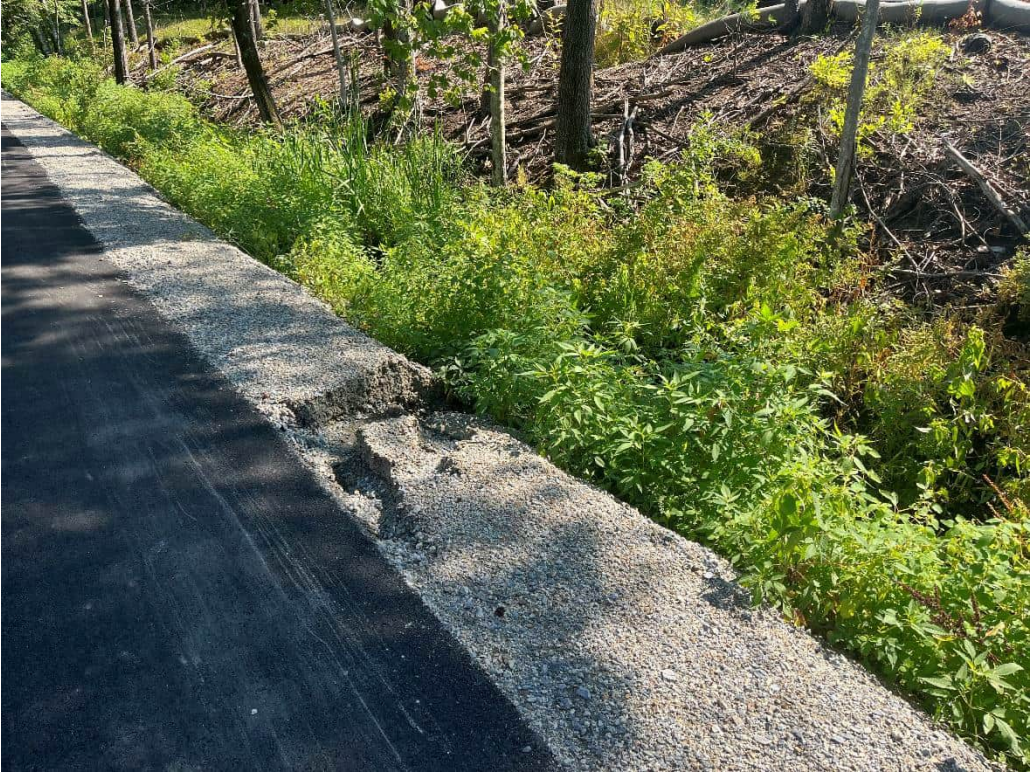
<b>Site Location</b> Bruce Freeman Rail Trail Right-of-Way		<b>BETA Project No.</b> 24.10326.23
<b>Photo No. 13</b>	<b>Date:</b> 8/5/2024

<b>Direction Photo Taken:</b>  Toward the West		
<b>Description:</b>  View of the location where crushed stone required removal from the streambed at Station 217+50 per Compliance Action Item 55.		
<b>Photo No. 14</b>	<b>Date:</b> 8/5/2024

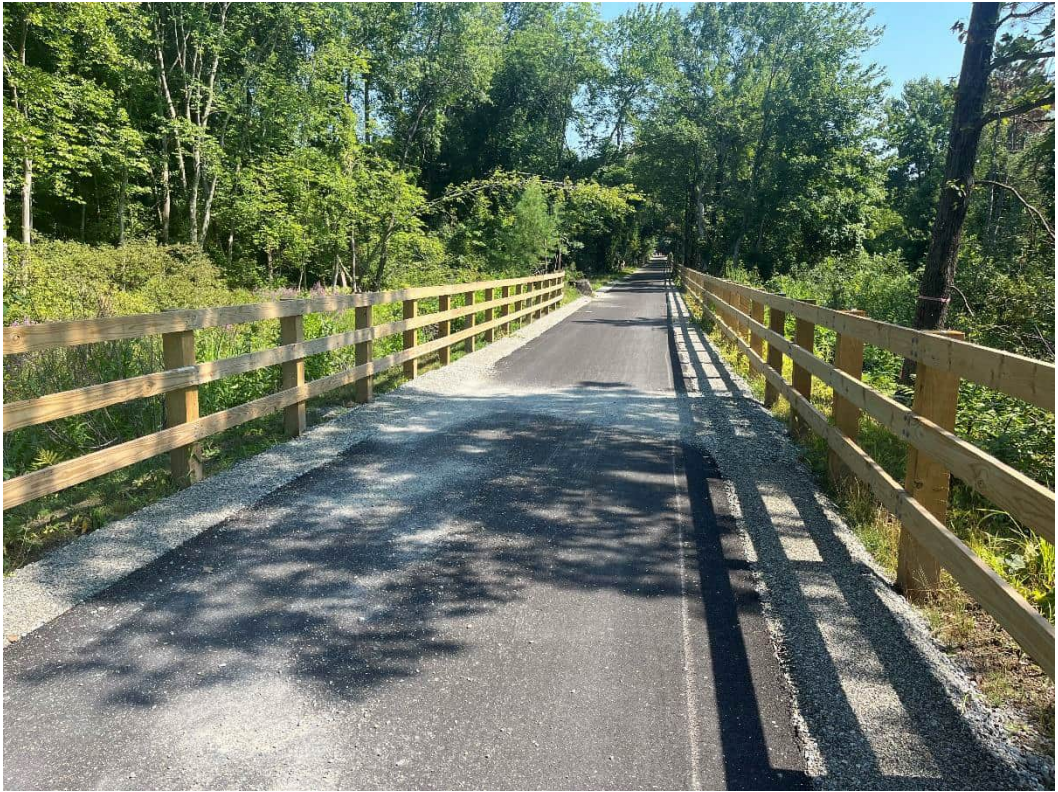
51	Stone dust requiring sweeping was observed within and to the east of the trail at Station 297+00 to 298+00 and 308+00. <b>Priority: High</b>	7/29/2024	8/6/2024	Sweep stone dust from trail and sides of trail.	8/5/2024 - Observation remains.
50	Catch basin requiring inlet protection at the Hudson Road intersection <b>Priority: Medium</b>	7/15/2024	7/22/2024	Install inlet protection within the catch basin.	7/22/2024 - Observation remains. 7/29/2024 - Observation remains. 8/5/2024 - Observation remains.
43	Overtopped compost filter tubes and exposed soils beyond the limits of work at Station 105+00 <b>Priority: High</b>	6/7/2024	6/14/2024	Stabilize the area with the approved seed mixture and provide interim stabilization such as straw mulch.	6/14/2024 - Observation remains. 6/17/2024 - Observation remains. 6/24/2024 - Observation remains. 6/27/2024 - Observation remains. 7/8/2024 - Observation remains. 7/15/2024 - Observation remains. 7/22/2024 - Observation remains. 7/29/2024 - Observation remains. 8/5/2024 - Observation remains.

<b>Direction Photo Taken:</b>  Toward the North		
<b>Description:</b>  Typical view of a location where crushed stone is required to be swept from the path at Station 308+00 per Compliance Action Item 51. This condition has been observed in multiple areas along the Project.
