**Environmental Monitor Construction Site Inspection Report  
MassDOT Project #608164 Construction Contract # 119678  
EM Report #16**

Project Description: Bruce Freeman Rail Trail Right-of-Way  
Permit Description(s): Order of Conditions (MGL Chapter 131, Section 40 and 310 CMR 10.00, Mass DEP File No. 301-1362); 2022 EPA NPDES General Permit for Discharges from Construction Areas; U.S. Army Corps of Engineers Permit No NAE-2021-01975.

Project Name:	Bruce Freeman Rail Trail - Phase 2d - Sudbury
Date of Inspections:	8/7/2024
Bi Weekly/ Monthly Period Covered:	August Weekly Inspection #2
Inspector's Name(s):	Anna Haznar
Inspectors' Contact Information:	<a href="mailto:ahaznar@beta-inc.com">ahaznar@beta-inc.com</a>

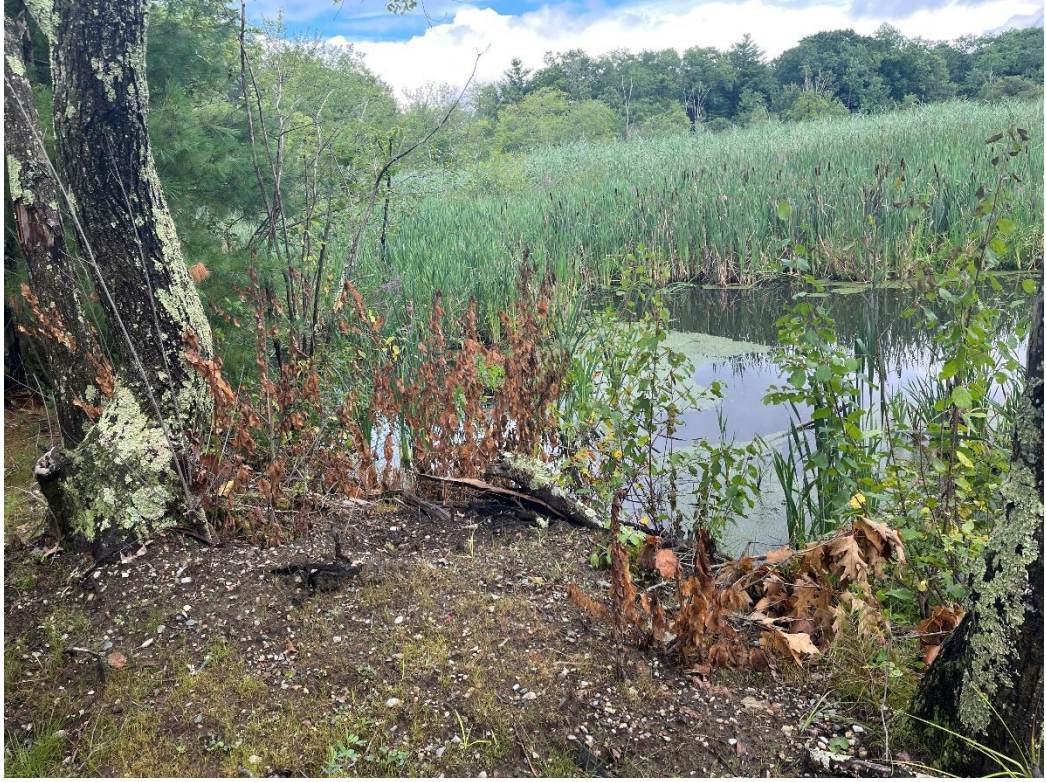
**Photo No. 1**     **Date:**  
8/7/2024

44	Slopes require stabilization / additional seed due to lack of compost filter tubes at 105+00 and 106+00 <b>Priority: High</b>	6/7/2024	6/14/2024	Stabilize the slope with the approved seed mixture and provide interim stabilization such as straw mulch.	6/14/2024 - Observation remains. 6/17/2024 - Observation remains. 6/24/2024 - Observation remains. 6/27/2024 - Observation remains. 7/8/2024 - Observation remains. 7/15/2024 - Observation remains. 7/22/2024 - Observation remains. 7/29/2024 - Regrowth of vegetation has been observed in this area. This item will remain open until the area is fully stabilized. 8/5/2024 - Observation remains. 8/7/2024 - Regrowth of vegetation has been observed but the area is not yet fully stabilized.

Typical view of slopes requiring stabilization and removal of gravel/sediment accumulation along compost filter tubes at Station 105+00 to 106+00 per Compliance Action Items 43 and 44.

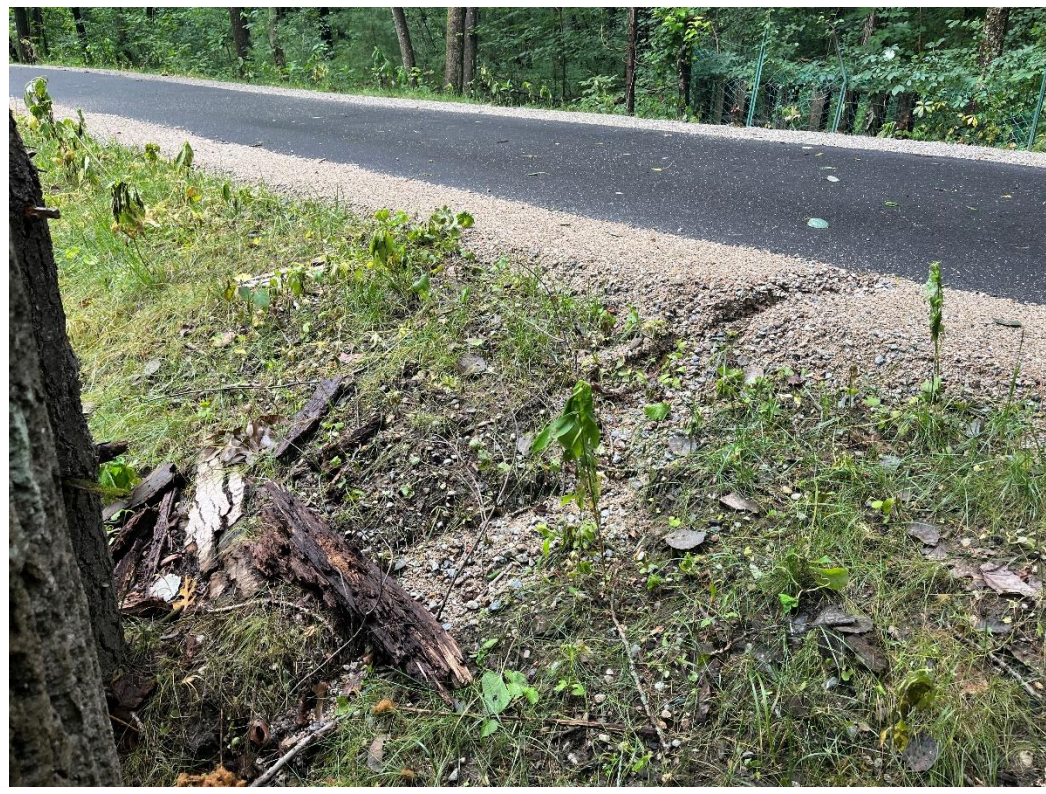
**Photo No. 2**     **Date:**  
8/7/2024

Item	Location/ Description	Observation Date	Resolution Due Date	Recommended/Discussed Resolution	Comments/Updates
58	Crushed stone used for the dense graded crush stone shoulders has been observed as migrating both onto the path, off the sides of the path, and into the adjacent Resource Areas throughout the Project Priority: High	8/7/2024	8/14/2024	Remove all crushed stone from Resource Areas and develop a plan to cease discharges of stone.	
57	Japanese hops ( <i>Humulus japonicus</i> ) has been observed throughout the Project and requires removal Priority: High	8/5/2024	8/12/2024	The Contractor should perform varying removal approaches including herbicide treatment and hand pulling to remove the vegetation throughout the Project.	8/5/2024 - Removal methods, including herbicide work and hand pulling have been observed to remove the plant throughout the Project. 8/7/2024 - Japanese hops and other invasives appear to be wilting due to herbicide application. Multiple areas along the trail appear to have not been treated and seed heads have appeared on some of the plants that were not treated. A second application of herbicide and pulling of plants with seedheads is recommended to ensure spreading does not continue.

Typical view of an area where crushed stone has migrated off the side of the shoulders per Compliance Action Item 58. This photo is located at Station 152+00 but this condition has been observed throughout the Project.

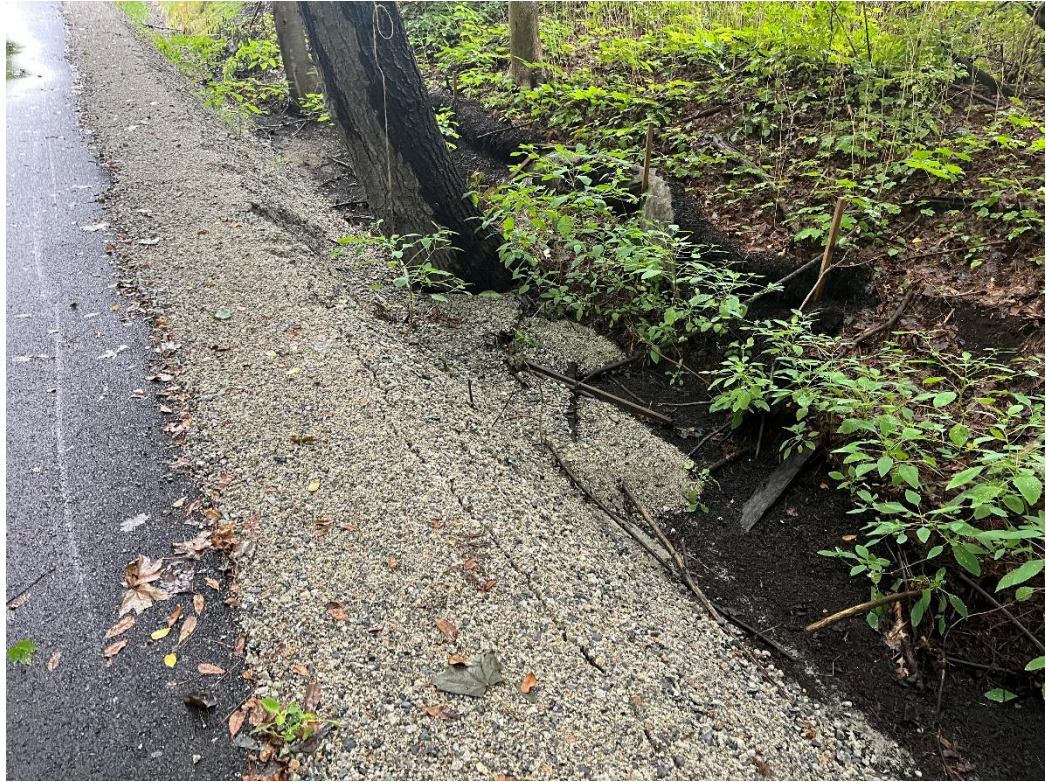
**Photo No. 3**    **Date:**  
8/7/2024

Item	Location/ Description	Observation Date	Resolution Due Date	Recommended Resolution / Resolution Date	Comments/Updates
56	Crushed stone discharged to the swale at Station 170+00 Priority: High	8/5/2024	8/12/2024	Remove crushed stone from swale and provide more robust erosion and sediment controls	8/7/2024 - Observation remains.
55	Crushed stone dust was observed requiring removal from the streambed on the west side of the path at Station 215+00 to 217+50 Priority: High	8/5/2024	8/12/2024	Remove crushed stone from streambed and provide more robust erosion controls	8/7/2024 - Observation remains.
54	Runoff associated with the stamped concrete splitter island was observed requiring removal from the streambed on the west side of the path at Station 216+00 Priority: High	8/5/2024	8/12/2024	Remove runoff from streambed and provide more robust erosion controls	8/7/2024 - Runoff was not visible within the streambed post-storm, but was still present downgradient and upgradient of erosion controls. Erosion controls at this location have been undermined and there is potential for more runoff to enter the streambed. This item will remain open until the material has fully hardened.

View of crushed stone that requires removal from the streambed at Station 170+00 per Compliance Action Item 56.

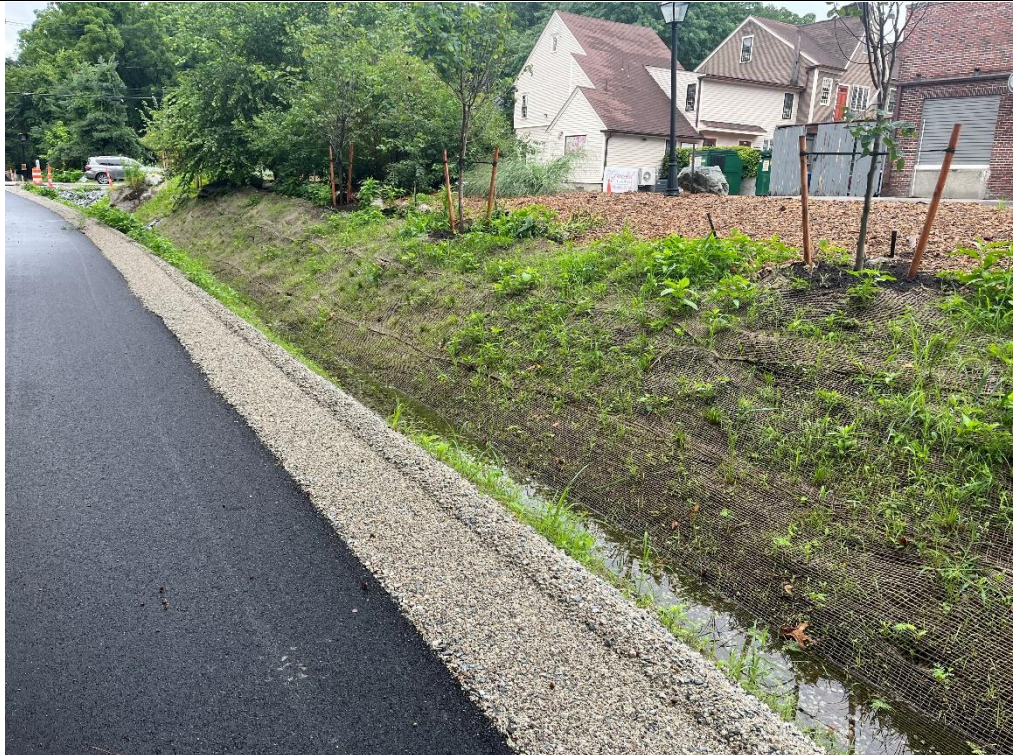
**Photo No. 4**    **Date:**  
8/7/2024

53	Stone was observed requiring removal from the swale on the east side of the trail at Station 172+00 to 173+00 Priority: High	7/29/2024	8/6/2024	Remove stone from the swale.	8/5/2024 - Observation remains. 8/7/2024 - Observation remains.
52	Slope along the driveway to the parking lot at Station 216+50 requires stabilization Priority: Medium	7/29/2024	8/6/2024	Install erosion control blanket and place seed.	8/5/2024 - Observation remains. 8/7/2024 - Observation remains.

View of the location where stone requiring removal from the swale at Station 172+00 to 173+00 per Compliance Action Item 53.

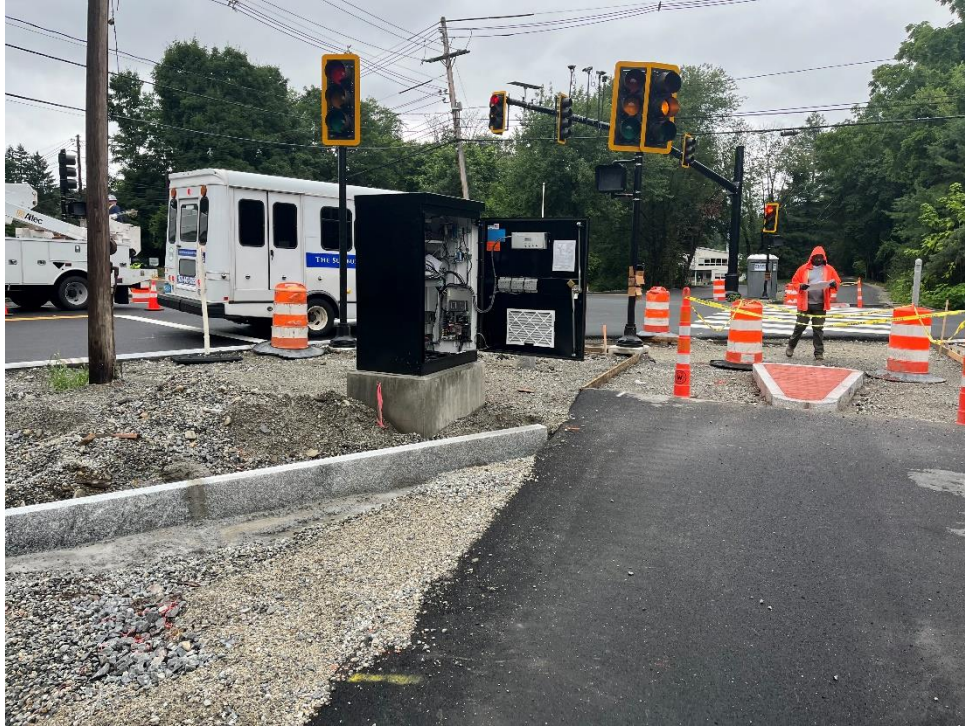
**Photo No. 5**    **Date:**  
8/7/2024

View of the newly installed traffic lights being tested at the Hudson Road intersection.

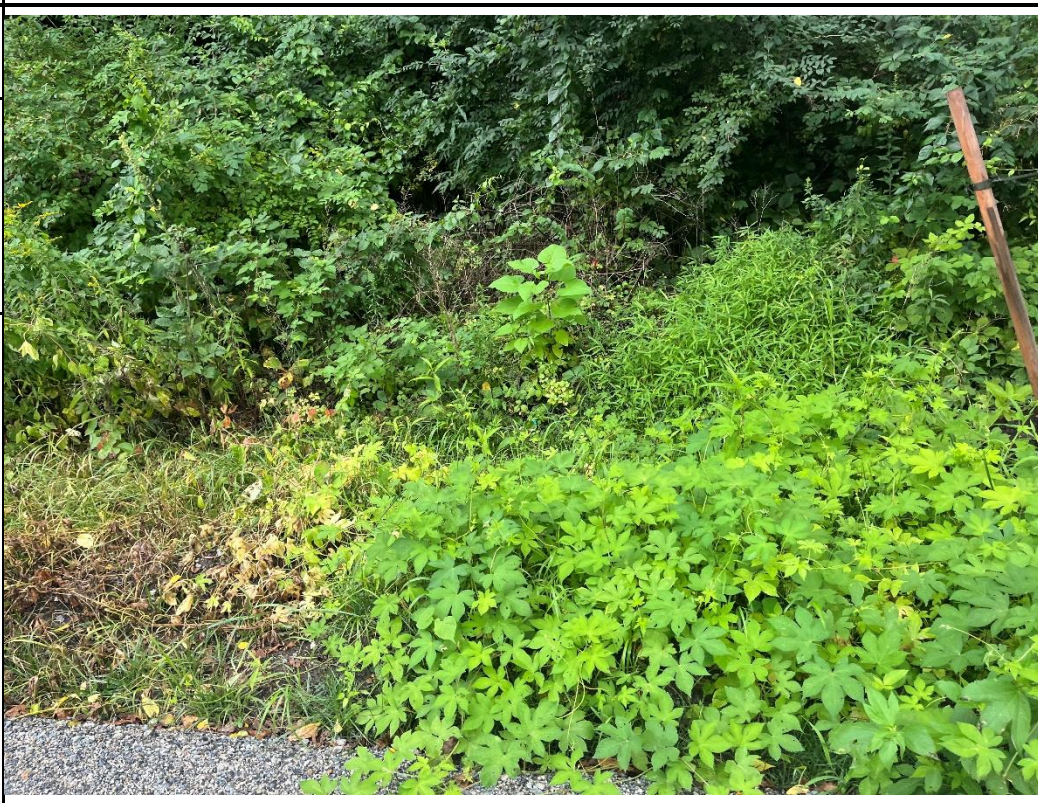
**Photo No. 6**    **Date:**  
8/7/2024

Typical view of a location where treatment should be performed on the Japanese Hops per Compliance Action Item 57. This photo was taken at Station 176+50 but this condition has been observed throughout the Project.

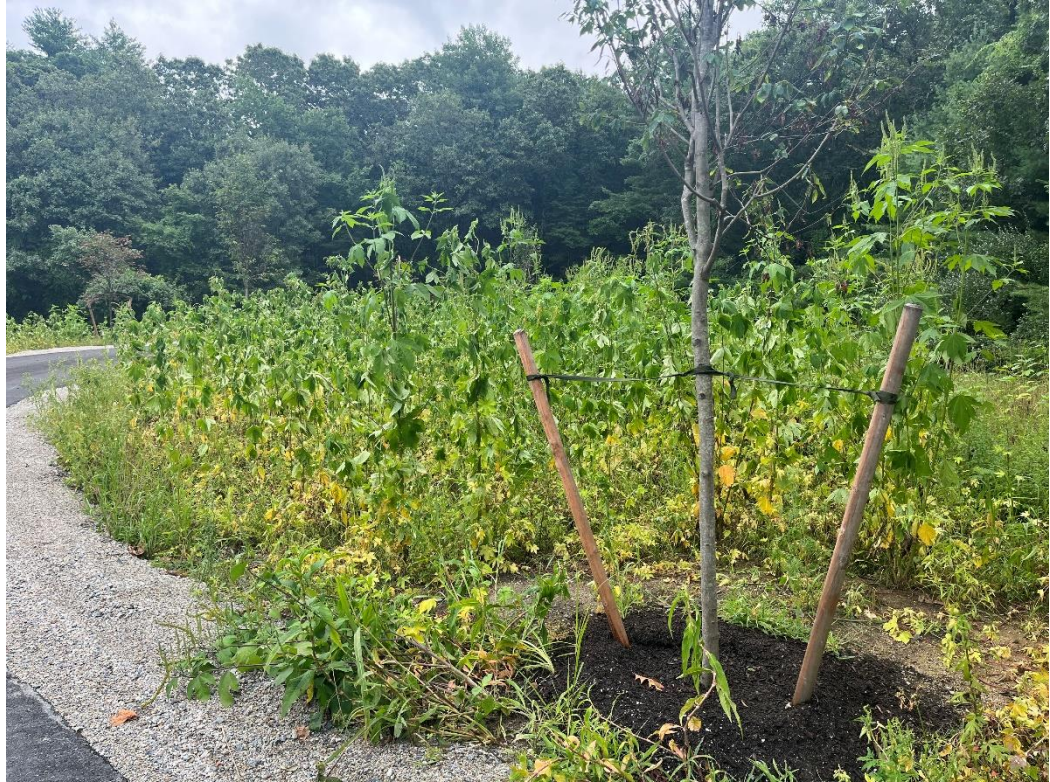
**Photo No. 7**     **Date:**  
8/7/2024

View of a location where the Japanese Hops have not been treated and have developed seed heads per Compliance Action item 57. This photo was taken at Station 1002+50 but this condition has been observed throughout the Project.

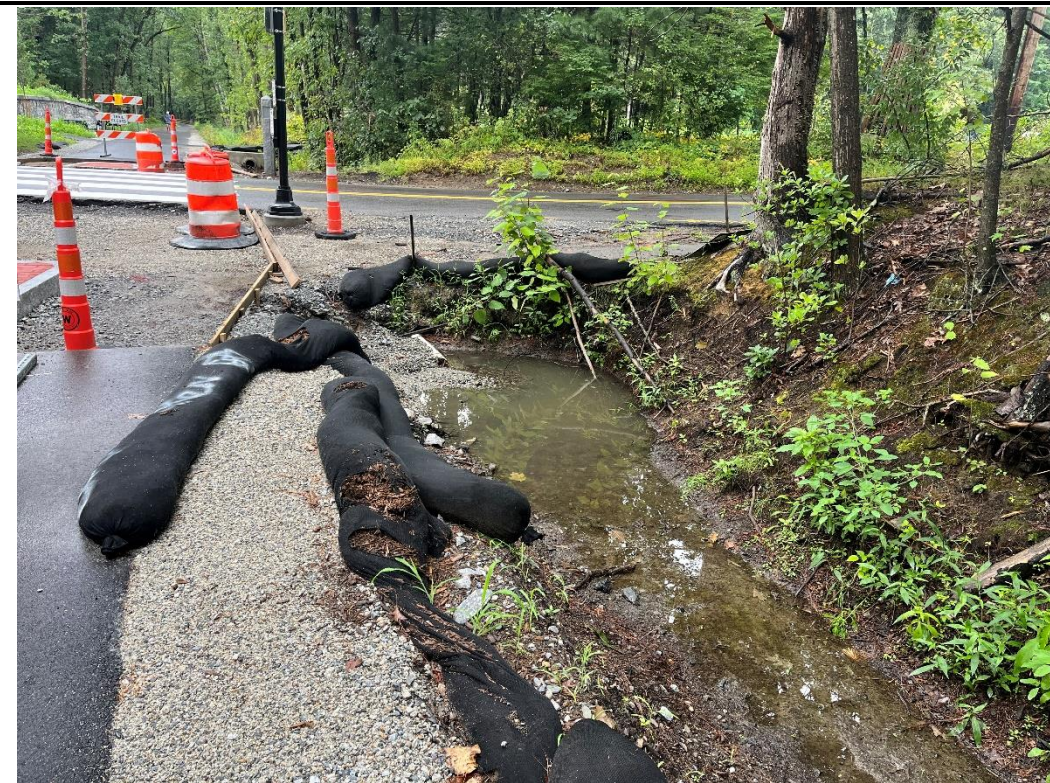
**Photo No. 8**     **Date:**  
8/7/2024

View of a location where crushed stone requires removal from the streambed at Station 215+50 per Compliance Action Item 55.

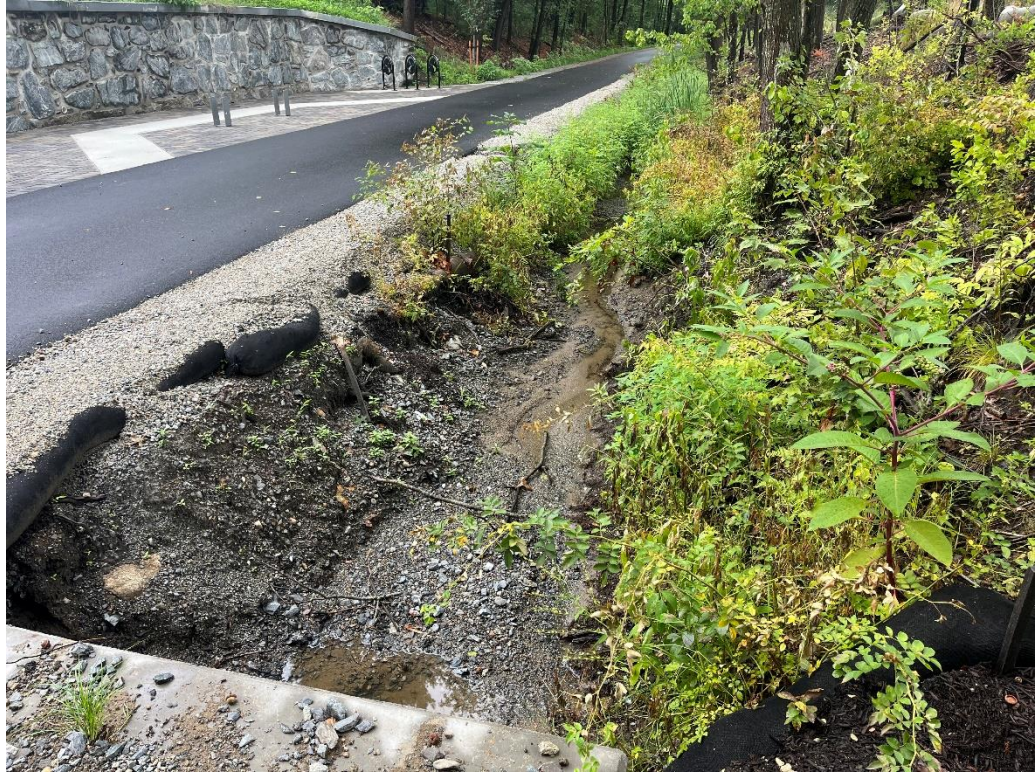
**Photo No. 11**    **Date:**  
8/7/2024

View of the location where crushed stone required removal from the streambed at Station 217+50 per Compliance Action Item 55.

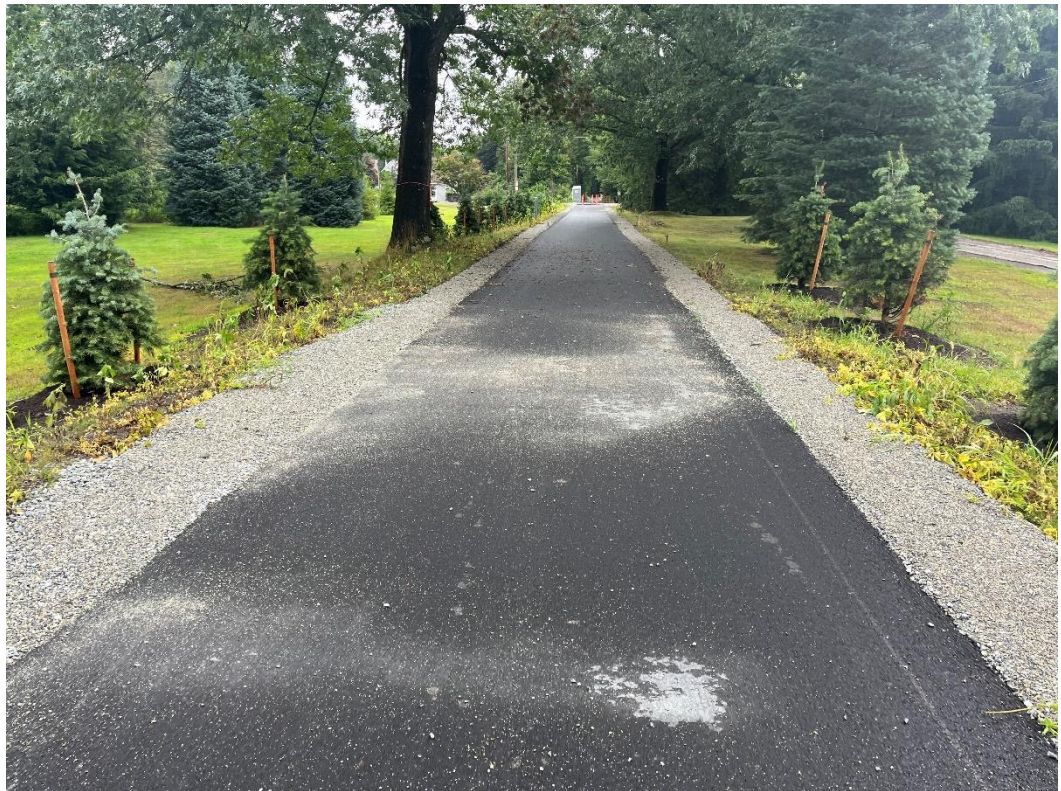
**Photo No. 12**    **Date:**  
8/7/2024

Typical view of crushed stone that has migrated onto the path and requires removal per Compliance Action Item 58. This photo was taken at Station 303+00 but this condition has been observed throughout the Project.
