**Environmental Monitor Construction Site Inspection Report  
MassDOT Project #608164 Construction Contract # 119678  
EM Report #17**

Project Description: Bruce Freeman Rail Trail Right-of-Way  
Permit Description(s): Order of Conditions (MGL Chapter 131, Section 40 and 310 CMR 10.00, Mass DEP File No. 301-1362); 2022 EPA NPDES General Permit for Discharges from Construction Areas; U.S. Army Corps of Engineers Permit No NAE-2021-01975

Project Name: Bruce Freeman Rail Trail - Phase 2d - Sudbury  
Date of Inspections: 8/12/2024  
Bi Weekly/ Monthly Period Covered: August Weekly Inspection #3  
Inspector's Name(s): Anna Haznar  
Inspectors' Contact Information: [ahaznar@beta-inc.com](mailto:ahaznar@beta-inc.com)

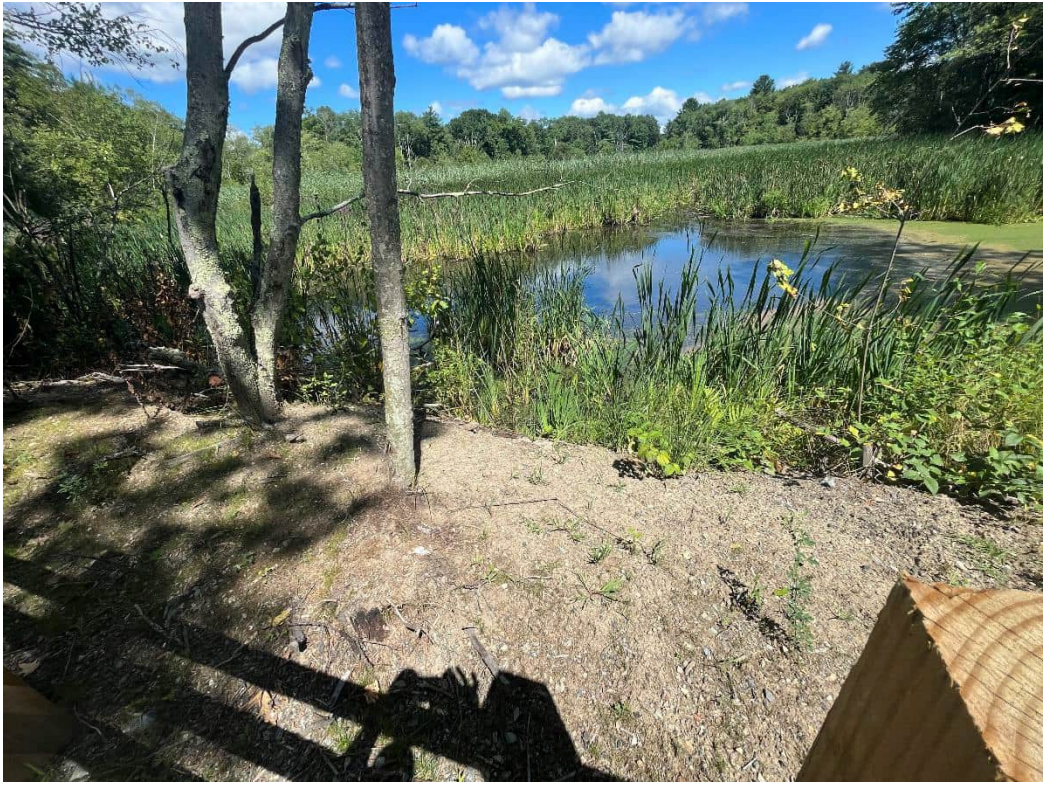
**Photo No. 1**    **Date:**  
8/12/2024

Typical view of slopes requiring stabilization and removal of gravel/sediment accumulation along compost filter tubes at Station 105+00 to 106+00 per Compliance Action Items 43 and 44.

44	Slopes require stabilization / additional seed due to lack of compost filter tubes at 105+00 and 106+00 <b>Priority: High</b>	6/7/2024	6/14/2024	Stabilize the slope with the approved seed mixture and provide interim stabilization such as straw mulch.	6/14/2024 - Observation remains. 6/17/2024 - Observation remains. 6/24/2024 - Observation remains. 6/27/2024 - Observation remains. 7/8/2024 - Observation remains. 7/15/2024 - Observation remains. 7/22/2024 - Observation remains. 7/29/2024 - Regrowth of vegetation has been observed in this area. This item will remain open until the area is fully stabilized. 8/5/2024 - Observation remains. 8/7/2024 - Regrowth of vegetation has been observed but the area is not yet fully stabilized. 8/12/2024 - Observation remains.

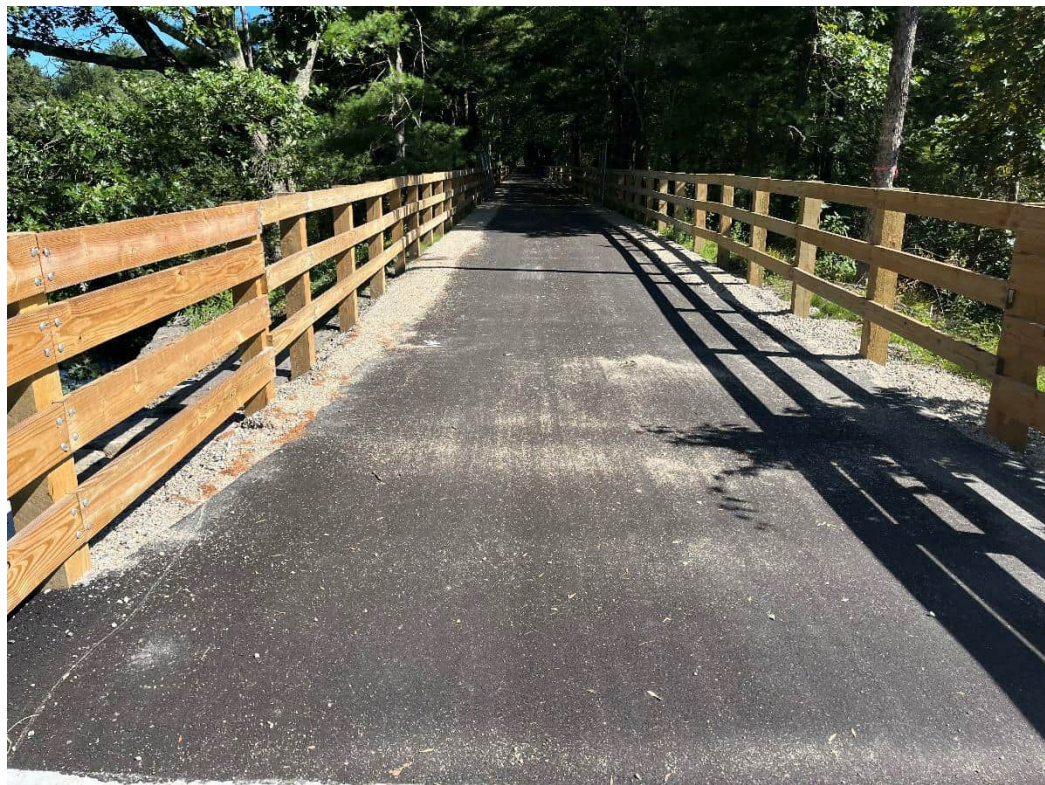
**Photo No. 2**    **Date:**  
8/12/2024

Typical view of an area where crushed stone has migrated onto the path per Compliance Action Item 58. This observation was made at Station 126+00 to 127+00; however, these conditions are present throughout the Project.

Item	Location/ Description	Observation Date	Resolution Due Date	Recommended/Discussed Resolution	Comments/Updates
58	Crushed stone used for the dense graded crush stone shoulders has been observed as migrating both onto the path, off the sides of the path, and into the adjacent Resource Areas throughout the Project <b>Priority: High</b>	8/7/2024	8/14/2024	Remove all crushed stone from Resource Areas and develop a plan to cease discharges of stone.	8/12/2024 - Crushed stone is still present in varying amounts throughout the path and on the sides of the path.
57	Japanese hops ( <i>Humulus japonicus</i> ) has been observed throughout the Project and requires removal <b>Priority: High</b>	8/5/2024	8/12/2024	The Contractor should perform varying removal approaches including herbicide treatment and hand pulling to remove the vegetation throughout the Project.	8/5/2024 - Removal methods, including herbicide work and hand pulling have been observed to remove the plant throughout the Project. 8/7/2024 - Japanese hops and other invasives appear to be wilting due to herbicide application. Multiple areas along the trail appear to have not been treated and seed heads have appeared on some of the plants that were not treated. A second application of herbicide and pulling of plants with seedheads is recommended to ensure spreading does not continue. 8/12/2024 - Herbicide application on the Japanese hops and other invasives was occurring at the time of the inspection. Plants that have been previously treated appear to be dead or wilting.

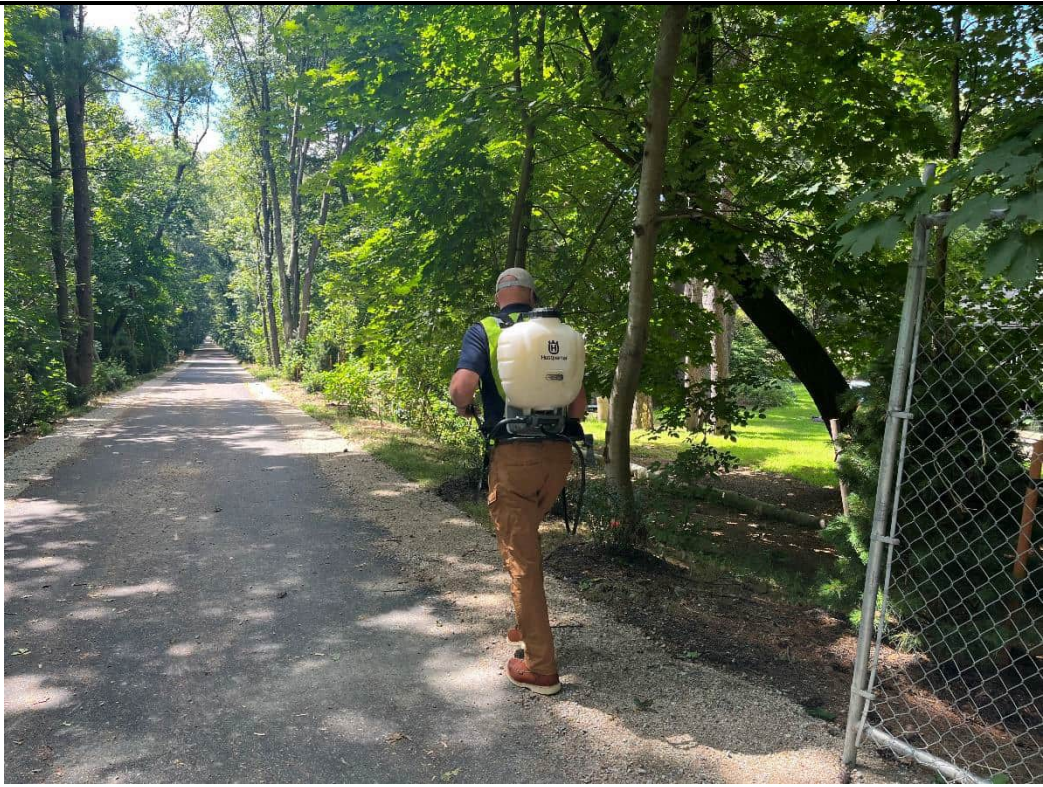
**Photo No. 3**    **Date:**  
8/12/2024

Typical view of herbicide application being performed at Station 142+50.

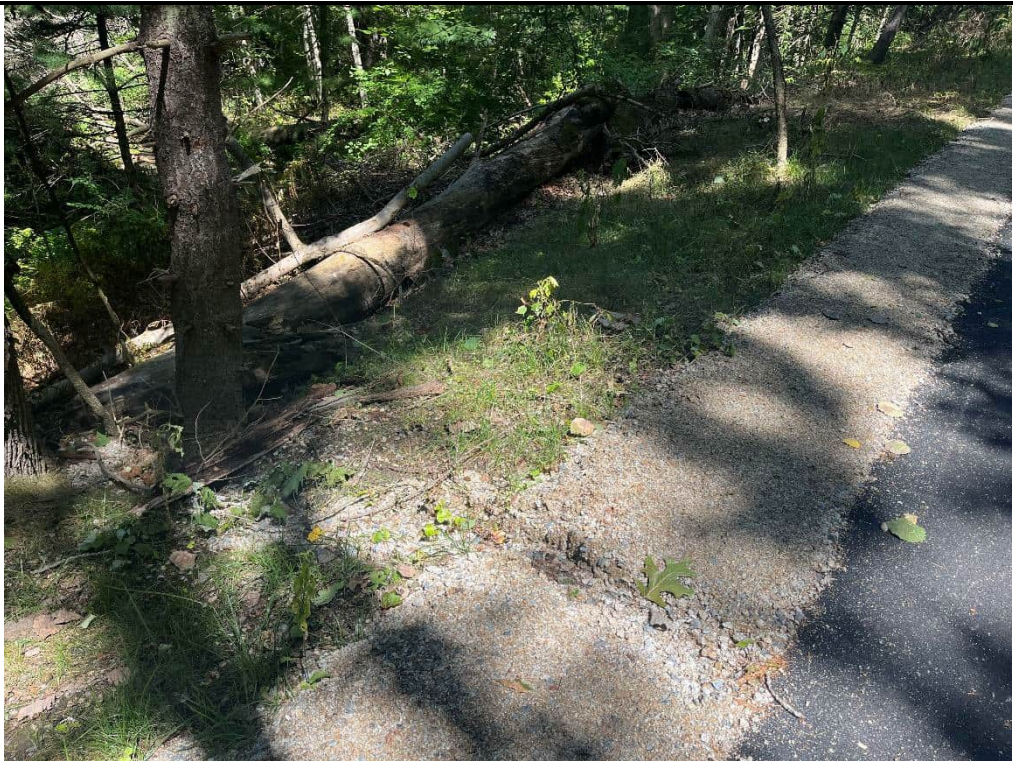
**Photo No. 4**    **Date:**  
8/12/2024

Typical view of an area where crushed stone has migrated off the side of the shoulders per Compliance Action Item 58. This photo is located at Station 152+00; however, this condition is present throughout the Project.

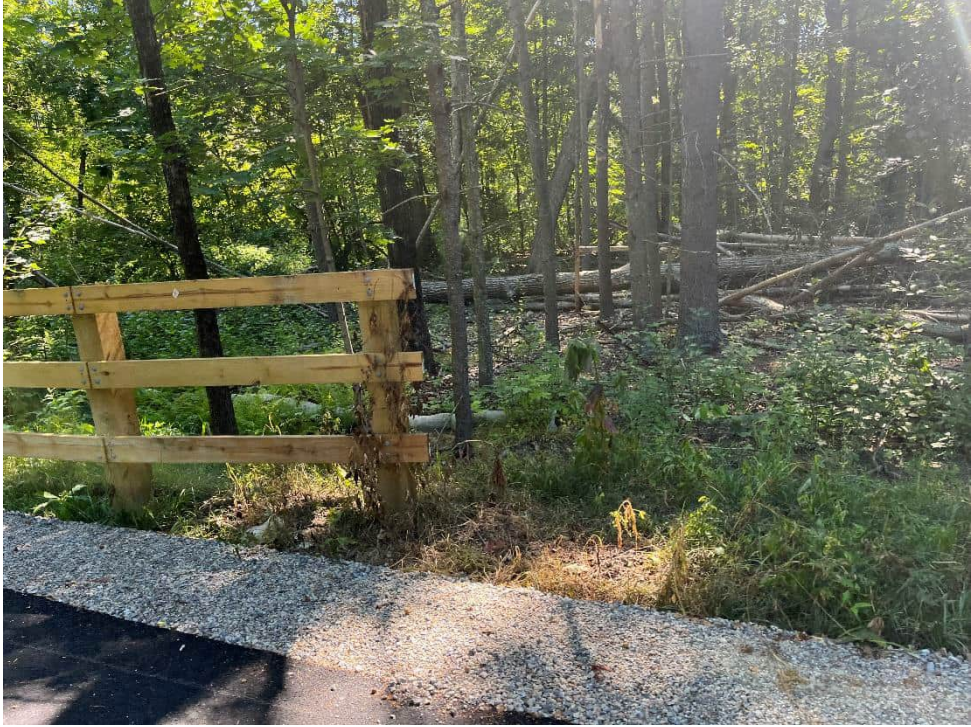
<b>Site Location</b> Bruce Freeman Rail Trail Right-of-Way		<b>BETA Project No.</b> 24.10326.23
<b>Photo No. 5</b>	<b>Date:</b> 8/12/2024

<b>Direction Photo Taken:</b>  Toward the North		
<b>Description:</b> View of Japanese hops that have been treated with herbicide and are wilting/dead per Compliance Action item 57. This photo was taken at Station 158+50.		
<b>Photo No. 6</b>	<b>Date:</b> 8/12/2024	 
<b>Direction Photo Taken:</b>  Toward the East		
<b>Description:</b> View of crushed stone that requires removal from the drainage swale at Station 170+00 per Compliance Action Item 56.

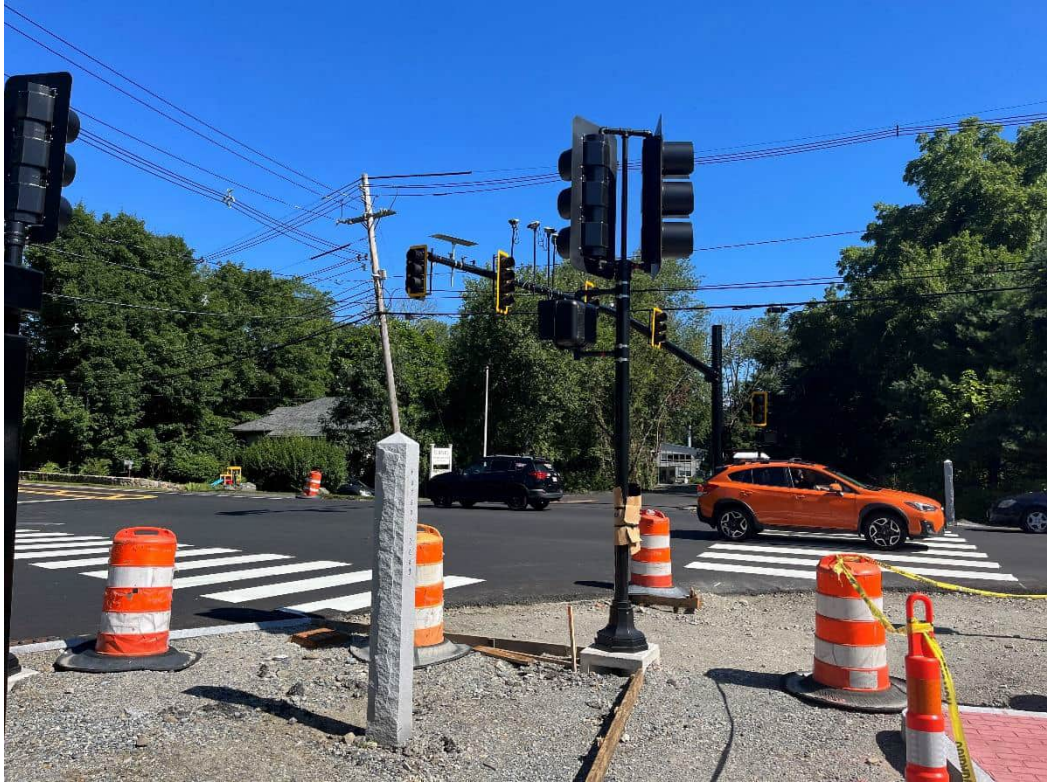
**Photo No. 7**    **Date:**  
8/12/2024

View of the location where utility work is occurring for the installation of the traffic signals at the Hudson Road intersection.

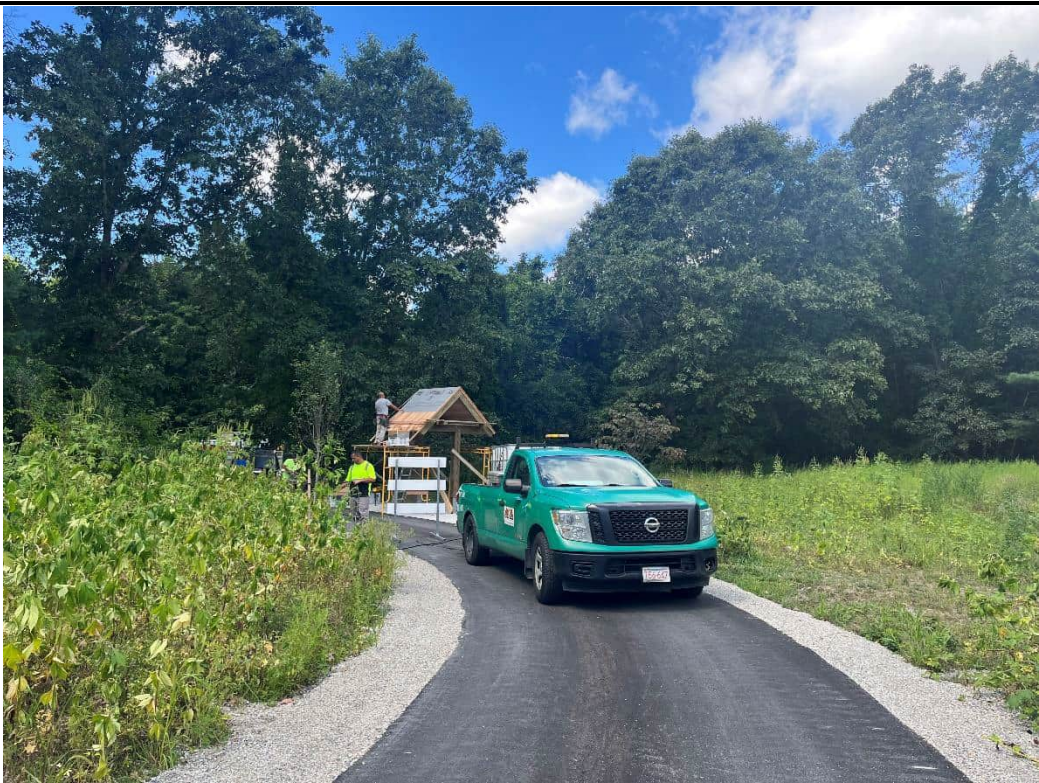
**Photo No. 8**    **Date:**  
8/12/2024

View of the installation of a kiosk at Station 1001+00.

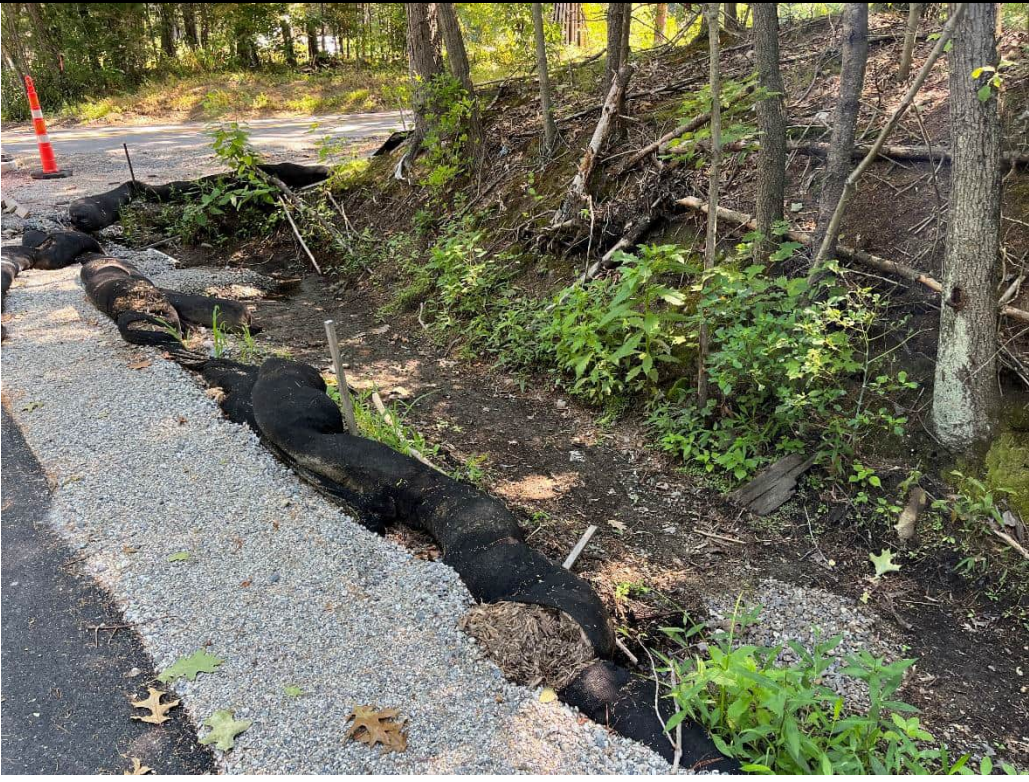
<b>Site Location</b> Bruce Freeman Rail Trail Right-of-Way		<b>BETA Project No.</b> 24.10326.23
<b>Photo No. 9</b>	<b>Date:</b> 8/12/2024

<b>Direction Photo Taken:</b>  Toward the South		
<b>Description:</b>  View of a location where crushed stone requires removal from the streambed at Station 215+50 per Compliance Action Item 55.		
<b>Photo No. 10</b>	<b>Date:</b> 8/12/2024	 
<b>Direction Photo Taken:</b>  Toward the East		
<b>Description:</b>  View of the location where runoff from the stamped concrete splitter island and crushed stone requires removal from the streambed at Station 216+00 per Compliance Action Item 54 and 55.

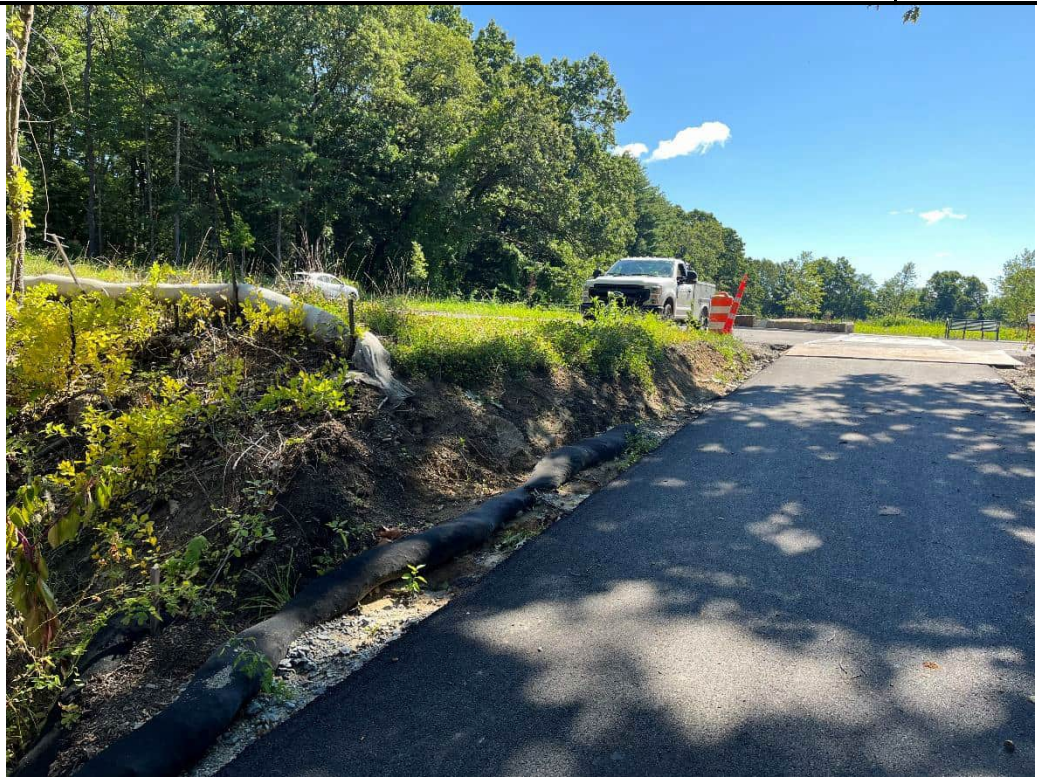
**Photo No. 11**    **Date:**  
8/12/2024

View of a slope requiring stabilization along the driveway to the parking lot near Station 216+50 per Compliance Action Item 52.

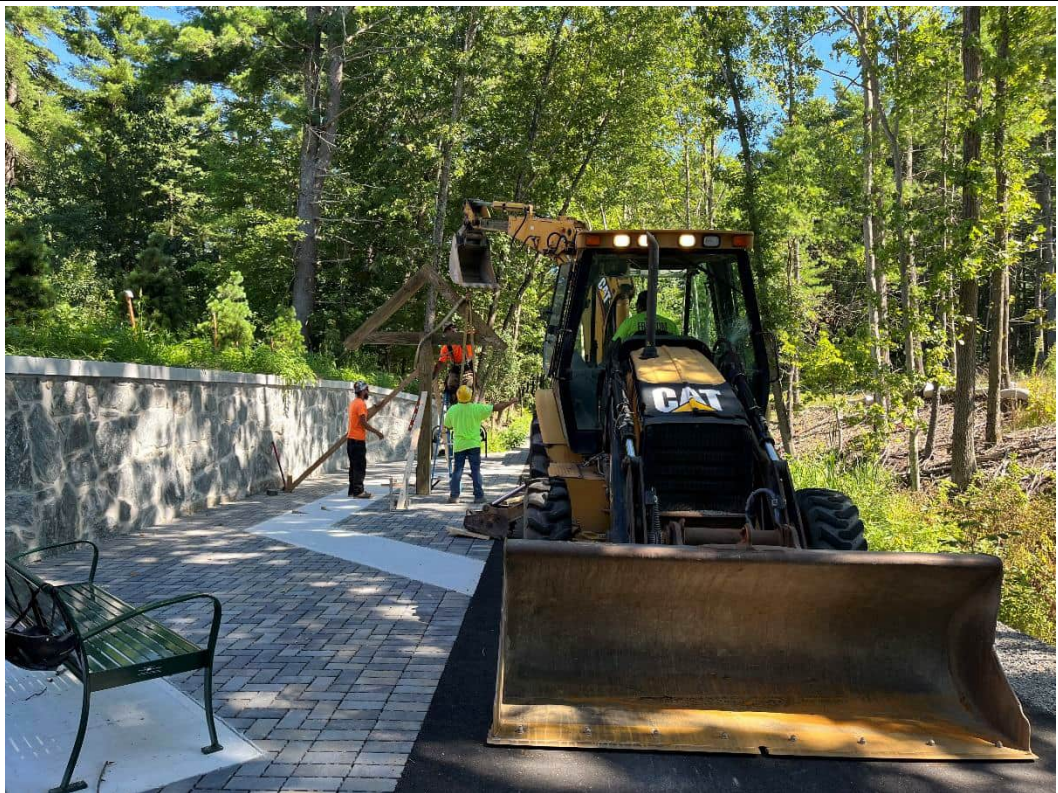
**Photo No. 12**    **Date:**  
8/12/2024

View of a kiosk being installed at Station 217+00.
