**Environmental Monitor Construction Site Inspection Report  
MassDOT Project #608164 Construction Contract # 119678  
EM Report #18**

Project Description: Bruce Freeman Rail Trail Right-of-Way  
Permit Description(s): Order of Conditions (MGL Chapter 131, Section 40 and 310 CMR 10.00, Mass DEP File No. 301-1362); 2022 EPA NPDES General Permit for Discharges from Construction Areas; U.S. Army Corps of Engineers Permit No NAE-2021-01975.

Project Name:	Bruce Freeman Rail Trail - Phase 2d - Sudbury
Date of Inspections:	8/16/2024
Bi Weekly/ Monthly Period Covered:	August Weekly Inspection #4
Inspector's Name(s):	Anna Haznar
Inspectors' Contact Information:	<a href="mailto:ahaznar@beta-inc.com">ahaznar@beta-inc.com</a>

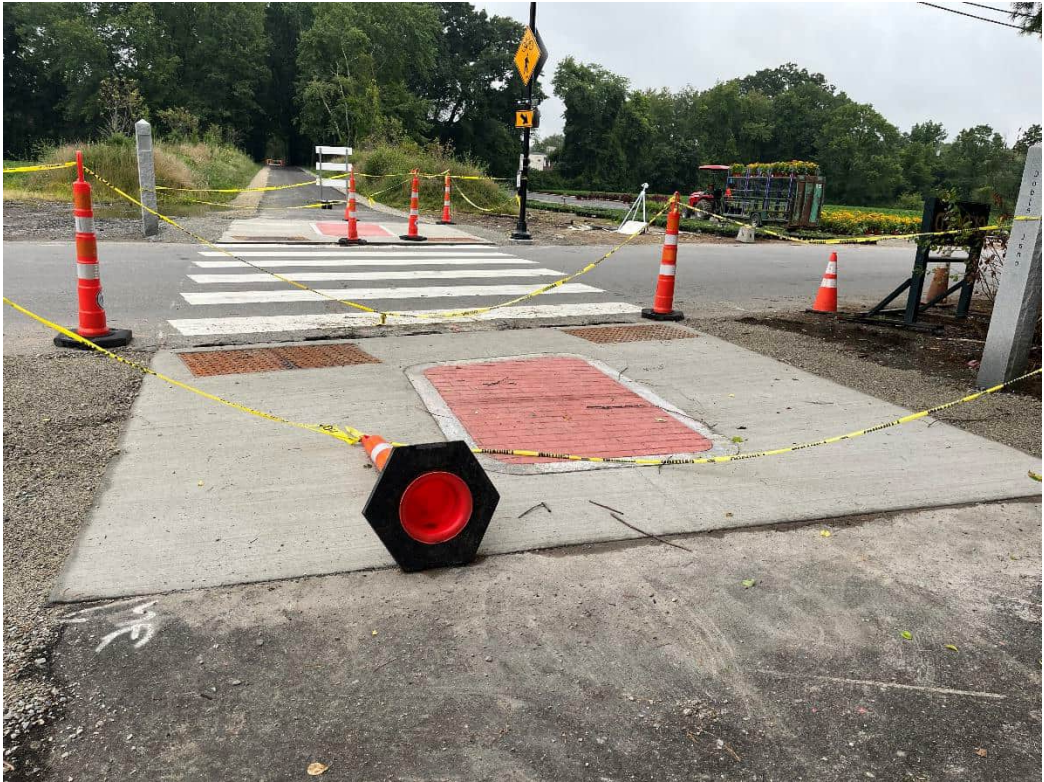
**Photo No. 1**    **Date:**  
8/16/2024

View of the recently installed concrete within the splitter island at the Codjer Lane intersection.

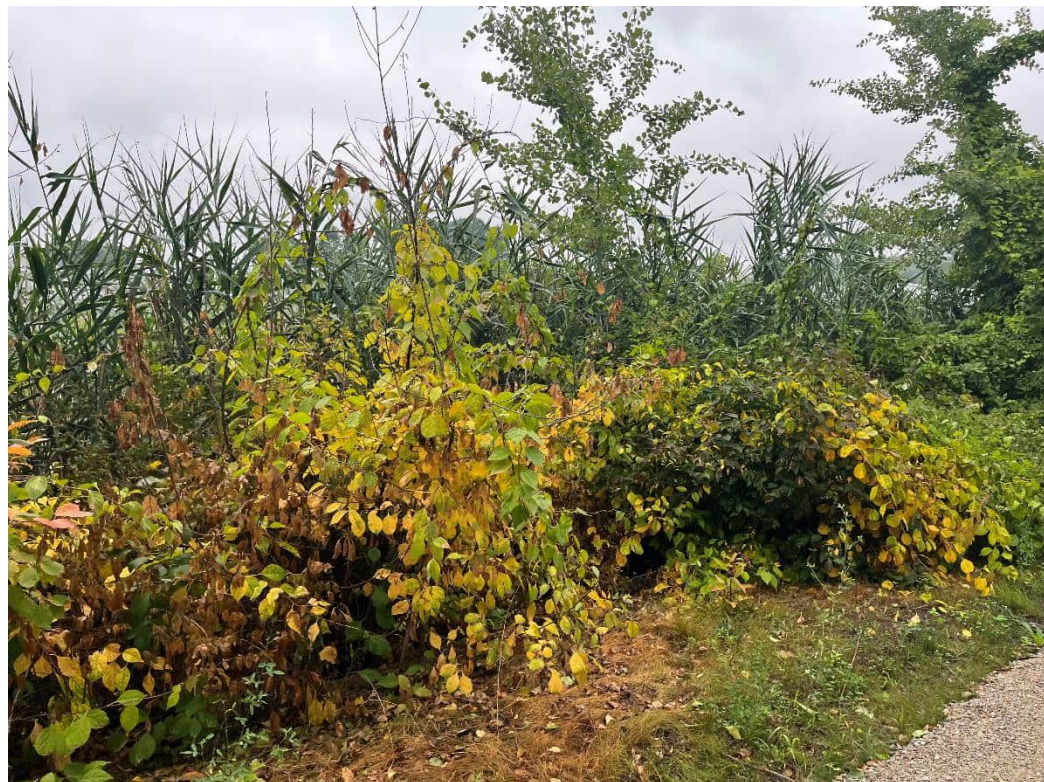
**Photo No. 2**    **Date:**  
8/16/2024

View of invasive species that have been treated with herbicide at Station 119+00 per Long Term Compliance Action Item 57.

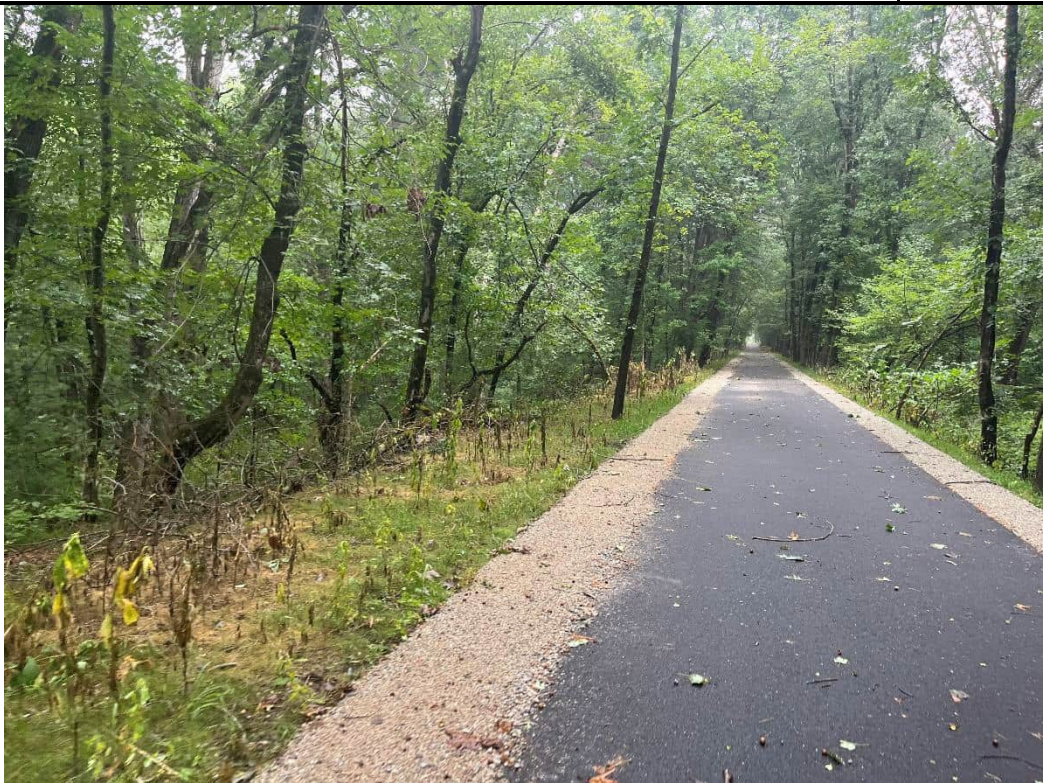
**Photo No. 3**    **Date:**  
8/16/2024

View of wilting Japanese hops that have been treated with herbicide at Station 145+00 per Long Term Compliance Action Item 57.

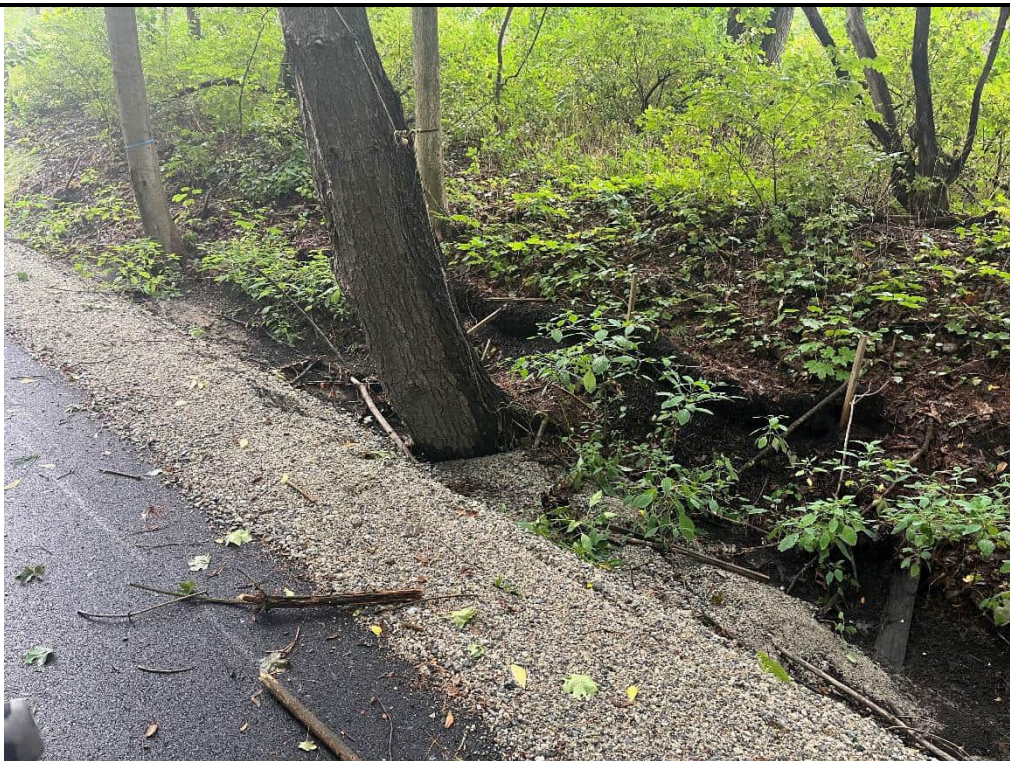
**Photo No. 4**    **Date:**  
8/16/2024

Item	Location/ Description	Observation Date	Resolution Due Date	Recommended Resolution / Resolution Date	Comments/Updates
56	Crushed stone discharged to the swale at Station 170+00 <b>Priority: High</b>	8/5/2024	8/12/2024	Remove crushed stone from swale and provide more robust erosion and sediment controls	8/7/2024 - Observation remains. 8/12/2024 - Observation remains. Stone was observed to have migrated further down the swale to Station 170+50 through Station 171+00. 8/16/2024 - Stone is still present within the swale.
55	Crushed stone dust was observed requiring removal from the streambed on the west side of the path at Station 215+00 to 217+50 <b>Priority: High</b>	8/5/2024	8/12/2024	Remove crushed stone from streambed and provide more robust erosion controls	8/7/2024 - Observation remains. 8/12/2024 - Observation remains. 8/16/2024- Crushed stone requires removal at Station 217+50.
53	Stone was observed requiring removal from the swale on the east side of the trail at Station 172+00 to 173+00 <b>Priority: High</b>	7/29/2024	8/6/2024	Remove stone from the swale.	8/5/2024 - Observation remains. 8/7/2024 - Observation remains. 8/12/2024 - Observation remains. Material was observed to have migrated within the swale to Station 173+50. 8/16/2024 - Stone is still present within the swale.

View of crushed stone that requires removal from the drainage swale at Station 170+00 per Compliance Action Item 56.

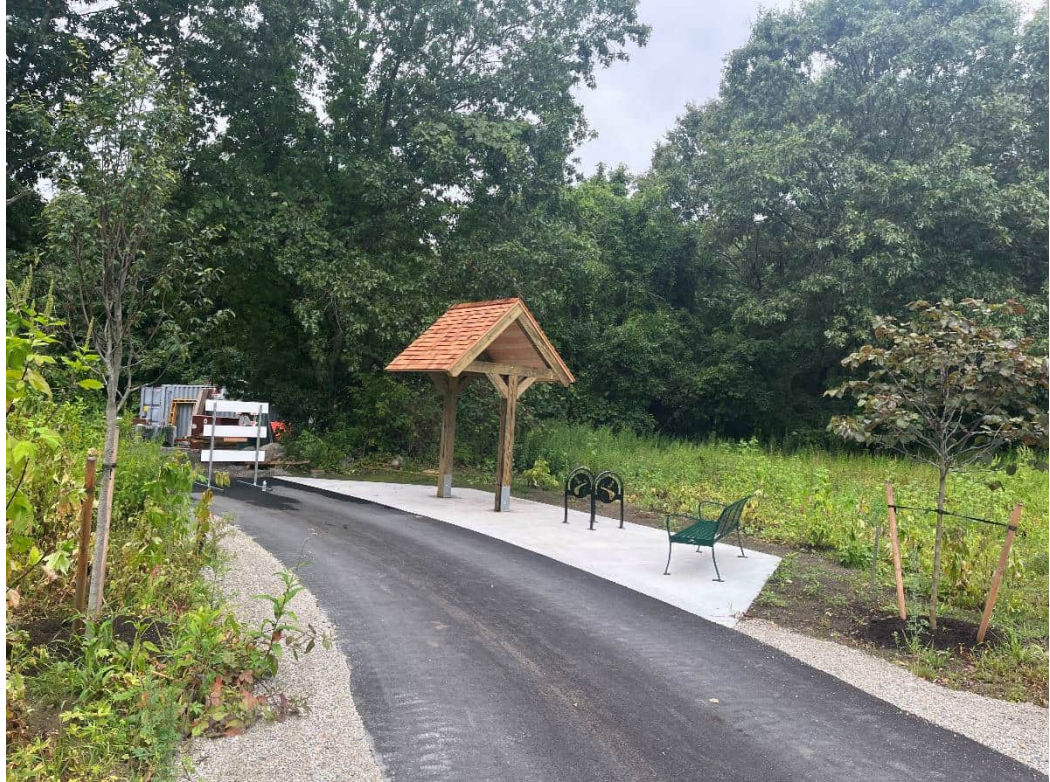
**Photo No. 7**    **Date:**  
8/16/2024

View of the kiosk that was installed at Station 1001+00.

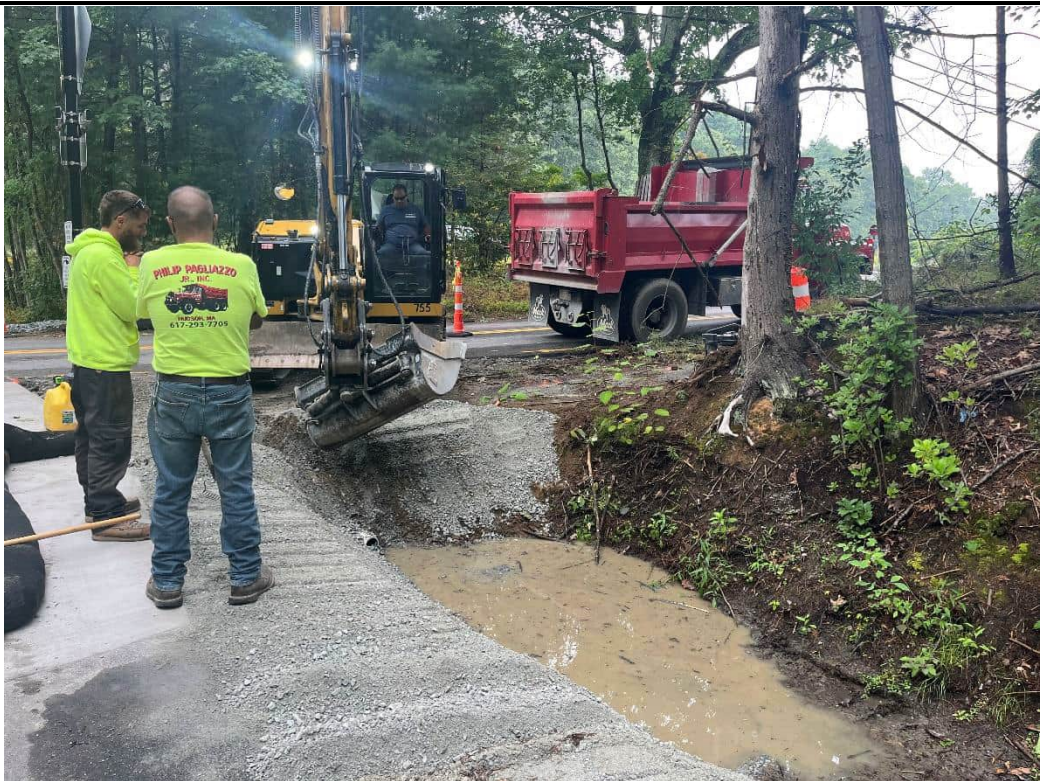
**Photo No. 8**    **Date:**  
8/16/2024

41	Stream Bank has been regraded beyond the limit of work at Station 216+00 <b>Priority: High</b>	5/28/2024	6/4/2024	The Contractor should confirm if this work was permitted by the Conservation Commission, as it does not appear to be a part of the approved plans/impacts. MassDOT should be consulted on next steps regarding notification and potential restoration.	<p>5/31/2024 - Observation remains.</p> <p>6/7/2024 - Observation remains.</p> <p>6/14/2024 - Observation remains.</p> <p>6/17/2024 - Observation remains.</p> <p>6/24/2024 - Observation remains.</p> <p>6/27/2024 - Observation remains.</p> <p>7/8/2024 - Observation remains.</p> <p>7/15/2024 - This area could not be assessed due to paving operations ongoing during the inspection.</p> <p>7/22/2024 - Crushed stone and sediment continue to be discharged to the stream between Stations 215+00 and 217+00 due to overtopped and undermined compost filter tubes.</p> <p>7/29/2024 - Observation remains.</p> <p>8/5/2024 - Observation remains.</p> <p>8/7/2024 - Observation remains.</p> <p>8/12/2024 - Observation remains. Crushed stone is still present in the streambed at this location.</p> <p>8/16/2024 - Observation remains.</p>

View of active removal of crushed stone from the streambed at Station 215+00 per Compliance Action Item 55. Unpermitted work per Long Term Compliance Action Item 41 is still occurring.

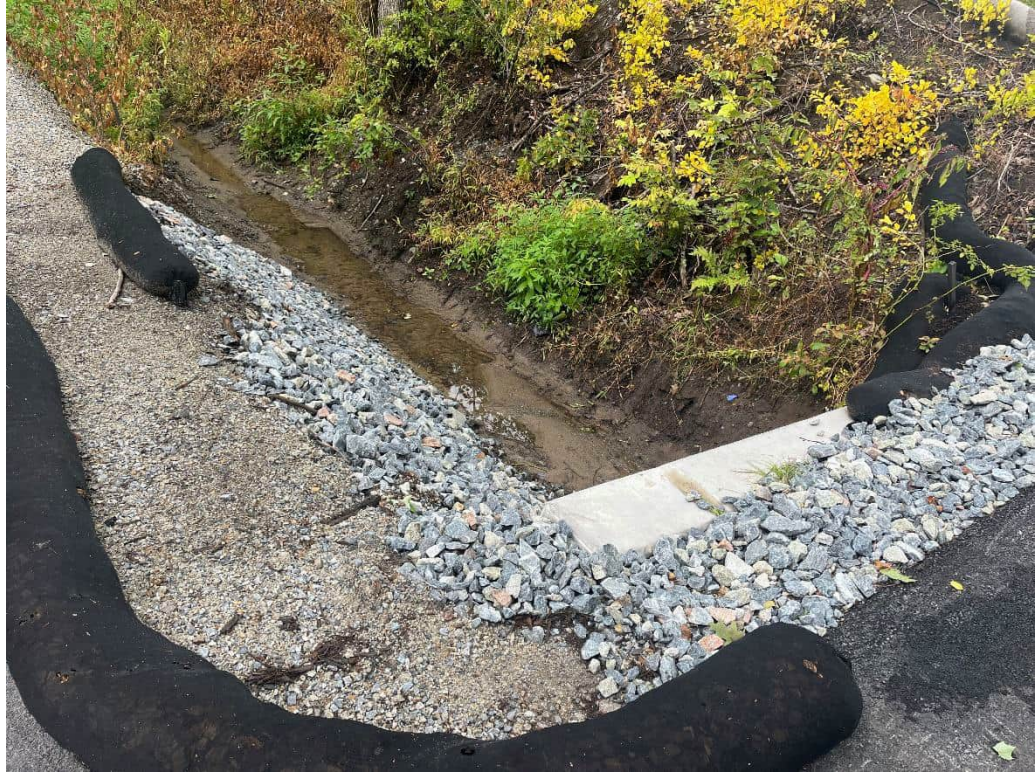
**Photo No. 11**    **Date:**  
8/16/2024

View of the crushed stone removed from the streambed at Station 217+00 per Compliance Action Item 55. Unpermitted work per Long Term Compliance Action Item 41 is still occurring.

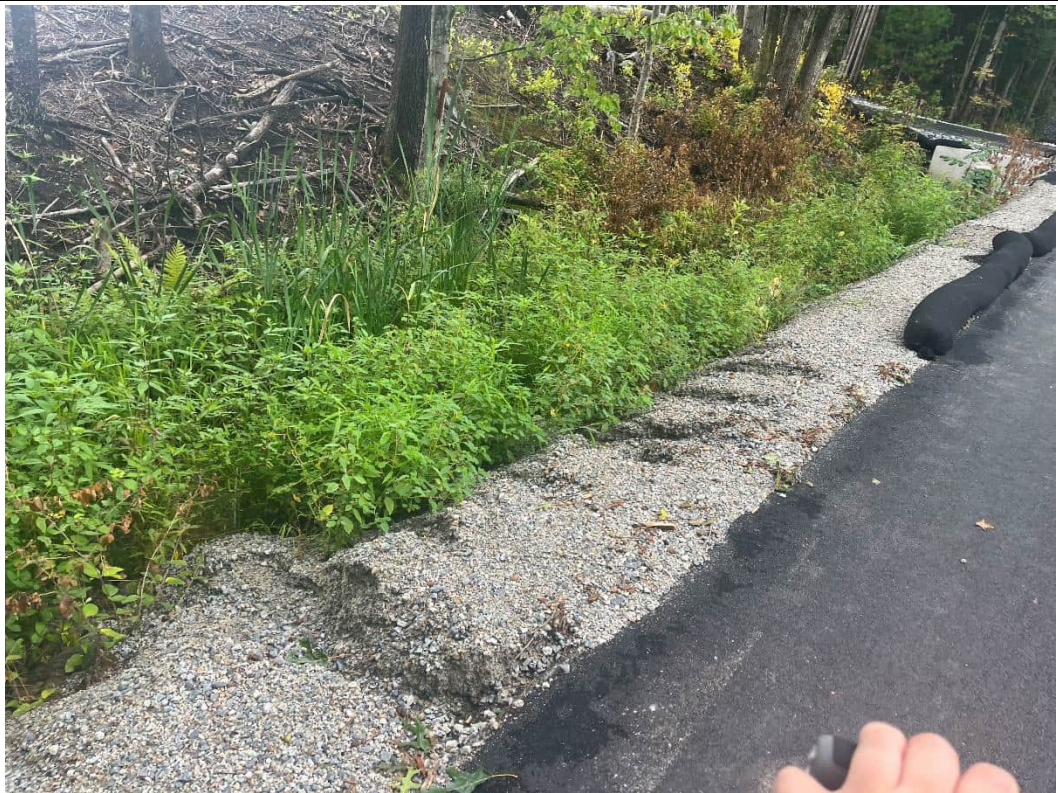
**Photo No. 12**    **Date:**  
8/16/2024

View of the location where crushed stone requires removal from the streambed at Station 217+50 per Compliance Action Item 55.

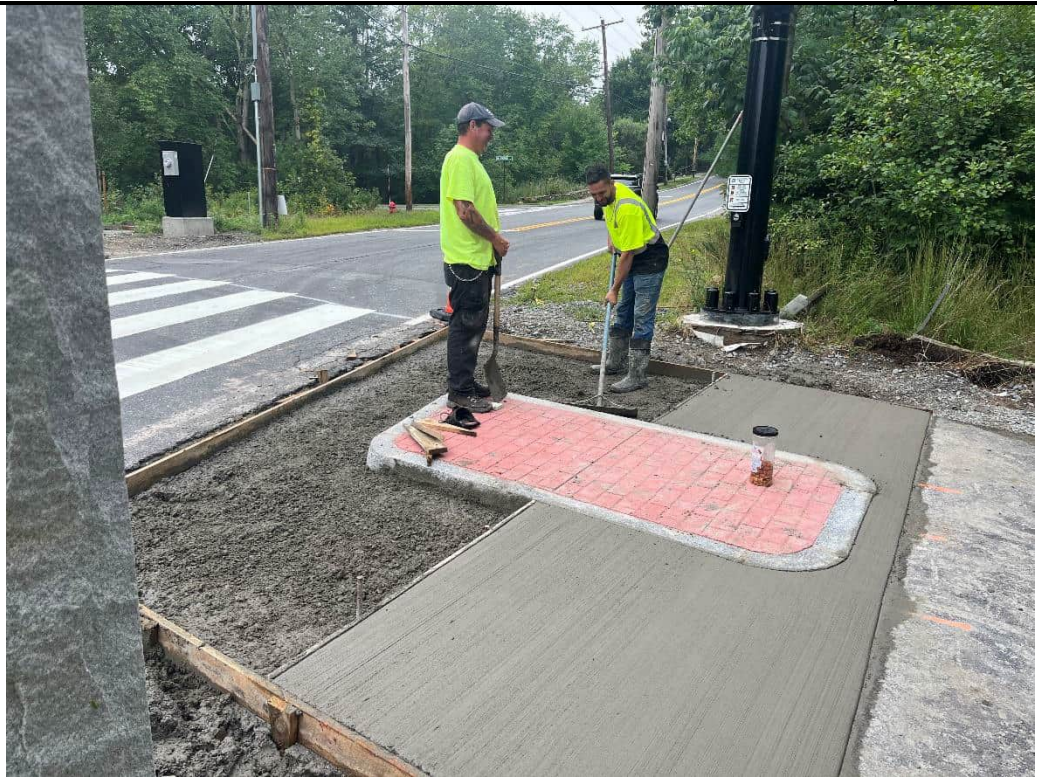
**Photo No. 13**    **Date:**  
8/16/2024

View of the location where concrete was being installed within the concrete splitter island at the intersection of Haynes Road.

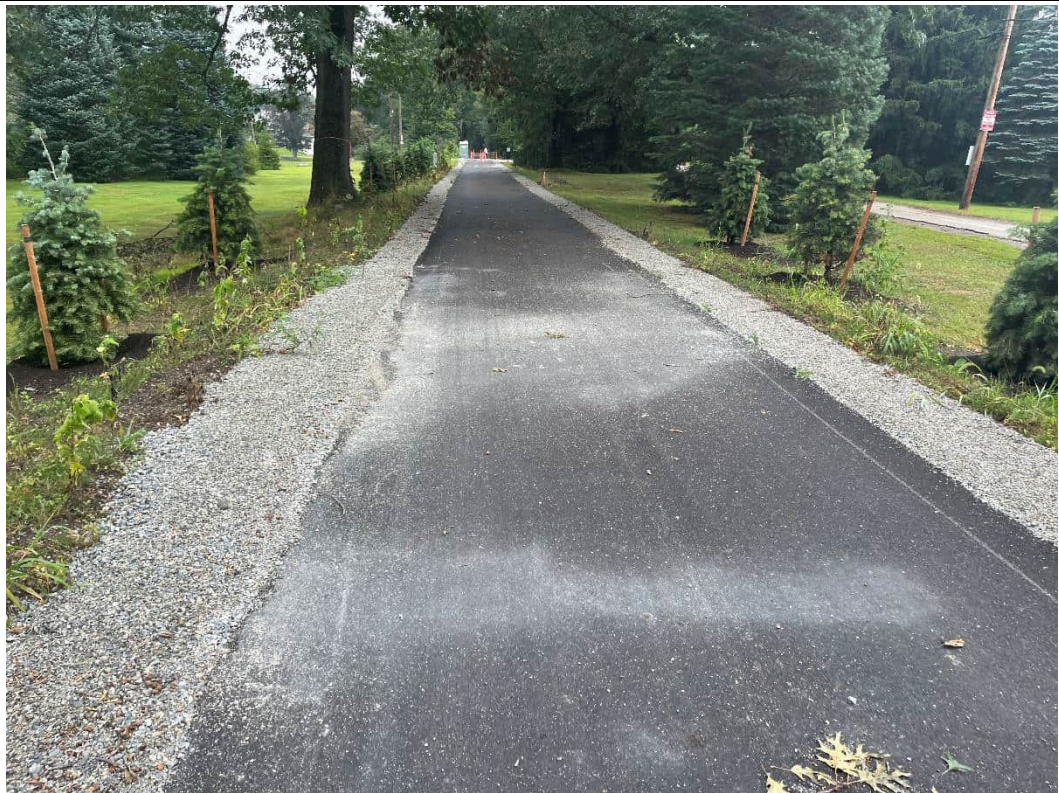
**Photo No. 14**    **Date:**  
8/16/2024

Item	Location/ Description	Observation Date	Resolution Due Date	Recommended/Discussed Resolution	Comments/Updates
58	Crushed stone used for the dense graded crush stone shoulders has been observed as migrating both onto the path, off the sides of the path, and into the adjacent Resource Areas throughout the Project <b>Priority: High</b>	8/7/2024	8/14/2024	Remove all crushed stone from Resource Areas and develop a plan to cease discharges of stone.	8/12/2024 - Crushed stone is still present in varying amounts throughout the path and on the sides of the path. 8/16/2024 - Observation remains.
57	Japanese hops ( <i>Humulus japonicus</i> ) has been observed throughout the Project and requires removal <b>Priority: High</b>	8/5/2024	8/12/2024	The Contractor should perform varying removal approaches including herbicide treatment and hand pulling to remove the vegetation throughout the Project.	8/5/2024 - Removal methods, including herbicide work and hand pulling have been observed to remove the plant throughout the Project. 8/7/2024 - Japanese hops and other invasives appear to be wilting due to herbicide application. Multiple areas along the trail appear to have not been treated and seed heads have appeared on some of the plants that were not treated. A second application of herbicide and pulling of plants with seedheads is recommended to ensure spreading does not continue. 8/12/2024 - Herbicide application on the Japanese hops and other invasives was occurring at the time of the inspection. Plants that have been previously treated appear to be dead or wilting. 8/16/2024 - A majority of the Japanese hops were observed as wilting, while some plants do not appear to have been treated (i.e., near Station 1003+00).

View of the location where crushed stone requires removal from the path. This photo was taken at Station 303+00; however, these conditions are present throughout the Project.
