Environmental Monitor Construction Site Inspection Report
MassDOT Project #608164 Construction Contract # 119678
EM Report #19

Project Description: Bruce Freeman Rail Trail Right-of-Way
 Permit Description(s): Order of Conditions (MGL Chapter 131, Section 40 and 310 CMR 10.00, Mass DEP File No. 301-1362); 2022 EPA NPDES General Permit for Discharges from Construction Areas; U.S. Army Corps of Engineers Permit No NAE-2021-01975.

Project Name:	Bruce Freeman Rail Trail - Phase 2d - Sudbury
Date of Inspections:	8/20/2024
Bi Weekly/ Monthly Period Covered:	August Weekly Inspection #5
Inspector's Name(s):	Anna Haznar
Inspectors' Contact Information:	ahaznar@beta-inc.com

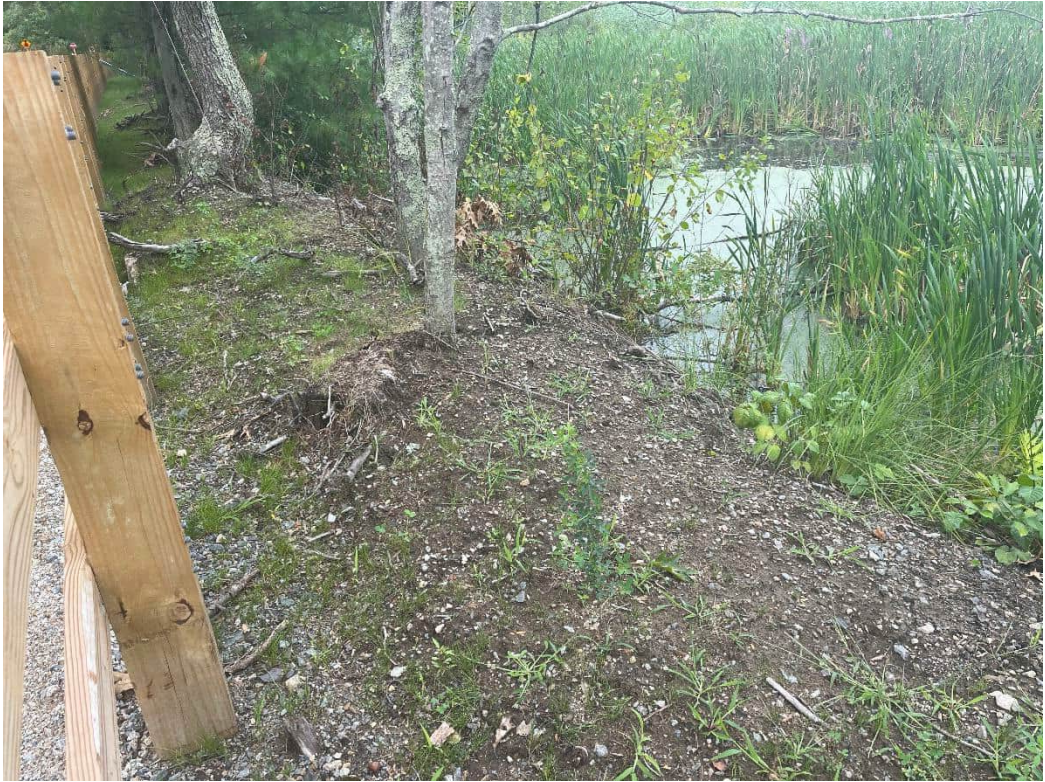
Photo No. 1 **Date:**
8/20/2024

View of the slopes that require stabilization at Station 106+00 per Compliance Action Item 44.

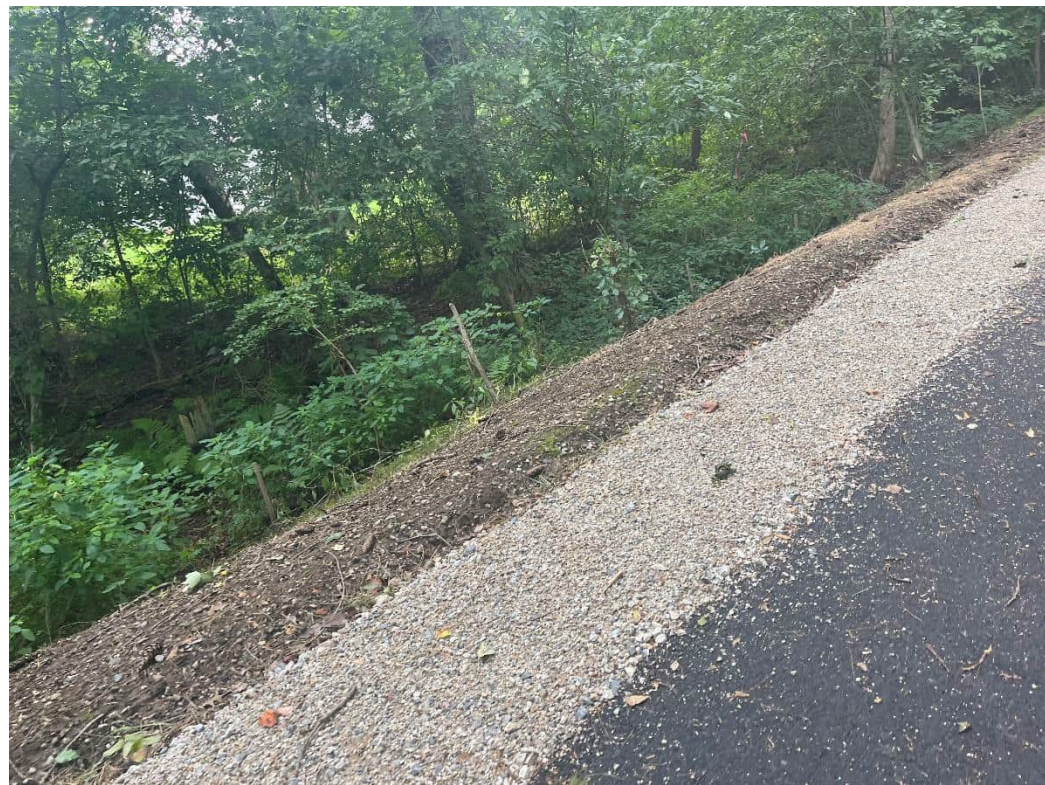
Photo No. 2 **Date:**
8/20/2024

View of a slope that has become destabilized due to herbicide application at Station 137+50 per Compliance Action item 57.

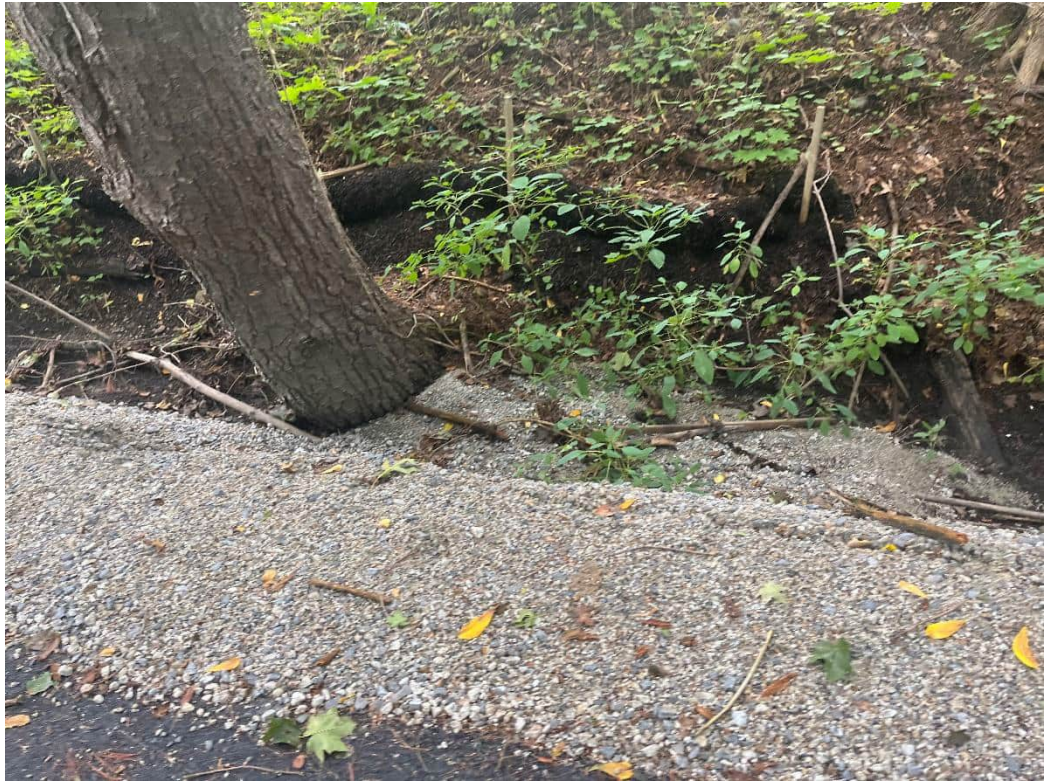
Photo No. 3 **Date:**
8/20/2024

View of crushed stone that requires removal from the drainage swale at Station 170+00 per Compliance Action Item 56.

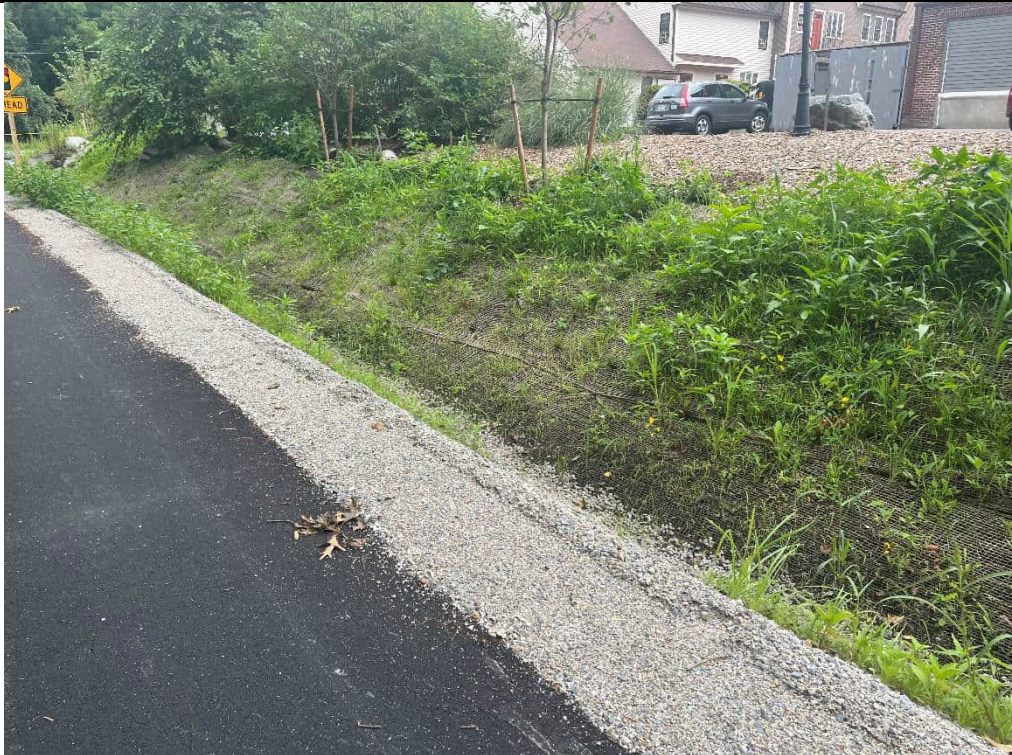
Photo No. 4 **Date:**
8/20/2024

View of crushed stone that requires removal from the swale at Station 173+50 per Compliance Action Item 53.

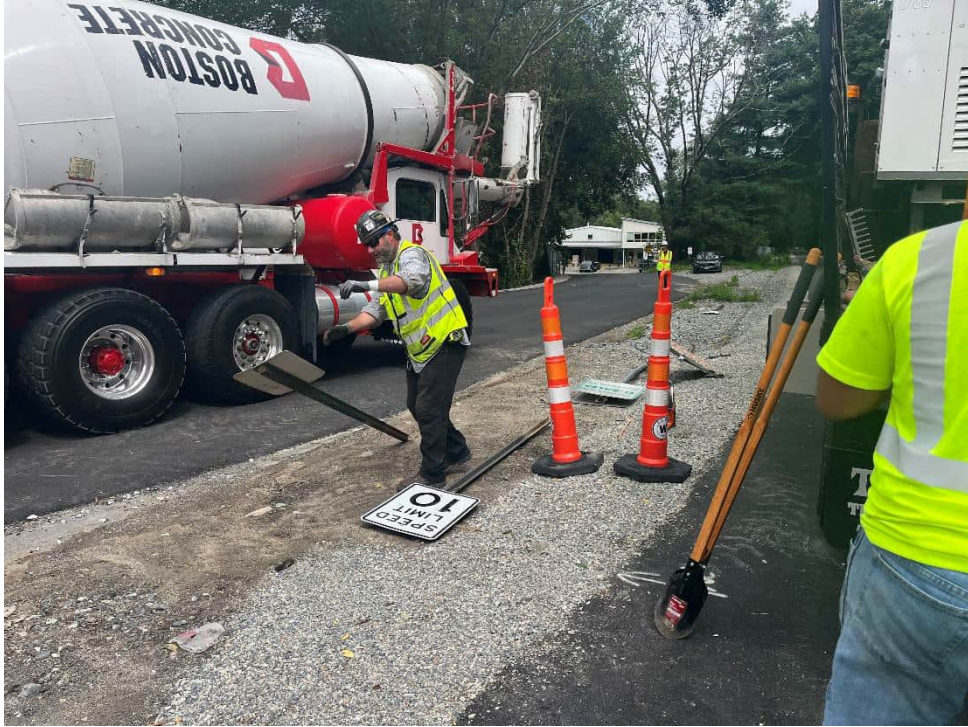
Photo No. 5 **Date:**
8/20/2024

View of the active installation of signage at the Hudson Road intersection.

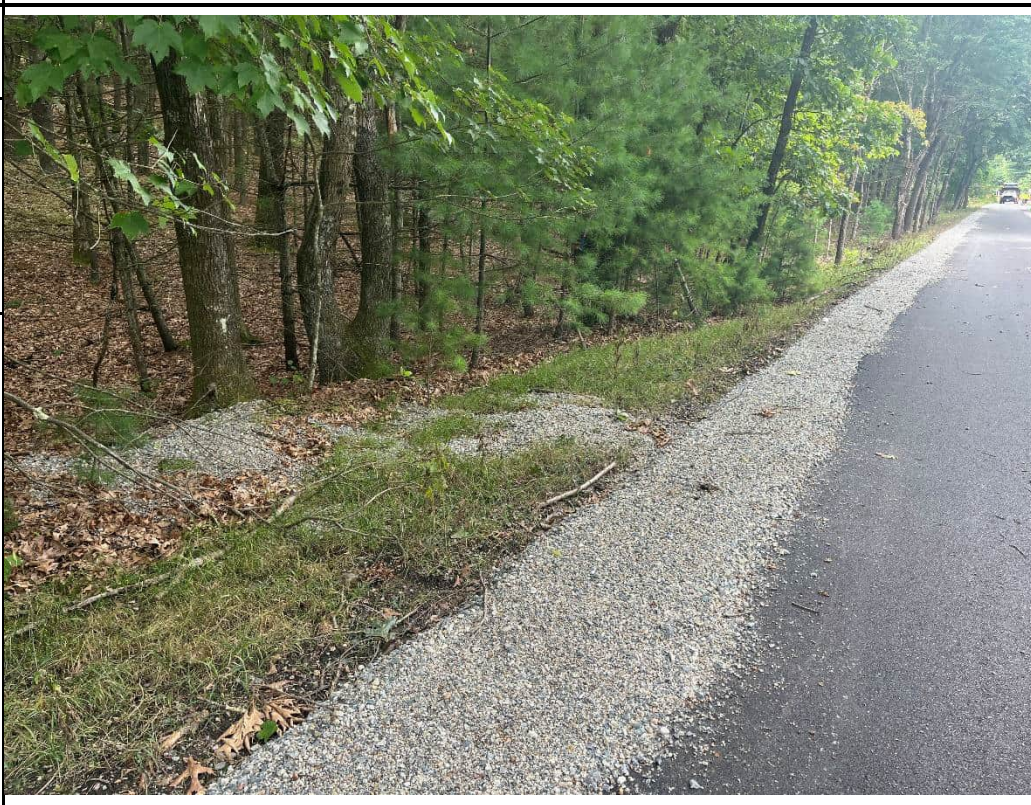
Photo No. 6 **Date:**
8/20/2024

View of crushed stone that has migrated off of the side of the path at Station 182+00 per Long Term Compliance Action Item 55.

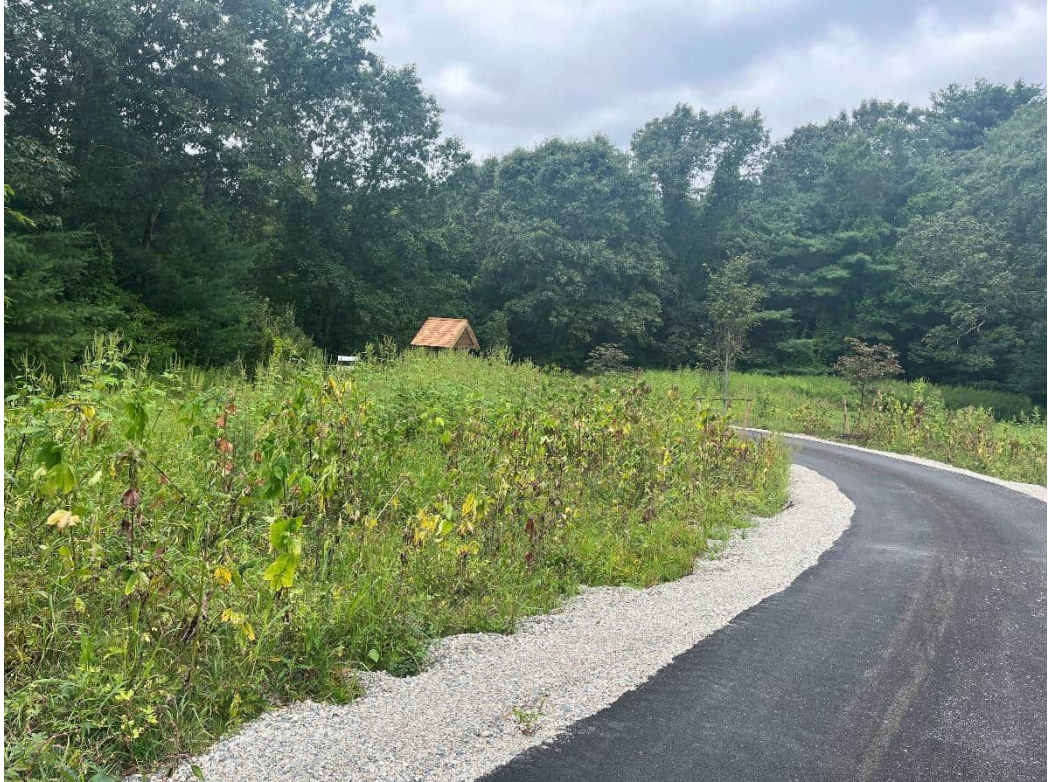
Photo No. 7 **Date:**
8/20/2024

View of an area where Japanese hops require treatment at Station 1002+00 per Long term Compliance Action Item 57.

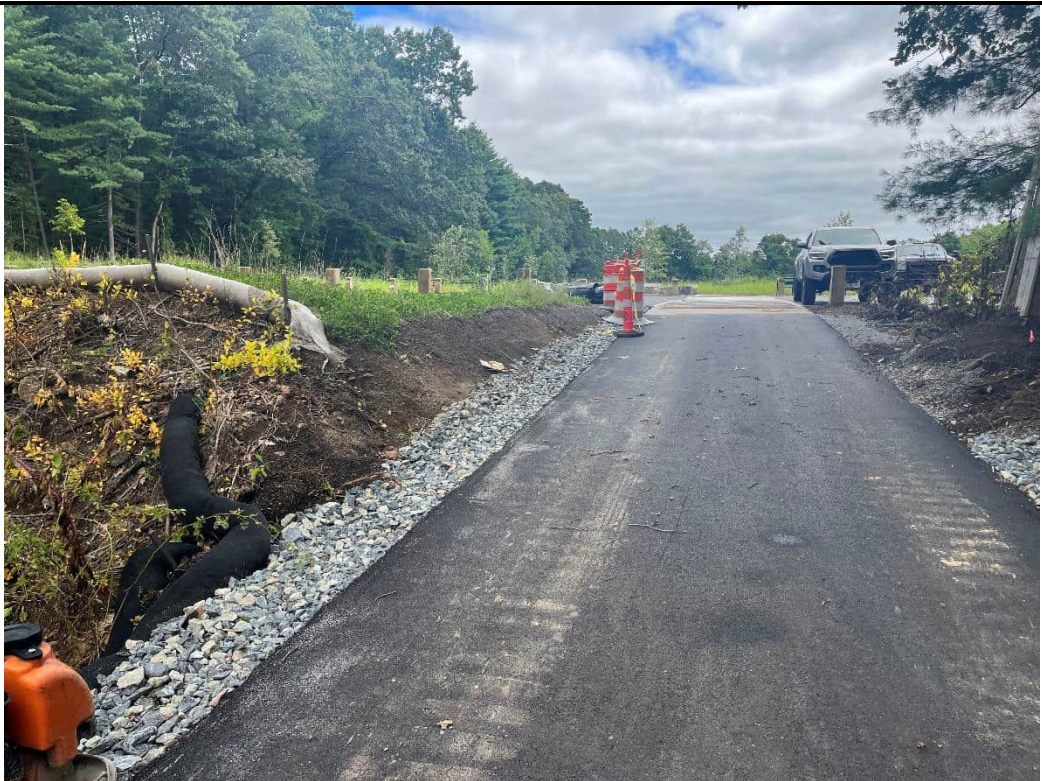
Photo No. 8 **Date:**
8/20/2024

52	Slope along the driveway to the parking lot at Station 216+50 requires stabilization Priority: Medium	7/29/2024	8/6/2024	Install erosion control blanket and place seed.	8/5/2024 - Observation remains. 8/7/2024 - Observation remains. 8/12/2024 - Observation remains. 8/16/2024 - Observation remains 8/20/2024 - Observation remains. Erosion controls have been installed between the slope and the downgradient stream, but seed is still required.
51	Stone dust requiring sweeping was observed within and to the east of the trail at Station 297+00 to 298+00 and 308+00. Priority: High	7/29/2024	8/6/2024	Sweep stone dust from trail and sides of trail.	8/5/2024 - Observation remains. 8/7/2024 - Observation remains. Crushed stone was observed in the path throughout the Project in varying volumes and requires sweeping. 8/12/2024 - Crushed stone was observed on the path throughout the Project. 8/16/2024 - Crushed stone is still present. 8/20/2024 - Observation remains.

View of the slope that requires stabilization along the driveway to the parking lot at Station 216+50 per Compliance Action item 52. Unpermitted work per Long Term Compliance Action Item 41 is still occurring.

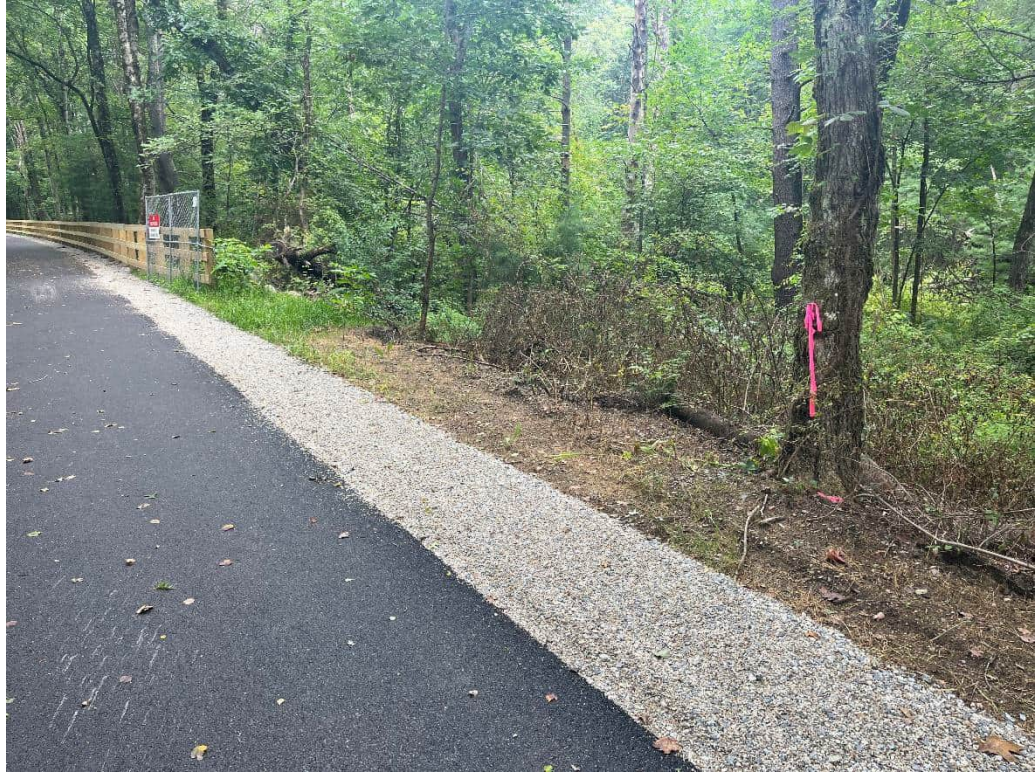
Photo No. 11 **Date:**
8/20/2024

View of another area that has become destabilized due to herbicide application at Station 223+00 per Long Term Compliance Action item 57.

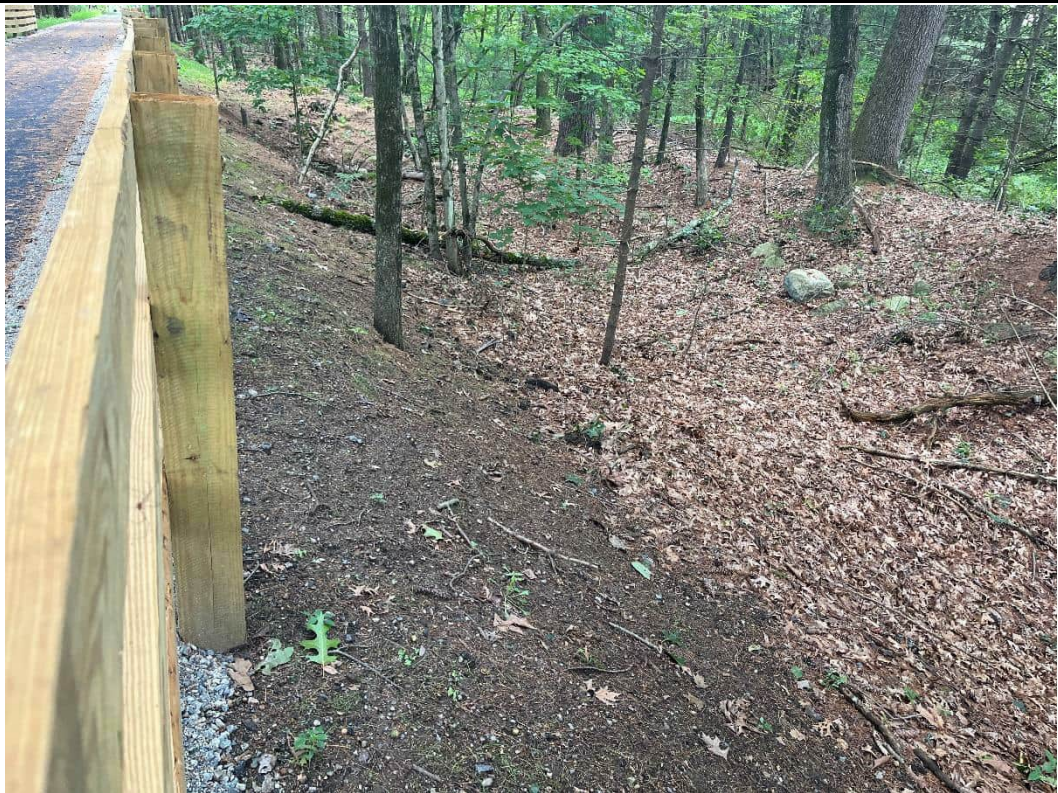
Photo No. 12 **Date:**
8/20/2024

47	Slope stabilization required due to condition of compost filter tubes at Station 265+50 and 273+00 Priority: High	6/7/2024	6/14/2024	Stabilize the slope with the approved seed mixture and provide interim stabilization such as straw mulch.	<p>6/14/2024 - Observation remains. 6/17/2024 - Observation remains. 6/24/2024 - Observation remains. 6/27/2024 - Observation remains. 7/8/2024 - Observation remains. 7/15/2024 - This area could not be assessed due to paving operations ongoing during the inspection. 7/22/2024 - Observation remains. 7/29/2024 - Observation remains. 8/5/2024 - Observation remains. 8/7/2024 - Regrowth of vegetation has been observed in this area. This item will remain open until the area is fully stabilized. 8/12/2024 - Observation remains. 8/16/2024 - Observation remains. 8/20/2024 - Application of the approved seed mixture is required at this location.</p>
34	Sediment is eroding downhill from behind the cemented stone masonry wall at Station 217+45 Priority: Low	5/28/2024	6/4/2024	Apply seed and temporarily stabilize the soils along the slope with straw, jute netting, etc.	<p>5/31/2024 - Observation remains. 6/7/2024 - Observation remains. 6/14/2024 - Observation remains. 6/17/2024 - Observation remains. 6/24/2024 - Observation remains. 6/27/2024 - Rills were raked, loam was added, and hydroseed was applied. 7/8/2024 - Observation remains. Grass was observed to be germinating at this location. Comment will remain open until stabilization is complete. 7/8/2024 - See previous update. 7/15/2024 - Additional hydroseed is required due to washouts. 7/22/2024 - Observation remains. 7/29/2024 - Observation remains. 8/5/2024 - Observation remains. 8/7/2024 - Regrowth of vegetation has been observed in this area. This item will remain open until the area is fully stabilized. 8/12/2024 - Observation remains. Regrowth has stabilized a portion of this hill; however, reseeding and additional temporary stabilized measures are recommended on the section that is currently unvegetated. 8/16/2024 - Observation remains. 8/20/2024 - Application of the approved seed mixture is required at this location.</p>

View of the a slope requiring stabilization at Station 270+00 per Compliance Action Item 47.
