**Environmental Monitor Construction Site Inspection Report  
 MassDOT Project #608164 Construction Contract # 119678  
 EM Report #6**

Project Description: Bruce Freeman Rail Trail Right-of-Way  
 Permit Description(s): Order of Conditions (MGL Chapter 131, Section 40 and 310 CMR 10.00, Mass DEP File No. 301-1362); 2022 EPA NPDES General Permit for Discharges from Construction Areas; U.S. Army Corps of Engineers Permit No NAE-2021-01975.

Project Name:	Bruce Freeman Rail Trail - Phase 2d - Sudbury
Date of Inspections:	6/7/2024
Bi Weekly/ Monthly Period Covered:	June Weekly Inspection #1
Inspector's Name(s):	Jonathan Niro
Inspectors' Contact Information:	<a href="mailto:jniro@beta-inc.com">jniro@beta-inc.com</a>

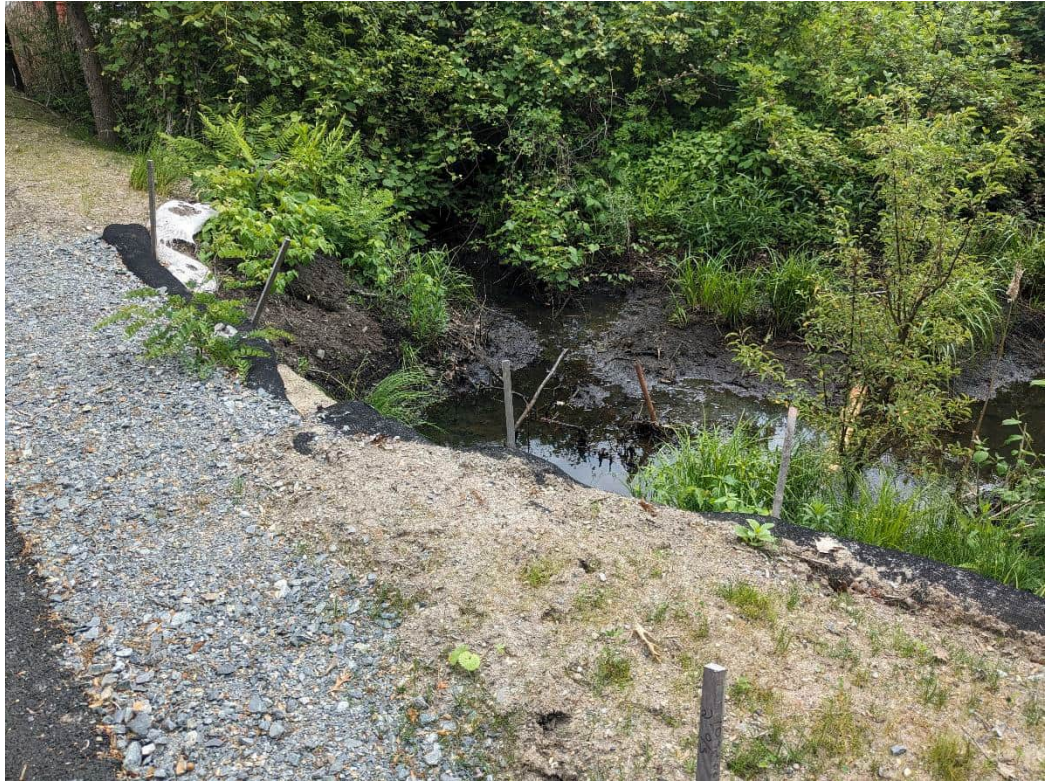
**Photo No. 1**    **Date:**  
6/7/2024

Item	Location/ Description	Observation Date	Resolution Due Date	Recommended Resolution / Resolution Date	Comments/Updates
43	Overtopped compost filter tubes and exposed soils beyond the limits of work at Station 105+00 <b>Priority: High</b>	6/7/2024	6/14/2024	Stabilize the area with the approved seed mixture and provide interim stabilization such as straw mulch.	
44	Slopes require stabilization/ additional seed due to lack of compost filter tubes at 105+00 and 106+00 <b>Priority: High</b>	6/7/2024	6/14/2024	Stabilize the slope with the approved seed mixture and provide interim stabilization such as straw mulch.	
45	Erosion observed along east side of trail at Station 225+50 <b>Priority: Medium</b>	6/7/2024	6/14/2024	Stabilize the slope with the approved seed mixture and provide interim stabilization such as straw mulch.	
46	Erosion control breaches observed at Station 310+00 <b>Priority: Medium</b>	6/7/2024	6/14/2024	Repair erosion controls.

View of slopes requiring stabilization and overtopped compost filter tubes at Station 105+00 to 106+00 per Compliance Action Items 43 and 44.

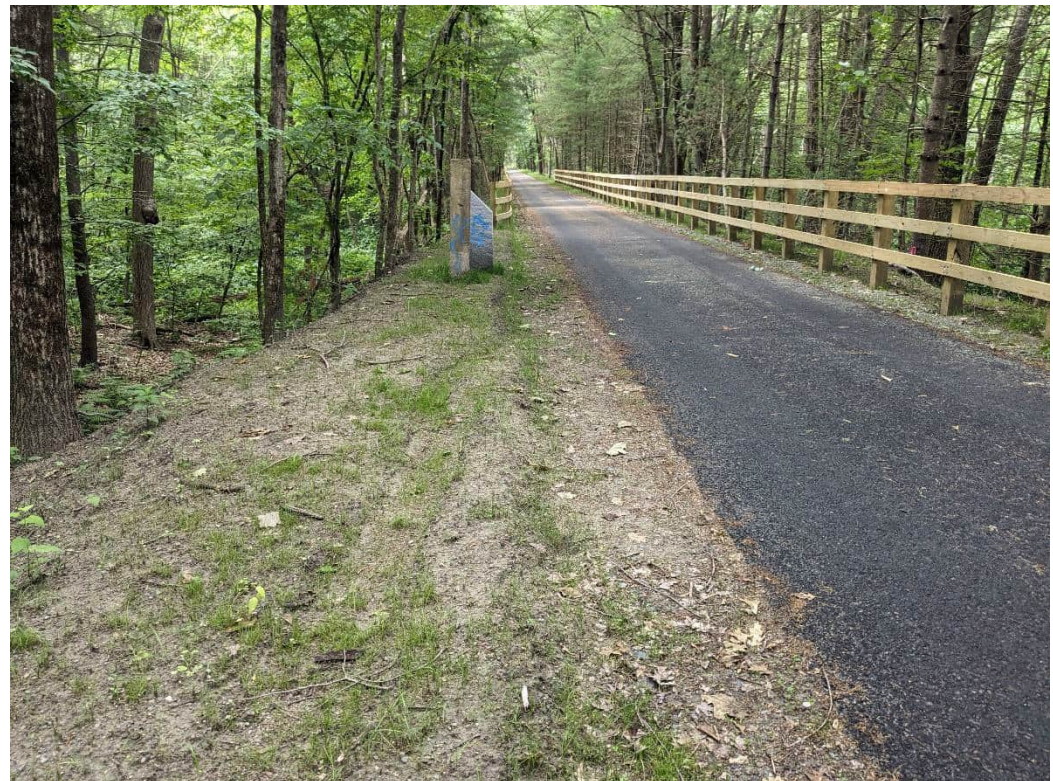
**Photo No. 2**    **Date:**  
6/7/2024

View of the location where stabilization and sediment removal is required near Station 162+00 per Compliance Action Item 3.

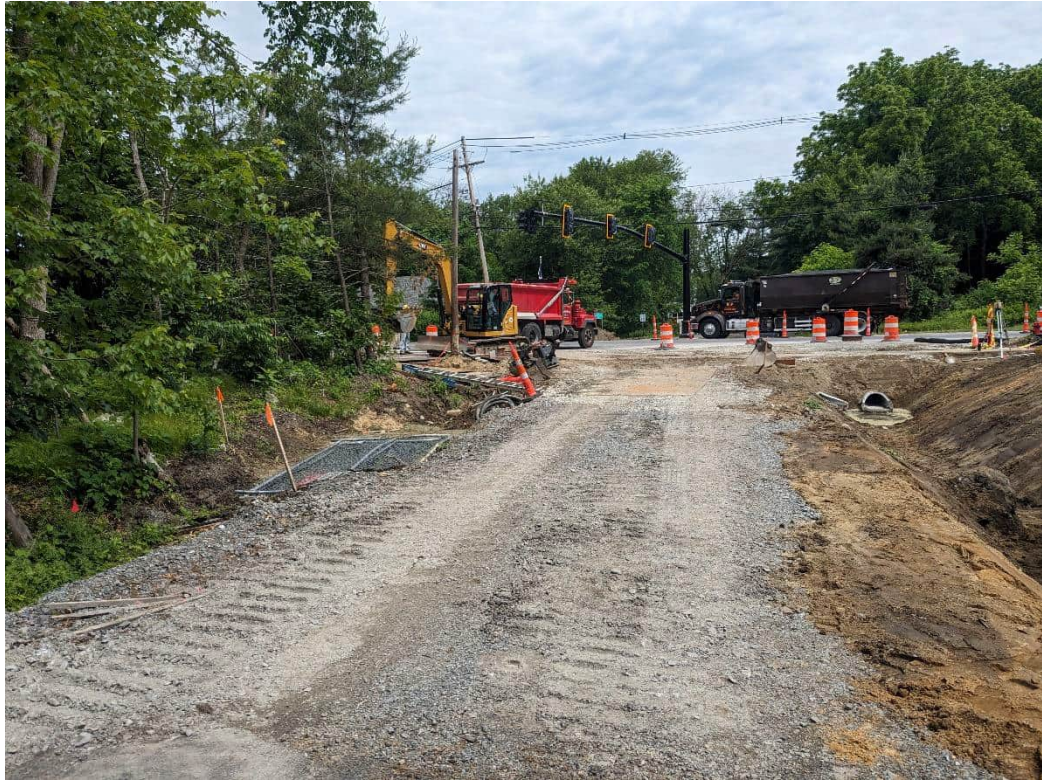
**Photo No. 3**    **Date:**  
6/7/2024

View of active construction and exposed soils near Station 174+00 per Compliance Action Item 6.

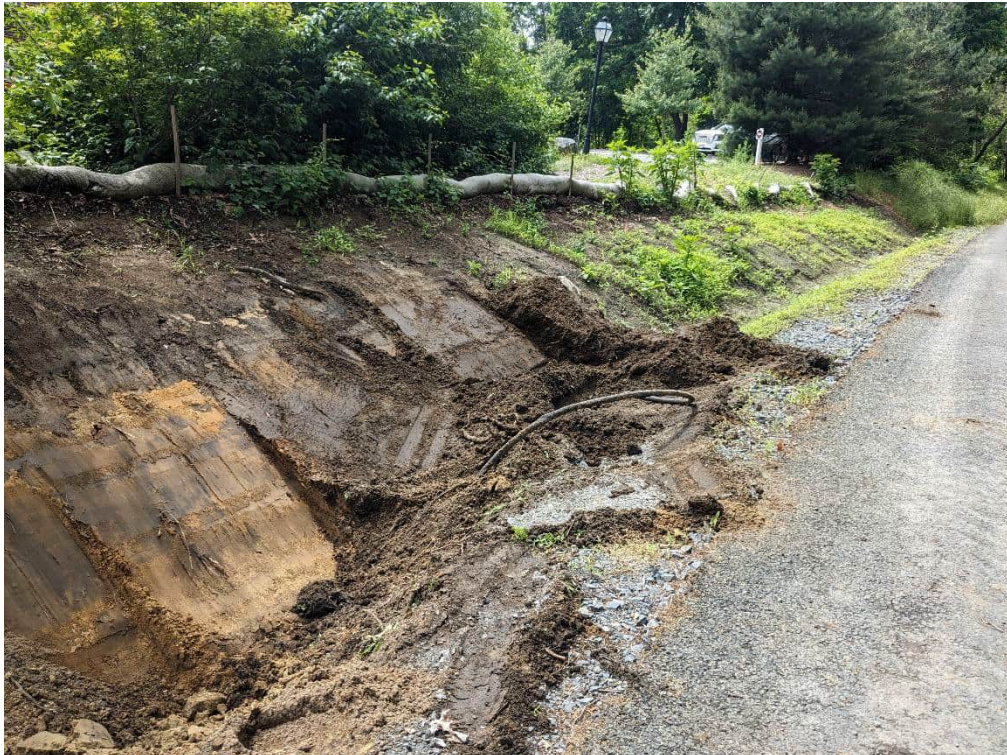
**Photo No. 4**    **Date:**  
6/7/2024

Another view of active construction and exposed soils near Station 174+00 per Compliance Action Item 6.

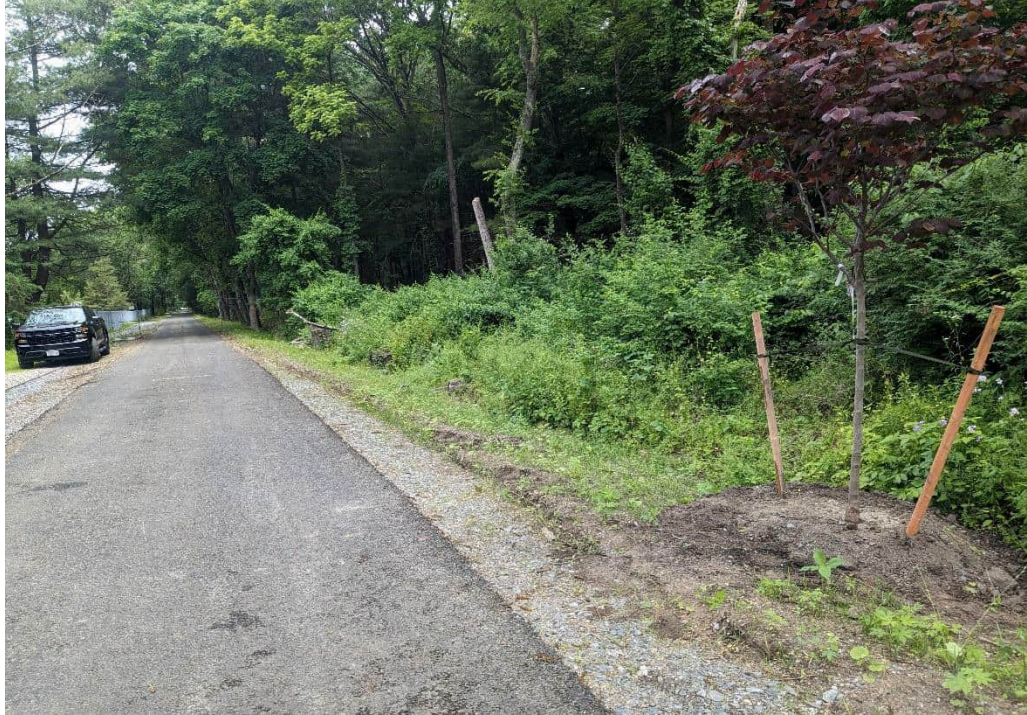
**Photo No. 5**    **Date:**  
6/7/2024

View of installed planting at 186+50

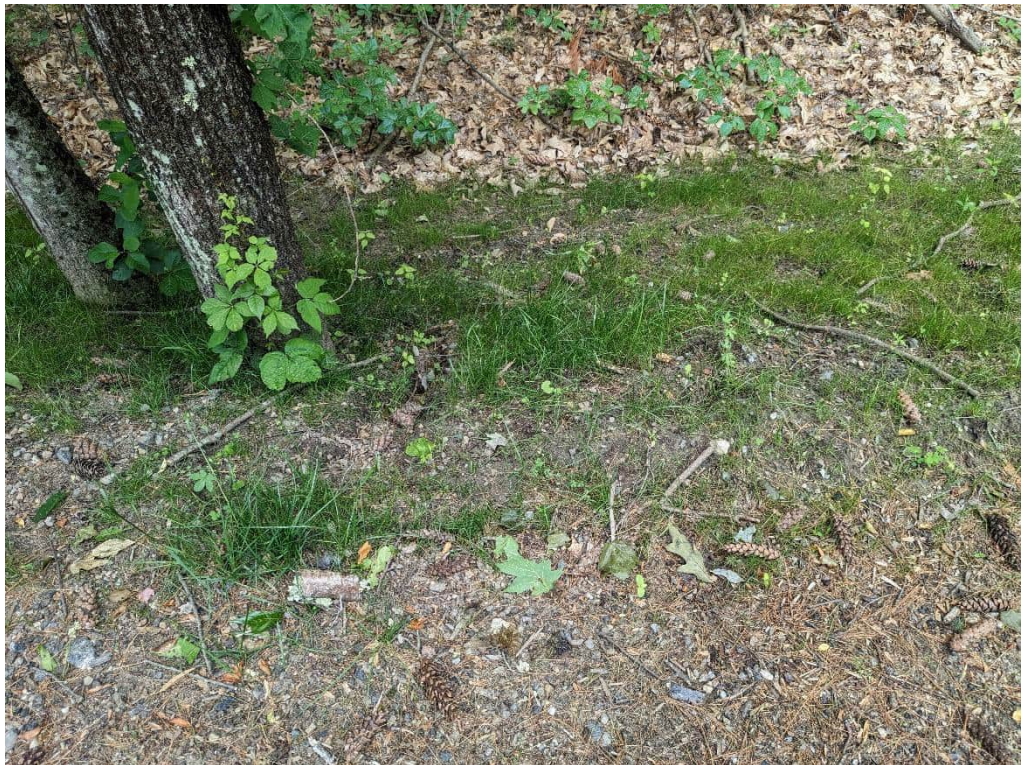
**Photo No. 6**    **Date:**  
6/7/2024

13	Rill erosion is occurring along the west side of the trail at Stations 201+50 to 204+00 <b>Priority: Low</b>	5/8/2024	5/15/2024	Fill in rills and apply seed to stabilize the area. Temporary stabilization measures such as straw and/or jute netting may be required.	5/16/2024 - Observation remains. 5/21/2024 - Observation remains. 5/28/2024 - Rill erosion has not been filled; however, germination was observed. 5/31/2024 - Observation remains. 6/7/2024 - Vegetation is becoming established; however, rills should be filled in and seeded.
14	Sediment-laden runoff is being discharged into a stream from the new parking lot at Station 216+50 <b>Priority: High</b>	5/8/2024	5/15/2024	Replace compost filter tubes around the stream and develop a method of redirecting runoff from the parking lot at the source.	5/16/2024 - New compost filter tubes have been installed but were observed to be undermined. In addition, a new earthen slope was observed to be constructed in this area and requires stabilization. 5/21/2024 - No turbidity was observed due to no rain preceding this inspection. However, additional erosion controls should be explored at this location to prevent future discharges. 5/28/2024 - Untreated runoff being discharged from the parking area has not been addressed, and work is occurring along the stream beyond the compost filter tubes. 5/31/2024 - Observation remains. 6/7/2024 - Observation remains.

View of typical rill erosion and sediment runoff along the west side of the trail from Station 201+00 through 204+00 per Compliance Action Item 13.

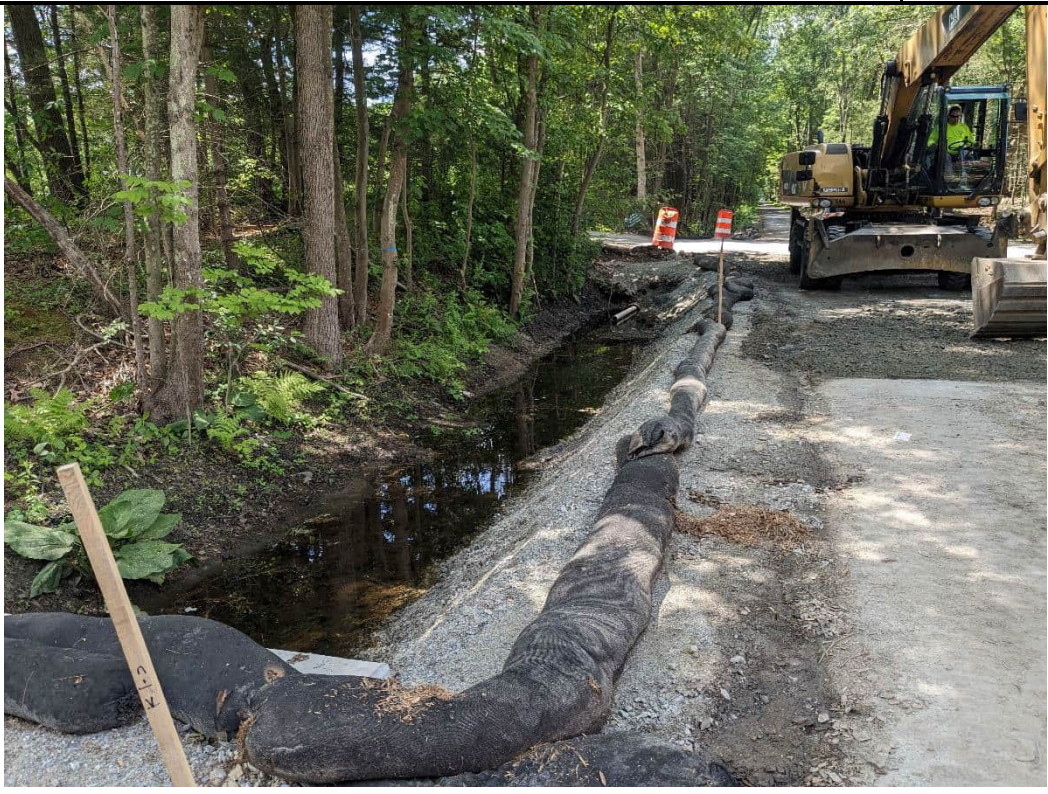
**Photo No. 7**    **Date:**  
6/7/2024

Overall Adherence to Environmental Permits	Yes	As noted in Action Items 41 and 42, it appears that work has been conducted beyond the limits of work approved under the Order of Conditions. These areas will require coordination amongst the Project Team to confirm if any restoration is required.

View of grading of the stream Bank beyond the limits of work at Station 216+00 per Compliance Action Item 41.

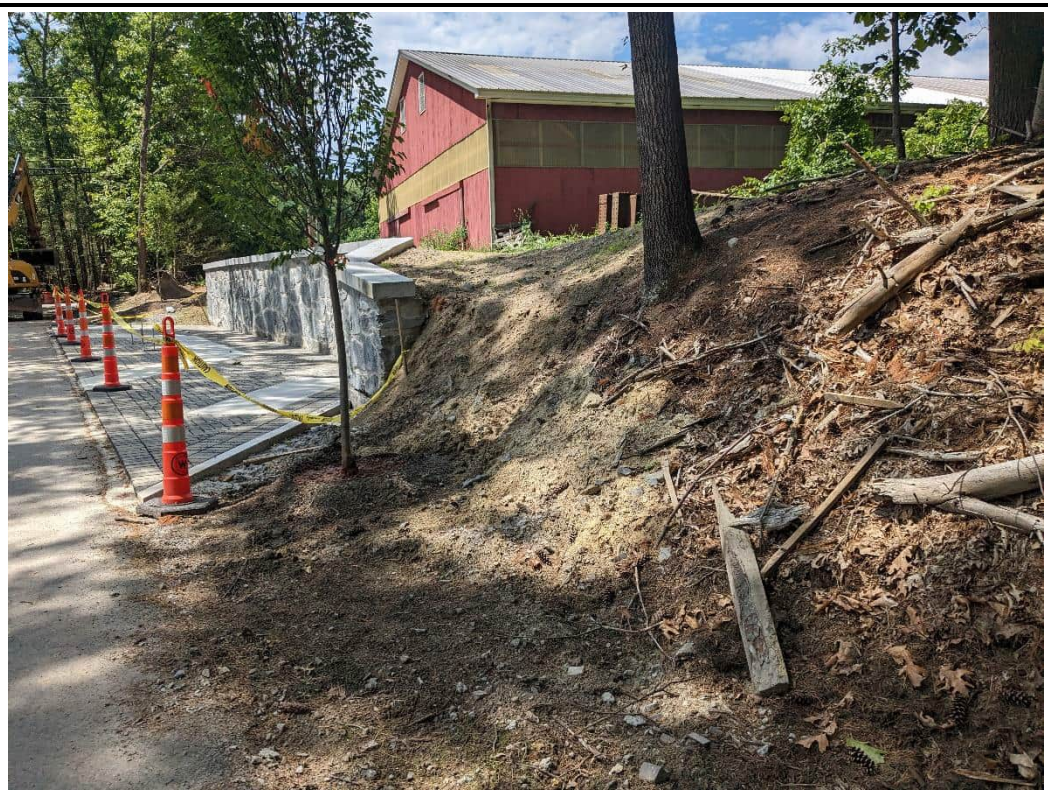
**Photo No. 8**    **Date:**  
6/7/2024

View of exposed soils along a newly constructed masonry wall that require stabilization at Station 217+45 per Compliance Action Item 34.
