**Environmental Monitor Construction Site Inspection Report
MassDOT Project #608164 Construction Contract # 119678
EM Report #7**

Project Description: Bruce Freeman Rail Trail Right-of-Way
Permit Description(s): Order of Conditions (MGL Chapter 131, Section 40 and 310 CMR 10.00, Mass DEP File No. 301-1362); 2022 EPA NPDES General Permit for Discharges from Construction Areas; U.S. Army Corps of Engineers Permit No NAE-2021-01975.

Project Name:	Bruce Freeman Rail Trail - Phase 2d - Sudbury
Date of Inspections:	6/14/2024
Bi Weekly/ Monthly Period Covered:	June Weekly Inspection #2
Inspector's Name(s):	Douglas Beach
Inspectors' Contact Information:	dbeach@beta-inc.com

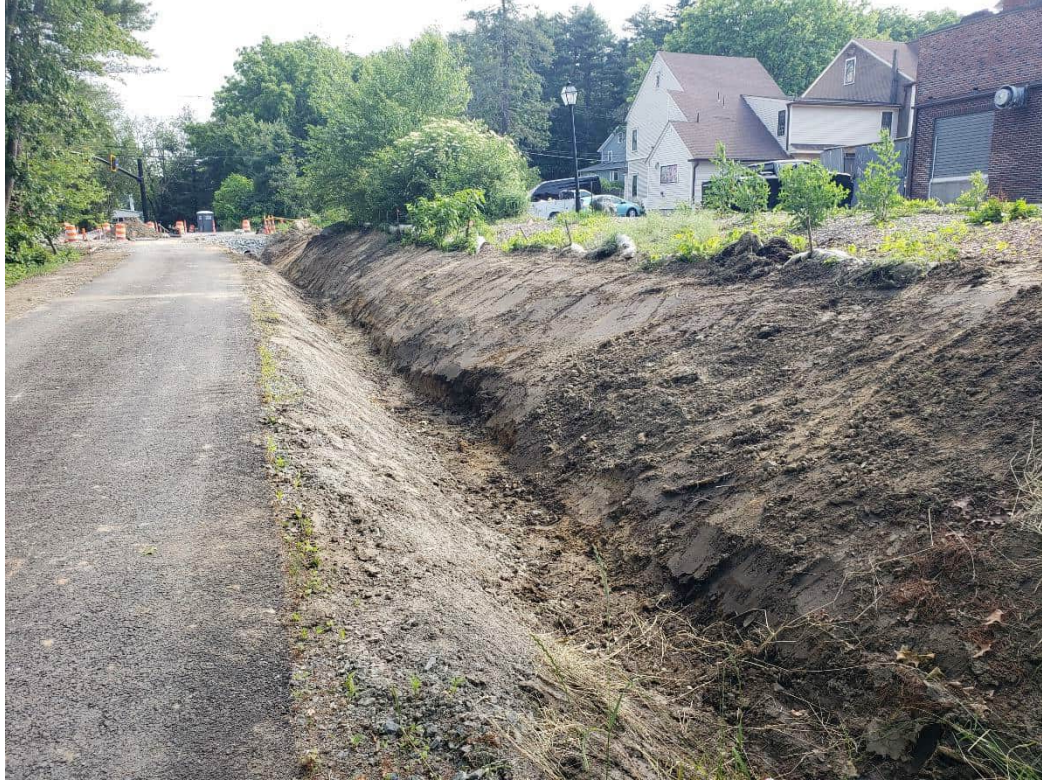
Photo No. 3 **Date:**
6/14/2024

6	Exposed sediment slope at Station 172+00 to 175+00 Priority: High	5/8/2024	5/15/2024	Install temporary sediment controls along the slope such as jute netting and/or straw following the application of seed.	5/16/2024 - Observation remains. 5/21/2024 - Observation remains. 5/28/2024 - Partial germination was observed. 5/31/2024 - See previous update. 6/7/2024 - Further earthwork has occurred and soils require stabilization. 6/14/2024 - Observation remains.

View of active construction and exposed soils near Station 174+00 per Compliance Action Item 6.

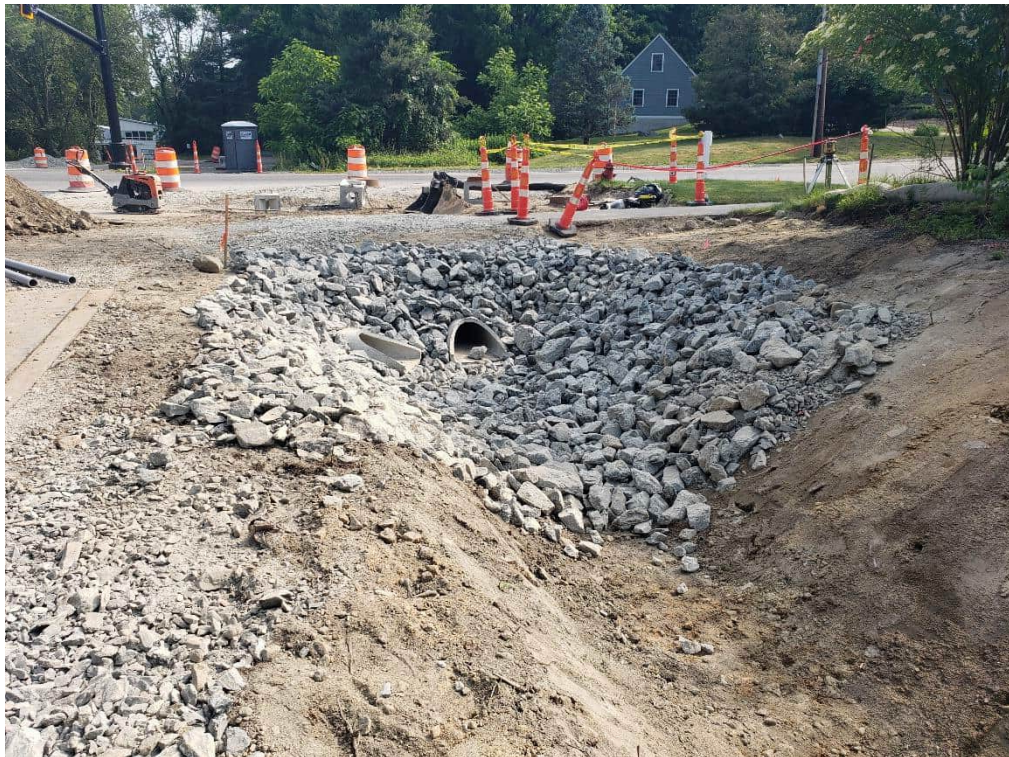
Photo No. 4 **Date:**
6/14/2024

Another view of active construction and exposed soils near Station 174+00 per Compliance Action Item 6.

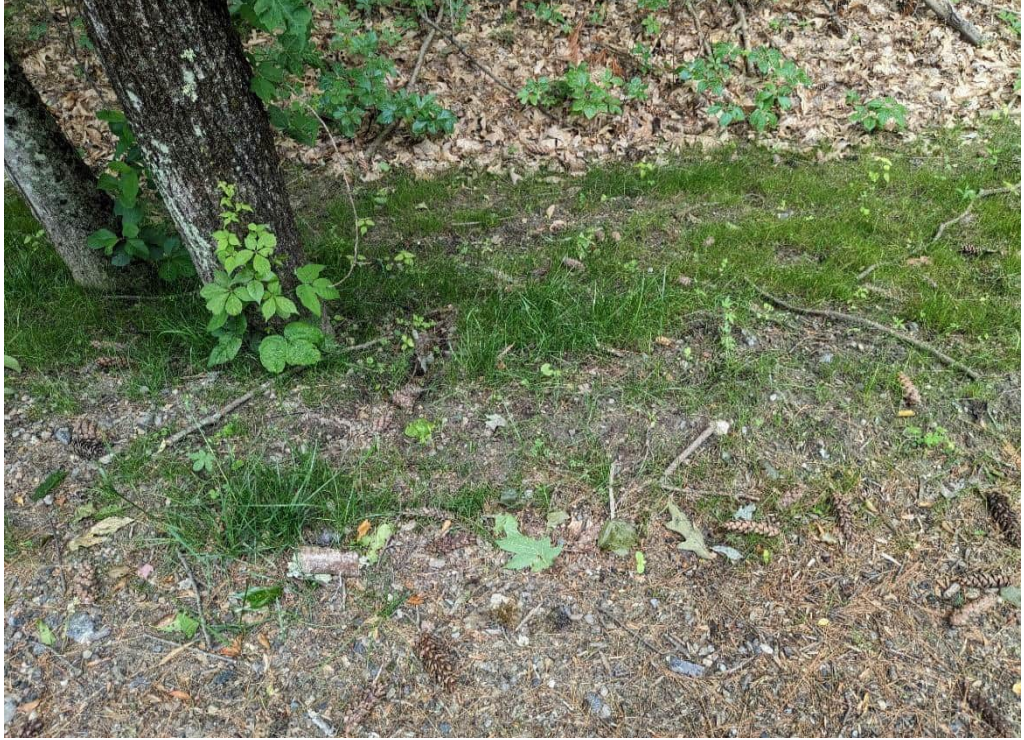
Site Location Bruce Freeman Rail Trail Right-of-Way		BETA Project No. 24.10326.23
Photo No. 5	Date: 6/14/2024

13	Rill erosion is occurring along the west side of the trail at Stations 201+50 to 204+00 Priority: Low	5/8/2024	5/15/2024	Fill in rills and apply seed to stabilize the area. Temporary stabilization measures such as straw and/or jute netting may be required.	5/16/2024 - Observation remains. 5/21/2024 - Observation remains. 5/28/2024 - Rill erosion has not been filled; however, germination was observed. 5/31/2024 - Observation remains. 6/7/2024 - Vegetation is becoming established; however, rills should be filled in and seeded. 6/14/2024 - Observation remains.
14	Sediment-laden runoff is being discharged into a stream from the new parking lot at Station 216+50 Priority: High	5/8/2024	5/15/2024	Replace compost filter tubes around the stream and develop a method of redirecting runoff from the parking lot at the source.	5/16/2024 - New compost filter tubes have been installed but were observed to be undermined. In addition, a new earthen slope was observed to be constructed in this area and requires stabilization. 5/21/2024 - No turbidity was observed due to no rain preceding this inspection. However, additional erosion controls should be explored at this location to prevent future discharges. 5/28/2024 - Untreated runoff being discharged from the parking area has not been addressed, and work is occurring along the stream beyond the compost filter tubes. 5/31/2024 - Observation remains. 6/7/2024 - Observation remains. 6/14/2024 - Observation remains.

Direction Photo Taken: Toward the Northwest		
Description: View of typical rill erosion and sediment runoff along the west side of the trail from Station 201+00 through 204+00 per Compliance Action Item 13.		
Photo No. 6	Date: 6/14/2024

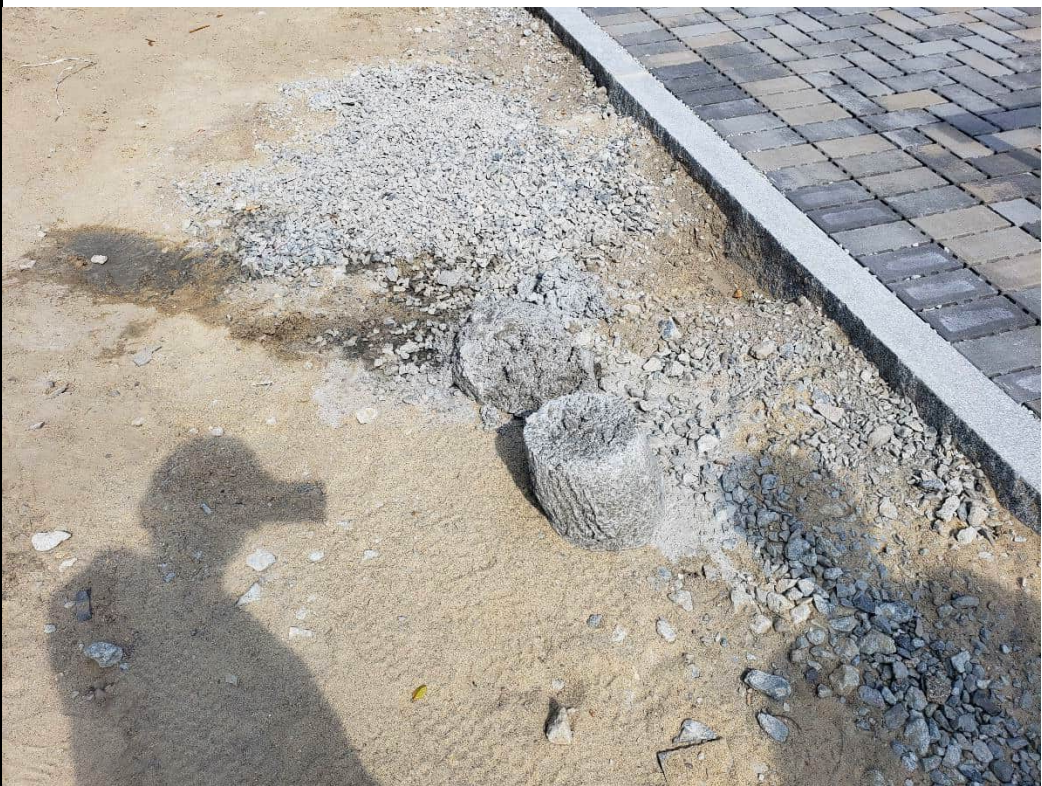
Direction Photo Taken: Toward the West		
Description: View of improperly disposed of concrete pile in parking lot next to rest stop near Station 216+00 per Compliance Action Item 48.

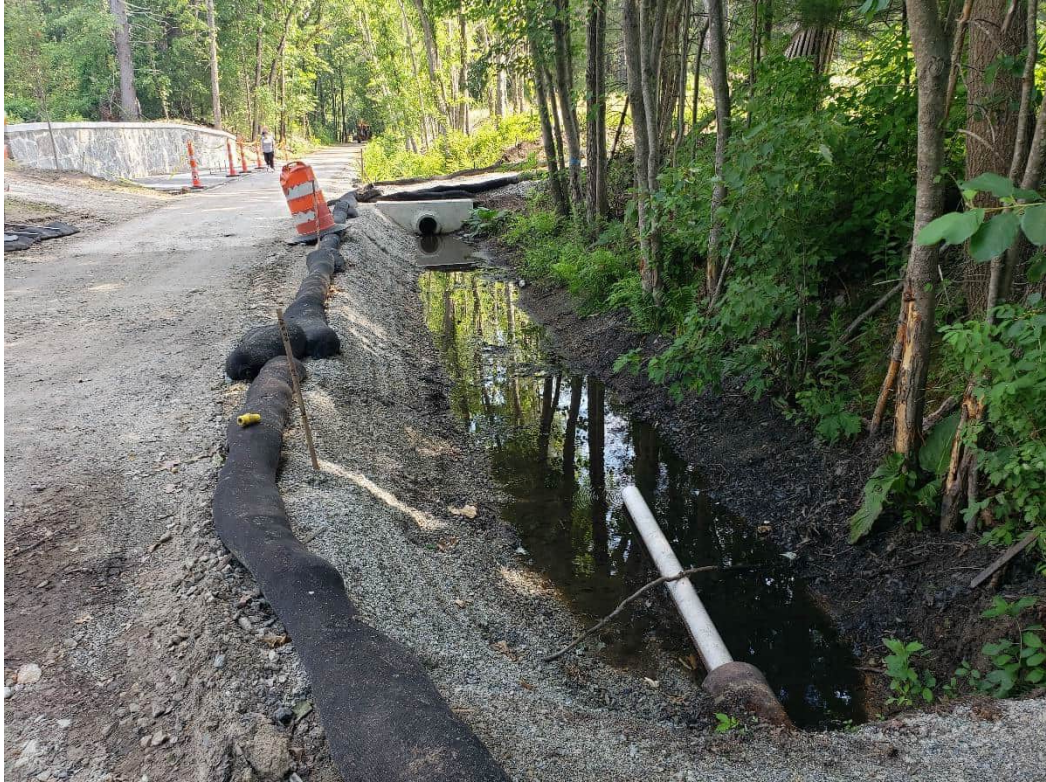
Photo No. 7 **Date:**
6/14/2024

Overall Adherence to Environmental Permits	Yes	As noted in Action Items 41 and 42, it appears that work has been conducted beyond the limits of work approved under the Order of Conditions. These areas will require coordination amongst the Project Team to confirm if any restoration is required.

View of grading of the stream Bank beyond the limits of work at Station 216+00 per Compliance Action Item 41.

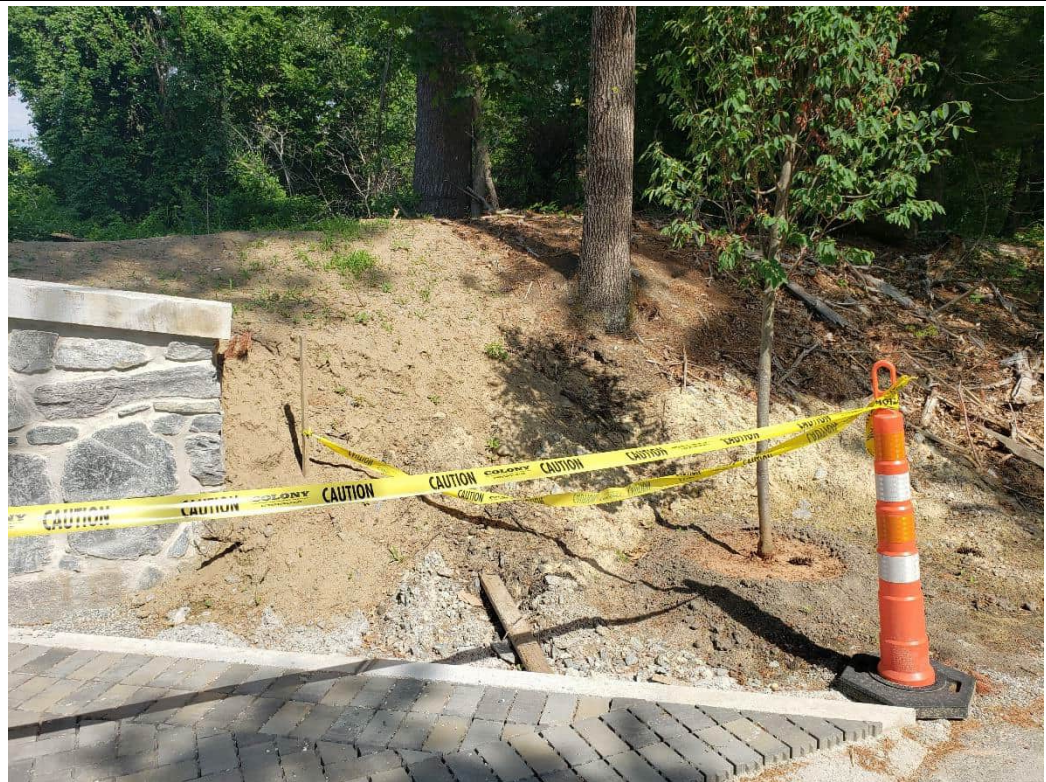
Photo No. 8 **Date:**
6/14/2024

34	Sediment is eroding downhill from behind the cemented stone masonry wall at Station 217+45 Priority: Low	5/28/2024	6/4/2024	Apply seed and temporarily stabilize the soils along the slope with straw, jute netting, etc.	5/31/2024 - Observation remains. 6/7/2024 - Observation remains. 6/14/2024 - Observation remains.
33	Sediment is eroding downhill and offsite at Station 222+00 through Station 236+00 Priority: High	5/21/2024	5/28/2024	Remove rill erosion and remove over washed material from outside limit of work.	5/28/2024 - Hydroseed has been applied and germination was observed. No new erosion was observed. 5/31/2024 - Observation remains. 6/7/2024 - Observation remains. In addition, seed is required on the west side of the trail. 6/14/2024 - Observation remains.
32	Soil and organic debris has been placed within the wetland between wetland flagging WF#23-119 and WF#23-118 at Station 224+00 Priority: High	5/21/2024	5/28/2024	Remove all material and provide stabilization of the area with the approved wetland seed mixture. Straw should also be placed for interim stabilization.	5/28/2024 - Observation remains. 5/31/2024 - Observation remains. 6/7/2024 - Observation remains. 6/14/2024 - Observation remains.

View of exposed soils along a newly constructed masonry wall that require stabilization at Station 217+45 per Compliance Action Item 34.

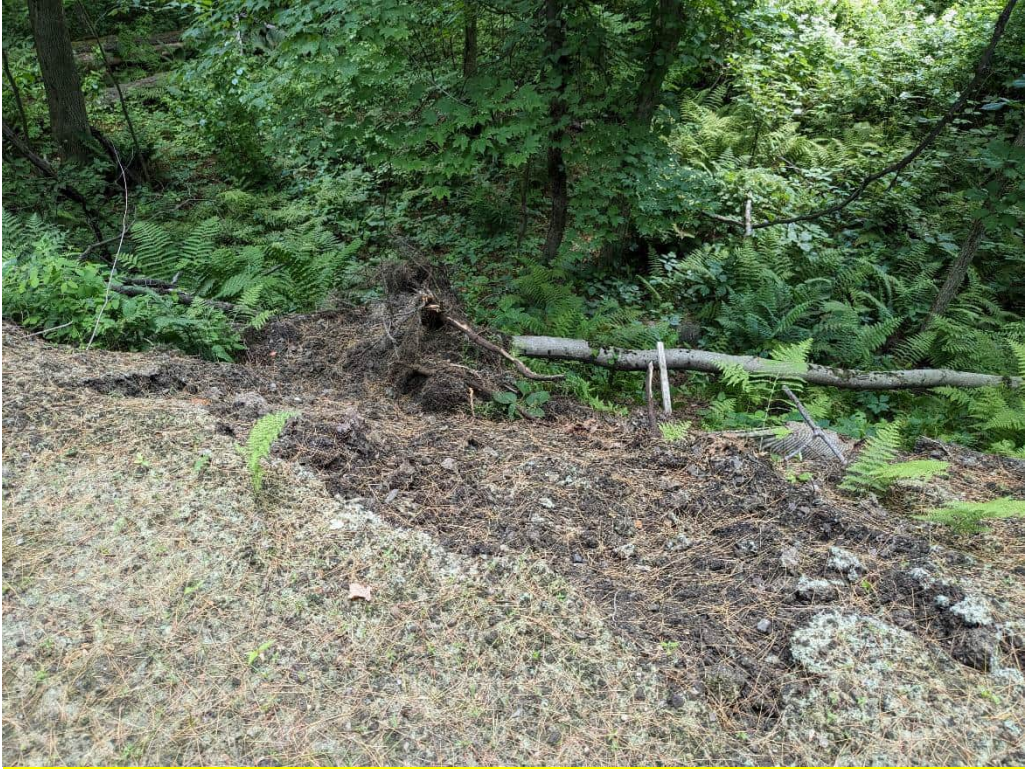
45	Erosion observed along east side of trail at Station 225+50 Priority: Medium	6/7/2024	6/14/2024	Stabilize the slope with the approved seed mixture and provide interim stabilization such as straw mulch.	6/14/2024 - Observation remains.
46	Erosion control breaches observed at Station 310+00 Priority: Medium	6/7/2024	6/14/2024	Repair erosion controls.	6/14/2024 - Observation remains.
47	Slope stabilization required due to condition of compost filter tubes at Station 265+50 and 273+00 Priority: High	6/7/2024	6/14/2024	Stabilize the slope with the approved seed mixture and provide interim stabilization such as straw mulch.	6/14/2024 - Observation remains.
36	Concrete pile improperly disposed of at Station 243+00 Priority: Low	5/28/2024	6/4/2024	Remove concrete pile from the area.	5/31/2024 - Observation remains. 6/7/2024 - Concrete has been removed. 6/14/2024 - Concrete needs to be removed from site once again.

Direction Photo Taken: Toward the West		
Description: View of erosion observed along east side of trail at Station 225+50 per Compliance Action Item 45.		
Photo No. 12	Date: 6/14/2024

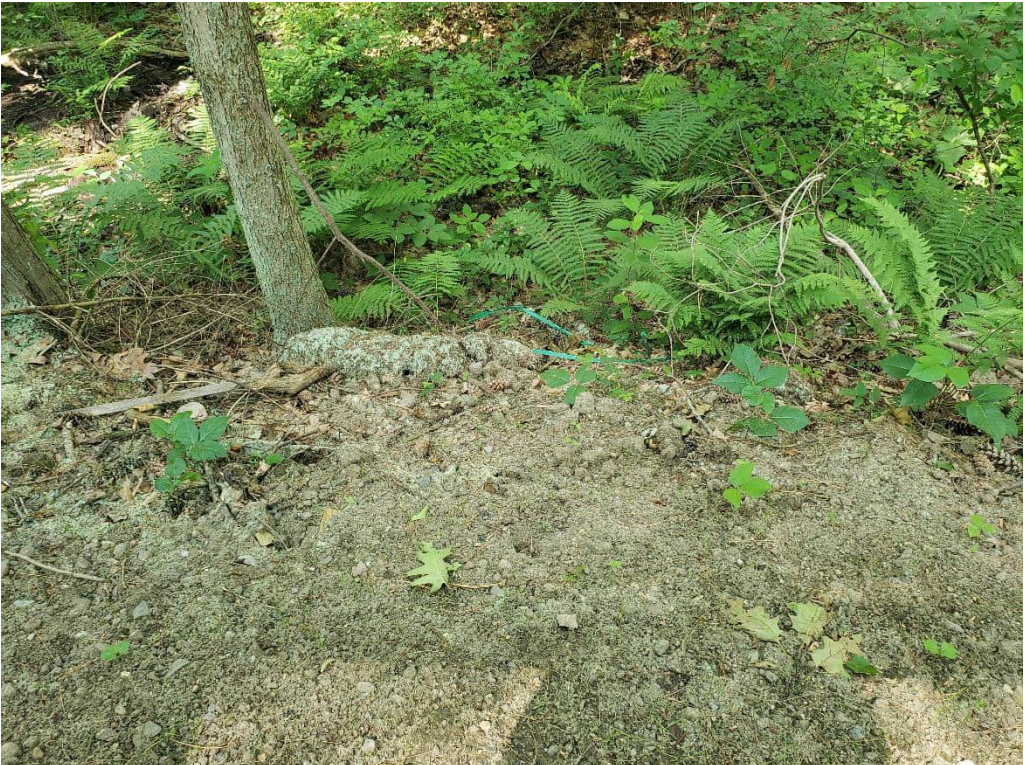
Direction Photo Taken: Toward the East		
Description: View of washout overtopping compost filter tubes at Station 231+00 per Compliance Action Item 16.
