**Environmental Monitor Construction Site Inspection Report  
MassDOT Project #608164 Construction Contract # 119678  
EM Report #8**

Project Description: Bruce Freeman Rail Trail Right-of-Way  
Permit Description(s): Order of Conditions (MGL Chapter 131, Section 40 and 310 CMR 10.00, Mass DEP File No. 301-1362); 2022 EPA NPDES General Permit for Discharges from Construction Areas; U.S. Army Corps of Engineers Permit No NAE-2021-01975.

Project Name:	Bruce Freeman Rail Trail - Phase 2d - Sudbury
Date of Inspections:	6/17/2024
Bi Weekly/ Monthly Period Covered:	June Weekly Inspection #3
Inspector's Name(s):	Douglas Beach
Inspectors' Contact Information:	<a href="mailto:dbeach@beta-inc.com">dbeach@beta-inc.com</a>

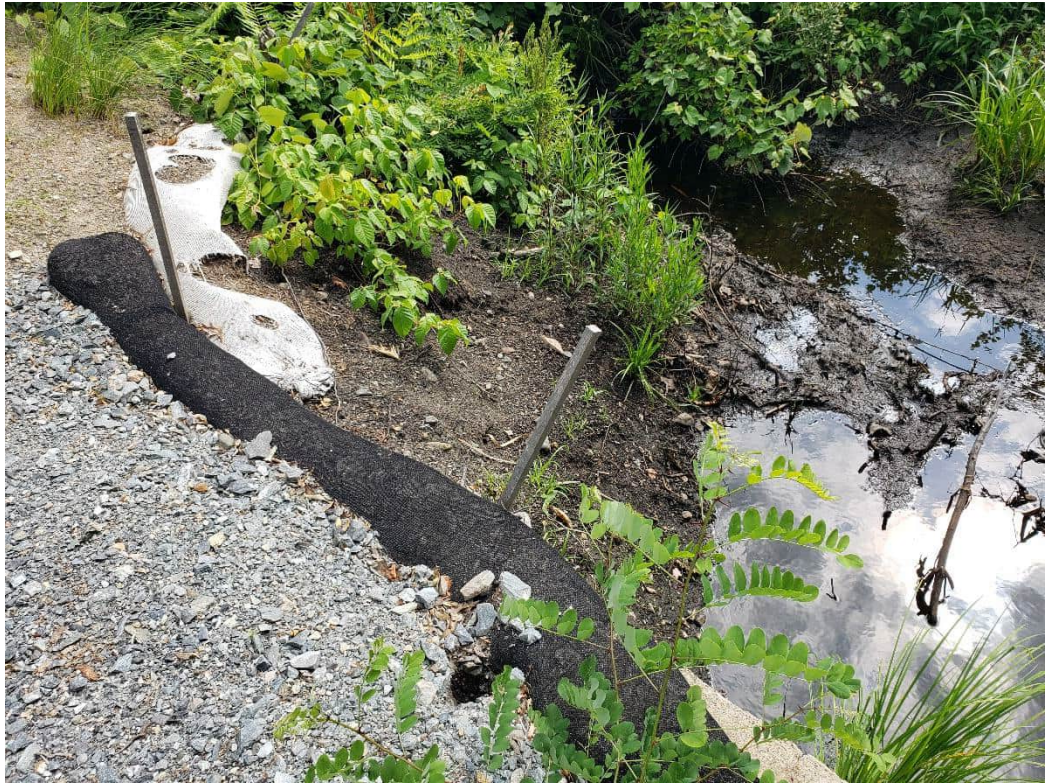
**Photo No. 1**    **Date:**  
6/17/2024

View of slopes requiring stabilization and gravel/sediment accumulation along compost filter tubes at Station 105+00 to 106+00 per Compliance Action Items 43 and 44.

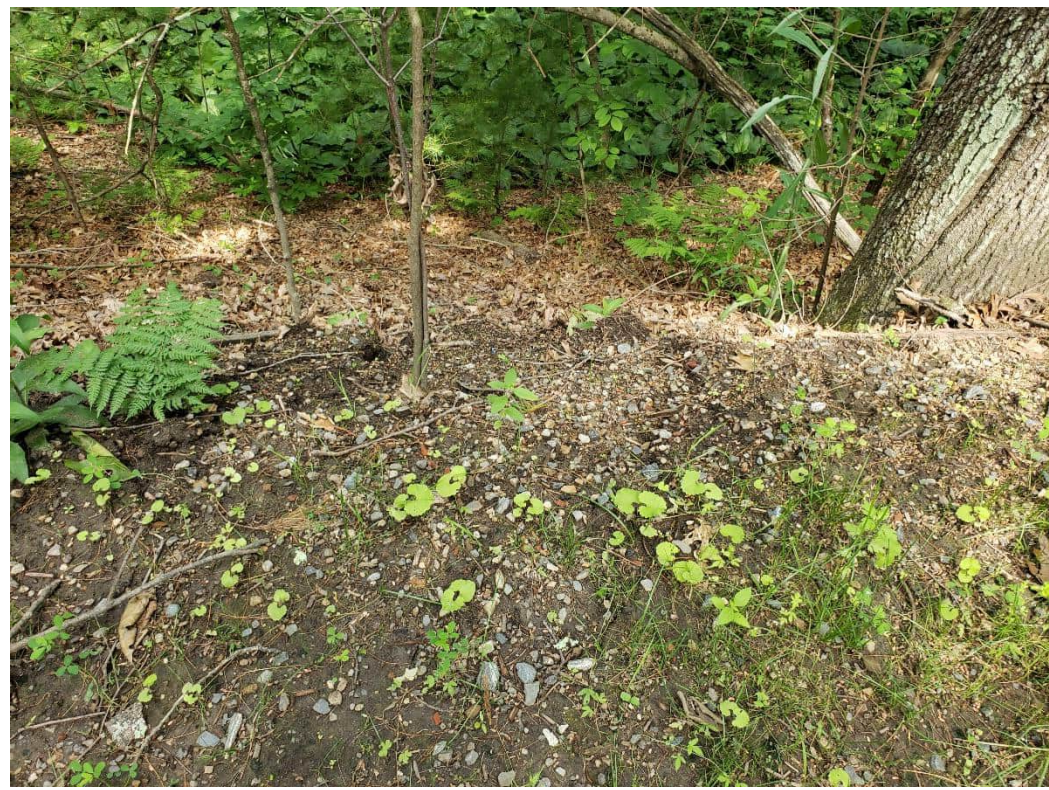
**Photo No. 2**    **Date:**  
6/17/2024

View of the location where stabilization and sediment removal is required near Station 162+00 per Compliance Action Item 3.

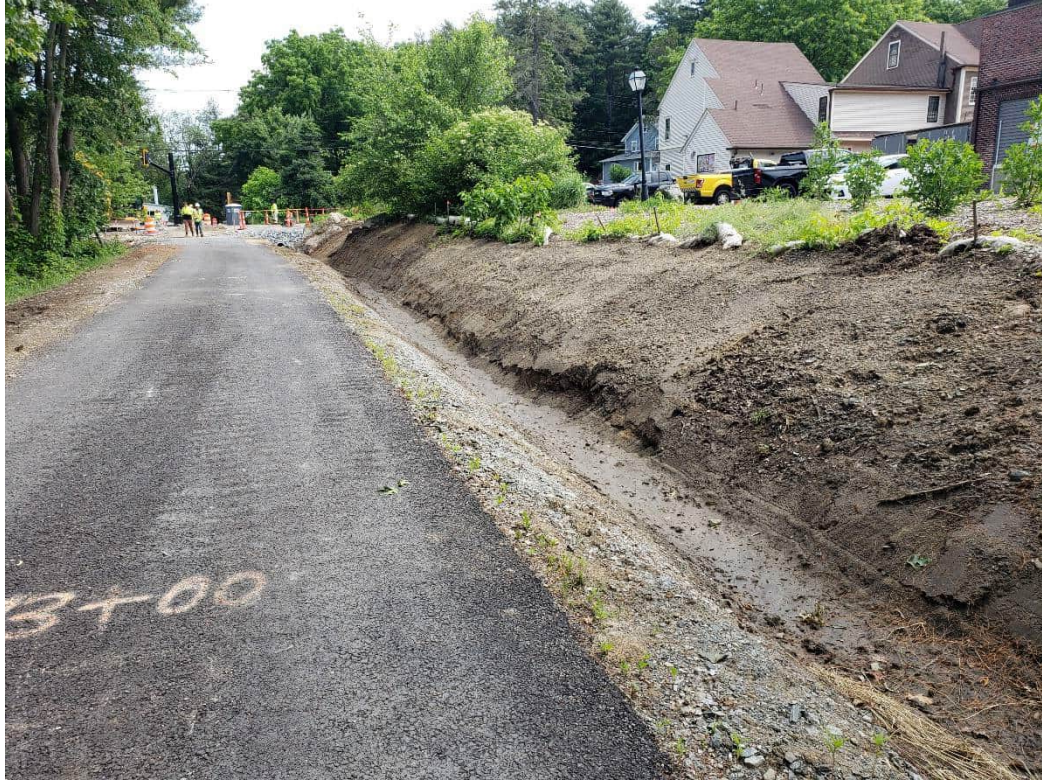
**Photo No. 3**    **Date:**  
6/17/2024

6	Exposed sediment slope at Station 172+00 to 175+00 <b>Priority: High</b>	5/8/2024	5/15/2024	Install temporary sediment controls along the slope such as jute netting and/or straw following the application of seed.	5/16/2024 - Observation remains. 5/21/2024 - Observation remains. 5/28/2024 - Partial germination was observed. 5/31/2024 - See previous update. 6/7/2024 - Further earthwork has occurred and soils require stabilization. 6/14/2024 - Observation remains. 6/17/2024 - Observation remains.
13	Rill erosion is occurring along the west side of the trail at Stations 201+50 to 204+00 <b>Priority: Low</b>	5/8/2024	5/15/2024	Fill in rills and apply seed to stabilize the area. Temporary stabilization measures such as straw and/or jute netting may be required.	5/16/2024 - Observation remains. 5/21/2024 - Observation remains. 5/28/2024 - Rill erosion has not been filled; however, germination was observed. 5/31/2024 - Observation remains. 6/7/2024 - Vegetation is becoming established; however, rills should be filled in and seeded. 6/14/2024 - Observation remains. 6/17/2024 - Rills have been filled; this area will be monitored for stabilization.

View of construction and exposed soils near Station 174+00 per Compliance Action Item 6.

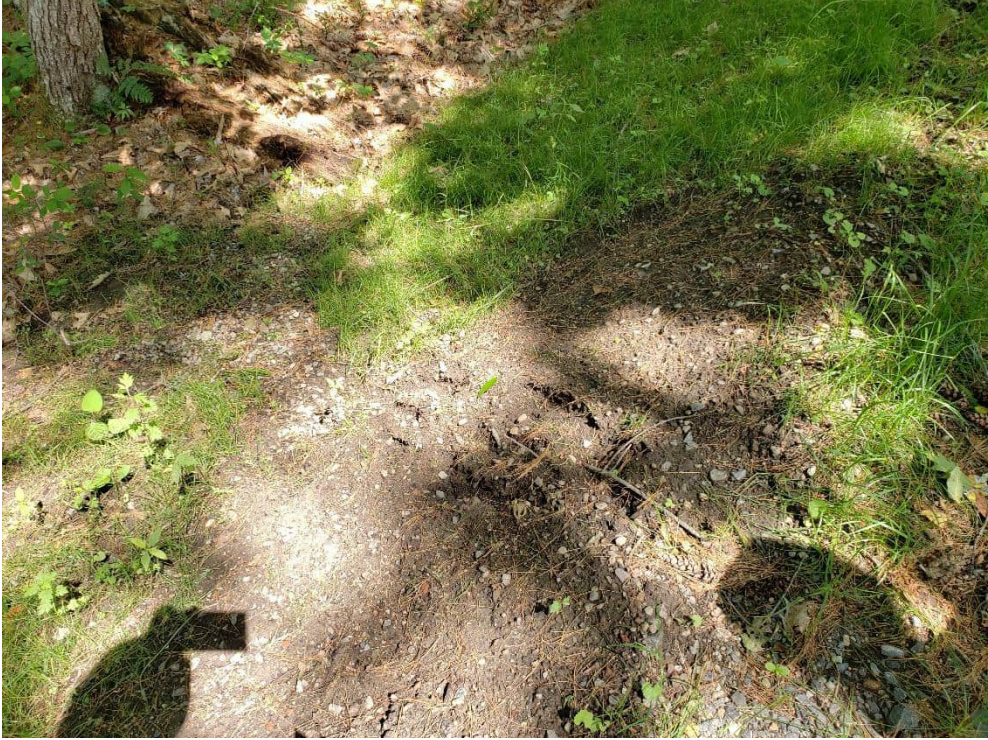
<b>Site Location</b> Bruce Freeman Rail Trail Right-of-Way		<b>BETA Project No.</b> 24.10326.23
<b>Photo No. 5</b>	<b>Date:</b> 6/17/2024

<b>Direction Photo Taken:</b>  Toward the Northwest		
<b>Description:</b>  View of typical rill erosion and sediment runoff along the west side of the trail from Station 201+00 through 204+00 per Compliance Action Item 13.		
<b>Photo No. 6</b>	<b>Date:</b> 6/17/2024

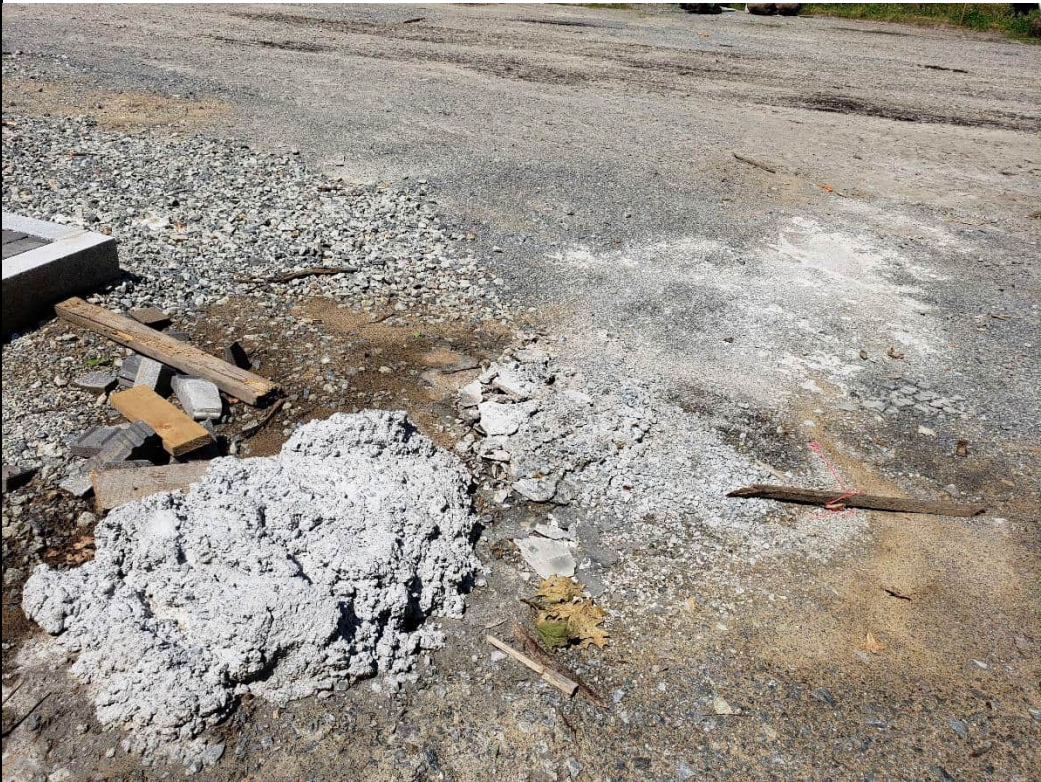
<b>Direction Photo Taken:</b>  Toward the West		
<b>Description:</b>  View of improperly disposed of concrete pile in parking lot next to rest stop near Station 216+00 per Compliance Action Item 48.

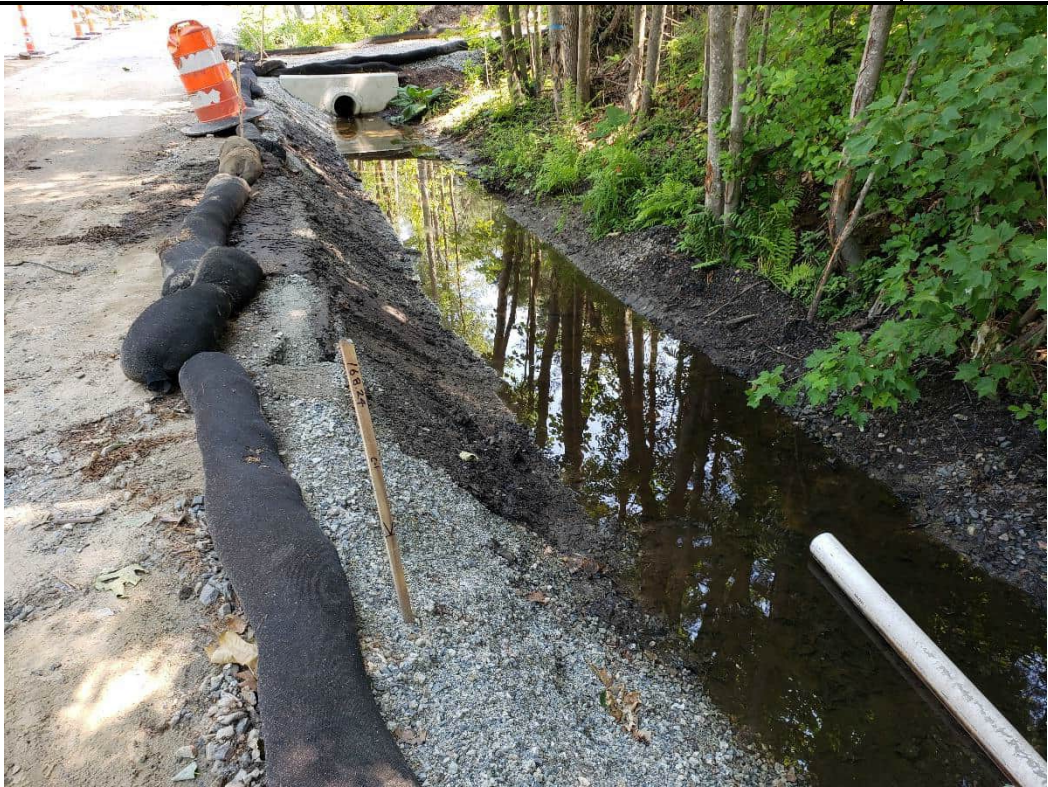
**Photo No. 7**    **Date:** 6/17/2024

41	Stream Bank has been regraded beyond the limit of work at Station 216+00 <b>Priority: High</b>	5/28/2024	6/4/2024	The Contractor should confirm if this work was permitted by the Conservation Commission, as it does not appear to be a part of the approved plans/impacts. MassDOT should be consulted on next steps regarding notification and potential restoration.	5/31/2024 - Observation remains. 6/7/2024 - Observation remains. 6/14/2024 - Observation remains. 6/17/2024 - Observation remains.

View of grading of the stream Bank beyond the limits of work at Station 216+00 per Compliance Action Item 41.

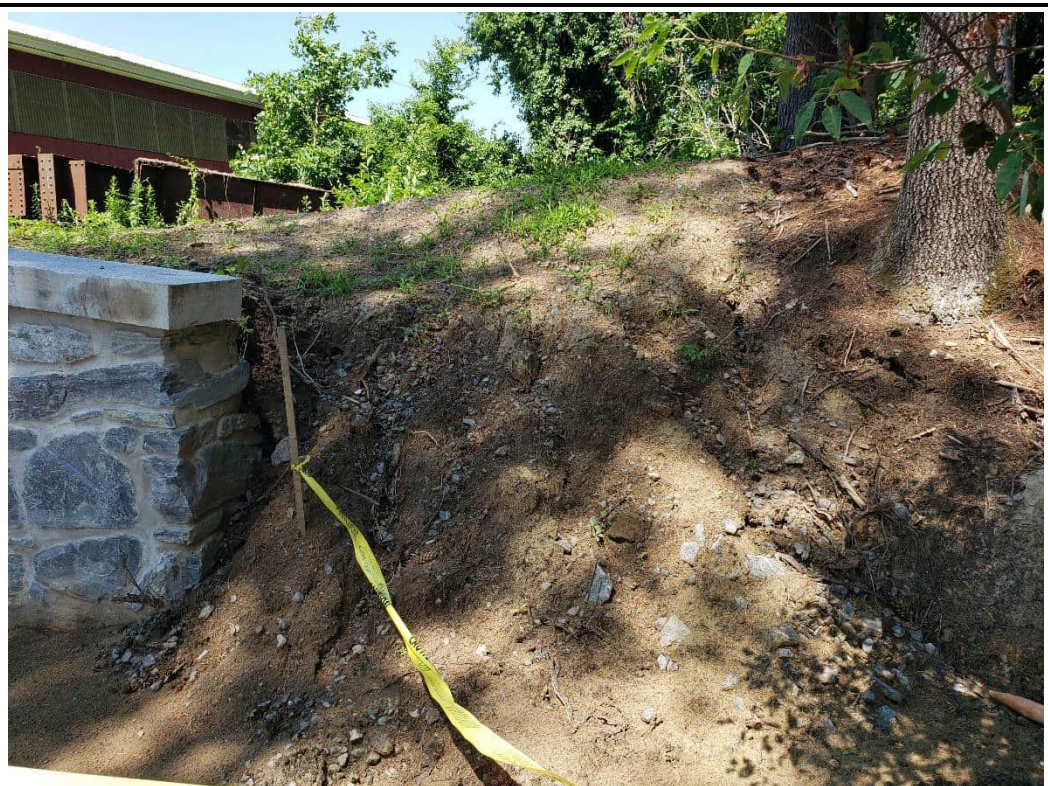
**Photo No. 8**    **Date:** 6/17/2024

View of exposed soils along a newly constructed masonry wall that require stabilization at Station 217+45 per Compliance Action Item 34.

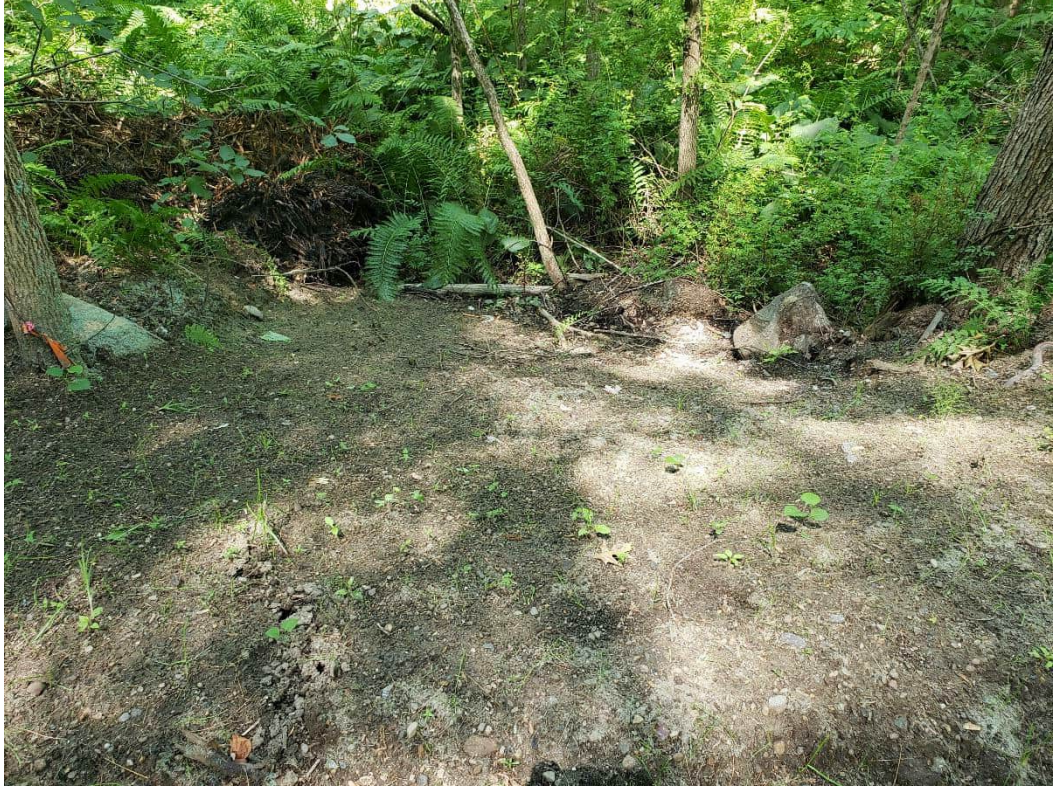
**Photo No. 9**     **Date:**  
6/17/2024

15	Sediment migration off of the trail and into wetlands at Station 221+50 <b>Priority: High</b>	5/8/2024	5/15/2024	Replace damaged compost filter tubes and remove accumulated sediment from areas beyond the limits of work. Once any grading work is completed, apply seed to the slope and stabilize it with jute netting, straw, etc.	5/16/2024 - Observation remains. 5/21/2024 - Observation remains. 5/28/2024 - The area has been hydroseeded. 5/31/2024 - No additional sediment migration was observed. See previous update. 6/7/2024 - Hydroseed is present but sediment beyond the compost filter tubes requires removal. 6/14/2024 - Observation remains. 6/17/2024 - Observation remains.
16	Sediment migration beyond the limits of work at Stations 231+00 to 232+00 <b>Priority: Medium</b>	5/8/2024	5/15/2024	Remove accumulated sediment from areas beyond the limits of work and replace compost filter tubes. Once any grading work is completed, apply seed to the slope and stabilize it with jute netting, straw, etc.	5/16/2024 - Observation remains. 5/21/2024 - Observation remains. 5/28/2024 - The area has been hydroseeded and additional sediment has not migrated since the last observation. 5/31/2024 - Observation remains. 6/7/2024 - Hydroseed is present but sediment beyond the compost filter tubes requires removal. 6/14/2024 - Observation remains. 6/17/2024 - Observation remains.

View of washout overtopping compost filter tubes at Station 221+50 per Compliance Action Item 15.

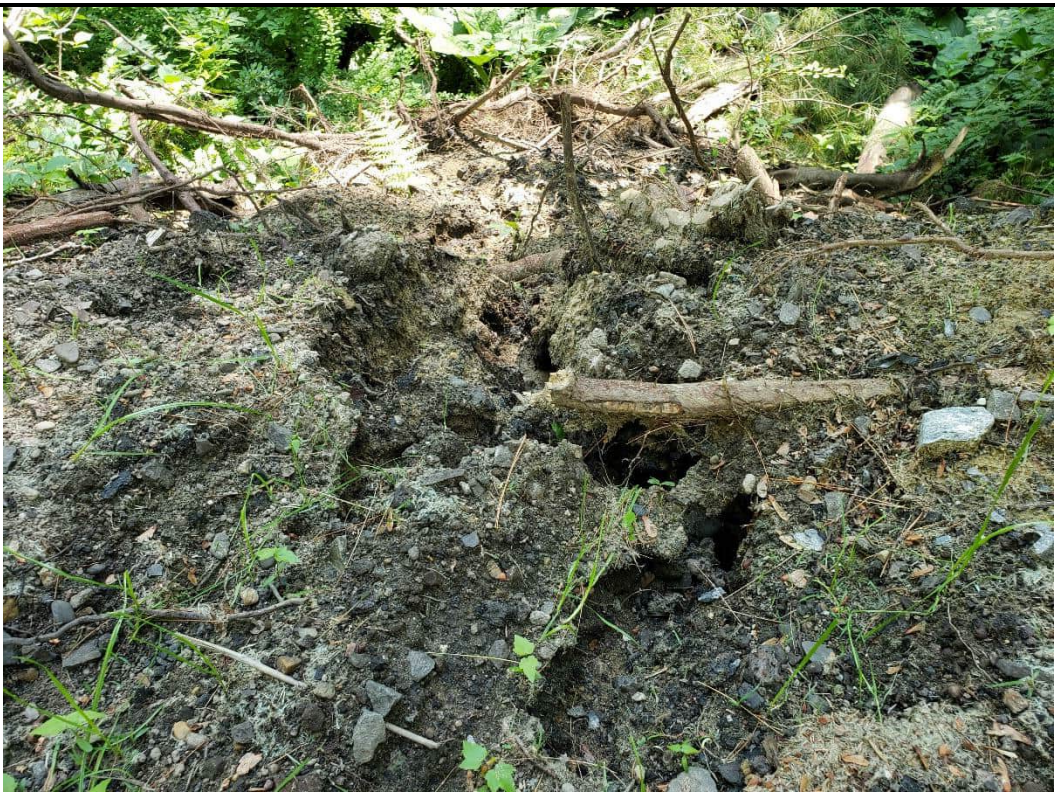
**Photo No. 10**     **Date:**  
6/17/2024

32	Soil and organic debris has been placed within the wetland between wetland flagging WF#23-119 and WF#23-118 at Station 224+00 <b>Priority: High</b>	5/21/2024	5/28/2024	Remove all material and provide stabilization of the area with the approved wetland seed mixture. Straw should also be placed for interim stabilization.	5/28/2024 - Observation remains. 5/31/2024 - Observation remains. 6/7/2024 - Observation remains. 6/14/2024 - Observation remains. 6/17/2024 - This area has been hydroseeded multiple times, but the debris should also be removed from the downgradient wetland.
3	Sediment washout over the slope and existing erosion controls at Stations 155+00 to 162+50 <b>Priority: Low</b>	5/8/2024	5/15/2024	Replace decomposed and damaged compost filter tubes in the areas necessary to contain sediment washout until stabilization measures are completed.	5/16/2024 - Observation remains. 5/21/2024 - Observation remains. 5/28/2024 - Grass and other vegetation has temporarily stabilized the area between Stations 155+00 and Station 160+00. Stations from 160+00 to 162+50 have not yet achieved temporary stabilization. 5/31/2024 - Observation remains. 6/7/2024 - Observation remains. 6/14/2024 - Observation remains. 6/17/2024 - Observation remains.

View of soil and organic debris placed within the wetland between flags WF#23-119 and WF#23-118 at Station 224+00 per Compliance Action Item 32.

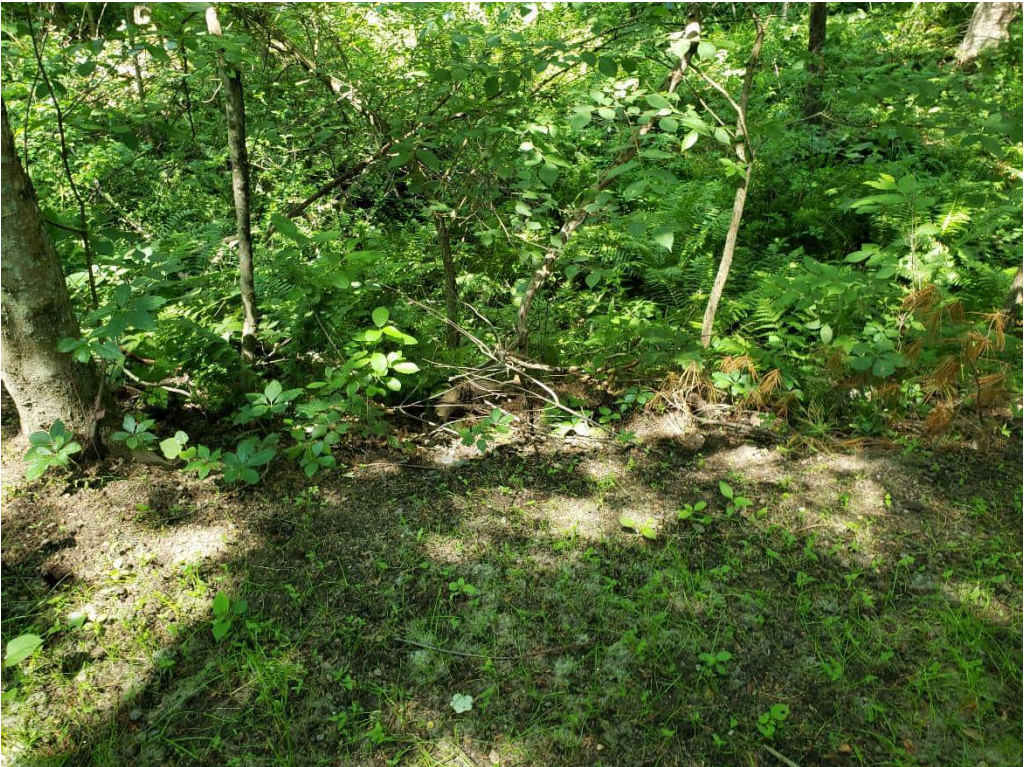
<b>Direction Photo Taken:</b>  Toward the East		
<b>Description:</b>  View of washout overtopping compost filter tubes at Station 231+00 per Compliance Action Item 16.
