**Environmental Monitor Construction Site Inspection Report  
 MassDOT Project #608164 Construction Contract # 119678  
 EM Report #9**

Project Description: Bruce Freeman Rail Trail Right-of-Way  
 Permit Description(s): Order of Conditions (MGL Chapter 131, Section 40 and 310 CMR 10.00, Mass DEP File No. 301-1362); 2022 EPA NPDES General Permit for Discharges from Construction Areas; U.S. Army Corps of Engineers Permit No NAE-2021-01975.

Project Name:	Bruce Freeman Rail Trail - Phase 2d - Sudbury
Date of Inspections:	6/24/2024
Bi Weekly/ Monthly Period Covered:	June Weekly Inspection #4
Inspector's Name(s):	Douglas Beach
Inspectors' Contact Information:	<a href="mailto:dbeach@beta-inc.com">dbeach@beta-inc.com</a>

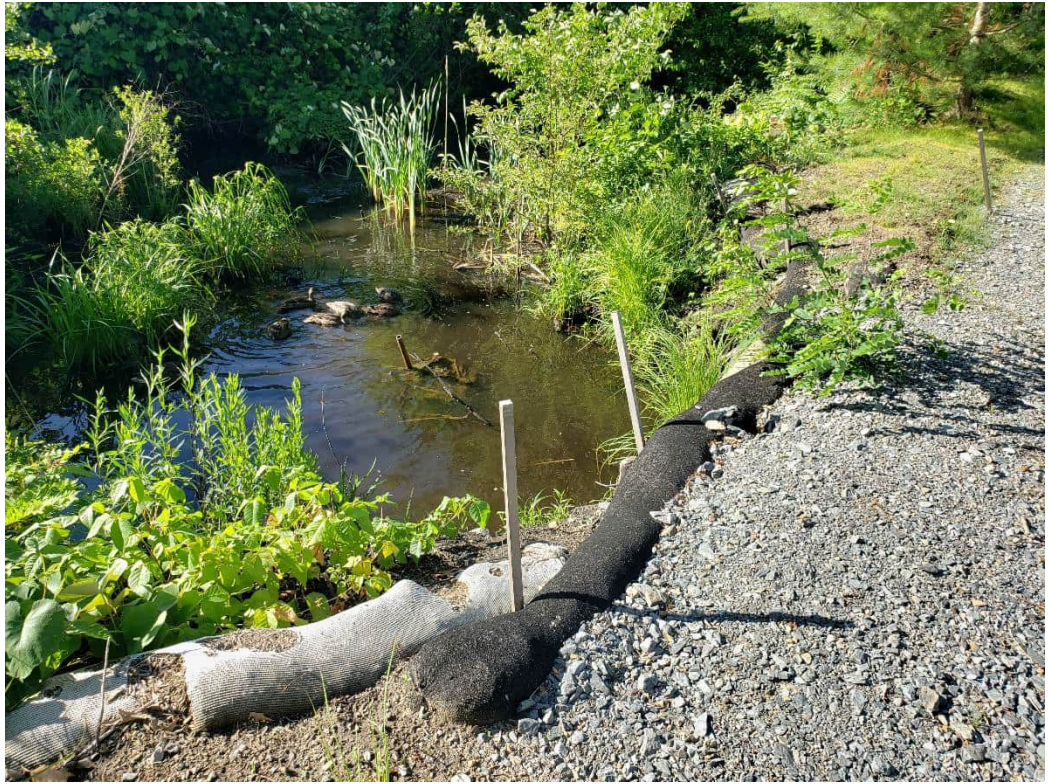
**Photo No. 1**    **Date:**  
6/24/2024

View of slopes requiring stabilization and gravel/sediment accumulation along compost filter tubes at Station 105+00 to 106+00 per Compliance Action Items 43 and 44.

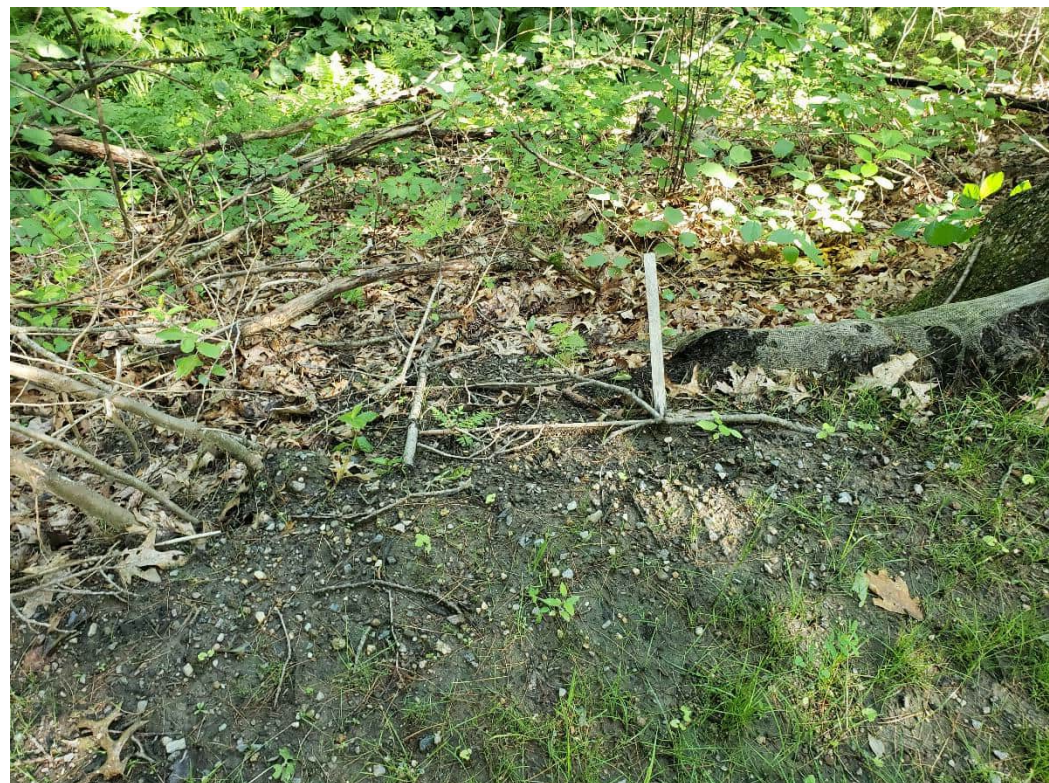
**Photo No. 2**    **Date:**  
6/24/2024

View of the location where stabilization and sediment removal is required near Station 162+00 per Compliance Action Item 3.

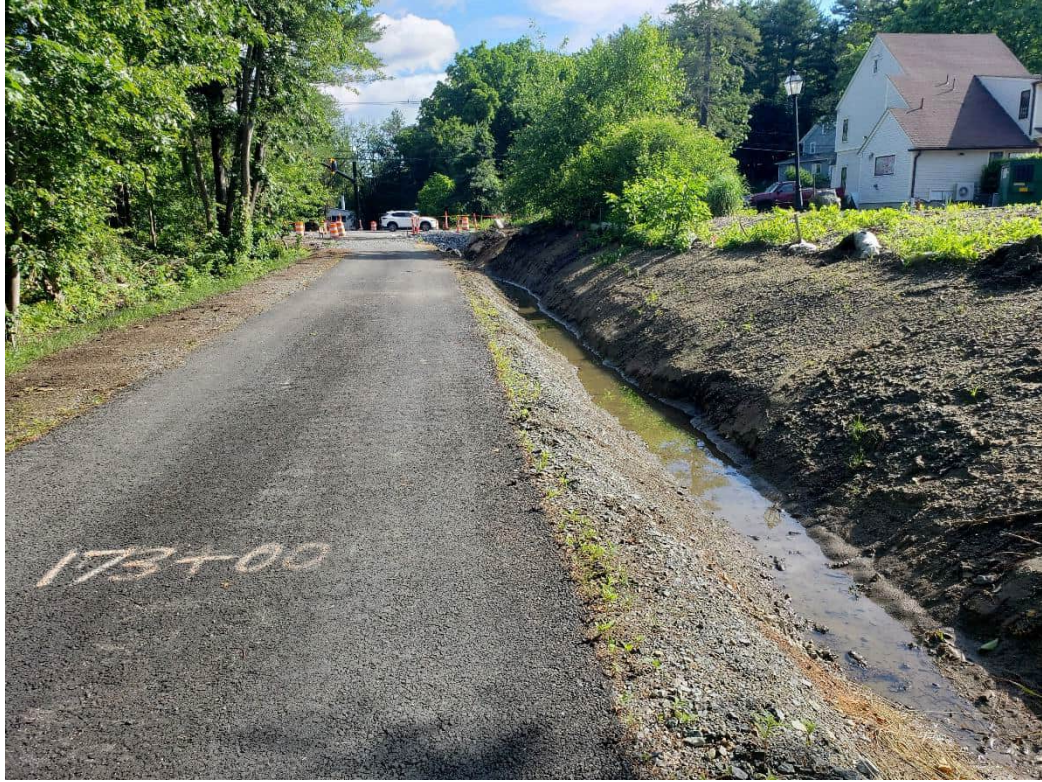
**Photo No. 3**    **Date:** 6/24/2024

6	Exposed sediment slope at Station 172+00 to 175+00 <b>Priority: High</b>	5/8/2024	5/15/2024	Install temporary sediment controls along the slope such as jute netting and/or straw following the application of seed.	5/16/2024 - Observation remains. 5/21/2024 - Observation remains. 5/28/2024 - Partial germination was observed. 5/31/2024 - See previous update. 6/7/2024 - Further earthwork has occurred and soils require stabilization. 6/14/2024 - Observation remains. 6/17/2024 - Observation remains. 6/24/2024 - Observation remains.
14	Sediment-laden runoff is being discharged into a stream from the new parking lot at Station 216+50 <b>Priority: High</b>	5/8/2024	5/15/2024	Replace compost filter tubes around the stream and develop a method of redirecting runoff from the parking lot at the source.	5/16/2024 - New compost filter tubes have been installed but were observed to be undermined. In addition, a new earthen slope was observed to be constructed in this area and requires stabilization. 5/21/2024 - No turbidity was observed due to no rain preceding this inspection. However, additional erosion controls should be explored at this location to prevent future discharges. 5/28/2024 - Untreated runoff being discharged from the parking area has not been addressed, and work is occurring along the stream beyond the compost filter tubes. 5/31/2024 - Observation remains. 6/7/2024 - Observation remains. 6/14/2024 - Observation remains. 6/17/2024 - Observation remains. 6/24/2024 - Observation remains.

View of construction and exposed soils near Station 174+00 per Compliance Action Item 6.

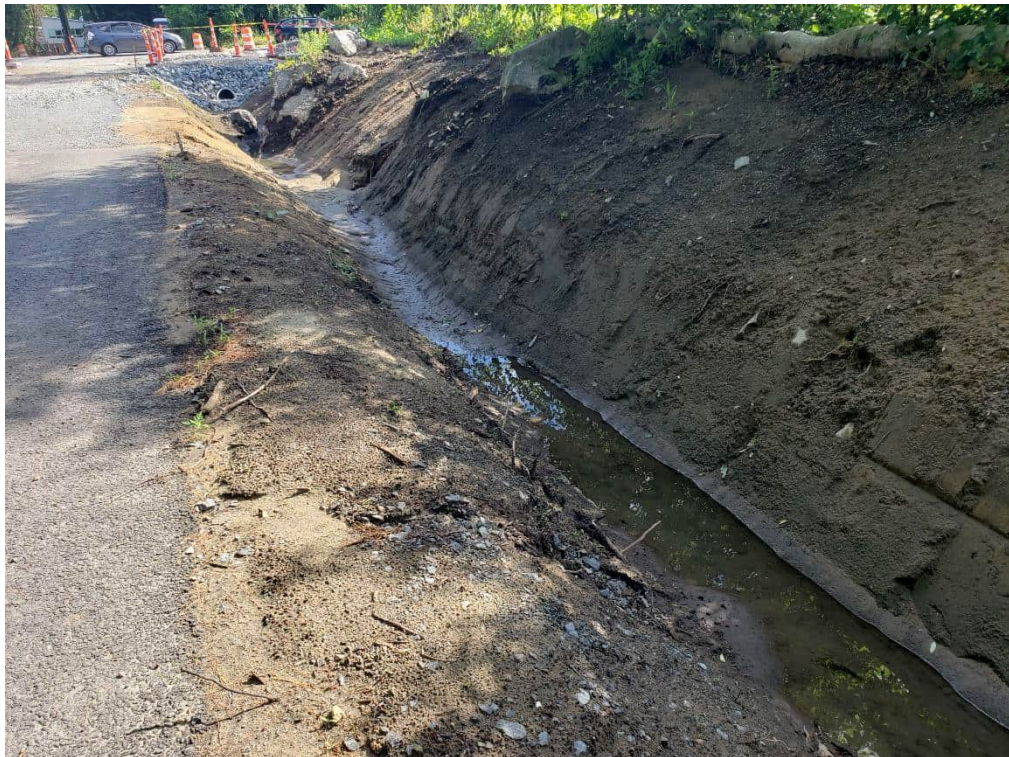
**Photo No. 4**    **Date:** 6/24/2024

Another view of active construction and exposed soils near Station 174+00 per Compliance Action Item 6.

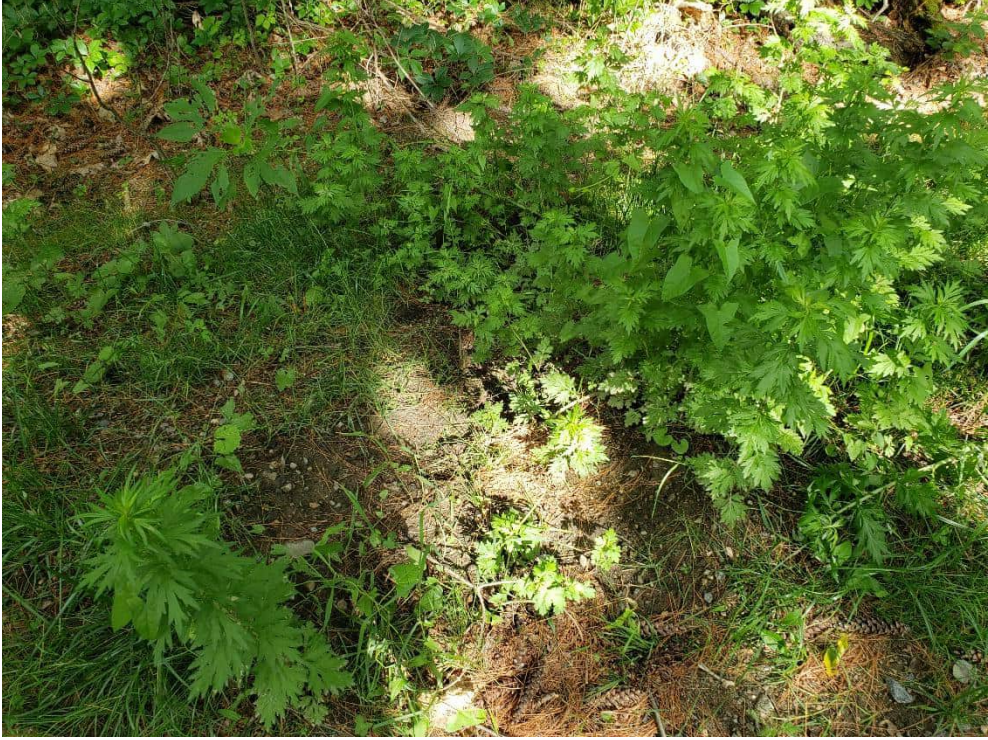
<b>Site Location</b> Bruce Freeman Rail Trail Right-of-Way		<b>BETA Project No.</b> 24.10326.23
<b>Photo No. 5</b>	<b>Date:</b> 6/24/2024

13	Rill erosion is occurring along the west side of the trail at Stations 201+50 to 204+00 <b>Priority: Low</b>	5/8/2024	5/15/2024	<b>Resolved: 6/24/2024</b> Fill in rills and apply seed to stabilize the area. Temporary stabilization measures such as straw and/or jute netting may be required.	5/16/2024 - Observation remains. 5/21/2024 - Observation remains. 5/28/2024 - Rill erosion has not been filled; however, germination was observed. 5/31/2024 - Observation remains. 6/7/2024 - Vegetation is becoming established; however, rills should be filled in and seeded. 6/14/2024 - Observation remains. 6/17/2024 - Rills have been filled; this area will be monitored for stabilization. 6/24/2024 - Rill erosion has been filled and vegetation has stabilized the slope.
9	Rill erosion resulting in offsite sediment migration at Station 1003+00 <b>Priority: Low</b>	5/8/2024	5/15/2024	<b>Resolved: 6/14/2024</b> Fill in rills and apply seed to stabilize the area. Temporary stabilization measures such as straw and/or jute netting may be required.	5/16/2024 - Observation remains. 5/21/2024 - Observation remains. 5/28/2024 - Rill erosion has been filled in and raked over, and germination was observed. 5/31/2024 - Rill erosion has been filled in and raked over, germination has been observed, and additional plantings in the area have been added. 6/7/2024 - Observation remains. 6/14/2024 - Rill erosion has been filled and raked over, and plantings and grass have grown over the previously eroded area.

<b>Direction Photo Taken:</b>  Toward the Northwest		
<b>Description:</b>  View of stabilized slope along the west side of the trail from Station 201+00 through 204+00 per Compliance Action Item 13.		
<b>Photo No. 6</b>	<b>Date:</b> 6/24/2024

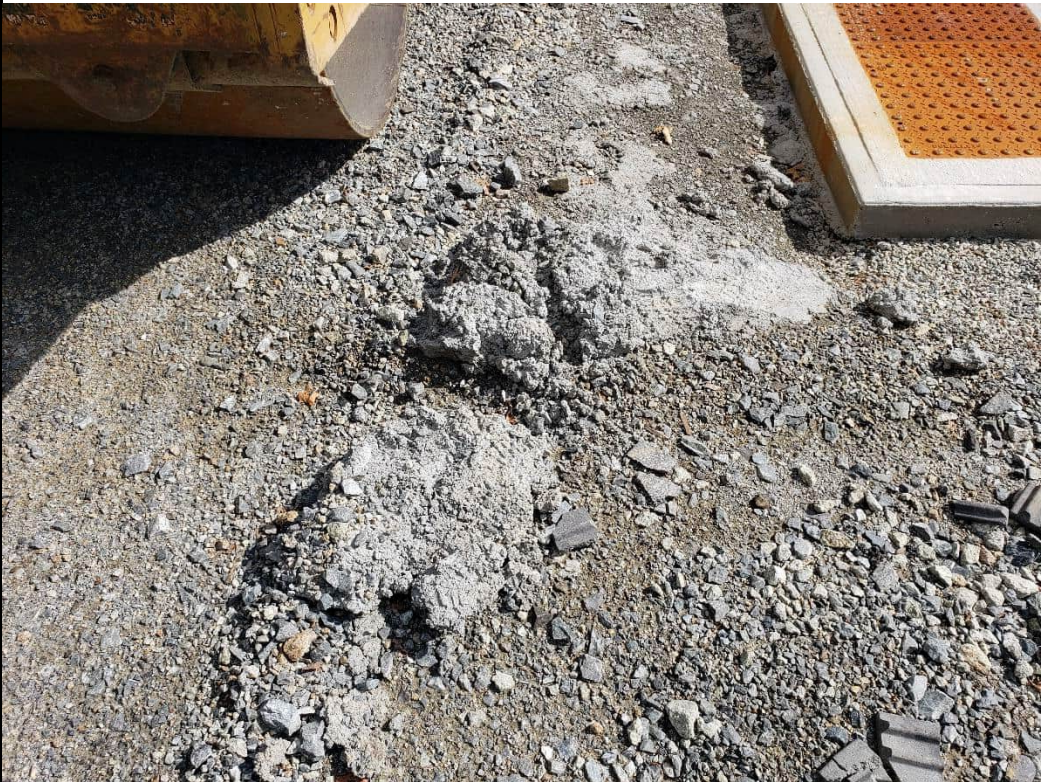
Item	Location/ Description	Observation Date	Resolution Due Date	Recommended Resolution / Resolution Date	Comments/Updates
48	Multiple concrete piles left around parking lot rest stop near Station 216+00 <b>Priority: Medium</b>	6/14/2024	6/21/2024	Remove concrete piles from site and dispose of properly.	6/17/2024 - Observation remains. 6/24/2024 - Some of the concrete piles have been removed. One pile of the three in this area remains.
43	Overtopped compost filter tubes and exposed soils beyond the limits of work at Station 105+00 <b>Priority: High</b>	6/7/2024	6/14/2024	Stabilize the area with the approved seed mixture and provide interim stabilization such as straw mulch.	6/14/2024 - Observation remains. 6/17/2024 - Observation remains. 6/24/2024 - Observation remains.
44	Slopes require stabilization/ additional seed due to lack of compost filter tubes at 105+00 and 106+00 <b>Priority: High</b>	6/7/2024	6/14/2024	Stabilize the slope with the approved seed mixture and provide interim stabilization such as straw mulch.	6/14/2024 - Observation remains. 6/17/2024 - Observation remains. 6/24/2024 - Observation remains.

<b>Direction Photo Taken:</b>  Toward the West		
<b>Description:</b>  View of an improperly disposed of concrete pile within the parking lot near Station 216+00 per Compliance Action Item 48.

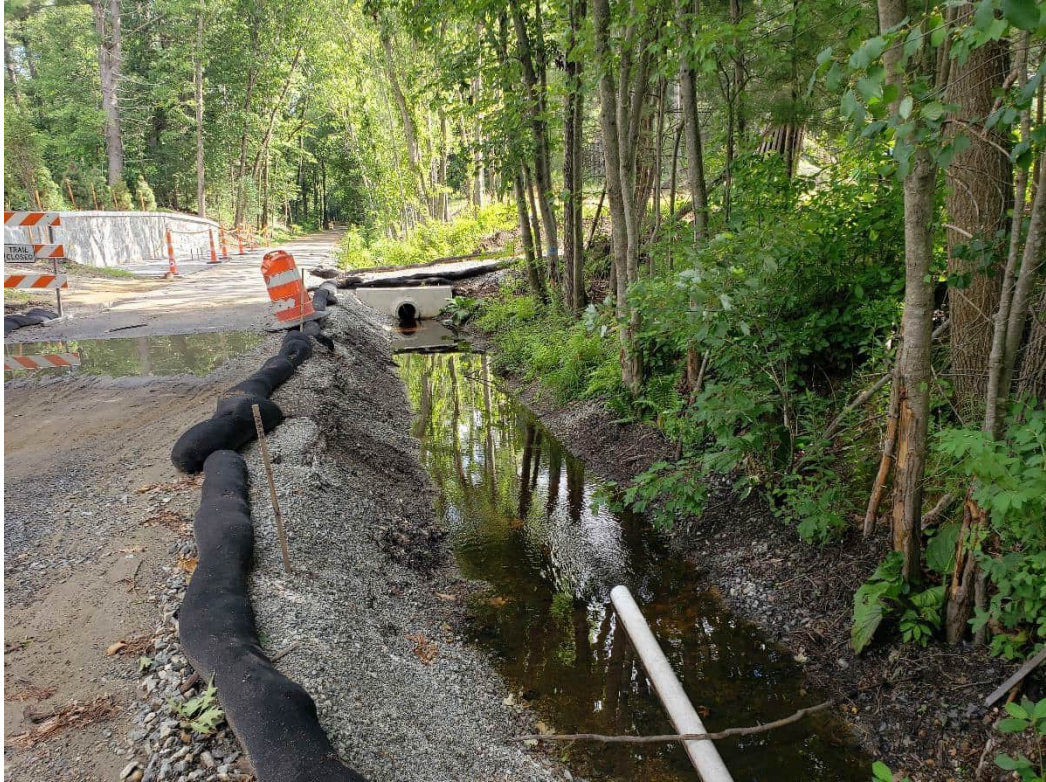
**Photo No. 7**    **Date:** 6/24/2024

41	Stream Bank has been regraded beyond the limit of work at Station 216+00 <b>Priority: High</b>	5/28/2024	6/4/2024	The Contractor should confirm if this work was permitted by the Conservation Commission, as it does not appear to be a part of the approved plans/impacts. MassDOT should be consulted on next steps regarding notification and potential restoration.	5/31/2024 - Observation remains. 6/7/2024 - Observation remains. 6/14/2024 - Observation remains. 6/17/2024 - Observation remains. 6/24/2024 - Observation remains.

View of the grading of the stream Bank beyond the limits of work at Station 216+00 per Compliance Action Item 41.

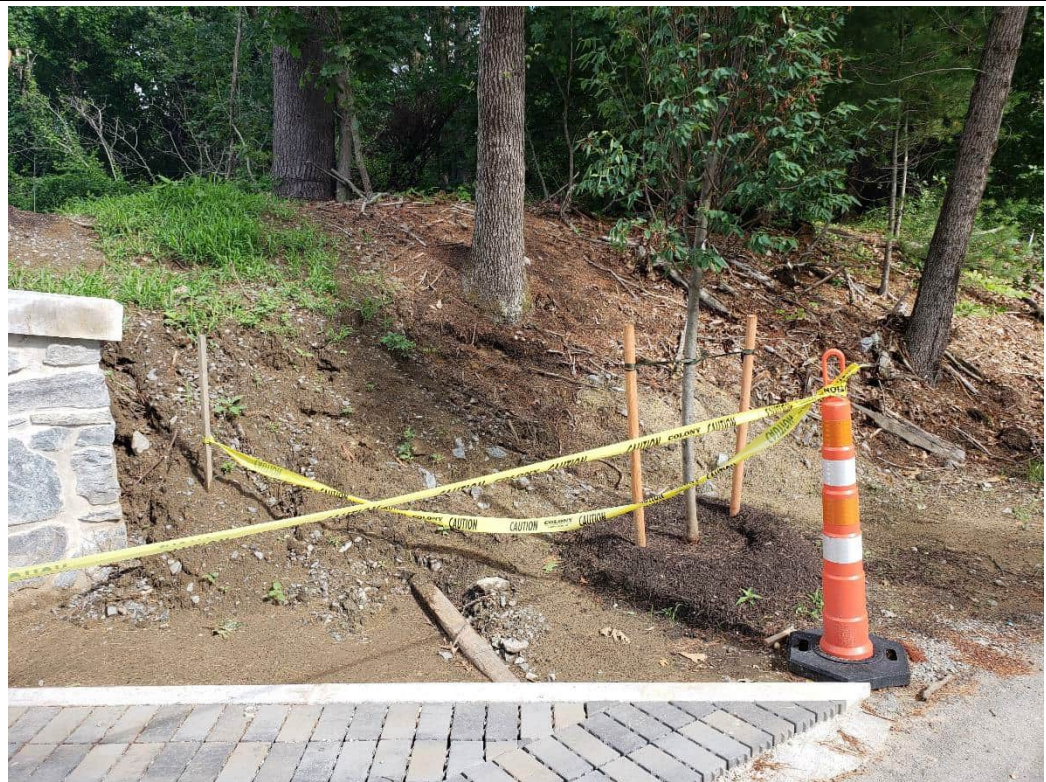
**Photo No. 8**    **Date:** 6/24/2024

View of exposed soils along a newly constructed masonry wall that require stabilization at Station 217+45 per Compliance Action Item 34.

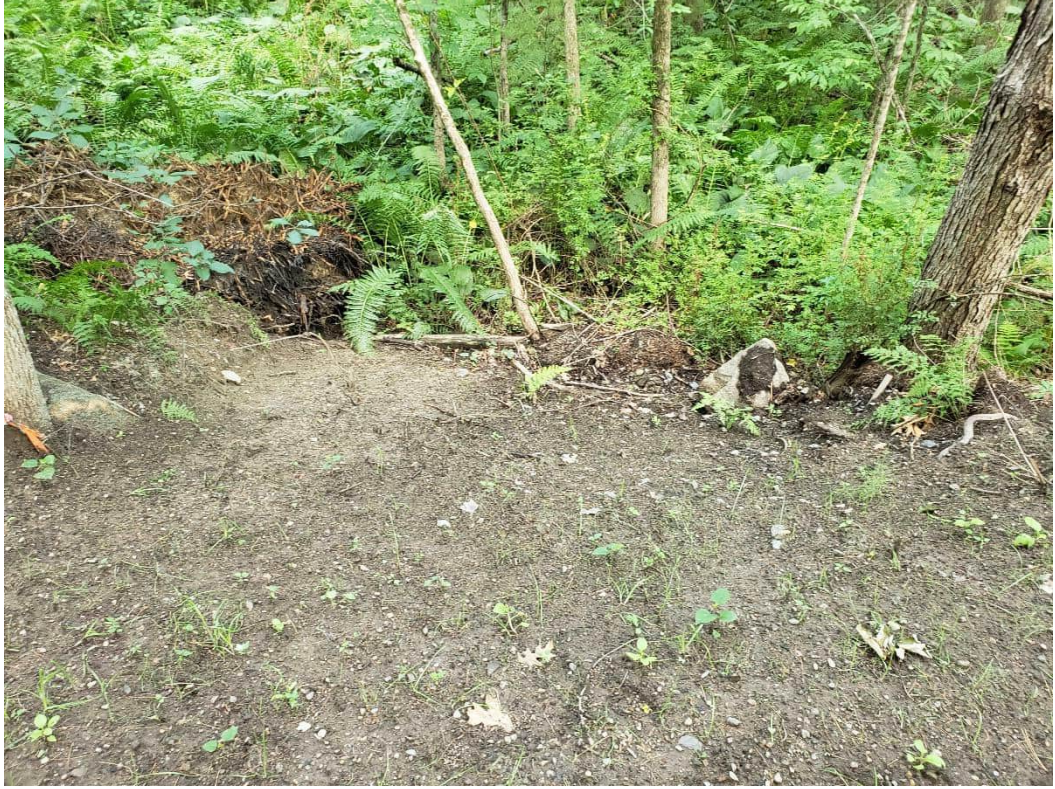
**Photo No. 9**     **Date:**  
6/24/2024

15	Sediment migration off of the trail and into wetlands at Station 221+50 <b>Priority: High</b>	5/8/2024	5/15/2024	Replace damaged compost filter tubes and remove accumulated sediment from areas beyond the limits of work. Once any grading work is completed, apply seed to the slope and stabilize it with jute netting, straw, etc.	5/16/2024 - Observation remains. 5/21/2024 - Observation remains. 5/28/2024 - The area has been hydroseeded. 5/31/2024 - No additional sediment migration was observed. See previous update. 6/7/2024 - Hydroseed is present but sediment beyond the compost filter tubes requires removal. 6/14/2024 - Observation remains. 6/17/2024 - Observation remains. 6/24/2024 - Observation remains.
16	Sediment migration beyond the limits of work at Stations 231+00 to 232+00 <b>Priority: Medium</b>	5/8/2024	5/15/2024	Remove accumulated sediment from areas beyond the limits of work and replace compost filter tubes. Once any grading work is completed, apply seed to the slope and stabilize it with jute netting, straw, etc.	5/16/2024 - Observation remains. 5/21/2024 - Observation remains. 5/28/2024 - The area has been hydroseeded and additional sediment has not migrated since the last observation. 5/31/2024 - Observation remains. 6/7/2024 - Hydroseed is present but sediment beyond the compost filter tubes requires removal. 6/14/2024 - Observation remains. 6/17/2024 - Observation remains. 6/24/2024 - Observation remains.

View of washout overtopping compost filter tubes at Station 221+50 per Compliance Action Item 15.

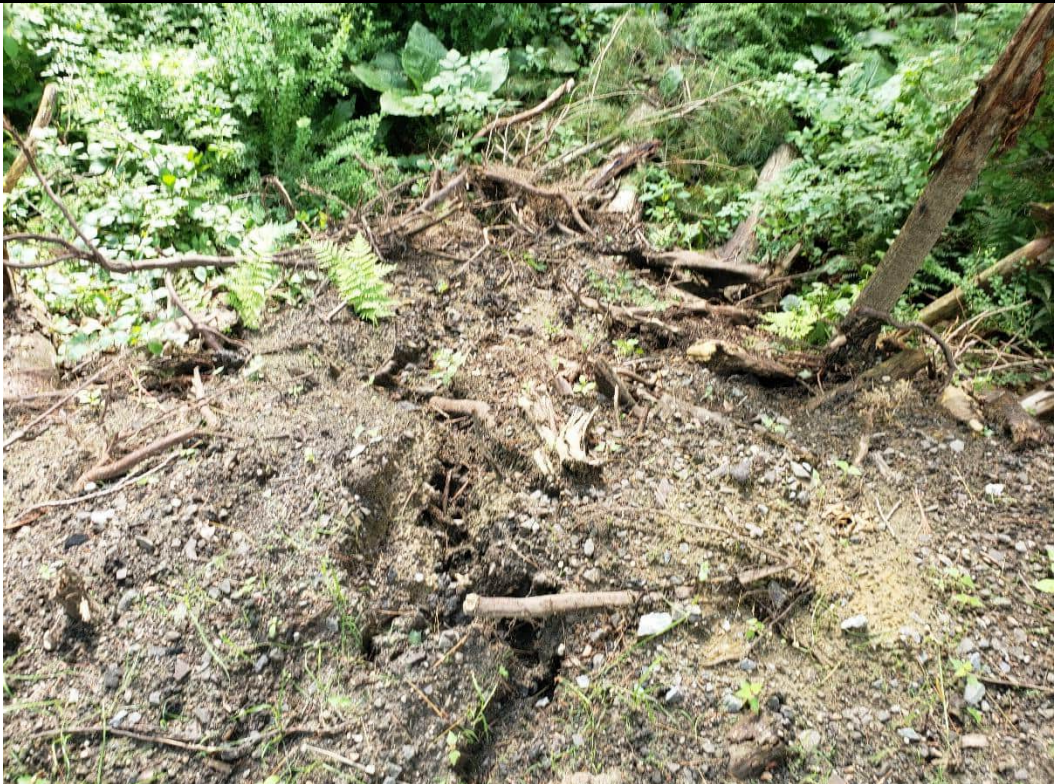
**Photo No. 10**     **Date:**  
6/24/2024

32	Soil and organic debris has been placed within the wetland between wetland flagging WF#23-119 and WF#23-118 at Station 224+00 <b>Priority: High</b>	5/21/2024	5/28/2024	Remove all material and provide stabilization of the area with the approved wetland seed mixture. Straw should also be placed for interim stabilization.	5/28/2024 - Observation remains. 5/31/2024 - Observation remains. 6/7/2024 - Observation remains. 6/14/2024 - Observation remains. 6/17/2024 - This area has been hydroseeded multiple times, but the debris should also be removed from the downgradient wetland. 6/24/2024 - Observation remains.
3	Sediment washout over the slope and existing erosion controls at Stations 155+00 to 162+50 <b>Priority: Low</b>	5/8/2024	5/15/2024	Replace decomposed and damaged compost filter tubes in the areas necessary to contain sediment washout until stabilization measures are completed.	5/16/2024 - Observation remains. 5/21/2024 - Observation remains. 5/28/2024 - Grass and other vegetation has temporarily stabilized the area between Stations 155+00 and Station 160+00. Stations from 160+00 to 162+50 have not yet achieved temporary stabilization. 5/31/2024 - Observation remains. 6/7/2024 - Observation remains. 6/14/2024 - Observation remains. 6/17/2024 - Observation remains. 6/24/2024 - Observation remains.

View of soil and organic debris placed within the wetland between flags WF#23-119 and WF#23-118 at Station 224+00 per Compliance Action Item 32.

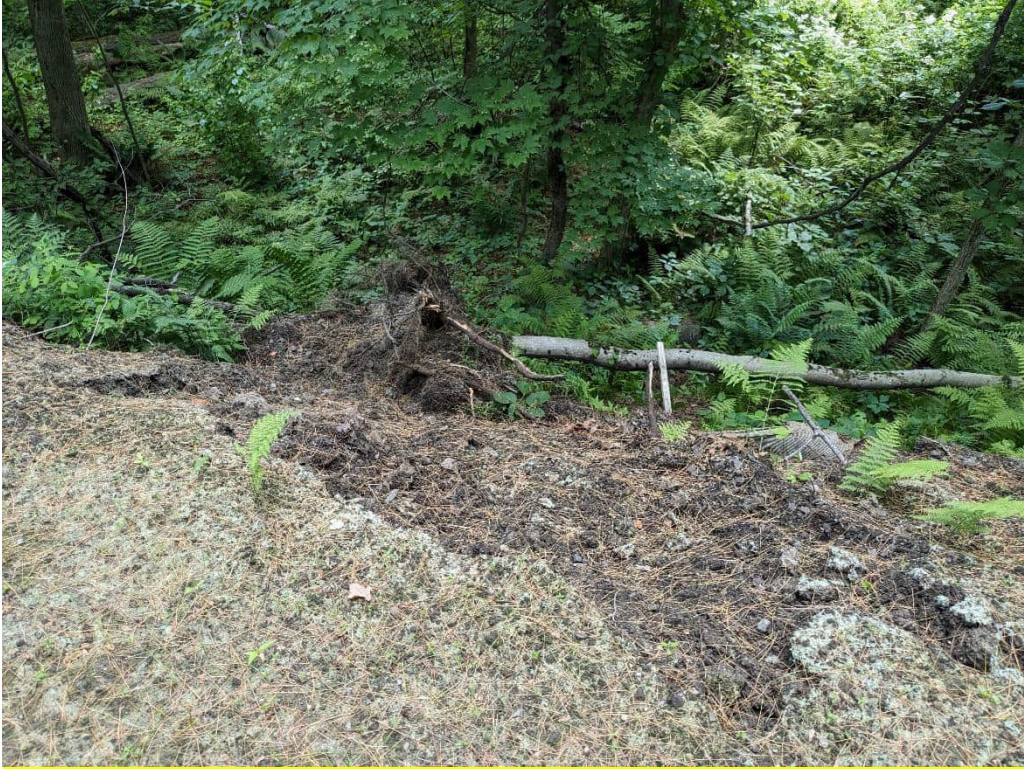
<b>Site Location</b> Bruce Freeman Rail Trail Right-of-Way		<b>BETA Project No.</b> 24.10326.23
<b>Photo No. 11</b>	<b>Date:</b> 6/24/2024

45	Erosion observed along east side of trail at Station 225+50 <b>Priority: Medium</b>	6/7/2024	6/14/2024	Stabilize the slope with the approved seed mixture and provide interim stabilization such as straw mulch.	6/14/2024 - Observation remains. 6/17/2024 - Observation remains. 6/24/2024 - Observation remains.
46	Erosion control breaches observed at Station 310+00 <b>Priority: Medium</b>	6/7/2024	6/14/2024	Repair erosion controls.	6/14/2024 - Observation remains. 6/17/2024 - Observation remains. 6/24/2024 - Observation remains.
47	Slope stabilization required due to condition of compost filter tubes at Station 265+50 and 273+00 <b>Priority: High</b>	6/7/2024	6/14/2024	Stabilize the slope with the approved seed mixture and provide interim stabilization such as straw mulch.	6/14/2024 - Observation remains. 6/17/2024 - Observation remains. 6/24/2024 - Observation remains.

<b>Direction Photo Taken:</b>  Toward the West		
<b>Description:</b>  View of erosion observed along east side of trail at Station 225+50 per Compliance Action Item 45.		
<b>Photo No. 12</b>	<b>Date:</b> 6/24/2024

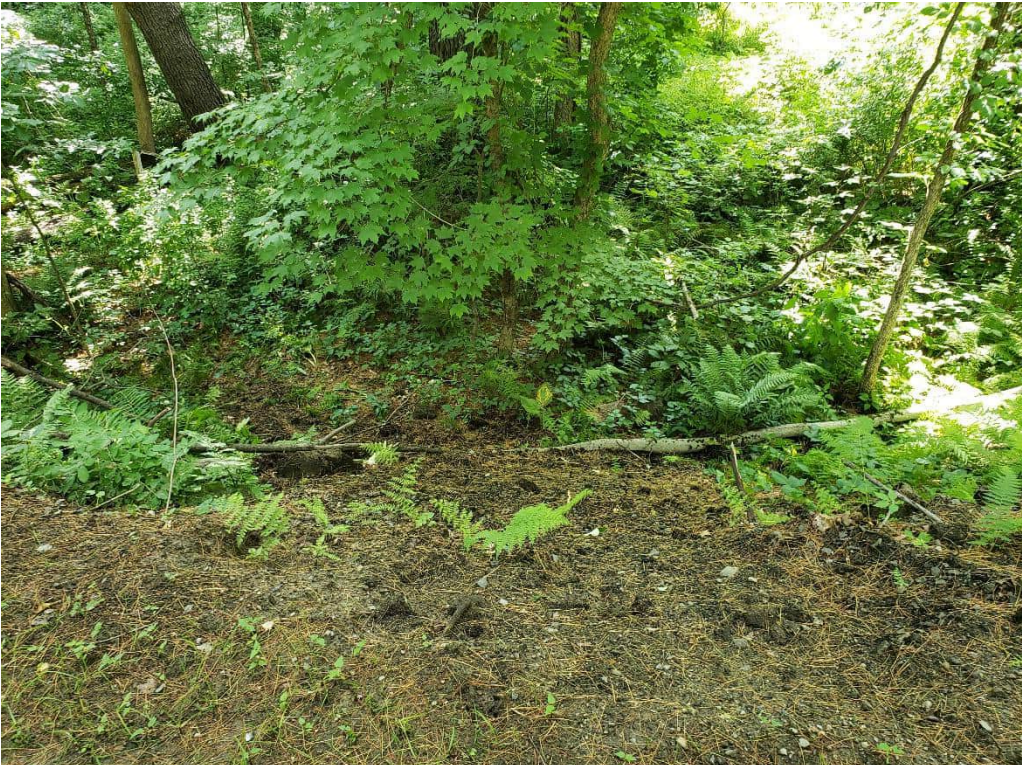
<b>Direction Photo Taken:</b>  Toward the East		
<b>Description:</b>  View of washout overtopping compost filter tubes at Station 231+00 per Compliance Action Item 16.

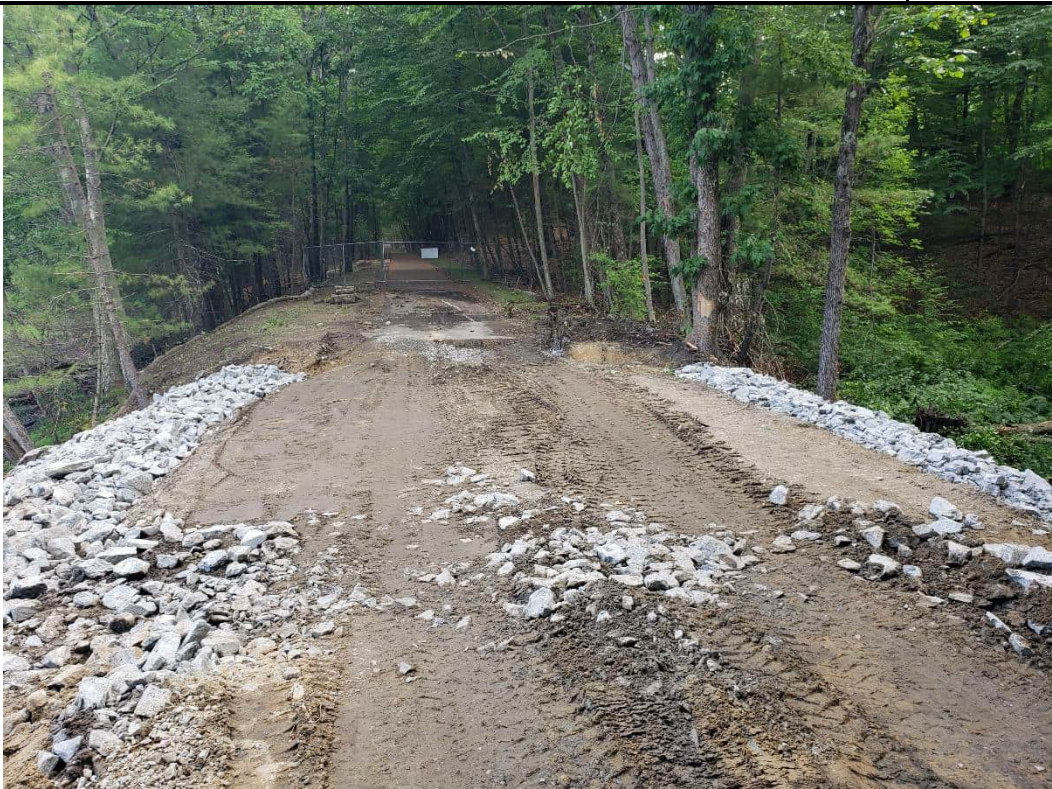
<b>Photo No. 17</b>	<b>Date:</b> 6/24/2024

<b>Direction Photo Taken:</b>  Toward the North		
<b>Description:</b>  View of the extents of excavation within the trail to replace the collapsed pipe between Stations 312+00 and 313+00 per Compliance Action Item 42.
