Weekly Environmental Compliance Summary

Sudbury to Hudson Transmission Reliability Project (USEPA Tracking # MAR1003UW)

Week of: September 3, 2024 to September 7, 2024

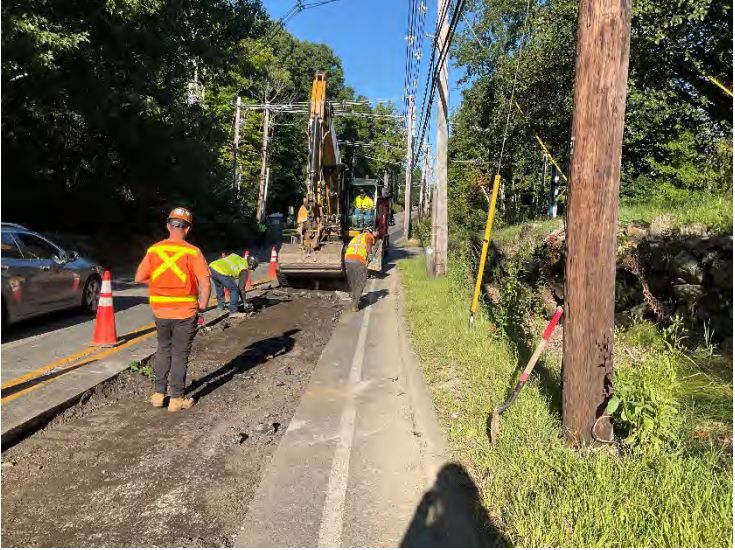
<p>PHOTOGRAPHIC LOG</p>	
<p>Client Name: Eversource</p>		<p>Site Location: Sudbury to Hudson Transmission Reliability Project</p>	<p>Town: Hudson</p>
<p>Photo No.: 1</p>	<p>Date: 9-3-24</p>

<p>Description:</p> <p>View of Bond trenching on Forest Avenue between MH#1 & MH#2. Facing west.</p>

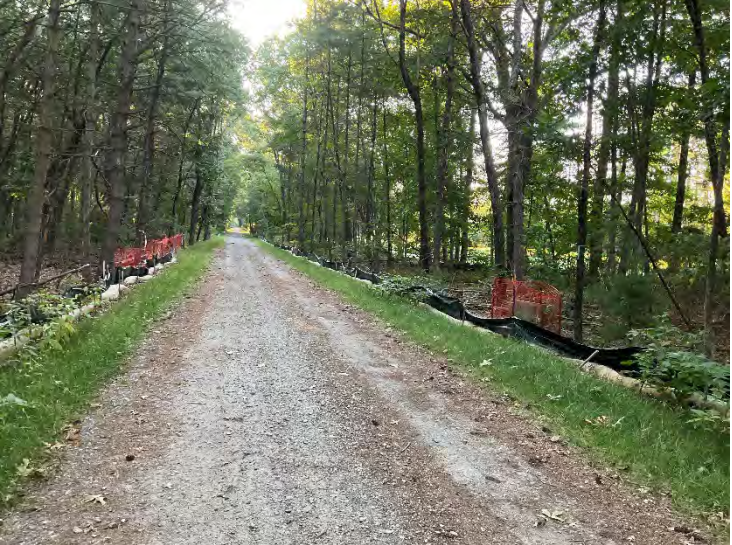
PHOTOGRAPHIC LOG	
Client Name: Eversource		Site Location: Sudbury to Hudson Transmission Reliability Project	Town: Hudson
Photo No.: 3	Date: 9-3-24

Description: View of E&S controls in segment 4. Facing east.

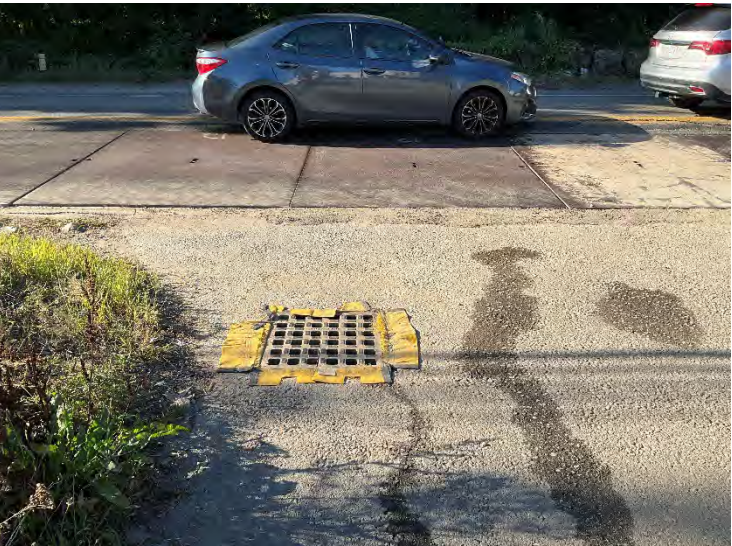
PHOTOGRAPHIC LOG	
Client Name: Eversource		Site Location: Sudbury to Hudson Transmission Reliability Project	Town: Hudson
Photo No.: 4	Date: 9-3-24

Description: View of installed silt sack on Forest Avenue by active Bond work area. Facing south.

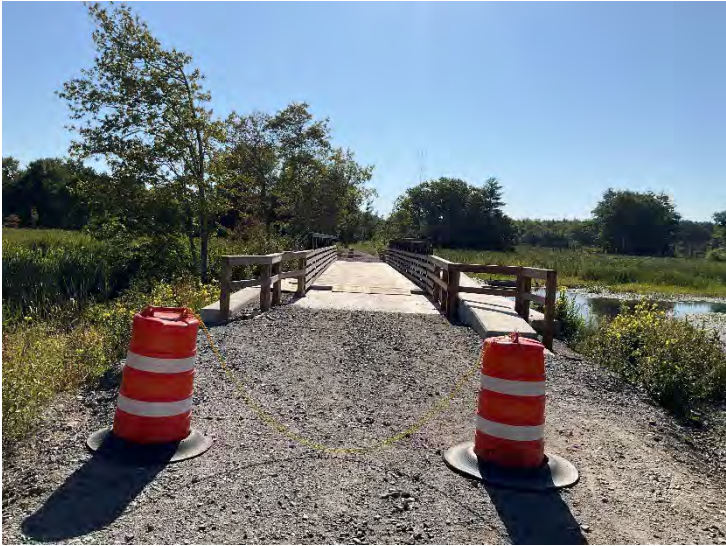
<p>PHOTOGRAPHIC LOG</p>	
<p>Client Name: Eversource</p>		<p>Site Location: Sudbury to Hudson Transmission Reliability Project</p>	<p>Town: Hudson</p>
<p>Photo No.: 5</p>	<p>Date: 9-3-24</p>

<p>Description: View of Bridge 130. Facing east.</p>

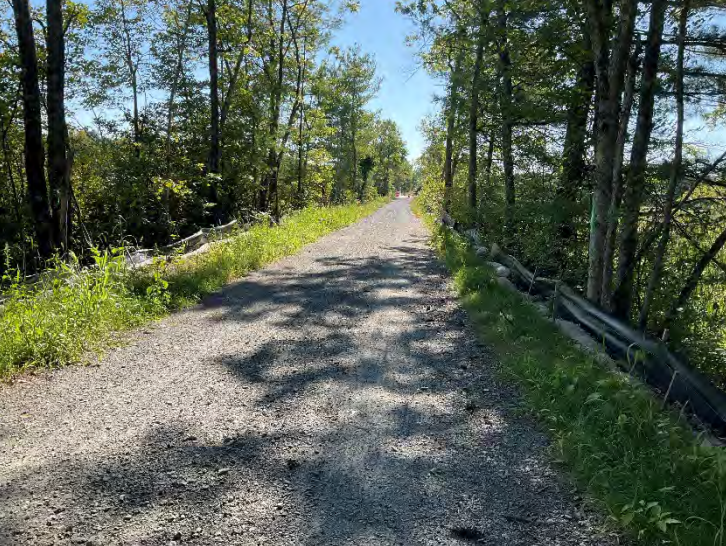
<p>PHOTOGRAPHIC LOG</p>	
<p>Client Name: Eversource</p>		<p>Site Location: Sudbury to Hudson Transmission Reliability Project</p>	<p>Town: Hudson</p>
<p>Photo No.: 6</p>	<p>Date: 9-3-24</p>

<p>Description: View of E&S controls in segment 2. Facing east.</p>

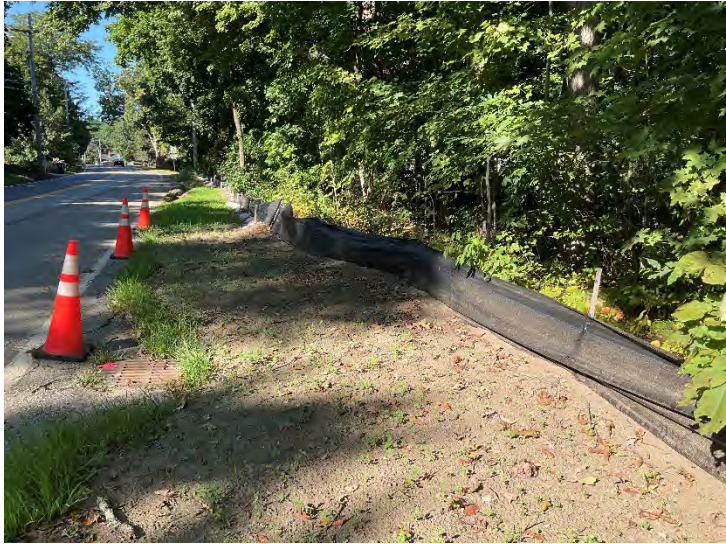
<p align="center">PHOTOGRAPHIC LOG</p>	
<p>Client Name: Eversource</p>		<p>Site Location: Sudbury to Hudson Transmission Reliability Project</p>	<p>Town: Hudson</p>
<p>Photo No.: 7</p>	<p>Date: 9-3-24</p>

<p>Description:</p> <p>View of silt fencing along Wilkins Street. Facing east.</p>

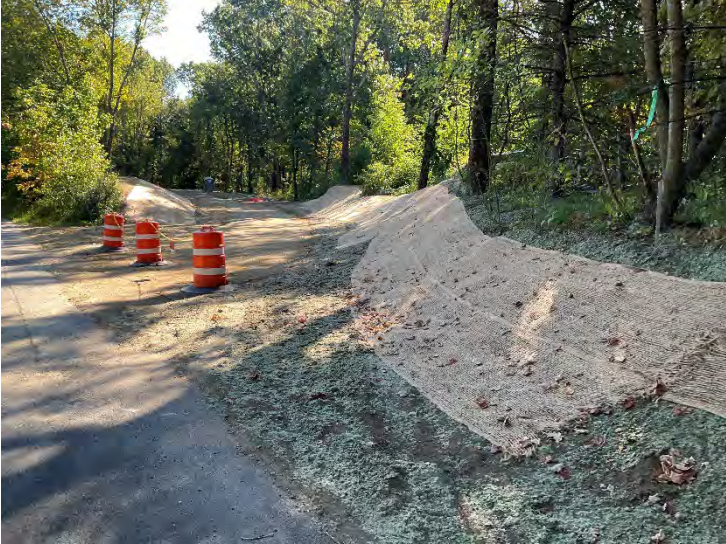
<p align="center">PHOTOGRAPHIC LOG</p>	
<p>Client Name: Eversource</p>		<p>Site Location: Sudbury to Hudson Transmission Reliability Project</p>	<p>Town: Hudson</p>
<p>Photo No.: 8</p>	<p>Date: 9-3-24</p>

<p>Description:</p> <p>View of construction entrance to segment 1. Facing east.</p>

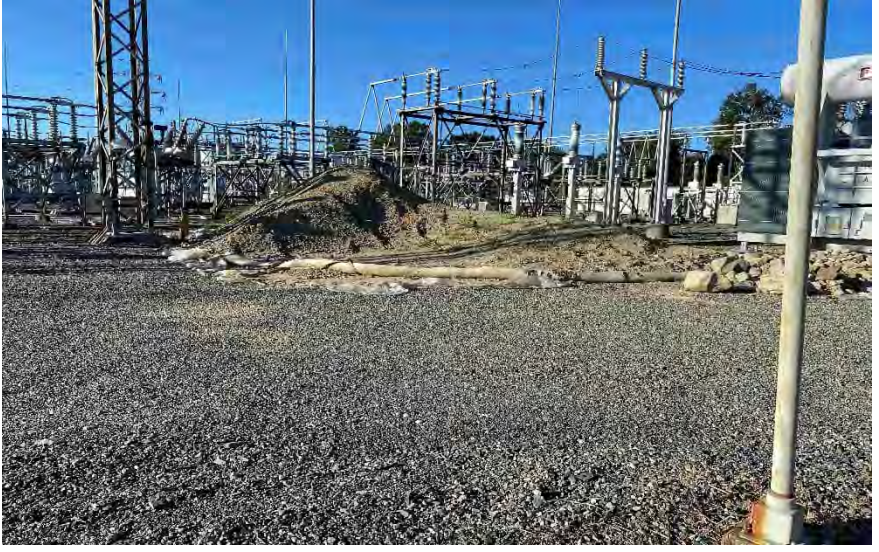
<p align="center">PHOTOGRAPHIC LOG</p>	
<p>Client Name: Eversource</p>		<p>Site Location: Sudbury to Hudson Transmission Reliability Project</p>	<p>Town: Sudbury</p>
<p>Photo No.: 1</p>	<p>Date: 9-3-24</p>

<p>Description:</p> <p>Spoil pile within Sudbury substation surrounded by compost filter tubes, looking southward.</p>

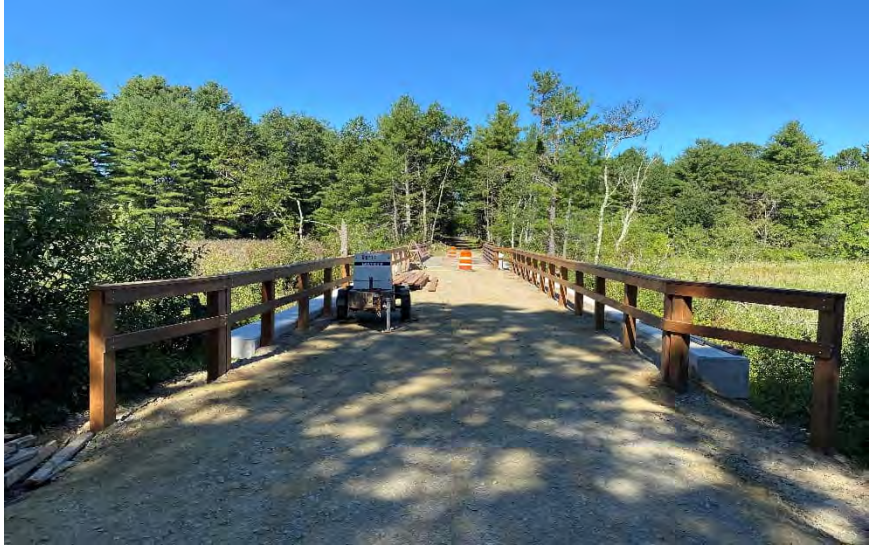
<p align="center">PHOTOGRAPHIC LOG</p>	
<p>Client Name: Eversource</p>		<p>Site Location: Sudbury to Hudson Transmission Reliability Project</p>	<p>Town: Sudbury</p>
<p>Photo No.: 2</p>	<p>Date: 9-3-24</p>

<p>Description:</p> <p>Work area within segment 8, Recently completed Bridge 128 posts/rails, erosion control, looking westward.</p>

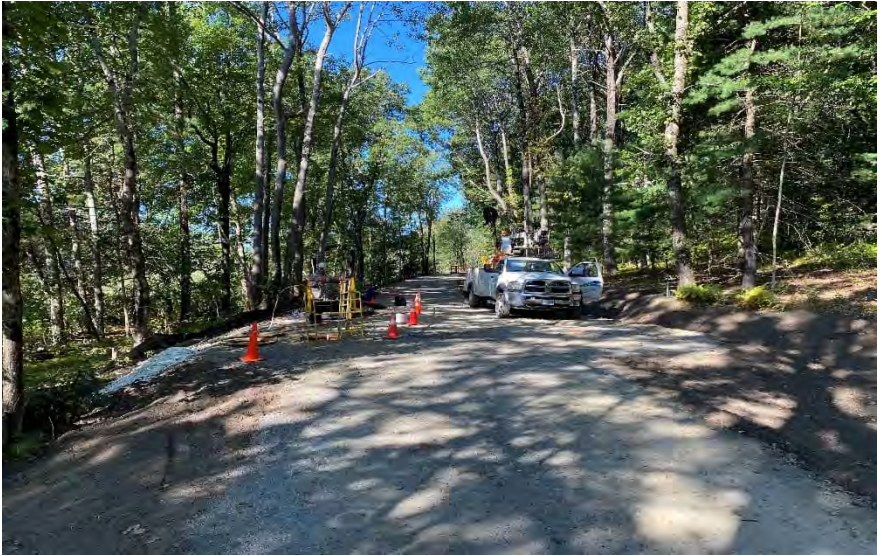
<p>PHOTOGRAPHIC LOG</p>	
<p>Client Name: Eversource</p>		<p>Site Location: Sudbury to Hudson Transmission Reliability Project</p>	<p>Town: Sudbury</p>
<p>Photo No.: 3</p>	<p>Date: 9-3-24</p>

<p>Description:</p> <p>New Wave conducting fiber optics work at manhole #26, existing erosion control, looking westward</p>

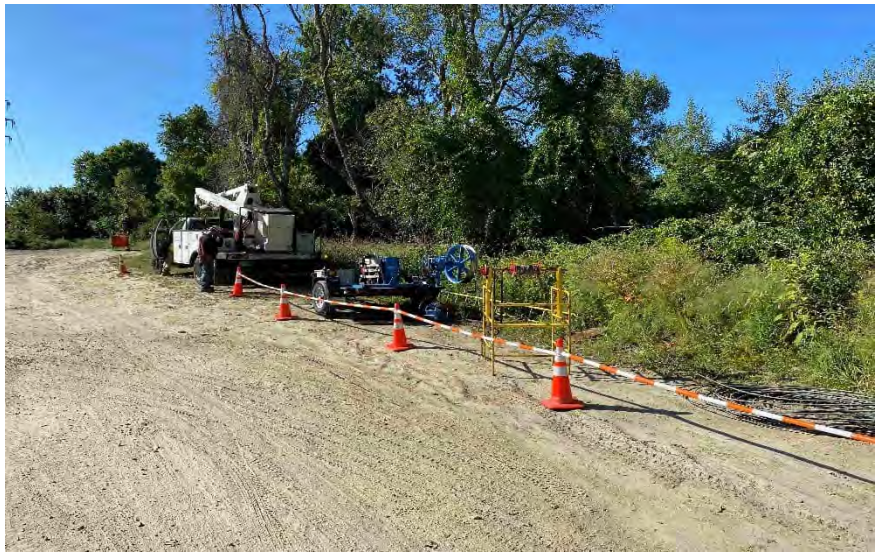
<p>PHOTOGRAPHIC LOG</p>	
<p>Client Name: Eversource</p>		<p>Site Location: Sudbury to Hudson Transmission Reliability Project</p>	<p>Town: Sudbury</p>
<p>Photo No.: 4</p>	<p>Date: 9-3-24</p>

<p>Description:</p> <p>Work area outside substation, New Wave conducting fiber optics work at manhole #28, existing erosion control, looking southward</p>

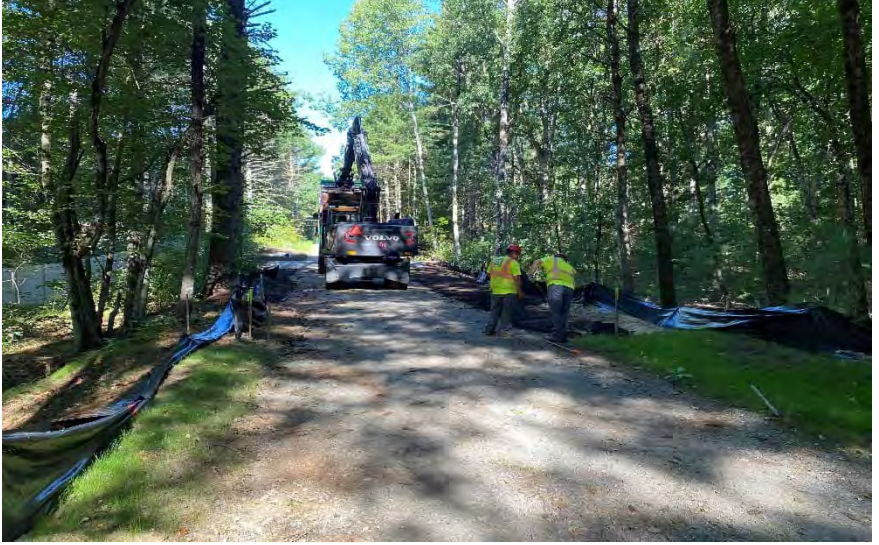
<p>PHOTOGRAPHIC LOG</p>	
<p>Client Name: Eversource</p>		<p>Site Location: Sudbury to Hudson Transmission Reliability Project</p>	<p>Town: Sudbury</p>
<p>Photo No.: 5</p>	<p>Date: 9-3-24</p>

<p>Description:</p> <p>ET&L performing site work within segment 10, adding loam to shoulders, existing erosion control, looking westward.</p>

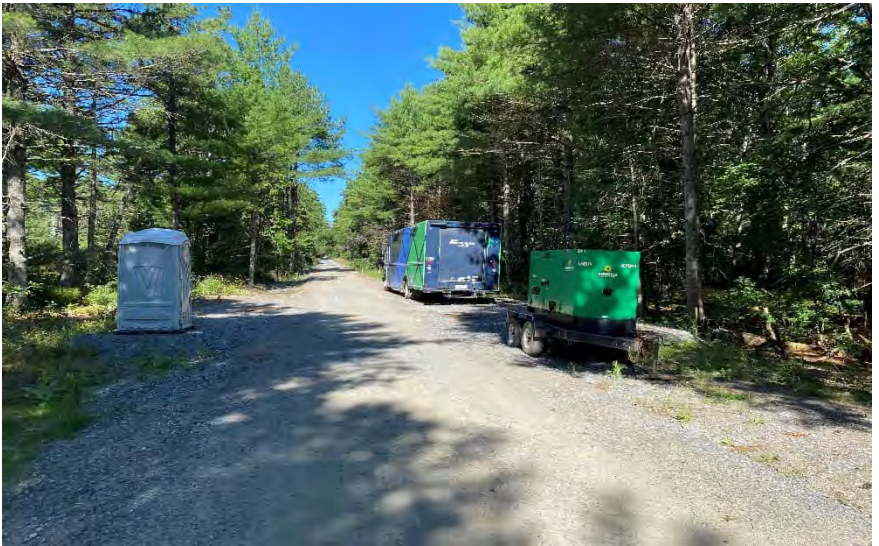
<p>PHOTOGRAPHIC LOG</p>	
<p>Client Name: Eversource</p>		<p>Site Location: Sudbury to Hudson Transmission Reliability Project</p>	<p>Town: Sudbury</p>
<p>Photo No.: 6</p>	<p>Date: 9-3-24</p>

<p>Description:</p> <p>Work area within segment 7, manhole #16, Haugland equipment staged, existing erosion control, looking westward</p>

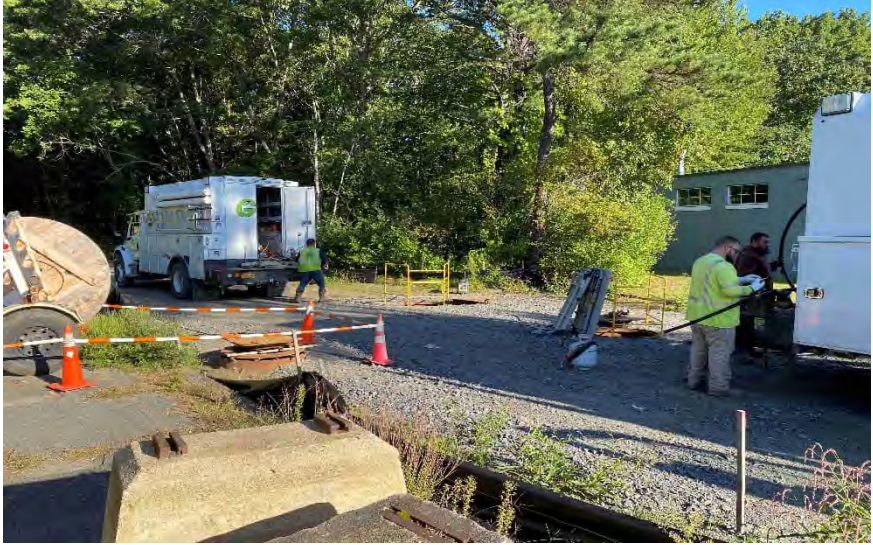
<p>PHOTOGRAPHIC LOG</p>	
<p>Client Name: Eversource</p>		<p>Site Location: Sudbury to Hudson Transmission Reliability Project</p>	<p>Town: Sudbury</p>
<p>Photo No.: 7</p>	<p>Date: 9-3-24</p>

<p>Description:</p> <p>Work area within segment 11, manhole #24 Haugland work, existing erosion control, looking westward.</p>

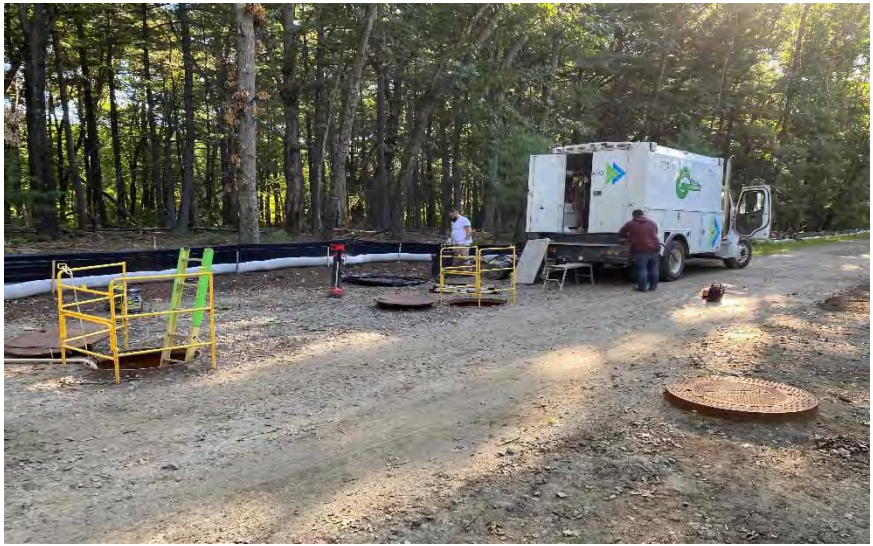
<p>PHOTOGRAPHIC LOG</p>	
<p>Client Name: Eversource</p>		<p>Site Location: Sudbury to Hudson Transmission Reliability Project</p>	<p>Town: Sudbury</p>
<p>Photo No.: 8</p>	<p>Date: 9-3-24</p>

<p>Description:</p> <p>Work area within segment 11, manhole #23 Haugland work, existing erosion control, looking eastward.</p>

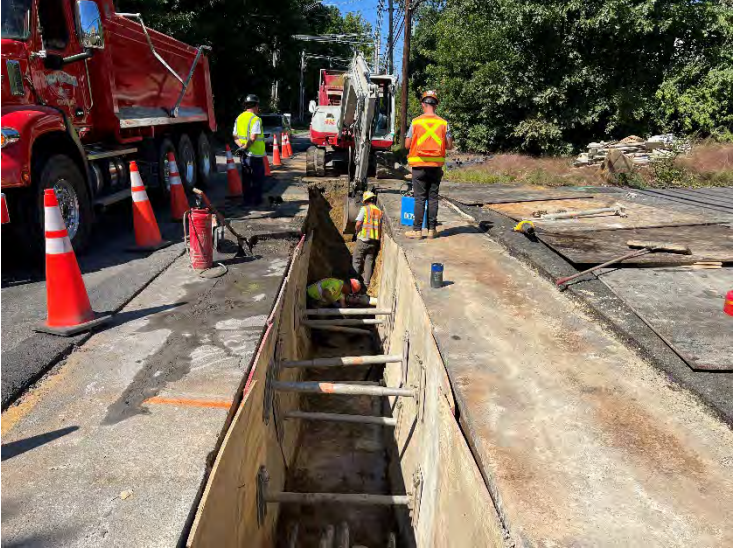
<p>PHOTOGRAPHIC LOG</p>	
<p>Client Name: Eversource</p>		<p>Site Location: Sudbury to Hudson Transmission Reliability Project</p>	<p>Town: Hudson</p>
<p>Photo No.: 1</p>	<p>Date: 9-4-24</p>

<p>Description:</p> <p>View of Bond trenching on Forest Avenue between MHs#1 & #2. Facing west.</p>

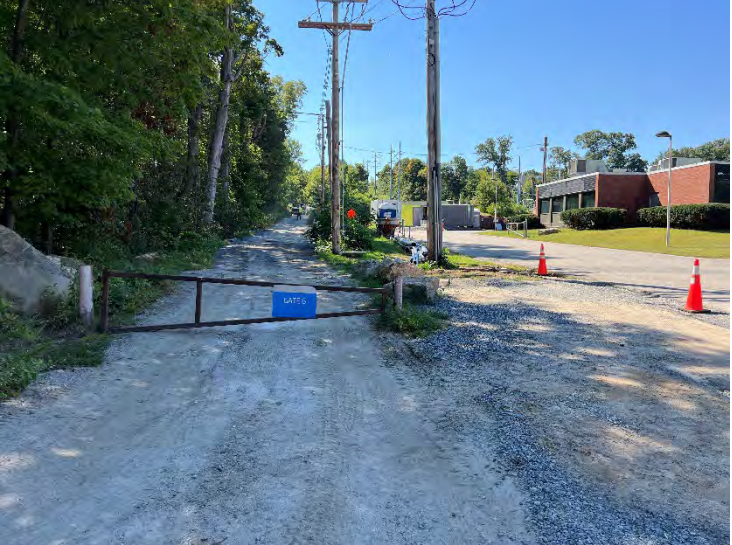
<p>PHOTOGRAPHIC LOG</p>	
<p>Client Name: Eversource</p>		<p>Site Location: Sudbury to Hudson Transmission Reliability Project</p>	<p>Town: Hudson</p>
<p>Photo No.: 3</p>	<p>Date: 9-4-24</p>

<p>Description:</p> <p>View of MH#1 by entrance to Hudson Light & Power off Forest Avenue. Facing south.</p>

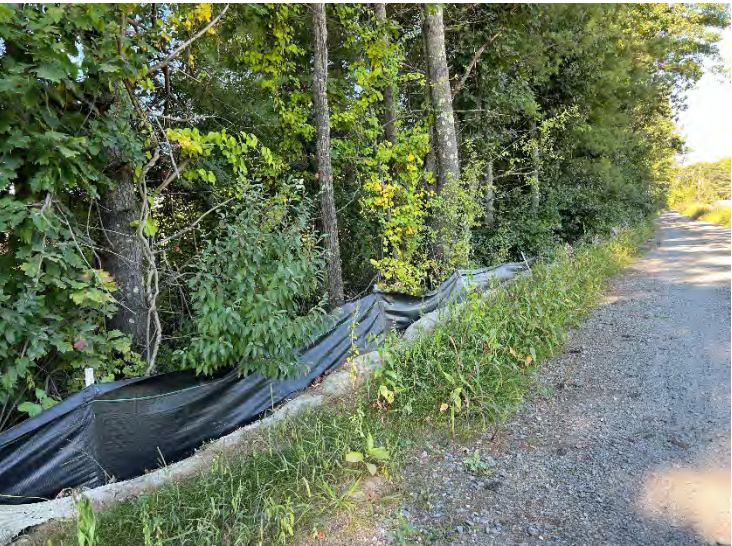
<p>PHOTOGRAPHIC LOG</p>	
<p>Client Name: Eversource</p>		<p>Site Location: Sudbury to Hudson Transmission Reliability Project</p>	<p>Town: Hudson</p>
<p>Photo No.: 4</p>	<p>Date: 9-4-24</p>

<p>Description:</p> <p>View of E&S controls in segment 3. Facing west.</p>

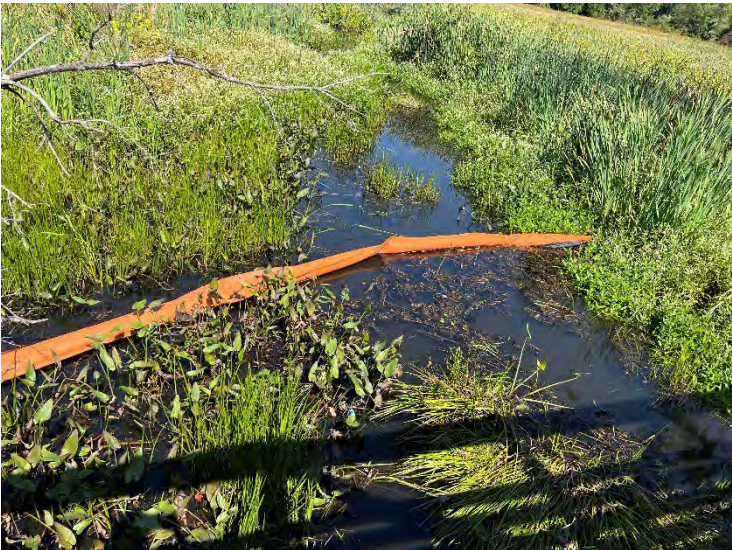
<p>PHOTOGRAPHIC LOG</p>	
<p>Client Name: Eversource</p>		<p>Site Location: Sudbury to Hudson Transmission Reliability Project</p>	<p>Town: Hudson</p>
<p>Photo No.: 6</p>	<p>Date: 9-4-24</p>

<p>Description:</p> <p>View of turbidity curtain at Bridge 130 between segments 2&3. Facing north.</p>

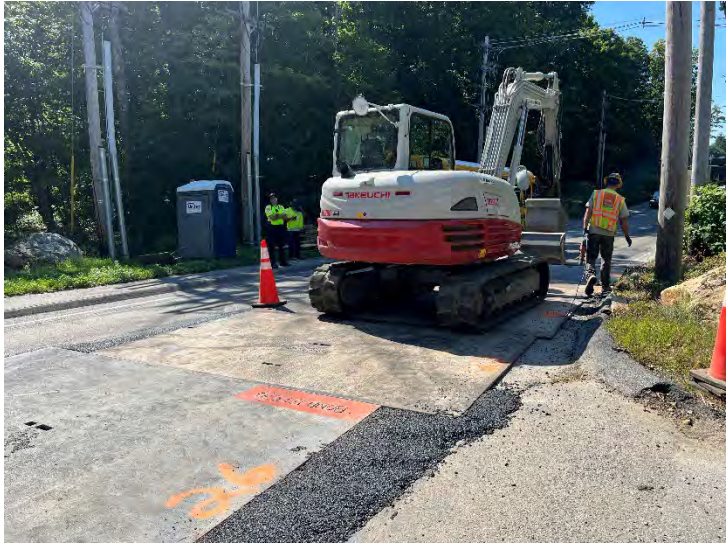
<p align="center">PHOTOGRAPHIC LOG</p>	
<p>Client Name: Eversource</p>		<p>Site Location: Sudbury to Hudson Transmission Reliability Project</p>	<p>Town: Hudson</p>
<p>Photo No.: 7</p>	<p>Date: 9-4-24</p>

<p>Description:</p> <p>View of Bond adjusting steel road plates on Forest Ave east of MH#1. Facing southwest.</p>

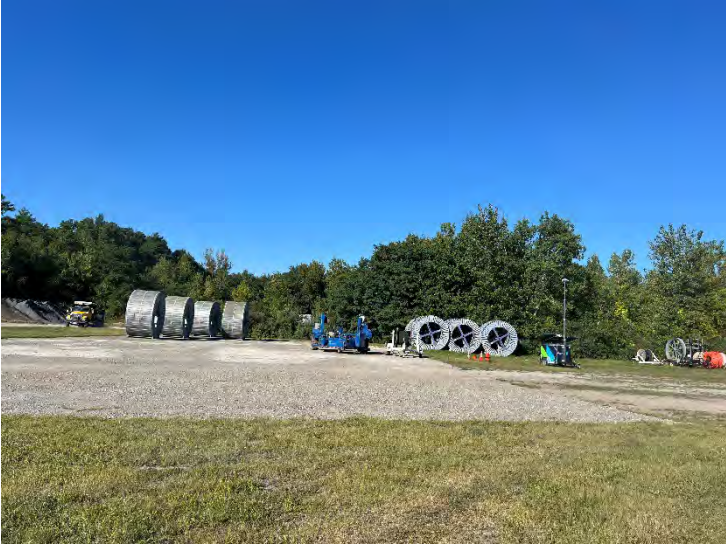
<p align="center">PHOTOGRAPHIC LOG</p>	
<p>Client Name: Eversource</p>		<p>Site Location: Sudbury to Hudson Transmission Reliability Project</p>	<p>Town: Hudson</p>
<p>Photo No.: 8</p>	<p>Date: 9-4-24</p>

<p>Description:</p> <p>View of stored cable reels in the Haugland laydown yard. Facing southwest.</p>

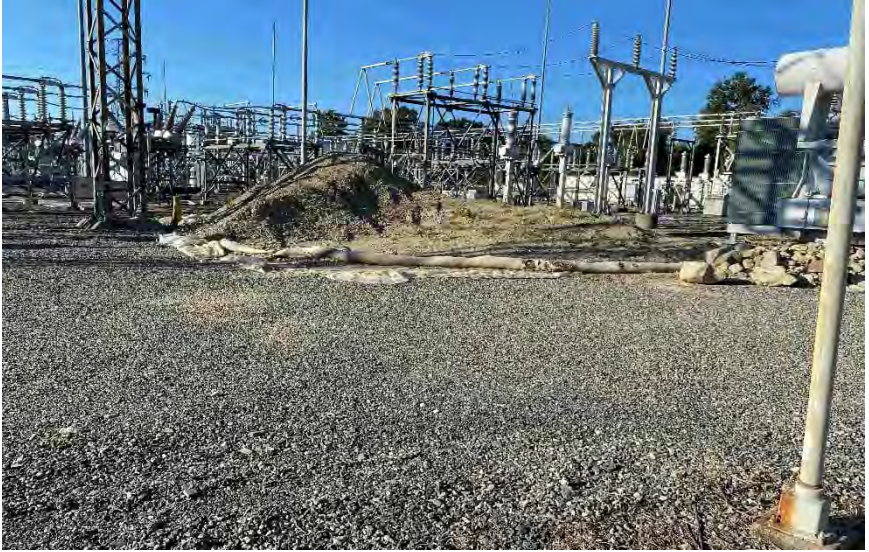
PHOTOGRAPHIC LOG	
Client Name: Eversource		Site Location: Sudbury to Hudson Transmission Reliability Project	
Photo No.: 1 Date: 9-4-24		Town: Sudbury	
Description: Spoil pile within Sudbury substation surrounded by compost filter tubes, looking southward.

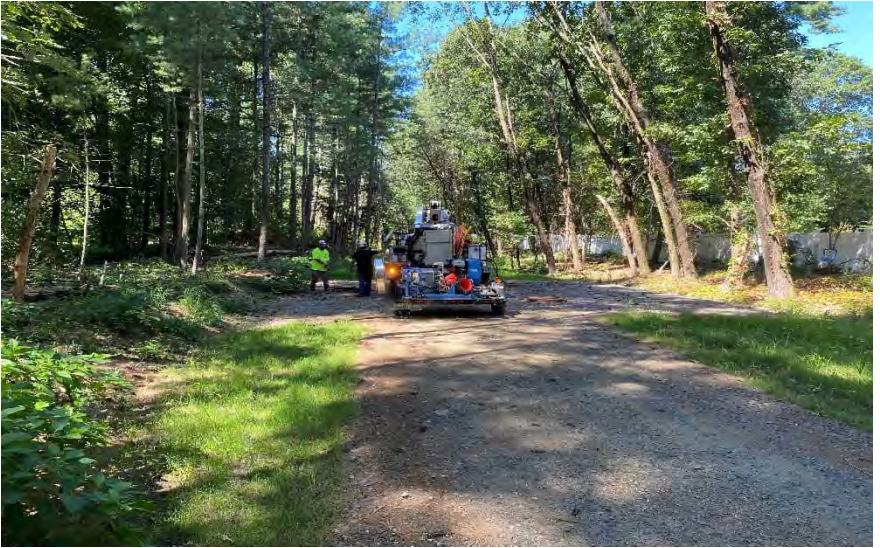
<p>Description:</p> <p>New Wave conducting fiber optics work at handhole #21, existing erosion control, looking westward</p>

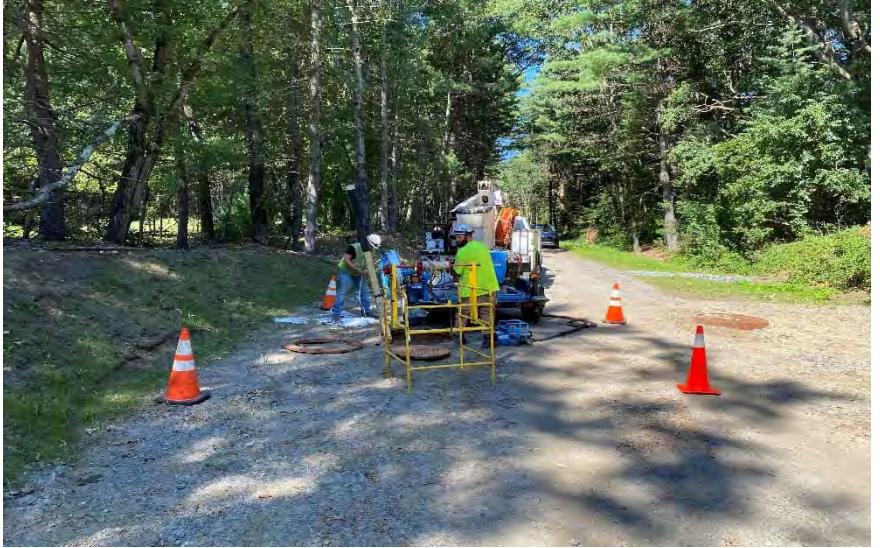
<p>Description:</p> <p>New Wave conducting fiber optics work at handhole #22, existing erosion control, looking westward</p>

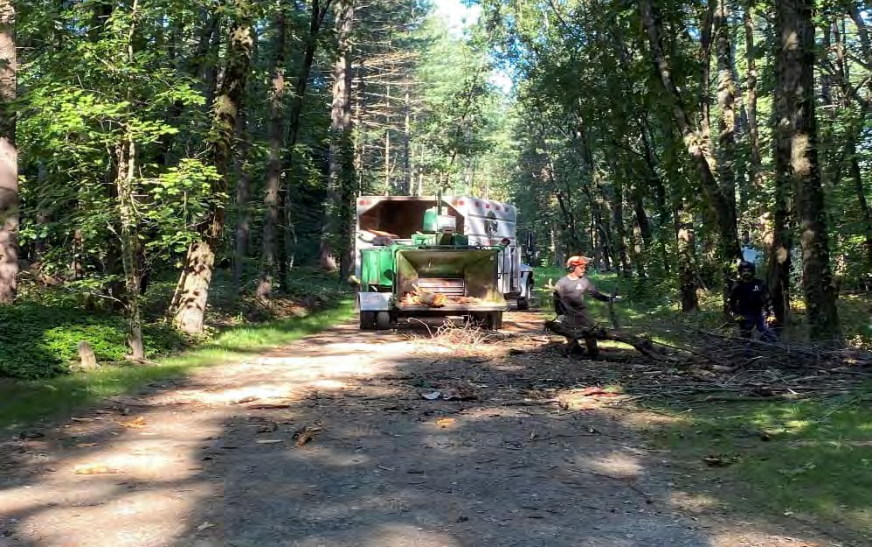
<p>Description:</p> <p>Outside contractor (not project related) performing timber clearing work within segment 10, off Horse Pond Road, looking westward.</p>

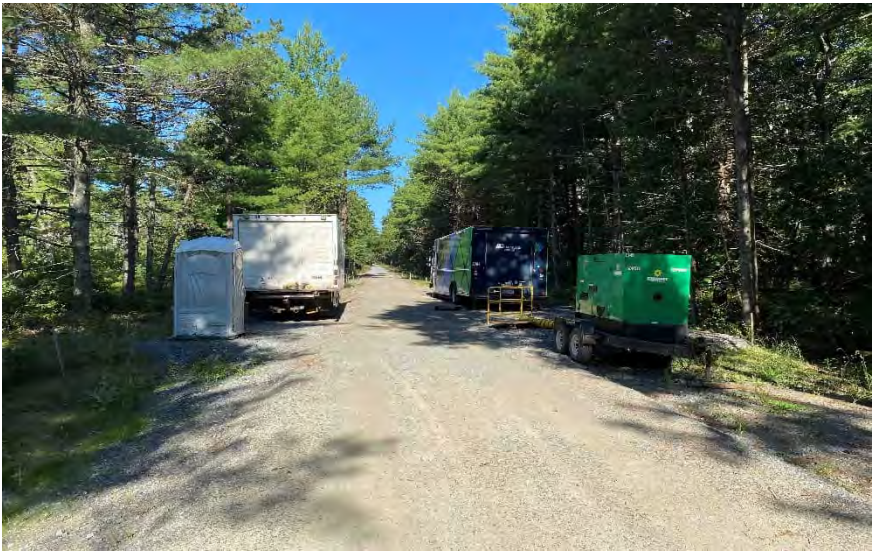
<p>Description:</p> <p>Work area within segment 7, manhole #16, Haugland equipment staged, existing erosion control, looking westward</p>

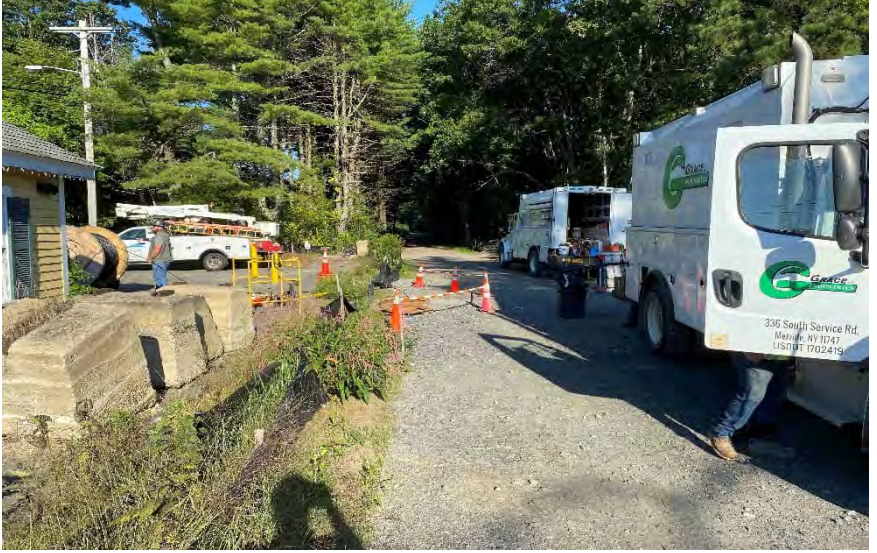
<p>Description:</p> <p>Work area within segment 11, manhole #24 Haugland splicing work, existing erosion control, looking westward.</p>

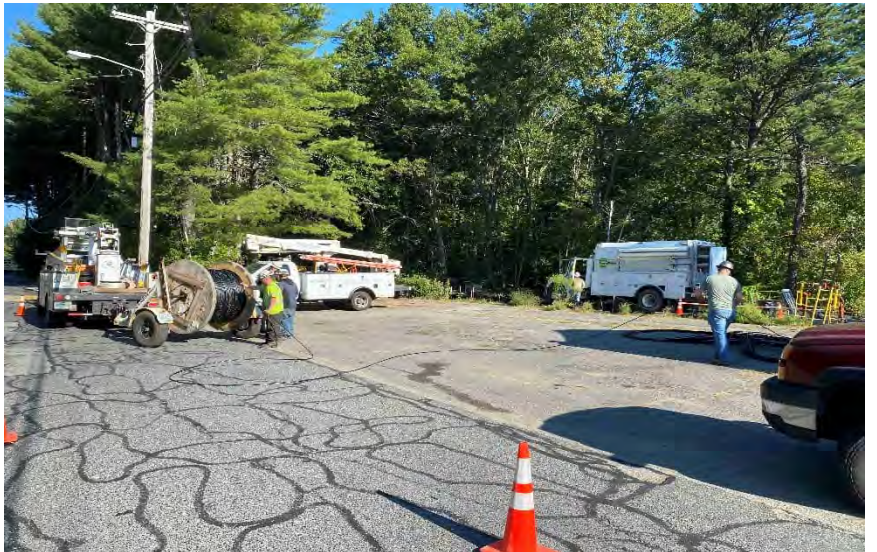
<p>Description:</p> <p>Work area within segment 11, handhole #24 New Wave fiber optics work.</p>

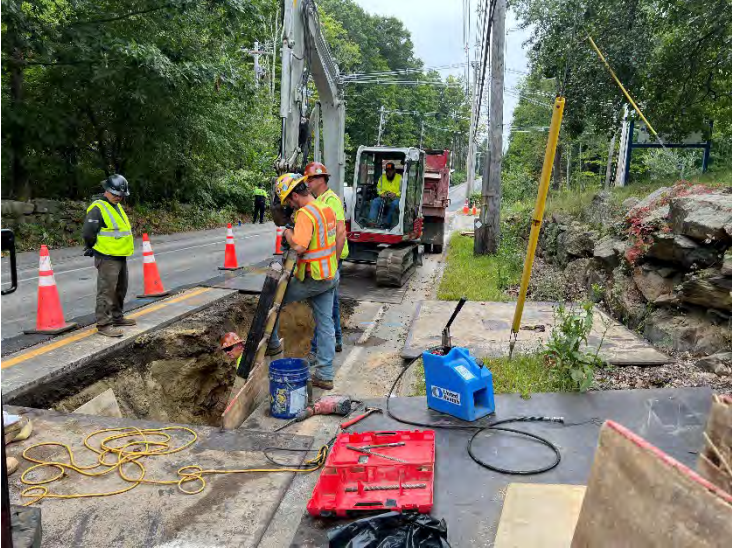
<p>Description:</p> <p>View of Bond trenching on Forest Avenue by MH#1. Facing west.</p>

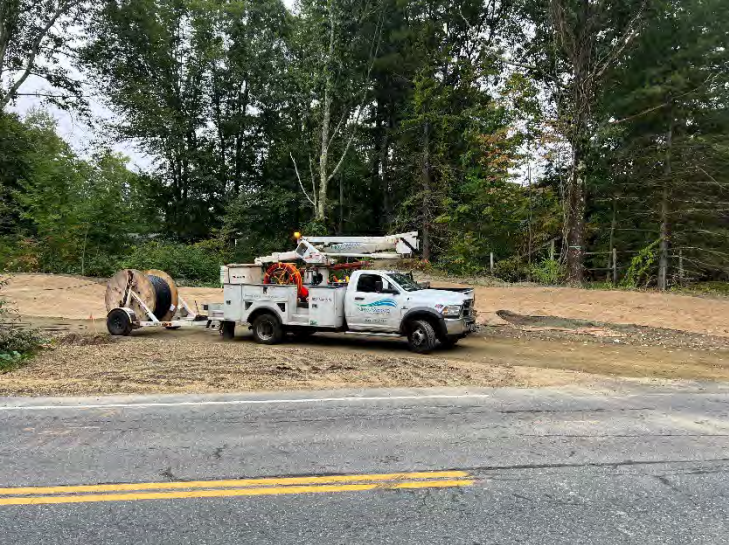
<p>Description:</p> <p>View of New Wave pulling inner fiber optics cable for installation in segment 1. Facing southeast.</p>

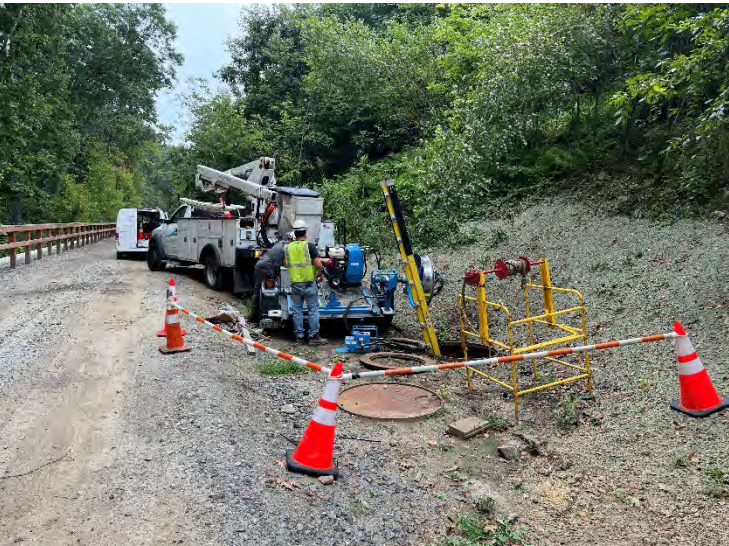
<p>Description:</p> <p>View of New Wave work area in segment 1 at HH#6. Facing east.</p>

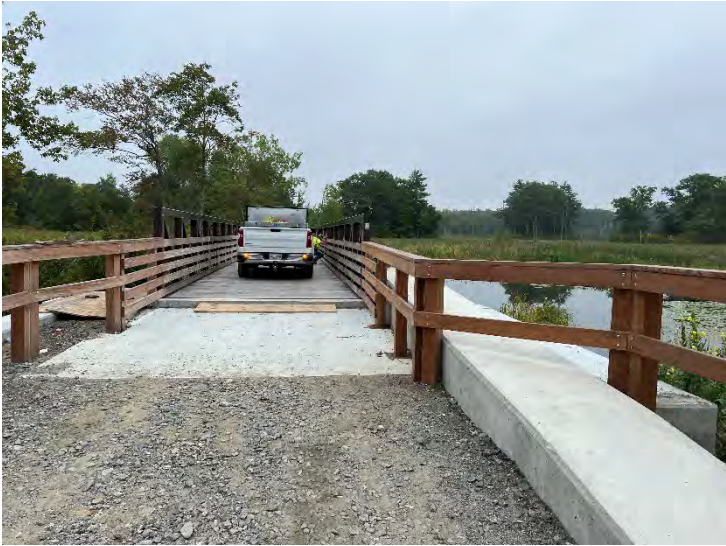
<p>Description:</p> <p>View of Bridge 130. Bond making conduit repairs. Facing east.</p>

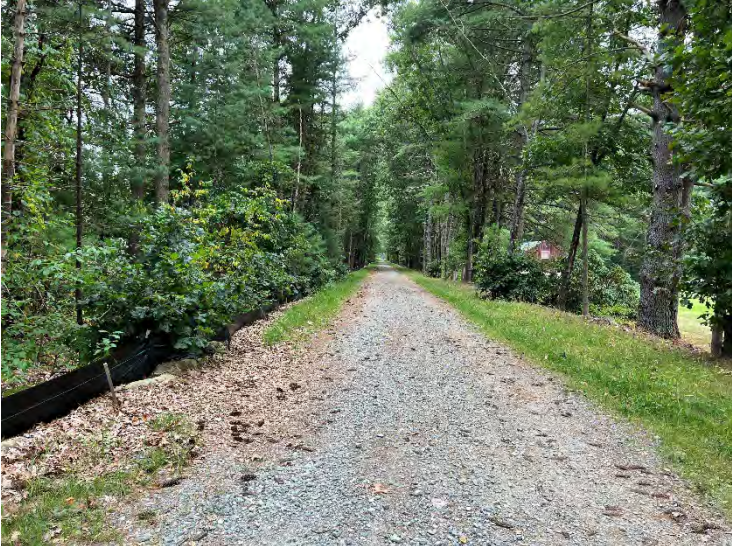
<p>Description:</p> <p>View of E&S controls in segment 4. Facing west.</p>

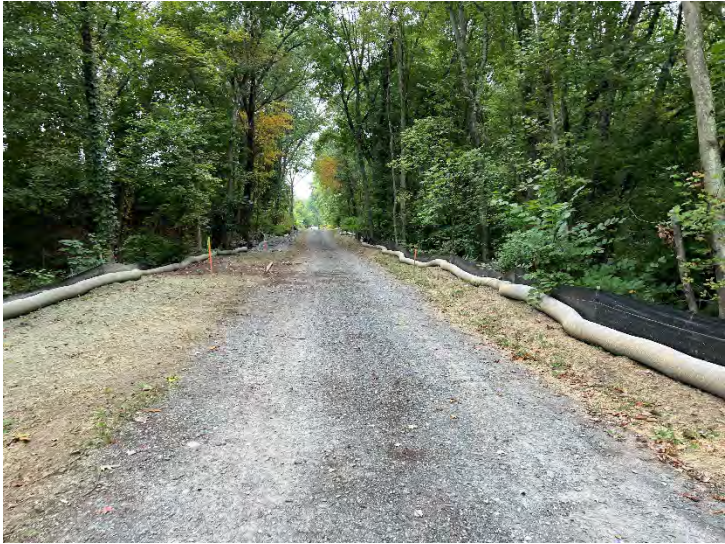
<p>Description: View of E&S controls in segment 1. Facing west.</p>

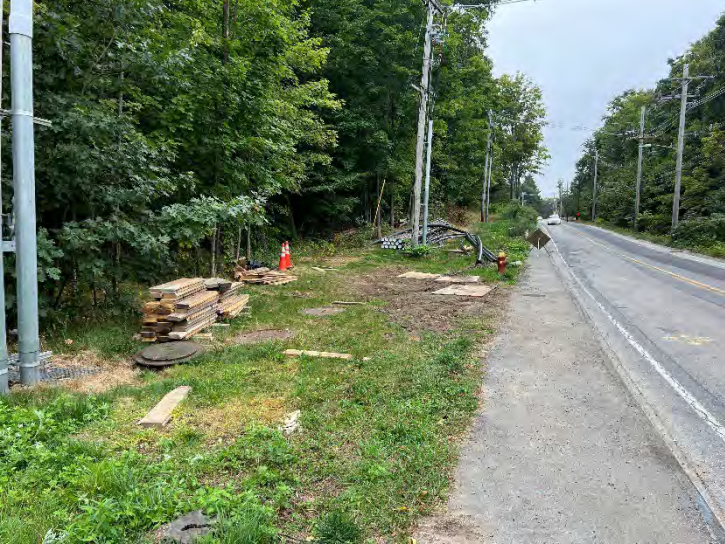
<p>Description: View of equipment staging along Forest Avenue for conduit installation. Facing west.</p>

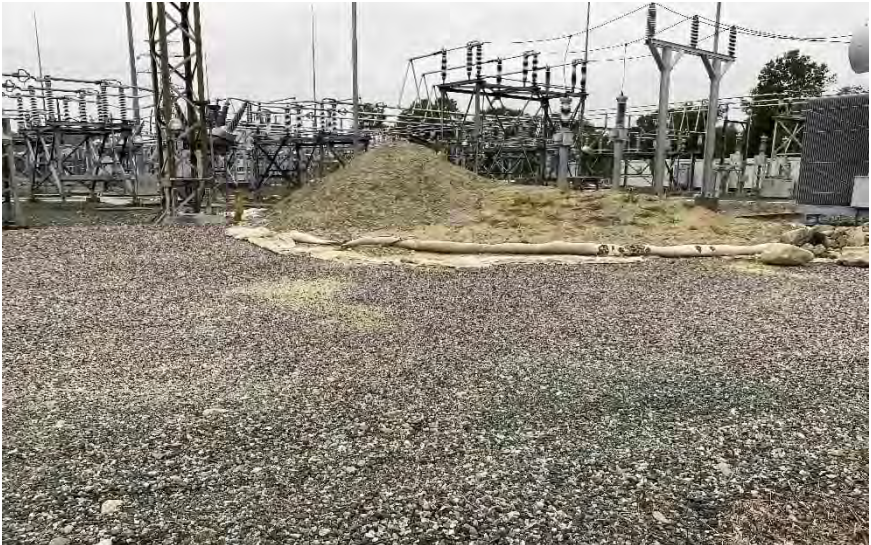
<p>Description:</p> <p>Spoil pile within Sudbury substation surrounded by compost filter tubes, looking southward.</p>

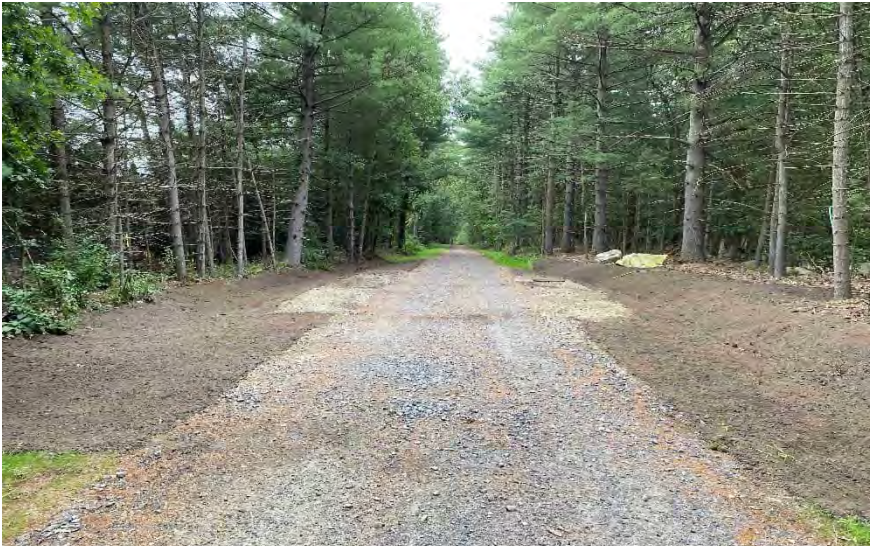
Description: Work area within segment 9, recently placed planting loam, existing erosion control, looking eastward

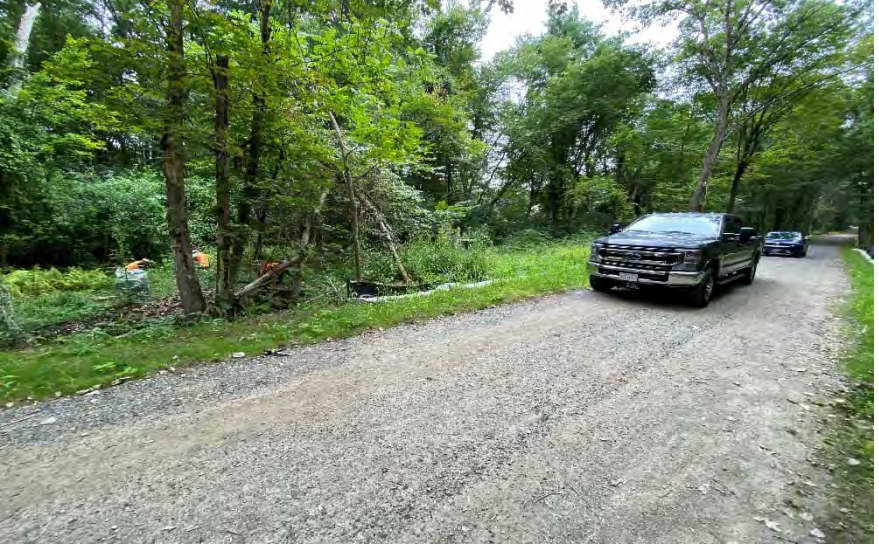
<p>Description:</p> <p>Work area within segment 9, SWCA personnel removing invasive species, looking eastward.</p>

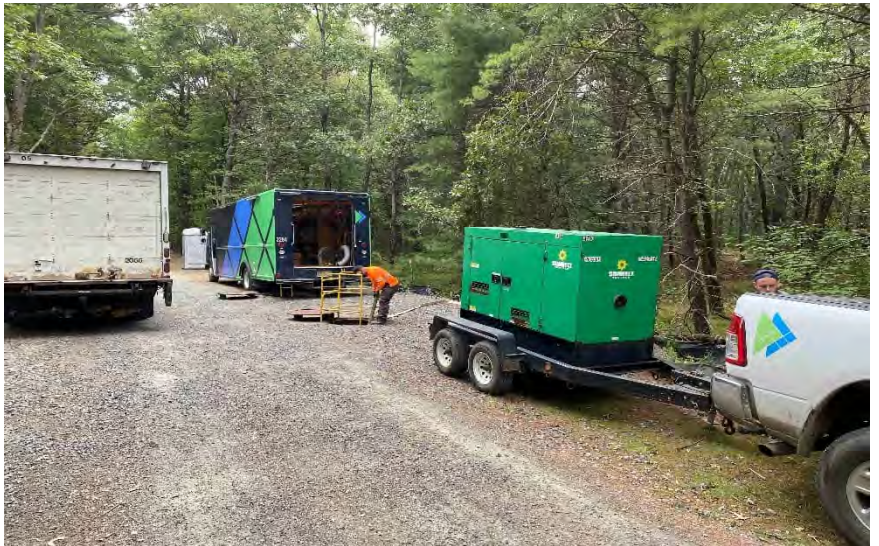
<p>Description:</p> <p>Work area within segment 7, manhole #15, Haugland equipment staged, existing erosion control, looking westward</p>

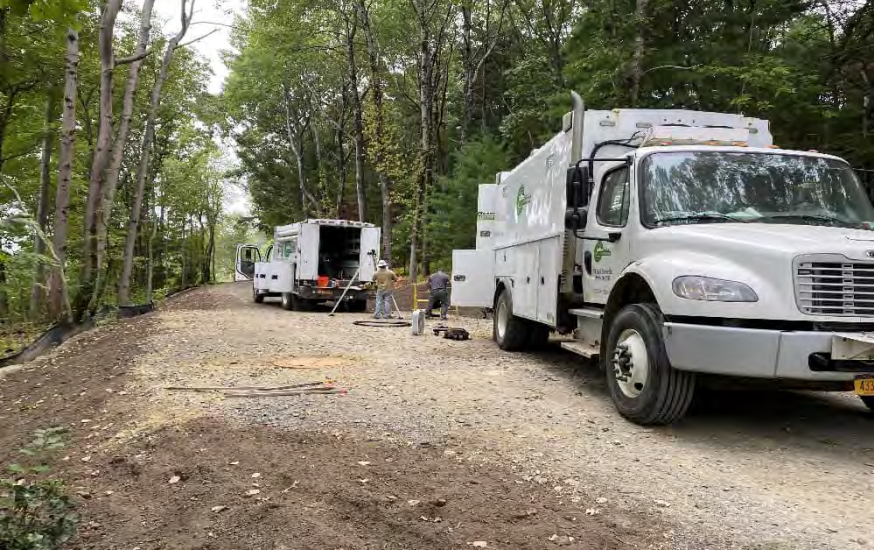
<p>Description:</p> <p>Work area within segment 14, manhole #26, Haugland equipment staged, existing erosion control, looking westward</p>

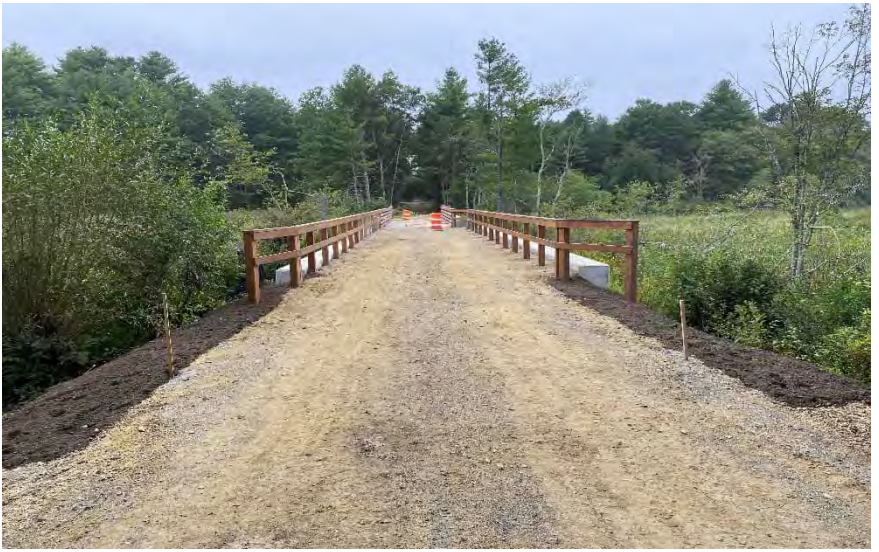
<p>Description:</p> <p>Bridge 128 area within segment 8, recently placed planting loam, existing erosion control, looking westward.</p>

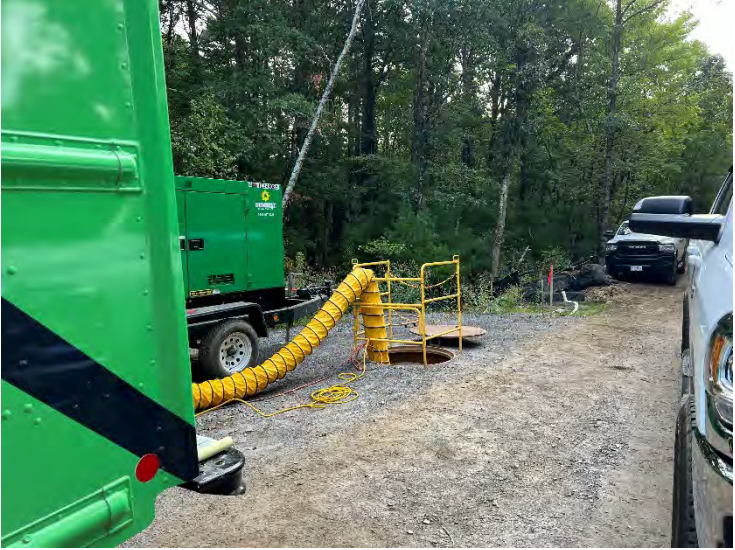
<p>Description:</p> <p>View of Haugland cable splicers at MH#14 in segment 6. Facing west.</p>

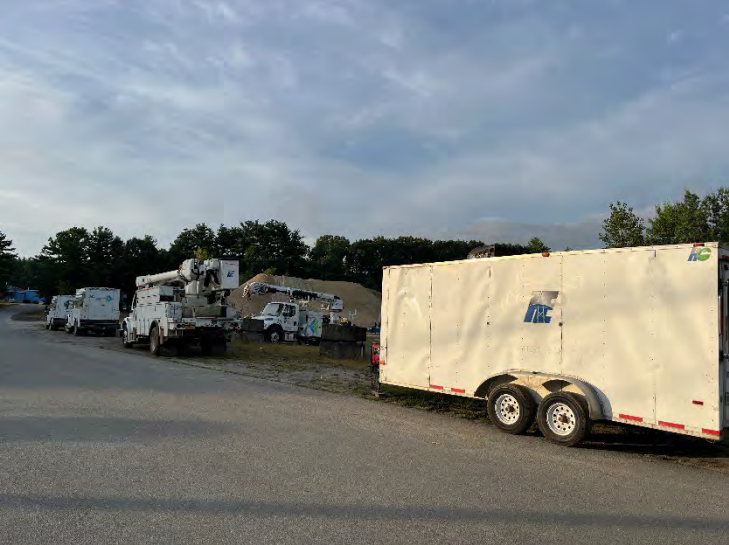
<p>Description:</p> <p>View of Haugland laydown yard. Crews active within. Facing southeast.</p>

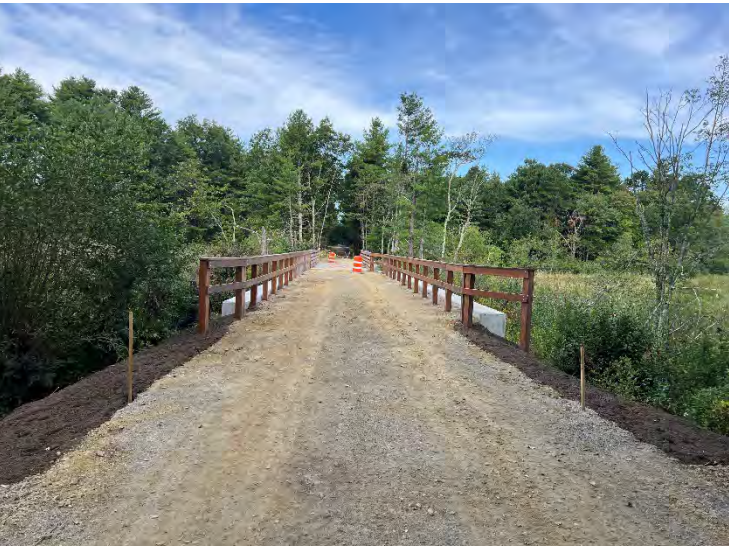
<p>Description:</p> <p>View of Bridge 128. Planting soil recently applied. Facing west.</p>

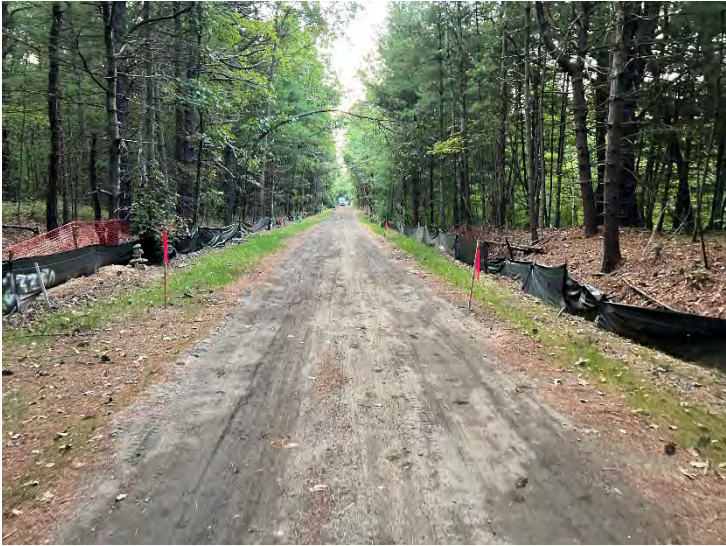
<p>Description: View of E&S controls within segment 6. Facing east.</p>

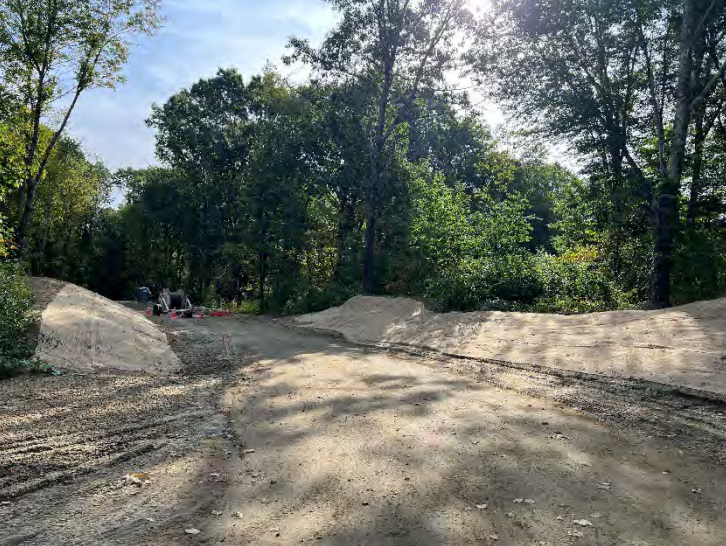
<p>Description: View of construction entrance to segment 1. New Wave cable reel staged at handhole (HH) #5. Facing east.</p>

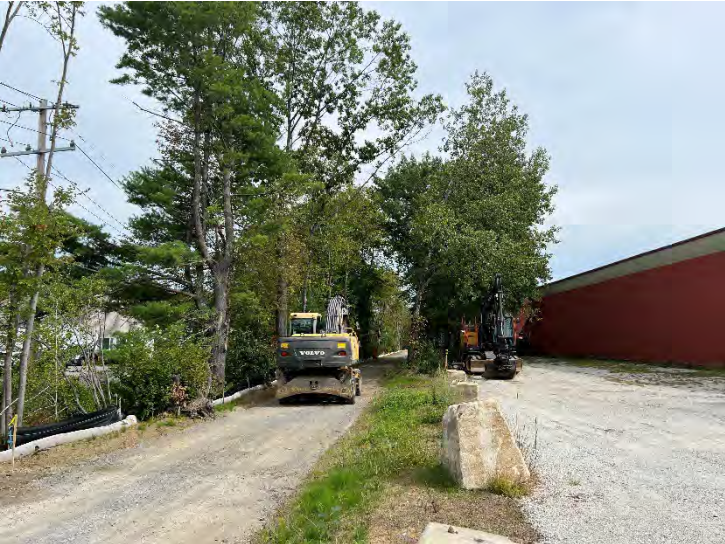
<p>Description:</p> <p>View of ET&L equipment staging in segment 12 in preparation for stump removal Monday 9/9. Facing east.</p>
