Weekly Environmental Compliance Summary

Sudbury to Hudson Transmission Reliability Project (USEPA Tracking # MAR1003UW)

Week of: September 3, 2024 to September 7, 2024

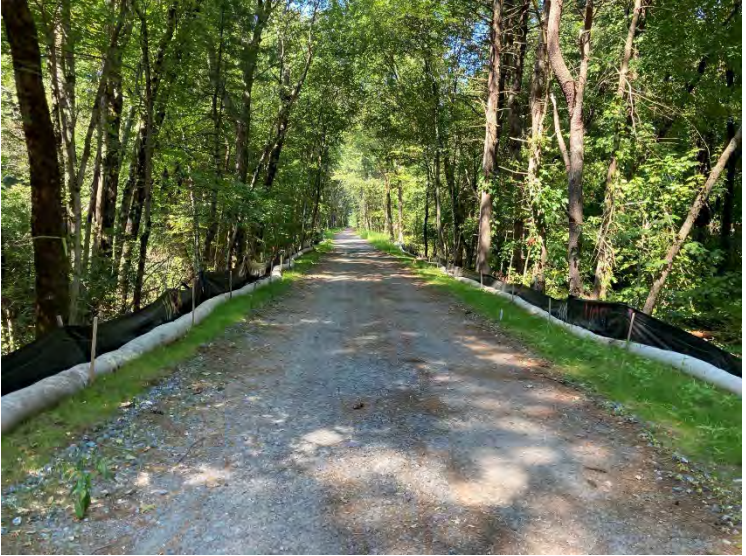
Description: View of E&S controls in segment 9. Facing west.

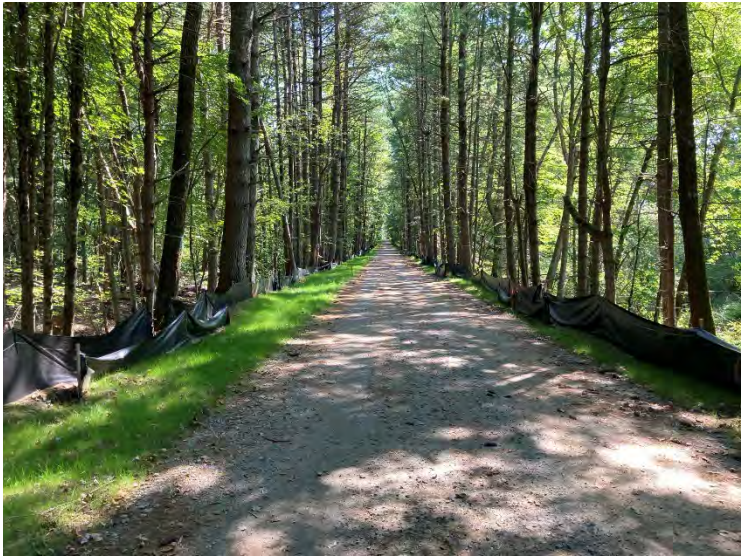
Description: View of E&S controls in segment 10. Facing east.

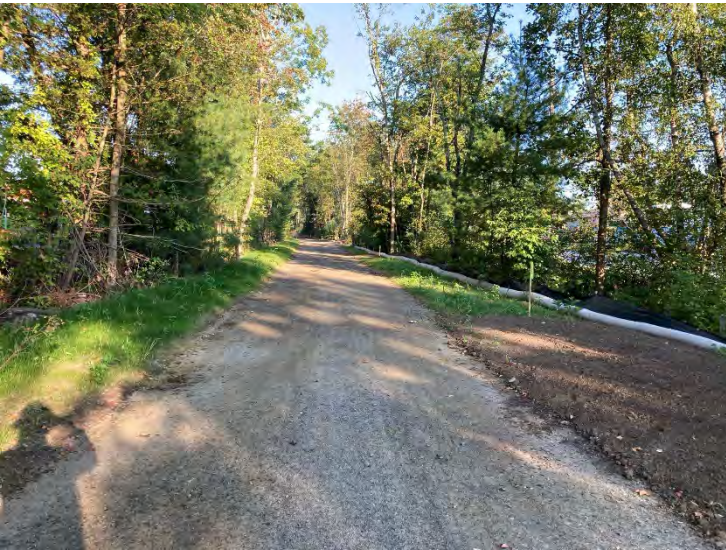
Description: View of E&S controls in segment 12. Facing west.

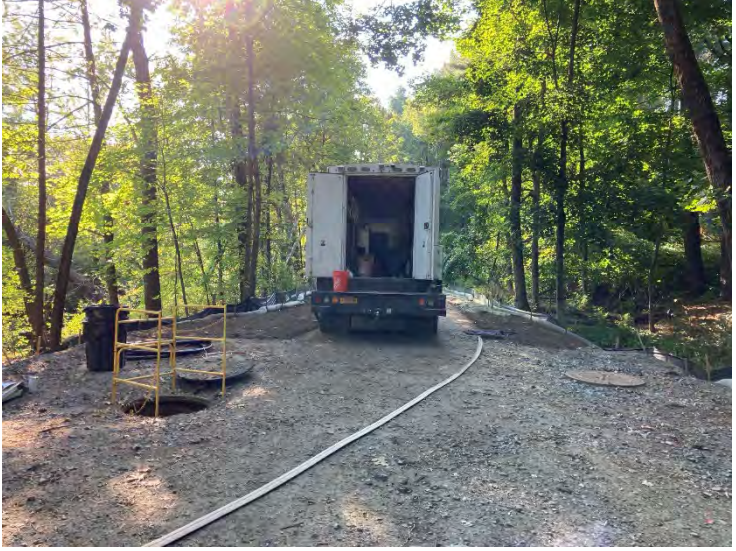
Description: View of Haugland working at MH #25 in segment 13. See additional dewatering inspection report. Facing east.

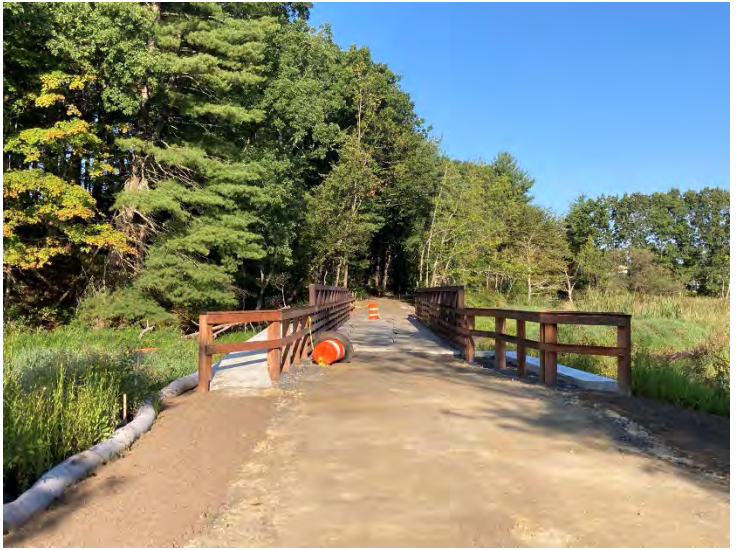
Description: View of bridge 127 from segment 14. Facing west.

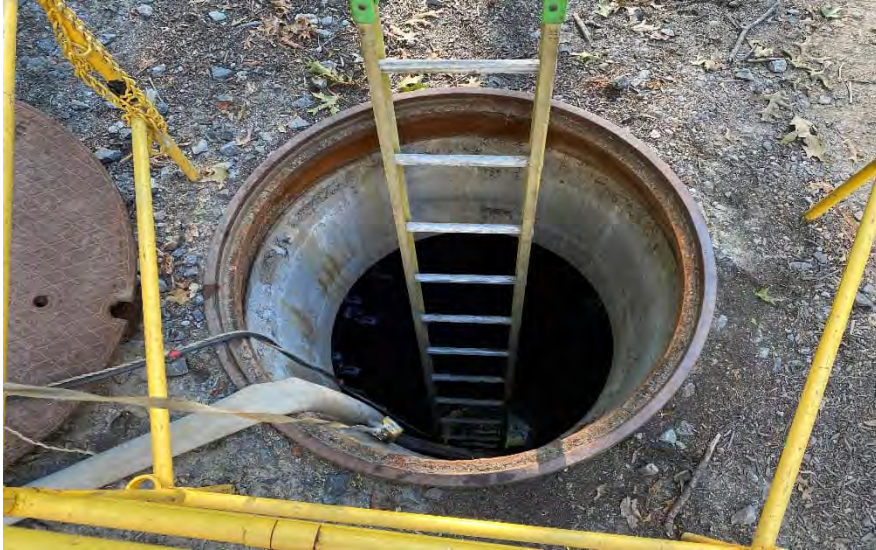
Description: View of area being pumped from manhole #23 segment 11.

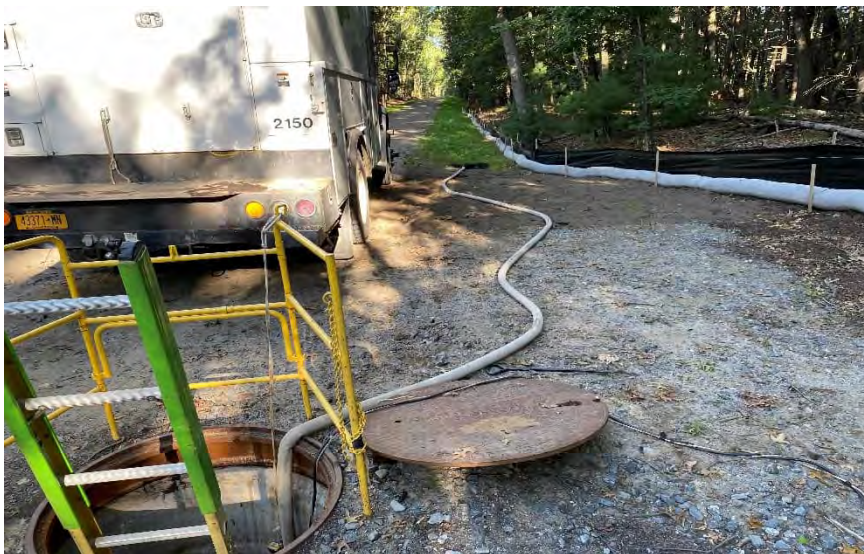
Description: Manhole #23. View of dewatering operation. Looking westward.

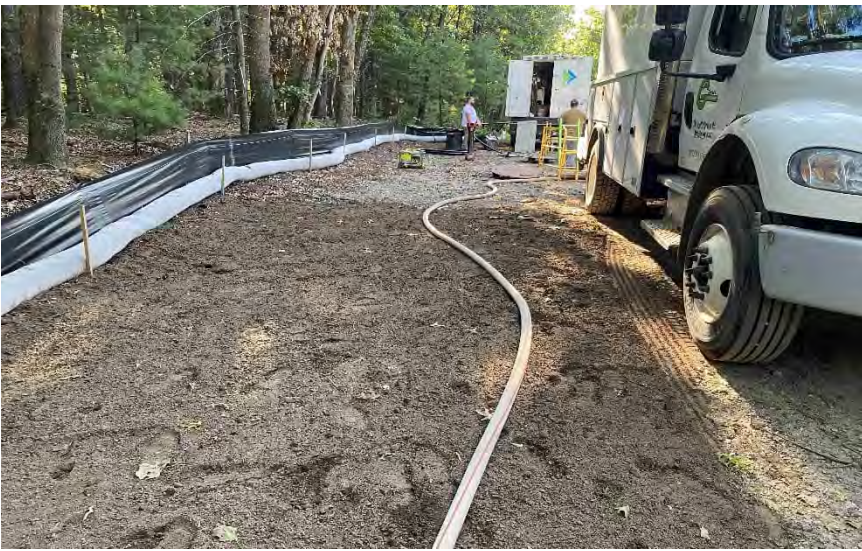
Description: Manhole #23. View of dewatering operation, looking eastward.

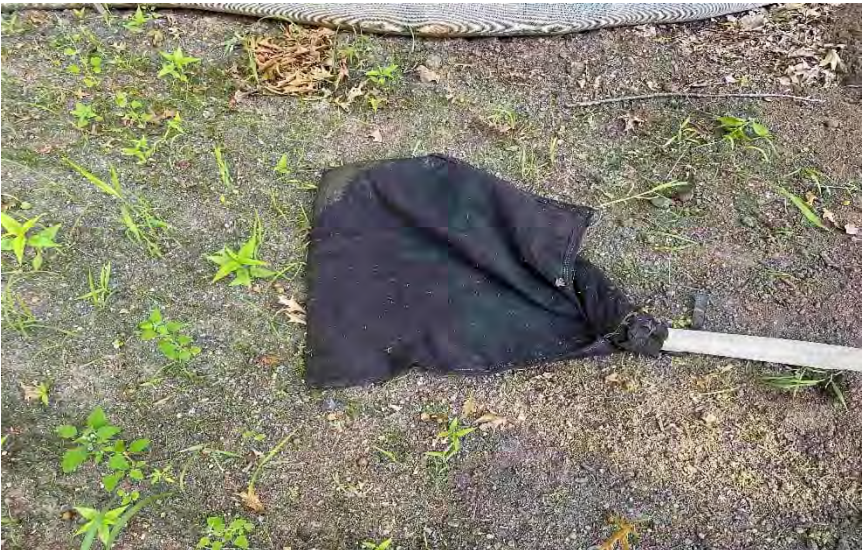
Description: Manhole #23. View of discharge bag. Water from bag discharged to adjacent area.

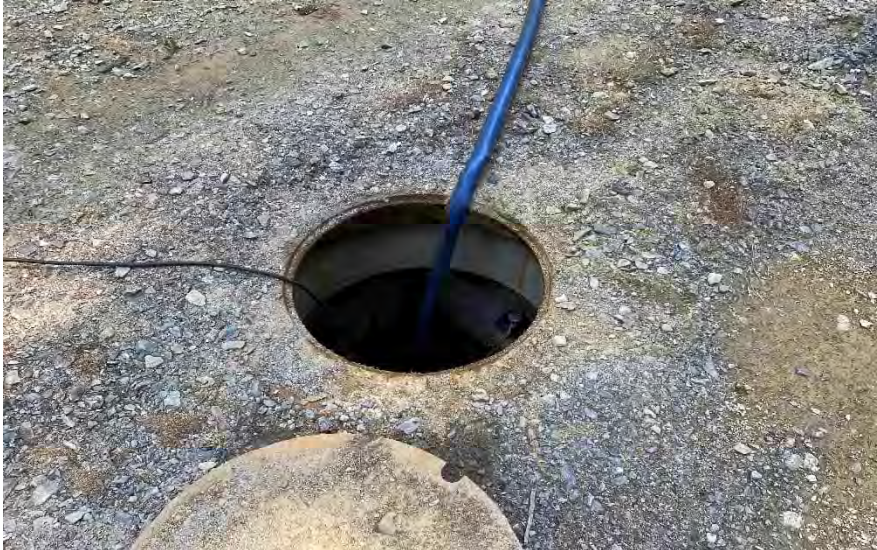
Description: View of area being pumped from handhole #20, segment 10.

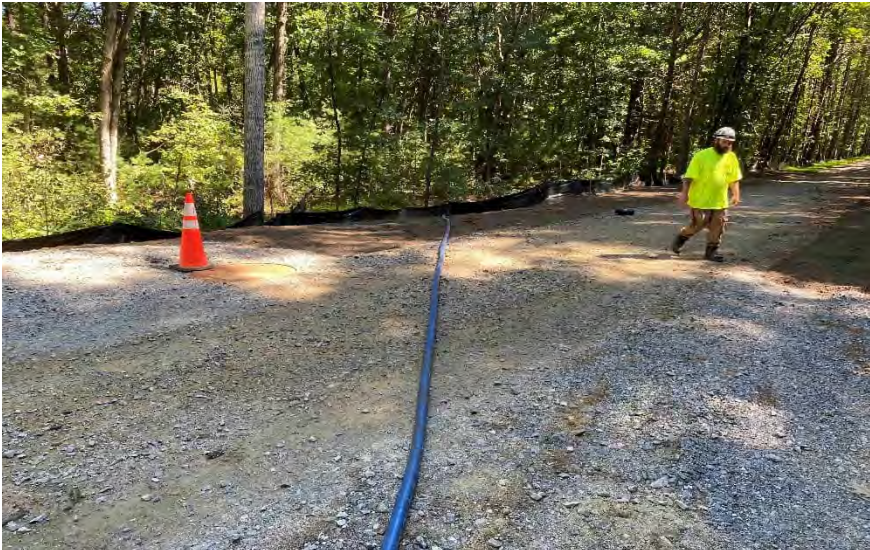
Description: Handhole #20. View of dewatering operation. Looking eastward.

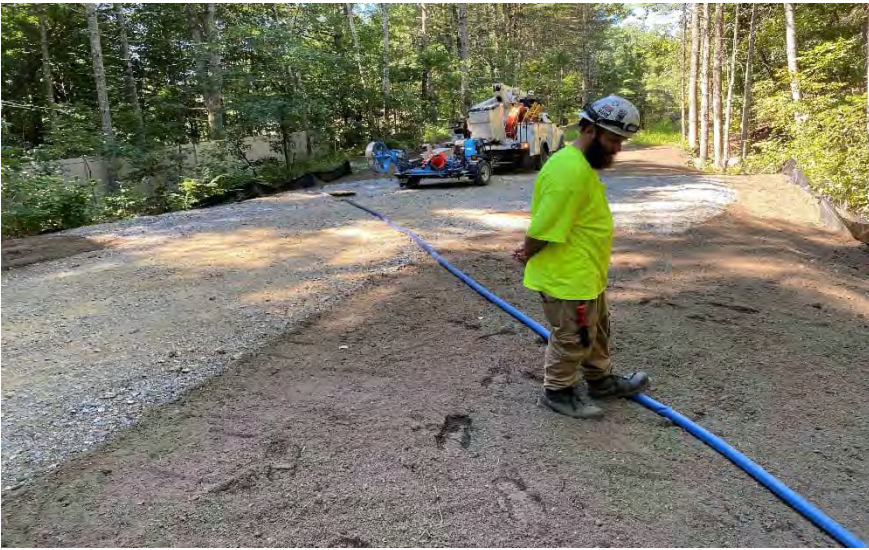
Description: Handhole #20. View of dewatering operation, looking westward.

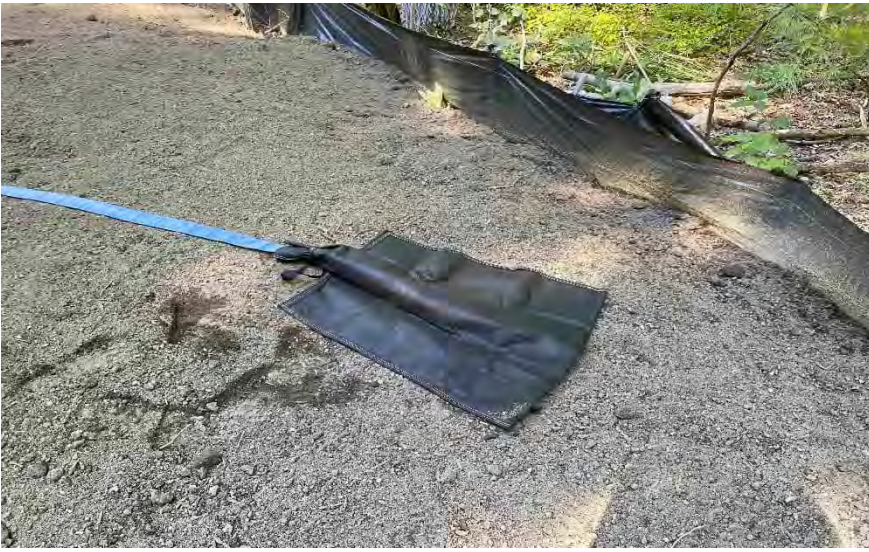
Description: Handhole #20. View of discharge bag, looking westward. Water from bag discharged to adjacent area.

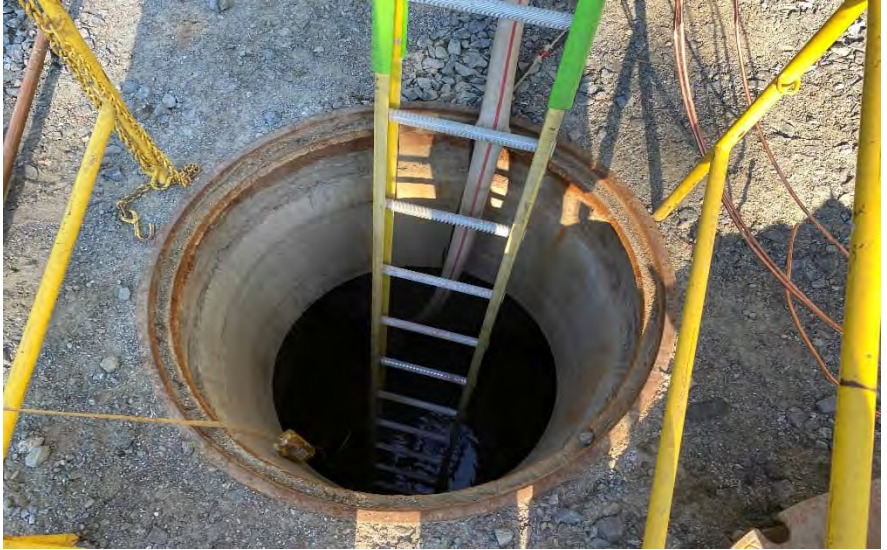
Description: View of area being pumped from manhole #24 segment 11.

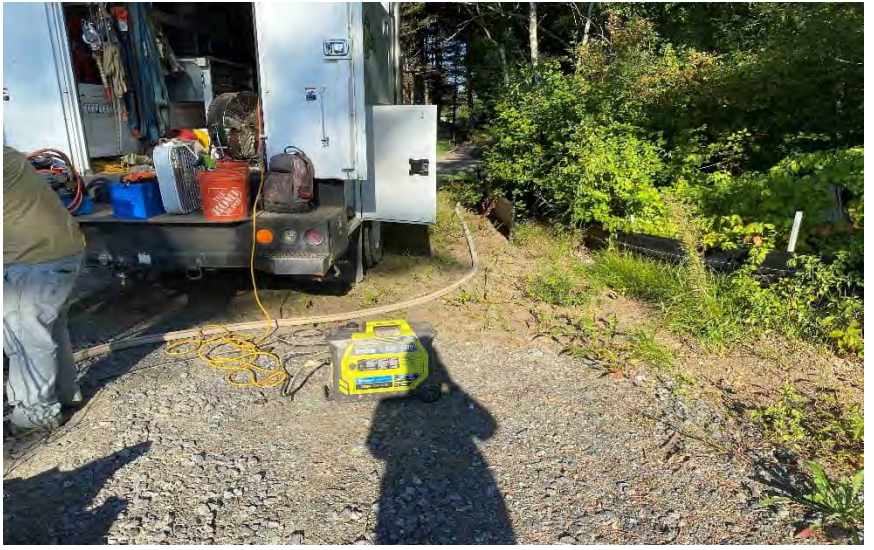
Description: Manhole #24. View of dewatering operation. Looking westward.

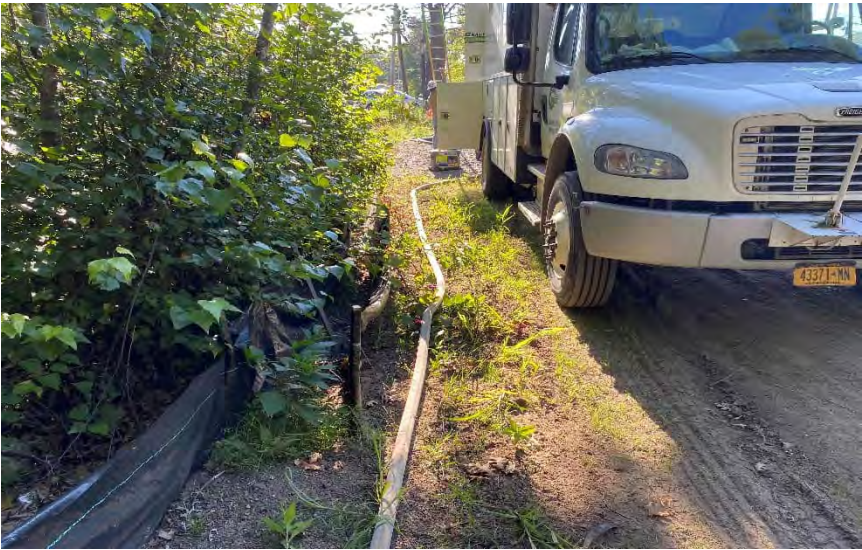
Description: Manhole #24. View of dewatering operation, looking eastward.

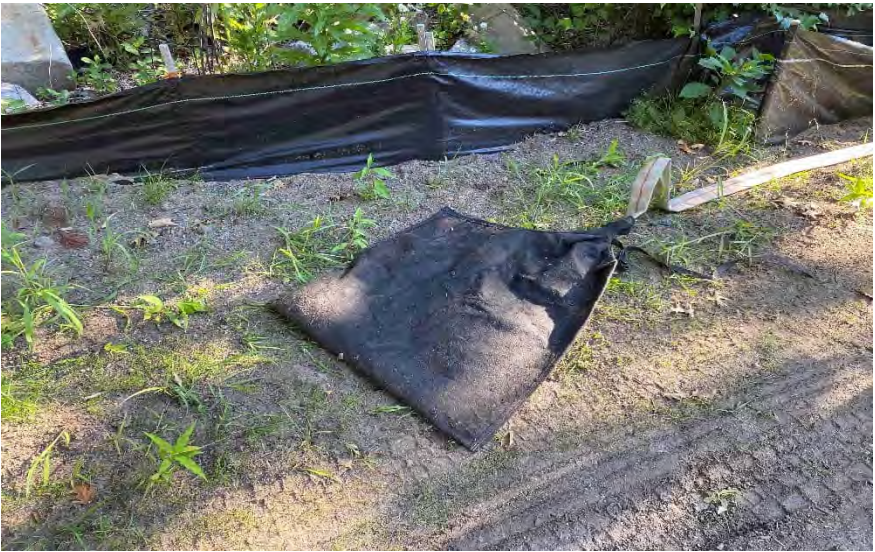
Description: Manhole #24. View of discharge bag. Water from bag discharged to adjacent area.

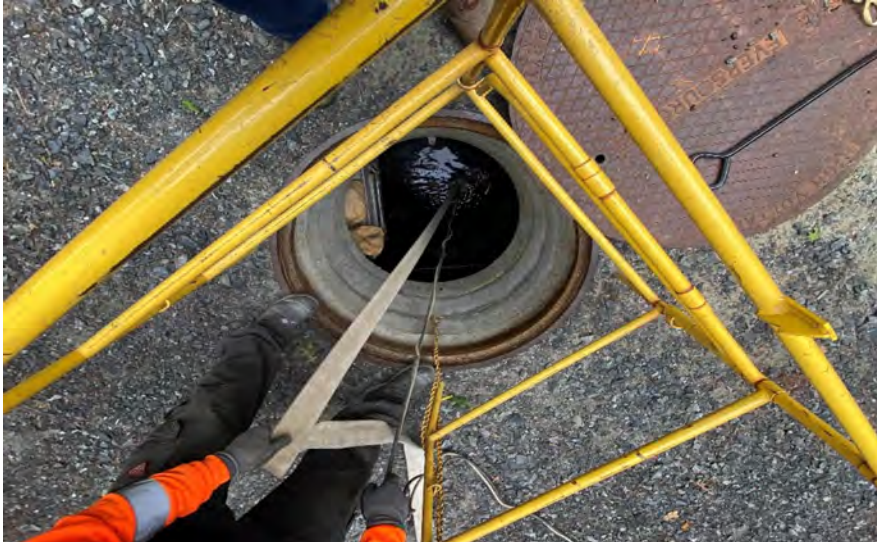
Description: View of area being pumped from manhole #15 segment 7.

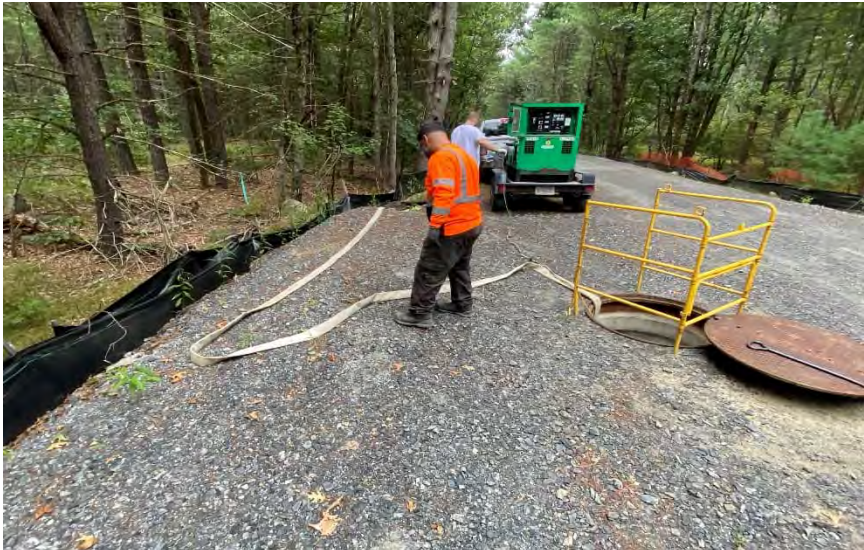
Description: Manhole #15. View of dewatering operation. Looking eastward.

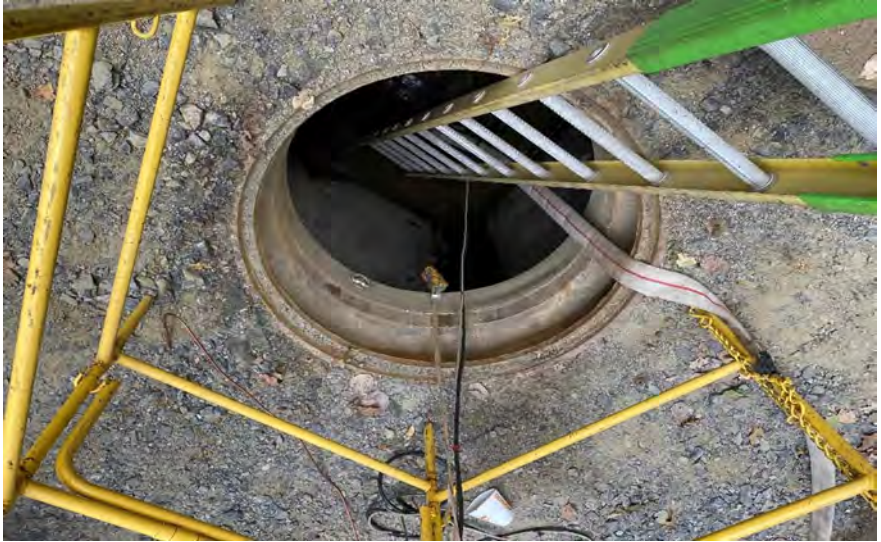
Description: View of area being pumped from manhole #26 segment 14.

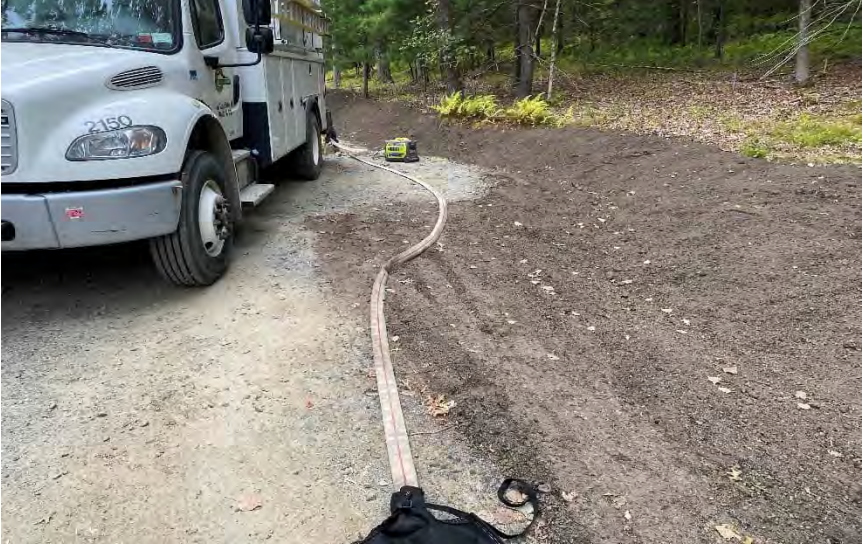
Description: Manhole #26. View of dewatering operation, looking westward.

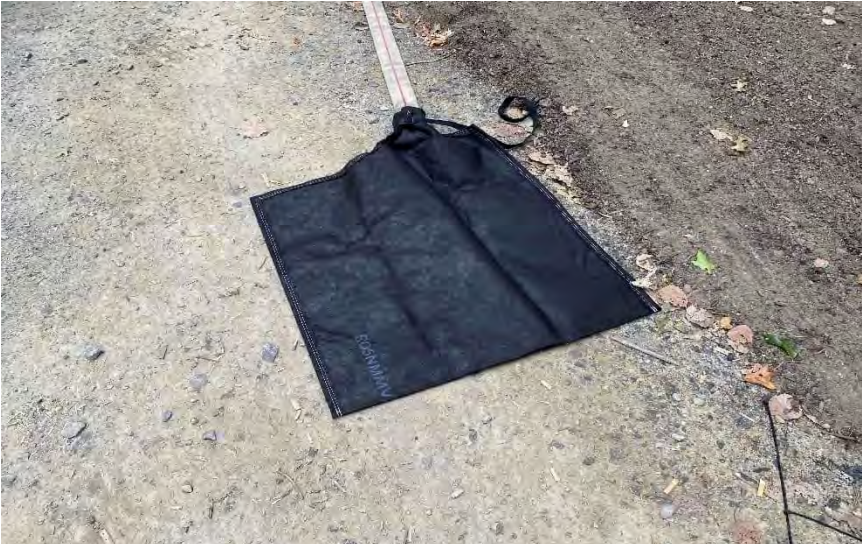
Description: Manhole #26. View of discharge bag. Water from bag discharged to adjacent area.
