Weekly Environmental Compliance Summary

Sudbury to Hudson Transmission Reliability Project (USEPA Tracking # MAR1003UW)

Sudbury, Hudson, and Stow, MA

Week of: September 9, 2024 to September 13, 2024

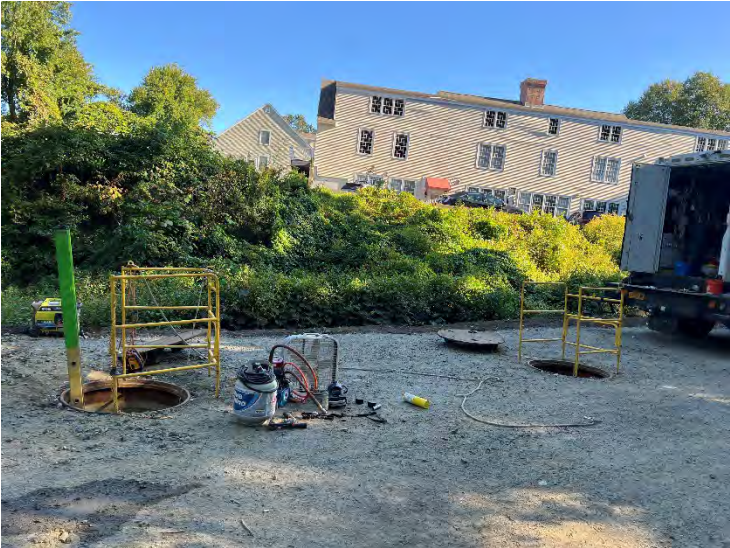
<p>PHOTOGRAPHIC LOG</p>	
<p>Client Name: Eversource</p>		<p>Site Location: Sudbury to Hudson Transmission Reliability Project</p>	<p>Town: Sudbury</p>
<p>Photo No.: 1</p>	<p>Date: 9/9/2024</p>

<p>Description: View of Haugland work area at MH #27 in segment 14. Facing north.</p>

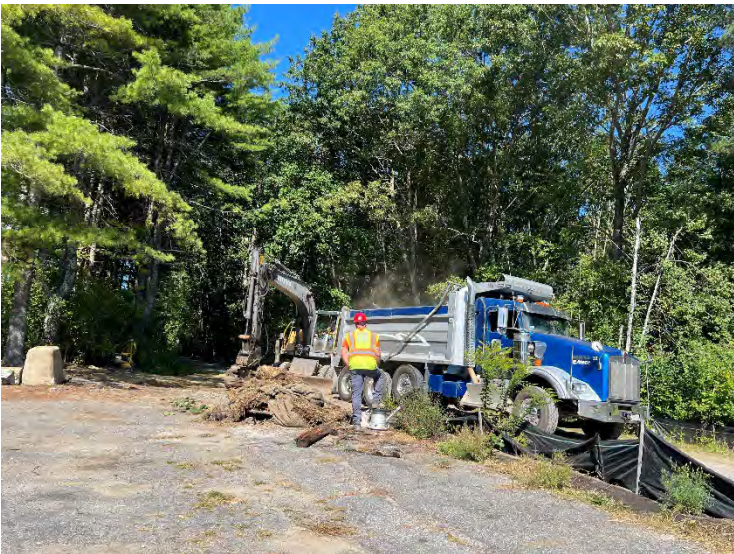
<p>PHOTOGRAPHIC LOG</p>	
<p>Client Name: Eversource</p>		<p>Site Location: Sudbury to Hudson Transmission Reliability Project</p>	<p>Town: Sudbury</p>
<p>Photo No.: 2</p>	<p>Date: 9/9/2024</p>

<p>Description: View of ET&L work area in segment 11. Silt fencing was reinstalled after work was completed. Facing west.</p>

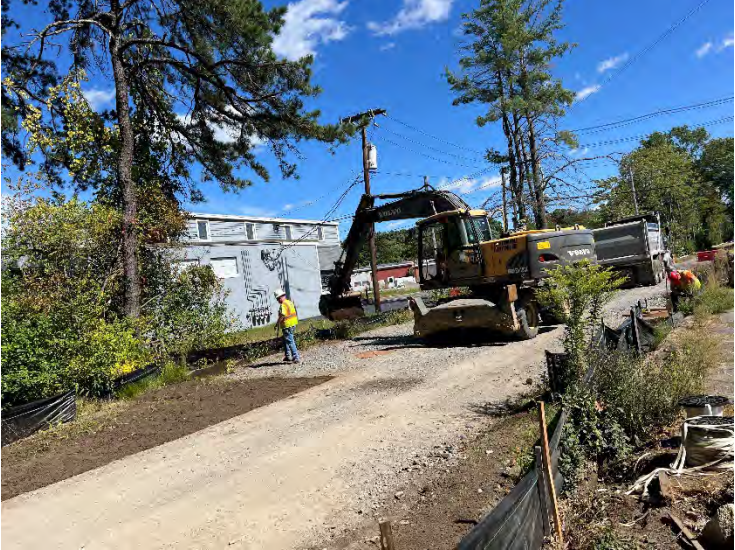
<p>PHOTOGRAPHIC LOG</p>	
<p>Client Name: Eversource</p>		<p>Site Location: Sudbury to Hudson Transmission Reliability Project</p>	<p>Town: Sudbury</p>
<p>Photo No.: 3</p>	<p>Date: 9/9/2024</p>

<p>Description: View of ET&L applying planting soil to ROW shoulders in segment 11. Facing northeast.</p>

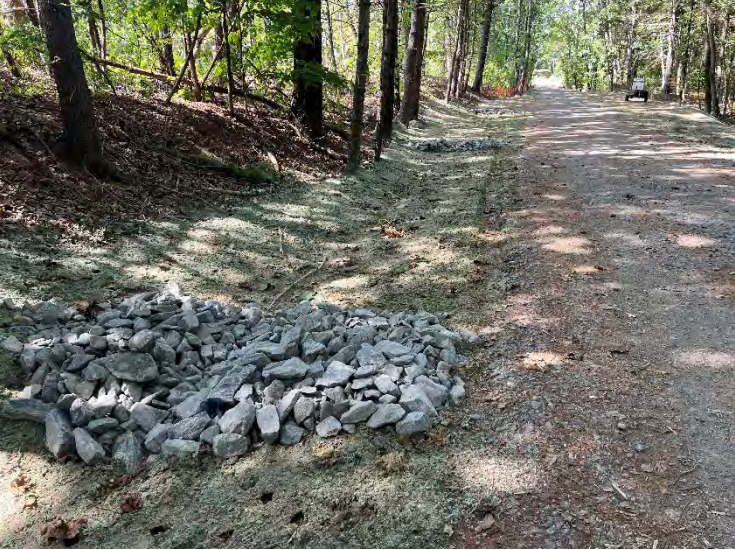
<p>PHOTOGRAPHIC LOG</p>	
<p>Client Name: Eversource</p>		<p>Site Location: Sudbury to Hudson Transmission Reliability Project</p>	<p>Town: Sudbury</p>
<p>Photo No.: 4</p>	<p>Date: 9/9/2024</p>

<p>Description: View of installed rock check dams in segment 8. Facing west.</p>

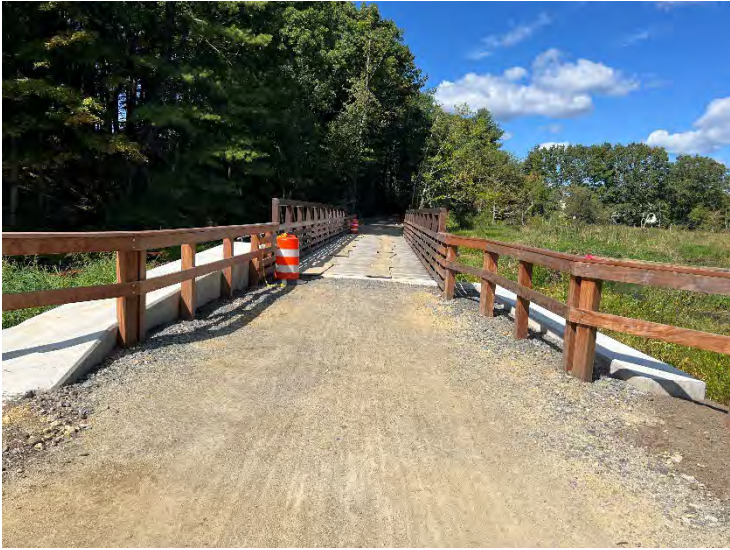
PHOTOGRAPHIC LOG	
Client Name: Eversource		Site Location: Sudbury to Hudson Transmission Reliability Project	Town: Sudbury
Photo No.: 5	Date: 9/9/2024

Description: View of Bridge 130. Facing west.

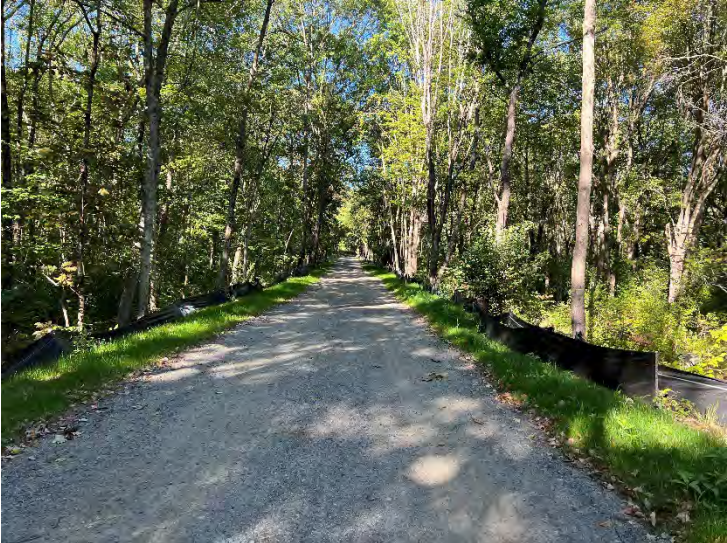
PHOTOGRAPHIC LOG	
Client Name: Eversource		Site Location: Sudbury to Hudson Transmission Reliability Project	Town: Sudbury
Photo No.: 6	Date: 9/9/2024

Description: View of E&S controls in segment 14. Facing west.

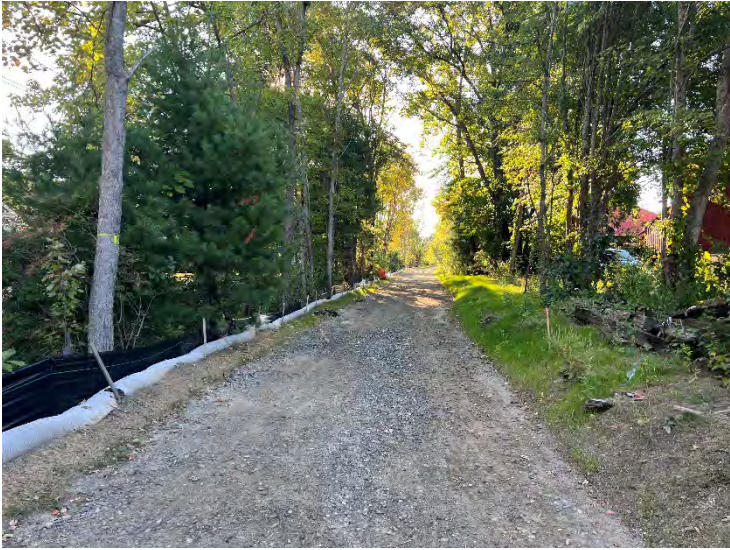
PHOTOGRAPHIC LOG	
Client Name: Eversource		Site Location: Sudbury to Hudson Transmission Reliability Project	Town: Sudbury
Photo No.: 7	Date: 9/9/2024

Description: View of E&S controls in segment 12. Facing east.

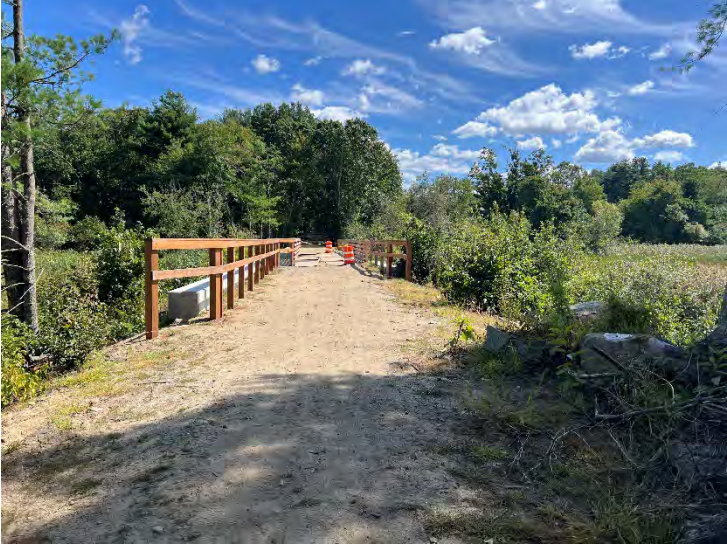
PHOTOGRAPHIC LOG	
Client Name: Eversource		Site Location: Sudbury to Hudson Transmission Reliability Project	Town: Sudbury
Photo No.: 8	Date: 9/9/2024

Description: View of Bridge 128. Facing east.

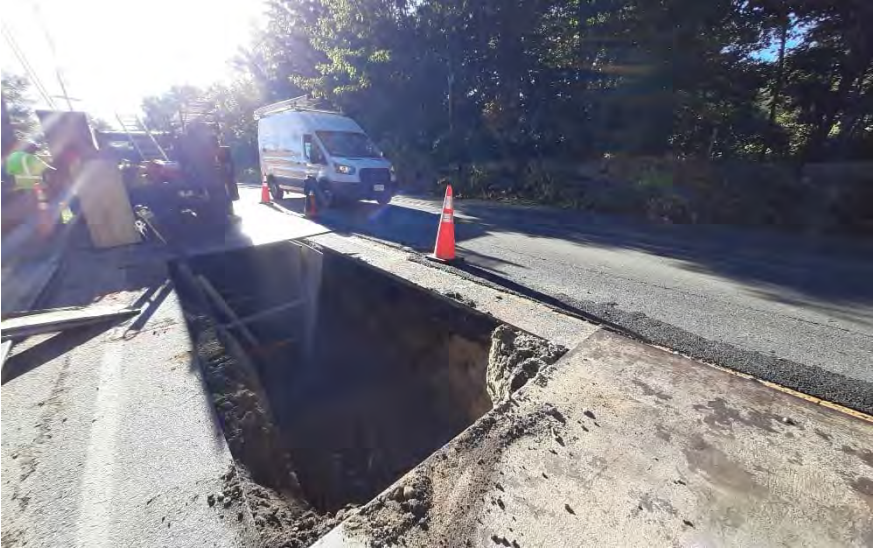
<p>PHOTOGRAPHIC LOG</p>	
<p>Client Name: Eversource</p>		<p>Site Location: Sudbury to Hudson Transmission Reliability Project</p>	
<p>Photo No.: 1 Date: 9-9-24</p>

<p>Description:</p> <p>Bond conducting conduit work along Forest Ave between manholes #1 and #2, near 100 Forest Ave, looking westward.</p>

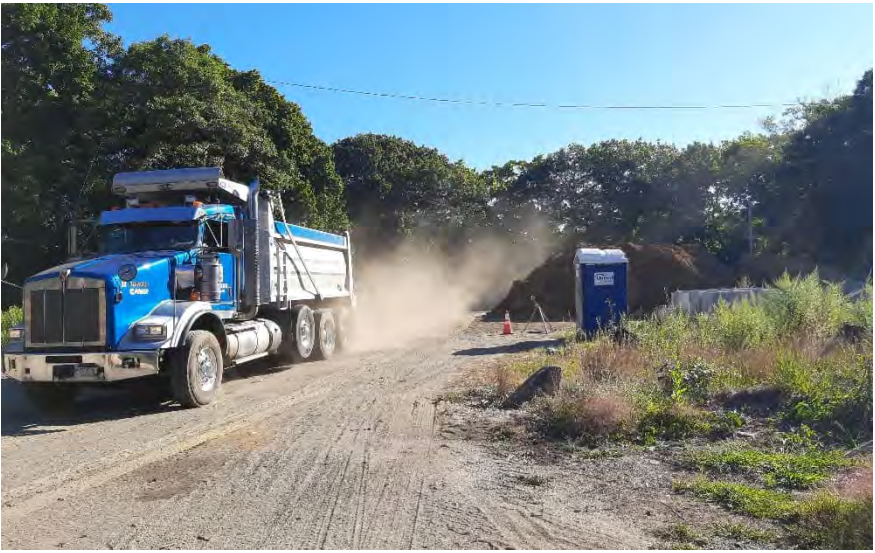
<p>PHOTOGRAPHIC LOG</p>	
<p>Client Name: Eversource</p>		<p>Site Location: Sudbury to Hudson Transmission Reliability Project</p>	
<p>Photo No.: 2 Date: 9-9-24</p>

<p>Description:</p> <p>ET&L active in Stowe Ct laydown yard, loam loadout, looking southward.</p>

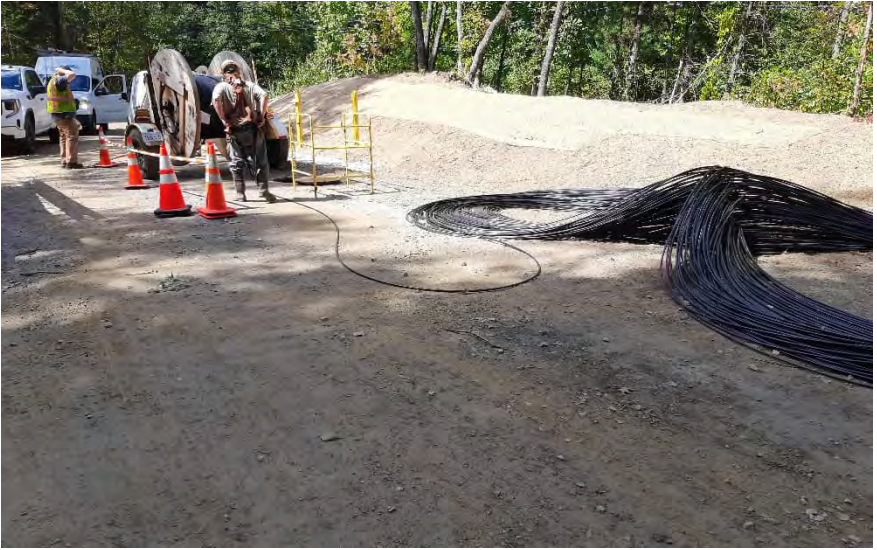
<p>PHOTOGRAPHIC LOG</p>	
<p>Client Name: Eversource</p>		<p>Site Location: Sudbury to Hudson Transmission Reliability Project</p>	<p>Town: Hudson</p>
<p>Photo No.: 3</p>	<p>Date: 9-9-24</p>

<p>Description:</p> <p>New Wave work area at handhole #5 (segment 1), fiber optic cable pulling, looking westward.</p>

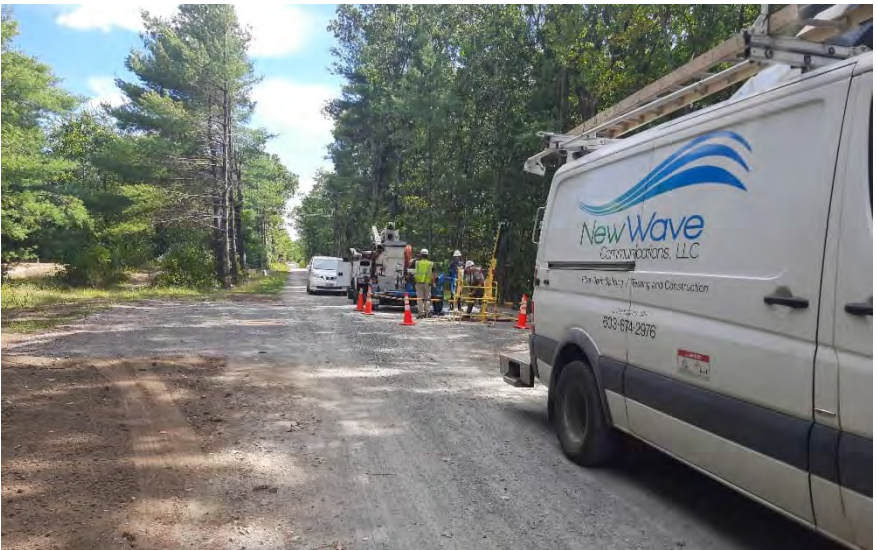
<p>PHOTOGRAPHIC LOG</p>	
<p>Client Name: Eversource</p>		<p>Site Location: Sudbury to Hudson Transmission Reliability Project</p>	<p>Town: Hudson</p>
<p>Photo No.: 4</p>	<p>Date: 9-9-24</p>

<p>Description:</p> <p>New Wave work area at handhole #7 (segment 2), fiber optic cable pulling, looking eastward.</p>

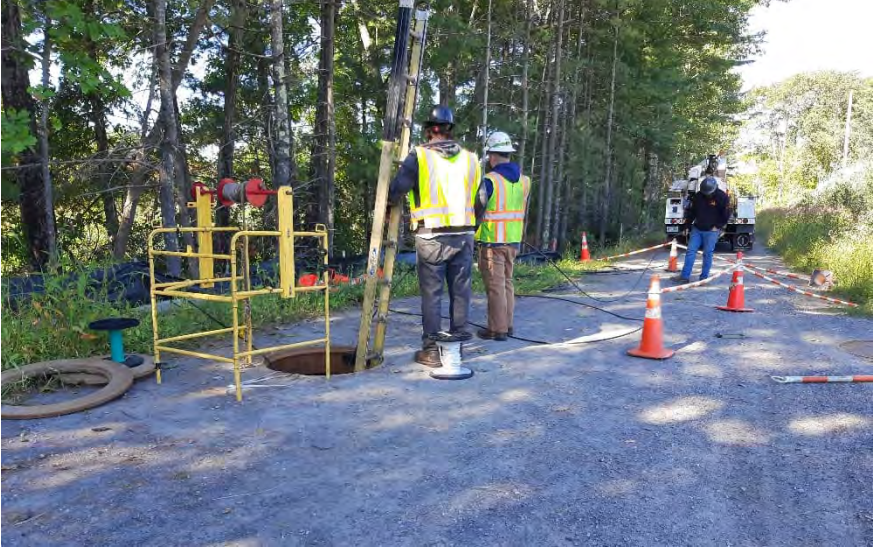
PHOTOGRAPHIC LOG	
Client Name: Eversource		Site Location: Sudbury to Hudson Transmission Reliability Project	Town: Hudson
Photo No.: 5	Date: 9-9-24

Description: New Wave work area at handhole #8 (segment 3), fiber optic cable pulling, looking westward.

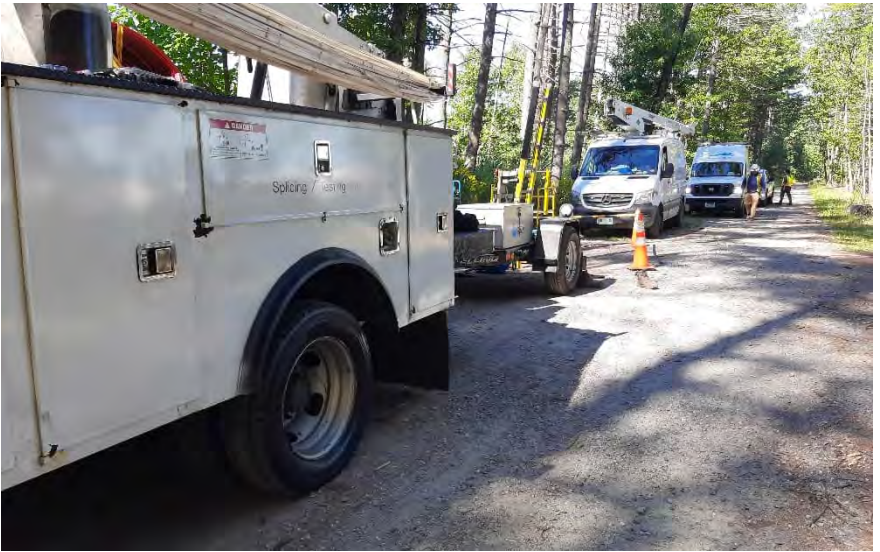
PHOTOGRAPHIC LOG	
Client Name: Eversource		Site Location: Sudbury to Hudson Transmission Reliability Project	Town: Hudson
Photo No.: 6	Date: 9-9-24

Description: New Wave work area at handhole #10 (segment 4), fiber optic cable pulling, looking westward.

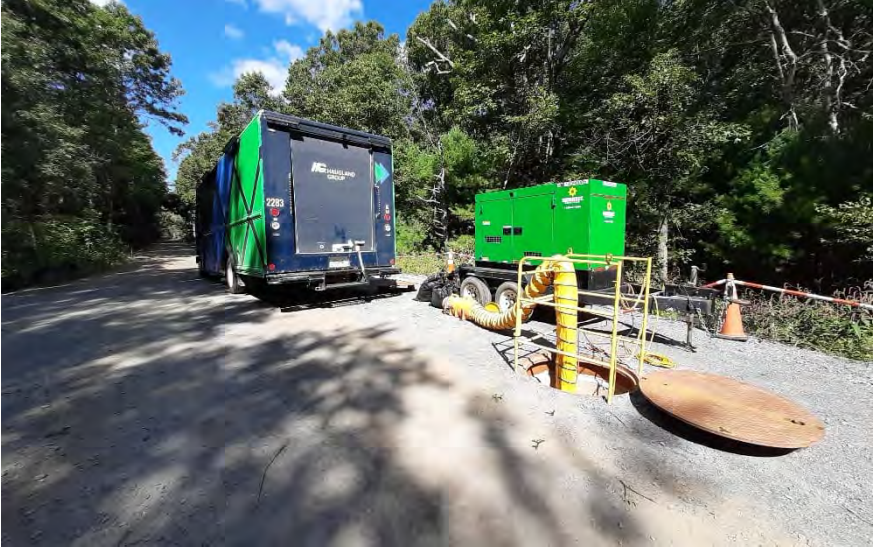
<p>PHOTOGRAPHIC LOG</p>	
<p>Client Name: Eversource</p>		<p>Site Location: Sudbury to Hudson Transmission Reliability Project</p>	<p>Town: Hudson</p>
<p>Photo No.: 7</p>	<p>Date: 9-9-24</p>

<p>Description:</p> <p>Haugland work area at manhole #14 (segment 6), crimping and splicing, looking westward.</p>

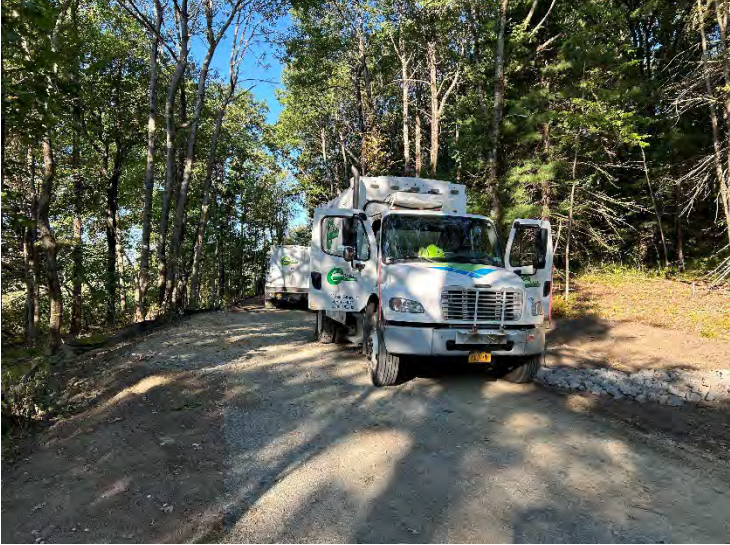
PHOTOGRAPHIC LOG	
Client Name: Eversource		Site Location: Sudbury to Hudson Transmission Reliability Project	Town: Sudbury
Photo No.: 1	Date: 9/10/2024

Description: View of Haugland work area at MH #26 in segment 14. Facing west.

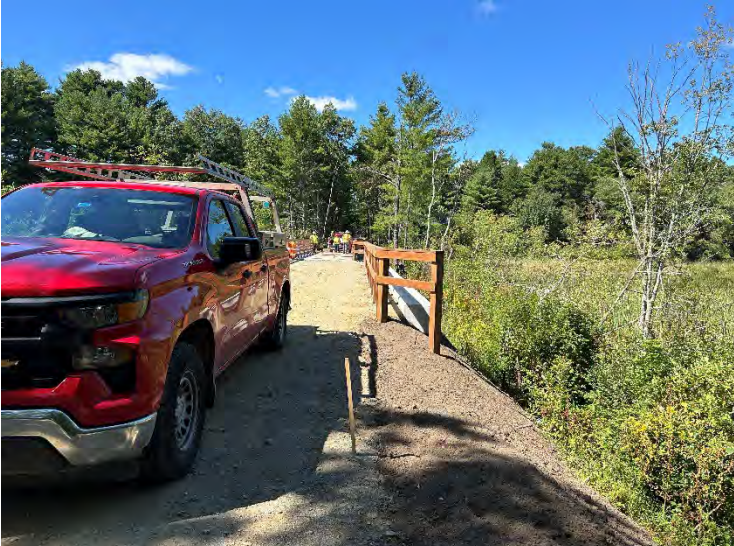
PHOTOGRAPHIC LOG	
Client Name: Eversource		Site Location: Sudbury to Hudson Transmission Reliability Project	Town: Sudbury
Photo No.: 2	Date: 9/10/2024

Description: View of ET&L at bridge 128. Facing west.

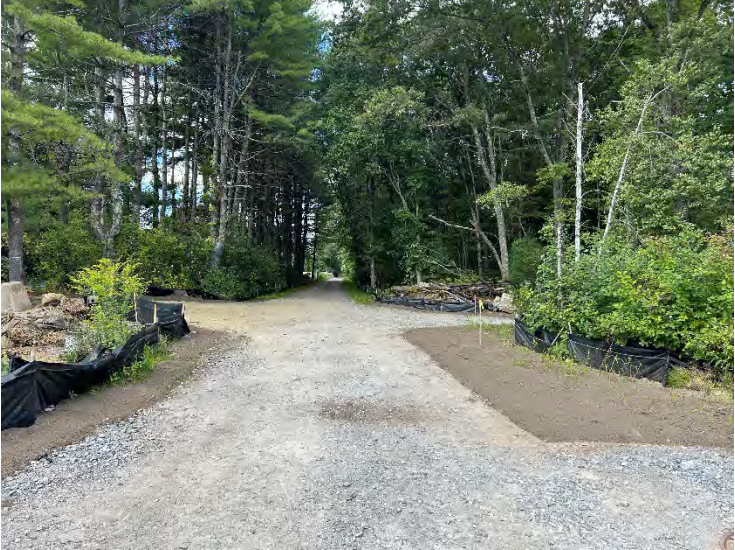
<p>PHOTOGRAPHIC LOG</p>	
<p>Client Name: Eversource</p>		<p>Site Location: Sudbury to Hudson Transmission Reliability Project</p>	<p>Town: Sudbury</p>
<p>Photo No.: 3</p>	<p>Date: 9/10/2024</p>

<p>Description: View of planting soil applied by ET&L to ROW shoulders in segment 11. Facing west.</p>

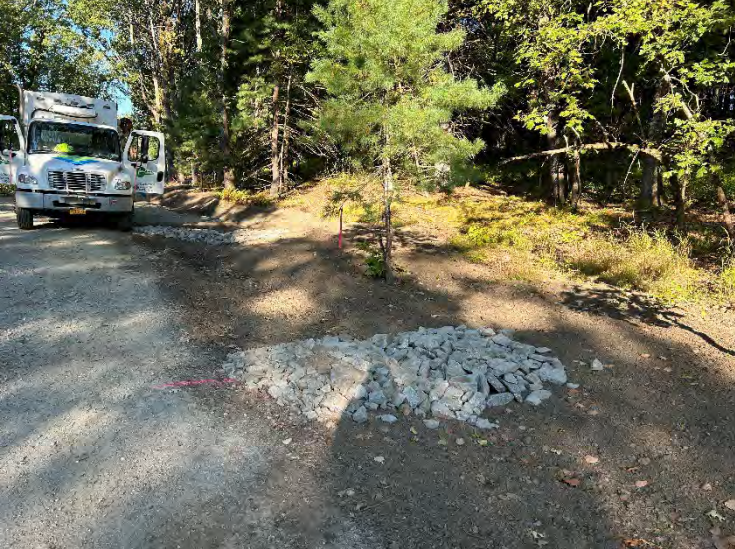
<p>PHOTOGRAPHIC LOG</p>	
<p>Client Name: Eversource</p>		<p>Site Location: Sudbury to Hudson Transmission Reliability Project</p>	<p>Town: Sudbury</p>
<p>Photo No.: 4</p>	<p>Date: 9/10/2024</p>

<p>Description: View of installed rock check dams and Haugland crew in segment 14. Facing west.</p>

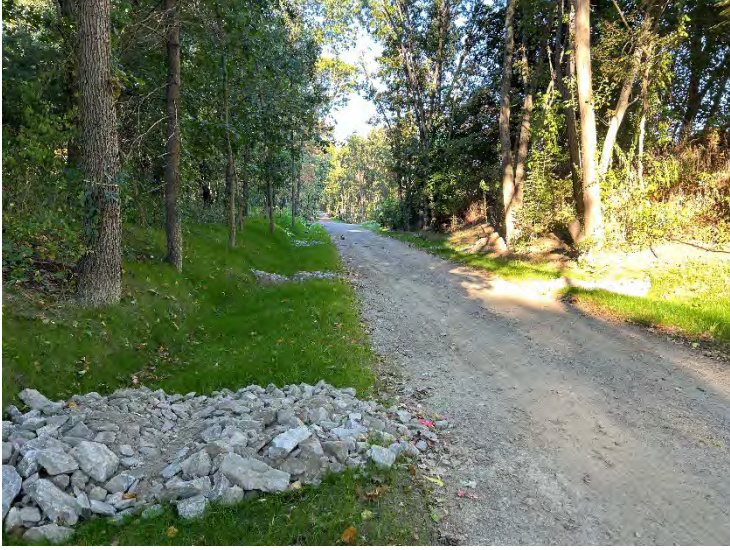
PHOTOGRAPHIC LOG	
Client Name: Eversource		Site Location: Sudbury to Hudson Transmission Reliability Project	Town: Sudbury
Photo No.: 5	Date: 9/10/2024

Description: View of installed check dams in segment 14. Facing west.

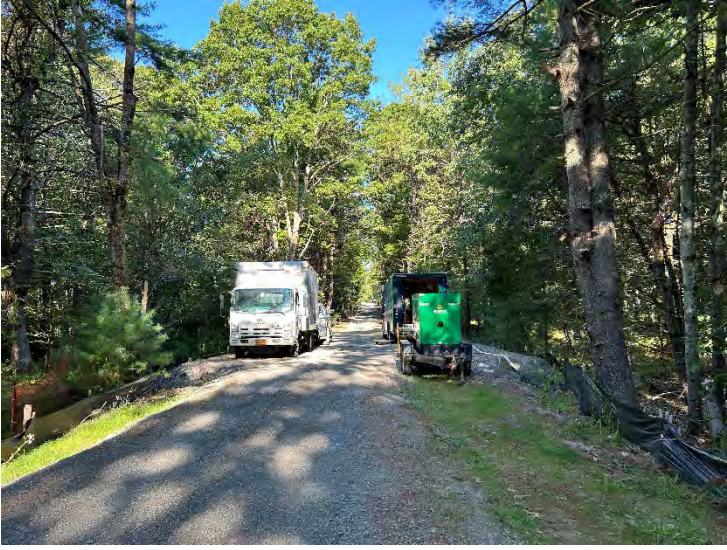
PHOTOGRAPHIC LOG	
Client Name: Eversource		Site Location: Sudbury to Hudson Transmission Reliability Project	Town: Sudbury
Photo No.: 6	Date: 9/10/2024

Description: View of Haugland crew working at MH #15 in segment 7. Facing west.

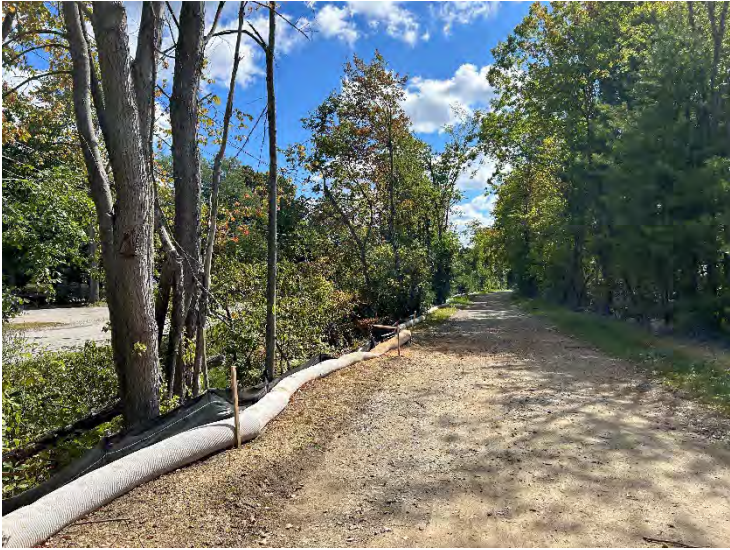
Description: View of E&S controls in segment 12. Facing east.

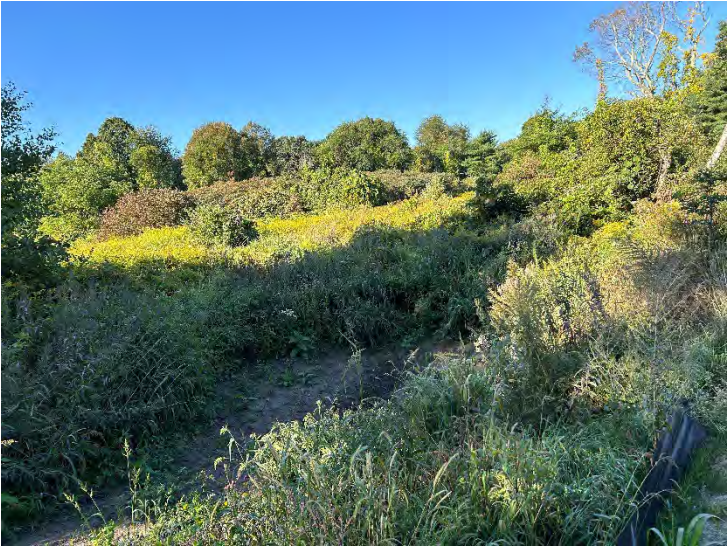
Description: View of the wetland replication area in segment 14. Facing southwest.

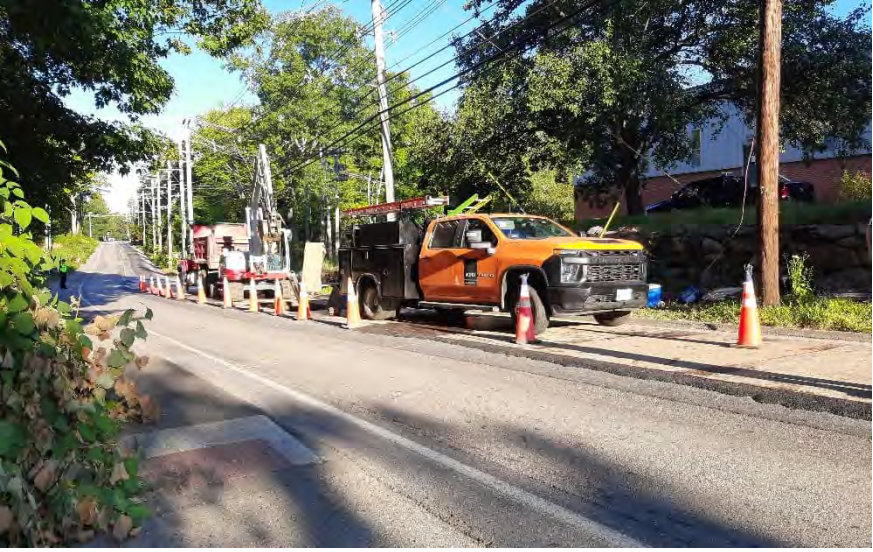
<p>Description:</p> <p>Bond conducting conduit work along Forest Ave between manholes #1 and #2, near 100 Forest Ave, looking southward.</p>

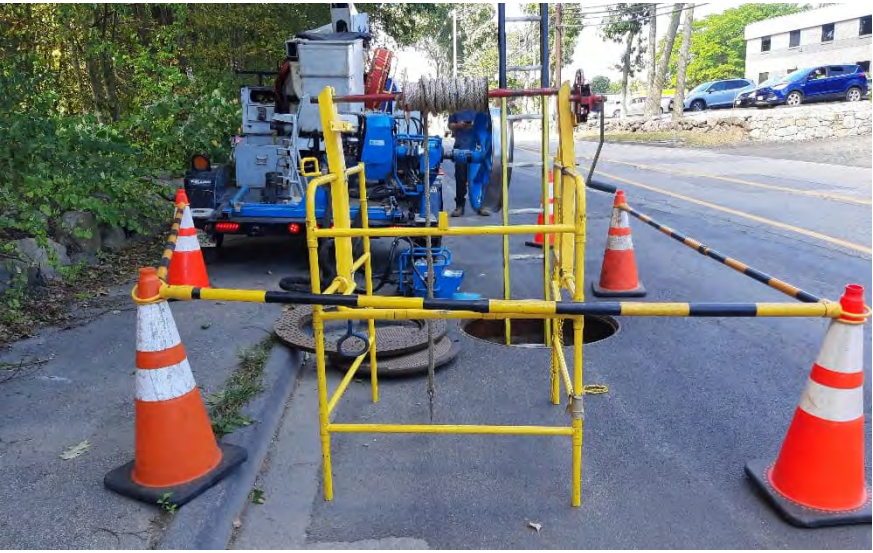
<p>Description:</p> <p>New Wave work area at handhole #2 (Forest Ave near Marlboro Street), fiber optic cable pulling, looking southward.</p>

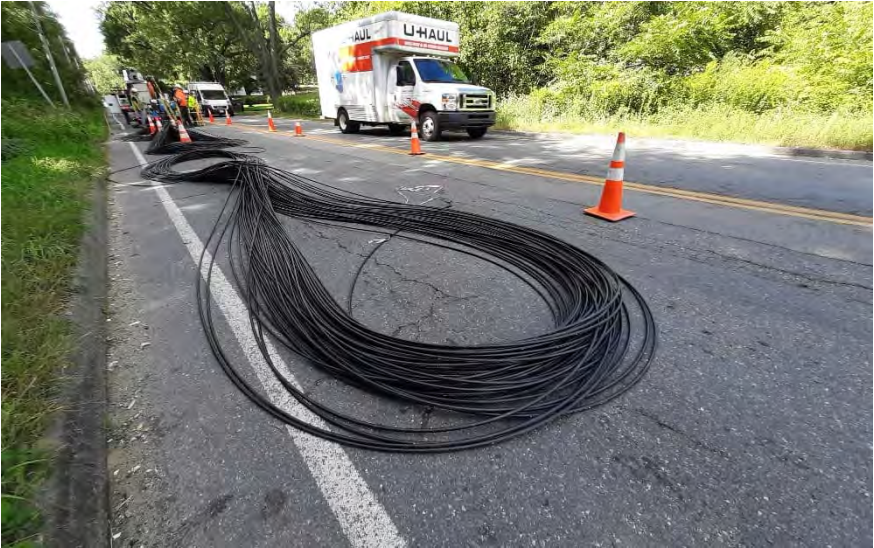
<p>Description:</p> <p>New Wave work area in Forest Ave at handhole #4 (near 156 Forest Ave), fiber optic cable pulling, looking northward.</p>

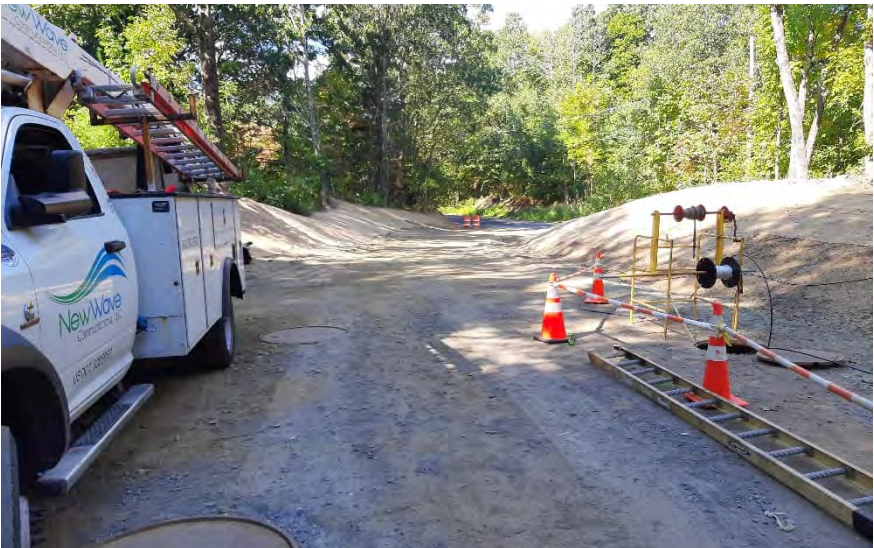
<p>Description:</p> <p>New Wave work area at handhole #5 (segment 1), fiber optic cable pulling, looking westward.</p>

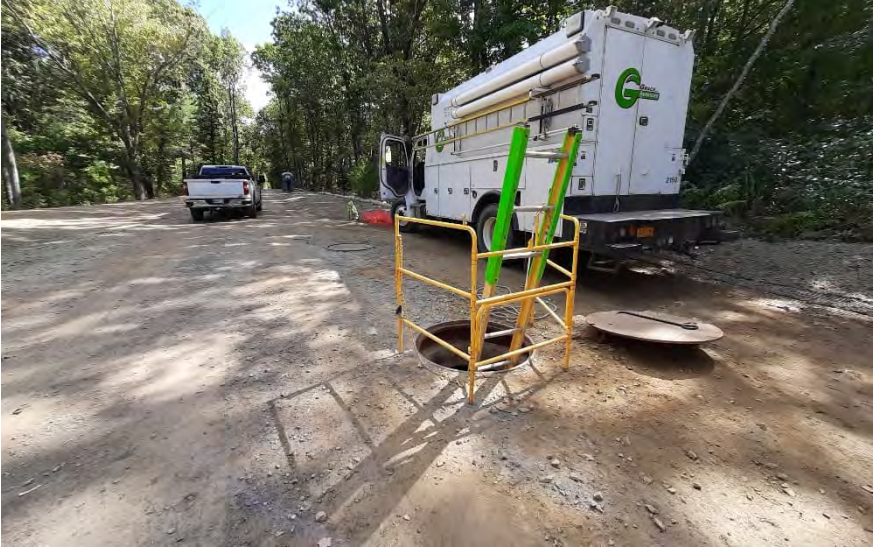
<p>Description:</p> <p>Haugland work area at manhole #5 (segment 1), inspecting manhole, looking eastward.</p>

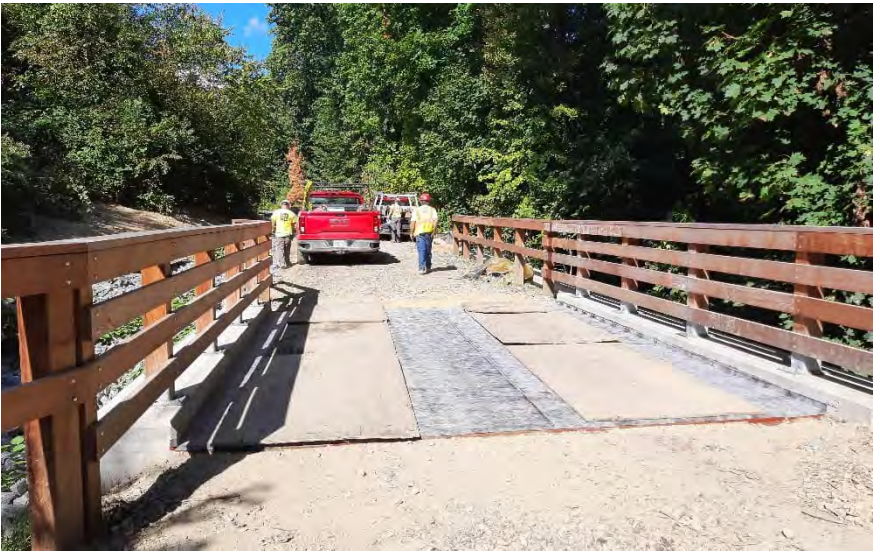
<p>Description:</p> <p>ET&L work area at cattle crossing (segment 1), installing protective membrane, looking westward.</p>

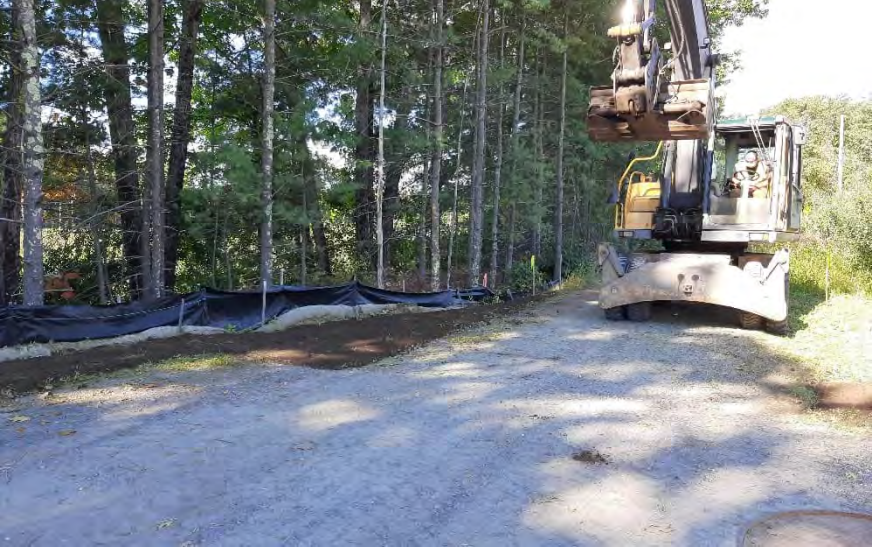
Description: ET&L work area in segment 3, loaming shoulders, looking westward.

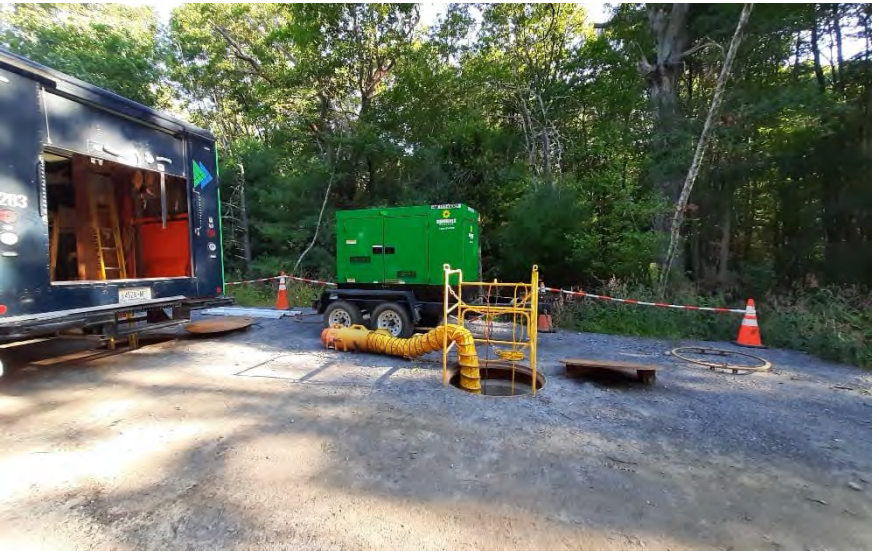
Description: Haugland work area at manhole #4 (segment 6), crimping and splicing, looking northward.

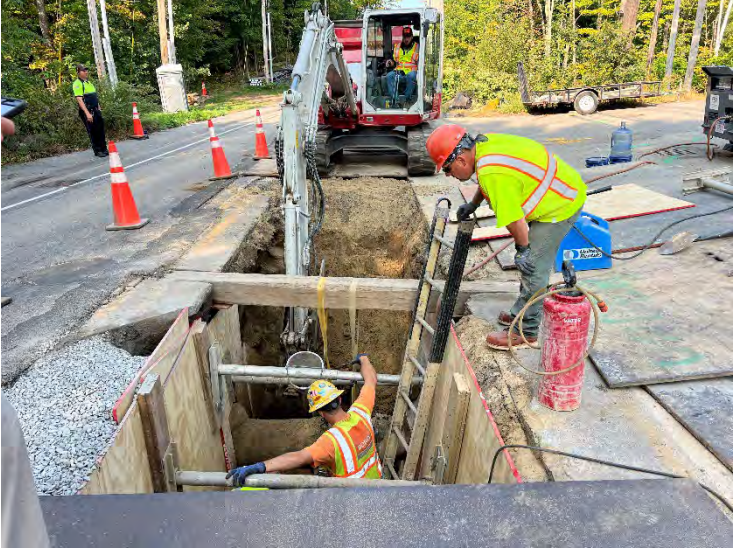
<p>Description:</p> <p>View of Bond trenching on Forest Avenue by MH#1. Facing west.</p>

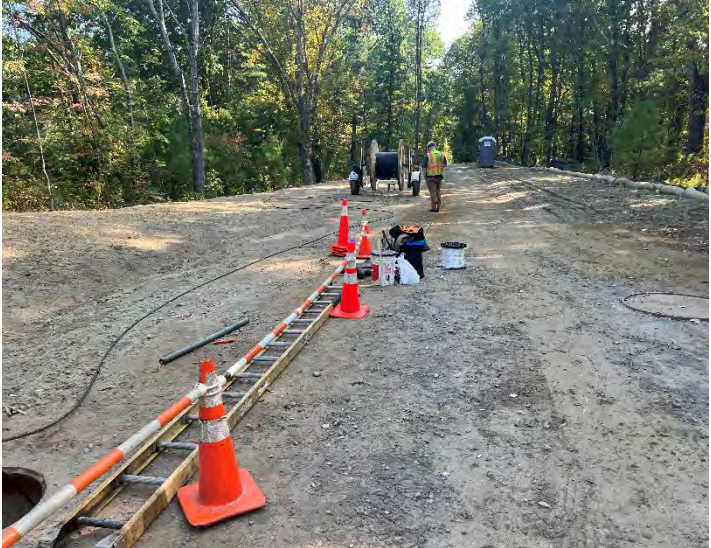
<p>Description:</p> <p>View of New Wave installing fiber optics at HH#5 in segment 1. Facing east.</p>

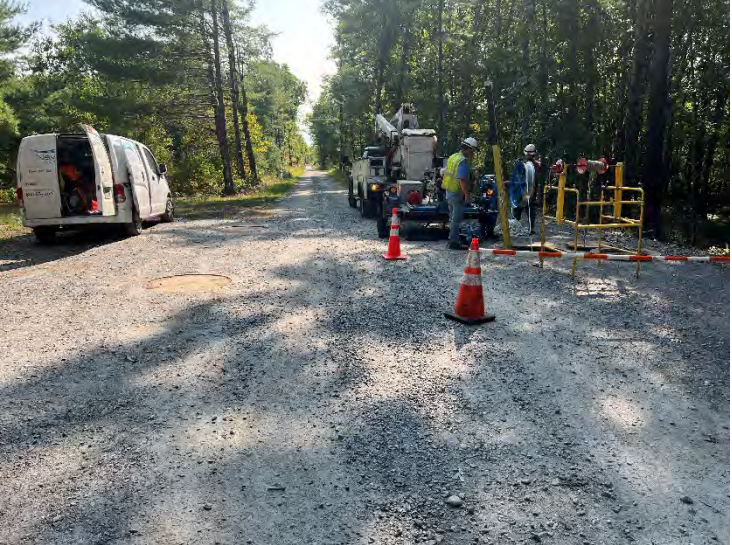
<p>Description:</p> <p>View of New Wave work zone in at HH#7 segment 2. Facing east.</p>

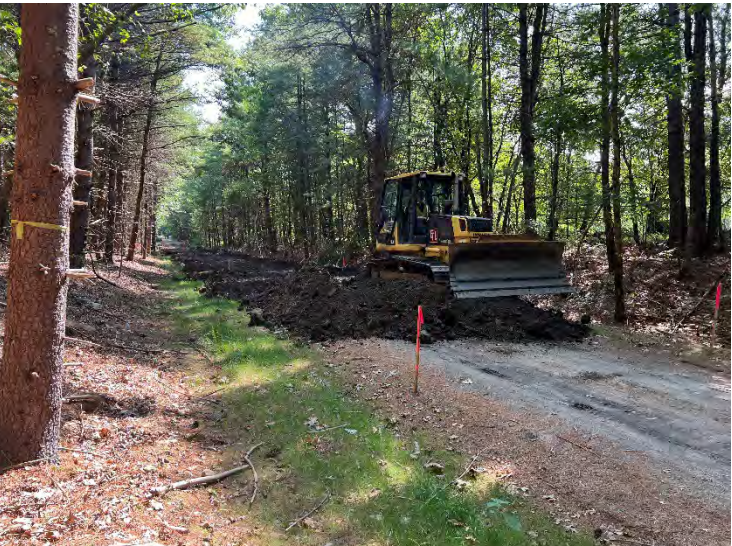
<p>Description:</p> <p>View of ET&L applying fill in segment 6. Facing east.</p>

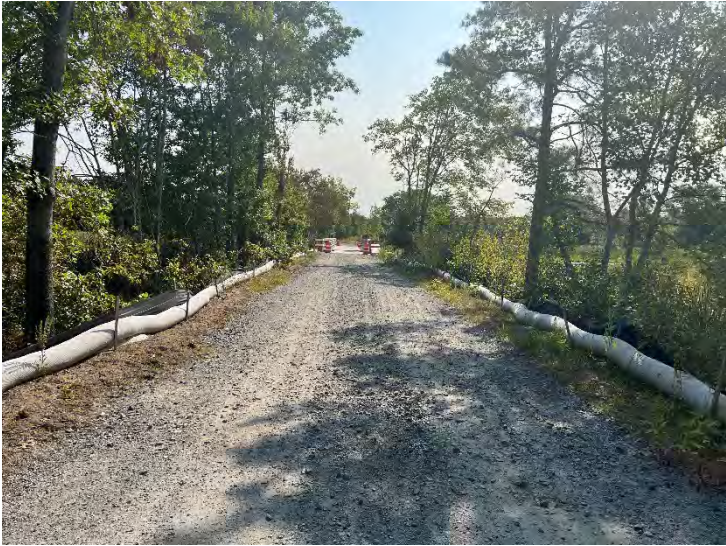
<p>Description: View of E&S controls in segment 2. Facing east.</p>

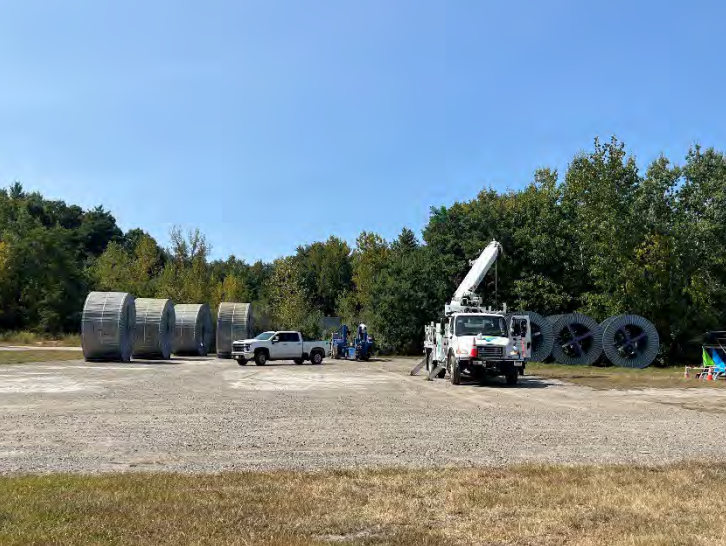
<p>Description: View of Haugland activity within their laydown yard. Facing southwest.</p>

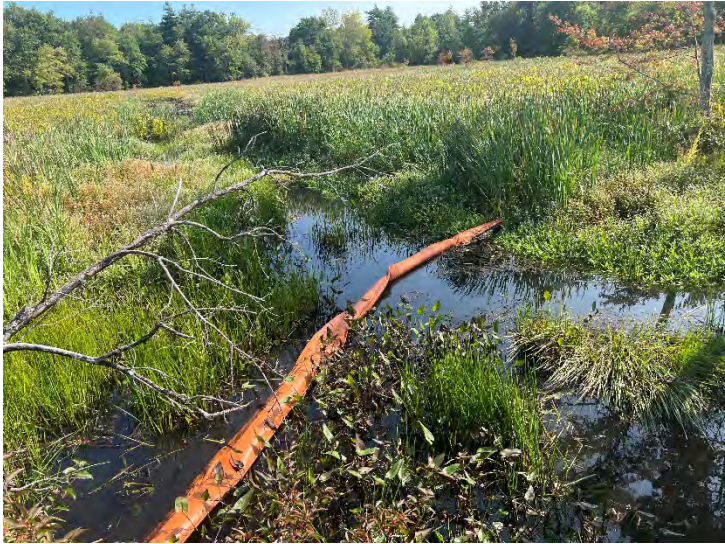
<p>Description: View of floating silt fencing at Bridge 130. Facing northwest.</p>

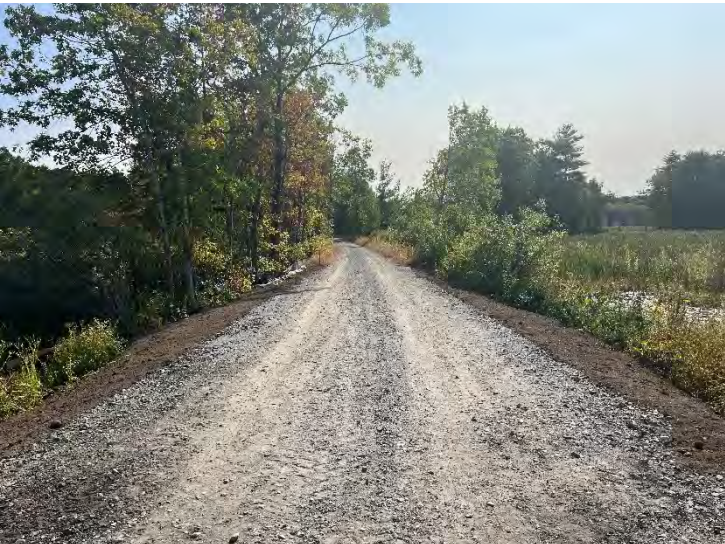
<p>Description: View of installed planting loam in segment 3 by Bridge 130. Facing east.</p>

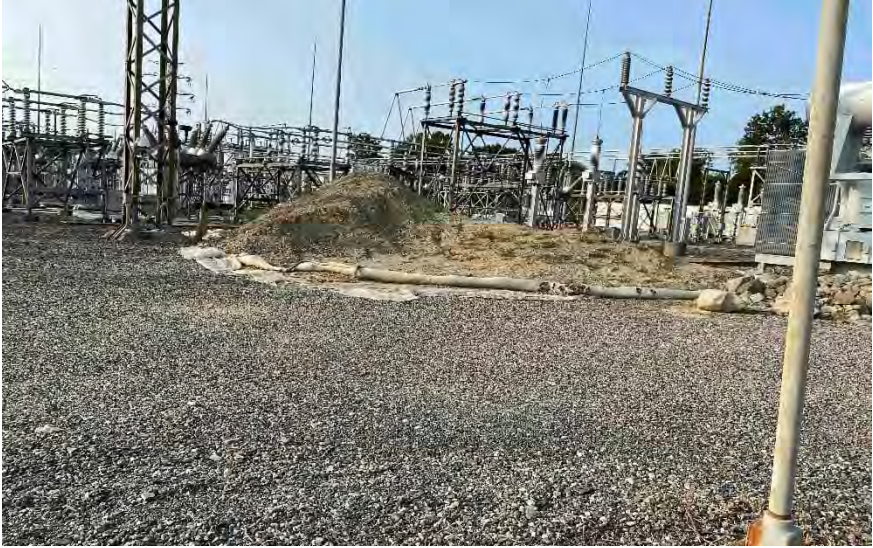
<p>Description:</p> <p>Spoil pile within Sudbury substation surrounded by compost filter tubes, looking southward.</p>

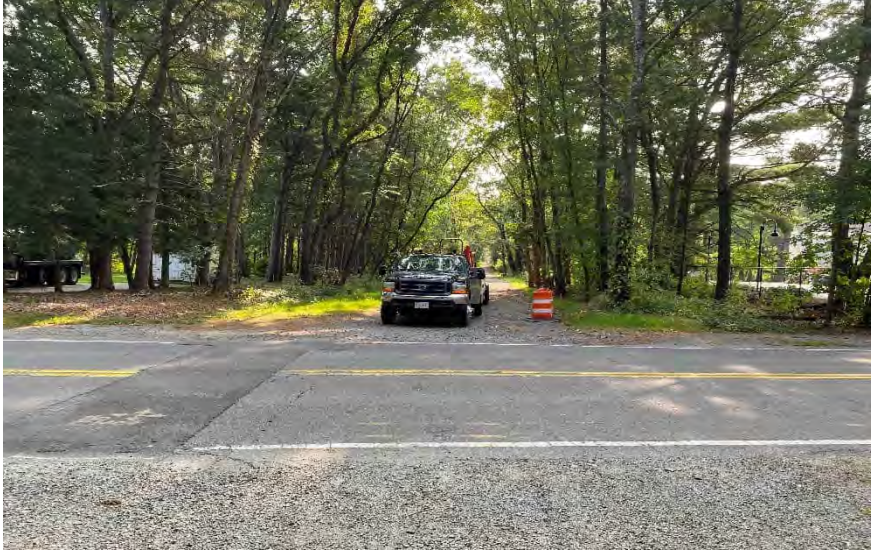
<p>Description:</p> <p>Work area within segment 11, Outside contractor working on-site (not project related), looking eastward</p>

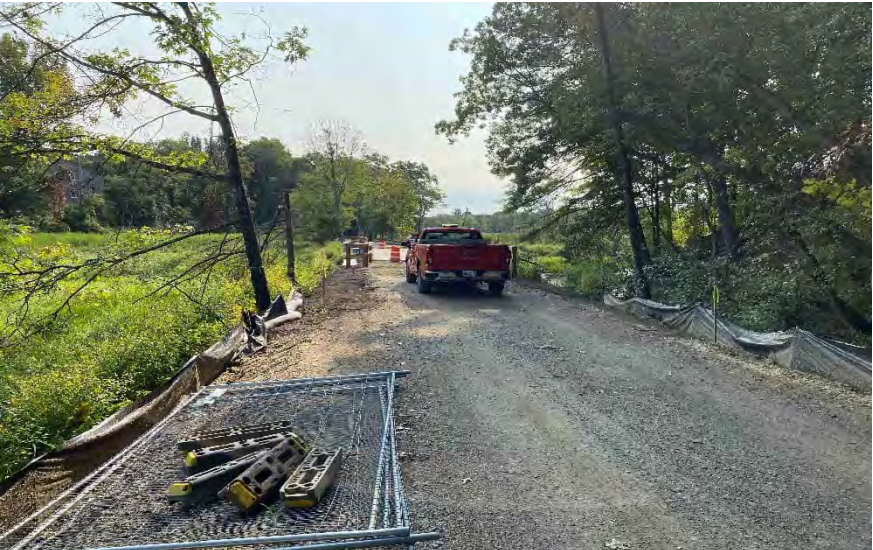
<p>Description:</p> <p>Work area within segment 13, ET&L on-site prior to paving work at bridge 127, existing erosion control, looking eastward</p>

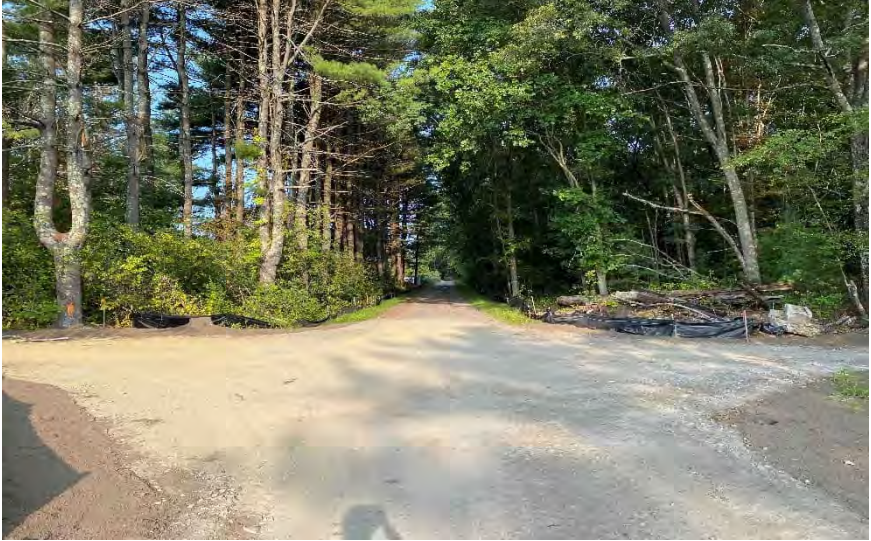
<p>Description:</p> <p>Work area within segment 11, Diamond Junction area, recent loaming prior to restoration plantings, existing erosion control, looking westward.</p>

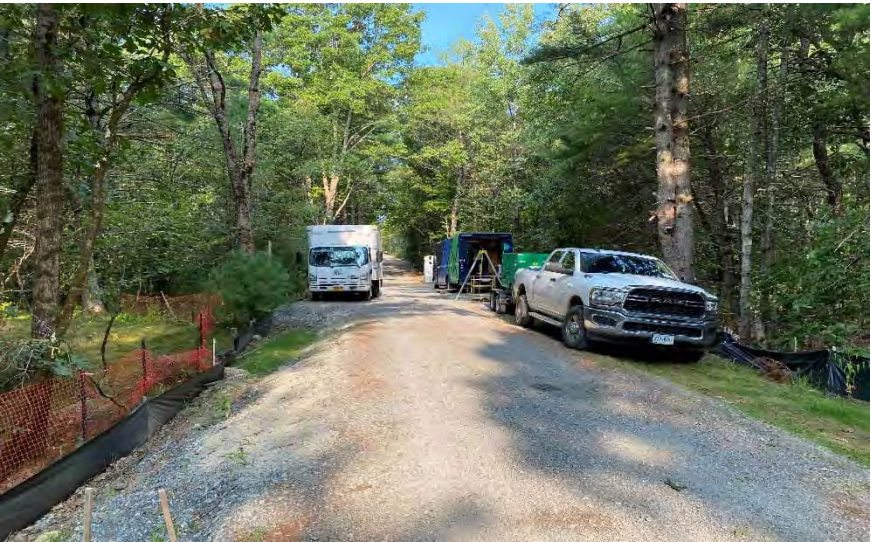
<p>Description:</p> <p>Work area within segment 7, manhole #15, Haugland splicing work, existing erosion control, looking westward</p>

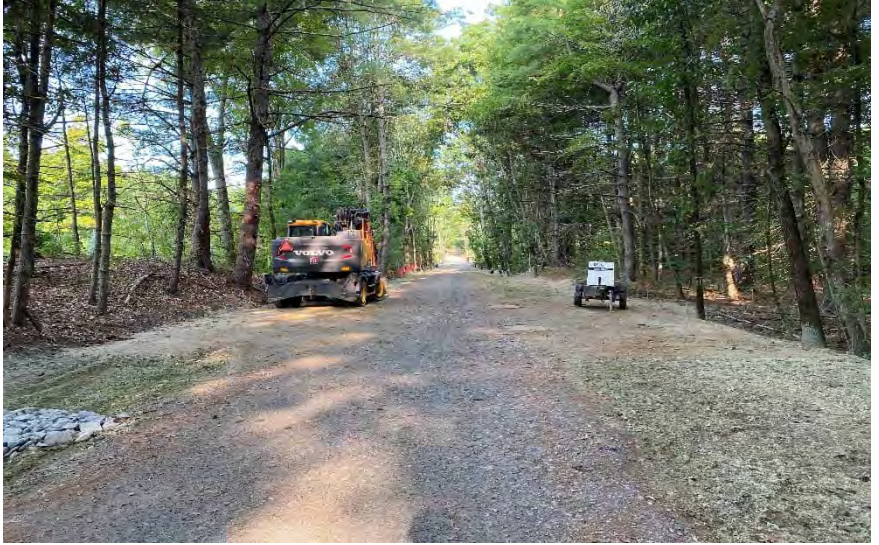
<p>Description: Work area within segment 8, manhole #17, ET&L equipment staged, existing erosion control, looking westward</p>

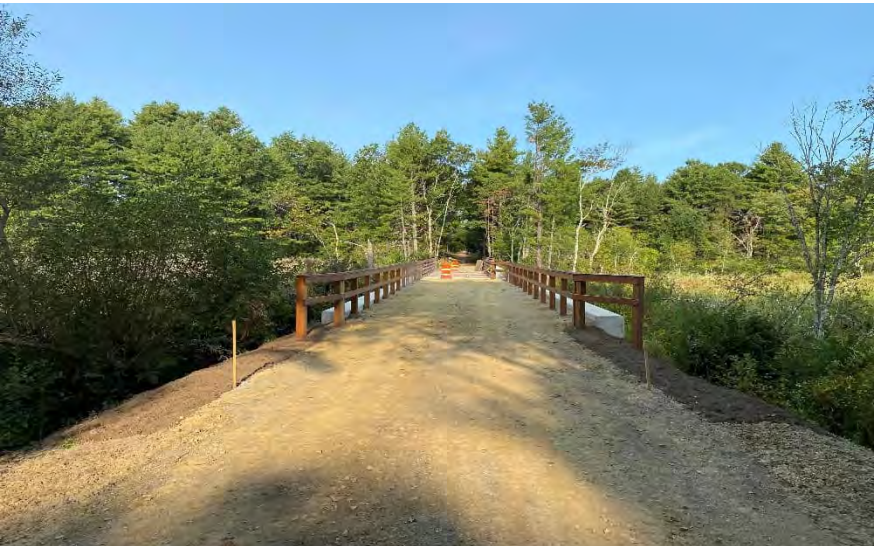
<p>Description: Bridge 128 area within segment 8, recently placed planting loam, existing erosion control, looking westward.</p>

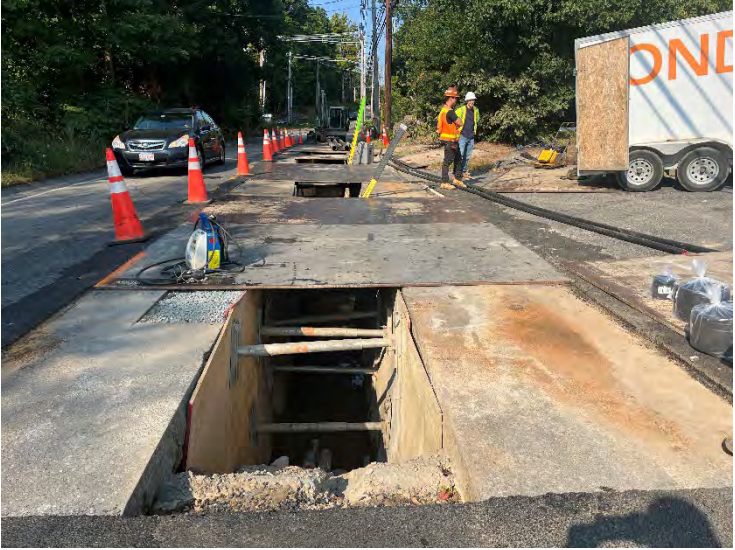
<p>Description:</p> <p>View of Bond trench on Forest Avenue by MH#1. Facing west.</p>
