Weekly Environmental Compliance Summary

Sudbury to Hudson Transmission Reliability Project (USEPA Tracking # MAR1003UW)

Sudbury, Hudson, and Stow, MA

Week of: September 9, 2024 to September 13, 2024

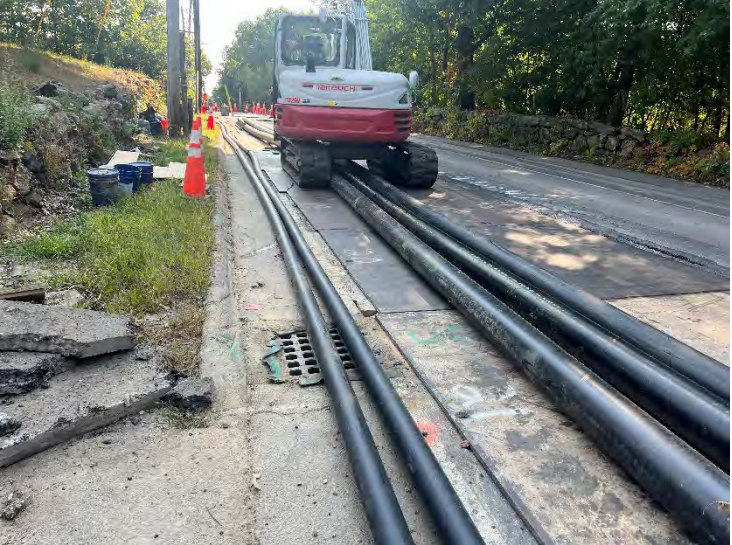
<p>Description:</p> <p>View of silt sack installed in catch basin by Bond work zone. Bond fusing pipes for installation. Facing east.</p>

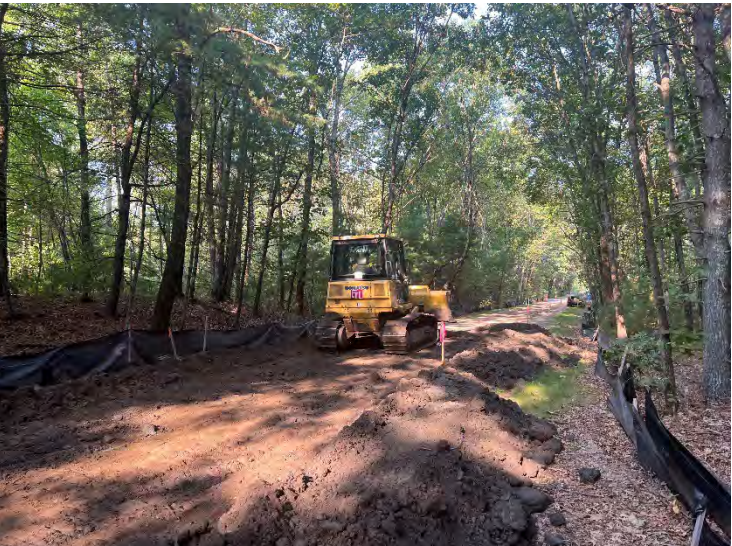
<p>Description:</p> <p>View of ET&L applying fill in segment 6. Facing southwest.</p>

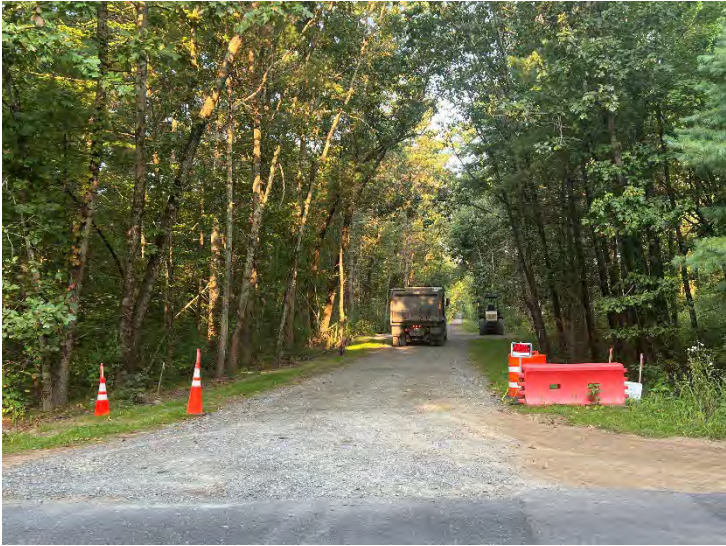
<p>Description:</p> <p>View of entrance to segment 5. Dump trucks arriving with fill for ET&L to spread in segment 6. Facing west.</p>

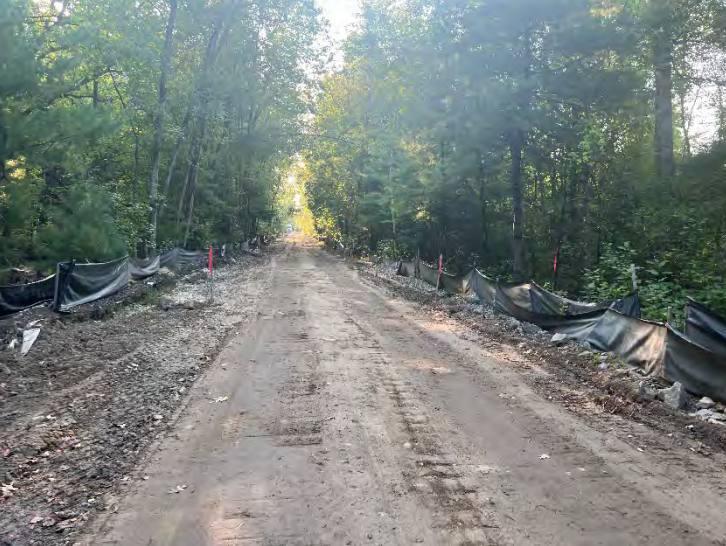
<p>Description:</p> <p>View of E&S controls in segment 6. Facing east.</p>

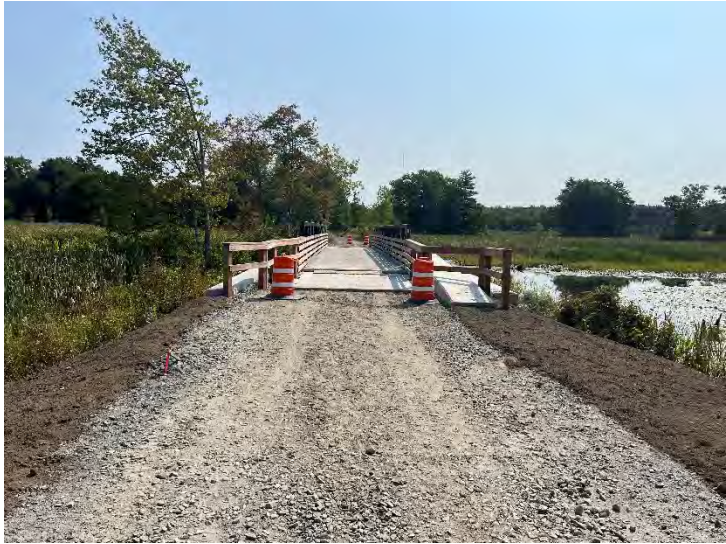
<p>Description: View of Bridge 130. Facing east.</p>

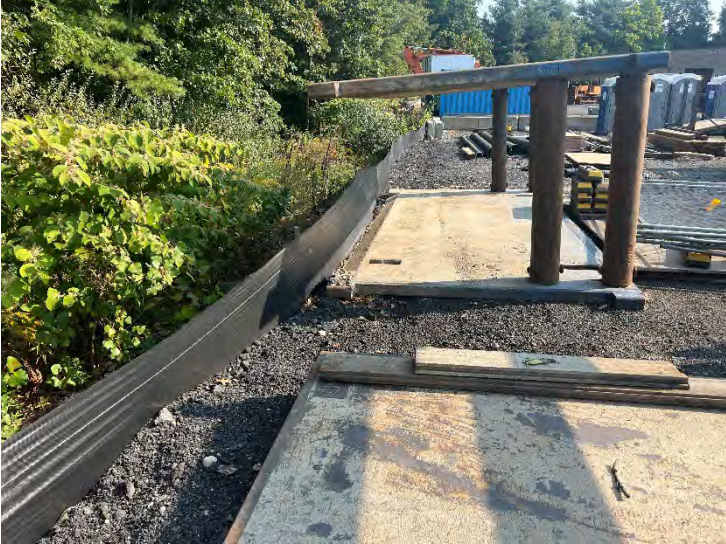
<p>Description: View of silt fencing behind Bonazzoli laydown yard. Facing northeast.</p>

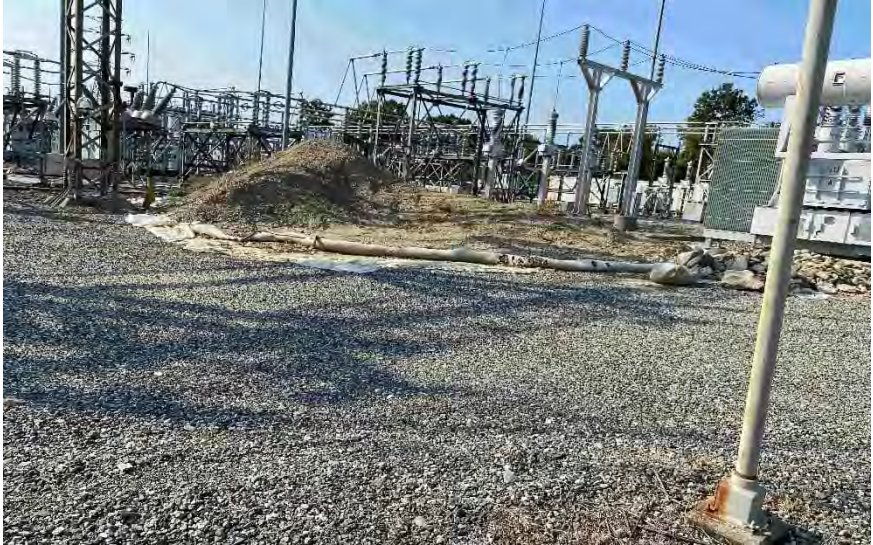
Description: Spoil pile within Sudbury substation surrounded by compost filter tubes, looking southward.

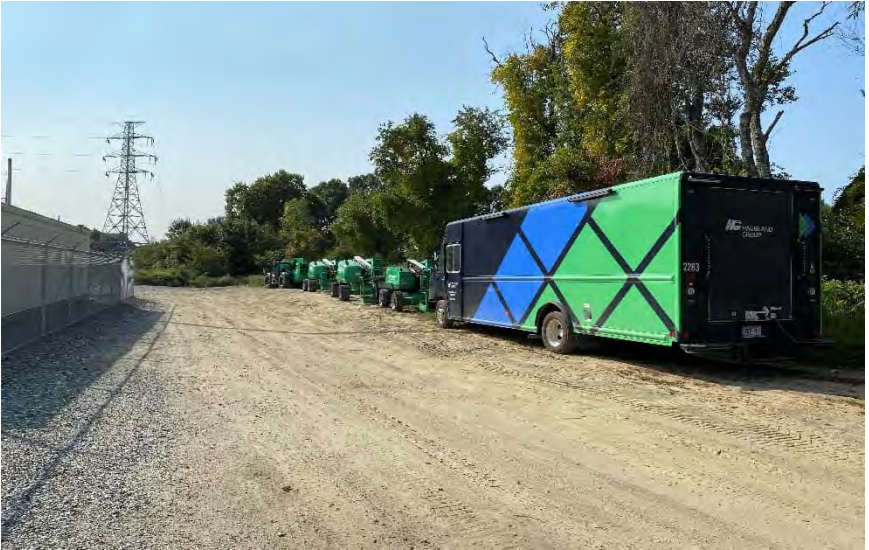
<p>Description:</p> <p>Work area outside substation, Haugland equipment staged for work within the substation, looking southward</p>

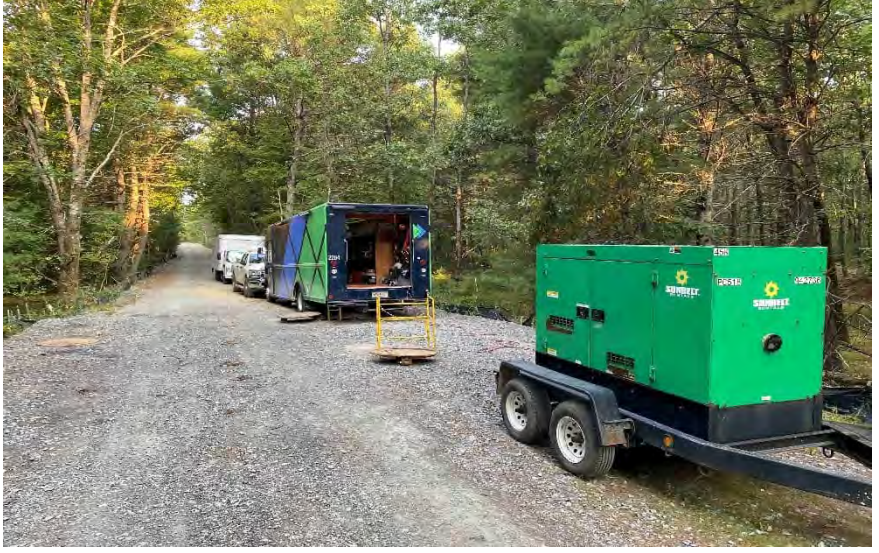
<p>Description:</p> <p>Work area within segment 7 manhole #15, splicing work, existing erosion control, looking westward.</p>

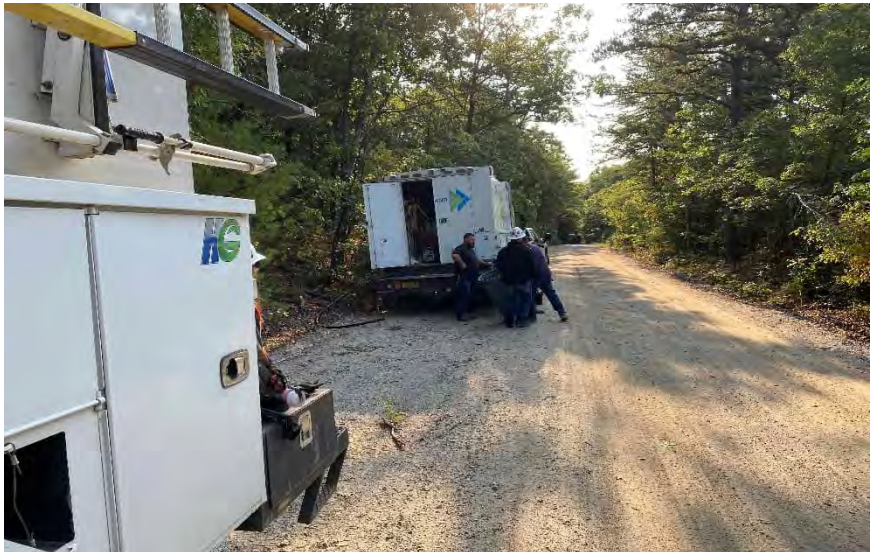
<p>Description:</p> <p>Work area within segment 7 at the town line, Haugland work, existing erosion control, looking eastward.</p>

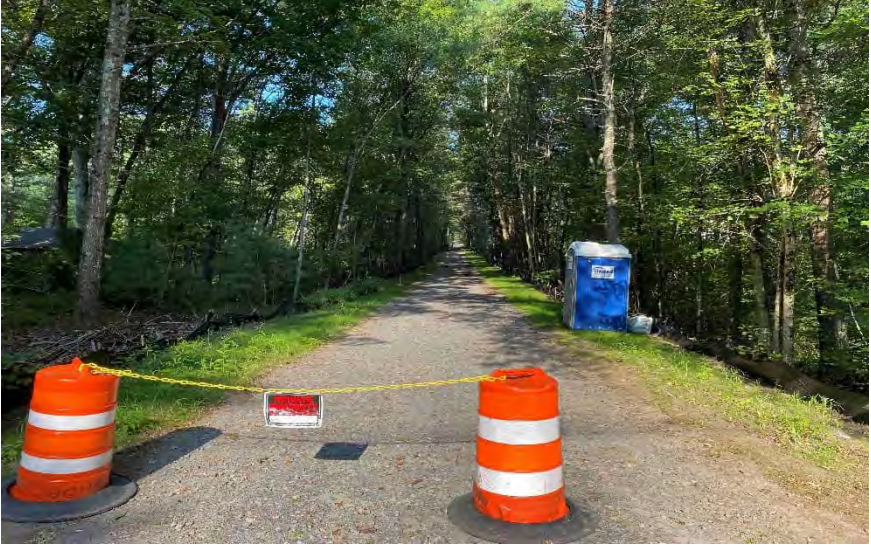
<p>Description:</p> <p>Work area within segment 9, existing erosion control, looking westward</p>

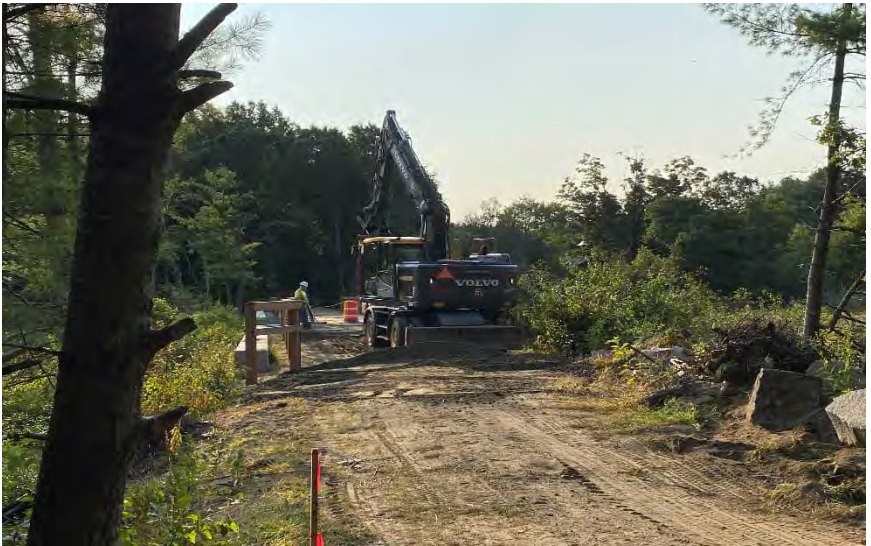
<p>Description:</p> <p>Bridge 128 area within segment 7, site work prior to paving, existing erosion control, looking westward.</p>

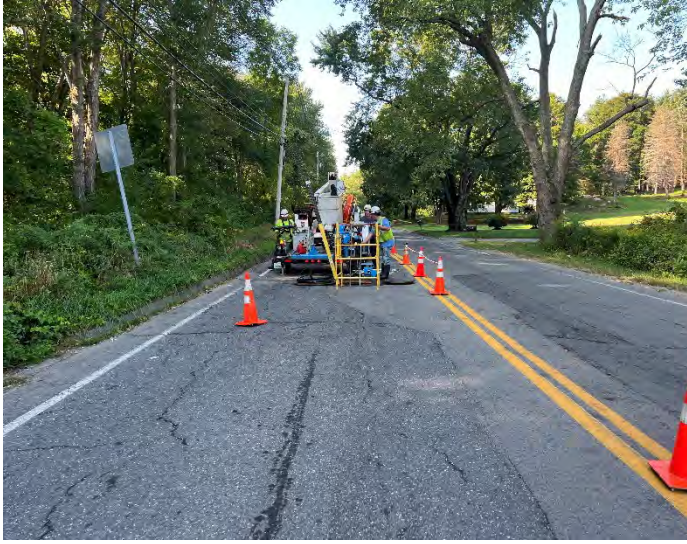
Description: View of New Wave at HH #4 in Forest Avenue. Facing west.

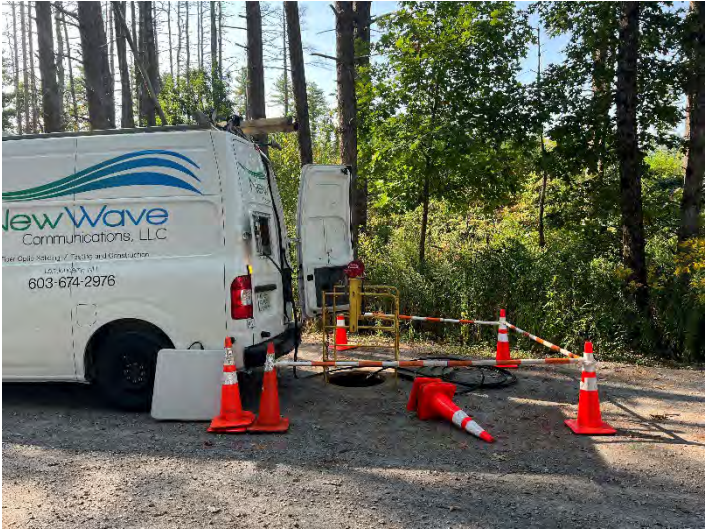
Description: View of New Wave cable splicers at HH#10 in segment 4. Facing south.

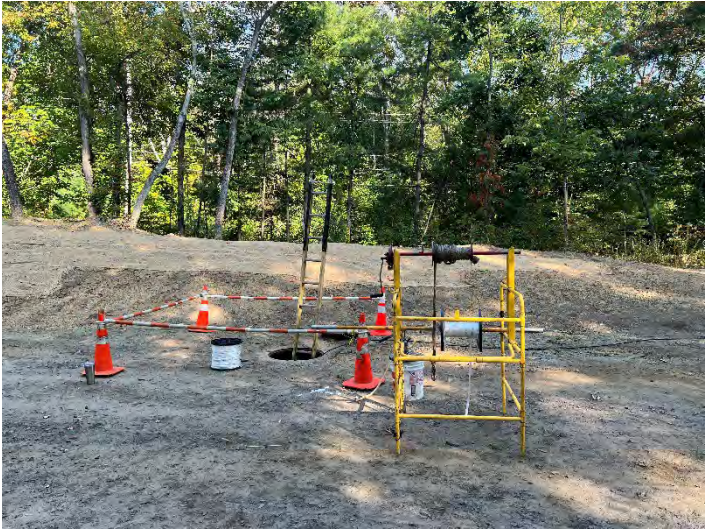
Description: View of New Wave work area installing inner fiber optics cable at HH#5 in segment 1. Facing north.

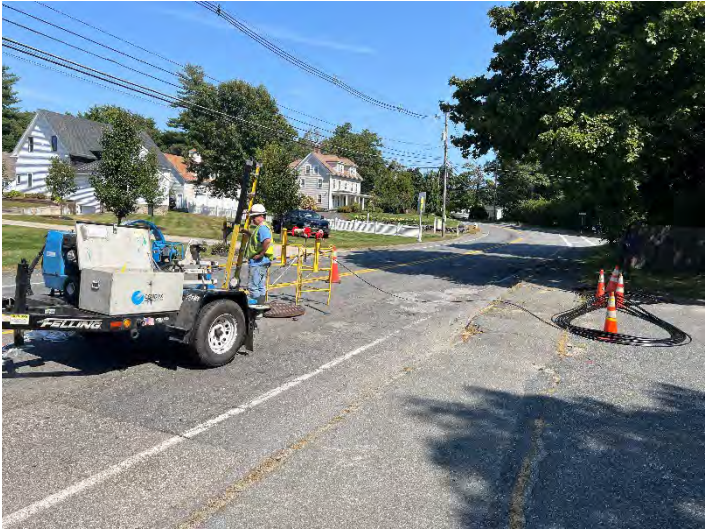
Description: View of New Wave work space at HH#3 on Forest Avenue. Facing north.

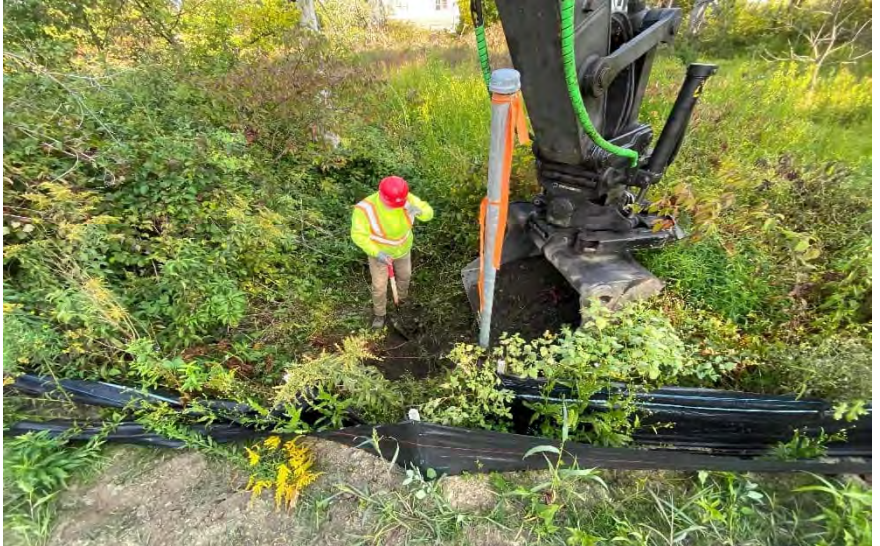
Description: Work area within segment 14, culvert work near wetland replication area, existing erosion control, looking northward.

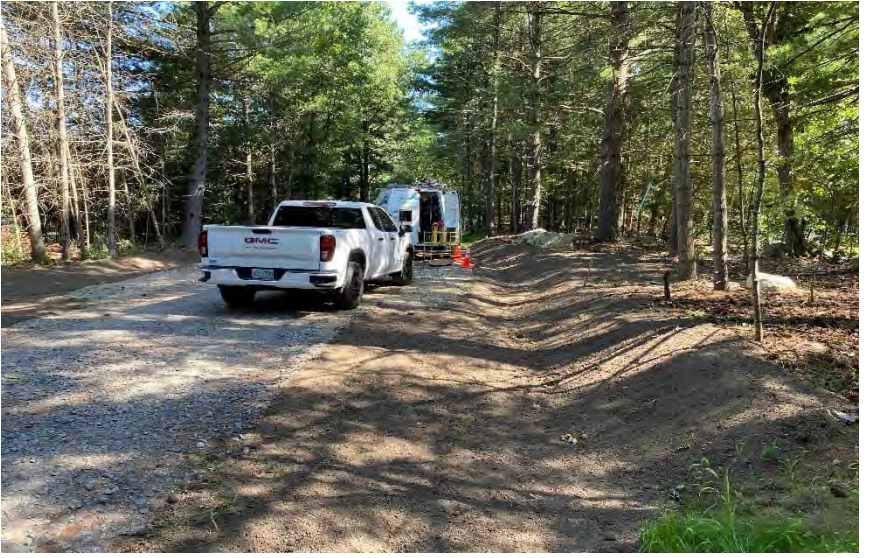
Description: Work area within segment 9, handhole #18 New Wave, existing erosion control, looking eastward.

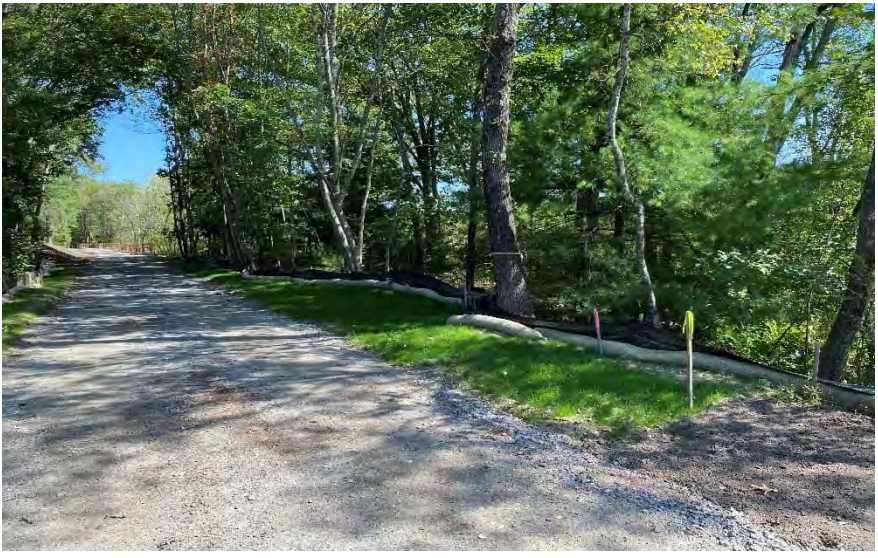
Description: Work area within segment 14 recently loamed/hydroseeded area & placement of planting soil, existing erosion control, looking eastward.

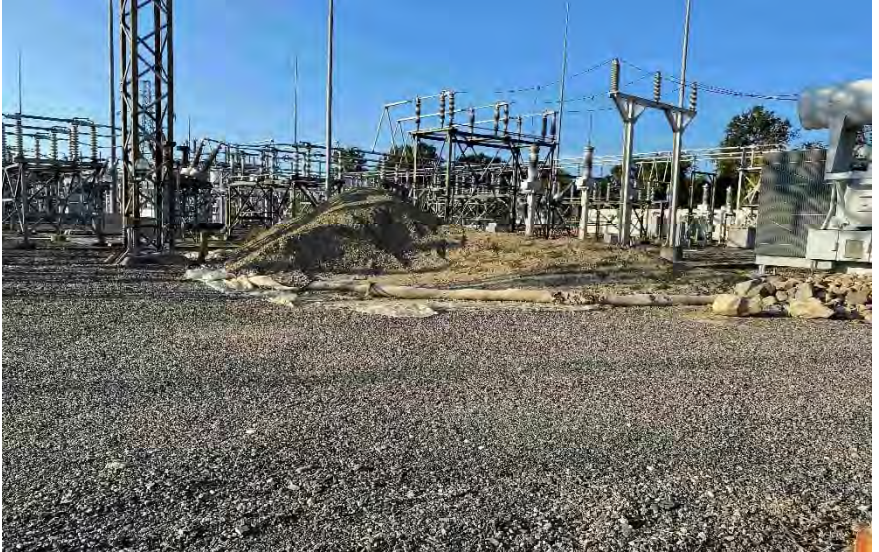
Description: Work area within substation, spoil pile with compost tubes surrounding pile, looking southward.

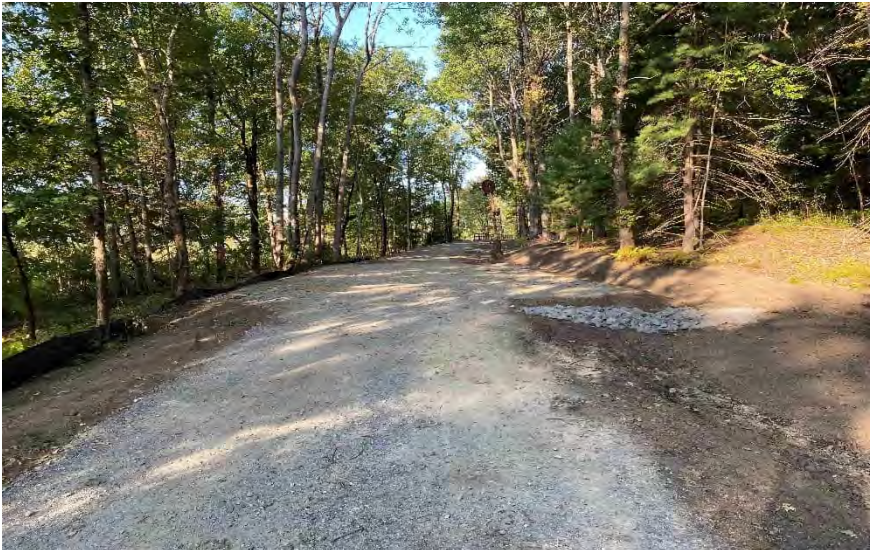
Description: Work area within segment 14 (manhole #26), shoulders recently loamed for plantings, existing erosion control, looking westward.

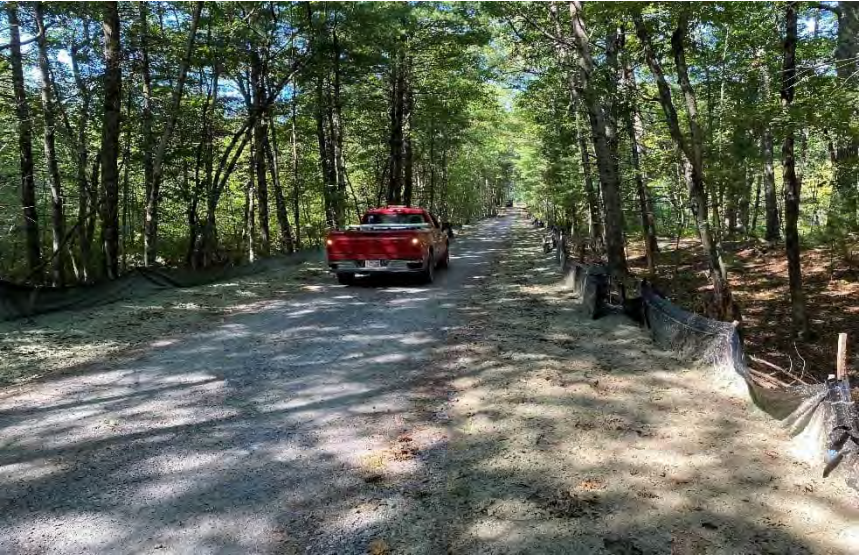
Description: Work area within segment 8, ET&L conducting site work, existing erosion control, looking westward.

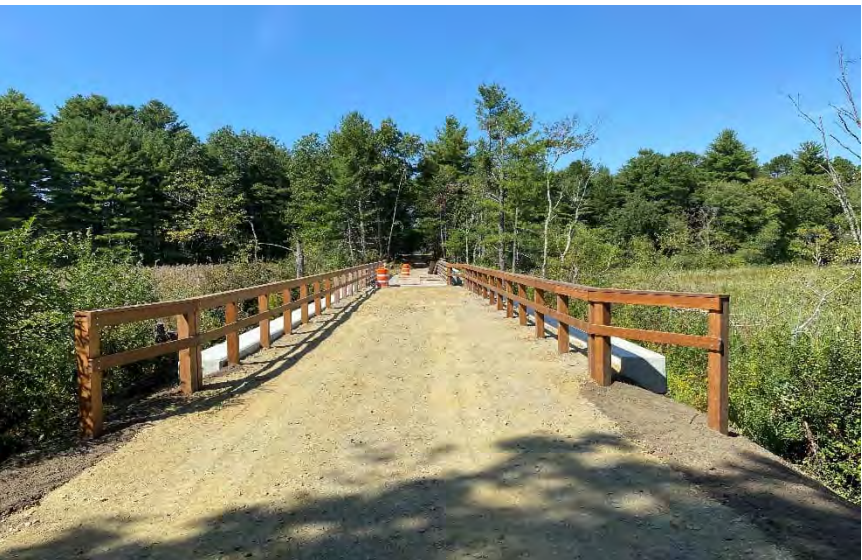
Description: Bridge 128 segment 8 recently completed post/rails & placement of planting loam, existing erosion control, looking westward.
