**Environmental Monitor Construction Site Inspection Report**  
**MassDOT Project #608164 Construction Contract # 119678**  
**EM Report #22**

Project Description: Bruce Freeman Rail Trail Right-of-Way  
 Permit Description(s): Order of Conditions (MGL Chapter 131, Section 40 and 310 CMR 10.00, Mass DEP File No. 301-1362); 2022 EPA NPDES General Permit for Discharges from Construction Areas; U.S. Army Corps of Engineers Permit No NAE-2021-01975.

Project Name:	Bruce Freeman Rail Trail - Phase 2d - Sudbury
Date of Inspections:	9/10/2024
Bi Weekly/ Monthly Period Covered:	September Weekly Inspection #2
Inspector's Name(s):	Anna Haznar
Inspectors' Contact Information:	ahaznar@beta-inc.com

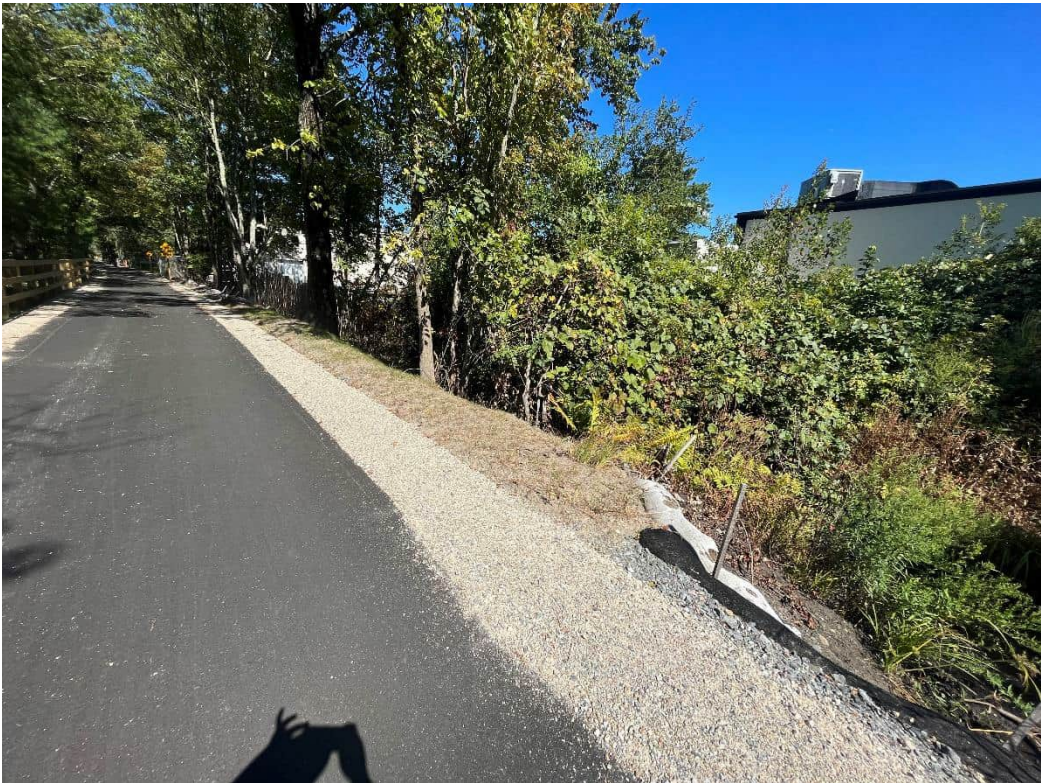
<b>Photo No. 2</b>	<b>Date:</b> 9/10/2024

44	Slopes require stabilization / additional seed due to lack of compost filter tubes at 105+00 and 106+00 <b>Priority: High</b>	6/7/2024	6/14/2024	Stabilize the slope with the approved seed mixture and provide interim stabilization such as straw mulch.	6/14/2024 - Observation remains. 6/17/2024 - Observation remains. 6/24/2024 - Observation remains. 6/27/2024 - Observation remains. 7/8/2024 - Observation remains. 7/15/2024 - Observation remains. 7/22/2024 - Observation remains. 7/29/2024 - Regrowth of vegetation has been observed in this area. This item will remain open until the area is fully stabilized. 8/5/2024 - Observation remains. 8/7/2024 - Regrowth of vegetation has been observed but the area is not yet fully stabilized. 8/12/2024 - Observation remains. 8/16/2024 - Observation remains. 8/20/2024 - Application of the approved seed mixture is required at this location. 8/27/2024 - Vegetation has partially stabilized this area; however, seed should be applied. 9/3/2024 - Observation remains. 9/10/2024 - Observation remains. Application of the approved seed mixture is require at this location.

<b>Direction Photo Taken:</b>  Toward the North		
<b>Description:</b>  View of slopes requiring stabilization at Station 105+00 to 106+00 per Compliance Action Item 44.

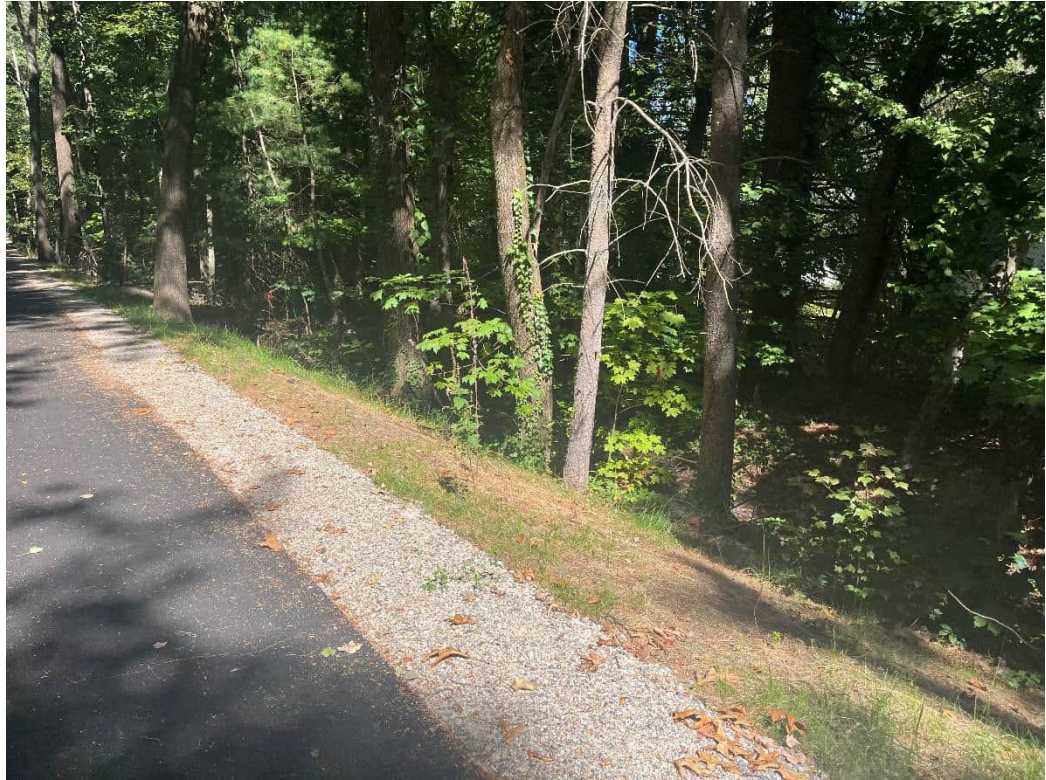
**Photo No. 3**    **Date:**  
9/10/2024

**Description:**  
View of an area that is no longer stabilized due to herbicide application and Japanese hops with seed heads that require removal at Station 135+00 per Long Term Compliance Action Item 59 and 57.

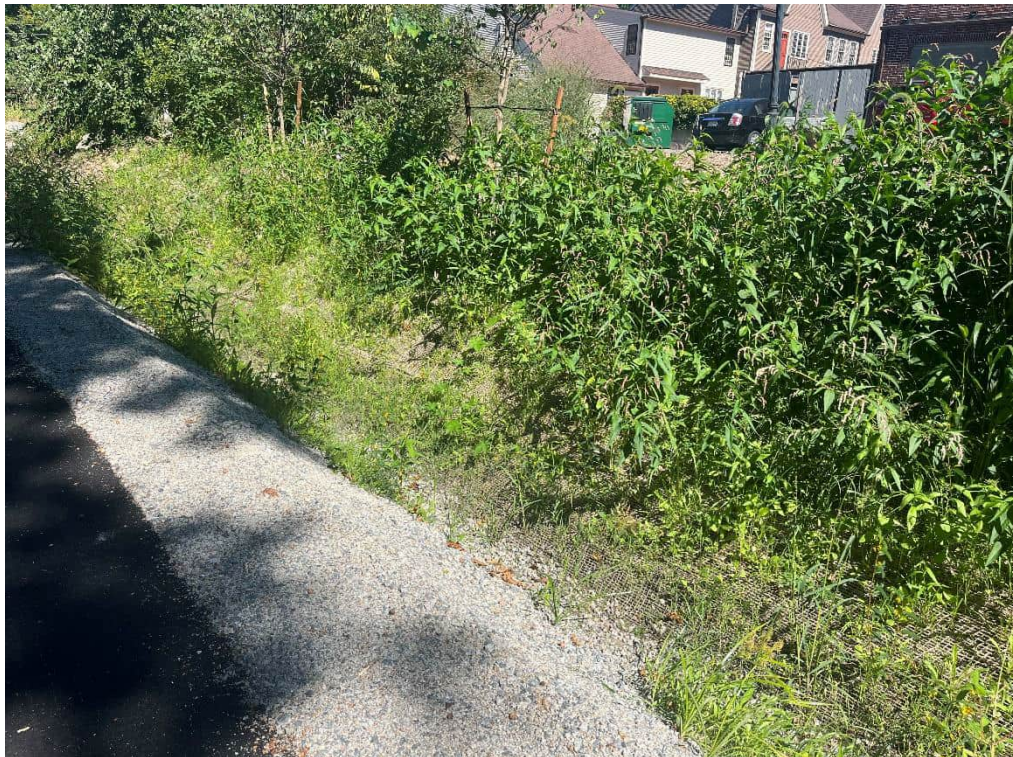
**Photo No. 4**    **Date:**  
9/10/2024

Item	Location/ Description	Observation Date	Resolution Due Date	Recommended Resolution / Resolution Date	Comments/Updates
53	Stone was observed requiring removal from the swale on the east side of the trail at Station 172+00 to 173+00 <b>Priority: High</b>	7/29/2024	8/6/2024	Remove stone from the swale.	8/5/2024 - Observation remains. 8/7/2024 - Observation remains. 8/12/2024 - Observation remains. Material was observed to have migrated within the swale to Station 173+50. 8/16/2024 - Stone is still present within the swale. 8/20/2024 - Observation remains. Crushed stone has migrated further down the swale to Station 171+50. 8/27/2024 - Observation remains. Stone is still present within the swale. 9/3/2024 - Observation remains. 9/10/2024 - Observation remains. Stone is still present within the swale.
52	Slopes along the driveway to the parking lot at Station 216+50 requires stabilization <b>Priority: Medium</b>	7/29/2024	8/6/2024	Install erosion control blanket and place seed.	8/5/2024 - Observation remains. 8/7/2024 - Observation remains. 8/12/2024 - Observation remains. 8/16/2024 - Observation remains. 8/20/2024 - Observation remains. Erosion controls have been installed between the slope and the downgradient stream, but seed is still required. 8/27/2024 - Observation remains. 9/3/2024 - Observation remains. 9/10/2024 - Slopes have been hydroseeded. Item will remain open till stabilization occurs.

**Description:**  
View of crushed stone requiring removal from the swale at Station 172+00 per Compliance Action Item 53.

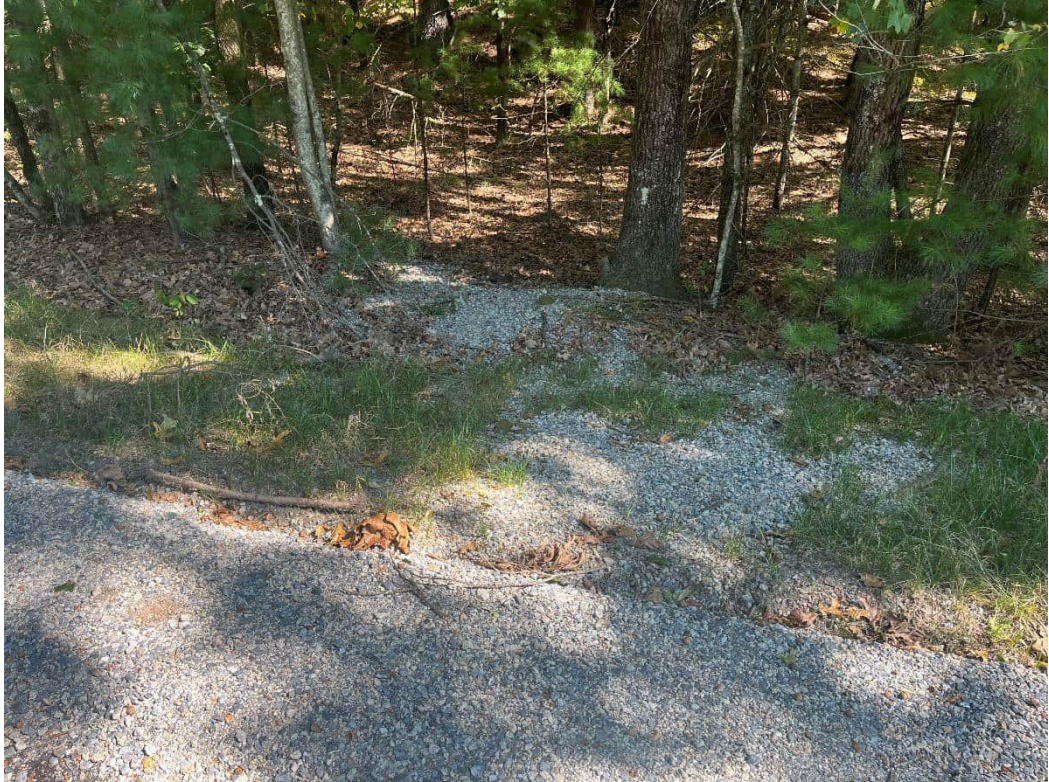
**Photo No. 7**    **Date:**  
9/10/2024

58	Crushed stone used for the dense graded crush stone shoulders has been observed as migrating both onto the path, off the sides of the path, and into the adjacent Resource Areas throughout the Project <b>Priority: High</b>	8/7/2024	8/14/2024	Remove all crushed stone from Resource Areas and develop a plan to cease discharges of stone.	8/12/2024 - Crushed stone is still present in varying amounts throughout the path and on the sides of the path. 8/16/2024 - Observation remains. 8/20/2024 - Crushed stone has been removed from some adjacent resource areas but is still observed as migrating onto and off of the path in multiple locations throughout the Project. 8/27/2024 - Crushed stone has been observed as migrating from the shoulders throughout the path. 9/3/2024 - Crushed stone was observed as migrating both onto the path and off the side of the path in multiple locations. Stone was observed to have discharged to the cattle crossing at Station 190+50 and within the streambed at Station 215+00 to 216+00. Crushed stone was observed to have been placed on the root system of a fallen tree at Station 310+00 near Bank flag #BF4-108. 9/10/2024 - Observation remains. Crushed stone is still present within the cattle crossing, the streambed, and on the root system of the fallen tree. Crushed stone continues to migrate on to and off of the path.

View of a location where crushed stone has migrated off of the shoulders at Station 180+00 per Long Term Compliance Action Item 58.

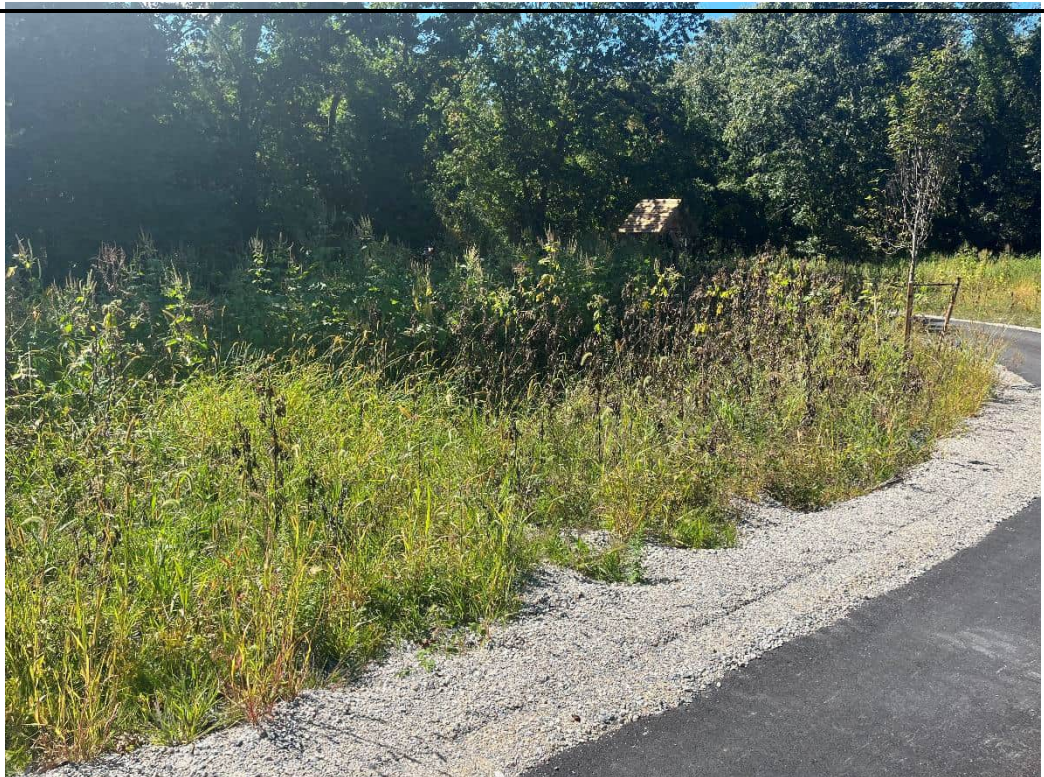
**Photo No. 8**    **Date:**  
9/10/2024

View of a location where Japanese hops require treatment and crushed stone has migrated off of the shoulders at Station 1002+00 per Long Term Compliance Action Item 57 and 58.

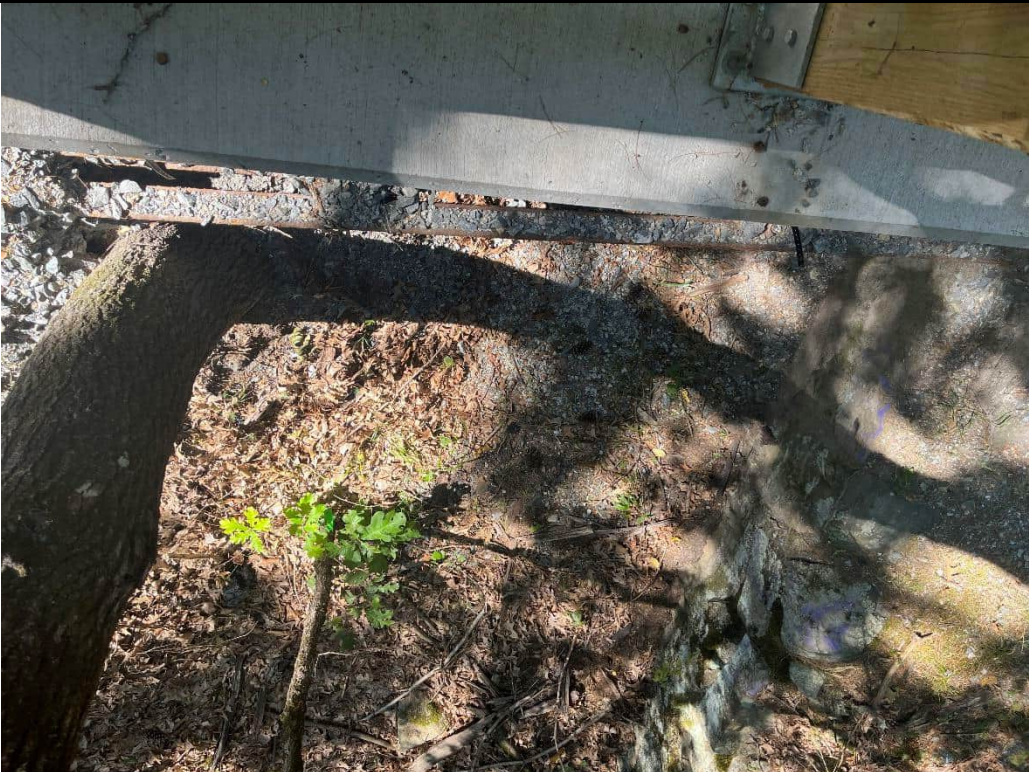
<b>Direction Photo Taken:</b>  Toward the East		
<b>Description:</b>  View of the crushed stone that has discharged into the cattle crossing at Station 190+50 per Long Term Compliance Action Item 58.		
<b>Photo No. 10</b>	<b>Date:</b> 9/10/2024

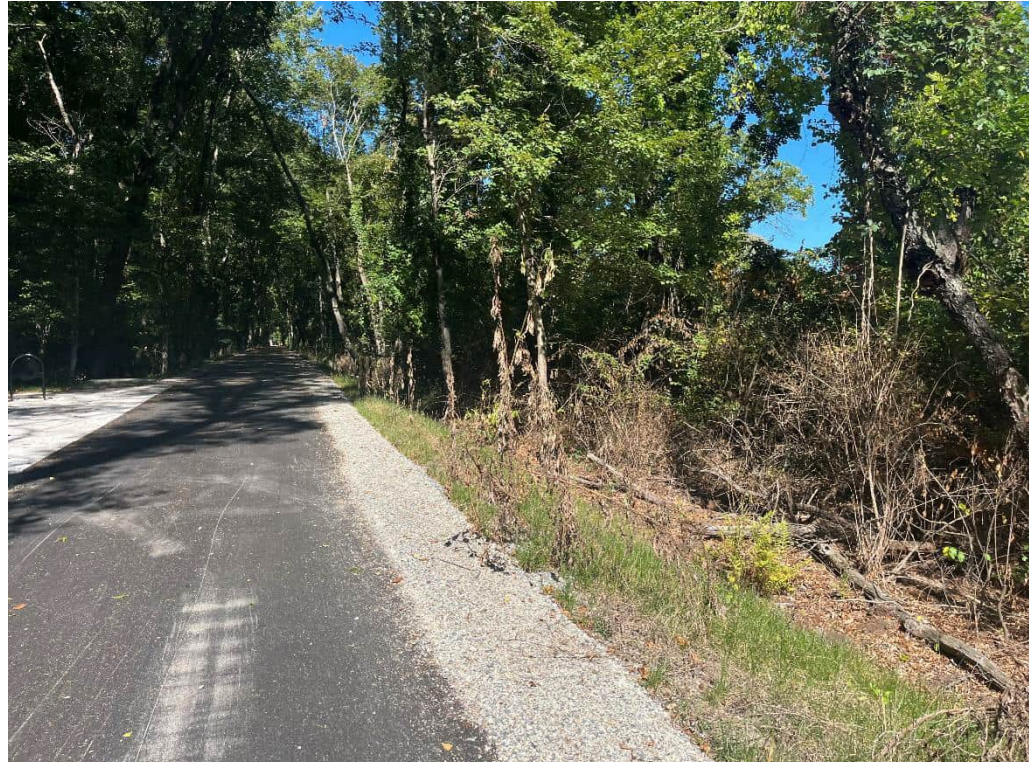
<b>Direction Photo Taken:</b>  Toward the East		
<b>Description:</b>  View of another area that is no longer stabilized due to herbicide application at Station 199+00 per Long Term Compliance Action Item 59.

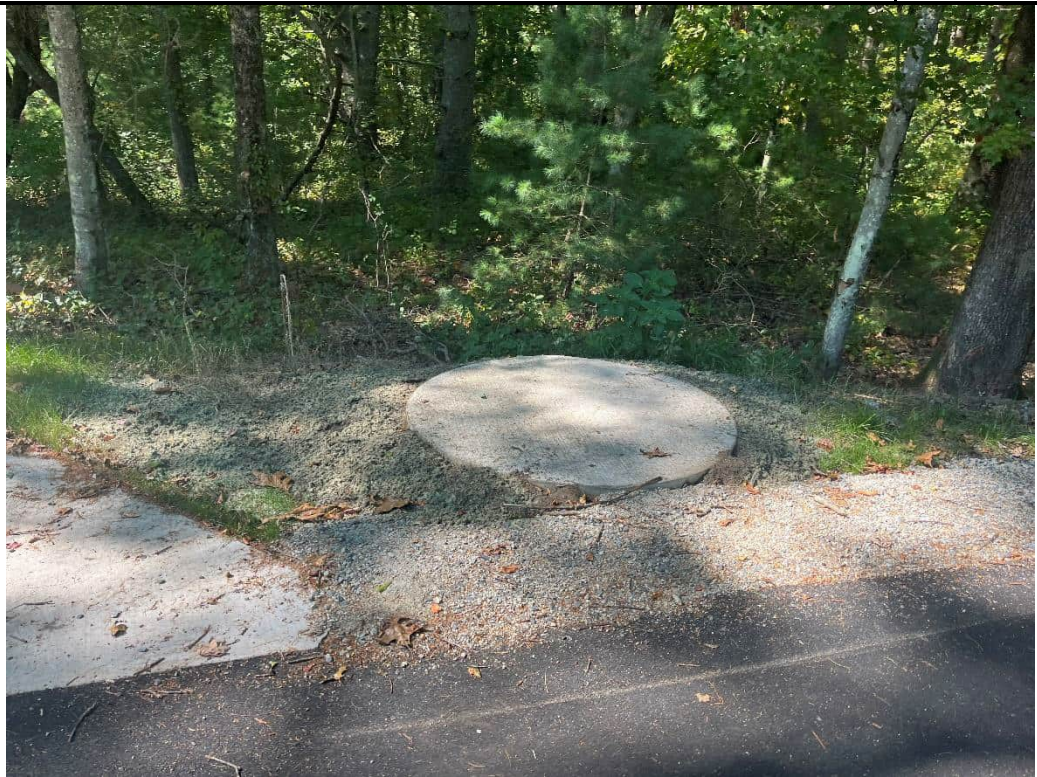
**Photo No. 11**    **Date:**  
9/10/2024

View of another location of exposed soil that has been hydroseeded at Station 201+50.

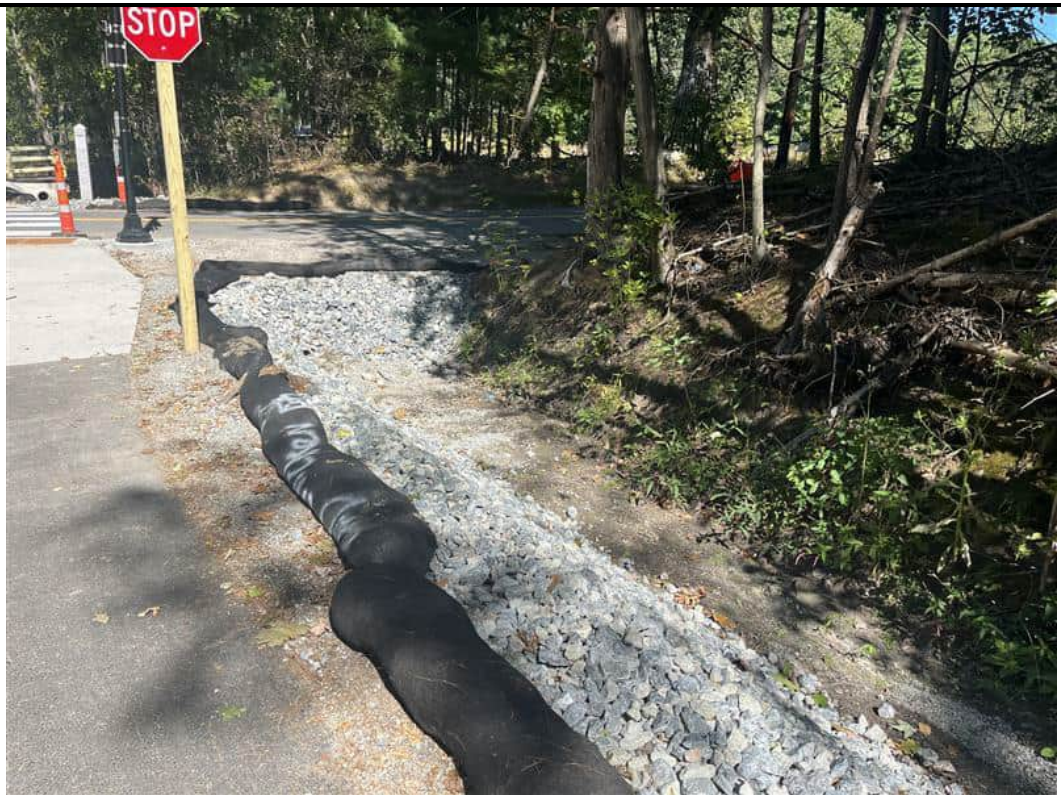
**Photo No. 12**    **Date:**  
9/10/2024

View of the location where crushed stone has discharged into the streambed at Station 215+00 per Long Term Compliance Action Item 58.

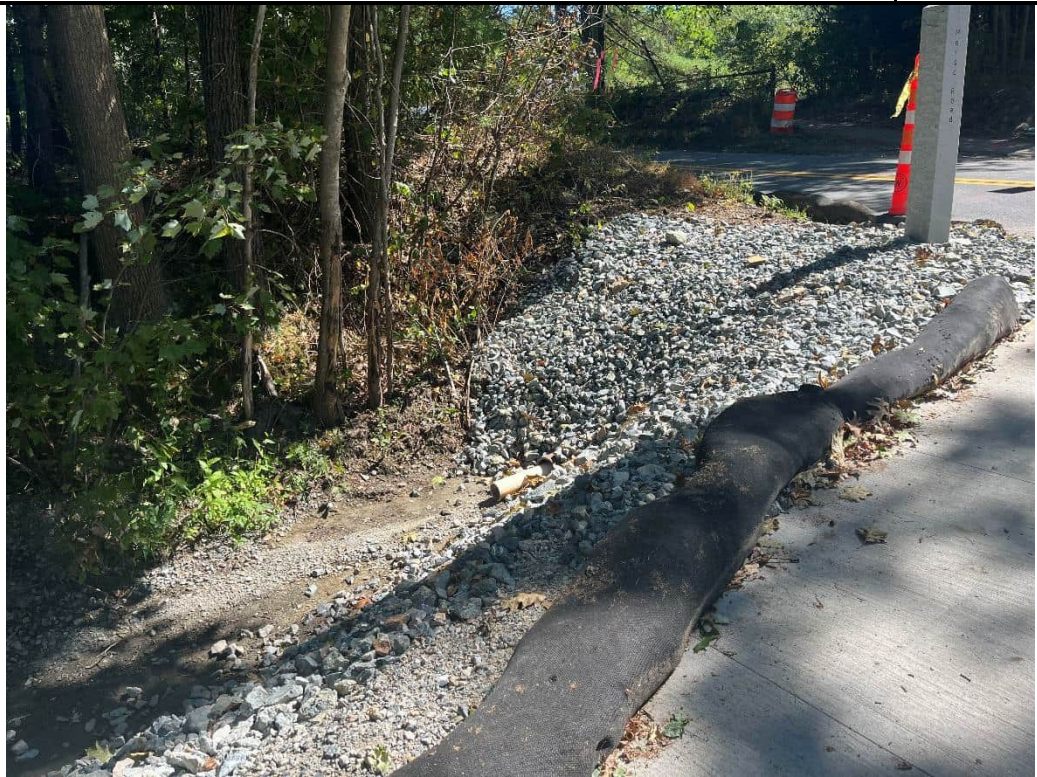
**Photo No. 13**    **Date:**  
9/10/2024

41	Stream Bank has been regraded beyond the limit of work at Station 216+00 <b>Priority: High</b>	5/28/2024	6/4/2024	The Contractor should confirm if this work was permitted by the Conservation Commission, as it does not appear to be a part of the approved plans/impacts. MassDOT should be consulted on next steps regarding notification and potential restoration.	<p>5/31/2024 - Observation remains.  6/7/2024 - Observation remains.  6/14/2024 - Observation remains.  6/17/2024 - Observation remains.  6/24/2024 - Observation remains.  6/27/2024 - Observation remains.  7/8/2024 - Observation remains.  7/15/2024 - This area could not be assessed due to paving operations ongoing during the inspection.  7/22/2024 - Crushed stone and sediment continue to be discharged to the stream between Stations 215+00 and 217+00 due to overtopped and undermined compost filter tubes.  7/29/2024 - Observation remains.  8/5/2024 - Observation remains.  8/7/2024 - Observation remains.  8/12/2024 - Observation remains. Crushed stone is still present in the streambed at this location.  8/16/2024 - Observation remains.  8/20/2024 - Stone has been removed; however, additional alteration to Resource Areas beyond the limit of work continue.  8/27/2024 - Observation remains.  9/3/2024 - Observation remains.  9/10/2024 - Observation remains. Stone has been observed as discharging into the streambed in this location again.</p>

View of crushed stone within the streambed and the location where the stream bank has been regarded beyond the limit of at Station 216+00 work per Long Term Compliance Action Items 41 and 58.

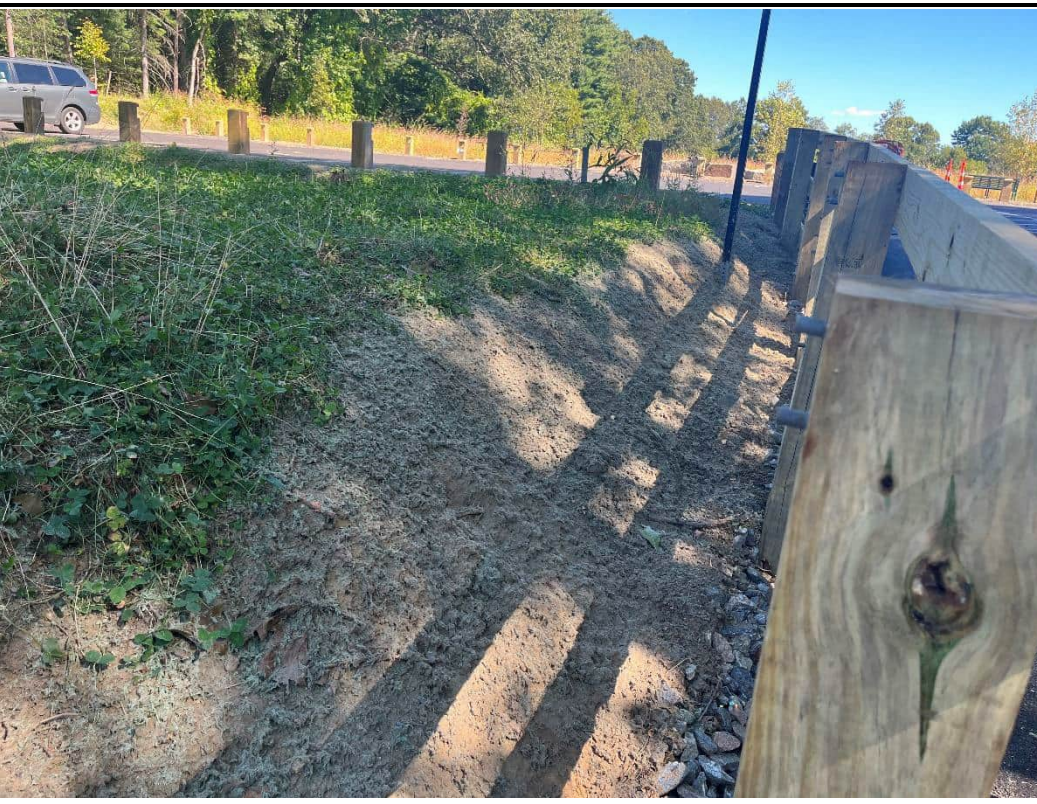
**Photo No. 14**    **Date:**  
9/10/2024

View of the slopes that has been hydroseeded along the driveway to the parking lot at Station 216+50 per Compliance Action Item 52.

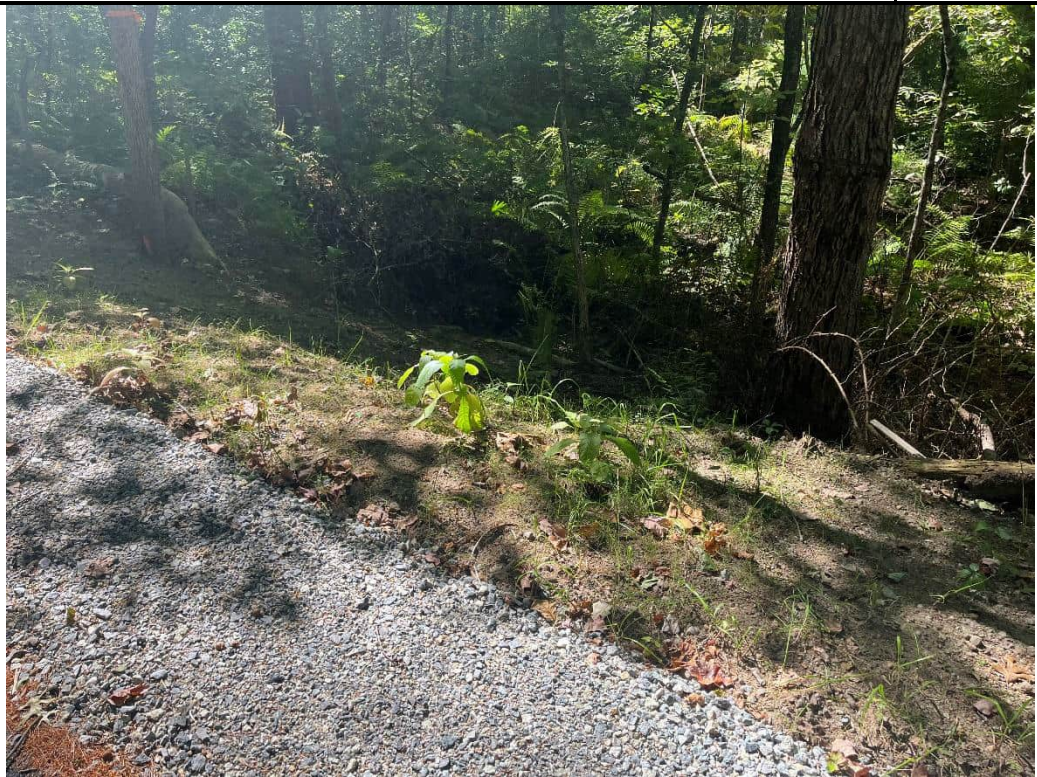
**Photo No. 15**    **Date:**  
9/10/2024

32	<p>Soil and organic debris has been placed within the wetland between wetland flagging WF#23-119 and WF#23-118 at Station 224+00  <b>Priority: High</b></p>	5/21/2024	5/28/2024	<p>Remove all material and provide stabilization of the area with the approved wetland seed mixture. Straw should also be placed for interim stabilization.</p>	<p>5/28/2024 - Observation remains.  5/31/2024 - Observation remains.  6/7/2024 - Observation remains.  6/14/2024 - Observation remains.  6/17/2024 - This area has been hydroseeded multiple times, but the debris should also be removed from the downgradient wetland.  6/24/2024 - Observation remains.  6/27/2024 - Observation remains. The area was hydroseeded again.  7/8/2024 - Germination was observed and the area will be monitored for stabilization.  7/15/2024 - See previous update.  7/22/2024 - Observation remains.  7/29/2024 - Observation remains.  8/5/2024 - Observation remains.  8/7/2024 - Regrowth of vegetation has been observed in this area. This item will remain open until the area is fully stabilized. Debris is still present in wetland and requires removal.  8/12/2024 - Observation remains.  8/16/2024 - Observation remains.  8/20/2024 - Debris is still present within the wetland.  8/27/2024 - Observation remains.  9/3/2024 - Debris is still present in the wetland and slopes upgradient of the wetland require stabilization.  9/10/2024 - Observation remains.</p>

View of the organic debris that has been placed within the wetland and exposed soil that requires stabilization at Station 224+00 per Compliance Action item 32.

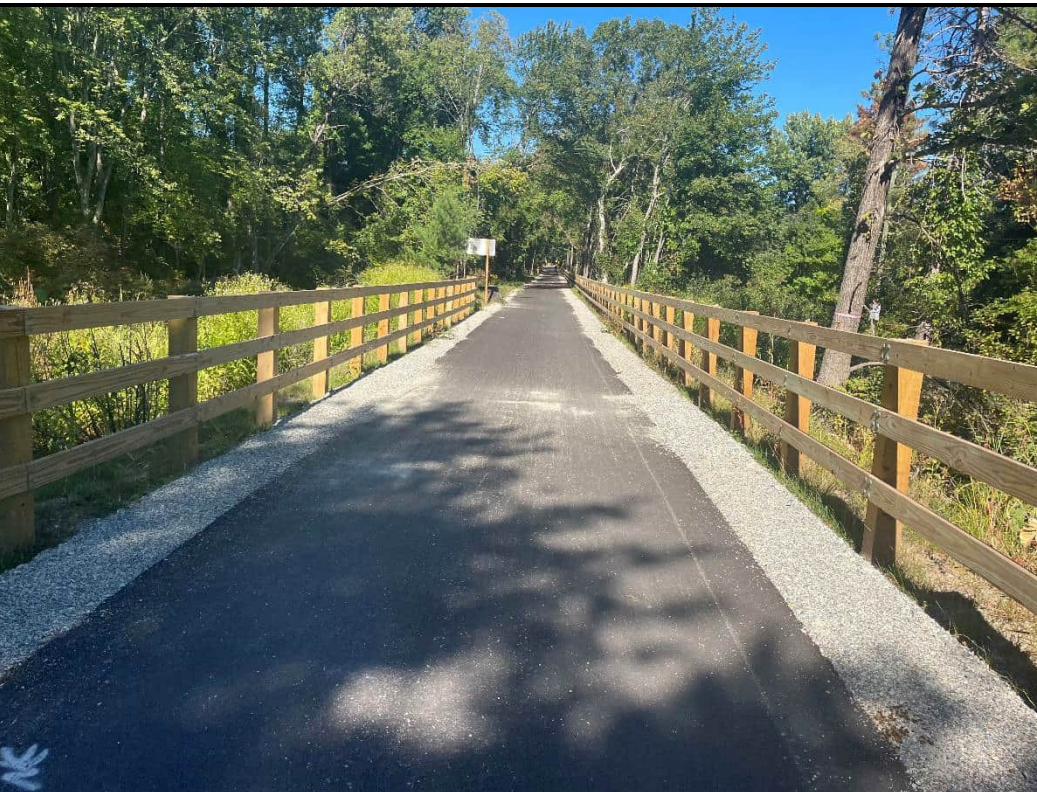
**Photo No. 16**    **Date:**  
9/10/2024

View of a location where crushed stone is present on the path at Station 309+00 per Long Term Compliance Action Item 58.

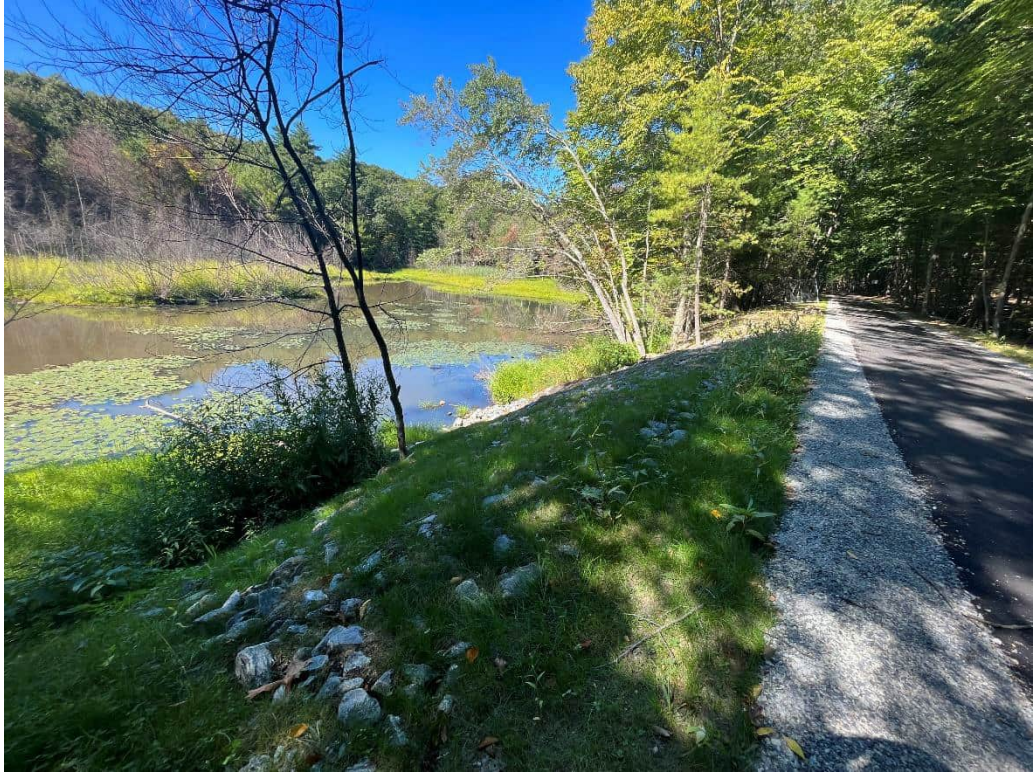
42	Riprap slope extends beyond limits of work along the WF1 Series wetland near flags 103 to 107 <b>Priority: High</b>	5/28/2024	6/4/2024	The Contractor should confirm if this work was permitted by the Conservation Commission, as it does not appear to be a part of the approved plans/impacts. MassDOT should be consulted on next steps regarding notification and potential restoration.	<p>5/31/2024 - Observation remains.  6/7/2024 - Observation remains.  6/14/2024 - Riprap slope has been altered and active construction is repairing the area.  6/17/2024 - During this inspection, additional work in support of the repair/potential replacement of an underlying pipe has been ongoing. It is recommended that the contractor confirm that they have coordinated with the Conservation Commission for this work and provide a restoration plan for the area once work is complete.  6/24/2024 - During this inspection, BETA was informed that the existing cast iron pipe was replaced with a new concrete 12-inch reinforced concrete pipe. It appears that riprap was replaced along the side slopes to mirror conditions observed prior to this inspection.  6/27/2024 - During this inspection, the area was observed to have been rolled and prepared for paving. Hydroseed was applied and plantings were installed.  7/8/2024 - Germination was observed and the area will be monitored for stabilization. See previous updates regarding Conservation Commission coordination.  7/15/2024 - This area could not be assessed due to paving operations ongoing during the inspection.  7/22/2024 - See previous updates regarding Conservation Commission coordination.  7/29/2024 - Observation remains.  8/5/2024 - Observation remains.  8/7/2024 - Observation remains.  8/12/2024 - Observation remains. Regrowth of vegetation has been observed in this area and will continue to be monitored.  8/16/2024 - Observation remains.  8/20/2024 - Observation remains.  8/27/2024 - Observation remains.  9/3/2024 - Observation remains.  9/10/2024 - Observation remains.</p>

<b>Direction Photo Taken:</b>  Toward the South		
<b>Description:</b>  View of the riprap slope that extends beyond the limit of work along the WF1 Series wetland at Station 332+00 per Long Term Compliance Action Item 42.
