**Environmental Monitor Construction Site Inspection Report
MassDOT Project #608164 Construction Contract # 119678
EM Report #23**

Project Description: Bruce Freeman Rail Trail Right-of-Way
Permit Description(s): Order of Conditions (MGL Chapter 131, Section 40 and 310 CMR 10.00, Mass DEP File No. 301-1362); 2022 EPA NPDES General Permit for Discharges from Construction Areas; U.S. Army Corps of Engineers Permit No NAE-2021-01975.

Project Name:	Bruce Freeman Rail Trail - Phase 2d - Sudbury
Date of Inspections:	9/16/2024
Bi Weekly/ Monthly Period Covered:	September Weekly Inspection #3
Inspector's Name(s):	Anna Haznar
Inspectors' Contact Information:	ahaznar@beta-inc.com

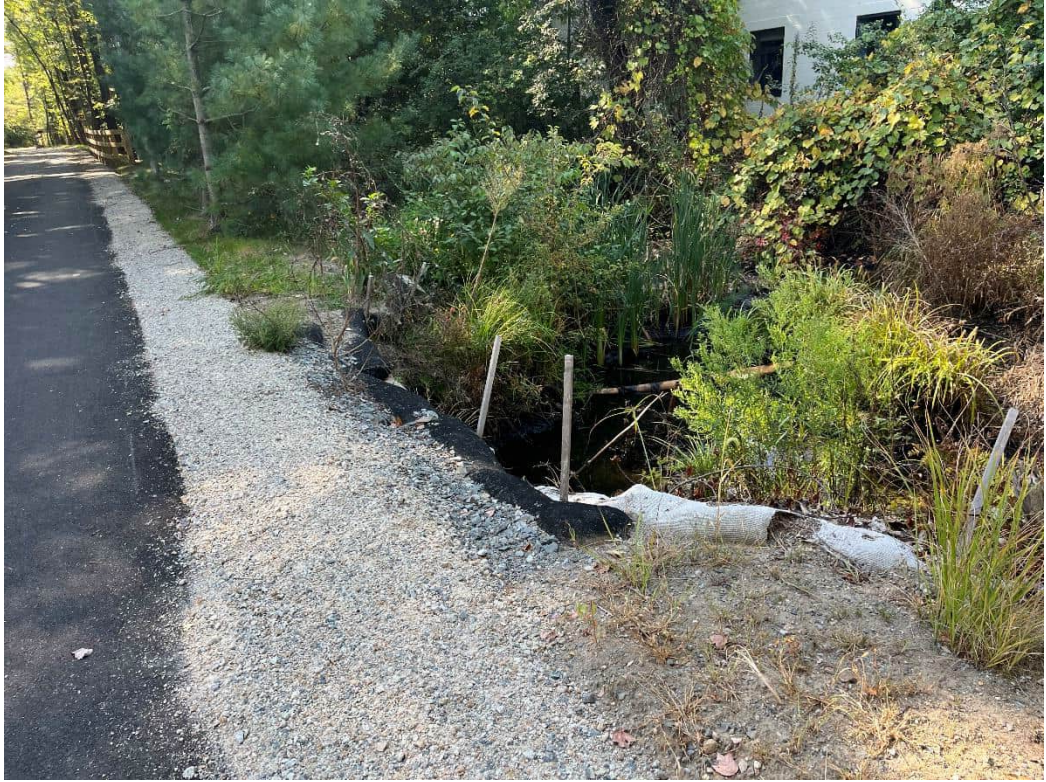
Photo No. 1 **Date:**
9/16/2024

View of the overtopped compost filter tube beyond the limits of work at Station 105+00 per Compliance Action Item 43.

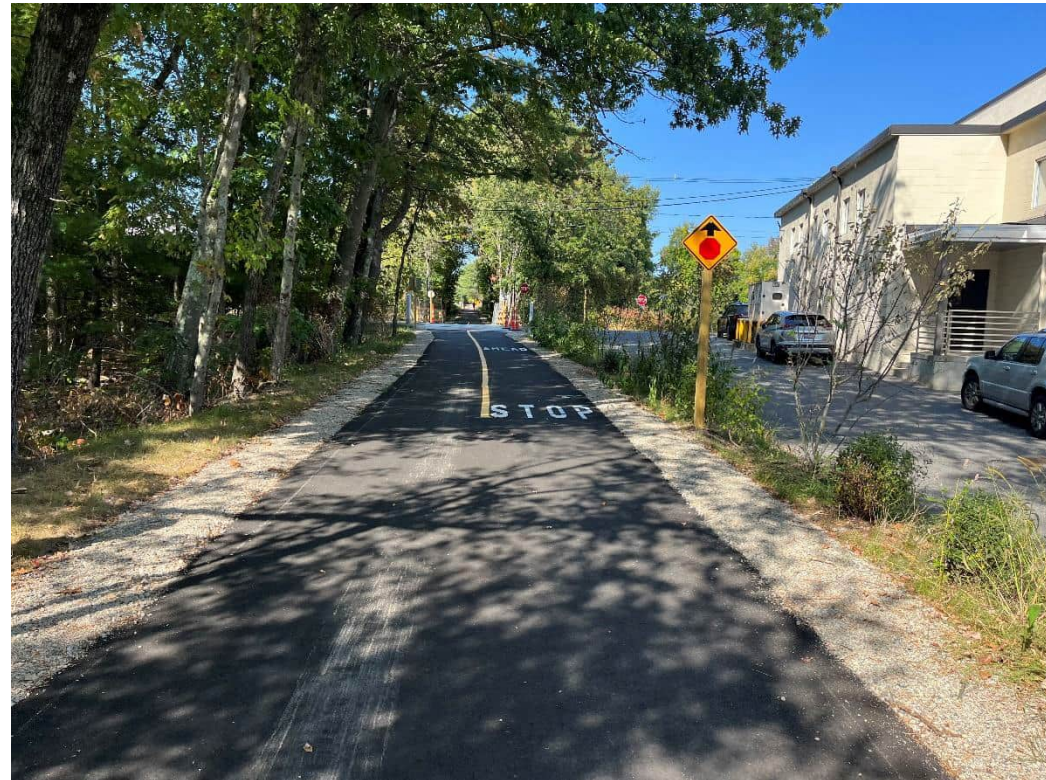
Photo No. 2 **Date:**
9/16/2024

Typical view of the center line and roadway markings that have been painted at all of the intersections along the path; this photo shows the intersection at 71 Union Ave Driveway (Station 108+50).

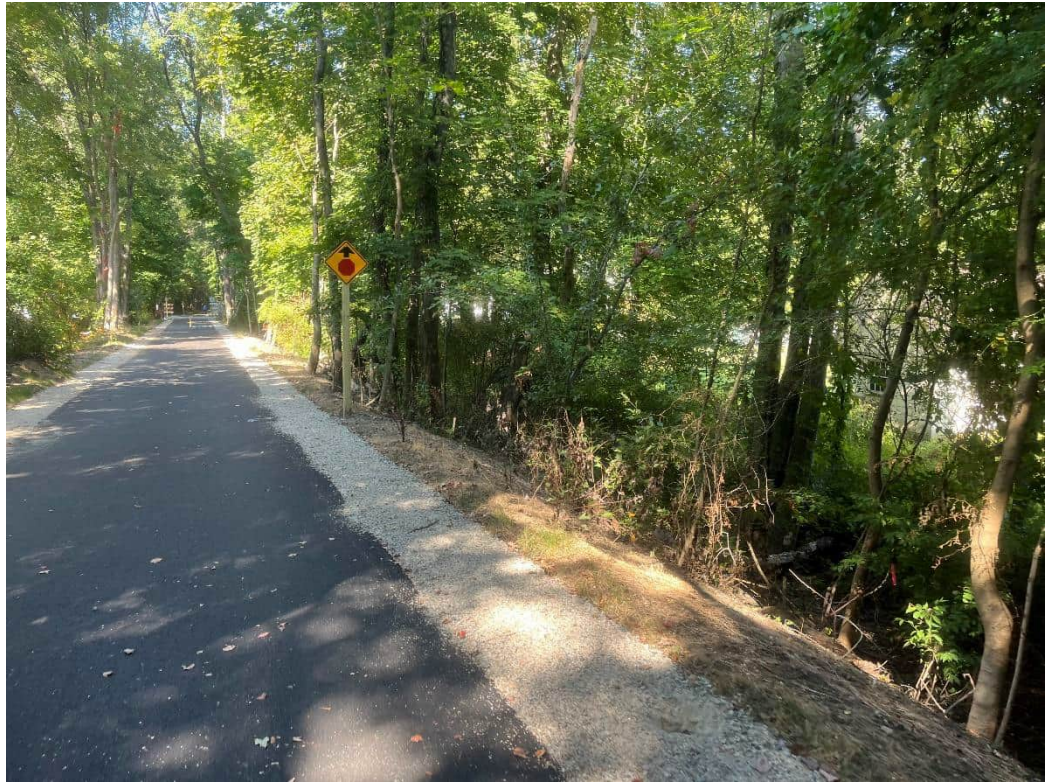
Photo No. 3 **Date:**
9/16/2024

View of an area that is no longer stabilized due to herbicide application at Station 140+00 per Long Term Compliance Action Item 59 and 57.

Item	Location/ Description	Observation Date	Resolution Due Date	Recommended/Discussed Resolution	Comments/Updates
59	Multiple locations of exposed soils along the Project corridor require stabilization Priority: High	9/3/2024	9/10/2024	The contactor should apply the approved seed mixture to areas of exposed soils and place straw.	9/3/2024 - Herbicide application caused multiple areas along the path to be no longer stabilized. If thatch is present in these locations the thatch should be removed before seeding occurs. A location near Station 320+50 has been cleared outside of the limit of work and requires stabilization. Other areas along the path where seed did not germinate should be reseeded with the approved seed mix and straw should be placed on the areas of exposed soil. 9/10/2024 - Observation remains, see previous update. A few locations along the trail have been hydroseeded but a majority of the locations of exposed soil require seed and stabilization. 9/16/2024 - Observation remains. The contactor indicated areas of bare soil will be hydroseeded.

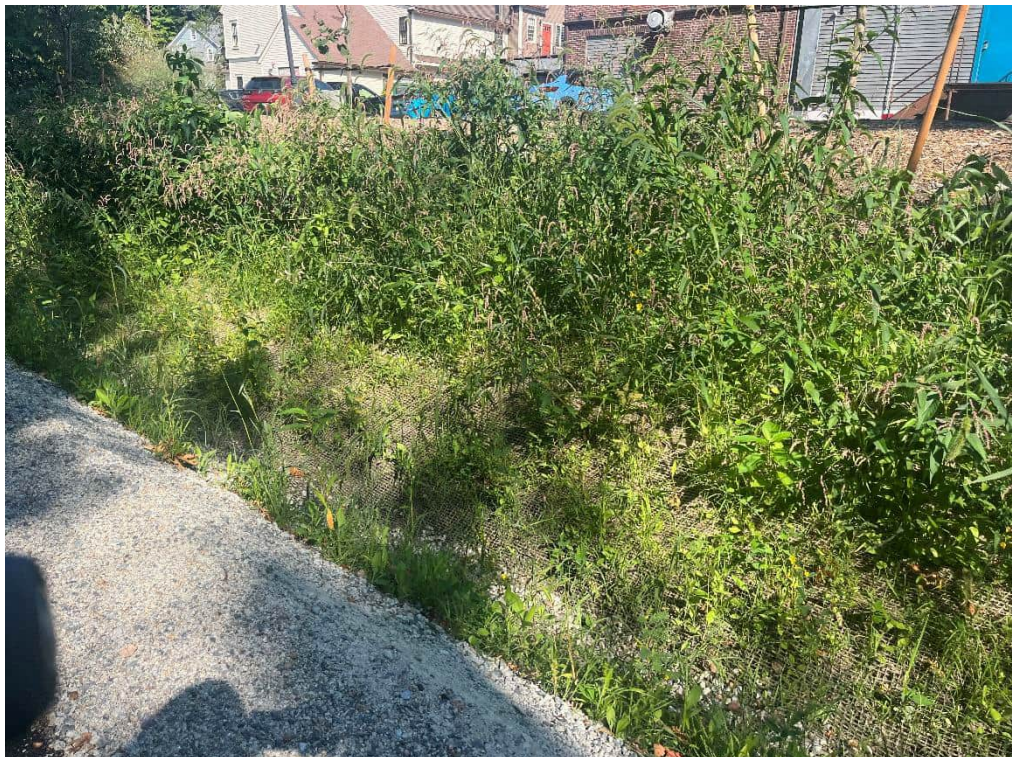
Photo No. 4 **Date:**
9/16/2024

Item	Location/ Description	Observation Date	Resolution Due Date	Recommended Resolution / Resolution Date	Comments/Updates
53	Stone was observed requiring removal from the swale on the east side of the trail at Station 172+00 to 173+00 Priority: High	7/29/2024	8/6/2024	Remove stone from the swale.	8/5/2024 - Observation remains. 8/7/2024 - Observation remains. 8/12/2024 - Observation remains. Material was observed to have migrated within the swale to Station 173+50. 8/16/2024 - Stone is still present within the swale. 8/20/2024 - Observation remains. Crushed stone has migrated further down the swale to Station 171+50. 8/27/2024 - Observation remains. Stone is still present within the swale. 9/3/2024 - Observation remains. 9/10/2024 - Observation remains. Stone is still present within the swale. 9/16/2024 - Observation remains. The contractor indicated that the stone within the swale would be hand removed.

View of crushed stone requiring removal from the swale at Station 172+00 per Compliance Action Item 53.

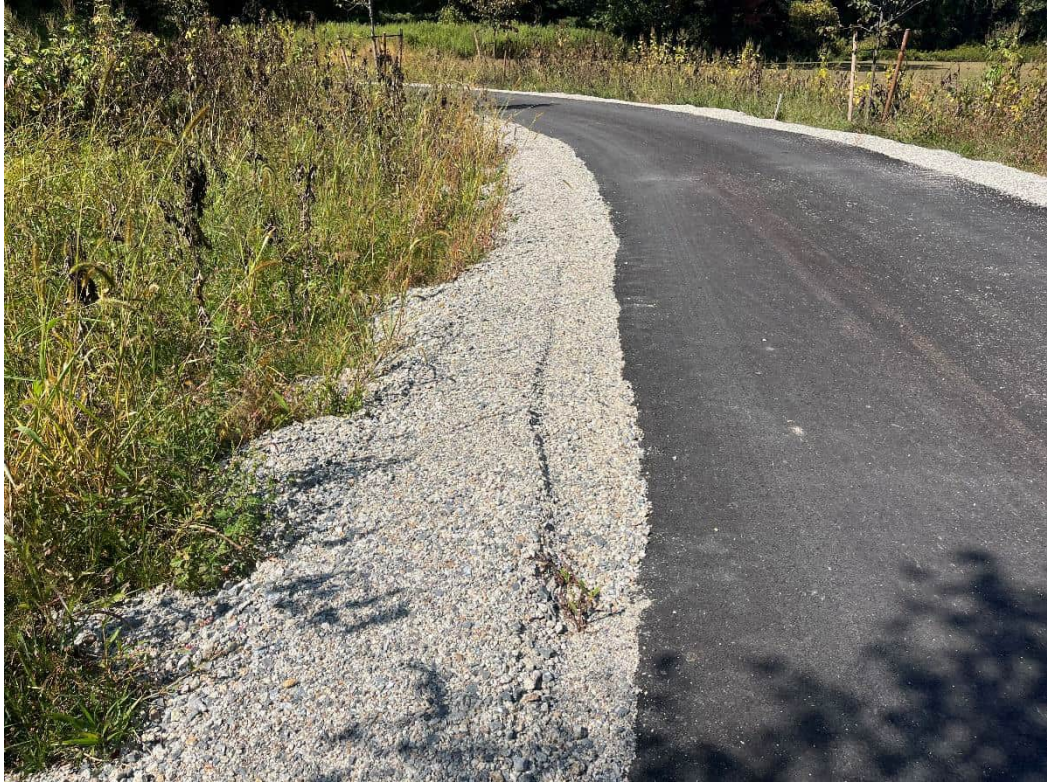
Photo No. 7 **Date:**
9/16/2024

58	Crushed stone used for the dense graded crush stone shoulders has been observed as migrating both onto the path, off the sides of the path, and into the adjacent Resource Areas throughout the Project Priority: High	8/7/2024	8/14/2024	Remove all crushed stone from Resource Areas and develop a plan to cease discharges of stone.	8/12/2024 - Crushed stone is still present in varying amounts throughout the path and on the sides of the path. 8/16/2024 - Observation remains. 8/20/2024 - Crushed stone has been removed from some adjacent resource areas but is still observed as migrating onto and off of the path in multiple locations throughout the Project. 8/27/2024 - Crushed stone has been observed as migrating from the shoulders throughout the path. 9/3/2024 - Crushed stone was observed as migrating both onto the path and off the side of the path in multiple locations. Stone was observed to have discharged to the cattle crossing at Station 190+50 and within the streambed at Station 215+00 to 216+00. Crushed stone was observed to have been placed on the root system of a fallen tree at Station 310+00 near Bank flag #BF4-108. 9/10/2024 - Observation remains. Crushed stone is still present within the cattle crossing, the streambed, and on the root system of the fallen tree. Crushed stone continues to migrate on to and off of the path. 9/16/2024 - Observation remains. The contractor indicated the locations where crushed stone has migrated off the path will be hand removed and crushed stone will be swept off the path prior to the opening of the trail.

View of a location where crushed stone has migrated off of the shoulders at Station 1002+00 per Long Term Compliance Action Item 58.

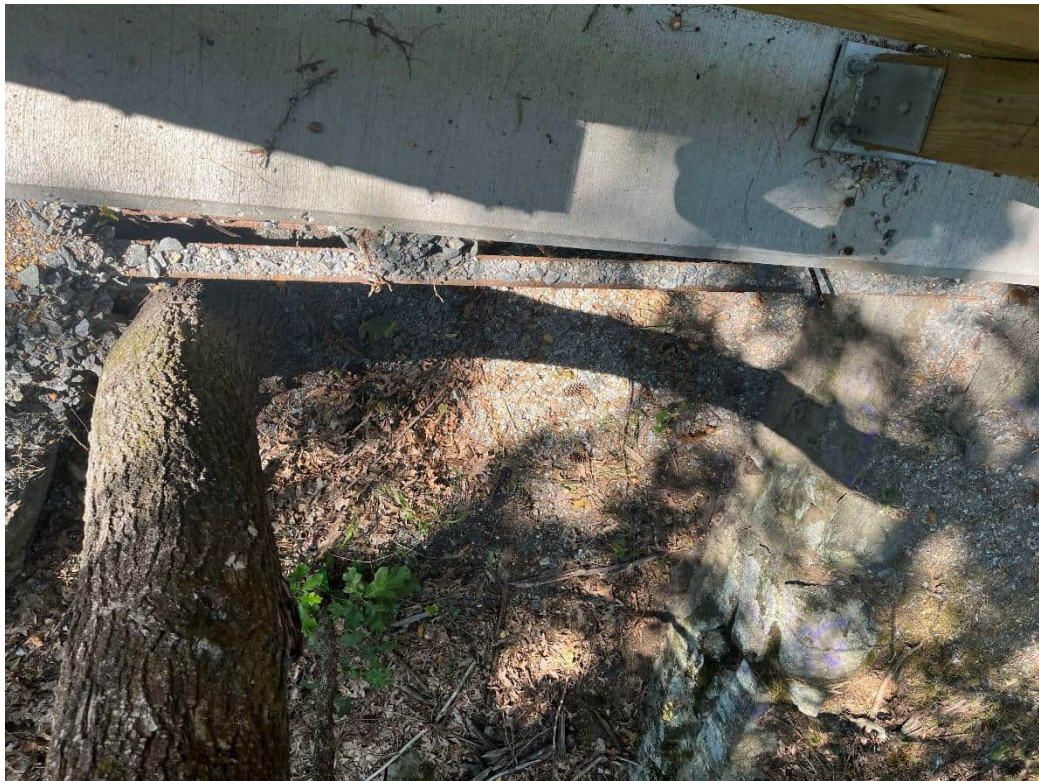
Photo No. 8 **Date:**
9/16/2024

View of the crushed stone that has discharged into the cattle crossing at Station 190+50 per Long Term Compliance Action Item 58.

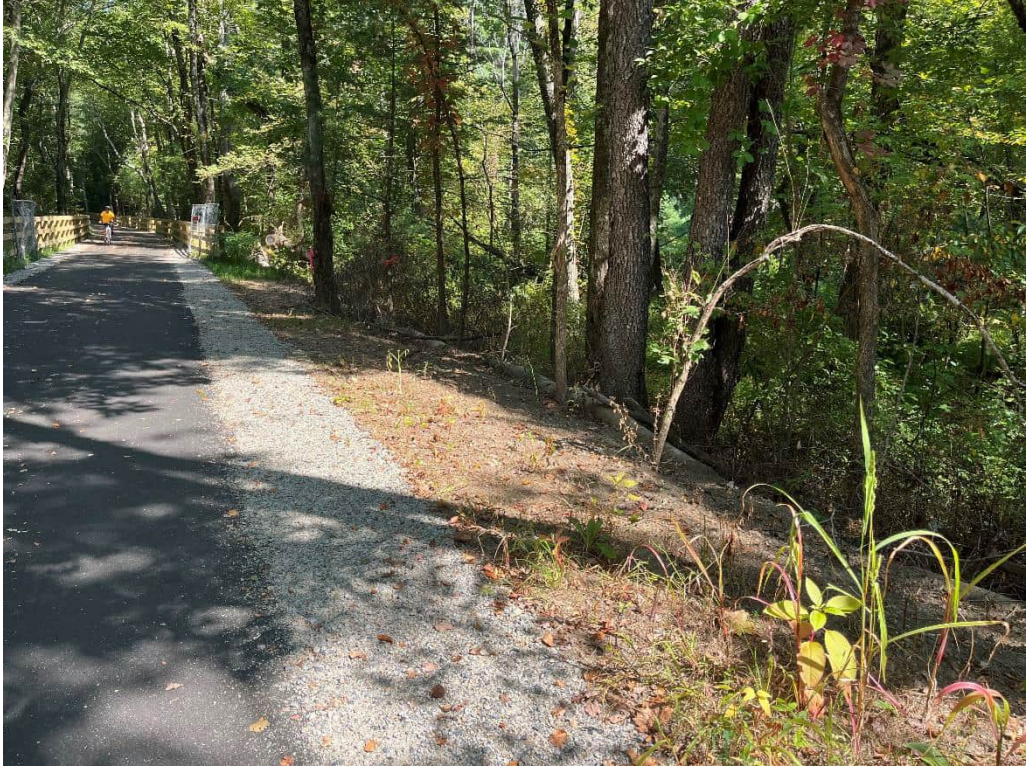
Direction Photo Taken: Toward the North		
Description: View of another area that is no longer stabilized due to herbicide application at Station 204+00 per Long Term Compliance Action Item 59.		
Photo No. 10	Date: 9/16/2024

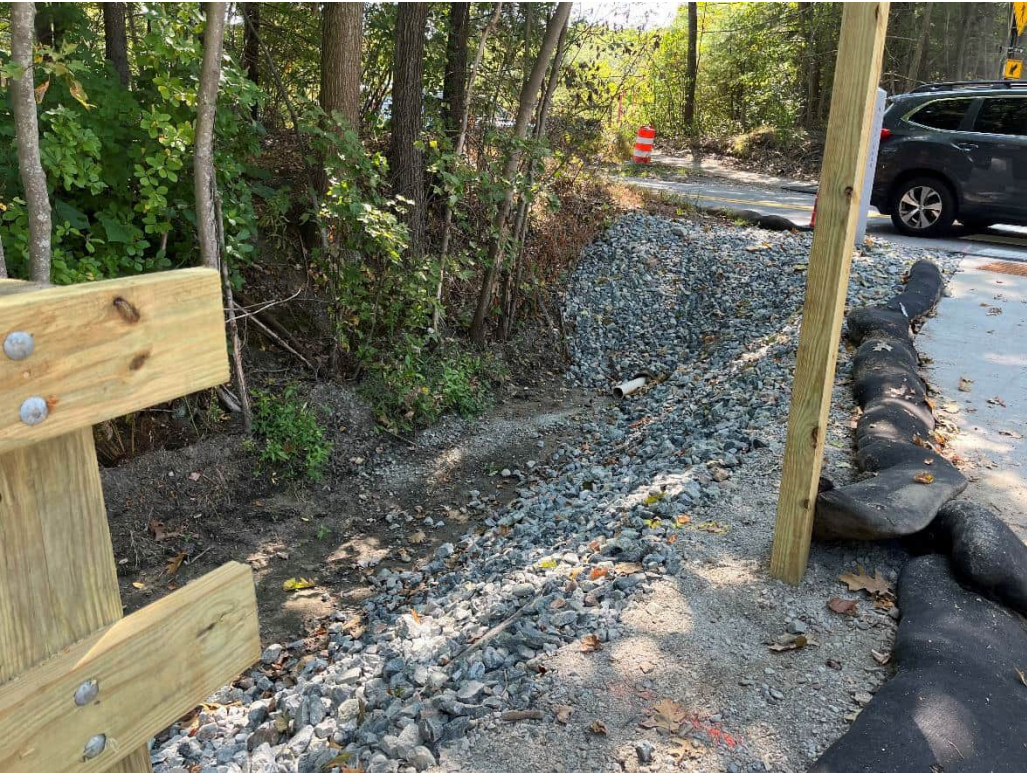
41	Stream Bank has been regraded beyond the limit of work at Station 216+00 Priority: High	5/28/2024	6/4/2024	The Contractor should confirm if this work was permitted by the Conservation Commission, as it does not appear to be a part of the approved plans/impacts. MassDOT should be consulted on next steps regarding notification and potential restoration.	<p>5/31/2024 - Observation remains. 6/7/2024 - Observation remains. 6/14/2024 - Observation remains. 6/17/2024 - Observation remains. 6/24/2024 - Observation remains. 6/27/2024 - Observation remains. 7/8/2024 - Observation remains. 7/15/2024 - This area could not be assessed due to paving operations ongoing during the inspection. 7/22/2024 - Crushed stone and sediment continue to be discharged to the stream between Stations 215+00 and 217+00 due to overtopped and undermined compost filter tubes. 7/29/2024 - Observation remains. 8/5/2024 - Observation remains. 8/7/2024 - Observation remains. 8/12/2024 - Observation remains. Crushed stone is still present in the streambed at this location. 8/16/2024 - Observation remains. 8/20/2024 - Stone has been removed; however, additional alteration to Resource Areas beyond the limit of work continue. 8/27/2024 - Observation remains. 9/3/2024 - Observation remains. 9/10/2024 - Observation remains. Stone has been observed as discharging into the streambed in this location again. 9/16/2024 - Observation remains.</p>

Direction Photo Taken: Toward the East		
Description: View of crushed stone within the streambed and the location where the stream bank has been regraded beyond the limits of work at Station 216+00 per Long Term Compliance Action Items 41 and 58.

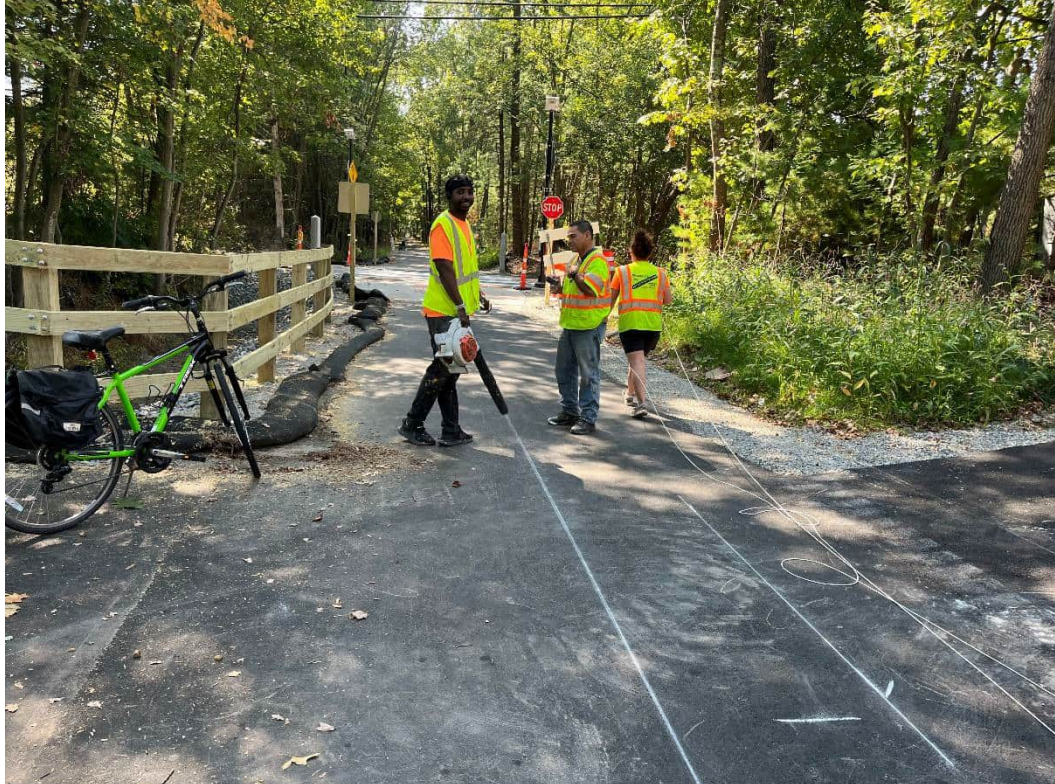
Photo No. 11 **Date:**
9/16/2024

View of the center line and roadway markings being painted at the intersection of Morse Road at Station 217+00.

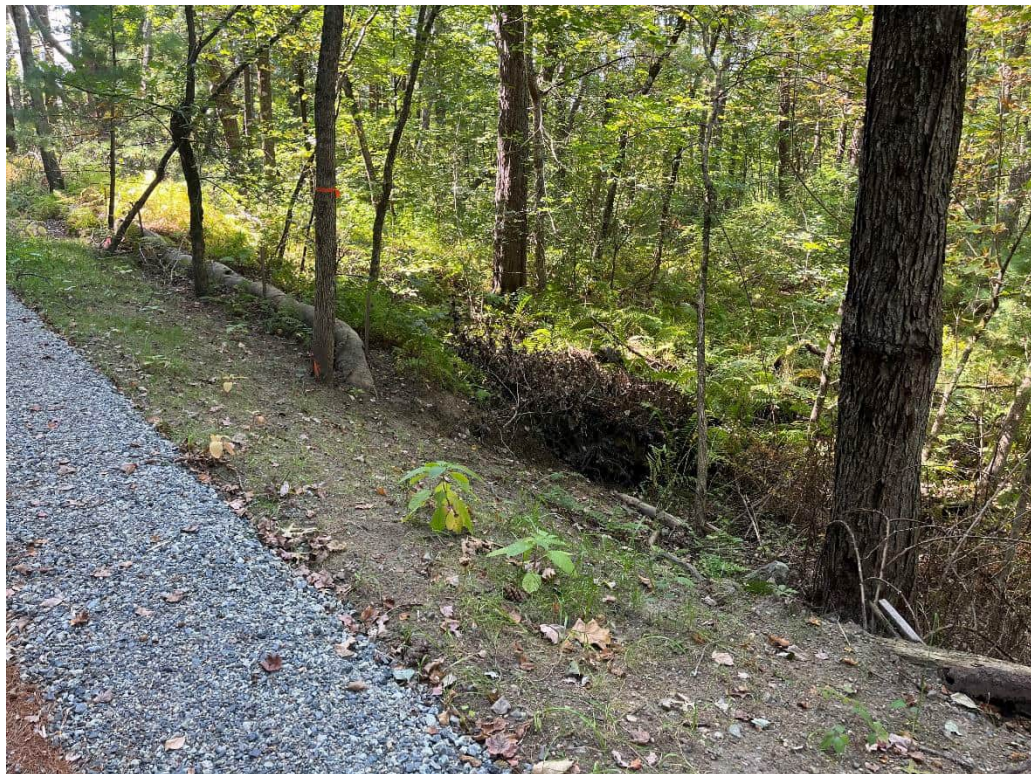
Photo No. 12 **Date:**
9/16/2024

32	<p>Soil and organic debris has been placed within the wetland between wetland flagging WF#23-119 and WF#23-118 at Station 224+00 Priority: High</p>	5/21/2024	5/28/2024	<p>Remove all material and provide stabilization of the area with the approved wetland seed mixture. Straw should also be placed for interim stabilization.</p>	<p>5/28/2024 - Observation remains. 5/31/2024 - Observation remains. 6/7/2024 - Observation remains. 6/14/2024 - Observation remains. 6/17/2024 - This area has been hydroseeded multiple times, but the debris should also be removed from the downgradient wetland. 6/24/2024 - Observation remains. 6/27/2024 - Observation remains. The area was hydroseeded again. 7/8/2024 - Germination was observed and the area will be monitored for stabilization. 7/15/2024 - See previous update. 7/22/2024 - Observation remains. 7/29/2024 - Observation remains. 8/5/2024 - Observation remains. 8/7/2024 - Regrowth of vegetation has been observed in this area. This item will remain open until the area is fully stabilized. Debris is still present in wetland and requires removal. 8/12/2024 - Observation remains. 8/16/2024 - Observation remains. 8/20/2024 - Debris is still present within the wetland. 8/27/2024 - Observation remains. 9/3/2024 - Debris is still present in the wetland and slopes upgradient of the wetland require stabilization. 9/10/2024 - Observation remains. 9/16/2024 - Debris has been removed from the wetland; however, soils require stabilization.</p>

View of the location where organic debris has been removed from the wetland and exposed soils require stabilization at Station 224+00 per Long Term Compliance Action Item 59.

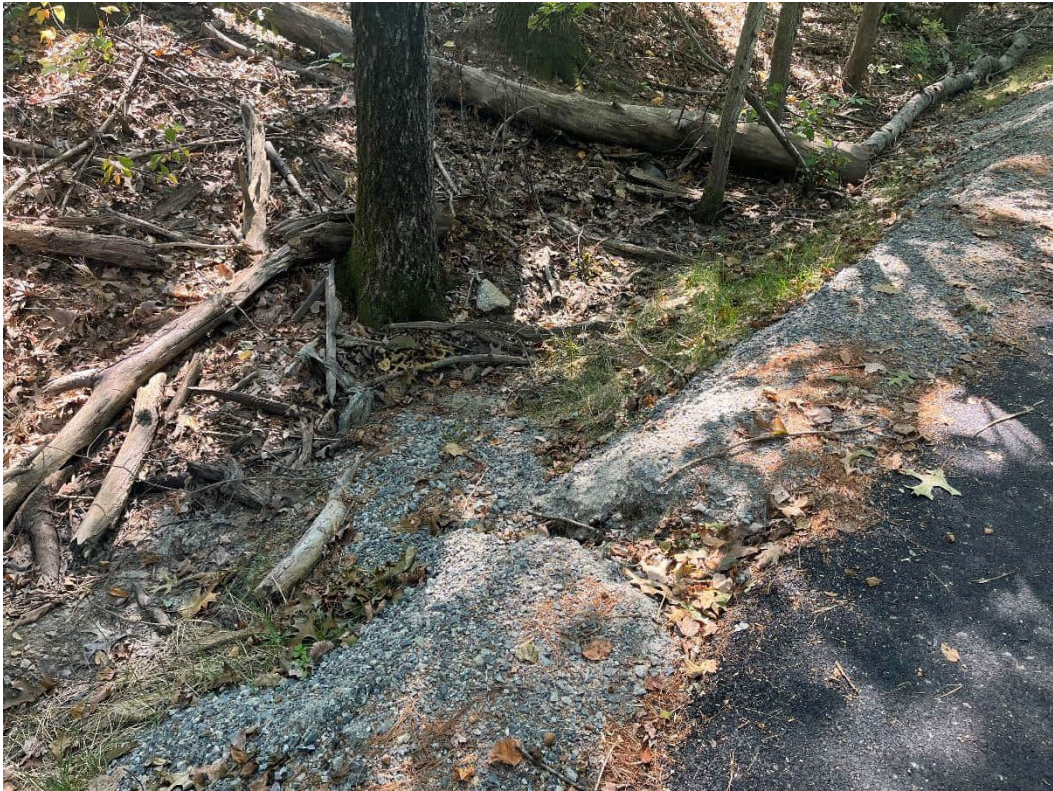
Photo No. 13 **Date:**
9/16/2024

View of the location where crushed stone has migrated off of the path at Station 302+00 per Long Term Compliance Action Item 58.

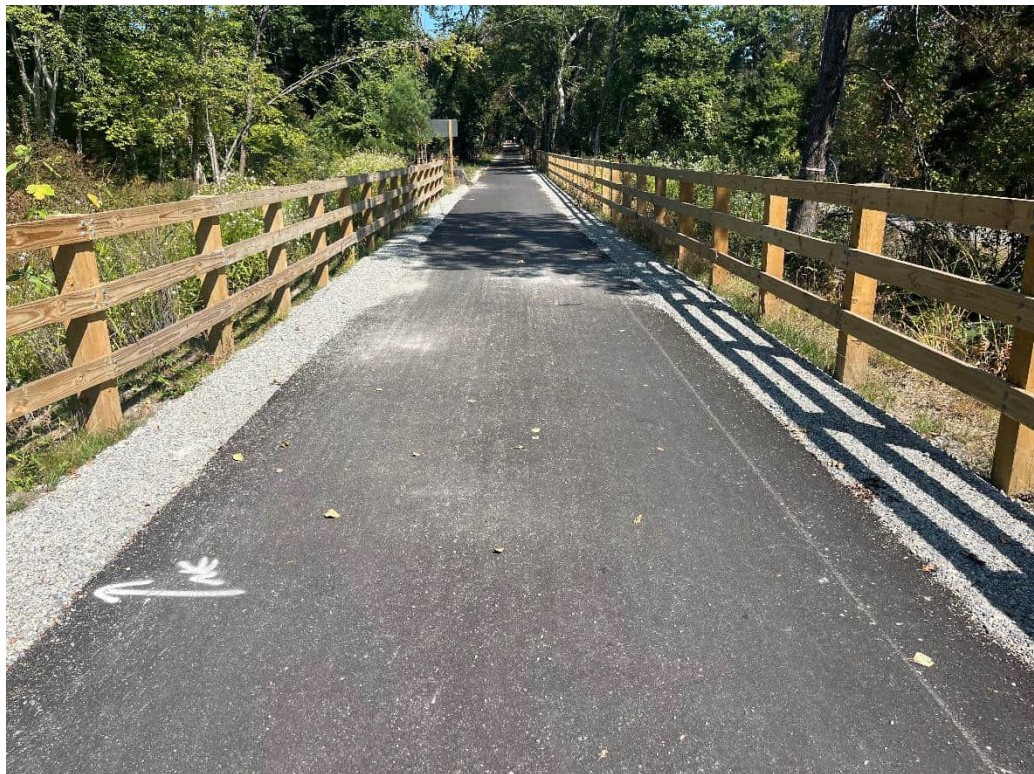
Photo No. 14 **Date:**
9/16/2024

View of a location where crushed stone is present on the path at Station 309+00 per Long Term Compliance Action Item 58.

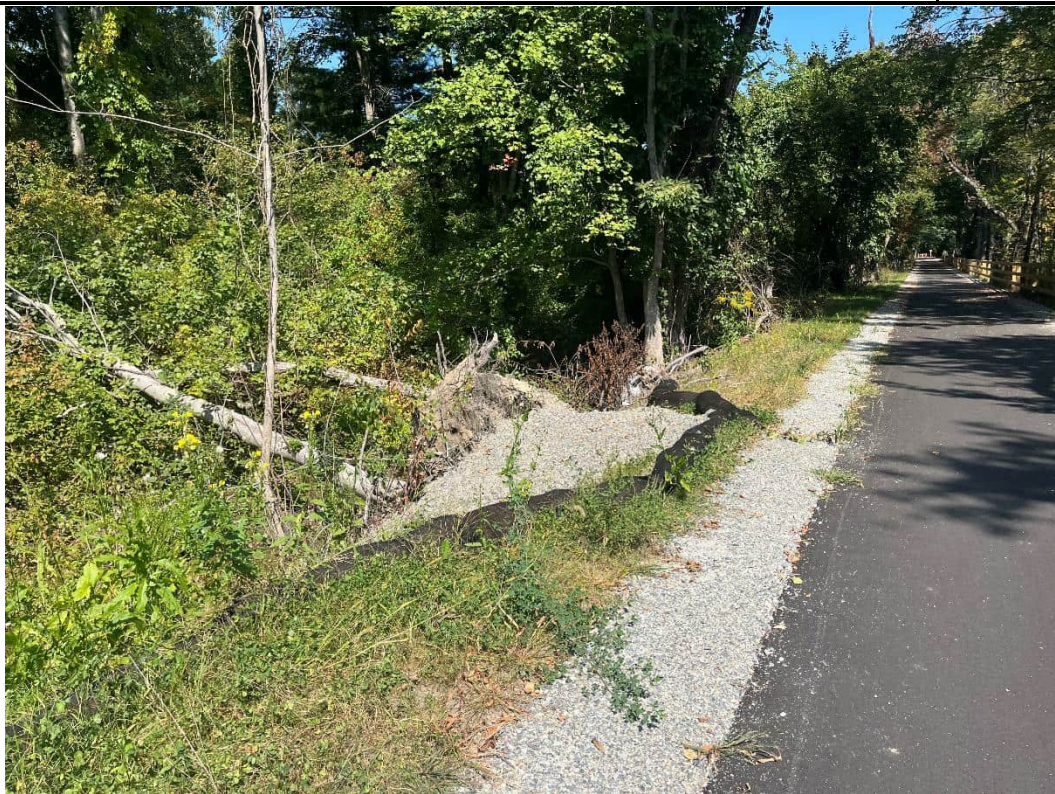
Photo No. 15 **Date:**
9/16/2024

View of the location where crushed stone has been placed on the roots of a fallen tree at Station 311+50 per Long Term Compliance Action Item 58.

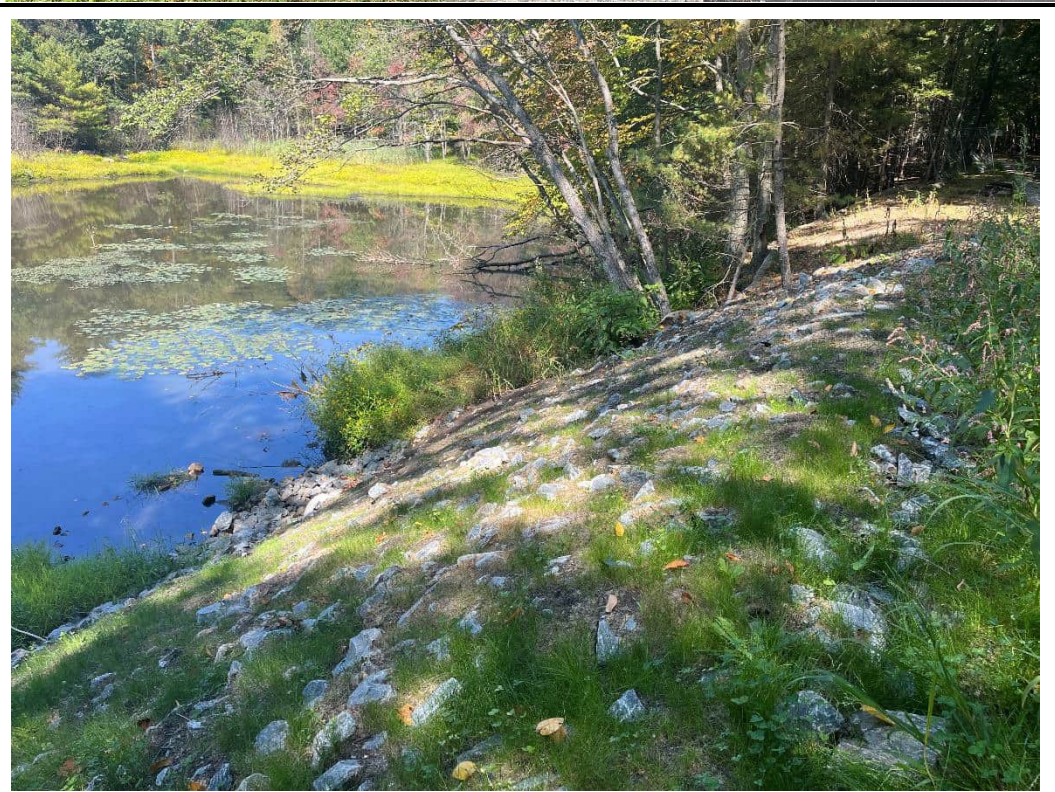
Photo No. 16 **Date:**
9/16/2024

42	Riprap slope extends beyond limits of work along the WF1 Series wetland near flags 103 to 107 Priority: High	5/28/2024	6/4/2024	The Contractor should confirm if this work was permitted by the Conservation Commission, as it does not appear to be a part of the approved plans/impacts. MassDOT should be consulted on next steps regarding notification and potential restoration.	<p>5/31/2024 - Observation remains. 6/7/2024 - Observation remains. 6/14/2024 - Riprap slope has been altered and active construction is repairing the area. 6/17/2024 - During this inspection, additional work in support of the repair/potential replacement of an underlying pipe has been ongoing. It is recommended that the contractor confirm that they have coordinated with the Conservation Commission for this work and provide a restoration plan for the area once work is complete. 6/24/2024 - During this inspection, BETA was informed that the existing cast iron pipe was replaced with a new concrete 12-inch reinforced concrete pipe. It appears that riprap was replaced along the side slopes to mirror conditions observed prior to this inspection. 6/27/2024 - During this inspection, the area was observed to have been rolled and prepared for paving. Hydroseed was applied and plantings were installed. 7/8/2024 - Germination was observed and the area will be monitored for stabilization. See previous updates regarding Conservation Commission coordination. 7/15/2024 - This area could not be assessed due to paving operations ongoing during the inspection. 7/22/2024 - See previous updates regarding Conservation Commission coordination. 7/29/2024 - Observation remains. 8/5/2024 - Observation remains. 8/7/2024 - Observation remains. 8/12/2024 - Observation remains. Regrowth of vegetation has been observed in this area and will continue to be monitored. 8/16/2024 - Observation remains. 8/20/2024 - Observation remains. 8/27/2024 - Observation remains. 9/3/2024 - Observation remains. 9/10/2024 - Observation remains. 9/16/2024 - Observation remains.</p>

View of the riprap slope that extends beyond the limit of work along the WF1 Series wetland at Station 332+00 per Long Term Compliance Action Item 42.
