Weekly Environmental Compliance Summary

Sudbury to Hudson Transmission Reliability Project (USEPA Tracking # MAR1003UW)

Week of: September 16, 2024 to September 20, 2024

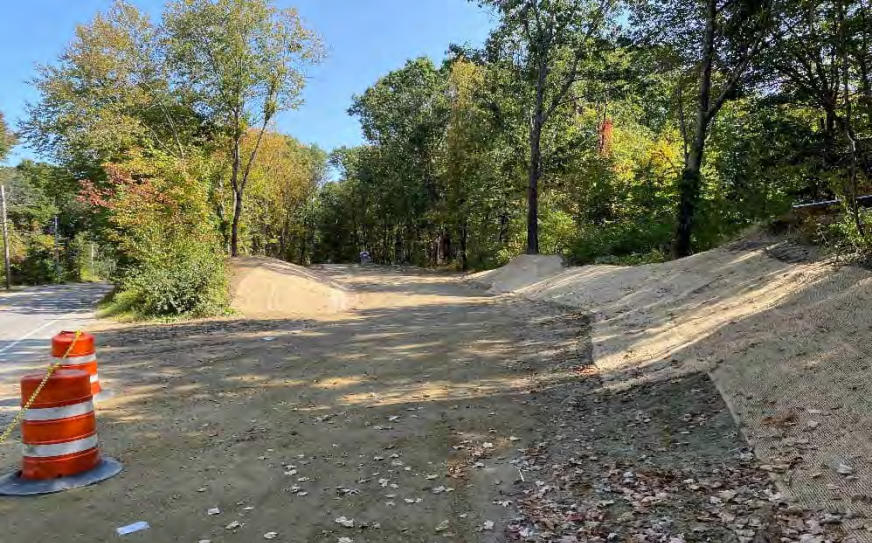
<p>PHOTOGRAPHIC LOG</p>	
<p>Client Name: Eversource</p>		<p>Site Location: Sudbury to Hudson Transmission Reliability Project</p>	<p>Town: Hudson</p>
<p>Photo No.: 2</p>	<p>Date: 9-16-24</p>

<p>Description:</p> <p>Work area within segment 1, newly placed jute netting to stabilize slopes, existing erosion control, looking eastward.</p>

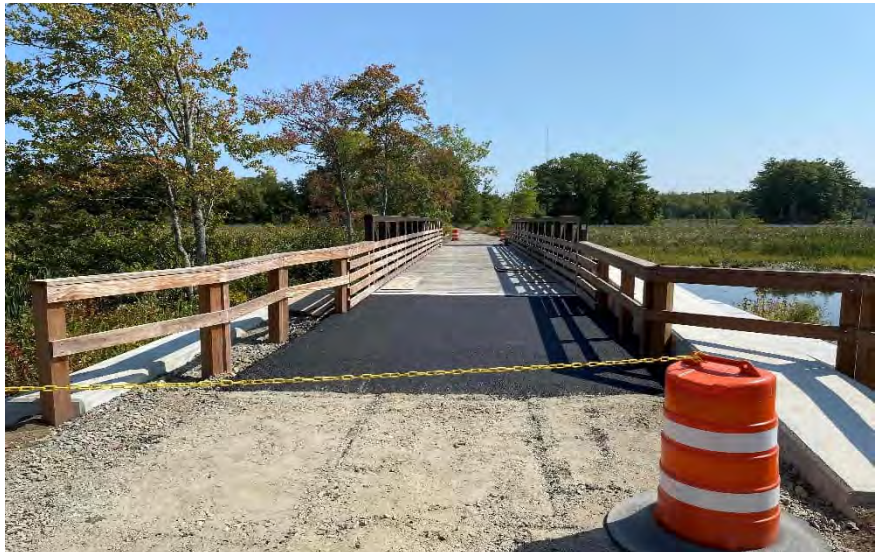
<p>PHOTOGRAPHIC LOG</p>	
<p>Client Name: Eversource</p>		<p>Site Location: Sudbury to Hudson Transmission Reliability Project</p>	<p>Town: Hudson</p>
<p>Photo No.: 6</p>	<p>Date: 9-16-24</p>

<p>Description:</p> <p>Bridge 130, recent paving of bridge approaches, existing erosion control, looking eastward.</p>

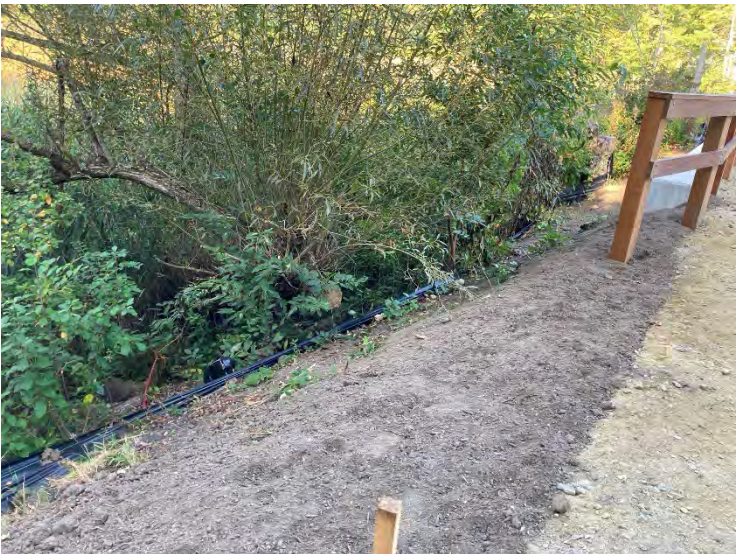
PHOTOGRAPHIC LOG	
Client Name: Eversource		Site Location: Sudbury to Hudson Transmission Reliability Project	Town: Sudbury
Photo No.: 2	Date: 9/16/2024

-Silt fence in segment 8 near bridge 128 is damaged and in need of repair.

Description: View of damaged silt fence in segment 8 near bridge 128. Facing southwest.

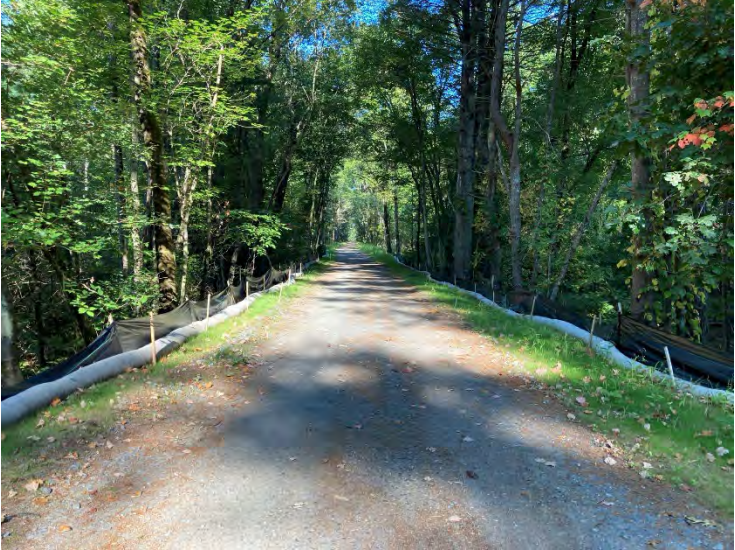
PHOTOGRAPHIC LOG	
Client Name: Eversource		Site Location: Sudbury to Hudson Transmission Reliability Project	Town: Sudbury
Photo No.: 3	Date: 9/16/2024

Description: View of E&S controls in segment 9. Facing west.

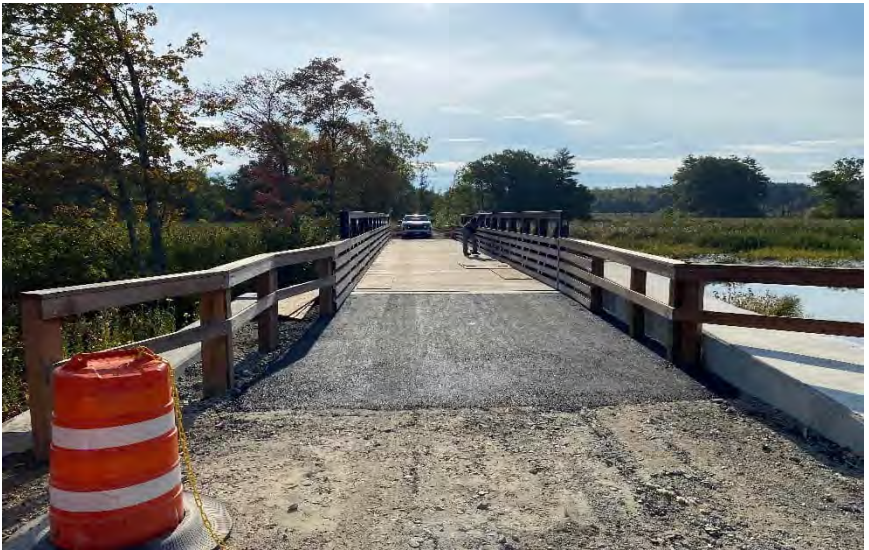
<p>Description:</p> <p>Bridge 130, Bond making repairs on the hanging conduit, existing erosion control, looking eastward.</p>

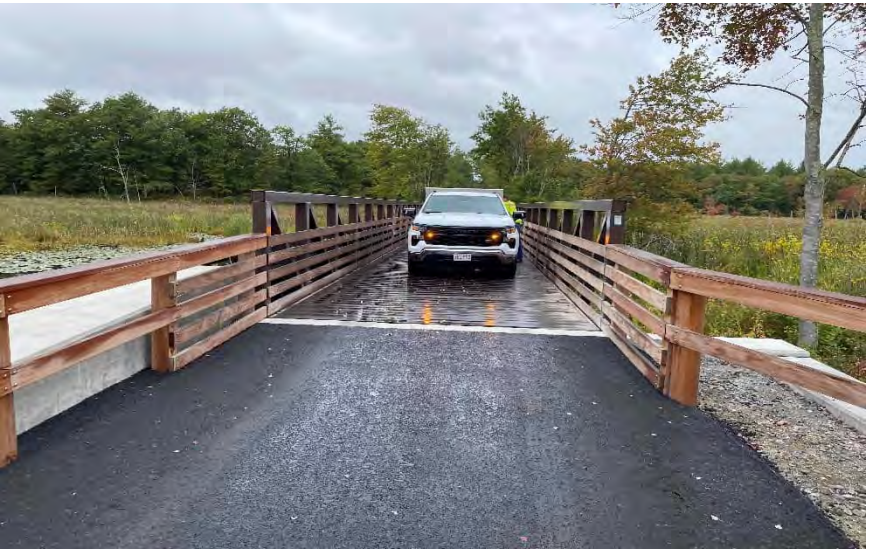
<p>Description:</p> <p>Bridge 130, Bond working on hanging conduit, existing erosion control, looking westward.</p>

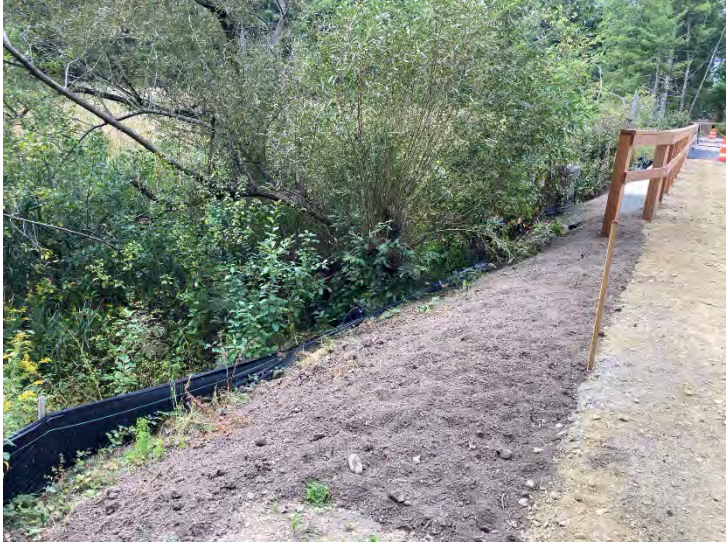
2. Silt Fencing on ROW in Sudbury	<input checked="" type="checkbox"/> Yes <input type="checkbox"/> No	1	<input type="checkbox"/> Yes <input checked="" type="checkbox"/> No	9/16/2024	-Silt fencing is installed and operating properly in segment 7-14. -Silt fence in segment 8 near bridge 128 is damaged and in need of repair.

Description: View of damaged silt fence in segment 8 near bridge 128. Facing southwest.

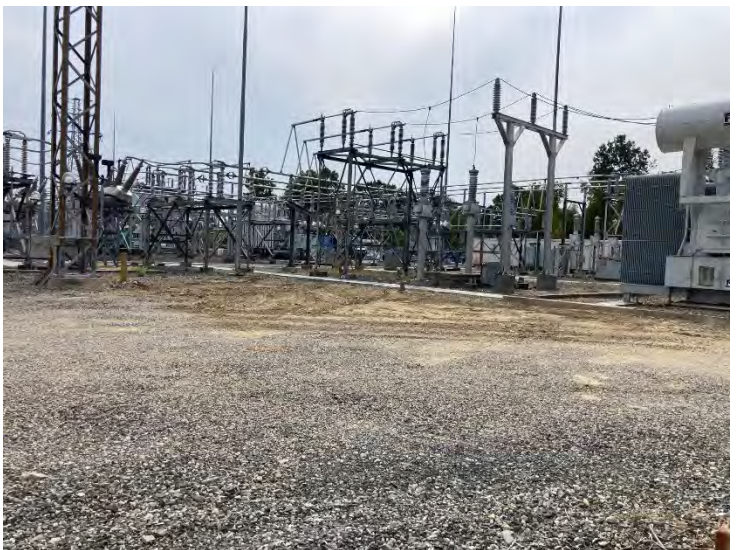
Description: View of former stockpile location within Sudbury Substation. Stockpile and compost filter tubes have been removed. Facing south.

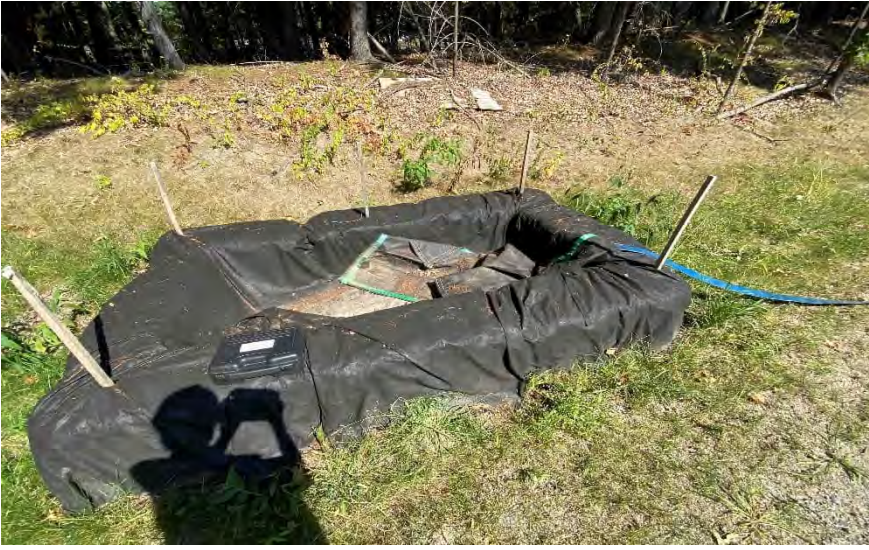
Description: Handhole #9. View of discharge bag/corral, looking eastward. Water from bag/corral discharged to adjacent area.
