Weekly Environmental Compliance Summary

Sudbury to Hudson Transmission Reliability Project (USEPA Tracking # MAR1003UW)

Week of: September 30, 2024 to October 4, 2024

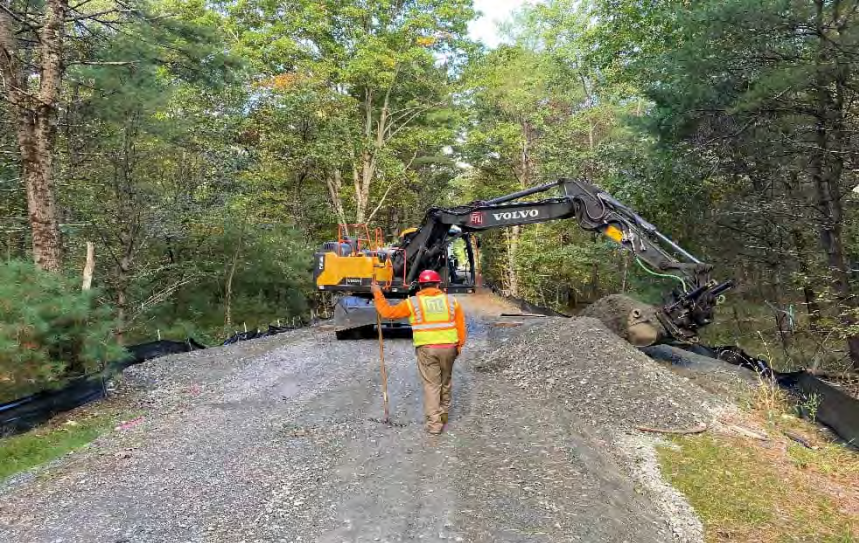
<p>Description:</p> <p>Segment 7, grading work (removal of gravels at manhole pad #15), existing erosion control, looking westward.</p>

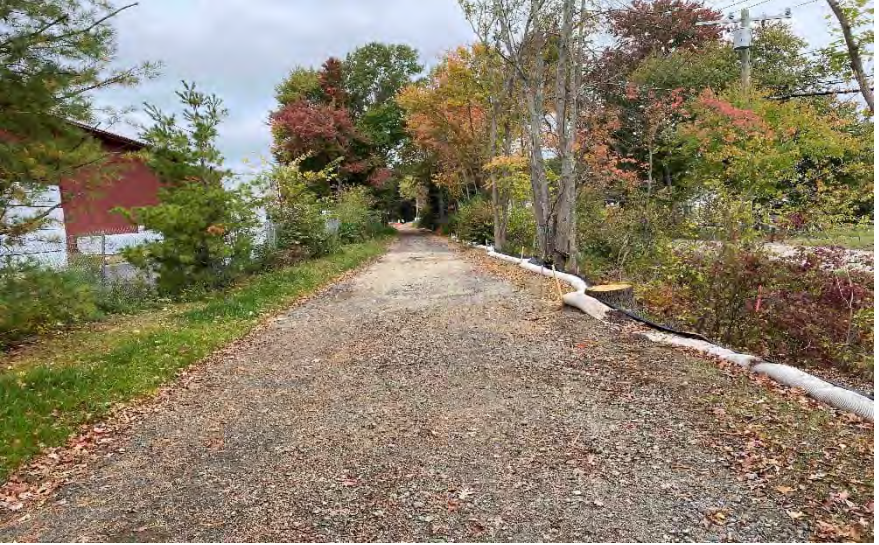
<p>Description:</p> <p>Work area within segment 12, recent tree removal (right side) to facilitate culvert extension, existing erosion control, looking westward</p>

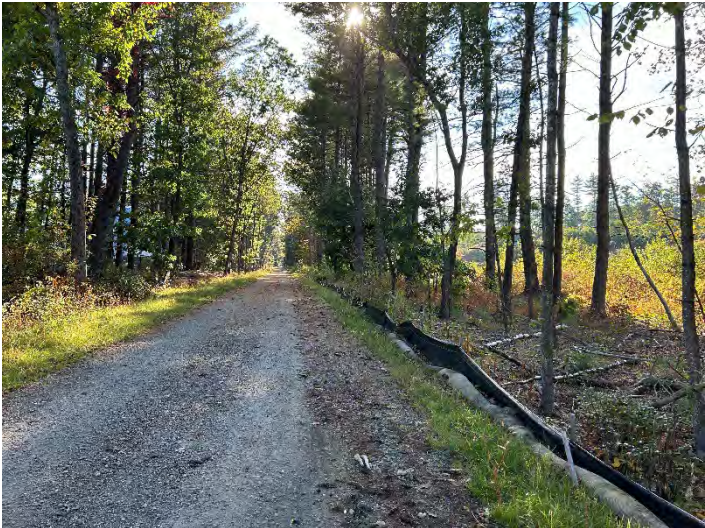
Description: View of E&S controls within segment 4. Controls are in good condition. Facing east.

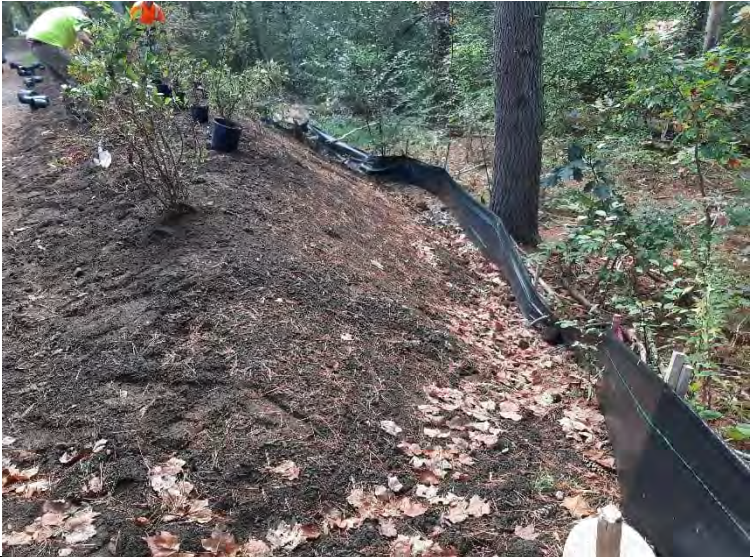
<p>Description:</p> <p>Segment 9, near MH19, south side. MON installing plantings, gap along slope due to spacing as prescribed in plans. Looking eastward.</p>

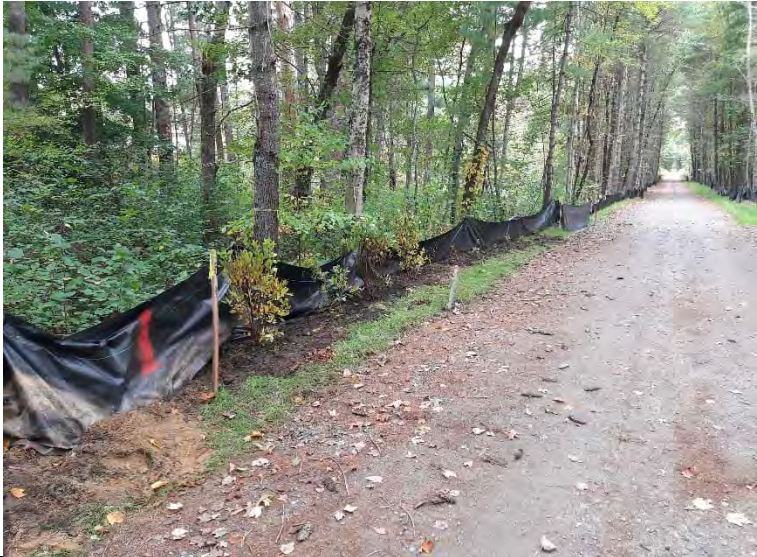
Description: Segment 10, STAs 539 + ~75 to 540+10, south side. Area of planting installations. Section of syncopated silt fence moved back to make room for plantings on narrow shoulder. Looking westward.

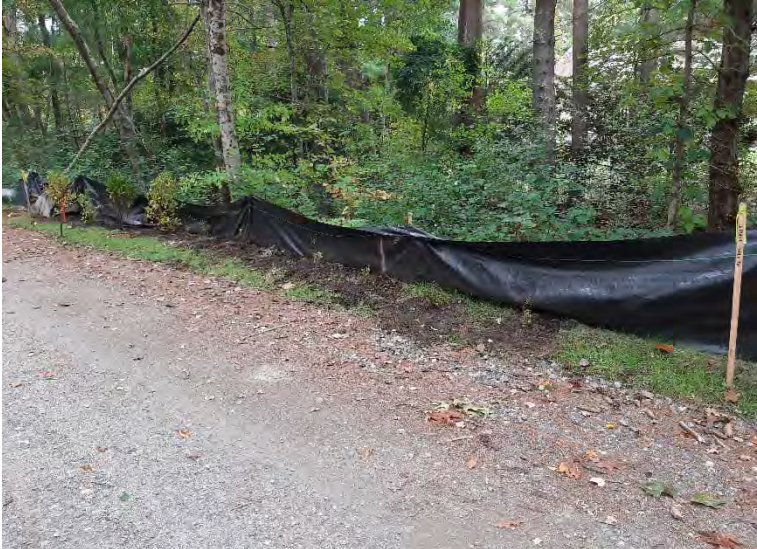
Description: Segment 10, STAs 539 + ~75 to 540+10, south side. Area of planting installations. Section of syncopated silt fence moved back to make room for plantings on narrow shoulder. Looking eastward.

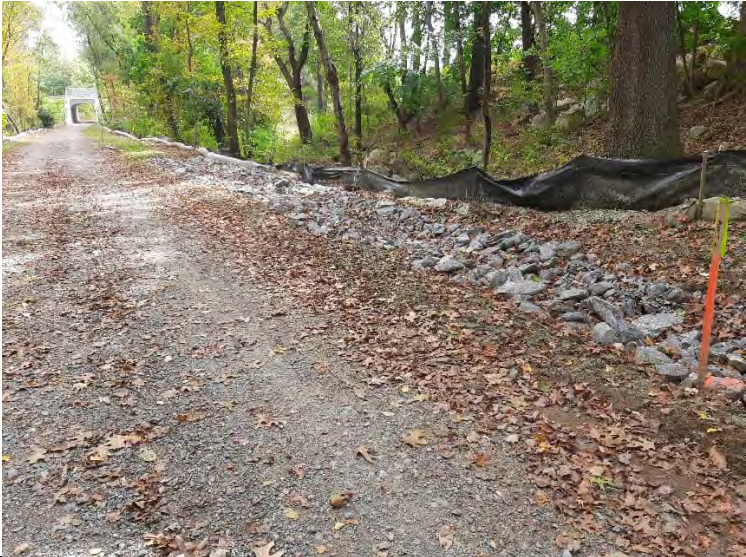
Description: Segment 1, STA 128 + -50, south side. Swale extended eastward into planting bed due to erosion, west end of bed not viable for planting as marked on plans. Looking eastward.

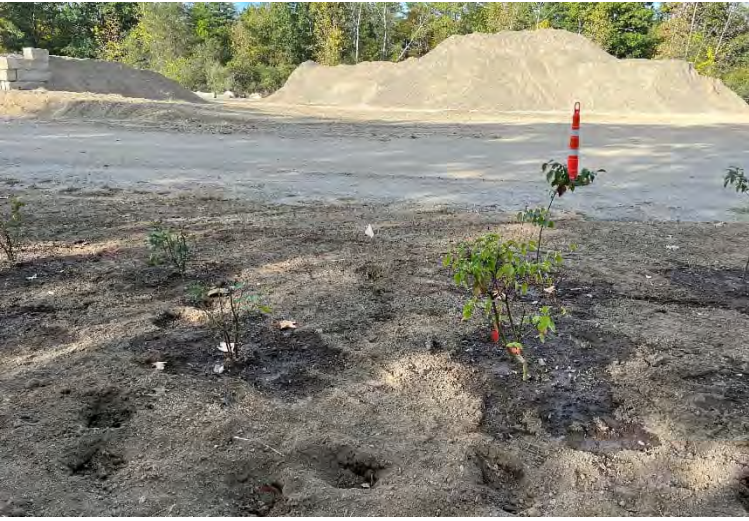
Description: View of installed plants. White flag used to mark missing SDs. <i>Facing north.</i>

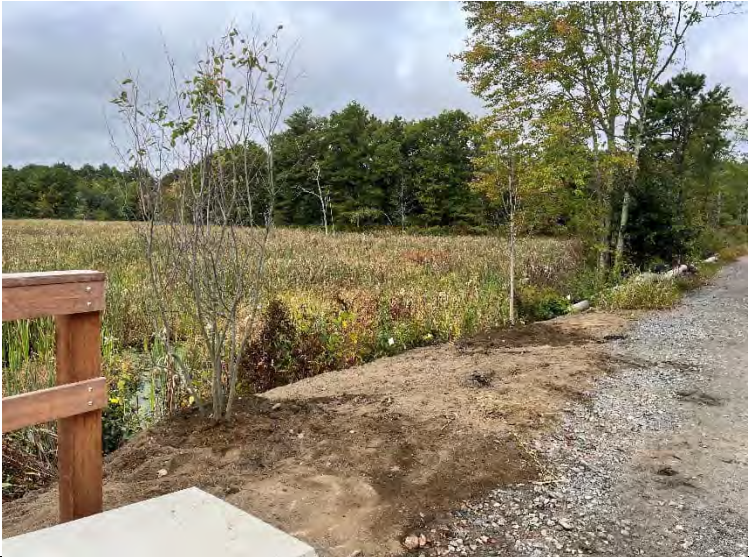
Description: View of installed trees on southern slope of Bridge 130. BP need to be delivered to be planted, flags were used to mark out Birch locations in bed. <i>Facing southwest.</i>

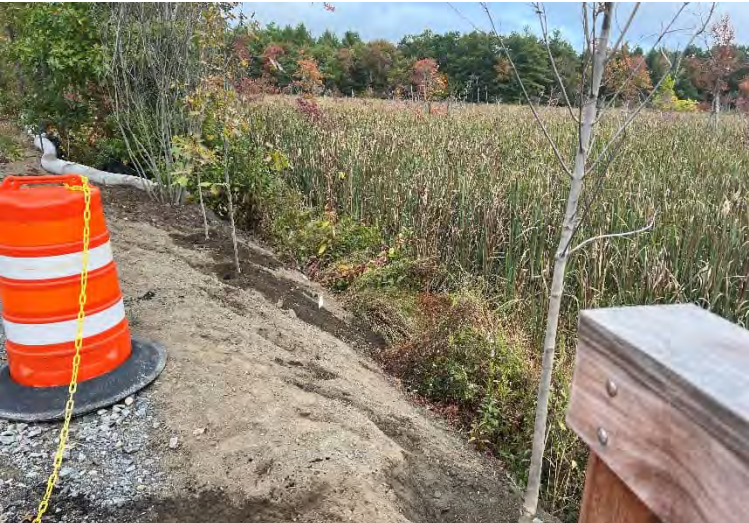
Description: View of installed trees along northern slope of work area. 1 BP missing from bed for trees. <i>Facing northwest.</i>

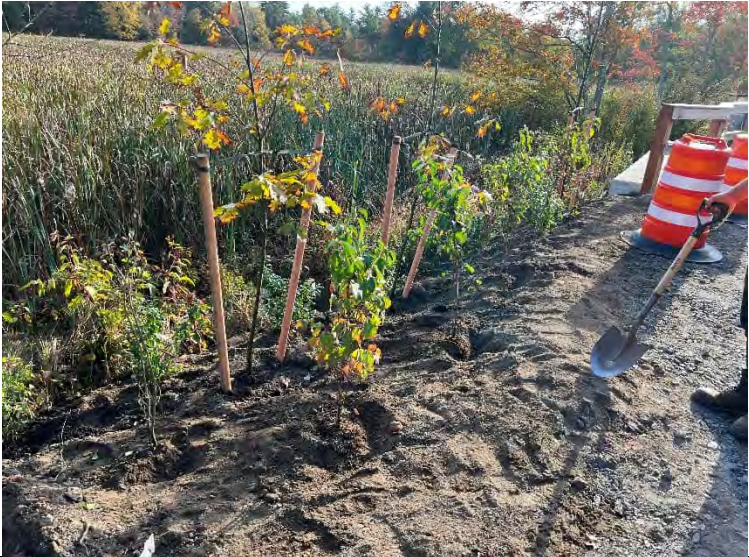
Description: Another view of installed plants. 1 SA, 7 IV, & 1 BP needed to finish bed. Plants position flagged out for future planting. <i>Facing northeast.</i>

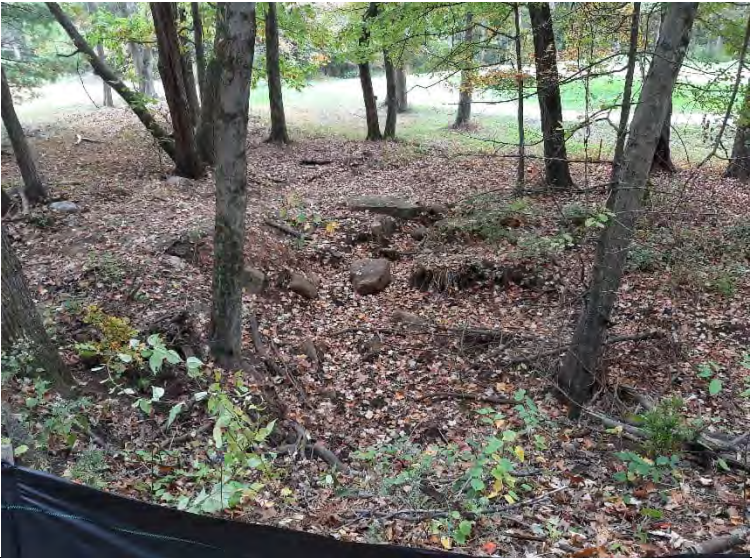
<p>Description: Segment 4, STA ~206+00, south side. Culvert outlet and planting area after installation of two (2) CAs, one on either side. CAs spaced slightly further from culvert than on plans due to numerous pre-existing rocks and root systems. Looking southward.</p>
