**Environmental Monitor Construction Site Inspection Report**  
**MassDOT Project #608164 Construction Contract # 119678**  
**EM Report #20**

Project Description: Bruce Freeman Rail Trail Right-of-Way  
 Permit Description(s): Order of Conditions (MGL Chapter 131, Section 40 and 310 CMR 10.00, Mass DEP File No. 301-1362); 2022 EPA NPDES General Permit for Discharges from Construction Areas; U.S. Army Corps of Engineers Permit No NAE-2021-01975.

Project Name:	Bruce Freeman Rail Trail - Phase 2d - Sudbury
Date of Inspections:	8/27/2024
Bi Weekly/ Monthly Period Covered:	August Weekly Inspection #6
Inspector's Name(s):	Anna Haznar
Inspectors' Contact Information:	ahaznar@beta-inc.com

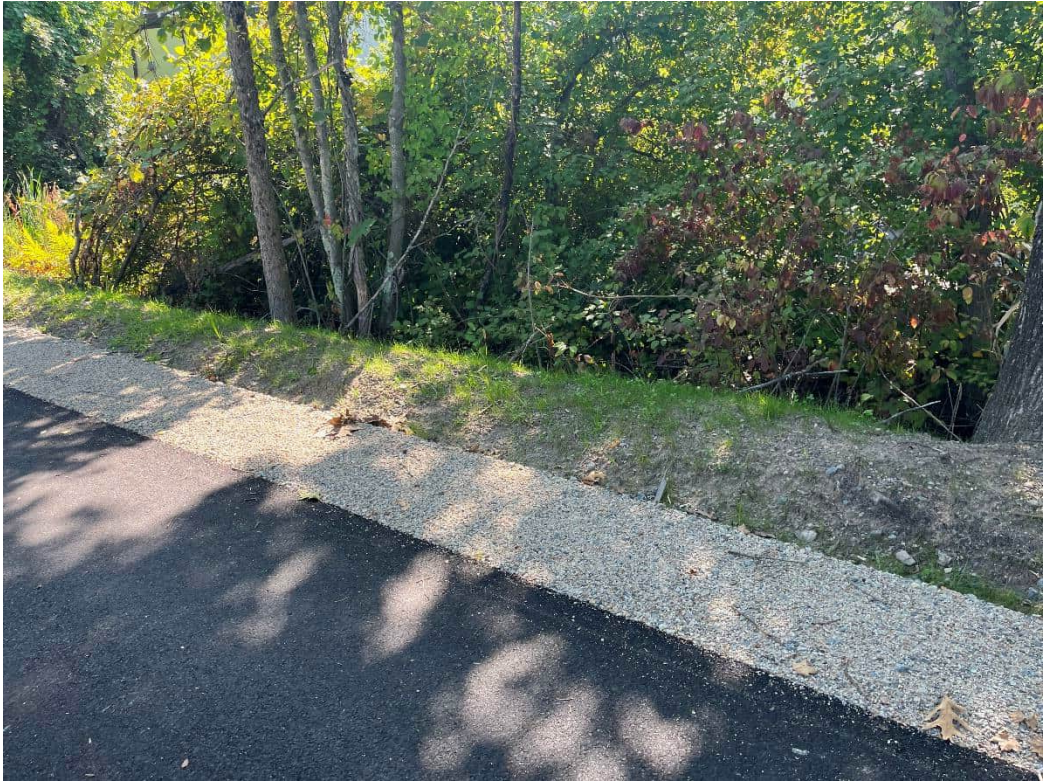
**Photo No. 1**     **Date:**  
8/27/2024

View of the slopes that have become partially stabilized and require application of seed at Station 106+00 per Compliance Action Item 44.

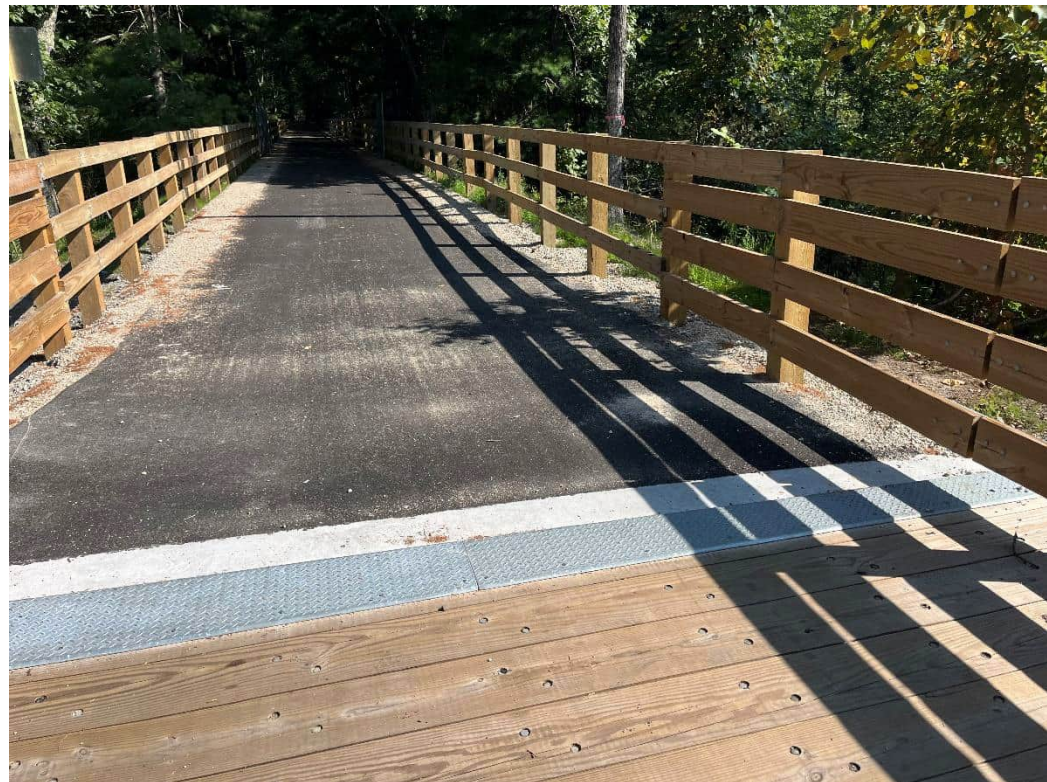
**Photo No. 2**     **Date:**  
8/27/2024

View of an area where stone dust requires sweeping and crushed stone that has migrated onto the path requires removal at Station 126+50 per Compliance Action Item 51 and Long Term Compliance Action Item 58.

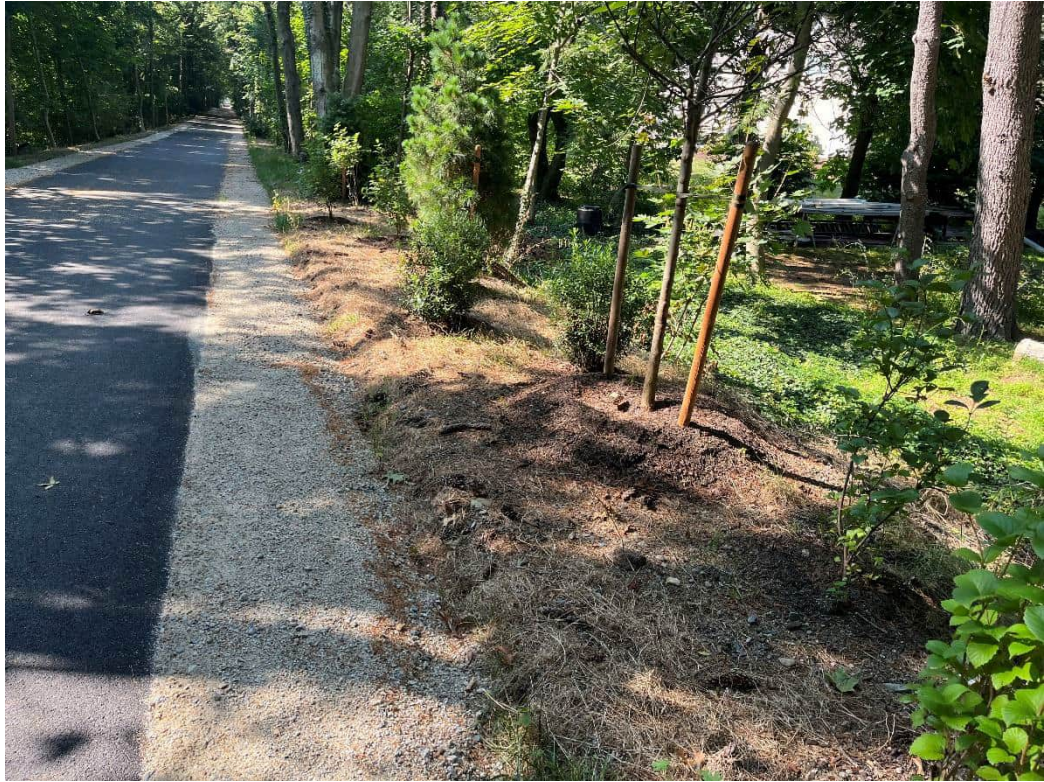
**Photo No. 3**    **Date:**  
8/27/2024

View of an area that is no longer stabilized due to herbicide application at Station 141+50 per Compliance Action Item 57.

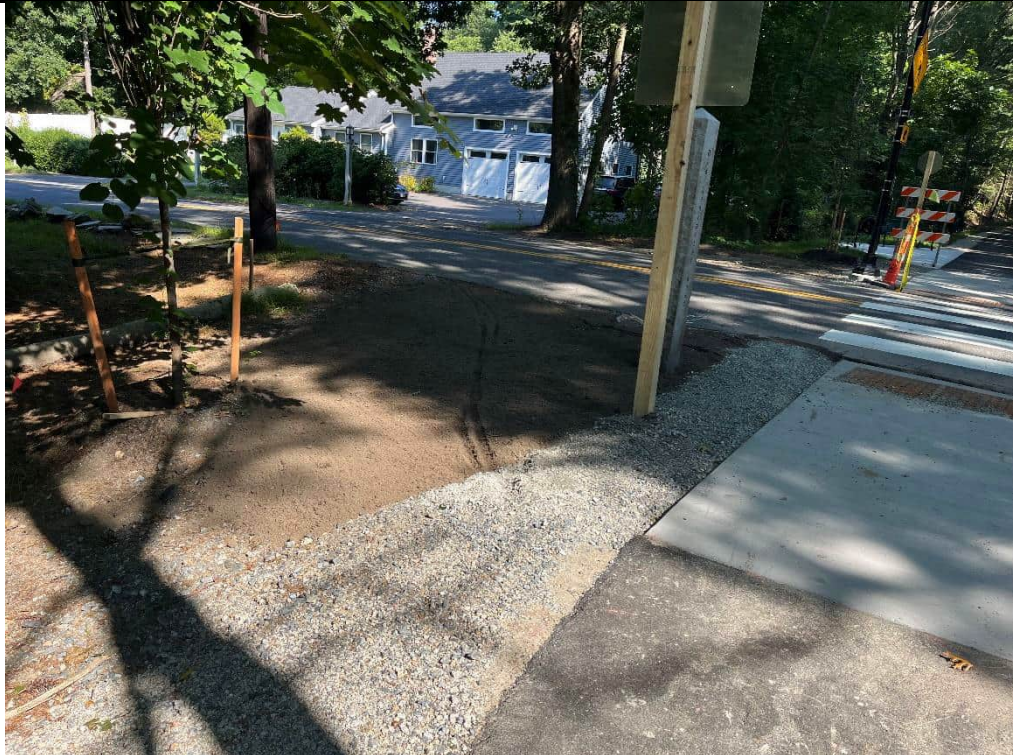
**Photo No. 4**    **Date:**  
8/27/2024

Typical view of loam that has been placed at all intersections along the Project, this photo was taken at the Old Lancaster Road intersection.

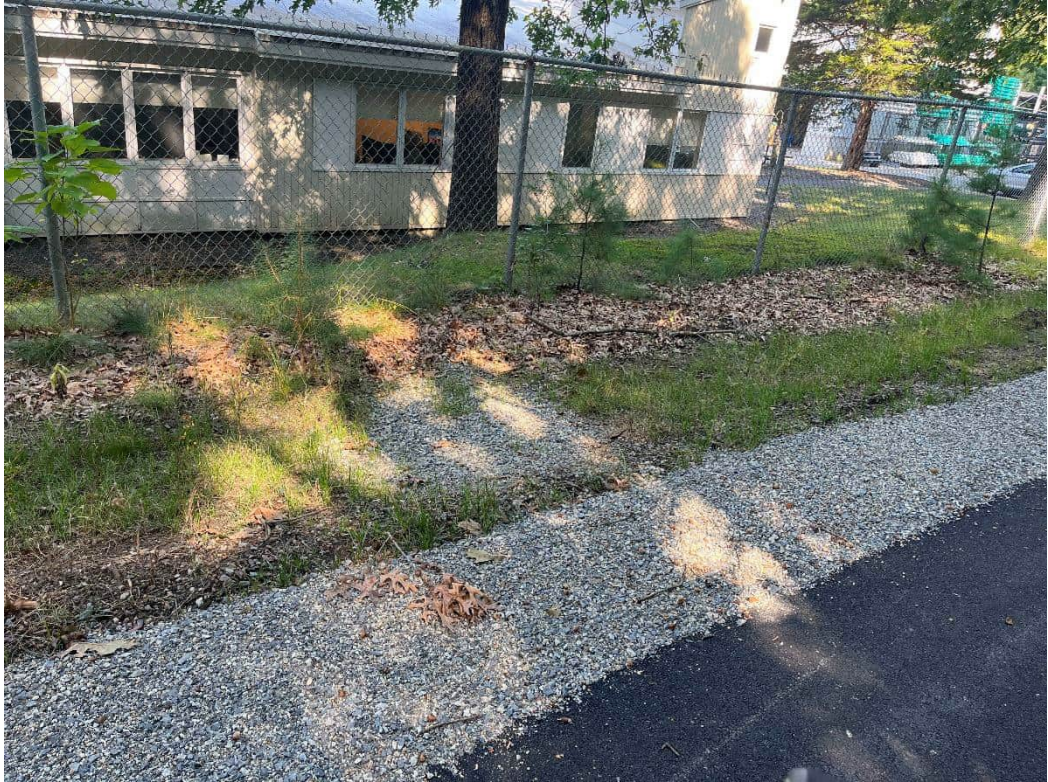
**Photo No. 7**     **Date:**  
8/27/2024

View of a location where crushed stone has migrated off of the shoulders at Station 180+50 per Long Term Compliance Action Item 58.

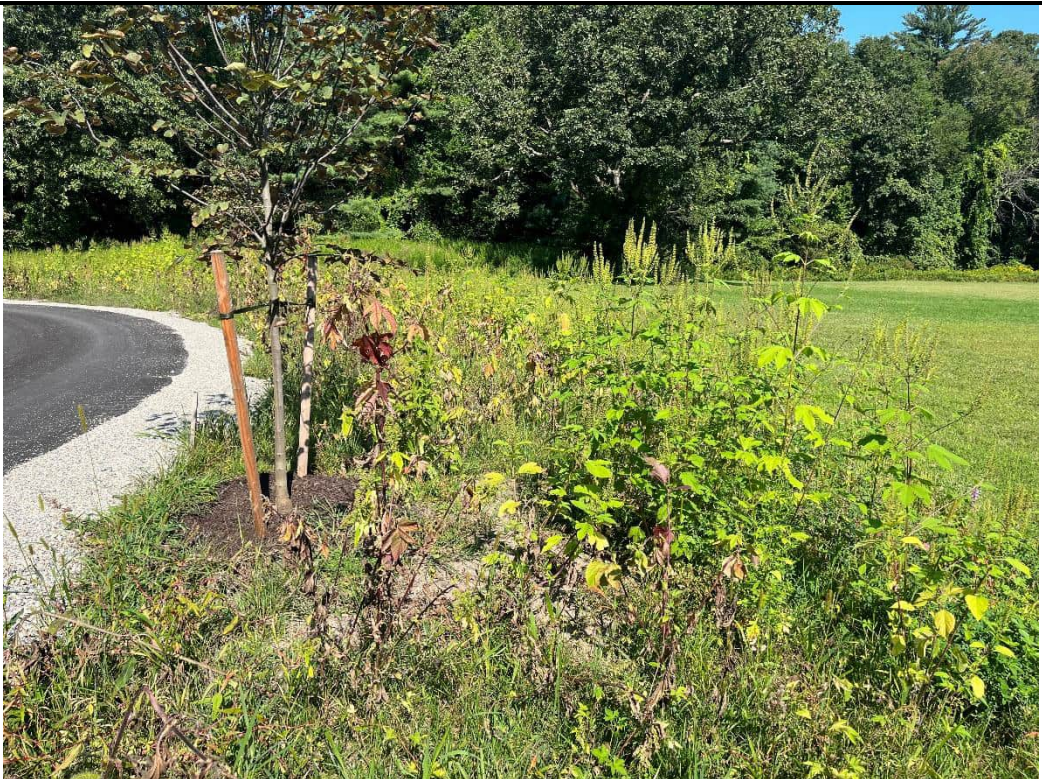
**Photo No. 8**     **Date:**  
8/27/2024

View of a location where Japanese hops requires treatment at Station 1002+00 per Long Term Compliance Action Item 57.

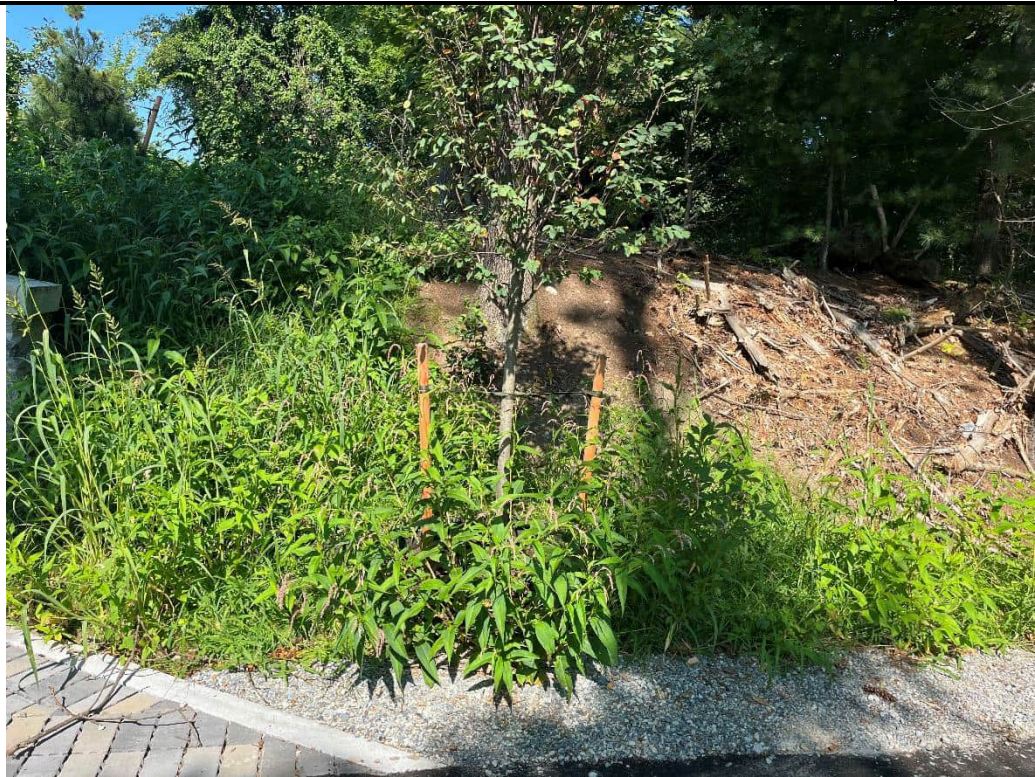
**Photo No. 11**    **Date:**  
8/27/2024

34	<p>Sediment is eroding downhill from behind the cemented stone masonry wall at Station 217+45  <b>Priority: Low</b></p>	5/28/2024	6/4/2024	<p>Apply seed and temporarily stabilize the soils along the slope with straw, jute netting, etc.</p>	<p>5/31/2024 - Observation remains.  6/7/2024 - Observation remains.  6/14/2024 - Observation remains.  6/17/2024 - Observation remains.  6/24/2024 - Observation remains.  6/27/2024 - Rills were raked, loam was added, and hydroseed was applied.  7/8/2024 - Observation remains. Grass was observed to be germinating at this location. Comment will remain open until stabilization is complete.  7/8/2024 - See previous update.  7/15/2024 - Additional hydroseed is required due to washouts.  7/22/2024 - Observation remains.  7/29/2024 - Observation remains.  8/5/2024 - Observation remains.  8/7/2024 - Regrowth of vegetation has been observed in this area. This item will remain open until the area is fully stabilized.  8/12/2024 - Observation remains. Regrowth has stabilized a portion of this hill; however, reseeded and additional temporary stabilized measures are recommended on the section that is currently unvegetated.  8/16/2024 - Observation remains.  8/20/2024 - Application of the approved seed mixture is required at this location.  8/27/2024 - Observation remains.</p>

View of the slope located behind the cemented masonry wall at Station 217+45 that has become partially stabilized and requires reseeding per Compliance Action Item 34.

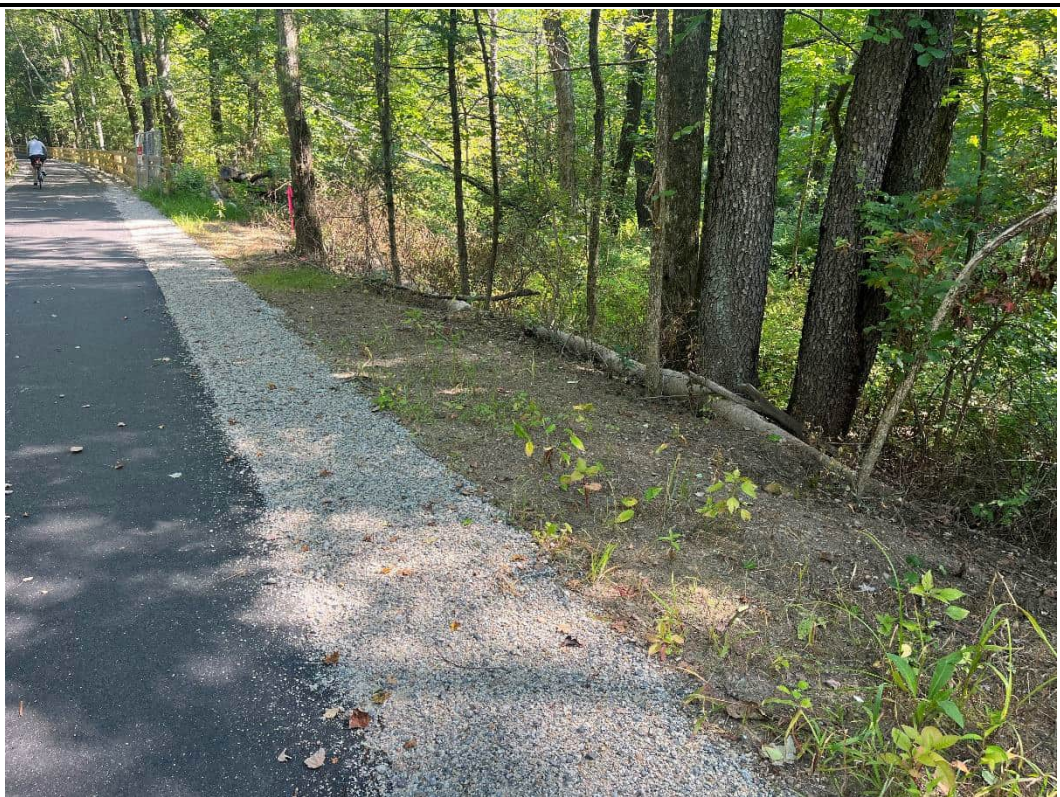
**Photo No. 12**    **Date:**  
8/27/2024

View of another location that is no longer stabilized due to herbicide application at Station 223+00 per Long Term Compliance Action Item 57.

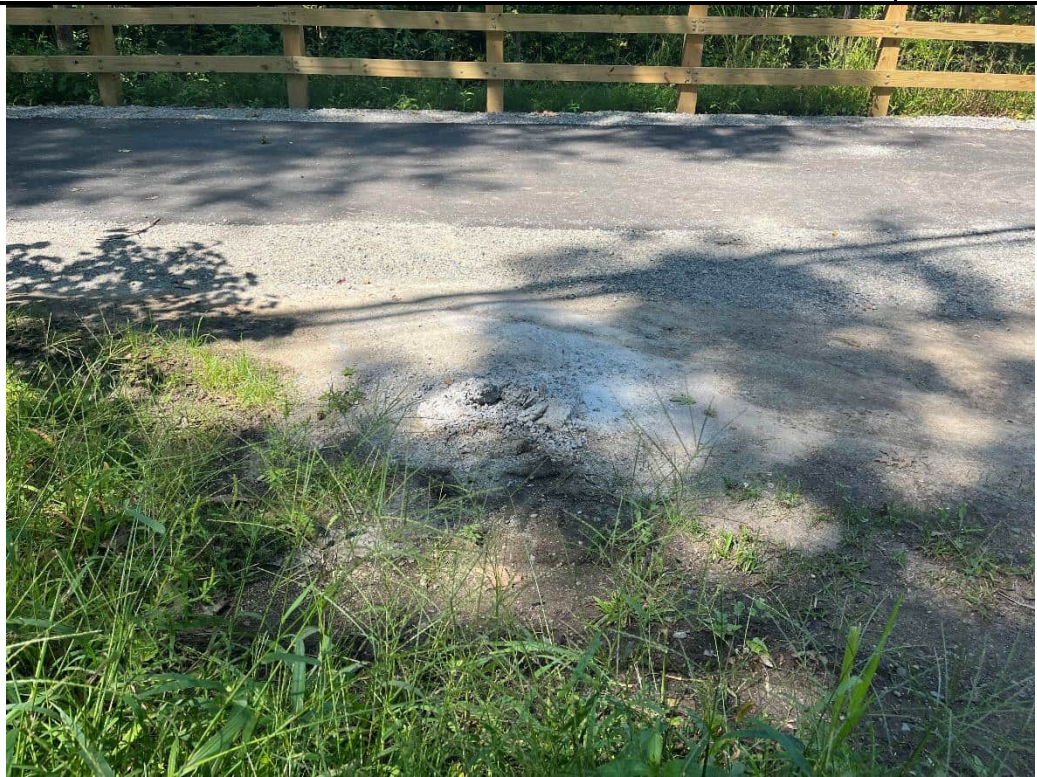
**Photo No. 13**    **Date:**  
8/27/2024

Item	Location/ Description	Observation Date	Resolution Due Date	Recommended Resolution / Resolution Date	Comments/Updates
58	Concrete requiring removal was observed from the side of the path adjacent to the Pantry Road intersection Priority: High	8/20/2024	8/27/2024	Remove and properly dispose of concrete	8/27/2024- Observation remains.
53	Stone was observed requiring removal from the swale on the east side of the trail at Station 172+00 to 173+00 Priority: High	7/29/2024	8/6/2024	Remove stone from the swale.	8/5/2024 - Observation remains. 8/7/2024 - Observation remains. 8/12/2024 - Observation remains. Material was observed to have migrated within the swale to Station 173+50. 8/16/2024 - Stone is still present within the swale. 8/20/2024 - Observation remains. Crushed stone has migrated further down the swale to Station 171+50. 8/27/2024 - Observation remains. Stone is still present within the swale.

View of concrete at the Pantry Road intersection that requires proper removal and disposal per Compliance Action Item 58.

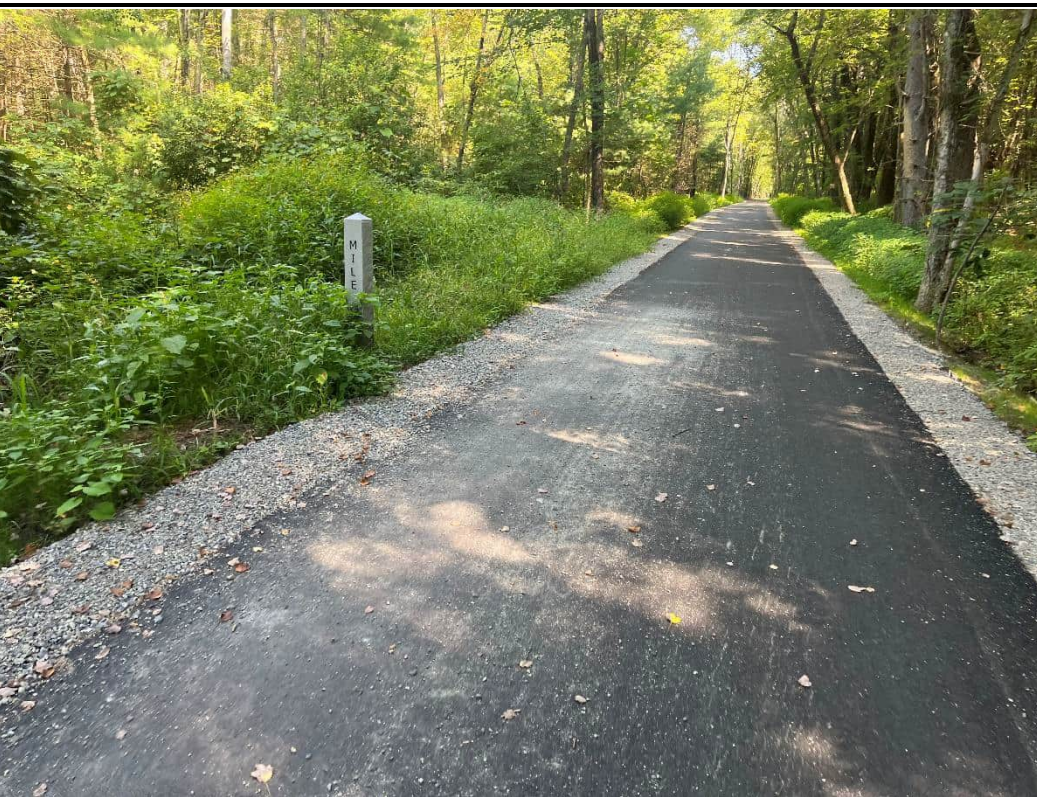
**Photo No. 14**    **Date:**  
8/27/2024

View of the location where crushed stone requires removal from the path per Long Term Compliance Action Item 58. This photo was taken at Station 295+00; however, these conditions are present throughout the Project.

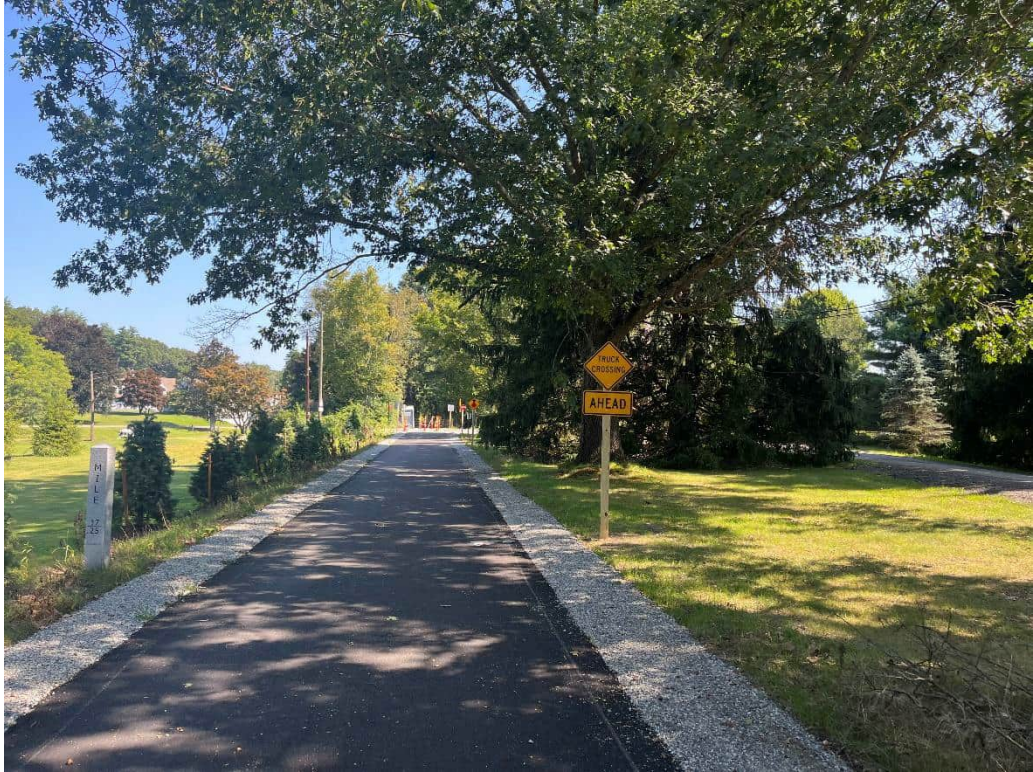
**Photo No. 15**    **Date:**  
8/27/2024

View of recently installed signage along the path at Station 318+00.
