Environmental Monitor Construction Site Inspection Report
MassDOT Project #608164 Construction Contract # 119678
EM Report #24

Project Description: Bruce Freeman Rail Trail Right-of-Way
 Permit Description(s): Order of Conditions (MGL Chapter 131, Section 40 and 310 CMR 10.00, Mass DEP File No. 301-1362); 2022 EPA NPDES General Permit for Discharges from Construction Areas; U.S. Army Corps of Engineers Permit No NAE-2021-01975.

| Project Name: | Bruce Freeman Rail Trail - Phase 2d - Sudbury |
| Date of Inspections: | 9/23/2024 |

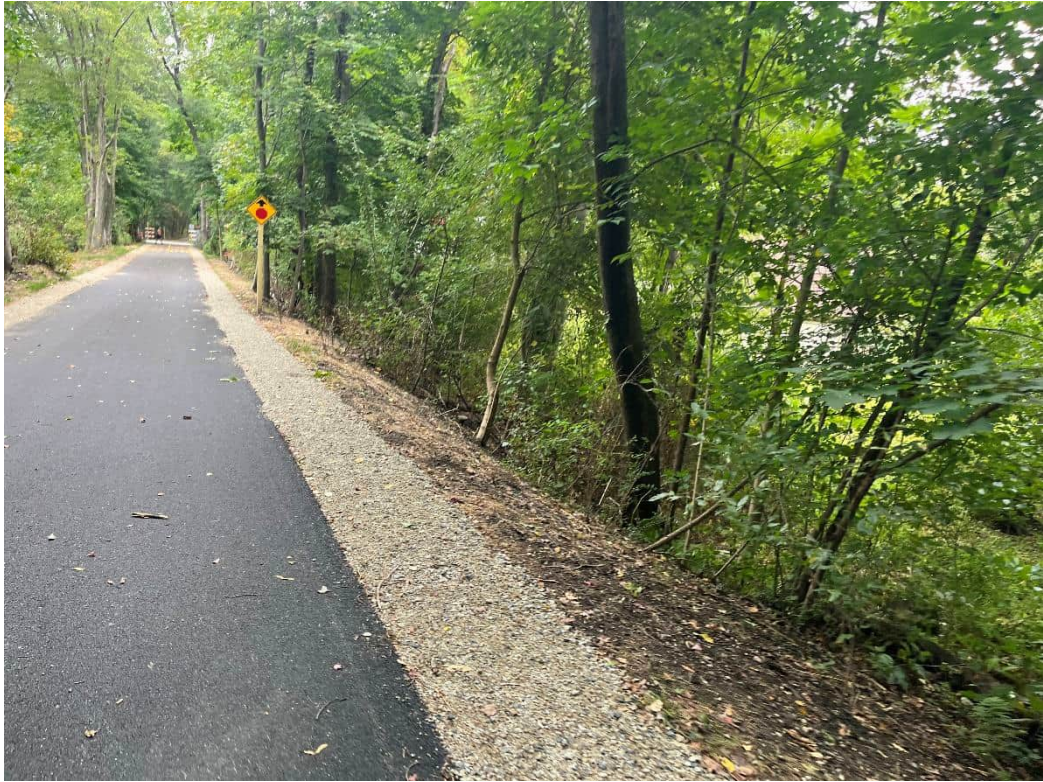
Photo No. 3 **Date:**
9/23/2024

| Item | Location/ Description | Observation Date | Resolution Due Date | Recommended/Discussed Resolution | Comments/Updates |
|---|---|---|---|---|---|
| 59 | Multiple locations of exposed soils along the Project corridor require stabilization Priority: High | 9/3/2024 | 9/10/2024 | The contactor should apply the approved seed mixture to areas of exposed soils and place straw. | <p>9/3/2024 - Herbicide application caused multiple areas along the path to be no longer stabilized. If thatch is present in these locations the thatch should be removed before seeding occurs. A location near Station 320+50 has been cleared outside of the limit of work and requires stabilization. Other areas along the path where seed did not germinate should be reseeded with the approved seed mix and straw should be placed on the areas of exposed soil.</p> <p>9/10/2024 - Observation remains, see previous update. A few locations along the trail have been hydroseeded but a majority of the locations of exposed soil require seed and stabilization.</p> <p>9/16/2024 - Observation remains. The contactor indicated areas of bare soil will be hydroseeded.</p> <p>9/23/2024 - Observation remains. It does not appear as though any hydroseeding has been conducted since the last inspection. Areas throughout the trail require removal of thatch and application of seed for stabilization.</p> |

View of an area that is no longer stabilized due to herbicide application at Station 139+00 per Long Term Compliance Action Item 59 and 57.

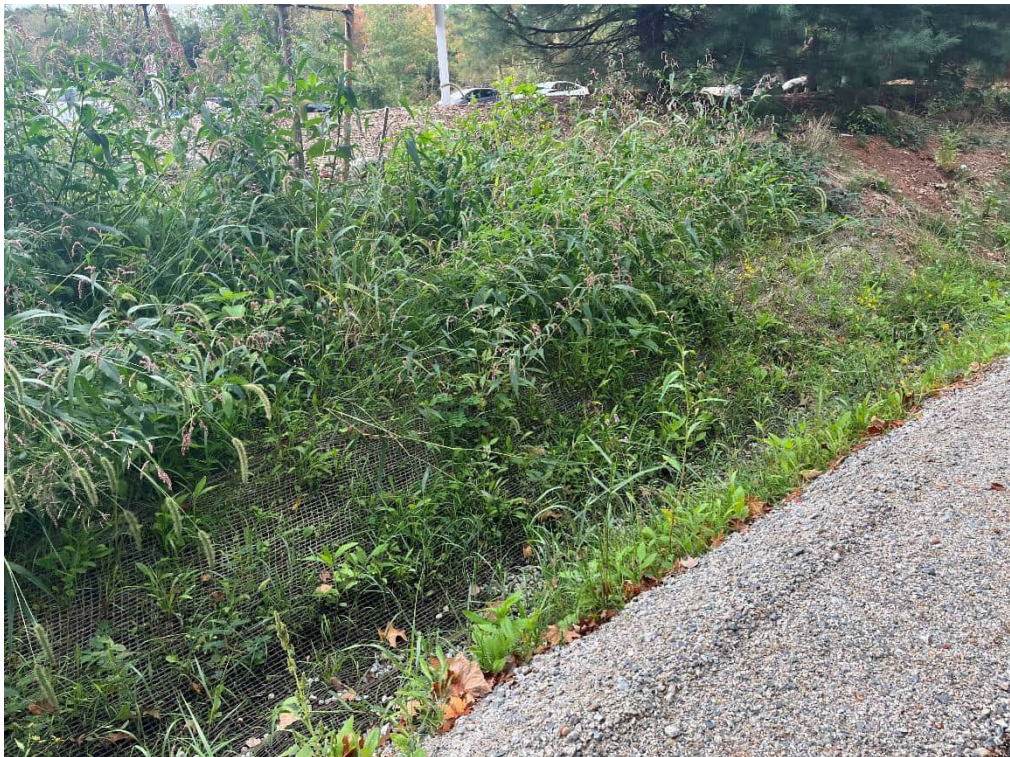
Photo No. 4 **Date:**
9/23/2024

| Item | Location/ Description | Observation Date | Resolution Due Date | Recommended Resolution / Resolution Date | Comments/Updates |
|---|---|---|---|---|---|
| 53 | Stone was observed requiring removal from the swale on the east side of the trail at Station 172+00 to 173+00 Priority: High | 7/29/2024 | 8/6/2024 | Remove stone from the swale. | 8/5/2024 - Observation remains. 8/7/2024 - Observation remains. 8/12/2024 - Observation remains. Material was observed to have migrated within the swale to Station 173+50. 8/16/2024 - Stone is still present within the swale. 8/20/2024 - Observation remains. Crushed stone has migrated further down the swale to Station 171+50. 8/27/2024 - Observation remains. Stone is still present within the swale. 9/3/2024 - Observation remains. 9/10/2024 - Observation remains. Stone is still present within the swale. 9/16/2024 - Observation remains. The contractor indicated that the stone within the swale would be hand removed. 9/23/2024 - Observation remains. |

View of crushed stone requiring removal from the swale at Station 172+00 per Compliance Action Item 53.

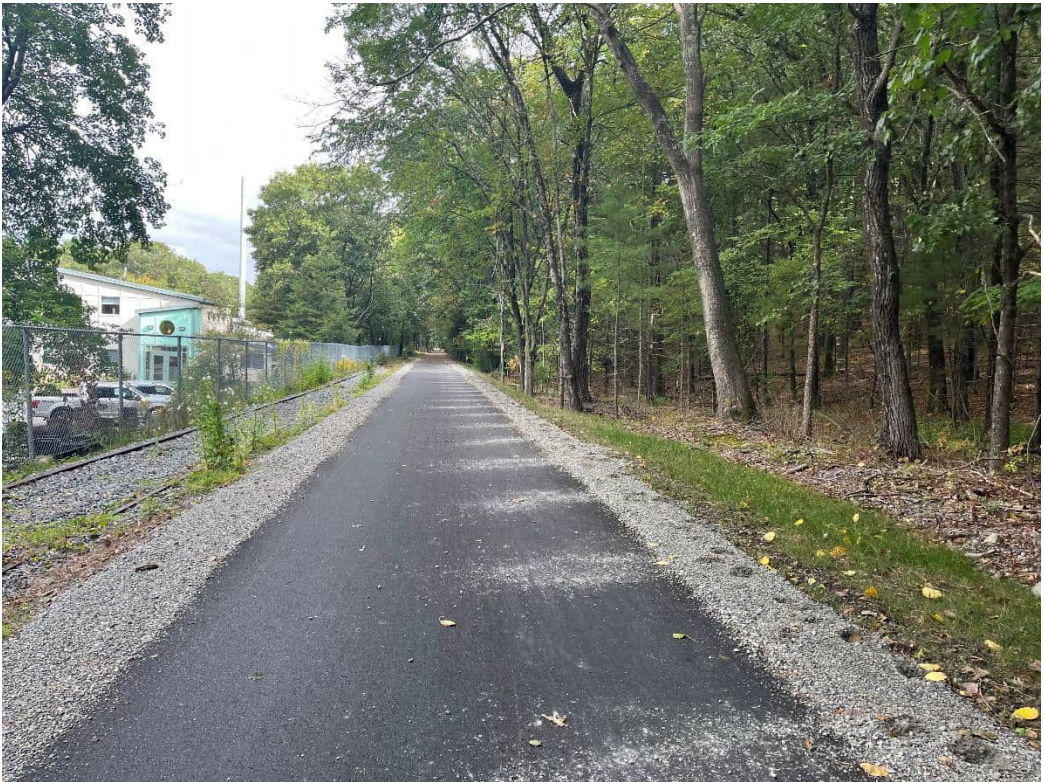
| Photo No. 5 | Date: 9/23/2024 | |

| 6 | <p>Exposed sediment slope at Station 172+00 to 175+00 Priority: High</p> | 5/8/2024 | 5/15/2024 | <p>Install temporary sediment controls along the slope such as jute netting and/or straw following the application of seed.</p> | <p>5/16/2024 - Observation remains. 5/21/2024 - Observation remains. 5/28/2024 - Partial germination was observed. 5/31/2024 - See previous update. 6/7/2024 - Further earthwork has occurred and soils require stabilization. 6/14/2024 - Observation remains. 6/17/2024 - Observation remains. 6/24/2024 - Observation remains. 6/27/2024 - The area has been regraded and loam has been spread. New trees have been planted upgradient of the swale. Stabilization is still required. 7/8/2024 - Jute netting has been installed over the applied seed, and the area will be monitored for germination. 7/15/2024 - See previous update. 7/22/2024 - Observation remains. 7/29/2024 - Observation remains. 8/5/2024 - Observation remains. 8/7/2024 - Regrowth of vegetation was observed in this location. This item will remain open until stabilization has been completed. 8/12/2024 - Observation remains. 8/16/2024 - Observation remains. 8/20/2024 - Application of the approved seed mixture is required at this location. 8/27/2024 - Observation remains. 9/3/2024 - Vegetation that is present in this location generally consists of lady's thumb smartweed, a non-native species. Removal of non-native species and application of the approved seed mixture is required at this location. 9/16/2024 - See previous update. 9/23/2024 - Observation remains. See 9/3/2024 update.</p> |

| Description: View of slopes requiring stabilization at Station 172+00 to 175+00 per Compliance Action Item 6. | | |

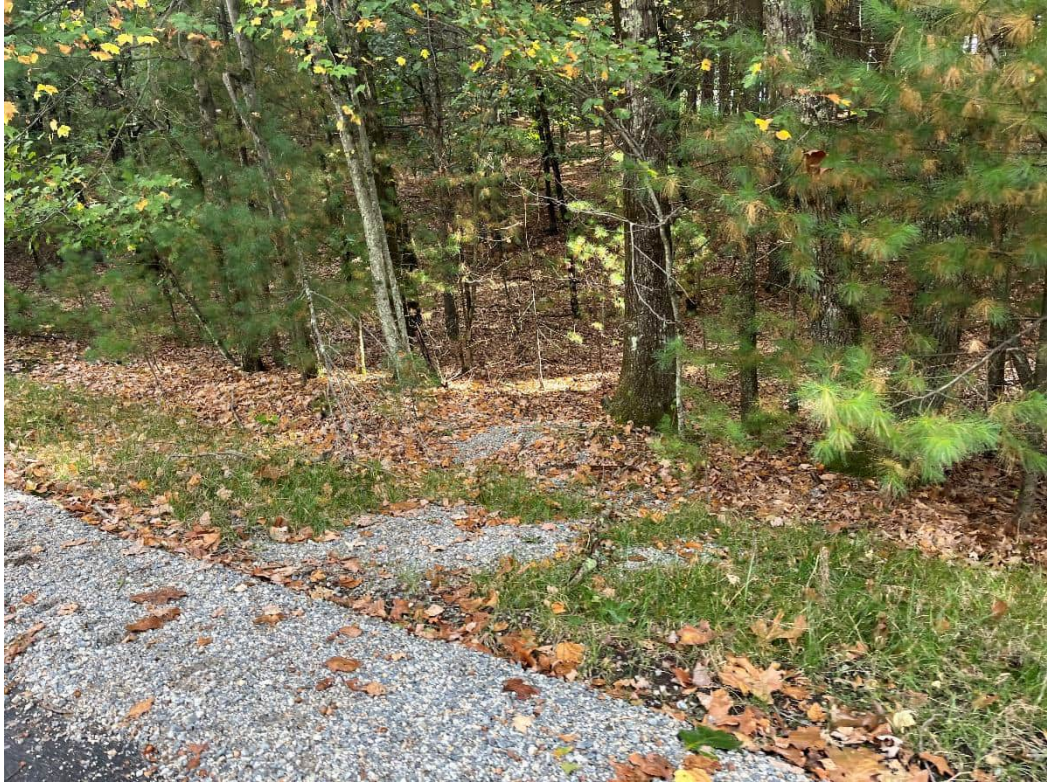
Photo No. 7 **Date:**
9/23/2024

| Item | Location/ Description | Observation Date | Resolution Due Date | Recommended/Discussed Resolution | Comments/Updates |
|---|---|---|---|---|---|
| 58 | Crushed stone used for the dense graded crush stone shoulders has been observed as migrating both onto the path, off the sides of the path, and into the adjacent Resource Areas throughout the Project Priority: High | 8/7/2024 | 8/14/2024 | Remove all crushed stone from Resource Areas and develop a plan to cease discharges of stone. | <p>8/12/2024 - Crushed stone is still present in varying amounts throughout the path and on the sides of the path.</p> <p>8/16/2024 - Observation remains.</p> <p>8/20/2024 - Crushed stone has been removed from some adjacent resource areas but is still observed as migrating onto and off of the path in multiple locations throughout the Project.</p> <p>8/27/2024 - Crushed stone has been observed as migrating from the shoulders throughout the path.</p> <p>9/3/2024 - Crushed stone was observed as migrating both onto the path and off the side of the path in multiple locations. Stone was observed to have discharged to the cattle crossing at Station 190+50 and within the streambed at Station 215+00 to 216+00. Crushed stone was observed to have been placed on the root system of a fallen tree at Station 310+00 near Bank flag #BF4-108.</p> <p>9/10/2024 - Observation remains. Crushed stone is still present within the cattle crossing, the streambed, and on the root system of the fallen tree. Crushed stone continues to migrate on to and off of the path.</p> <p>9/16/2024 - Observation remains. The contractor indicated the locations where crushed stone has migrated off the path will be hand removed and crushed stone will be swept off the path prior to the opening of the trail.</p> <p>9/23/2024 - Observation remains. It does not appear as though crushed stone that has migrated onto or off of the path has been removed at any locations along the Project. Additional crushed stone has migrated onto the path throughout a significant length of the path.</p> |

View crushed stone that has migrated off of the shoulders at Station 180+00 per Long Term Compliance Action Item 58.

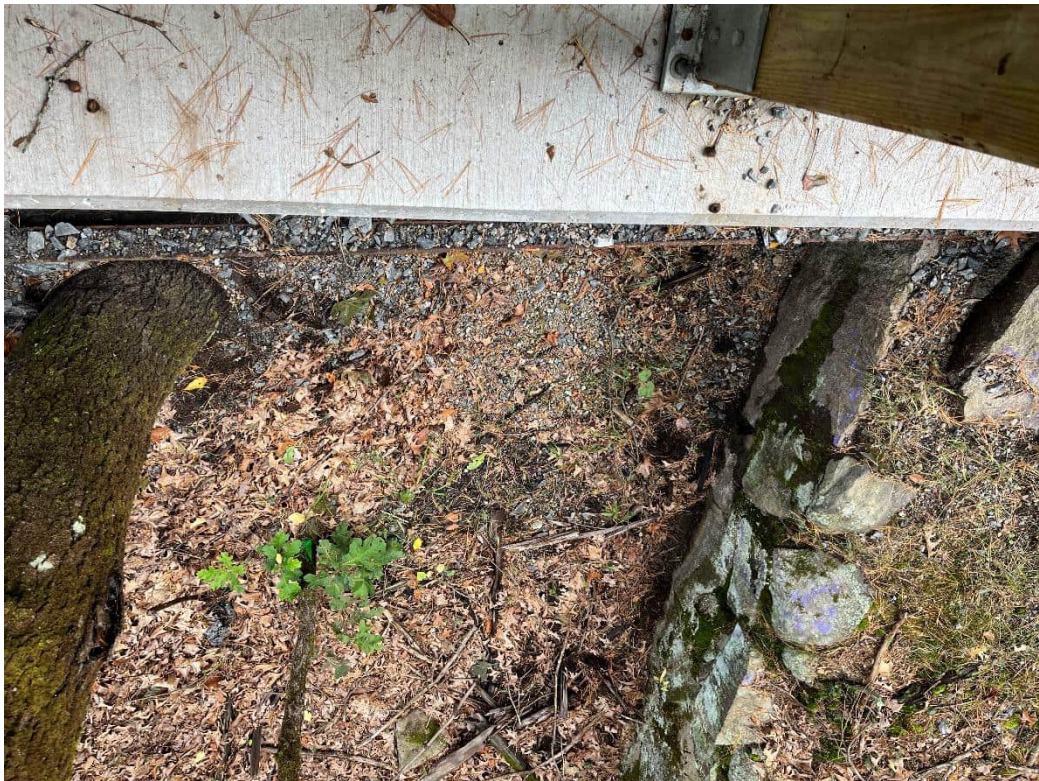
Photo No. 8 **Date:**
9/23/2024

| | Inspection #1 | Inspection #2 | Inspection #3 | Inspection #4 | Inspection #5 | Inspection #6 |
|---|---|---|---|---|---|---|
| If yes, please describe: | Stone was observed to have discharged to the cattle crossing at Station 190+50 and within the streambed at Station 215+00 to 216+00. | | | | | |

View of the crushed stone that has discharged into the cattle crossing at Station 190+50 per Long Term Compliance Action Item 58.

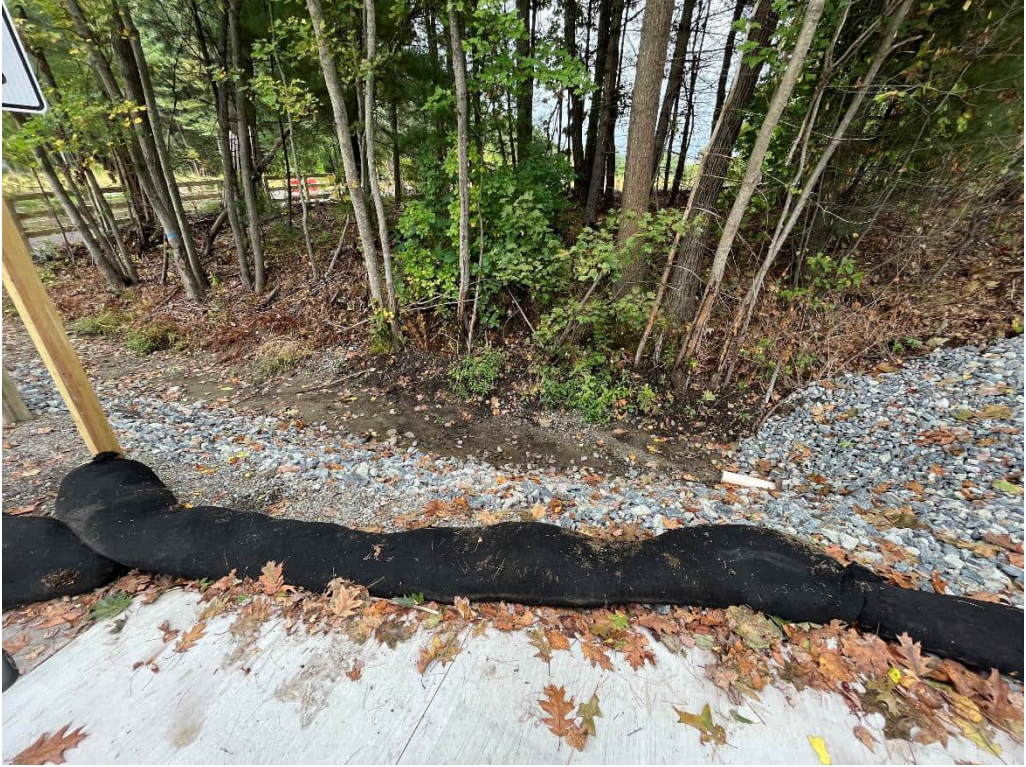
| Photo No. 9 | Date: 9/23/2024 | |

| 41 | <p>Stream Bank has been regraded beyond the limit of work at Station 216+00 Priority: High</p> | 5/28/2024 | 6/4/2024 | <p>The Contractor should confirm if this work was permitted by the Conservation Commission, as it does not appear to be a part of the approved plans/impacts. MassDOT should be consulted on next steps regarding notification and potential restoration.</p> | <p>5/31/2024 - Observation remains. 6/7/2024 - Observation remains. 6/14/2024 - Observation remains. 6/17/2024 - Observation remains. 6/24/2024 - Observation remains. 6/27/2024 - Observation remains. 7/8/2024 - Observation remains. 7/15/2024 - This area could not be assessed due to paving operations ongoing during the inspection. 7/22/2024 - Crushed stone and sediment continue to be discharged to the stream between Stations 215+00 and 217+00 due to overtopped and undermined compost filter tubes. 7/29/2024 - Observation remains. 8/5/2024 - Observation remains. 8/7/2024 - Observation remains. 8/12/2024 - Observation remains. Crushed stone is still present in the streambed at this location. 8/16/2024 - Observation remains. 8/20/2024 - Stone has been removed; however, additional alteration to Resource Areas beyond the limit of work continue. 8/27/2024 - Observation remains. 9/3/2024 - Observation remains. 9/10/2024 - Observation remains. Stone has been observed as discharging into the streambed in this location again. 9/16/2024 - Observation remains. 9/23/2024 - Observation remains. Stone is still present within the streambed at this location.</p> |

| Description: View of crushed stone within the streambed and the location where the stream bank has been regraded beyond the limits of work at Station 216+00 per Long Term Compliance Action Items 41 and 58. | | |

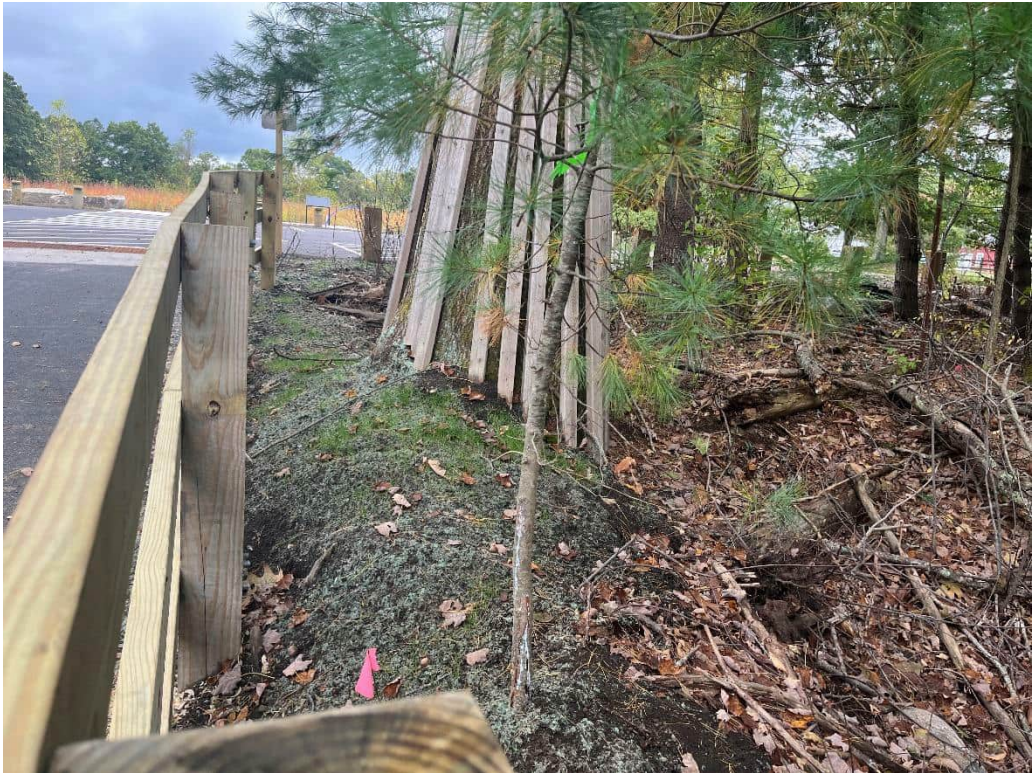
| Photo No. 10 | Date: 9/23/2024 | |

| Item | Location/ Description | Observation Date | Resolution Due Date | Recommended Resolution / Resolution Date | Comments/Updates |
|---|---|---|---|---|---|
| 52 | Slopes along the driveway to the parking lot at Station 216+50 requires stabilization Priority: Medium | 7/29/2024 | 8/6/2024 | Install erosion control blanket and place seed. | 8/5/2024 - Observation remains. 8/7/2024 - Observation remains. 8/12/2024 - Observation remains. 8/16/2024 - Observation remains. 8/20/2024 - Observation remains. Erosion controls have been installed between the slope and the downgradient stream, but seed is still required. 8/27/2024 - Observation remains. 9/3/2024 - Observation remains. 9/10/2024 - Slopes have been hydroseeded. Item will remain open till stabilization occurs. 9/16/2024 - Observation remains. Some germination has been observed at this location. 9/23/2024 - Germination has been observed at this location. Item will remain open until the area is stabilized. |

| Description: View of germination on the slopes that have been hydroseeded along the driveway to the parking lot at Station 216+50 per Compliance Action Item 52. | | |

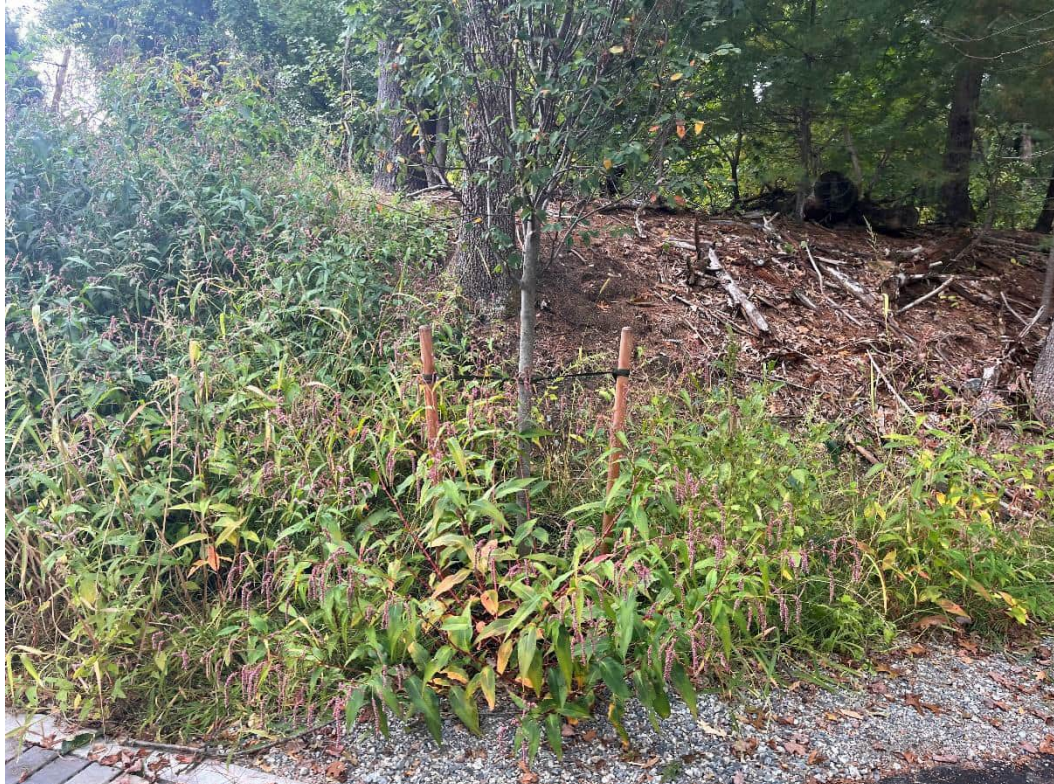
Photo No. 11 **Date:**
9/23/2024

| 34 | Sediment is eroding downhill from behind the cemented stone masonry wall at Station 217+45 Priority: Low | 5/28/2024 | 6/4/2024 | Apply seed and temporarily stabilize the soils along the slope with straw, jute netting, etc. | 5/31/2024 - Observation remains. 6/7/2024 - Observation remains. 6/14/2024 - Observation remains. 6/17/2024 - Observation remains. 6/24/2024 - Observation remains. 6/27/2024 - Rills were raked, loam was added, and hydroseed was applied. 7/8/2024 - Observation remains. Grass was observed to be germinating at this location. Comment will remain open until stabilization is complete. 7/8/2024 - See previous update. 7/15/2024 - Additional hydroseed is required due to washouts. 7/22/2024 - Observation remains. 7/29/2024 - Observation remains. 8/5/2024 - Observation remains. 8/7/2024 - Regrowth of vegetation has been observed in this area. This item will remain open until the area is fully stabilized. 8/12/2024 - Observation remains. Regrowth has stabilized a portion of this hill; however, reseeding and additional temporary stabilized measures are recommended on the section that is currently unvegetated. 8/16/2024 - Observation remains. 8/20/2024 - Application of the approved seed mixture is required at this location. 8/27/2024 - Observation remains. 9/3/2024 - Vegetation that is present in this location generally consists of lady's thumb smartweed (<i>Persicaria maculosa</i>), a non-native species. Removal of non-native species and application of the approved seed mixture is required at this location. 9/10/2024 - Observation remains. See previous update. 9/16/2024 - Observation remains. See update from 9/3/2024. 9/23/2024 - Observation remains. See update from 9/3/2024. |

View of the slope at Station 217+45 that requires stabilization per Compliance Action Item 34.

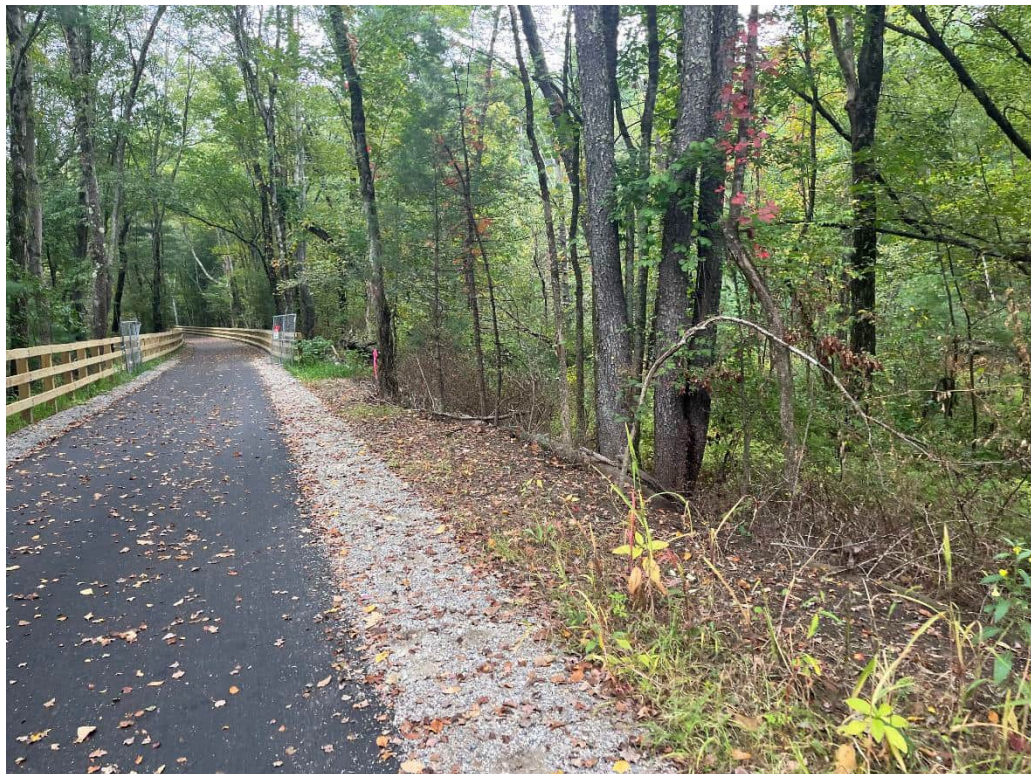
Photo No. 12 **Date:**
9/23/2024

View of a slope that is no longer stabilized due to herbicide application at Station 233+00 per Long Term Compliance Action Item 59.

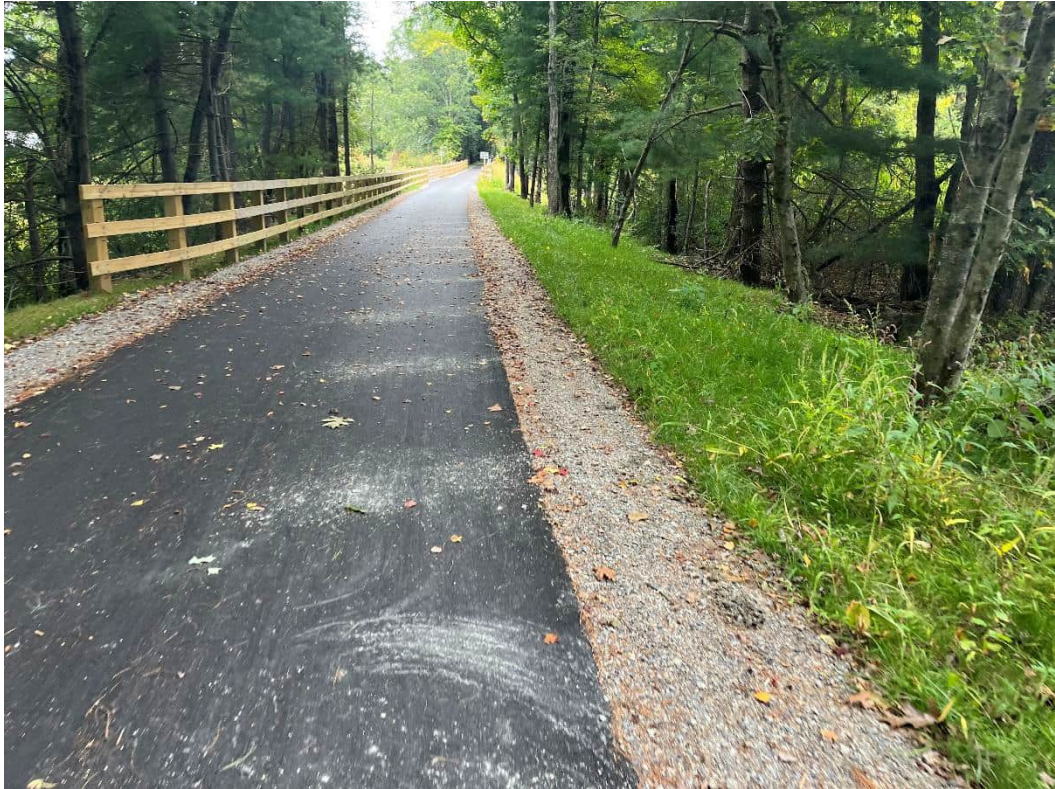
Photo No. 13 **Date:**
9/23/2024

View another location where crushed stone has migrated on to the path at Station 261+50 per Long Term Compliance Action Item 58.

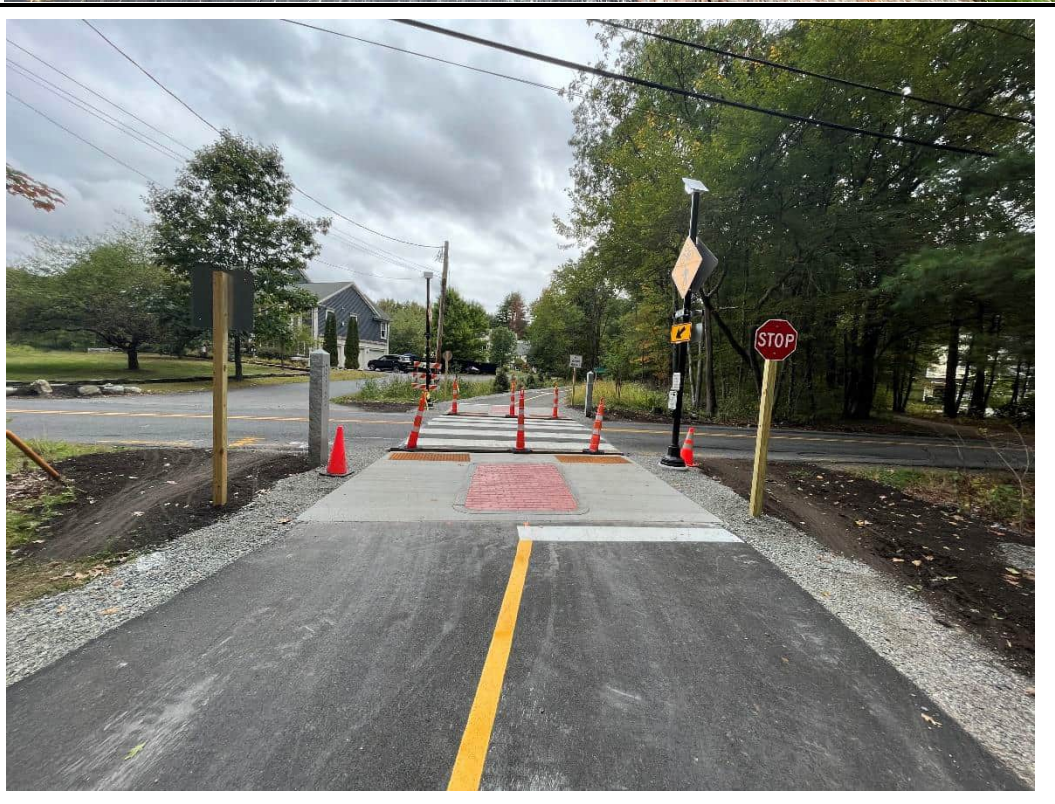
Photo No. 14 **Date:**
9/23/2024

View of the intersection of Hayes Road where loam has been placed and requires seeding per Long Term Compliance Action Item 59. This condition has been observed at multiple intersections.

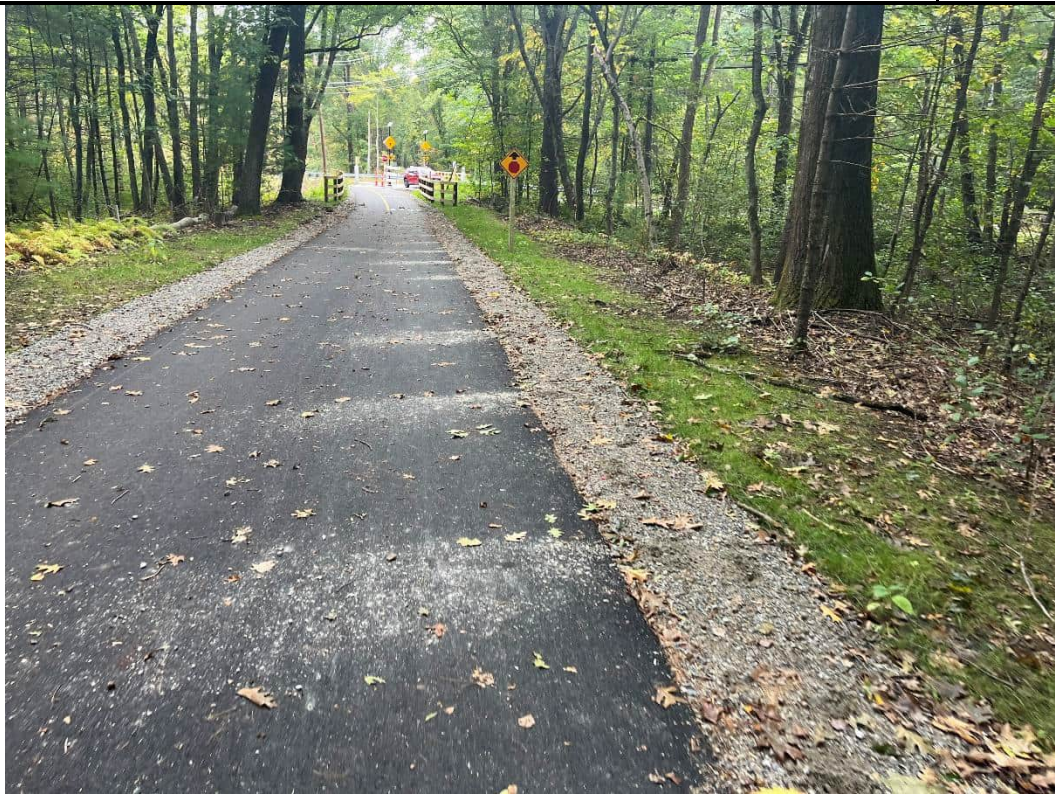
Photo No. 15 **Date:**
9/23/2024

View of another location where crushed stone has migrated onto the path at Station 311+50 per Long Term Compliance Action Item 58.

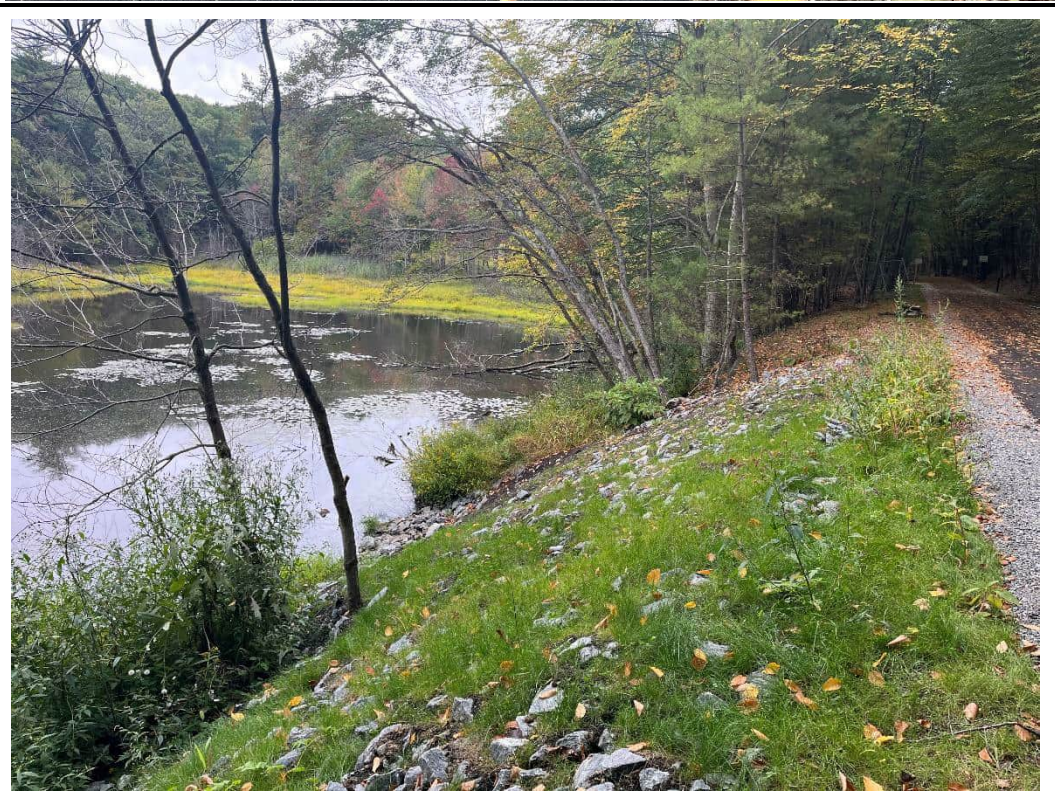
Photo No. 16 **Date:**
9/23/2024

| 42 | <p>Riprap slope extends beyond limits of work along the WF1 Series wetland near flags 103 to 107 Priority: High</p> | 5/28/2024 | 6/4/2024 | <p>The Contractor should confirm if this work was permitted by the Conservation Commission, as it does not appear to be a part of the approved plans/impacts. MassDOT should be consulted on next steps regarding notification and potential restoration.</p> | <p>5/31/2024 - Observation remains. 6/7/2024 - Observation remains. 6/14/2024 - Riprap slope has been altered and active construction is repairing the area. 6/17/2024 - During this inspection, additional work in support of the repair/potential replacement of an underlying pipe has been ongoing. It is recommended that the contractor confirm that they have coordinated with the Conservation Commission for this work and provide a restoration plan for the area once work is complete. 6/24/2024 - During this inspection, BETA was informed that the existing cast iron pipe was replaced with a new concrete 12-inch reinforced concrete pipe. It appears that riprap was replaced along the side slopes to mirror conditions observed prior to this inspection. 6/27/2024 - During this inspection, the area was observed to have been rolled and prepared for paving. Hydroseed was applied and plantings were installed. 7/8/2024 - Germination was observed and the area will be monitored for stabilization. See previous updates regarding Conservation Commission coordination. 7/15/2024 - This area could not be assessed due to paving operations ongoing during the inspection. 7/22/2024 - See previous updates regarding Conservation Commission coordination. 7/29/2024 - Observation remains. 8/5/2024 - Observation remains. 8/7/2024 - Observation remains. 8/12/2024 - Observation remains. Regrowth of vegetation has been observed in this area and will continue to be monitored. 8/16/2024 - Observation remains. 8/20/2024 - Observation remains. 8/27/2024 - Observation remains. 9/3/2024 - Observation remains. 9/10/2024 - Observation remains. 9/16/2024 - Observation remains. 9/23/2024 - Observation remains.</p> |

View of the riprap slope that extends beyond the limit of work along the WF1 Series wetland at Station 332+00 per Long Term Compliance Action Item 42.
