Environmental Monitor Construction Site Inspection Report
MassDOT Project #608164 Construction Contract # 119678
EM Report #26

Project Description: Bruce Freeman Rail Trail Right-of-Way
 Permit Description(s): Order of Conditions (MGL Chapter 131, Section 40 and 310 CMR 10.00, Mass DEP File No. 301-1362); 2022 EPA NPDES General Permit for Discharges from Construction Areas; U.S. Army Corps of Engineers Permit No NAE-2021-01975.

Project Name:	Bruce Freeman Rail Trail - Phase 2d - Sudbury
Date of Inspections:	10/4/2024
Bi Weekly/ Monthly Period Covered:	October Weekly Inspection #1
Inspector's Name(s):	Anna Haznar
Inspectors' Contact Information:	ahaznar@beta-inc.com

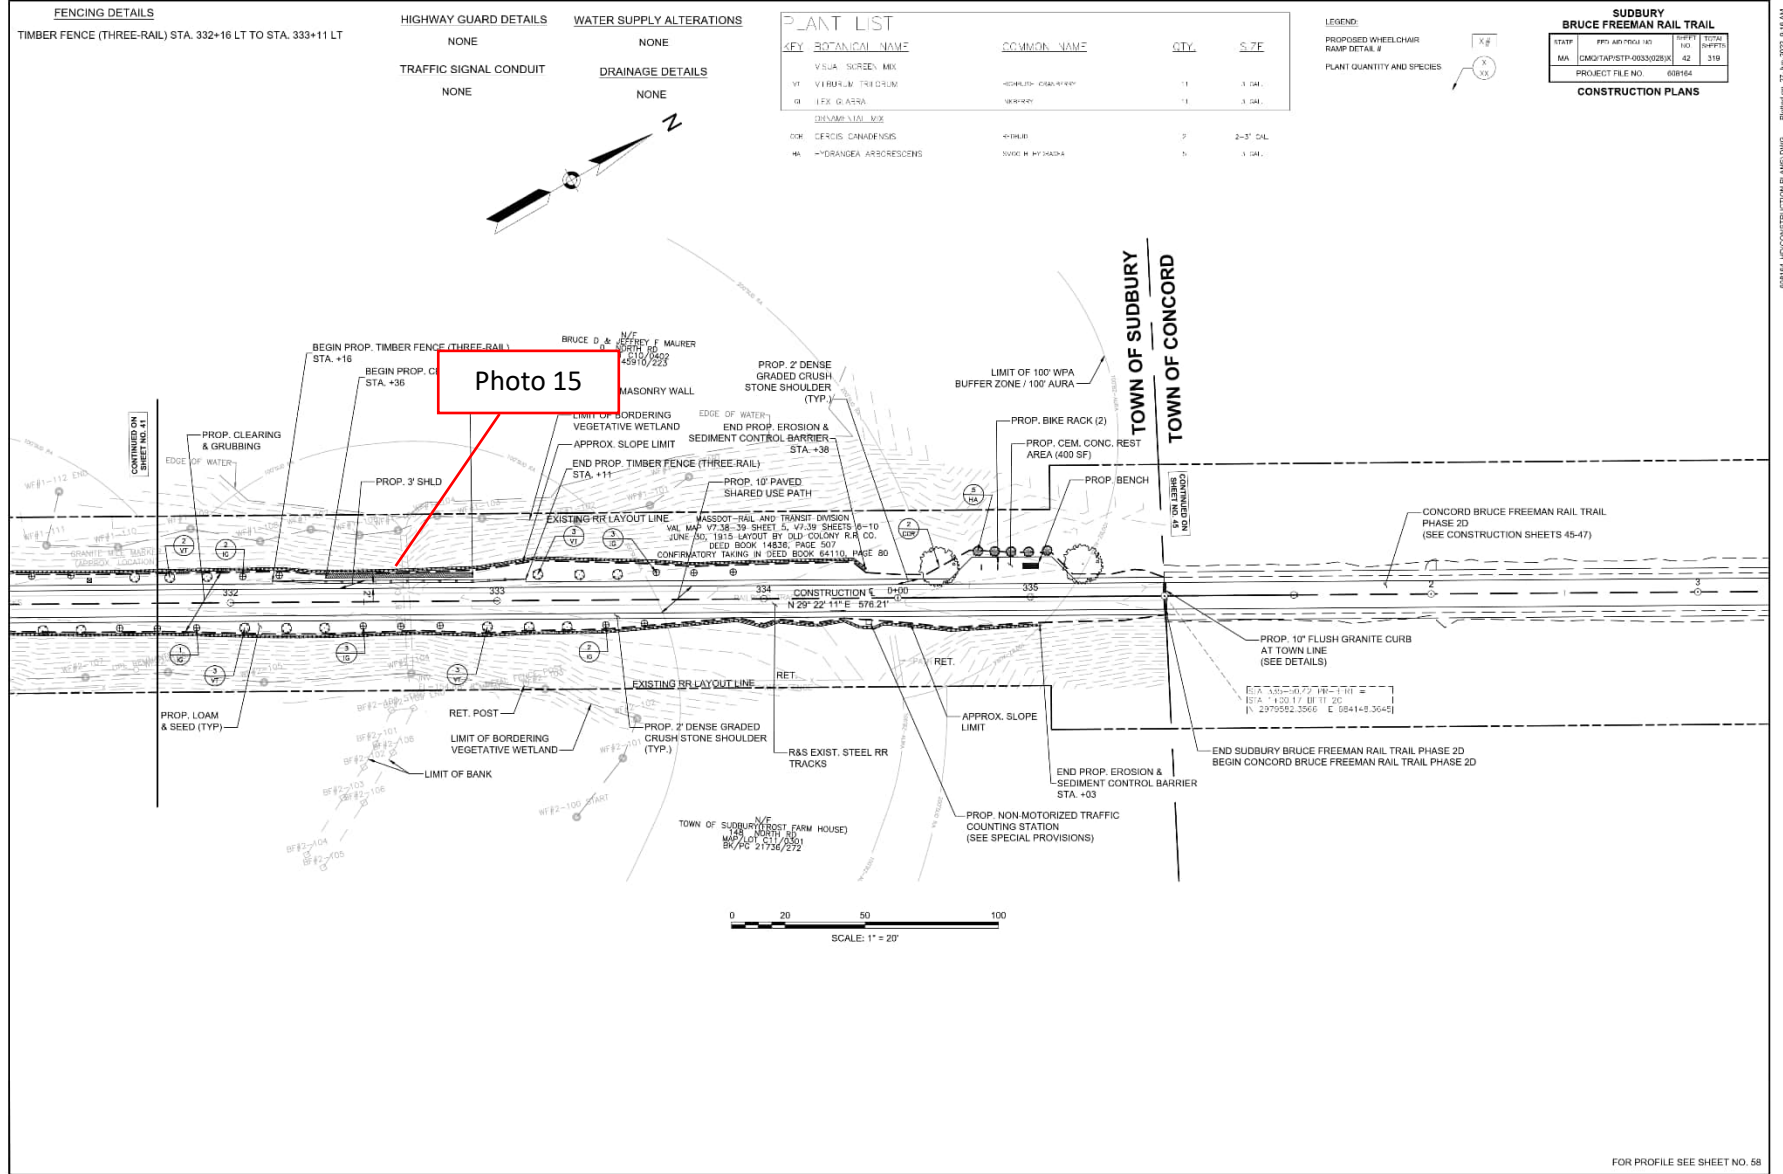
Photo 15

42	<p>Riprap slope extends beyond limits of work along the WF1 Series wetland near flags 103 to 107 Priority: High</p>	5/28/2024	6/4/2024	<p>The Contractor should confirm if this work was permitted by the Conservation Commission, as it does not appear to be a part of the approved plans/impacts. MassDOT should be consulted on next steps regarding notification and potential restoration.</p>	<p>5/31/2024 - Observation remains. 6/7/2024 - Observation remains. 6/14/2024 - Riprap slope has been altered and active construction is repairing the area. 6/17/2024 - During this inspection, additional work in support of the repair/potential replacement of an underlying pipe has been ongoing. It is recommended that the contractor confirm that they have coordinated with the Conservation Commission for this work and provide a restoration plan for the area once work is complete. 6/24/2024 - During this inspection, BETA was informed that the existing cast iron pipe was replaced with a new concrete 12-inch reinforced concrete pipe. It appears that riprap was replaced along the side slopes to mirror conditions observed prior to this inspection. 6/27/2024 - During this inspection, the area was observed to have been rolled and prepared for paving. Hydroseed was applied and plantings were installed. 7/8/2024 - Germination was observed and the area will be monitored for stabilization. See previous updates regarding Conservation Commission coordination. 7/15/2024 - This area could not be assessed due to paving operations ongoing during the inspection. 7/22/2024 - See previous updates regarding Conservation Commission coordination. 7/29/2024 - Observation remains. 8/5/2024 - Observation remains. 8/7/2024 - Observation remains. 8/12/2024 - Observation remains. Regrowth of vegetation has been observed in this area and will continue to be monitored. 8/16/2024 - Observation remains. 8/20/2024 - Observation remains. 8/27/2024 - Observation remains. 9/3/2024 - Observation remains. 9/10/2024 - Observation remains. 9/16/2024 - Observation remains. 9/23/2024 - Observation remains. 9/27/2024 - Observation remains. 10/4/2024 - Observation remains.</p>

<p>Site Location Bruce Freeman Rail Trail Right-of-Way</p>		<p>BETA Project No. 24.10326.23</p>
<p>Photo No. 15</p>	<p>Date: 10/4/2024</p>	 
<p>Direction Photo Taken: Toward the North</p>		
<p>Description: View of the riprap slope that extends beyond the limit of work along the WF1 Series wetland at Station 332+00 per Long Term Compliance Action Item 42.</p>

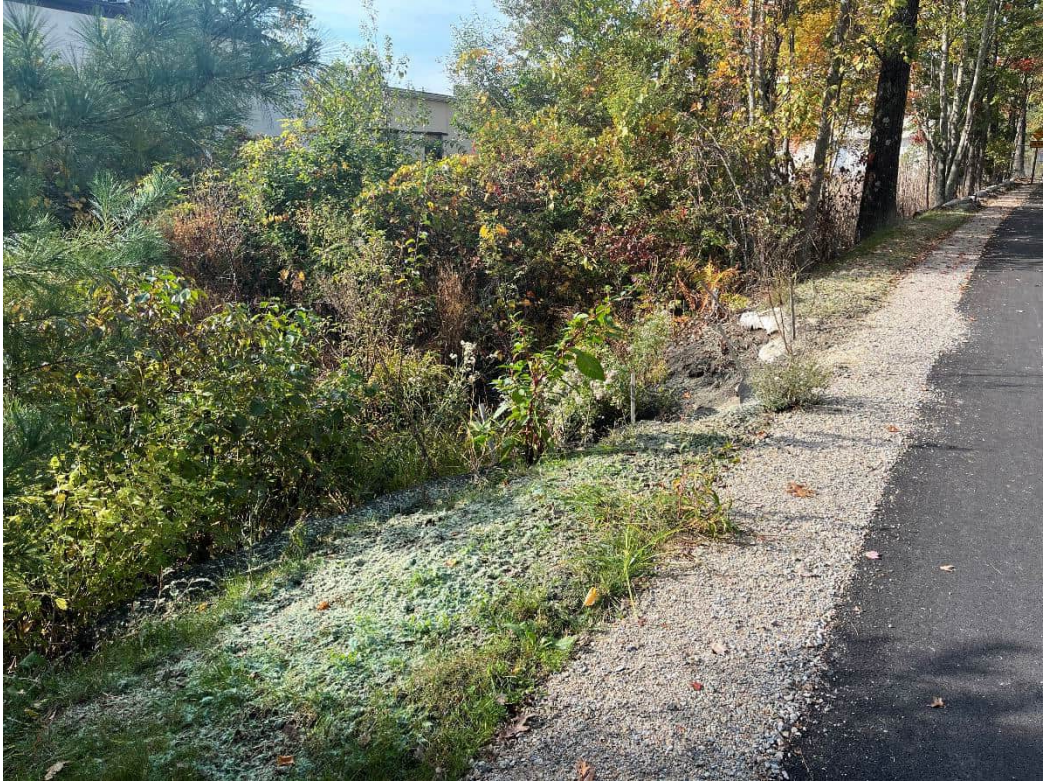
Site Location Bruce Freeman Rail Trail Right-of-Way		BETA Project No. 24.10326.23
Photo No. 1	Date: 10/4/2024

43	<p>Overtopped compost filter tubes and exposed soils beyond the limits of work at Station 105+00 Priority: High</p>	6/7/2024	6/14/2024	<p>Stabilize the area with the approved seed mixture and provide interim stabilization such as straw mulch.</p>	<p>6/14/2024 - Observation remains. 6/17/2024 - Observation remains. 6/24/2024 - Observation remains. 6/27/2024 - Observation remains. 7/8/2024 - Observation remains. 7/15/2024 - Observation remains. 7/22/2024 - Observation remains. 7/29/2024 - Observation remains. 8/5/2024 - Observation remains. 8/7/2024 - Observation remains. 8/12/2024 - Observation remains. Some material has migrated off of the compost filter tubes due to erosion. 8/16/2024 - Observation remains. 8/20/2024 - Application of the approved seed mixture is required at this location. 8/27/2024 - Observation remains. 9/3/2024 - Observation remains. 9/10/2024 - Observation remains. Application of the approved seed mixture is required at this location. 9/16/2024 - Observation remains. 9/23/2024 - Observation remains. 9/27/2024 - Observation remains. 10/4/2024 - Hydroseed has been applied here; however, the contractor should provide an update on long-term slope stabilization plans.</p>

44	<p>Slopes require stabilization / additional seed due to lack of compost filter tubes at 105+00 and 106+00 Priority: High</p>	6/7/2024	6/14/2024	<p>Stabilize the slope with the approved seed mixture and provide interim stabilization such as straw mulch.</p>	<p>6/14/2024 - Observation remains. 6/17/2024 - Observation remains. 6/24/2024 - Observation remains. 6/27/2024 - Observation remains. 7/8/2024 - Observation remains. 7/15/2024 - Observation remains. 7/22/2024 - Observation remains. 7/29/2024 - Regrowth of vegetation has been observed in this area. This item will remain open until the area is fully stabilized. 8/5/2024 - Observation remains. 8/7/2024 - Regrowth of vegetation has been observed but the area is not yet fully stabilized. 8/12/2024 - Observation remains. 8/16/2024 - Observation remains. 8/20/2024 - Application of the approved seed mixture is required at this location. 8/27/2024 - Vegetation has partially stabilized this area; however, seed should be applied. 9/3/2024 - Observation remains. 9/10/2024 - Observation remains. Application of the approved seed mixture is require at this location. 9/16/2024 - Observation remains. 9/23/2024 - Observation remains. Application of the approved seed mixture is require at this location. 9/27/2024 - Observation remains. The contractor reached out and indicated this area was hydroseeded after the inspection occurred. 10/4/2024 - Hydroseed has been applied here and the item will remain open until the area is fully stabilized.</p>

Direction Photo Taken: Toward the Southeast		
Description: View of the overtopped compost filter tube beyond the limits of work and the recently applied hydroseed at Station 105+00 per Compliance Action Item 43 and 44.		
Photo No. 2	Date: 10/4/2024

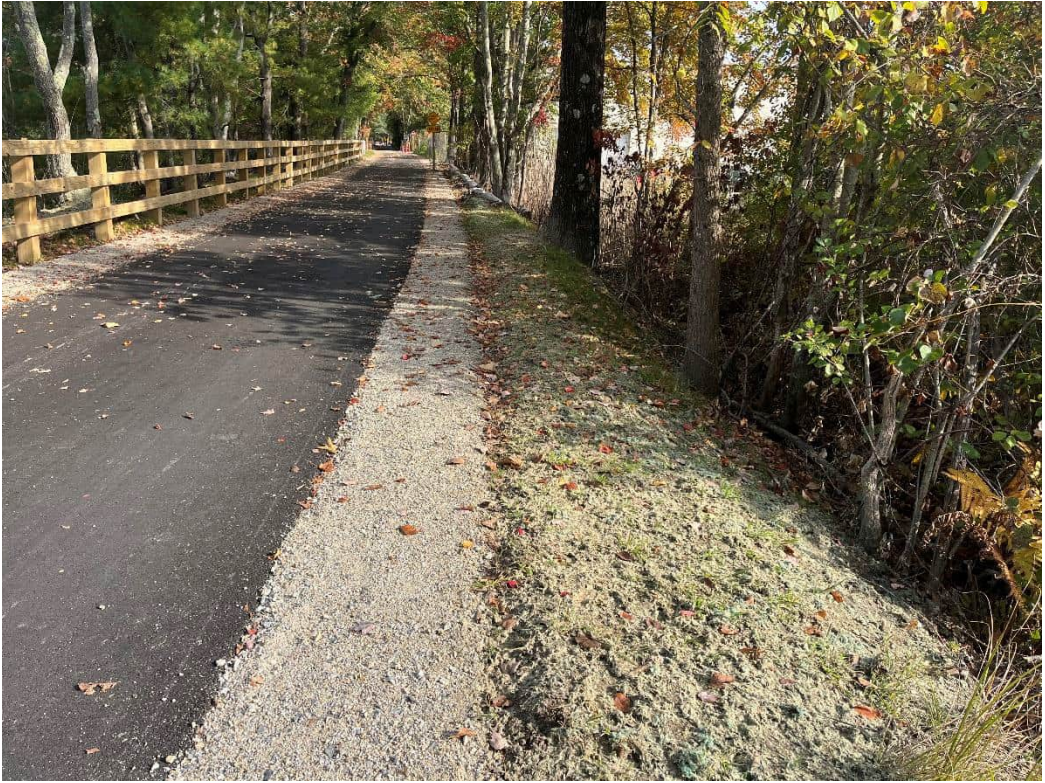
Direction Photo Taken: Toward the North		
Description: View of recently applied hydroseed along the slope at Station 106+00 per Compliance Action Item 44.

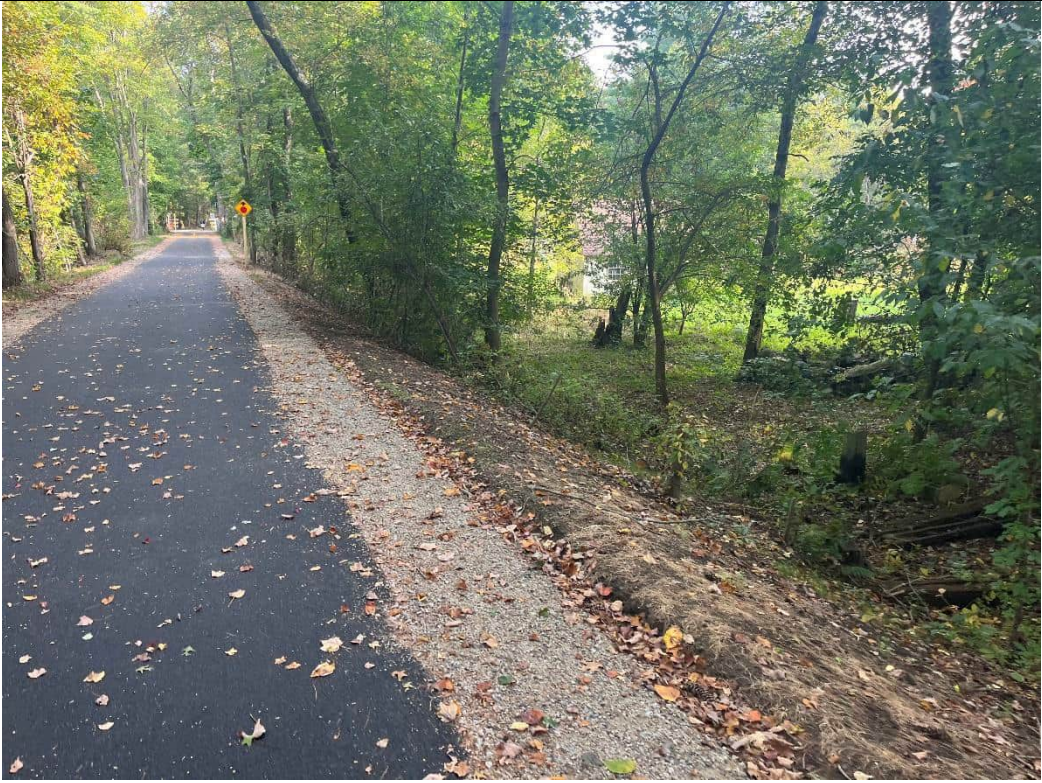
Photo No. 3	Date: 10/4/2024

Typically, these items require coordination with MassDEP. If so, remove once approval is obtained from MassDEP					
Item	Location/ Description	Observation Date	Resolution Due Date	Recommended/Discussed Resolution	Comments/Updates
59	Multiple locations of exposed soils along the Project corridor require stabilization Priority: High	9/3/2024	9/10/2024	The contactor should apply the approved seed mixture to areas of exposed soils and place straw.	9/3/2024 - Herbicide application caused multiple areas along the path to be no longer stabilized. If thatch is present in these locations the thatch should be removed before seeding occurs. A location near Station 320+50 has been cleared outside of the limit of work and requires stabilization. Other areas along the path where seed did not germinate should be reseeded with the approved seed mix and straw should be placed on the areas of exposed soil. 9/10/2024 - Observation remains, see previous update. A few locations along the trail have been hydroseeded but a majority of the locations of exposed soil require seed and stabilization. 9/16/2024 - Observation remains. The contactor indicated areas of bare soil will be hydroseeded. 9/23/2024 - Observation remains. It does not appear as though any hydroseeding has been done since the last inspection. Areas throughout the trail require removal of thatch and application of seed for stabilization. 9/27/2024 - Observation remains. The contractor reached out and indicated all areas of exposed soils south of Hudson Road were hydroseeded after the inspection occurred. 10/4/2024 - All areas south of Hudson Road were not seeded using hydroseed, hydroseed was applied in a few locations, but there are still large areas of exposed soil both south and north of Hudson Road that require seeding. Thatch was not removed in any areas before hydroseed was applied. The contractor should provide the tag from the seed mix that was used to the Conservation Commission to ensure that the required native seed mix was used per the design plans. Once vegetation has sufficiently stabilized the item will be closed.

Direction Photo Taken: Toward the North		
Description: View of an area that is no longer stabilized due to herbicide application at Station 140+00 per Long Term Compliance Action Item 59.

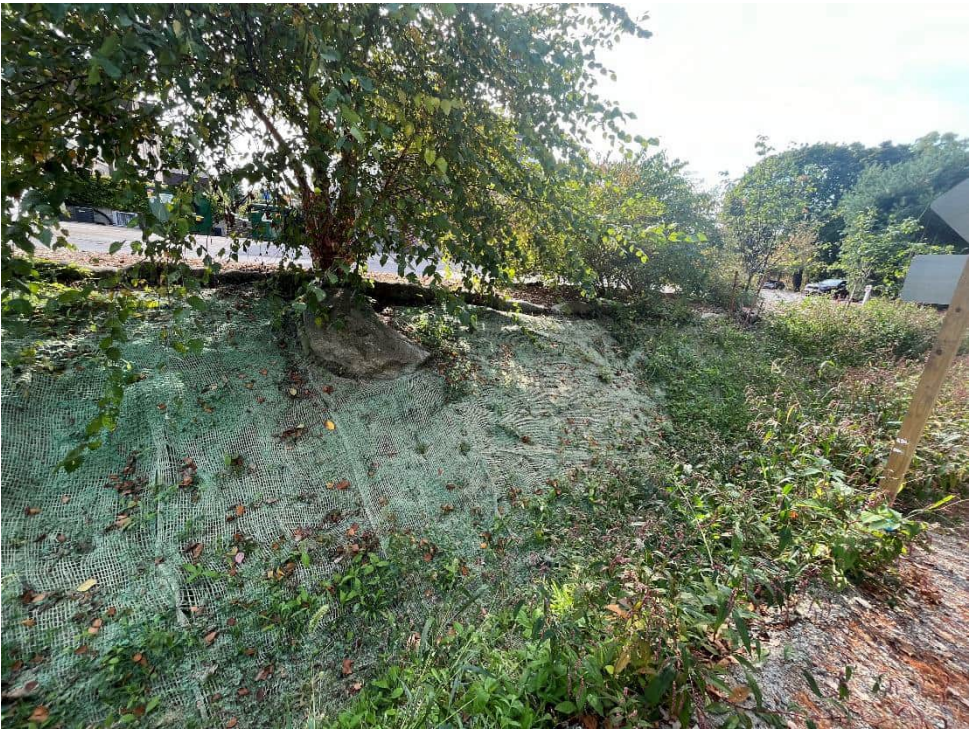
Photo No. 5	Date: 10/4/2024

6	<p>Exposed sediment slope at Station 172+00 to 175+00 Priority: High</p>	5/8/2024	5/15/2024	<p>Install temporary sediment controls along the slope such as jute netting and/or straw following the application of seed.</p>	<p>5/16/2024 - Observation remains. 5/21/2024 - Observation remains. 5/28/2024 - Partial germination was observed. 5/31/2024 - See previous update. 6/7/2024 - Further earthwork has occurred and soils require stabilization. 6/14/2024 - Observation remains. 6/17/2024 - Observation remains. 6/24/2024 - Observation remains. 6/27/2024 - The area has been regraded and loam has been spread. New trees have been planted upgradient of the swale. Stabilization is still required. 7/8/2024 - Jute netting has been installed over the applied seed, and the area will be monitored for germination. 7/15/2024 - See previous update. 7/22/2024 - Observation remains. 7/29/2024 - Observation remains. 8/5/2024 - Observation remains. 8/7/2024 - Regrowth of vegetation was observed in this location. This item will remain open until stabilization has been completed. 8/12/2024 - Observation remains. 8/16/2024 - Observation remains. 8/20/2024 - Application of the approved seed mixture is required at this location. 8/27/2024 - Observation remains. 9/3/2024 - Vegetation that is present in this location generally consists of lady's thumb smartweed, a non-native species. Removal of non-native species and application of the approved seed mixture is required at this location. 9/16/2024 - See previous update. 9/23/2024 - Observation remains. See 9/3/2024 update. 9/27/2024 - Observation remains. The contractor reached out hydroseed has been applied to this area. 10/4/2024 - Hydroseed has been applied to this area; the hydroseed was observed to have been applied over the erosion control blanket that is located in this area. Once vegetation has sufficiently stabilized this area the item will be closed. The contractor should provide the tag from the seed mix that was used to the Conservation Commission to ensure that the required native seed mix was used per the design plans.</p>

Direction Photo Taken: Toward the East		
Description: View of hydroseed applied along slopes at Station 172+00 to 175+00 per Compliance Action Item 6.

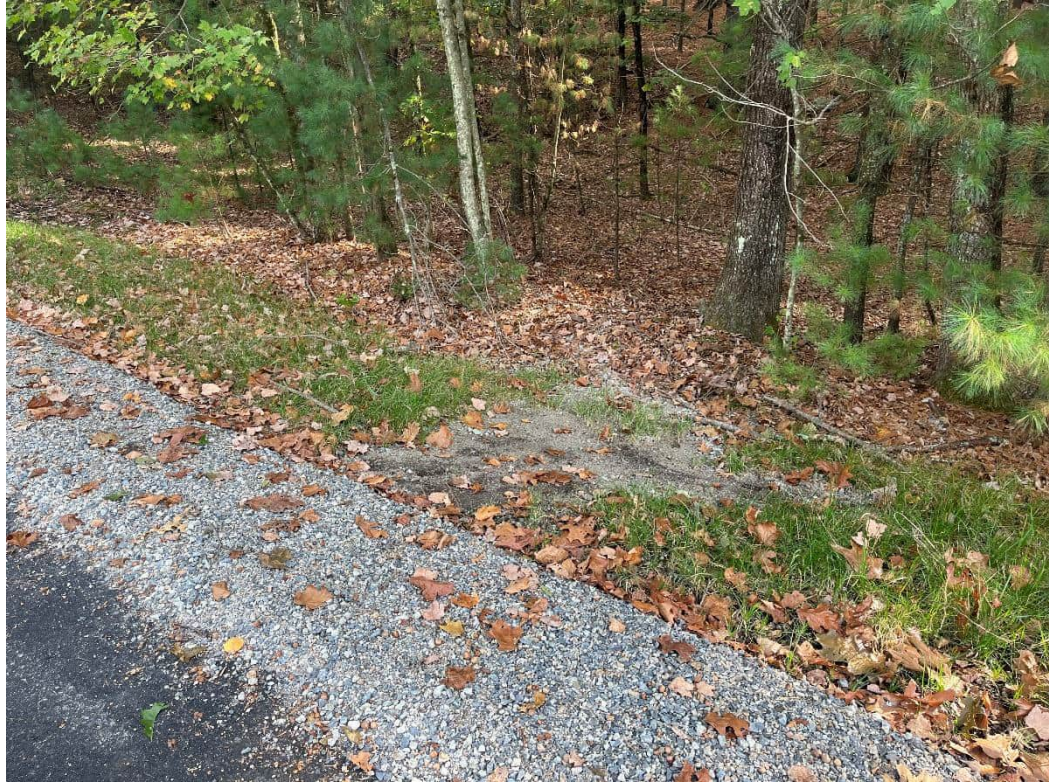
Photo No. 7 **Date:**
10/4/2024

58	<p>Crushed stone used for the dense graded crush stone shoulders has been observed as migrating both onto the path, off the sides of the path, and into the adjacent Resource Areas throughout the Project Priority: High</p>	8/7/2024	8/14/2024	<p>Remove all crushed stone from Resource Areas and develop a plan to cease discharges of stone.</p>	<p>8/12/2024 - Crushed stone is still present in varying amounts throughout the path and on the sides of the path. 8/16/2024 - Observation remains. 8/20/2024 - Crushed stone has been removed from some adjacent resource areas but is still observed as migrating onto and off of the path in multiple locations throughout the Project. 8/27/2024 - Crushed stone has been observed as migrating from the shoulders throughout the path. 9/3/2024 - Crushed stone was observed as migrating both onto the path and off the side of the path in multiple locations. Stone was observed to have discharged to the cattle crossing at Station 190+50 and within the streambed at Station 215+00 to 216+00. Crushed stone was observed to have been placed on the root system of a fallen tree at Station 310+00 near Bank flag #BF4-108. 9/10/2024 - Observation remains. Crushed stone is still present within the cattle crossing, the streambed, and on the root system of the fallen tree. Crushed stone continues to migrate on to and off of the path. 9/16/2024 - Observation remains. The contractor indicated the locations where crushed stone has migrated off the path will be hand removed and crushed stone will be swept off the path prior to the opening of the trail. 9/23/2024 - Observation remains. It does not appear as though crushed stone that has migrated onto or off of the path has been removed in any location along the Project. More crushed stone has migrated onto the path throughout significant portions of the path. 9/27/2024 - Observation remains. Crushed stone is still located on the side of the path and on the path in varying amounts. 10/4/2024 - Crushed stone has been removed from multiple locations along the trail but was still observed on and on the sides of the trail in several locations.</p>

View of the area at Station 180+00 where crushed stone was removed and seeding is required per Long Term Compliance Action Item 58 and 59.

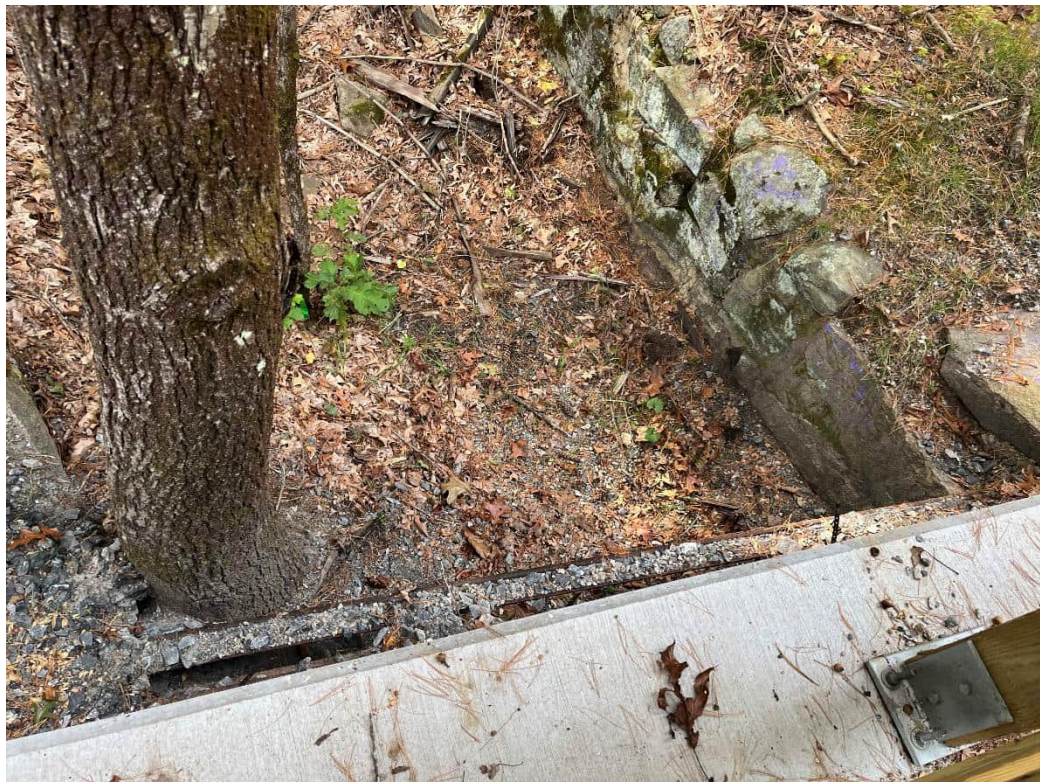
Photo No. 8 **Date:**
10/4/2024

View of the crushed stone that has discharged into the cattle crossing at Station 190+50 per Long Term Compliance Action Item 58.

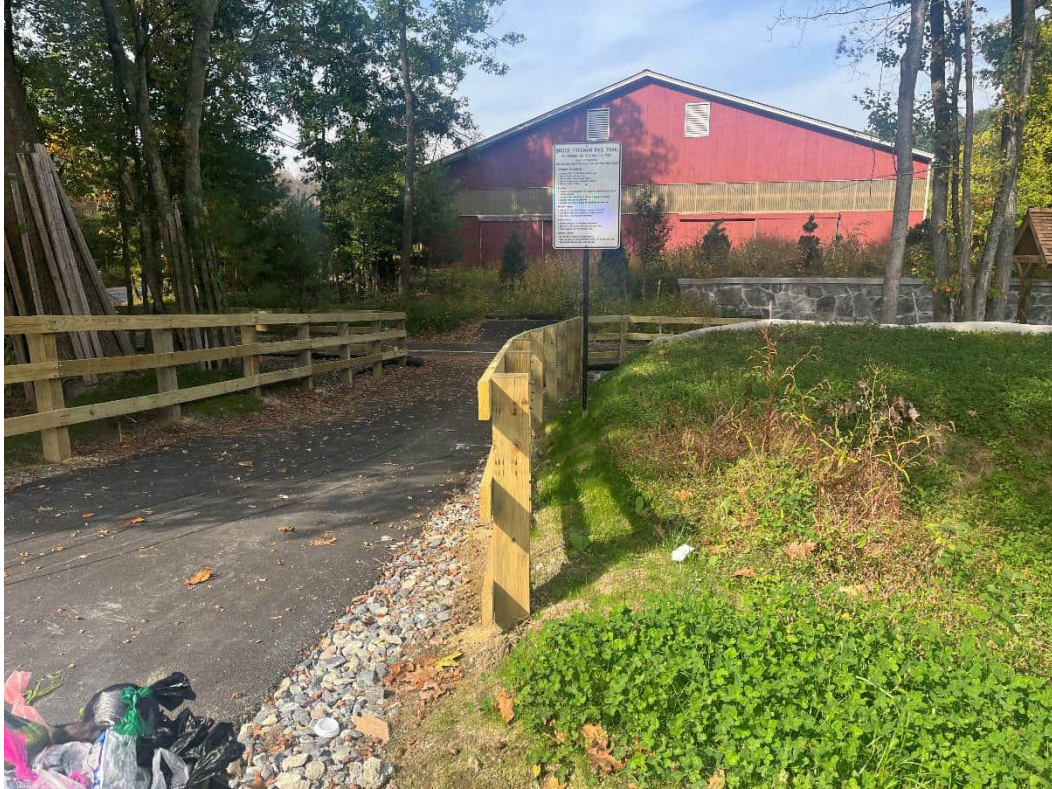
Photo No. 11 **Date:** 10/4/2024

52	Slopes along the driveway to the parking lot at Station 216+50 requires stabilization Priority: Medium	7/29/2024	Resolved: 10/4/2024 8/6/2024	Install erosion control blanket and place seed.	8/5/2024 - Observation remains. 8/7/2024 - Observation remains. 8/12/2024 - Observation remains. 8/16/2024 - Observation remains 8/20/2024 - Observation remains. Erosion controls have been installed between the slope and the downgradient stream, but seed is still required. 8/27/2024 - Observation remains. 9/3/2024 - Observation remains. 9/10/2024 - Slopes have been hydroseeded. Item will remain open till stabilization occurs. 9/16/2024 - Observation remains. Some germination has been observed at this location. 9/23/2024 - Some germination has been observed at this location. Item will remain open till full stabilization occurs. 9/27/2024 - Observation remains. See previous update. 10/4/2024 - The slopes have become sufficiently stabilized with vegetation.

View of the slopes that have become stabilized along the driveway to the parking lot at Station 216+50 per Compliance Action Item 52.

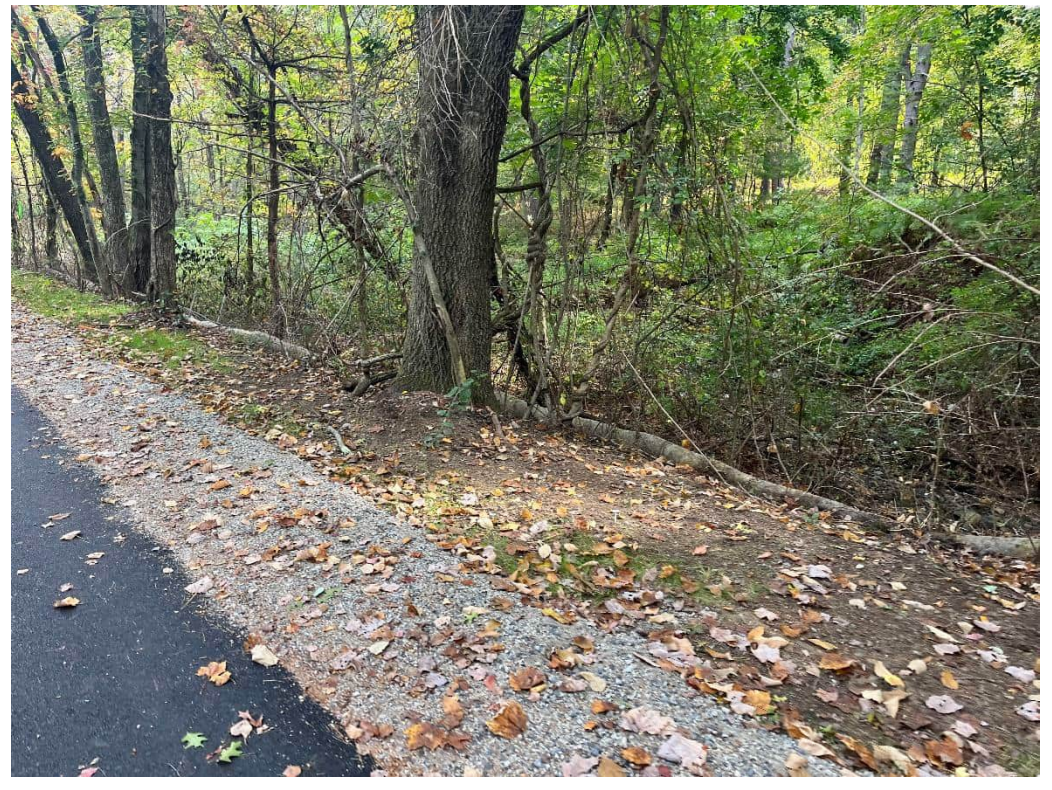
Photo No. 12 **Date:** 10/4/2024

View of another area that is no longer stabilized due to herbicide application at Station 223+00 per Long Term Compliance Action Item 59. occurred.

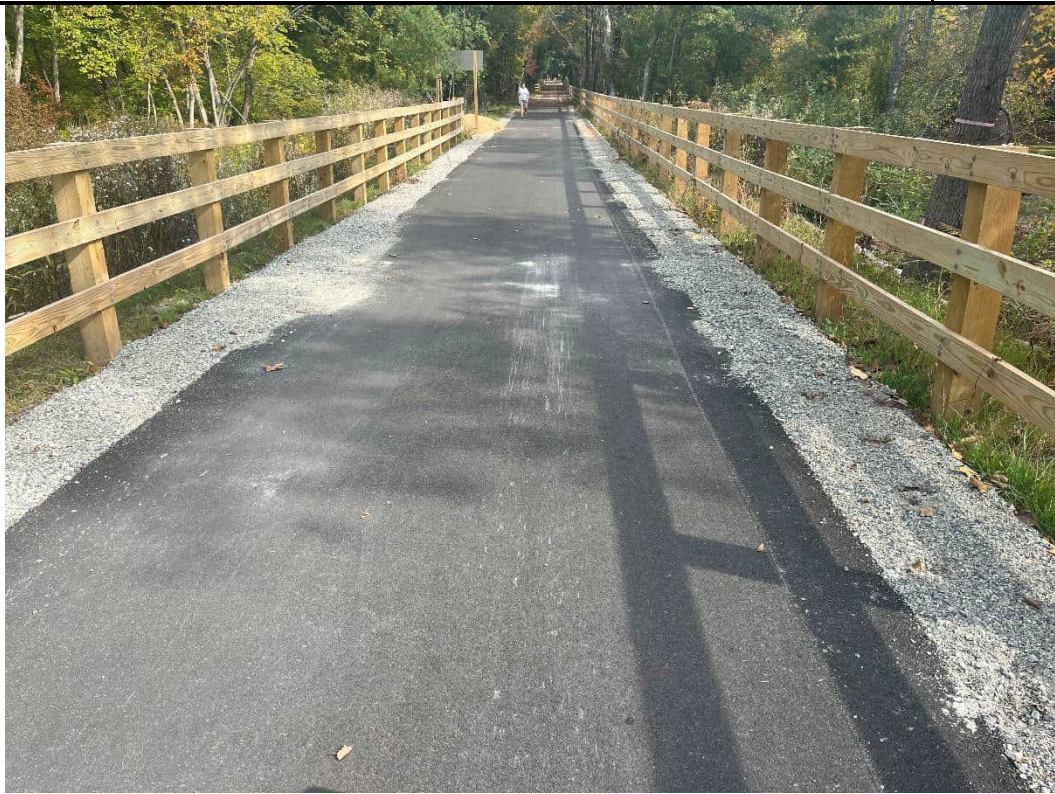
Photo No. 13 **Date:** 10/4/2024

View of a location where crushed stone has migrated on to the path at Station 312+00 per Long Term Compliance Action Item 58.

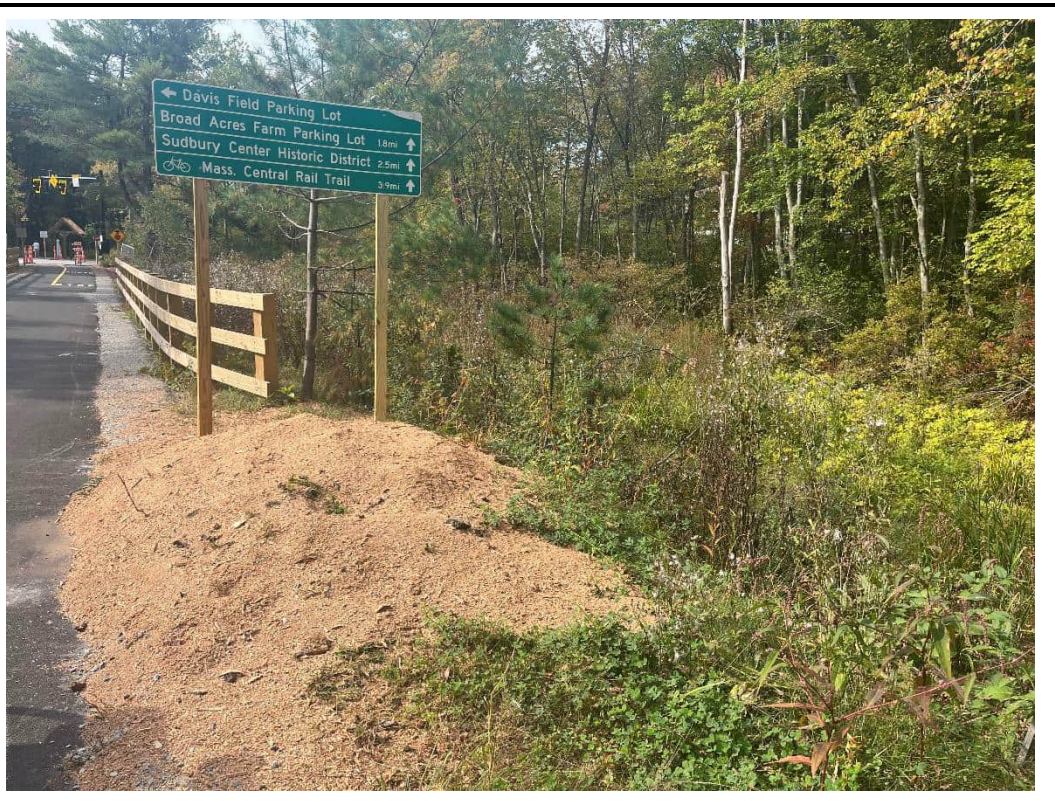
Photo No. 14 **Date:** 10/4/2024

Item	Location/ Description	Observation Date	Resolution Due Date	Recommended Resolution / Resolution Date	Comments/Updates
60	Multiple piles of wood shavings were observed along the trail shoulders. In some locations, wood shavings are located directly adjacent to Resource Areas. Priority: High	10/4/2024	10/18/2024	Remove wood shavings from the shoulders.	
53	Stone was observed requiring removal from the swale on the east side of the trail at Station 172+00 to 173+00 Priority: High	7/29/2024	8/6/2024	Remove stone from the swale.	8/5/2024 - Observation remains. 8/7/2024 - Observation remains. 8/12/2024 - Observation remains. Material was observed to have migrated within the swale to Station 173+50. 8/16/2024 - Stone is still present within the swale. 8/20/2024 - Observation remains. Crushed stone has migrated further down the swale to Station 171+50. 8/27/2024 - Observation remains. Stone is still present within the swale. 9/3/2024 - Observation remains. 9/10/2024 - Observation remains. Stone is still present within the swale. 9/16/2024 - Observation remains. The contractor indicated that the stone within the swale would be hand removed. 9/23/2024 - Observation remains. 9/27/2024 - Observation remains. It appears as though some stone has migrated further south down the swale. 10/4/2024 - Observation remains. Stone is still present within the swale.

Typical view of a pile of wood shavings that requires removal at Station 317+00 per Compliance Action Item 60. This condition was observed in multiple locations along the trail.
