Environmental Monitor Construction Site Inspection Report
MassDOT Project #608164 Construction Contract # 119678
EM Report #28

Project Description: Bruce Freeman Rail Trail Right-of-Way
 Permit Description(s): Order of Conditions (MGL Chapter 131, Section 40 and 310 CMR 10.00, Mass DEP File No. 301-1362); 2022 EPA NPDES General Permit for Discharges from Construction Areas; U.S. Army Corps of Engineers Permit No NAE-2021-01975.

Project Name:	Bruce Freeman Rail Trail - Phase 2d - Sudbury
Date of Inspections:	10/15/2024
Bi Weekly/ Monthly Period Covered:	October Weekly Inspection #3
Inspector's Name(s):	Anna Haznar
Inspectors' Contact Information:	ahaznar@beta-inc.com

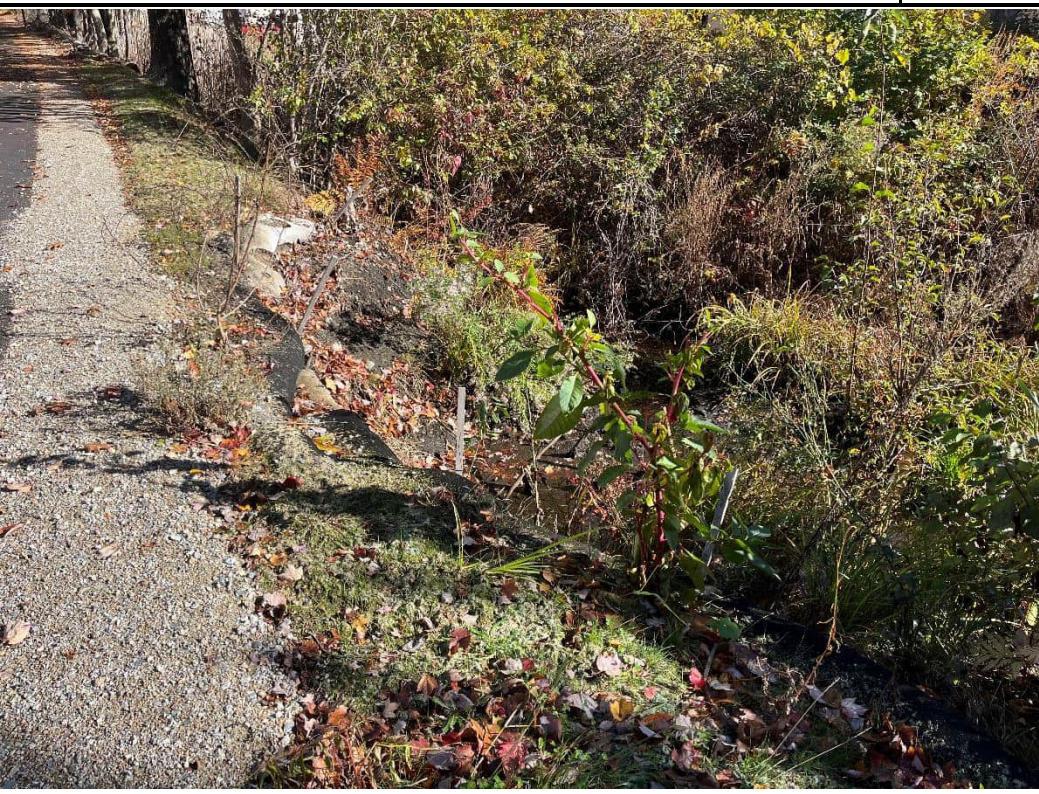
<p>Site Location Bruce Freeman Rail Trail Right-of-Way</p>		<p>BETA Project No. 24.10326.23</p>
<p>Photo No. 1</p>	<p>Date: 10/15/2024</p>

43	<p>Overtopped compost filter tubes and exposed soils beyond the limits of work at Station 105+00 Priority: High</p>	6/7/2024	6/14/2024	<p>Stabilize the area with the approved seed mixture and provide interim stabilization such as straw mulch.</p>	<p>6/14/2024 - Observation remains. 6/17/2024 - Observation remains. 6/24/2024 - Observation remains. 6/27/2024 - Observation remains. 7/8/2024 - Observation remains. 7/15/2024 - Observation remains. 7/22/2024 - Observation remains. 7/29/2024 - Observation remains. 8/5/2024 - Observation remains. 8/7/2024 - Observation remains. 8/12/2024 - Observation remains. Some material has migrated off of the compost filter tubes due to erosion. 8/16/2024 - Observation remains. 8/20/2024 - Application of the approved seed mixture is required at this location. 8/27/2024 - Observation remains. 9/3/2024 - Observation remains. 9/10/2024 - Observation remains. Application of the approved seed mixture is required at this location. 9/16/2024 - Observation remains. 9/23/2024 - Observation remains. 9/27/2024 - Observation remains. 10/4/2024 - Hydroseed has been applied here; however, the contractor should provide an update on long-term slope stabilization plans. 10/8/2024 - Observation remains. Germination has not been observed. 10/15/2024 - Observation remains. Germination has not been observed.</p>

44	<p>Slopes require stabilization / additional seed due to lack of compost filter tubes at 105+00 and 106+00 Priority: High</p>	6/7/2024	6/14/2024	<p>Stabilize the slope with the approved seed mixture and provide interim stabilization such as straw mulch.</p>	<p>6/14/2024 - Observation remains. 6/17/2024 - Observation remains. 6/24/2024 - Observation remains. 6/27/2024 - Observation remains. 7/8/2024 - Observation remains. 7/15/2024 - Observation remains. 7/22/2024 - Observation remains. 7/29/2024 - Regrowth of vegetation has been observed in this area. This item will remain open until the area is fully stabilized. 8/5/2024 - Observation remains. 8/7/2024 - Regrowth of vegetation has been observed but the area is not yet fully stabilized. 8/12/2024 - Observation remains. 8/16/2024 - Observation remains. 8/20/2024 - Application of the approved seed mixture is required at this location. 8/27/2024 - Vegetation has partially stabilized this area; however, seed should be applied. 9/3/2024 - Observation remains. 9/10/2024 - Observation remains. Application of the approved seed mixture is require at this location. 9/16/2024 - Observation remains. 9/23/2024 - Observation remains. Application of the approved seed mixture is require at this location. 9/27/2024 - Observation remains. The contractor reached out and indicated this area was hydroseeded after the inspection occurred. 10/4/2024 - Hydroseed has been applied here and the item will remain open until the area is fully stabilized. 10/8/2024 - Observation remains. Germination has not been observed. 10/15/2024 - Observation remains. Germination has not been observed.</p>

<p>Direction Photo Taken: Toward the Northeast</p>		
<p>Description: View of the overtopped compost filter tube beyond the limits of work and the recently applied hydroseed at Station 105+00 per Compliance Action Item 43 and 44.</p>		
<p>Photo No. 2</p>	<p>Date: 10/15/2024</p>

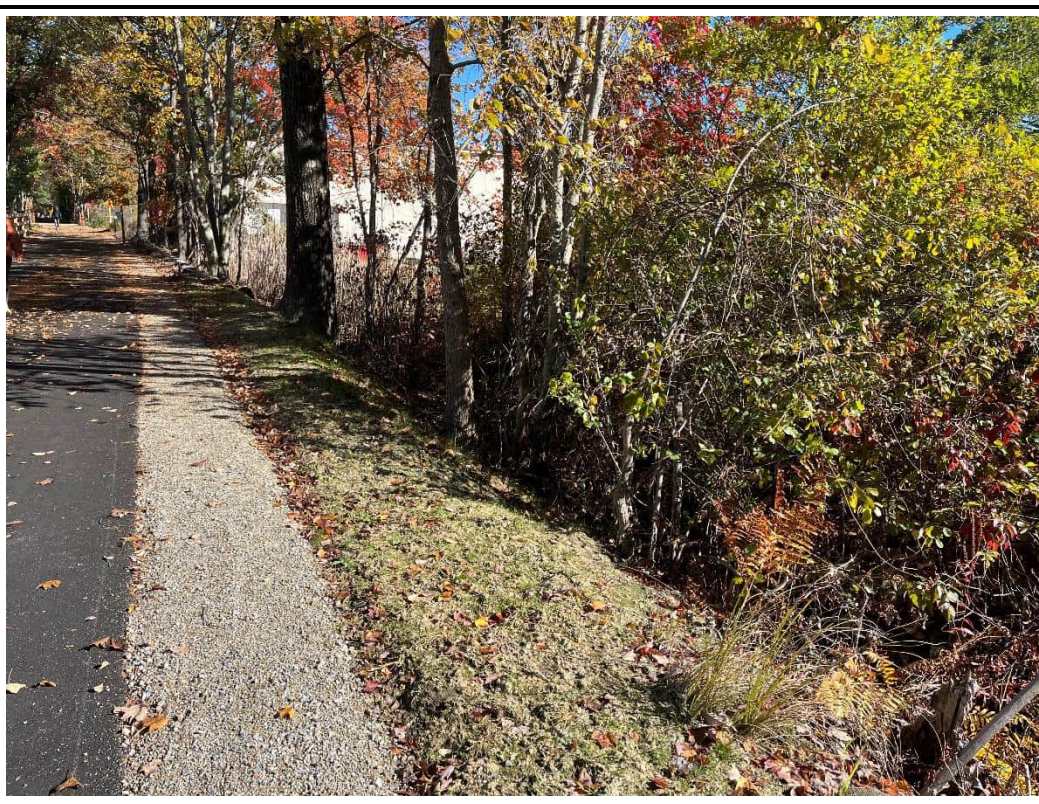
<p>Direction Photo Taken: Toward the North</p>		
<p>Description: View of recently applied hydroseed along the slope at Station 106+00 per Compliance Action Item 44.</p>

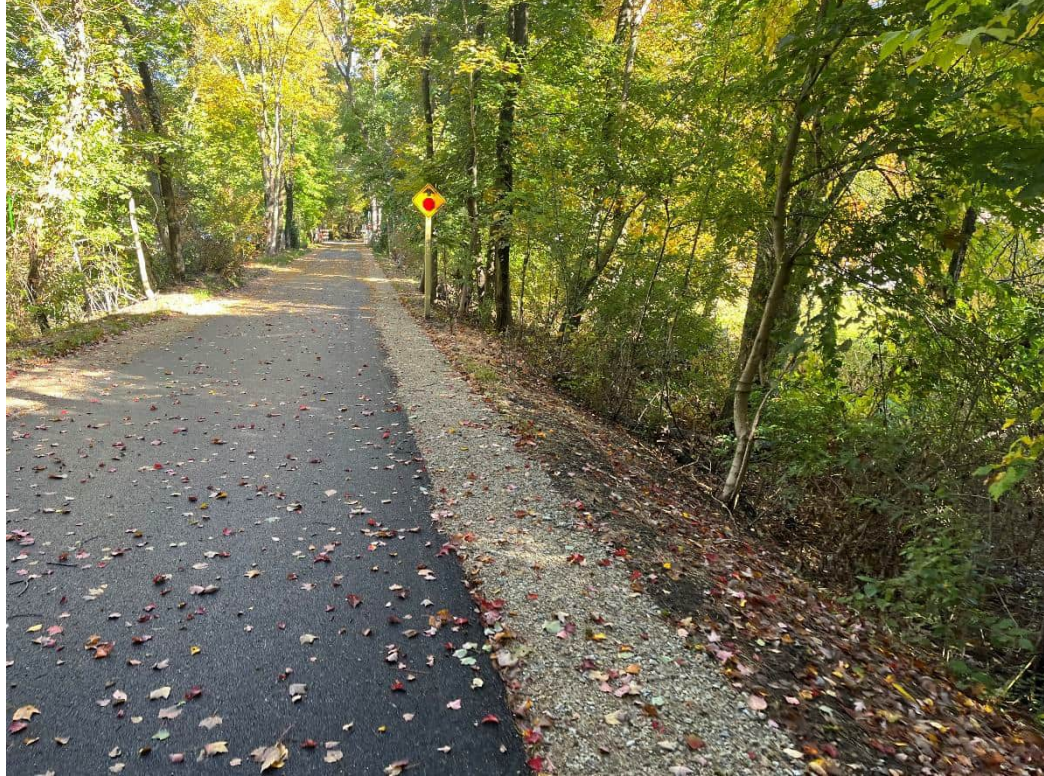
Photo No. 3 **Date:**
10/15/2024

Item	Location/ Description	Observation Date	Resolution Due Date	Recommended/Discussed Resolution	Comments/Updates
59	Multiple locations of exposed soils along the Project corridor require stabilization Priority: High	9/3/2024	9/10/2024	The contactor should apply the approved seed mixture to areas of exposed soils and place straw.	9/3/2024 - Herbicide application caused multiple areas along the path to be no longer stabilized. If thatch is present in these locations the thatch should be removed before seeding occurs. A location near Station 320+50 has been cleared outside of the limit of work and requires stabilization. Other areas along the path where seed did not germinate should be reseeded with the approved seed mix and straw should be placed on the areas of exposed soil. 9/10/2024 - Observation remains, see previous update. A few locations along the trail have been hydroseeded but a majority of the locations of exposed soil require seed and stabilization. 9/16/2024 - Observation remains. The contactor indicated areas of bare soil will be hydroseeded. 9/23/2024 - Observation remains. It does not appear as though any hydroseeding has been done since the last inspection. Areas throughout the trail require removal of thatch and application of seed for stabilization. 9/27/2024 - Observation remains. The contractor reached out and indicated all areas of exposed soils south of Hudson Road were hydroseeded after the inspection occurred. 10/4/2024 - All areas south of Hudson Road were not seeded using hydroseed; hydroseed was applied in a few locations, but there are still large areas of exposed soil both south and north of Hudson Road that require seeding. Thatch was not removed in any areas before hydroseed was applied. The contractor should provide the tag from the seed mix that was used to the Conservation Commission to ensure that the required native seed mix was used per the design plans. Once vegetation has sufficiently stabilized, this item will be closed. 10/8/2024 - Observation remains. See update from 10/4/2024. No additional hydroseed has been applied since the last inspection. 10/15/2024 - Observation remains. See update from 10/4/2024. No additional hydroseed has been applied. No germination has been observed in areas where hydroseed was applied.

View of an area that is no longer stabilized due to herbicide application at Station 140+00 per Long Term Compliance Action Item 59.

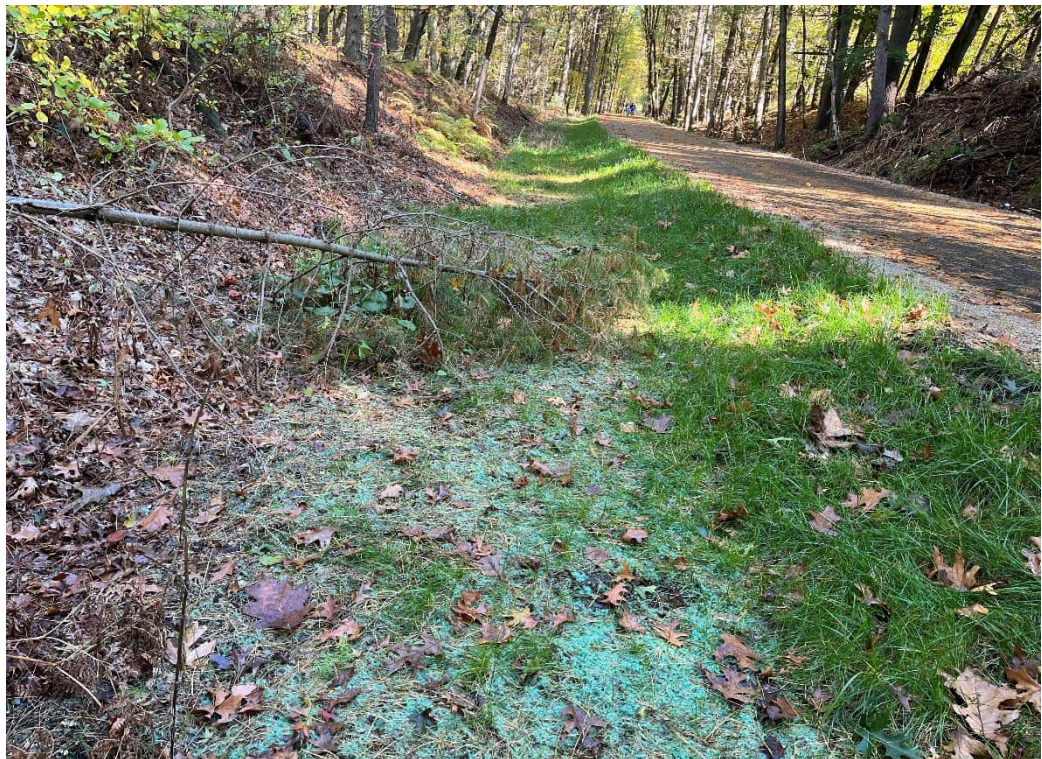
Photo No. 4 **Date:**
10/15/2024

View of an area that has been hydroseeded with no germination at Station 148+00 per Long Term Compliance Action Item 59.

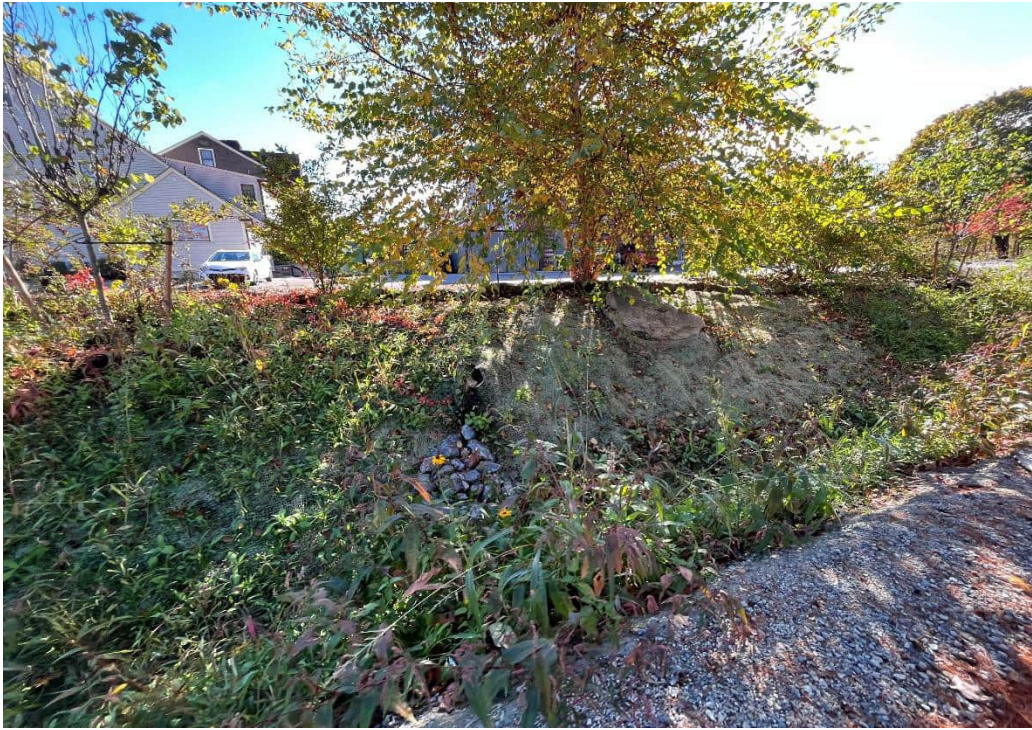
Photo No. 5 **Date:**
10/15/2024

6	<p>Exposed sediment slope at Station 172+00 to 175+00 Priority: High</p>	5/8/2024	5/15/2024	<p>Install temporary sediment controls along the slope such as jute netting and/or straw following the application of seed.</p>	<p>5/16/2024 - Observation remains. 5/21/2024 - Observation remains. 5/28/2024 - Partial germination was observed. 5/31/2024 - See previous update. 6/7/2024 - Further earthwork has occurred and soils require stabilization. 6/14/2024 - Observation remains. 6/17/2024 - Observation remains. 6/24/2024 - Observation remains. 6/27/2024 - The area has been regraded and loam has been spread. New trees have been planted upgradient of the swale. Stabilization is still required. 7/8/2024 - Jute netting has been installed over the applied seed, and the area will be monitored for germination. 7/15/2024 - See previous update. 7/22/2024 - Observation remains. 7/29/2024 - Observation remains. 8/5/2024 - Observation remains. 8/7/2024 - Regrowth of vegetation was observed in this location. This item will remain open until stabilization has been completed. 8/12/2024 - Observation remains. 8/16/2024 - Observation remains. 8/20/2024 - Application of the approved seed mixture is required at this location. 8/27/2024 - Observation remains. 9/3/2024 - Vegetation that is present in this location generally consists of lady's thumb smartweed, a non-native species. Removal of non-native species and application of the approved seed mixture is required at this location. 9/16/2024 - See previous update. 9/23/2024 - Observation remains. See 9/3/2024 update. 9/27/2024 - Observation remains. The contractor reached out hydroseed has been applied to this area. 10/4/2024 - Hydroseed has been applied to this area; the hydroseed was observed to have been applied over the erosion control blanket that is located in this area. Once vegetation has sufficiently stabilized this area the item will be closed. The contractor should provide the tag from the seed mix that was used to the Conservation Commission to ensure that the required native seed mix was used per the design plans. 10/8/2024 - Observation remains. See update from 10/4/2024. 10/15/2024 - Observation remains. See update from 10/4/2024.</p>

View of hydroseed applied along slopes at Station 172+00 to 175+00 per Compliance Action Item 6.

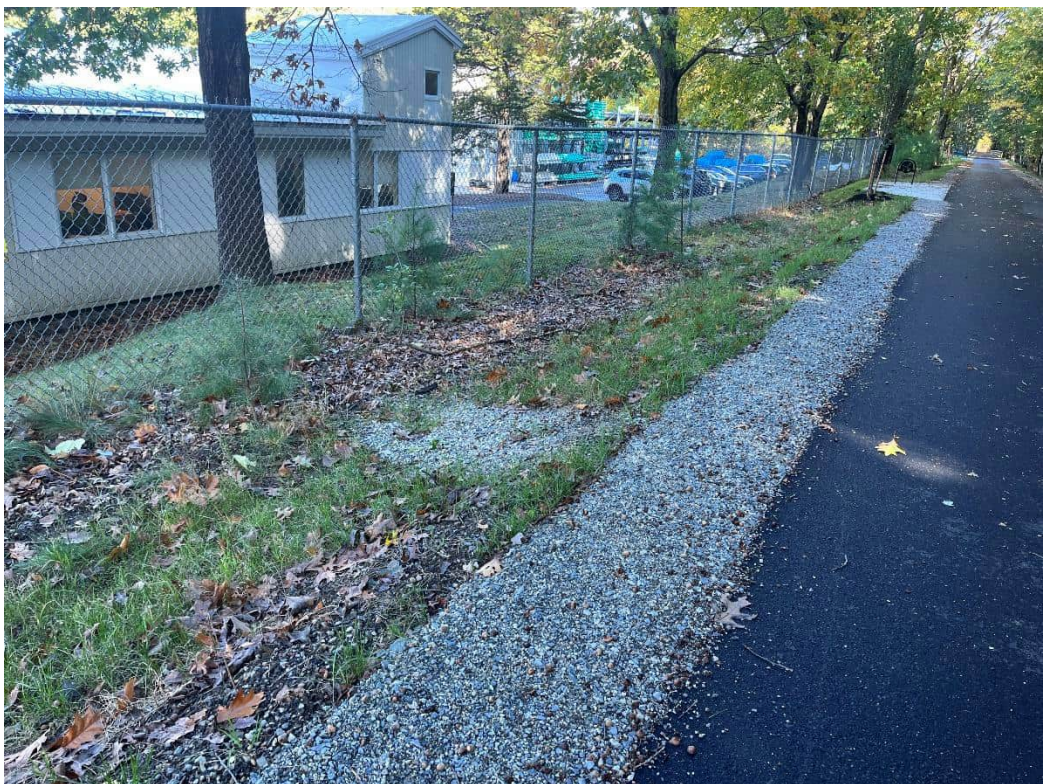
Photo No. 6 **Date:**
10/15/2024

Typical view of an area where crushed stone has migrated off of the path at Station 181+00 per Compliance Action Item 59. This condition was observed in multiple locations along the trail.

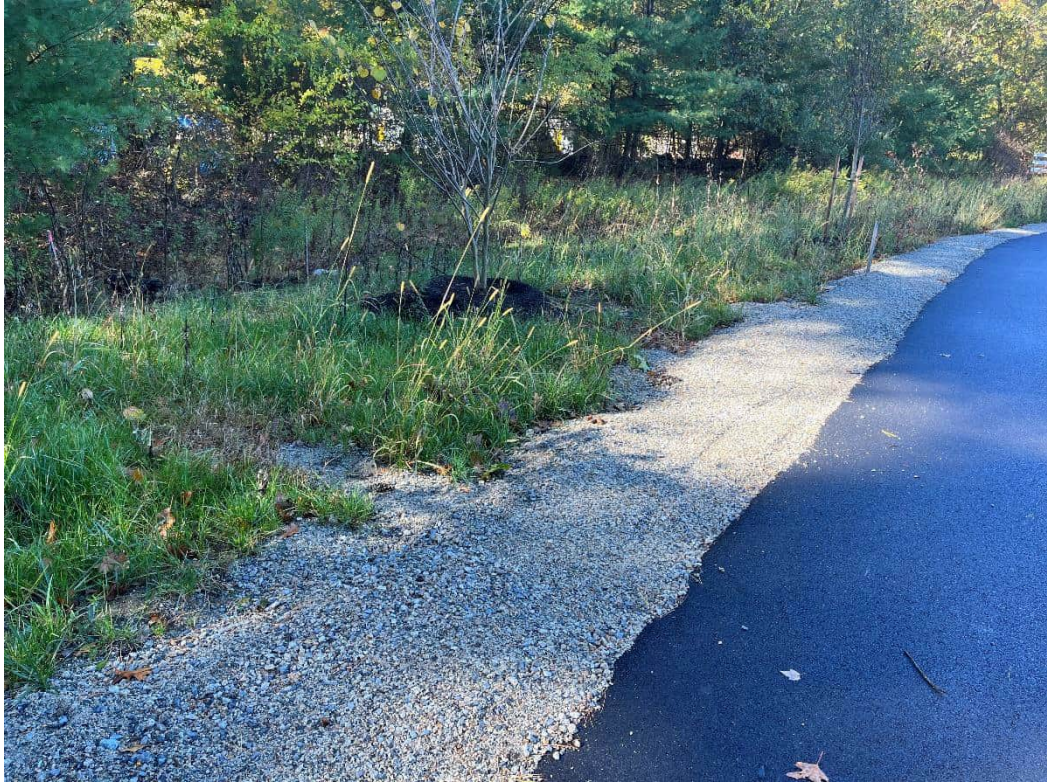
Photo No. 7 **Date:** 10/15/2024

58	Crushed stone used for the dense graded crush stone shoulders has been observed as migrating both onto the path, off the sides of the path, and into the adjacent Resource Areas throughout the Project Priority: High	8/7/2024	8/14/2024	Remove all crushed stone from Resource Areas and develop a plan to cease discharges of stone.	<p>8/12/2024 - Crushed stone is still present in varying amounts throughout the path and on the sides of the path.</p> <p>8/16/2024 - Observation remains.</p> <p>8/20/2024 - Crushed stone has been removed from some adjacent resource areas but is still observed as migrating onto and off of the path in multiple locations throughout the Project.</p> <p>8/27/2024 - Crushed stone has been observed as migrating from the shoulders throughout the path.</p> <p>9/3/2024 - Crushed stone was observed as migrating both onto the path and off the side of the path in multiple locations. Stone was observed to have discharged to the cattle crossing at Station 190+50 and within the streambed at Station 215+00 to 216+00. Crushed stone was observed to have been placed on the root system of a fallen tree at Station 310+00 near Bank flag #BF4-108.</p> <p>9/10/2024 - Observation remains. Crushed stone is still present within the cattle crossing, the streambed, and on the root system of the fallen tree. Crushed stone continues to migrate on to and off of the path.</p> <p>9/16/2024 - Observation remains. The contractor indicated the locations where crushed stone has migrated off the path will be hand removed and crushed stone will be swept off the path prior to the opening of the trail.</p> <p>9/23/2024 - Observation remains. It does not appear as though crushed stone that has migrated onto or off of the path has been removed in any location along the Project. More crushed stone has migrated onto the path throughout significant portions of the path.</p> <p>9/27/2024 - Observation remains. Crushed stone is still located on the side of the path and on the path in varying amounts.</p> <p>10/4/2024 - Crushed stone has been removed from multiple locations along the trail but was still observed on and on the sides of the trail in several locations.</p> <p>10/8/2024 - Observation remains. Crushed stone is still present in multiple locations on and off the sides of the path.</p> <p>10/15/2024 - Observation remains. Crushed stone is still present in multiple locations on and off the sides of the path.</p>

View of crushed stone that has migrated off of the shoulders at Station 1003+00 per Long Term Compliance Action Item 58.

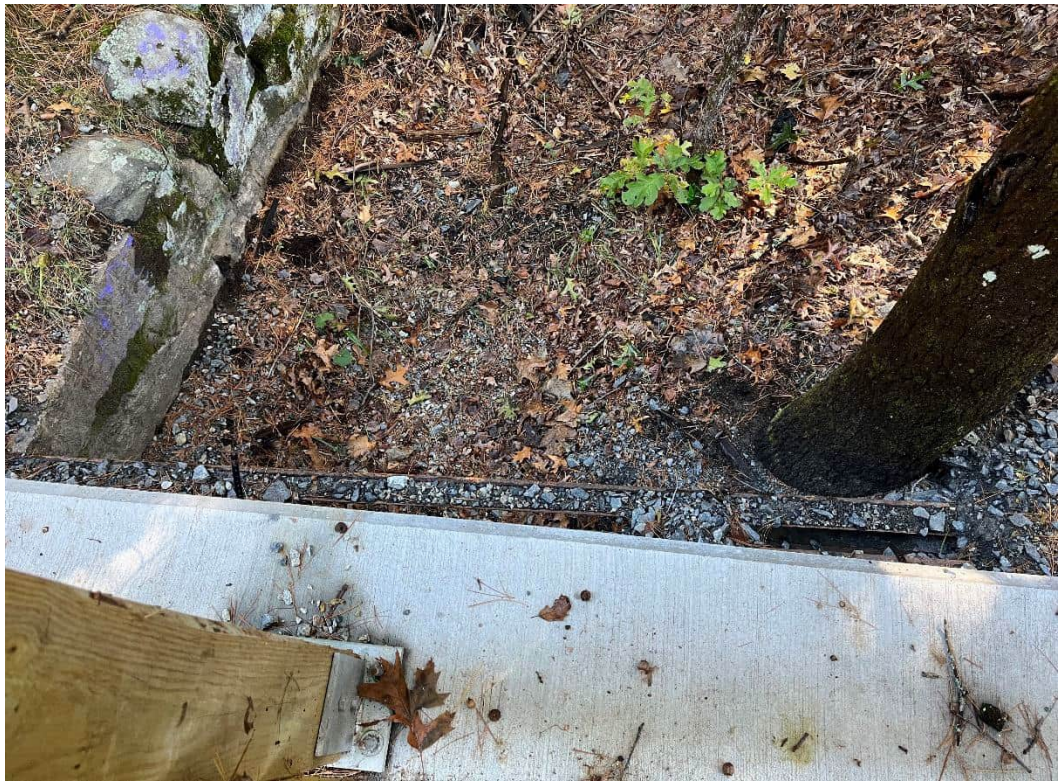
Photo No. 8 **Date:** 10/15/2024

View of crushed stone that has discharged into the cattle crossing at Station 190+50 per Long Term Compliance Action Item 58.

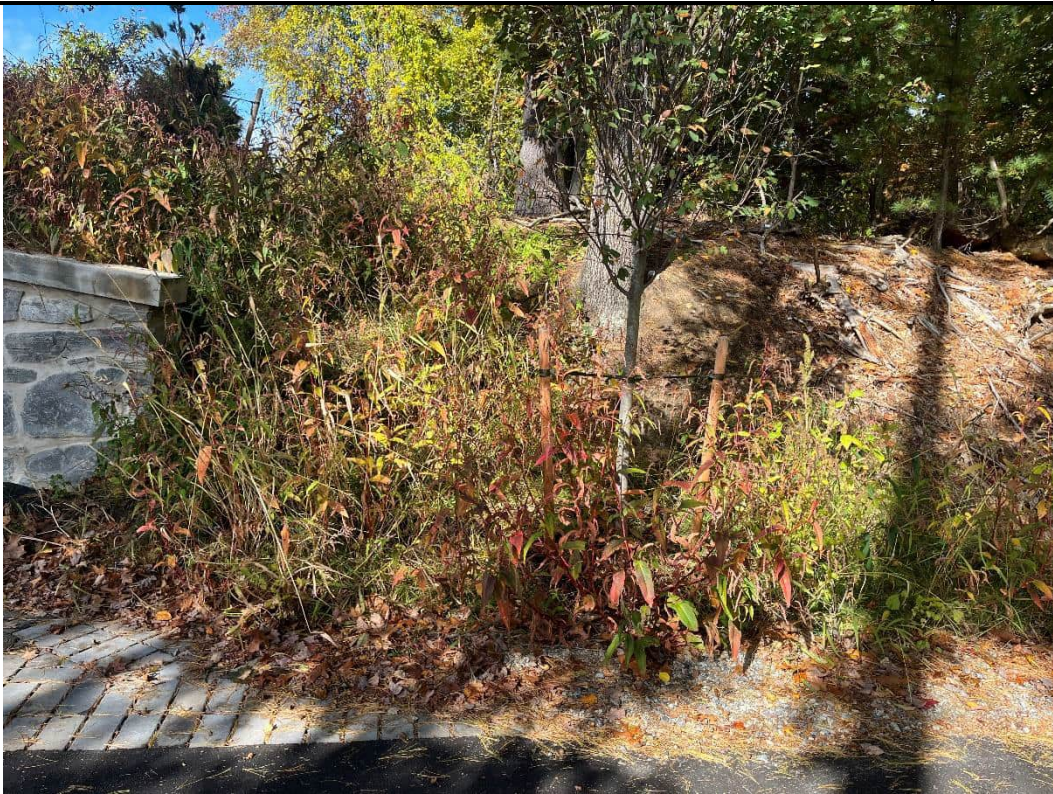
Photo No. 11 **Date:**
10/15/2024

34	Sediment is eroding downhill from behind the cemented stone masonry wall at Station 217+45 Priority: Low	5/28/2024	6/4/2024	Apply seed and temporarily stabilize the soils along the slope with straw, jute netting, etc.	<p>5/31/2024 - Observation remains. 6/7/2024 - Observation remains. 6/14/2024 - Observation remains. 6/17/2024 - Observation remains. 6/24/2024 - Observation remains. 6/27/2024 - Rills were raked, loam was added, and hydroseed was applied. 7/8/2024 - Observation remains. Grass was observed to be germinating at this location. Comment will remain open until stabilization is complete. 7/8/2024 - See previous update. 7/15/2024 - Additional hydroseed is required due to washouts. 7/22/2024 - Observation remains. 7/29/2024 - Observation remains. 8/5/2024 - Observation remains. 8/7/2024 - Regrowth of vegetation has been observed in this area. This item will remain open until the area is fully stabilized. 8/12/2024 - Observation remains. Regrowth has stabilized a portion of this hill; however, reseeding and additional temporary stabilized measures are recommended on the section that is currently unvegetated. 8/16/2024 - Observation remains. 8/20/2024 - Application of the approved seed mixture is required at this location. 8/27/2024 - Observation remains. 9/3/2024 - Vegetation that is present in this location generally consists of lady's thumb smartweed (<i>Persicaria maculosa</i>), a non-native species. Removal of non-native species and application of the approved seed mixture is required at this location. 9/10/2024 - Observation remains. See previous update. 9/16/2024 - Observation remains. See update from 9/3/2024. 9/23/2024 - Observation remains. See update from 9/3/2024. 9/27/2024 - Observation remains. 10/4/2024 - Observation remains. See update from 9/3/2024. 10/8/2024 - Observation remains. See update from 9/3/2024. 10/15/2024 - Observation remains. See update from 9/3/2024.</p>

View of the location of exposed soil and erosion at Station 217+45 per Compliance Action Item 34.

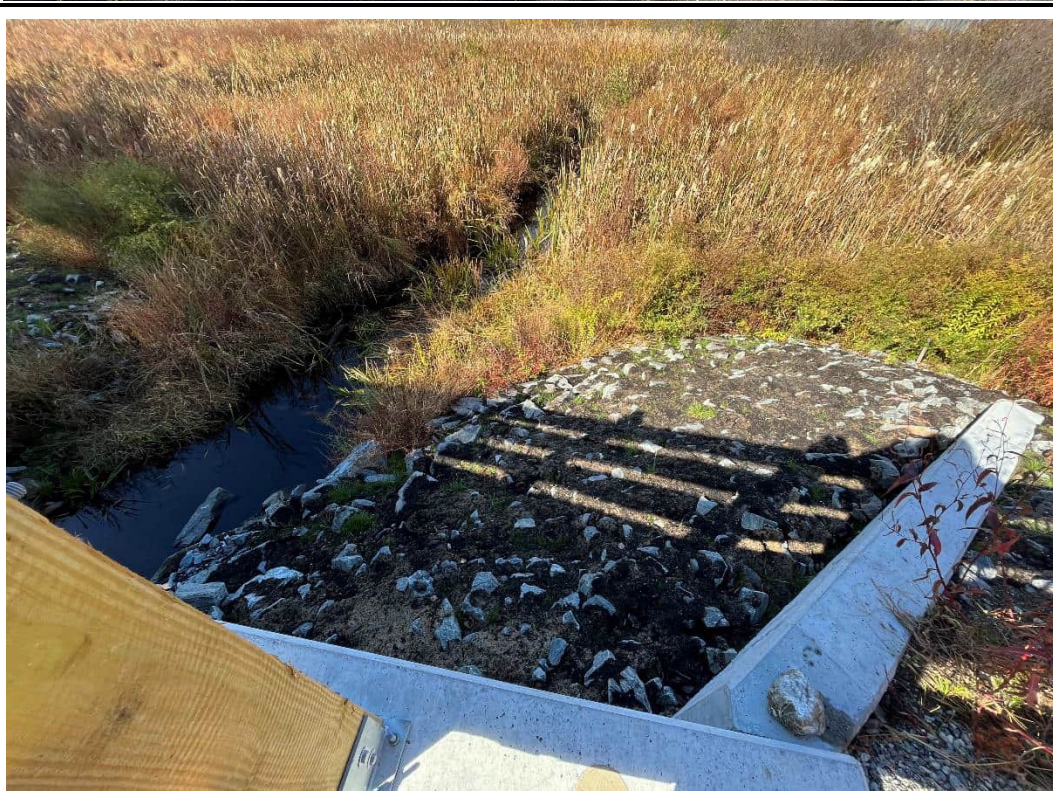
Photo No. 12 **Date:**
10/15/2024

View of an area requiring stabilization at Station 264+50 adjacent to Pantry Brook per Long Term Compliance Action Item 59. occurred.

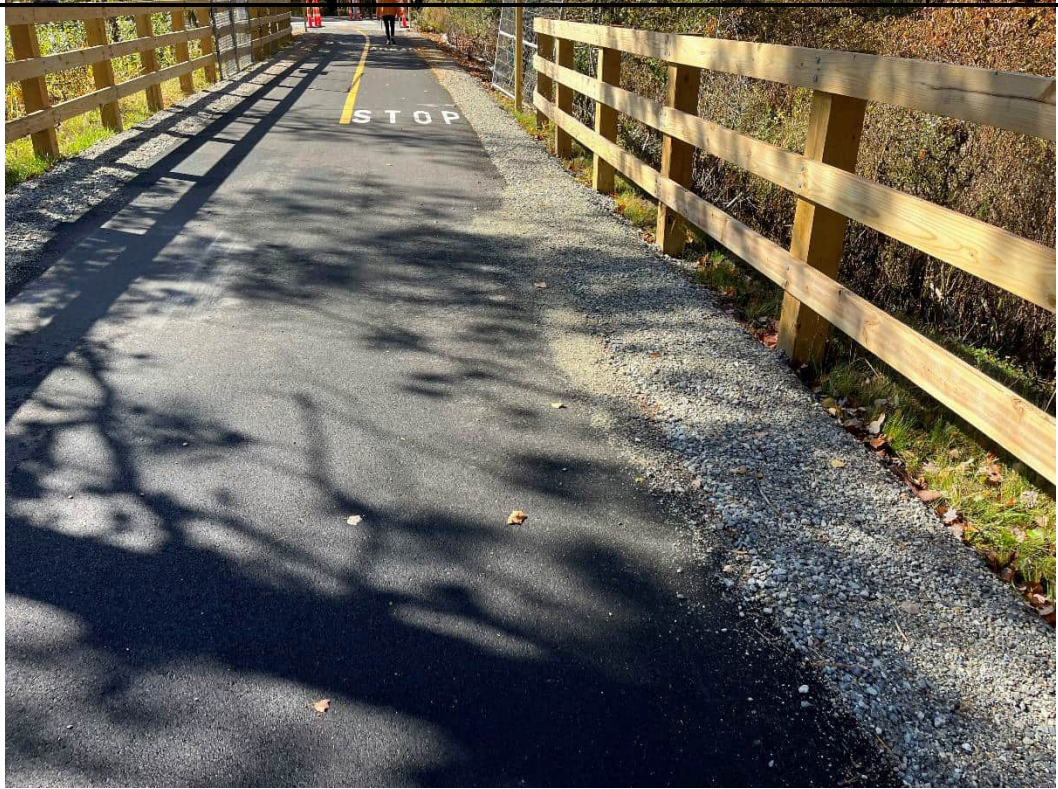
Photo No. 13 **Date:** 10/15/2024

View of a location where crushed stone has migrated on to the path at Station 312+00 per Long Term Compliance Action Item 58.

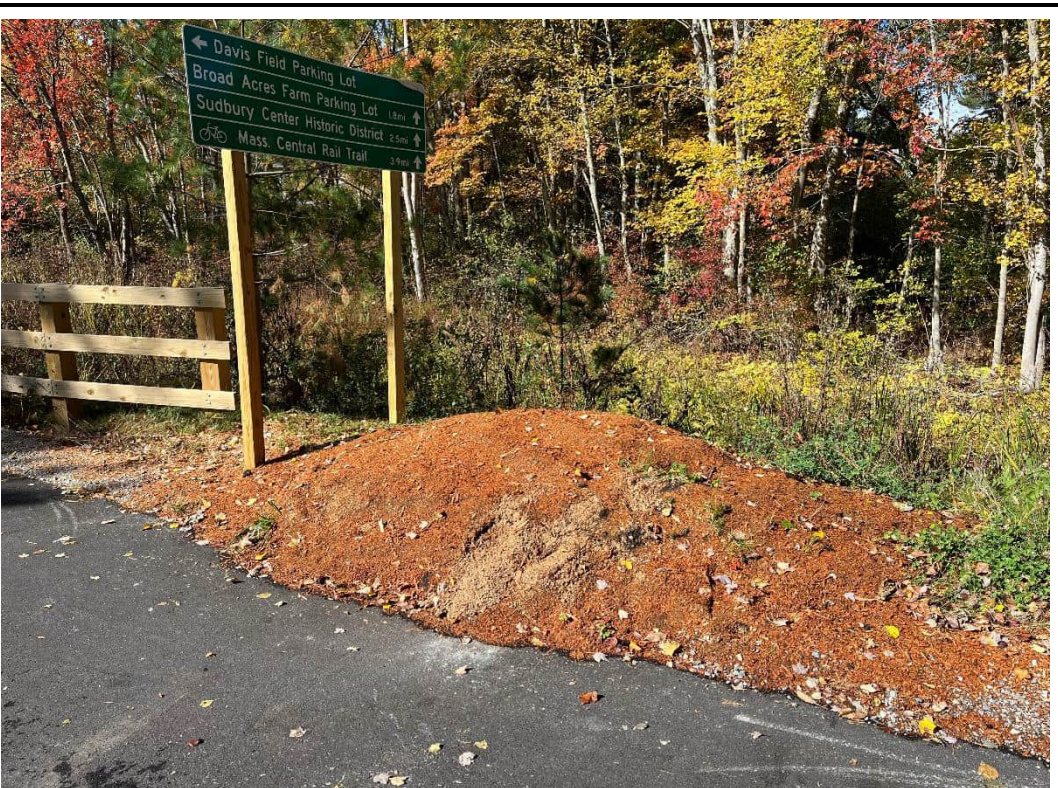
Photo No. 14 **Date:** 10/15/2024

Item	Location/ Description	Observation Date	Resolution Due Date	Recommended Resolution / Resolution Date	Comments/Updates
60	Multiple piles of wood shavings were observed along the trail shoulders. In some locations, wood shavings are located directly adjacent to Resource Areas. Priority: High	10/4/2024	10/18/2024	Remove wood shavings from the shoulders.	10/8/2024 - Observation remains. Wood shaving that are in the pile at Station 315+00 were observed as migrating down into the adjacent Resource Areas and require removal. 10/15/2024 - Observation remains. Piles of wood shavings are present in multiple locations throughout the trail and wood shavings are present within the Bank/BVW adjacent to Station 315+00.
53	Stone was observed requiring removal from the swale on the east side of the trail at Station 172+00 to 173+00 Priority: High	7/29/2024	8/6/2024	Remove stone from the swale.	8/5/2024 - Observation remains. 8/7/2024 - Observation remains. 8/12/2024 - Observation remains. Material was observed to have migrated within the swale to Station 173+50. 8/16/2024 - Stone is still present within the swale. 8/20/2024 - Observation remains. Crushed stone has migrated further down the swale to Station 171+50. 8/27/2024 - Observation remains. Stone is still present within the swale. 9/3/2024 - Observation remains. 9/10/2024 - Observation remains. Stone is still present within the swale. 9/16/2024 - Observation remains. The contractor indicated that the stone within the swale would be hand removed. 9/23/2024 - Observation remains. 9/27/2024 - Observation remains. It appears as though some stone has migrated further south down the swale. 10/4/2024 - Observation remains. Stone is still present within the swale. 10/8/2024 - Observation remains. 10/15/2024 - Observation remains. Stone is covered with vegetation in some areas within the swale.

Typical view of a pile of wood shavings that requires removal at Station 315+00 per Compliance Action Item 60. This condition was observed in multiple locations along the trail.

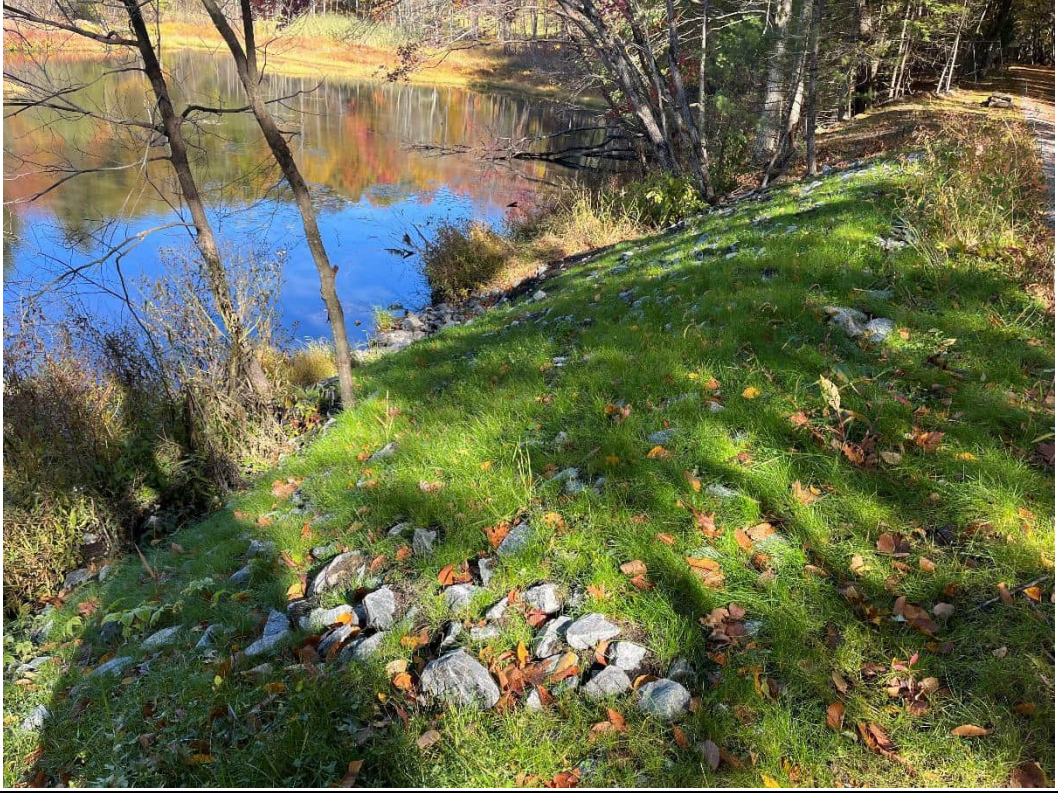
Site Location Bruce Freeman Rail Trail Right-of-Way		BETA Project No. 24.10326.23
Photo No. 15	Date: 10/15/2024

42	Riprap slope extends beyond limits of work along the WF1 Series wetland near flags 103 to 107 Priority: High	5/28/2024	6/4/2024	The Contractor should confirm if this work was permitted by the Conservation Commission, as it does not appear to be a part of the approved plans/impacts. MassDOT should be consulted on next steps regarding notification and potential restoration.	<p>5/31/2024 - Observation remains.</p> <p>6/7/2024 - Observation remains.</p> <p>6/14/2024 - Riprap slope has been altered and active construction is repairing the area.</p> <p>6/17/2024 - During this inspection, additional work in support of the repair/potential replacement of an underlying pipe has been ongoing. It is recommended that the contractor confirm that they have coordinated with the Conservation Commission for this work and provide a restoration plan for the area once work is complete.</p> <p>6/24/2024 - During this inspection, BETA was informed that the existing cast iron pipe was replaced with a new concrete 12-inch reinforced concrete pipe. It appears that riprap was replaced along the side slopes to mirror conditions observed prior to this inspection.</p> <p>6/27/2024 - During this inspection, the area was observed to have been rolled and prepared for paving. Hydroseed was applied and plantings were installed.</p> <p>7/8/2024 - Germination was observed and the area will be monitored for stabilization. See previous updates regarding Conservation Commission coordination.</p> <p>7/15/2024 - This area could not be assessed due to paving operations ongoing during the inspection.</p> <p>7/22/2024 - See previous updates regarding Conservation Commission coordination.</p> <p>7/29/2024 - Observation remains.</p> <p>8/5/2024 - Observation remains.</p> <p>8/7/2024 - Observation remains.</p> <p>8/12/2024 - Observation remains. Regrowth of vegetation has been observed in this area and will continue to be monitored.</p> <p>8/16/2024 - Observation remains.</p> <p>8/20/2024 - Observation remains.</p> <p>8/27/2024 - Observation remains.</p> <p>9/3/2024 - Observation remains.</p> <p>9/10/2024 - Observation remains.</p> <p>9/16/2024 - Observation remains.</p> <p>9/23/2024 - Observation remains.</p> <p>9/27/2024 - Observation remains.</p> <p>10/4/2024 - Observation remains.</p> <p>10/8/2024 - Observation remains.</p> <p>10/15/2024 - Observation remains.</p>

Direction Photo Taken: Toward the Northwest		
Description: View of the riprap slope that extends beyond the limit of work along the WF1 Series wetland at Station 332+00 per Long Term Compliance Action Item 42.
