Environmental Monitor Construction Site Inspection Report
MassDOT Project #608164 Construction Contract # 119678
EM Report #30

Project Description: Bruce Freeman Rail Trail Right-of-Way
 Permit Description(s): Order of Conditions (MGL Chapter 131, Section 40 and 310 CMR 10.00, Mass DEP File No. 301-1362); 2022 EPA NPDES General Permit for Discharges from Construction Areas; U.S. Army Corps of Engineers Permit No NAE-2021-01975.

Project Name:	Bruce Freeman Rail Trail - Phase 2d - Sudbury
Date of Inspections:	10/29/2024
Bi Weekly/ Monthly Period Covered:	October Weekly Inspection #5
Inspector's Name(s):	Anna Haznar
Inspectors' Contact Information:	ahaznar@beta-inc.com

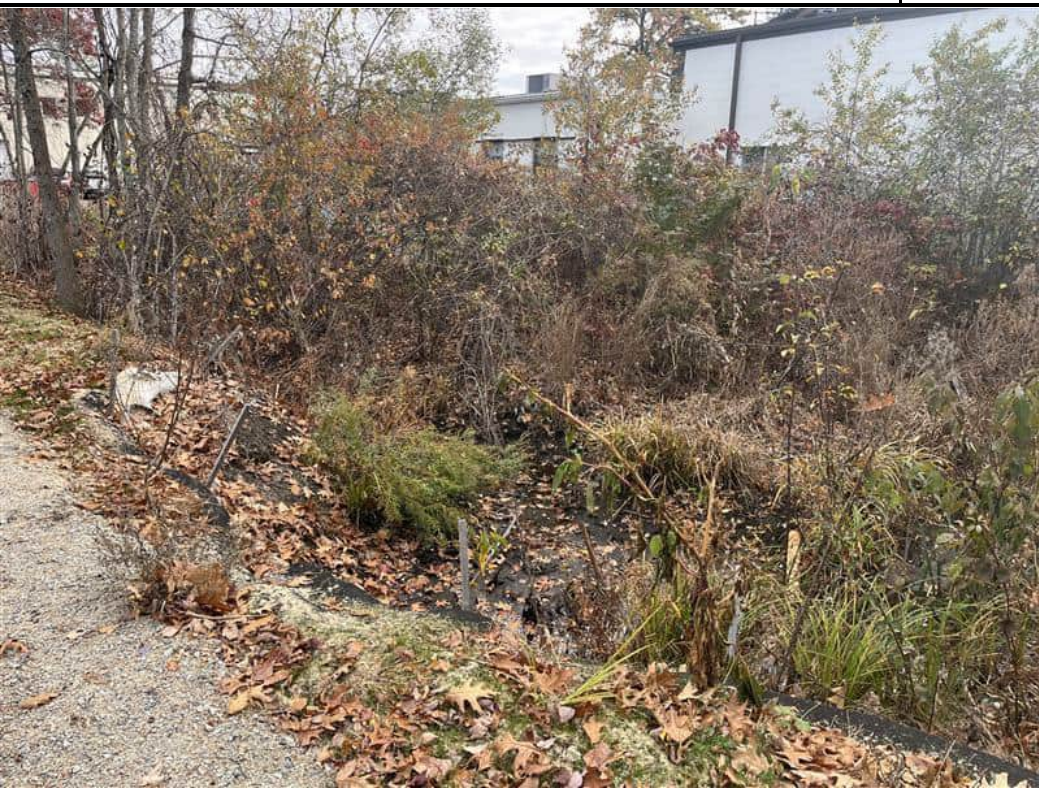
<p>Site Location Bruce Freeman Rail Trail Right-of-Way</p>		<p>BETA Project No. 24.10326.23</p>
<p>Photo No. 1</p>	<p>Date: 10/29/2024</p>

43	<p>Overtopped compost filter tubes and exposed soils beyond the limits of work at Station 105+00 Priority: High</p>	6/7/2024	6/14/2024	Stabilize the area with the approved seed mixture and provide interim stabilization such as straw mulch.	<p>6/14/2024 - Observation remains. 6/17/2024 - Observation remains. 6/24/2024 - Observation remains. 6/27/2024 - Observation remains. 7/8/2024 - Observation remains. 7/15/2024 - Observation remains. 7/22/2024 - Observation remains. 7/29/2024 - Observation remains. 8/5/2024 - Observation remains. 8/7/2024 - Observation remains. 8/12/2024 - Observation remains. Some material has migrated off of the compost filter tubes due to erosion. 8/16/2024 - Observation remains. 8/20/2024 - Application of the approved seed mixture is required at this location. 8/27/2024 - Observation remains. 9/3/2024 - Observation remains. 9/10/2024 - Observation remains. Application of the approved seed mixture is required at this location. 9/16/2024 - Observation remains. 9/23/2024 - Observation remains. 9/27/2024 - Observation remains. 10/4/2024 - Hydroseed has been applied here; however, the contractor should provide an update on long-term slope stabilization plans. 10/8/2024 - Observation remains. Germination has not been observed. 10/15/2024 - Observation remains. Germination has not been observed. 10/22/2024 - Observation remains. Some germination has been observed but the area is not considered stabilized. 10/29/2024 - Observation remains. No further germination has been observed since the last inspection.</p>

44	Slopes require stabilization / additional seed due to lack of compost filter tubes at 105+00 and 106+00 Priority: High	6/7/2024	6/14/2024	Stabilize the slope with the approved seed mixture and provide interim stabilization such as straw mulch.	<p>6/14/2024 - Observation remains. 6/17/2024 - Observation remains. 6/24/2024 - Observation remains. 6/27/2024 - Observation remains. 7/8/2024 - Observation remains. 7/15/2024 - Observation remains. 7/22/2024 - Observation remains. 7/29/2024 - Regrowth of vegetation has been observed in this area. This item will remain open until the area is fully stabilized. 8/5/2024 - Observation remains. 8/7/2024 - Regrowth of vegetation has been observed but the area is not yet fully stabilized. 8/12/2024 - Observation remains. 8/16/2024 - Observation remains. 8/20/2024 - Application of the approved seed mixture is required at this location. 8/27/2024 - Vegetation has partially stabilized this area; however, seed should be applied. 9/3/2024 - Observation remains. 9/10/2024 - Observation remains. Application of the approved seed mixture is require at this location. 9/16/2024 - Observation remains. 9/23/2024 - Observation remains. Application of the approved seed mixture is require at this location. 9/27/2024 - Observation remains. The contractor reached out and indicated this area was hydroseeded after the inspection occurred. 10/4/2024 - Hydroseed has been applied here and the item will remain open until the area is fully stabilized. 10/8/2024 - Observation remains. Germination has not been observed. 10/15/2024 - Observation remains. Germination has not been observed. 10/22/2024 - Observation remains. Some germination has been observed but the area is not considered stabilized. 10/29/2024 - Observation remains. No further germination has been observed since the last inspection.</p>

<p>Direction Photo Taken: Toward the Northeast</p>		
<p>Description: View of the overtopped compost filter tube beyond the limits of work and the recently applied hydroseed at Station 105+00 per Compliance Action Item 43 and 44.</p>		
<p>Photo No. 2</p>	<p>Date: 10/29/2024</p>

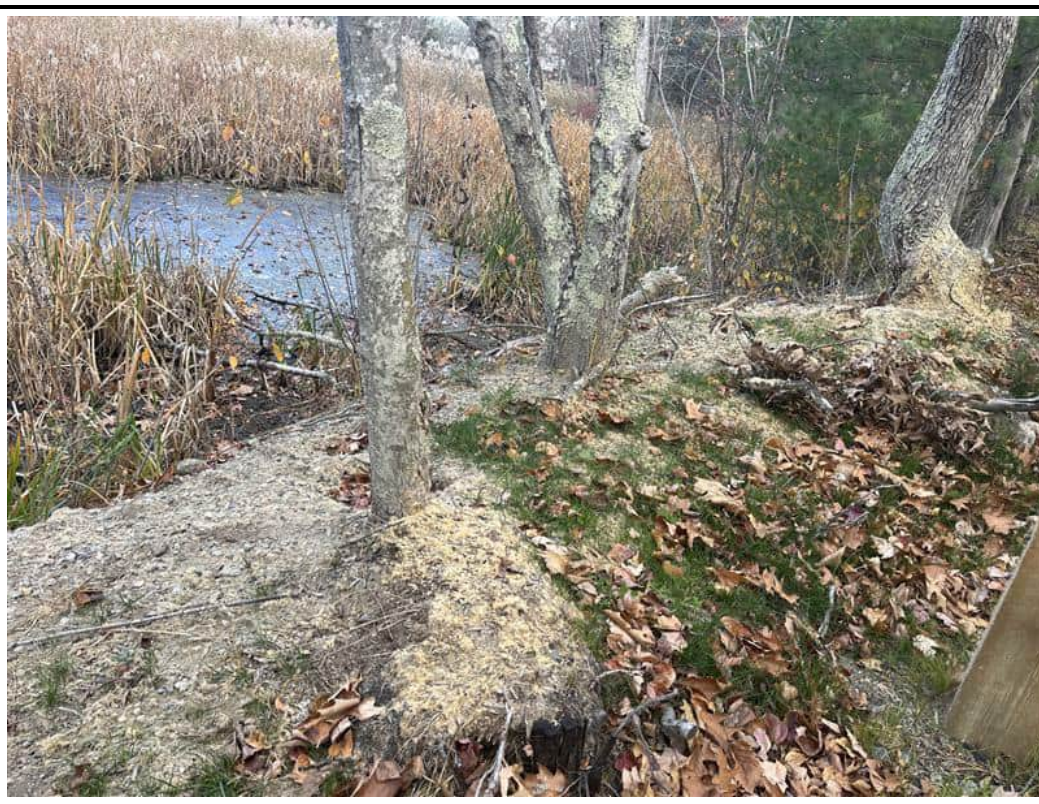
<p>Direction Photo Taken: Toward the North</p>		
<p>Description: View of recently applied hydroseed with no recent germination along the slope at Station 106+00 per Compliance Action Item 44.</p>

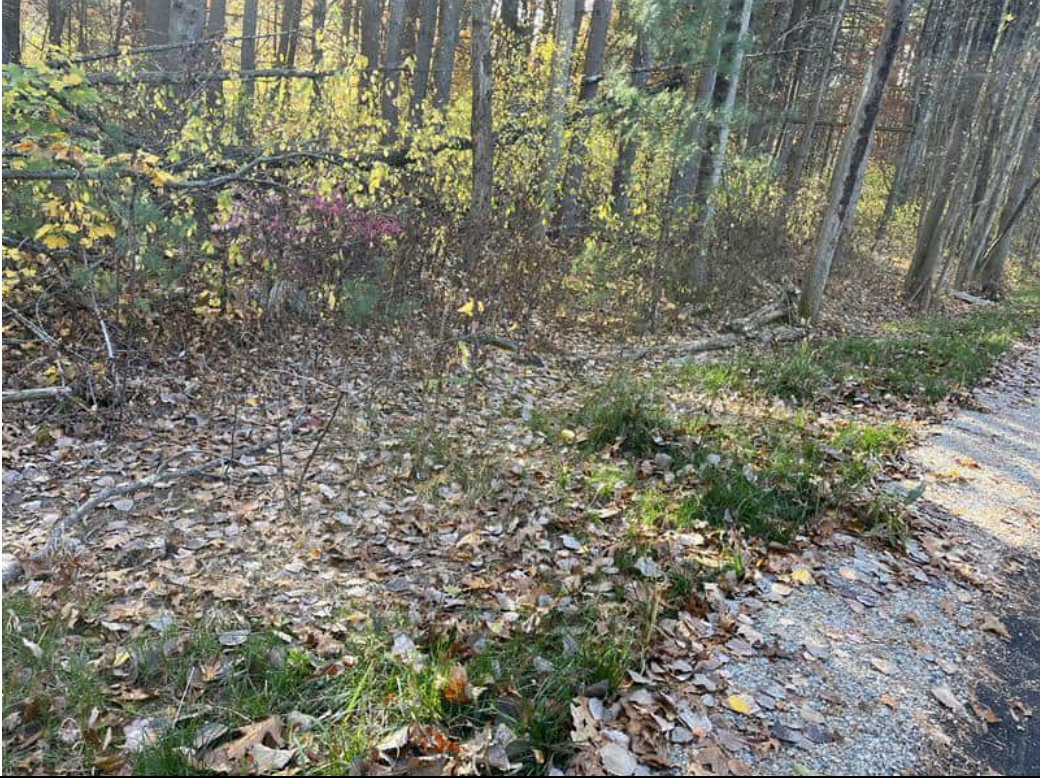
Site Location Bruce Freeman Rail Trail Right-of-Way		BETA Project No. 24.10326.23
Photo No. 3	Date: 10/29/2024

Item	Location/ Description	Observation Date	Resolution Due Date	Recommended/Discussed Resolution	Comments/Updates
59	Multiple locations of exposed soils along the Project corridor require stabilization Priority: High	9/3/2024	9/10/2024	The contactor should apply the approved seed mixture to areas of exposed soils and place straw.	<p>9/3/2024 - Herbicide application caused multiple areas along the path to be no longer stabilized. If thatch is present in these locations the thatch should be removed before seeding occurs. A location near Station 320+50 has been cleared outside of the limit of work and requires stabilization. Other areas along the path where seed did not germinate should be reseeded with the approved seed mix and straw should be placed on the areas of exposed soil.</p> <p>9/10/2024 - Observation remains, see previous update. A few locations along the trail have been hydroseeded but a majority of the locations of exposed soil require seed and stabilization.</p> <p>9/16/2024 - Observation remains. The contactor indicated areas of bare soil will be hydroseeded.</p> <p>9/23/2024 - Observation remains. It does not appear as though any hydroseeding has been done since the last inspection. Areas throughout the trail require removal of thatch and application of seed for stabilization.</p> <p>9/27/2024 - Observation remains. The contractor reached out and indicated all areas of exposed soils south of Hudson Road were hydroseeded after the inspection occurred.</p> <p>10/4/2024 - All areas south of Hudson Road were not seeded using hydroseed; hydroseed was applied in a few locations, but there are still large areas of exposed soil both south and north of Hudson Road that require seeding. Thatch was not removed in any areas before hydroseed was applied. The contractor should provide the tag from the seed mix that was used to the Conservation Commission to ensure that the required native seed mix was used per the design plans. Once vegetation has sufficiently stabilized, this item will be closed.</p> <p>10/8/2024 - Observation remains. See update from 10/4/2024. No additional hydroseed has been applied since the last inspection.</p> <p>10/15/2024 - Observation remains. See update from 10/4/2024. No additional hydroseed has been applied since the last inspection. No germination has been observed in areas where hydroseed was applied.</p> <p>10/22/2024 - Observation remains. See update from 10/4/2024. No additional hydroseed has been applied since the last inspection. Some germination has been observed in a few locations where hydroseed was previously applied.</p> <p>10/29/2024 - Observation remains. No additional hydroseed has been applied since the last inspection. If additional hydroseed will be applied leaf litter and thatch should be removed so the seed can make contact with the soil. See update from 10/4/2024.</p>

Direction Photo Taken: Toward the East		
Description: View of an area that is no longer stabilized due to herbicide application at Station 169+50 per Long Term Compliance Action Item 59.		
Photo No. 4	Date: 10/29/2024

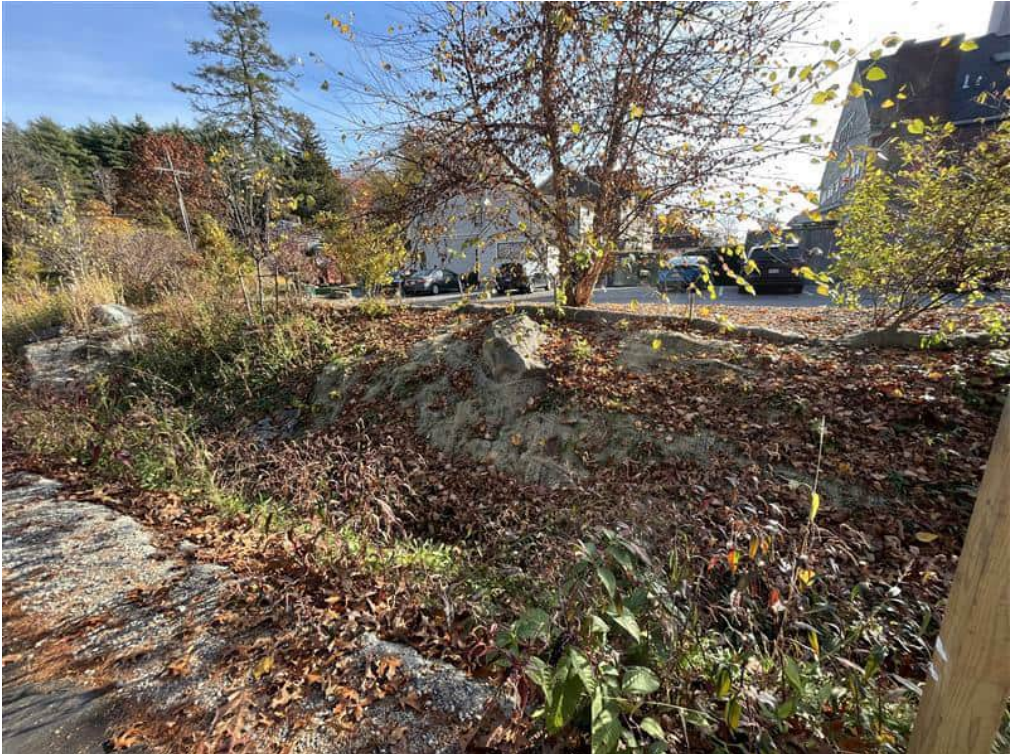
6	Exposed sediment slope at Station 172+00 to 175+00 Priority: High	5/8/2024	5/15/2024	Install temporary sediment controls along the slope such as jute netting and/or straw following the application of seed.	<p>5/16/2024 - Observation remains. 5/21/2024 - Observation remains. 5/28/2024 - Partial germination was observed. 5/31/2024 - See previous update. 6/7/2024 - Further earthwork has occurred and soils require stabilization. 6/14/2024 - Observation remains. 6/17/2024 - Observation remains. 6/24/2024 - Observation remains. 6/27/2024 - The area has been regraded and loam has been spread. New trees have been planted upgradient of the swale. Stabilization is still required. 7/8/2024 - Jute netting has been installed over the applied seed, and the area will be monitored for germination. 7/15/2024 - See previous update. 7/22/2024 - Observation remains. 7/29/2024 - Observation remains. 8/5/2024 - Observation remains. 8/7/2024 - Regrowth of vegetation was observed in this location. This item will remain open until stabilization has been completed. 8/12/2024 - Observation remains. 8/16/2024 - Observation remains. 8/20/2024 - Application of the approved seed mixture is required at this location. 8/27/2024 - Observation remains. 9/3/2024 - Vegetation that is present in this location generally consists of lady's thumb smartweed, a non-native species. Removal of non-native species and application of the approved seed mixture is required at this location. 9/16/2024 - See previous update. 9/23/2024 - Observation remains. See 9/3/2024 update. 9/27/2024 - Observation remains. The contractor reached out hydroseed has been applied to this area. 10/4/2024 - Hydroseed has been applied to this area; the hydroseed was observed to have been applied over the erosion control blanket that is located in this area. Once vegetation has sufficiently stabilized this area the item will be closed. The contractor should provide the tag from the seed mix that was used to the Conservation Commission to ensure that the required native seed mix was used per the design plans. 10/8/2024 - Observation remains. See update from 10/4/2024. 10/15/2024 - Observation remains. See update from 10/4/2024. 10/22/2024 - Observation remains. See update from 10/4/2024. 10/29/2024 - Observation remains. No germination has been observed in this location since the application of hydroseed. See update from 10/4/2024.</p>

Direction Photo Taken: Toward the West		
Description: View of hydroseed with no recent germination along slopes at Station 172+00 to 175+00 per Compliance Action Item 6.

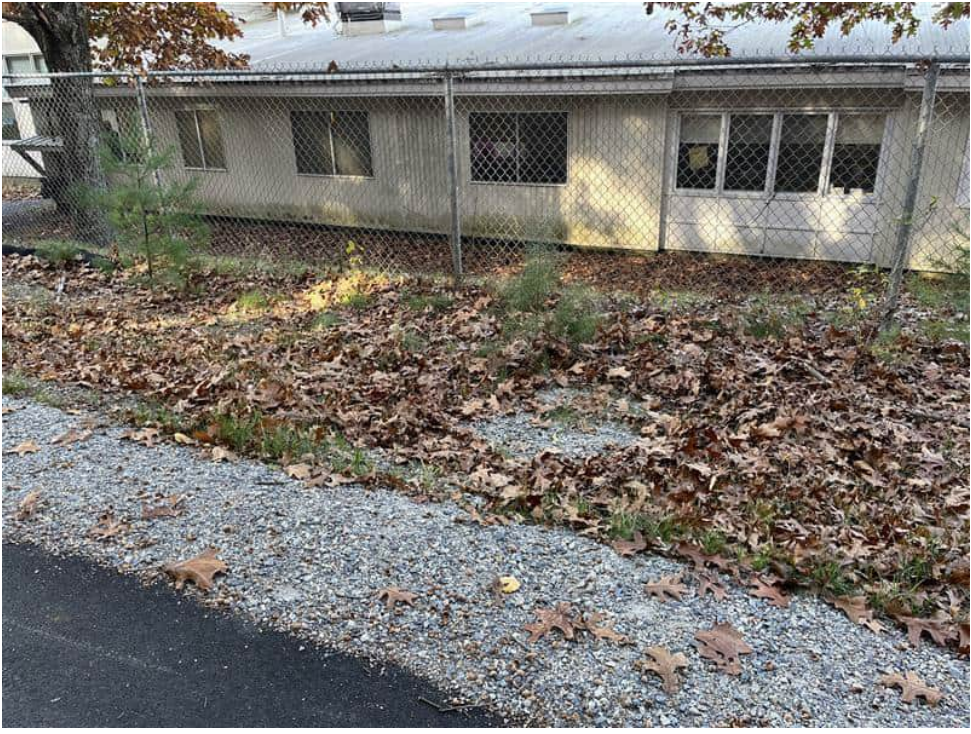
<p>Site Location Bruce Freeman Rail Trail Right-of-Way</p>		<p>BETA Project No. 24.10326.23</p>
<p>Photo No. 5</p>	<p>Date: 10/29/2024</p>

<p>Direction Photo Taken: Toward the East</p>		
<p>Description: Typical view of an area where crushed stone has migrated off of the path at Station 181+00 per Compliance Action Item 59. This condition was observed in multiple locations along the trail.</p>		
<p>Photo No. 6</p>	<p>Date: 10/29/2024</p>

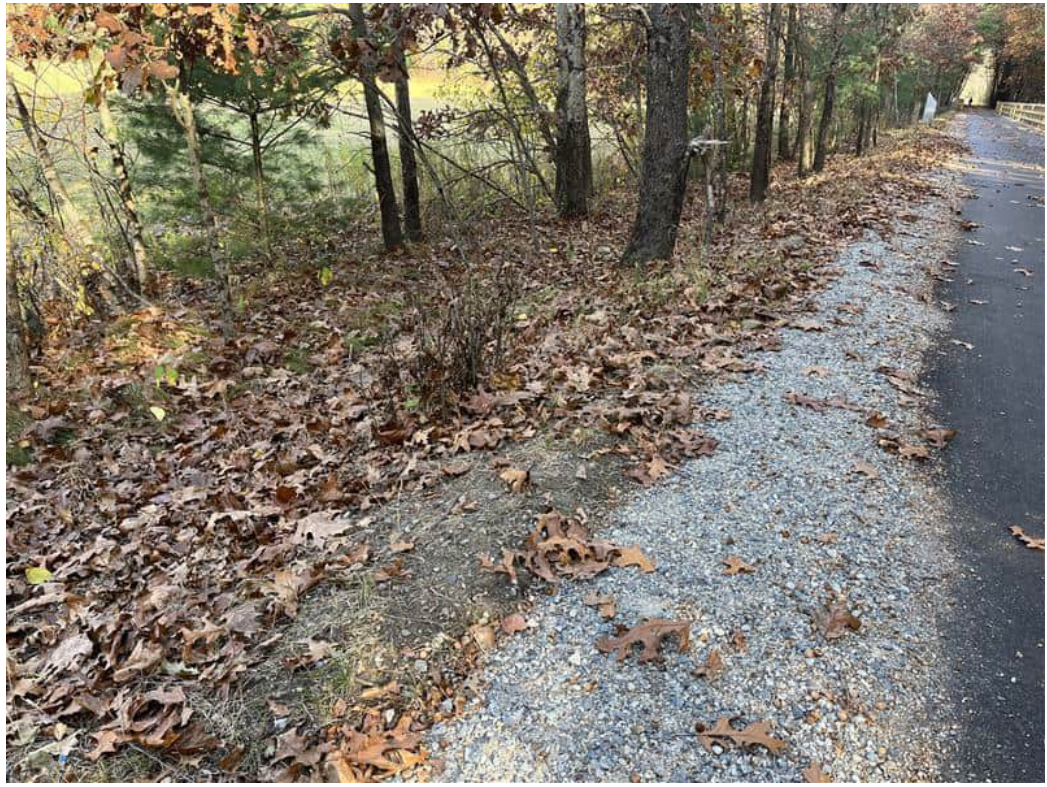
<p>Direction Photo Taken: Toward the West</p>		
<p>Description: View of an area that is no longer stabilized due to herbicide application at Station 187+00 per Long Term Compliance Action Item 59. Note that exposed soils are currently covered in leaf litter.</p>

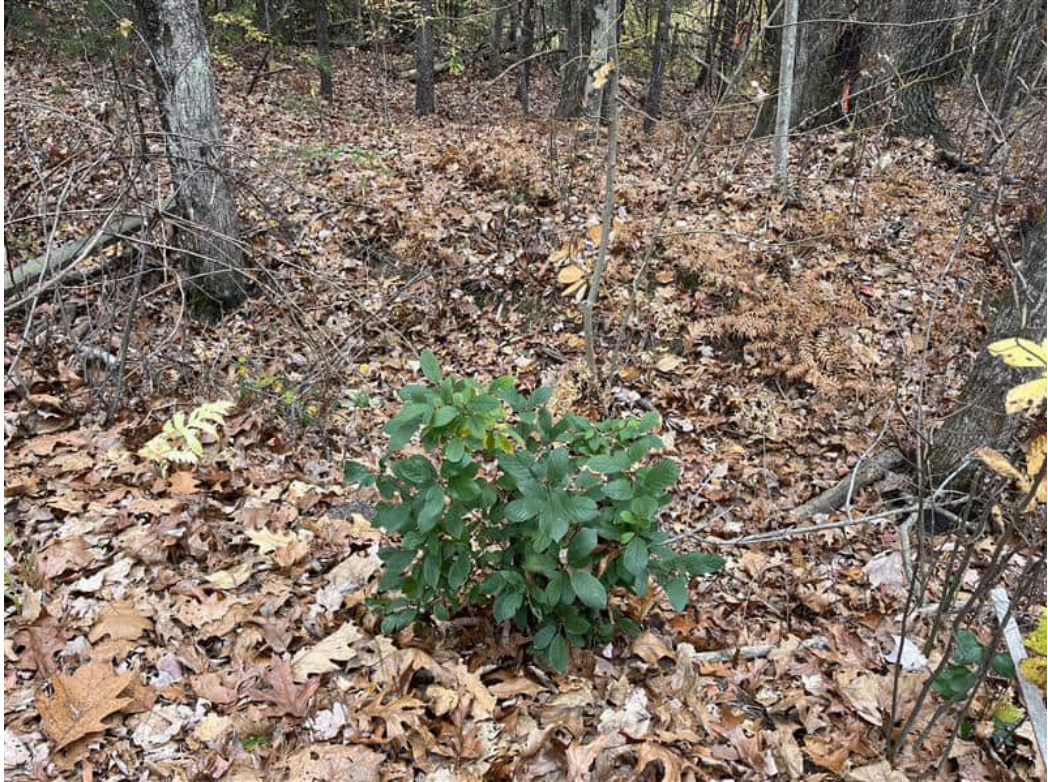
Photo No. 7 **Date:** 10/29/2024

Item	Location/ Description	Observation Date	Resolution Due Date	Recommended Resolution / Resolution Date	Comments/Updates
61	Invasive vegetation including Japanese knotweed (<i>Reynoutria japonica</i>), bittersweet (<i>Celastrus orbiculatus</i>), bush honeysuckle (<i>Lonicera</i> spp.), burning bush (<i>Euonymus alatus</i>), purple loosestrife (<i>Lythrum salicaria</i>), glossy buckthorn (<i>Frangula alnus</i>) and garlic mustard (<i>Alliaria petiolata</i>) have been observed throughout the path. Priority: High	10/22/2024	10/29/2024	Invasive Species should be removed by manual and/or chemical removal methods	10/29/2024 - Invasive species are present throughout the trail both within upland and Resource Areas. Populations of glossy buckthorn and purple loosestrife are present within the wetland replication area.
57-1	Japanese hops (<i>Humulus japonicus</i>) has been observed throughout the Project and requires removal Priority: High	10/22/2024	10/29/2024	The Contractor should manage remaining Japanese hops by hand pulling and the application of herbicide.	10/22/2024 - This Action Item has been reopened due to observations of both dead and living Japanese hops in select locations along the Project. BETA and MassDOT will coordinate further with the Sudbury Conservation Agent to clarify the extents of remaining living vegetation as removal efforts progress. 10/29/2024 - Plants that were observed as alive along Route 117 during the last inspection were observed to be wilting due to winter die back.

View of glossy buckthorn at Station 206+00 that requires removal per Compliance Action Item 61.

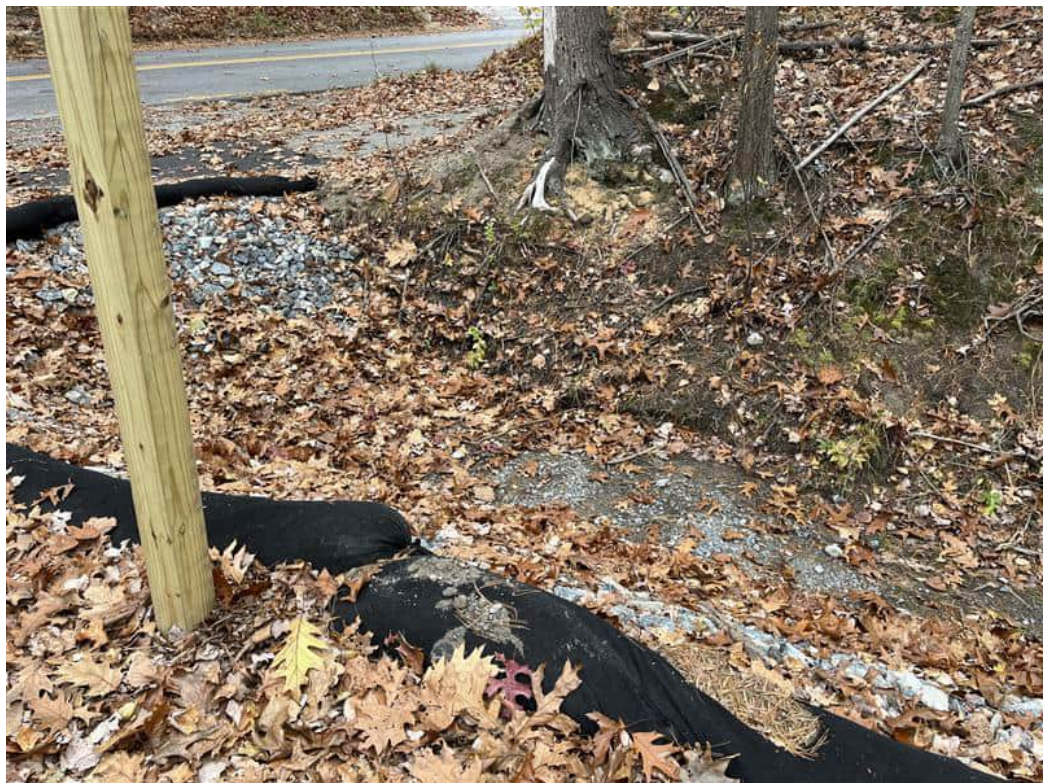
Photo No. 8 **Date:** 10/29/2024

58	Crushed stone used for the dense graded crush stone shoulders has been observed as migrating both onto the path, off the sides of the path, and into the adjacent Resource Areas throughout the Project Priority: High	8/7/2024	8/14/2024	Remove all crushed stone from Resource Areas and develop a plan to cease discharges of stone.	<p>8/12/2024 - Crushed stone is still present in varying amounts throughout the path and on the sides of the path.</p> <p>8/16/2024 - Observation remains.</p> <p>8/20/2024 - Crushed stone has been removed from some adjacent resource areas but is still observed as migrating onto and off of the path in multiple locations throughout the Project.</p> <p>8/27/2024 - Crushed stone has been observed as migrating from the shoulders throughout the path.</p> <p>9/3/2024 - Crushed stone was observed as migrating both onto the path and off the side of the path in multiple locations. Stone was observed to have discharged to the cattle crossing at Station 190+50 and within the streambed at Station 215+00 to 216+00. Crushed stone was observed to have been placed on the root system of a fallen tree at Station 310+00 near Bank flag #BF4-108.</p> <p>9/10/2024 - Observation remains. Crushed stone is still present within the cattle crossing, the streambed, and on the root system of the fallen tree. Crushed stone continues to migrate on to and off of the path.</p> <p>9/16/2024 - Observation remains. The contractor indicated the locations where crushed stone has migrated off the path will be hand removed and crushed stone will be swept off the path prior to the opening of the trail.</p> <p>9/23/2024 - Observation remains. It does not appear as though crushed stone that has migrated onto or off of the path has been removed in any location along the Project. More crushed stone has migrated onto the path throughout significant portions of the path.</p> <p>9/27/2024 - Observation remains. Crushed stone is still located on the side of the path and on the path in varying amounts.</p> <p>10/4/2024 - Crushed stone has been removed from multiple locations along the trail but was still observed on and on the sides of the trail in several locations.</p> <p>10/8/2024 - Observation remains. Crushed stone is still present in multiple locations on and off the sides of the path.</p> <p>10/15/2024 - Observation remains. Crushed stone is still present in multiple locations on and off the sides of the path.</p> <p>10/22/2024 - Observation remains. Crushed stone is still present in multiple locations on and off the sides of the path. The crushed stone shoulders along Station 1000+00 to 1003+00 has been moved back into the shoulders and regraded.</p> <p>10/29/2024 - Observation remains. Crushed stone is still present in multiple locations on and off the sides of the path.</p>

View of the location where crushed stone has discharged into the streambed at Station 215+50 per Long Term Compliance Action Item 58.

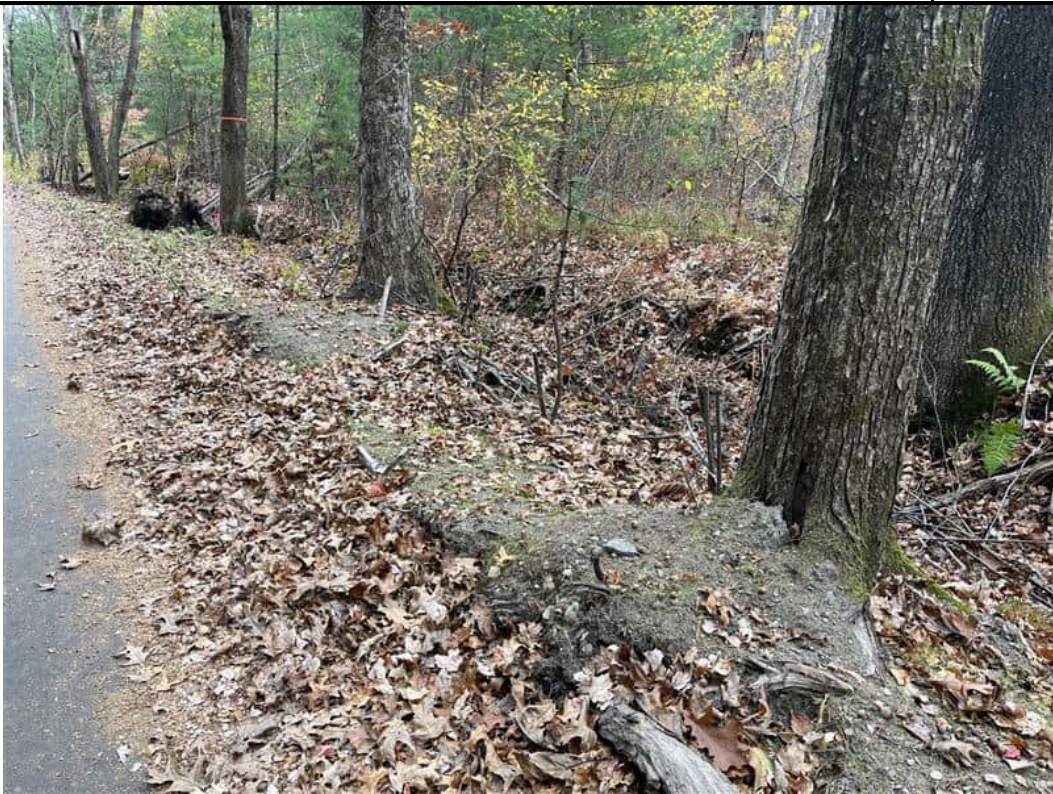
Photo No. 11 **Date:** 10/29/2024

View of a location that requires stabilization at Station 299+00 per Long Term Compliance Action Item 59. Note that exposed soils are currently covered in leaf litter.

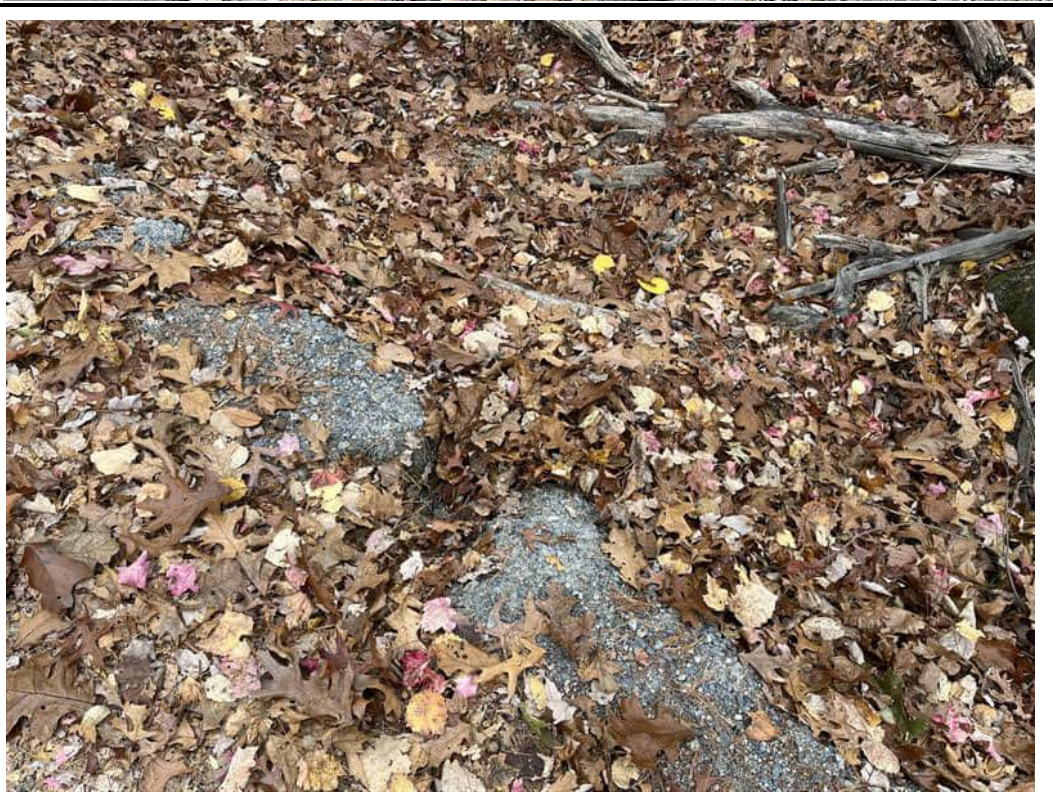
Photo No. 12 **Date:** 10/29/2024

View of crushed stone that requires removal from the swale at Station 303+00 per Long Term Compliance Action Item 58. Note that crushed stone is currently covered by leaf litter.

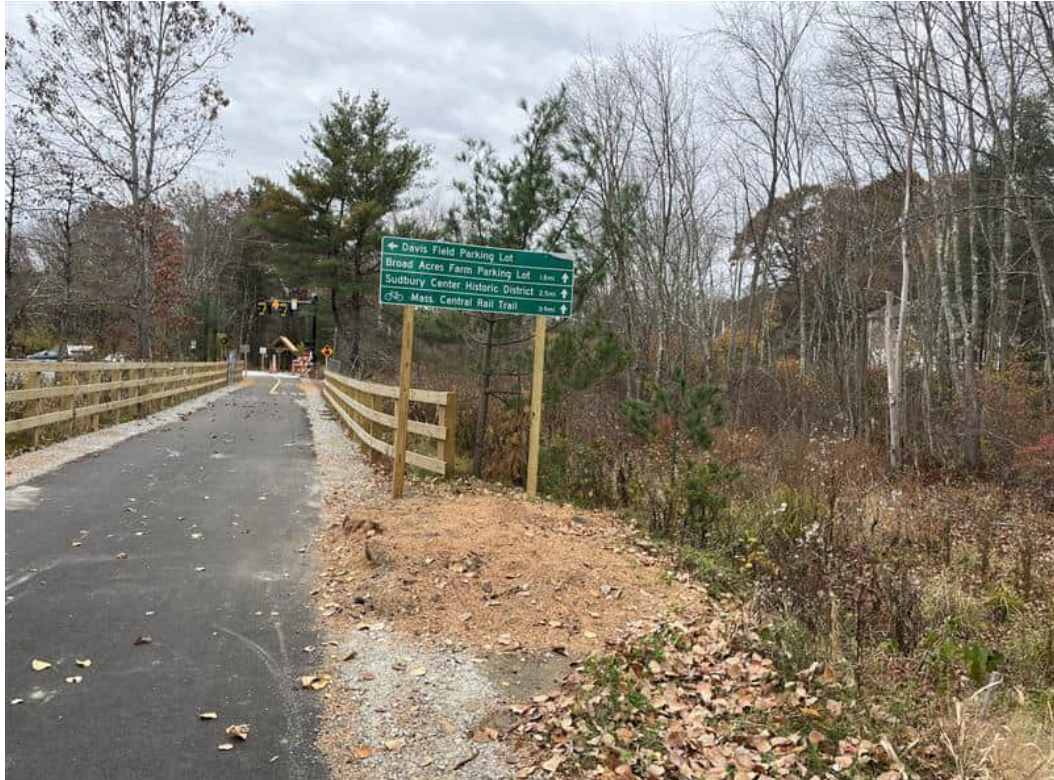
Photo No. 13 **Date:** 10/29/2024

60	Multiple piles of wood shavings were observed along the trail shoulders. In some locations, wood shavings are located directly adjacent to Resource Areas. Priority: High	10/4/2024	10/11/2024	Remove wood shavings from the shoulders.	10/8/2024 - Observation remains. Wood shaving that are in the pile at Station 315+00 were observed as migrating down into the adjacent Resource Areas and require removal. 10/15/2024 - Observation remains. Piles of wood shavings are present in multiple locations throughout the trail and wood shavings are present within the Resource Area adjacent to Station 315+00. 10/22/2024 - Observation remains. See previous update. 10/29/2024 - Observation remains. See update from 10/15/2024.

Typical view of a pile of wood shavings that requires removal at Station 315+00 per Compliance Action Item 60. This condition was observed in multiple locations along the trail.

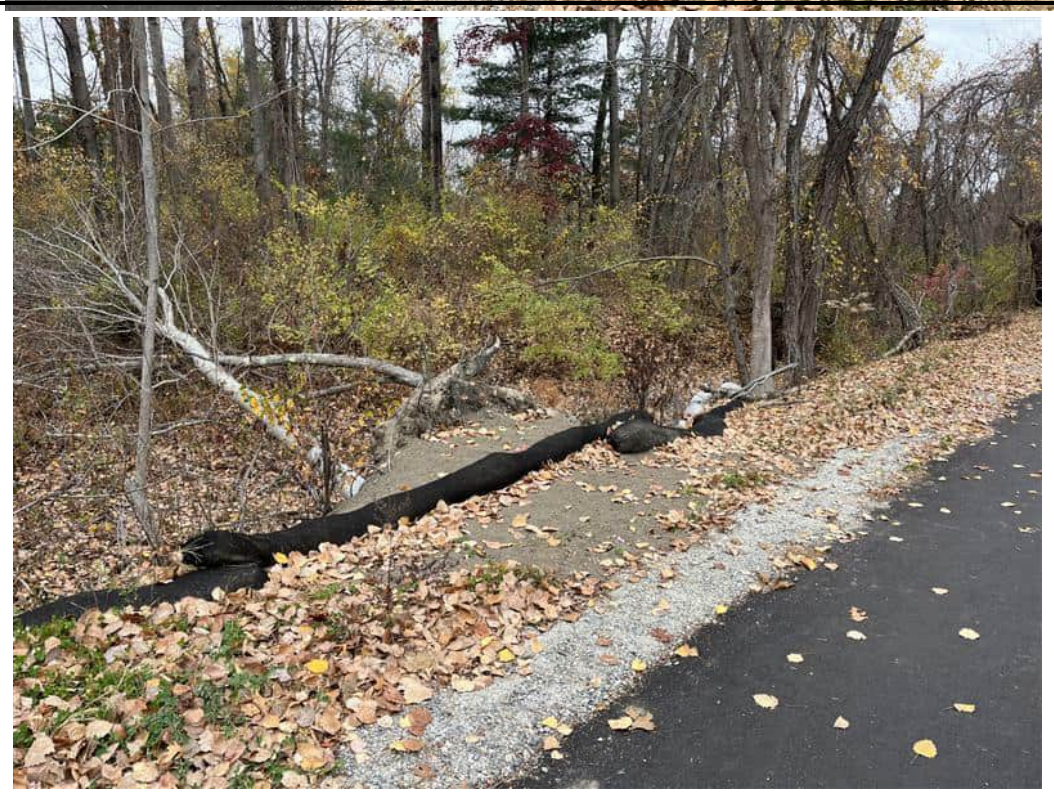
Photo No. 14 **Date:** 10/29/2024

View of recently placed loam that requires stabilization at Station 316+00 per Long Term Compliance Action Item 59.

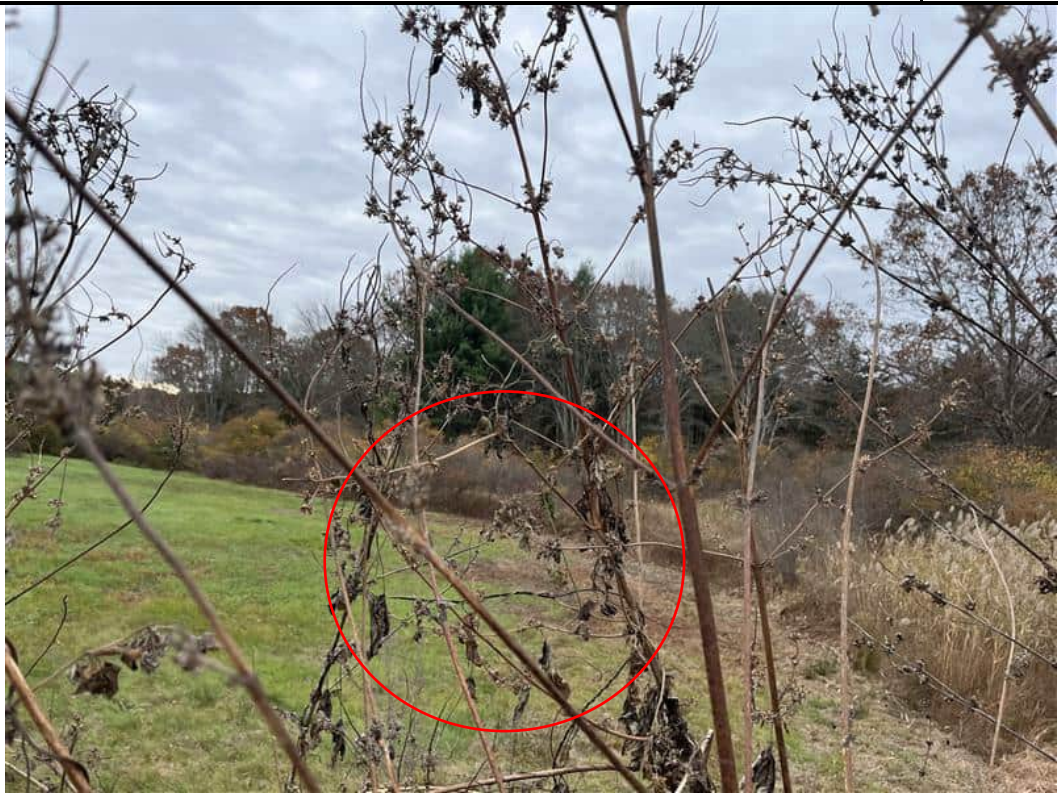
Photo No. 15 **Date:**
10/29/2024

View of wilting Japanese hops that were observed along Route 117 at Station 1103+50 near Davis Field per Compliance Action Item 57-1.
