Weekly Environmental Compliance Summary

Sudbury to Hudson Transmission Reliability Project (USEPA Tracking # MAR1003UW)

Week of: November 4, 2024 to November 9, 2024

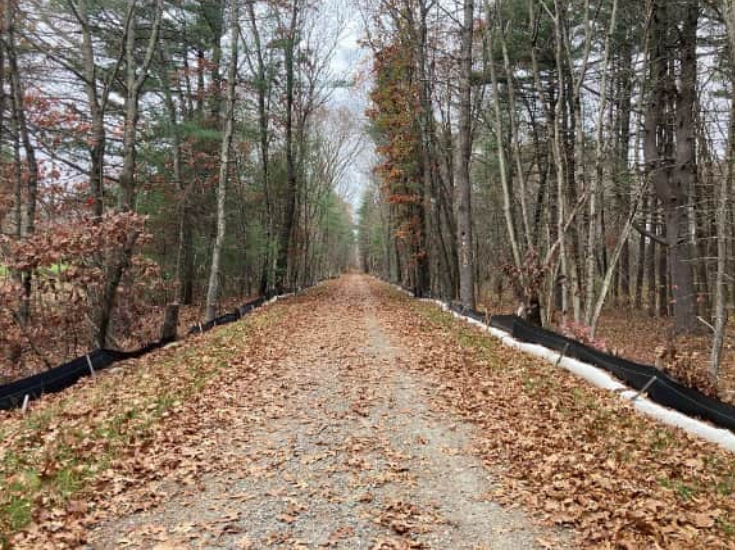
<p>PHOTOGRAPHIC LOG</p>	
<p>Client Name: Eversource</p>		<p>Site Location: Sudbury to Hudson Transmission Reliability Project</p>	<p>Town: Hudson</p>
<p>Photo No.: 4</p>	<p>Date: 11/04/2024</p>

<p>Description: View of E&S controls in segment 4. Facing west.</p>

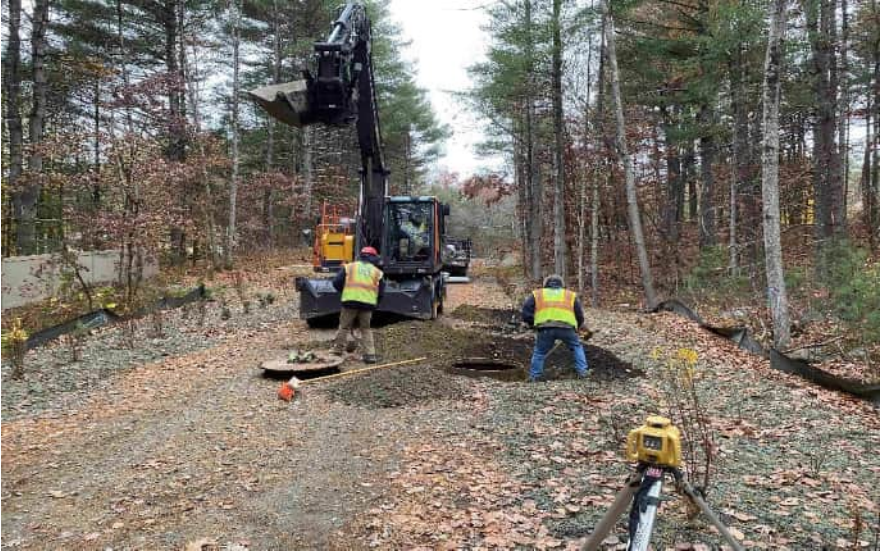
<p align="center">PHOTOGRAPHIC LOG</p>	
<p>Client Name: Eversource</p>		<p>Site Location: Sudbury to Hudson Transmission Reliability Project</p>	<p>Town: Sudbury</p>
<p>Photo No.: 1</p>	<p>Date: 11-4-24</p>

<p>Description:</p> <p>Segment 10, ET&L conducting frame/cover work at manhole #20, existing erosion control, looking eastward.</p>

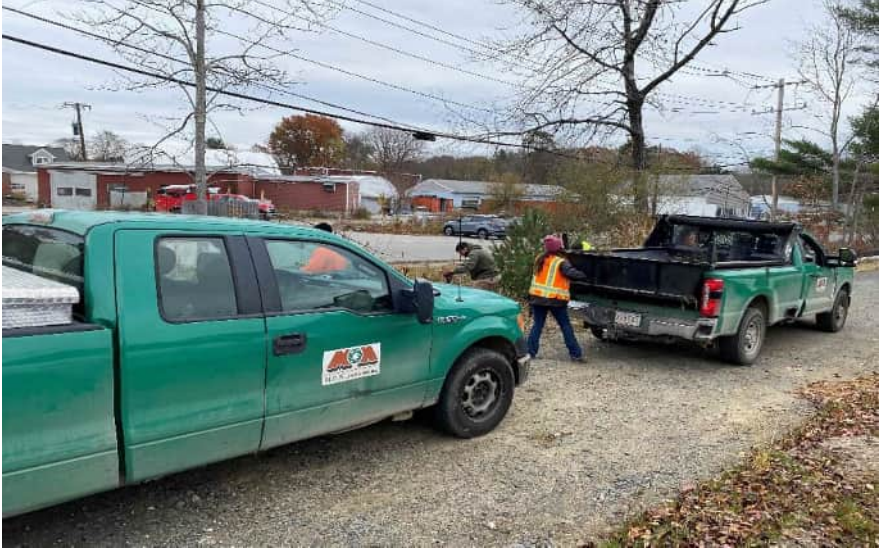
PHOTOGRAPHIC LOG	
Client Name: Eversource		Site Location: Sudbury to Hudson Transmission Reliability Project	Town: Sudbury
Photo No.: 3	Date: 11-4-24

Description: Work area within segment 12, MON planting at area of additional plantings, existing erosion control, looking eastward.

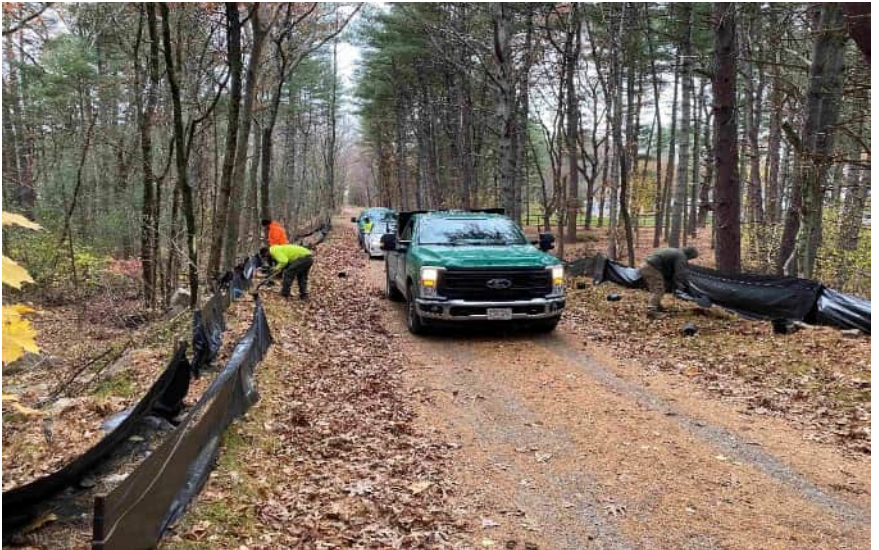
PHOTOGRAPHIC LOG	
Client Name: Eversource		Site Location: Sudbury to Hudson Transmission Reliability Project	Town: Sudbury
Photo No.: 4	Date: 11-4-24

Description: Work area within segment 9, MON planting at area of additional plantings, existing erosion control, looking westward.

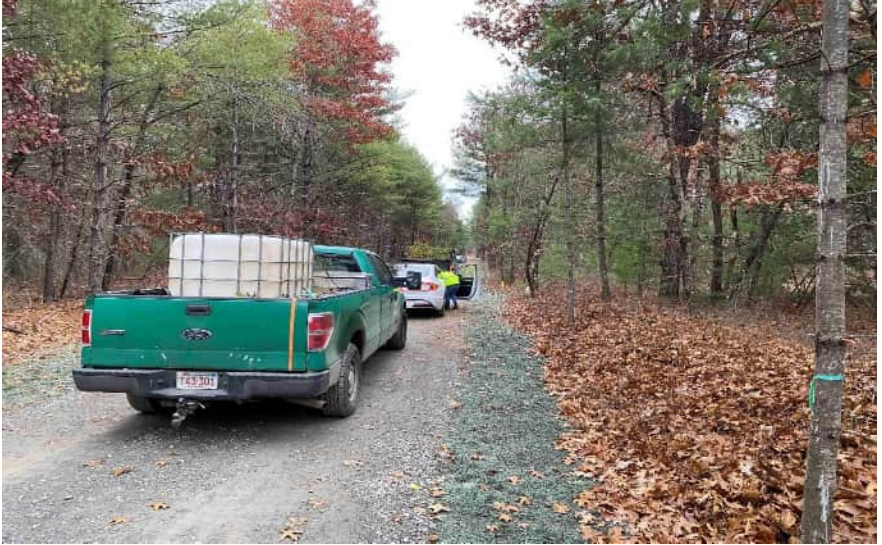
PHOTOGRAPHIC LOG	
Client Name: Eversource		Site Location: Sudbury to Hudson Transmission Reliability Project	Town: Sudbury
Photo No.: 5	Date: 11-4-24

Description: Work area within segment 7, MON planting, existing erosion control, looking westward.

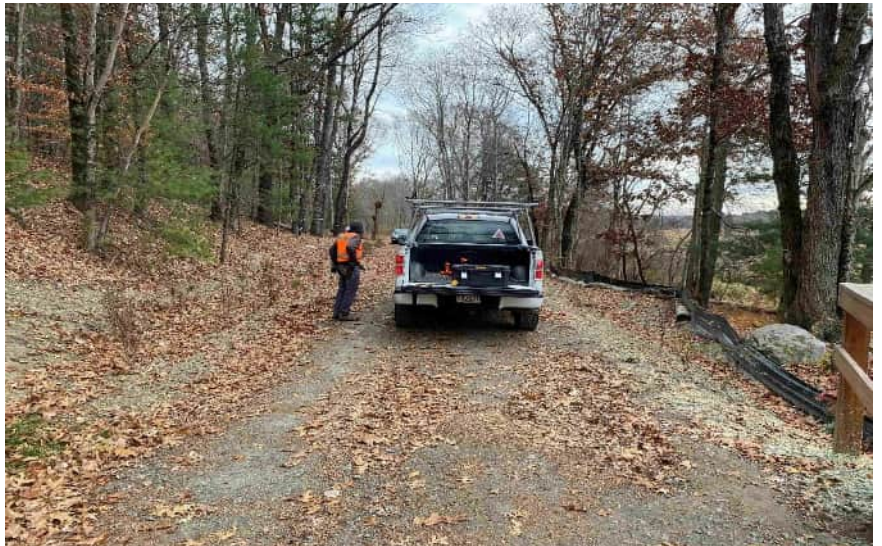
PHOTOGRAPHIC LOG	
Client Name: Eversource		Site Location: Sudbury to Hudson Transmission Reliability Project	Town: Sudbury
Photo No.: 6	Date: 11-4-24

Description: Work area within segment 14, SWCA removing invasive species, existing erosion control, looking eastward.

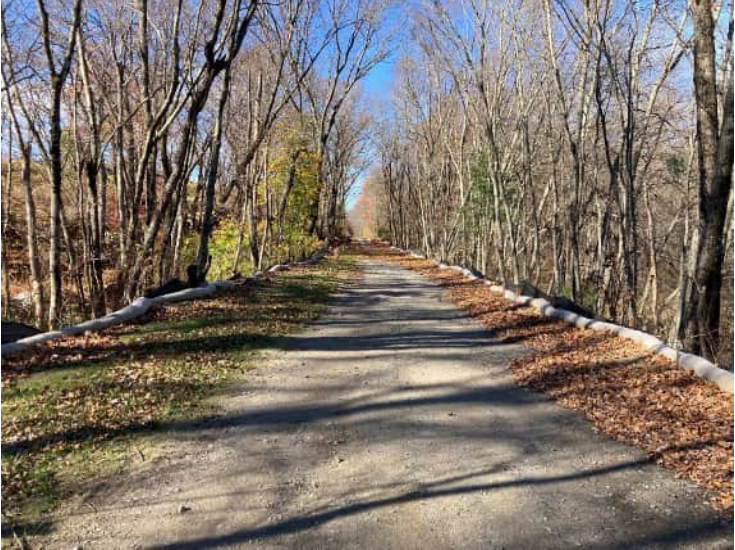
Epsilon ASSOCIATES INC.		PHOTOGRAPHIC LOG	
Client Name: Eversource		Site Location: Sudbury to Hudson Transmission Reliability Project	Town: Hudson
Photo No.: 3	Date: 11/06/2024

Description: View of E&S controls in segment 1. Facing west.

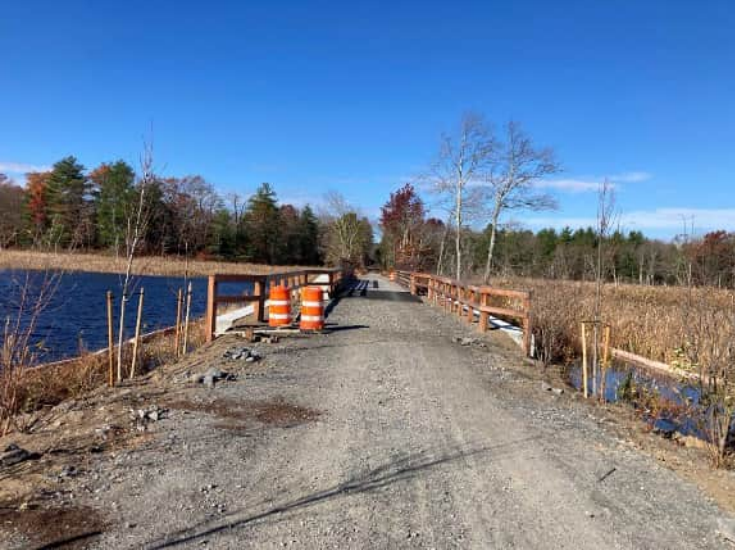
Epsilon ASSOCIATES INC.		PHOTOGRAPHIC LOG	
Client Name: Eversource		Site Location: Sudbury to Hudson Transmission Reliability Project	Town: Hudson
Photo No.: 4	Date: 11/06/2024

Description: View of bridge 130. Facing west.

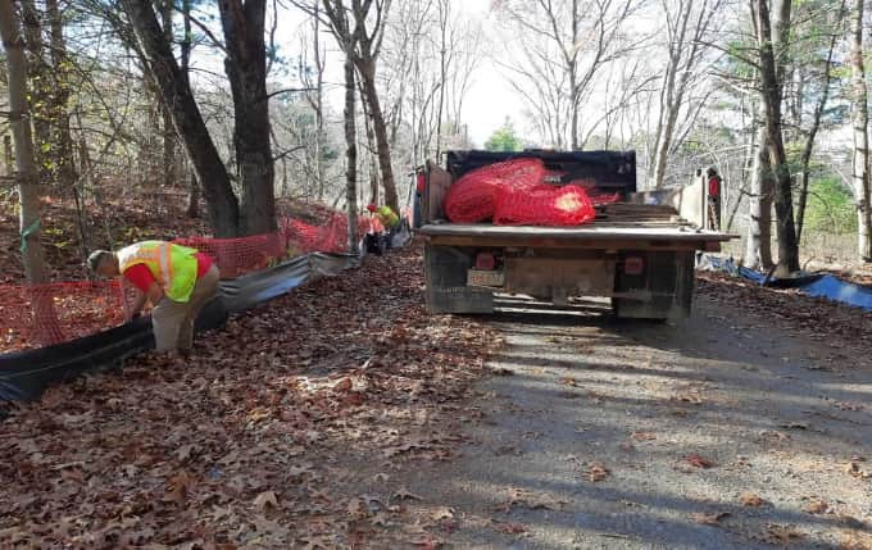
<p>Description:</p> <p>Segment 8, ET&L conducting orange fencing repair/replacement, existing erosion control, looking westward. Photo courtesy of Mary Toner (AECOM).</p>

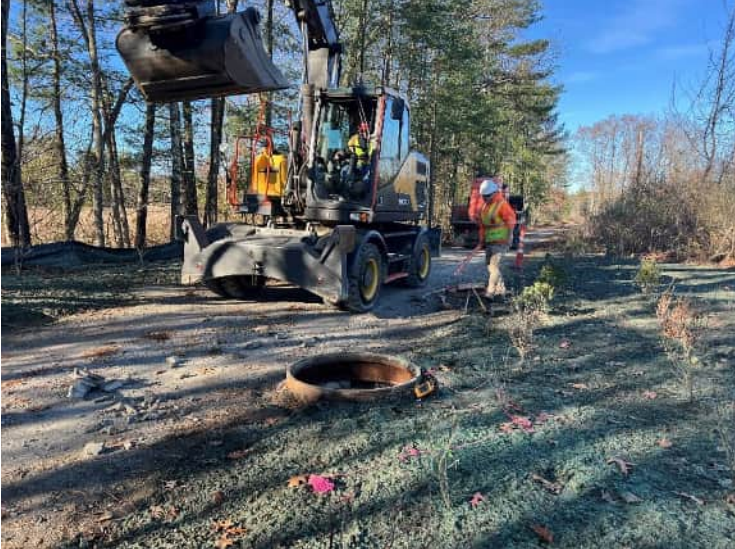
<p>Description: View of ET&L repairing manhole #8's grade. Facing southwest.</p>

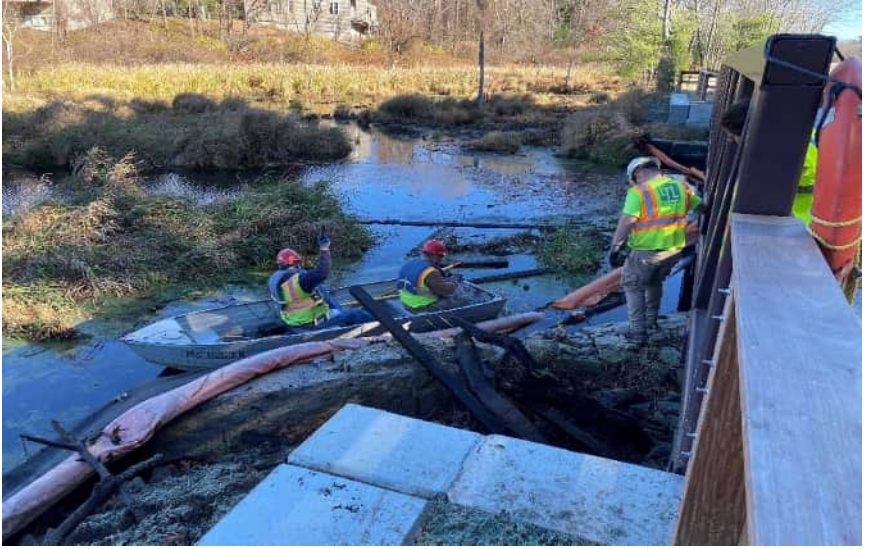
<p>Description:</p> <p>Work area within segments 13/14, Bridge 127, ET&L cleaning Hop Brook prior to removal of floating silt curtain, existing erosion control, looking eastward.</p>

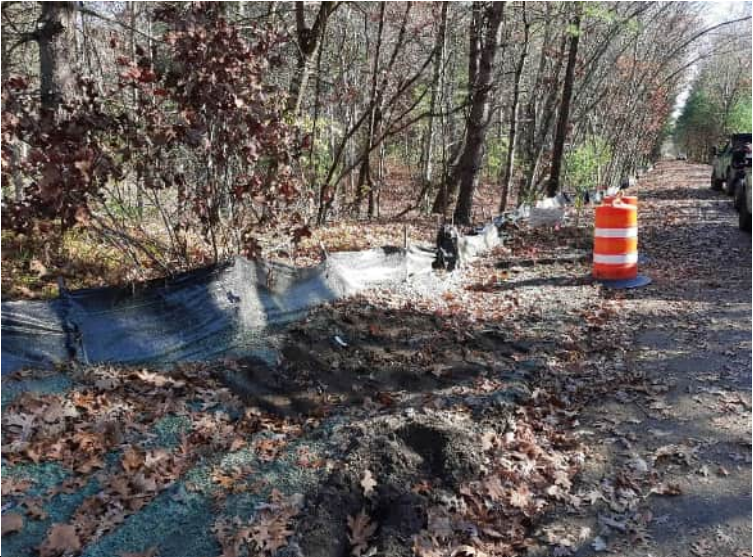
<p>Description: Segment 6, north side, STA 337 + 30 to 340 + 75. Planting area following plant installation, missing sedges (CS), sweetfern (CP) and some blueberries (VA), plantings extended west of marked end on plans. Looking eastward.</p>

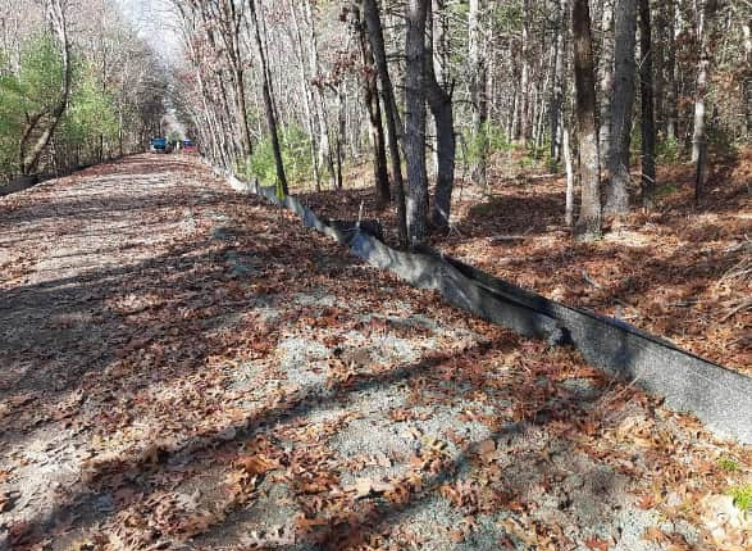
<p>Description: Segment 6, north side, STA 337 + 30 to 340 + 75. Planting area following plant installation, missing CS, CP, and VA. Looking westward.</p>

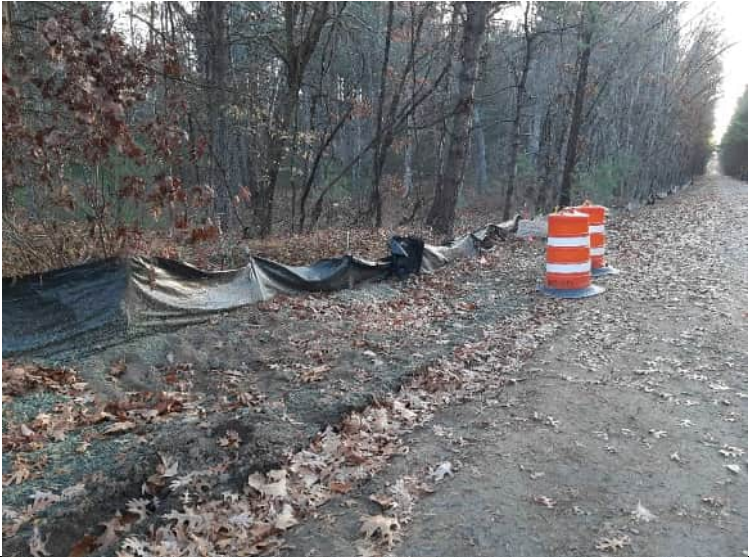
<p>Description:</p> <p>Segment 6, north side, ~STAs 337 + 30 to 340 + 75, adjacent to vernal pool 1 (VP 1) and White Pond Road. North side area pending installation of remaining plantings. Looking eastward.</p>

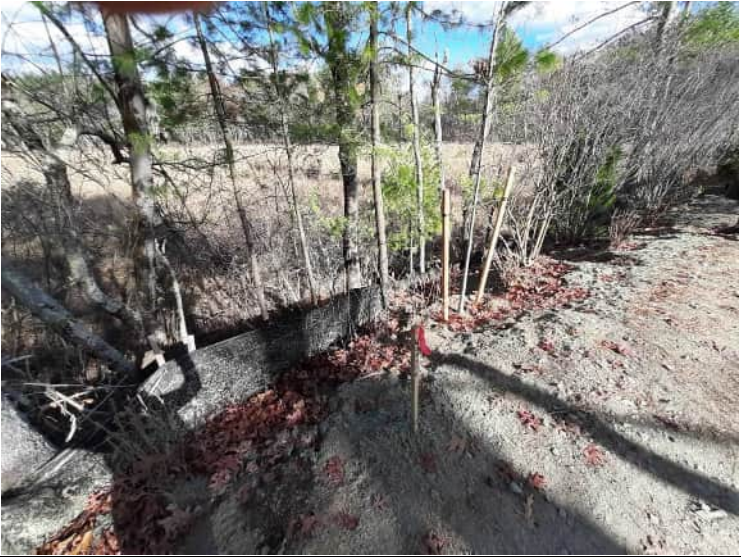
<p>Description:</p> <p>Segment 7, north side, -STAs 399 + 00 to 400 + 00, west abutment of Bridge 128. North side prior to installation of missing bayberries (MP) on north and south. Looking eastward.</p>

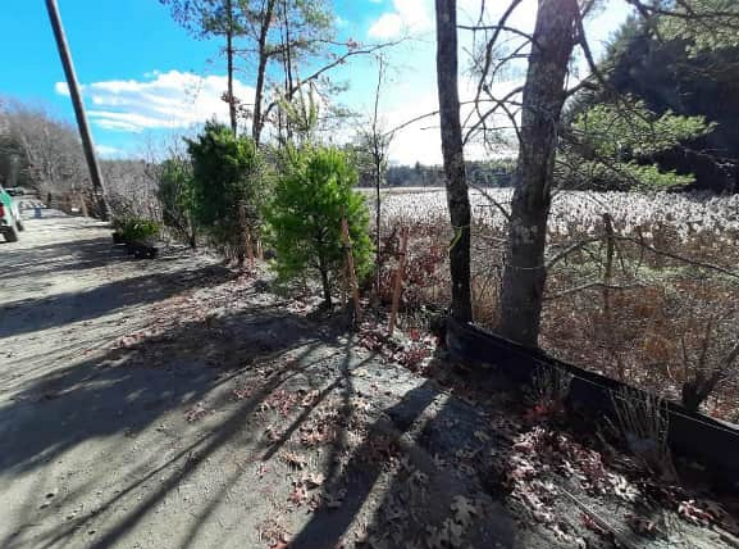
<p>Description:</p> <p>Segment 7, south side, -STAs 399 + 00 to 400 + 00, west abutment of Bridge 128. South side prior to installation of missing MPs on north and south, staged MPs. Looking eastward.</p>
