Environmental Monitor Construction Site Inspection Report
MassDOT Project #608164 Construction Contract # 119678
EM Report #31

Project Description: Bruce Freeman Rail Trail Right-of-Way
 Permit Description(s): Order of Conditions (MGL Chapter 131, Section 40 and 310 CMR 10.00, Mass DEP File No. 301-1362); 2022 EPA NPDES General Permit for Discharges from Construction Areas; U.S. Army Corps of Engineers Permit No NAE-2021-01975.

Project Name:	Bruce Freeman Rail Trail - Phase 2d - Sudbury
Date of Inspections:	11/5/2024
Bi Weekly/ Monthly Period Covered:	November Weekly Inspection #1
Inspector's Name(s):	Anna Haznar
Inspectors' Contact Information:	ahaznar@beta-inc.com

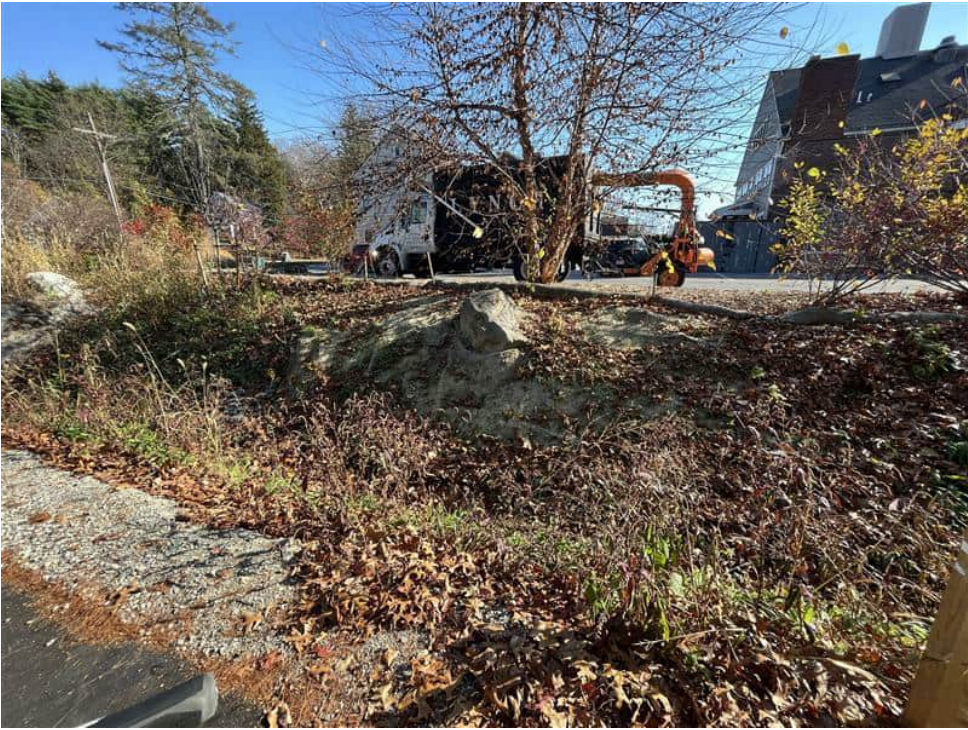
Site Location Bruce Freeman Rail Trail Right-of-Way		BETA Project No. 24.10326.23
Photo No. 5	Date: 11/5/2024

6	Exposed sediment slope at Station 172+00 to 175+00 Priority: High	5/8/2024	5/15/2024	Install temporary sediment controls along the slope such as jute netting and/or straw following the application of seed.	<p>5/16/2024 - Observation remains.</p> <p>5/21/2024 - Observation remains.</p> <p>5/28/2024 - Partial germination was observed.</p> <p>5/31/2024 - See previous update.</p> <p>6/7/2024 - Further earthwork has occurred and soils require stabilization.</p> <p>6/14/2024 - Observation remains.</p> <p>6/17/2024 - Observation remains.</p> <p>6/24/2024 - Observation remains.</p> <p>6/27/2024 - The area has been regraded and loam has been spread. New trees have been planted upgradient of the swale. Stabilization is still required.</p> <p>7/8/2024 - Jute netting has been installed over the applied seed, and the area will be monitored for germination.</p> <p>7/15/2024 - See previous update.</p> <p>7/22/2024 - Observation remains.</p> <p>7/29/2024 - Observation remains.</p> <p>8/5/2024 - Observation remains.</p> <p>8/7/2024 - Regrowth of vegetation was observed in this location. This item will remain open until stabilization has been completed.</p> <p>8/12/2024 - Observation remains.</p> <p>8/16/2024 - Observation remains.</p> <p>8/20/2024 - Application of the approved seed mixture is required at this location.</p> <p>8/27/2024 - Observation remains.</p> <p>9/3/2024 - Vegetation that is present in this location generally consists of lady's thumb smartweed, a non-native species. Removal of non-native species and application of the approved seed mixture is required at this location.</p> <p>9/16/2024 - See previous update.</p> <p>9/23/2024 - Observation remains. See 9/3/2024 update.</p> <p>9/27/2024 - Observation remains. The contractor reached out hydroseed has been applied to this area.</p> <p>10/4/2024 - Hydroseed has been applied to this area; the hydroseed was observed to have been applied over the erosion control blanket that is located in this area. Once vegetation has sufficiently stabilized this area the item will be closed. The contractor should provide the tag from the seed mix that was used to the Conservation Commission to ensure that the required native seed mix was used per the design plans.</p> <p>10/8/2024 - Observation remains. See update from 10/4/2024.</p> <p>10/15/2024 - Observation remains. See update from 10/4/2024.</p> <p>10/22/2024 - Observation remains. See update from 10/4/2024.</p> <p>10/29/2024 - Observation remains. No germination has been observed in this location since the application of hydroseed. See update from 10/4/2024.</p> <p>11/5/2024 - Observation remains. Some germination has been observed but the area is not considered stabilized.</p>

Direction Photo Taken: Toward the East		
Description: View of hydroseeded with some germination along slopes at Station 172+00 to 175+00 per Compliance Action Item 6.		
Photo No. 6	Date: 11/5/2024

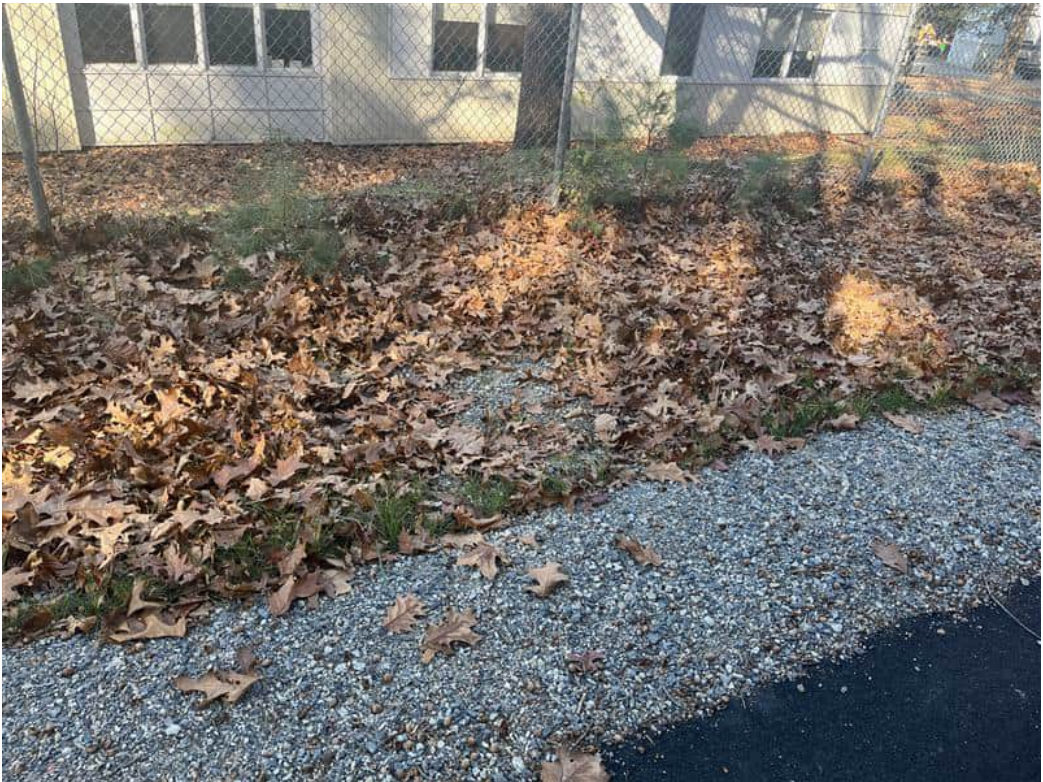
58	<p>Crushed stone used for the dense graded crush stone shoulders has been observed as migrating both onto the path, off the sides of the path, and into the adjacent Resource Areas throughout the Project</p> <p>Priority: High</p>	8/7/2024	8/14/2024	<p>Remove all crushed stone from Resource Areas and develop a plan to cease discharges of stone.</p>	<p>8/12/2024 - Crushed stone is still present in varying amounts throughout the path and on the sides of the path.</p> <p>8/16/2024 - Observation remains.</p> <p>8/20/2024 - Crushed stone has been removed from some adjacent resource areas but is still observed as migrating onto and off of the path in multiple locations throughout the Project.</p> <p>8/27/2024 - Crushed stone has been observed as migrating from the shoulders throughout the path.</p> <p>9/3/2024 - Crushed stone was observed as migrating both onto the path and off the side of the path in multiple locations. Stone was observed to have discharged to the cattle crossing at Station 190+50 and within the streambed at Station 215+00 to 216+00. Crushed stone was observed to have been placed on the root system of a fallen tree at Station 310+00 near Bank flag #BF4-108.</p> <p>9/10/2024 - Observation remains. Crushed stone is still present within the cattle crossing, the streambed, and on the root system of the fallen tree. Crushed stone continues to migrate on to and off of the path.</p> <p>9/16/2024 - Observation remains. The contractor indicated the locations where crushed stone has migrated off the path will be hand removed and crushed stone will be swept off the path prior to the opening of the trail.</p> <p>9/23/2024 - Observation remains. It does not appear as though crushed stone that has migrated onto or off of the path has been removed in any location along the Project. More crushed stone has migrated onto the path throughout significant portions of the path.</p> <p>9/27/2024 - Observation remains. Crushed stone is still located on the side of the path and on the path in varying amounts.</p> <p>10/4/2024 - Crushed stone has been removed from multiple locations along the trail but was still observed on and on the sides of the trail in several locations.</p> <p>10/8/2024 - Observation remains. Crushed stone is still present in multiple locations on and off the sides of the path.</p> <p>10/15/2024 - Observation remains. Crushed stone is still present in multiple locations on and off the sides of the path.</p> <p>10/22/2024 - Observation remains. Crushed stone is still present in multiple locations on and off the sides of the path. The crushed stone shoulders along Station 1000+00 to 1003+00 has been moved back into the shoulders and regraded.</p> <p>10/29/2024 - Observation remains. Crushed stone is still present in multiple locations on and off the sides of the path.</p> <p>11/5/2024 - Observation remains. See previous update.</p>

Direction Photo Taken: Toward the West		
Description: Typical view of an area where crushed stone has migrated off of the path at Station 181+00 per Compliance Action Item 59. This condition was observed in multiple locations along the trail.

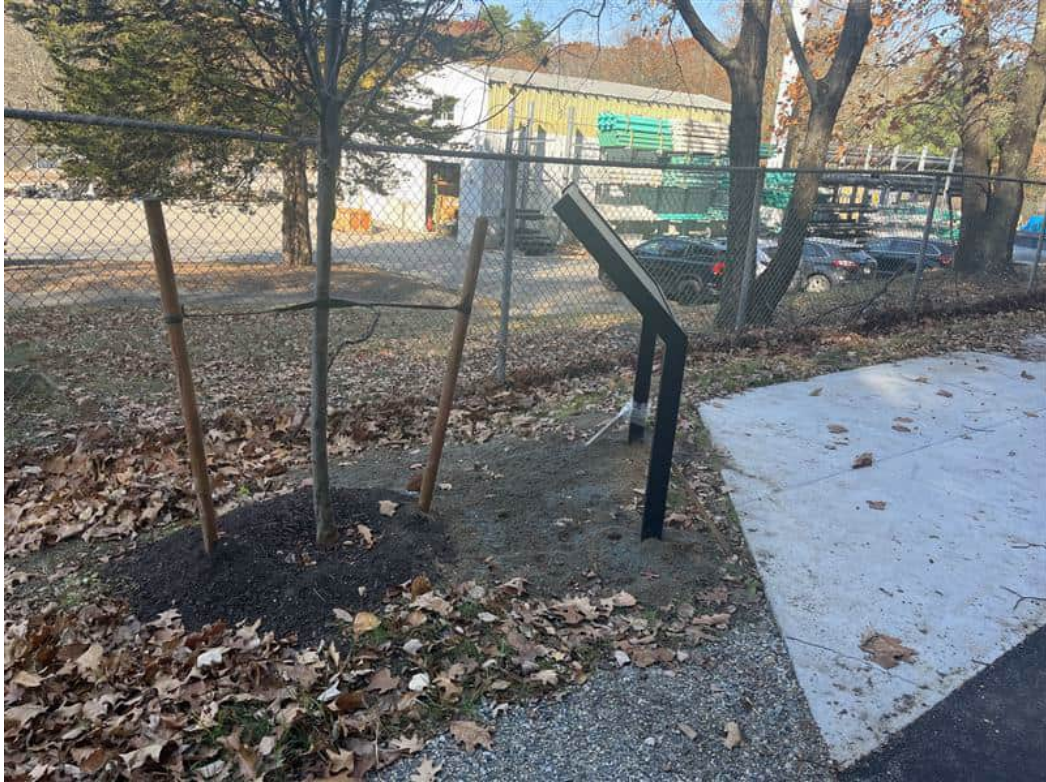
Photo No. 7 **Date:** 11/5/2024

View of the recently installed interpretative signage and seed placed on exposed soil at Station 181+75.

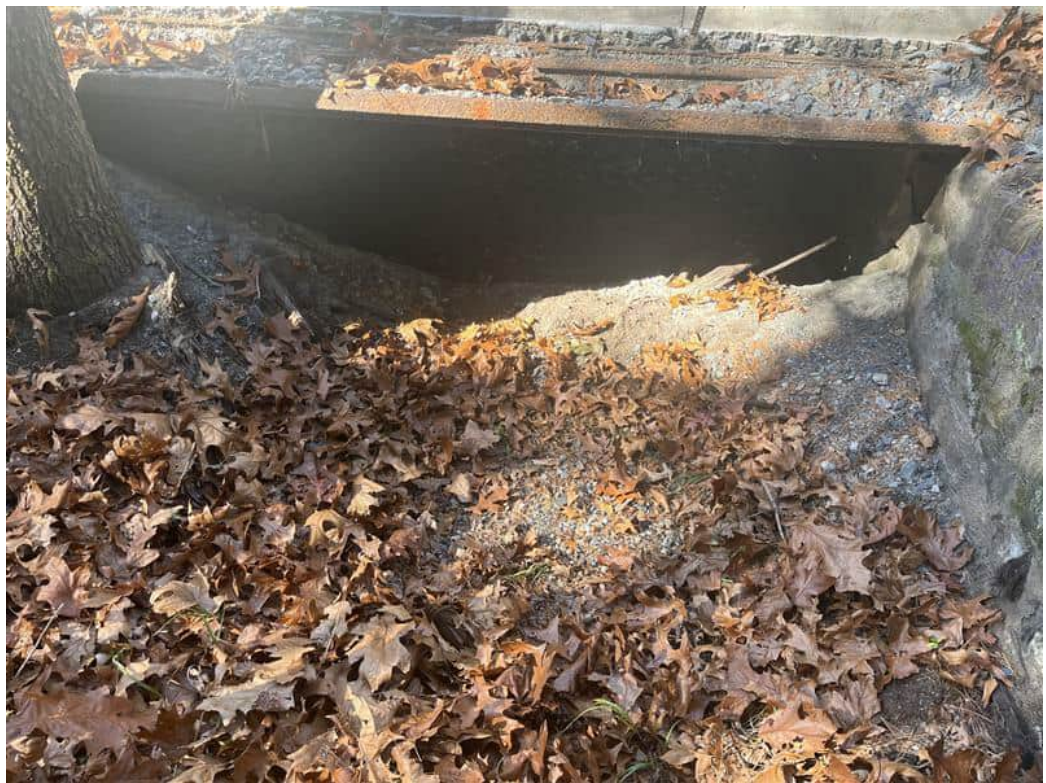
Photo No. 8 **Date:** 11/5/2024

View of crushed stone present within the cattle crossing at Station 190+50 per Long Term Compliance Action Item 58.

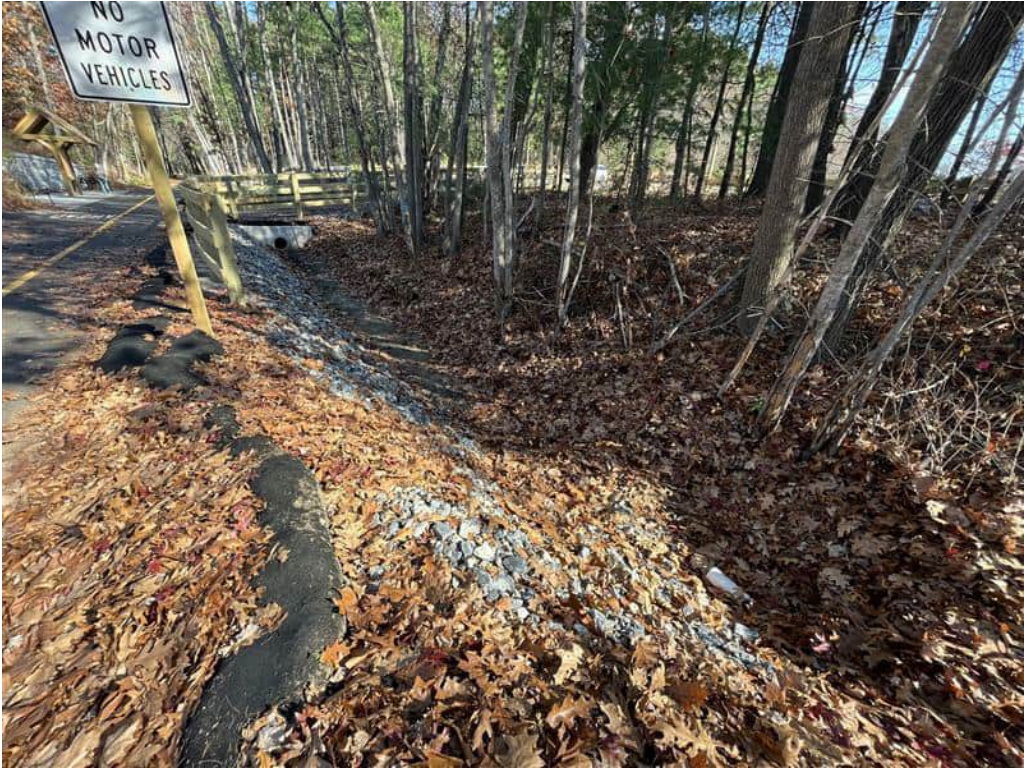
Site Location Bruce Freeman Rail Trail Right-of-Way		BETA Project No. 24.10326.23
Photo No. 9	Date: 11/5/2024

41	Stream Bank has been regraded beyond the limit of work at Station 216+00 Priority: High	5/28/2024	6/4/2024	The Contractor should confirm if this work was permitted by the Conservation Commission, as it does not appear to be a part of the approved plans/impacts. MassDOT should be consulted on next steps regarding notification and potential restoration.	<p>5/31/2024 - Observation remains. 6/7/2024 - Observation remains. 6/14/2024 - Observation remains. 6/17/2024 - Observation remains. 6/24/2024 - Observation remains. 6/27/2024 - Observation remains. 7/8/2024 - Observation remains. 7/15/2024 - This area could not be assessed due to paving operations ongoing during the inspection. 7/22/2024 - Crushed stone and sediment continue to be discharged to the stream between Stations 215+00 and 217+00 due to overtopped and undermined compost filter tubes. 7/29/2024 - Observation remains. 8/5/2024 - Observation remains. 8/7/2024 - Observation remains. 8/12/2024 - Observation remains. Crushed stone is still present in the streambed at this location. 8/16/2024 - Observation remains. 8/20/2024 - Stone has been removed; however, additional alteration to Resource Areas beyond the limit of work continue. 8/27/2024 - Observation remains. 9/3/2024 - Observation remains. 9/10/2024 - Observation remains. Stone has been observed as discharging into the streambed in this location again. 9/16/2024 - Observation remains. 9/23/2024 - Observation remains. Stone is still present within the streambed at this location. 9/27/2024 - Observation remains. 10/4/2024 - Observation remains. 10/8/2024 - Observation remains. 10/15/2024 - Observation remains. Stone is still present within the streambed at this location. 10/22/2024 - Observation remains. Stone is still present within the streambed at this location. 10/29/2024 - Observation remains. Stone is still present within the streambed at this location. 11/5/2024 - Observation remains. The PVC pipe that was installed at this location was observed to be covered with stone and is no longer visible near Station 215+00. Stone is still present within the streambed at this location.</p>

Direction Photo Taken: Toward the North		
Description: View of crushed stone within the streambed and the streambed and the location where the stream bank has been regraded beyond the limits of work at Station 216+00 per Long Term Compliance Action Item 41.		
Photo No. 10	Date: 11/5/2024

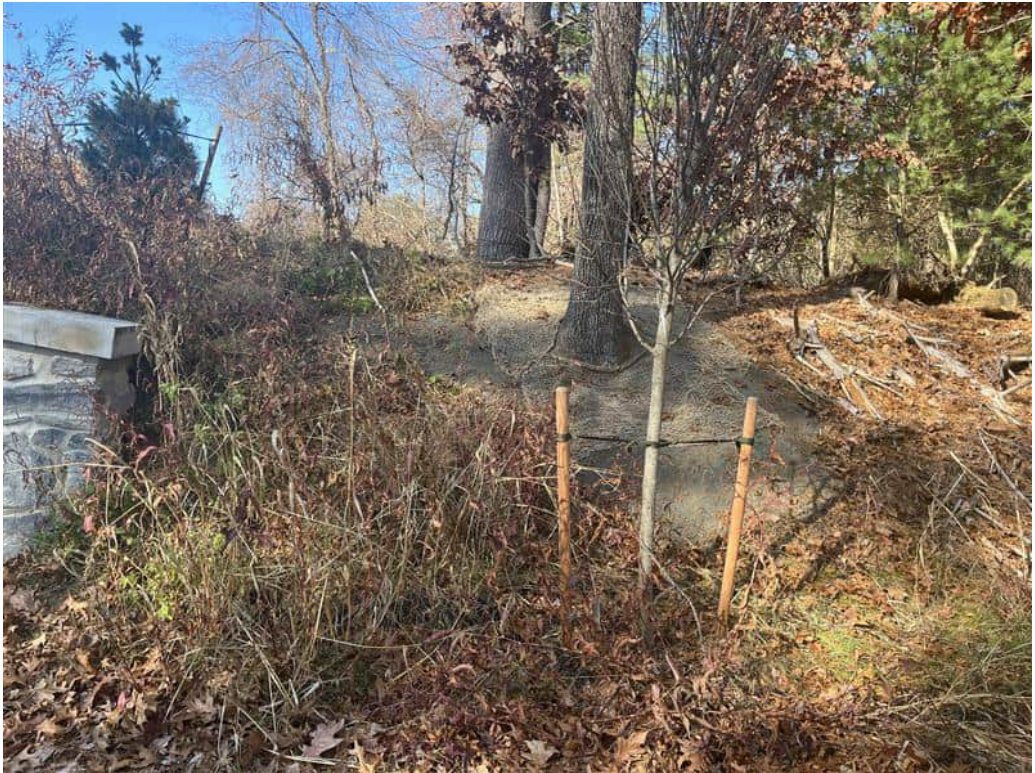
34	<p>Sediment is eroding downhill from behind the cemented stone masonry wall at Station 217+45</p> <p>Priority: Low</p>	5/28/2024	6/4/2024	<p>Apply seed and temporarily stabilize the soils along the slope with straw, jute netting, etc.</p>	<p>5/31/2024 - Observation remains. 6/7/2024 - Observation remains. 6/14/2024 - Observation remains. 6/17/2024 - Observation remains. 6/24/2024 - Observation remains. 6/27/2024 - Rills were raked, loam was added, and hydroseed was applied. 7/8/2024 - Observation remains. Grass was observed to be germinating at this location. Comment will remain open until stabilization is complete. 7/8/2024 - See previous update. 7/15/2024 - Additional hydroseed is required due to washouts. 7/22/2024 - Observation remains. 7/29/2024 - Observation remains. 8/5/2024 - Observation remains. 8/7/2024 - Regrowth of vegetation has been observed in this area. This item will remain open until the area is fully stabilized. 8/12/2024 - Observation remains. Regrowth has stabilized a portion of this hill; however, reseeding and additional temporary stabilized measures are recommended on the section that is currently unvegetated. 8/16/2024 - Observation remains. 8/20/2024 - Application of the approved seed mixture is required at this location. 8/27/2024 - Observation remains. 9/3/2024 - Vegetation that is present in this location generally consists of lady's thumb smartweed (<i>Persicaria maculosa</i>), a non-native species. Removal of non-native species and application of the approved seed mixture is required at this location. 9/10/2024 - Observation remains. See previous update. 9/16/2024 - Observation remains. See update from 9/3/2024. 9/23/2024 - Observation remains. See update from 9/3/2024. 9/27/2024 - Observation remains. 10/4/2024 - Observation remains. See update from 9/3/2024. 10/8/2024 - Observation remains. See update from 9/3/2024. 10/15/2024 - Observation remains. See update from 9/3/2024. 10/22/2024 - Observation remains. See update from 9/3/2024. 10/29/2024 - Observation remains. No additional seed has been applied to this location and the slope is generally vegetated by non-native species. See update from 9/3/2024. 11/5/2024 - Observation remains. Erosion control and seed has been applied to part of this slope, no germination has been observed.</p>

Direction Photo Taken: Toward the North		
Description: View of the newly installed erosion control blanket and placed seed on the slope at Station 217+45 per Compliance Action Item 34.

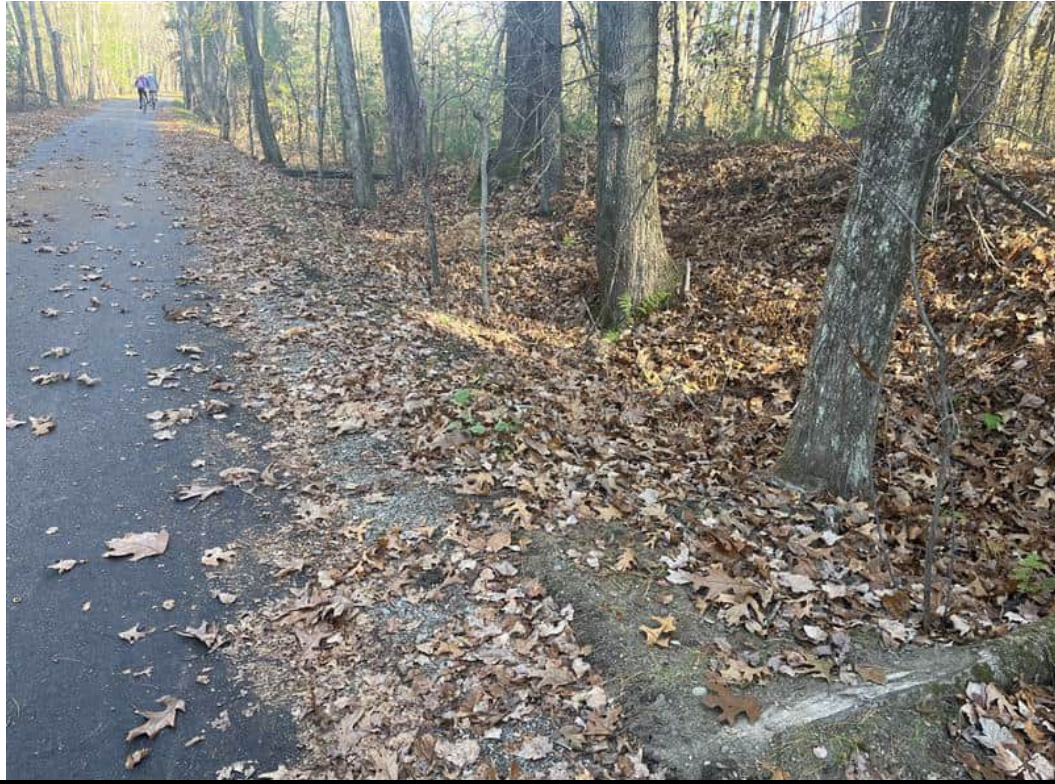
Photo No. 13 **Date:**
11/5/2024

Item	Location/ Description	Observation Date	Resolution Due Date	Recommended Resolution / Resolution Date	Comments/Updates
61	Invasive vegetation including Japanese knotweed (<i>Reynoutria japonica</i>), bittersweet (<i>Celastrus orbiculatus</i>), bush honeysuckle (<i>Lonicera</i> spp.), burning bush (<i>Euonymus alatus</i>), purple loosestrife (<i>Lythrum salicaria</i>), glossy buckthorn (<i>Frangula alnus</i>) and garlic mustard (<i>Alliaria petiolata</i>) have been observed throughout the path. Priority: High	10/22/2024	10/29/2024	Invasive Species should be removed by manual and/or chemical removal methods	10/29/2024 - Invasive species are present throughout the trail both within upland and Resource Areas. Populations of glossy buckthorn and purple loosestrife are present within the wetland replication area. 11/5/2024 - Observation remains. See update from 10/29/2024.
57-1	Japanese hops (<i>Humulus japonicus</i>) has been observed throughout the Project and requires removal Priority: High	10/22/2024	10/29/2024	The Contractor should manage remaining Japanese hops by hand pulling and the application of herbicide.	10/22/2024 - This Action Item has been reopened due to observations of both dead and living Japanese hops in select locations along the Project. BETA and MassDOT will coordinate further with the Sudbury Conservation Agent to clarify the extents of remaining living vegetation as removal efforts progress. 10/29/2024 - Plants that were observed as alive along Route 117 during the last inspection were observed to be wilting due to winter die back. 11/5/2024 - Observation remains. See update from 10/29/2024.

Item	Location/ Description	Observation Date	Resolution Due Date	Recommended/Discussed Resolution	Comments/Updates
59	Multiple locations of exposed soils along the Project corridor require stabilization Priority: High	9/3/2024	9/10/2024	The contactor should apply the approved seed mixture to areas of exposed soils and place straw.	<p>9/3/2024 - Herbicide application caused multiple areas along the path to be no longer stabilized. If thatch is present in these locations the thatch should be removed before seeding occurs. A location near Station 320+50 has been cleared outside of the limit of work and requires stabilization. Other areas along the path where seed did not germinate should be reseeded with the approved seed mix and straw should be placed on the areas of exposed soil.</p> <p>9/10/2024 - Observation remains, see previous update. A few locations along the trail have been hydroseeded but a majority of the locations of exposed soil require seed and stabilization.</p> <p>9/16/2024 - Observation remains. The contactor indicated areas of bare soil will be hydroseeded.</p> <p>9/23/2024 - Observation remains. It does not appear as though any hydroseeding has been done since the last inspection. Areas throughout the trail require removal of thatch and application of seed for stabilization.</p> <p>9/27/2024 - Observation remains. The contractor reached out and indicated all areas of exposed soils south of Hudson Road were hydroseeded after the inspection occurred.</p> <p>10/4/2024 - All areas south of Hudson Road were not seeded using hydroseed; hydroseed was applied in a few locations, but there are still large areas of exposed soil both south and north of Hudson Road that require seeding. Thatch was not removed in any areas before hydroseed was applied. The contractor should provide the tag from the seed mix that was used to the Conservation Commission to ensure that the required native seed mix was used per the design plans. Once vegetation has sufficiently stabilized, this item will be closed.</p> <p>10/8/2024 - Observation remains. See update from 10/4/2024. No additional hydroseed has been applied since the last inspection.</p> <p>10/15/2024 - Observation remains. See update from 10/4/2024. No additional hydroseed has been applied since the last inspection. No germination has been observed in areas where hydroseed was applied.</p> <p>10/22/2024 - Observation remains. See update from 10/4/2024. No additional hydroseed has been applied since the last inspection. Some germination has been observed in a few locations where hydroseed was previously applied.</p> <p>10/29/2024 - Observation remains. No additional hydroseed has been applied since the last inspection. If additional hydroseed is applied leaf litter and thatch should be removed so the seed can make contact with the soil. See update from 10/4/2024.</p> <p>11/5/2024 - Seed and erosion control blankets have been applied to part of the slope at Station 217+45 and seed has been applied to the exposed soil around a newly installed interpretive sign at Station 181+75. The contractor should provide the tag from the seed mix that was used to the Conservation Commission to ensure that the required native seed mix was used per the design plans. Exposed soil with little to no vegetation is still present throughout the trail.</p>

View of a location that requires stabilization and removal of invasive species at Station 298+00 per Long Term Compliance Action Item 59 and 61.

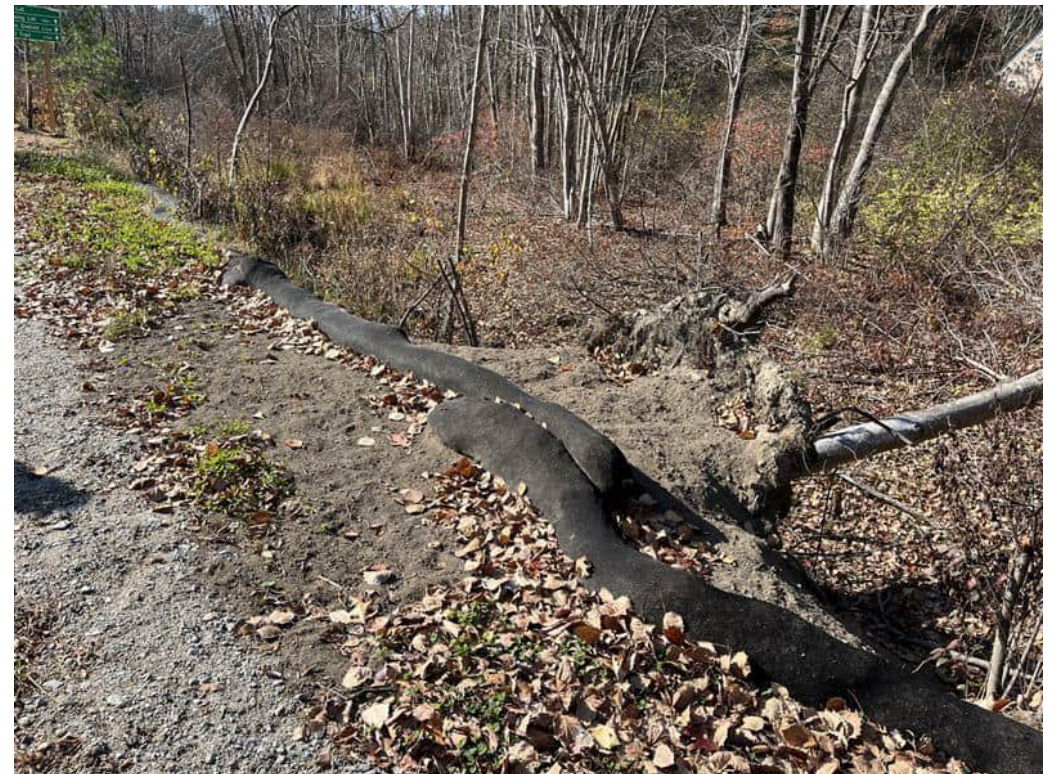
Photo No. 14 **Date:**
11/5/2024

View of recently placed loam that requires stabilization at Station 316+00 per Long Term Compliance Action Item 59.
