Environmental Monitor Construction Site Inspection Report
MassDOT Project #608164 Construction Contract # 119678
EM Report #32

Project Description: Bruce Freeman Rail Trail Right-of-Way
 Permit Description(s): Order of Conditions (MGL Chapter 131, Section 40 and 310 CMR 10.00, Mass DEP File No. 301-1362); 2022 EPA NPDES General Permit for Discharges from Construction Areas; U.S. Army Corps of Engineers Permit No NAE-2021-01975.

Project Name:	Bruce Freeman Rail Trail - Phase 2d - Sudbury
Date of Inspections:	11/12/2024
Bi Weekly/ Monthly Period Covered:	November Weekly Inspection #2
Inspector's Name(s):	Anna Haznar
Inspectors' Contact Information:	ahaznar@beta-inc.com

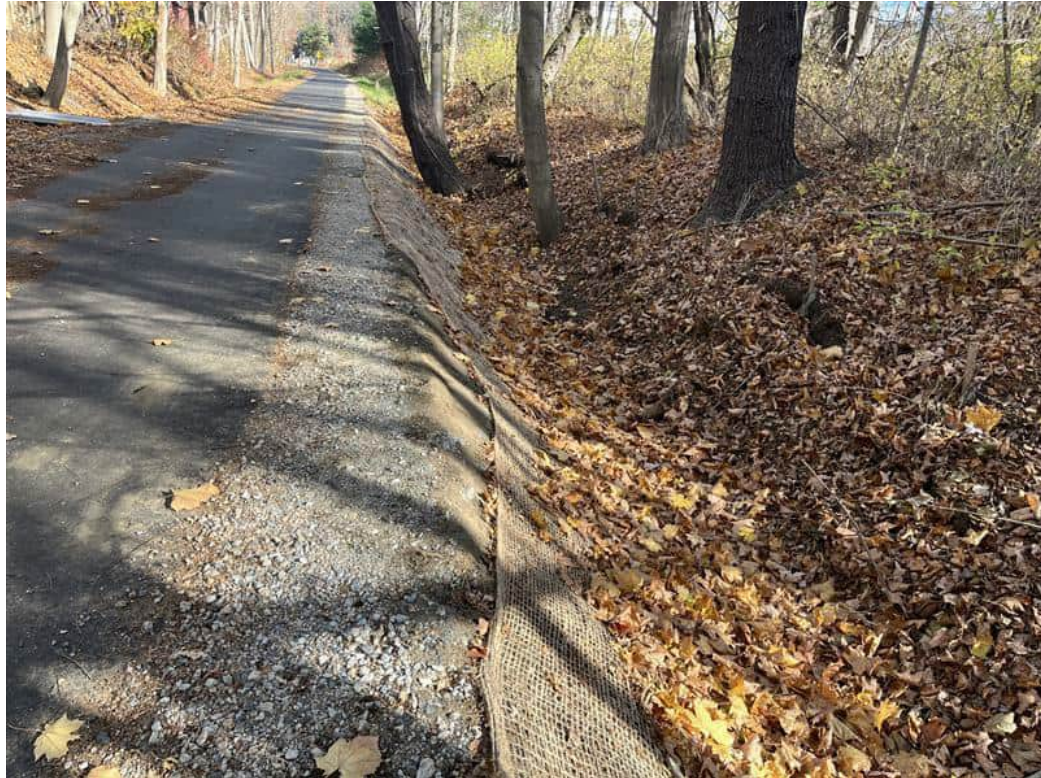
Photo No. 3 **Date:** 11/12/2024

View of an erosion control blanket and seed that were installed at Station 170+00.

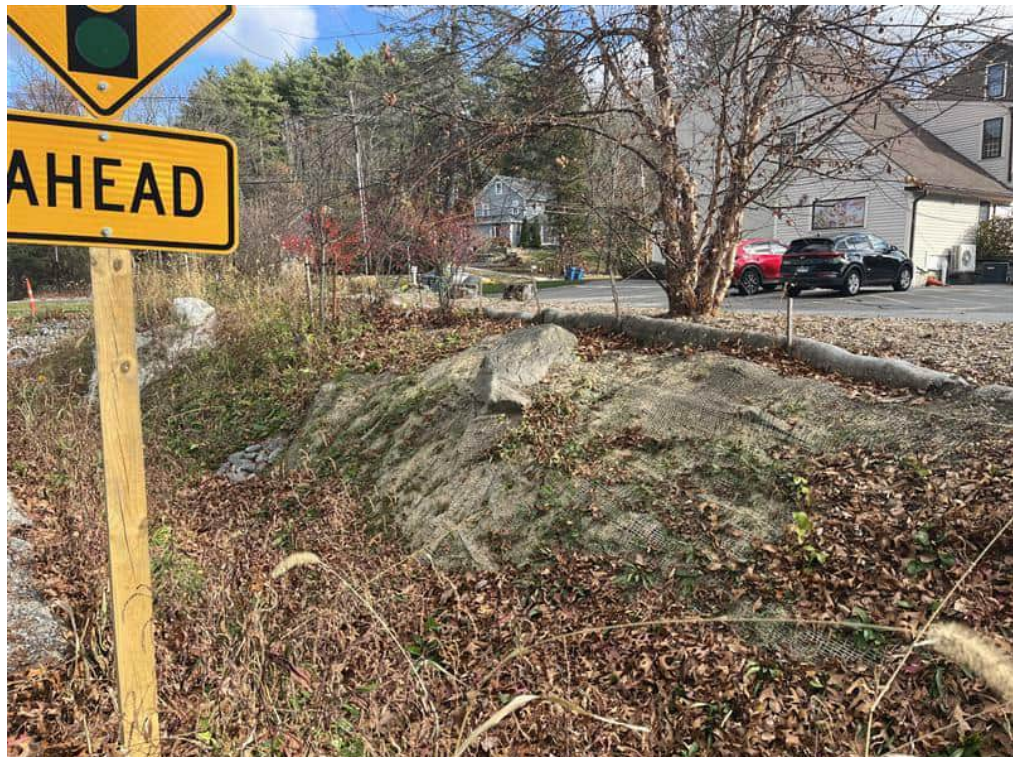
Photo No. 4 **Date:** 11/12/2024

6	Exposed sediment slope at Station 172+00 to 175+00 Priority: High	5/8/2024	5/15/2024	Install temporary sediment controls along the slope such as jute netting and/or straw following the application of seed.	<p>5/16/2024 - Observation remains.</p> <p>5/21/2024 - Observation remains.</p> <p>5/28/2024 - Partial germination was observed.</p> <p>5/31/2024 - See previous update.</p> <p>6/7/2024 - Further earthwork has occurred and soils require stabilization.</p> <p>6/14/2024 - Observation remains.</p> <p>6/17/2024 - Observation remains.</p> <p>6/24/2024 - Observation remains.</p> <p>6/27/2024 - The area has been regraded and loam has been spread. New trees have been planted upgradient of the swale. Stabilization is still required.</p> <p>7/8/2024 - Jute netting has been installed over the applied seed, and the area will be monitored for germination.</p> <p>7/15/2024 - See previous update.</p> <p>7/22/2024 - Observation remains.</p> <p>7/29/2024 - Observation remains.</p> <p>8/5/2024 - Observation remains.</p> <p>8/7/2024 - Regrowth of vegetation was observed in this location. This item will remain open until stabilization has been completed.</p> <p>8/12/2024 - Observation remains.</p> <p>8/16/2024 - Observation remains.</p> <p>8/20/2024 - Application of the approved seed mixture is required at this location.</p> <p>8/27/2024 - Observation remains.</p> <p>9/3/2024 - Vegetation that is present in this location generally consists of lady's thumb smartweed, a non-native species. Removal of non-native species and application of the approved seed mixture is required at this location.</p> <p>9/16/2024 - See previous update.</p> <p>9/23/2024 - Observation remains. See 9/3/2024 update.</p> <p>9/27/2024 - Observation remains. The contractor reached out hydroseed has been applied to this area.</p> <p>10/4/2024 - Hydroseed has been applied to this area; the hydroseed was observed to have been applied over the erosion control blanket that is located in this area. Once vegetation has sufficiently stabilized this area the item will be closed. The contractor should provide the tag from the seed mix that was used to the Conservation Commission to ensure that the required native seed mix was used per the design plans.</p> <p>10/8/2024 - Observation remains. See update from 10/4/2024.</p> <p>10/15/2024 - Observation remains. See update from 10/4/2024.</p> <p>10/22/2024 - Observation remains. See update from 10/4/2024.</p> <p>10/29/2024 - Observation remains. No germination has been observed in this location since the application of hydroseed. See update from 10/4/2024.</p> <p>11/5/2024 - Observation remains. Some germination has been observed but the area is not considered stabilized.</p> <p>11/12/2024 - Observation remains.</p>

View of hydroseed with some germination along slopes at Station 172+00 to 175+00 per Compliance Action Item 6.

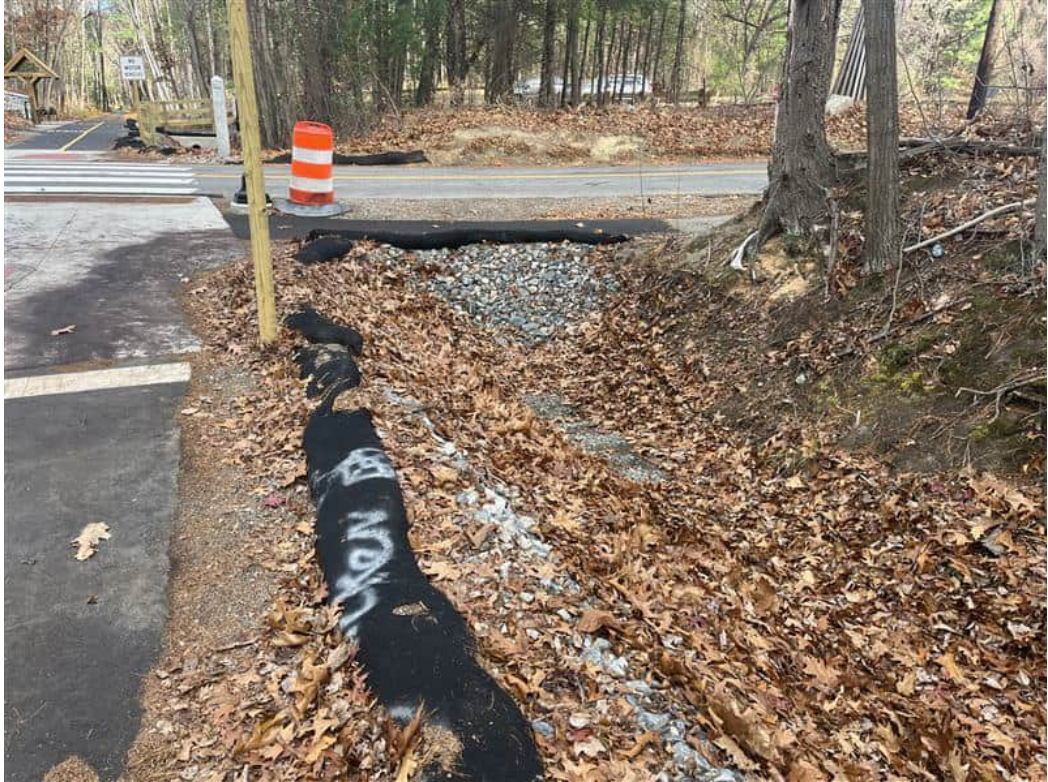
Photo No. 7 **Date:** 11/12/2024

58	<p>Crushed stone used for the dense graded crush stone shoulders has been observed as migrating both onto the path, off the sides of the path, and into the adjacent Resource Areas throughout the Project Priority: High</p>	8/7/2024	8/14/2024	<p>Remove all crushed stone from Resource Areas and develop a plan to cease discharges of stone.</p>	<p>8/12/2024 - Crushed stone is still present in varying amounts throughout the path and on the sides of the path. 8/16/2024 - Observation remains. 8/20/2024 - Crushed stone has been removed from some adjacent resource areas but is still observed as migrating onto and off of the path in multiple locations throughout the Project. 8/27/2024 - Crushed stone has been observed as migrating from the shoulders throughout the path. 9/3/2024 - Crushed stone was observed as migrating both onto the path and off the side of the path in multiple locations. Stone was observed to have discharged to the cattle crossing at Station 190+50 and within the streambed at Station 215+00 to 216+00. Crushed stone was observed to have been placed on the root system of a fallen tree at Station 310+00 near Bank flag #BF4-108. 9/10/2024 - Observation remains. Crushed stone is still present within the cattle crossing, the streambed, and on the root system of the fallen tree. Crushed stone continues to migrate on to and off of the path. 9/16/2024 - Observation remains. The contractor indicated the locations where crushed stone has migrated off the path will be hand removed and crushed stone will be swept off the path prior to the opening of the trail. 9/23/2024 - Observation remains. It does not appear as though crushed stone that has migrated onto or off of the path has been removed in any location along the Project. More crushed stone has migrated onto the path throughout significant portions of the path. 9/27/2024 - Observation remains. Crushed stone is still located on the side of the path and on the path in varying amounts. 10/4/2024 - Crushed stone has been removed from multiple locations along the trail but was still observed on and on the sides of the trail in several locations. 10/8/2024 - Observation remains. Crushed stone is still present in multiple locations on and off the sides of the path. 10/15/2024 - Observation remains. Crushed stone is still present in multiple locations on and off the sides of the path. 10/22/2024 - Observation remains. Crushed stone is still present in multiple locations on and off the sides of the path. The crushed stone shoulders along Station 1000+00 to 1003+00 has been moved back into the shoulders and regraded. 10/29/2024 - Observation remains. Crushed stone is still present in multiple locations on and off the sides of the path. 11/5/2024 - Observation remains. See previous update. 11/12/2024 - Observation remains. Crushed stone is still present on the side of the path in multiple locations, within the streambed and drainage swale and within the cattle crossing at Station 190+50.</p>

View of crushed stone within the streambed at Station 215+00 per Long Term Compliance Action Item 58.

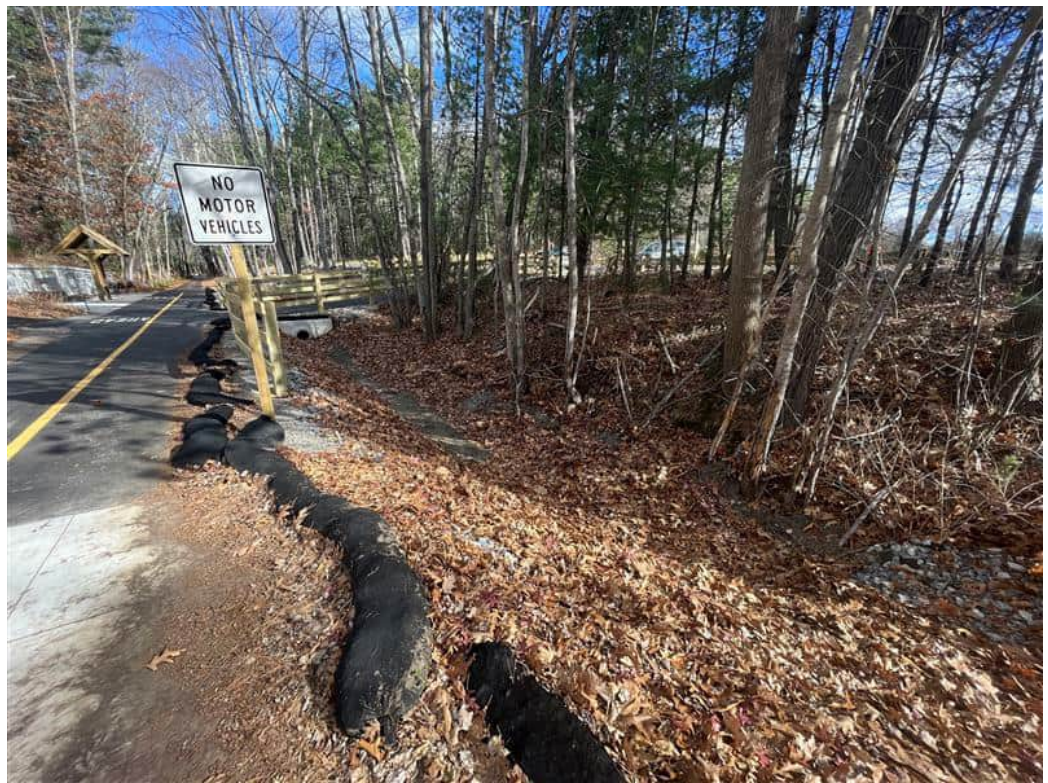
Photo No. 8 **Date:** 11/12/2024

41	Stream Bank has been regraded beyond the limit of work at Station 216+00 Priority: High	5/28/2024	6/4/2024	The Contractor should confirm if this work was permitted by the Conservation Commission, as it does not appear to be a part of the approved plans/impacts. MassDOT should be consulted on next steps regarding notification and potential restoration.	<p>5/31/2024 - Observation remains. 6/7/2024 - Observation remains. 6/14/2024 - Observation remains. 6/17/2024 - Observation remains. 6/24/2024 - Observation remains. 6/27/2024 - Observation remains. 7/8/2024 - Observation remains. 7/15/2024 - This area could not be assessed due to paving operations ongoing during the inspection. 7/22/2024 - Crushed stone and sediment continue to be discharged to the stream between Stations 215+00 and 217+00 due to overtopped and undermined compost filter tubes. 7/29/2024 - Observation remains. 8/5/2024 - Observation remains. 8/7/2024 - Observation remains. 8/12/2024 - Observation remains. Crushed stone is still present in the streambed at this location. 8/16/2024 - Observation remains. 8/20/2024 - Stone has been removed; however, additional alteration to Resource Areas beyond the limit of work continue. 8/27/2024 - Observation remains. 9/3/2024 - Observation remains. 9/10/2024 - Observation remains. Stone has been observed as discharging into the streambed in this location again. 9/16/2024 - Observation remains. 9/23/2024 - Observation remains. Stone is still present within the streambed at this location. 9/27/2024 - Observation remains. 10/4/2024 - Observation remains. 10/8/2024 - Observation remains. 10/15/2024 - Observation remains. Stone is still present within the streambed at this location. 10/22/2024 - Observation remains. Stone is still present within the streambed at this location. 10/29/2024 - Observation remains. Stone is still present within the streambed at this location. 11/5/2024 - Observation remains. The PVC pipe that was installed at this location was observed to be covered with stone and is no longer visible near Station 215+00. Stone is still present within the streambed at this location. 11/12/2024 - Observation remains. The streambed in this location is covered with leaf litter. See previous update.</p>

View of crushed stone within the streambed and the location where the stream bank has been regraded beyond the limits of work at Station 216+00 per Long Term Compliance Action Item 41.

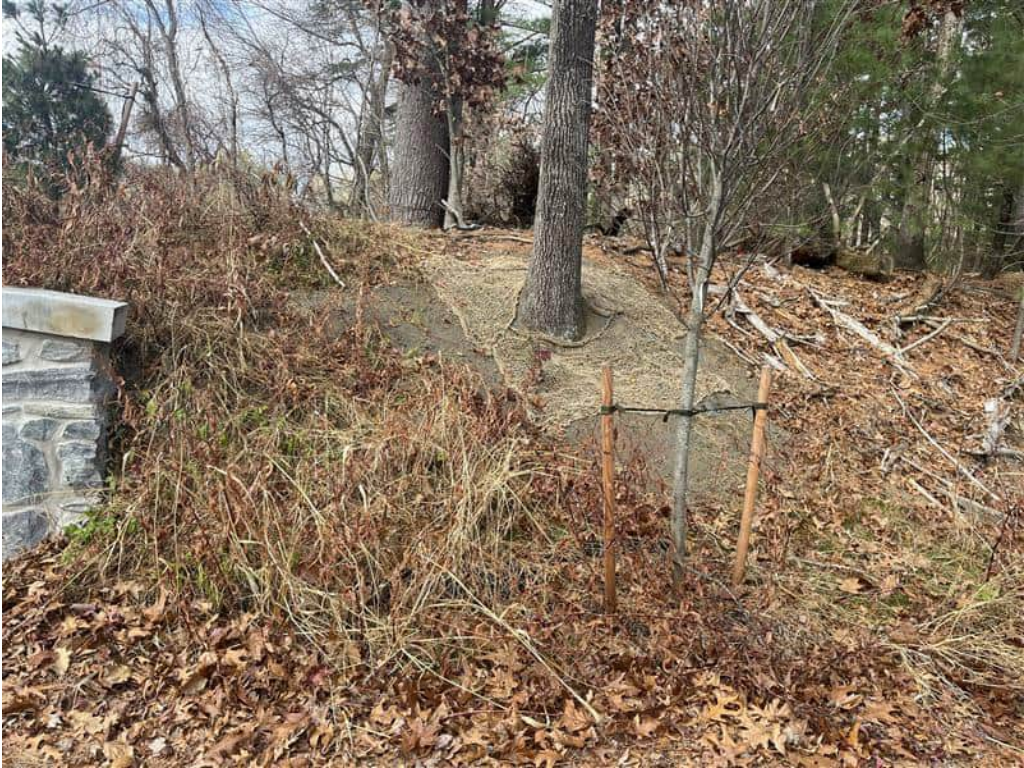
Site Location Bruce Freeman Rail Trail Right-of-Way		BETA Project No. 24.10326.23
Photo No. 9	Date: 11/12/2024

34	<p>Sediment is eroding downhill from behind the cemented stone masonry wall at Station 217+45 Priority: Low</p>	5/28/2024	6/4/2024	<p>Apply seed and temporarily stabilize the soils along the slope with straw, jute netting, etc.</p>	<p>5/31/2024 - Observation remains. 6/7/2024 - Observation remains. 6/14/2024 - Observation remains. 6/17/2024 - Observation remains. 6/24/2024 - Observation remains. 6/27/2024 - Rills were raked, loam was added, and hydroseed was applied. 7/8/2024 - Observation remains. Grass was observed to be germinating at this location. Comment will remain open until stabilization is complete. 7/8/2024 - See previous update. 7/15/2024 - Additional hydroseed is required due to washouts. 7/22/2024 - Observation remains. 7/29/2024 - Observation remains. 8/5/2024 - Observation remains. 8/7/2024 - Regrowth of vegetation has been observed in this area. This item will remain open until the area is fully stabilized. 8/12/2024 - Observation remains. Regrowth has stabilized a portion of this hill; however, reseeding and additional temporary stabilized measures are recommended on the section that is currently unvegetated. 8/16/2024 - Observation remains. 8/20/2024 - Application of the approved seed mixture is required at this location. 8/27/2024 - Observation remains. 9/3/2024 - Vegetation that is present in this location generally consists of lady's thumb smartweed (<i>Persicaria maculosa</i>), a non-native species. Removal of non-native species and application of the approved seed mixture is required at this location. 9/10/2024 - Observation remains. See previous update. 9/16/2024 - Observation remains. See update from 9/3/2024. 9/23/2024 - Observation remains. See update from 9/3/2024. 9/27/2024 - Observation remains. 10/4/2024 - Observation remains. See update from 9/3/2024. 10/8/2024 - Observation remains. See update from 9/3/2024. 10/15/2024 - Observation remains. See update from 9/3/2024. 10/22/2024 - Observation remains. See update from 9/3/2024. 10/29/2024 - Observation remains. No additional seed has been applied to this location and the slope is generally vegetated by non-native species. See update from 9/3/2024. 11/5/2024 - Observation remains. Erosion control and seed has been applied to part of this slope, no germination has been observed. 11/12/2024 - Observation remains. No germination has been observed in this location.</p>

Direction Photo Taken: Toward the Northwest		
Description: View of the newly installed erosion control blanket and placed seed on the slope at Station 217+45 per Compliance Action Item 34.		
Photo No. 10	Date: 11/12/2024

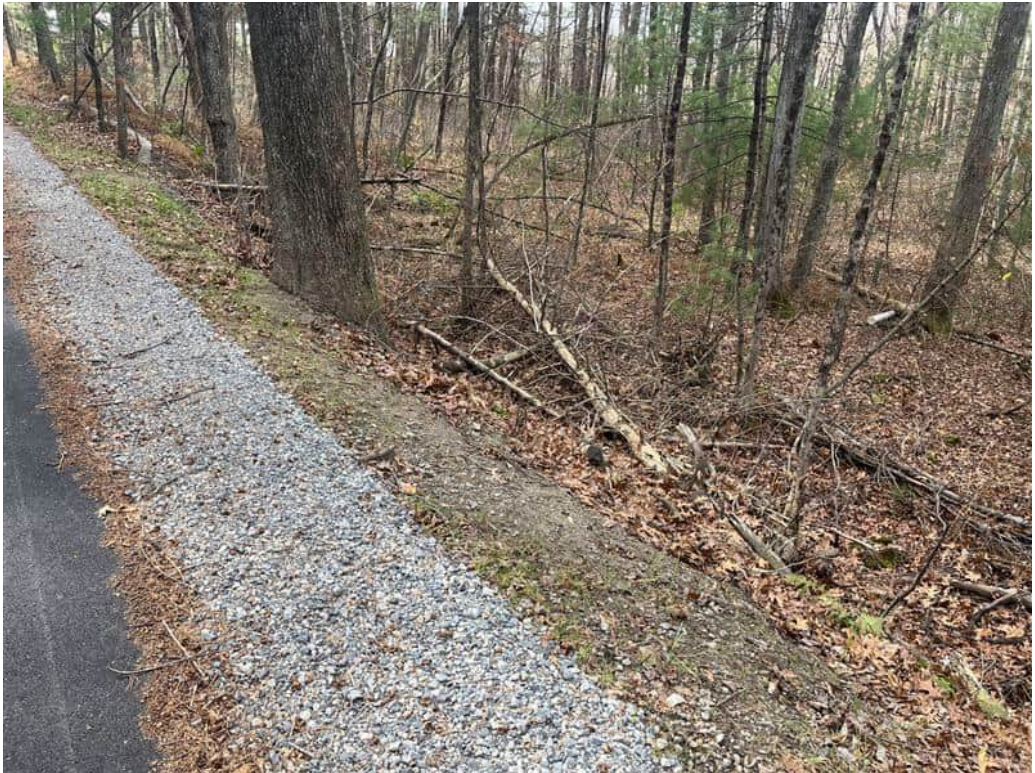
32	<p>Soil and organic debris has been placed within the wetland between wetland flagging WF#23-119 and WF#23-118 at Station 224+00</p> <p>Priority: High</p>	5/21/2024	5/28/2024	<p>Remove all material and provide stabilization of the area with the approved wetland seed mixture. Straw should also be placed for interim stabilization.</p>	<p>5/28/2024 - Observation remains. 5/31/2024 - Observation remains. 6/7/2024 - Observation remains. 6/14/2024 - Observation remains. 6/17/2024 - This area has been hydroseeded multiple times, but the debris should also be removed from the downgradient wetland. 6/24/2024 - Observation remains. 6/27/2024 - Observation remains. The area was hydroseeded again. 7/8/2024 - Germination was observed and the area will be monitored for stabilization. 7/15/2024 - See previous update. 7/22/2024 - Observation remains. 7/29/2024 - Observation remains. 8/5/2024 - Observation remains. 8/7/2024 - Regrowth of vegetation has been observed in this area. This item will remain open until the area is fully stabilized. Debris is still present in wetland and requires removal. 8/12/2024 - Observation remains. 8/16/2024 - Observation remains. 8/20/2024 - Debris is still present within the wetland. 8/27/2024 - Observation remains. 9/3/2024 - Debris is still present in the wetland and slopes upgradient of the wetland require stabilization. 9/10/2024 - Observation remains. 9/16/2024 - Debris has been removed from the wetland; however, soils require stabilization. 9/23/2024 - Observation remains. Soils require stabilization at this location. 9/27/2024 - Observation remains. The contractor indicated hydroseed will be applied to this area soon. 10/4/2024 - Observation remains. Hydroseed has not been applied to this area. 10/8/2024 - Observation remains. Hydroseed has not been applied to this area. 10/15/2024 - Observation remains. Hydroseed has not been applied to this area. 10/22/2024 - Observation remains. Hydroseed has not been applied to this area. 10/29/2024 - Observation remains. Hydroseed has not been applied to this area. 10/29/2024 - Observation remains. Hydroseed has not been applied to this area. 11/5/2024 - Observation remains. Hydroseed has not been applied to this area. 11/12/2024 - Observation remains.</p>

Direction Photo Taken: Toward the Northeast		
Description: View of a location that requires stabilization at Station 224+00 per Long Term Compliance Action Item 32.

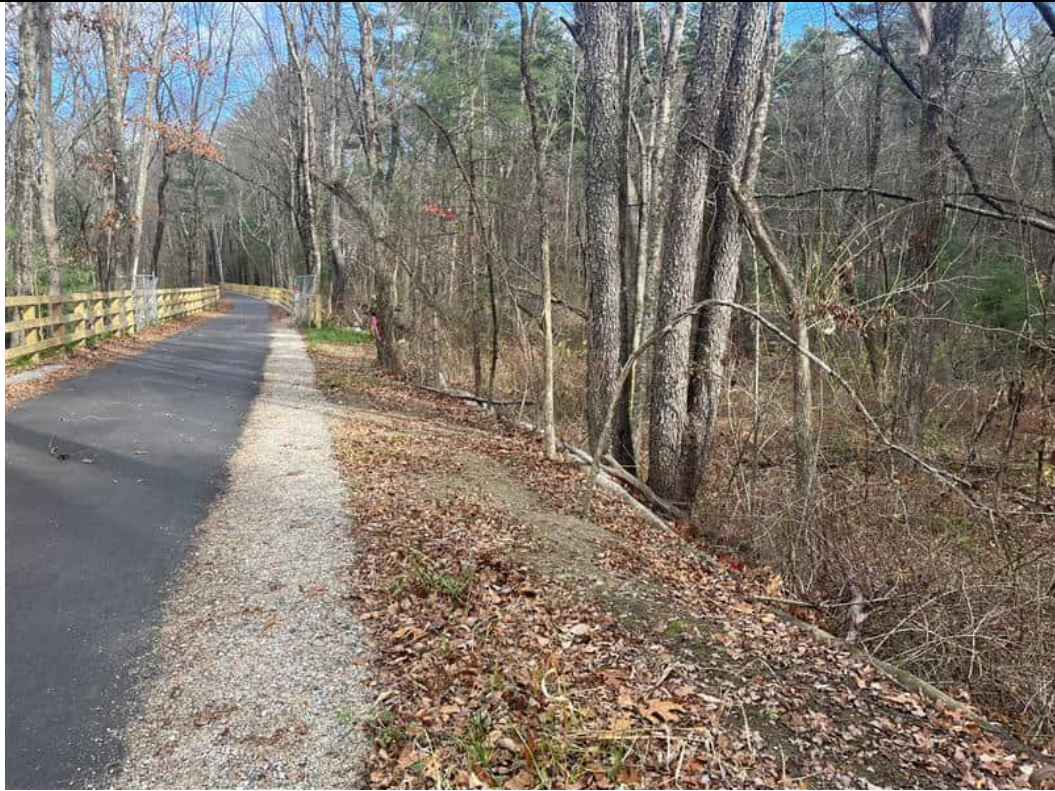
Photo No. 11 **Date:** 11/12/2024

Item	Location/ Description	Observation Date	Resolution Due Date	Recommended/Discussed Resolution	Comments/Updates
59	Multiple locations of exposed soils along the Project corridor require stabilization Priority: High	9/3/2024	9/10/2024	The contactor should apply the approved seed mixture to areas of exposed soils and place straw.	<p>9/3/2024 - Herbicide application caused multiple areas along the path to be no longer stabilized. If thatch is present in these locations the thatch should be removed before seeding occurs. A location near Station 320+50 has been cleared outside of the limit of work and requires stabilization. Other areas along the path where seed did not germinate should be reseeded with the approved seed mix and straw should be placed on the areas of exposed soil.</p> <p>9/10/2024 - Observation remains, see previous update. A few locations along the trail have been hydroseeded but a majority of the locations of exposed soil require seed and stabilization.</p> <p>9/16/2024 - Observation remains. The contractor indicated areas of bare soil will be hydroseeded.</p> <p>9/23/2024 - Observation remains. It does not appear as though any hydroseeding has been done since the last inspection. Areas throughout the trail require removal of thatch and application of seed for stabilization.</p> <p>9/27/2024 - Observation remains. The contractor reached out and indicated all areas of exposed soils south of Hudson Road were hydroseeded after the inspection occurred.</p> <p>10/4/2024 - All areas south of Hudson Road were not seeded using hydroseed; hydroseed was applied in a few locations, but there are still large areas of exposed soil both south and north of Hudson Road that require seeding. Thatch was not removed in any areas before hydroseed was applied. The contractor should provide the tag from the seed mix that was used to the Conservation Commission to ensure that the required native seed mix was used per the design plans. Once vegetation has sufficiently stabilized, this item will be closed.</p> <p>10/8/2024 - Observation remains. See update from 10/4/2024. No additional hydroseed has been applied since the last inspection.</p> <p>10/15/2024 - Observation remains. See update from 10/4/2024. No additional hydroseed has been applied since the last inspection. No germination has been observed in areas where hydroseed was applied.</p> <p>10/22/2024 - Observation remains. See update from 10/4/2024. No additional hydroseed has been applied since the last inspection. Some germination has been observed in a few locations where hydroseed was previously applied.</p> <p>10/29/2024 - Observation remains. No additional hydroseed has been applied since the last inspection. If additional hydroseed is applied leaf litter and thatch should be removed so the seed can make contact with the soil. See update from 10/4/2024.</p> <p>11/5/2024 - Seed and erosion control blankets have been applied to part of the slope at Station 217+45 and seed has been applied to the exposed soil around a newly installed interpretive sign at Station 181+75. The contractor should provide the tag from the seed mix that was used to the Conservation Commission to ensure that the required native seed mix was used per the design plans. Exposed soil with little to no vegetation is still present throughout the trail.</p> <p>11/12/2024 - Observation remains. Loam and seed have been placed on an area where crushed stone had migrated off of the path at 181+00. No additional hydroseed has been applied.</p>

View of a location that requires stabilization at Station 224+00 per Long Term Compliance Action Item 59. Note that exposed soils are currently covered in leaf litter.

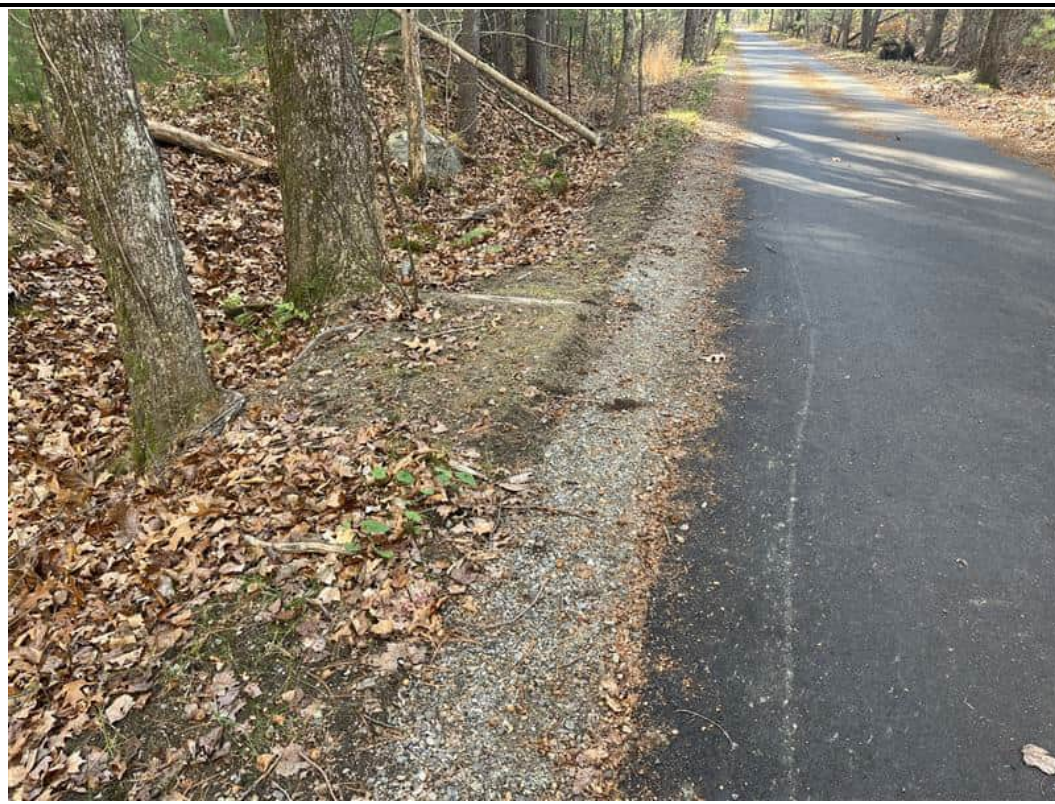
Photo No. 12 **Date:** 11/12/2024

Item	Location/ Description	Observation Date	Resolution Due Date	Recommended Resolution / Resolution Date	Comments/Updates
61	Invasive vegetation including Japanese knotweed (<i>Reynoutria japonica</i>), bittersweet (<i>Celastrus orbiculatus</i>), bush honeysuckle (<i>Lonicera</i> spp.), burning bush (<i>Euonymus alatus</i>), purple loosestrife (<i>Lythrum salicaria</i>), glossy buckthorn (<i>Frangula alnus</i>) and garlic mustard (<i>Alliaria petiolata</i>) have been observed throughout the path. Priority: High	10/22/2024	10/29/2024	Invasive Species should be removed by manual and/or chemical removal methods	10/29/2024 - Invasive species are present throughout the trail both within upland and Resource Areas. Populations of glossy buckthorn and purple loosestrife are present within the wetland replication area. 11/5/2024 - Observation remains. See update from 10/29/2024. 11/12/2024 - Observation remains. Invasive species are still present throughout the trail. Some invasives have been observed with no leaves due to winter die back.

View of a location that requires stabilization and removal of invasive species at Station 298+00 per Long Term Compliance Action Item 59 and 61.

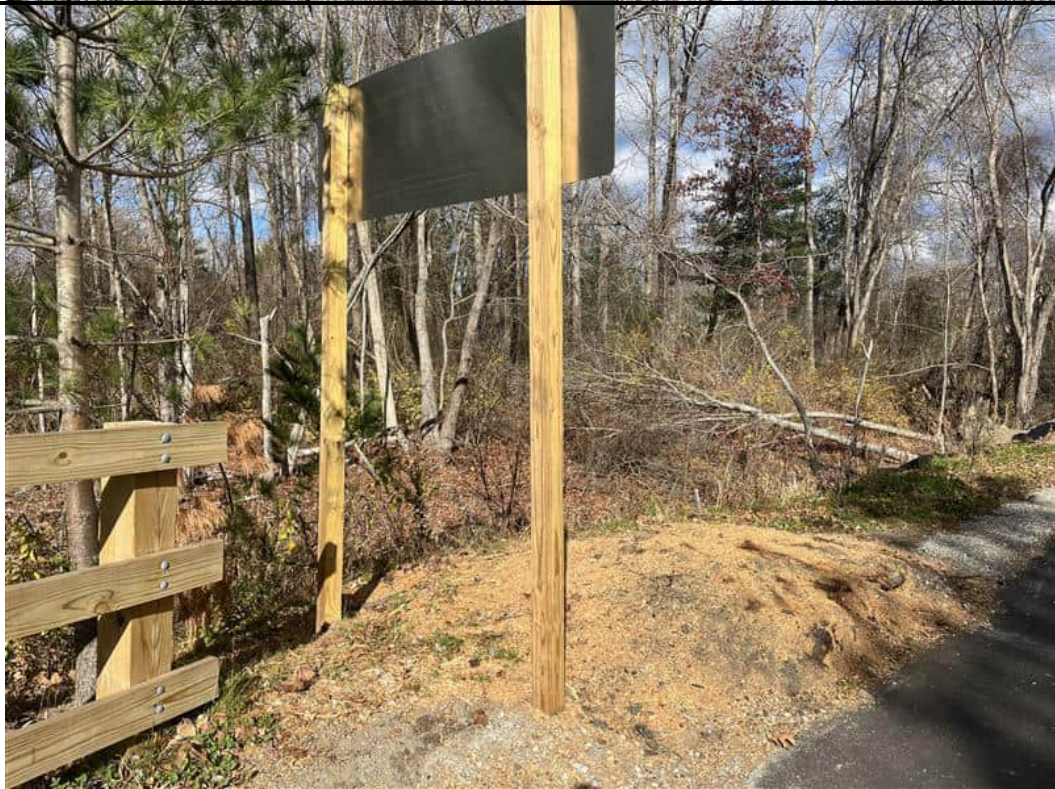
Photo No. 13 **Date:** 11/12/2024

60	Multiple piles of wood shavings were observed along the trail shoulders. In some locations, wood shavings are located directly adjacent to Resource Areas. Priority: High	10/4/2024	10/11/2024 Resolved: 11/12/2024	Remove wood shavings from the shoulders.	<p>10/8/2024 - Observation remains. Wood shaving that are in the pile at Station 311+00 were observed as migrating down into the adjacent Resource Areas and require removal. 10/15/2024 - Observation remains. Piles of wood shavings are present in multiple locations throughout the trail and wood shavings are present within the Resource Area adjacent to Station 311+00. 10/22/2024 - Observation remains. See previous update. 10/29/2024 - Observation remains. See update from 10/15/2024. 11/5/2024 - Observation remains. See update from 10/15/2024. 11/12/2024 - It appears as though the pile of wood shavings has been partially removed.</p>

View of a pile of wood shavings that ~~require removal~~ at Station 310+00 per Compliance Action Item 60.

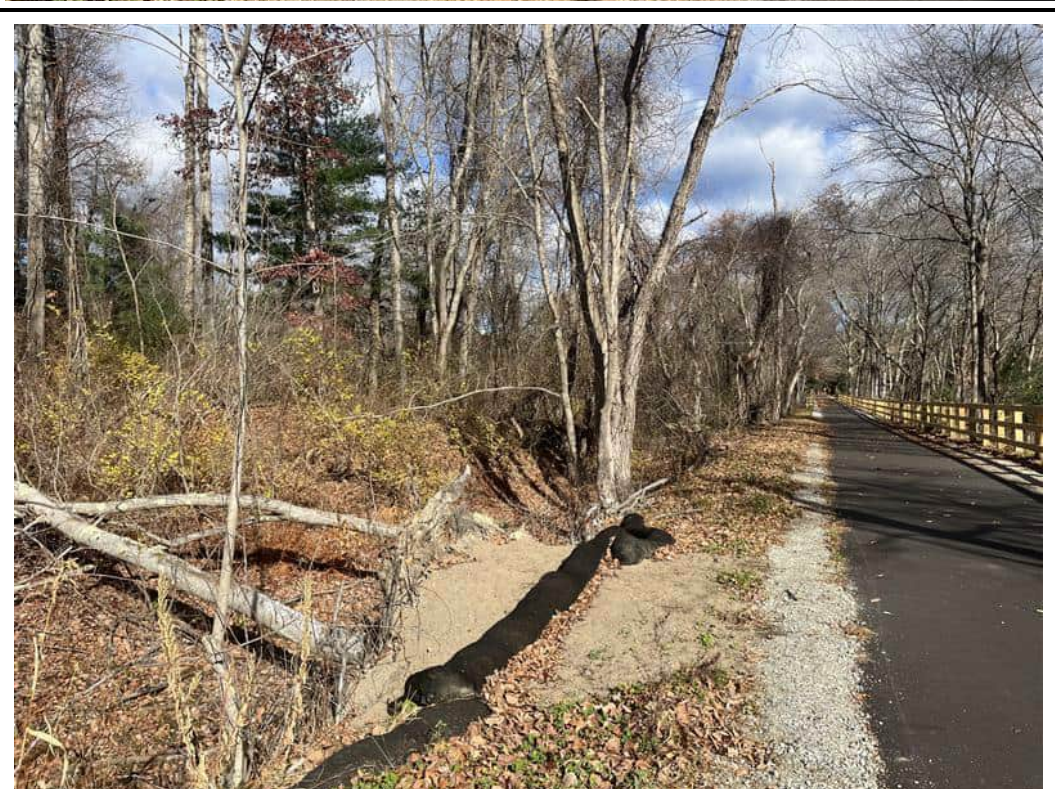
Photo No. 14 **Date:** 11/12/2024

View of recently placed loam that requires stabilization at Station 311+00 per Long Term Compliance Action Item 59.
