Weekly Environmental Compliance Summary

Sudbury to Hudson Transmission Reliability Project (USEPA Tracking # MAR1003UW)

Week of: December 16, 2024 to December 20, 2024

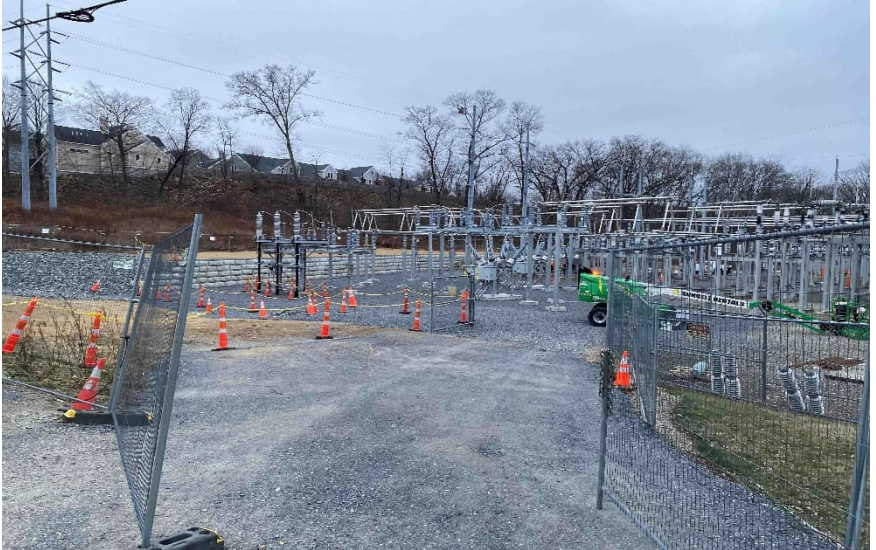
<p>PHOTOGRAPHIC LOG</p>	
<p>Client Name: Eversource</p>		<p>Site Location: Sudbury to Hudson Transmission Reliability Project</p>	<p>Town: Hudson</p>
<p>Photo No.: 2</p>	<p>Date: 12-16-24</p>

<p>Description: Hudson Power & Light facility, conduit potheads in left center, looking eastward.</p>

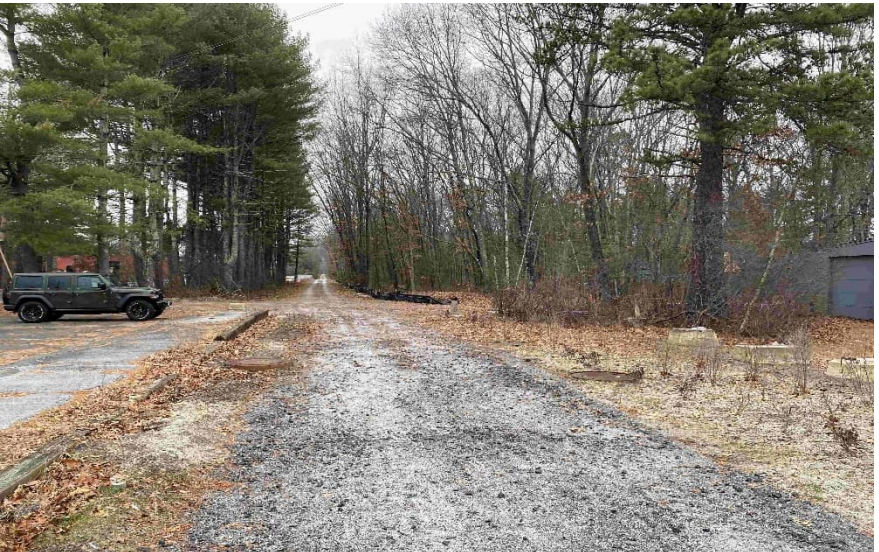
<p>PHOTOGRAPHIC LOG</p>	
<p>Client Name: Eversource</p>		<p>Site Location: Sudbury to Hudson Transmission Reliability Project</p>	<p>Town: Sudbury</p>
<p>Photo No.: 6</p>	<p>Date: 12-16-24</p>

<p>Description:</p> <p>Work area within segment 11 at manhole #24, erosion control in area recently removed, remaining existing erosion control in background, looking westward.</p>

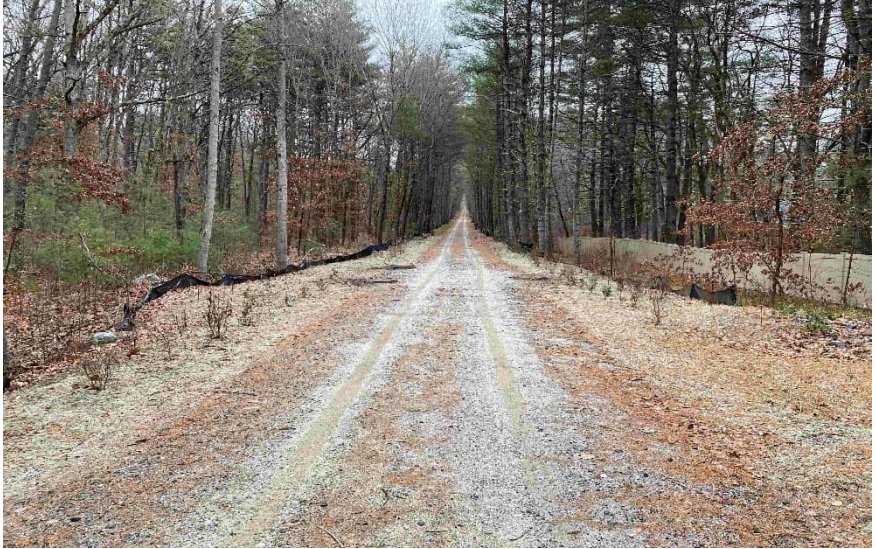
PHOTOGRAPHIC LOG	
Client Name: Eversource		Site Location: Sudbury to Hudson Transmission Reliability Project	
Town: Sudbury			
Photo No.: 7	Date: 12-16-24

Description: Work area within segment 10, manhole #20, recently planted & hydroseeded, existing erosion control, looking eastward.

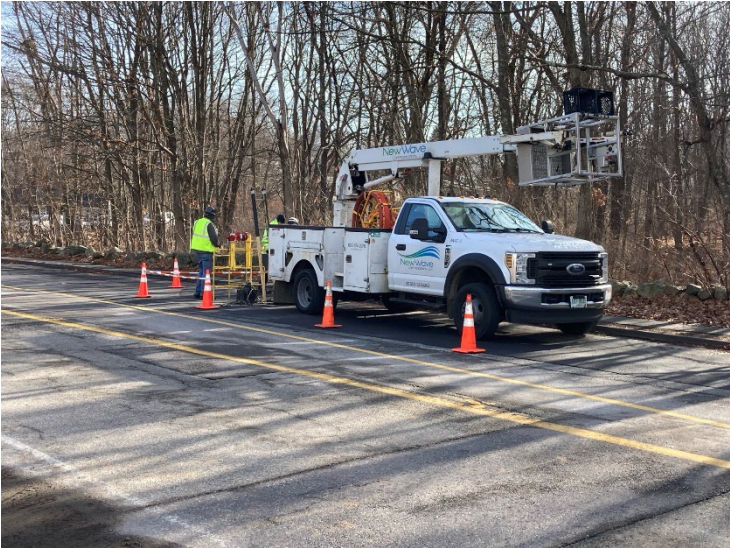
PHOTOGRAPHIC LOG	
Client Name: Eversource		Site Location: Sudbury to Hudson Transmission Reliability Project	Town: Hudson
Photo No.: 1	Date: 12/18/2024

Description: View of New Wave working at HH #2 on Forest Ave. No dewatering was necessary. Facing southeast.

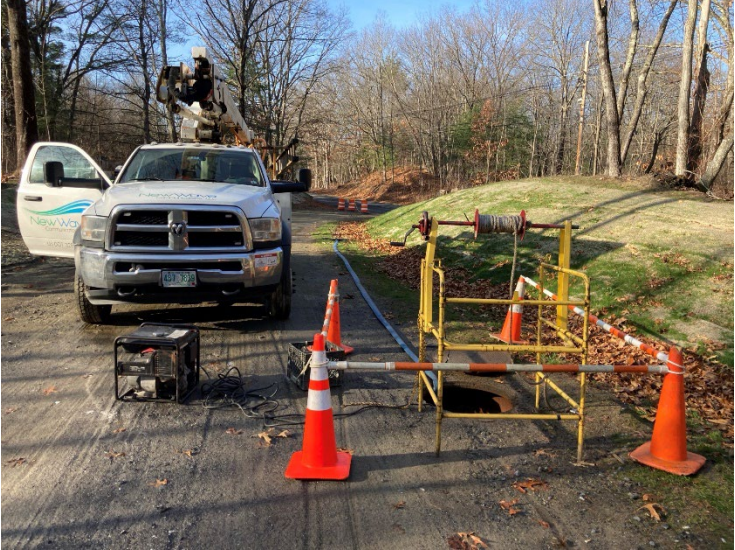
PHOTOGRAPHIC LOG	
Client Name: Eversource		Site Location: Sudbury to Hudson Transmission Reliability Project	Town: Hudson
Photo No.: 3	Date: 12/18/2024

Description: View of New Wave working at HH #5 in segment 1. Dewatering was necessary to complete work. See additional dewatering inspection report. Facing west.

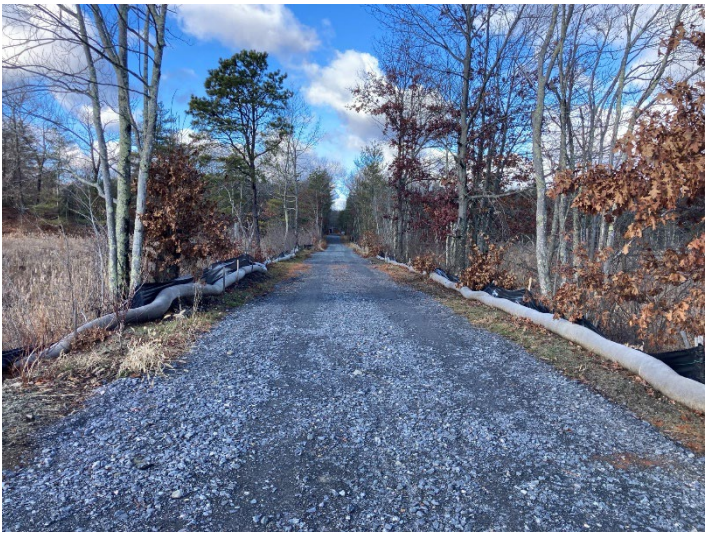
PHOTOGRAPHIC LOG	
Client Name: Eversource		Site Location: Sudbury to Hudson Transmission Reliability Project	Town: Hudson
Photo No.: 2	Date: 12-19-2024

Description: View of E&S controls in segment 2. Facing east.

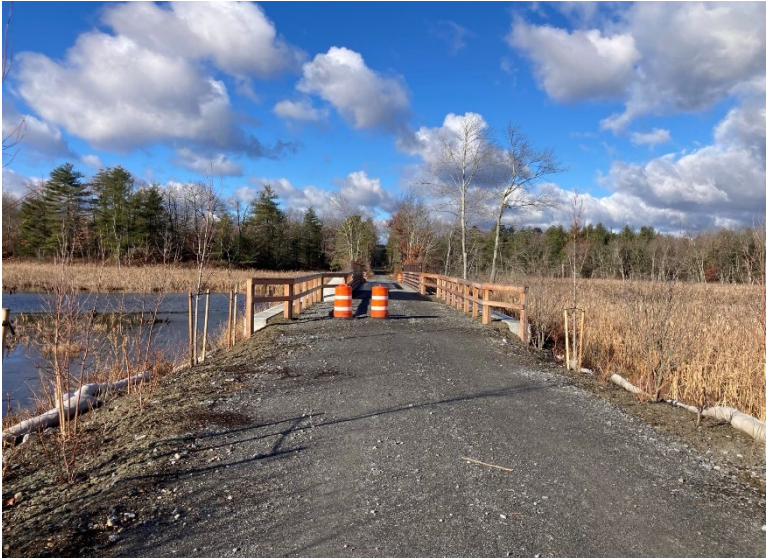
Epsilon ASSOCIATES INC.		PHOTOGRAPHIC LOG	
Client Name: Eversource		Site Location: Sudbury to Hudson Transmission Reliability Project	Town: Hudson
Photo No.: 3	Date: 12-19-2024

Description: View of bridge 130 from segment 3. Facing west.

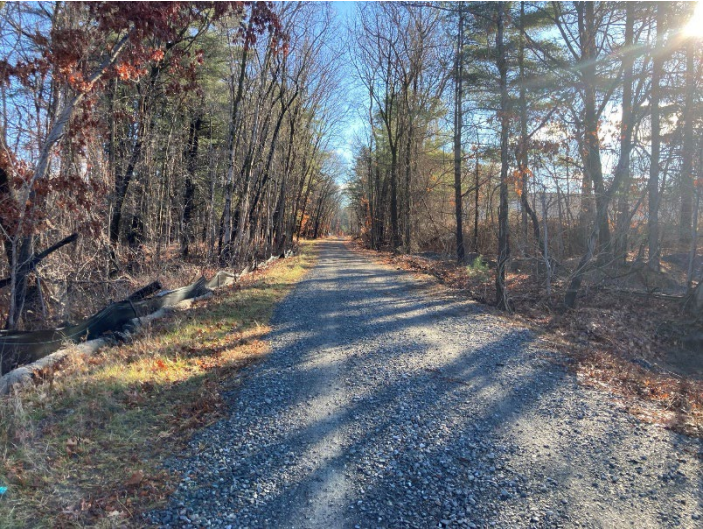
Epsilon ASSOCIATES INC.		PHOTOGRAPHIC LOG	
Client Name: Eversource		Site Location: Sudbury to Hudson Transmission Reliability Project	Town: Hudson
Photo No.: 4	Date: 12-19-2024

Description: View of E&S controls in segment 3. Portion of E&S controls in this area (right side of photo) have recently been removed. Compost tubes were cut, and compost material was spread. Facing east.

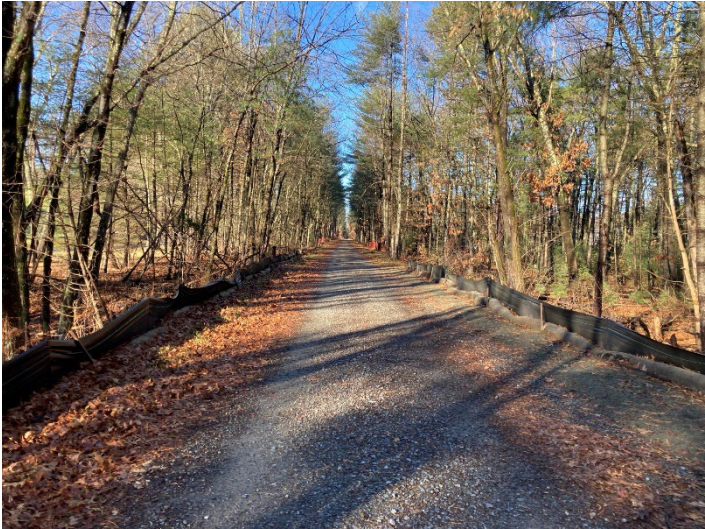
Epsilon ASSOCIATES INC.		PHOTOGRAPHIC LOG	
Client Name: Eversource		Site Location: Sudbury to Hudson Transmission Reliability Project	Town: Hudson
Photo No.: 5	Date: 12-19-2024

Description: View of E&S controls in segment 4. Facing west.

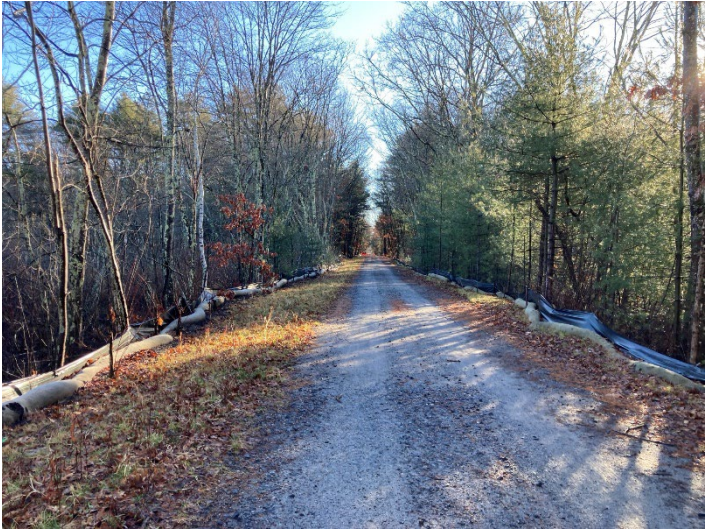
Epsilon ASSOCIATES INC.		PHOTOGRAPHIC LOG	
Client Name: Eversource		Site Location: Sudbury to Hudson Transmission Reliability Project	Town: Hudson
Photo No.: 6	Date: 12-19-2024

Description: View of E&S controls in segment 5. Facing east.

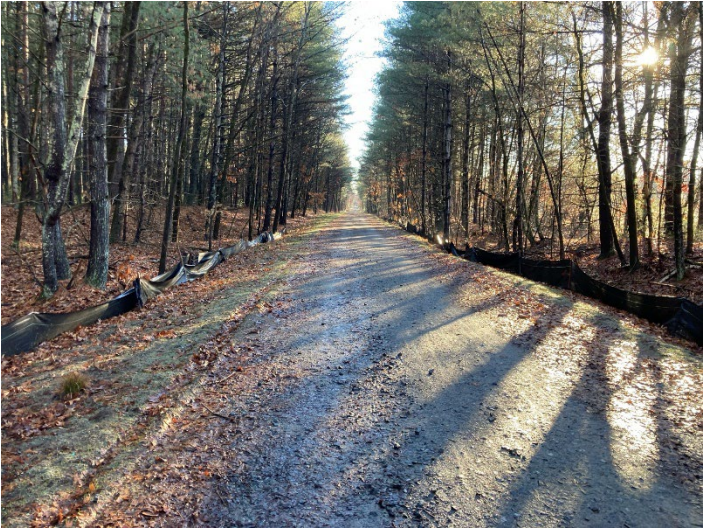
PHOTOGRAPHIC LOG	
Client Name: Eversource		Site Location: Sudbury to Hudson Transmission Reliability Project	Town: Hudson
Photo No.: 7	Date: 12-19-2024

Description: View of E&S controls in segment 6. Facing east.

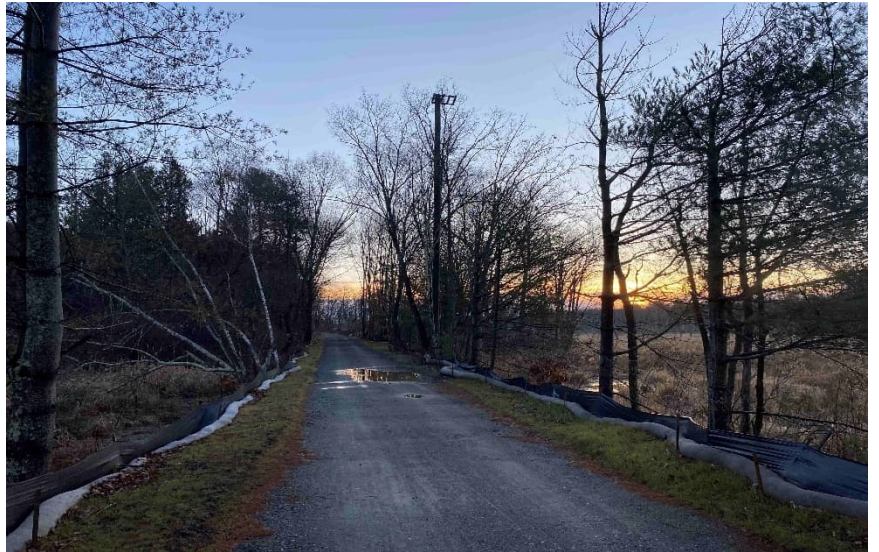
PHOTOGRAPHIC LOG	
Client Name: Eversource		Site Location: Sudbury to Hudson Transmission Reliability Project	Town: Sudbury
Photo No.: 2	Date: 12-19-24

Description: Work area within segment 14, area of recently placed osprey platform (right side), existing erosion control, looking eastward.

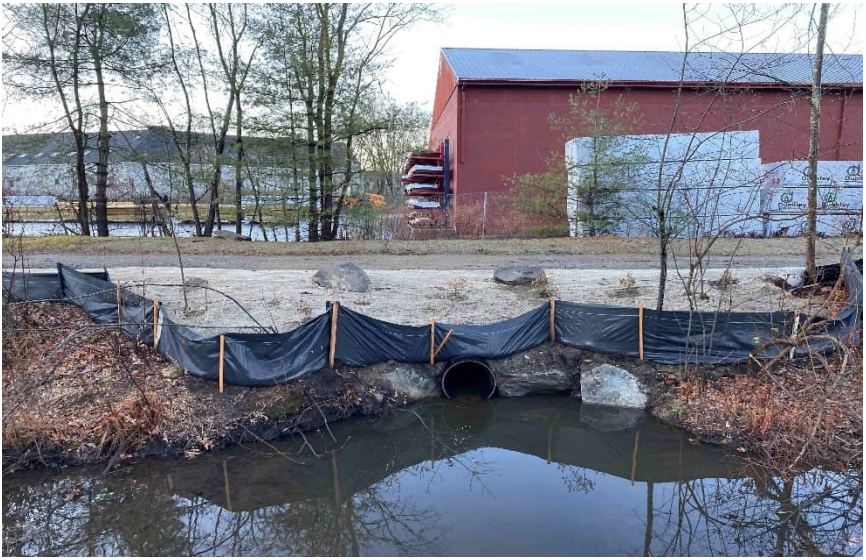
PHOTOGRAPHIC LOG	
Client Name: Eversource		Site Location: Sudbury to Hudson Transmission Reliability Project	Town: Sudbury
Photo No.: 3	Date: 12-19-24

Description: Work area within segment 12, culvert extension area, existing erosion control, looking northward.

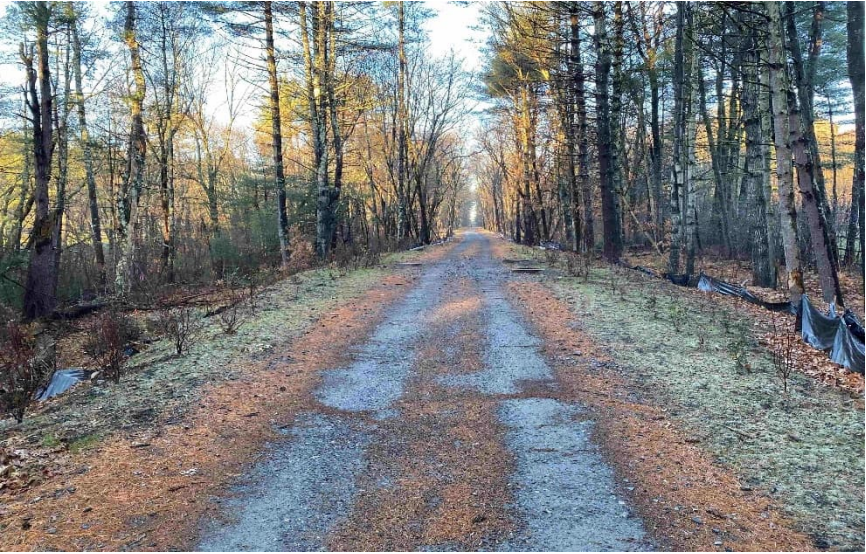
PHOTOGRAPHIC LOG	
Client Name: Eversource		Site Location: Sudbury to Hudson Transmission Reliability Project	Town: Sudbury
Photo No.: 4	Date: 12-19-24

Description: Work area within Segment 9, manhole #19, area recently planted & hydroseeded, existing erosion control, looking westward.

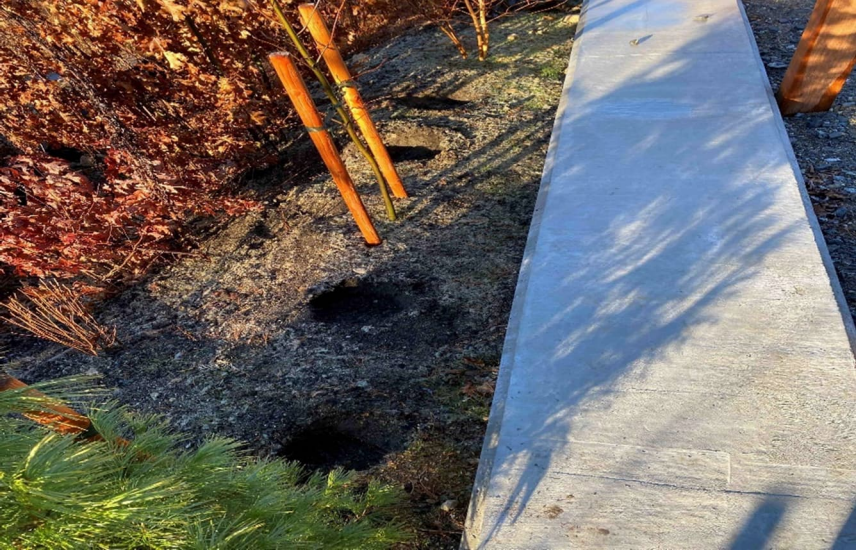
PHOTOGRAPHIC LOG	
Client Name: Eversource		Site Location: Sudbury to Hudson Transmission Reliability Project	Town: Sudbury
Photo No.: 6	Date: 12-19-24

Other Comments & Observations	
This SWPPP inspection covers Segments 7-14 & Sudbury substation. Balance of SWPPP inspection-Segments 1-6; all laydown yards in Hudson & manhole areas (Forest Ave.) conducted by Ariel Leclerc (SWCA).	Authorized Signature Date 12-19-24
Previous request was made to flag out the wetland replication area (segment 14). I flagged that area out today. Please see photo 1.	
Previous inspection on 12-12-24 by Ariel Leclerc in Sudbury noted downed silt fencing within segments 7 & 12. I repaired those two (2) damaged areas today. Please see photos 7 & 8 below.	
Previous inspection on 12-12-24 by Ariel Leclerc in Sudbury noted damaged plants at manhole #25/Segment 13. I noted today that two (2) Bayberry (<i>Myrica pensylvanica</i>) plants had been sheared off at ground level, plants destroyed.	
Today I noted that at Bridge 128 previously installed plants had been removed. Approximately twelve (12) locations were noted. Five (5) of the missing plants were found down slope of their original locations, but the others were gone. I replanted the 5 missing plants including four (4) Bayberries (<i>Myrica pensylvanica</i>) and one (1) silky dogwood (<i>Cornus amomum</i>). The other plants were not found. Please see photo 6 below showing missing plant locations.

Description: Work area within Segment 8, Bridge 128 at southeast corner (also see photo 5 for reference), recent plantings removed (holes left & plants gone), looking westward.

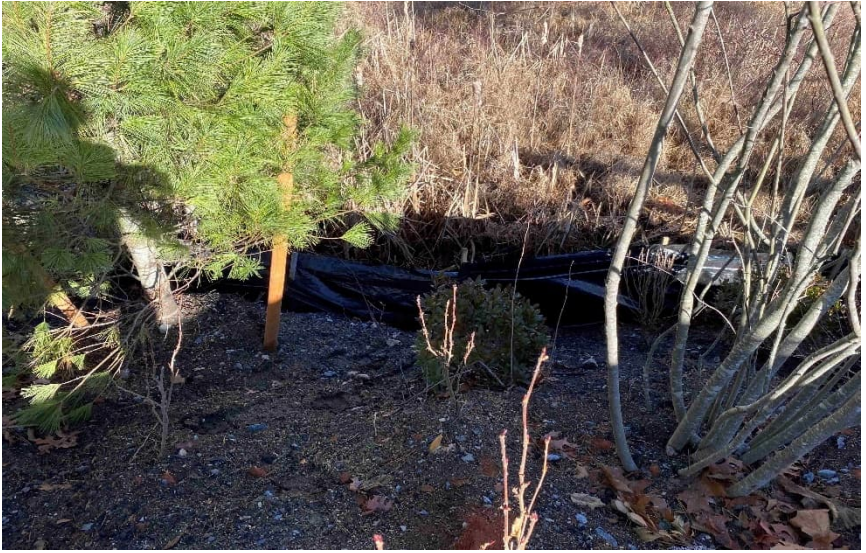
PHOTOGRAPHIC LOG	
Client Name: Eversource		Site Location: Sudbury to Hudson Transmission Reliability Project	Town: Sudbury
Photo No.: 7	Date: 12-19-24

Description: Work area within segment 7, silt fencing repaired, existing erosion control, looking northward.

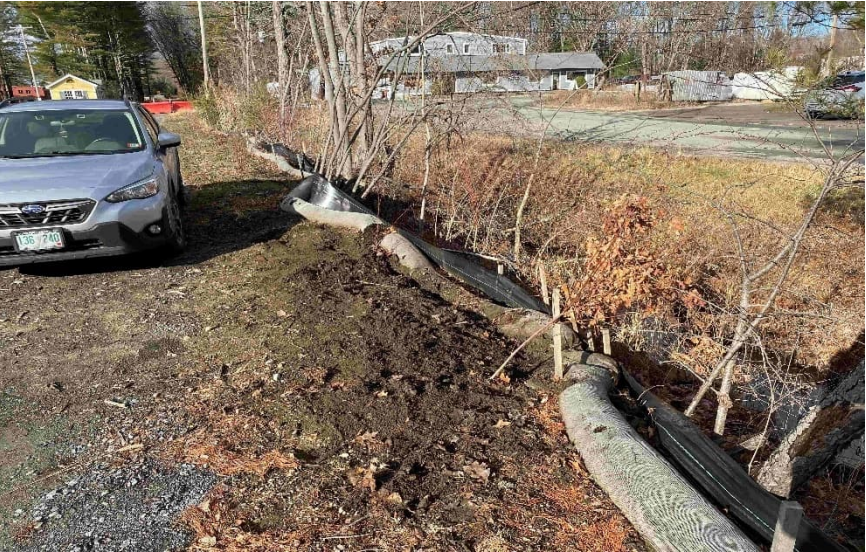
PHOTOGRAPHIC LOG	
Client Name: Eversource		Site Location: Sudbury to Hudson Transmission Reliability Project	Town: Sudbury
Photo No.: 8	Date: 12-19-24

Description: Work area within segment 12, silt fencing/tubing repaired, existing erosion control, looking westward.

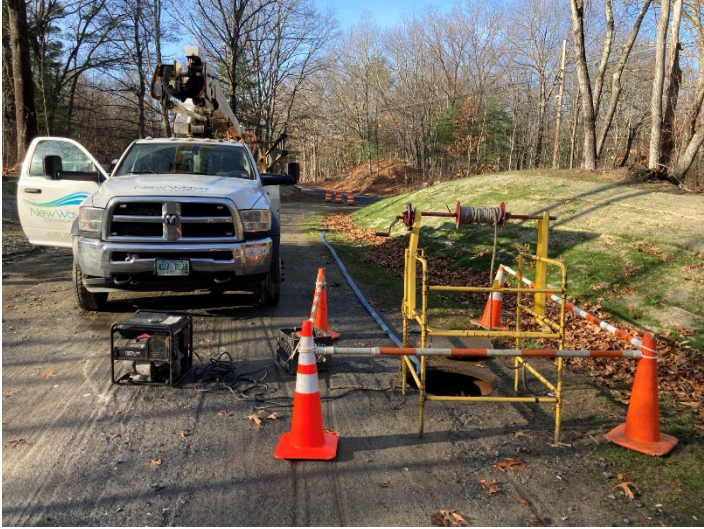
PHOTOGRAPHIC LOG		
Client Name: Eversource		Site Location: Sudbury to Hudson Transmission Reliability Project		Town: Hudson
Photo No.: 1	Date: 12/18/2024

Description: View of New Wave working at HH #5 in segment 1. Facing west.

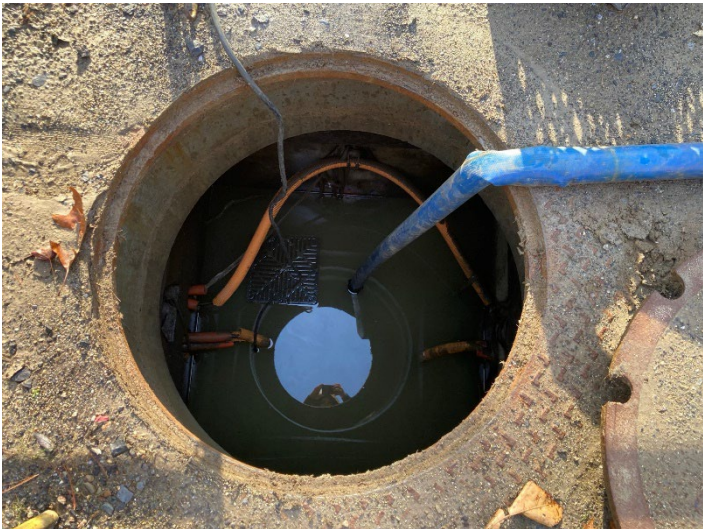
PHOTOGRAPHIC LOG		
Client Name: Eversource		Site Location: Sudbury to Hudson Transmission Reliability Project		Town: Hudson
Photo No.: 2	Date: 12/18/2024

Description: View of pump in HH #5. Water appeared mostly clear prior to treatment.

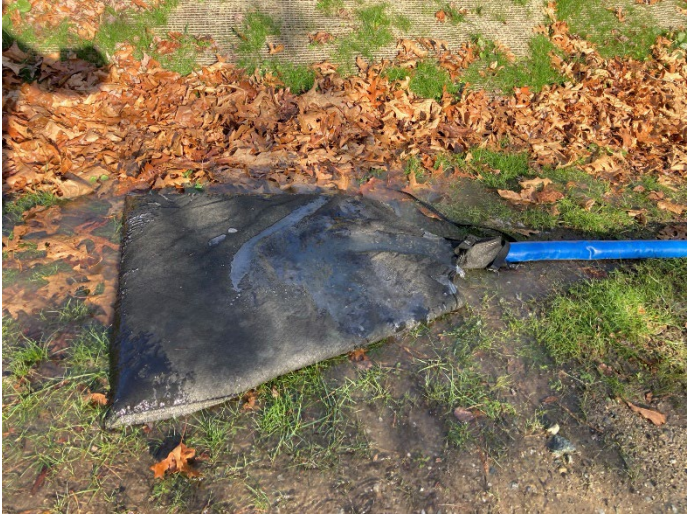
PHOTOGRAPHIC LOG		
Client Name: Eversource		Site Location: Sudbury to Hudson Transmission Reliability Project		Town: Hudson
Photo No.: 3	Date: 12/18/2024

Description: View of dewatering controls (silt bag) located in swale near HH #5.

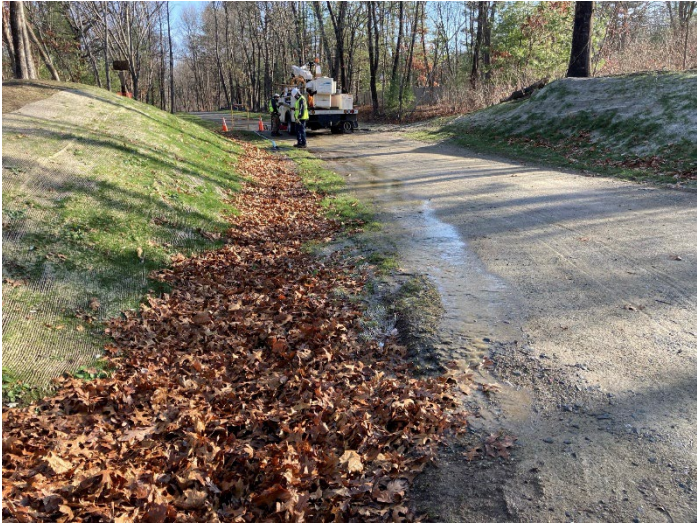
PHOTOGRAPHIC LOG		
Client Name: Eversource		Site Location: Sudbury to Hudson Transmission Reliability Project		Town: Hudson
Photo No.: 4	Date: 12/18/2024

Section A – Dewatering Discharges (CGP Part 4.6.3) Complete this section <u>within 24 hours</u> of completing the inspection. (If necessary, complete additional inspection reports for each separate inspection location.)	
Inspector Information	
Inspector Name: Ariel Leclerc	Title: Compliance Monitor, CESSWI, QCIS, QPSWPPP
Company Name: SWCA Environmental Consultants	Email: ariel.leclerc@swca.com
Address: 153 Cordaville Road, Suite 130, Southborough, MA 01772	Phone Number: 401-496-8471
Inspection Details	
Inspection Date: 12/18/2024	Inspection Location: Handhole (HH) #5 in segment 1
Discharge Start Time: 10:00am	Discharge End Time: 10:10am
Rate of Discharge (gallons per day): 118,080 (82 gallons per minute)	Corrective Action Required? ¹ <input type="checkbox"/> Yes <input checked="" type="checkbox"/> No
Describe Indicators of Pollutant Discharge at Point of Dewatering Discharge: ¹ Dewatering was necessary in handhole (HH) #5 for New Wave’s work activities. Dewatering setup to filter bag west of handhole. Discharge from bag appeared mostly clear but picked up sediment as it flowed down the ROW. Turbidity reading was higher than 50 NTUs.

Description: View of discharge from silt bag. Discharge flowed to catch basin (Drainage Structure 2). Discharge from bag appeared mostly clear but picked up sediment as it flowed down the ROW. Turbidity reading was higher than 50 NTUs. Facing east.
