Environmental Monitor Construction Site Inspection Report
MassDOT Project #608164 Construction Contract # 119678
EM Report #35

Project Description: Bruce Freeman Rail Trail Right-of-Way
 Permit Description(s): Order of Conditions (MGL Chapter 131, Section 40 and 310 CMR 10.00, Mass DEP File No. 301-1362); 2022 EPA NPDES General Permit for Discharges from Construction Areas; U.S. Army Corps of Engineers Permit No NAE-2021-01975.

Project Name:	Bruce Freeman Rail Trail - Phase 2d - Sudbury
Date of Inspections:	11/25/2024
Bi Weekly/ Monthly Period Covered:	November Weekly Inspection #5
Inspector's Name(s):	Anna Haznar
Inspectors' Contact Information:	ahaznar@beta-inc.com

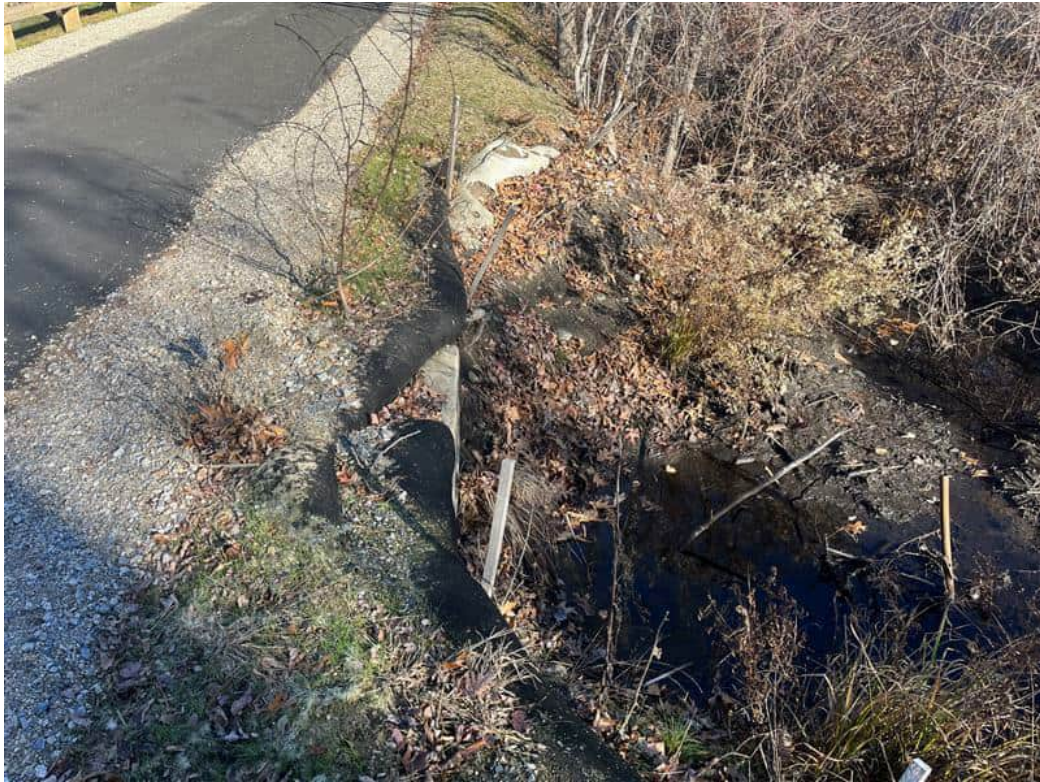
Photo No. 1 **Date:**
11/25/2024

43	<p>Overtopped compost filter tubes and exposed soils beyond the limits of work at Station 105+00 Priority: High</p>	6/7/2024	6/14/2024	<p>Stabilize the area with the approved seed mixture and provide interim stabilization such as straw mulch.</p>	<p>6/14/2024 - Observation remains. 6/17/2024 - Observation remains. 6/24/2024 - Observation remains. 6/27/2024 - Observation remains. 7/8/2024 - Observation remains. 7/15/2024 - Observation remains. 7/22/2024 - Observation remains. 7/29/2024 - Observation remains. 8/5/2024 - Observation remains. 8/7/2024 - Observation remains. 8/12/2024 - Observation remains. Some material has migrated off of the compost filter tubes due to erosion. 8/16/2024 - Observation remains. 8/20/2024 - Application of the approved seed mixture is required at this location. 8/27/2024 - Observation remains. 9/3/2024 - Observation remains. 9/10/2024 - Observation remains. Application of the approved seed mixture is required at this location. 9/16/2024 - Observation remains. 9/23/2024 - Observation remains. 9/27/2024 - Observation remains. 10/4/2024 - Hydroseed has been applied here; however, the contractor should provide an update on long-term slope stabilization plans. 10/8/2024 - Observation remains. Germination has not been observed. 10/15/2024 - Observation remains. Germination has not been observed. 10/22/2024 - Observation remains. Some germination has been observed but the area is not considered stabilized. 10/29/2024 - Observation remains. No further germination has been observed since the last inspection. 11/5/2024 - Observation remains. Some germination has been observed but the area is not considered stabilized. 11/12/2024 - Observation remains. Seed has stabilized the area. 11/19/2024 - The area adjacent to the path has become stabilized; however, exposed soil is still present next to the culvert past the limit of work. 11/22/2024 - Observation remains. See previous update. 11/25/2024 - Observation remains. See update from 11/19/2024.</p>

View of the overtopped compost filter tube beyond the limits of work at Station 105+00 per Compliance Action Item 43.

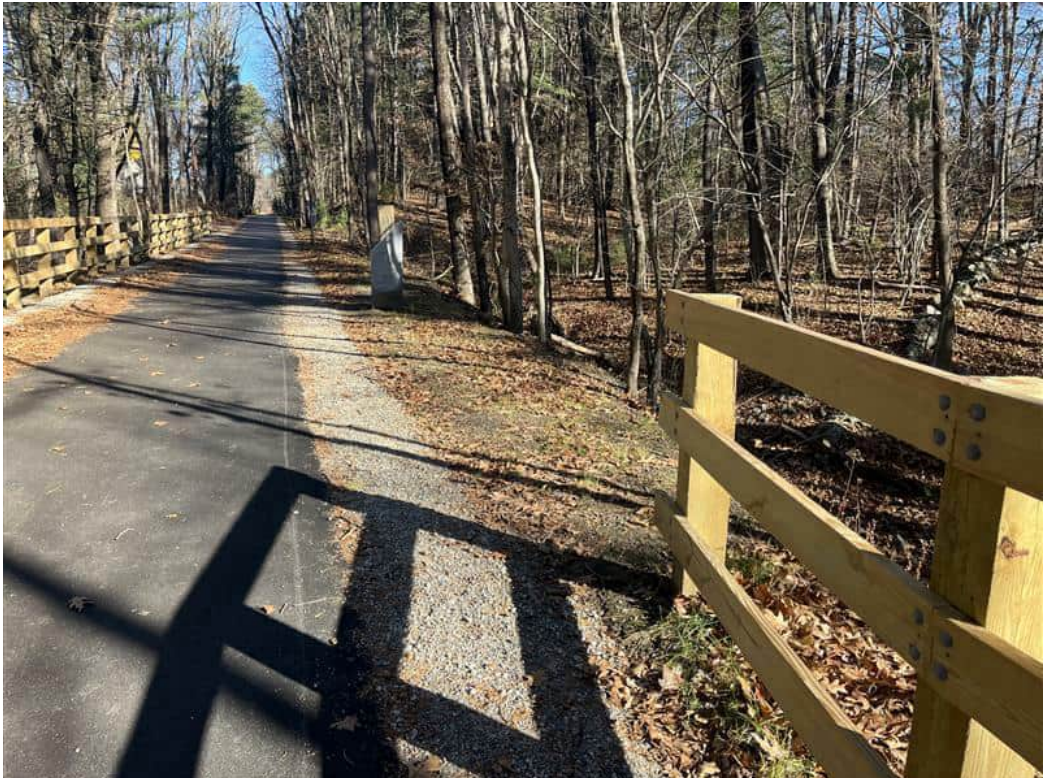
Photo No. 2 **Date:**
11/25/2024

View of a slope at Station 162+00 that requires stabilization per Long Term Compliance Action Item 59.

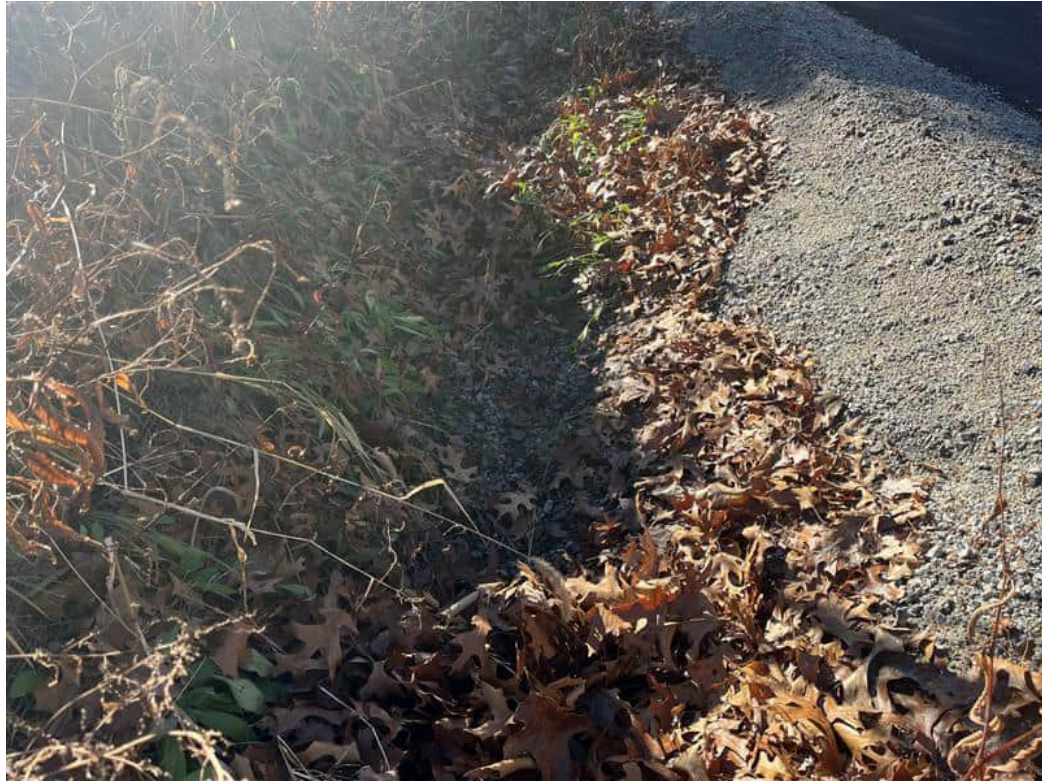
Photo No. 3 **Date:** 11/25/2024

53	<p>Stone was observed requiring removal from the swale on the east side of the trail at Station 172+00 to 173+00 Priority: High</p>	7/29/2024	8/6/2024	Remove stone from the swale.	<p>8/5/2024 - Observation remains. 8/7/2024 - Observation remains. 8/12/2024 - Observation remains. Material was observed to have migrated within the swale to Station 173+50. 8/16/2024 - Stone is still present within the swale. 8/20/2024 - Observation remains. Crushed stone has migrated further down the swale to Station 171+50. 8/27/2024 - Observation remains. Stone is still present within the swale. 9/3/2024 - Observation remains. 9/10/2024 - Observation remains. Stone is still present within the swale. 9/16/2024 - Observation remains. The contractor indicated that the stone within the swale would be hand removed. 9/23/2024 - Observation remains. 9/27/2024 - Observation remains. It appears as though some stone has migrated further south down the swale. 10/4/2024 - Observation remains. Stone is still present within the swale. 10/8/2024 - Observation remains. 10/15/2024 - Observation remains. Stone is covered with vegetation in some areas. 10/22/2024 - Observation remains. Stone is covered with vegetation in some areas. 10/29/2024 - Observation remains. 11/5/2024 - Observation remains. 11/12/2024 - Leaf litter has completely covered the stone in this location. The Contractor should indicate if stone has been removed from this location. 11/19/2024 - See previous update. 11/22/2024 - Observation remains. Stone is still present within the swale and requires removal. Leaf litter is currently covering a majority of the stone. 11/25/2024 - Observation remains. Leaf litter is covering a majority of the stone.</p>

View of stone that is covered in leaf litter and requires removal from the swale at Station 172+00 to 173+00 per Compliance Action Item 53.

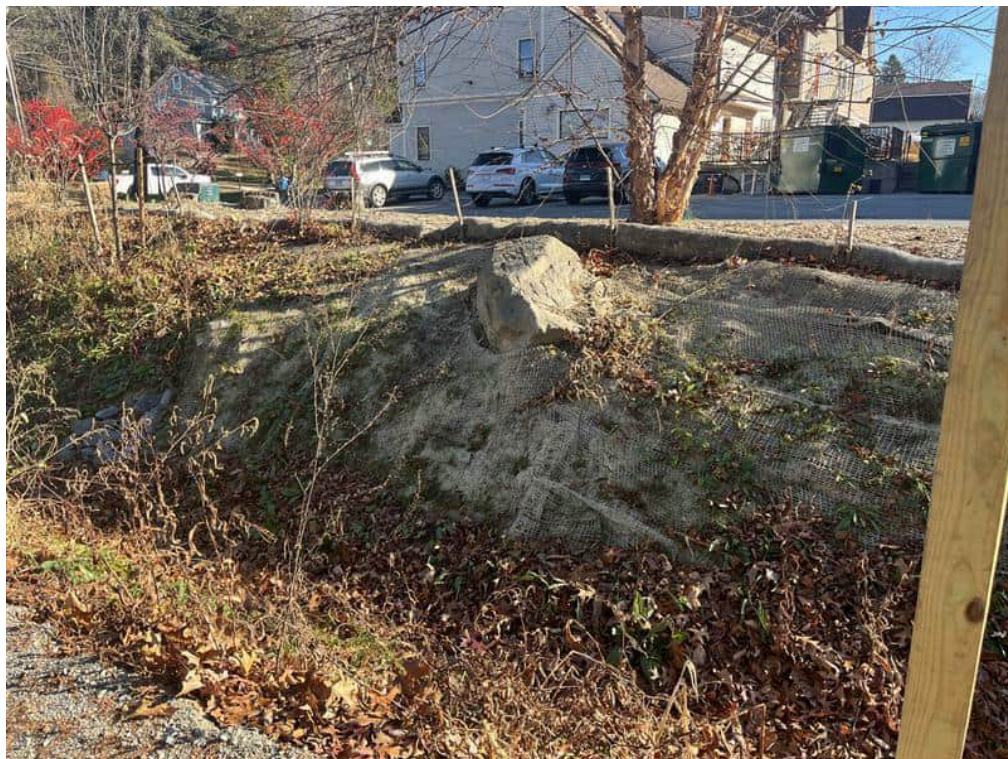
Photo No. 4 **Date:** 11/25/2024

6	Exposed sediment slope at Station 172+00 to 175+00 Priority: High	5/8/2024	5/15/2024	Install temporary sediment controls along the slope such as jute netting and/or straw following the application of seed.	<p>5/16/2024 - Observation remains. 5/21/2024 - Observation remains. 5/28/2024 - Partial germination was observed. 5/31/2024 - See previous update. 6/7/2024 - Further earthwork has occurred and soils require stabilization. 6/14/2024 - Observation remains. 6/17/2024 - Observation remains. 6/24/2024 - Observation remains. 6/27/2024 - The area has been regraded and loam has been spread. New trees have been planted upgradient of the swale. Stabilization is still required. 7/8/2024 - Jute netting has been installed over the applied seed, and the area will be monitored for germination. 7/15/2024 - See previous update. 7/22/2024 - Observation remains. 7/29/2024 - Observation remains. 8/5/2024 - Observation remains. 8/7/2024 - Regrowth of vegetation was observed in this location. This item will remain open until stabilization has been completed. 8/12/2024 - Observation remains. 8/16/2024 - Observation remains. 8/20/2024 - Application of the approved seed mixture is required at this location. 8/27/2024 - Observation remains. 9/3/2024 - Vegetation that is present in this location generally consists of lady's thumb smartweed, a non-native species. Removal of non-native species and application of the approved seed mixture is required at this location. 9/16/2024 - See previous update. 9/23/2024 - Observation remains. See 9/3/2024 update. 9/27/2024 - Observation remains. The contractor reached out hydroseed has been applied to this area. 10/4/2024 - Hydroseed has been applied to this area; the hydroseed was observed to have been applied over the erosion control blanket that is located in this area. Once vegetation has sufficiently stabilized this area the item will be closed. The contractor should provide the tag from the seed mix that was used to the Conservation Commission to ensure that the required native seed mix was used per the design plans. 10/8/2024 - Observation remains. See update from 10/4/2024. 10/15/2024 - Observation remains. See update from 10/4/2024. 10/22/2024 - Observation remains. See update from 10/4/2024. 10/29/2024 - Observation remains. No germination has been observed in this location since the application of hydroseed. See update from 10/4/2024. 11/5/2024 - Observation remains. Some germination has been observed but the area is not considered stabilized. 11/12/2024 - Observation remains. 11/19/2024 - Germination has been observed in this location but it has not fully stabilized. 11/22/2024 - Observation remains. See previous update. 11/25/2024 - Observation remains. See update from 11/19/2024.</p>

View of hydroseed with some germination along slopes at Station 172+00 to 175+00 per Compliance Action Item 6.

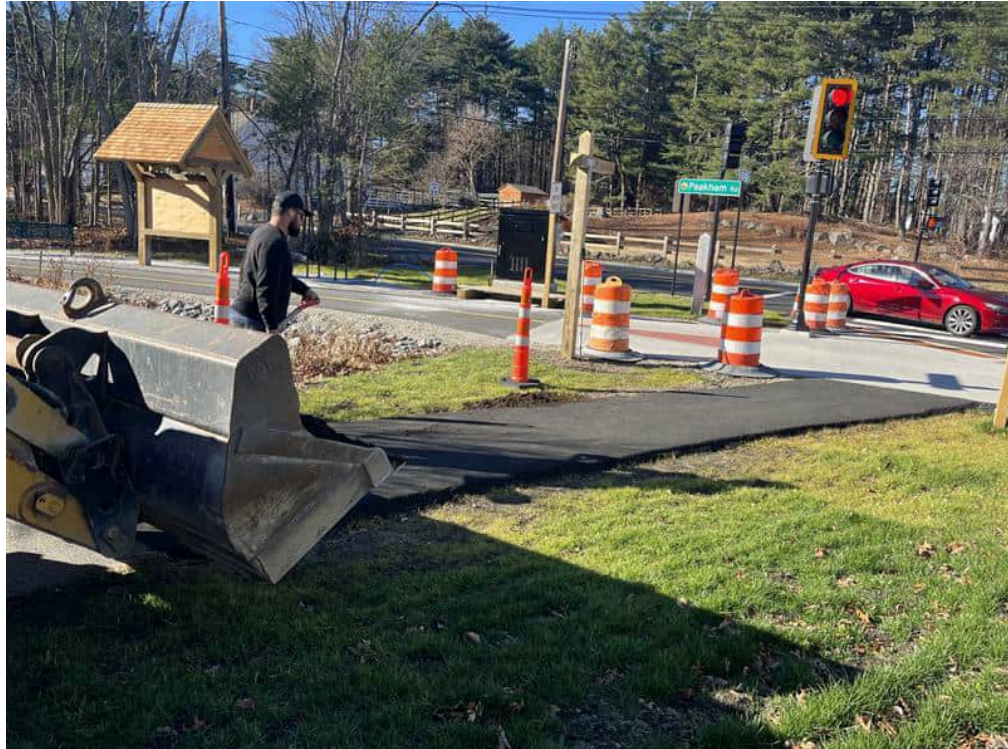
Photo No. 5	Date: 11/25/2024
Direction Photo Taken: Toward the West	
Description: View of loam being applied to the side of a path adjacent to Hudson Road at Station 176+00.

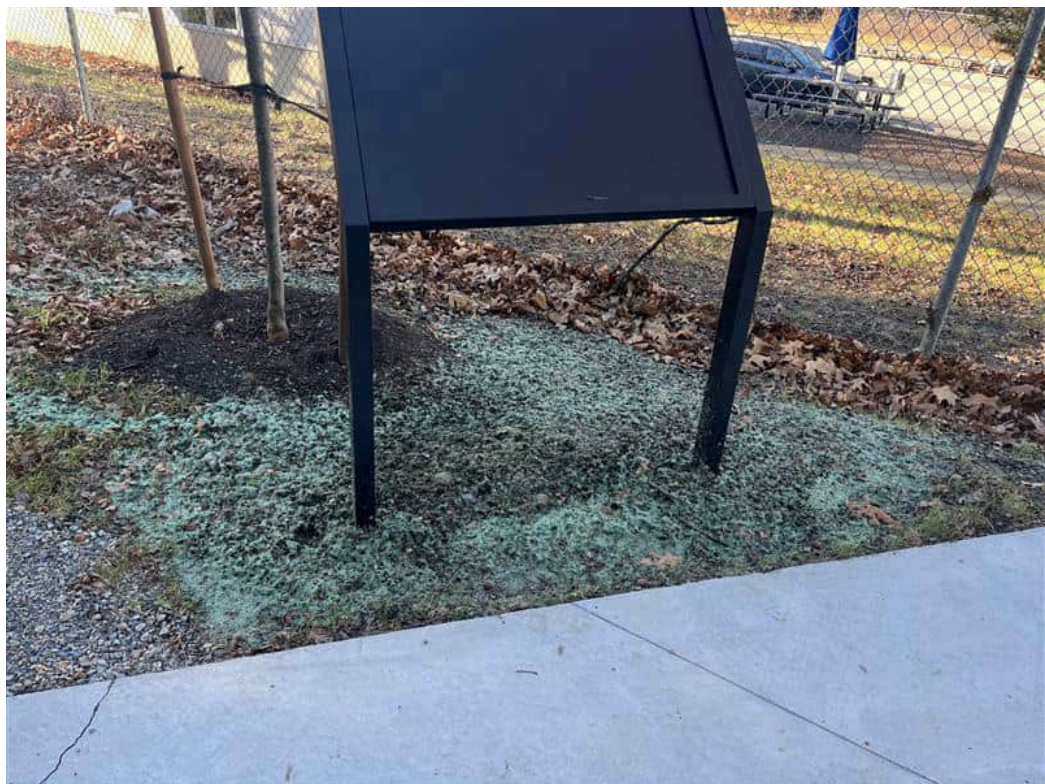
Photo No. 6	Date: 11/25/2024
Direction Photo Taken: Toward the West	
Description: View of a location where hydroseed was recently applied with no observable germination at Station 180+00 per Long Term Compliance Action Item 59.

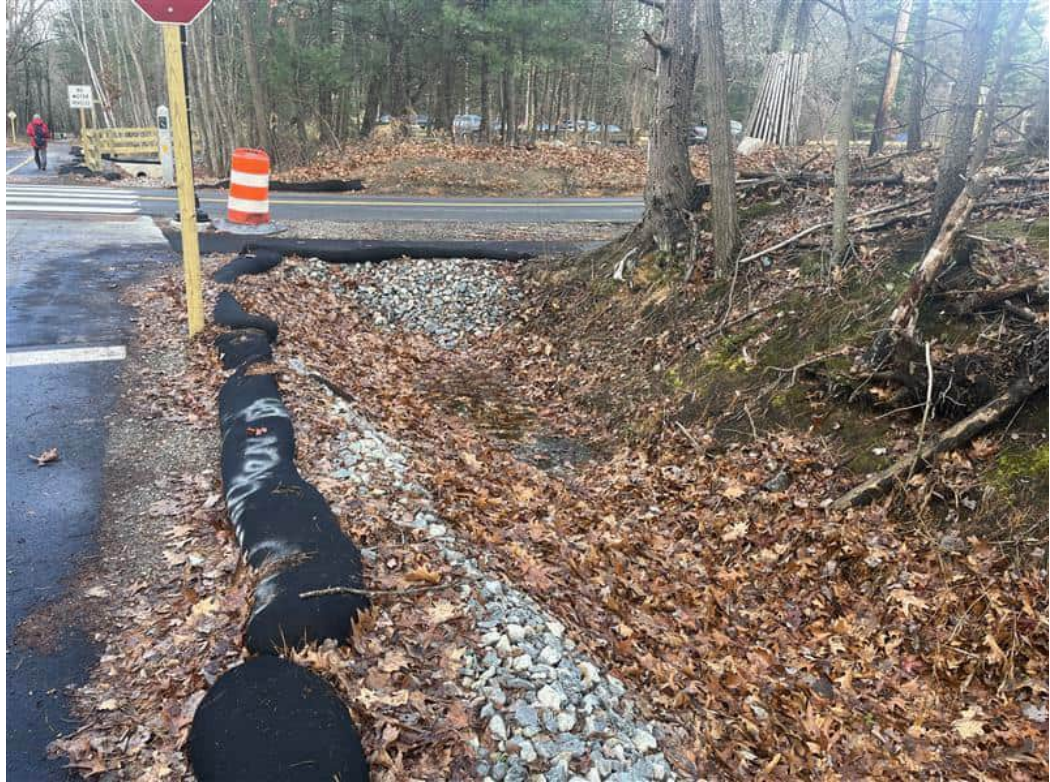
Photo No. 7 **Date:** 11/25/2024

58	Crushed stone used for the dense graded crush stone shoulders has been observed as migrating both onto the path, off the sides of the path, and into the adjacent Resource Areas throughout the Project Priority: High	8/7/2024	8/14/2024	Remove all crushed stone from Resource Areas and develop a plan to cease discharges of stone.	<p>8/12/2024 - Crushed stone is still present in varying amounts throughout the path and on the sides of the path.</p> <p>8/16/2024 - Observation remains.</p> <p>8/20/2024 - Crushed stone has been removed from some adjacent resource areas but is still observed as migrating onto and off of the path in multiple locations throughout the Project.</p> <p>8/27/2024 - Crushed stone has been observed as migrating from the shoulders throughout the path.</p> <p>9/3/2024 - Crushed stone was observed as migrating both onto the path and off the side of the path in multiple locations. Stone was observed to have discharged to the cattle crossing at Station 190+50 and within the streambed at Station 215+00 to 216+00. Crushed stone was observed to have been placed on the root system of a fallen tree at Station 310+00 near Bank flag #BF4-108.</p> <p>9/10/2024 - Observation remains. Crushed stone is still present within the cattle crossing, the streambed, and on the root system of the fallen tree. Crushed stone continues to migrate on to and off of the path.</p> <p>9/16/2024 - Observation remains. The contractor indicated the locations where crushed stone has migrated off the path will be hand removed and crushed stone will be swept off the path prior to the opening of the trail.</p> <p>9/23/2024 - Observation remains. It does not appear as though crushed stone that has migrated onto or off of the path has been removed in any location along the Project. More crushed stone has migrated onto the path throughout significant portions of the path.</p> <p>9/27/2024 - Observation remains. Crushed stone is still located on the side of the path and on the path in varying amounts.</p> <p>10/4/2024 - Crushed stone has been removed from multiple locations along the trail but was still observed on and on the sides of the trail in several locations.</p> <p>10/8/2024 - Observation remains. Crushed stone is still present in multiple locations on and off the sides of the path.</p> <p>10/15/2024 - Observation remains. Crushed stone is still present in multiple locations on and off the sides of the path.</p> <p>10/22/2024 - Observation remains. Crushed stone is still present in multiple locations on and off the sides of the path. The crushed stone shoulders along Station 1000+00 to 1003+00 has been moved back into the shoulders and regraded.</p> <p>10/29/2024 - Observation remains. Crushed stone is still present in multiple locations on and off the sides of the path.</p> <p>11/5/2024 - Observation remains. See previous update.</p> <p>11/12/2024 - Observation remains. Crushed stone is still present on the side of the path in multiple locations, within the streambed and drainage swale and within the cattle crossing at Station 190+50.</p> <p>11/19/2024 - Crushed stone was removed from the cattle crossing at Station 190+50. Further removal of stone is required in multiple locations along the path that are currently covered with leaf litter.</p> <p>11/22/2024 - Observation remains. See previous update.</p> <p>11/25/2024 - Observation remains. See update from 11/19/2024.</p>

View of crushed stone within the streambed at Station 215+00 per Long Term Compliance Action Item 58.

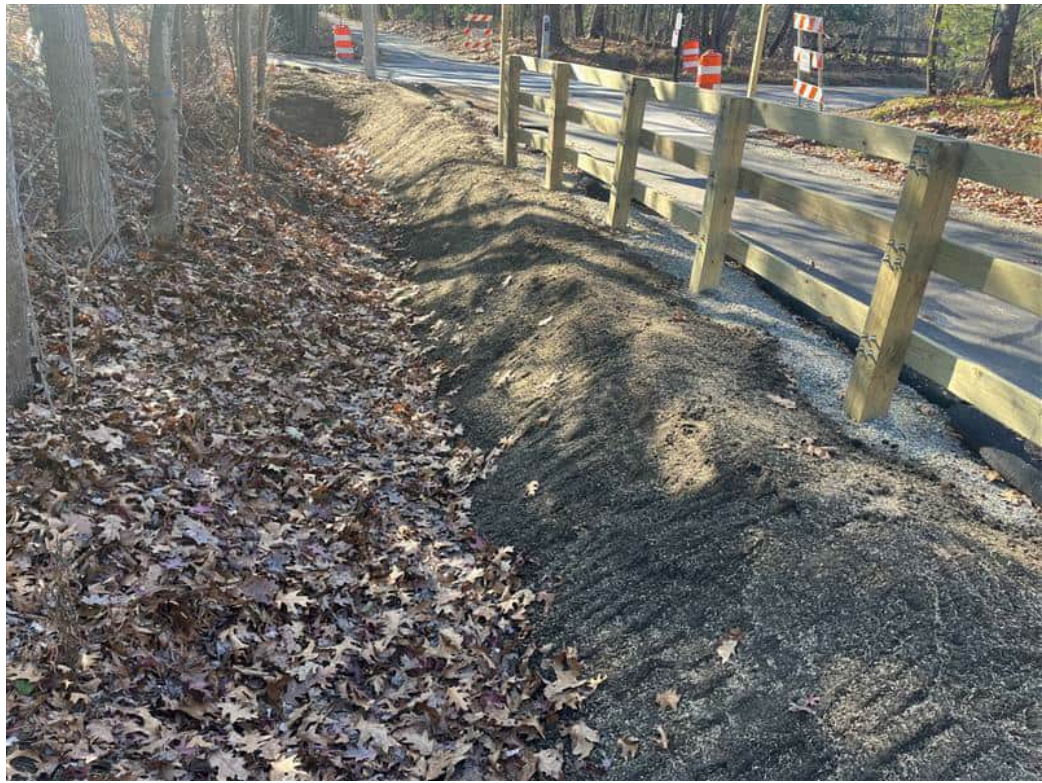
Photo No. 8 **Date:** 11/25/2024

Item	Location/ Description	Observation Date	Resolution Due Date	Recommended Resolution / Resolution Date	Comments/Updates
62	Loam and seed was applied to the streambank at Station 216+00 to 217+00 and requires further stabilization	11/25/2024	12/2/2024	An erosion control blanket should be installed along this slope.	
61	Invasive vegetation including Japanese knotweed (<i>Reynoutria japonica</i>), bittersweet (<i>Celastrus orbiculatus</i>), bush honeysuckle (<i>Lonicera</i> spp.), burning bush (<i>Euonymus alatus</i>), purple loosestrife (<i>Lythrum salicaria</i>), glossy buckthorn (<i>Frangula alnus</i>) and garlic mustard (<i>Alliaria petiolata</i>) have been observed throughout the path. Priority: High	10/22/2024	10/29/2024	Invasive Species should be removed by manual and/or chemical removal methods	10/29/2024 - Invasive species are present throughout the trail both within upland and Resource Areas. Populations of glossy buckthorn and purple loosestrife are present within the wetland replication area. 11/5/2024 - Observation remains. See update from 10/29/2024. 11/12/2024 - Observation remains. Invasive species are still present throughout the trail. Some invasives have been observed with no leaves due to winter die back. 11/19/2024 - Observation remains. Further invasive species management will be required during the next growing season. 11/22/2024 - Observation remains. 11/25/2024 - Observation remains.

41	Stream Bank has been regraded beyond the limit of work at Station 216+00 Priority: High	5/28/2024	6/4/2024	The Contractor should confirm if this work was permitted by the Conservation Commission, as it does not appear to be a part of the approved plans/impacts. MassDOT should be consulted on next steps regarding notification and potential restoration.	<p>5/31/2024 - Observation remains. 6/7/2024 - Observation remains. 6/14/2024 - Observation remains. 6/17/2024 - Observation remains. 6/24/2024 - Observation remains. 6/27/2024 - Observation remains. 7/8/2024 - Observation remains. 7/15/2024 - This area could not be assessed due to paving operations ongoing during the inspection. 7/22/2024 - Crushed stone and sediment continue to be discharged to the stream between Stations 215+00 and 217+00 due to overtopped and undermined compost filter tubes. 7/29/2024 - Observation remains. 8/5/2024 - Observation remains. 8/7/2024 - Observation remains. 8/12/2024 - Observation remains. Crushed stone is still present in the streambed at this location. 8/16/2024 - Observation remains. 8/20/2024 - Stone has been removed; however, additional alteration to Resource Areas beyond the limit of work continue. 8/27/2024 - Observation remains. 9/3/2024 - Observation remains. 9/10/2024 - Observation remains. Stone has been observed as discharging into the streambed in this location again. 9/16/2024 - Observation remains. 9/23/2024 - Observation remains. Stone is still present within the streambed at this location. 9/27/2024 - Observation remains. 10/4/2024 - Observation remains. 10/8/2024 - Observation remains. 10/15/2024 - Observation remains. Stone is still present within the streambed at this location. 10/22/2024 - Observation remains. Stone is still present within the streambed at this location. 10/29/2024 - Observation remains. Stone is still present within the streambed at this location. 11/5/2024 - Observation remains. The PVC pipe that was installed at this location was observed to be covered with stone and is no longer visible near Station 215+00. Stone is still present within the streambed at this location. 11/12/2024 - Observation remains. The streambed in this location is covered with leaf litter. See previous update. 11/19/2024 - Observation remains. As discussed with the Conservation Agent in the field, further coordination between the Town and MassDOT will be required to clean/repair the culvert, as the degraded condition of the culvert prompted the contractor to armor the stream banks. Further coordination will also be required for restoration of banks. 11/22/2024 - Observation remains. See previous update. 11/25/2024 - Observation remains. See update from 11/19/2024.</p>

Description:
View of the location where the stream bank has been regraded beyond the limits of work and where stabilization of the newly placed loam is required at Station 216+00 per Long Term Compliance Action Item 41 and 62.

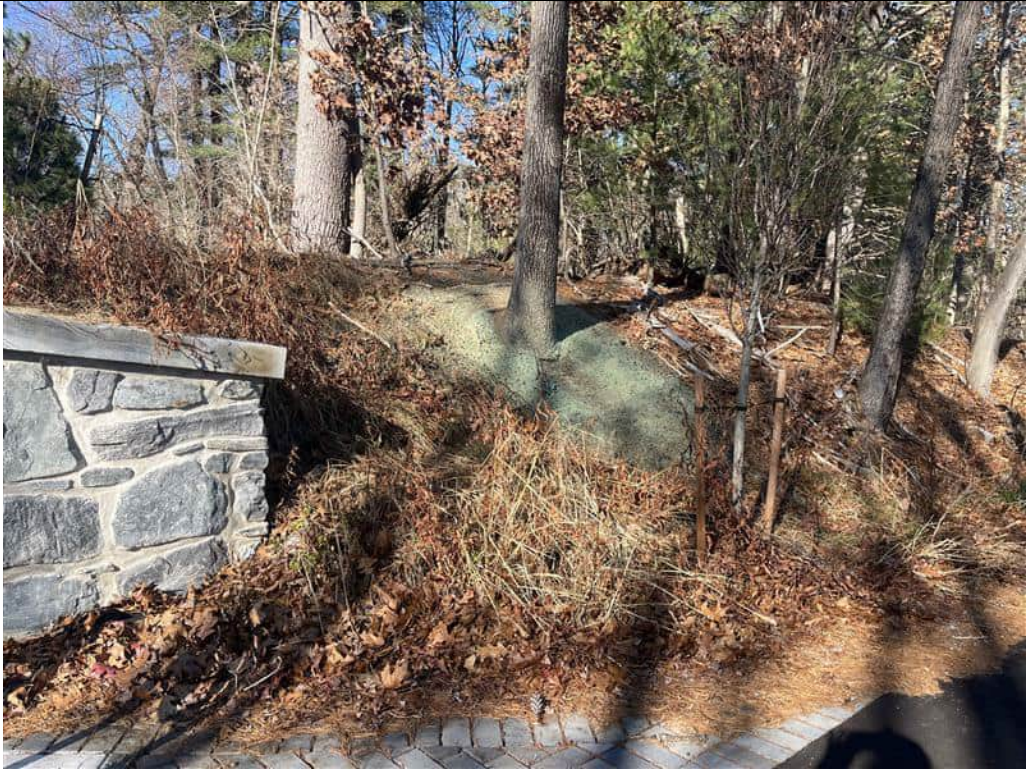
Site Location Bruce Freeman Rail Trail Right-of-Way		BETA Project No. 24.10326.23
Photo No. 9	Date: 11/25/2024

34	<p>Sediment is eroding downhill from behind the cemented stone masonry wall at Station 217+45 Priority: Low</p>	5/28/2024	6/4/2024	<p>Apply seed and temporarily stabilize the soils along the slope with straw, jute netting, etc.</p>	<p>5/31/2024 - Observation remains. 6/7/2024 - Observation remains. 6/14/2024 - Observation remains. 6/17/2024 - Observation remains. 6/24/2024 - Observation remains. 6/27/2024 - Rills were raked, loam was added, and hydroseed was applied. 7/8/2024 - Observation remains. Grass was observed to be germinating at this location. Comment will remain open until stabilization is complete. 7/8/2024 - See previous update. 7/15/2024 - Additional hydroseed is required due to washouts. 7/22/2024 - Observation remains. 7/29/2024 - Observation remains. 8/5/2024 - Observation remains. 8/7/2024 - Regrowth of vegetation has been observed in this area. This item will remain open until the area is fully stabilized. 8/12/2024 - Observation remains. Regrowth has stabilized a portion of this hill; however, reseeded and additional temporary stabilized measures are recommended on the section that is currently unvegetated. 8/16/2024 - Observation remains. 8/20/2024 - Application of the approved seed mixture is required at this location. 8/27/2024 - Observation remains. 9/3/2024 - Vegetation that is present in this location generally consists of lady's thumb smartweed (<i>Persicaria maculosa</i>), a non-native species. Removal of non-native species and application of the approved seed mixture is required at this location. 9/10/2024 - Observation remains. See previous update. 9/16/2024 - Observation remains. See update from 9/3/2024. 9/23/2024 - Observation remains. See update from 9/3/2024. 9/27/2024 - Observation remains. 10/4/2024 - Observation remains. See update from 9/3/2024. 10/8/2024 - Observation remains. See update from 9/3/2024. 10/15/2024 - Observation remains. See update from 9/3/2024. 10/22/2024 - Observation remains. See update from 9/3/2024. 10/29/2024 - Observation remains. No additional seed has been applied to this location and the slope is generally vegetated by non-native species. See update from 9/3/2024. 11/5/2024 - Observation remains. Erosion control and seed has been applied to part of this slope, no germination has been observed. 11/12/2024 - Observation remains. No germination has been observed in this location. 11/19/2024 - Observation remains. 11/22/2024 - Observation remains. No germination has been observed in this location. 11/25/2024 - Observation remains. No germination has been observed in this location.</p>

Direction Photo Taken: Toward the West		
Description: View of the slope where hydroseed was applied at Station 217+45 per Compliance Action Item 34.		
Photo No. 10	Date: 11/25/2024

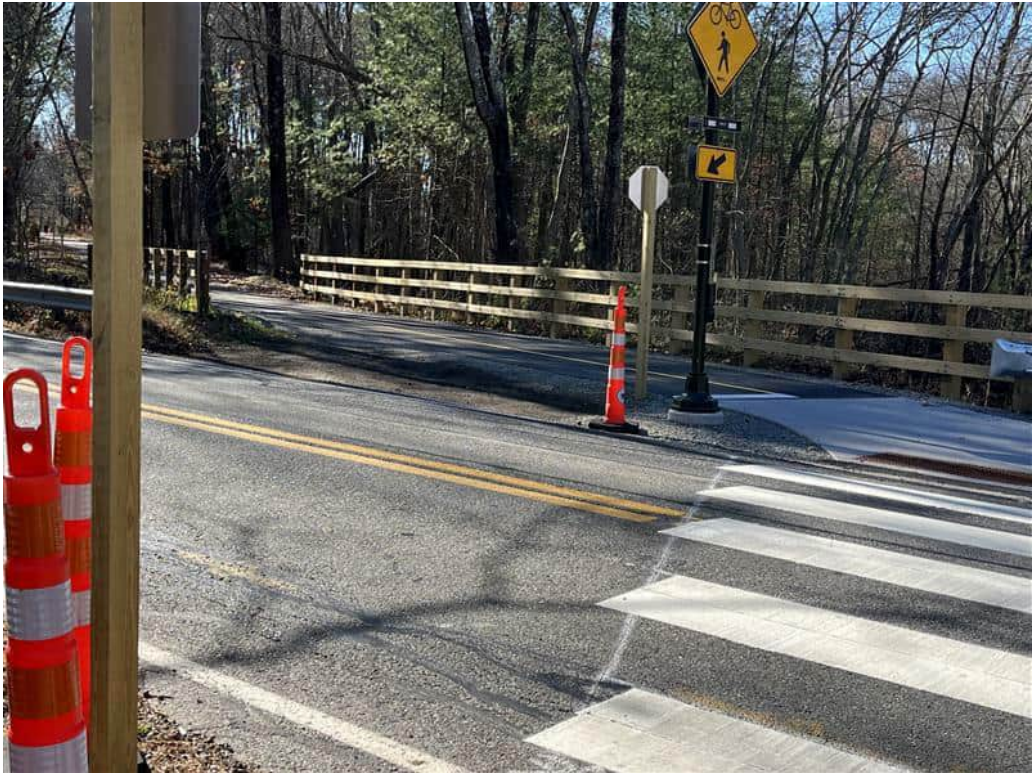
Direction Photo Taken: Toward the South		
Description: View of the placed loam at the intersection of Pantry Road that requires stabilization per Long Term Compliance Action Item 59.

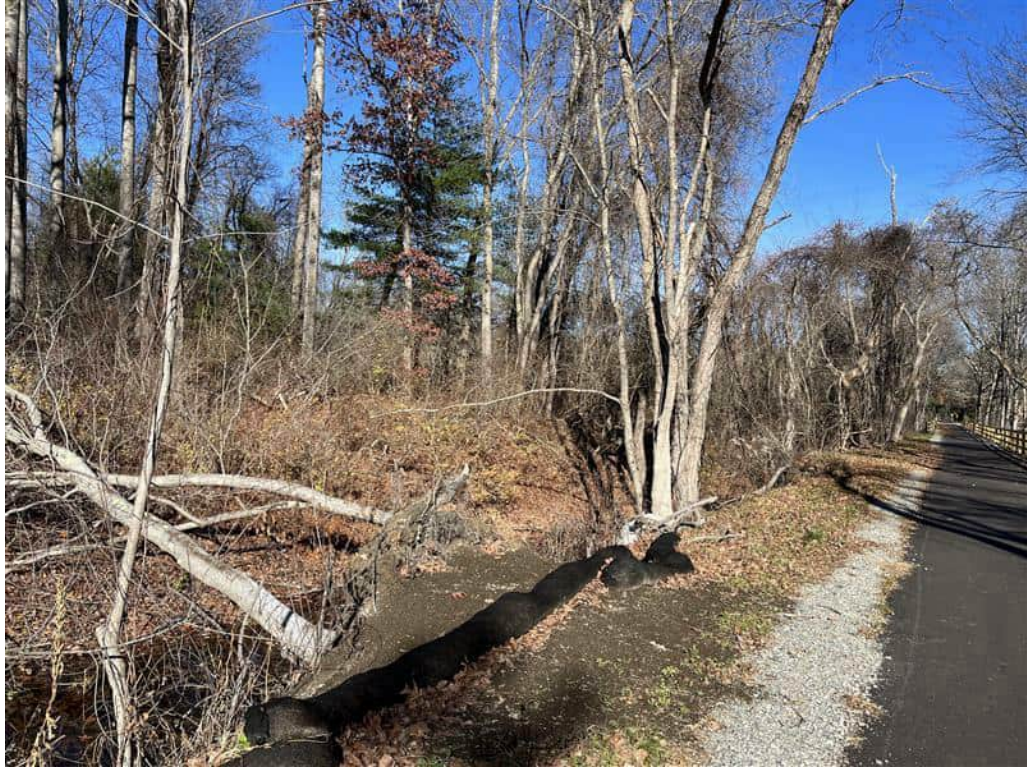
Photo No. 13 **Date:** 11/25/2024

View of placed loam that requires stabilization at Station 311+00 per Long Term Compliance Action Item 59.

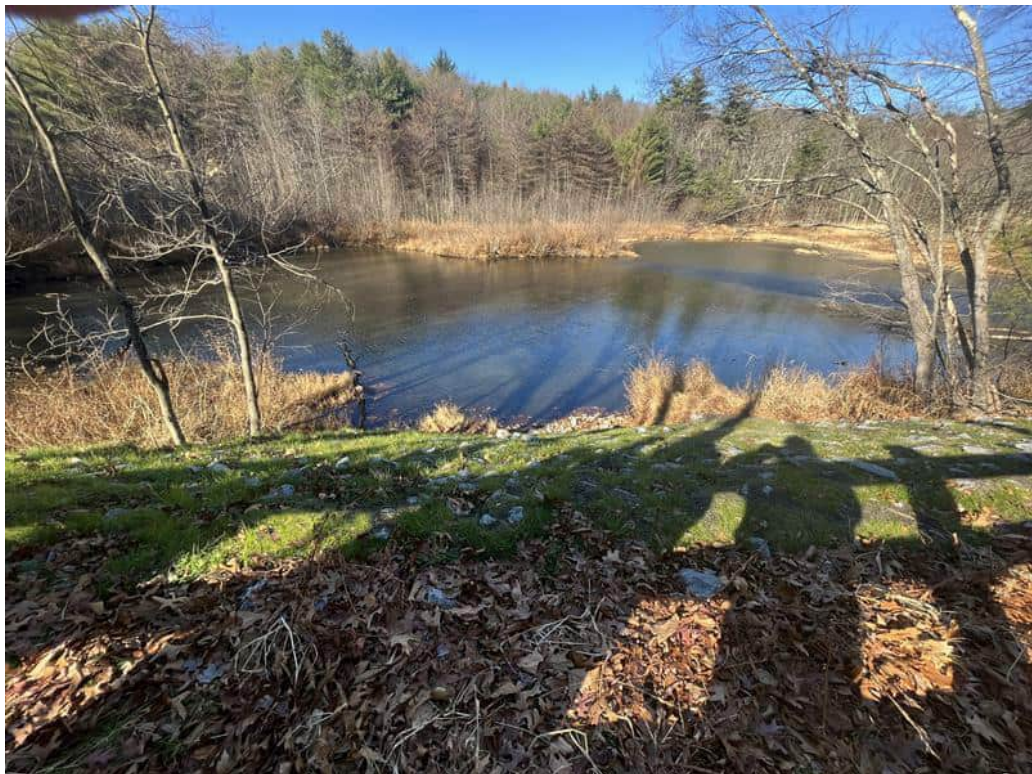
Photo No. 14 **Date:** 11/25/2024

42	<p>Riprap slope extends beyond limits of work along the WF1 Series wetland near flags 103 to 107</p> <p>Priority: High</p>	5/28/2024	6/4/2024	<p>The Contractor should confirm if this work was permitted by the Conservation Commission, as it does not appear to be a part of the approved plans/impacts. MassDOT should be consulted on next steps regarding notification and potential restoration.</p>	<p>5/31/2024 - Observation remains. 6/7/2024 - Observation remains. 6/14/2024 - Riprap slope has been altered and active construction is repairing the area. 6/17/2024 - During this inspection, additional work in support of the repair/potential replacement of an underlying pipe has been ongoing. It is recommended that the contractor confirm that they have coordinated with the Conservation Commission for this work and provide a restoration plan for the area once work is complete. 6/24/2024 - During this inspection, BETA was informed that the existing cast iron pipe was replaced with a new concrete 12-inch reinforced concrete pipe. It appears that riprap was replaced along the side slopes to mirror conditions observed prior to this inspection. 6/27/2024 - During this inspection, the area was observed to have been rolled and prepared for paving. Hydroseed was applied and plantings were installed. 7/8/2024 - Germination was observed and the area will be monitored for stabilization. See previous updates regarding Conservation Commission coordination. 7/15/2024 - This area could not be assessed due to paving operations ongoing during the inspection. 7/22/2024 - See previous updates regarding Conservation Commission coordination. 7/29/2024 - Observation remains. 8/5/2024 - Observation remains. 8/7/2024 - Observation remains. 8/12/2024 - Observation remains. Regrowth of vegetation has been observed in this area and will continue to be monitored. 8/16/2024 - Observation remains. 8/20/2024 - Observation remains. 8/27/2024 - Observation remains. 9/3/2024 - Observation remains. 9/10/2024 - Observation remains. 9/16/2024 - Observation remains. 9/23/2024 - Observation remains. 9/27/2024 - Observation remains. 10/4/2024 - Observation remains. 10/8/2024 - Observation remains. 10/15/2024 - Observation remains. 10/22/2024 - Observation remains. 10/29/2024 - Observation remains. 11/5/2024 - Observation remains. 11/12/2024 - Observation remains. The timber fence has been installed upgradient of this area. 11/19/2024 - Observation remains. As discussed with the Conservation Agent in the field, an as-built should be prepared for this area to quantify any additional impacts that may be addressed through a permit amendment. 11/22/2024 - Observation remains. See previous update. 11/25/2024 - Observation remains. See update for, 11/19/2024.</p>

View of the riprap slope that extends beyond the limit of work along the WF1 Series wetland at Station 332+00 per Long Term Compliance Action Item 42.
