Sudbury to Hudson TRP Week of 1/20/2025

Epsilon Team Full SWPPP Inspection Report(s)

CONSTRUCTION MONITORING REPORT

Sudbury to Hudson Transmission Project

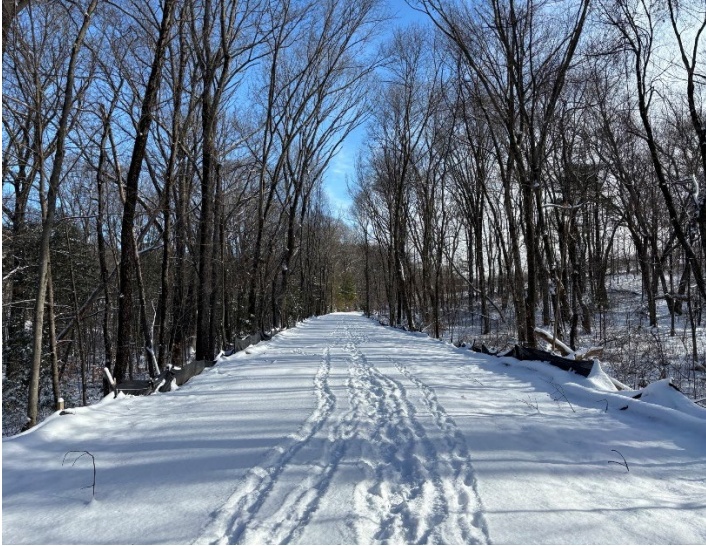
PHOTOGRAPHIC LOG	
Client Name: Eversource		Site Location: Sudbury to Hudson Transmission Reliability Project	Town: Hudson
Photo No.: 1	Date: 1-21-2025

Description: View of E&S controls and snowcover in segment 1. Facing east.

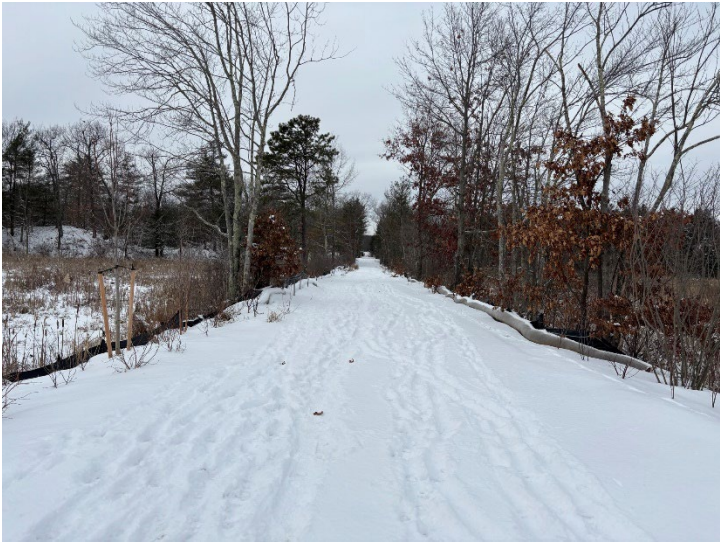
PHOTOGRAPHIC LOG	
Client Name: Eversource		Site Location: Sudbury to Hudson Transmission Reliability Project	Town: Hudson
Photo No.: 2	Date: 1-21-2025

Description: View of E&S controls and snow cover in segment 2. Facing west.

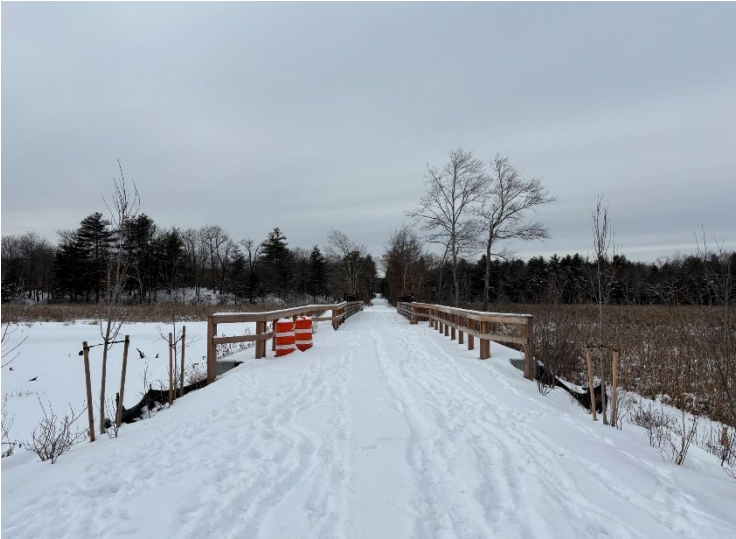
Epsilon ASSOCIATES INC.		PHOTOGRAPHIC LOG	
Client Name: Eversource		Site Location: Sudbury to Hudson Transmission Reliability Project	Town: Hudson
Photo No.: 3	Date: 1-21-2025

Description: View of bridge 130 from segment 3. Facing west.

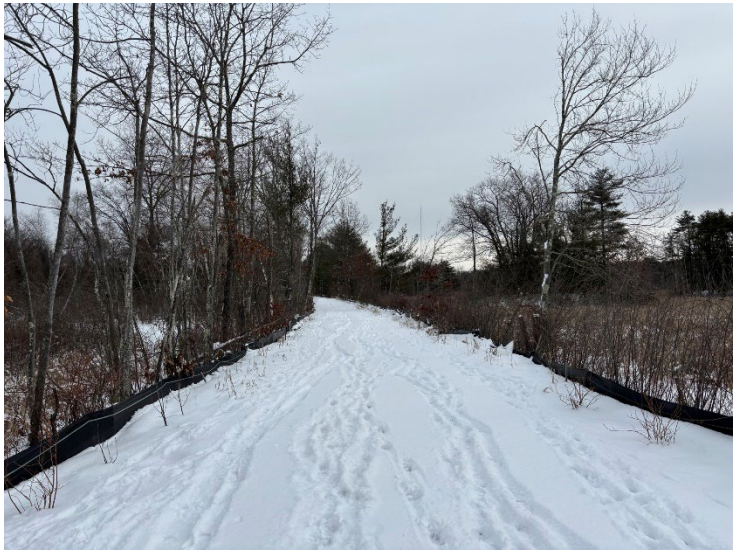
Epsilon ASSOCIATES INC.		PHOTOGRAPHIC LOG	
Client Name: Eversource		Site Location: Sudbury to Hudson Transmission Reliability Project	Town: Hudson
Photo No.: 4	Date: 1-21-2025

Description: View of E&S controls and snowcover in segment 3. Facing east.

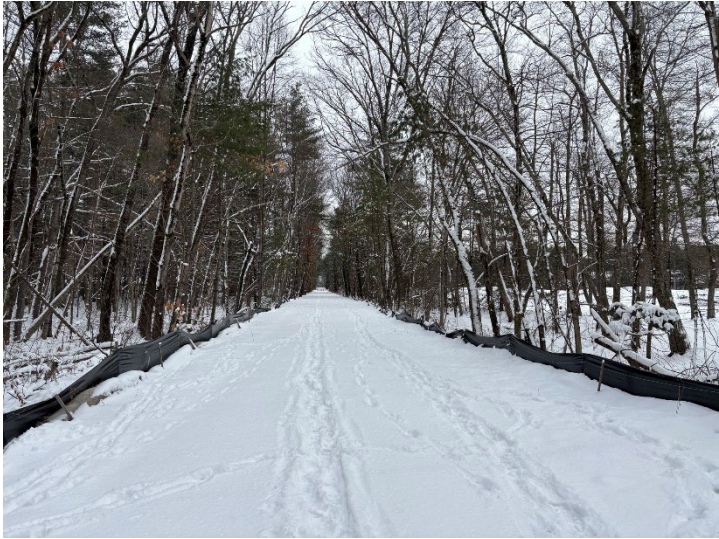
Epsilon ASSOCIATES INC.		PHOTOGRAPHIC LOG	
Client Name: Eversource		Site Location: Sudbury to Hudson Transmission Reliability Project	Town: Hudson
Photo No.: 5	Date: 1-21-2025

Description: View of E&S controls and snowcover in segment 4. Facing east.

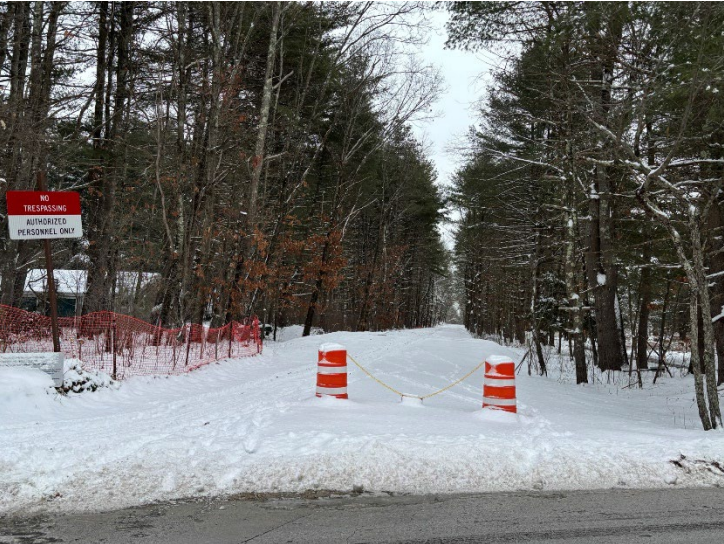
Epsilon ASSOCIATES INC.		PHOTOGRAPHIC LOG	
Client Name: Eversource		Site Location: Sudbury to Hudson Transmission Reliability Project	Town: Hudson
Photo No.: 6	Date: 1-21-2025

Description: View of entrance to segment 5 off of Parmenter Rd. Facing east.

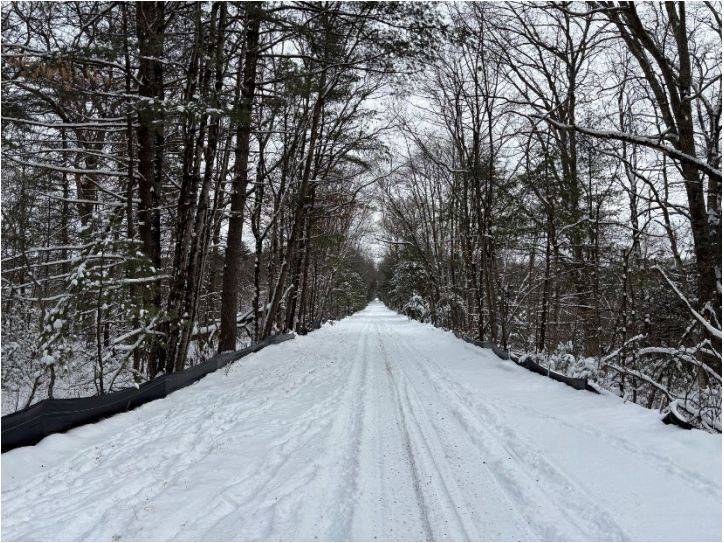
Epsilon ASSOCIATES INC.		PHOTOGRAPHIC LOG	
Client Name: Eversource		Site Location: Sudbury to Hudson Transmission Reliability Project	Town: Hudson
Photo No.: 7	Date: 1-21-2025

Description: View of E&S controls and snow cover in segment 5. Facing east.

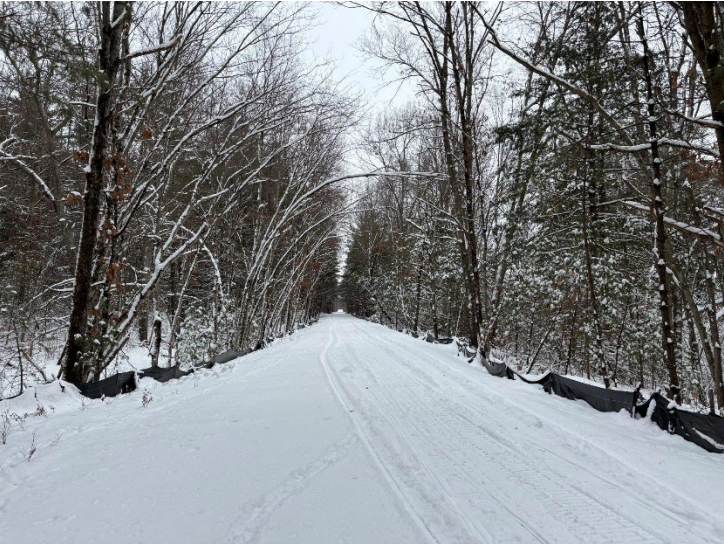
Epsilon ASSOCIATES INC.		PHOTOGRAPHIC LOG	
Client Name: Eversource		Site Location: Sudbury to Hudson Transmission Reliability Project	Town: Hudson
Photo No.: 8	Date: 1-21-2025

Description: View of E&S controls and snowcover in segment 6. Facing east.

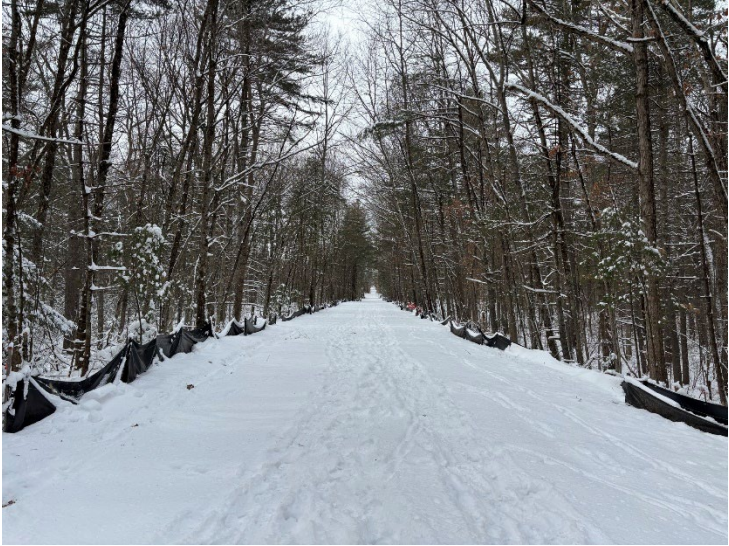
PHOTOGRAPHIC LOG	
Client Name: Eversource		Site Location: Sudbury to Hudson Transmission Reliability Project	Town: Sudbury
Photo No.: 1	Date: 1-21-2025

Description: View of E&S controls and snowcover in segment 8. Facing west.

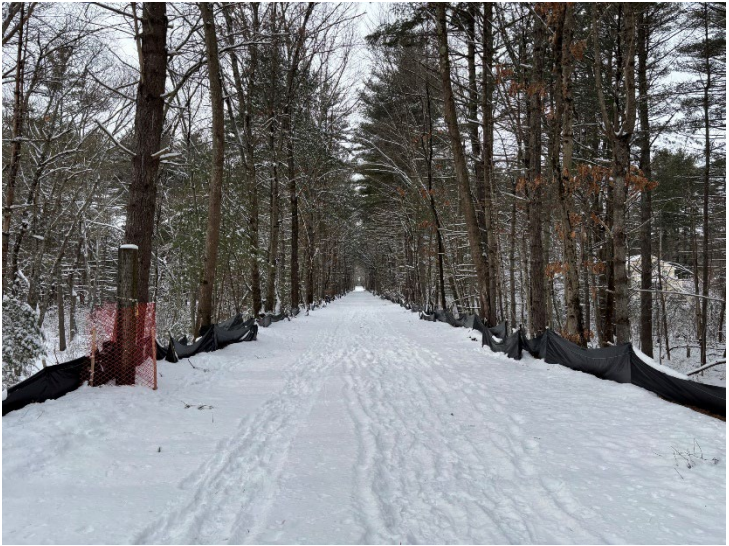
PHOTOGRAPHIC LOG	
Client Name: Eversource		Site Location: Sudbury to Hudson Transmission Reliability Project	Town: Sudbury
Photo No.: 2	Date: 1-21-2025

Description: View of E&S controls and snowcover in segment 9. Facing west.

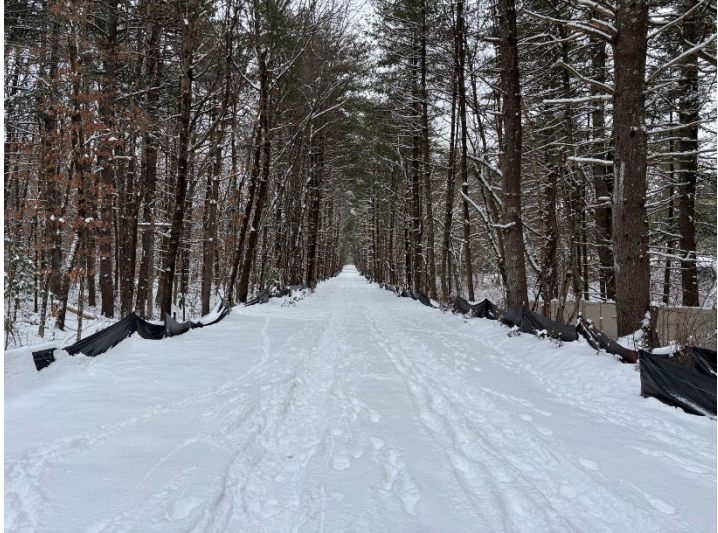
Epsilon ASSOCIATES INC.		PHOTOGRAPHIC LOG	
Client Name: Eversource		Site Location: Sudbury to Hudson Transmission Reliability Project	Town: Sudbury
Photo No.: 3	Date: 1-21-2025

Description: View of E&S controls and snowcover in segment 10. Facing east.

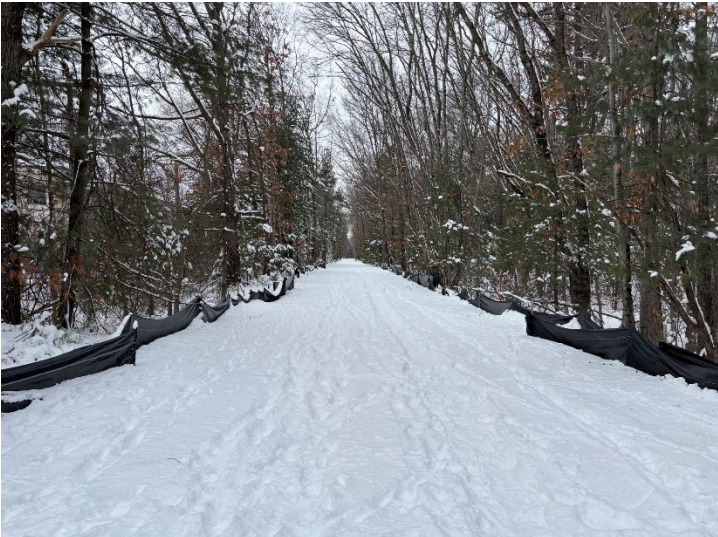
Epsilon ASSOCIATES INC.		PHOTOGRAPHIC LOG	
Client Name: Eversource		Site Location: Sudbury to Hudson Transmission Reliability Project	Town: Sudbury
Photo No.: 4	Date: 1-21-2025

Description: View of E&S controls and snowcover in segment 11. Facing west.

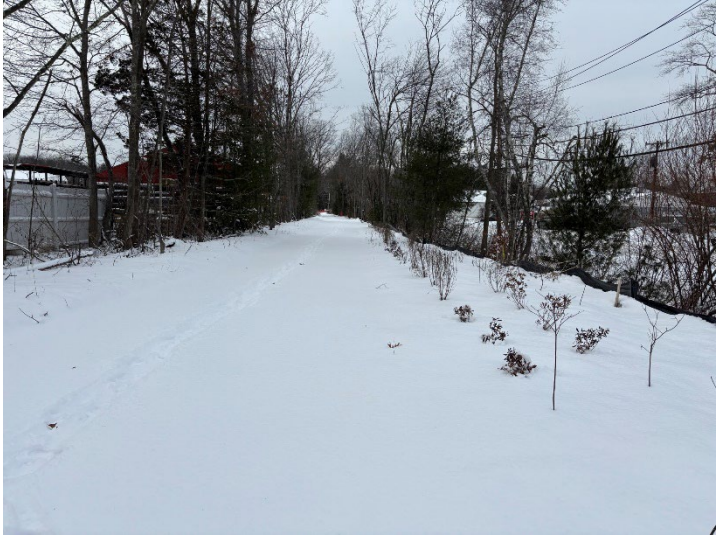
Epsilon ASSOCIATES INC.		PHOTOGRAPHIC LOG	
Client Name: Eversource		Site Location: Sudbury to Hudson Transmission Reliability Project	Town: Sudbury
Photo No.: 5	Date: 1-21-2025

Description: View of E&S controls, plantings, and snowcover in segment 12. Facing west.

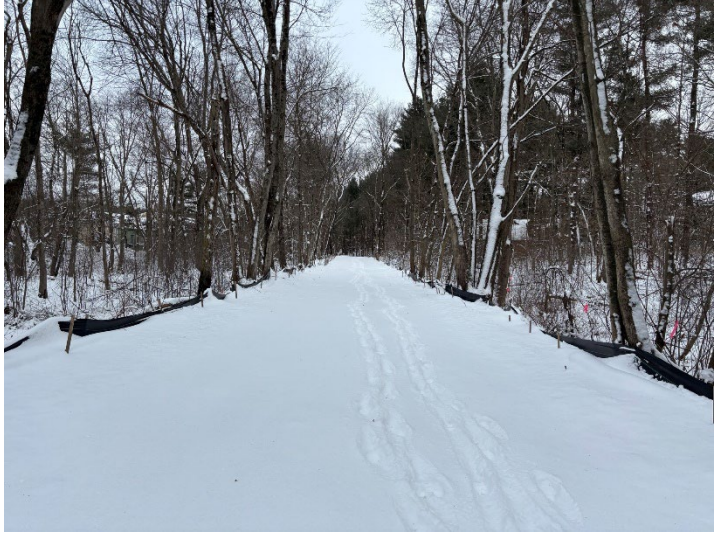
Epsilon ASSOCIATES INC.		PHOTOGRAPHIC LOG	
Client Name: Eversource		Site Location: Sudbury to Hudson Transmission Reliability Project	Town: Sudbury
Photo No.: 6	Date: 1-21-2025

Description: View of E&S controls and snowcover in segment 13. Facing east.

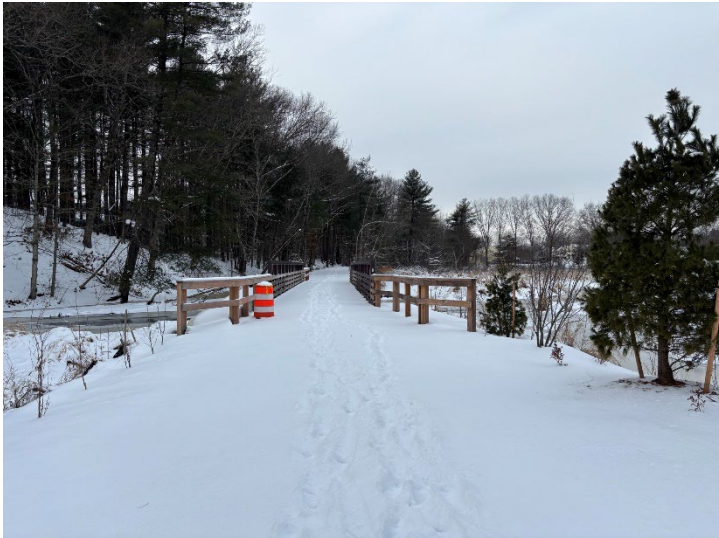
Client Name: Eversource		Site Location: Sudbury to Hudson Transmission Reliability Project	Town: Sudbury
Photo No.: 7	Date: 1-21-2025

Description: View of bridge 127 from segment 14. Facing west.

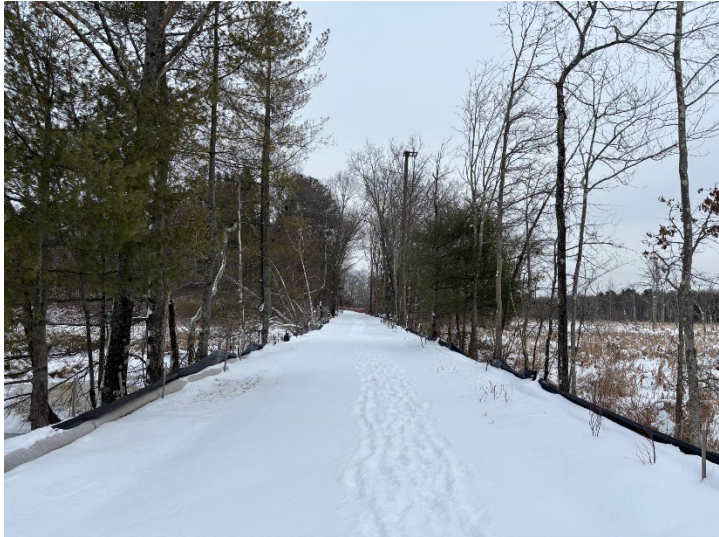
Client Name: Eversource		Site Location: Sudbury to Hudson Transmission Reliability Project	Town: Sudbury
Photo No.: 8	Date: 1-21-2025

Description: View of E&S controls and osprey nest at west end of segment 14. Facing east.
