Wildlife Habitat Features Report
Eversource Transmission Reliability
Project
Sudbury, Massachusetts

JULY 2024- DECEMBER 2024

SWCA Project No. 67849

January 2025

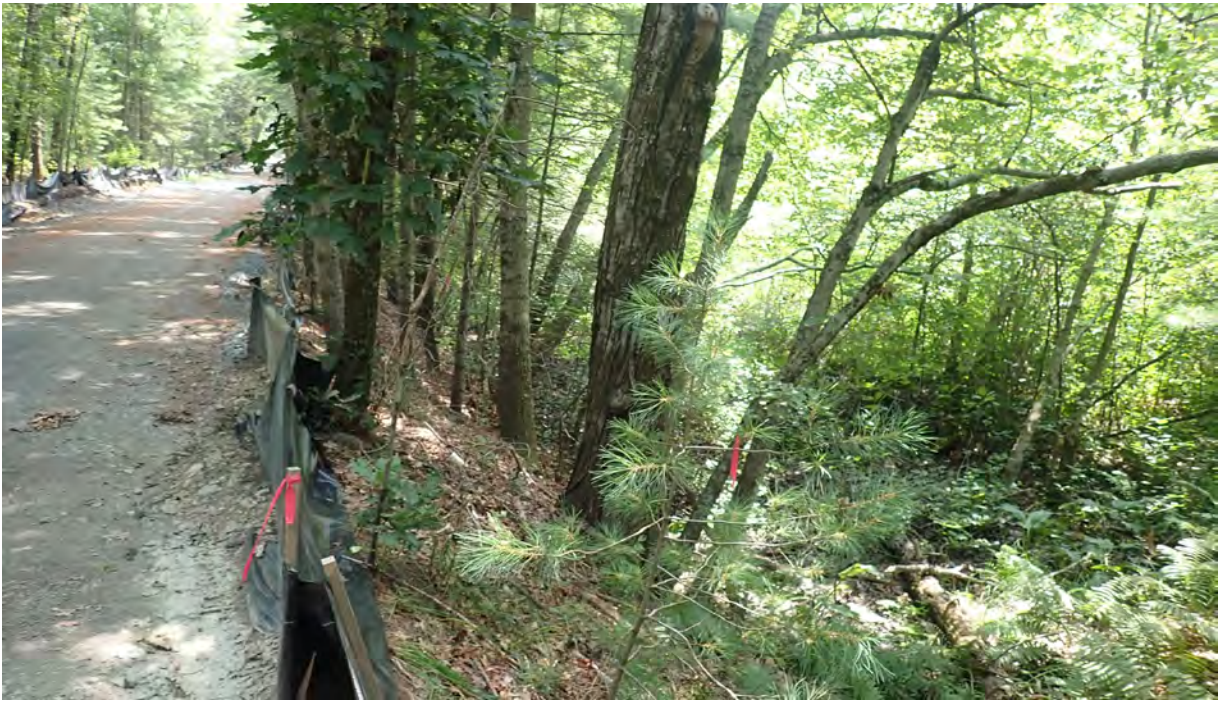
Photo #1: View of installed downed tree within vernal pool #5 in Segment 8. No sediment or debris observed within the resource area. *Facing east.*

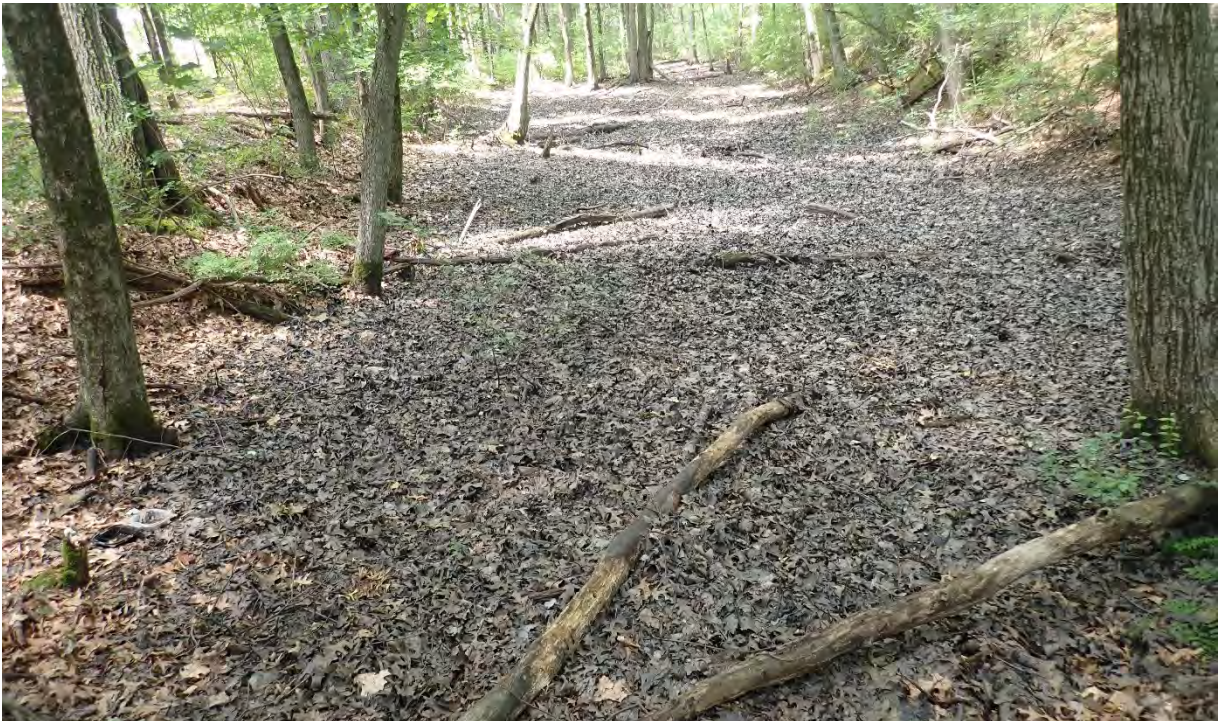
Photo #2: View of installed downed trees in vernal pool #11 in Segment 11. No sediment or construction debris observed within the resource area or beyond the silt fencing. Silt fence in the area is in good condition. *Facing west.*

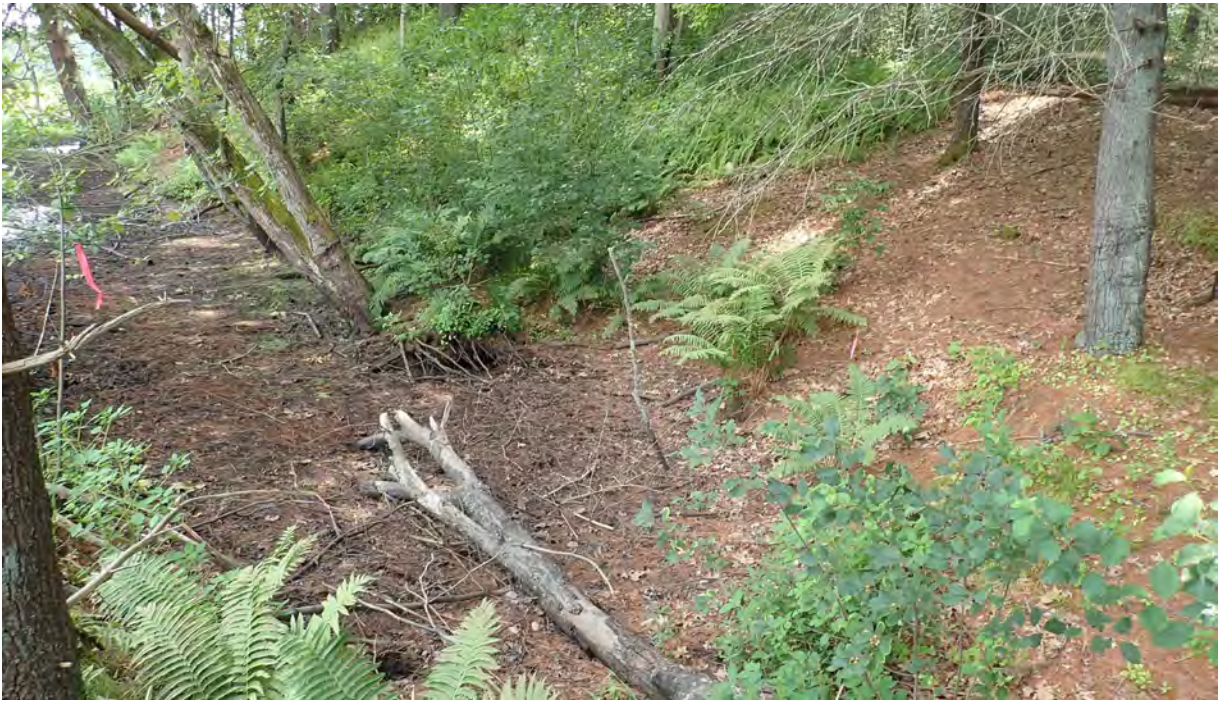
Photo #3: View of installed downed tree within wetland west of Bridge 127 in Segment 13. Silt fencing is in good condition. No sediment or debris observed in the resource area or associated buffer zones. *Facing east.*

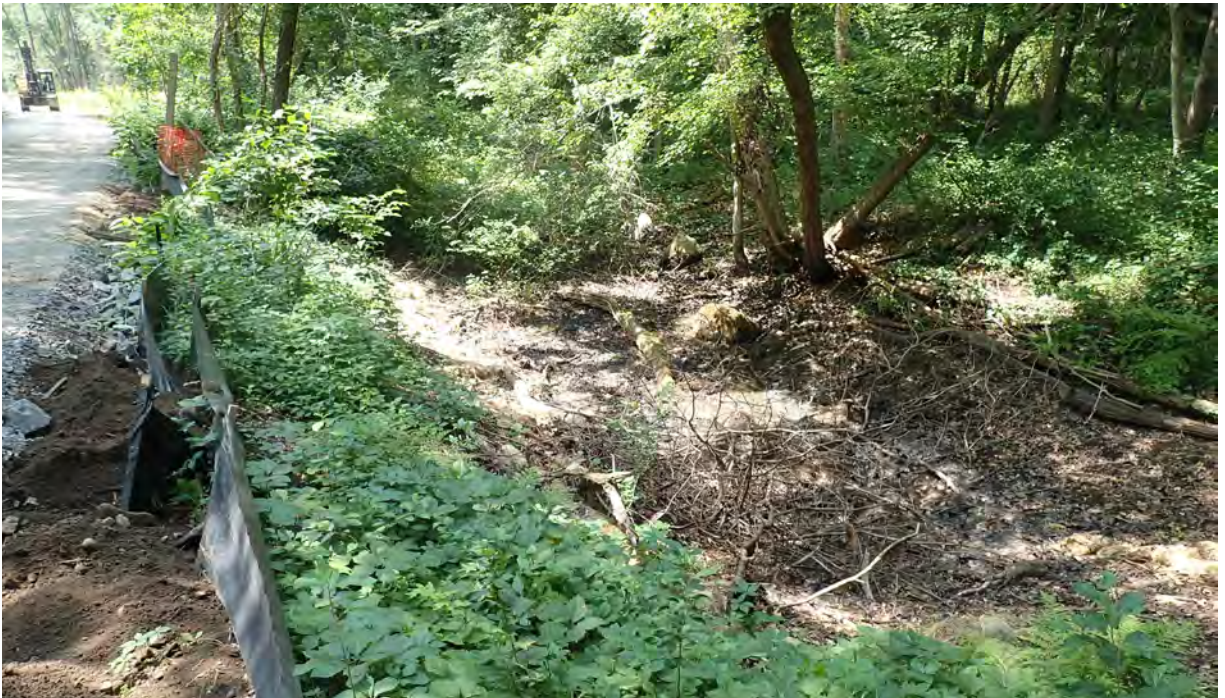
Photo #4: View of installed downed tree within vernal pool #12 in Segment 14. Silt fence has recently been repaired in this area. No sediment or debris observed within the resource area. *Facing west.*

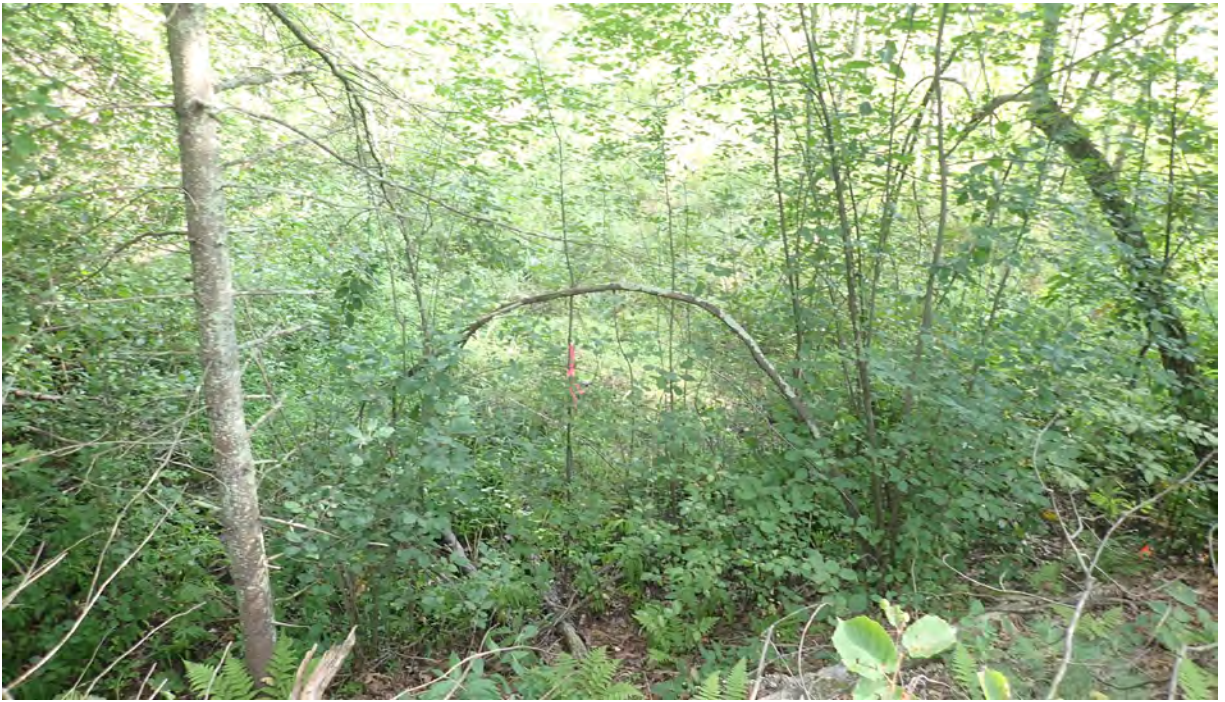
Photo #1: View of installed downed trees in Segment 7. Silt fence in the area is in good condition. No sediment or debris observed within the resource area. *Facing north.*

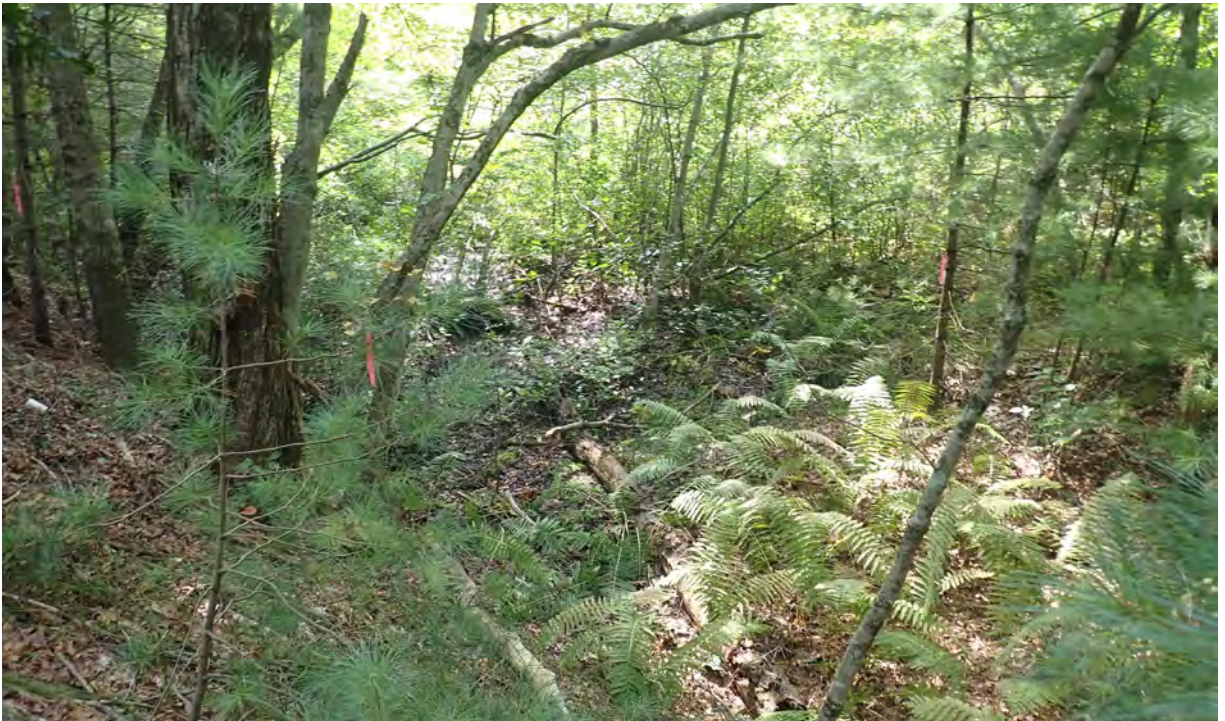
Photo #2: View of installed downed trees in Segment 8. No sediment or construction debris observed within the resource area or beyond the silt fencing. *Facing east.*

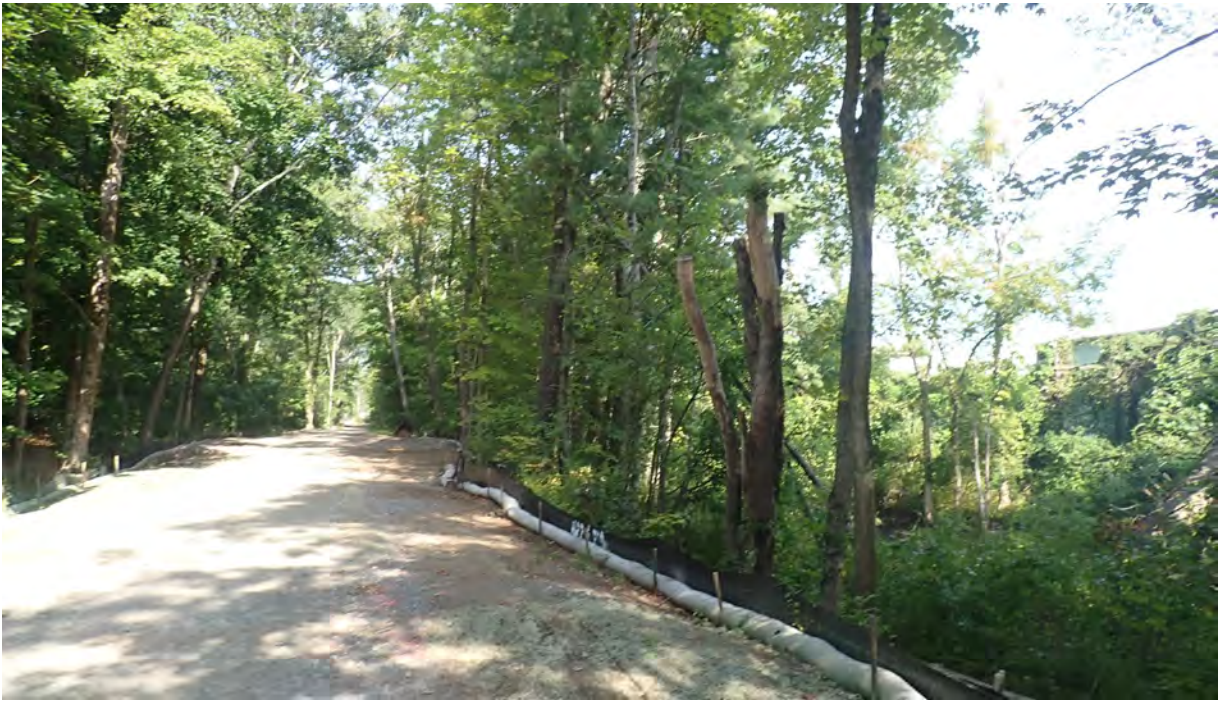
Photo #3: View of installed snag in Segment 13. Snag appears to stable. Silt fencing is in good condition. No sediment or debris observed in the resource area or associated buffer zones.
Facing west.

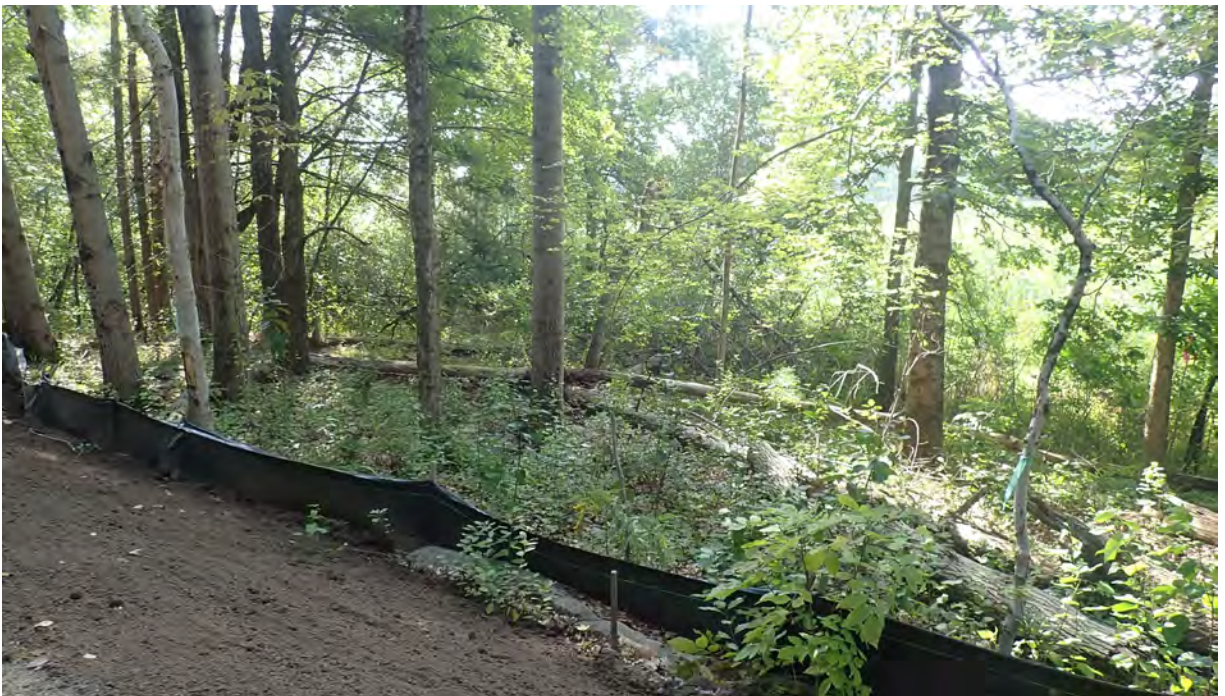
Photo #4: View of installed downed tree in Segment 14. Area adjacent to the silt fencing has been prepared for planting installation. No sediment or debris observed within the resource area.
Facing south.

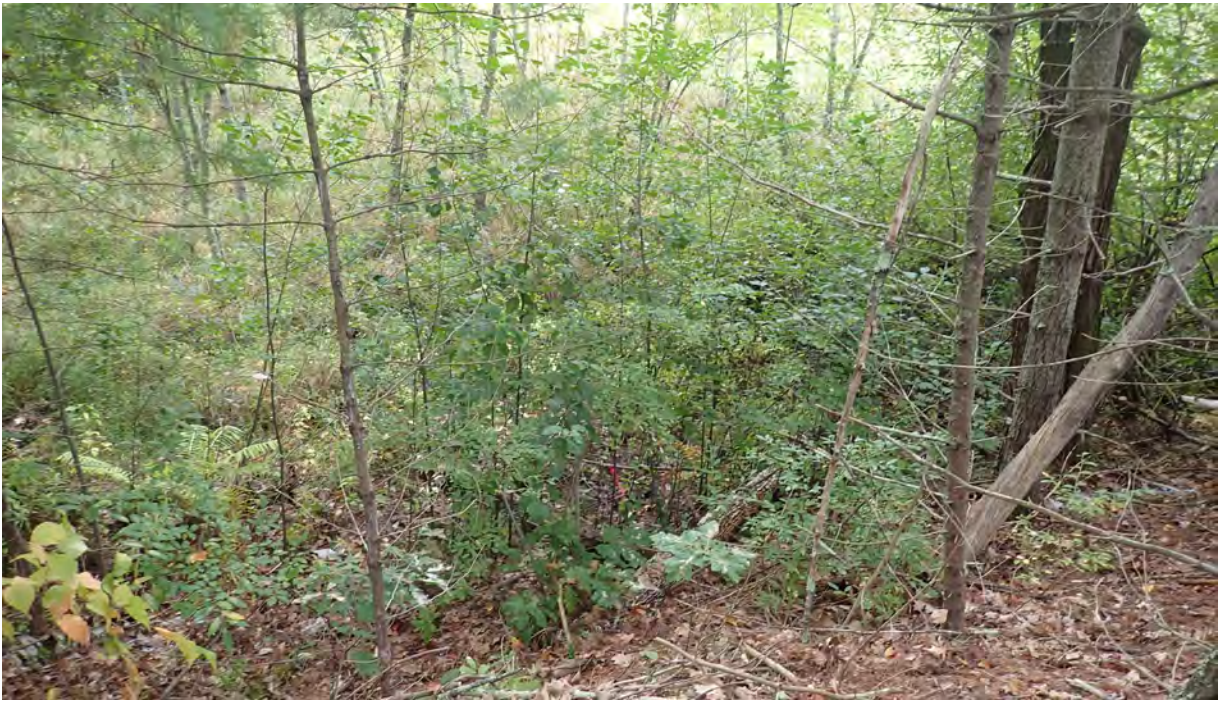
Photo #1: View of installed downed trees in Segment 7. Silt fence in the area is in good condition. No sediment or debris observed within the resource area. *Facing north.*

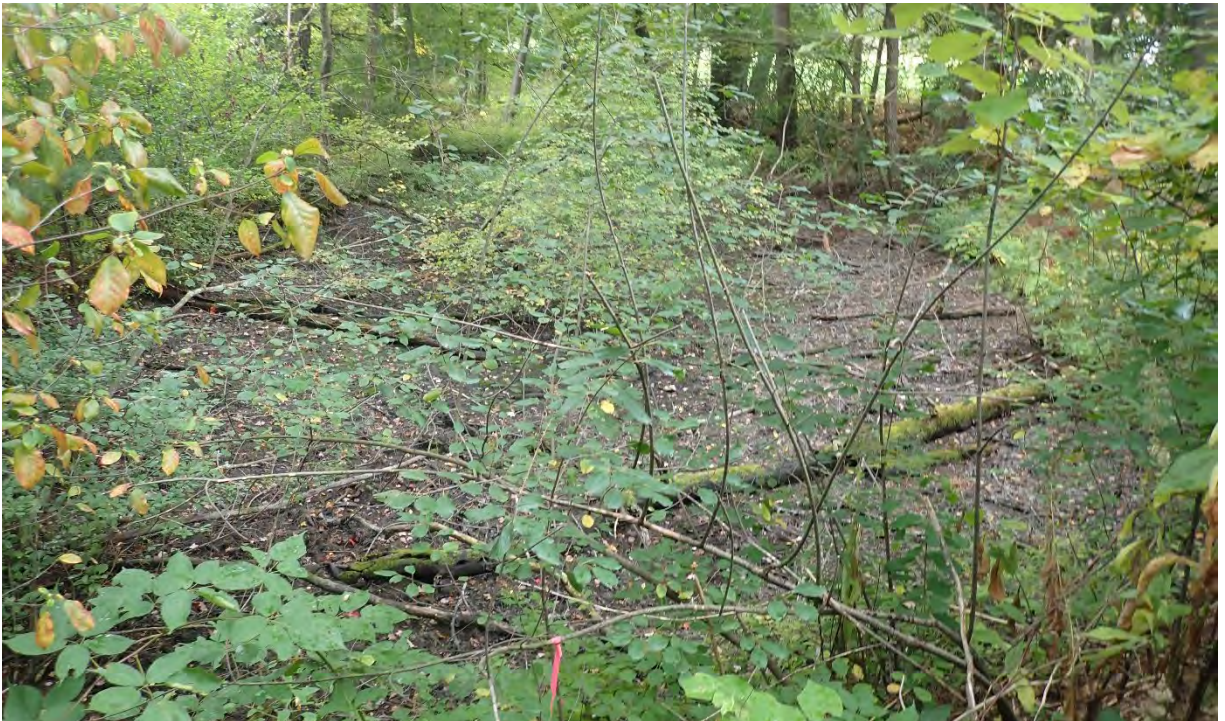
Photo #2: View of installed fallen logs within vernal pool 10 in Segment 11. No sediment or construction debris observed within the resource area or beyond the silt fencing. *Facing north.*

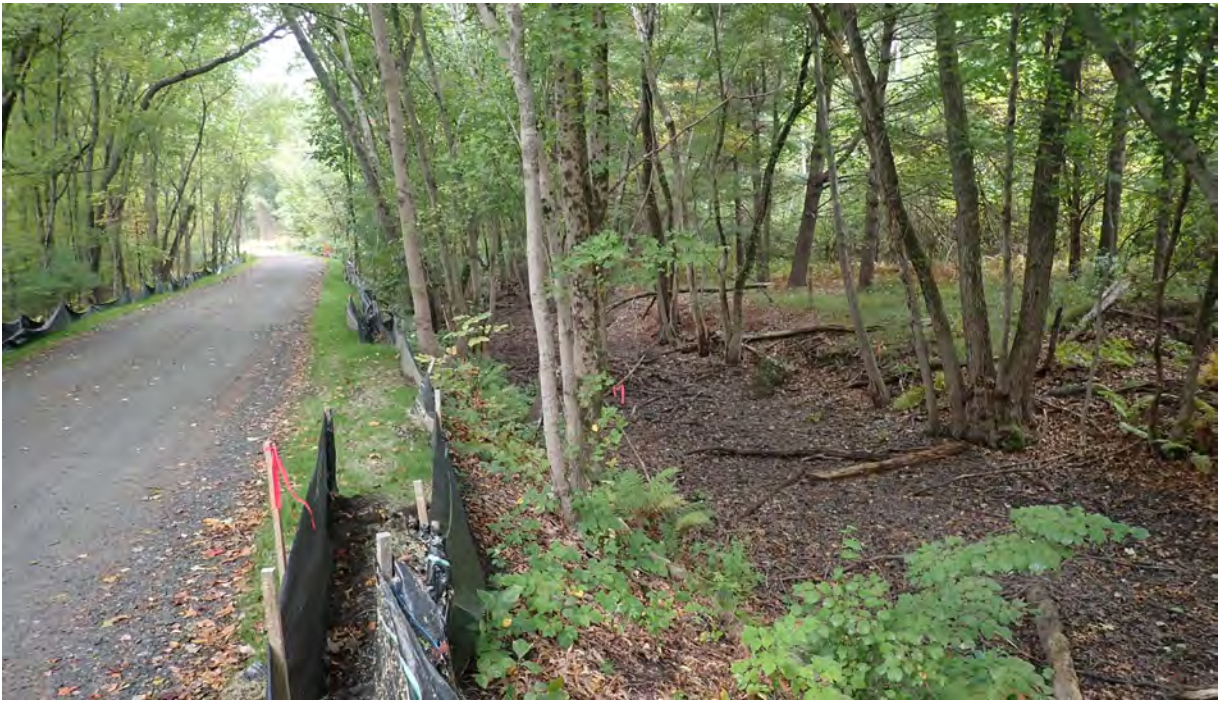
Photo #3: View of installed fallen logs in Segment 14. Silt fencing in this area is in good condition. No sediment or debris observed in the resource area or associated buffer zones. *Facing west.*

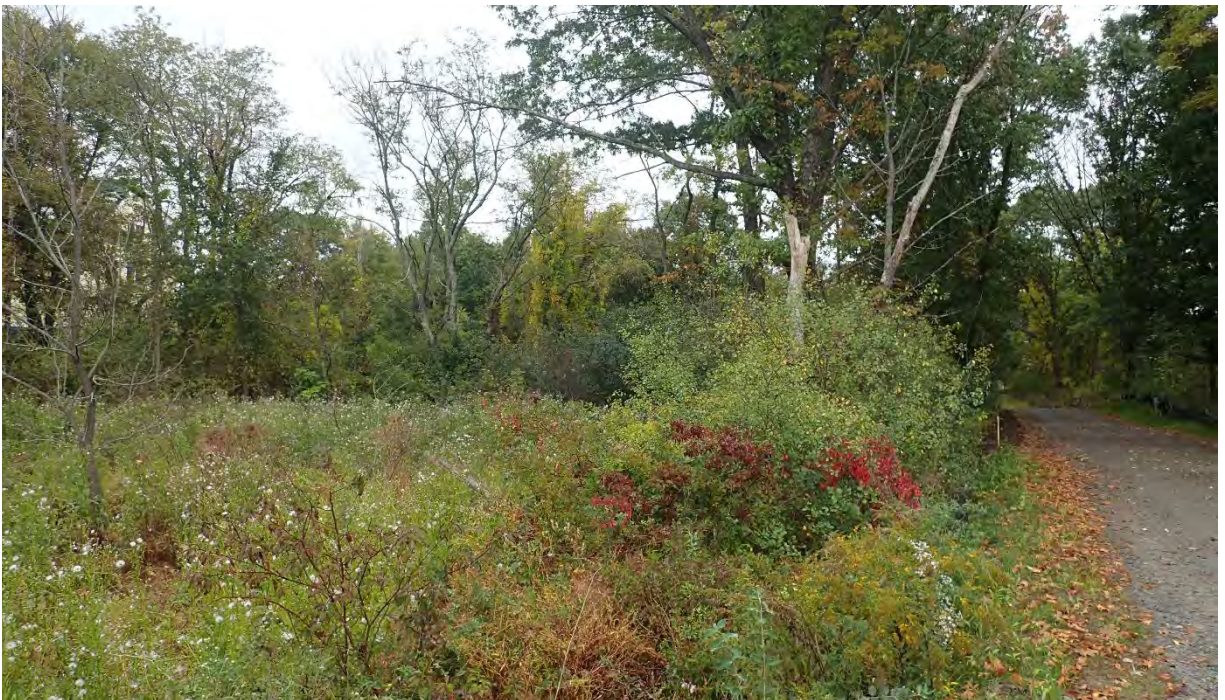
Photo #4: View of installed fallen logs in Segment 14 near the eastern end of the Project route. Silt fencing in this area is in good condition. No sediment or debris observed in the resource area or associated buffer zones. *Facing east.*

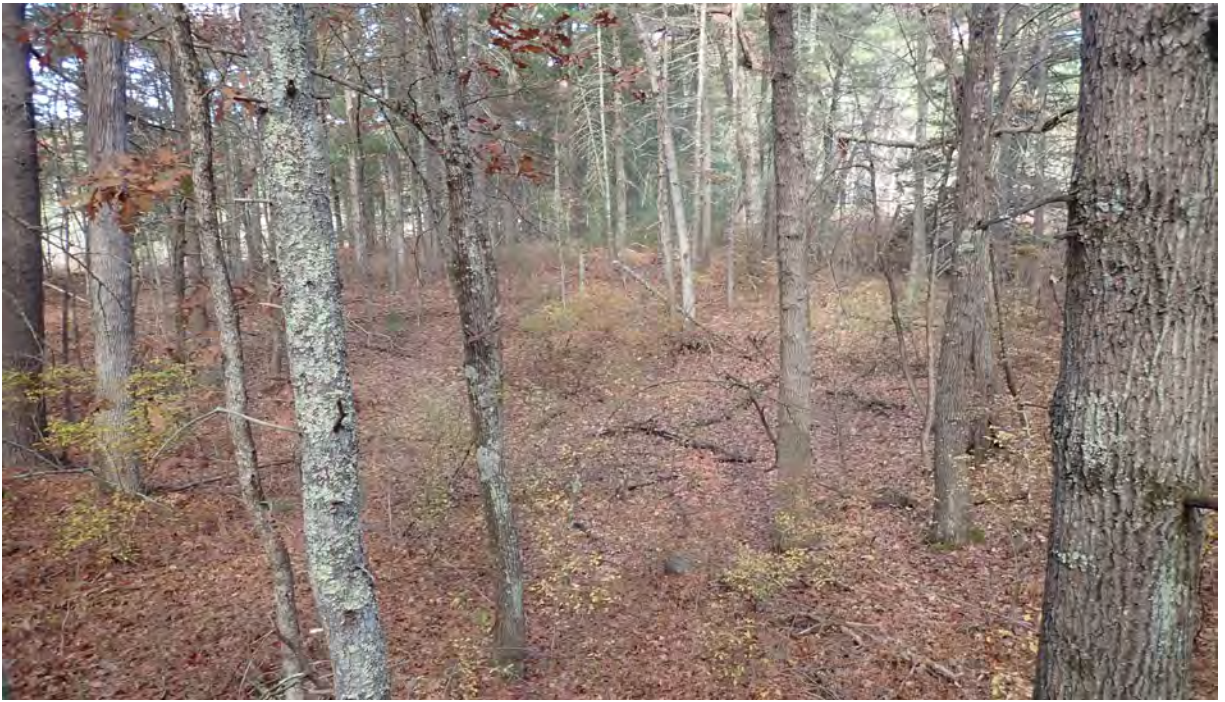
Photo #1: View of installed downed tree within vernal pool 6 in Segment 8. Silt fence in the area is in good condition. No sediment or debris observed within the resource area. *Facing north.*

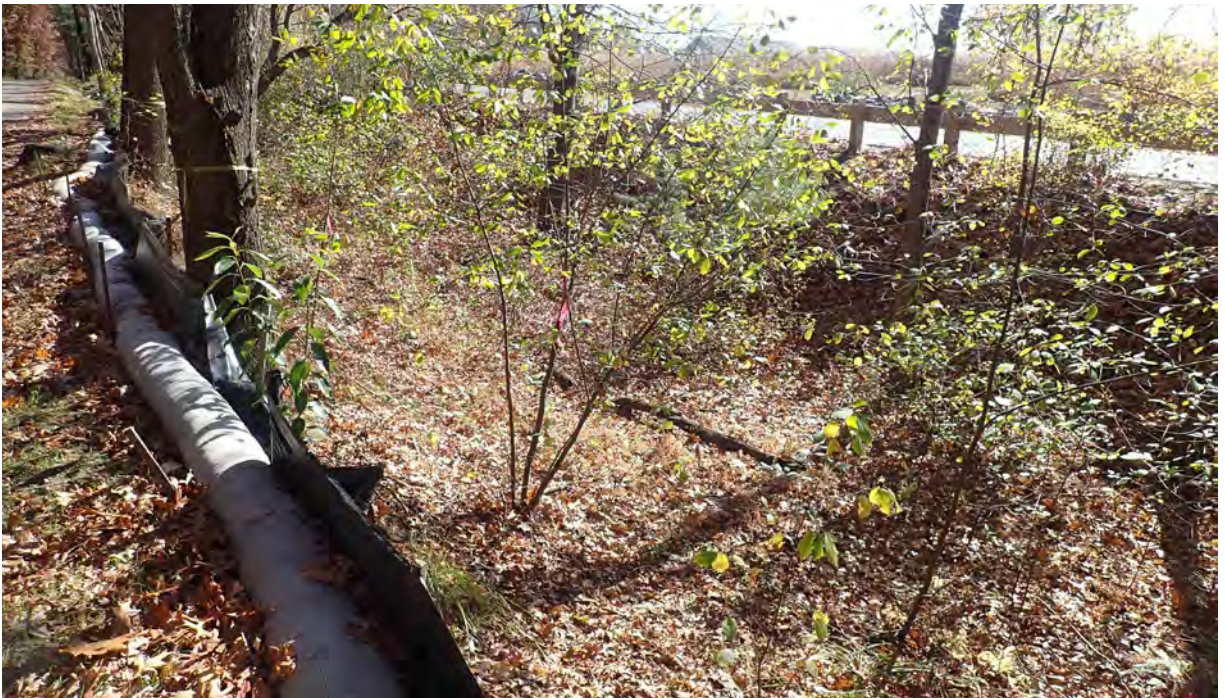
Photo #2: View of installed downed tree in Segment 11 near condominium complex. No sediment or construction debris observed within the resource area or beyond the silt fencing. Silt fencing are in good condition. *Facing east.*

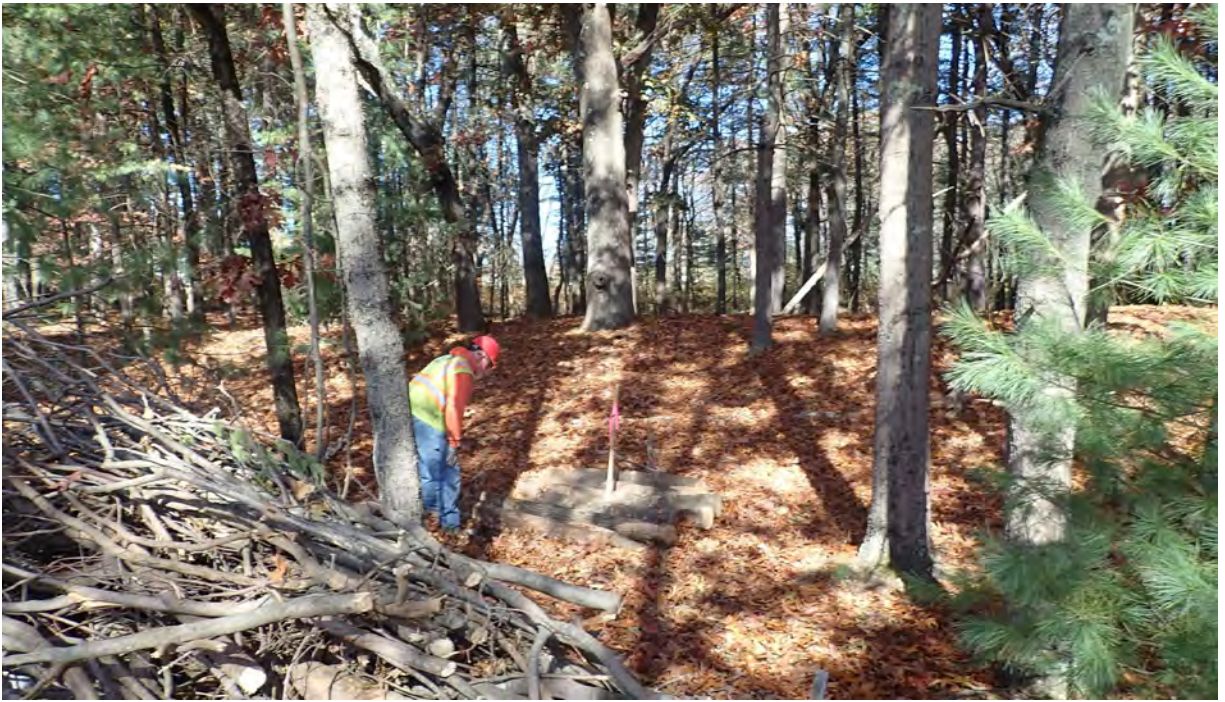
Photo #3: View of brush pile installation in Segment 11. Silt fencing in this area is in good condition. No sediment or debris observed in the resource area or associated buffer zones. *Facing north.*

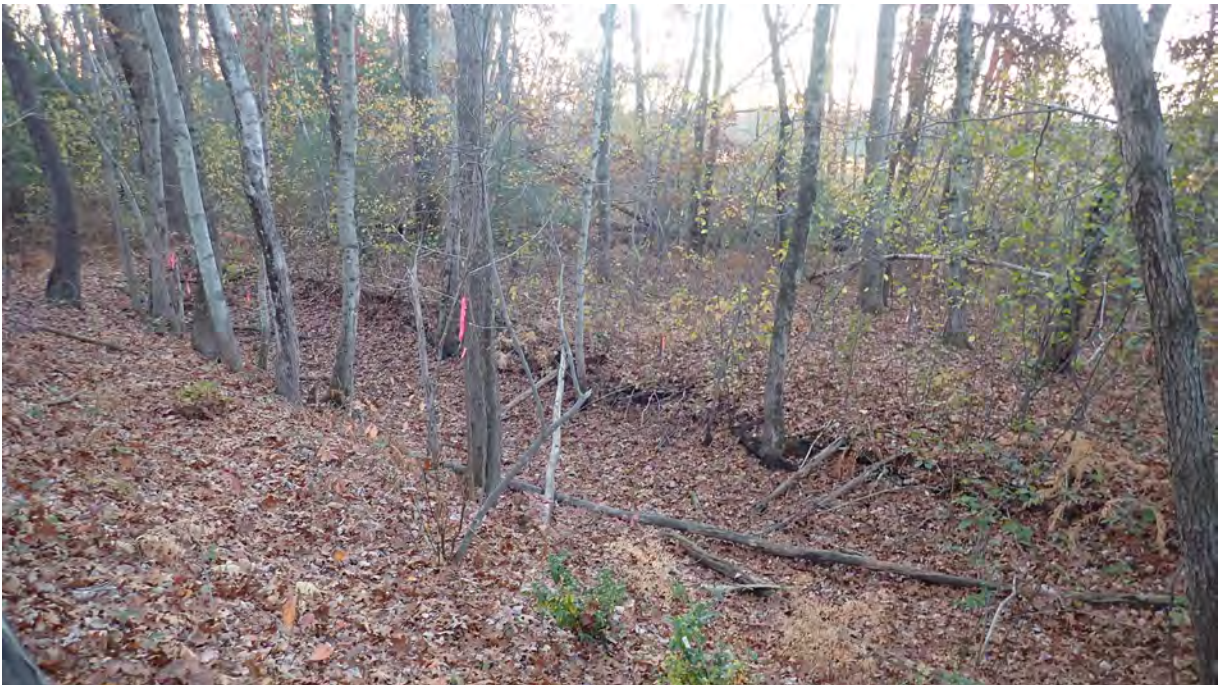
Photo #4: View of installed downed tree within vernal pool 14 in Segment 14. Silt fencing in this area is in good condition. No sediment or debris observed in the resource area or associated buffer zones. Brush pile installation is located adjacent to vernal pool 14. *Facing southeast.*

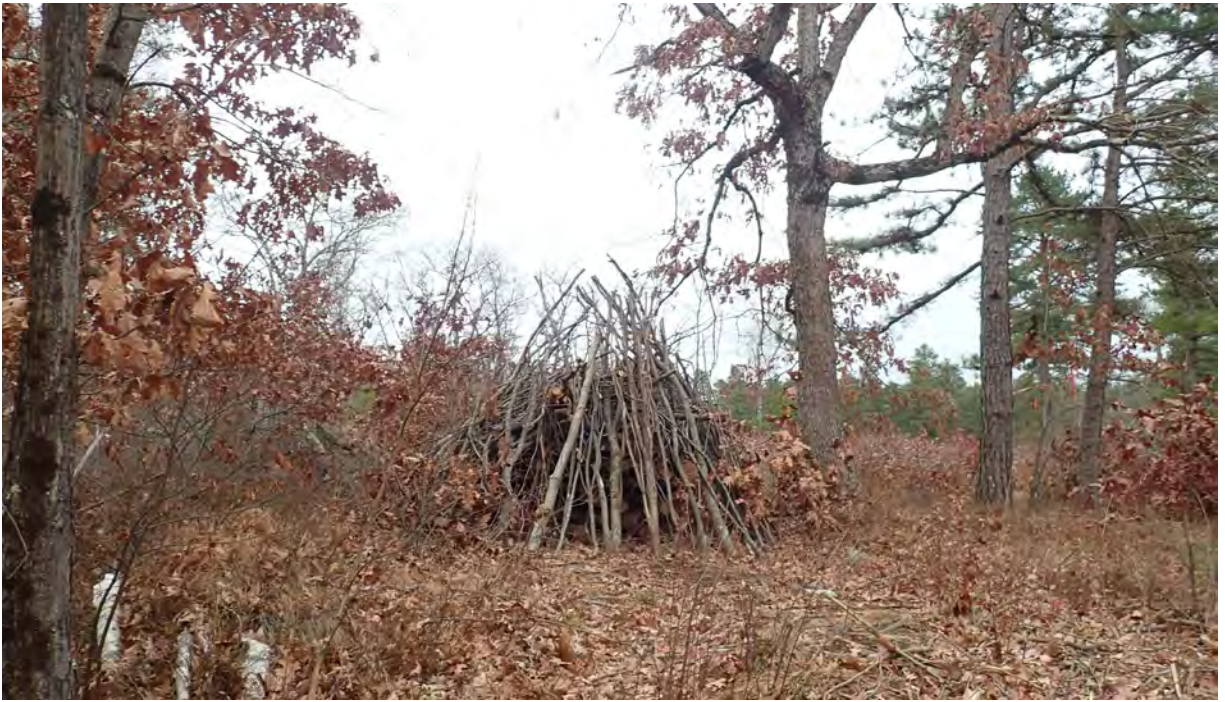
Photo #1: View of installed brush pile in Segment 7 by the Sudbury Town line. Chipmunks and squirrels observed using the brush pile. *Facing southeast.*

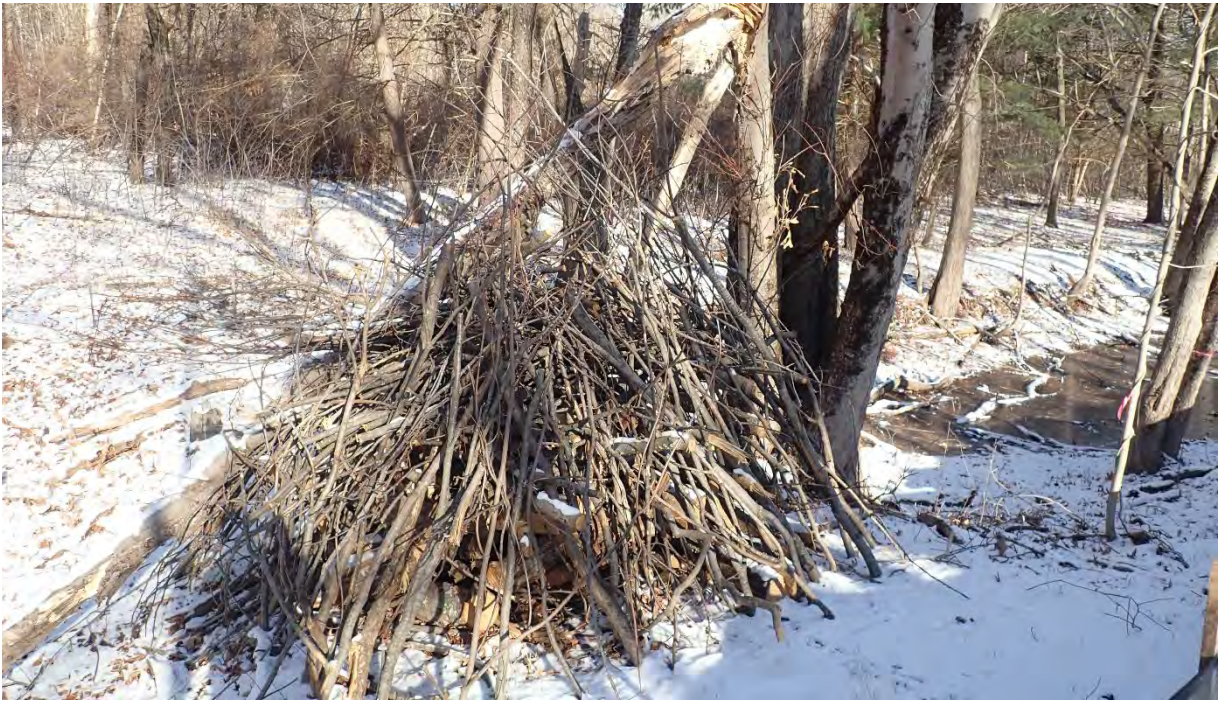
Photo #5: View of installed brush pile between vernal pools 12 and 13 in Segment 14. Squirrel tracks observed going towards the brush pile. *Facing northeast.*
