Environmental Monitor Construction Site Inspection Report
MassDOT Project #608164 Construction Contract # 119678
EM Report #41

Project Description: Bruce Freeman Rail Trail Right-of-Way
 Permit Description(s): Order of Conditions (MGL Chapter 131, Section 40 and 310 CMR 10.00, Mass DEP File No. 301-1362); 2022 EPA NPDES General Permit for Discharges from Construction Areas; U.S. Army Corps of Engineers Permit No NAE-2021-01975.

Project Name:	Bruce Freeman Rail Trail - Phase 2d - Sudbury
Date of Inspections:	12/31/2024
Bi Weekly/ Monthly Period Covered:	December Weekly Inspection #6
Inspector's Name(s):	Anna Haznar
Inspectors' Contact Information:	ahaznar@beta-inc.com

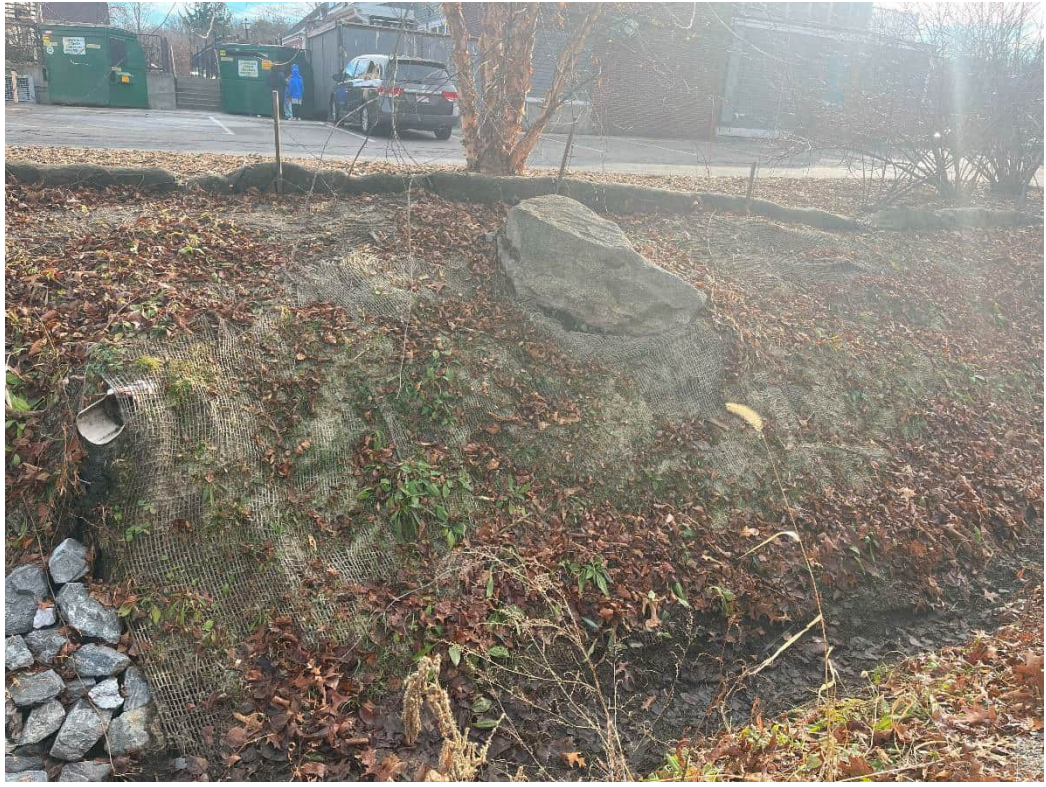
Photo No. 3 **Date:** 12/31/2024

6	Exposed sediment slope at Station 172+00 to 175+00 Priority: High	5/8/2024	5/15/2024	Install temporary sediment controls along the slope such as jute netting and/or straw following the application of seed.	<p>5/16/2024 - Observation remains.</p> <p>5/21/2024 - Observation remains.</p> <p>5/28/2024 - Partial germination was observed.</p> <p>5/31/2024 - See previous update.</p> <p>6/7/2024 - Further earthwork has occurred and soils require stabilization.</p> <p>6/14/2024 - Observation remains.</p> <p>6/17/2024 - Observation remains.</p> <p>6/24/2024 - Observation remains.</p> <p>6/27/2024 - The area has been regraded and loam has been spread. New trees have been planted upgradient of the swale. Stabilization is still required.</p> <p>7/8/2024 - Jute netting has been installed over the applied seed, and the area will be monitored for germination.</p> <p>7/15/2024 - See previous update.</p> <p>7/22/2024 - Observation remains.</p> <p>7/29/2024 - Observation remains.</p> <p>8/5/2024 - Observation remains.</p> <p>8/7/2024 - Regrowth of vegetation was observed in this location. This item will remain open until stabilization has been completed.</p> <p>8/12/2024 - Observation remains.</p> <p>8/16/2024 - Observation remains.</p> <p>8/20/2024 - Application of the approved seed mixture is required at this location.</p> <p>8/27/2024 - Observation remains.</p> <p>9/3/2024 - Vegetation that is present in this location generally consists of lady's thumb smartweed, a non-native species. Removal of non-native species and application of the approved seed mixture is required at this location.</p> <p>9/16/2024 - See previous update.</p> <p>9/23/2024 - Observation remains. See 9/3/2024 update.</p> <p>9/27/2024 - Observation remains. The contractor reached out hydroseed has been applied to this area.</p> <p>10/4/2024 - Hydroseed has been applied to this area; the hydroseed was observed to have been applied over the erosion control blanket that is located in this area. Once vegetation has sufficiently stabilized this area the item will be closed. The contractor should provide the tag from the seed mix that was used to the Conservation Commission to ensure that the required native seed mix was used per the design plans.</p> <p>10/8/2024 - Observation remains. See update from 10/4/2024.</p> <p>10/15/2024 - Observation remains. See update from 10/4/2024.</p> <p>10/22/2024 - Observation remains. See update from 10/4/2024.</p> <p>10/29/2024 - Observation remains. No germination has been observed in this location since the application of hydroseed. See update from 10/4/2024.</p> <p>11/5/2024 - Observation remains. Some germination has been observed but the area is not considered stabilized.</p> <p>11/12/2024 - Observation remains.</p> <p>11/19/2024 - Germination has been observed in this location but it has not fully stabilized.</p> <p>11/22/2024 - Observation remains. See previous update.</p> <p>11/25/2024 - Observation remains. See update from 11/19/2024.</p> <p>12/2/2024 - Observation remains. See update for 11/19/2024.</p> <p>12/6/2024 - Observation remains. See update for 11/19/2024.</p> <p>12/12/2024 - Observation remains. Some germination has been observed within this location. Observation will remain open until stabilization is complete.</p> <p>12/20/2024 - Observation remains. See previous update.</p> <p>12/26/2024 - Observation remains. See update from 12/12/2024.</p> <p>12/31/2024 - Observation remains. Some germination has been observed within this location. Observation will remain open until stabilization is complete.</p>

View of hydroseed with some germination along slopes at Station 172+00 to 175+00 per Compliance Action Item 6.

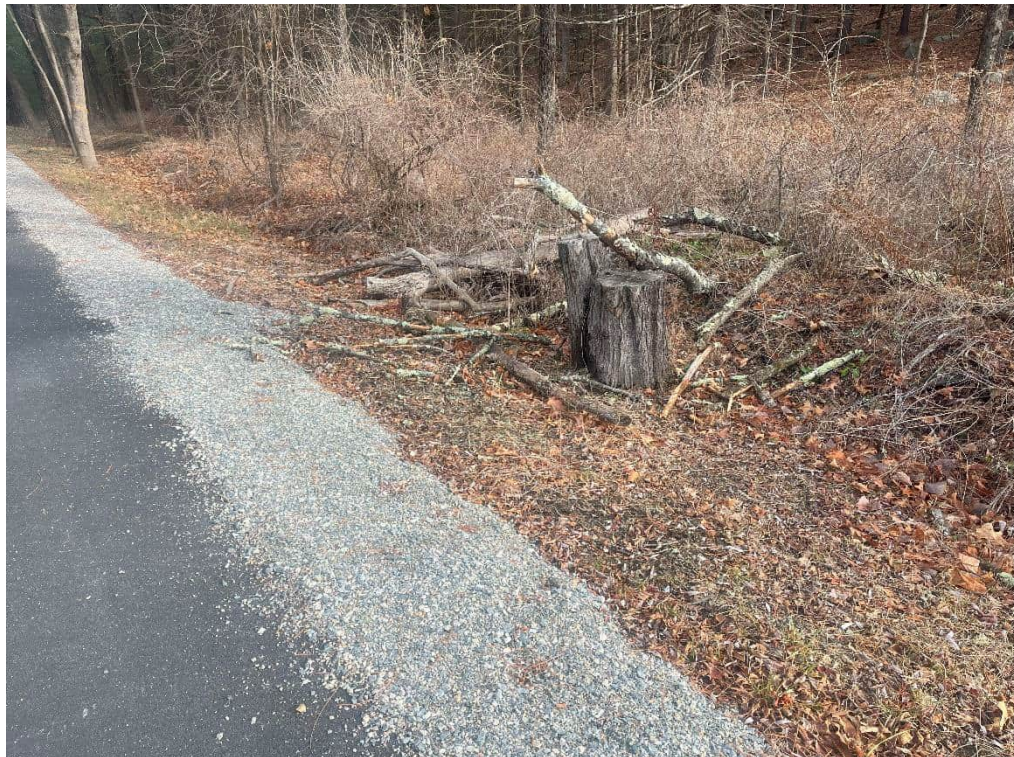
Photo No. 4 **Date:** 12/31/2024

58	<p>Crushed stone used for the dense graded crush stone shoulders has been observed as migrating both onto the path, off the sides of the path, and into the adjacent Resource Areas throughout the Project Priority: High</p>	8/7/2024	8/14/2024	<p>Remove all crushed stone from Resource Areas and develop a plan to cease discharges of stone.</p>	<p>8/12/2024 - Crushed stone is still present in varying amounts throughout the path and on the sides of the path. 8/16/2024 - Observation remains. 8/20/2024 - Crushed stone has been removed from some adjacent resource areas but is still observed as migrating onto and off of the path in multiple locations throughout the Project. 8/27/2024 - Crushed stone has been observed as migrating from the shoulders throughout the path. 9/3/2024 - Crushed stone was observed as migrating both onto the path and off the side of the path in multiple locations. Stone was observed to have discharged to the cattle crossing at Station 190+50 and within the streambed at Station 215+00 to 216+00. Crushed stone was observed to have been placed on the root system of a fallen tree at Station 310+00 near Bank flag #BF4-108. 9/10/2024 - Observation remains. Crushed stone is still present within the cattle crossing, the streambed, and on the root system of the fallen tree. Crushed stone continues to migrate on to and off of the path. 9/16/2024 - Observation remains. The contractor indicated the locations where crushed stone has migrated off the path will be hand removed and crushed stone will be swept off the path prior to the opening of the trail. 9/23/2024 - Observation remains. It does not appear as though crushed stone that has migrated onto or off of the path has been removed in any location along the Project. More crushed stone has migrated onto the path throughout significant portions of the path. 9/27/2024 - Observation remains. Crushed stone is still located on the side of the path and on the path in varying amounts. 10/4/2024 - Crushed stone has been removed from multiple locations along the trail but was still observed on and on the sides of the trail in several locations. 10/8/2024 - Observation remains. Crushed stone is still present in multiple locations on and off the sides of the path. 10/15/2024 - Observation remains. Crushed stone is still present in multiple locations on and off the sides of the path. 10/22/2024 - Observation remains. Crushed stone is still present in multiple locations on and off the sides of the path. The crushed stone shoulders along Station 1000+00 to 1003+00 has been moved back into the shoulders and regraded. 10/29/2024 - Observation remains. Crushed stone is still present in multiple locations on and off the sides of the path. 11/5/2024 - Observation remains. See previous update. 11/12/2024 - Observation remains. Crushed stone is still present on the side of the path in multiple locations, within the streambed and drainage swale and within the cattle crossing at Station 190+50. 11/19/2024 - Crushed stone was removed from the cattle crossing at Station 190+50. Further removal of stone is required in multiple locations along the path that are currently covered with leaf litter. 11/22/2024 - Observation remains. See previous update. 11/25/2024 - Observation remains. See update from 11/19/2024. 12/2/2024 - Observation remains. Stone is covered with leaf litter in multiple locations along the path. 12/6/2024 - Observation remains. Crushed stone is located both on and off of the trail in multiple locations throughout the path. 12/12/2024 - Observation remains. Crushed stone is located both on and off of the trail in multiple locations throughout the path. 12/20/2024 - Observation remains. Crushed stone is located both on and off of the trail in multiple locations throughout the path. 12/26/2024 - Observation remains. See previous update. 12/31/2024 - Observation remains. Crushed stone is located both on and off of the trail in multiple locations throughout the path.</p>

View of a location where hydroseed was recently applied with no observable germination and crushed stone that requires removal at Station 180+00 per Long Term Compliance Action Item 58 and 59.

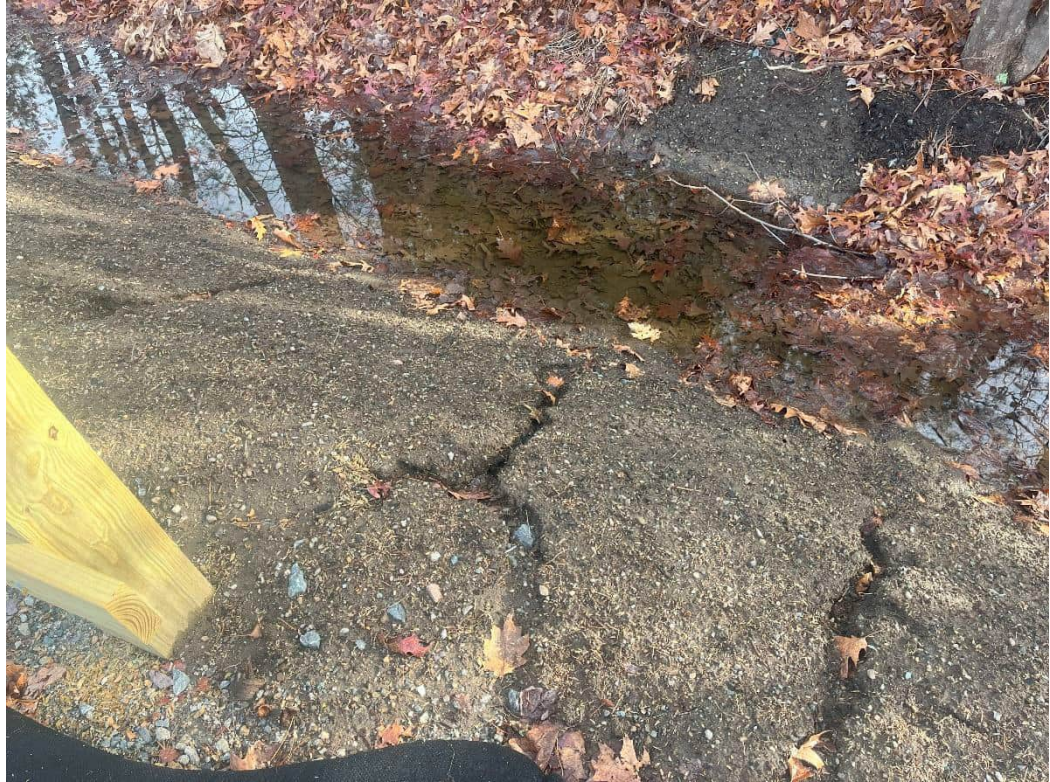
Photo No. 7 **Date:** 12/31/2024

Item	Location/ Description	Observation Date	Resolution Due Date	Recommended Resolution / Resolution Date	Comments/Updates
62	Loam and seed was applied to the streambank at Station 216+00 to 217+00 and requires further stabilization Priority: High	11/25/2024	12/2/2024	An erosion control blanket should be installed along this slope.	12/2/2024 - Loam and seed have been applied to the streambank at Station 215+00. Stabilization is required at Stations 215+00 to 217+00. 12/6/2024 - Observation remains. See previous update. 12/12/2024 - Observation remains. Rill erosion was observed within the loam applied to this area from Station 215+00 to 216+00. 12/20/2024 - Observation remains. Loam has begun to erode, resulting in a discharge to the stream at Station 216+50. 12/26/2024 - Observation remains. No further discharge was observed in this location. 12/31/2024 - Observation remains. Additional loam has eroded resulting in a discharge to the stream at Station 216+50.

View of the location where loam that was placed on the streambank has eroded into the streambed at Station 216+50, resulting in a discharge per Compliance Action Item 62.

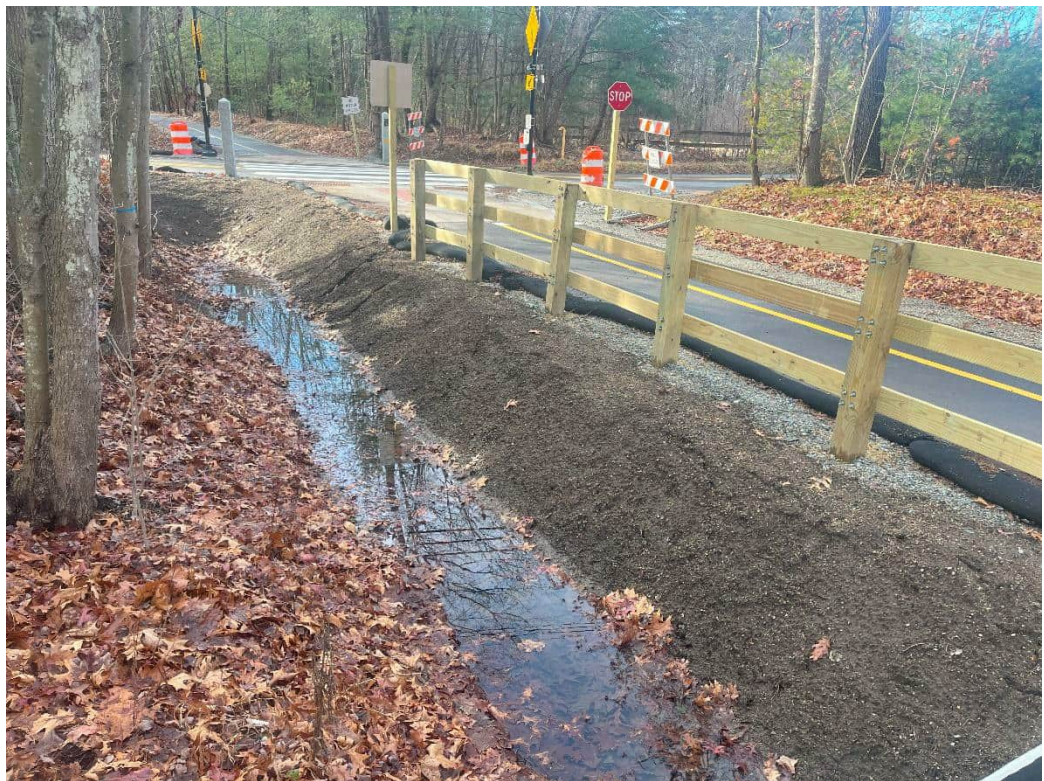
Photo No. 8 **Date:** 12/31/2024

41	Stream Bank has been regraded beyond the limit of work at Station 216+00 Priority: High	5/28/2024	6/4/2024	The Contractor should confirm if this work was permitted by the Conservation Commission, as it does not appear to be a part of the approved plans/impacts. MassDOT should be consulted on next steps regarding notification and potential restoration.	<p>5/31/2024 - Observation remains. 6/7/2024 - Observation remains. 6/14/2024 - Observation remains. 6/17/2024 - Observation remains. 6/24/2024 - Observation remains. 6/27/2024 - Observation remains. 7/8/2024- Observation remains. 7/15/2024 - This area could not be assessed due to paving operations ongoing during the inspection. 7/22/2024 - Crushed stone and sediment continue to be discharged to the stream between Stations 215+00 and 217+00 due to overtopped and undermined compost filter tubes. 7/29/2024 - Observation remains. 8/5/2024 - Observation remains. 8/7/2024 - Observation remains. 8/12/2024 - Observation remains. Crushed stone is still present in the streambed at this location. 8/16/2024 - Observation remains. 8/20/2024 - Stone has been removed; however, additional alteration to Resource Areas beyond the limit of work continue. 8/27/2024 - Observation remains. 9/3/2024 - Observation remains. 9/10/2024 - Observation remains. Stone has been observed as discharging into the streambed in this location again. 9/16/2024 - Observation remains. 9/23/2024 - Observation remains. Stone is still present within the streambed at this location. 9/27/2024 - Observation remains. 10/4/2024 - Observation remains. 10/8/2024 - Observation remains. 10/15/2024 - Observation remains. Stone is still present within the streambed at this location. 10/22/2024 - Observation remains. Stone is still present within the streambed at this location. 10/29/2024 - Observation remains. Stone is still present within the streambed at this location. 11/5/2024 - Observation remains. The PVC pipe that was installed at this location was observed to be covered with stone and is no longer visible near Station 215+00. Stone is still present within the streambed at this location. 11/12/2024 - Observation remains. The streambed in this location is covered with leaf litter. See previous update. 11/19/2024 - Observation remains. As discussed with the Conservation Agent in the field, further coordination between the Town and MassDOT will be required to clean/repair the culvert, as the degraded condition of the culvert prompted the contractor to armor the stream banks. Further coordination will also be required for restoration of banks. 11/22/2024 - Observation remains. See previous update. 11/25/2024 - Observation remains. See update from 11/19/2024. 12/2/2024 - Observation remains. See update from 11/19/2024. 12/6/2024 - Observation remains. See update from 11/19/2024. 12/12/2024 - Observation remains. See update from 11/19/2024. 12/20/2024 - Observation remains. See update from 11/19/2024. 12/26/2024 - Observation remains. See update from 11/19/2024. 12/31/2024 - Observation remains. See update from 11/19/2024.</p>

View of the location where the stream bank has been regraded beyond the limits of work and stabilization of loam is required at Station 216+00 per Long Term Compliance Action Item 41 and 62. Note rill erosion is occurring in this area.

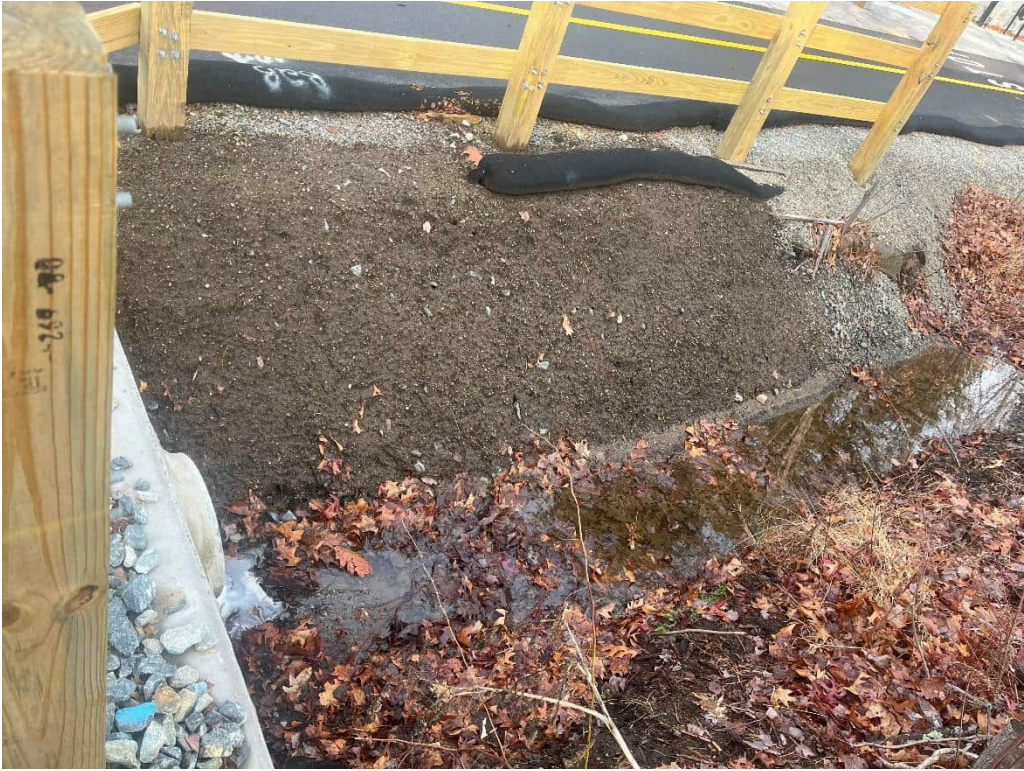
Site Location Bruce Freeman Rail Trail Right-of-Way		BETA Project No. 24.10326.23
Photo No. 9	Date: 12/31/2024

Direction Photo Taken: Toward the West		
Description: View of loam that requires stabilization at Station 217+00 per Compliance Action Item 62.		
Photo No. 10	Date: 12/31/2024

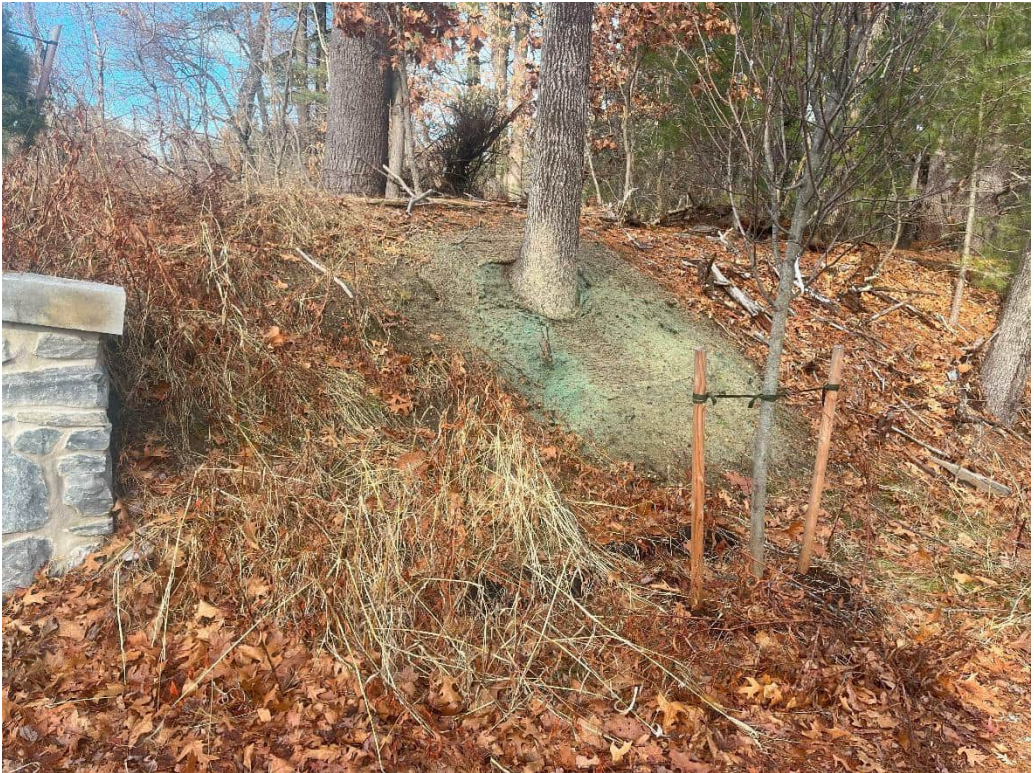
34	<p>Sediment is eroding downhill from behind the cemented stone masonry wall at Station 217+45 Priority: Low</p>	5/28/2024	6/4/2024	<p>Apply seed and temporarily stabilize the soils along the slope with straw, jute netting, etc.</p>	<p>5/31/2024 - Observation remains. 6/7/2024 - Observation remains. 6/14/2024 - Observation remains. 6/17/2024 - Observation remains. 6/24/2024 - Observation remains. 6/27/2024 - Rills were raked, loam was added, and hydroseed was applied. 7/8/2024- Observation remains. Grass was observed to be germinating at this location. Comment will remain open until stabilization is complete. 7/8/2024 - See previous update. 7/15/2024 - Additional hydroseed is required due to washouts. 7/22/2024 - Observation remains. 7/29/2024 - Observation remains. 8/5/2024 - Observation remains. 8/7/2024 - Regrowth of vegetation has been observed in this area. This item will remain open until the area is fully stabilized. 8/12/2024 - Observation remains. Regrowth has stabilized a portion of this hill; however, reseeded and additional temporary stabilized measures are recommended on the section that is currently unvegetated. 8/16/2024 - Observation remains. 8/20/2024 - Application of the approved seed mixture is required at this location. 8/27/2024 - Observation remains. 9/3/2024 - Vegetation that is present in this location generally consists of lady's thumb smartweed (<i>Persicaria maculosa</i>), a non-native species. Removal of non-native species and application of the approved seed mixture is required at this location. 9/10/2024 - Observation remains. See previous update. 9/16/2024 - Observation remains. See update from 9/3/2024. 9/23/2024 - Observation remains. See update from 9/3/2024. 9/27/2024 - Observation remains. 10/4/2024 - Observation remains. See update from 9/3/2024. 10/8/2024 - Observation remains. See update from 9/3/2024. 10/15/2024 - Observation remains. See update from 9/3/2024. 10/22/2024 - Observation remains. See update from 9/3/2024. 10/29/2024 - Observation remains. No additional seed has been applied to this location and the slope is generally vegetated by non-native species. See update from 9/3/2024. 11/5/2024 - Observation remains. Erosion control and seed has been applied to part of this slope, no germination has been observed. 11/12/2024 - Observation remains. No germination has been observed in this location. 11/19/2024 - Observation remains. 11/22/2024 - Observation remains. No germination has been observed in this location. 11/25/2024 - Observation remains. No germination has been observed in this location. 12/2/2024 - Observation remains. No germination has been observed in this location. 12/6/2024 - Observation remains. No germination has been observed in this location. 12/12/2024 - Observation remains. Some germination has been observed within this location. Observation will remain open until stabilization is complete. 12/20/2024 - Observation remains. See previous update. 12/26/2024 - Observation remains. See update from 12/12/2024. 12/31/2024 - Observation remains. See update from 12/12/2024.</p>

Direction Photo Taken: Toward the West		
Description: View of the slope where hydroseed was applied and some germination has occurred at Station 217+45 per Compliance Action Item 34.

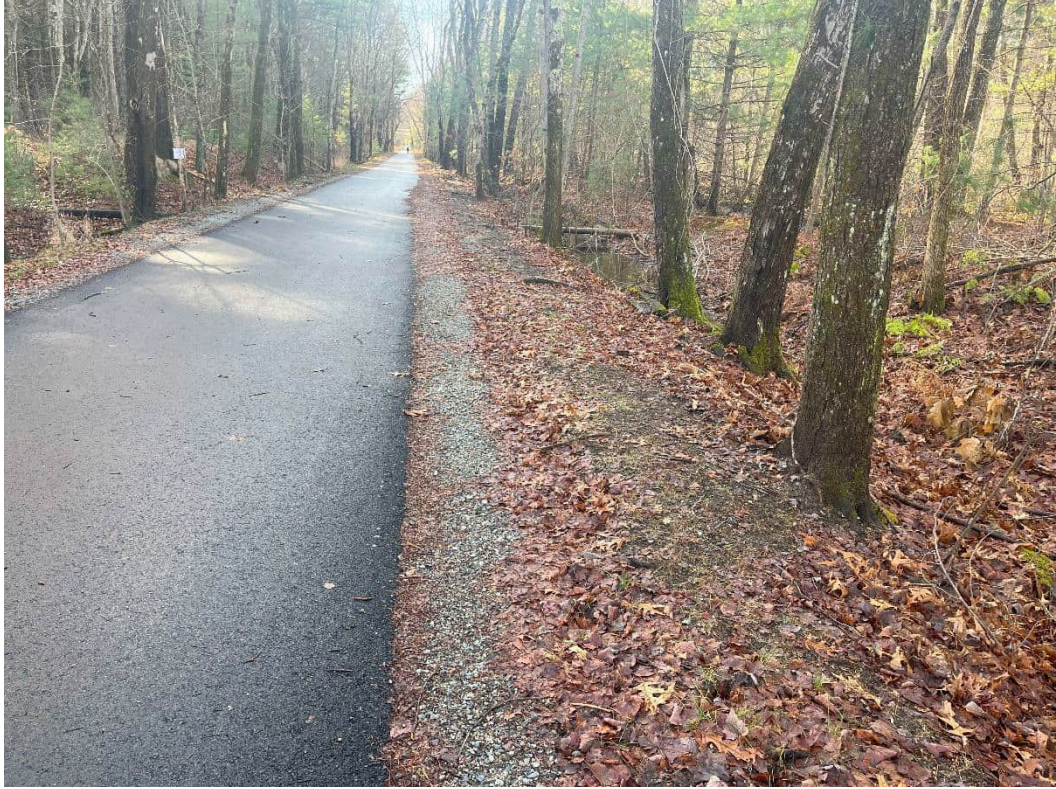
Site Location Bruce Freeman Rail Trail Right-of-Way		BETA Project No. 24.10326.23
Photo No. 11	Date: 12/31/2024

Direction Photo Taken: Toward the South		
Description: View of an area of exposed soil at Station 297+50 per Long Term Compliance Action Item 59.		
Photo No. 12	Date: 12/31/2024

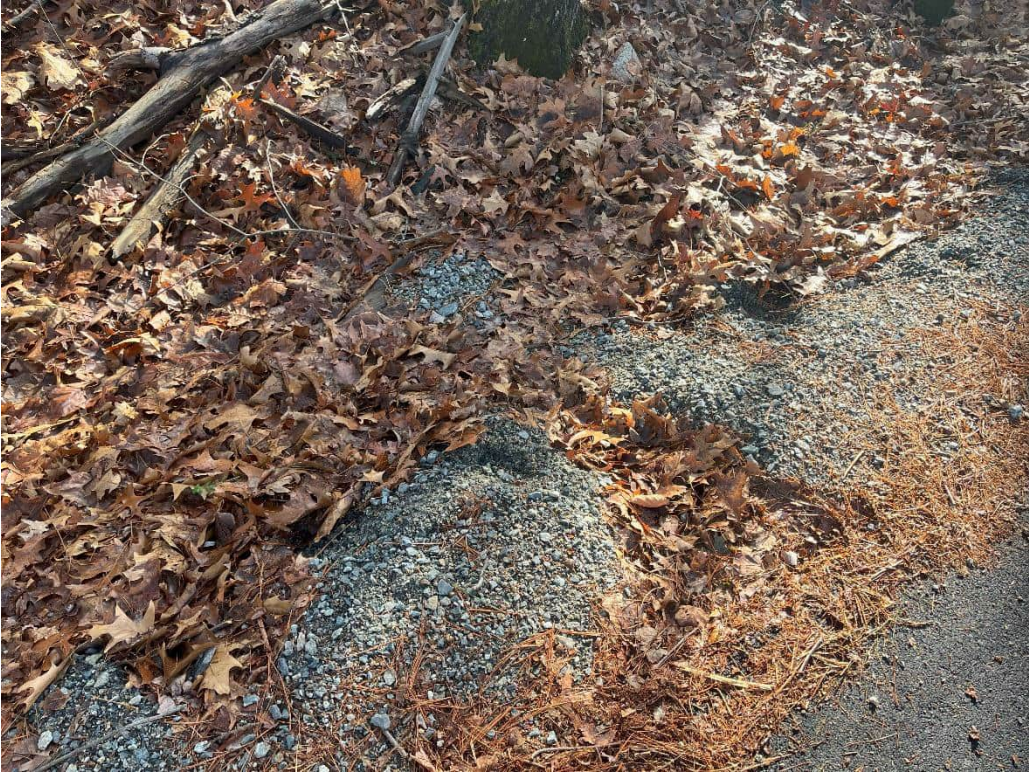
Direction Photo Taken: Toward the West		
Description: View of crushed stone that requires removal from the swale at Station 303+00 per Long Term Compliance Action Item 58.

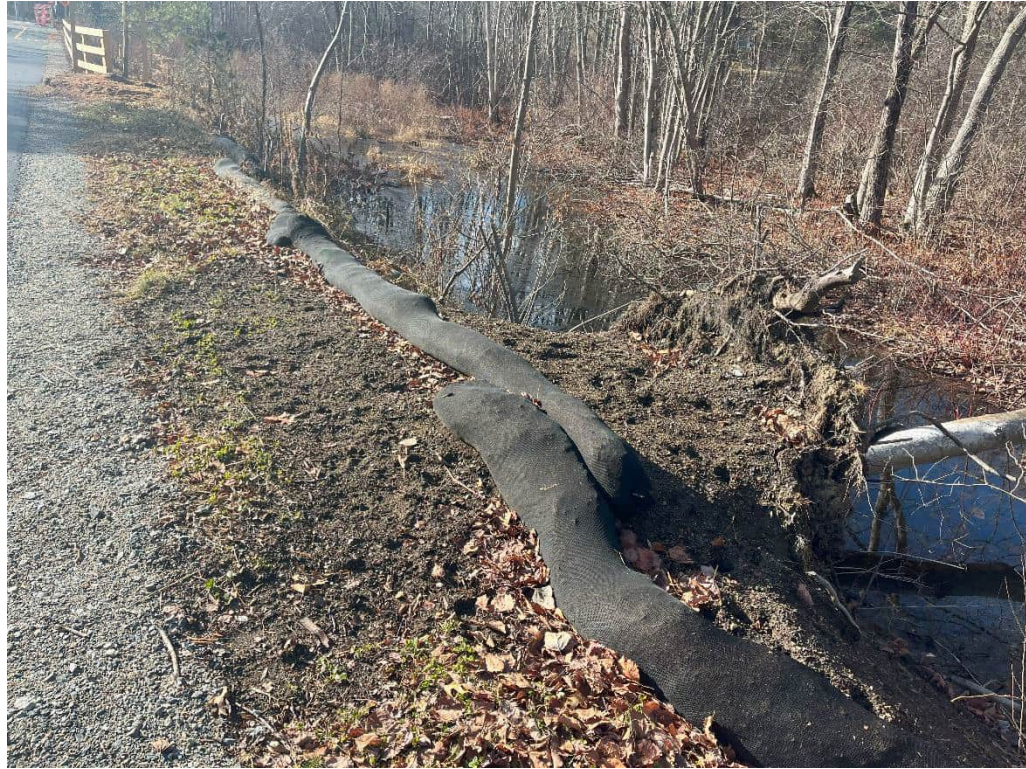
Photo No. 13 **Date:** 12/31/2024

View of placed loam that requires stabilization at Station 311+00 per Long Term Compliance Action Item 59.

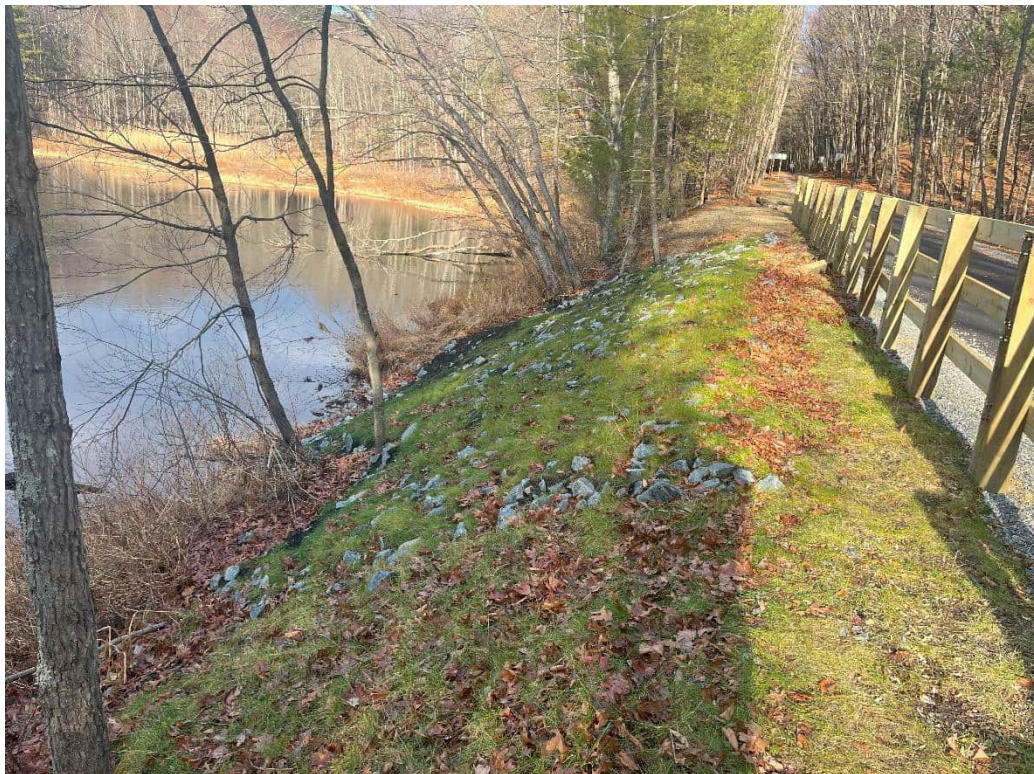
Photo No. 14 **Date:** 12/31/2024

42	<p>Riprap slope extends beyond limits of work along the WF1 Series wetland near flags 103 to 107 Priority: High</p>	5/28/2024	6/4/2024	<p>The Contractor should confirm if this work was permitted by the Conservation Commission, as it does not appear to be a part of the approved plans/impacts. MassDOT should be consulted on next steps regarding notification and potential restoration.</p>	<p>5/31/2024 - Observation remains. 6/7/2024 - Observation remains. 6/14/2024 - Riprap slope has been altered and active construction is repairing the area. 6/17/2024 - During this inspection, additional work in support of the repair/potential replacement of an underlying pipe has been ongoing. It is recommended that the contractor confirm that they have coordinated with the Conservation Commission for this work and provide a restoration plan for the area once work is complete. 6/24/2024 - During this inspection, BETA was informed that the existing cast iron pipe was replaced with a new concrete 12-inch reinforced concrete pipe. It appears that riprap was replaced along the side slopes to mirror conditions observed prior to this inspection. 6/27/2024 - During this inspection, the area was observed to have been rolled and prepared for paving. Hydroseed was applied and plantings were installed. 7/8/2024 - Germination was observed and the area will be monitored for stabilization. See previous updates regarding Conservation Commission coordination. 7/15/2024 - This area could not be assessed due to paving operations ongoing during the inspection. 7/22/2024 - See previous updates regarding Conservation Commission coordination. 7/29/2024 - Observation remains. 8/5/2024 - Observation remains. 8/7/2024 - Observation remains. 8/12/2024 - Observation remains. Regrowth of vegetation has been observed in this area and will continue to be monitored. 8/16/2024 - Observation remains. 8/20/2024 - Observation remains. 8/27/2024 - Observation remains. 9/3/2024 - Observation remains. 9/10/2024 - Observation remains. 9/16/2024 - Observation remains. 9/23/2024 - Observation remains. 9/27/2024 - Observation remains. 10/4/2024 - Observation remains. 10/8/2024 - Observation remains. 10/15/2024 - Observation remains. 10/22/2024 - Observation remains. 10/29/2024 - Observation remains. 11/5/2024 - Observation remains. 11/12/2024 - Observation remains. The timber fence has been installed upgradient of this area. 11/19/2024 - Observation remains. As discussed with the Conservation Agent in the field, an as-built should be prepared for this area to quantify any additional impacts that may be addressed through a permit amendment. 11/22/2024 - Observation remains. See previous update. 11/25/2024 - Observation remains. See update from 11/19/2024. 12/2/2024 - Observation remains. See update from 11/19/2024. 12/6/2024 - Observation remains. See update from 11/19/2024. 12/12/2024 - Observation remains. See update from 11/19/2024. 12/20/2024 - Observation remains. See update from 11/19/2024. 12/26/2024 - Observation remains. See update from 11/19/2024. 12/31/2024 - Observation remains. See update from 11/19/2024.</p>

View of the riprap slope that extends beyond the limit of work along the WF1 Series wetland at Station 332+00 per Long Term Compliance Action Item 42.
