**Environmental Monitor Construction Site Inspection Report**  
**MassDOT Project #608164 Construction Contract # 119678**  
**EM Report #42**

Project Description: Bruce Freeman Rail Trail Right-of-Way  
 Permit Description(s): Order of Conditions (MGL Chapter 131, Section 40 and 310 CMR 10.00, Mass DEP File No. 301-1362); 2022 EPA NPDES General Permit for Discharges from Construction Areas; U.S. Army Corps of Engineers Permit No NAE-2021-01975.

Project Name:	Bruce Freeman Rail Trail - Phase 2d - Sudbury
Date of Inspections:	1/2/2025
Bi Weekly/ Monthly Period Covered:	January Weekly Inspection #1
Inspector's Name(s):	Jonathan Niro
Inspectors' Contact Information:	<a href="mailto:jniro@beta-inc.com">jniro@beta-inc.com</a>

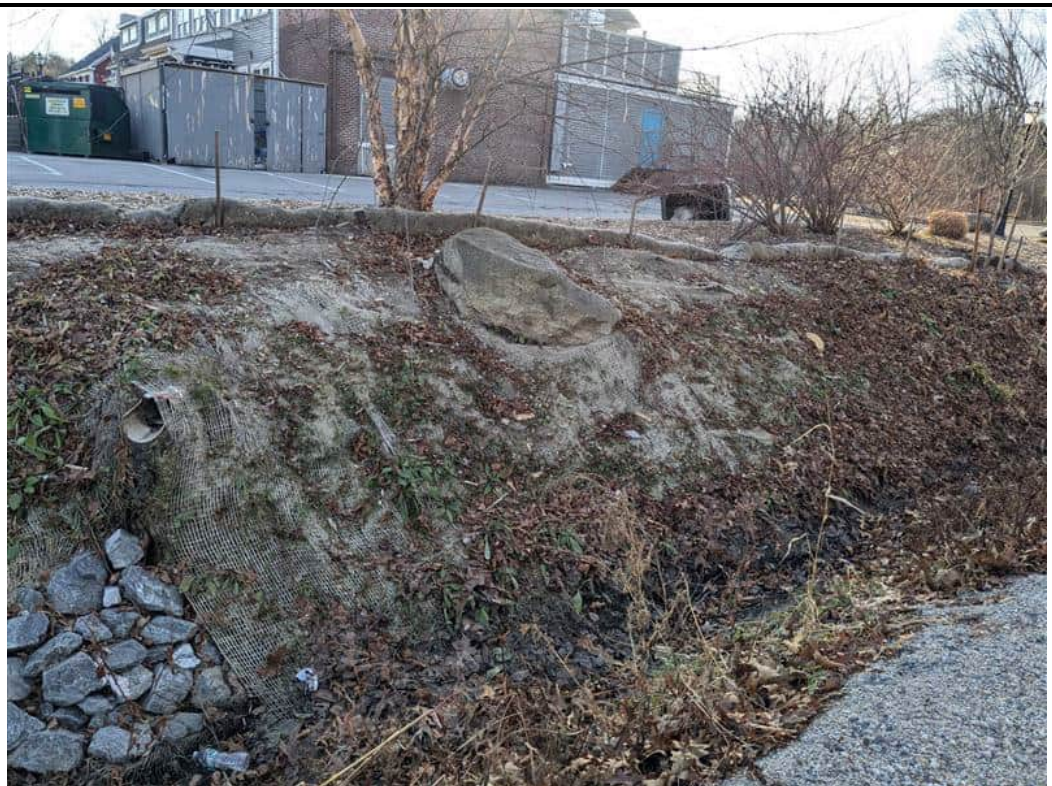
**Photo No. 3**    **Date:**  
1/2/2025

View of a location where hydroseed was recently applied with no observable germination and crushed stone removal at Station 180+00 per Long Term Compliance Action Item 58 and 59.

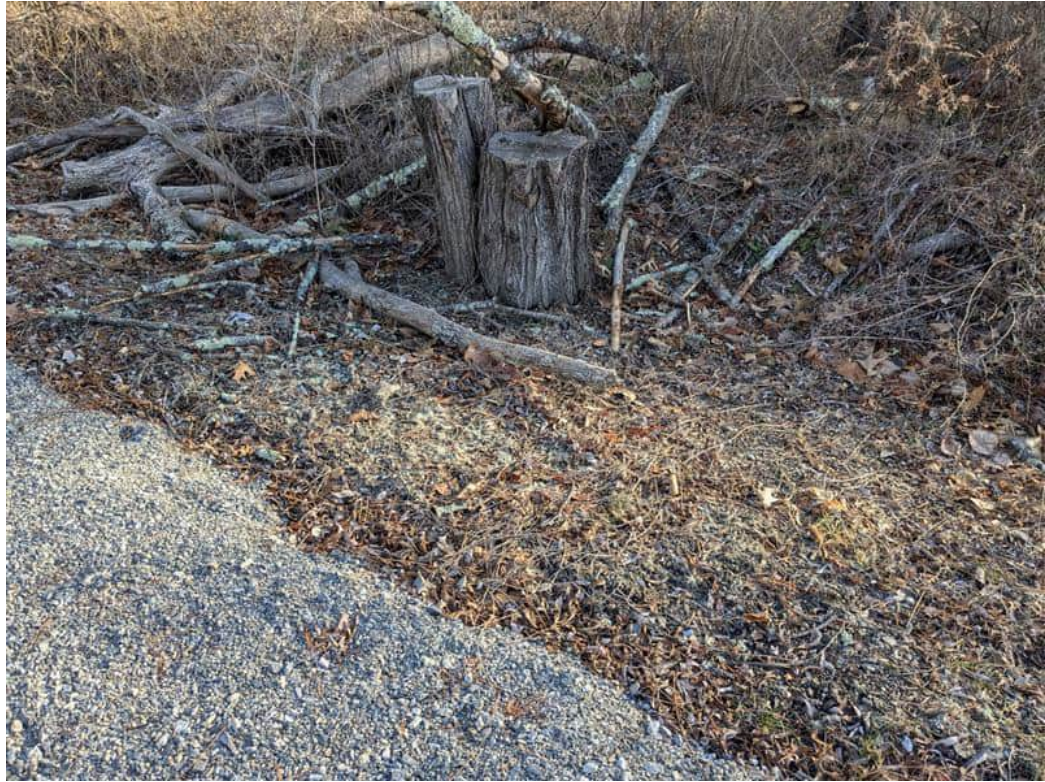
**Photo No. 4**    **Date:**  
1/2/2025

View of crushed stone on the trail at Station 181+00 to 183+00 per Compliance Action Item 58.

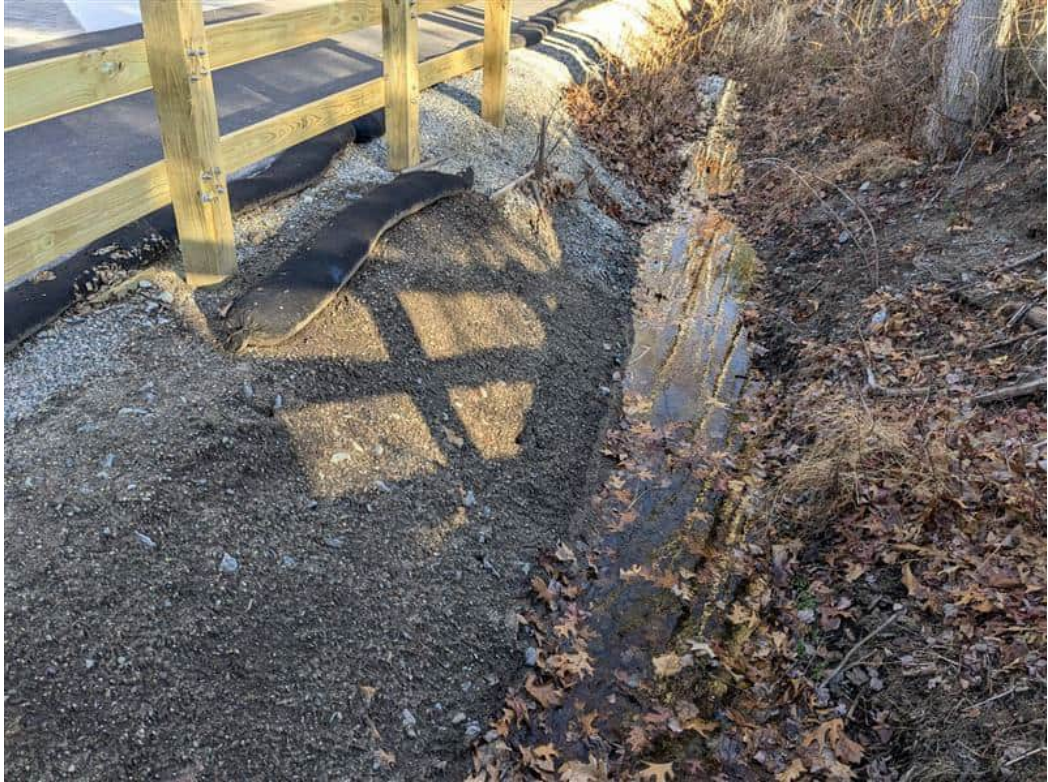
**Photo No. 7**     **Date:**  
1/2/2025

Item	Location/ Description	Observation Date	Resolution Due Date	Recommended Resolution / Resolution Date	Comments/Updates
62	Loam and seed was applied to the streambank at Station 216+00 to 217+00 and requires further stabilization <b>Priority: High</b>	11/25/2024	12/2/2024	An erosion control blanket should be installed along this slope.	12/2/2024 - Loam and seed have been applied to the streambank at Station 215+00. Stabilization is required at Stations 215+00 to 217+00. 12/6/2024 - Observation remains. See previous update. 12/12/2024 - Observation remains. Rill erosion was observed within the loam applied to this area from Station 215+00 to 216+00. 12/20/2024 - Observation remains. Loam has begun to erode, resulting in a discharge to the stream at Station 216+50. 12/26/2024 - Observation remains. No further discharge was observed in this location. 12/31/2024 - Observation remains. Additional loam has eroded resulting in a discharge to the stream at Station 216+50. 1/2/2025 - Observation remains. No further discharge was observed in this location.

View of loam that requires stabilization at Station 217+00 per Compliance Action Item 62.

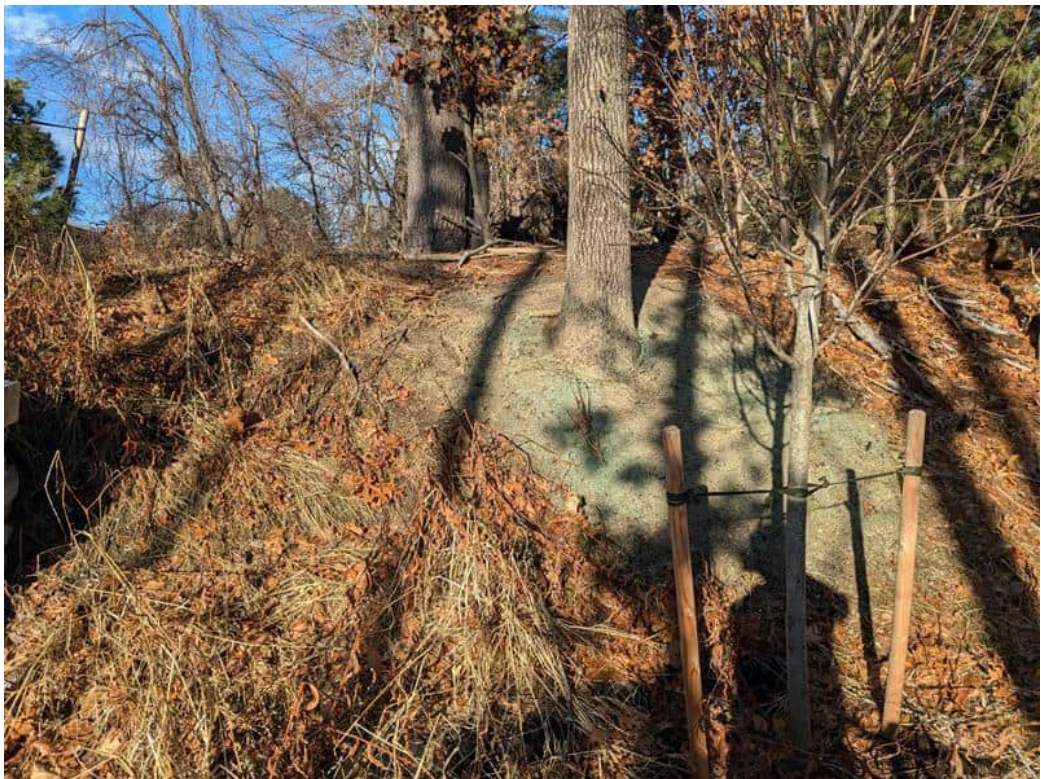
**Photo No. 8**     **Date:**  
1/2/2025

34	Sediment is eroding downhill from behind the cemented stone masonry wall at Station 217+45 <b>Priority: Low</b>	5/28/2024	6/4/2024	Apply seed and temporarily stabilize the soils along the slope with straw, jute netting, etc.	<p>5/31/2024 - Observation remains.  6/7/2024 - Observation remains.  6/14/2024 - Observation remains.  6/17/2024 - Observation remains.  6/24/2024 - Observation remains.  6/27/2024 - Rills were raked, loam was added, and hydroseed was applied.  7/8/2024 - Observation remains. Grass was observed to be germinating at this location. Comment will remain open until stabilization is complete.  7/8/2024 - See previous update.  7/15/2024 - Additional hydroseed is required due to washouts.  7/22/2024 - Observation remains.  7/29/2024 - Observation remains.  8/5/2024 - Observation remains.  8/7/2024 - Regrowth of vegetation has been observed in this area. This item will remain open until the area is fully stabilized.  8/12/2024 - Observation remains. Regrowth has stabilized a portion of this hill; however, reseeded and additional temporary stabilized measures are recommended on the section that is currently unvegetated.  8/16/2024 - Observation remains.  8/20/2024 - Application of the approved seed mixture is required at this location.  8/27/2024 - Observation remains.  9/3/2024 - Vegetation that is present in this location generally consists of lady's thumb smartweed (<i>Persicaria maculosa</i>), a non-native species. Removal of non-native species and application of the approved seed mixture is required at this location.  9/10/2024 - Observation remains. See previous update.  9/16/2024 - Observation remains. See update from 9/3/2024.  9/23/2024 - Observation remains. See update from 9/3/2024.  9/27/2024 - Observation remains.  10/4/2024 - Observation remains. See update from 9/3/2024.  10/8/2024 - Observation remains. See update from 9/3/2024.  10/15/2024 - Observation remains. See update from 9/3/2024.  10/22/2024 - Observation remains. See update from 9/3/2024.  10/29/2024 - Observation remains. No additional seed has been applied to this location and the slope is generally vegetated by non-native species. See update from 9/3/2024.  11/5/2024 - Observation remains. Erosion control and seed has been applied to part of this slope, no germination has been observed.  11/12/2024 - Observation remains. No germination has been observed in this location.  11/19/2024 - Observation remains.  11/22/2024 - Observation remains. No germination has been observed in this location.  11/25/2024 - Observation remains. No germination has been observed in this location.  12/2/2024 - Observation remains. No germination has been observed in this location.  12/6/2024 - Observation remains. No germination has been observed in this location.  12/12/2024 - Observation remains. Some germination has been observed within this location. Observation will remain open until stabilization is complete.  12/20/2024 - Observation remains. See previous update.  12/26/2024 - Observation remains. See update from 12/12/2024.  12/31/2024 - Observation remains. See update from 12/12/2024.  1/2/2025 - Observation remains. See update from 12/12/2024.</p>

View of the slope where hydroseed was applied and some germination has occurred at Station 217+45 per Compliance Action Item 34.

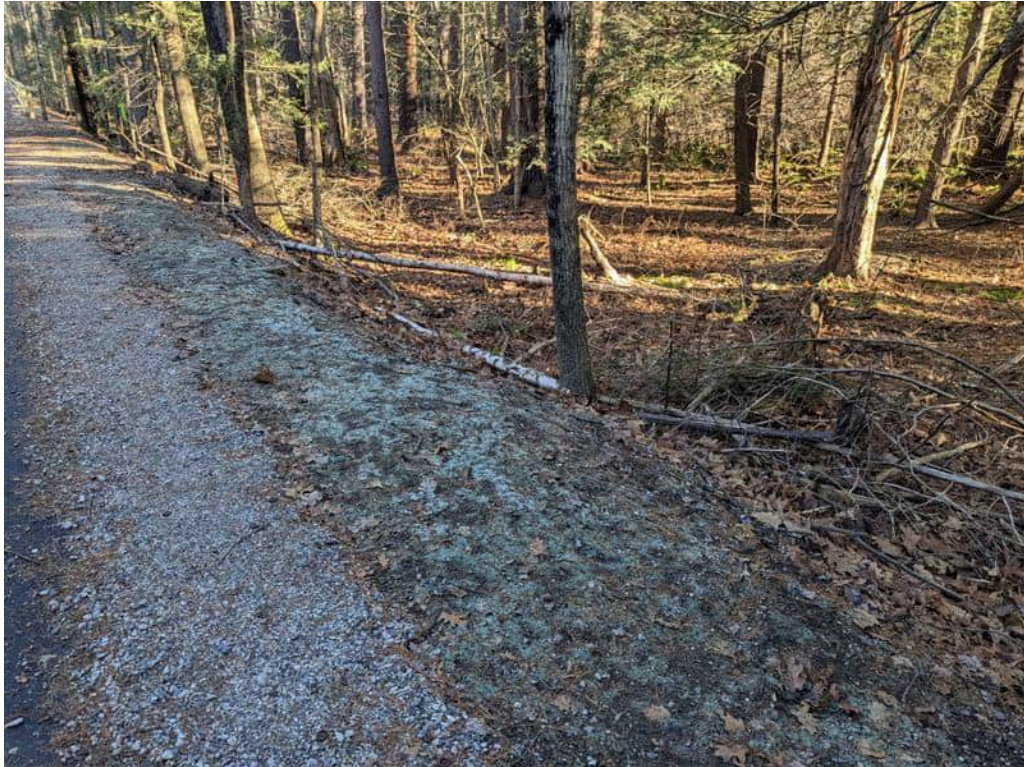
<b>Site Location</b> Bruce Freeman Rail Trail Right-of-Way		<b>BETA Project No.</b> 24.10326.23
<b>Photo No. 9</b>	<b>Date:</b> 1/2/2025

32	<p>Soil and organic debris has been placed within the wetland between wetland flagging WF#23-119 and WF#23-118 at Station 224+00  <b>Priority: High</b></p>	5/21/2024	5/28/2024	<p>Remove all material and provide stabilization of the area with the approved wetland seed mixture. Straw should also be placed for interim stabilization.</p>	<p>5/28/2024 - Observation remains.  5/31/2024 - Observation remains.  6/7/2024 - Observation remains.  6/14/2024 - Observation remains.  6/17/2024 - This area has been hydroseeded multiple times, but the debris should also be removed from the downgradient wetland.  6/24/2024 - Observation remains.  6/27/2024 - Observation remains. The area was hydroseeded again.  7/8/2024 - Germination was observed and the area will be monitored for stabilization.  7/15/2024 - See previous update.  7/22/2024 - Observation remains.  7/29/2024 - Observation remains.  8/5/2024 - Observation remains.  8/7/2024 - Regrowth of vegetation has been observed in this area. This item will remain open until the area is fully stabilized. Debris is still present in wetland and requires removal.  8/12/2024 - Observation remains.  8/16/2024 - Observation remains.  8/20/2024 - Debris is still present within the wetland.  8/27/2024 - Observation remains.  9/3/2024 - Debris is still present in the wetland and slopes upgradient of the wetland require stabilization.  9/10/2024 - Observation remains.  9/16/2024 - Debris has been removed from the wetland; however, soils require stabilization.  9/23/2024 - Observation remains. Soils require stabilization at this location.  9/27/2024 - Observation remains. The contractor indicated hydroseed will be applied to this area soon.  10/4/2024 - Observation remains. Hydroseed has not been applied to this area.  10/8/2024 - Observation remains. Hydroseed has not been applied to this area.  10/15/2024 - Observation remains. Hydroseed has not been applied to this area.  10/22/2024 - Observation remains. Hydroseed has not been applied to this area.  10/29/2024 - Observation remains. Hydroseed has not been applied to this area.  10/29/2024 - Observation remains. Hydroseed has not been applied to this area.  11/5/2024 - Observation remains. Hydroseed has not been applied to this area.  11/12/2024 - Observation remains.  11/19/2024 - Hydroseed has been applied to this location. Once the area has become stabilized this action item will be closed.  11/22/2024 - Observation remains. No germination has been observed in this area.  11/25/2024 - Observation remains. No germination has been observed in this area.  12/2/2024 - Observation remains. No germination has been observed in this area.  12/6/2024 - Observation remains. No germination has been observed in this area.  12/12/2024 - Observation remains. Some germination has been observed within this location. Observation will remain open until stabilization is complete.  12/20/2024 - Observation remains. See previous update.  12/26/2024 - Observation remains. See update from 12/12/2024.  12/31/2024 - Observation remains. See update from 12/12/2024.  1/2/2025 - Observation remains. See update from 12/12/2024.</p>

<b>Direction Photo Taken:</b>  Toward the North		
<b>Description:</b>  View of the location where hydroseed has been applied at Station 224+00 per Long Term Compliance Action Item 59 and Compliance Action Item 32.		
<b>Photo No. 10</b>	<b>Date:</b> 1/2/2025

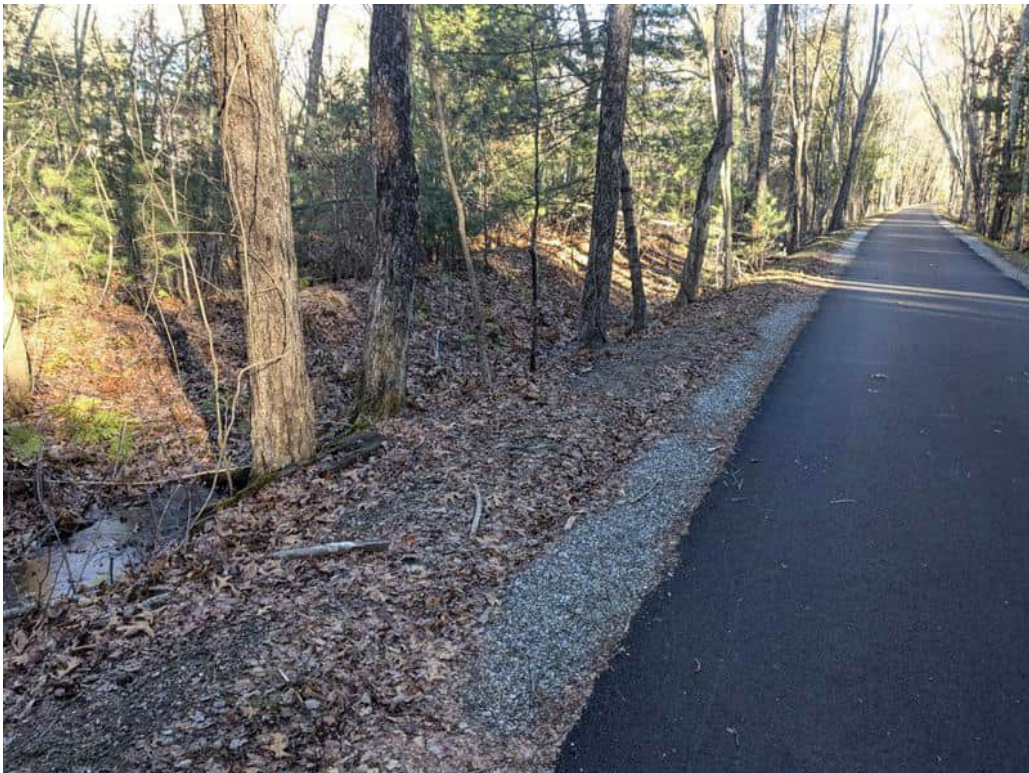
<b>Direction Photo Taken:</b>  Toward the North		
<b>Description:</b>  View of an area of exposed soil at Station 297+50 per Long Term Compliance Action Item 59.

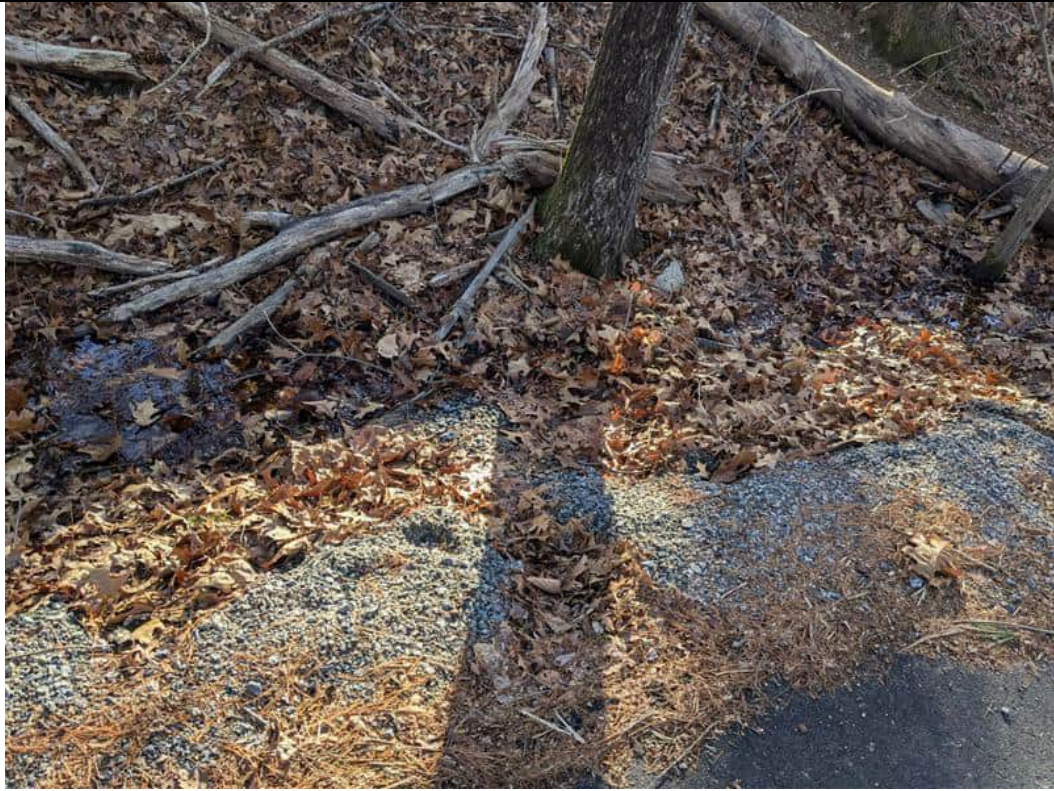
**Photo No. 11**    **Date:**  
1/2/2025

View of crushed stone that requires removal from the swale at Station 303+00 per Long Term Compliance Action Item 58.

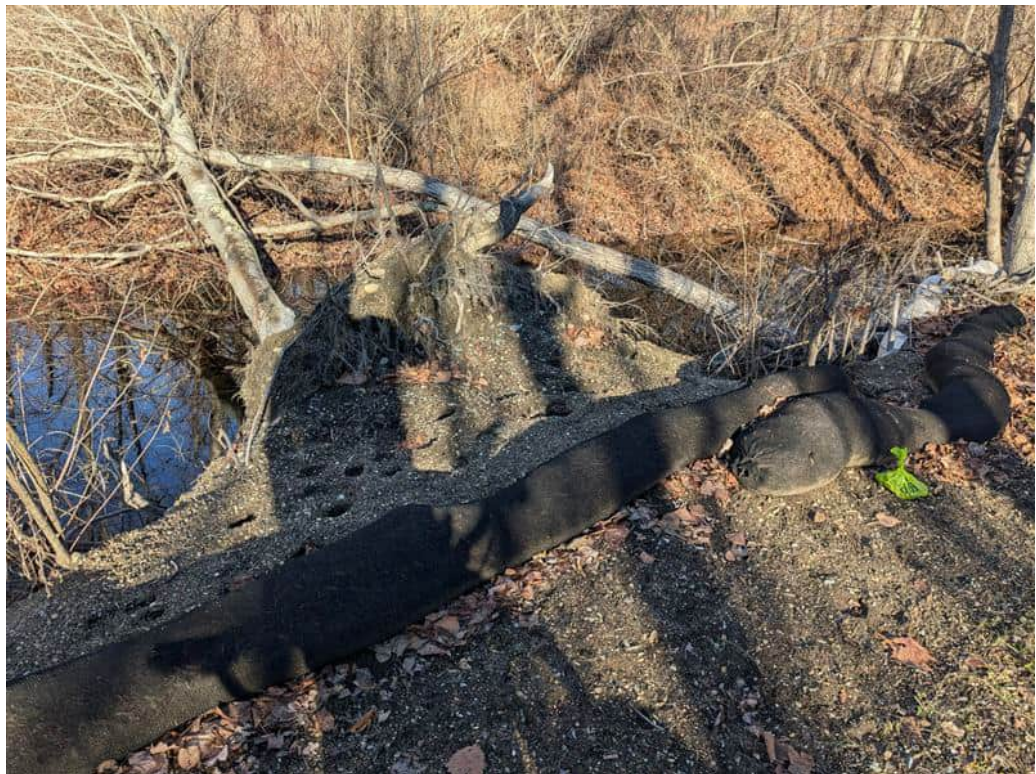
**Photo No. 12**    **Date:**  
1/2/2025

View of placed loam that requires stabilization at Station 311+00 per Long Term Compliance Action Item 59.
