Environmental Monitor Construction Site Inspection Report
MassDOT Project #608164 Construction Contract # 119678
EM Report #43

Project Description: Bruce Freeman Rail Trail Right-of-Way
 Permit Description(s): Order of Conditions (MGL Chapter 131, Section 40 and 310 CMR 10.00, Mass DEP File No. 301-1362); 2022 EPA NPDES General Permit for Discharges from Construction Areas; U.S. Army Corps of Engineers Permit No NAE-2021-01975.

Project Name:	Bruce Freeman Rail Trail - Phase 2d - Sudbury
Date of Inspections:	1/9/2025
Bi Weekly/ Monthly Period Covered:	January Weekly Inspection #2
Inspector's Name(s):	Anna Haznar
Inspectors' Contact Information:	ahaznar@beta-inc.com

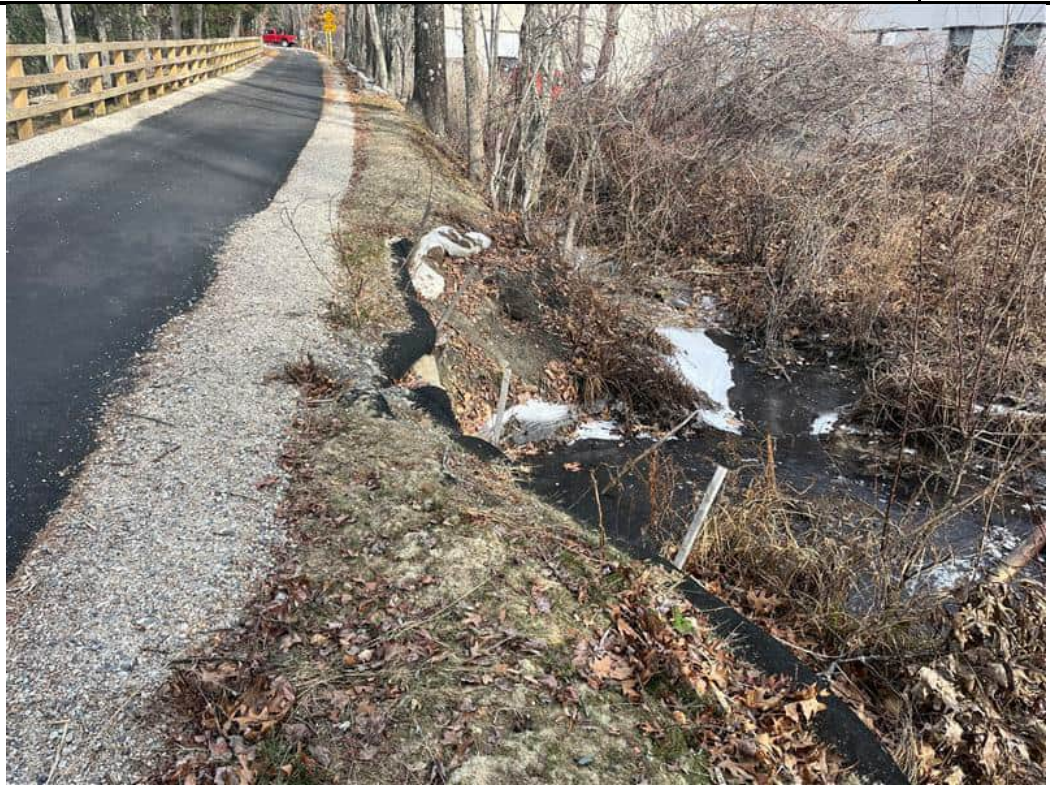
Photo No. 1 **Date:**
1/9/2025

43	<p>Overtopped compost filter tubes and exposed soils beyond the limits of work at Station 105+00 Priority: High</p>	6/7/2024	6/14/2024	<p>Stabilize the area with the approved seed mixture and provide interim stabilization such as straw mulch.</p>	<p>6/14/2024 - Observation remains. 6/17/2024 - Observation remains. 6/24/2024 - Observation remains. 6/27/2024 - Observation remains. 7/8/2024 - Observation remains. 7/15/2024 - Observation remains. 7/22/2024 - Observation remains. 7/29/2024 - Observation remains. 8/5/2024 - Observation remains. 8/7/2024 - Observation remains. 8/12/2024 - Observation remains. Some material has migrated off of the compost filter tubes due to erosion. 8/16/2024 - Observation remains. 8/20/2024 - Application of the approved seed mixture is required at this location. 8/27/2024 - Observation remains. 9/3/2024 - Observation remains. 9/10/2024 - Observation remains. Application of the approved seed mixture is required at this location. 9/16/2024 - Observation remains. 9/23/2024 - Observation remains. 9/27/2024 - Observation remains. 10/4/2024 - Hydroseed has been applied here; however, the contractor should provide an update on long-term slope stabilization plans. 10/8/2024 - Observation remains. Germination has not been observed. 10/15/2024 - Observation remains. Germination has not been observed. 10/22/2024 - Observation remains. Some germination has been observed but the area is not considered stabilized. 10/29/2024 - Observation remains. No further germination has been observed since the last inspection. 11/5/2024 - Observation remains. Some germination has been observed but the area is not considered stabilized. 11/12/2024 - Observation remains. Seed has stabilized the area. 11/19/2024 - The area adjacent to the path has become stabilized; however, exposed soil is still present next to the culvert past the limit of work. 11/22/2024 - Observation remains. See previous update. 11/25/2024 - Observation remains. See update from 11/19/2024. 12/2/2024 - Observation remains. See update from 11/19/2024. 12/6/2024 - Observation remains. See update for 11/19/2024. 12/12/2024 - Observation remains. See update from 11/19/2024. 12/20/2024 - Observation remains. See update from 11/19/2024. 12/26/2024 - Observation remains. See update from 11/19/2024. 12/31/2024 - Observation remains. See update from 11/19/2024. 1/2/2025 - Observation remains. See update from 11/19/2024. 1/9/2025 - Observation remains. See update from 11/19/2024.</p>

View of the overtopped compost filter tube and exposed soils beyond the limits of work at Station 105+00 per Compliance Action Item 43.

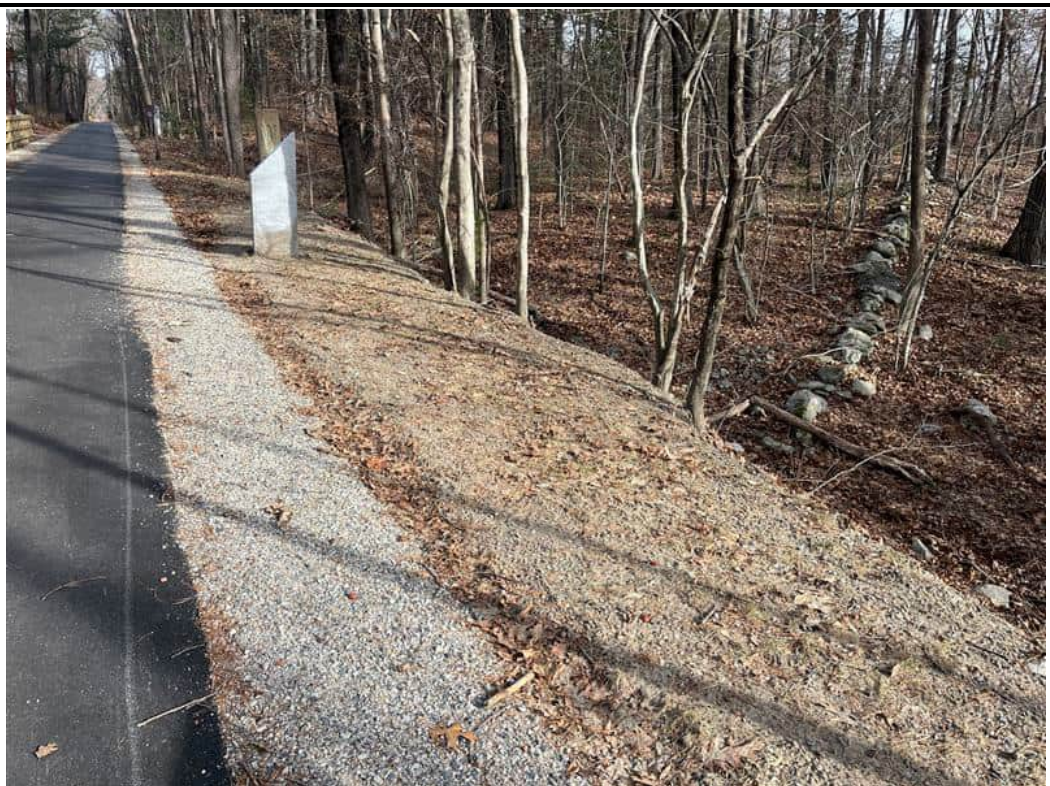
Photo No. 2 **Date:**
1/9/2025

View of exposed soil at Station 165+00 that requires stabilization per Long Term Compliance Action item 59.

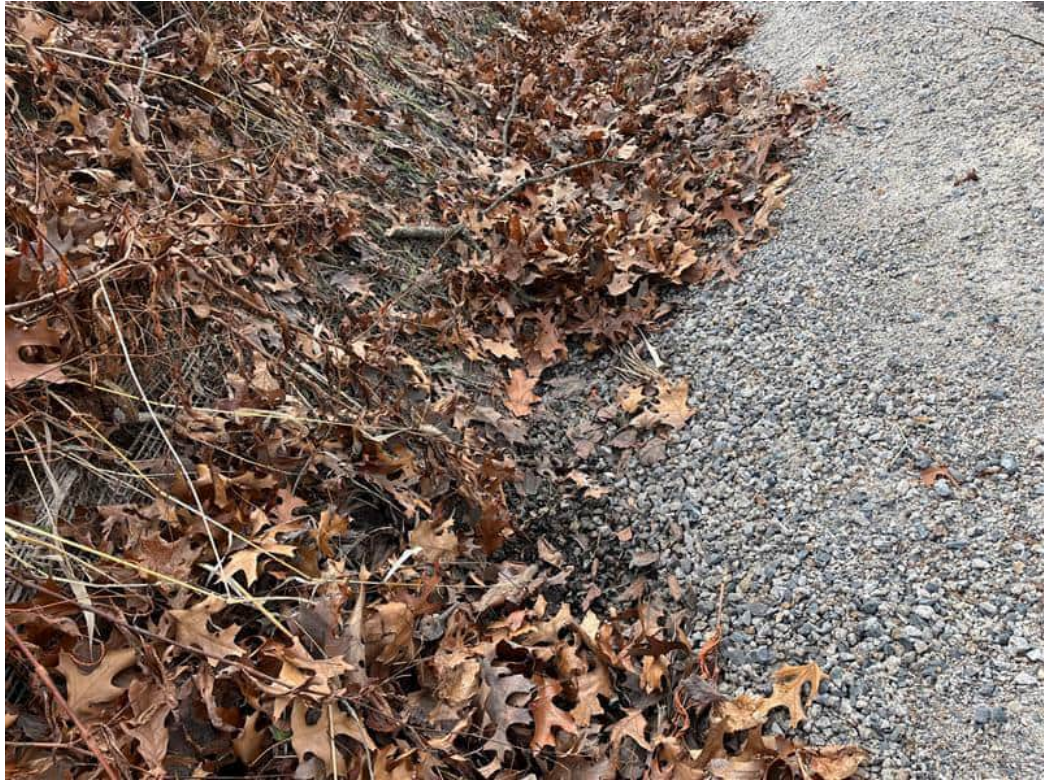
Photo No. 3 **Date:**
1/9/2025

53	Stone was observed requiring removal from the swale on the east side of the trail at Station 172+00 to 173+00 Priority: High	7/29/2024	8/6/2024	Remove stone from the swale.	8/5/2024 - Observation remains. 8/7/2024 - Observation remains. 8/12/2024 - Observation remains. Material was observed to have migrated within the swale to Station 173+50. 8/16/2024 - Stone is still present within the swale. 8/20/2024 - Observation remains. Crushed stone has migrated further down the swale to Station 171+50. 8/27/2024 - Observation remains. Stone is still present within the swale. 9/3/2024 - Observation remains. 9/10/2024 - Observation remains. Stone is still present within the swale. 9/16/2024 - Observation remains. The contractor indicated that the stone within the swale would be hand removed. 9/23/2024 - Observation remains. 9/27/2024 - Observation remains. It appears as though some stone has migrated further south down the swale. 10/4/2024 - Observation remains. Stone is still present within the swale. 10/8/2024 - Observation remains. 10/15/2024 - Observation remains. Stone is covered with vegetation in some areas. 10/22/2024 - Observation remains. Stone is covered with vegetation in some areas. 10/29/2024 - Observation remains. 11/5/2024 - Observation remains. 11/12/2024 - Leaf litter has completely covered the stone in this location. The Contractor should indicate if stone has been removed from this location. 11/19/2024 - See previous update. 11/22/2024 - Observation remains. Stone is still present within the swale and requires removal. Leaf litter is currently covering a majority of the stone. 11/25/2024 - Observation remains. Leaf litter is covering a majority of the stone. 12/2/2024 - Observation remains. Stone is present within the swale under leaf litter. 12/6/2024 - Observation remains. See previous update. 12/12/2024 - Observation remains. Stone is present within the swale under the leaf litter. 12/20/2024 - Observation remains. Stone is present within the swale under the leaf litter. 12/26/2024 - Observation remains. Stone is present within the swale under the leaf litter and snow. 12/31/2024 - Observation remains. Stone is present within the swale under the leaf litter. 1/2/2025 - Observation remains. Stone is present within the swale under the leaf litter. 1/9/2025 - Observation remains. Stone is present within the swale under the leaf litter.

View of crushed stone within the swale at Station 172+00 per Compliance Action item 53. Note stone is covered with leaf litter.

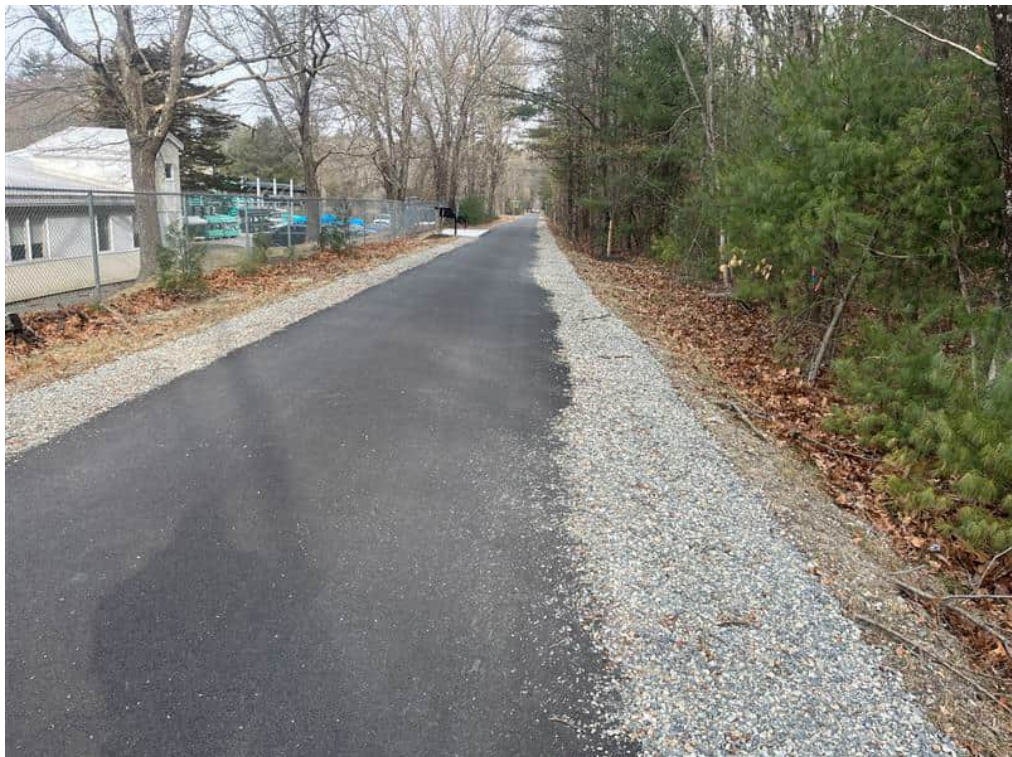
Photo No. 4 **Date:**
1/9/2025

View of crushed stone on the trail at Station 181+00 to 183+00 per Compliance Action Item 58.

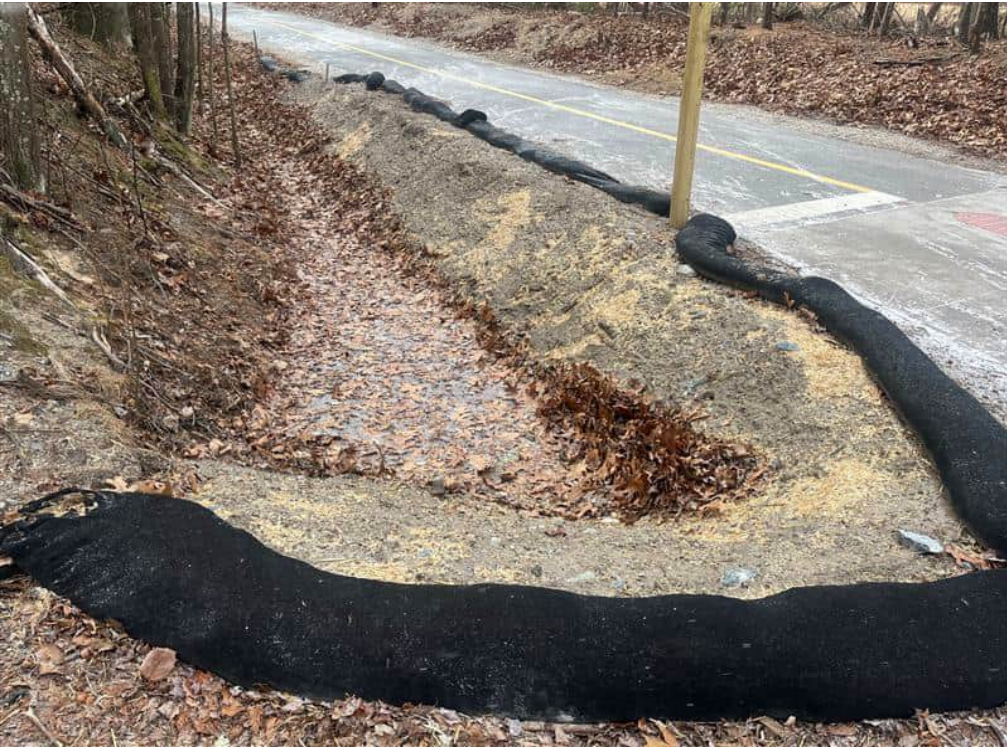
Site Location Bruce Freeman Rail Trail Right-of-Way		BETA Project No. 24.10326.23
Photo No. 5	Date: 1/9/2025

Item	Location/ Description	Observation Date	Resolution Due Date	Recommended Resolution / Resolution Date	Comments/Updates
62	Loam and seed was applied to the streambank at Station 216+00 to 217+00 and requires further stabilization Priority: High	11/25/2024	12/2/2024	An erosion control blanket should be installed along this slope.	12/2/2024 - Loam and seed have been applied to the streambank at Station 215+00. Stabilization is required at Stations 215+00 to 217+00. 12/6/2024 - Observation remains. See previous update. 12/12/2024 - Observation remains. Rill erosion was observed within the loam applied to this area from Station 215+00 to 216+00. 12/20/2024 - Observation remains. Loam has begun to erode, resulting in a discharge to the stream at Station 216+50. 12/26/2024 - Observation remains. No further discharge was observed in this location. 12/31/2024 - Observation remains. Additional loam has eroded resulting in a discharge to the stream at Station 216+50. 1/2/2025 - Observation remains. No further discharge was observed in this location. 1/9/2025 - Observation remains. Straw was observed to have been placed along portions of the streambank; however, this area should be stabilized using an erosion control blanket.

Direction Photo Taken: Toward the South		
Description: View of loam that requires stabilization at Station 215+00 per Compliance Action Item 62. Note straw has been placed on the streambank in this location.		
Photo No. 6	Date: 1/9/2025

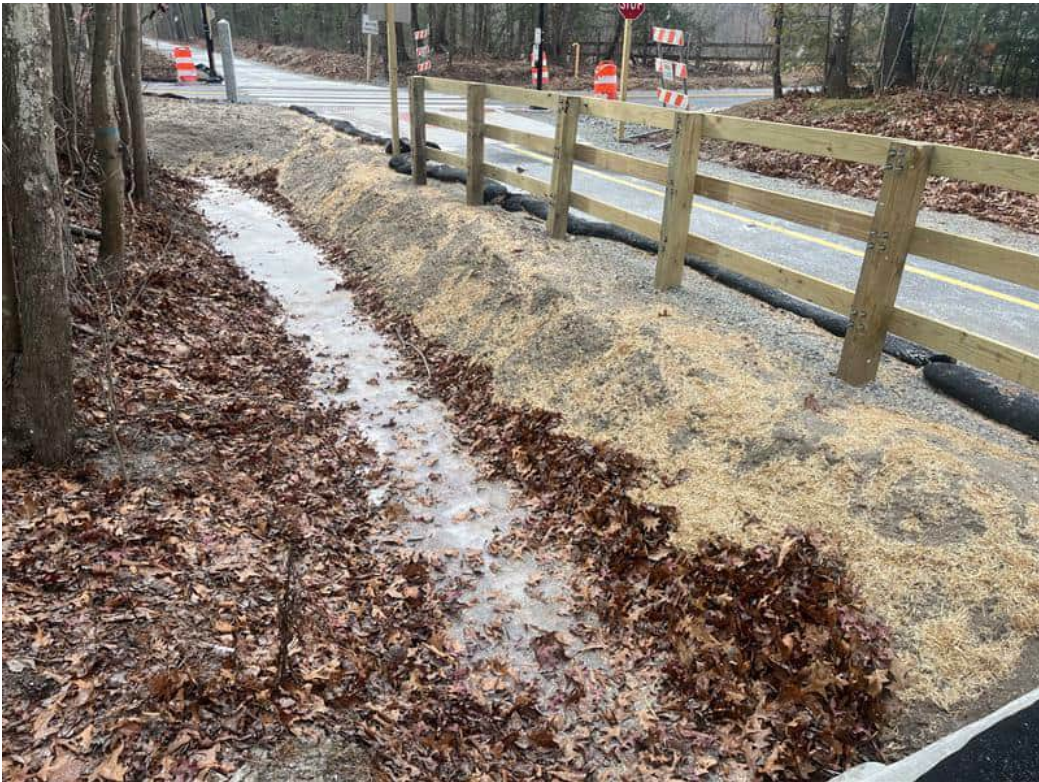
41	Stream Bank has been regraded beyond the limit of work at Station 216+00 Priority: High	5/28/2024	6/4/2024	The Contractor should confirm if this work was permitted by the Conservation Commission, as it does not appear to be a part of the approved plans/impacts. MassDOT should be consulted on next steps regarding notification and potential restoration.	<p>5/31/2024 - Observation remains. 6/7/2024 - Observation remains. 6/14/2024 - Observation remains. 6/17/2024 - Observation remains. 6/24/2024 - Observation remains. 6/27/2024 - Observation remains. 7/8/2024 - Observation remains. 7/15/2024 - This area could not be assessed due to paving operations ongoing during the inspection. 7/22/2024 - Crushed stone and sediment continue to be discharged to the stream between Stations 215+00 and 217+00 due to overtopped and undermined compost filter tubes. 7/29/2024 - Observation remains. 8/5/2024 - Observation remains. 8/7/2024 - Observation remains. 8/12/2024 - Observation remains. Crushed stone is still present in the streambed at this location. 8/16/2024 - Observation remains. 8/20/2024 - Stone has been removed; however, additional alteration to Resource Areas beyond the limit of work continue. 8/27/2024 - Observation remains. 9/3/2024 - Observation remains. 9/10/2024 - Observation remains. Stone has been observed as discharging into the streambed in this location again. 9/16/2024 - Observation remains. 9/23/2024 - Observation remains. Stone is still present within the streambed at this location. 9/27/2024 - Observation remains. 10/4/2024 - Observation remains. 10/8/2024 - Observation remains. 10/15/2024 - Observation remains. Stone is still present within the streambed at this location. 10/22/2024 - Observation remains. Stone is still present within the streambed at this location. 10/29/2024 - Observation remains. Stone is still present within the streambed at this location. 11/5/2024 - Observation remains. The PVC pipe that was installed at this location was observed to be covered with stone and is no longer visible near Station 215+00. Stone is still present within the streambed at this location. 11/12/2024 - Observation remains. The streambed in this location is covered with leaf litter. See previous update. 11/19/2024 - Observation remains. As discussed with the Conservation Agent in the field, further coordination between the Town and MassDOT will be required to clean/repair the culvert, as the degraded condition of the culvert prompted the contractor to armor the stream banks. Further coordination will also be required for restoration of banks. 11/22/2024 - Observation remains. See previous update. 11/25/2024 - Observation remains. See update from 11/19/2024. 12/2/2024 - Observation remains. See update from 11/19/2024. 12/6/2024 - Observation remains. See update from 11/19/2024. 12/12/2024 - Observation remains. See update from 11/19/2024. 12/20/2024 - Observation remains. See update from 11/19/2024. 12/26/2024 - Observation remains. See update from 11/19/2024. 12/31/2024 - Observation remains. See update from 11/19/2024. 1/2/2025 - Observation remains. See update from 11/19/2024. 1/9/2025 - Observation remains. See update from 11/19/2024.</p>

Direction Photo Taken: Toward the South		
Description: View of the location where the stream bank has been regraded beyond the limits of work and stabilization of loam is required at Station 216+00 per Long Term Compliance Action Item 41 and 62. Note straw has been placed on the streambank in this location.

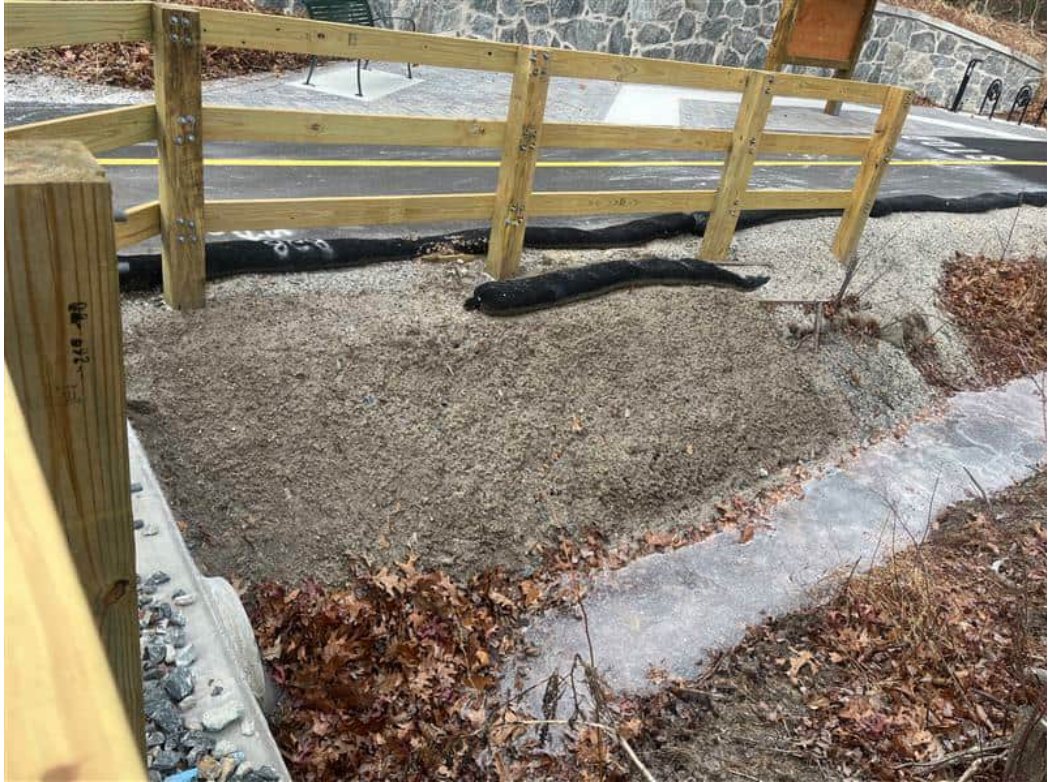
Photo No. 7 **Date:**
1/9/2025

View of loam that requires stabilization at Station 217+00 per Compliance Action Item 62.

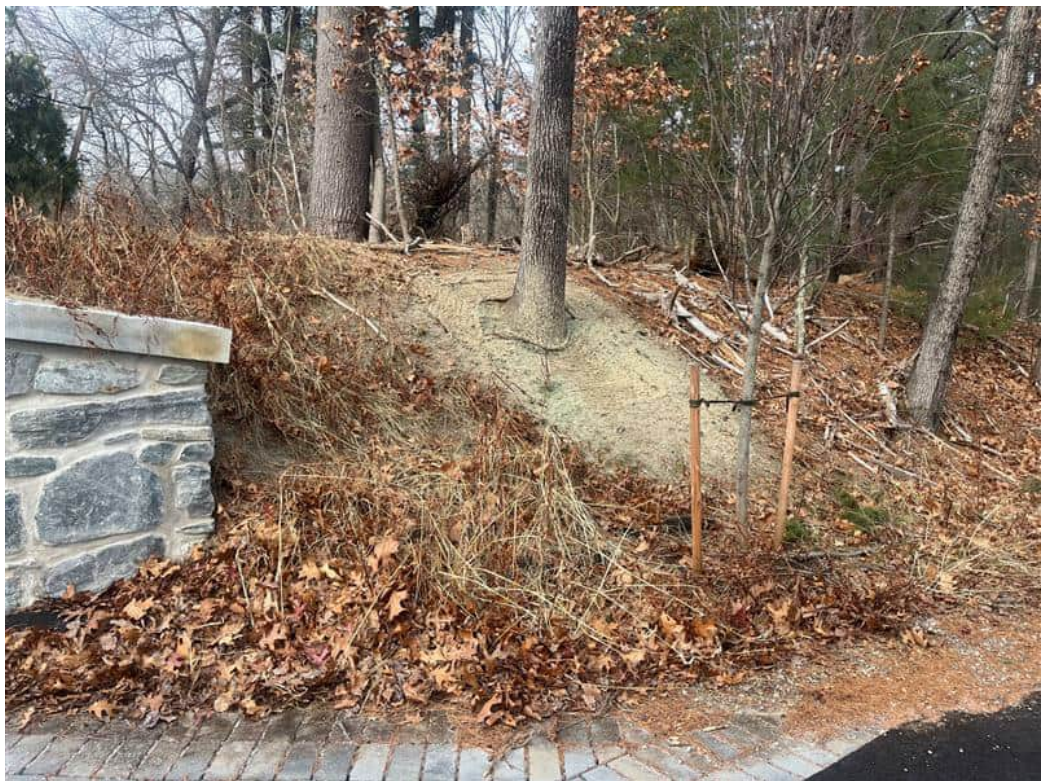
Photo No. 8 **Date:**
1/9/2025

34	Sediment is eroding downhill from behind the cemented stone masonry wall at Station 217+45 Priority: Low	5/28/2024	6/4/2024	Apply seed and temporarily stabilize the soils along the slope with straw, jute netting, etc.	<p>5/31/2024 - Observation remains.</p> <p>6/7/2024 - Observation remains.</p> <p>6/14/2024 - Observation remains.</p> <p>6/17/2024 - Observation remains.</p> <p>6/24/2024 - Observation remains.</p> <p>6/27/2024 - Rills were raked, loam was added, and hydroseed was applied.</p> <p>7/8/2024 - Observation remains. Grass was observed to be germinating at this location. Comment will remain open until stabilization is complete.</p> <p>7/8/2024 - See previous update.</p> <p>7/15/2024 - Additional hydroseed is required due to washouts.</p> <p>7/22/2024 - Observation remains.</p> <p>7/29/2024 - Observation remains.</p> <p>8/5/2024 - Observation remains.</p> <p>8/7/2024 - Regrowth of vegetation has been observed in this area. This item will remain open until the area is fully stabilized.</p> <p>8/12/2024 - Observation remains. Regrowth has stabilized a portion of this hill; however, reseeded and additional temporary stabilized measures are recommended on the section that is currently unvegetated.</p> <p>8/16/2024 - Observation remains.</p> <p>8/20/2024 - Application of the approved seed mixture is required at this location.</p> <p>8/27/2024 - Observation remains.</p> <p>9/3/2024 - Vegetation that is present in this location generally consists of lady's thumb smartweed (<i>Persicaria maculosa</i>), a non-native species. Removal of non-native species and application of the approved seed mixture is required at this location.</p> <p>9/10/2024 - Observation remains. See previous update.</p> <p>9/16/2024 - Observation remains. See update from 9/3/2024.</p> <p>9/23/2024 - Observation remains. See update from 9/3/2024.</p> <p>9/27/2024 - Observation remains.</p> <p>10/4/2024 - Observation remains. See update from 9/3/2024.</p> <p>10/8/2024 - Observation remains. See update from 9/3/2024.</p> <p>10/15/2024 - Observation remains. See update from 9/3/2024.</p> <p>10/22/2024 - Observation remains. See update from 9/3/2024.</p> <p>10/29/2024 - Observation remains. No additional seed has been applied to this location and the slope is generally vegetated by non-native species. See update from 9/3/2024.</p> <p>11/5/2024 - Observation remains. Erosion control and seed has been applied to part of this slope, no germination has been observed.</p> <p>11/12/2024 - Observation remains. No germination has been observed in this location.</p> <p>11/19/2024 - Observation remains.</p> <p>11/22/2024 - Observation remains. No germination has been observed in this location.</p> <p>11/25/2024 - Observation remains. No germination has been observed in this location.</p> <p>12/2/2024 - Observation remains. No germination has been observed in this location.</p> <p>12/6/2024 - Observation remains. No germination has been observed in this location.</p> <p>12/12/2024 - Observation remains. Some germination has been observed within this location. Observation will remain open until stabilization is complete.</p> <p>12/20/2024 - Observation remains. See previous update.</p> <p>12/26/2024 - Observation remains. See update from 12/12/2024.</p> <p>12/31/2024 - Observation remains. See update from 12/12/2024.</p> <p>1/2/2025 - Observation remains. See update from 12/12/2024.</p> <p>1/9/2025 - Observation remains. See update from 12/12/2024.</p>

View of the slope where hydroseed was applied and some germination has occurred at Station 217+45 per Compliance Action Item 34.

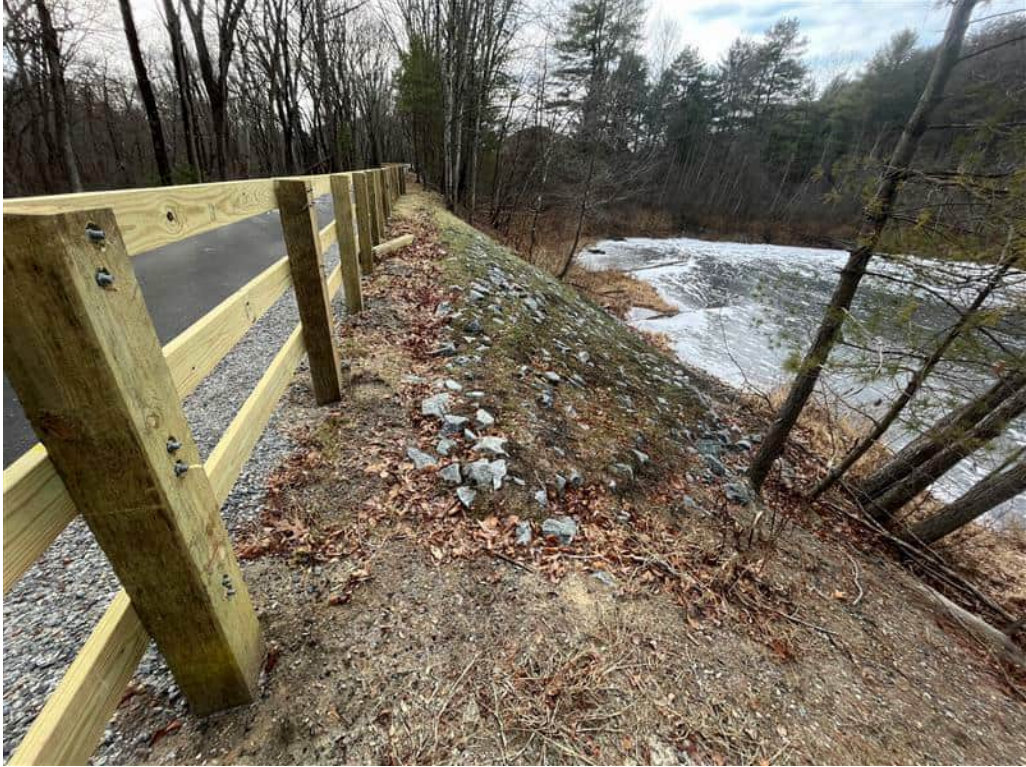
<p>Site Location Bruce Freeman Rail Trail Right-of-Way</p>		<p>BETA Project No. 24.10326.23</p>
<p>Photo No. 13</p>	<p>Date: 1/9/2025</p>

42	<p>Riprap slope extends beyond limits of work along the WF1 Series wetland near flags 103 to 107 Priority: High</p>	5/28/2024	6/4/2024	<p>The Contractor should confirm if this work was permitted by the Conservation Commission, as it does not appear to be a part of the approved plans/impacts. MassDOT should be consulted on next steps regarding notification and potential restoration.</p>	<p>5/31/2024 - Observation remains. 6/7/2024 - Observation remains. 6/14/2024 - Riprap slope has been altered and active construction is repairing the area. 6/17/2024 - During this inspection, additional work in support of the repair/potential replacement of an underlying pipe has been ongoing. It is recommended that the contractor confirm that they have coordinated with the Conservation Commission for this work and provide a restoration plan for the area once work is complete. 6/24/2024 - During this inspection, BETA was informed that the existing cast iron pipe was replaced with a new concrete 12-inch reinforced concrete pipe. It appears that riprap was replaced along the side slopes to mirror conditions observed prior to this inspection. 6/27/2024 - During this inspection, the area was observed to have been rolled and prepared for paving. Hydroseed was applied and plantings were installed. 7/8/2024 - Germination was observed and the area will be monitored for stabilization. See previous updates regarding Conservation Commission coordination. 7/15/2024 - This area could not be assessed due to paving operations ongoing during the inspection. 7/22/2024 - See previous updates regarding Conservation Commission coordination. 7/29/2024 - Observation remains. 8/5/2024 - Observation remains. 8/7/2024 - Observation remains. 8/12/2024 - Observation remains. Regrowth of vegetation has been observed in this area and will continue to be monitored. 8/16/2024 - Observation remains. 8/20/2024 - Observation remains. 8/27/2024 - Observation remains. 9/3/2024 - Observation remains. 9/10/2024 - Observation remains. 9/16/2024 - Observation remains. 9/23/2024 - Observation remains. 9/27/2024 - Observation remains. 10/4/2024 - Observation remains. 10/8/2024 - Observation remains. 10/15/2024 - Observation remains. 10/22/2024 - Observation remains. 10/29/2024 - Observation remains. 11/5/2024 - Observation remains. 11/12/2024 - Observation remains. The timber fence has been installed upgradient of this area. 11/19/2024 - Observation remains. As discussed with the Conservation Agent in the field, an as-built should be prepared for this area to quantify any additional impacts that may be addressed through a permit amendment. 11/22/2024 - Observation remains. See previous update. 11/25/2024 - Observation remains. See update from 11/19/2024. 12/2/2024 - Observation remains. See update from 11/19/2024. 12/6/2024 - Observation remains. See update from 11/19/2024. 12/12/2024 - Observation remains. See update from 11/19/2024. 12/20/2024 - Observation remains. See update from 11/19/2024. 12/26/2024 - Observation remains. See update from 11/19/2024. 12/31/2024 - Observation remains. See update from 11/19/2024. 1/2/2025 - Observation remains. Leaf litter that was previously observed at the bottom of the slope has blown away and it appears that exposed soil with no observable germination is present. 1/9/2025 - Observation remains. See update from 1/2/2025 and 11/19/2024.</p>

<p>Direction Photo Taken:</p> <p>Toward the South</p>		
<p>Description:</p> <p>View of the riprap slope that extends beyond the limit of work along the WF1 Series wetland at Station 332+00 per Long Term Compliance Action Item 42.</p>
