**Environmental Monitor Construction Site Inspection Report  
MassDOT Project #608164 Construction Contract # 119678  
EM Report #44**

Project Description: Bruce Freeman Rail Trail Right-of-Way  
Permit Description(s): Order of Conditions (MGL Chapter 131, Section 40 and 310 CMR 10.00, Mass DEP File No. 301-1362); 2022 EPA NPDES General Permit for Discharges from Construction Areas; U.S. Army Corps of Engineers Permit No NAE-2021-01975.

Project Name:	Bruce Freeman Rail Trail - Phase 2d - Sudbury
Date of Inspections:	1/15/2025
Bi Weekly/ Monthly Period Covered:	January Weekly Inspection #3
Inspector's Name(s):	Anna Haznar
Inspectors' Contact Information:	<a href="mailto:ahaznar@beta-inc.com">ahaznar@beta-inc.com</a>

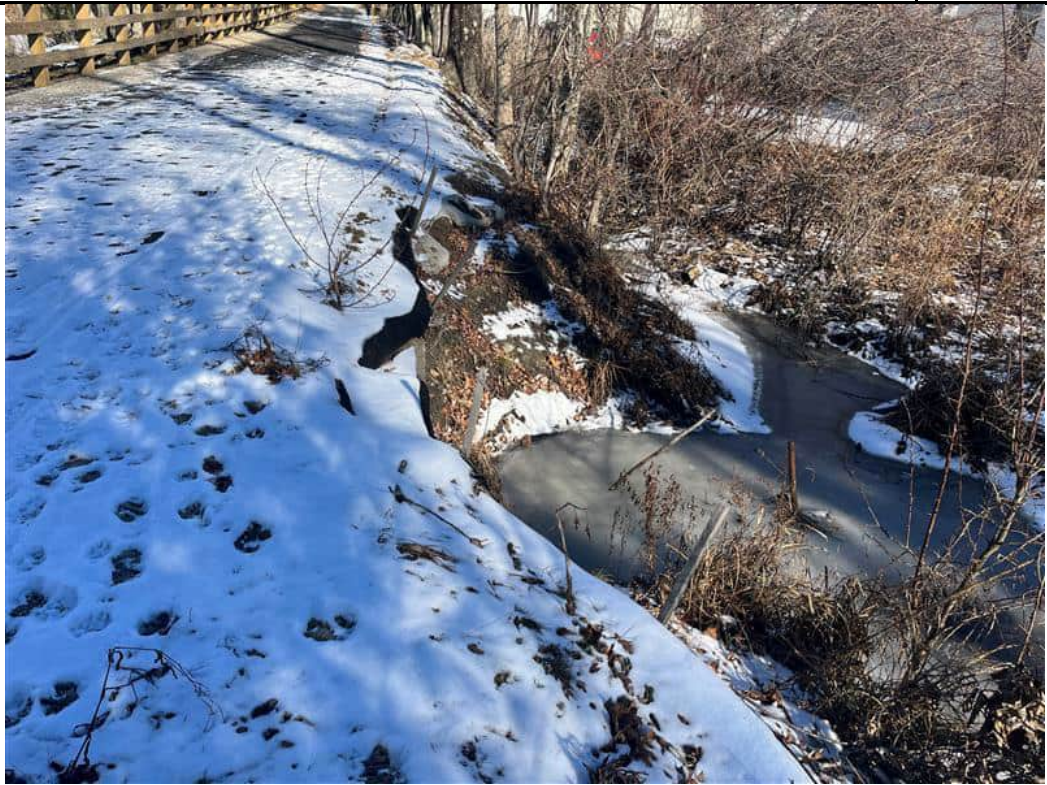
**Photo No. 1**    **Date:**  
1/15/2025

43	<p>Overtopped compost filter tubes and exposed soils beyond the limits of work at Station 105+00  <b>Priority: High</b></p>	6/7/2024	6/14/2024	<p>Stabilize the area with the approved seed mixture and provide interim stabilization such as straw mulch.</p>	<p>6/14/2024 - Observation remains.  6/17/2024 - Observation remains.  6/24/2024 - Observation remains.  6/27/2024 - Observation remains.  7/8/2024 - Observation remains.  7/15/2024 - Observation remains.  7/22/2024 - Observation remains.  7/29/2024 - Observation remains.  8/5/2024 - Observation remains.  8/7/2024 - Observation remains.  8/12/2024 - Observation remains. Some material has migrated off of the compost filter tubes due to erosion.  8/16/2024 - Observation remains.  8/20/2024 - Application of the approved seed mixture is required at this location.  8/27/2024 - Observation remains.  9/3/2024 - Observation remains.  9/10/2024 - Observation remains. Application of the approved seed mixture is required at this location.  9/16/2024 - Observation remains.  9/23/2024 - Observation remains.  9/27/2024 - Observation remains.  10/4/2024 - Hydroseed has been applied here; however, the contractor should provide an update on long-term slope stabilization plans.  10/8/2024 - Observation remains. Germination has not been observed.  10/15/2024 - Observation remains. Germination has not been observed.  10/22/2024 - Observation remains. Some germination has been observed but the area is not considered stabilized.  10/29/2024 - Observation remains. No further germination has been observed since the last inspection.  11/5/2024 - Observation remains. Some germination has been observed but the area is not considered stabilized.  11/12/2024 - Observation remains. Seed has stabilized the area.  11/19/2024 - The area adjacent to the path has become stabilized; however, exposed soil is still present next to the culvert past the limit of work.  11/22/2024 - Observation remains. See previous update.  11/25/2024 - Observation remains. See update from 11/19/2024.  12/2/2024 - Observation remains. See update from 11/19/2024.  12/6/2024 - Observation remains. See update for 11/19/2024.  12/12/2024 - Observation remains. See update from 11/19/2024.  12/20/2024 - Observation remains. See update from 11/19/2024.  12/26/2024 - Observation remains. See update from 11/19/2024.  12/31/2024 - Observation remains. See update from 11/19/2024.  1/2/2025 - Observation remains. See update from 11/19/2024.  1/9/2025 - Observation remains. See update from 11/19/2024.  1/15/2025 - Observation remains. Exposed soils are still present next to the culvert past the limit of work.</p>

View of the overtopped compost filter tube and exposed soils beyond the limits of work at Station 105+00 per Compliance Action Item 43.

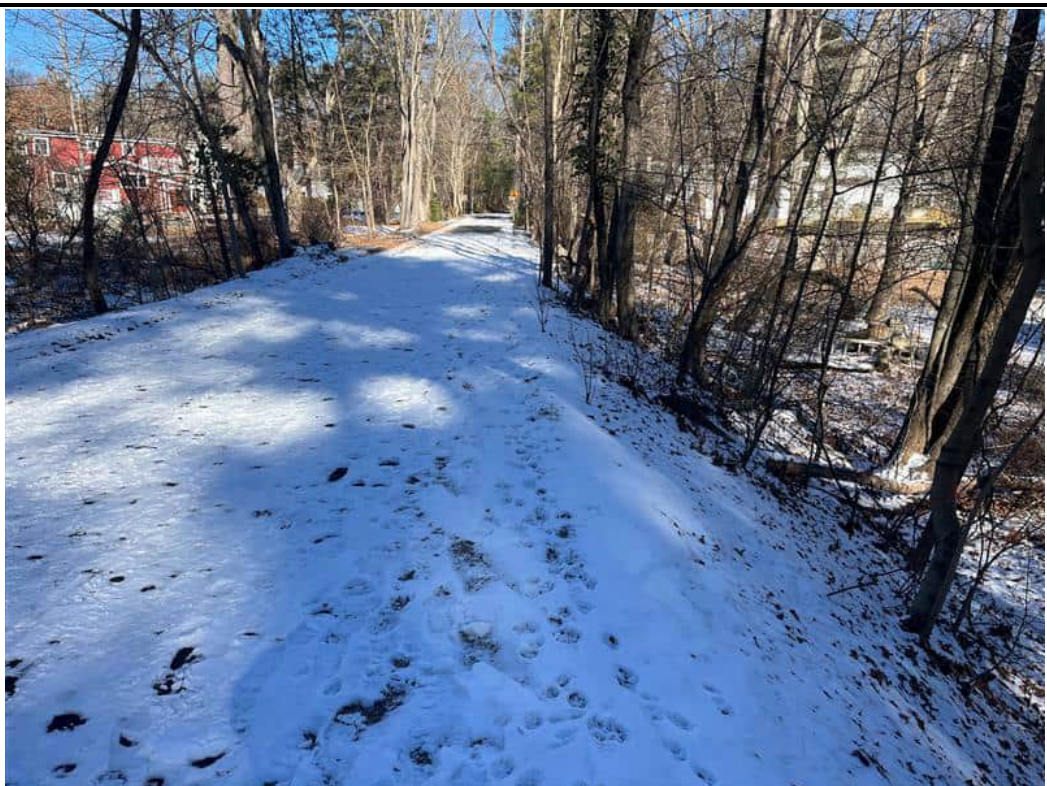
**Photo No. 2**    **Date:**  
1/15/2025

View of exposed soil at Station 139+00 that requires stabilization per Long Term Compliance Action Item. Note exposed soil is covered with snow.

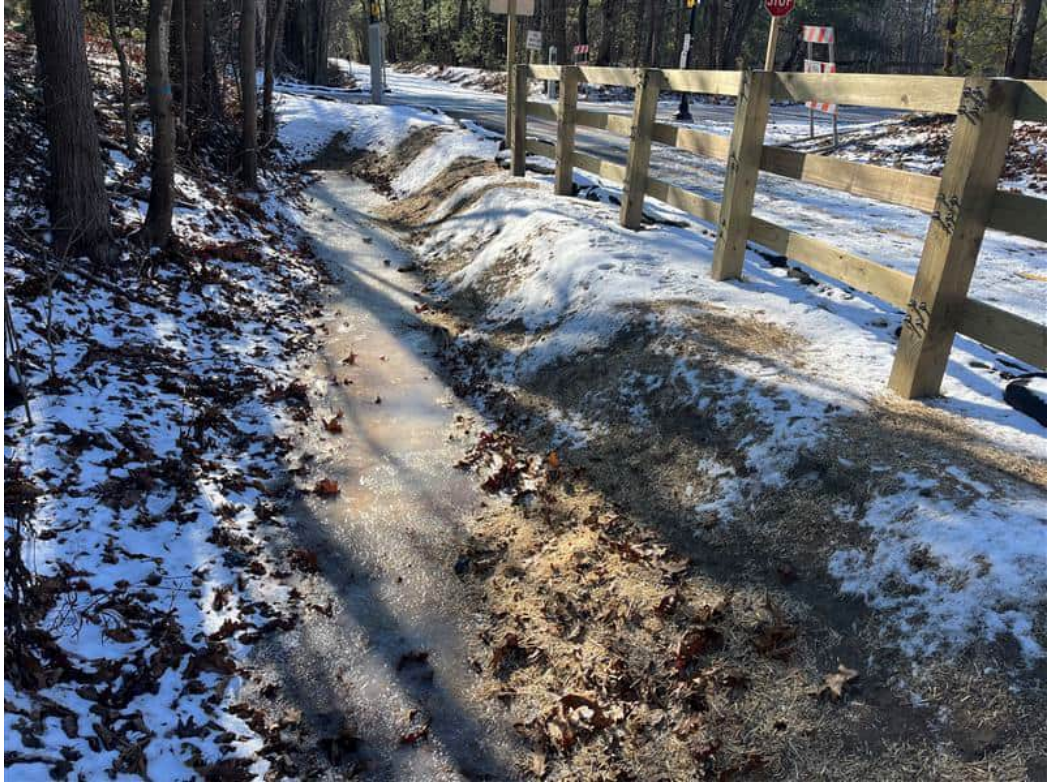
**Photo No. 7**     **Date:**  
1/15/2025

Item	Location/ Description	Observation Date	Resolution Due Date	Recommended Resolution / Resolution Date	Comments/Updates
62	Loam and seed was applied to the streambank at Station 216+00 to 217+00 and requires further stabilization <b>Priority: High</b>	11/25/2024	12/2/2024	An erosion control blanket should be installed along this slope.	12/2/2024 - Loam and seed have been applied to the streambank at Station 215+00. Stabilization is required at Stations 215+00 to 217+00. 12/6/2024 - Observation remains. See previous update. 12/12/2024 - Observation remains. Rill erosion was observed within the loam applied to this area from Station 215+00 to 216+00. 12/20/2024 - Observation remains. Loam has begun to erode, resulting in a discharge to the stream at Station 216+50. 12/26/2024 - Observation remains. No further discharge was observed in this location. 12/31/2024 - Observation remains. Additional loam has eroded resulting in a discharge to the stream at Station 216+50. 1/2/2025 - Observation remains. No further discharge was observed in this location. 1/9/2025 - Observation remains. Straw was observed to have been placed along portions of the streambank; however, this area should be stabilized using an erosion control blanket. 1/15/2025 - Observation remains. Erosion causing a discharge of loam and straw into the stream was observed at Station 216+50.

41	Stream Bank has been regraded beyond the limit of work at Station 216+00 Priority: High	5/28/2024	6/4/2024	;0.].	<p>5/31/2024 - Observation remains.  6/7/2024 - Observation remains.  6/14/2024 - Observation remains.  6/17/2024 - Observation remains.  6/24/2024 - Observation remains.  6/27/2024 - Observation remains.  7/8/2024- Observation remains.  7/15/2024 - This area could not be assessed due to paving operations ongoing during the inspection.  7/22/2024 - Crushed stone and sediment continue to be discharged to the stream between Stations 215+00 and 217+00 due to overtopped and undermined compost filter tubes.  7/29/2024 - Observation remains.  8/5/2024 - Observation remains.  8/7/2024 - Observation remains.  8/12/2024 - Observation remains. Crushed stone is still present in the streambed at this location.  8/16/2024 - Observation remains.  8/20/2024 - Stone has been removed; however, additional alteration to Resource Areas beyond the limit of work continue.  8/27/2024 - Observation remains.  9/3/2024 - Observation remains.  9/10/2024 - Observation remains. Stone has been observed as discharging into the streambed in this location again.  9/16/2024 - Observation remains.  9/23/2024 - Observation remains. Stone is still present within the streambed at this location.  9/27/2024 - Observation remains.  10/4/2024 - Observation remains.  10/8/2024 - Observation remains.  10/15/2024 - Observation remains. Stone is still present within the streambed at this location.  10/22/2024 - Observation remains. Stone is still present within the streambed at this location.  10/29/2024 - Observation remains. Stone is still present within the streambed at this location.  11/5/2024 - Observation remains. The PVC pipe that was installed at this location was observed to be covered with stone and is no longer visible near Station 215+00. Stone is still present within the streambed at this location.  11/12/2024 - Observation remains. The streambed in this location is covered with leaf litter. See previous update.  11/19/2024 - Observation remains. As discussed with the Conservation Agent in the field, further coordination between the Town and MassDOT will be required to clean/repair the culvert, as the degraded condition of the culvert prompted the contractor to armor the stream banks. Further coordination will also be required for restoration of banks.  11/22/2024 - Observation remains. See previous update.  11/25/2024 - Observation remains. See update from 11/19/2024.  12/2/2024 - Observation remains. See update from 11/19/2024.  12/6/2024 - Observation remains. See update from 11/19/2024.  12/12/2024 - Observation remains. See update from 11/19/2024.  12/20/2024 - Observation remains. See update from 11/19/2024.  12/26/2024 - Observation remains. See update from 11/19/2024.  12/31/2024 - Observation remains. See update from 11/19/2024.  1/2/2025 - Observation remains. See update from 11/19/2024.  1/9/2025 - Observation remains. See update from 11/19/2024.  1/15/2025 - Observation remains. See update from 11/19/2024.</p>

**Description:**  
View of the location where the stream bank has been regraded beyond the limits of work and stabilization of loam is required at Station 216+00 per Long Term Compliance Action Item 41 and 62. Note straw has been placed on the streambank in this location.

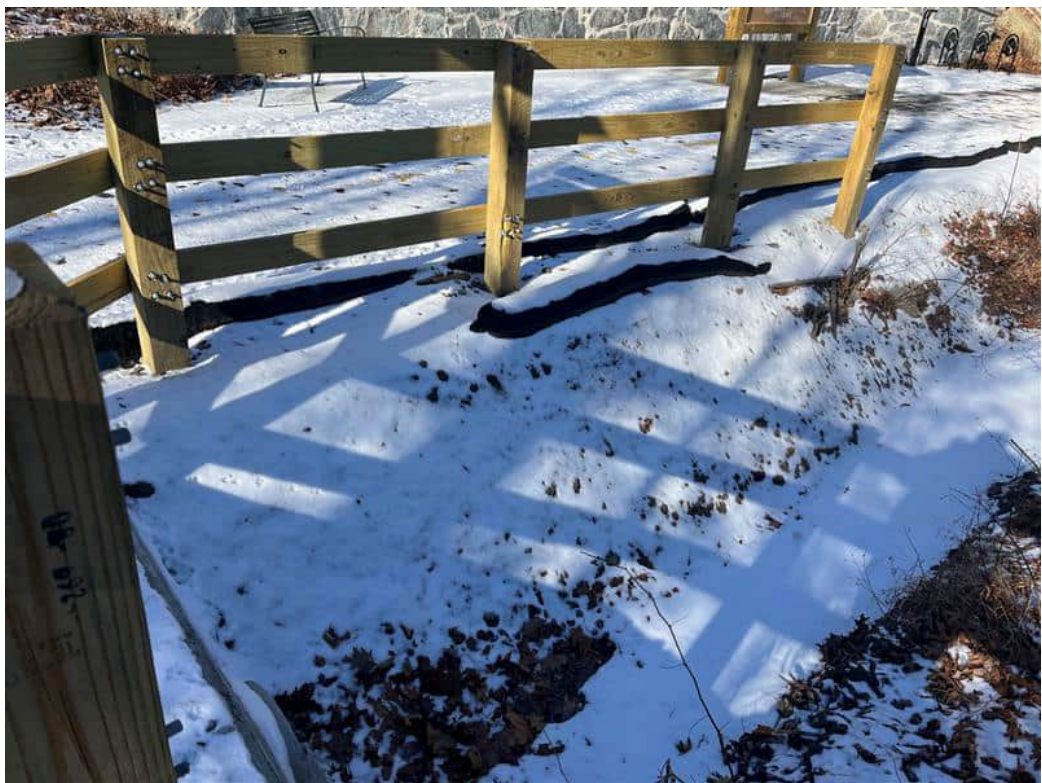
**Photo No. 8**     **Date:**  
1/15/2025

View of loam that requires stabilization at Station 217+00 per Compliance Action Item 62.

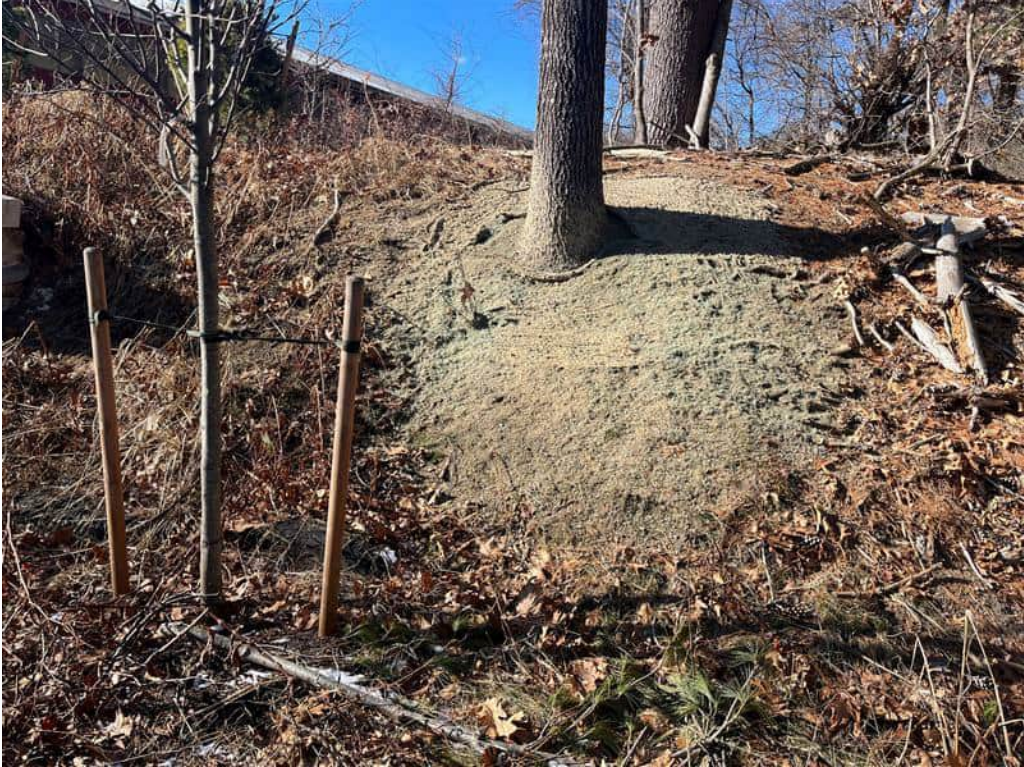
34	<p>Sediment is eroding downhill from behind the cemented stone masonry wall at Station 217+45  <b>Priority: Low</b></p>	5/28/2024	6/4/2024	<p>Apply seed and temporarily stabilize the soils along the slope with straw, jute netting, etc.</p>	<p>5/31/2024 - Observation remains.  6/7/2024 - Observation remains.  6/14/2024 - Observation remains.  6/17/2024 - Observation remains.  6/24/2024 - Observation remains.  6/27/2024 - Rills were raked, loam was added, and hydroseed was applied.  7/8/2024- Observation remains. Grass was observed to be germinating at this location. Comment will remain open until stabilization is complete.  7/8/2024 - See previous update.  7/15/2024 - Additional hydroseed is required due to washouts.  7/22/2024 - Observation remains.  7/29/2024 - Observation remains.  8/5/2024 - Observation remains.  8/7/2024 - Regrowth of vegetation has been observed in this area. This item will remain open until the area is fully stabilized.  8/12/2024 - Observation remains. Regrowth has stabilized a portion of this hill; however, reseeded and additional temporary stabilized measures are recommended on the section that is currently unvegetated.  8/16/2024 - Observation remains.  8/20/2024 - Application of the approved seed mixture is required at this location.  8/27/2024 - Observation remains.  9/3/2024 - Vegetation that is present in this location generally consists of lady's thumb smartweed (<i>Persicaria maculosa</i>), a non-native species. Removal of non-native species and application of the approved seed mixture is required at this location.  9/10/2024 - Observation remains. See previous update.  9/16/2024 - Observation remains. See update from 9/3/2024.  9/23/2024 - Observation remains. See update from 9/3/2024.  9/27/2024 - Observation remains.  10/4/2024 - Observation remains. See update from 9/3/2024.  10/8/2024 - Observation remains. See update from 9/3/2024.  10/15/2024 - Observation remains. See update from 9/3/2024.  10/22/2024 - Observation remains. See update from 9/3/2024.  10/29/2024 - Observation remains. No additional seed has been applied to this location and the slope is generally vegetated by non-native species. See update from 9/3/2024.  11/5/2024 - Observation remains. Erosion control and seed has been applied to part of this slope, no germination has been observed.  11/12/2024 - Observation remains. No germination has been observed in this location.  11/19/2024 - Observation remains.  11/22/2024 - Observation remains. No germination has been observed in this location.  11/25/2024 - Observation remains. No germination has been observed in this location.  12/2/2024 - Observation remains. No germination has been observed in this location.  12/6/2024 - Observation remains. No germination has been observed in this location.  12/12/2024 - Observation remains. Some germination has been observed within this location. Observation will remain open until stabilization is complete.  12/20/2024 - Observation remains. See previous update.  12/26/2024 - Observation remains. See update from 12/12/2024.  12/31/2024 - Observation remains. See update from 12/12/2024.  1/2/2025 - Observation remains. See update from 12/12/2024.  1/9/2025 - Observation remains. See update from 12/12/2024.  1/15/2025 - Observation remains.</p>

<b>Direction Photo Taken:</b>  Toward the North		
<b>Description:</b>  View of the slope where hydroseed was applied and some germination has occurred at Station 217+45 per Compliance Action Item 34.		
<b>Photo No. 10</b>	<b>Date:</b> 1/15/2025

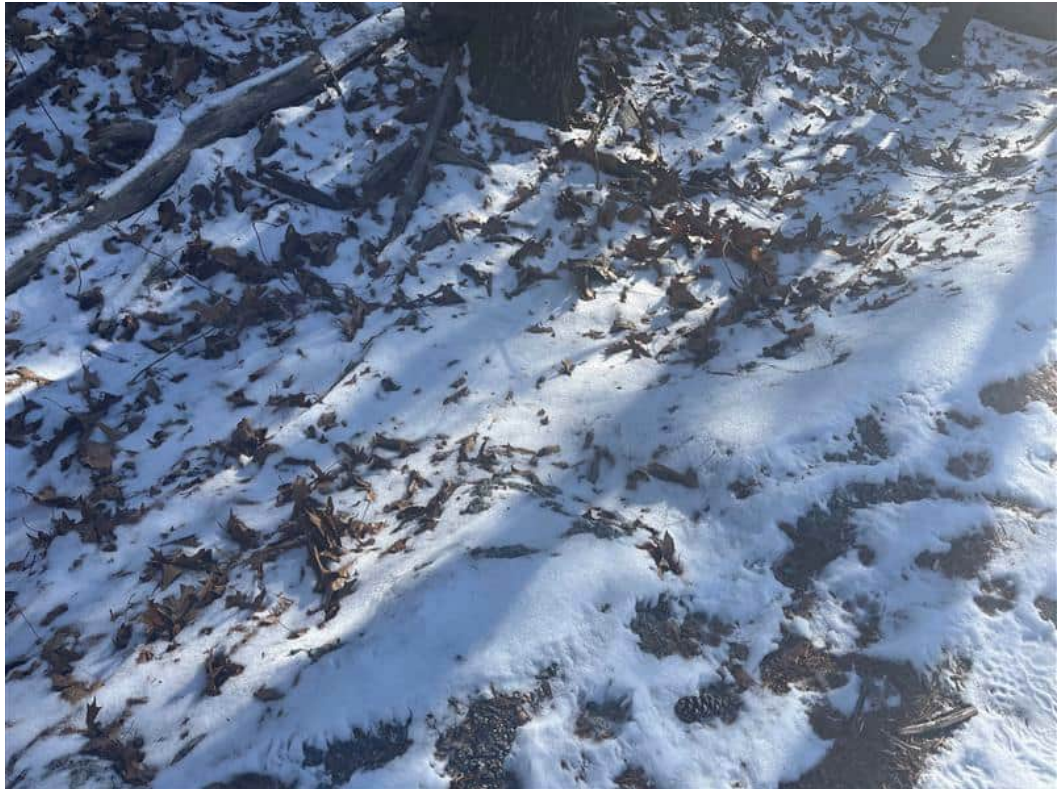
**Photo No. 11**    **Date:**  
1/15/2025

View of crushed stone that requires removal from the swale at Station 303+00 per Long Term Compliance Action Item 58. Note stone is currently covered in snow.

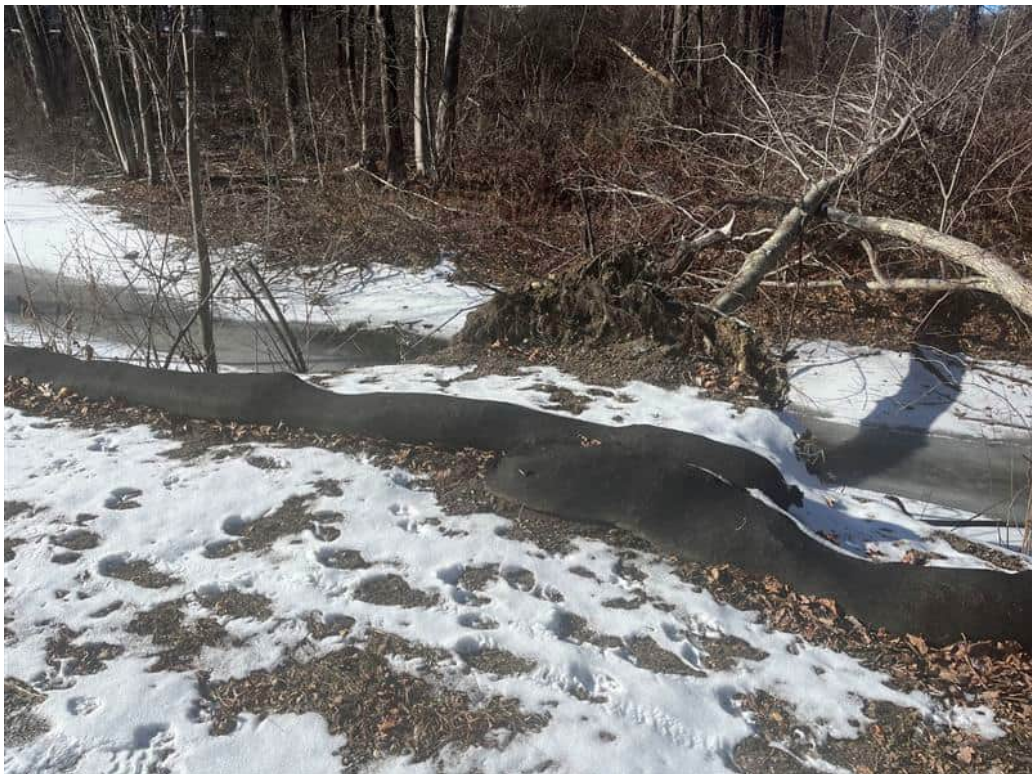
**Photo No. 12**    **Date:**  
1/15/2025

View of placed loam that requires stabilization at Station 311+00 per Long Term Compliance Action Item 59.
