Sudbury to Hudson TRP Week of 2/24/2025

Epsilon Team Full SWPPP Inspection Report(s)

CONSTRUCTION MONITORING REPORT

Sudbury to Hudson Transmission Project

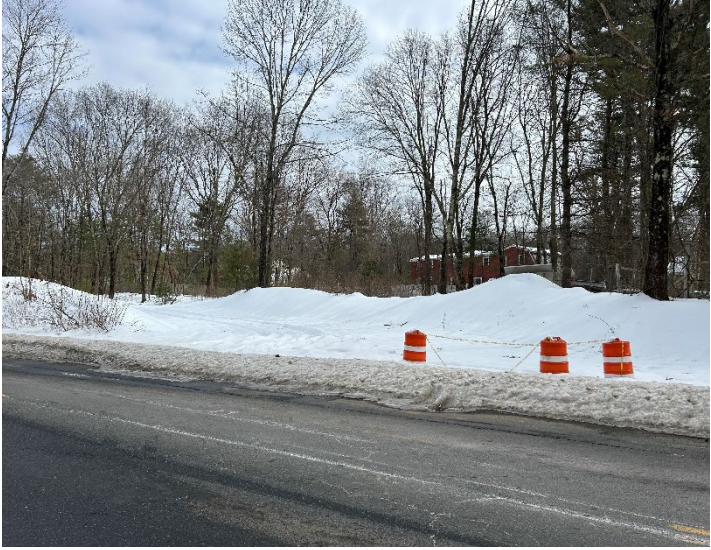
Description: View of entrance to segment 1 at Wilkins St. Facing east.

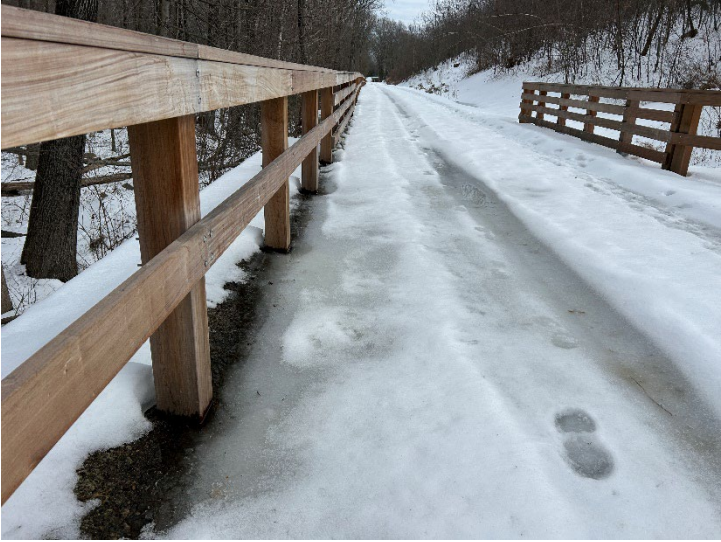
Description: View of snowmelt beginning to occur in segment 1. Facing east.

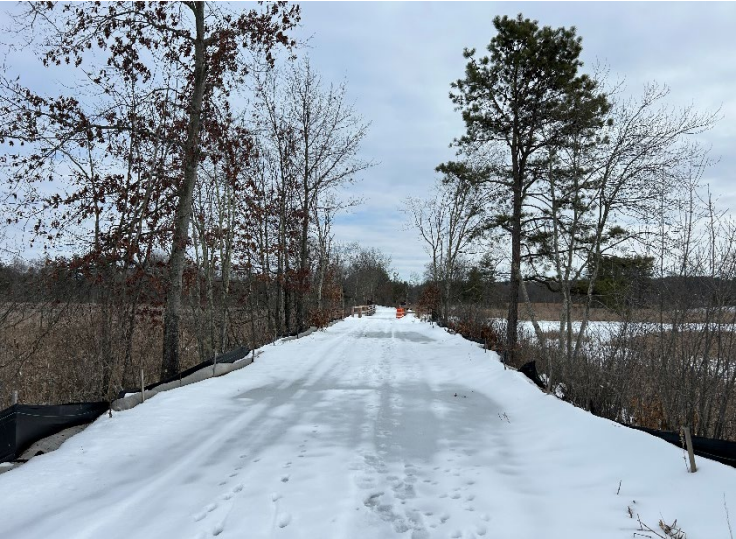
Description: View of E&S controls and snowcover in segment 2. Facing east.

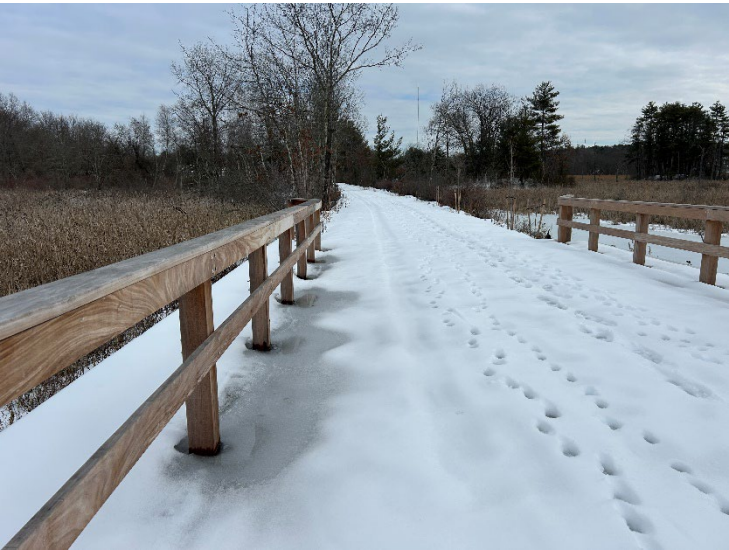
Description: View of snowmelt at bridge 130 in segment 3. Facing east.

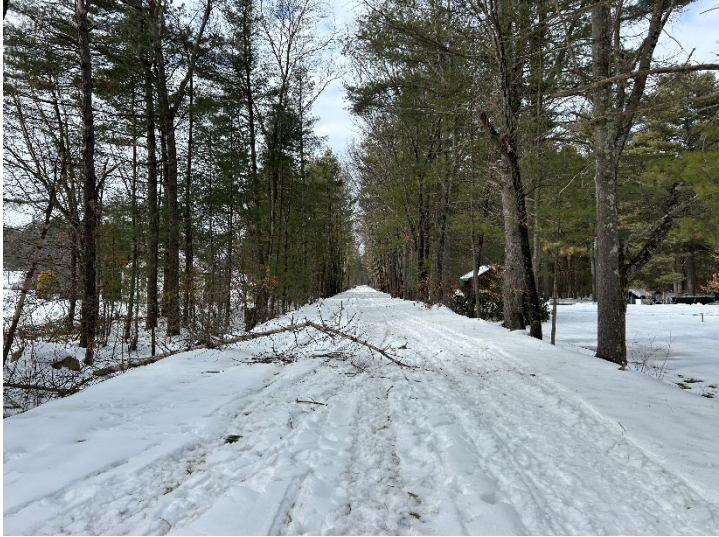
-Multiple trees/limbs have fallen in segment 4.

Description: View of fallen tree in segment 4. Facing west.

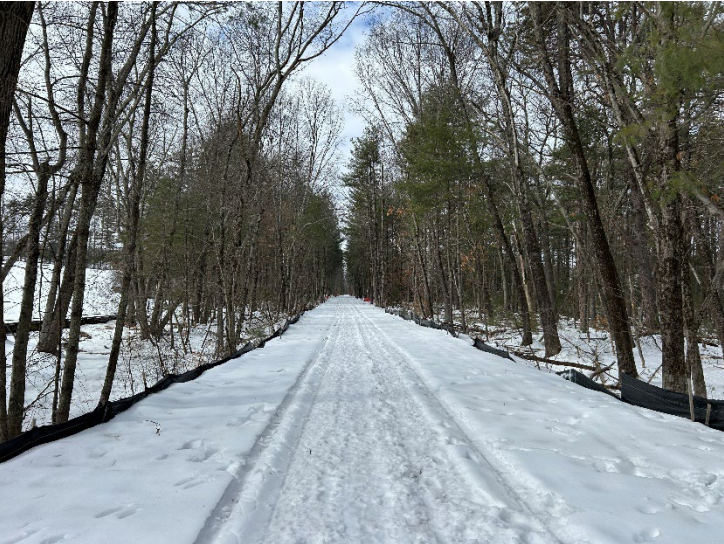
Description: View of E&S controls and snowcover in segment 4. Facing west.

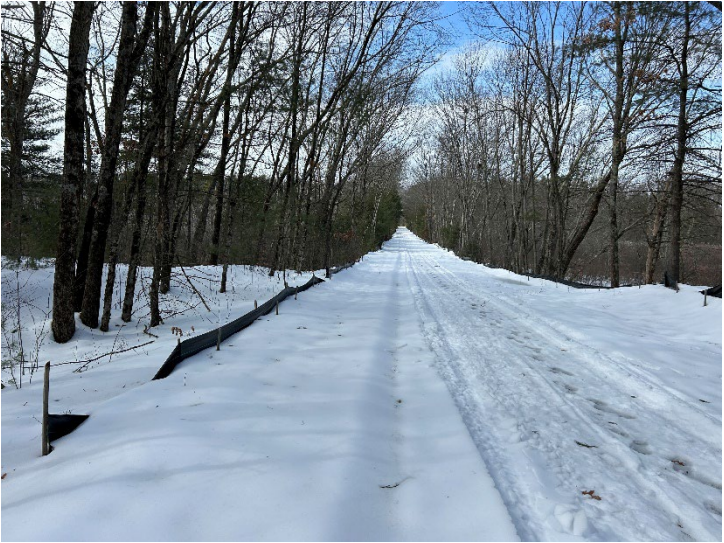
Description: View of E&S controls and snowcover in segment 5. Facing west.

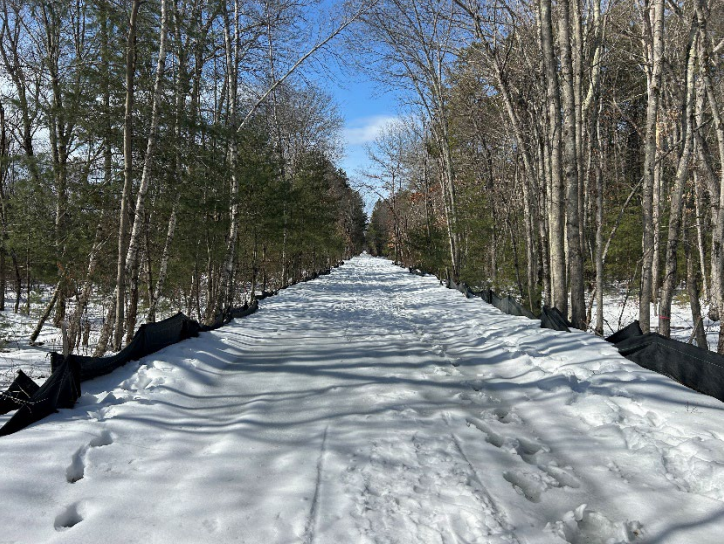
Description: View of E&S controls and snowcover in segment 6. Facing west.

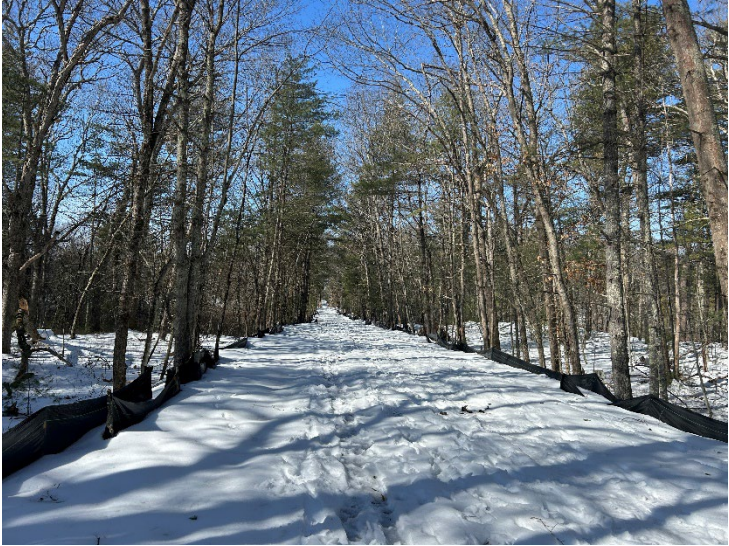
Description: View of E&S controls and snowcover in segment 8. Facing west.

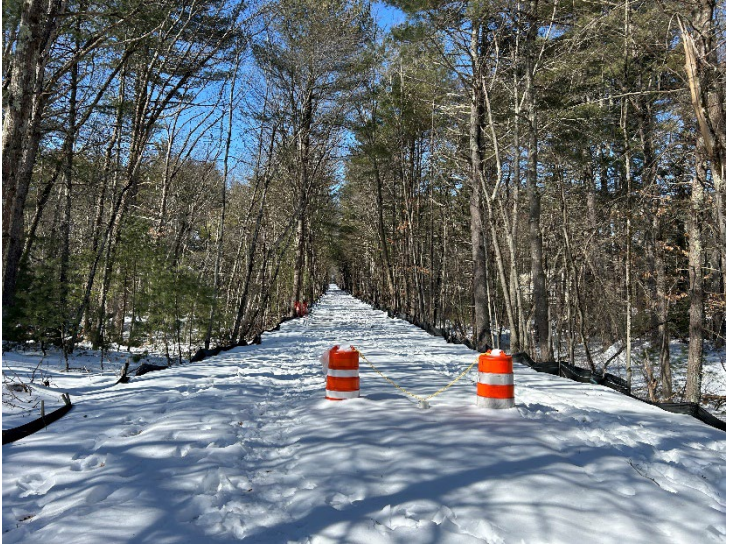
Description: View of E&S controls and snowcover in segment 9. Facing west.

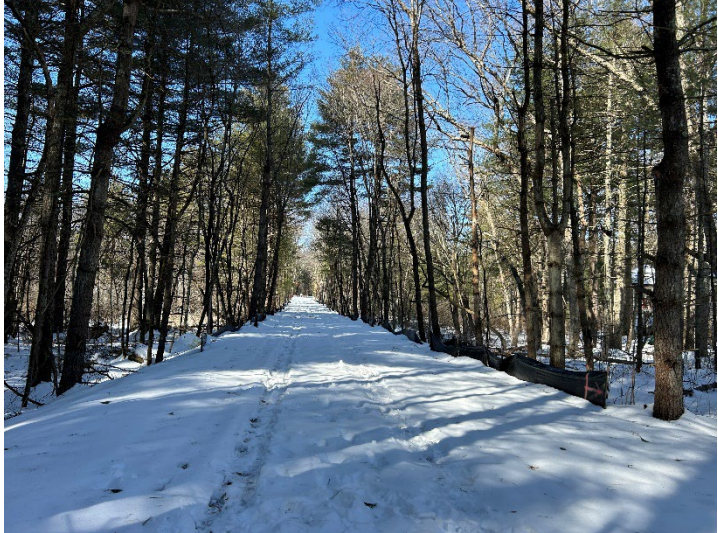
Description: View of E&S controls and snowcover in segment 11. Facing west.

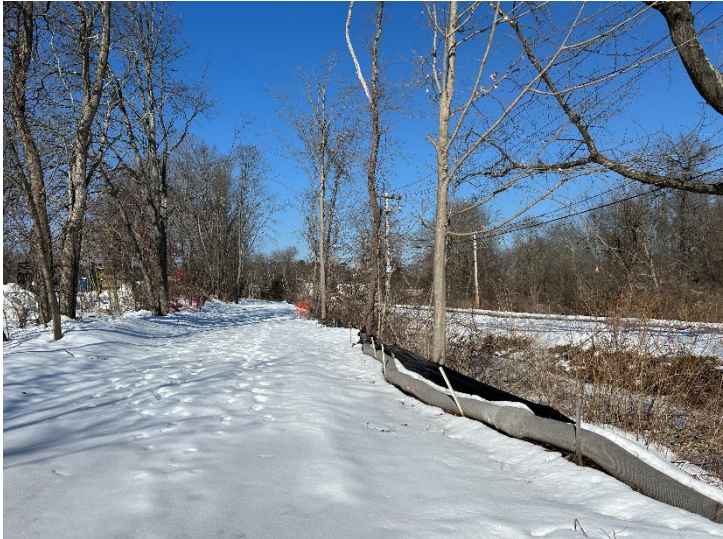
Description: View of E&S controls and snowcover in segment 12. Facing west.

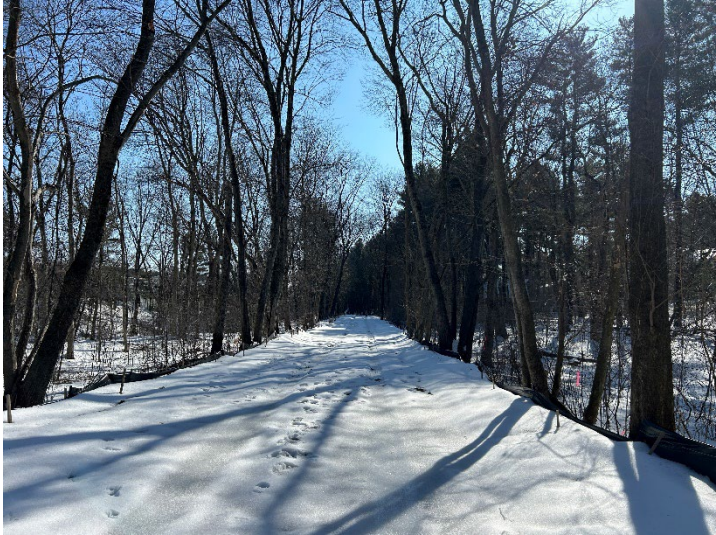
Description: View of E&S controls and snowcover in segment 13. Facing east.

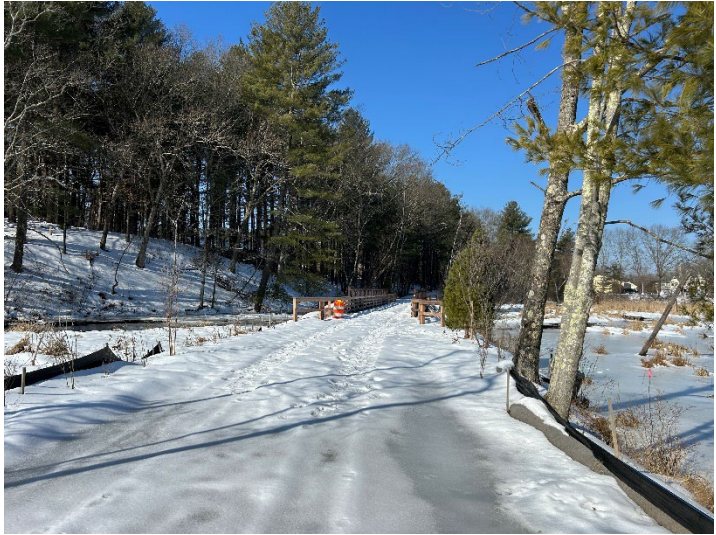
Description: View of bridge 127 from segment 14. Facing west.

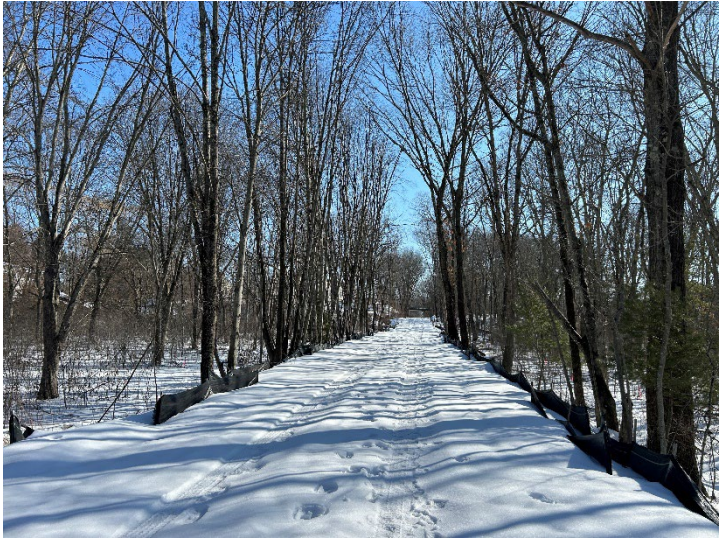
Description: View of E&S controls and snowcover in segment 14. Facing east.

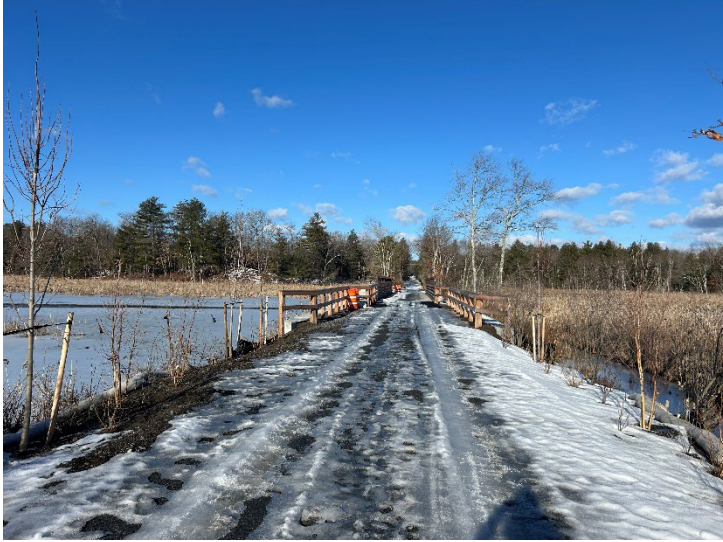
Description: View of bridge 130 from segment 3. Facing west.

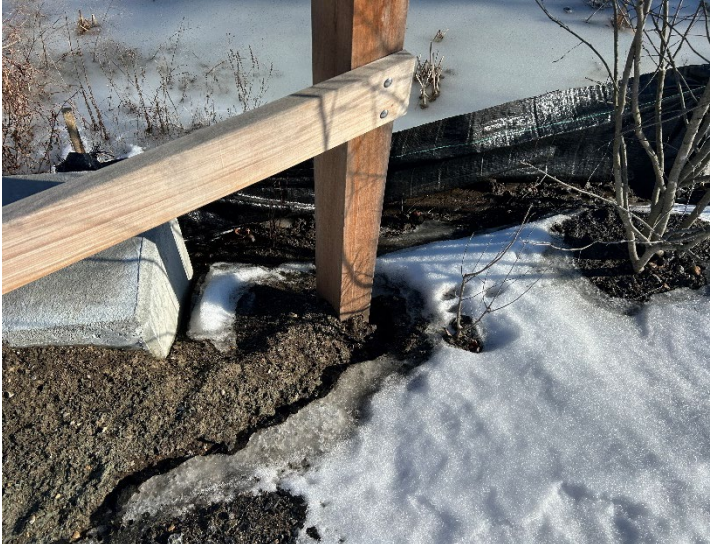
-Rill erosion noted at bridge 130.

Description: View of rill erosion at northeast corner of bridge 130. Facing north.

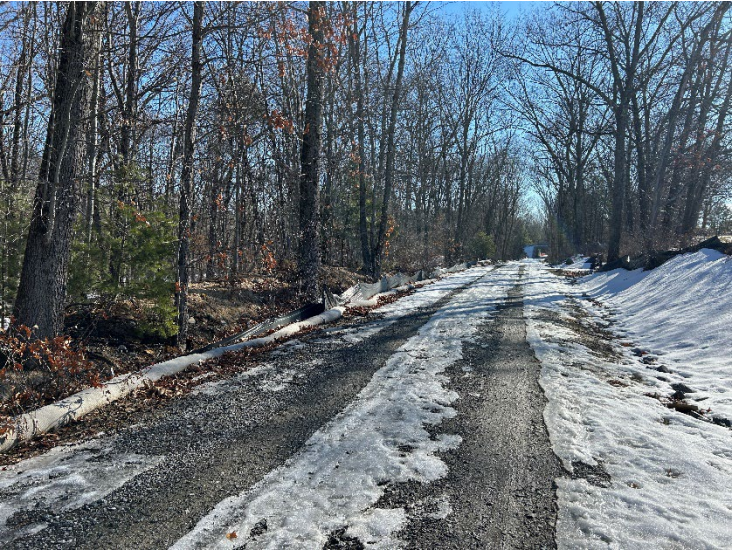
Description: View of E&S controls and melting snowcover in segment 1. Facing east.

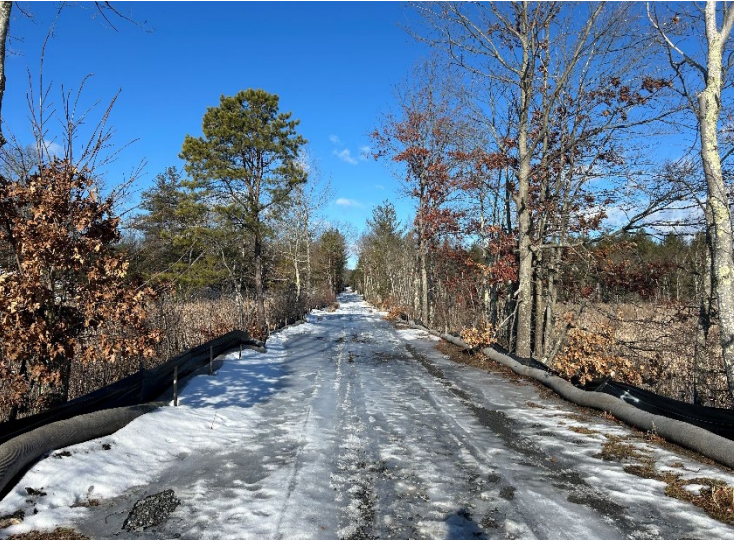
Description: View of E&S controls and melting snowcover in segment 2. Facing west.

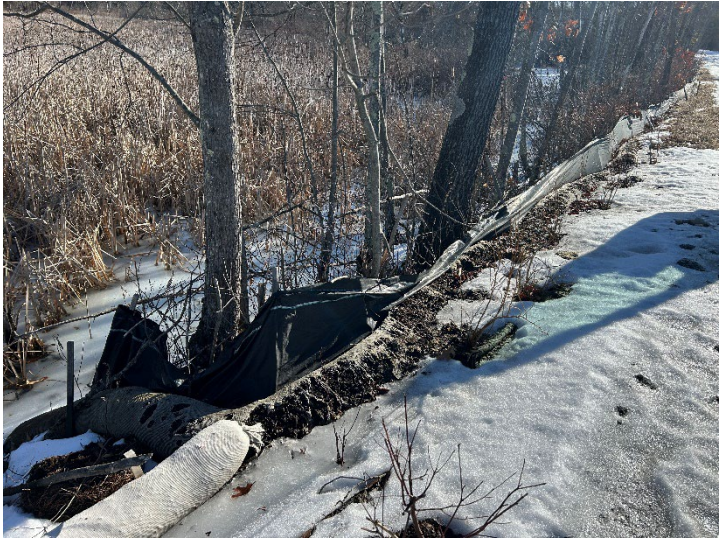
Description: View of deteriorating wattles in segment 3. Silt fence is in fair condition and is functioning properly. Facing east.

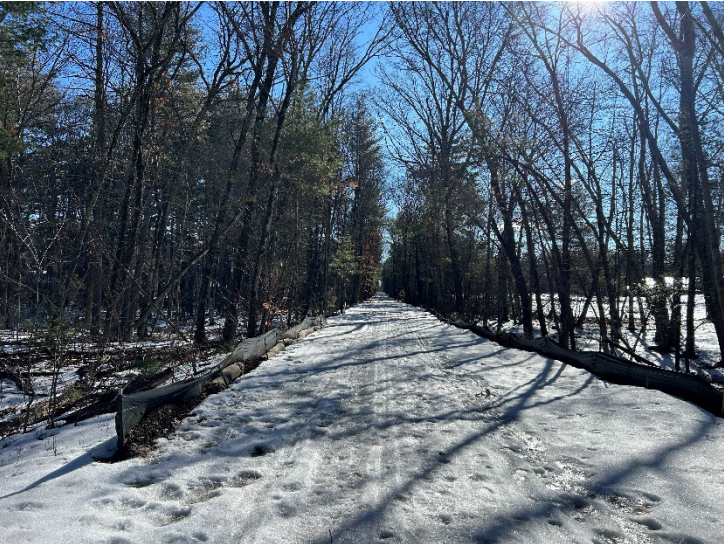
Description: View of E&S controls and snowcover in segment 4. Facing east.

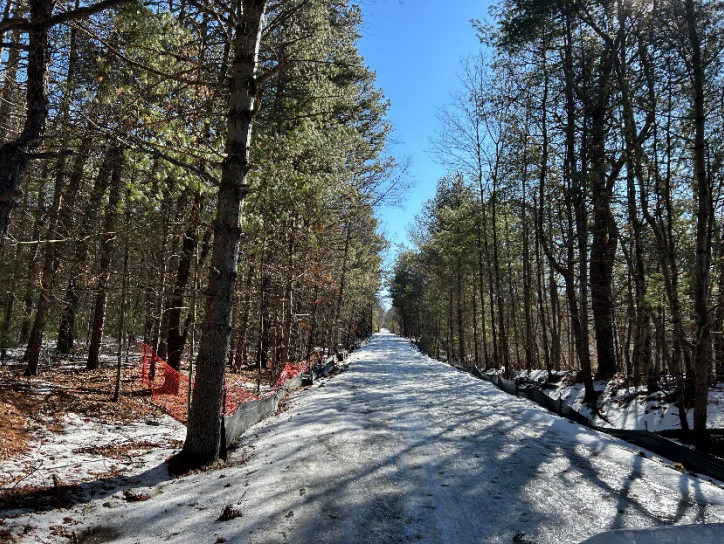
Description: View of E&S controls and snowcover in segment 6. Facing west.

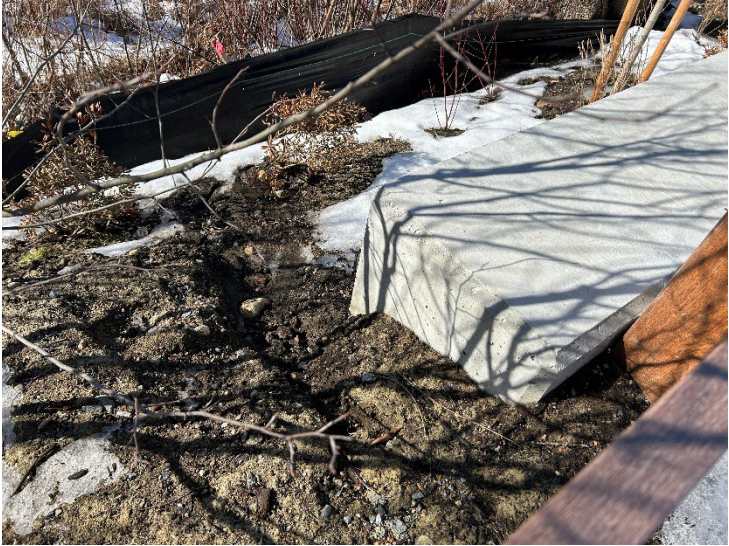
Description: View of rill erosion at the southeast corner of bridge 128 in segment 8. Facing south.

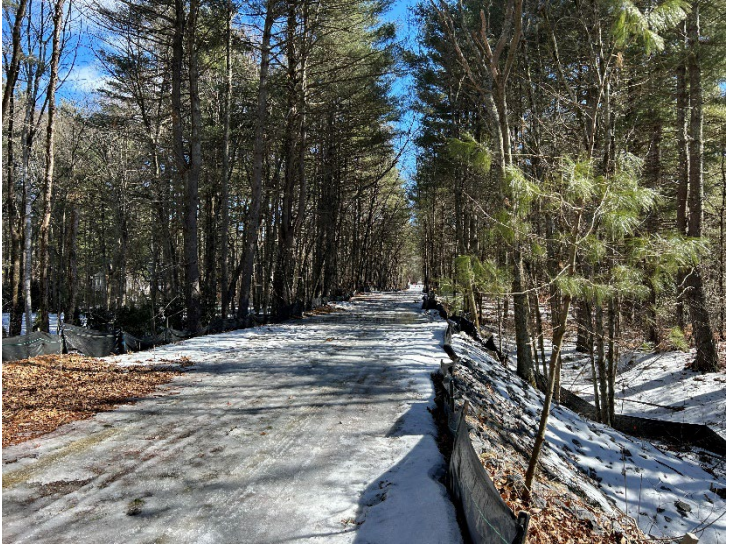
Description: View of E&S controls and snowmelt in segment 9. Facing east.

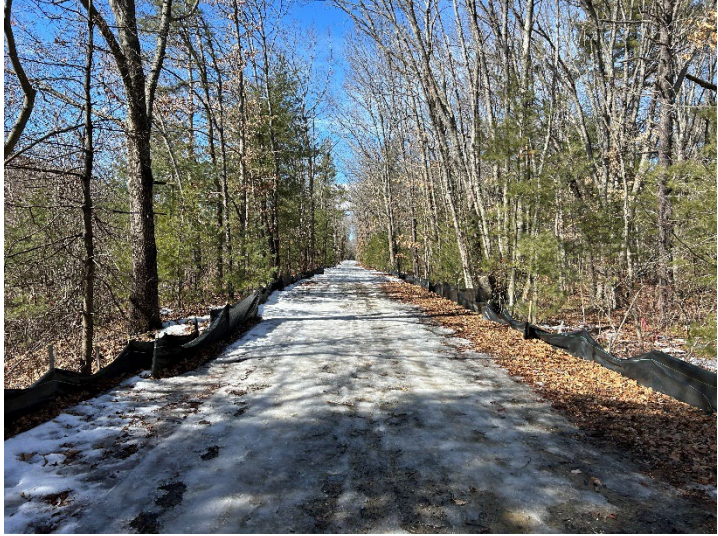
Description: View of E&S controls and snowcover in segment 11. Facing west.

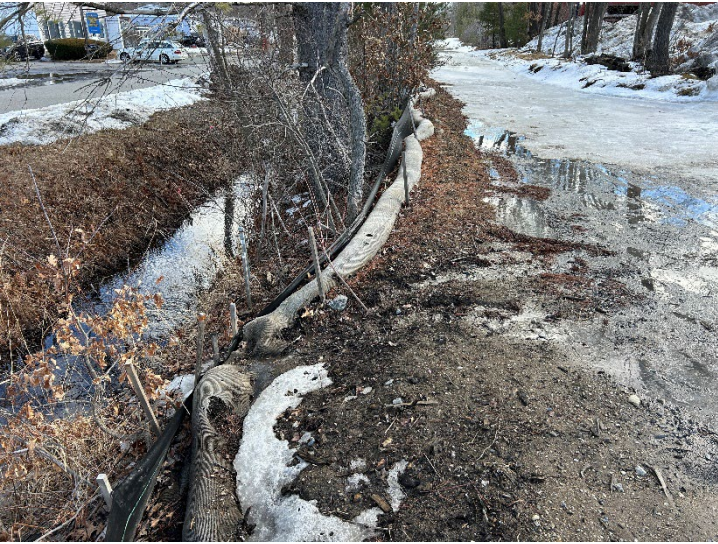
Description: View of erosion in segment 12. Sediment is accumulating at filter tubes. Facing east.

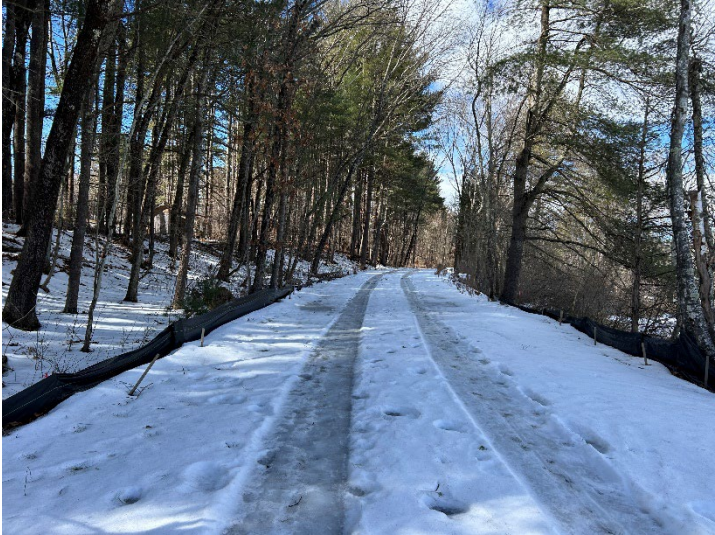
Description: View of E&S controls and snowcover in segment 13. Facing west.

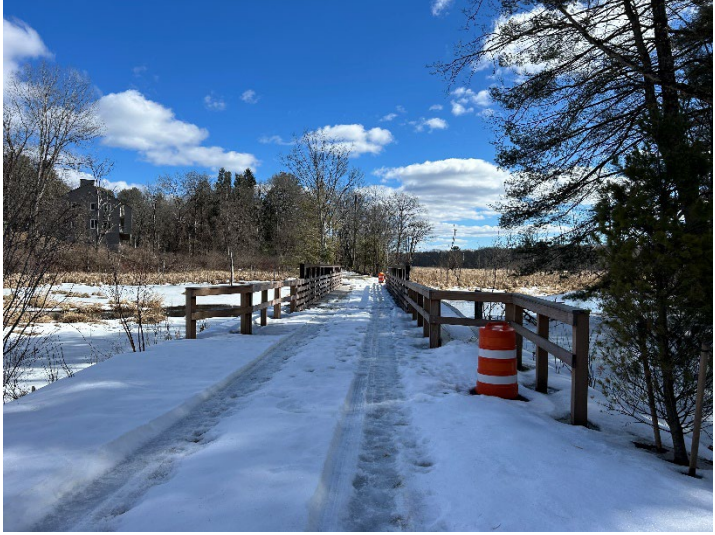
Description: View of bridge 127 from segment 13. Facing east.

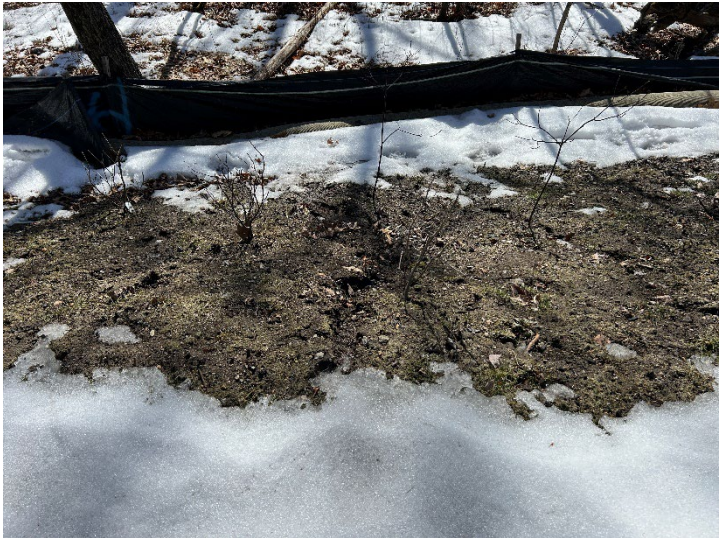
Description: View of rills forming in planting bed near station 738 in segment 14. Facing south.

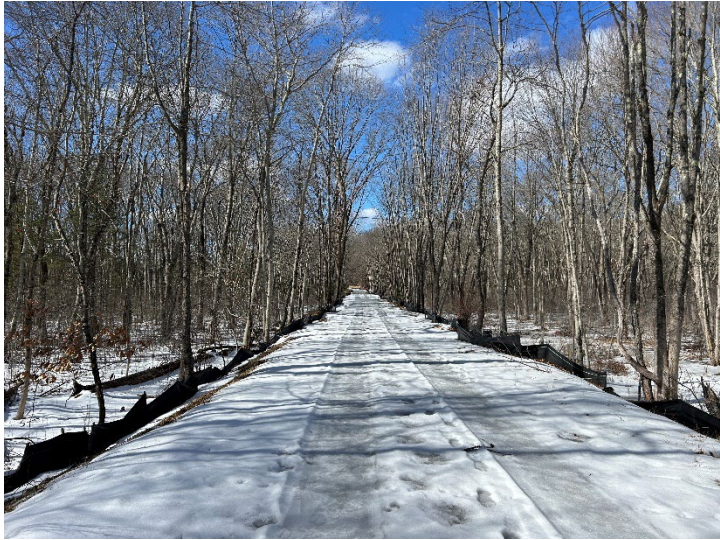
Description: View of E&S controls and snowcover in segment 14. Facing west.
