# **CONSTRUCTION MONITORING REPORT Sudbury to Hudson Transmission Project**

☑ Weekly ☐ Storm Event ☐ Other Date: 3-13-2025 Time: 11:45am-2:30pm	Project Name:
Inspector name(s), title(s), and qualifications: Gabriella Suazo (SWCA), Compliance Monitor, QCIS, QPSWPPP, EPA CGP Certified	Sudbury to Hudson Transmission Reliability Project
Others present/affiliation(s): N/A	
Precipitation/Weather (since last inspection): Clear, 20s-60s	Project Location: Sudbury, Hudson, Stow, and
Weather conditions (time of inspection & future outlook): Partly cloudy, 40s	Marlborough, MA
Inspection Location Description (include segment # and stationing): Segments 1-6 & MHs #1-4 on Wilkins and Forest Ave (Hudson)	USEPA #:
*Storm event info (approx):Start date/time: <b>N/A</b> Duration: <b>N/A</b> Amount of rainfall (inches): <b>N/A</b>	MAR1003UW
Summary of Activities/Locations Inspected (include segment # and stationing):	
ET&L on site conducting as-built survey. All E&S controls in Hudson inspected.

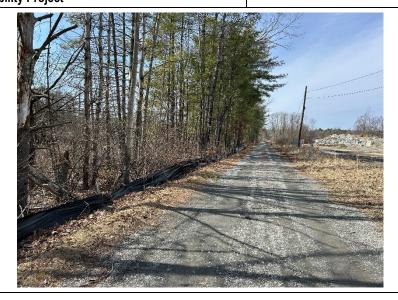
Photo No.: 3

View of E&S controls in segment 3. Facing west.

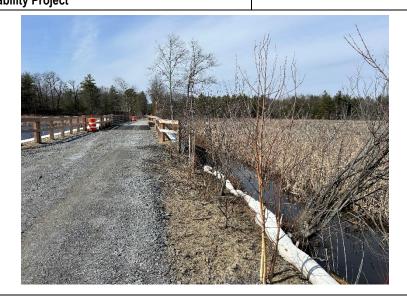
Photo No.: 4 Date: 3-13-2025

View of E&S controls at bridge 130 from segment 3. Facing west.

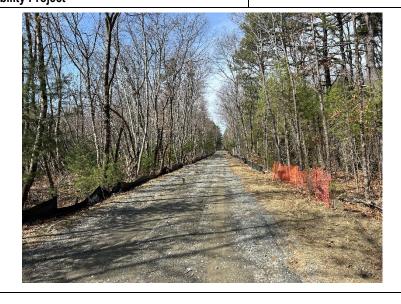
Photo No.: 7

View of E&S controls in segment 6. Facing west.

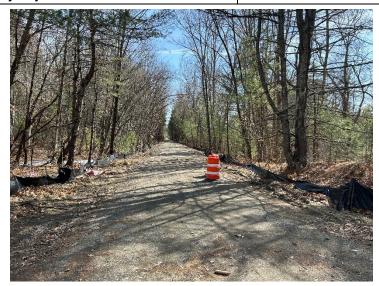
Photo No.: 8

View of entrance to segment 6 from White Pond Road. Facing east.

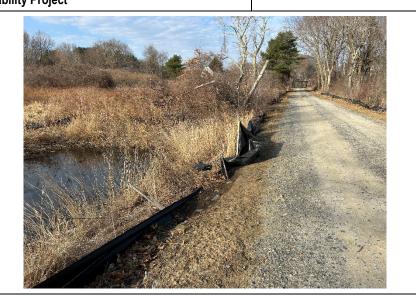
2. Silt Fencing on ROW in Sudbury	⊠ Yes □ No	1	□ Yes ⊠ No	3/13/2025	-Silt fencing is installed per the plan & operating properly within segment 7-14. Portions of erosion controls approved and marked for removal were removed 11/25 & 11/26/2024Silt fencing is down in segment 14 at the wetland replication area and at approximately station 745+50, north side of the work area.
Construction entrance pads	☐ Yes ☒ No	N/A	☐ Yes ☒ No	N/A	All construction entrance pads have been removed from segments 7-14.

View of damaged silt fence in front of wetland replication area in segment 14. Facing west.

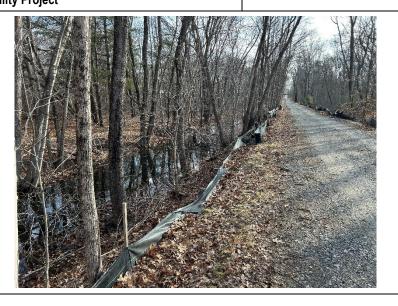
View of damaged silt fence at approximately station 745+50 in segment 14. Facing east.

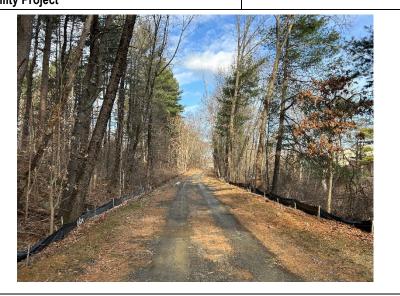
View of E&S controls in segment 13. Facing west.

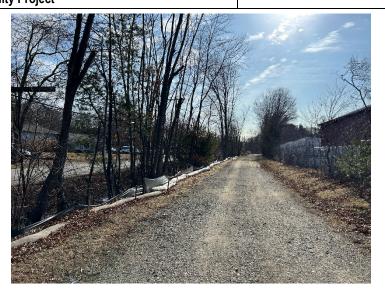
View of E&S controls in segment

12. Facing east.

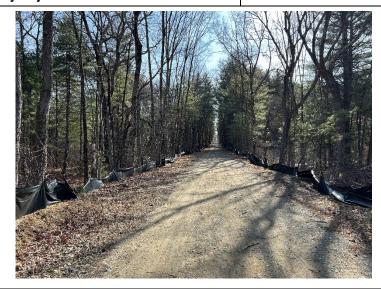
View of E&S controls in segment 11. Facing east.

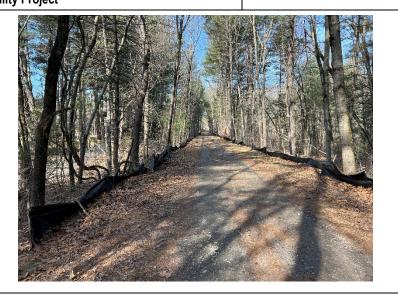
View of E&S controls in segment

10. Facing west.
