<b>Environmental Monitor Construction Site Inspection Report</b> <b>MassDOT Project #608164 Construction Contract # 119678</b> <b>EM Report #49</b>						
Project Description: Bruce Freeman Rail Trail Right-of-Way Permit Description(s): Order of Conditions (MGL Chapter 131, Section 40 and 310 CMR 10.00, Mass DEP File No. 301-1362); 2022 EPA NPDES General Permit for Discharges from Construction Areas; U.S. Army Corps of Engineers Permit No NAE-2021-01975.

I. General Project Information						
Project Name:	Bruce Freeman Rail Trail - Phase 2d - Sudbury					
Date of Inspections:	4/2/2025					
Bi Weekly/ Monthly Period Covered:	April Weekly Inspection #1					
Inspector's Name(s):	Anna Haznar					
Inspectors' Contact Information:	ahaznar@beta-inc.com					
II. Weather Information						
	Inspection #1	Inspection #2	Inspection #3	Inspection #4	Inspection #5	Inspection #6
<a href="#">WeatherUnderground</a>	Inspector: Anna Haznar 4/2/2025	Inspector:	Inspector:	Inspector:	Inspector:	Inspector:
Type of Inspection (i.e. non-storm event, pre-storm event, during-storm event or post-storm event):	Post-storm					
Number of days since last rain event greater than .25"	1					
Has there been a storm ev

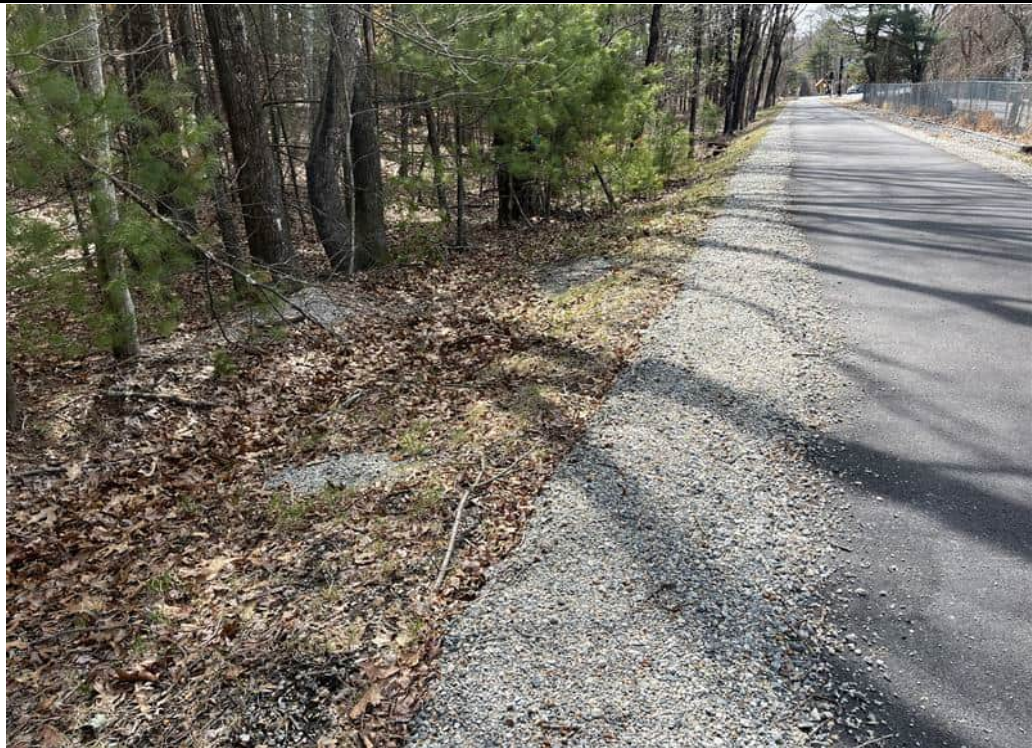
<b>Site Location</b>		Bruce Freeman Rail Trail Right-of-Way	<b>BETA Project No.</b> 24.10326.23
<b>Photo No. 5</b>	<b>Date:</b> 4/2/2025

<b>Direction Photo Taken:</b>  Toward the South			
<b>Description:</b>  View of a location where crushed stone has migrated off of the path at Station 181+00 per Compliance Action Item 58.			
<b>Photo No. 6</b>	<b>Date:</b> 4/2/2025

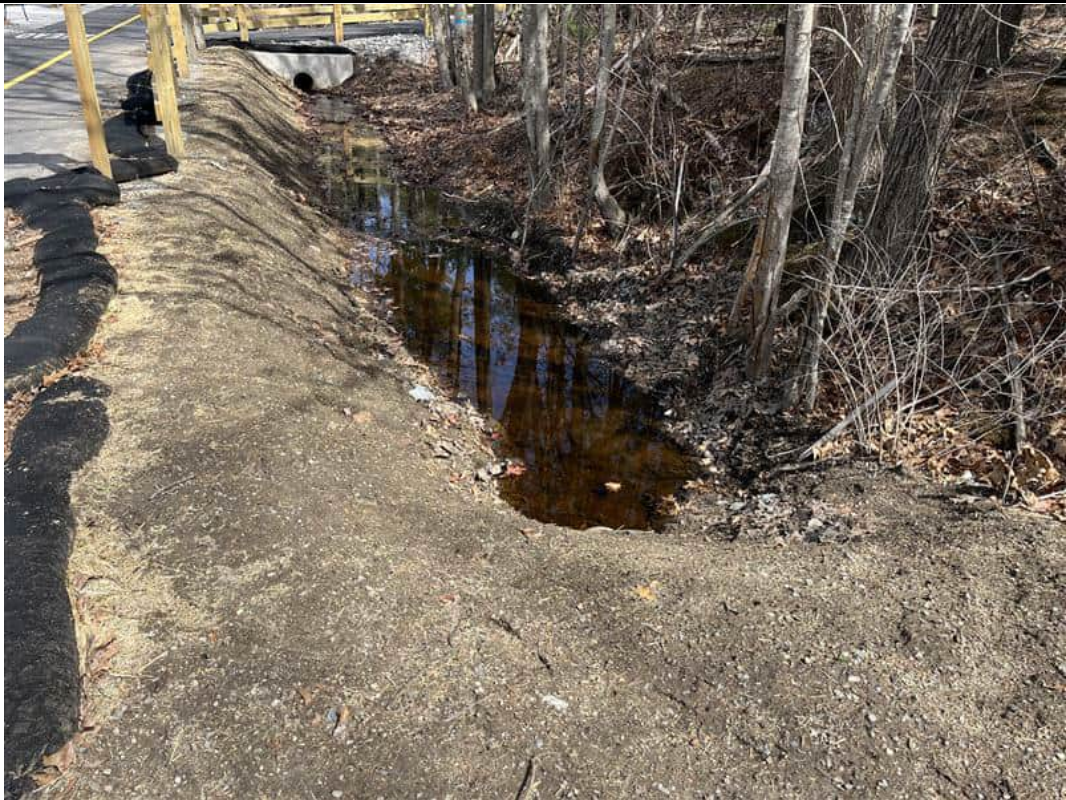
<b>Site Location</b> Bruce Freeman Rail Trail Right-of-Way		<b>BETA Project No.</b> 24.10326.23
<b>Photo No. 7</b>	<b>Date:</b> 4/2/2025

<b>Direction Photo Taken:</b>  Toward the West		
<b>Description:</b>  View of exposed soils requiring stabilization at Station 216+00 per Compliance Action Item 62.		
<b>Photo No. 8</b>	<b>Date:</b> 4/2/2025

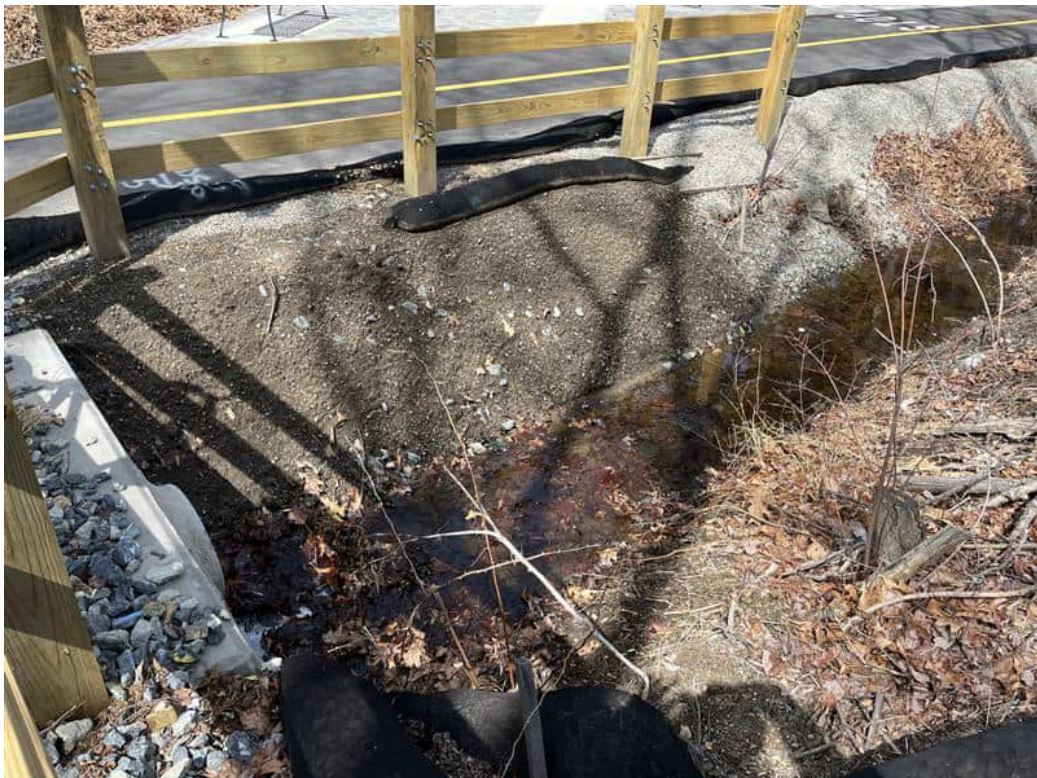
<b>Direction Photo Taken:</b>  Toward the South		
<b>Description:</b>  View of exposed soils requiring stabilization at Station 217+25 per Long Term Compliance Action item 62.

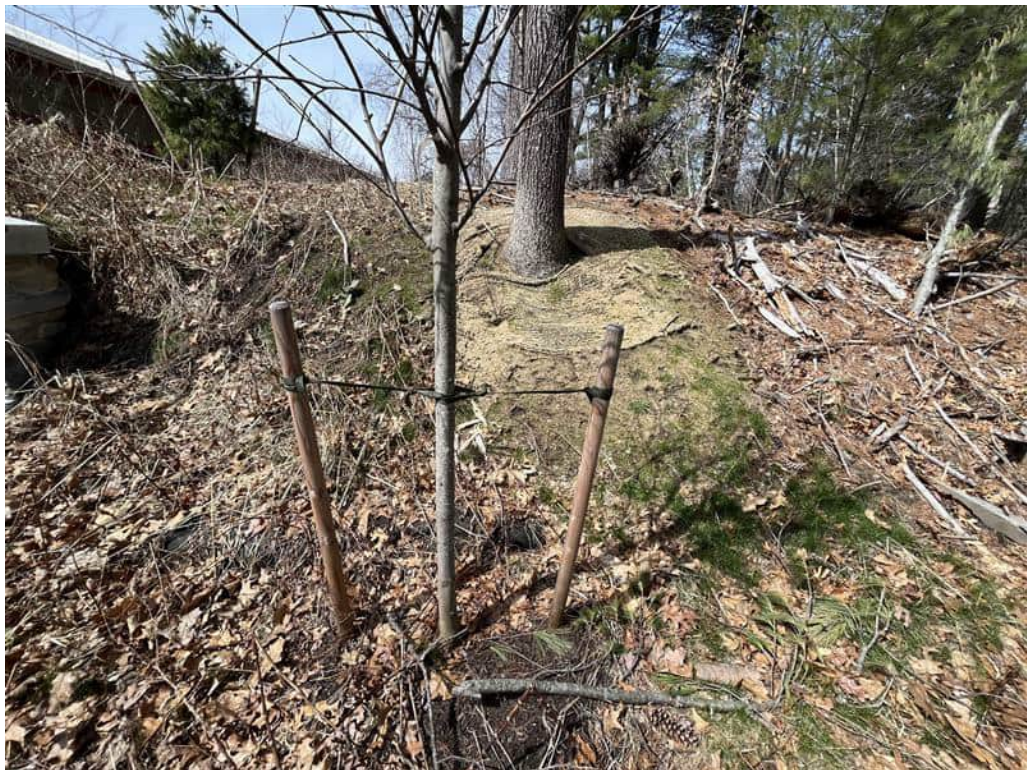
<b>Site Location</b>		Bruce Freeman Rail Trail Right-of-Way		<b>BETA Project No.</b> 24.10326.23
<b>Photo No. 9</b>	<b>Date:</b> 4/2/2025

<b>Direction Photo Taken:</b>  Toward the West				
<b>Description:</b>  View of the location where stabilization has been achieved on the slope at Station 217+45 per Compliance Action Item 34.				
<b>Photo No. 10</b>	<b>Date:</b> 4/2/2025

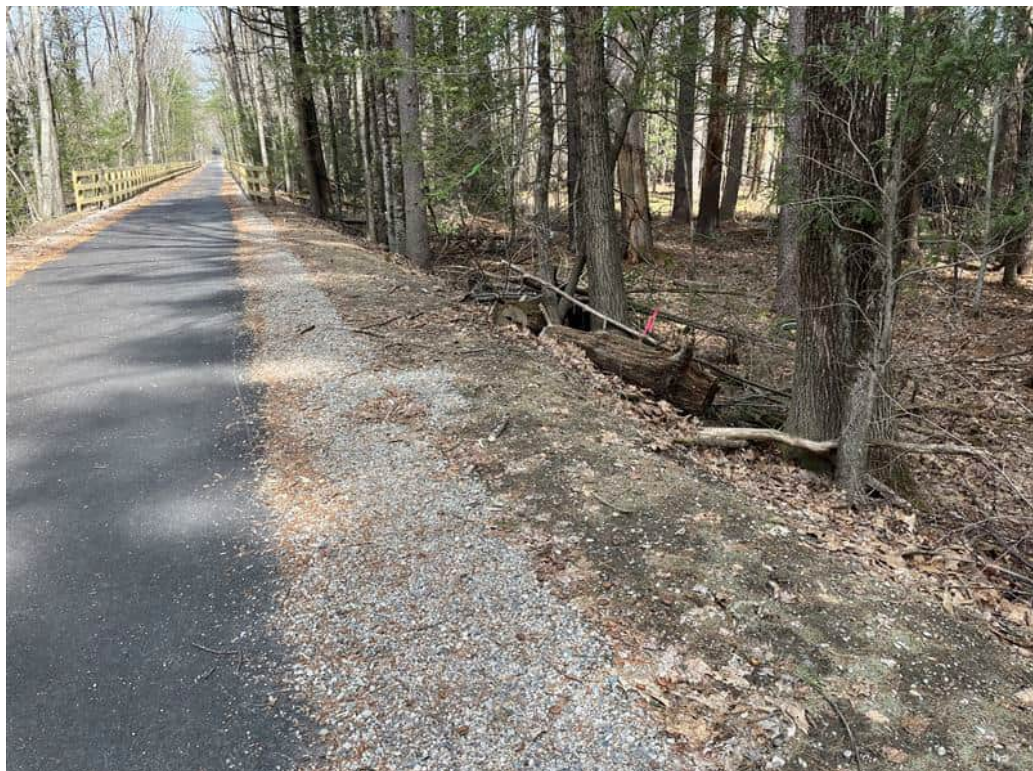
<b>Direction Photo Taken:</b>  Toward the West				
<b>Description:</b>  View of the location of exposed soil that requires stabilization and crushed stone that has migrated off of the path at Station 226+00 per Long Term Compliance Action Items 59 and 58.

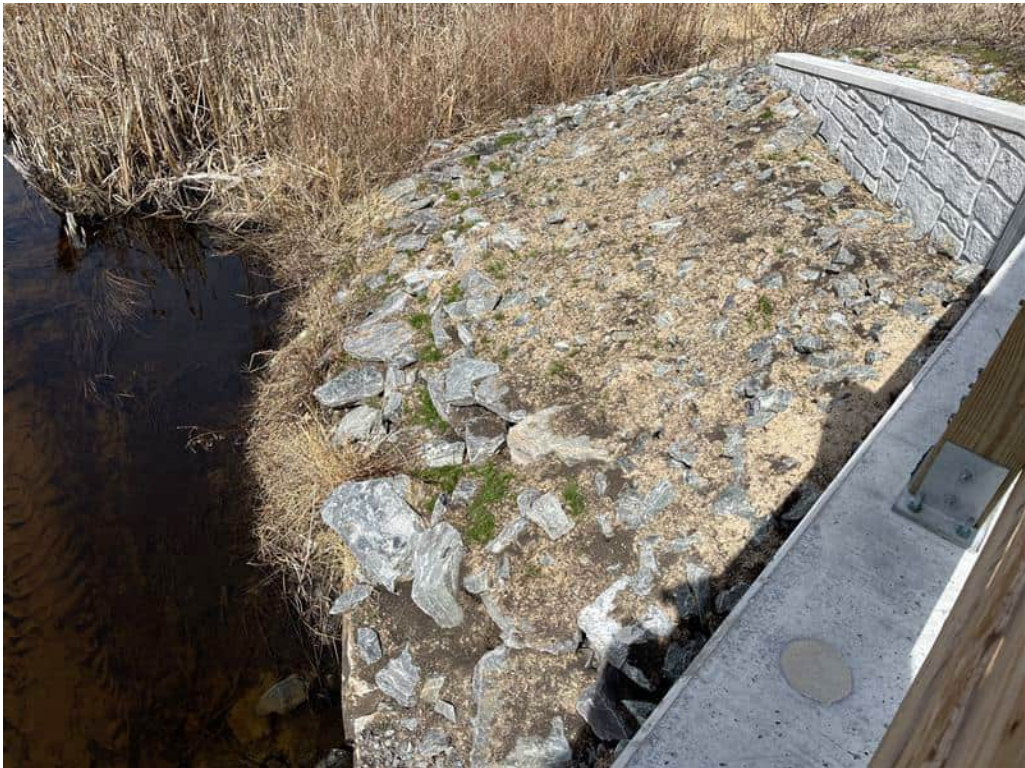
Site Location		Bruce Freeman Rail Trail Right-of-Way	BETA Project No. 24.10326.23
Photo No. 11	Date: 4/2/2025

Direction Photo Taken:  Toward the West			
Description:  View of the Bank of Pantry Brook that has been hydroseeded but is not considered stabilized at Station 264+50 per Long Term Compliance Action Item 59.			
Photo No. 12	Date: 4/2/2025

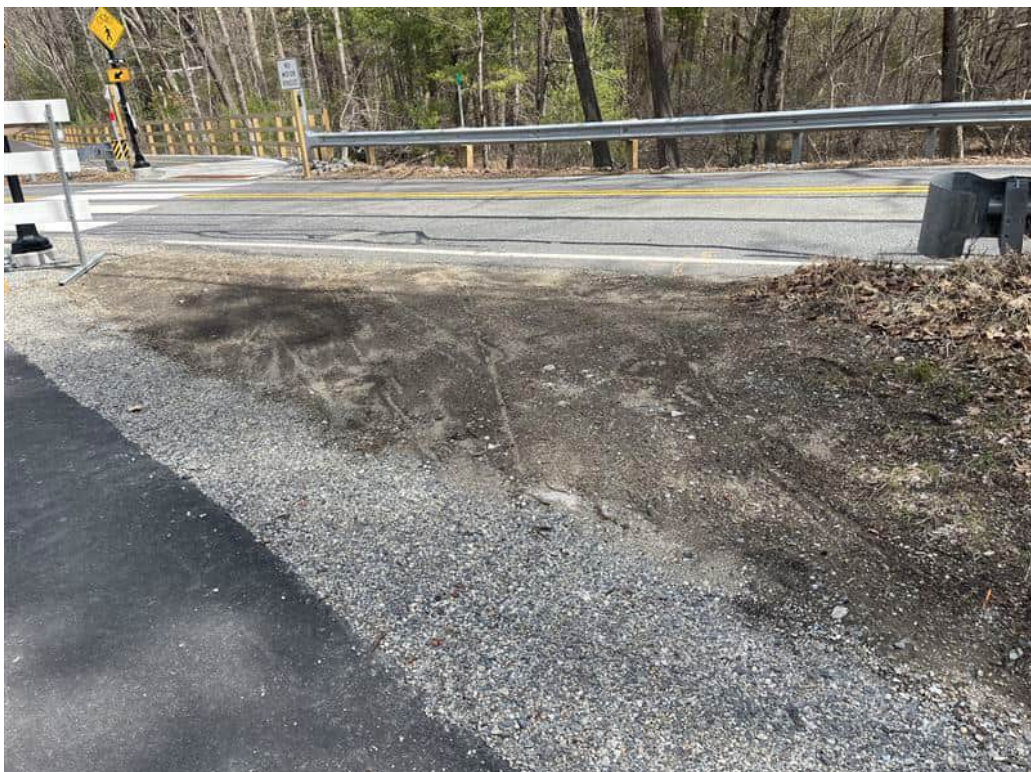
Direction Photo Taken:  Toward the West			
Description:  View of the Pantry Road intersection at Station 284+00 that required stabilization per Long Term Compliance Action Item 59.

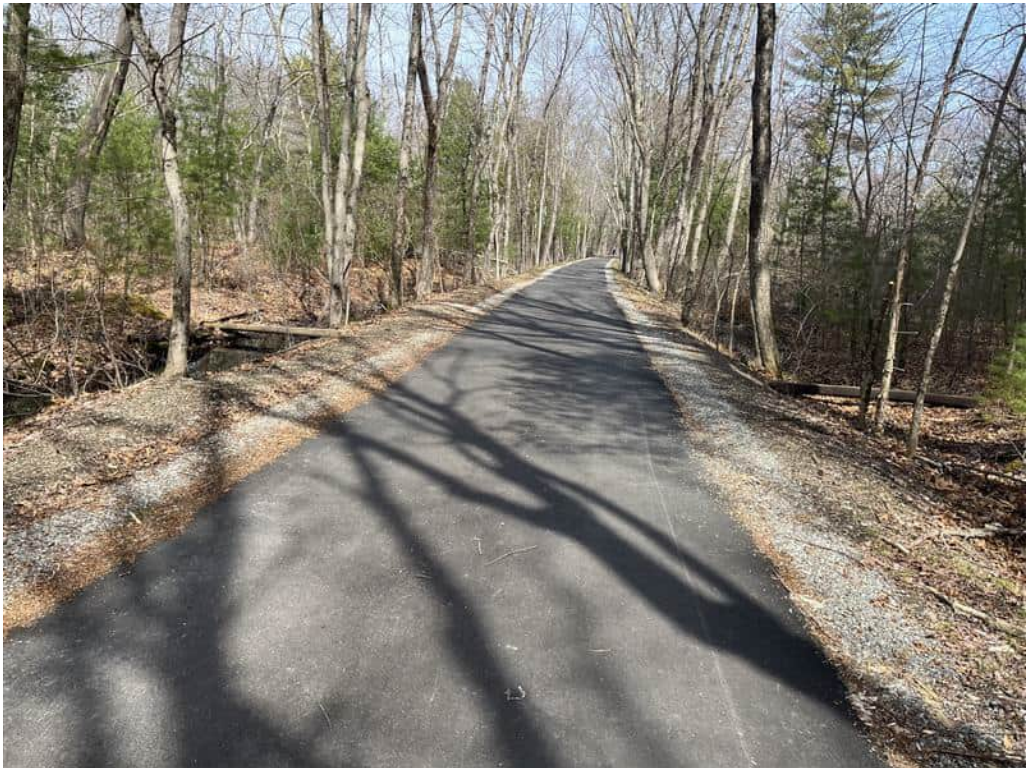
<b>Site Location</b>		Bruce Freeman Rail Trail Right-of-Way	<b>BETA Project No.</b> 24.10326.23
<b>Photo No. 13</b>	<b>Date:</b> 4/2/2025

<b>Direction Photo Taken:</b>  Toward the West			
<b>Description:</b>  View of exposed soil that requires stabilization at Station 298+00 per Long Term Compliance Action Item 59.			
<b>Photo No. 14</b>	<b>Date:</b> 4/2/2025

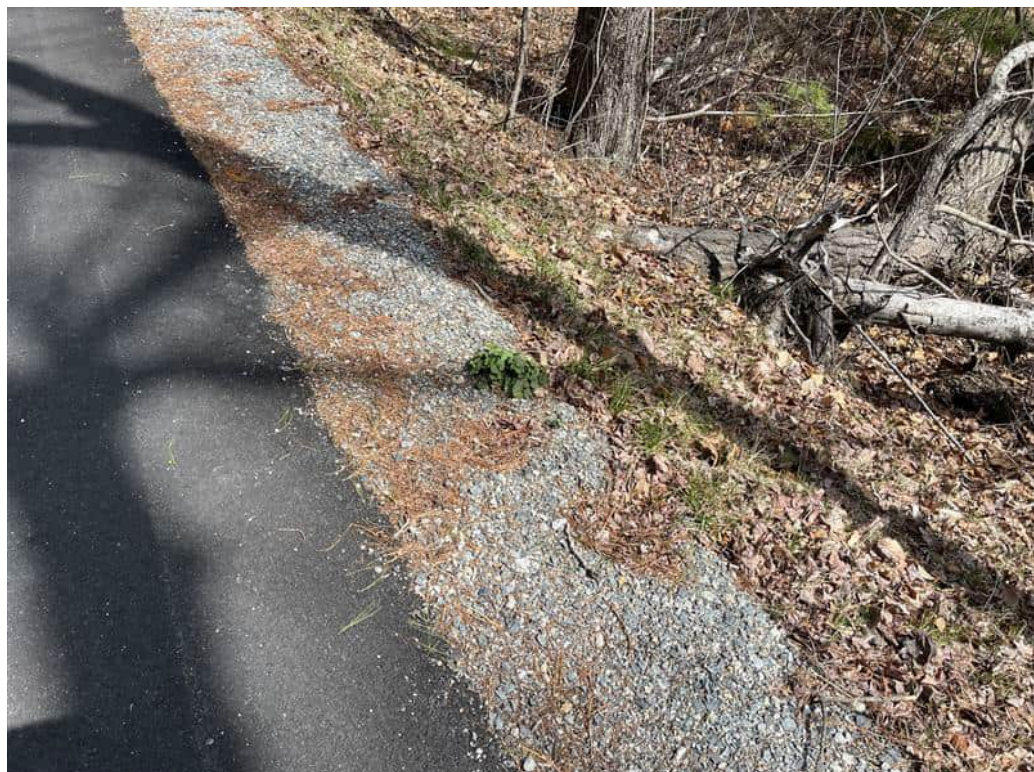
Item	Location/ Description	Observation Date	Resolution Due Date	Recommended/Discussed Resolution	Comments/Updates
61	Invasive/ non-native vegetation including Japanese knotweed ( <i>Reynoutria japonica</i> ), bittersweet ( <i>Celastrus orbiculatus</i> ), bush honeysuckle ( <i>Lonicera</i> spp.), burning bush ( <i>Euonymus alatus</i> ), purple loosestrife ( <i>Lythrum salicaria</i> ), glossy buckthorn ( <i>Frangula alnus</i> ) and garlic mustard ( <i>Alliaria petiolata</i> ) have been observed throughout the path. Priority: High	10/22/2024	10/29/2024	Invasive Species should be removed by manual and/or chemical removal methods	<p>10/29/2024 - Invasive species are present throughout the trail both within upland and Resource Areas. Populations of glossy buckthorn and purple loosestrife are present within the wetland replication area.</p> <p>11/5/2024 - Observation remains. See update from 10/29/2024.</p> <p>11/12/2024 - Observation remains. Invasive species are still present throughout the trail. Some invasives have been observed with no leaves due to winter die back.</p> <p>11/19/2024 - Observation remains. Further invasive species management will be required during the next growing season.</p> <p>11/22/2024 - Observation remains.</p> <p>11/25/2024 - Observation remains.</p> <p>12/2/2024 - Observation remains.</p> <p>12/6/2024 - Observation remains. This action item has been moved to the Long-Term Compliance Items section because it can only be resolved during the next growing season.</p> <p>12/12/2024 - Observation remains.</p> <p>12/20/2024 - Observation remains.</p> <p>12/26/2024 - Observation remains.</p> <p>12/31/2024 - Observation remains.</p> <p>1/2/2025 - Observation remains.</p> <p>1/9/2025 - Observation remains.</p> <p>1/15/2025 - Observation remains.</p> <p>1/23/2025 - Observation remains.</p> <p>1/30/2025 - Observation remains.</p> <p>2/4/2025 - Observation remains.</p> <p>2/11/2025 - Observation remains.</p> <p>4/2/2025 - Observation remains. Invasive species including, bush honeysuckle, multiflora rose, garlic mustard and buckthorn were observed to be developing buds and leaves throughout the site. In addition, non-invasives but non-native species have been observed along the corridor within areas where the establishment of native species is required.</p>

<b>Direction Photo Taken:</b>  Toward the West			
<b>Description:</b>  View of garlic mustard sprouting at Station 301+00 per Long Term Compliance Action Item 61. Note invasive and non-native species were observed throughout the path.

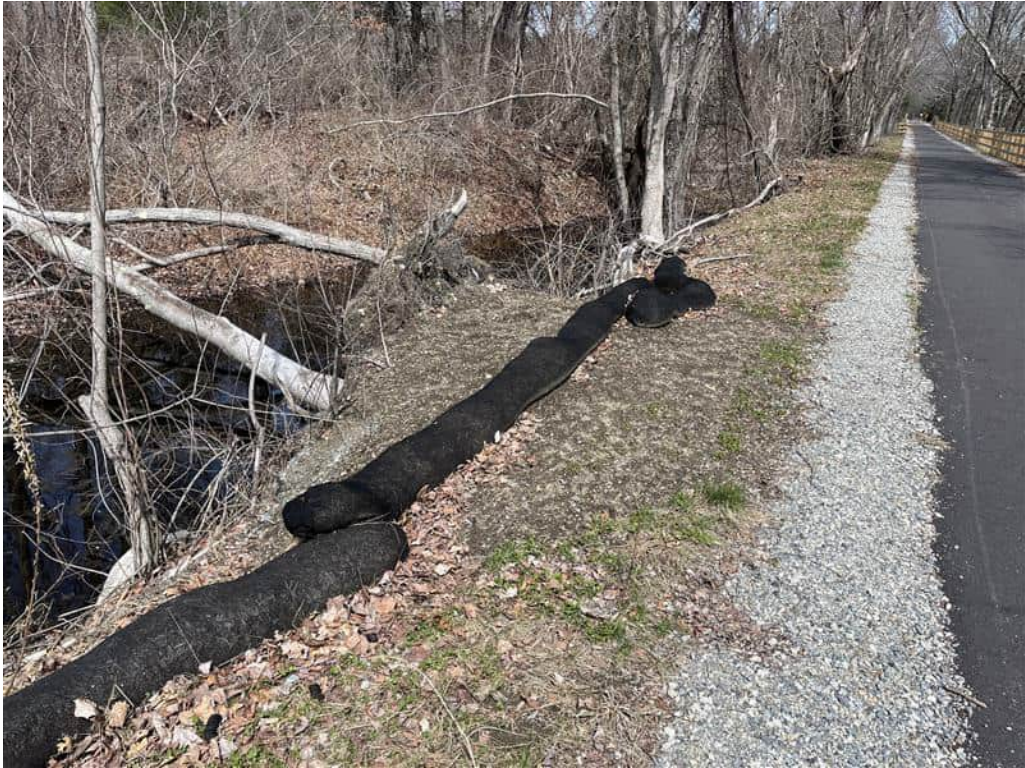
<b>Site Location</b> Bruce Freeman Rail Trail Right-of-Way		<b>BETA Project No.</b> 24.10326.23
<b>Photo No. 15</b>	<b>Date:</b> 4/2/2025

<b>Direction Photo Taken:</b>  Toward the West		
<b>Description:</b>  View of the location of placed loam that requires stabilization at Station 311+50 per Long Term Compliance Action Item 59.		
<b>Photo No. 16</b>	<b>Date:</b> 4/2/2025

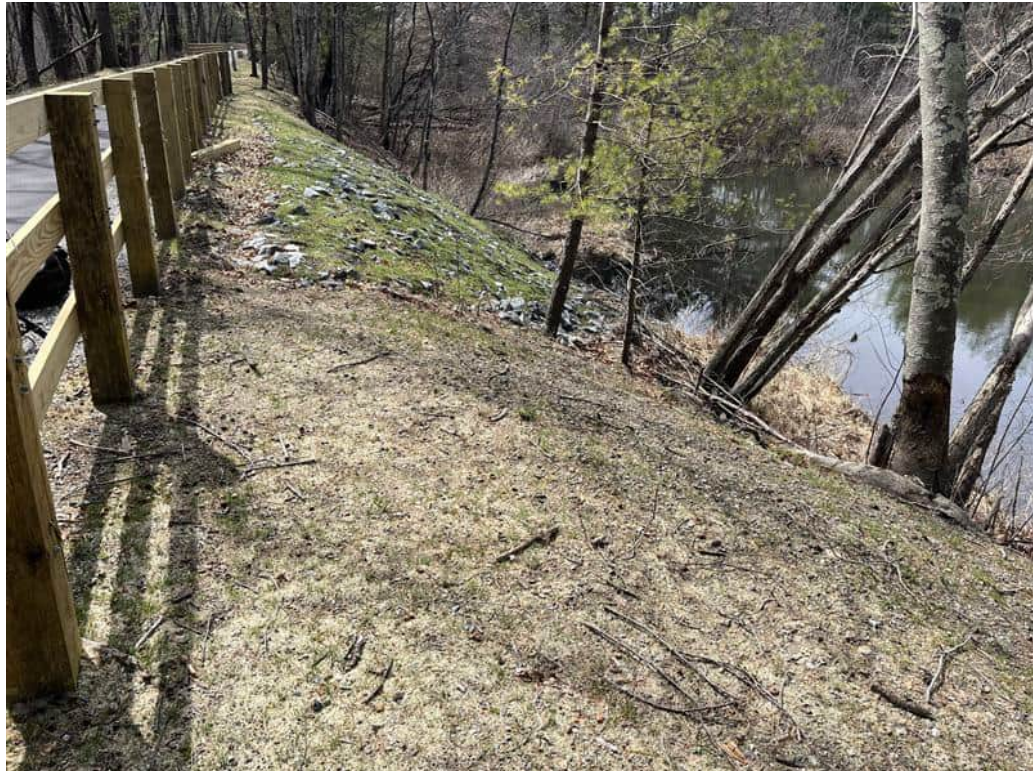
42	Riprap slope extends beyond limits of work along the WF1 Series wetland near flags 103 to 107 <b>Priority: High</b>	5/28/2024	6/4/2024	<p>The Contractor should confirm if this work was permitted by the Conservation Commission, as it does not appear to be a part of the approved plans/impacts. MassDOT should be consulted on next steps regarding notification and potential restoration.</p> <p>5/31/2024 - Observation remains.  6/7/2024 - Observation remains.  6/14/2024 - Riprap slope has been altered and active construction is repairing the area.  6/17/2024 - During this inspection, additional work in support of the repair/potential replacement of an underlying pipe has was ongoing. It is recommended that the contractor confirm that they have coordinated with the Conservation Commission for this work and provide a restoration plan for the area once work is complete.  6/24/2024 - During this inspection, BETA was informed that the existing cast iron pipe was replaced with a new concrete 12-inch reinforced concrete pipe. It appears that riprap was replaced along the side slopes to mirror conditions observed prior to this inspection.  6/27/2024 - During this inspection, the area was observed to have been rolled and prepared for paving. Hydroseed was applied and plantings were installed.  7/8/2024 - Germination was observed and the area will be monitored for stabilization. See previous updates regarding Conservation Commission coordination.  7/15/2024 - This area could not be assessed due to paving operations ongoing during the inspection.  7/22/2024 - See previous updates regarding Conservation Commission coordination.  7/29/2024 - Observation remains.  8/5/2024 - Observation remains.  8/7/2024 - Observation remains.  8/12/2024 - Observation remains. Regrowth of vegetation has been observed in this area and will continue to be monitored.  8/16/2024 - Observation remains.  8/20/2024 - Observation remains.  8/27/2024 - Observation remains.  9/3/2024 - Observation remains.  9/10/2024 - Observation remains.  9/16/2024 - Observation remains.  9/23/2024 - Observation remains.  9/27/2024 - Observation remains.  10/4/2024 - Observation remains.  10/8/2024 - Observation remains.  10/15/2024 - Observation remains.  10/22/2024 - Observation remains.  10/29/2024 - Observation remains.  11/5/2024 - Observation remains.  11/12/2024 - Observation remains. The timber fence has been installed upgradient of this area.  11/19/2024 - Observation remains. As discussed with the Conservation Agent in the field, an as-built should be prepared for this area to quantify any additional impacts that may be addressed through a permit amendment.  11/22/2024 - Observation remains. See previous update.  11/25/2024 - Observation remains. See update from 11/19/2024.  12/2/2024 - Observation remains. See update from 11/19/2024.  12/6/2024 - Observation remains. See update from 11/19/2024.  12/12/2024 - Observation remains. See update from 11/19/2024.  12/20/2024 - Observation remains. See update from 11/19/2024.  12/26/2024 - Observation remains. See update from 11/19/2024.  12/31/2024 - Observation remains. See update from 11/19/2024.  1/2/2025 - Observation remains. Leaf litter that was previously observed at the bottom of the slope has blown away and it appears that exposed soil with no observable germination is present.  1/9/2025 - Observation remains. See update from 1/2/2025 and 11/19/2024.  1/15/2025 - Observation remains. See update from 1/2/2025 and 11/19/2024.  1/23/2025 - Observation remains. See update from 1/2/2025 and 11/19/2024.  1/30/2025 - Observation remains. See update from 1/2/2025 and 11/19/2024.  2/4/2025 - Observation remains. See update from 1/2/2025 and 11/19/2024.  2/11/2025 - Observation remains. See update from 1/2/2025 and 11/19/2024.  4/2/2025 - Observation remains. See update from 1/2/2025 and 11/19/2024.</p>

<b>Direction Photo Taken:</b>  Toward the West		
<b>Description:</b>  View of the location of the riprap slope that extends beyond the limit of work along the WF1 Series wetland and exposed soil requiring stabilization at Station 332+00 per Long Term Compliance Action Item 42 and 59.
