**Environmental Monitor Construction Site Inspection Report  
MassDOT Project #608164 Construction Contract # 119678  
EM Report #50**

Project Description: Bruce Freeman Rail Trail Right-of-Way  
Permit Description(s): Order of Conditions (MGL Chapter 131, Section 40 and 310 CMR 10.00, Mass DEP File No. 301-1362); 2022 EPA NPDES General Permit for Discharges from Construction Areas; U.S. Army Corps of Engineers Permit No NAE-2021-01975.

Project Name:	Bruce Freeman Rail Trail - Phase 2d - Sudbury
Date of Inspections:	4/7/2025
Bi Weekly/ Monthly Period Covered:	April Weekly Inspection #2
Inspector's Name(s):	Anna Haznar
Inspectors' Contact Information:	<a href="mailto:ahaznar@beta-inc.com">ahaznar@beta-inc.com</a>

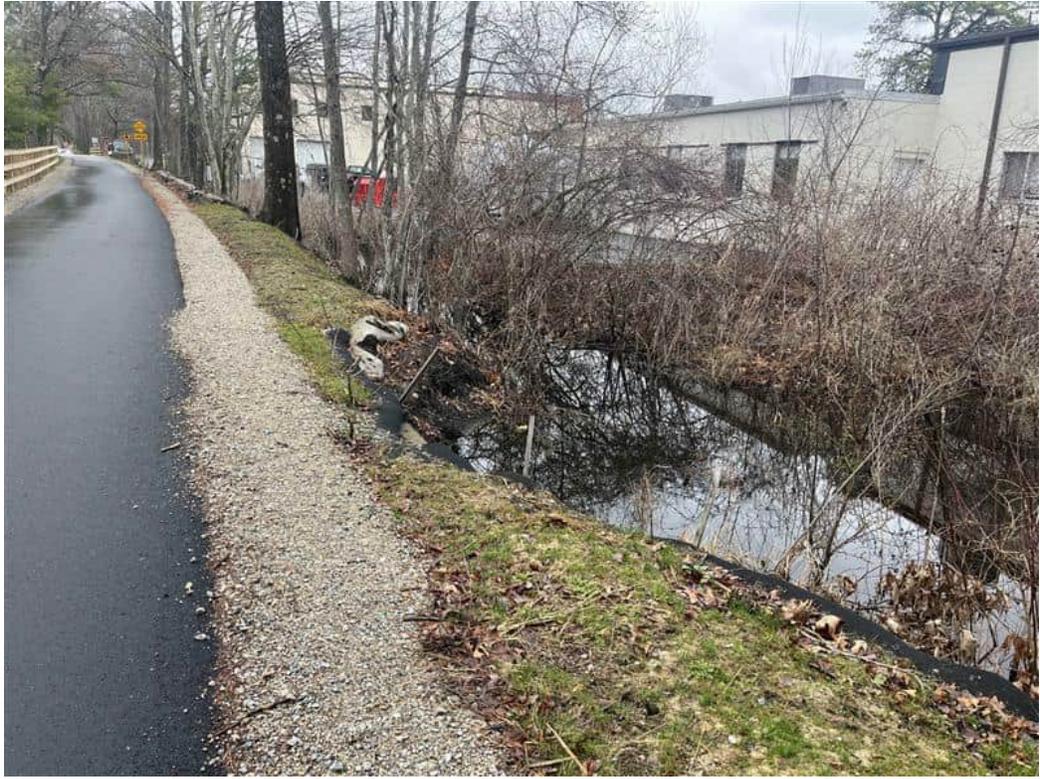
**Photo No. 1**    **Date:**  
4/7/2025

43	<p>Overtopped compost filter tubes and exposed soils beyond the limits of work at Station 105+00  <b>Priority: High</b></p>	6/7/2024	6/14/2024	<p>Stabilize the area with the approved seed mixture and provide interim stabilization such as straw mulch.</p>	<p>6/14/2024 - Observation remains.  6/17/2024 - Observation remains.  6/24/2024 - Observation remains.  6/27/2024 - Observation remains.  7/8/2024 - Observation remains.  7/15/2024 - Observation remains.  7/22/2024 - Observation remains.  7/29/2024 - Observation remains.  8/5/2024 - Observation remains.  8/7/2024 - Observation remains.  8/12/2024 - Observation remains. Some material has migrated off of the compost filter tubes due to erosion.  8/16/2024 - Observation remains.  8/20/2024 - Application of the approved seed mixture is required at this location.  8/27/2024 - Observation remains.  9/3/2024 - Observation remains.  9/10/2024 - Observation remains. Application of the approved seed mixture is required at this location.  9/16/2024 - Observation remains.  9/23/2024 - Observation remains.  9/27/2024 - Observation remains.  10/4/2024 - Hydroseed has been applied here; however, the contractor should provide an update on long-term slope stabilization plans.  10/8/2024 - Observation remains. Germination has not been observed.  10/15/2024 - Observation remains. Germination has not been observed.  10/22/2024 - Observation remains. Some germination has been observed but the area is not considered stabilized.  10/29/2024 - Observation remains. No further germination has been observed since the last inspection.  11/5/2024 - Observation remains. Some germination has been observed but the area is not considered stabilized.  11/12/2024 - Observation remains. Seed has stabilized the area.  11/19/2024 - The area adjacent to the path has become stabilized; however, exposed soil is still present next to the culvert past the limit of work.  11/22/2024 - Observation remains. See previous update.  11/25/2024 - Observation remains. See update from 11/19/2024.  12/2/2024 - Observation remains. See update from 11/19/2024.  12/6/2024 - Observation remains. See update for 11/19/2024.  12/12/2024 - Observation remains. See update from 11/19/2024.  12/20/2024 - Observation remains. See update from 11/19/2024.  12/26/2024 - Observation remains. See update from 11/19/2024.  12/31/2024 - Observation remains. See update from 11/19/2024.  1/2/2025 - Observation remains. See update from 11/19/2024.  1/9/2025 - Observation remains. See update from 11/19/2024.  1/15/2025 - Observation remains. Exposed soils are still present next to the culvert past the limits of work.  1/23/2025 - Observation remains. See previous update.  1/30/2025 - Observation remains. Exposed soils are present next to the culvert past the limits of work.  2/4/2025 - Observation remains. Exposed soils are present next to the culvert past the limits of work.  2/11/2025 - Observation remains. Exposed soils past the limits of work are currently frozen and covered with snow.  4/2/2025 - Observation remains. Exposed soil past the limits of work is present and requires further stabilization.  4/7/2025 - Observation remains. See previous update.</p>

View of the location of the overtopped compost filter tube and exposed soils beyond the limits of work at Station 105+00 per Compliance Action Item 43.

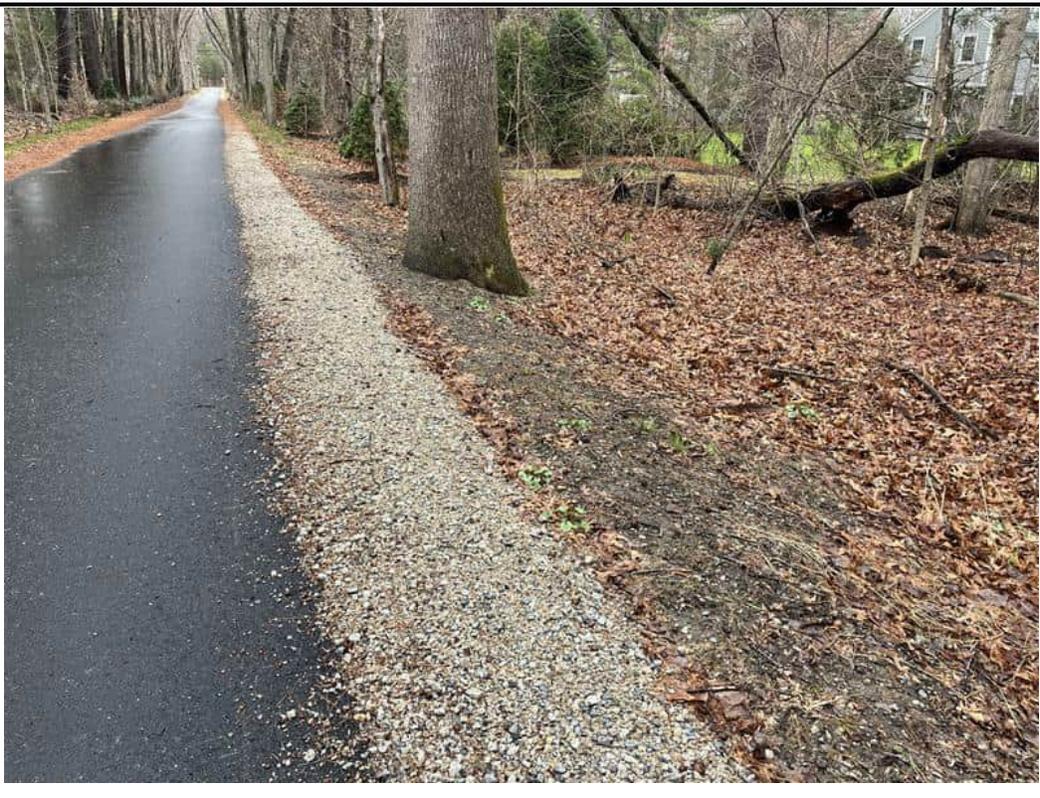
**Photo No. 2**    **Date:**  
4/7/2025

**Description:**  
View of garlic mustard sprouting in an area of exposed soil at Station 137+00 per Long Term Compliance Action Item 61 and 59. Note invasive and non-native species were observed throughout the path.

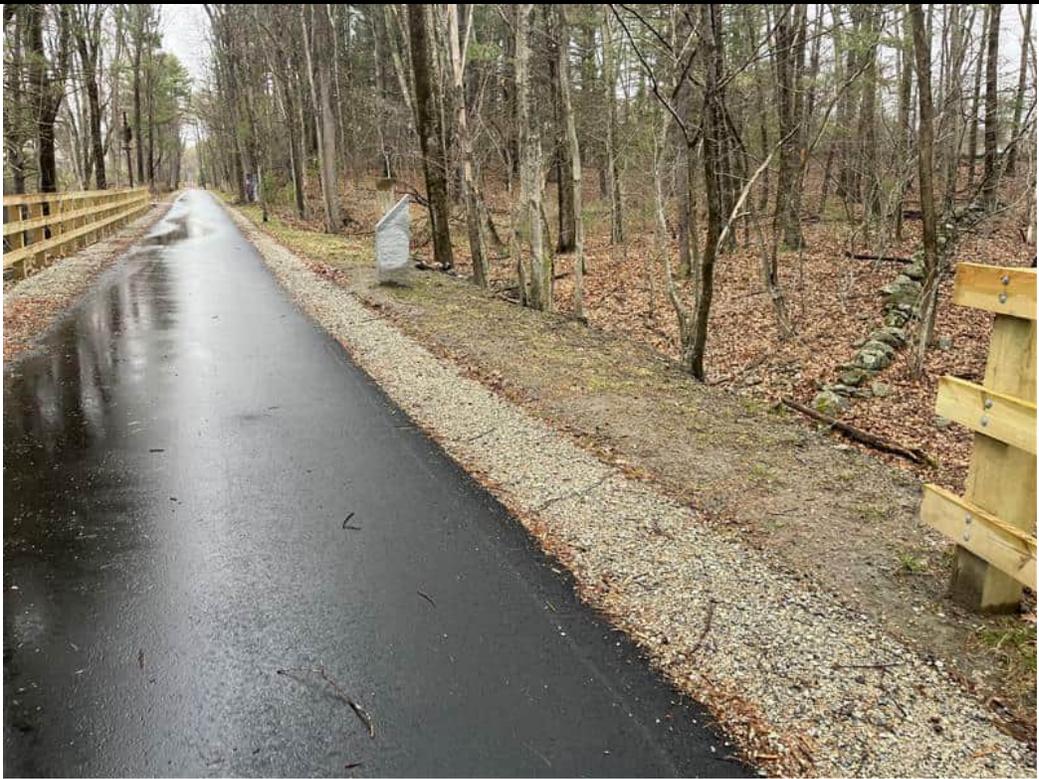
**Photo No. 3**    **Date:**  
4/7/2025

View of the location of exposed soil at Station 166+00 that requires stabilization per Long Term Compliance Action item 59.

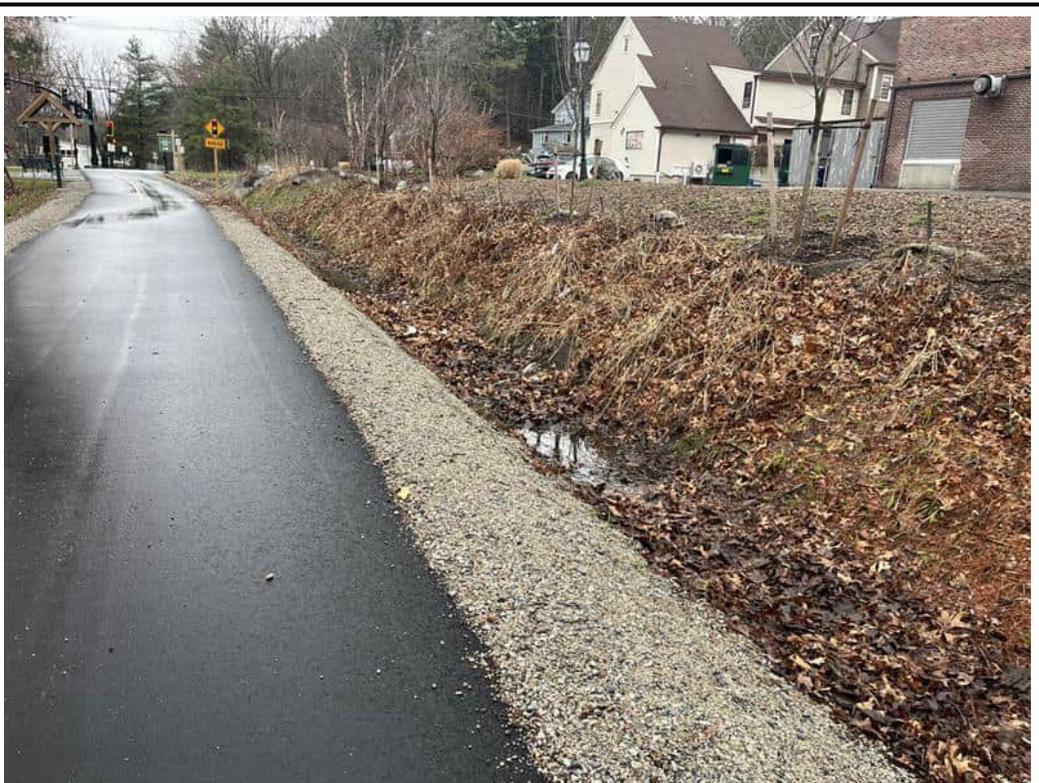
**Photo No. 4**    **Date:**  
4/7/2025

53	<p>Stone was observed requiring removal from the swale on the east side of the trail at Station 172+00 to 173+00  <b>Priority: High</b></p>	7/29/2024	8/6/2024	Remove stone from the swale.	<p>8/5/2024 - Observation remains.  8/7/2024 - Observation remains.  8/12/2024 - Observation remains. Material was observed to have migrated within the swale to Station 173+50.  8/16/2024 - Stone is still present within the swale.  8/20/2024 - Observation remains. Crushed stone has migrated further down the swale to Station 171+50.  8/27/2024 - Observation remains. Stone is still present within the swale.  9/3/2024 - Observation remains.  9/10/2024 - Observation remains. Stone is still present within the swale.  9/16/2024 - Observation remains. The contractor indicated that the stone within the swale would be hand removed.  9/23/2024 - Observation remains.  9/27/2024 - Observation remains. It appears as though some stone has migrated further south down the swale.  10/4/2024 - Observation remains. Stone is still present within the swale.  10/8/2024 - Observation remains.  10/15/2024 - Observation remains. Stone is covered with vegetation in some areas.  10/22/2024 - Observation remains. Stone is covered with vegetation in some areas.  10/29/2024 - Observation remains.  11/5/2024 - Observation remains.  11/12/2024 - Leaf litter has completely covered the stone in this location. The Contractor should indicate if stone has been removed from this location.  11/19/2024 - See previous update.  11/22/2024 - Observation remains. Stone is still present within the swale and requires removal. Leaf litter is currently covering a majority of the stone.  11/25/2024 - Observation remains. Leaf litter is covering a majority of the stone.  12/2/2024 - Observation remains. Stone is present within the swale under leaf litter.  12/6/2024 - Observation remains. See previous update.  12/12/2024 - Observation remains. Stone is present within the swale under the leaf litter.  12/20/2024 - Observation remains. Stone is present within the swale under the leaf litter.  12/26/2024 - Observation remains. Stone is present within the swale under the leaf litter and snow.  12/31/2024 - Observation remains. Stone is present within the swale under the leaf litter.  1/2/2025 - Observation remains. Stone is present within the swale under the leaf litter.  1/9/2025 - Observation remains. Stone is present within the swale under the leaf litter.  1/15/2025 - Observation remains. Further stone has discharged into the swale at this location, and stone is still present under leaf litter.  1/23/2025 - Observation remains. Stone is present within the swale under the leaf litter and snow.  1/30/2025 - Observation remains. Stone is present within the swale under the leaf litter and snow. Trash was also observed within the swale in this area.  2/4/2025 - Observation remains. Stone is present within the swale under the leaf litter and snow. Trash was also present within the swale in this area.  2/11/2025 - Observation remains. Stone is present within the swale under the leaf litter and snow. Trash is present within the swale in this area.  4/2/2025 - Observation remains. Stone is present within the swale under the leaf litter.  4/7/2025 - Observation remains. Stone is present within the swale under the leaf litter.</p>

View of the location where crushed stone is present in the swale at Station 173+00 per Compliance Action Item 53.

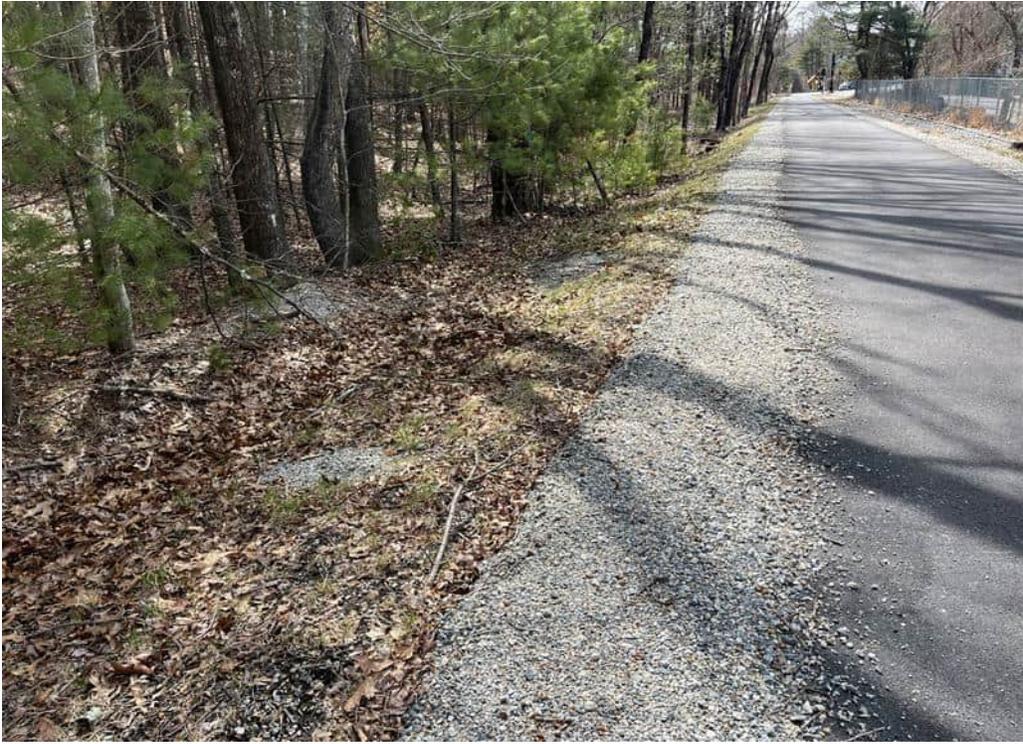
<p><b>Site Location</b> Bruce Freeman Rail Trail Right-of-Way</p>		<p><b>BETA Project No.</b> 24.10326.23</p>
<p><b>Photo No. 5</b></p>	<p><b>Date:</b> 4/7/2025</p>

<p><b>Direction Photo Taken:</b>  Toward the South</p>		
<p><b>Description:</b>  View of a location where crushed stone has migrated on to and off of the path at Station 181+00 per Compliance Action Item 58.</p>		
<p><b>Photo No. 6</b></p>	<p><b>Date:</b> 4/7/2025</p>

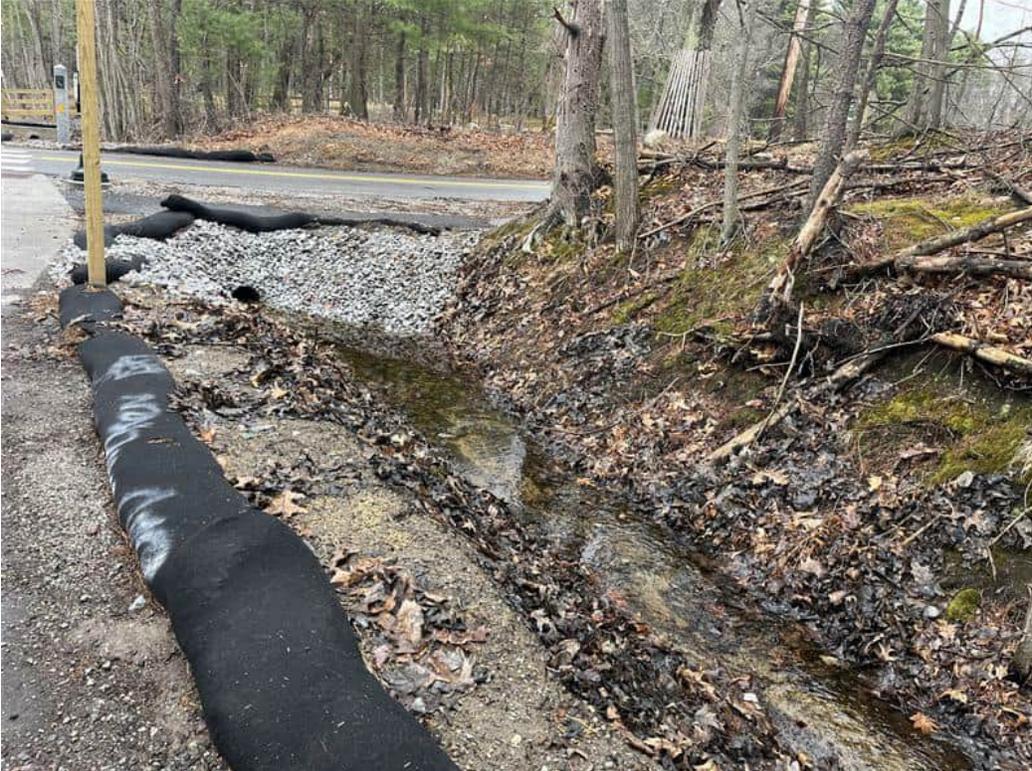
41	Stream Bank has been regraded beyond the limit of work at Station 216+00 <b>Priority: High</b>	5/28/2024	6/4/2024	The Contractor should confirm if this work was permitted by the Conservation Commission, as it does not appear to be a part of the approved plans/impacts. MassDOT should be consulted on next steps regarding notification and potential restoration.	<p>5/31/2024 - Observation remains.  6/7/2024 - Observation remains.  6/14/2024 - Observation remains.  6/17/2024 - Observation remains.  6/24/2024 - Observation remains.  6/27/2024 - Observation remains.  7/8/2024- Observation remains.  7/15/2024 - This area could not be assessed due to paving operations ongoing during the inspection.  7/22/2024 - Crushed stone and sediment continue to be discharged to the stream between Stations 215+00 and 217+00 due to overtopped and undermined compost filter tubes.  7/29/2024 - Observation remains.  8/5/2024 - Observation remains.  8/7/2024 - Observation remains.  8/12/2024 - Observation remains. Crushed stone is still present in the streambed at this location.  8/16/2024 - Observation remains.  8/20/2024 - Stone has been removed; however, additional alteration to Resource Areas beyond the limit of work continue.  8/27/2024 - Observation remains.  9/3/2024 - Observation remains.  9/10/2024 - Observation remains. Stone has been observed as discharging into the streambed in this location again.  9/16/2024 - Observation remains.  9/23/2024 - Observation remains. Stone is still present within the streambed at this location.  9/27/2024 - Observation remains.  10/4/2024 - Observation remains.  10/8/2024 - Observation remains.  10/15/2024 - Observation remains. Stone is still present within the streambed at this location.  10/22/2024 - Observation remains. Stone is still present within the streambed at this location.  10/29/2024 - Observation remains. Stone is still present within the streambed at this location.  11/5/2024 - Observation remains. The PVC pipe that was installed at this location was observed to be covered with stone and is no longer visible near Station 215+00. Stone is still present within the streambed at this location.  11/12/2024 - Observation remains. The streambed in this location is covered with leaf litter. See previous update.  11/19/2024 - Observation remains. As discussed with the Conservation Agent in the field, further coordination between the Town and MassDOT will be required to clean/repair the culvert, as the degraded condition of the culvert prompted the contractor to armor the stream banks. Further coordination will also be required for restoration of banks.  11/22/2024 - Observation remains. See previous update.  11/25/2024 - Observation remains. See update from 11/19/2024.  12/2/2024 - Observation remains. See update from 11/19/2024.  12/6/2024 - Observation remains. See update from 11/19/2024.  12/12/2024 - Observation remains. See update from 11/19/2024.  12/20/2024 - Observation remains. See update from 11/19/2024.  12/26/2024 - Observation remains. See update from 11/19/2024.  12/31/2024 - Observation remains. See update from 11/19/2024.  1/2/2025 - Observation remains. See update from 11/19/2024.  1/9/2025 - Observation remains. See update from 11/19/2024.  1/15/2025 - Observation remains. See update from 11/19/2024.  1/23/2025 - Observation remains. See update from 11/19/2024.  1/30/2024 - Observation remains. See update from 11/19/2024.  2/4/2025 - Observation remains. See update from 11/19/2024.  2/11/2025 - Observation remains. See update from 11/19/2024.  4/2/2025 - Observation remains. See update from 11/19/2024.  4/7/2025 - Observation remains. Stone was placed along the culvert to stabilize the Bank at Station 215+75. See update from 11/19/2024.</p>

<p><b>Direction Photo Taken:</b>  Toward the South</p>		
<p><b>Description:</b> View of the location where the stream bank has been regraded beyond the limits of work and the newly installed stone around the culvert at Station 215+75 per Long Term Compliance Action Items 41 and 62. Note soils along the Bank require stabilization.</p>

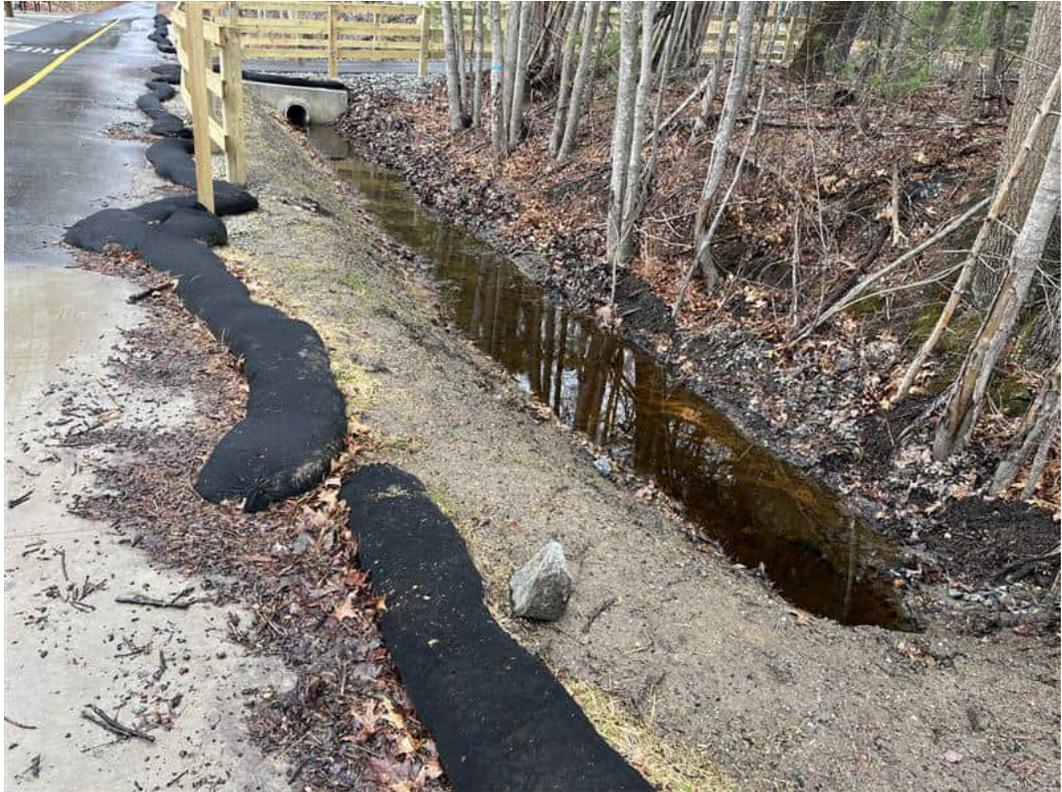
**Photo No. 7**     **Date:**  
4/7/2025

Item	Location/ Description	Observation Date	Resolution Due Date	Recommended Resolution / Resolution Date	Comments/Updates
62	Loam and seed was applied to the streambank at Station 215+00 to 217+00 and requires further stabilization <b>Priority: High</b>	11/25/2024	12/2/2024	An erosion control blanket should be installed along this slope.	<p>12/2/2024 - Loam and seed have been applied to the streambank at Station 215+00. Stabilization is required at Stations 215+00 to 217+00.</p> <p>12/6/2024 - Observation remains. See previous update.</p> <p>12/12/2024 - Observation remains. Rill erosion was observed within the loam applied to this area from Station 215+00 to 216+00.</p> <p>12/20/2024 - Observation remains. Loam has begun to erode, resulting in a discharge to the stream at Station 216+50.</p> <p>12/26/2024 - Observation remains. No further discharge was observed in this location.</p> <p>12/31/2024 - Observation remains. Additional loam has eroded resulting in a discharge to the stream at Station 216+50.</p> <p>1/2/2025 - Observation remains. No further discharge was observed in this location.</p> <p>1/9/2025 - Observation remains. Straw was observed to have been placed along portions of the streambank; however, this area should be stabilized using an erosion control blanket.</p> <p>1/15/2025 - Observation remains. Erosion causing a discharge of loam and straw into the stream was observed at Station 216+50.</p> <p>1/23/2025 - Observation remains. Snow coverage is present within the stream and on the streambank. No further discharge was observed during this inspection.</p> <p>1/30/2025 - Observation remains. Snow coverage is present within the stream and on the streambank. No further discharge was observed during this inspection.</p> <p>2/4/2025 - Observation remains. Snow coverage is still present over a majority of the stream and on the streambank. No further discharge was observed; however, stabilization is still required.</p> <p>2/11/2025 - Observation remains. Snow coverage is present over the stream and on the streambank.</p> <p>4/2/2025 - Observation remains. Loam was observed to have eroded and discharged into the stream at Station 215+75. Rill erosion was also observed on the streambank at Station 216+25.</p> <p>4/7/2025 - Observation remains. Stone has been installed around the culvert at Station 215+75 to stabilize the Bank. No further discharge in this location was observed; however stabilization still required.</p>

View of exposed soils requiring stabilization at Station 216+00 per Compliance Action Item 62.

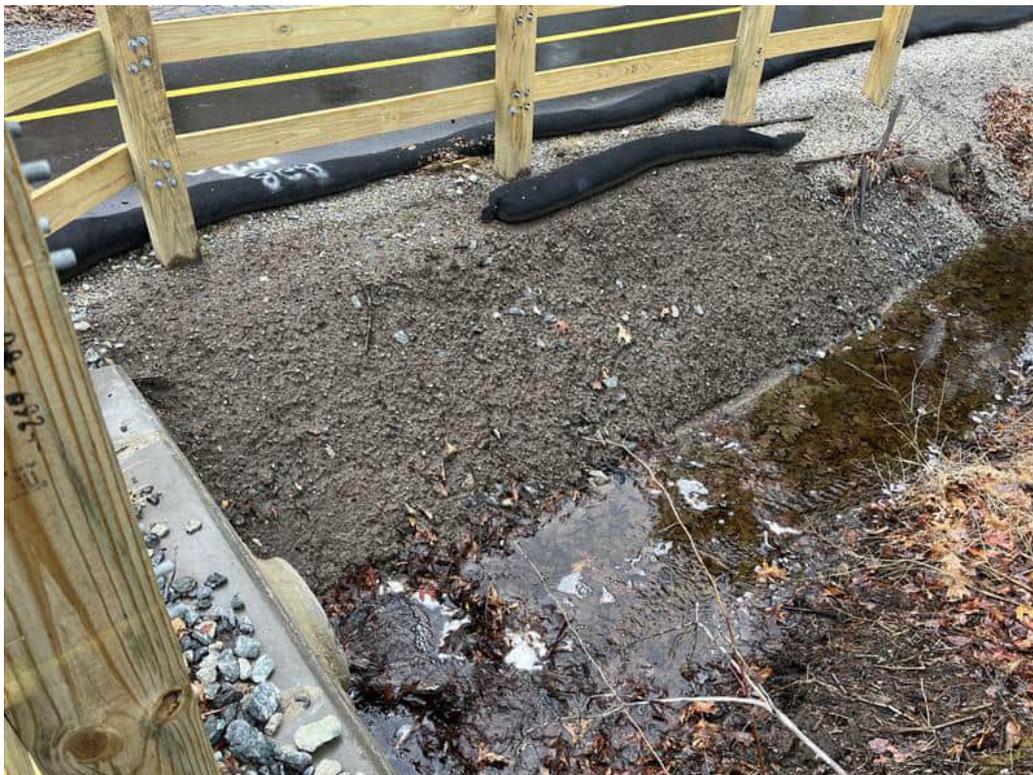
**Photo No. 8**     **Date:**  
4/7/2025

View of exposed soils requiring stabilization at Station 217+25 per Long Term Compliance Action item 62.

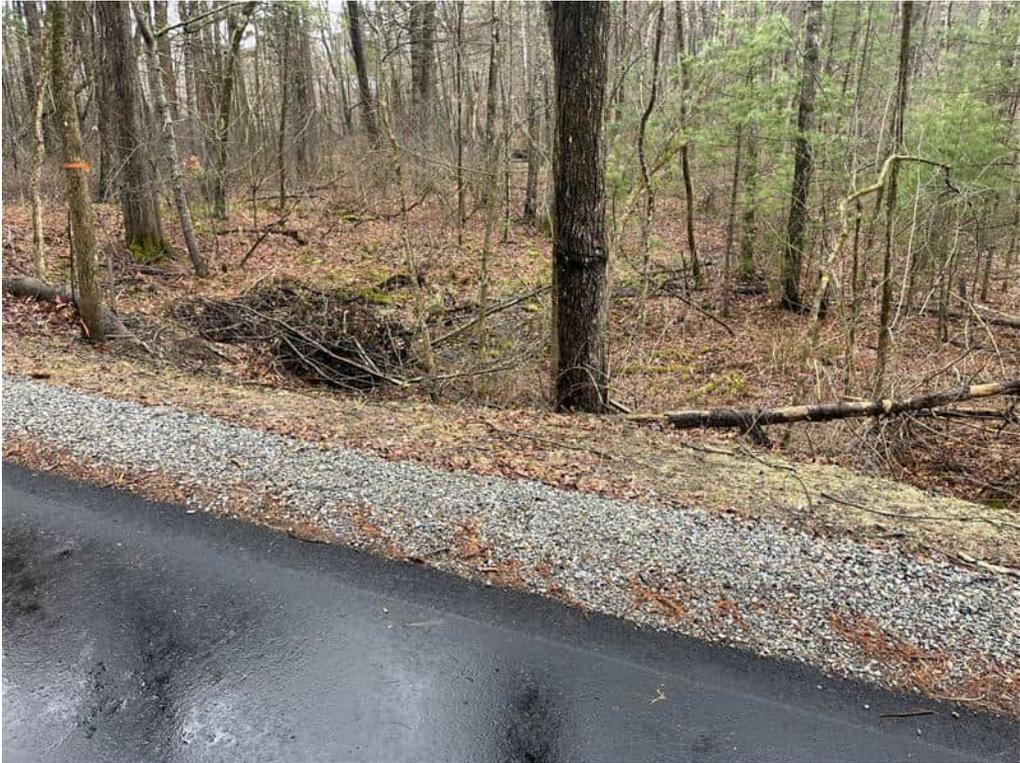
<b>Site Location</b> Bruce Freeman Rail Trail Right-of-Way		<b>BETA Project No.</b> 24.10326.23
<b>Photo No. 9</b>	<b>Date:</b> 4/7/2025

32	<p>Soil and organic debris has been placed within the wetland between wetland flagging WF#23-119 and WF#23-118 at Station 224+00  <b>Priority: High</b></p>	5/21/2024	5/28/2024	<p>Remove all material and provide stabilization of the area with the approved wetland seed mixture. Straw should also be placed for interim stabilization.</p>	<p>5/28/2024 - Observation remains.  5/31/2024 - Observation remains.  6/7/2024 - Observation remains.  6/14/2024 - Observation remains.  6/17/2024 - This area has been hydroseeded multiple times, but the debris should also be removed from the downgradient wetland.  6/24/2024 - Observation remains.  6/27/2024 - Observation remains. The area was hydroseeded again.  7/8/2024 - Germination was observed and the area will be monitored for stabilization.  7/15/2024 - See previous update.  7/22/2024 - Observation remains.  7/29/2024 - Observation remains.  8/5/2024 - Observation remains.  8/7/2024 - Regrowth of vegetation has been observed in this area. This item will remain open until the area is fully stabilized. Debris is still present in wetland and requires removal.  8/12/2024 - Observation remains.  8/16/2024 - Observation remains.  8/20/2024 - Debris is still present within the wetland.  8/27/2024 - Observation remains.  9/3/2024 - Debris is still present in the wetland and slopes upgradient of the wetland require stabilization.  9/10/2024 - Observation remains.  9/16/2024 - Debris has been removed from the wetland; however, soils require stabilization.  9/23/2024 - Observation remains. Soils require stabilization at this location.  9/27/2024 - Observation remains. The contractor indicated hydroseed will be applied to this area soon.  10/4/2024 - Observation remains. Hydroseed has not been applied to this area.  10/8/2024 - Observation remains. Hydroseed has not been applied to this area.  10/15/2024 - Observation remains. Hydroseed has not been applied to this area.  10/22/2024 - Observation remains. Hydroseed has not been applied to this area.  10/29/2024 - Observation remains. Hydroseed has not been applied to this area.  10/29/2024 - Observation remains. Hydroseed has not been applied to this area.  11/5/2024 - Observation remains. Hydroseed has not been applied to this area.  11/12/2024 - Observation remains.  11/19/2024 - Hydroseed has been applied to this location. Once the area has become stabilized this action item will be closed.  11/22/2024 - Observation remains. No germination has been observed in this area.  11/25/2024 - Observation remains. No germination has been observed in this area.  12/2/2024 - Observation remains. No germination has been observed in this area.  12/6/2024 - Observation remains. No germination has been observed in this area.  12/12/2024 - Observation remains. Some germination has been observed within this location. Observation will remain open until stabilization is complete.  12/20/2024 - Observation remains. See previous update.  12/26/2024 - Observation remains. See update from 12/12/2024.  12/31/2024 - Observation remains. See update from 12/12/2024.  1/2/2025 - Observation remains. See update from 12/12/2024.  1/9/2025 - Observation remains. See update from 12/12/2024.  1/15/2025 - Observation remains.  1/23/2025 - Observation remains.  1/30/2025 - Observation remains.  2/4/2025 - Observation remains.  2/11/2025 - Observation remains.  4/2/2025 - Observation remains. Hydroseed was applied to this location in November of 2024; however, exposed soil is still present. This area will be monitored to determine if additional seed will be required to stabilize the area.  4/7/2025 - Observation remains. No further vegetation was observed in this location, see previous update.</p>

<b>Direction Photo Taken:</b>  Toward the West		
<b>Description:</b>  View of the location where stabilization is required at Station 224+00 per Compliance Action Item 32.		
<b>Photo No. 10</b>	<b>Date:</b> 4/7/2025

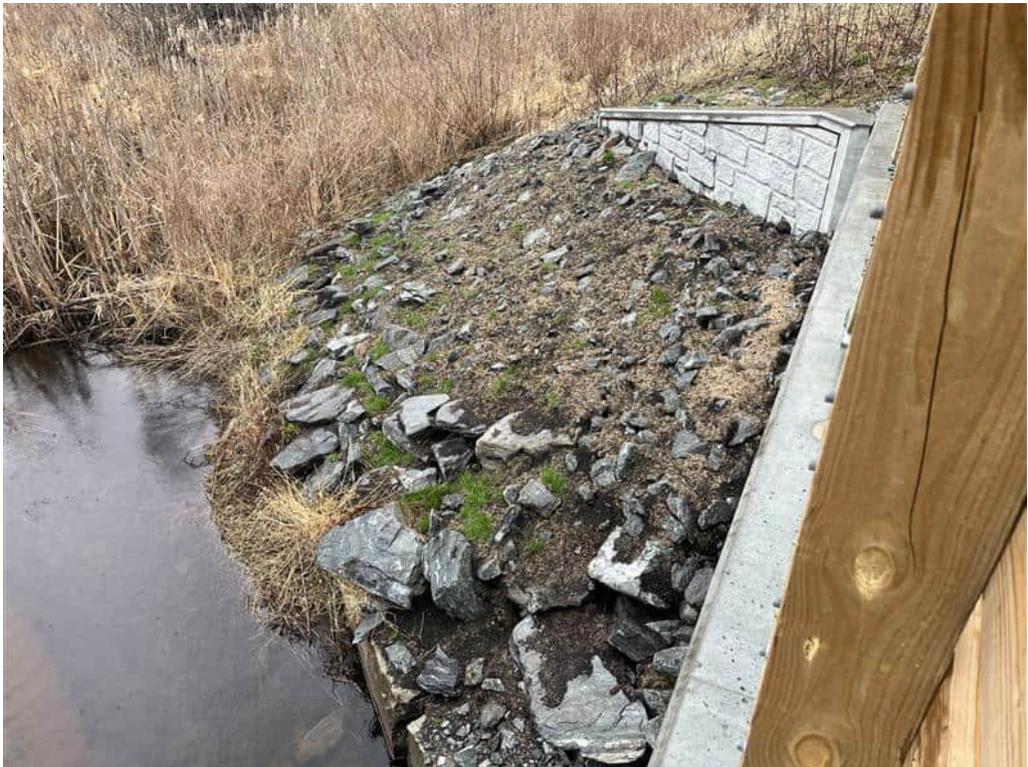
<b>Direction Photo Taken:</b>  Toward the West		
<b>Description:</b>  View of the Bank of Pantry Brook that has been hydroseeded but is not considered stabilized at Station 264+50 per Long Term Compliance Action Item 59.

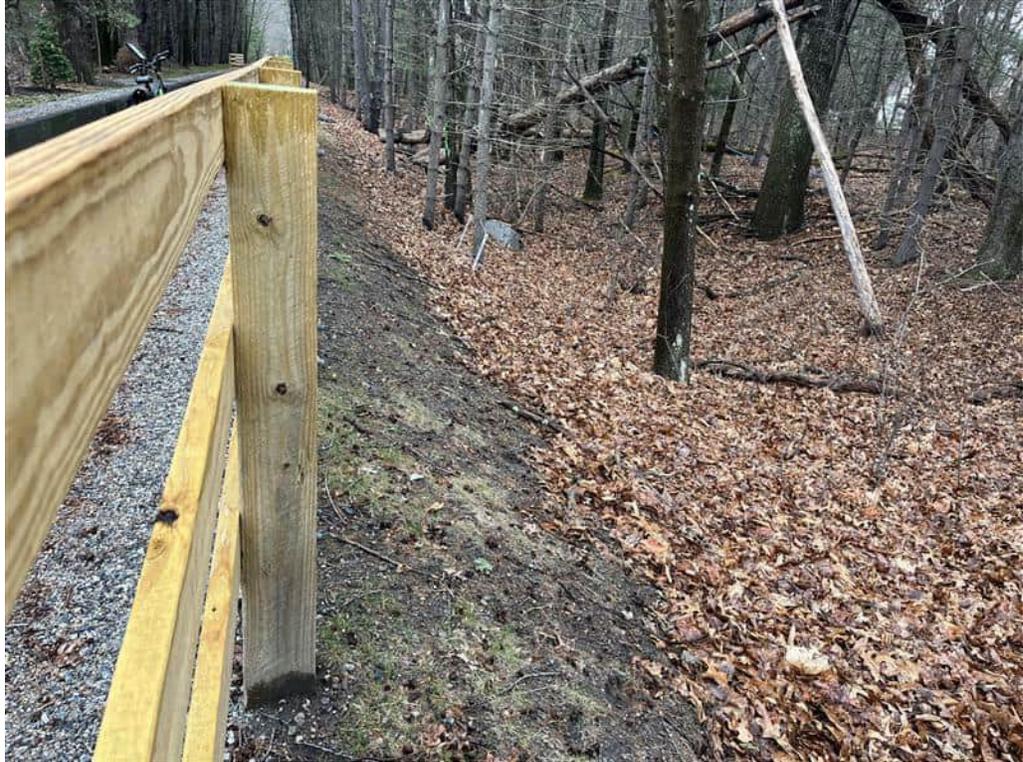
**Photo No. 11**    **Date:** 4/7/2025

47	<p>Slope stabilization required due to condition of compost filter tubes at Stations 265+50 and 273+00  <b>Priority: High</b></p>	6/7/2024	6/14/2024	<p>Stabilize the slope with the approved seed mixture and provide interim stabilization such as straw mulch.</p>	<p>6/14/2024 - Observation remains.  6/17/2024 - Observation remains.  6/24/2024 - Observation remains.  6/27/2024 - Observation remains.  7/8/2024 - Observation remains.  7/15/2024 - This area could not be assessed due to paving operations ongoing during the inspection.  7/22/2024 - Observation remains.  7/29/2024 - Observation remains.  8/5/2024 - Observation remains.  8/7/2024 - Regrowth of vegetation has been observed in this area. This item will remain open until the area is fully stabilized.  8/12/2024 - Observation remains.  8/16/2024 - Observation remains.  8/20/2024 - Application of the approved seed mixture is required at this location.  8/27/2024 - Observation remains.  9/3/2024 - Observation remains.  9/10/2024 - Observation remains. Application of the approved seed mixture if required at this location.  9/16/2024 - Observation remains.  9/23/2024 - Observation remains.  9/27/2024 - Observation remains. The contractor indicated hydroseed will be applied here soon.  10/4/2024 - Observation remains. Hydroseed has not been applied to this area.  10/8/2024 - Observation remains. Hydroseed has not been applied to this area.  10/15/2024 - Observation remains. See previous update.  10/22/2024 - Observation remains. No germination has been observed.  10/29/2024 - Observation remains. No germination has been observed.  11/5/2024 - Observation remains. Some germination has been observed but the area is not considered stabilized.  11/12/2024 - Observation remains. See previous update.  11/19/2024 - Observation remains. See previous updates.  11/22/2024 - Observation remains. See update from 11/5/2024.  11/25/2024 - Observation remains.  12/2/2024 - Observation remains.  12/6/2024 - Observation remains.  12/12/2024 - Observation remains.  12/20/2024 - Observation remains.  12/26/2024 - Observation remains.  12/31/2024 - Observation remains.  1/2/2025 - Observation remains.  1/9/2025 - Observation remains.  1/15/2025 - Observation remains.  1/23/2025 - Observation remains.  1/30/2025 - Observation remains.  2/4/2025 - Observation remains.  2/11/2025 - Observation remains.  4/2/2025 - Observation remains. Vegetative stabilization has been achieved in some areas; however, the northwestern Bank of Pantry Brook has been hydroseeded but stabilization has not been achieved. The Bank will continue to be monitored to determine if more seed is required.  4/7/2025 - Observation remains. Exposed soil is present within this area both on the Bank of Pantry Brook and throughout the trail. Areas where hydroseed was applied will be monitored to determine if more seed is required.</p>

View of exposed soils requiring stabilization at Station 269+00 per Compliance Action Item 47.

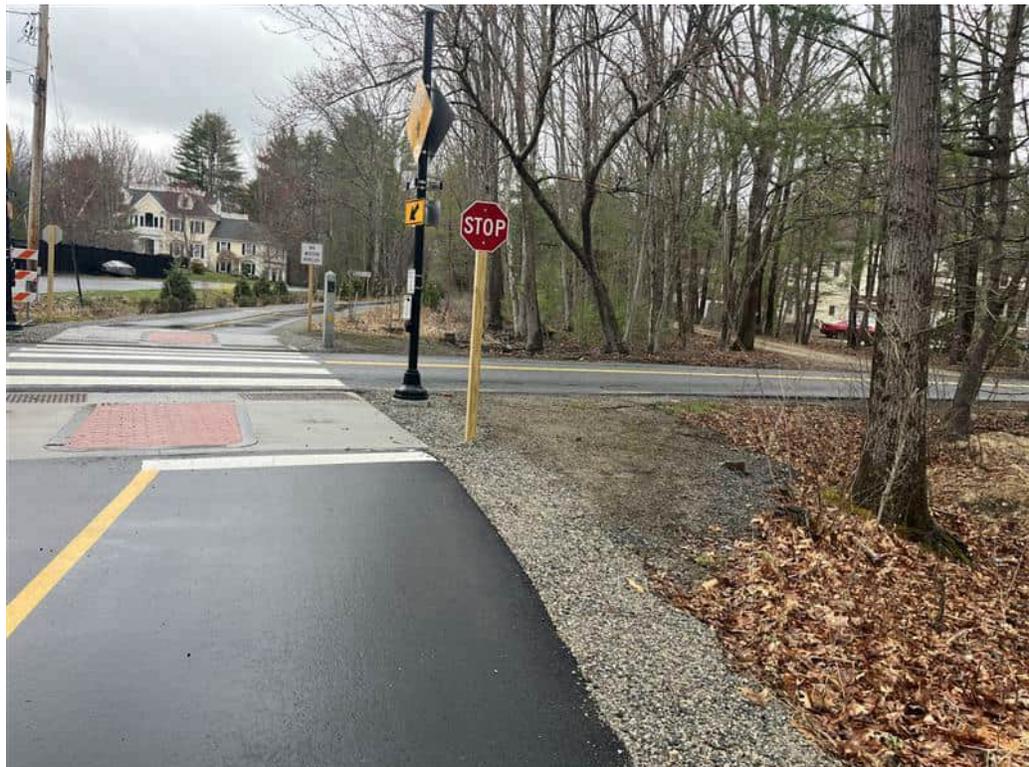
**Photo No. 12**    **Date:** 4/7/2025

View of the Haynes Road intersection at Station 275+00 that required stabilization per Long Term Compliance Action Item 59.

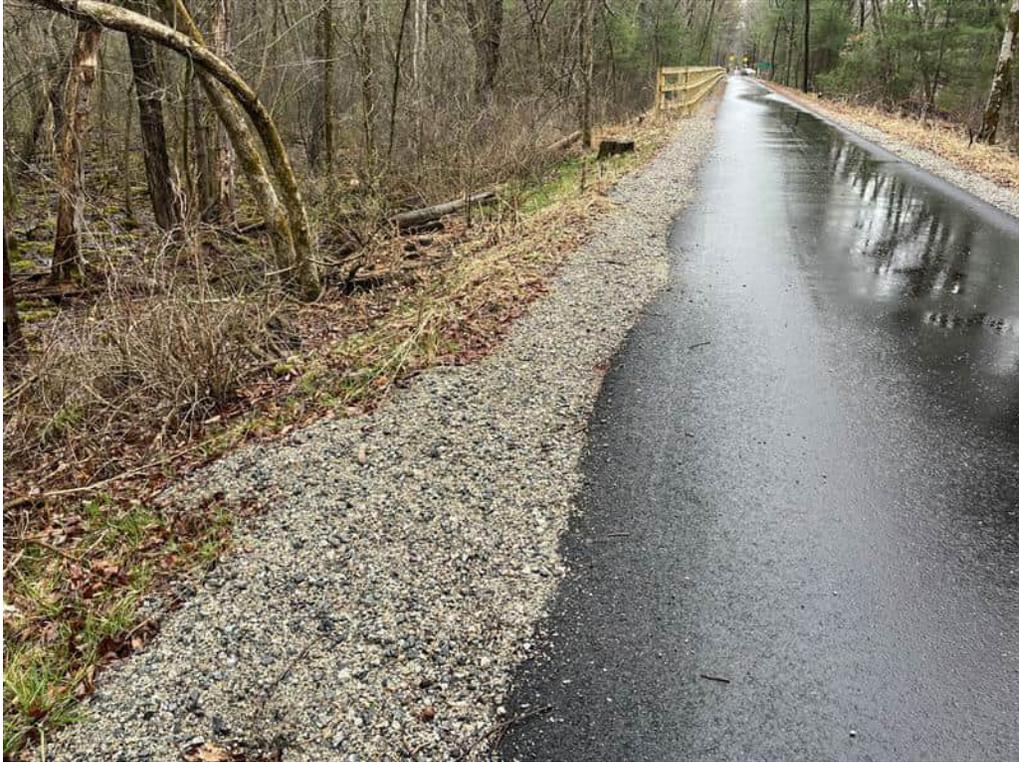
**Photo No. 13**     **Date:**  
4/7/2025

View of a location where crushed stone has migrated off of the path at Station 279+00 per Compliance Action Item 58.

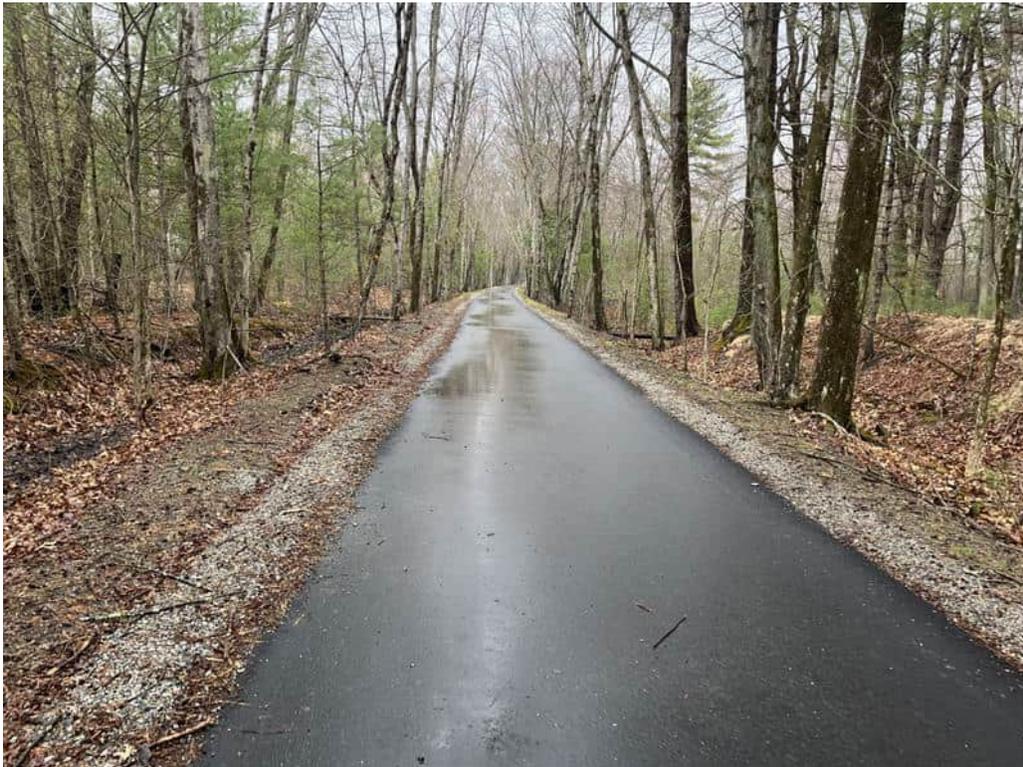
**Photo No. 14**     **Date:**  
4/7/2025

View of exposed soil that requires stabilization at Station 298+00 per Long Term Compliance Action Item 59.

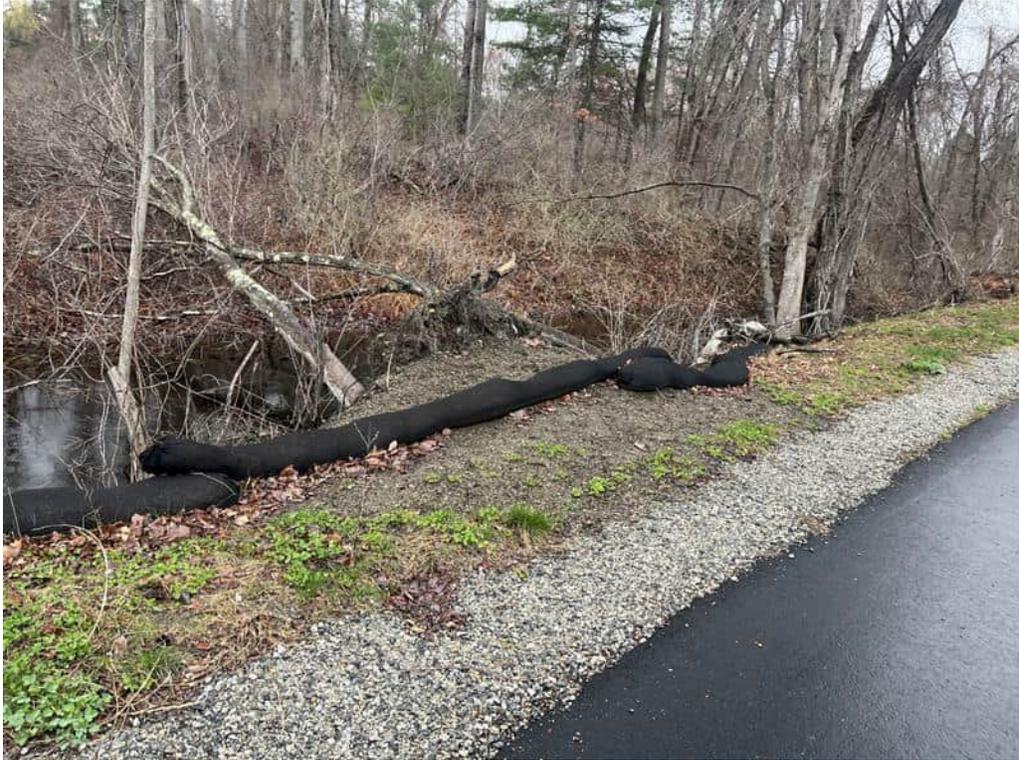
**Photo No. 15**    **Date:** 4/7/2025

View of the location of placed loam that requires stabilization at Station 311+50 per Long Term Compliance Action Item 59.

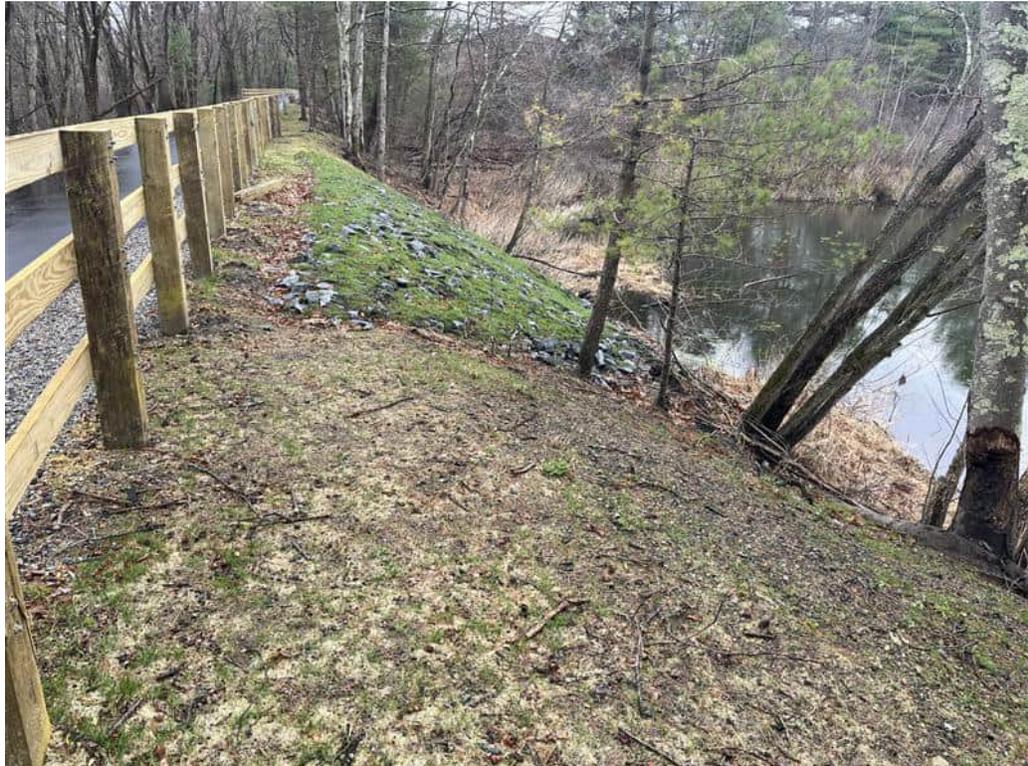
**Photo No. 16**    **Date:** 4/7/2025

42	<p>Riprap slope extends beyond limits of work along the WF1 Series wetland near flags 103 to 107  <b>Priority: High</b></p>	5/28/2024	6/4/2024	<p>The Contractor should confirm if this work was permitted by the Conservation Commission, as it does not appear to be a part of the approved plans/impacts. MassDOT should be consulted on next steps regarding notification and potential restoration.</p>	<p>5/31/2024 - Observation remains.  6/7/2024 - Observation remains.  6/14/2024 - Riprap slope has been altered and active construction is repairing the area.  6/17/2024 - During this inspection, additional work in support of the repair/potential replacement of an underlying pipe has been ongoing. It is recommended that the contractor confirm that they have coordinated with the Conservation Commission for this work and provide a restoration plan for the area once work is complete.  6/24/2024 - During this inspection, BETA was informed that the existing cast iron pipe was replaced with a new concrete 12-inch reinforced concrete pipe. It appears that riprap was replaced along the side slopes to mirror conditions observed prior to this inspection.  6/27/2024 - During this inspection, the area was observed to have been rolled and prepared for paving. Hydroseed was applied and plantings were installed.  7/8/2024 - Germination was observed and the area will be monitored for stabilization. See previous updates regarding Conservation Commission coordination.  7/15/2024 - This area could not be assessed due to paving operations ongoing during the inspection.  7/22/2024 - See previous updates regarding Conservation Commission coordination.  7/29/2024 - Observation remains.  8/5/2024 - Observation remains.  8/7/2024 - Observation remains.  8/12/2024 - Observation remains. Regrowth of vegetation has been observed in this area and will continue to be monitored.  8/16/2024 - Observation remains.  8/20/2024 - Observation remains.  8/27/2024 - Observation remains.  9/3/2024 - Observation remains.  9/10/2024 - Observation remains.  9/16/2024 - Observation remains.  9/23/2024 - Observation remains.  9/27/2024 - Observation remains.  10/4/2024 - Observation remains.  10/8/2024 - Observation remains.  10/15/2024 - Observation remains.  10/22/2024 - Observation remains.  10/29/2024 - Observation remains.  11/5/2024 - Observation remains.  11/12/2024 - Observation remains. The timber fence has been installed upgradient of this area.  11/19/2024 - Observation remains. As discussed with the Conservation Agent in the field, an as-built should be prepared for this area to quantify any additional impacts that may be addressed through a permit amendment.  11/22/2024 - Observation remains. See previous update.  11/25/2024 - Observation remains. See update from 11/19/2024.  12/2/2024 - Observation remains. See update from 11/19/2024.  12/6/2024 - Observation remains. See update from 11/19/2024.  12/12/2024 - Observation remains. See update from 11/19/2024.  12/20/2024 - Observation remains. See update from 11/19/2024.  12/26/2024 - Observation remains. See update from 11/19/2024.  12/31/2024 - Observation remains. See update from 11/19/2024.  1/2/2025 - Observation remains. Leaf litter that was previously observed at the bottom of the slope has blown away and it appears that exposed soil with no observable germination is present.  1/9/2025 - Observation remains. See update from 1/2/2025 and 11/19/2024.  1/15/2025 - Observation remains. See update from 1/2/2025 and 11/19/2024.  1/23/2025 - Observation remains. See update from 1/2/2025 and 11/19/2024.  1/30/2025 - Observation remains. See update from 1/2/2025 and 11/19/2024.  2/4/2025 - Observation remains. See update from 1/2/2025 and 11/19/2024.  2/11/2025 - Observation remains. See update from 1/2/2025 and 11/19/2024.  4/2/2025 - Observation remains. See update from 1/2/2025 and 11/19/2024.  4/7/2025 - Observation remains. See update from 1/2/2025 and 11/19/2024.</p>

View of the location of the riprap slope that extends beyond the limit of work along the WF1 Series wetland and exposed soil requiring stabilization at Station 332+00 per Long Term Compliance Action Item 42 and 59.
