Environmental Monitor Construction Site Inspection Report MassDOT Project #608164 Construction Contract # 119678 EM Report #51						
Project Description: Bruce Freeman Rail Trail Right-of-Way Permit Description(s): Order of Conditions (MGL Chapter 131, Section 40 and 310 CMR 10.00, Mass DEP File No. 301-1362); 2022 EPA NPDES General Permit for Discharges from Construction Areas; U.S. Army Corps of Engineers Permit No NAE-2021-01975.

I. General Project Information						
Project Name:	Bruce Freeman Rail Trail - Phase 2d - Sudbury					
Date of Inspections:	4/14/2025					
Bi Weekly/ Monthly Period Covered:	April Weekly Inspection #3					
Inspector's Name(s):	Anna Haznar					
Inspectors' Contact Information:	ahaznar@beta-inc.com					
II. Weather Information						
	Inspection #1	Inspection #2	Inspection #3	Inspection #4	Inspection #5	Inspection #6
<a href="#">WeatherUnderground</a>	Inspector: Anna Haznar 4/2/2025	Inspector: Anna Haznar 4/7/2025	Inspector: Anna Haznar 4/14/2025	Inspector:	Inspector:	Inspector:
Type of Inspection (i.e. non-storm event, pre-storm event, during-storm event or post-storm event):	Post-storm	Post-storm	Post-storm			
Number of days since last rain event greater

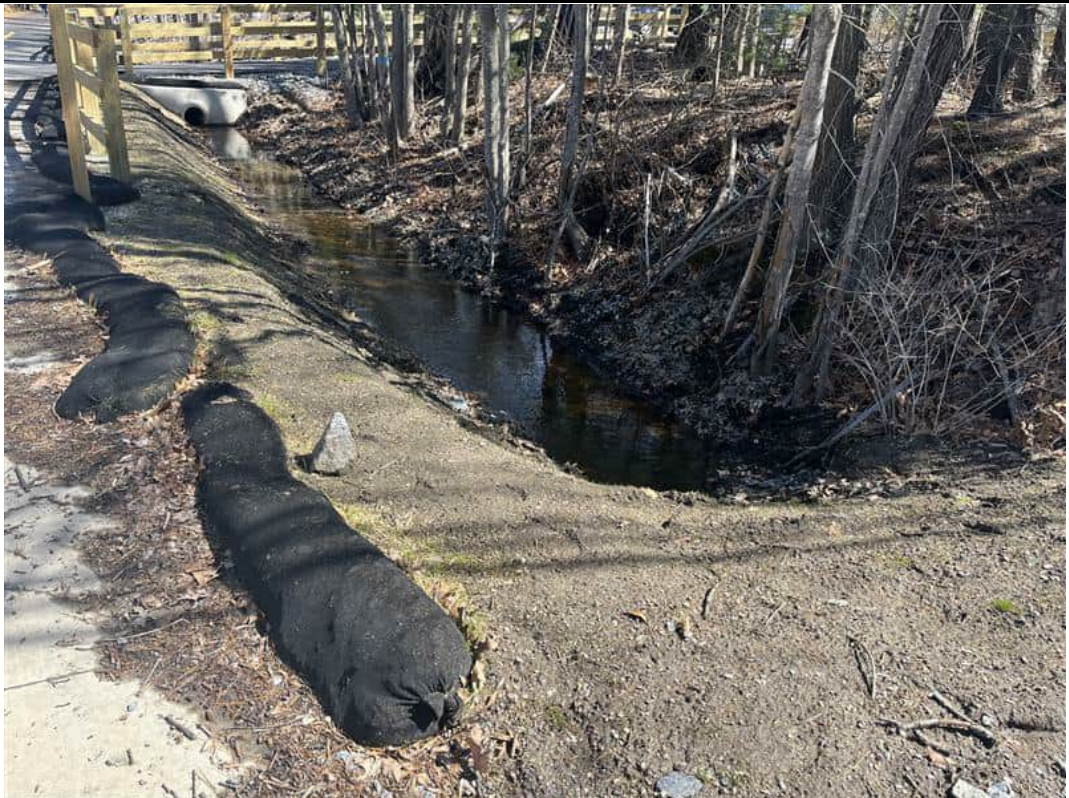
<b>Site Location</b>		<b>BETA Project No.</b>
Bruce Freeman Rail Trail Right-of-Way		24.10326.23
<b>Photo No. 7</b>	<b>Date:</b> 4/14/2025

<b>Direction Photo Taken:</b>  Toward the North		
<b>Description:</b>  View of exposed soils requiring stabilization at Station 216+00 per Compliance Action Item 62. Note some vegetation has been observed along the Bank.		
<b>Photo No. 8</b>	<b>Date:</b> 4/14/2025	 
<b>Direction Photo Taken:</b>  Toward the West		
<b>Description:</b>  View of exposed soils requiring stabilization at Station 217+25 per Long Term Compliance Action item 62.

Item	Location/ Description	Observation Date	Resolution Due Date	Recommended Resolution / Resolution Date	Comments/Updates
62	Loam and seed was applied to the streambank at Station 215+00 to 217+00 and requires further stabilization <b>Priority: High</b>	11/25/2024	12/2/2024	An erosion control blanket should be installed along this slope.	<p>12/2/2024 - Loam and seed have been applied to the streambank at Station 215+00. Stabilization is required at Stations 215+00 to 217+00.</p> <p>12/6/2024 - Observation remains. See previous update.</p> <p>12/12/2024 - Observation remains. Rill erosion was observed within the loam applied to this area from Station 215+00 to 216+00.</p> <p>12/20/2024 - Observation remains. Loam has begun to erode, resulting in a discharge to the stream at Station 216+50.</p> <p>12/26/2024 - Observation remains. No further discharge was observed in this location.</p> <p>12/31/2024 - Observation remains. Additional loam has eroded resulting in a discharge to the stream at Station 216+50.</p> <p>1/2/2025 - Observation remains. No further discharge was observed in this location.</p> <p>1/9/2025 - Observation remains. Straw was observed to have been placed along portions of the streambank; however, this area should be stabilized using an erosion control blanket.</p> <p>1/15/2025 - Observation remains. Erosion causing a discharge of loam and straw into the stream was observed at Station 216+50.</p> <p>1/23/2025 - Observation remains. Snow coverage is present within the stream and on the streambank. No further discharge was observed during this inspection.</p> <p>1/30/2025 - Observation remains. Snow coverage is present within the stream and on the streambank. No further discharge was observed during this inspection.</p> <p>2/4/2025 - Observation remains. Snow coverage is still present over a majority of the stream and on the streambank. No further discharge was observed; however, stabilization is still required.</p> <p>2/11/2025 - Observation remains. Snow coverage is present over the stream and on the streambank.</p> <p>4/2/2025 - Observation remains. Loam was observed to have eroded and discharged into the stream at Station 215+75. Rill erosion was also observed on the streambank at Station 216+25.</p> <p>4/7/2025 - Observation remains. Stone has been installed around the culvert at Station 215+75 to stabilize the Bank. No further discharge in this location was observed; however stabilization still required.</p> <p>4/14/2025 - Observation remains. Some vegetative growth was observed along the Bank of the stream at Station 216+25; however, the area is not considered stabilized. Hydroseed should be applied to the exposed soil.</p>

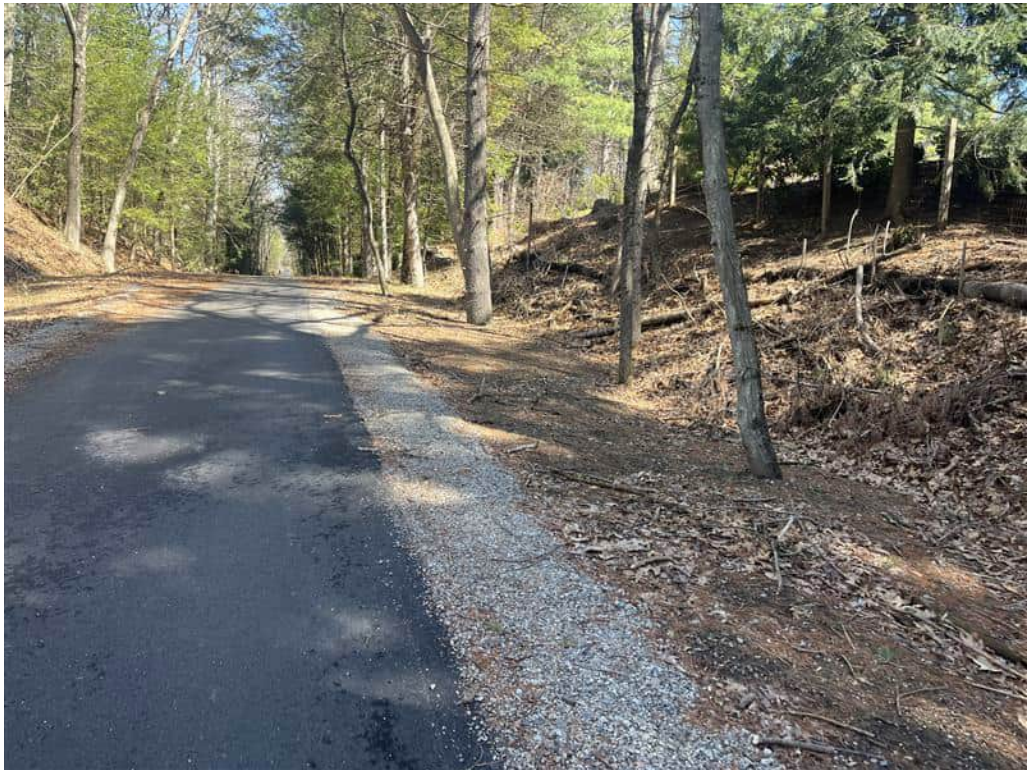
<b>Site Location</b>		Bruce Freeman Rail Trail Right-of-Way		<b>BETA Project No.</b> 24.10326.23
<b>Photo No. 9</b>	<b>Date:</b> 4/14/2025

<b>Direction Photo Taken:</b>  Toward the North				
<b>Description:</b>  View of exposed soils requiring stabilization at Station 231+00 per Long Term Compliance Action item 59.				
<b>Photo No. 10</b>	<b>Date:</b> 4/14/2025

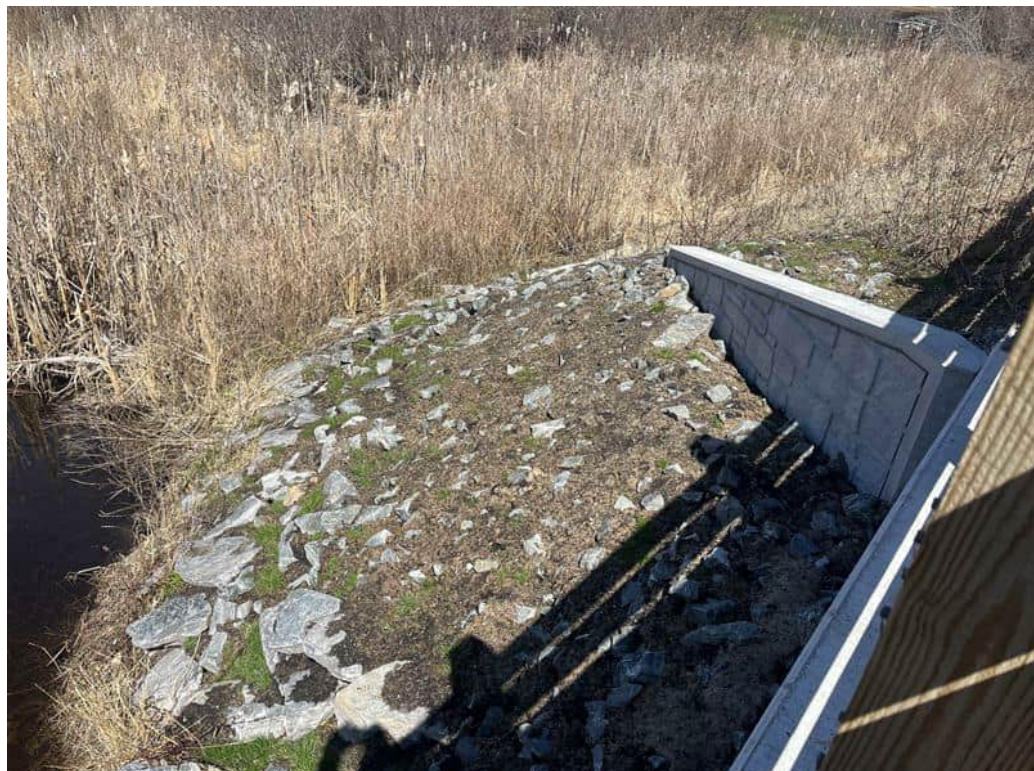
<b>Direction Photo Taken:</b>  Toward the West				
<b>Description:</b>  View of the Bank of Pantry Brook that has been hydroseeded but is not considered stabilized at Station 264+50 per Long Term Compliance Action Item 59.

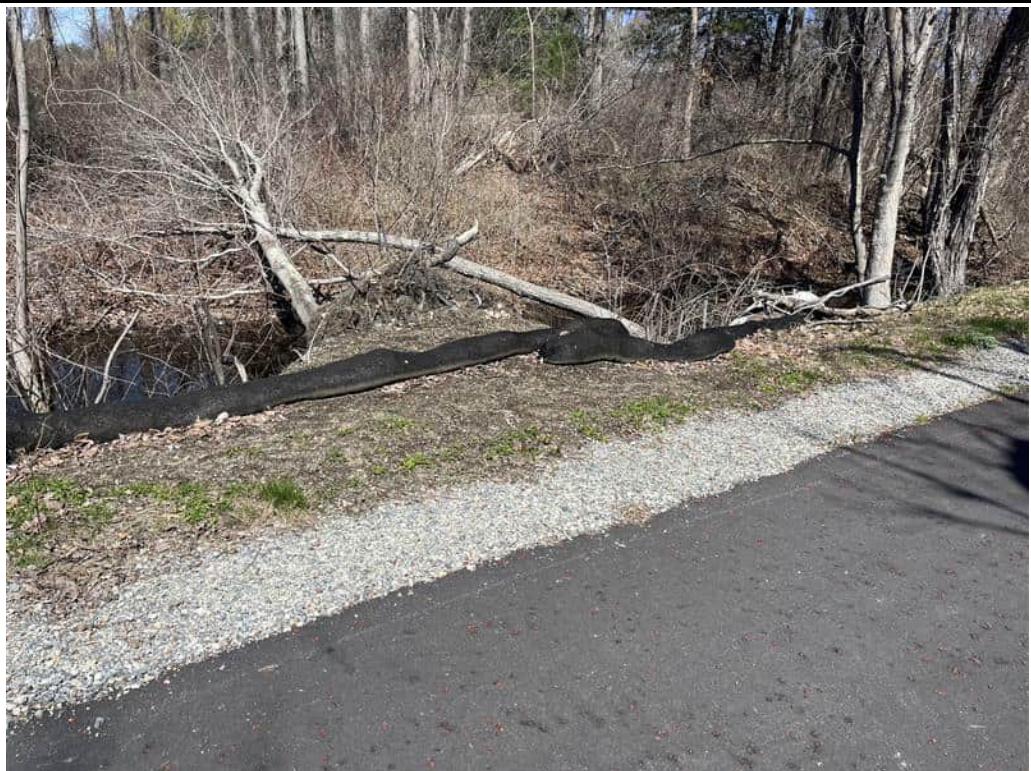
<b>Site Location</b> Bruce Freeman Rail Trail Right-of-Way		<b>BETA Project No.</b> 24.10326.23
<b>Photo No. 15</b>	<b>Date:</b> 4/14/2025

<b>Direction Photo Taken:</b>  Toward the West		
<b>Description:</b>  View of the location of placed loam that requires stabilization at Station 311+50 per Long Term Compliance Action Item 59.		
<b>Photo No. 16</b>	<b>Date:</b> 4/14/2025	 
<b>Direction Photo Taken:</b>  Toward the South		
<b>Description:</b>  View of the location of the riprap slope that extends beyond the limit of work along the WF1 Series wetland and exposed soil requiring stabilization at Station 332+00 per Long Term Compliance Action Item 42 and 59.
