Environmental Monitor Construction Site Inspection Report MassDOT Project #608164 Construction Contract # 119678 EM Report #53						
Project Description: Bruce Freeman Rail Trail Right-of-Way Permit Description(s): Order of Conditions (MGL Chapter 131, Section 40 and 310 CMR 10.00, Mass DEP File No. 301-1362); 2022 EPA NPDES General Permit for Discharges from Construction Areas; U.S. Army Corps of Engineers Permit No NAE-2021-01975.

I. General Project Information						
Project Name:	Bruce Freeman Rail Trail - Phase 2d - Sudbury					
Date of Inspections:	4/28/2025					
Bi Weekly/ Monthly Period Covered:	April Weekly Inspection #5					
Inspector's Name(s):	Jonathan Niro					
Inspectors' Contact Information:	jniro@beta-inc.com					
II. Weather Information						
	Inspection #1	Inspection #2	Inspection #3	Inspection #4	Inspection #5	Inspection #6
<a href="#">WeatherUnderground</a>	Inspector: Anna Haznar 4/2/2025	Inspector: Anna Haznar 4/7/2025	Inspector: Anna Haznar 4/14/2025	Inspector: Anna Haznar 4/21/2025	Inspector: Jonathan Niro 4/28/2025	Inspector:
Type of Inspection (i.e. non-storm event, pre-storm event, during-storm event or post-storm event):	Post-storm	Post-storm	Post-storm	N

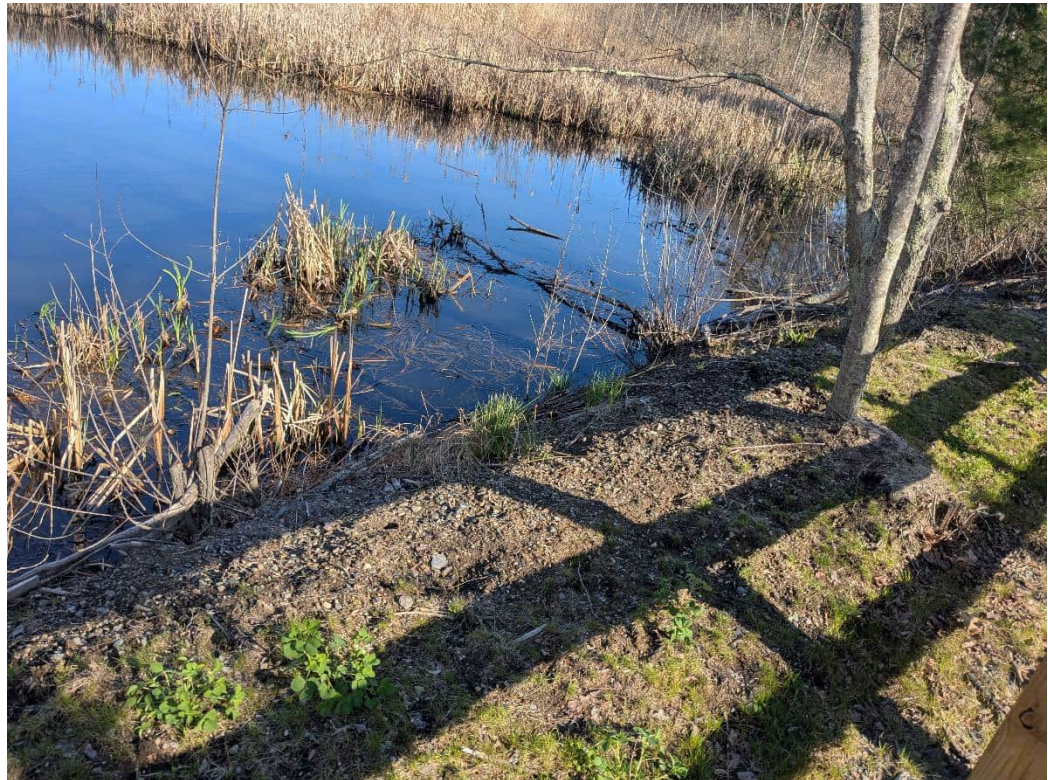
<b>Site Location</b> Bruce Freeman Rail Trail Right-of-Way		<b>BETA Project No.</b> 24.10326.23
<b>Photo No. 1</b>	<b>Date:</b> 4/28/2025

<b>Direction Photo Taken:</b>  Toward the West		
<b>Description:</b>  View of the location of the overtopped compost filter tube and exposed soils beyond the limits of work at Station 105+00 per Compliance Action Item 43.		
<b>Photo No. 2</b>	<b>Date:</b> 4/28/2025

43	<p>Overtopped compost filter tubes and exposed soils beyond the limits of work at Station 105+00</p> <p><b>Priority: High</b></p>	6/7/2024	6/14/2024	<p>Stabilize the area with the approved seed mixture and provide interim stabilization such as straw mulch.</p>	<p>6/14/2024 - Observation remains.</p> <p>6/17/2024 - Observation remains.</p> <p>6/24/2024 - Observation remains.</p> <p>6/27/2024 - Observation remains.</p> <p>7/8/2024 - Observation remains.</p> <p>7/15/2024 - Observation remains.</p> <p>7/22/2024 - Observation remains.</p> <p>7/29/2024 - Observation remains.</p> <p>8/5/2024 - Observation remains.</p> <p>8/7/2024 - Observation remains.</p> <p>8/12/2024 - Observation remains. Some material has migrated off of the compost filter tubes due to erosion.</p> <p>8/16/2024 - Observation remains.</p> <p>8/20/2024 - Application of the approved seed mixture is required at this location.</p> <p>8/27/2024 - Observation remains.</p> <p>9/3/2024 - Observation remains.</p> <p>9/10/2024 - Observation remains. Application of the approved seed mixture is required at this location.</p> <p>9/16/2024 - Observation remains.</p> <p>9/23/2024 - Observation remains.</p> <p>9/27/2024 - Observation remains.</p> <p>10/4/2024 - Hydroseed has been applied here; however, the contractor should provide an update on long-term slope stabilization plans.</p> <p>10/8/2024 - Observation remains. Germination has not been observed.</p> <p>10/15/2024 - Observation remains. Germination has not been observed.</p> <p>10/22/2024 - Observation remains. Some germination has been observed but the area is not considered stabilized.</p> <p>10/29/2024 - Observation remains. No further germination has been observed since the last inspection.</p> <p>11/5/2024 - Observation remains. Some germination has been observed but the area is not considered stabilized.</p> <p>11/12/2024 - Observation remains. Seed has stabilized the area.</p> <p>11/19/2024 - The area adjacent to the path has become stabilized; however, exposed soil is still present next to the culvert past the limit of work.</p> <p>11/22/2024 - Observation remains. See previous update.</p> <p>11/25/2024 - Observation remains. See update from 11/19/2024.</p> <p>12/2/2024 - Observation remains. See update from 11/19/2024.</p> <p>12/6/2024 - Observation remains. See update for 11/19/2024.</p> <p>12/12/2024 - Observation remains. See update from 11/19/2024.</p> <p>12/20/2024 - Observation remains. See update from 11/19/2024.</p> <p>12/26/2024 - Observation remains. See update from 11/19/2024.</p> <p>12/31/2024 - Observation remains. See update from 11/19/2024.</p> <p>1/2/2025 - Observation remains. See update from 11/19/2024.</p> <p>1/9/2025 - Observation remains. See update from 11/19/2024.</p> <p>1/15/2025 - Observation remains. Exposed soils are still present next to the culvert past the limits of work.</p> <p>1/23/2025 - Observation remains. See previous update.</p> <p>1/30/2025 - Observation remains. Exposed soils are present next to the culvert past the limits of work.</p> <p>2/4/2025 - Observation remains. Exposed soils are present next to the culvert past the limits of work.</p> <p>2/11/2025 - Observation remains. Exposed soils past the limits of work are currently frozen and covered with snow.</p> <p>4/2/2025 - Observation remains. Exposed soil past the limits of work is present and requires further stabilization.</p> <p>4/7/2025 - Observation remains. See previous update.</p> <p>4/14/2025 - Observation remains. Exposed soil past the limits of work is present and requires further stabilization.</p> <p>4/21/2025 - Observation remains. Exposed soil past the limits of work is present and requires further stabilization.</p> <p>4/28/2025 - Observation remains. See previous update.</p>

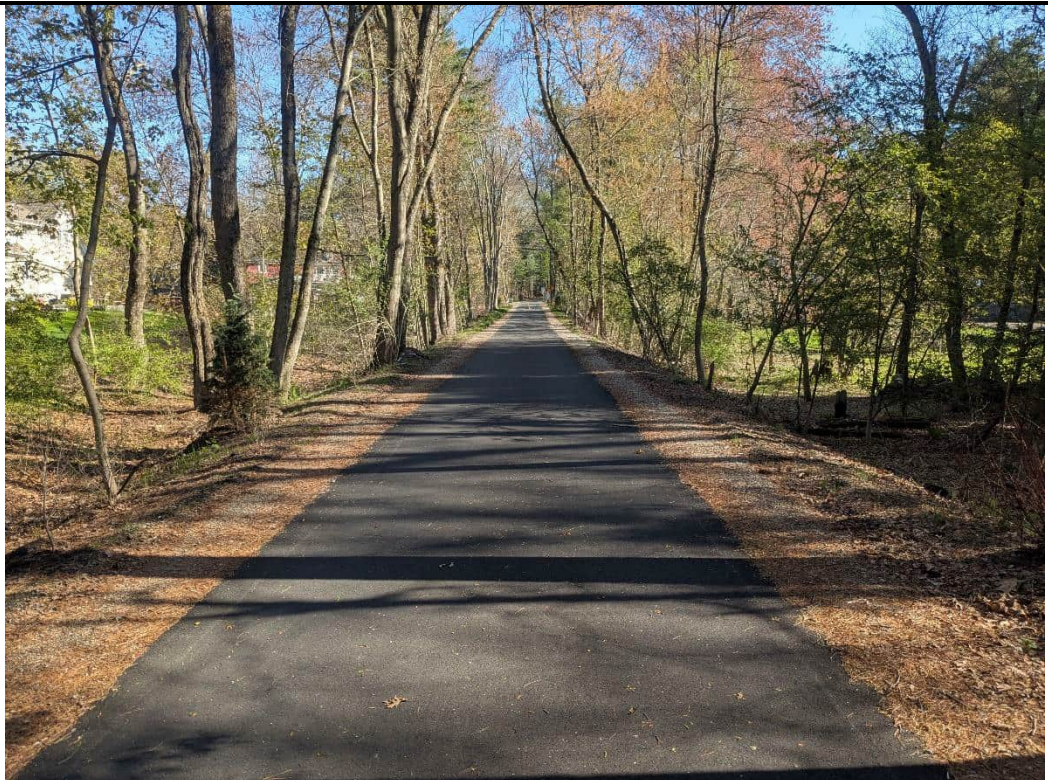
<b>Direction Photo Taken:</b>  Toward the North		
<b>Description:</b>  View of exposed soil at Station 138+00 and garlic mustard per Long Term Compliance Action Item 59.

59	Multiple locations of exposed soils along the Project corridor require stabilization <b>Priority: High</b>	9/3/2024	9/10/2024	The contactor should apply the approved seed mixture to areas of exposed soils and place straw.	<p>4/21/2025 - For readability all previous observations have been removed from the report. Please reference the report from 4/14/2025 to see past observations. Observation remains. Vegetation has begun sprouting in some areas that were hydroseeded; however, most areas are not considered fully stabilized. Multiple areas of exposed soil along the trail still require the application of hydroseed. The seed mix used for stabilization should be submitted to the Conservation Commission.</p> <p>4/28/2025 - Observation remains. See previous update.</p>
58	Crushed stone used for the dense graded crush stone shoulders has been observed as migrating both onto the path, off the sides of the path, and into the adjacent Resource Areas throughout the Project <b>Priority: High</b>	8/7/2024	8/14/2024	Remove all crushed stone from Resource Areas and develop a plan to cease discharges of stone.	<p>4/21/2025 - For readability all previous observations have been removed from the report. Please reference the report from 4/14/2025 to see past observations. Observation remains. Crushed stone was observed both on and off the trail in multiple locations.</p> <p>4/28/2025 - Observation remains. See previous update.</p>

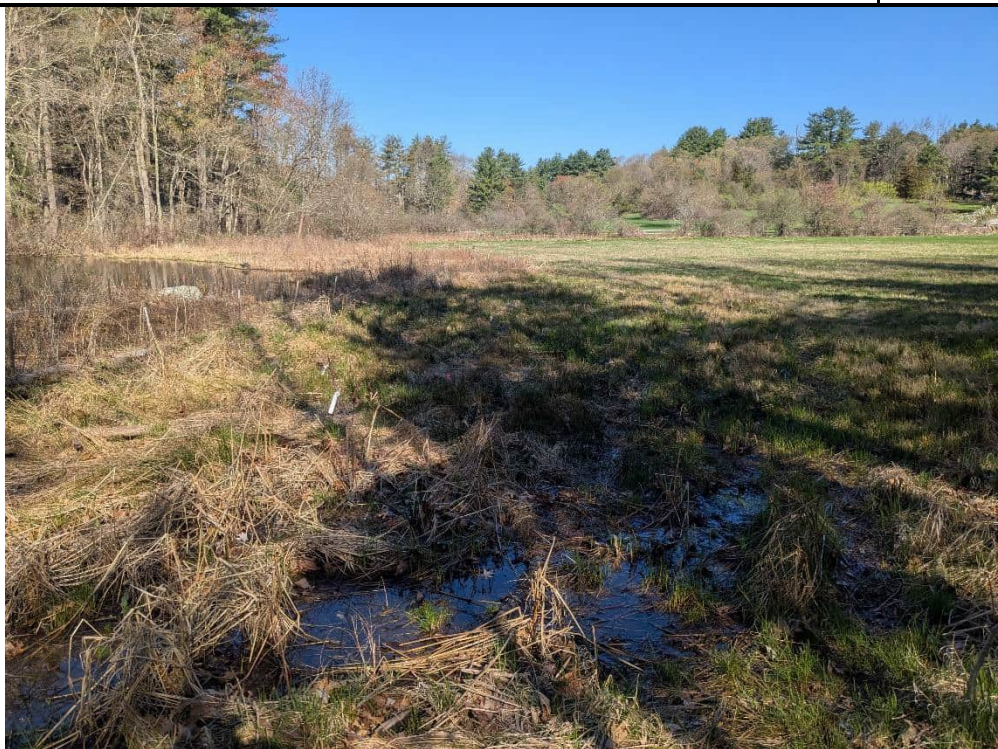
<b>Site Location</b>		Bruce Freeman Rail Trail Right-of-Way	<b>BETA Project No.</b> 24.10326.23
<b>Photo No. 5</b>	<b>Date:</b> 4/28/2025

<b>Direction Photo Taken:</b>  Toward the West			
<b>Description:</b>  View of the wetland replication area.			
<b>Photo No. 6</b>	<b>Date:</b> 4/28/2025

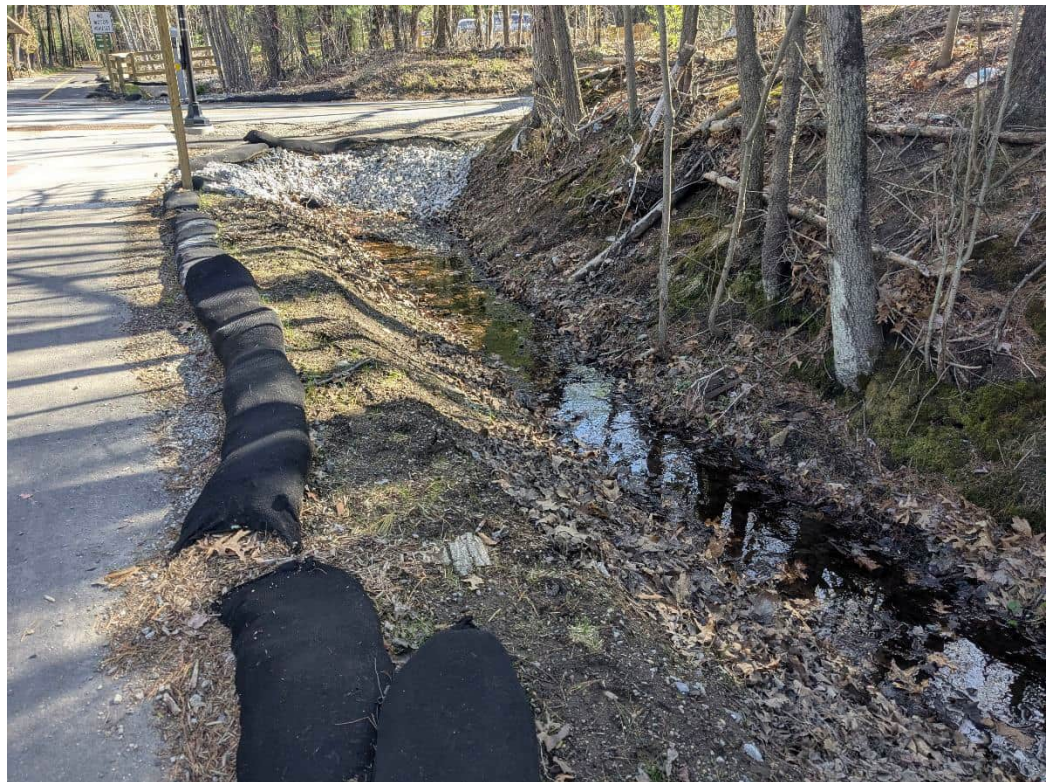
<b>Direction Photo Taken:</b>  Toward the North			
<b>Description:</b>  View of the location where the stream bank has been regraded beyond the limits of work and exposed soils along the Bank at Station 215+75 per Long Term Compliance Action Items 41 and 62.

Item	Location/ Description	Observation Date	Resolution Due Date	Recommended Resolution / Resolution Date	Comments/Updates
62	Loam and seed was applied to the streambank at Station 215+00 to 217+00 and requires further stabilization <b>Priority: High</b>	11/25/2024	12/2/2024	An erosion control blanket should be installed along this slope.	<p>12/2/2024 - Loam and seed have been applied to the streambank at Station 215+00. Stabilization is required at Stations 215+00 to 217+00.</p> <p>12/6/2024 - Observation remains. See previous update.</p> <p>12/12/2024 - Observation remains. Rill erosion was observed within the loam applied to this area from Station 215+00 to 216+00.</p> <p>12/20/2024 - Observation remains. Loam has begun to erode, resulting in a discharge to the stream at Station 216+50.</p> <p>12/26/2024 - Observation remains. No further discharge was observed in this location.</p> <p>12/31/2024 - Observation remains. Additional loam has eroded resulting in a discharge to the stream at Station 216+50.</p> <p>1/2/2025 - Observation remains. No further discharge was observed in this location.</p> <p>1/9/2025 - Observation remains. Straw was observed to have been placed along portions of the streambank; however, this area should be stabilized using an erosion control blanket.</p> <p>1/15/2025 - Observation remains. Erosion causing a discharge of loam and straw into the stream was observed at Station 216+50.</p> <p>1/23/2025 - Observation remains. Snow coverage is present within the stream and on the streambank. No further discharge was observed during this inspection.</p> <p>1/30/2025 - Observation remains. Snow coverage is present within the stream and on the streambank. No further discharge was observed during this inspection.</p> <p>2/4/2025 - Observation remains. Snow coverage is still present over a majority of the stream and on the streambank. No further discharge was observed; however, stabilization is still required.</p> <p>2/11/2025 - Observation remains. Snow coverage is present over the stream and on the streambank.</p> <p>4/2/2025 - Observation remains. Loam was observed to have eroded and discharged into the stream at Station 215+75. Rill erosion was also observed on the streambank at Station 216+25.</p> <p>4/7/2025 - Observation remains. Stone has been installed around the culvert at Station 215+75 to stabilize the Bank. No further discharge in this location was observed; however stabilization still required.</p> <p>4/14/2025 - Observation remains. Some vegetative growth was observed along the Bank of the stream at Station 216+25; however, the area is not considered stabilized. Hydroseed should be applied to the exposed soil.</p> <p>4/21/2025 - Observation remains. No further vegetative growth was observed along the Bank of the stream. Hydroseed should be applied to the exposed soil.</p> <p>4/28/2025 - Observation remains.</p>

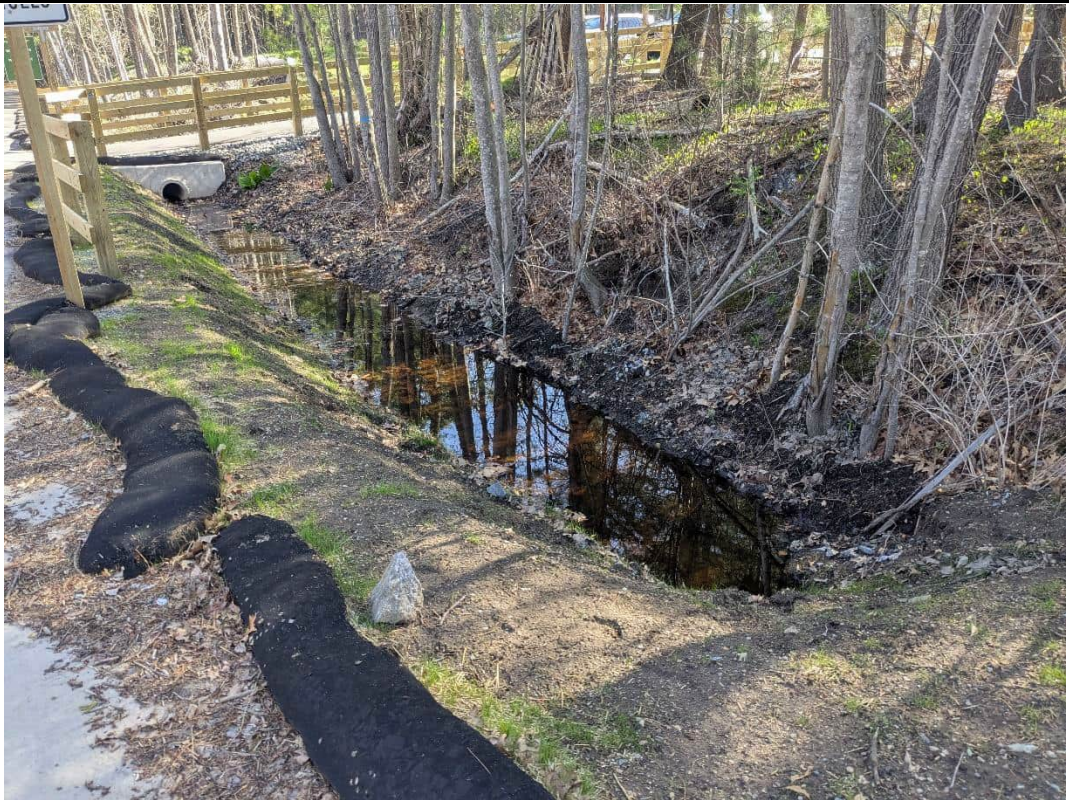
<b>Site Location</b> Bruce Freeman Rail Trail Right-of-Way		<b>BETA Project No.</b> 24.10326.23
<b>Photo No. 7</b>	<b>Date:</b> 4/28/2025

<b>Direction Photo Taken:</b>  Toward the North		
<b>Description:</b>  View of exposed soils requiring stabilization at Station 216+00 per Compliance Action Item 62. Note some vegetation has been observed along the Bank.		
<b>Photo No. 8</b>	<b>Date:</b> 4/28/2025

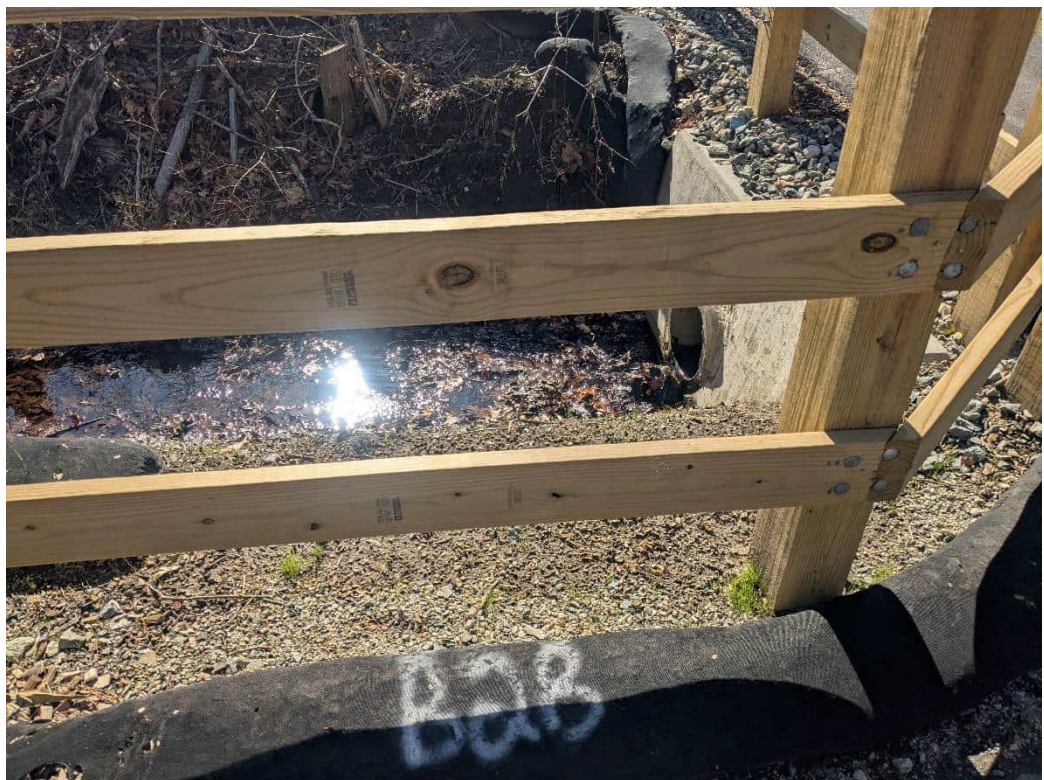
<b>Direction Photo Taken:</b>  Toward the East		
<b>Description:</b>  View of exposed soils requiring stabilization at Station 217+25 per Long Term Compliance Action item 62.

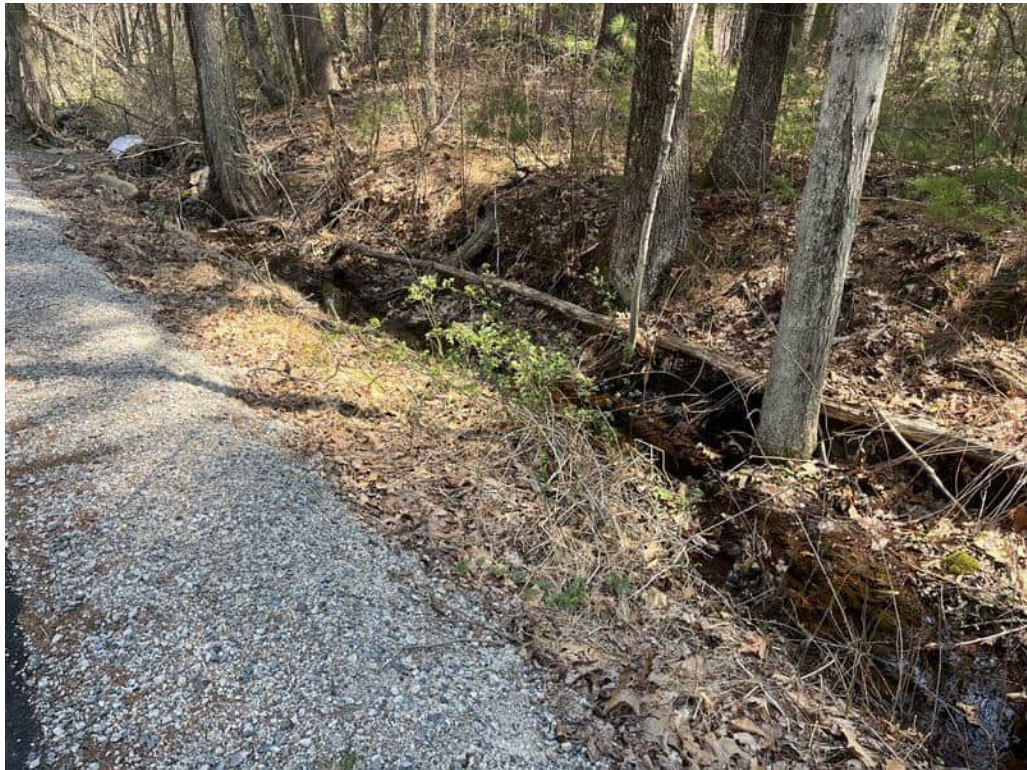
<b>Site Location</b>		Bruce Freeman Rail Trail Right-of-Way		<b>BETA Project No.</b> 24.10326.23
<b>Photo No. 9</b>	<b>Date:</b> 4/28/2025

<b>Direction Photo Taken:</b>  Toward the North				
<b>Description:</b>  View of multiflora rose along the WF23 wetland at Station 225+00 per Long Term Compliance Action item 61.				
<b>Photo No. 10</b>	<b>Date:</b> 4/28/2025

Item	Location/ Description	Observation Date	Resolution Due Date	Recommended/Discussed Resolution	Comments/Updates
61	<p>Invasive/ non-native vegetation including Japanese knotweed (<i>Reynoutria japonica</i> ), bittersweet (<i>Celastrus orbiculatus</i> ), bush honeysuckle (<i>Lonicera spp.</i> ), burning bush (<i>Euonymus alatus</i> ), purple loosestrife (<i>Lythrum salicaria</i> ), glossy buckthorn (<i>Frangula alnus</i> ) multiflora rose (<i>Rosa multiflora</i> ), and garlic mustard (<i>Alliaria petiolata</i> ) have been observed throughout the path.</p> <p>Priority: High</p>	10/22/2024	10/29/2024	Invasive Species should be removed by manual and/or chemical removal methods	<p>10/29/2024 - Invasive species are present throughout the trail both within upland and Resource Areas. Populations of glossy buckthorn and purple loosestrife are present within the wetland replication area.</p> <p>11/5/2024 - Observation remains. See update from 10/29/2024.</p> <p>11/12/2024 - Observation remains. Invasive species are still present throughout the trail. Some invasives have been observed with no leaves due to winter die back.</p> <p>11/19/2024 - Observation remains. Further invasive species management will be required during the next growing season.</p> <p>11/22/2024 - Observation remains.</p> <p>11/25/2024 - Observation remains.</p> <p>12/2/2024 - Observation remains.</p> <p>12/6/2024 - Observation remains. This action item has been moved to the Long-Term Compliance Items section because it can only be resolved during the next growing season.</p> <p>12/12/2024 - Observation remains.</p> <p>12/20/2024 - Observation remains.</p> <p>12/26/2024 - Observation remains.</p> <p>12/31/2024 - Observation remains.</p> <p>1/2/2025 - Observation remains.</p> <p>1/9/2025 - Observation remains.</p> <p>1/15/2025 - Observation remains.</p> <p>1/23/2025 - Observation remains.</p> <p>1/30/2025 - Observation remains.</p> <p>2/4/2025 - Observation remains.</p> <p>2/11/2025 - Observation remains.</p> <p>4/2/2025 - Observation remains. Invasive species including, bush honeysuckle, multiflora rose, garlic mustard and buckthorn were observed to be developing buds and leaves throughout the site. In addition, non-invasives but non-native species have been observed along the corridor within areas where the establishment of native species is required.</p> <p>4/7/2025 - Observation remains. See previous update.</p> <p>4/14/2025- Observation remains. Invasive/non-native species are present throughout the trail.</p> <p>4/21/2025 - Observation remains. Lesser celandine (<i>Ficaria verna</i> ) was observed along the trail at Station 312+00.</p> <p>Garlic mustard is present throughout the trail in locations on exposed soil. Invasive species including bittersweet, bush honeysuckle, burning bush, multiflora rose and glossy buckthorn are also present throughout the trail.</p> <p>4/28/2025 - Observation remains. See previous update.</p>

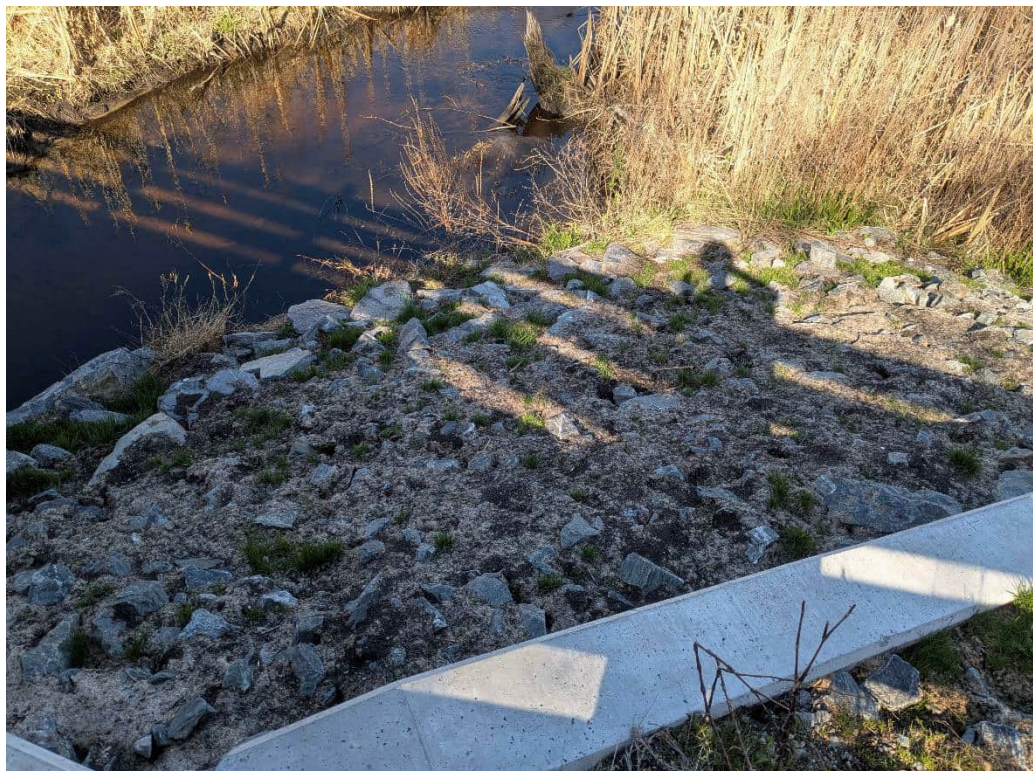
<b>Direction Photo Taken:</b>  Toward the West				
<b>Description:</b>  View of the Bank of Pantry Brook that has been hydroseeded but is not considered stabilized at Station 264+50 per Long Term Compliance Action Item 59.

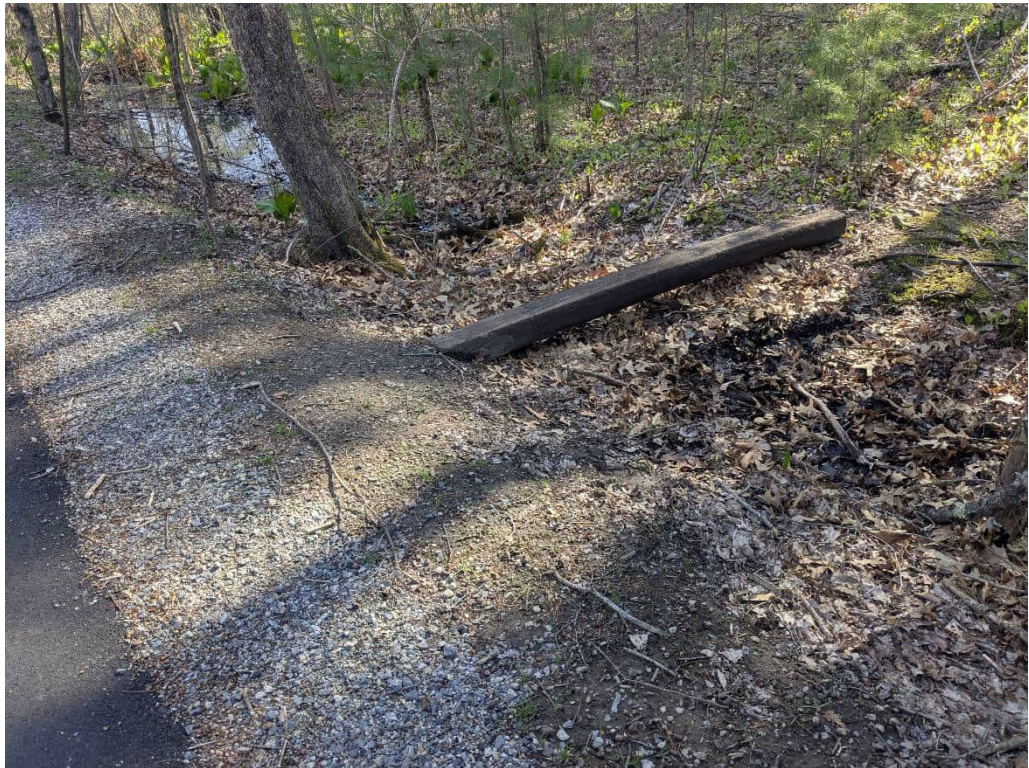
<b>Site Location</b>		Bruce Freeman Rail Trail Right-of-Way	<b>BETA Project No.</b> 24.10326.23
<b>Photo No. 13</b>	<b>Date:</b> 4/28/2025

<b>Direction Photo Taken:</b>  Toward the Northeast			
<b>Description:</b>  View of exposed soil that requires stabilization at Station 298+00 per Long Term Compliance Action Item 59.			
<b>Photo No. 14</b>	<b>Date:</b> 4/28/2025

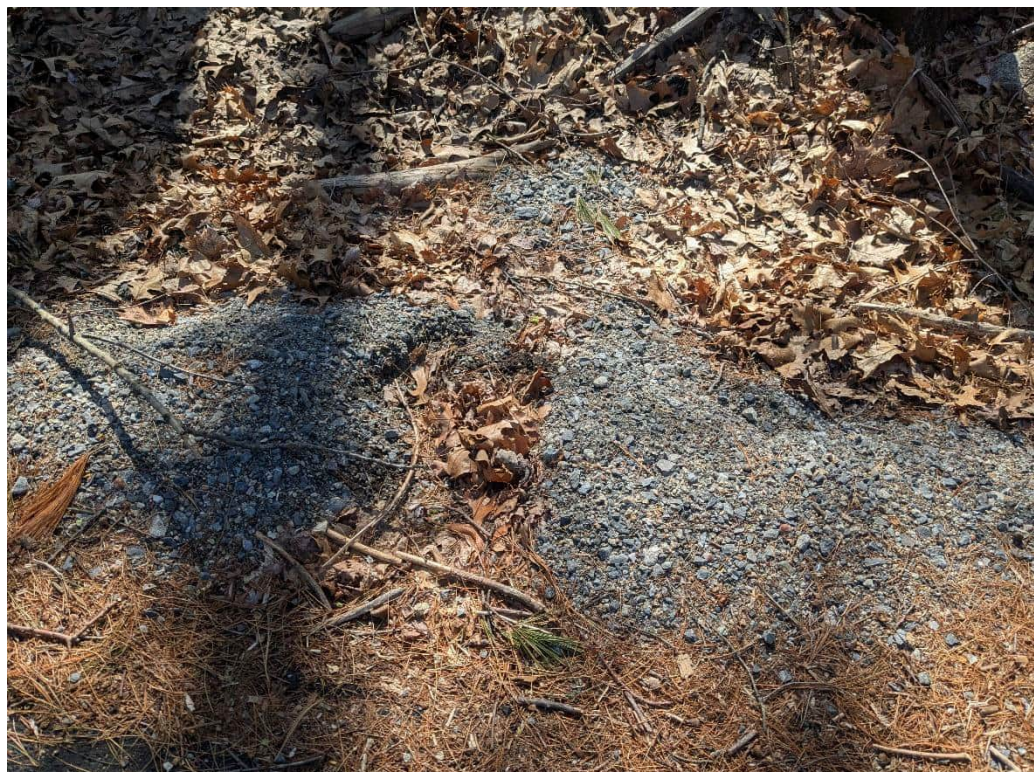
<b>Direction Photo Taken:</b>  Toward the East			
<b>Description:</b>  View of a location where crushed stone has migrated off of the path at Station 303+00 per Compliance Action Item 58.

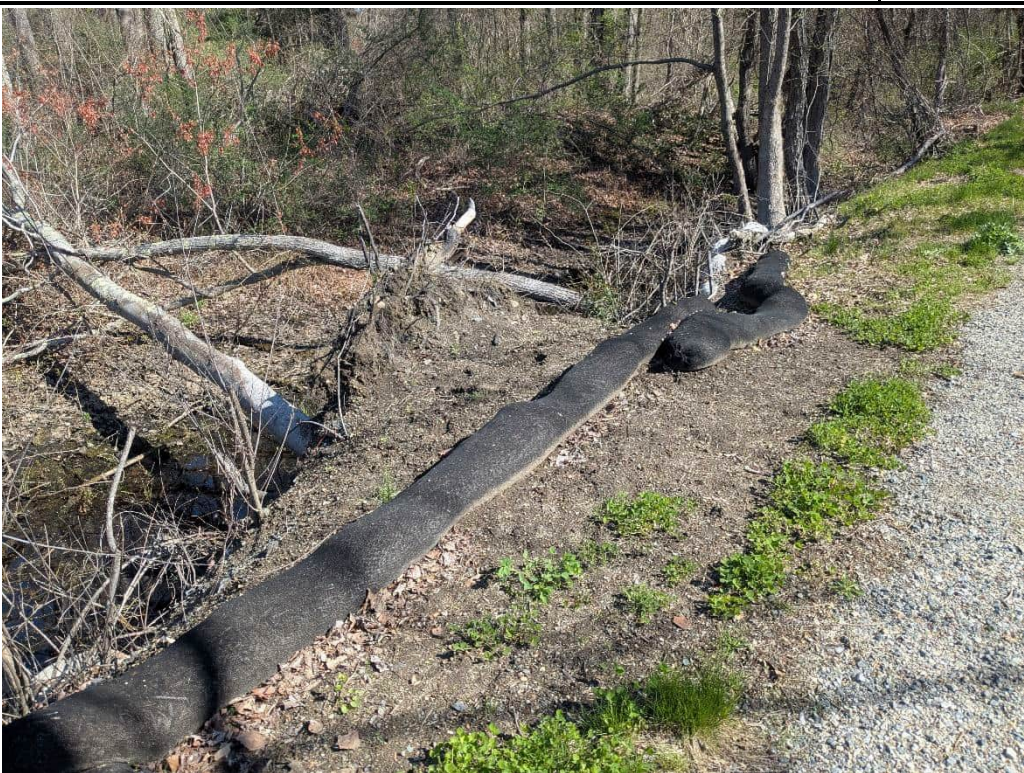
<b>Site Location</b>		Bruce Freeman Rail Trail Right-of-Way	<b>BETA Project No.</b> 24.10326.23
<b>Photo No. 15</b>	<b>Date:</b> 4/28/2025

<b>Direction Photo Taken:</b>  Toward the West			
<b>Description:</b>  View of the location of placed loam that requires stabilization at Station 311+50 per Long Term Compliance Action Item 59.			
<b>Photo No. 16</b>	<b>Date:</b> 4/28/2025

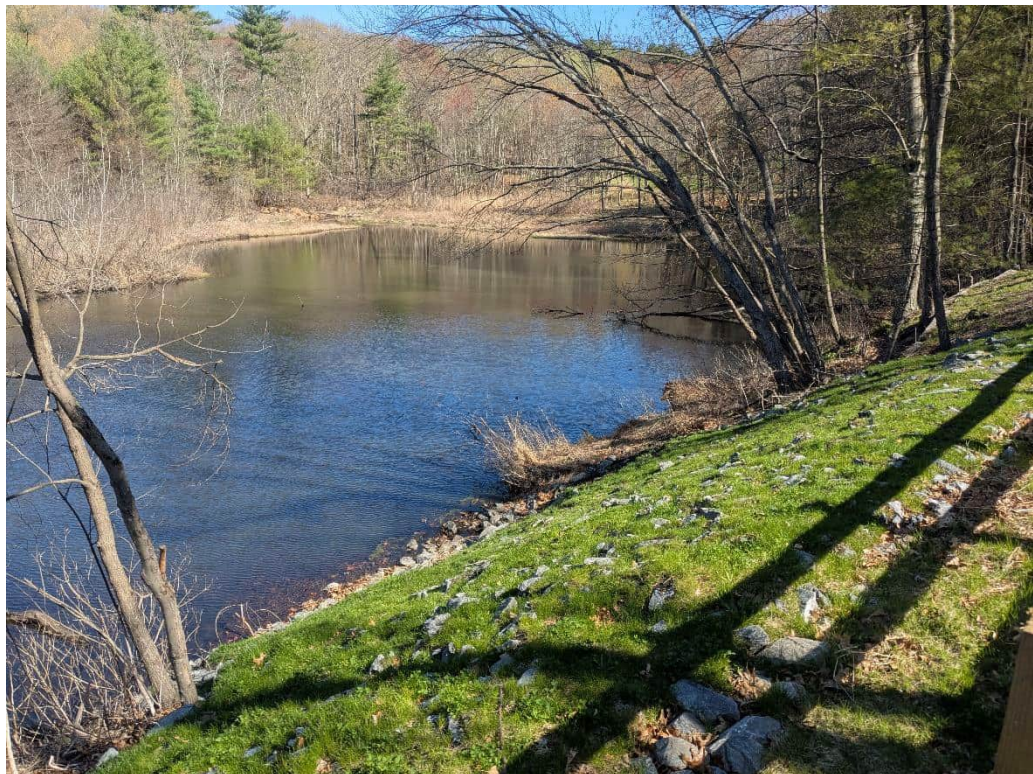
<b>Direction Photo Taken:</b>  Toward the Northwest			
<b>Description:</b>  View of the location of the riprap slope that extends beyond the limit of work along the WF1 Series wetland and exposed soil requiring stabilization at Station 332+00 per Long Term Compliance Action Item 42 and 59.
