<b>Environmental Monitor Construction Site Inspection Report</b> <b>MassDOT Project #608164 Construction Contract # 119678</b> <b>EM Report #57</b>						
Project Description: Bruce Freeman Rail Trail Right-of-Way Permit Description(s): Order of Conditions (MGL Chapter 131, Section 40 and 310 CMR 10.00, Mass DEP File No. 301-1362); 2022 EPA NPDES General Permit for Discharges from Construction Areas; U.S. Army Corps of Engineers Permit No NAE-2021-01975.

I. General Project Information						
Project Name:	Bruce Freeman Rail Trail - Phase 2d - Sudbury					
Date of Inspections:	5/23/2025					
Bi Weekly/ Monthly Period Covered:	May Weekly Inspection #4					
Inspector's Name(s):	Anna Haznar					
Inspectors' Contact Information:	<a href="mailto:ahaznar@beta-inc.com">ahaznar@beta-inc.com</a>					
II. Weather Information						
	Inspection #1	Inspection #2	Inspection #3	Inspection #4	Inspection #5	Inspection #6
<a href="#">WeatherUnderground</a>	Inspector: Anna Haznar 5/5/2025	Inspector: Anna Haznar 5/12/2025	Inspector: Anna Haznar 5/16/2025	Inspector: Anna Haznar 5/23/2025	Inspector:	Inspector:
Type of Inspection (i.e. non-storm event, pre-storm event, during-storm event or post-storm even

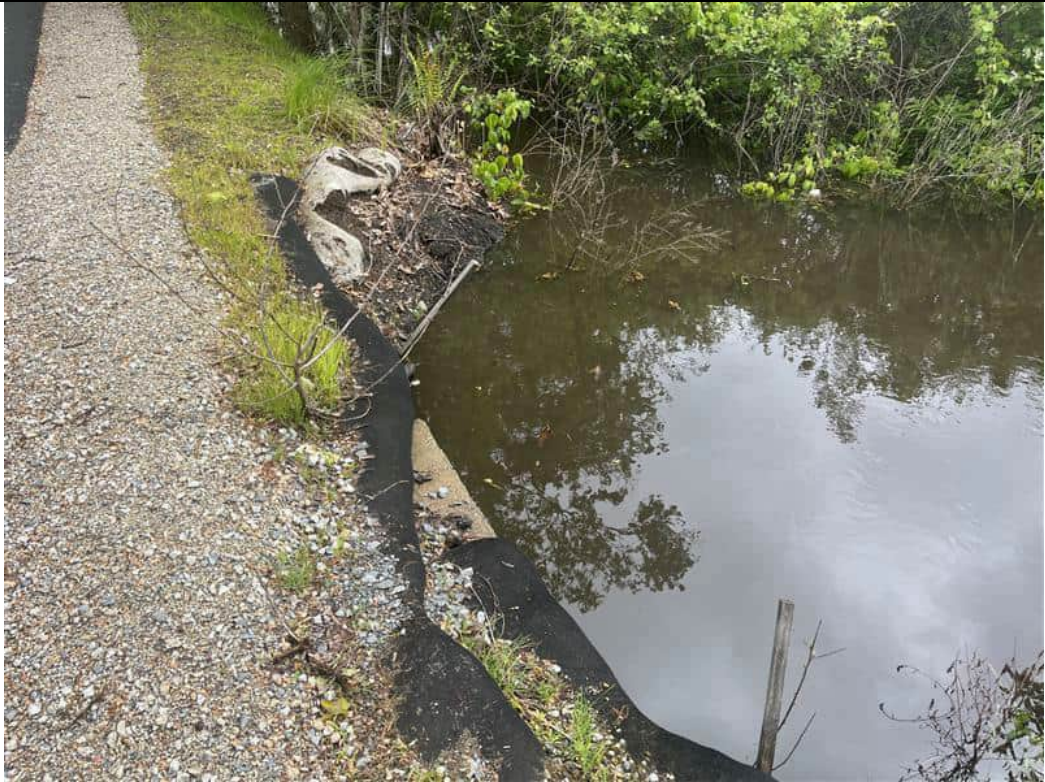
Site Location		Bruce Freeman Rail Trail Right-of-Way	BETA Project No. 24.10326.23
Photo No. 1	Date: 5/23/2025

Direction Photo Taken:  Toward the North			
Description:  View of the location of the overtopped compost filter tube and exposed soils beyond the limits of work at Station 105+00 per Compliance Action Item 43.			
Photo No. 2	Date: 5/23/2025

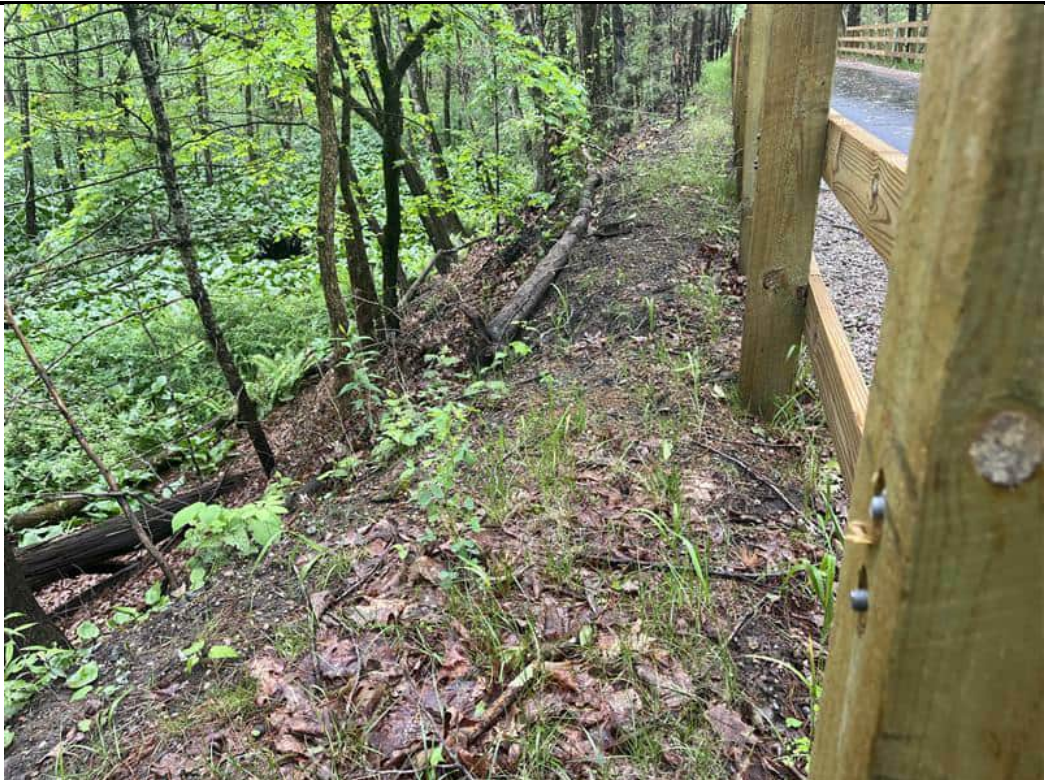
59	Multiple locations of exposed soils along the Project corridor require stabilization <b>Priority: High</b>	9/3/2024	9/10/2024	The contractor should apply the approved seed mixture to areas of exposed soils and place straw.	<p>4/21/2025 - For readability all previous observations have been removed from the report. Please reference the report from 4/14/2025 to see past observations. Observation remains. Vegetation has begun sprouting in some areas that were hydroseeded; however, most areas are not considered fully stabilized. Multiple areas of exposed soil along the trail still require the application of hydroseed. The seed mix used for stabilization should be submitted to the Conservation Commission.</p> <p>4/28/2025 - Observation remains. See previous update.</p> <p>5/5/2025 - Observation remains. Areas where hydroseed was applied have been observed as being partially or fully stabilized. Areas of exposed soil are still present in multiple locations throughout the trail. Further application of hydroseed should occur. The seed mix used for stabilization should be submitted to the Conservation Commission.</p> <p>5/12/2025 - Observation remains. See previous update.</p> <p>5/16/2025 - Observation remains. Areas of exposed soil are present in multiple locations throughout the trail. Further application of hydroseed should occur. The seed mix used for stabilization should be submitted to the Conservation Commission.</p> <p>5/23/2025 - Observation remains. See previous update.</p>

Direction Photo Taken:  Toward the North			
Description:  View of exposed soil that requires stabilization at Station 161+00 per Long Term Compliance Action Item 59.

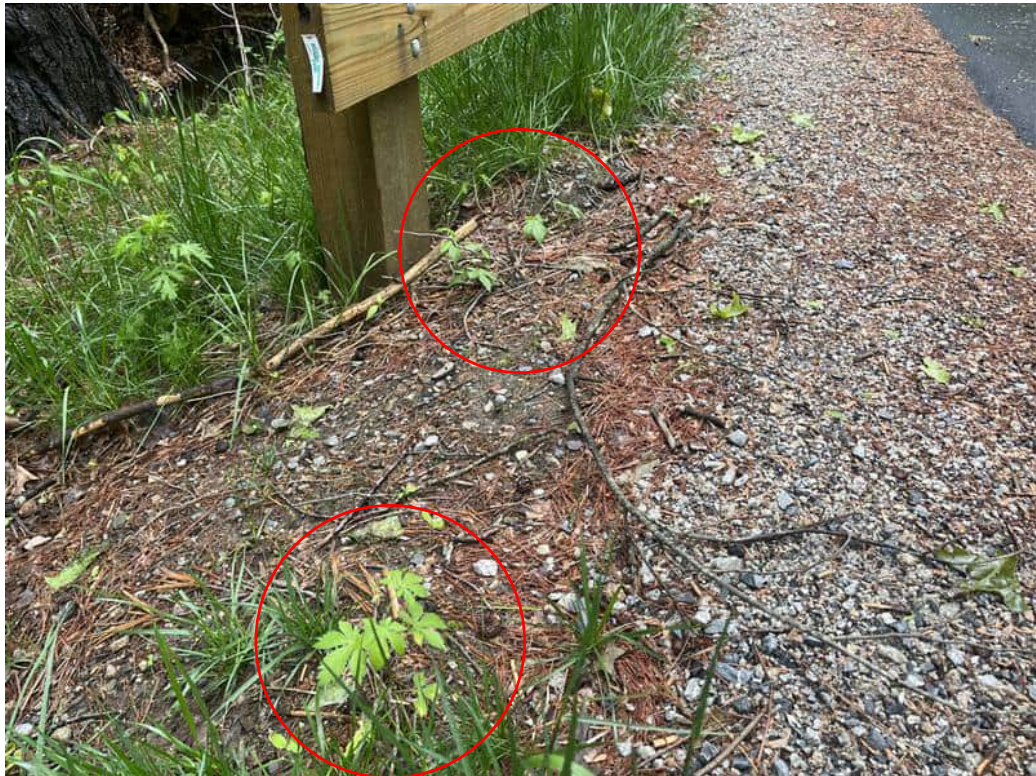
Site Location		Bruce Freeman Rail Trail Right-of-Way	BETA Project No. 24.10326.23
Photo No. 3	Date: 5/23/2025

Direction Photo Taken:  Toward the North			
Description:  View of Japanese hops that require removal at Station 167+50 per Long Term Compliance Action Item 61.			
Photo No. 4	Date: 5/23/2025

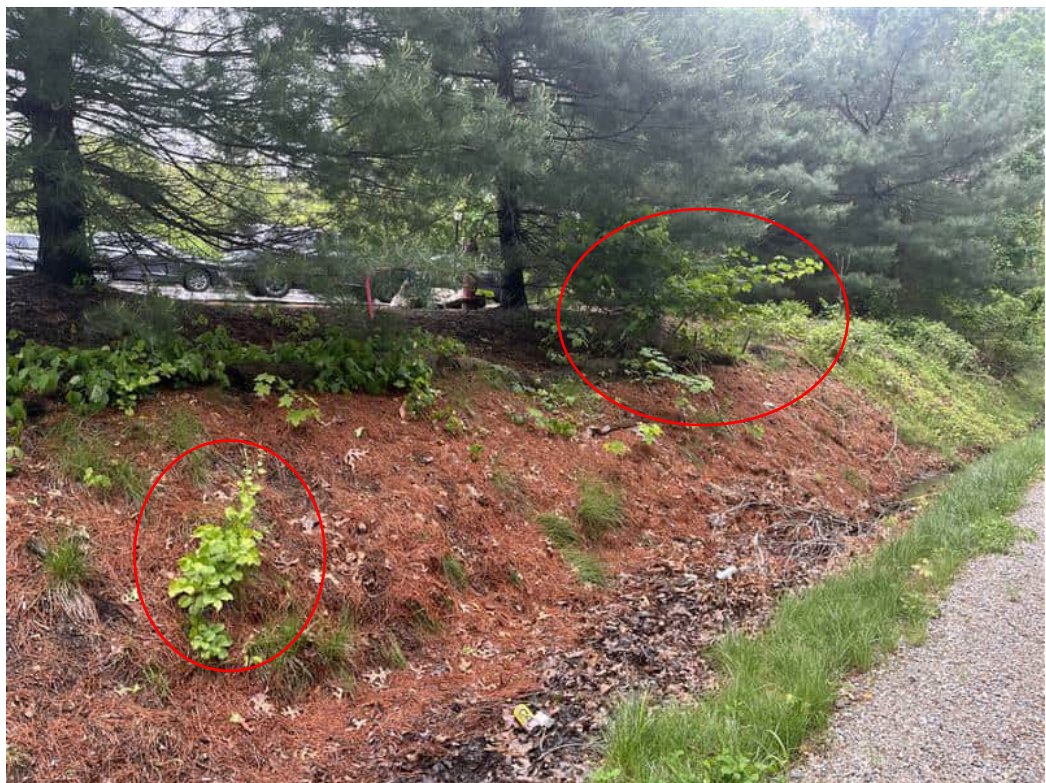
Direction Photo Taken:  Toward the East			
Description:  View of Japanese knotweed and bittersweet that require removal at Station 170+00 per Long Term Compliance Action Item 61.

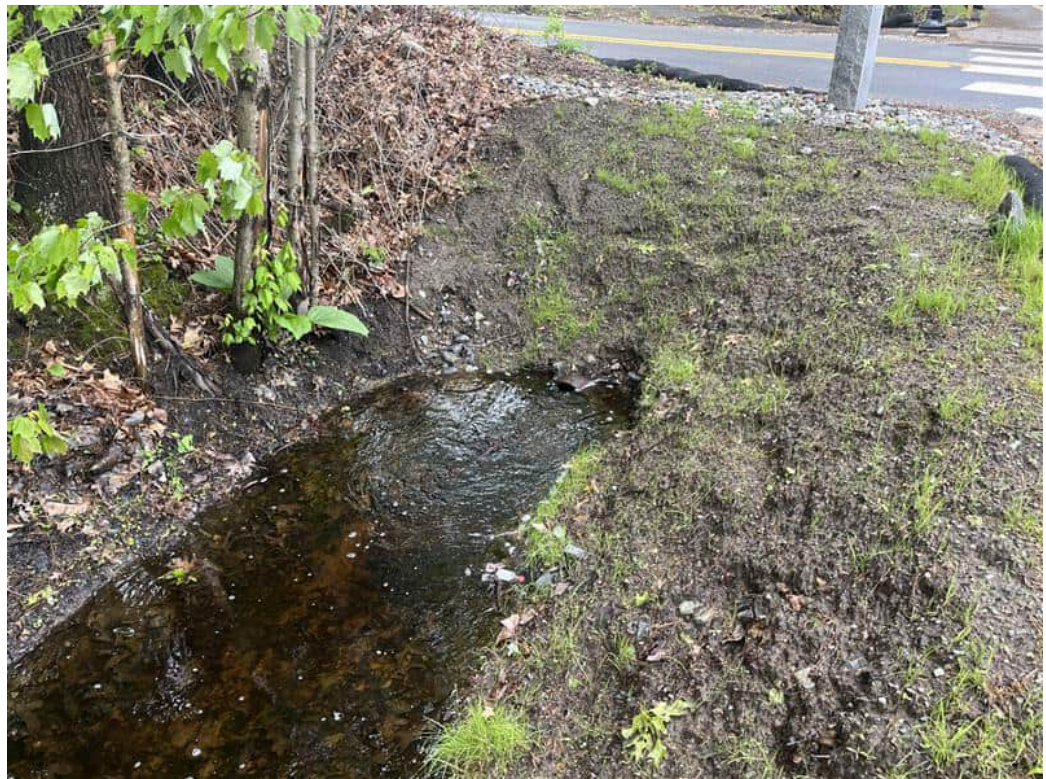
Item	Location/ Description	Observation Date	Resolution Due Date	Recommended Resolution / Resolution Date	Comments/Updates
62	Loam and seed was applied to the streambank at Station 215+00 to 217+00 and requires further stabilization <b>Priority: High</b>	11/25/2024	12/2/2024	An erosion control blanket should be installed along this slope.	<p>12/2/2024 - Loam and seed have been applied to the streambank at Station 215+00. Stabilization is required at Stations 215+00 to 217+00.</p> <p>12/6/2024 - Observation remains. See previous update.</p> <p>12/12/2024 - Observation remains. Rill erosion was observed within the loam applied to this area from Station 215+00 to 216+00.</p> <p>12/20/2024 - Observation remains. Loam has begun to erode, resulting in a discharge to the stream at Station 216+50.</p> <p>12/26/2024 - Observation remains. No further discharge was observed in this location.</p> <p>12/31/2024 - Observation remains. Additional loam has eroded resulting in a discharge to the stream at Station 216+50.</p> <p>1/2/2025 - Observation remains. No further discharge was observed in this location.</p> <p>1/9/2025 - Observation remains. Straw was observed to have been placed along portions of the streambank; however, this area should be stabilized using an erosion control blanket.</p> <p>1/15/2025 - Observation remains. Erosion causing a discharge of loam and straw into the stream was observed at Station 216+50.</p> <p>1/23/2025 - Observation remains. Snow coverage is present within the stream and on the streambank. No further discharge was observed during this inspection.</p> <p>1/30/2025 - Observation remains. Snow coverage is present within the stream and on the streambank. No further discharge was observed during this inspection.</p> <p>2/4/2025 - Observation remains. Snow coverage is still present over a majority of the stream and on the streambank. No further discharge was observed; however, stabilization is still required.</p> <p>2/11/2025 - Observation remains. Snow coverage is present over the stream and on the streambank.</p> <p>4/2/2025 - Observation remains. Loam was observed to have eroded and discharged into the stream at Station 215+75. Rill erosion was also observed on the streambank at Station 216+25.</p> <p>4/7/2025 - Observation remains. Stone has been installed around the culvert at Station 215+75 to stabilize the Bank. No further discharge in this location was observed; however stabilization still required.</p> <p>4/14/2025 - Observation remains. Some vegetative growth was observed along the Bank of the stream at Station 216+25; however, the area is not considered stabilized. Hydroseed should be applied to the exposed soil.</p> <p>4/21/2025 - Observation remains. No further vegetative growth was observed along the Bank of the stream. Hydroseed should be applied to the exposed soil.</p> <p>4/28/2025 - Observation remains.</p> <p>5/5/2025 - Observation remains. Vegetation has begun stabilization the slope along the stream at Station 215+00 to 216+50; however, these areas are not considered fully stabilized and will continue to be monitored to determine if further stabilization is required. The slope at Station 216+50 to 217+00 currently requires further stabilization as minimal vegetation has germinated on this slope.</p> <p>5/12/2025 - Observation remains. Vegetation has partially stabilized the slope at Station 215+00 to 217+00; however further application of seed is required.</p> <p>5/16/2025 - Observation remains. See previous update.</p> <p>5/23/2025 - Observation remains. Scour erosion as a result of heavy rainfall was observed directly adjacent to the culverts at Station 216+00 and 217+00 . Further seed should be applied to the slopes adjacent to the stream to provide stabilization.</p>

<b>Direction Photo Taken:</b>  Toward the East		
<b>Description:</b>  View of exposed soils requiring stabilization and scour erosion at Station 216+00 per Compliance Action Item 62. Note some vegetation has been observed along the Bank.

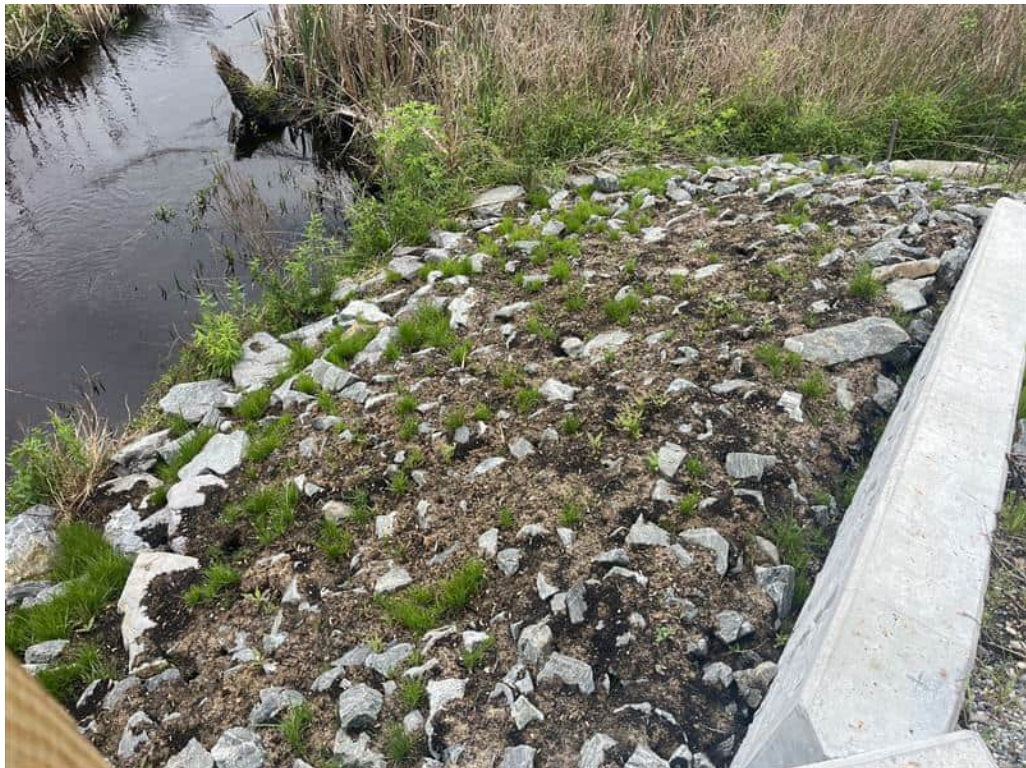
<b>Direction Photo Taken:</b>  Toward the North			
<b>Description:</b>  View of exposed soils along the Bank of Pantry Brook that requires the application of seed at Station 264+50 per Long Term Compliance Action Item 59.

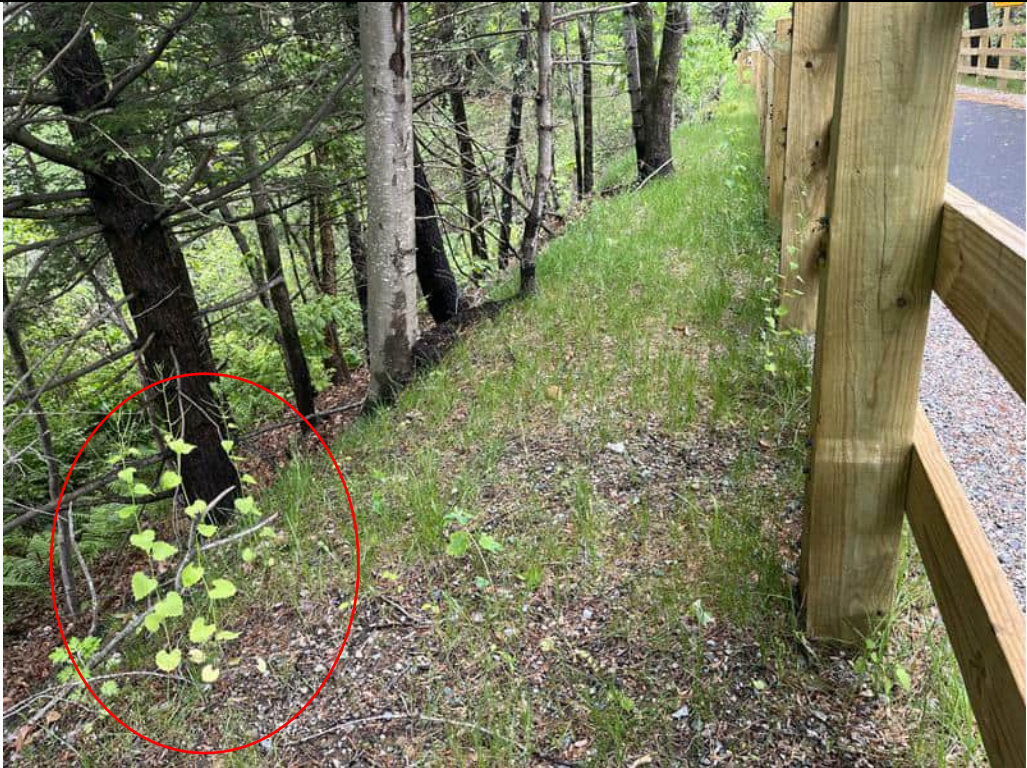
Site Location		Bruce Freeman Rail Trail Right-of-Way	BETA Project No. 24.10326.23
Photo No. 11	Date: 5/23/2025

Direction Photo Taken:  Toward the North			
Description:  View of garlic mustard that has gone to seed and requires removal at Station 268+00 per Long Term Compliance Action Item 61.			
Photo No. 12	Date: 5/23/2025

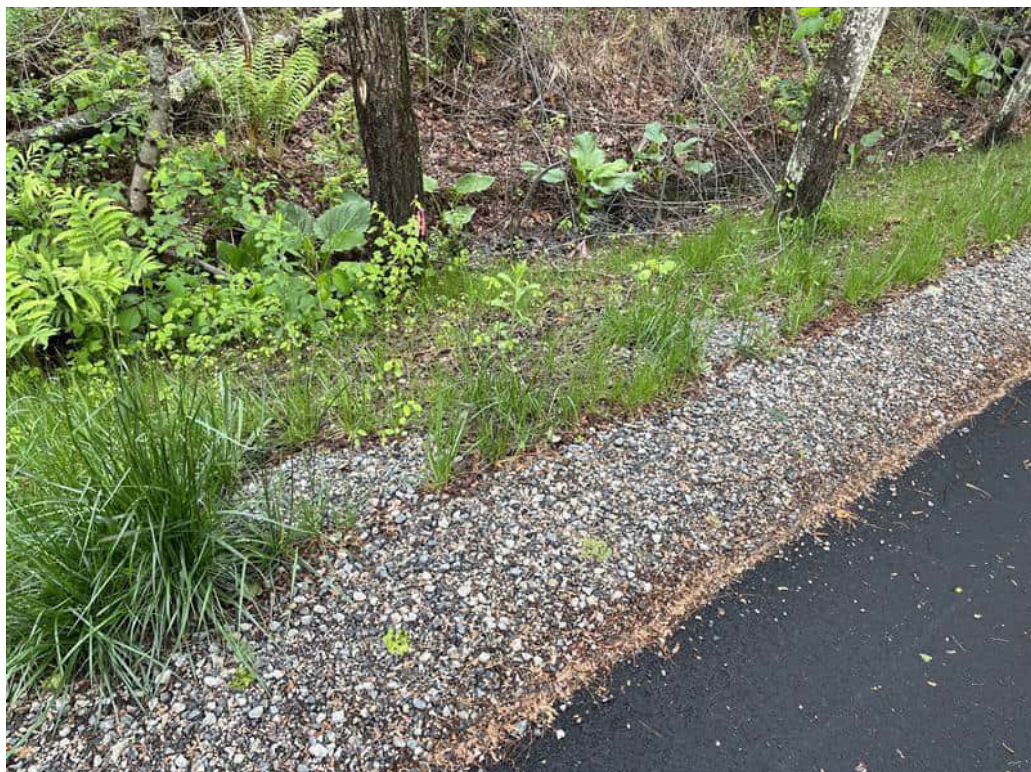
58	Crushed stone used for the dense graded crush stone shoulders has been observed as migrating both onto the path, off the sides of the path, and into the adjacent Resource Areas throughout the Project <b>Priority: High</b>	8/7/2024	8/14/2024	Remove all crushed stone from Resource Areas and develop a plan to cease discharges of stone.	<p>4/21/2025 - For readability all previous observations have been removed from the report. Please reference the report from 4/14/2025 to see past observations. Observation remains. Crushed stone was observed both on and off the trail in multiple locations.</p> <p>4/28/2025 - Observation remains. See previous update.</p> <p>5/5/2025 - Observation remains. See update from 4/21/2025.</p> <p>5/12/2025 - Observation remains. See update from 4/21/2025.</p> <p>5/16/2025 - Observation remains. Crushed stone is present both on and on the side of the trail in multiple locations.</p> <p>5/23/2025 - Observation remains. See previous update.</p>

Direction Photo Taken:  Toward the North			
Description:  View of crushed stone that migrated off of the path at Station 289+00 per Long Term Compliance Action Item 58.

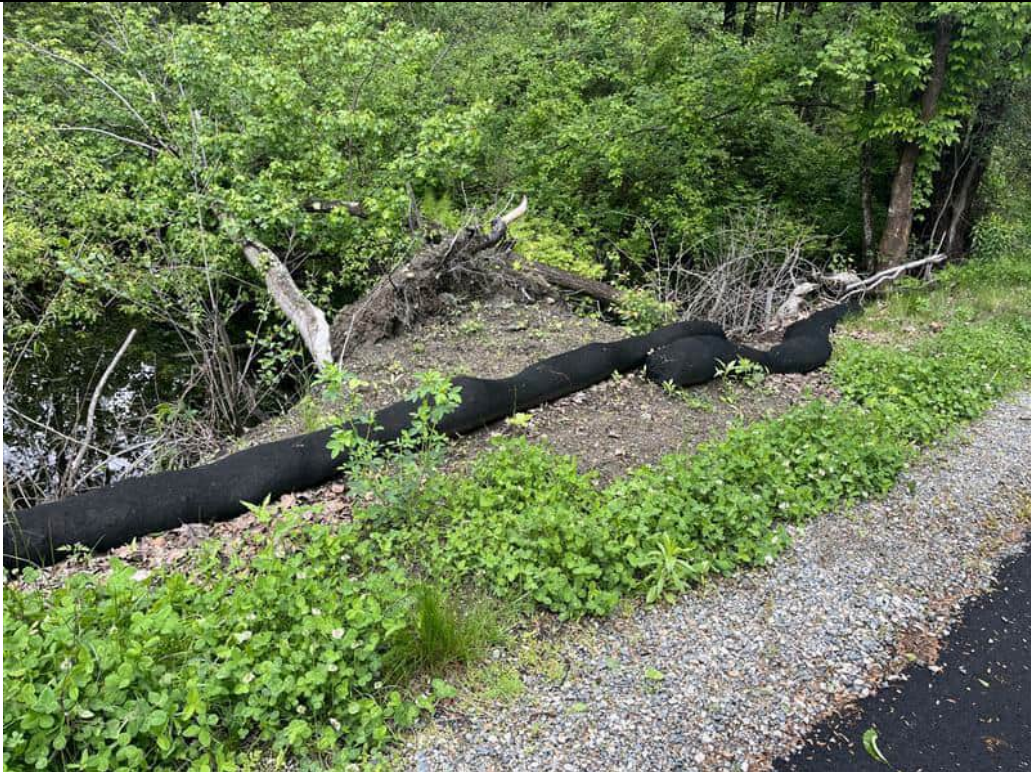
<b>Site Location</b>		Bruce Freeman Rail Trail Right-of-Way	<b>BETA Project No.</b> 24.10326.23
<b>Photo No. 13</b>	<b>Date:</b> 5/23/2025

<b>Direction Photo Taken:</b>  Toward the North			
<b>Description:</b>  View of the location of placed loam that requires stabilization at Station 311+50 per Long Term Compliance Action Item 59.			
<b>Photo No. 14</b>	<b>Date:</b> 5/23/2025

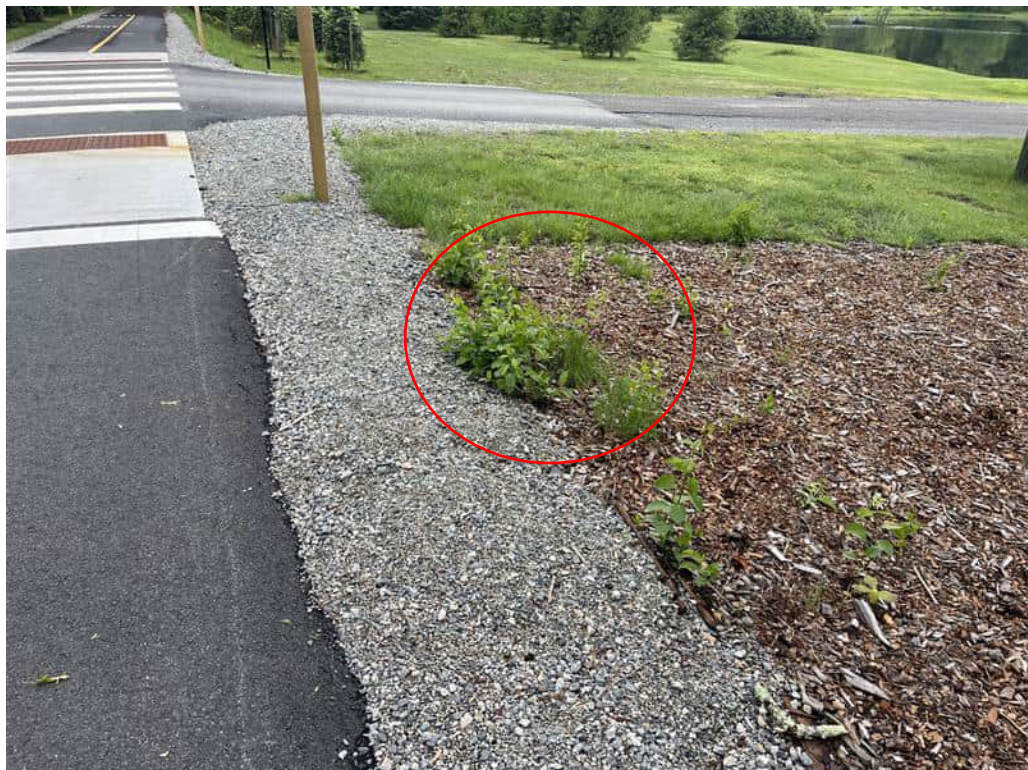
<b>Direction Photo Taken:</b>  Toward the North			
<b>Description:</b>  View of bittersweet that requires removal at Station 320+50 per Long Term Compliance Action Item 61.

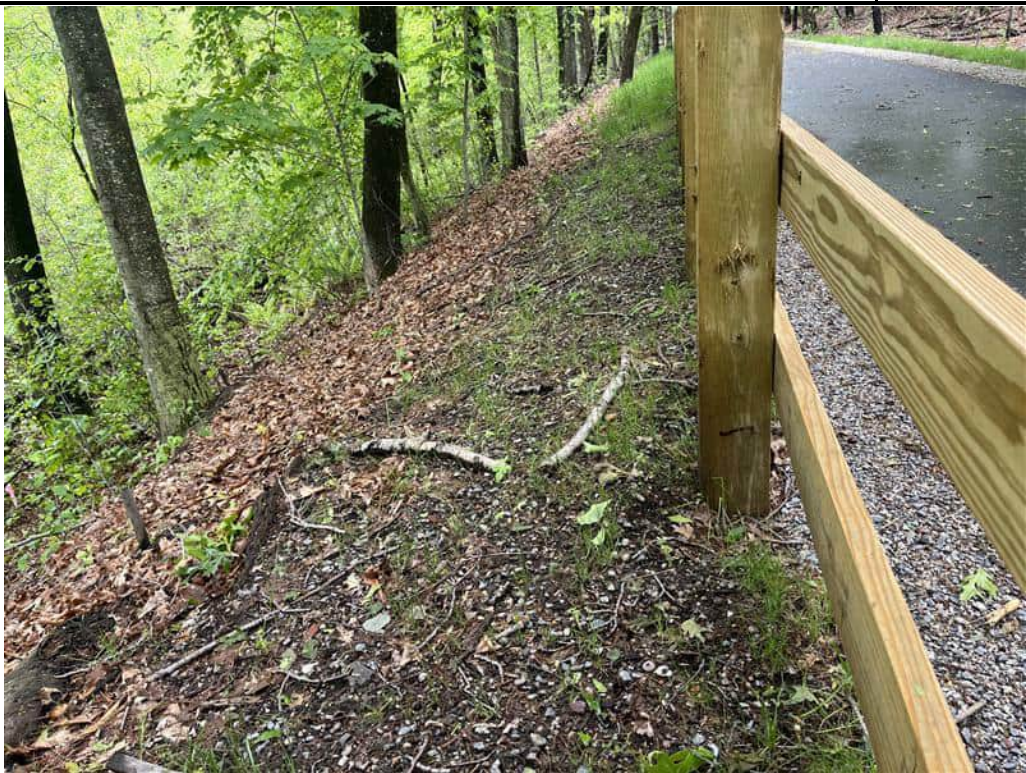
<b>Site Location</b>		Bruce Freeman Rail Trail Right-of-Way	<b>BETA Project No.</b> 24.10326.23
<b>Photo No. 15</b>	<b>Date:</b> 5/23/2025

<b>Direction Photo Taken:</b>  Toward the West			
<b>Description:</b>  View of exposed soil that requires stabilization at Station 328+00 per Long Term Compliance Action Item 59.			
<b>Photo No. 16</b>	<b>Date:</b> 5/23/2025

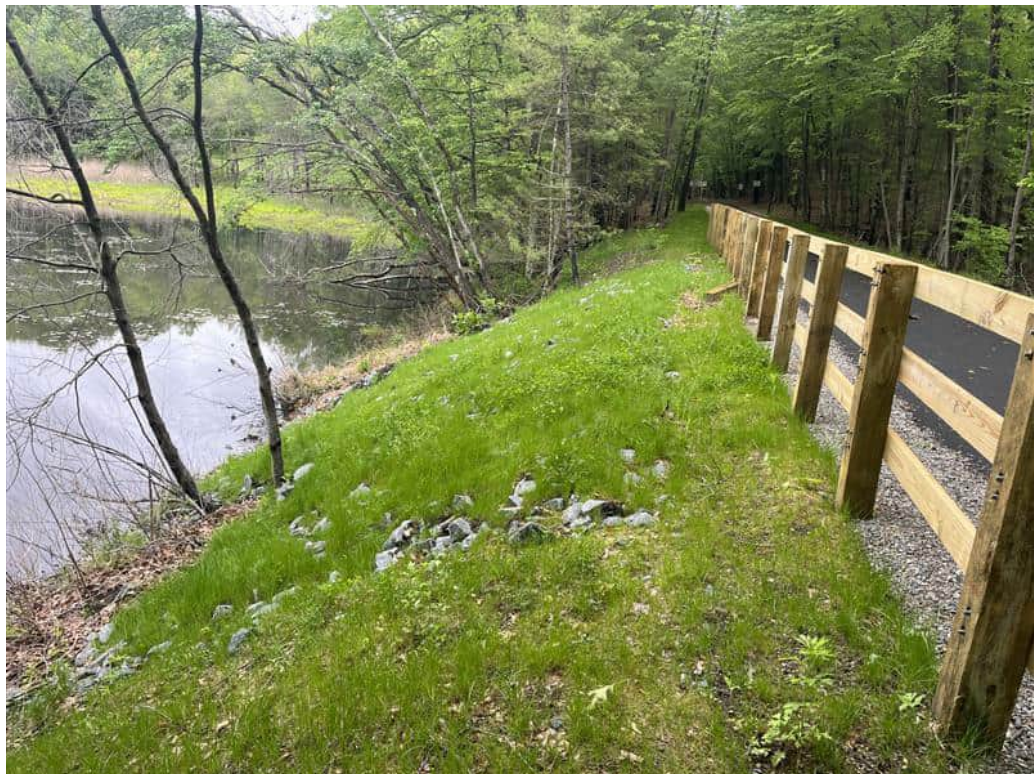
<b>Direction Photo Taken:</b>  Toward the North			
<b>Description:</b>  View of the location of the riprap slope that extends beyond the limit of work along the WF1 Series wetland and exposed soil requiring stabilization at Station 332+00 per Long Term Compliance Action Item 42 and 59.
