Environmental Monitor Construction Site Inspection Report MassDOT Project #608164 Construction Contract # 119678 EM Report #61						
Project Description: Bruce Freeman Rail Trail Right-of-Way Permit Description(s): Order of Conditions (MGL Chapter 131, Section 40 and 310 CMR 10.00, Mass DEP File No. 301-1362); 2022 EPA NPDES General Permit for Discharges from Construction Areas; U.S. Army Corps of Engineers Permit No NAE-2021-01975.

I. General Project Information						
Project Name:	Bruce Freeman Rail Trail - Phase 2d - Sudbury					
Date of Inspections:	7/1/2025					
Bi Weekly/ Monthly Period Covered:	July Inspection					
Inspector's Name(s):	Anna Haznar					
Inspectors' Contact Information:	ahaznar@beta-inc.com					
II. Weather Information						
	Inspection #1	Inspection #2	Inspection #3	Inspection #4	Inspection #5	Inspection #6
WeatherUnderground	Inspector: Anna Haznar 7/1/2025	Inspector:	Inspector:	Inspector:	Inspector:	Inspector:
Type of Inspection (i.e. non-storm event, pre-storm event, during-storm event or post-storm event):	Non-storm					
Number of days since last rain event greater than .25"						
Has there been a storm event since the last inspection?	Yes					
If yes, pl

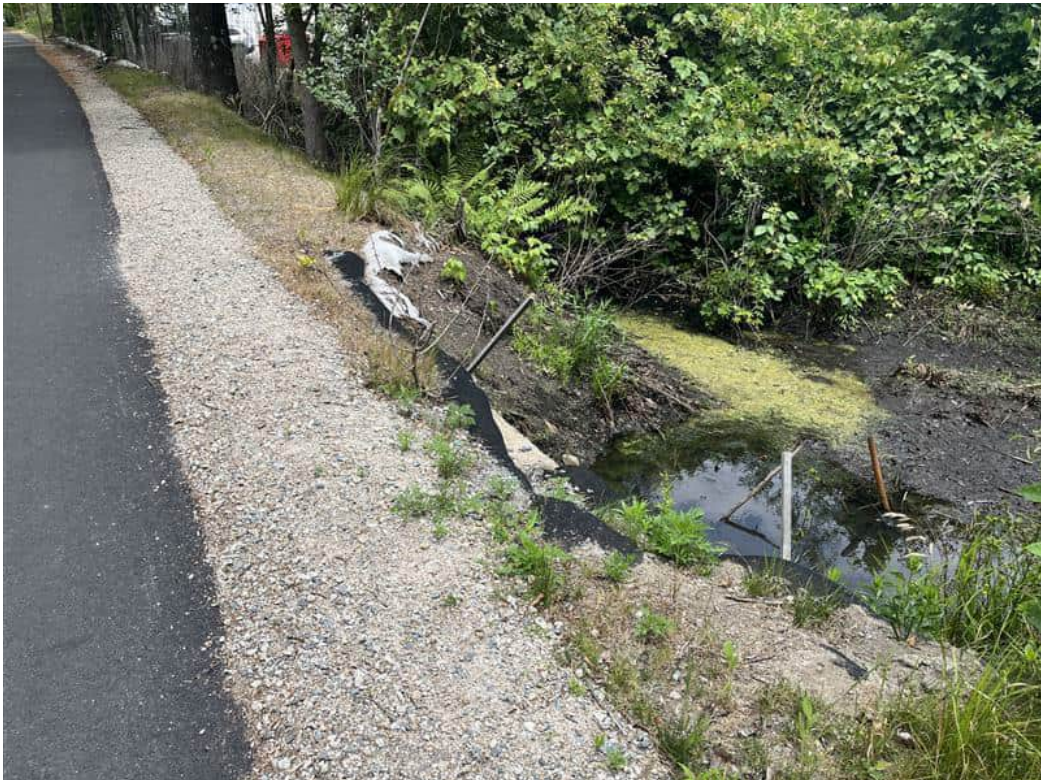
Site Location		Bruce Freeman Rail Trail Right-of-Way	BETA Project No. 24.10326.23
Photo No. 1	Date: 7/1/2025

Direction Photo Taken: Toward the North			
Description: View of the location of the overtopped compost filter tube and exposed soils beyond the limits of work at Station 105+00 per Compliance Action Item 43.			
Photo No. 2	Date: 7/1/2025

43	<p>Overtopped compost filter tubes and exposed soils beyond the limits of work at Station 105+00</p> <p>Priority: High</p>	6/7/2024	6/14/2024	<p>Stabilize the area with the approved seed mixture and provide interim stabilization such as straw mulch.</p>	<p>5/5/2025 - Observation remains. Exposed soil past the limits of work is present and requires further stabilization.</p> <p>5/12/2025 - Observation remains. See previous update.</p> <p>5/16/2025 - Observation remains. Exposed soil past the limits of work is present and requires further stabilization.</p> <p>5/23/2025 - Observation remains. See previous update.</p> <p>5/29/2025 - Observation remains. Exposed soil past the limits of work is present and requires further stabilization.</p> <p>6/6/2025 - Observation remains. See previous update.</p> <p>6/9/2025 - Observation remains. Exposed soil past the limits of work is present and requires further stabilization.</p> <p>7/1/2025 - Observation remains. For readability, observations from 6/14/2024 to 4/28/2025 have been removed - see report #60 for previous observations. Exposed soil past the limits of work is present and requires further stabilization.</p>

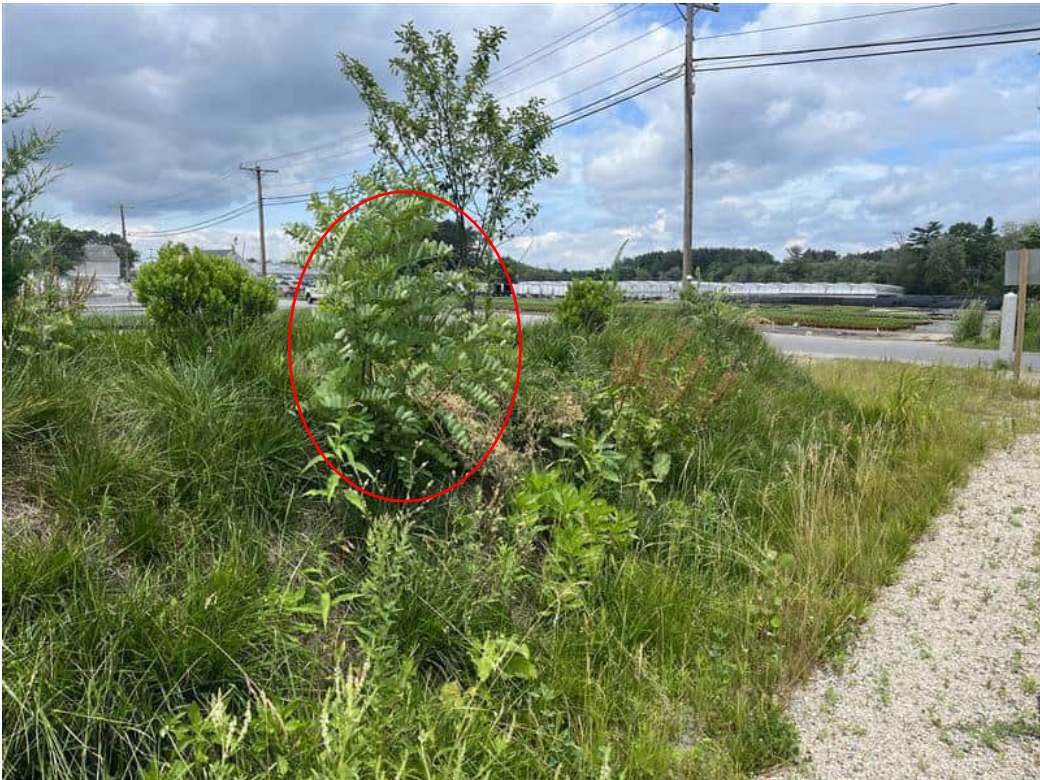
Direction Photo Taken: Toward the Northwest			
Description: View of a black locust that requires removal at Station 115+50 per Long Term Compliance Action item 61.

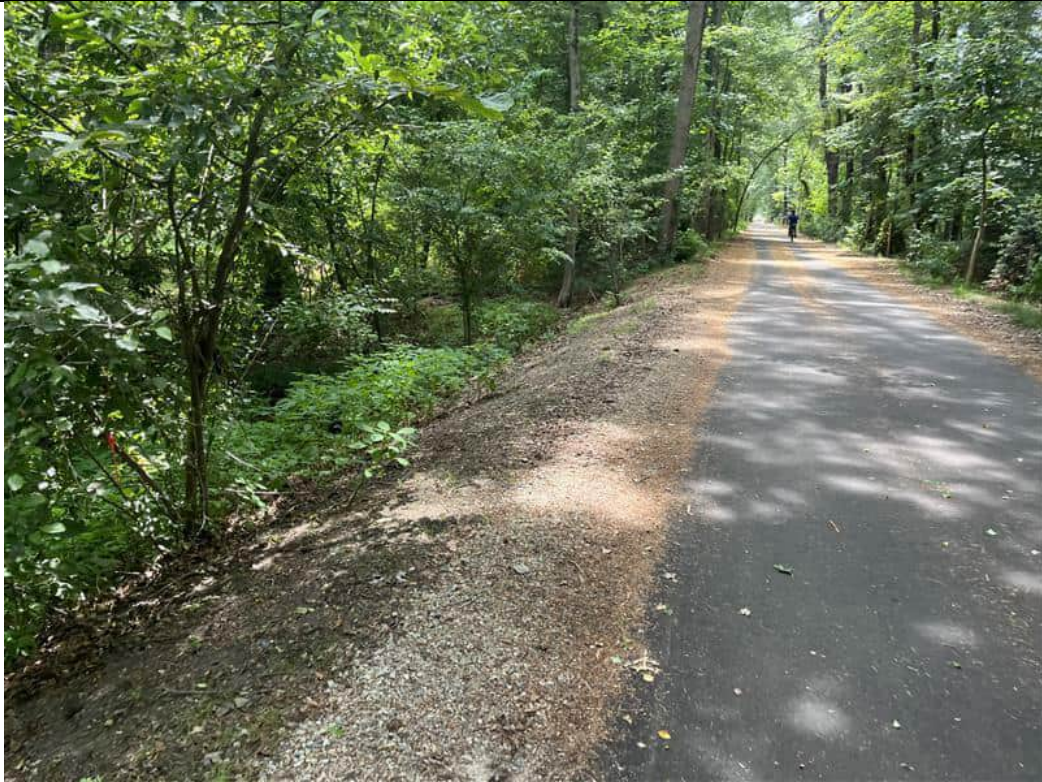
Site Location		Bruce Freeman Rail Trail Right-of-Way	BETA Project No. 24.10326.23
Photo No. 3	Date: 7/1/2025

Direction Photo Taken: Toward the South			
Description: View of exposed soil that requires at Station 138+00 per Long Term Compliance Action item 61.			
Photo No. 4	Date: 7/1/2025

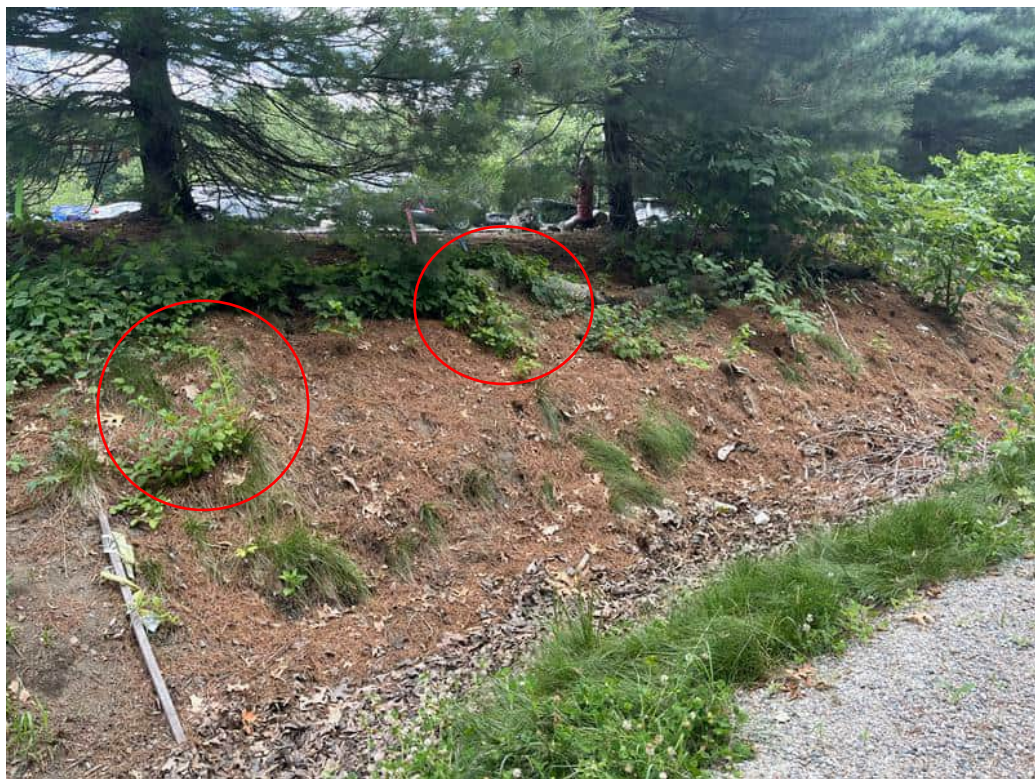
Direction Photo Taken: Toward the East			
Description: View of bittersweet and Japanese knotweed that require removal in an area of exposed soil at Station 172+00 per Long Term Compliance Action Item 59 and 61.

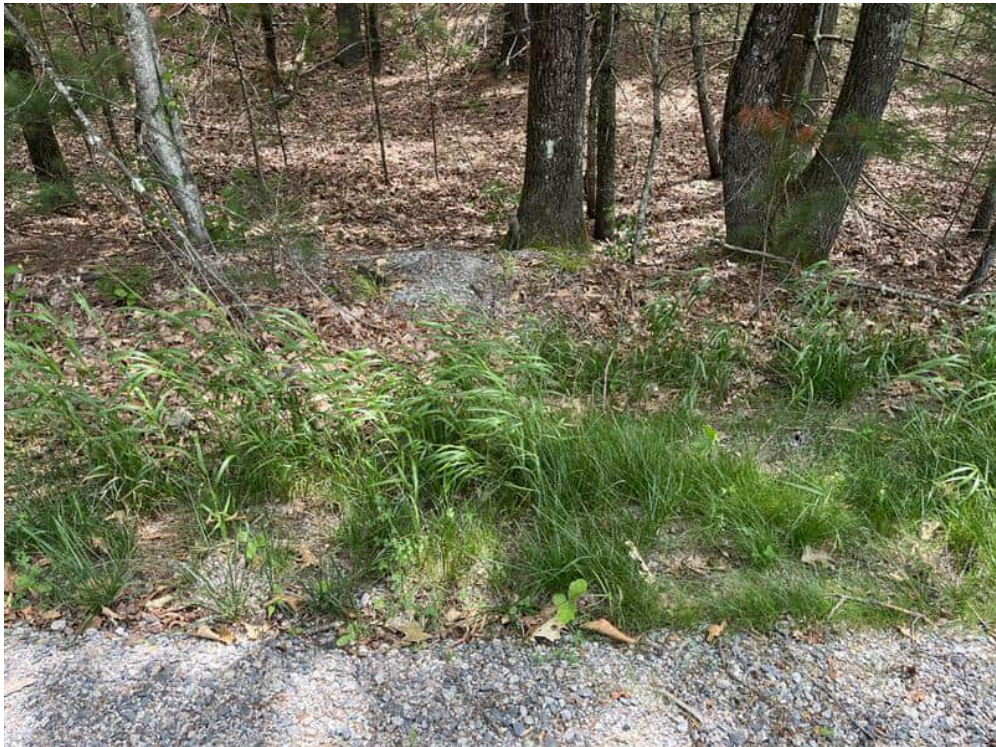
Site Location		Bruce Freeman Rail Trail Right-of-Way	BETA Project No. 24.10326.23
Photo No. 5	Date: 7/1/2025

Direction Photo Taken: Toward the East			
Description: View of a location where crushed stone has migrated off of the path at Station 181+00 per Long Term Compliance Action Item 58.			
Photo No. 6	Date: 7/1/2025

58	Crushed stone used for the dense graded crush stone shoulders has been observed as migrating both onto the path, off the sides of the path, and into the adjacent Resource Areas throughout the Project Priority: High	8/7/2024	8/14/2024	Remove all crushed stone from Resource Areas and develop a plan to cease discharges of stone.	<p>4/21/2025 - For readability all previous observations have been removed from the report. Please reference the report from 4/14/2025 to see past observations. Observation remains. Crushed stone was observed both on and off the trail in multiple locations.</p> <p>4/28/2025 - Observation remains. See previous update.</p> <p>5/5/2025 - Observation remains. See update from 4/21/2025.</p> <p>5/12/2025 - Observation remains. See update from 4/21/2025.</p> <p>5/16/2025 - Observation remains. Crushed stone is present both on and on the side of the trail in multiple locations.</p> <p>5/23/2025 - Observation remains. See previous update.</p> <p>5/29/2025 - Observation remains. Crushed stone is present both on and on the side of the trail in multiple locations.</p> <p>6/6/2025 - Observation remains. See previous update.</p> <p>6/9/2025 - Observation remains. Crushed stone is present both on and on the side of the trail in multiple locations.</p> <p>7/1/2025 - Observation remains. Crushed stone is present both on and on the side of the trail in multiple locations.</p>

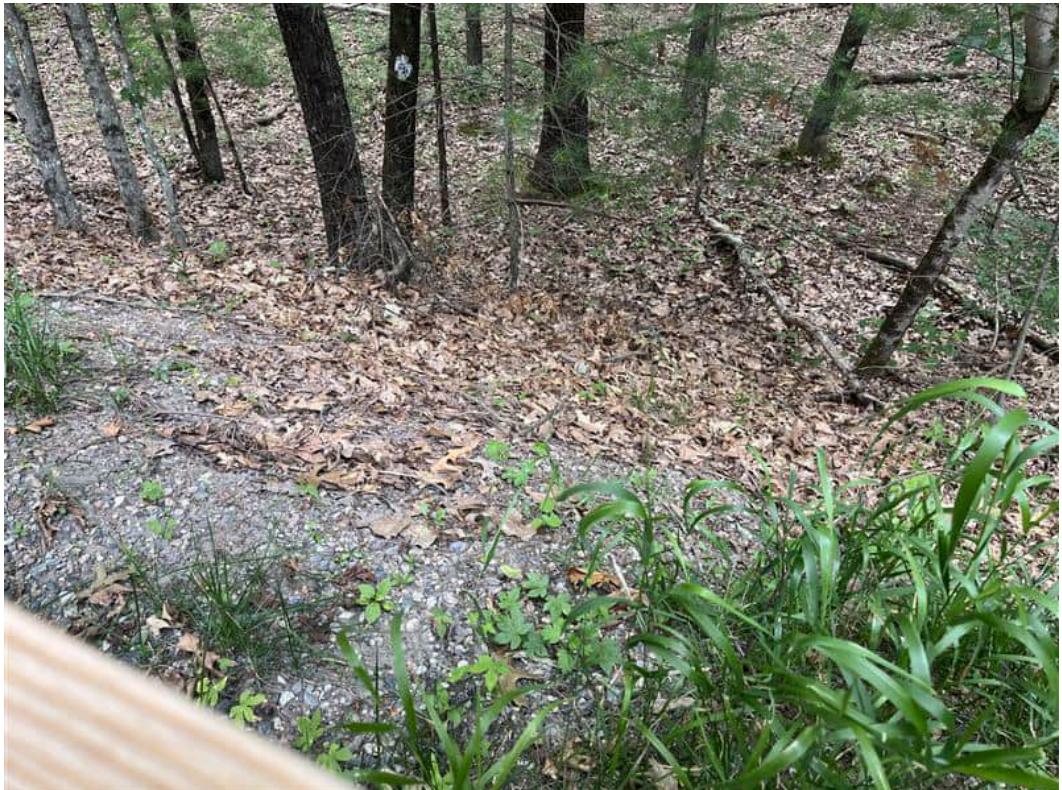
Direction Photo Taken: Toward the North			
Description: View of a location where crush stone has migrated off of the path and a population of Japanese hops that require removal at Station 187+00 per Long Term Compliance Action Item 58 and 57-1.

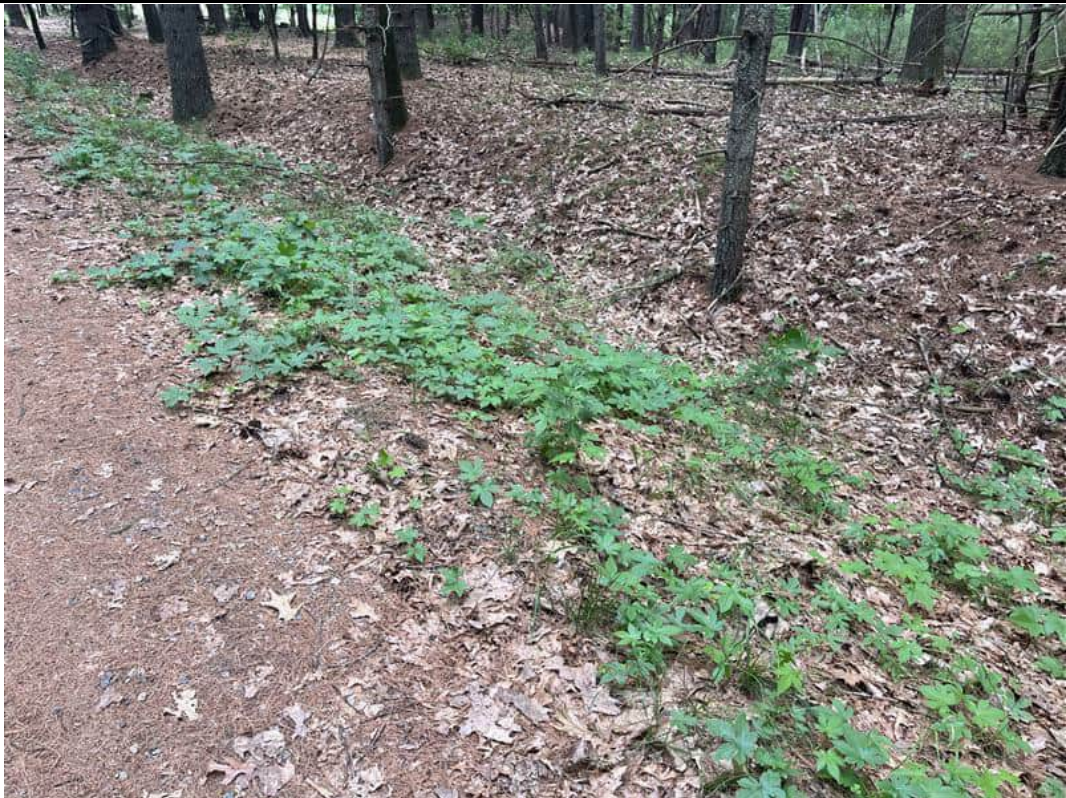
Site Location		Bruce Freeman Rail Trail Right-of-Way	BETA Project No. 24.10326.23
Photo No. 7	Date: 7/1/2025

Direction Photo Taken: Toward the South			
Description: View of a population of Japanese hops that require removal at Station 193+00 per Long Term Compliance Action item 57-1.			
Photo No. 8	Date: 7/1/2025

57-1	Japanese hops (<i>Humulus japonicus</i>) has been observed throughout the Project and requires removal Priority: High	10/22/2024	10/29/2024	The Contractor should manage remaining Japanese hops by hand pulling and the application of herbicide.	<p>10/22/2024 - This Action Item has been reopened due to observations of both dead and living Japanese hops in select locations along the Project. BETA and MassDOT will coordinate further with the Sudbury Conservation Agent to clarify the extents of remaining living vegetation as removal efforts progress.</p> <p>10/29/2024 - Plants that were observed as alive along Route 117 during the last inspection were observed to be wilting due to winter die back.</p> <p>4/14/2025 - Japanese hops were observed within Parkinsons Field and require removal.</p> <p>4/21/2025 - Japanese hops were observed within Parkinsons Field and require removal. Japanese hops have not been observed in other locations throughout the trail.</p> <p>4/28/2025 - Observation remains. See previous update.</p> <p>5/5/2025 - Observation remains. Japanese hops have been observed in multiple locations throughout the trail. Management should occur prior to the setting of seed to ensure further spread does not occur.</p> <p>5/12/2025 - Observation remains. See previous update.</p> <p>5/16/2025 - Observation remains. Japanese hops have been observed throughout the trail in both vegetated areas and areas of exposed soils. Management should occur prior to the setting of seed to ensure further spread does not occur.</p> <p>5/23/2025 - Observation remains. See previous update.</p> <p>5/29/2025 - Observation remains. For readability, observations from 11/5/2024 to 4/7/2025 have been removed. Japanese hops have been observed throughout the trail in both vegetated areas and areas of exposed soils. Management should occur prior to the setting of seed to ensure further spread does not occur.</p> <p>6/6/2025 - Observation remains. Treatment occurred on some plants throughout the trail; however, evidence of treatment was not observed on all plants. Japanese hops will continue to be monitored to evaluate the success of the treatment.</p> <p>6/9/2025 - Observation remains. No further evidence of treatment has been observed on Japanese hops throughout the trail. Multiple populations were observed both in areas of exposed soil and in vegetated areas. Vines were also observed within plantings.</p> <p>7/1/2025 - Observation remains. Japanese hops are present throughout the trail and were observed within areas of minimal vegetation and within plantings.</p>

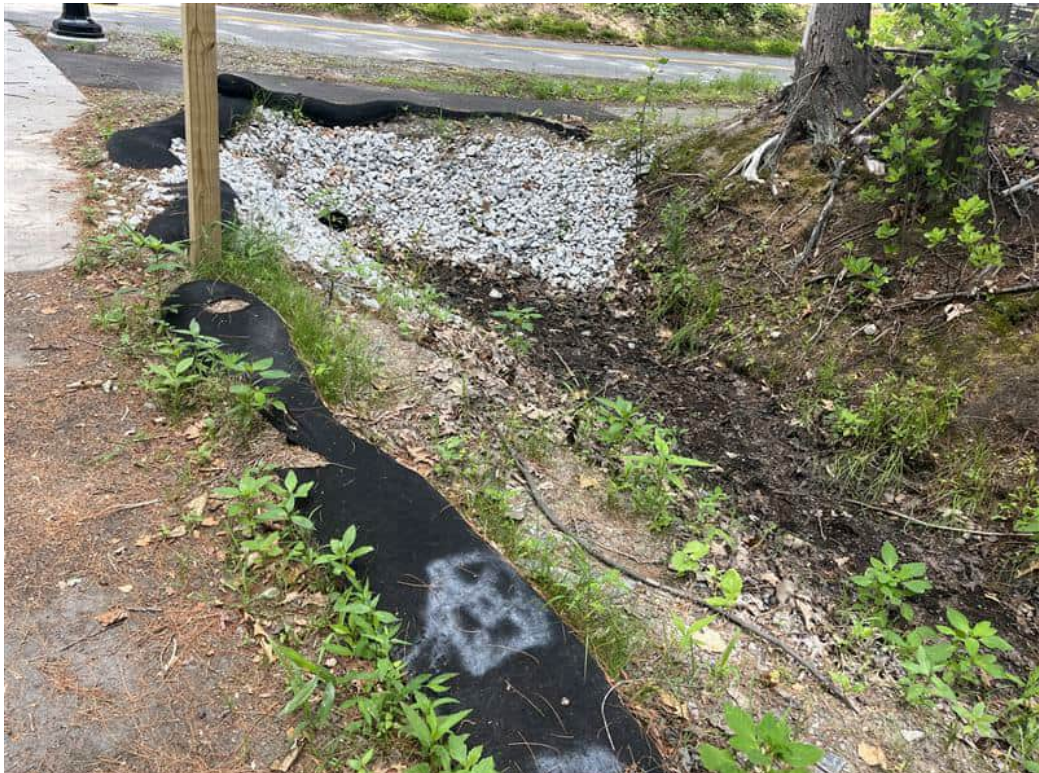
Direction Photo Taken: Toward the South			
Description: View of the location where the stream bank has been regraded beyond the limits of work and exposed soils along the Bank at Station 215+75 per Long Term Compliance Action Items 41 and 62.

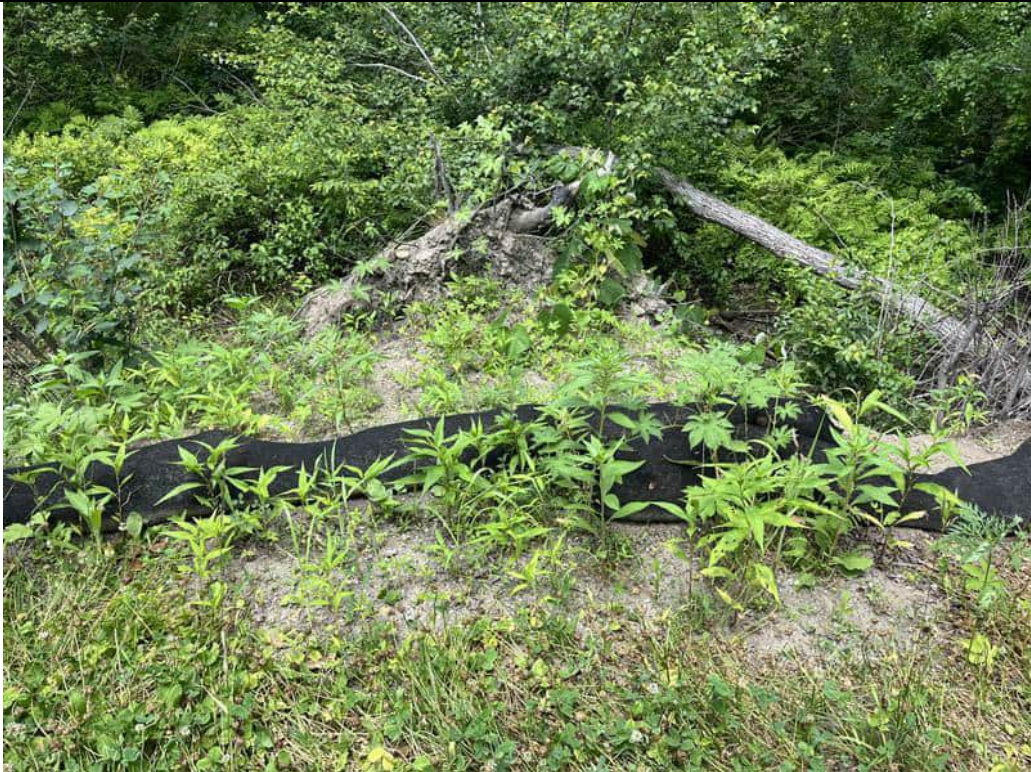
Site Location		Bruce Freeman Rail Trail Right-of-Way	BETA Project No. 24.10326.23
Photo No. 13	Date: 7/1/2025

Direction Photo Taken: Toward the West			
Description: View of the location of placed loam that requires stabilization and Japanese hops within the loam that require removal at Station 311+50 per Long Term Compliance Action Item 59 and 57-1.			
Photo No. 14	Date: 7/1/2025

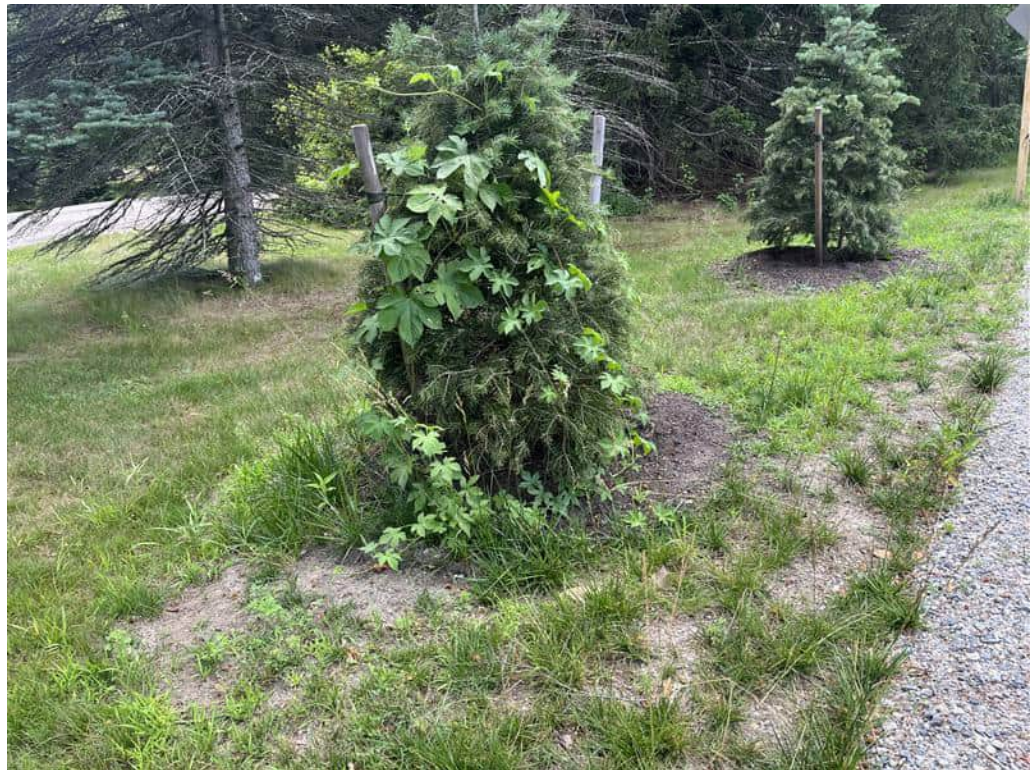
Direction Photo Taken: Toward the South			
Description: View of Japanese hops that require removal within a planted tree at Station 319+75 per Long Term Compliance Action Item 57-1.
