Environmental Monitor Construction Site Inspection Report MassDOT Project #608164 Construction Contract # 119678 EM Report #63						
Project Description: Bruce Freeman Rail Trail Right-of-Way Permit Description(s): Order of Conditions (MGL Chapter 131, Section 40 and 310 CMR 10.00, Mass DEP File No. 301-1362); 2022 EPA NPDES General Permit for Discharges from Construction Areas; U.S. Army Corps of Engineers Permit No NAE-2021-01975.

I. General Project Information						
Project Name:	Bruce Freeman Rail Trail - Phase 2d - Sudbury					
Date of Inspections:	9/10/2025					
Bi Weekly/ Monthly Period Covered:	September Inspection					
Inspector's Name(s):	Anna Haznar					
Inspectors' Contact Information:	<a href="mailto:ahaznar@beta-inc.com">ahaznar@beta-inc.com</a>					
II. Weather Information						
	Inspection #1	Inspection #2	Inspection #3	Inspection #4	Inspection #5	Inspection #6
<a href="#">WeatherUnderground</a>	Inspector: Anna Haznar 7/1/2025	Inspector: Anna Haznar 8/8/2025	Inspector: Anna Haznar 9/10/2025	Inspector:	Inspector:	Inspector:
Type of Inspection (i.e. non-storm event, pre-storm event, during-storm event or post-storm event):	Non-storm	Non-storm	Non-storm			
Number of d

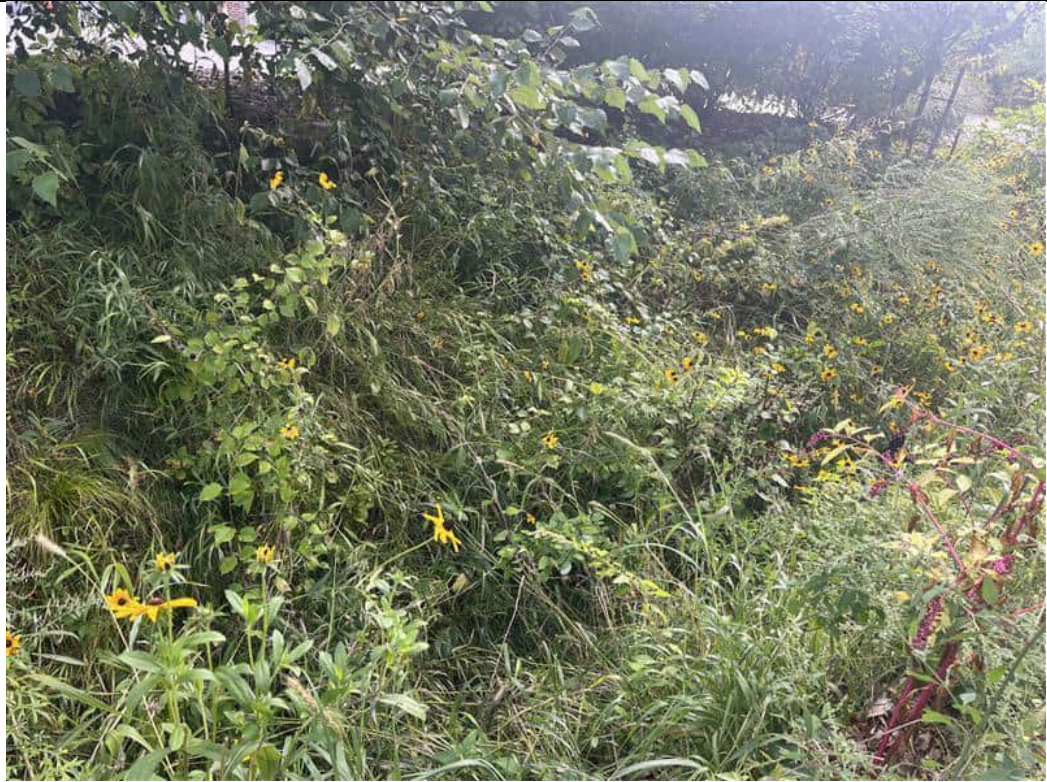
<b>Site Location</b>		Bruce Freeman Rail Trail Right-of-Way	<b>BETA Project No.</b> 24.10326.23
<b>Photo No. 3</b>	<b>Date:</b> 9/10/2025

<b>Direction Photo Taken:</b>  Toward the Southeast			
<b>Description:</b>  View of a population of bittersweet along the slope at Station 173+00 per Long Term Compliance Action Item 61.			
<b>Photo No. 4</b>	<b>Date:</b> 9/10/2025

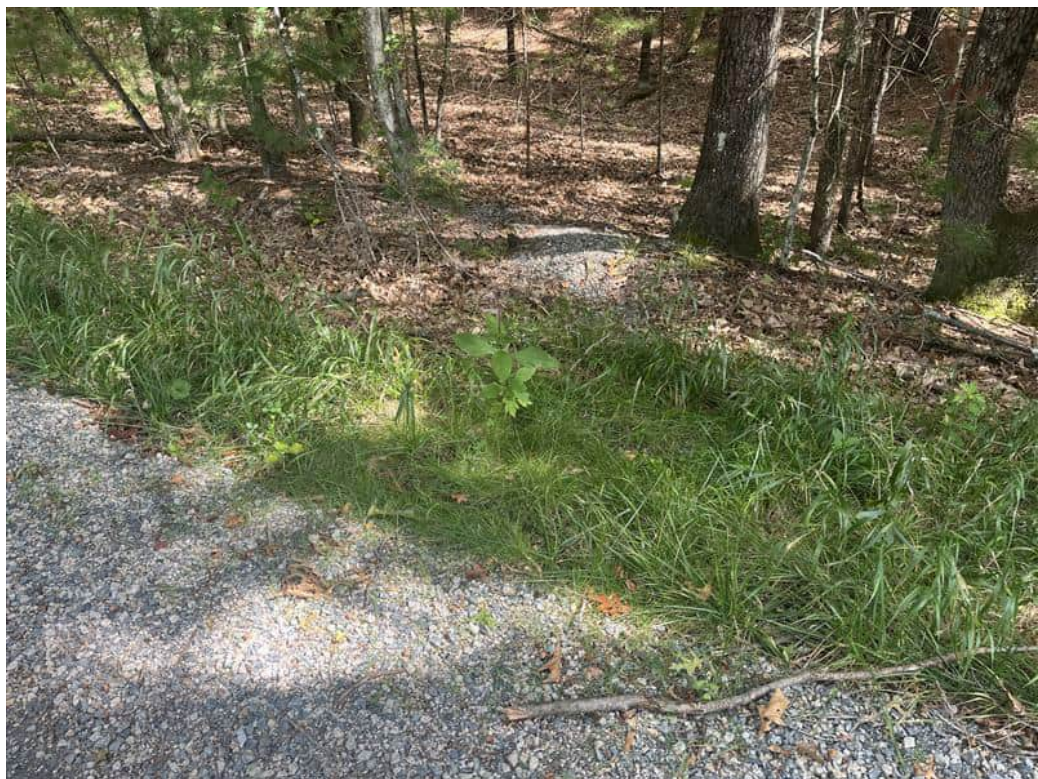
<b>Direction Photo Taken:</b>  Toward the Northeast			
<b>Description:</b>  View of a location where crush stone has migrated off of the path at Station 181+00 per Long Term Compliance Action Item 58.

58	Crushed stone used for the dense graded crush stone shoulders has been observed as migrating both onto the path, off the sides of the path, and into the adjacent Resource Areas throughout the Project <b>Priority: High</b>	8/7/2024	8/14/2024	Remove all crushed stone from Resource Areas and develop a plan to cease discharges of stone.	4/21/2025 - For readability all previous observations have been removed from the report. Please reference the report from 4/14/2025 to see past observations. Observation remains. Crushed stone was observed both on and off the trail in multiple locations. 4/28/2025 - Observation remains. See previous update. 5/5/2025 - Observation remains. See update from 4/21/2025. 5/12/2025 - Observation remains. See update from 4/21/2025. 5/16/2025 - Observation remains. Crushed stone is present both on and on the side of the trail in multiple locations. 5/23/2025 - Observation remains. See previous update. 5/29/2025 - Observation remains. Crushed stone is present both on and on the side of the trail in multiple locations. 6/6/2025 - Observation remains. See previous update. 6/9/2025 - Observation remains. Crushed stone is present both on and on the side of the trail in multiple locations. 7/1/2025 - Observation remains. Crushed stone is present both on and on the side of the trail in multiple locations. 8/8/2025 - Observation remains. Crushed stone is present both on and on the side of the trail in multiple locations. 9/10/2025 - Observation remains. Crushed stone is present both on and on the side of the trail in multiple locations.

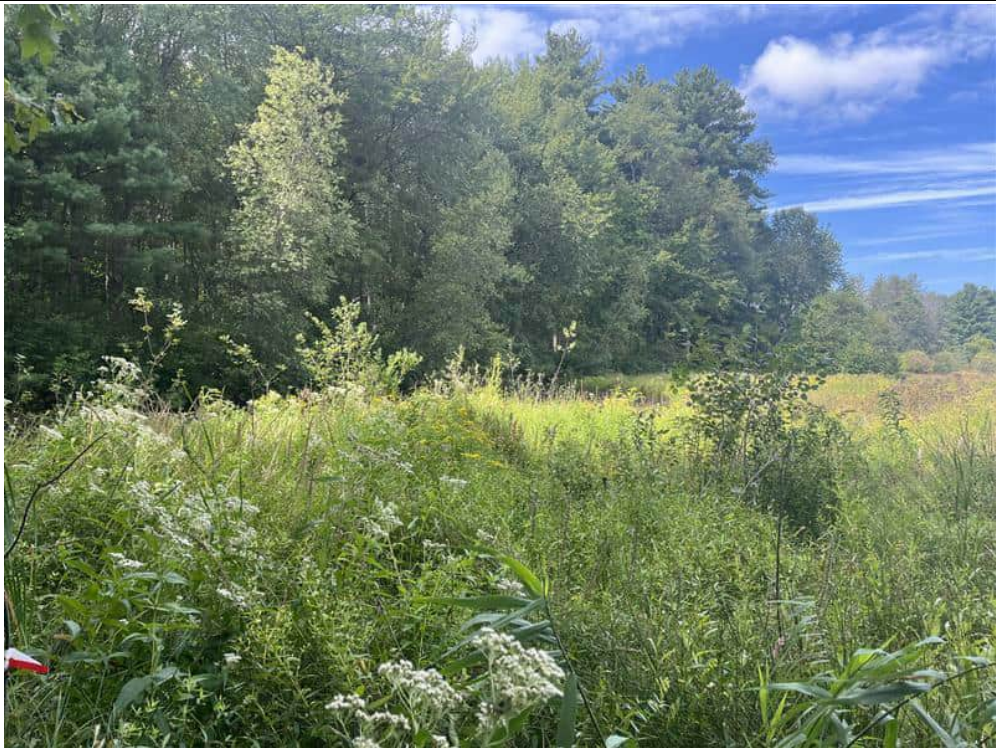
<b>Site Location</b>		Bruce Freeman Rail Trail Right-of-Way	<b>BETA Project No.</b> 24.10326.23
<b>Photo No. 5</b>	<b>Date:</b> 9/10/2025

<b>Direction Photo Taken:</b>  Toward the East			
<b>Description:</b>  View of the wetland replication area.			
<b>Photo No. 6</b>	<b>Date:</b> 9/10/2025

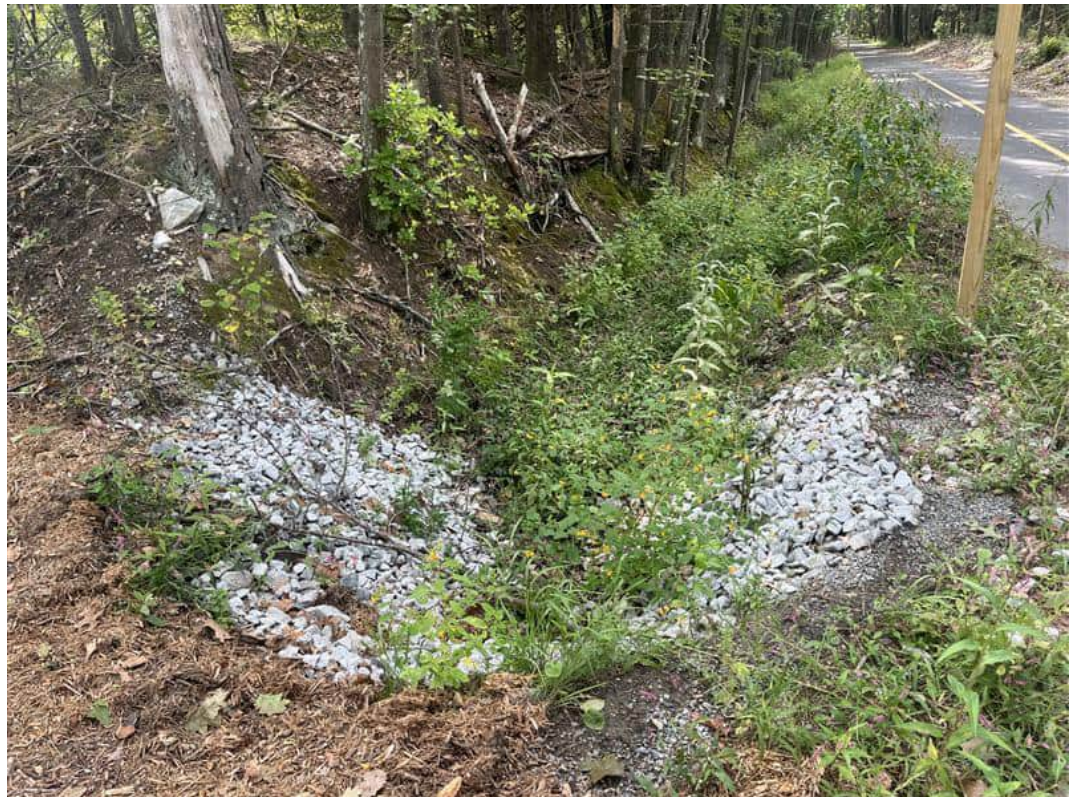
41	Stream Bank has been regraded beyond the limit of work at Station 216+00 Priority: High	5/28/2024	6/4/2024	The Contractor should confirm if this work was permitted by the Conservation Commission, as it does not appear to be a part of the approved plans/impacts. MassDOT should be consulted on next steps regarding notification and potential restoration.	5/31/2024 - Observation remains. 6/7/2024 - Observation remains. 6/14/2024 - Observation remains. 6/17/2024 - Observation remains. 6/24/2024 - Observation remains. 6/27/2024 - Observation remains. 7/8/2024- Observation remains. 7/15/2024 - This area could not be assessed due to paving operations ongoing during the inspection. 7/22/2024 - Crushed stone and sediment continue to be discharged to the stream between Stations 215+00 and 217+00 due to overtopped and undermined compost filter tubes. 7/29/2024 - Observation remains. 8/5/2024 - Observation remains. 8/7/2024 - Observation remains. 8/12/2024 - Observation remains. Crushed stone is still present in the streambed at this location. 8/16/2024 - Observation remains. 8/20/2024 - Stone has been removed; however, additional alteration to Resource Areas beyond the limit of work continue. 8/27/2024 - Observation remains. 9/3/2024 - Observation remains. 9/10/2024 - Observation remains. Stone has been observed as discharging into the streambed in this location again. 9/16/2024 - Observation remains. 9/23/2024 - Observation remains. Stone is still present within the streambed at this location. 9/27/2024 - Observation remains. 10/4/2024 - Observation remains. 10/8/2024 - Observation remains. 10/15/2024 - Observation remains. Stone is still present within the streambed at this location. 10/22/2024 - Observation remains. Stone is still present within the streambed at this location. 10/29/2024 - Observation remains. Stone is still present within the streambed at this location. 11/5/2024 - Observation remains. The PVC pipe that was installed at this location was observed to be covered with stone and is no longer visible near Station 215+00. Stone is still present within the streambed at this location. 11/12/2024 - Observation remains. The streambed in this location is covered with leaf litter. See previous update. 11/19/2024 - Observation remains. As discussed with the Conservation Agent in the field, further coordination between the Town and MassDOT will be required to clean/repair the culvert, as the degraded condition of the culvert prompted the contractor to armor the stream banks. Further coordination will also be required for restoration of banks. 7/1/2025 - Observation remains. For readability, observations from 11/22/2025 to 6/9/2025 have been removed - see report #60 for previous observations. See update from 11/19/2024. 8/8/2025 - Observation remains. See update from 11/19/2024. 9/10/2025 - Observation remains. See update from 11/19/2024.

<b>Direction Photo Taken:</b>  Toward the West			
<b>Description:</b>  View of the location where the stream bank has been regraded beyond the limits of work at Station 215+75 per Long Term Compliance Action Items 41.

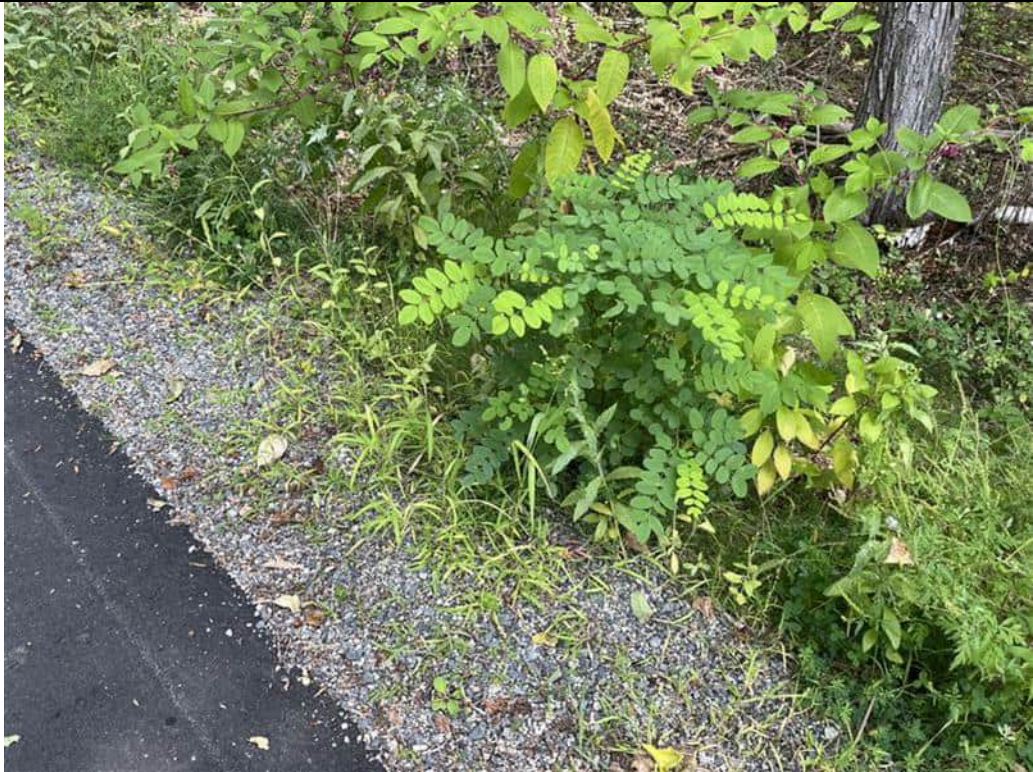
<b>Site Location</b>		Bruce Freeman Rail Trail Right-of-Way	<b>BETA Project No.</b> 24.10326.23
<b>Photo No. 11</b>	<b>Date:</b> 9/10/2025

<b>Direction Photo Taken:</b>  Toward the South			
<b>Description:</b>  View of black locust that requires removal at Station 279+00 per Long Term Compliance Item 61.			
<b>Photo No. 12</b>	<b>Date:</b> 9/10/2025

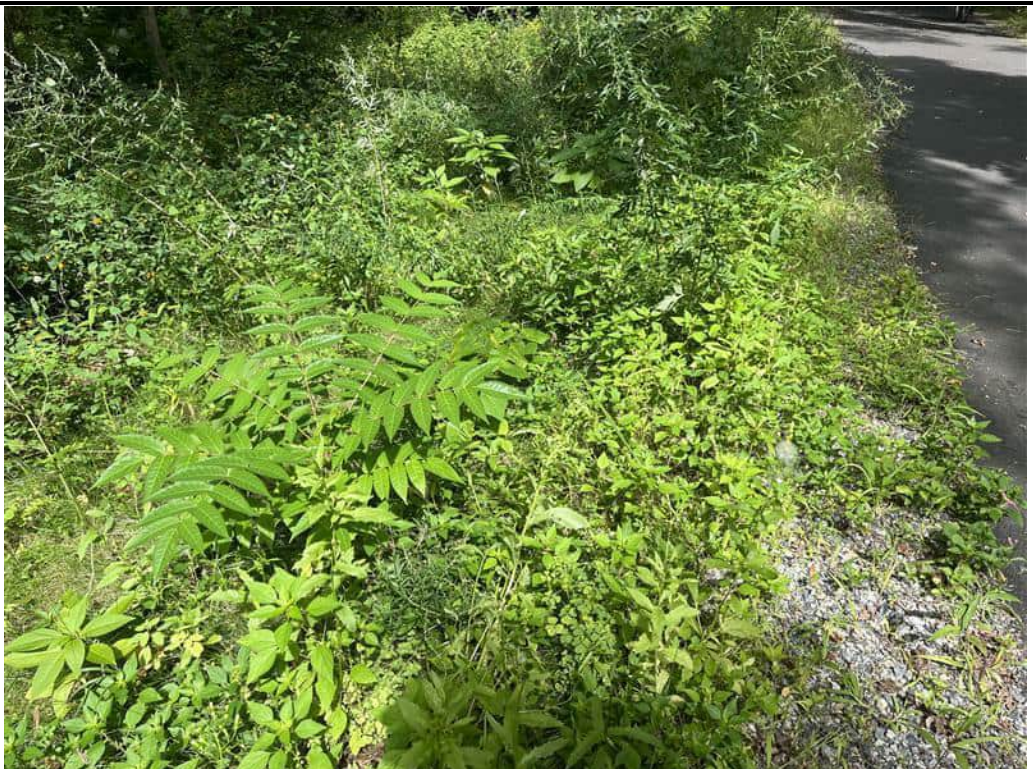
<b>Direction Photo Taken:</b>  Toward the West			
<b>Description:</b>  View of tree of heaven that requires removal at Station 291+00 per Long Term Compliance Item 61.

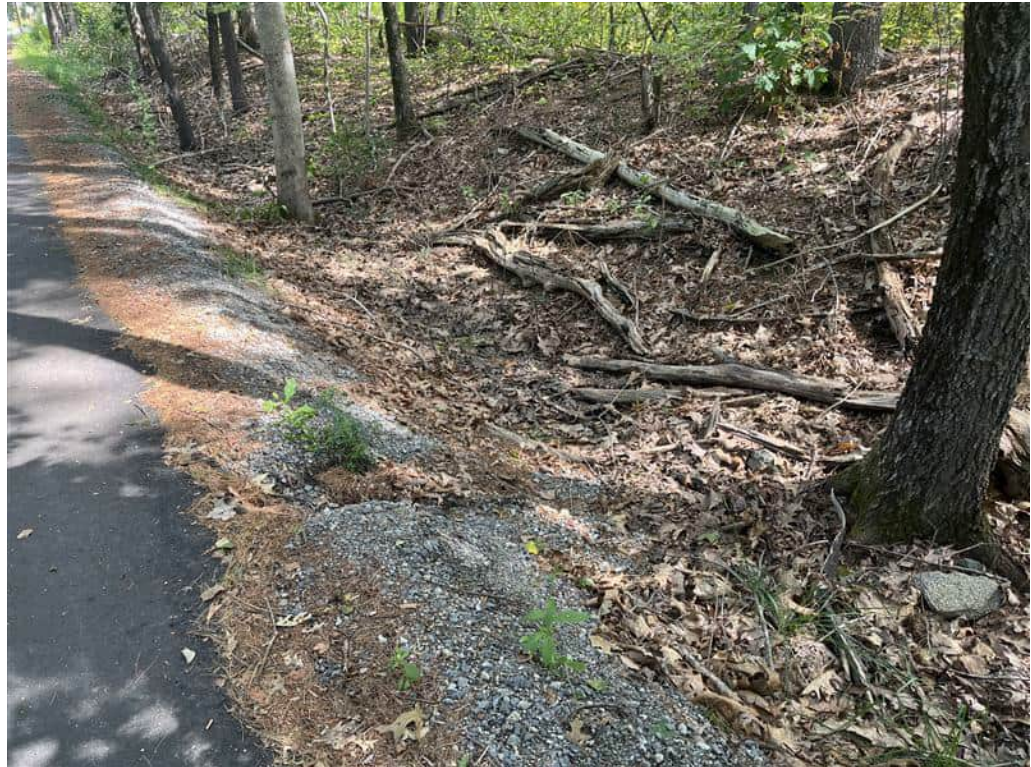
<b>Site Location</b>		Bruce Freeman Rail Trail Right-of-Way	<b>BETA Project No.</b> 24.10326.23
<b>Photo No. 13</b>	<b>Date:</b> 9/10/2025

<b>Direction Photo Taken:</b>  Toward the West			
<b>Description:</b>  View of crushed stone that has migrated off of the shoulder at Station 303+00 per Compliance Action Item 58.			
<b>Photo No. 14</b>	<b>Date:</b> 9/10/2025

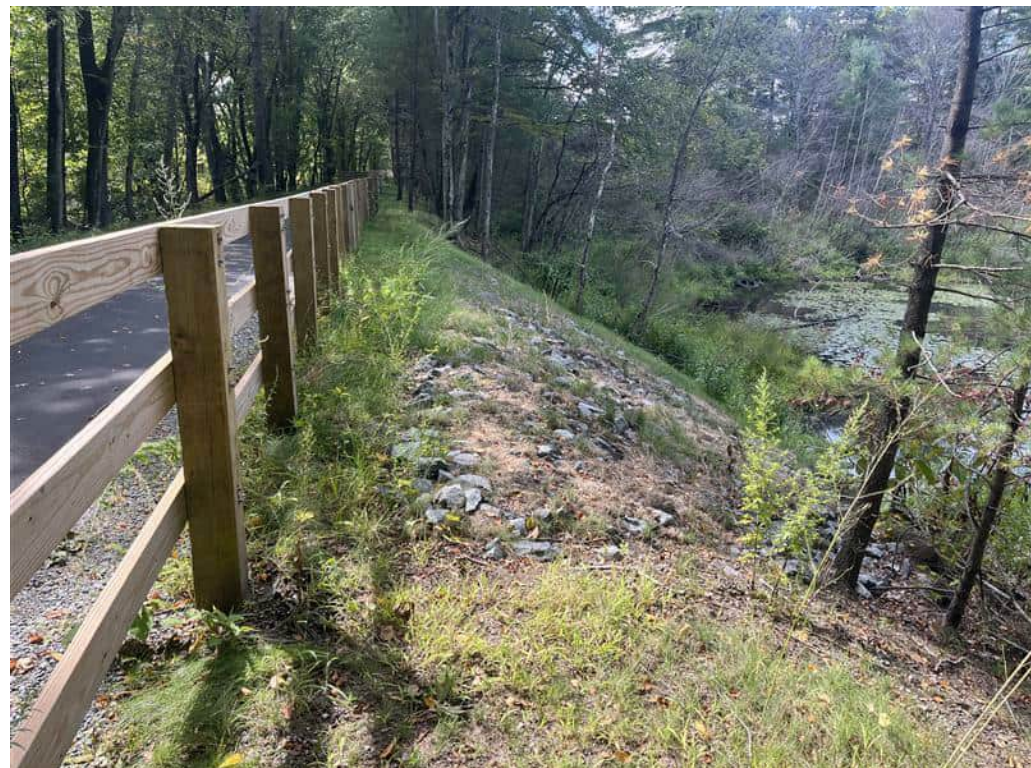
42	Riprap slope extends beyond limits of work along the WF1 Series wetland near flags 103 to 107 <b>Priority: High</b>	5/28/2024	6/4/2024	The Contractor should confirm if this work was permitted by the Conservation Commission, as it does not appear to be a part of the approved plans/impacts. MassDOT should be consulted on next steps regarding notification and potential restoration.	5/31/2024 - Observation remains. 6/7/2024 - Observation remains. 6/14/2024 - Riprap slope has been altered and active construction is repairing the area. 6/17/2024 - During this inspection, additional work in support of the repair/potential replacement of an underlying pipe has was ongoing. It is recommended that the contractor confirm that they have coordinated with the Conservation Commission for this work and provide a restoration plan for the area once work is complete. 6/24/2024 - During this inspection, BETA was informed that the existing cast iron pipe was replaced with a new concrete 12-inch reinforced concrete pipe. It appears that riprap was replaced along the side slopes to mirror conditions observed prior to this inspection. 6/27/2024 - During this inspection, the area was observed to have been rolled and prepared for paving. Hydroseed was applied and plantings were installed. 7/8/2024 - Germination was observed and the area will be monitored for stabilization. See previous updates regarding Conservation Commission coordination. 7/15/2024 - This area could not be assessed due to paving operations ongoing during the inspection. 7/22/2024 - See previous updates regarding Conservation Commission coordination. 11/12/2024 - Observation remains. The timber fence has been installed upgradient of this area. 11/19/2024 - Observation remains. As discussed with the Conservation Agent in the field, an as-built should be prepared for this area to quantify any additional impacts that may be addressed through a permit amendment. 11/22/2024 - Observation remains. See previous update. 11/25/2024 - Observation remains. See update from 11/19/2024. 12/2/2024 - Observation remains. See update from 11/19/2024. 12/6/2024 - Observation remains. See update from 11/19/2024. 12/12/2024 - Observation remains. See update from 11/19/2024. 12/20/2024 - Observation remains. See update from 11/19/2024. 12/26/2024 - Observation remains. See update from 11/19/2024. 12/31/2024 - Observation remains. See update from 11/19/2024. 1/2/2025 - Observation remains. Leaf litter that was previously observed at the bottom of the slope has blown away and it appears that exposed soil with no observable germination is present. 7/1/2025 - Observation remains. For readability, observations from 7/29/2024 to 11/5/2024 and from 1/9/2025 to 6/9/2025 have been removed - see report #60 for previous observations. See update from 1/2/2025 and 11/19/2024. 8/8/2025 - Observation remains. A majority of the exposed soil that was previously observed in this area has become stabilized. See update for 11/19/2024. 9/10/2025 - Observation remains. See update from 11/19/2024.

<b>Direction Photo Taken:</b>  Toward the Northeast			
<b>Description:</b>  View of the location of the riprap slope that extends beyond the limit of work along the WF1 Series wetland at Station 333+00 per Long Term Compliance Action Item 42.
