RECEIVED
AUG 30 2024

BY: R. Poteat

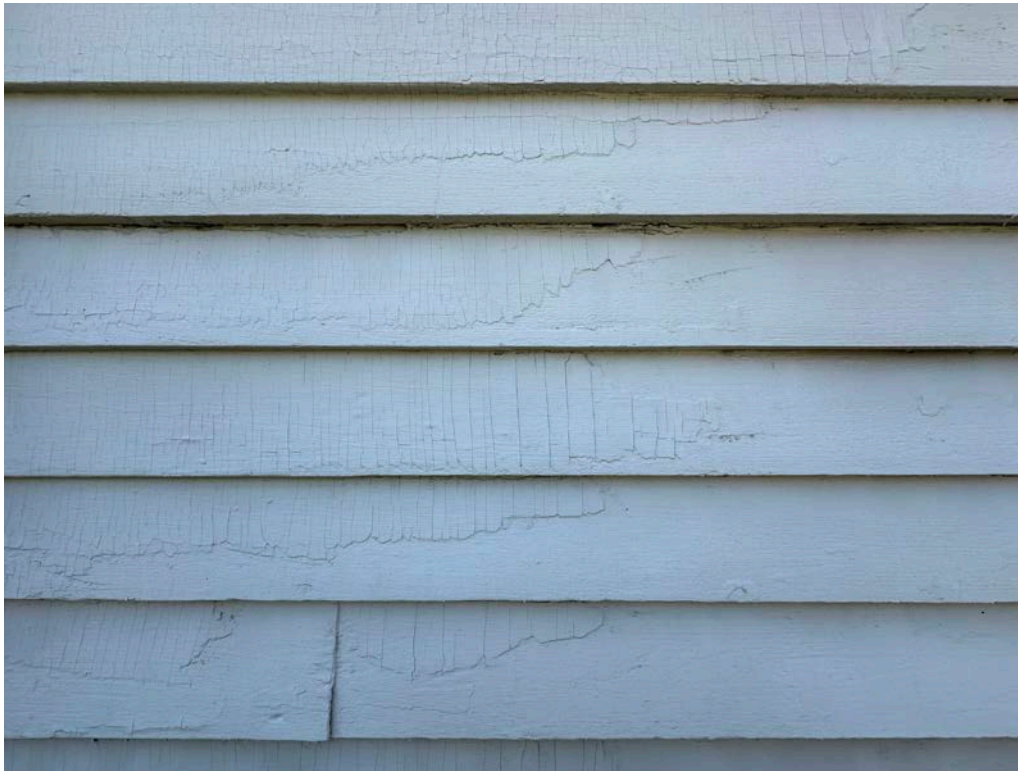
Figure 4.1-1
Clapboard painted a pale yellow, with an average exposure of 4 inches.

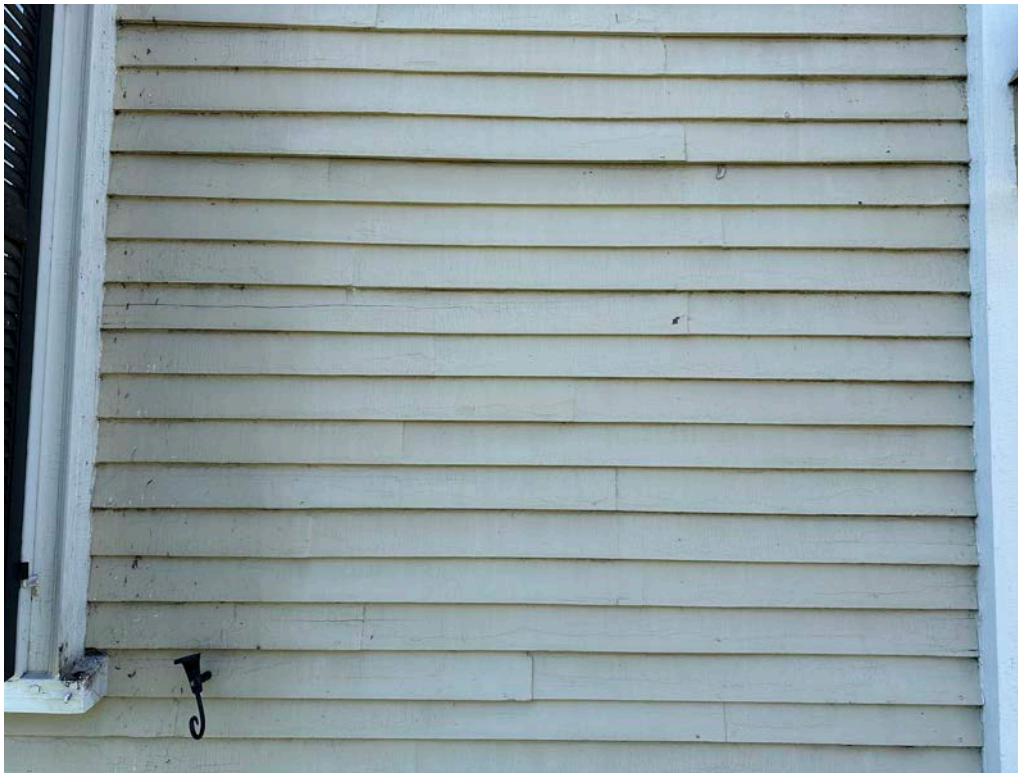
Figure 4.1-4
Large horizontal
cracks visible across
the north elevation.

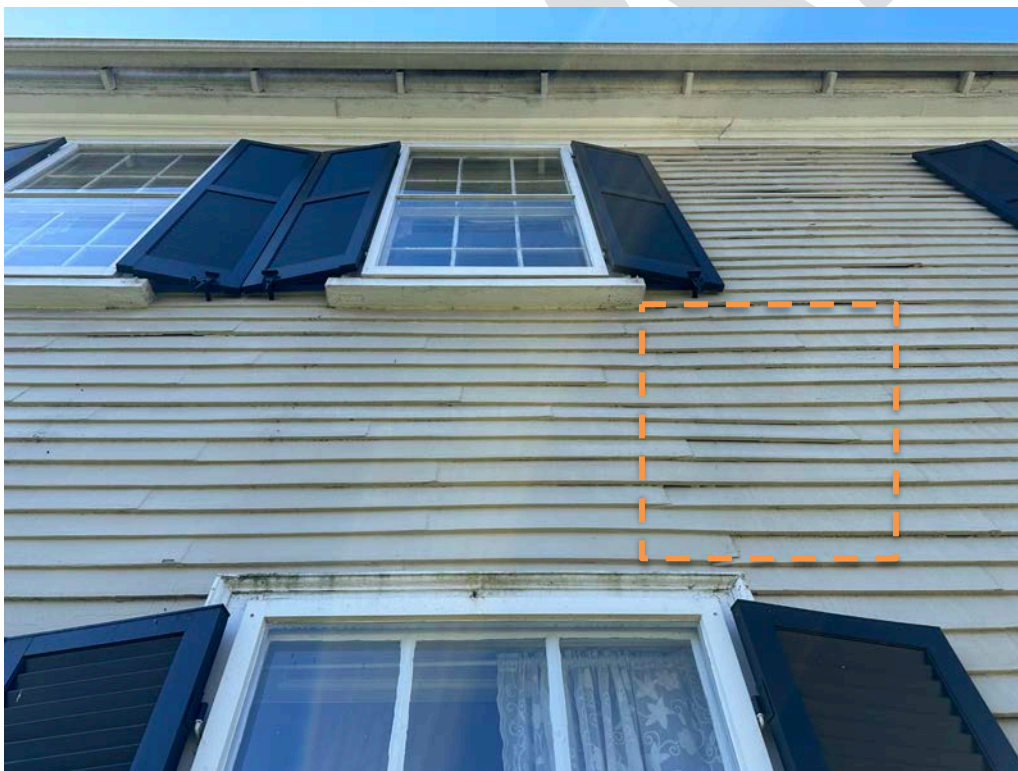
Figure 4.1-5
Depression in the
clapboard,
approximately 4
square feet in size.

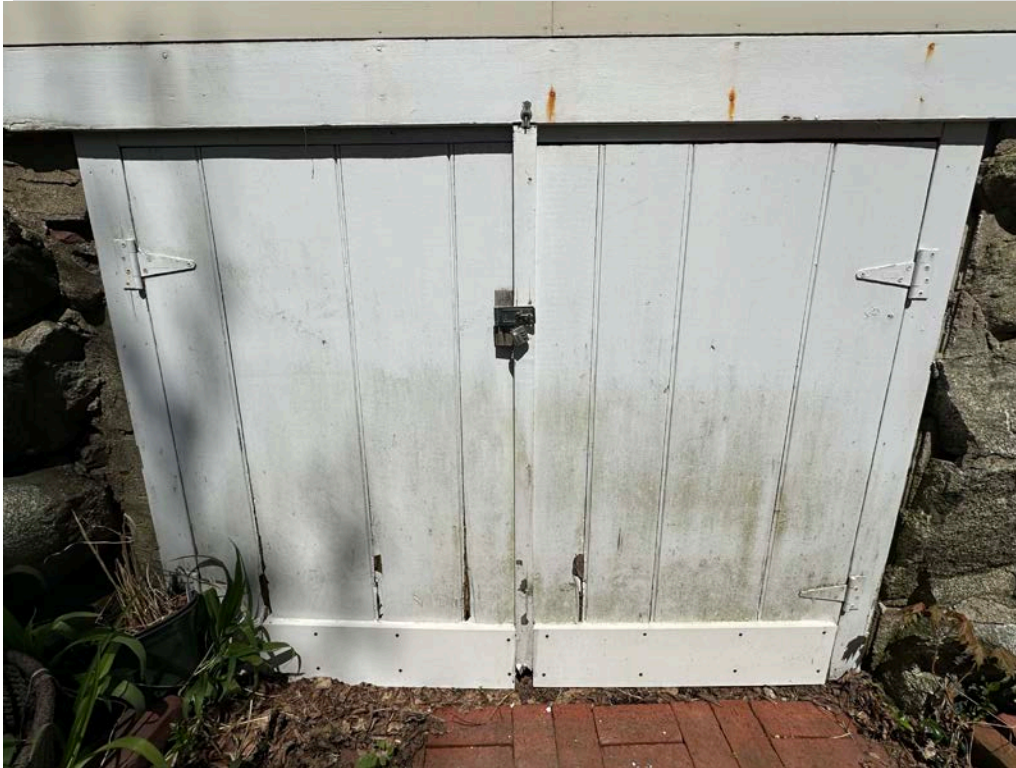
Figure 4.1-12
Fasteners used to secure the trim, corner boards and water tables have begun to corrode and stain the wood.

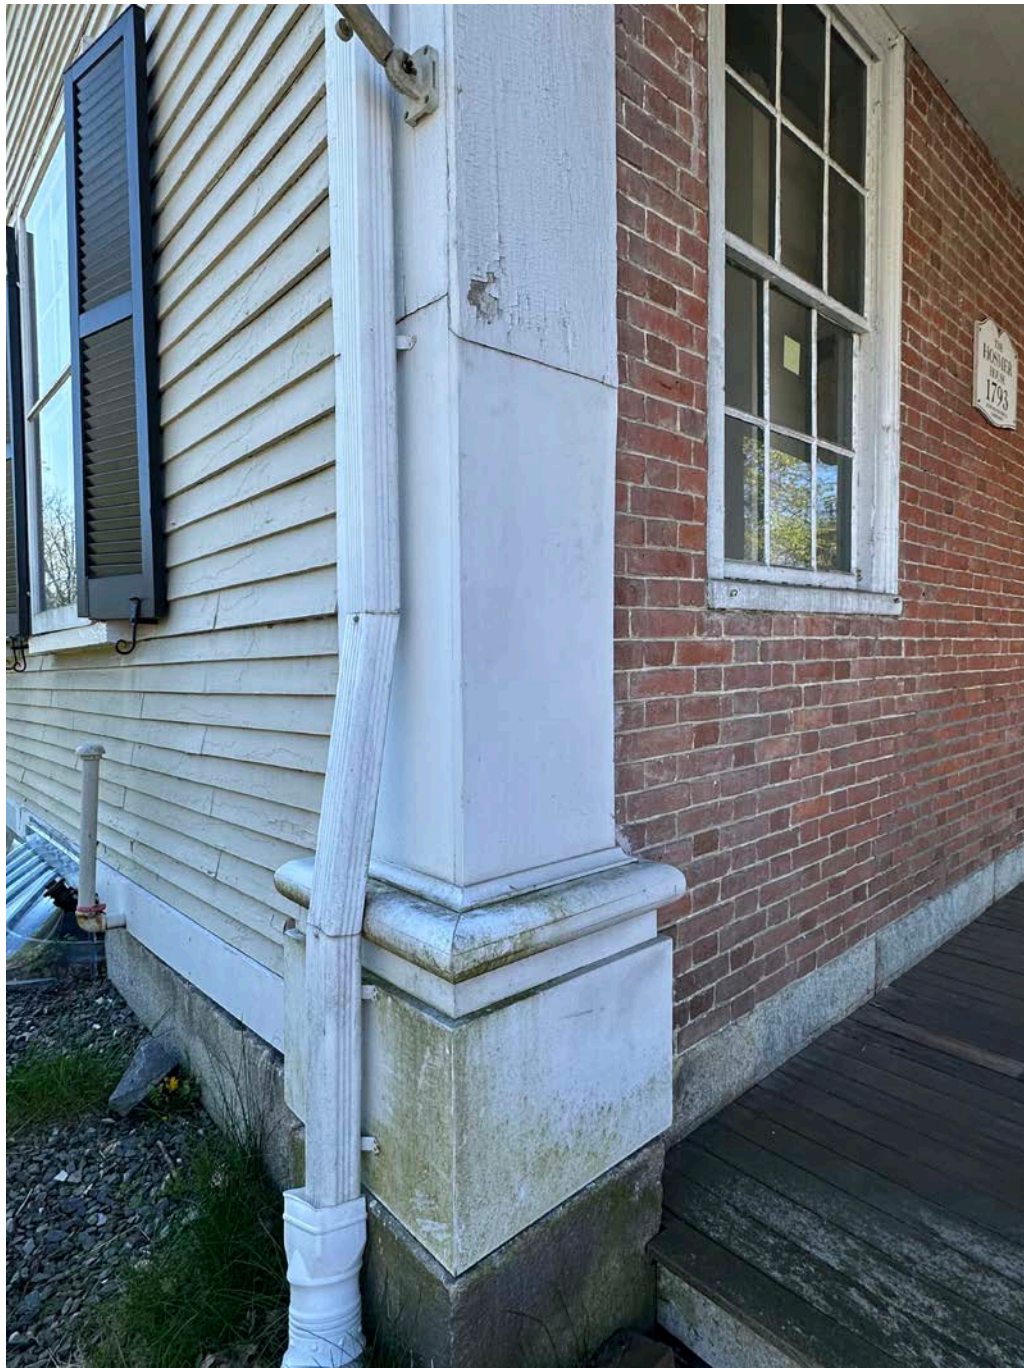
Figure 4.1-13
Bottom 3 feet of
each pilaster shaft
and both bases have
been replaced.

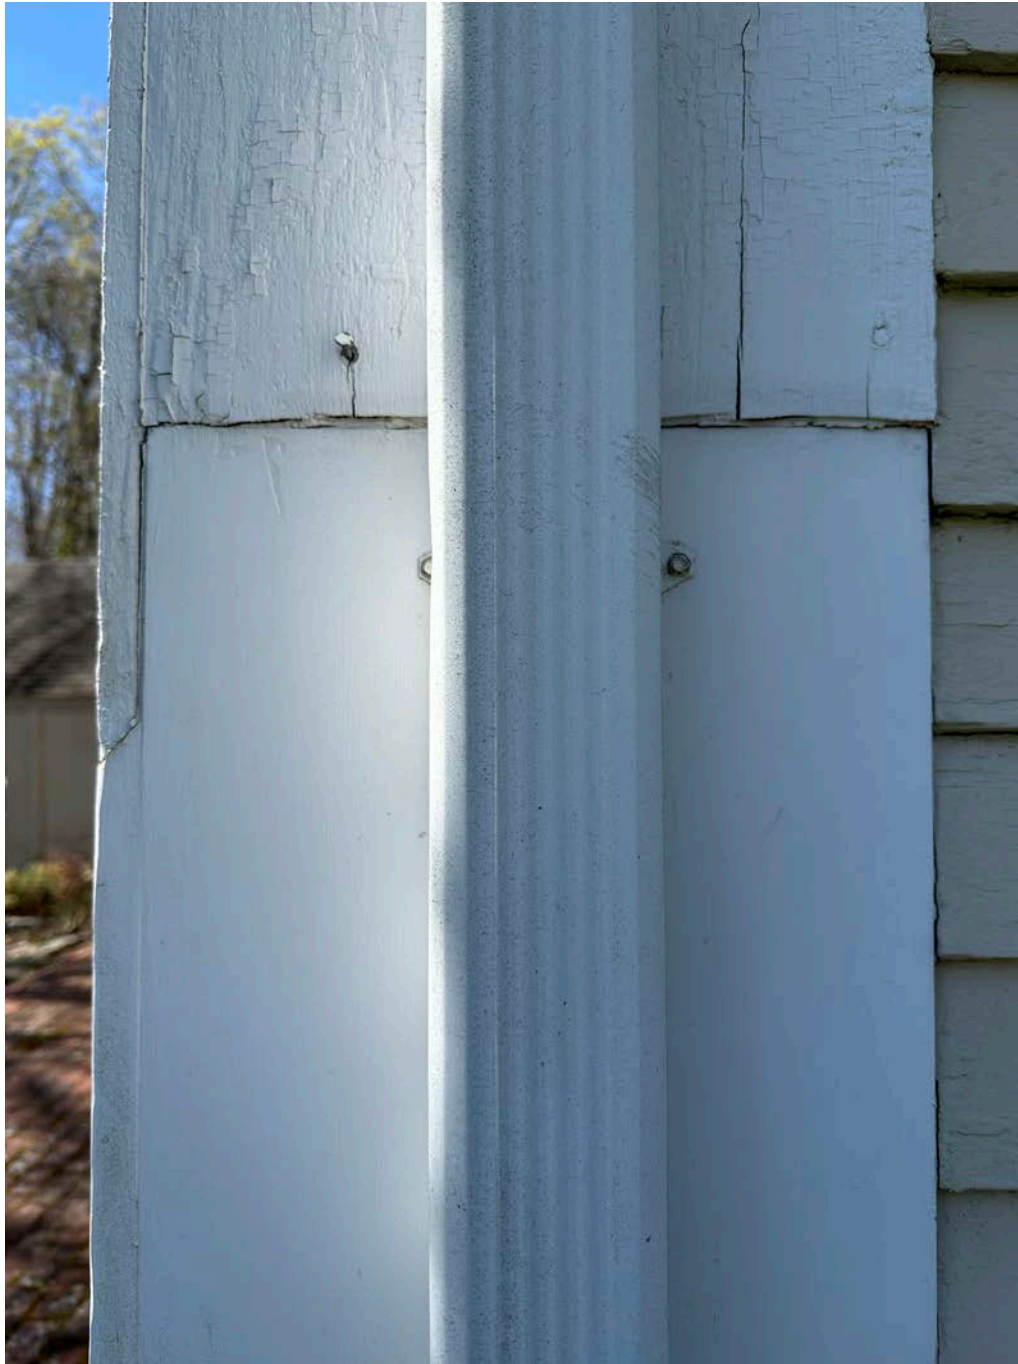
Figure 4.1-14
At the joint of the repaired pilasters, there are several splits in the wood ranging from 8 inches to 2 feet in length.

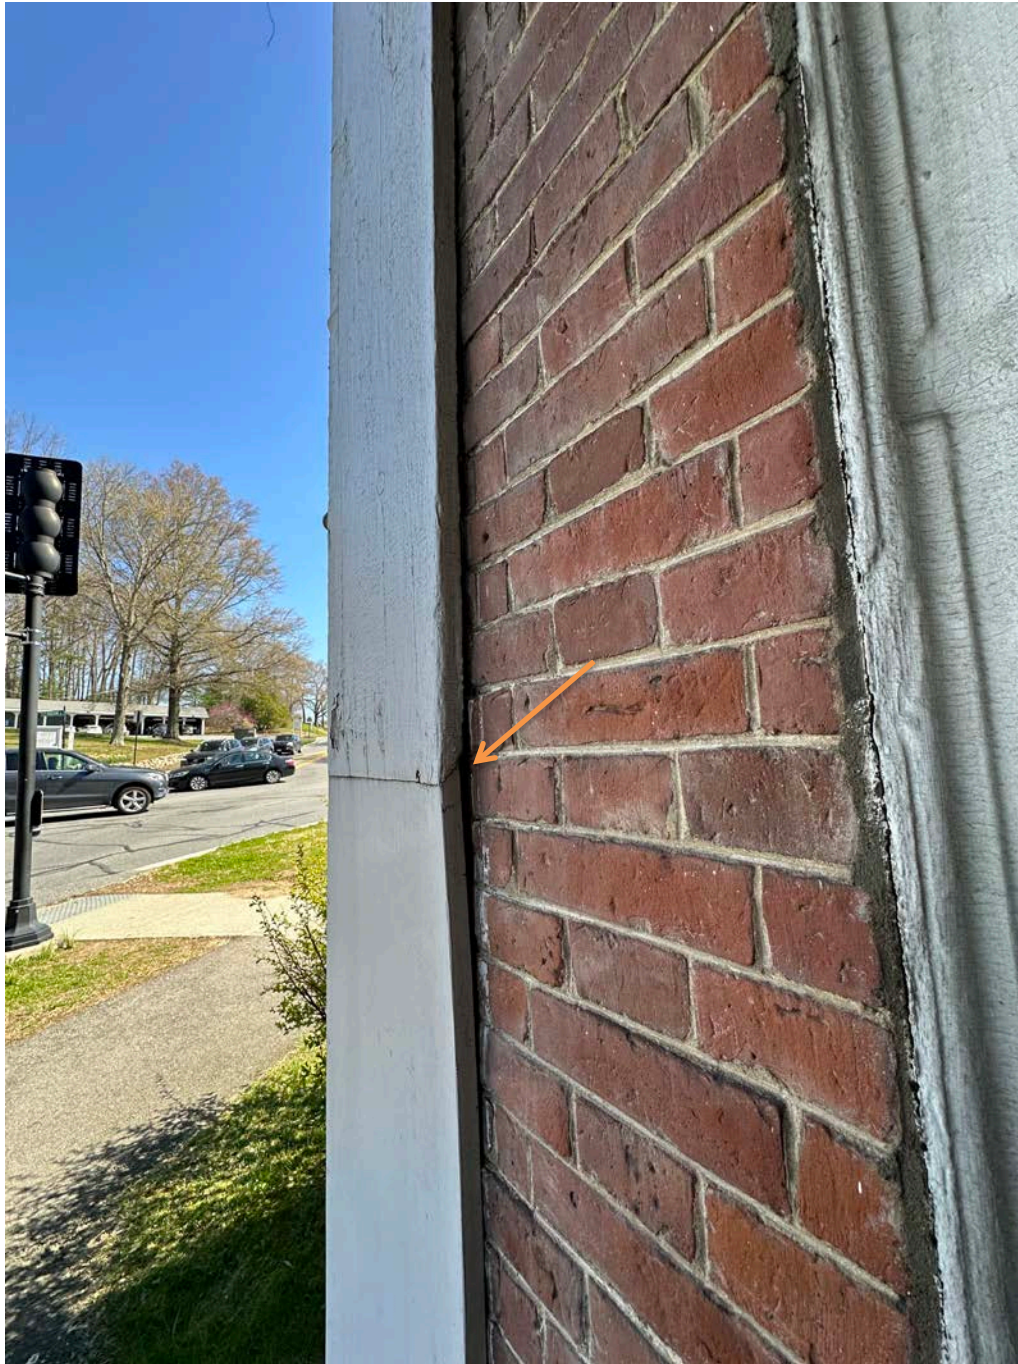
Figure 4.1-15
The pilasters are separating from the brick walls causing gaps between the materials.

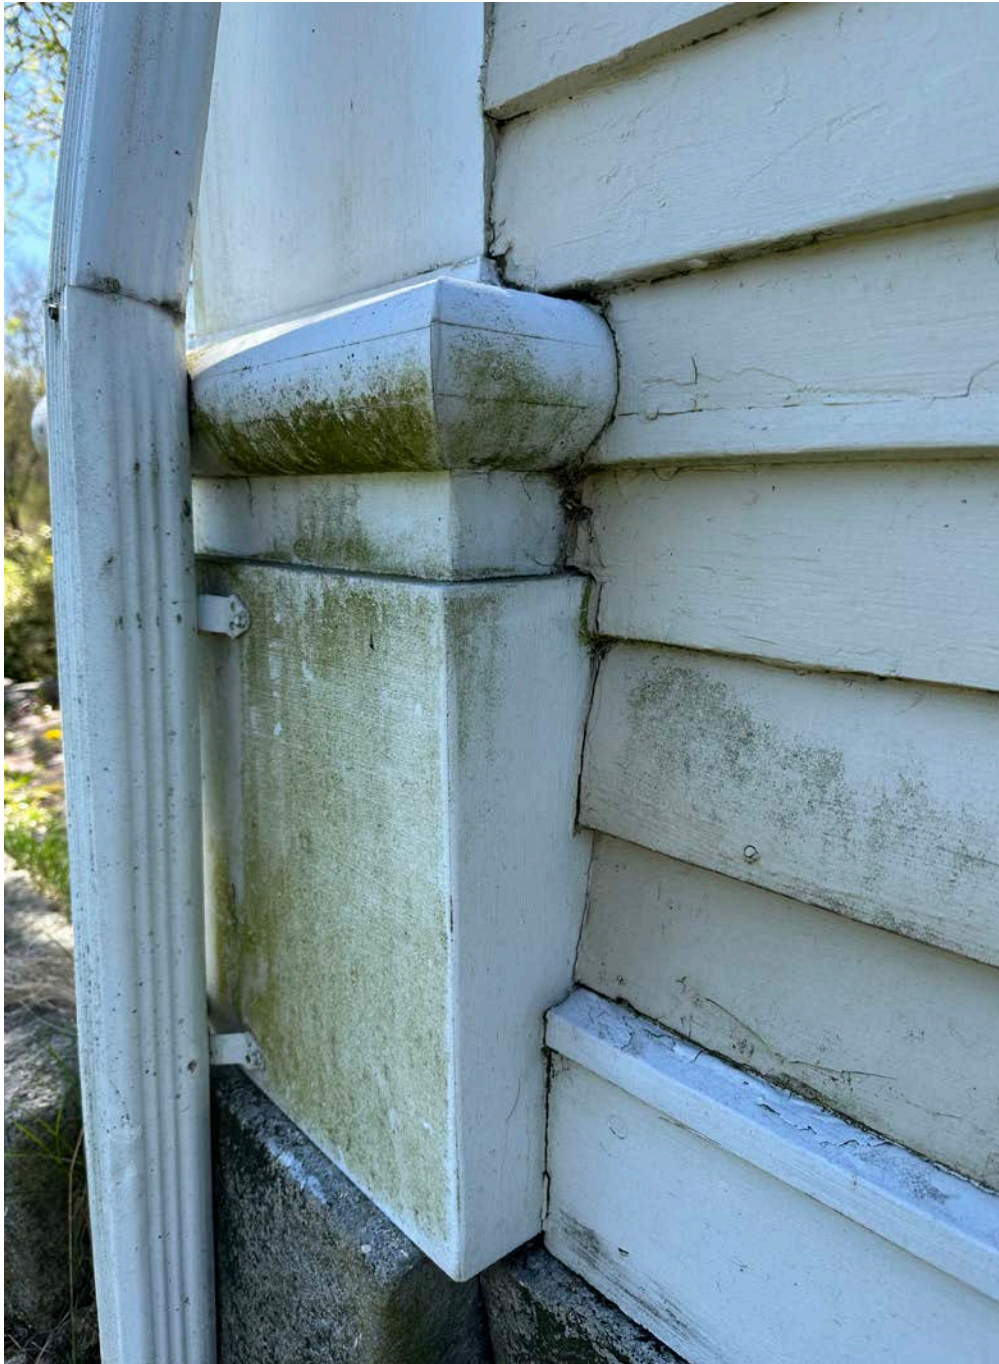
Figure 4.1-16
Both bases of the pilasters are covered in a slight layer of biological growth and mildew due to excessive moisture on the surface of the wood, and the proximity of vegetation to the lower elements of the building.

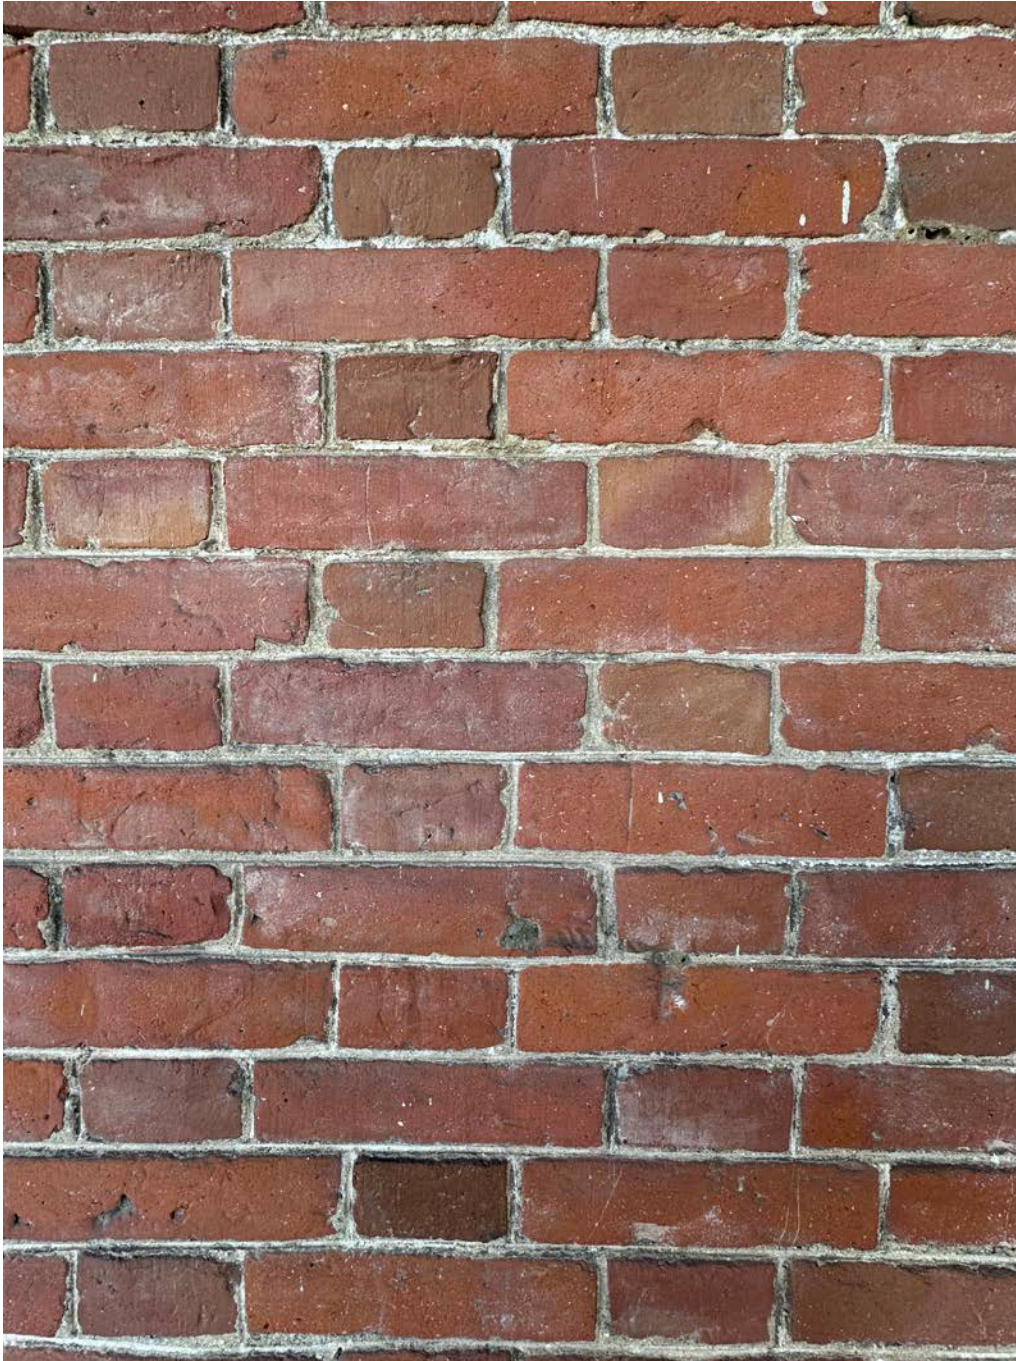
Figure 4.2-1
Bricks laid in Flemish
Bond pattern with one
quarter inch (1/4")
mortar joints.

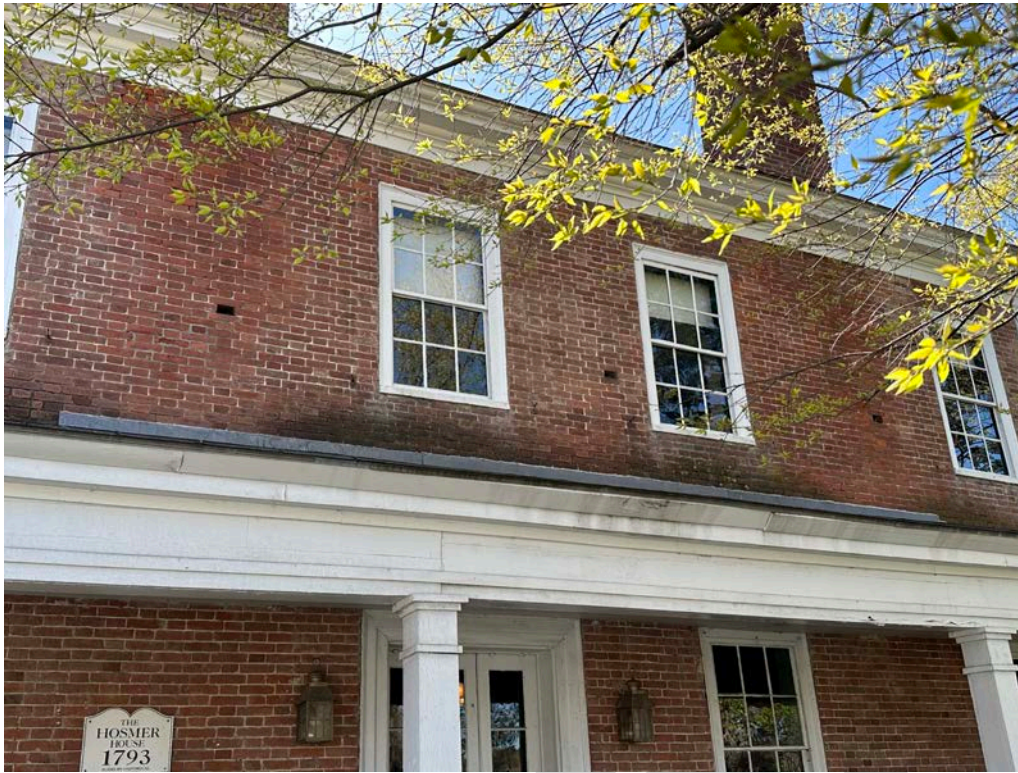
Figure 4.2-2
Discolored bricks due
to water infiltration.
And inadequate
flashing.

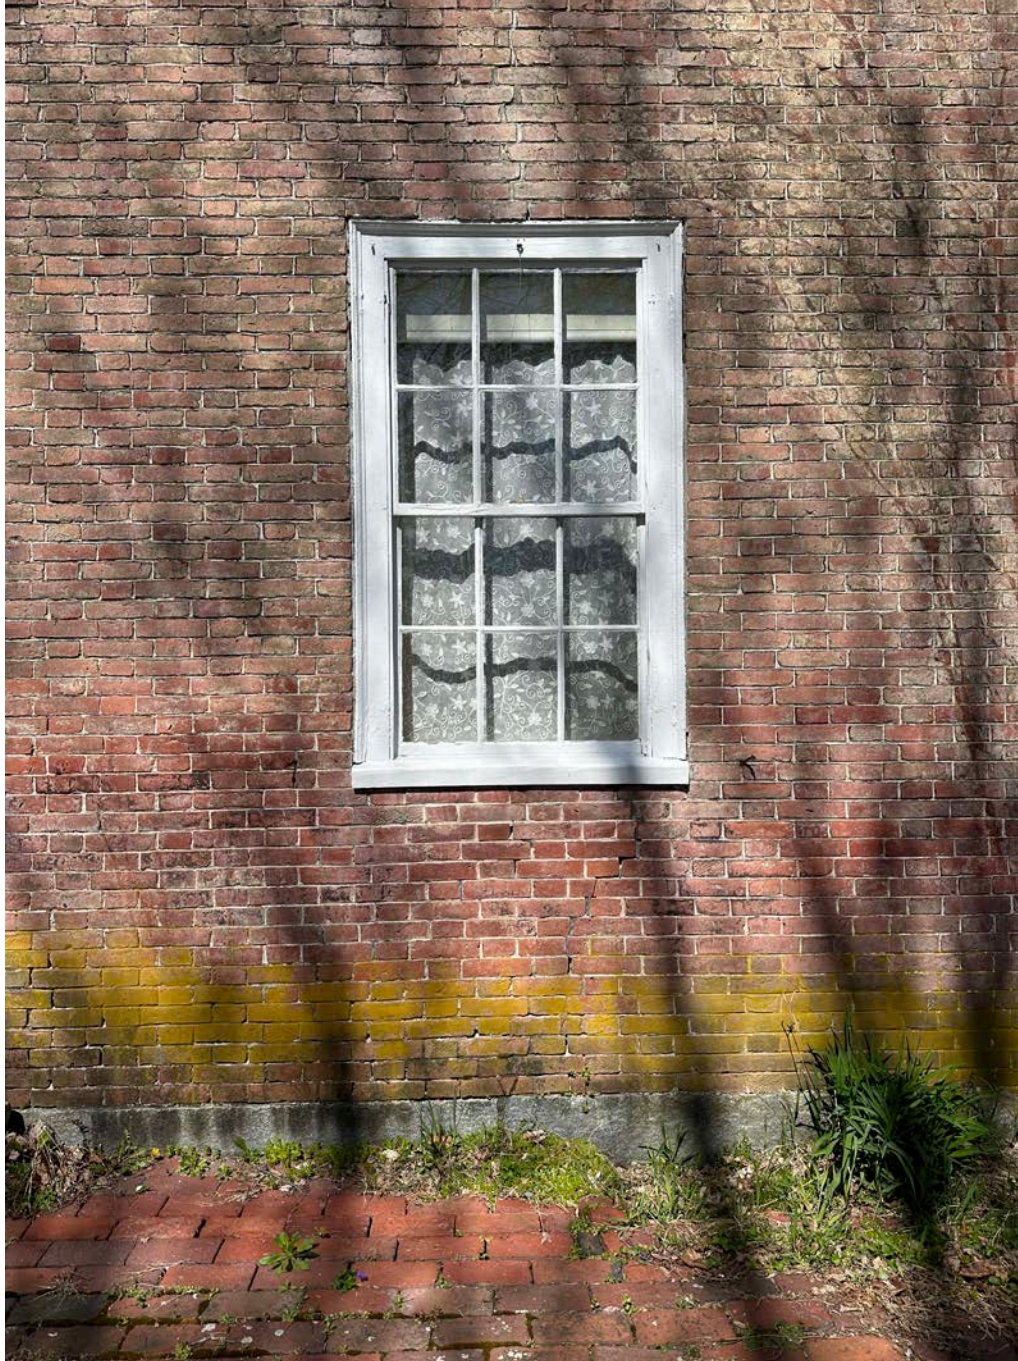
Figure 4.2-3
Extensive biological
growth on the east
elevation along the
entire wall.

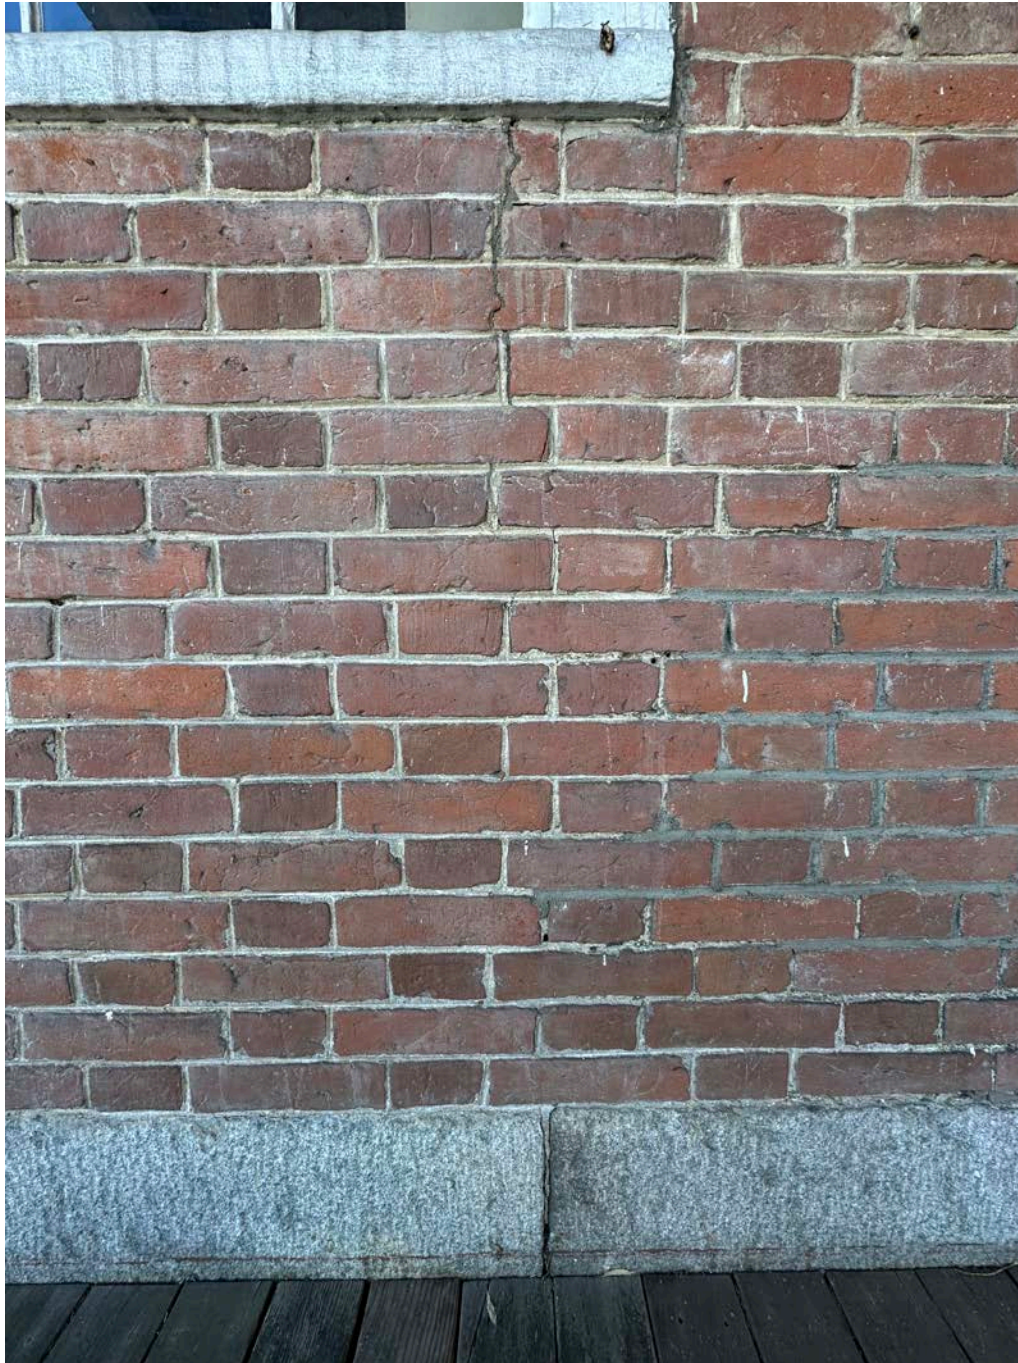
Figure 4.2-4
Crack on the west
elevation below W-23.
Previously improperly
patched.

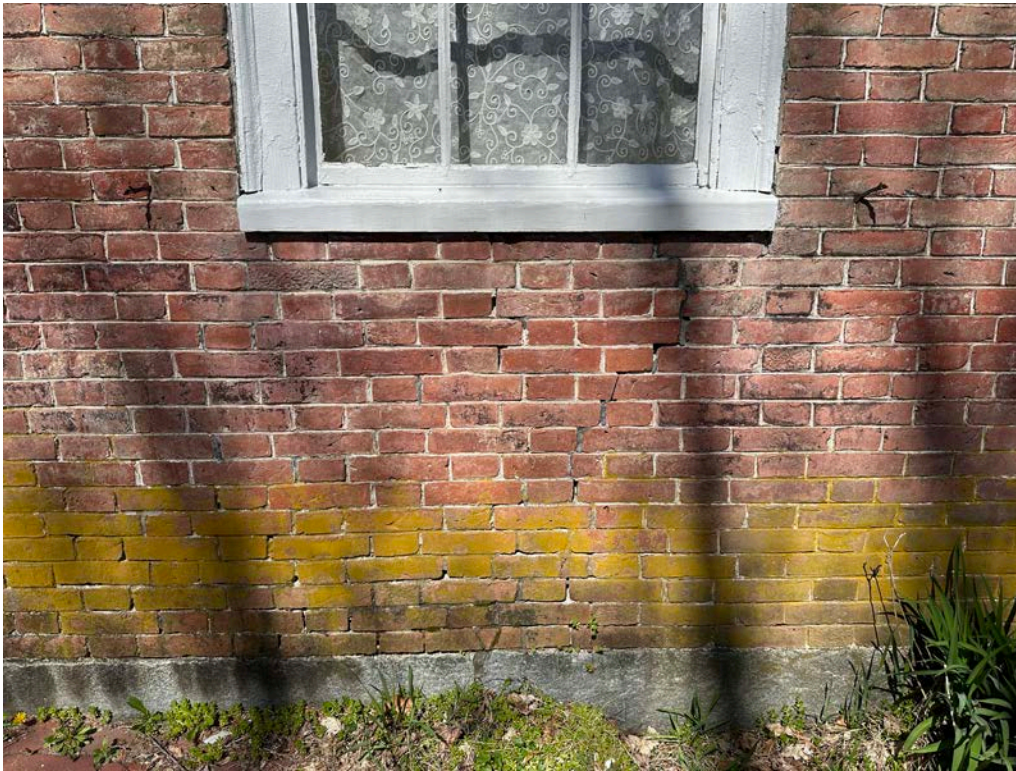
Figure 4.2-5
Crack on the east
elevation below
W-07. Previously
improperly
patched.

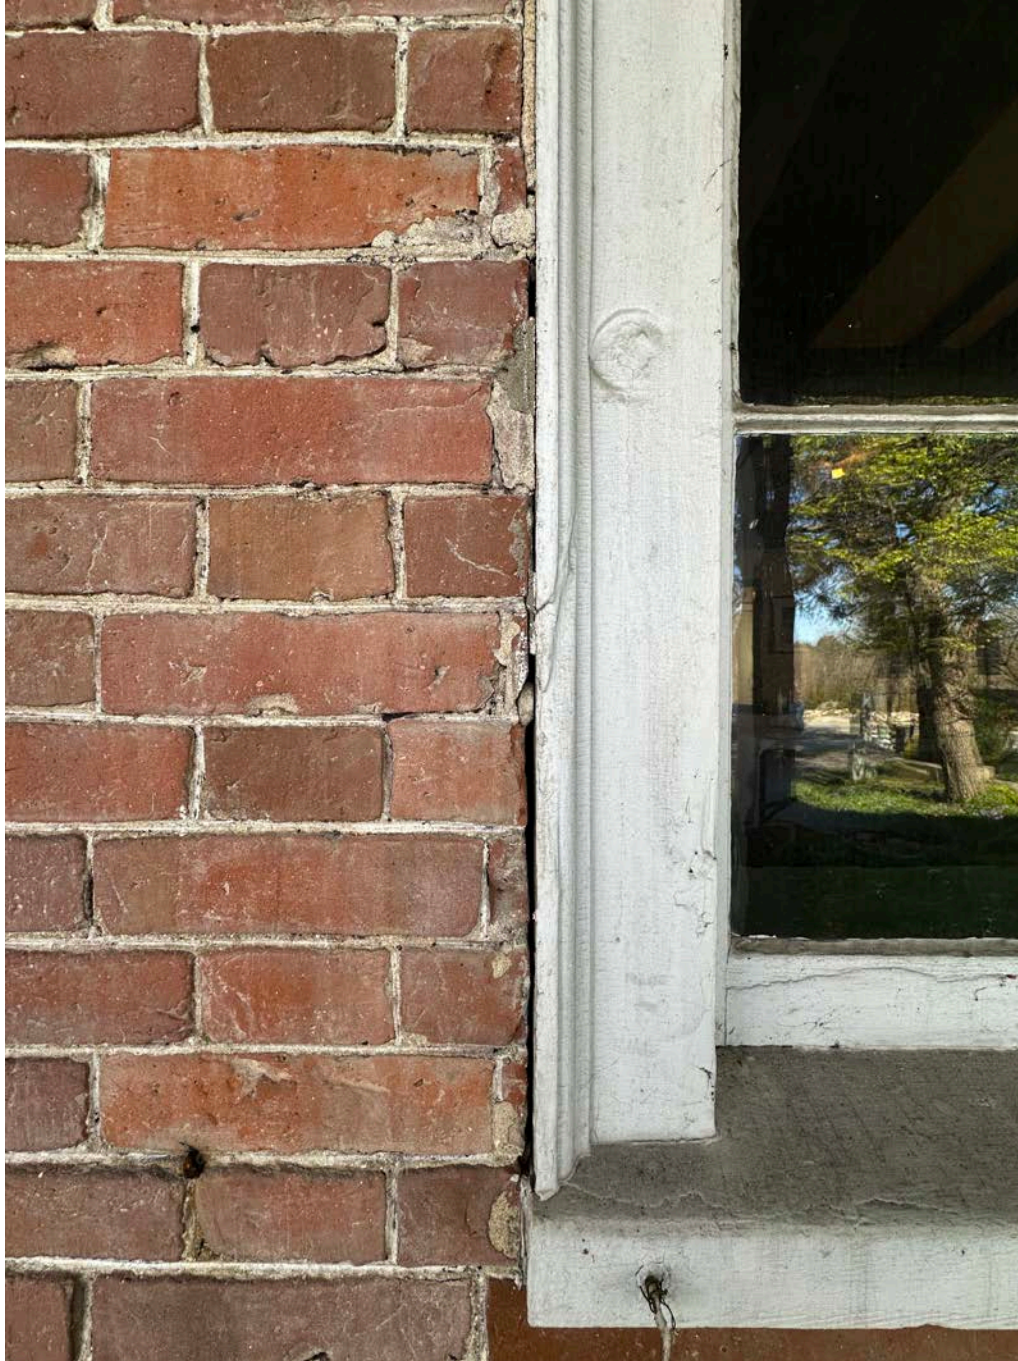
Figure 4.2-6
Several of the bricks
at the outer edge of
the masonry openings
are damaged, missing
pieces, and patched
with mortar.

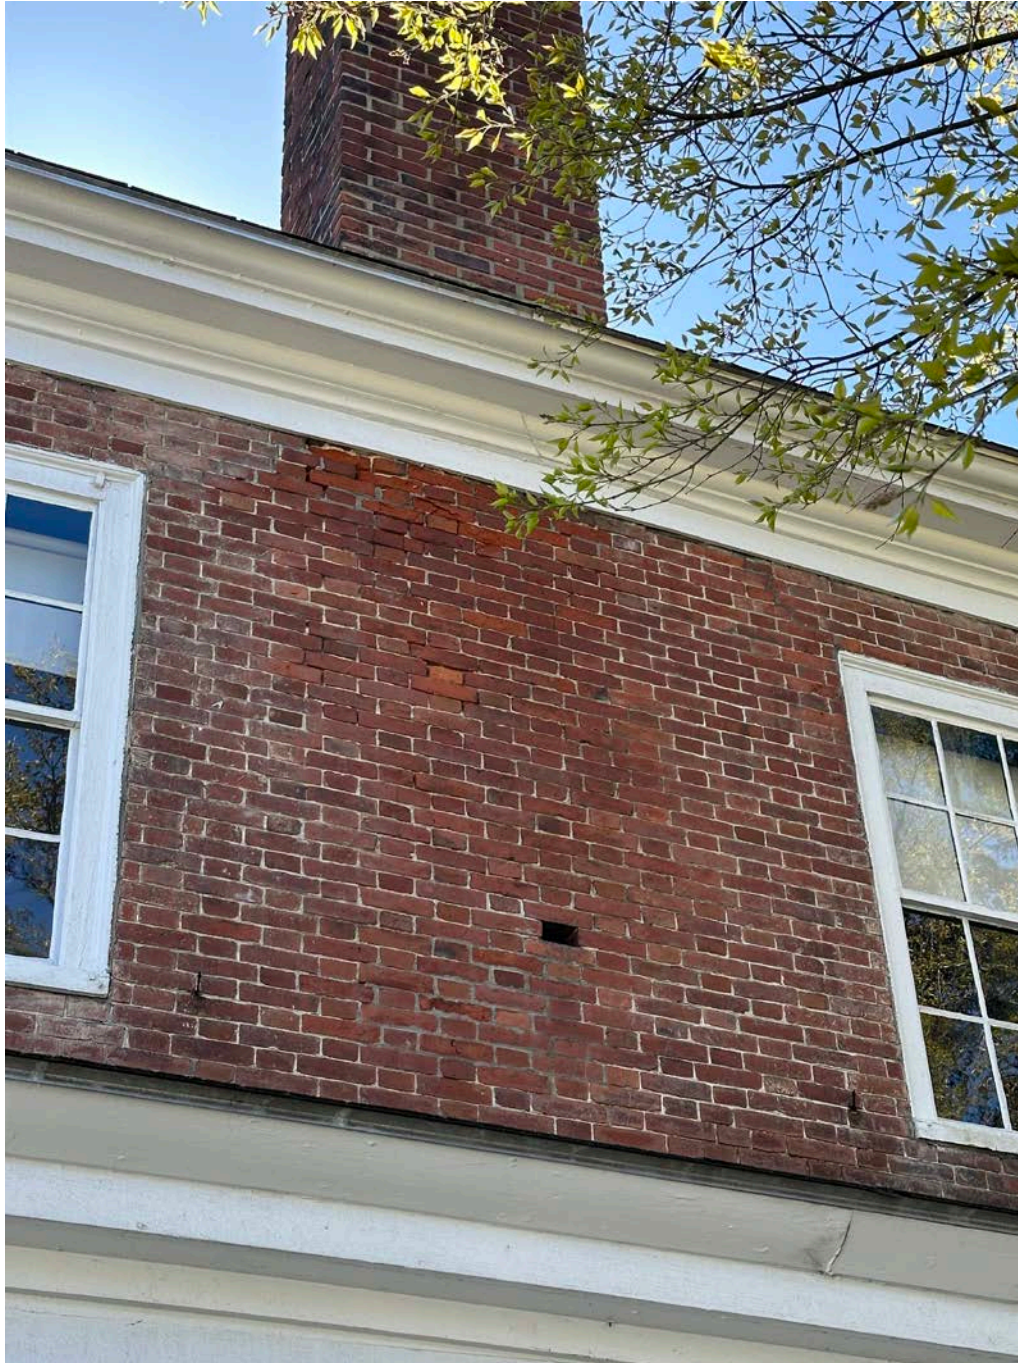
Figure 4.2-7
There are two areas on the west elevation of approximately 3' by 5' between windows W-46 and W-47, which show signs of deterioration. Bricks are missing their fire faces or cracked, and there is extensive mortar loss.

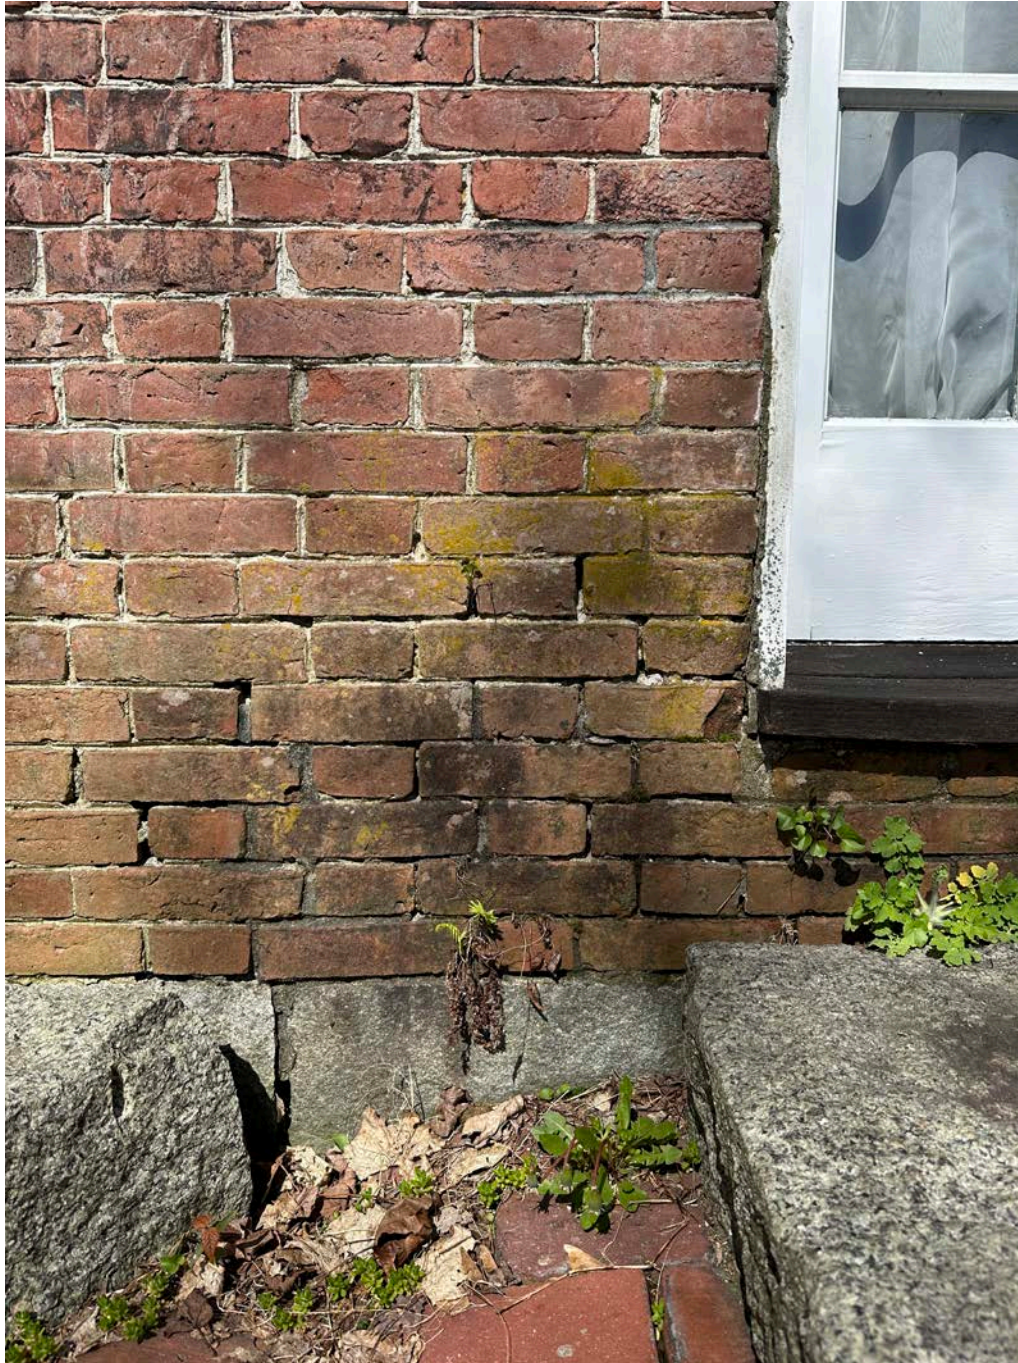
Figure 4.2-8
Several areas along the base of the building on the east elevation in which the mortar has deteriorated due to water infiltration, and in these gaps, small plants have taken root.

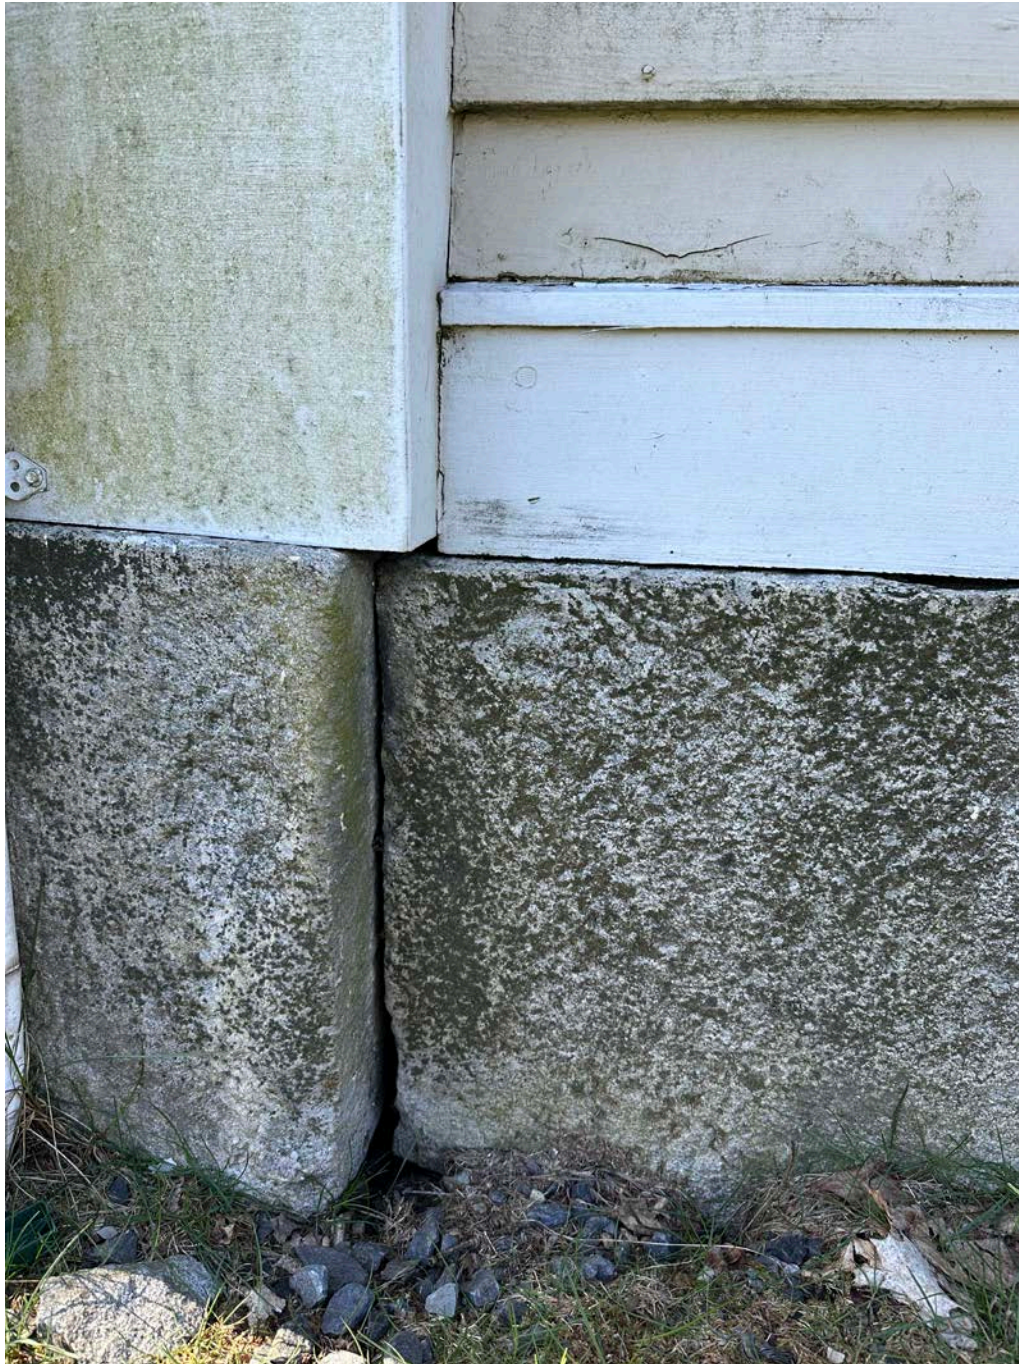
Figure 4.3-1
Along the north, east and west elevations, the base is constructed with a single rectilinear cut stone atop ashlar masonry walls, laid to sit directly below the exterior brick or wood wall system.

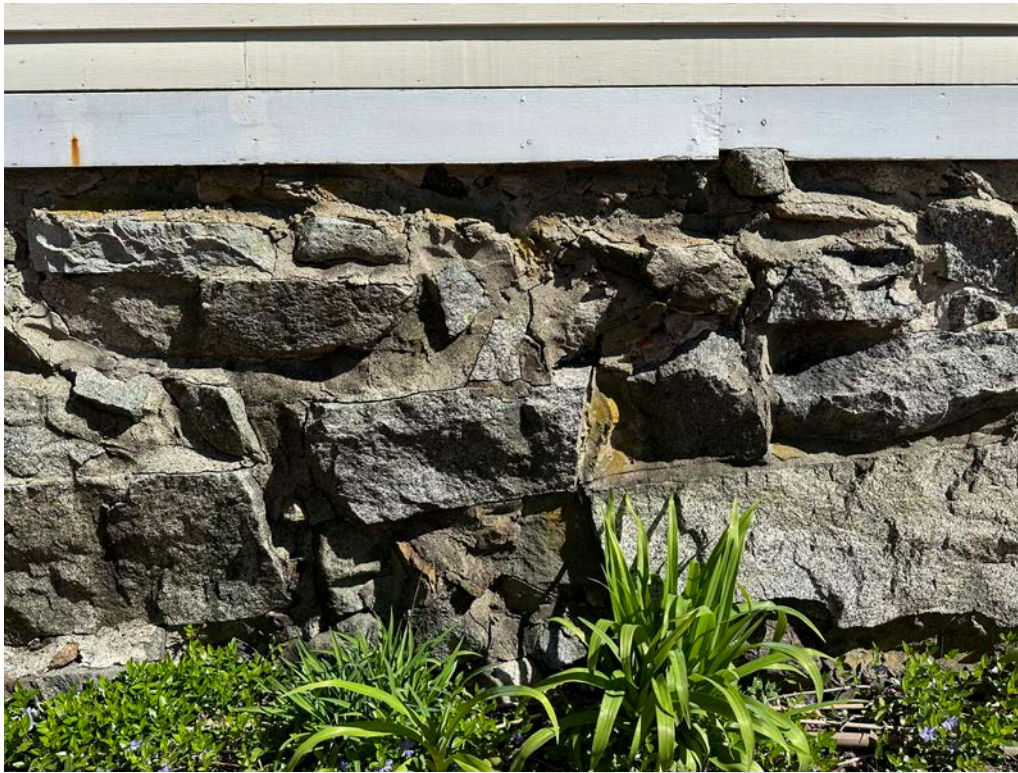
Figure 4.3-2
Foundation below
rooms F-05 and F-
07 is constructed
from ashlar
masonry.

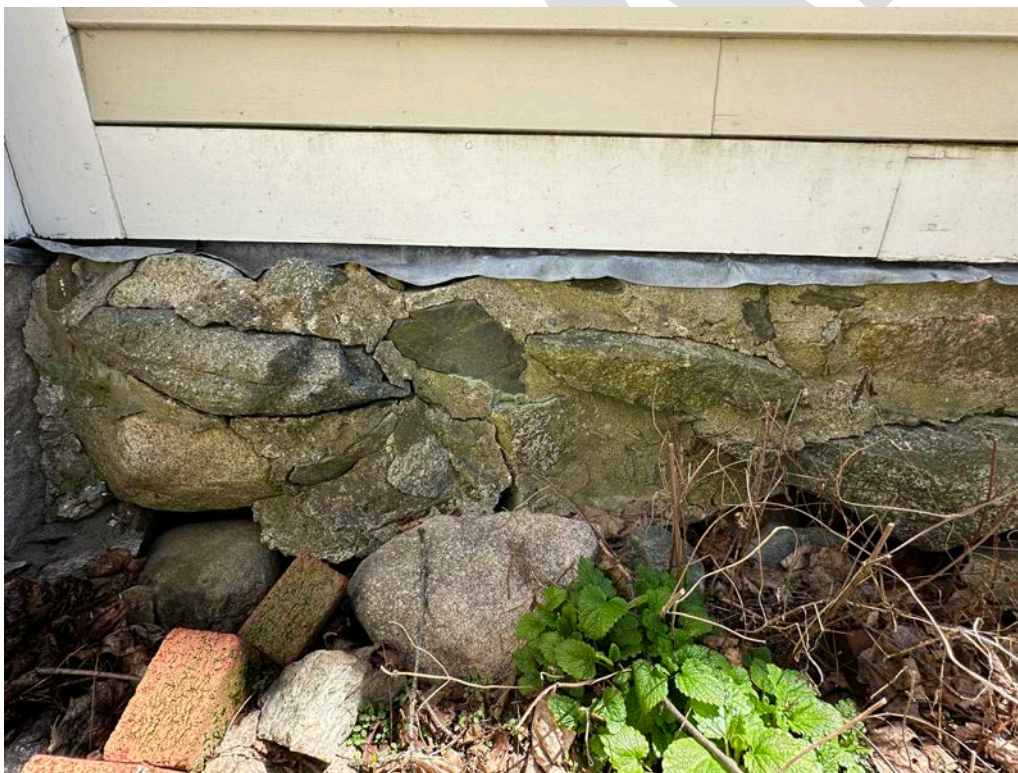
Figure 4.3-3
Base flashing was
found in certain
locations along the
ashlar stone walls;
however it is not
entirely covering the
foundation wall, and
is bent out of shape
in several locations.
