RECEIVED
AUG 30 2024

BY: R. Poteat

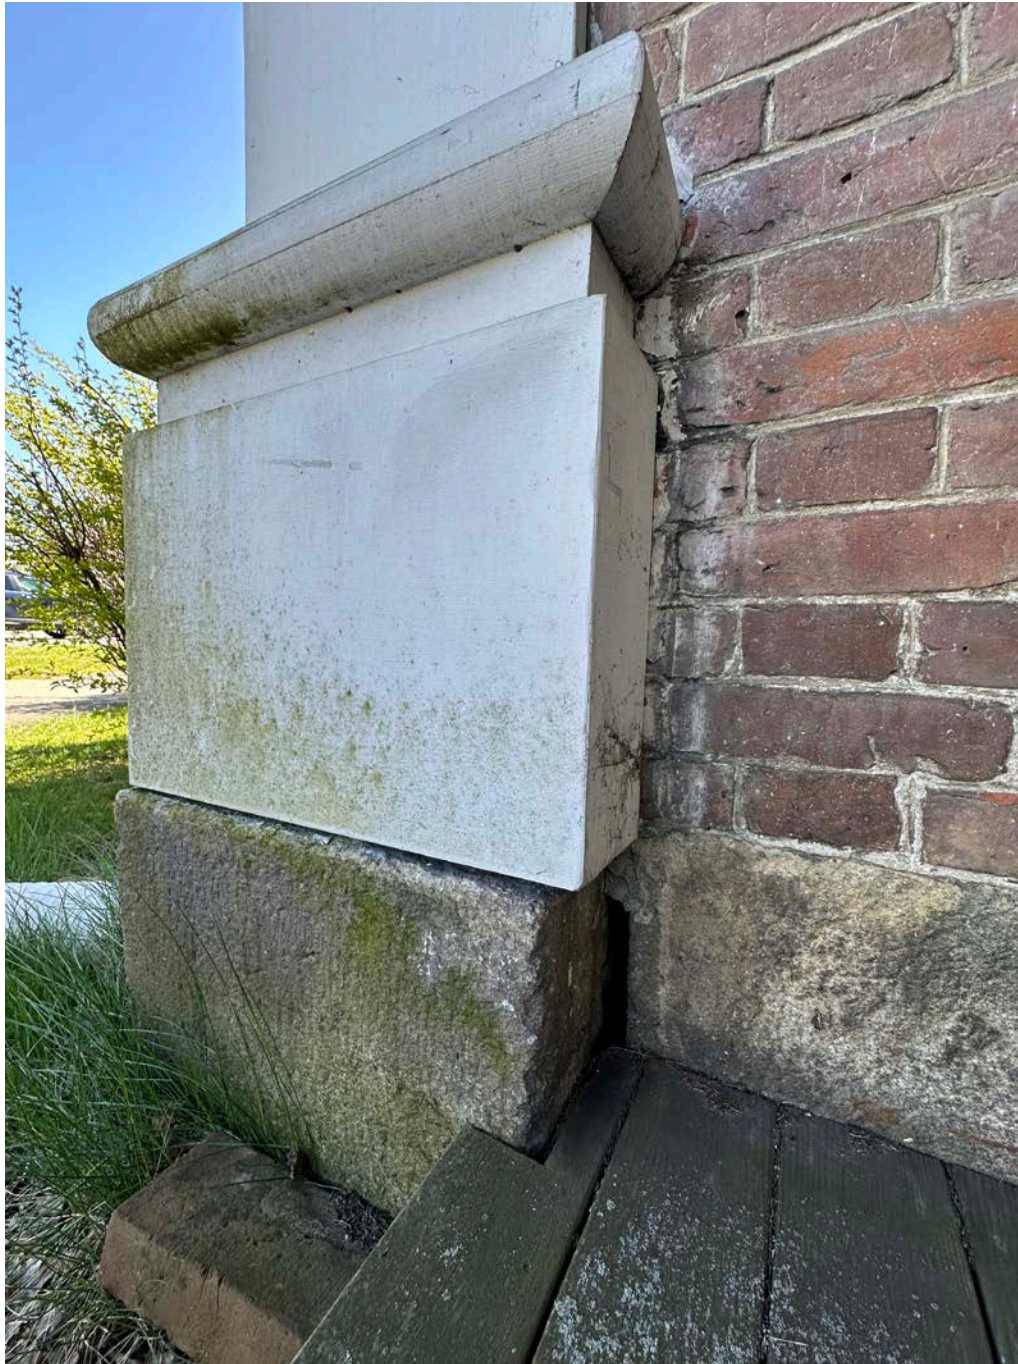
Figure 4.3-4
There is no evident base flashing between the wood pilaster and the granite foundation.

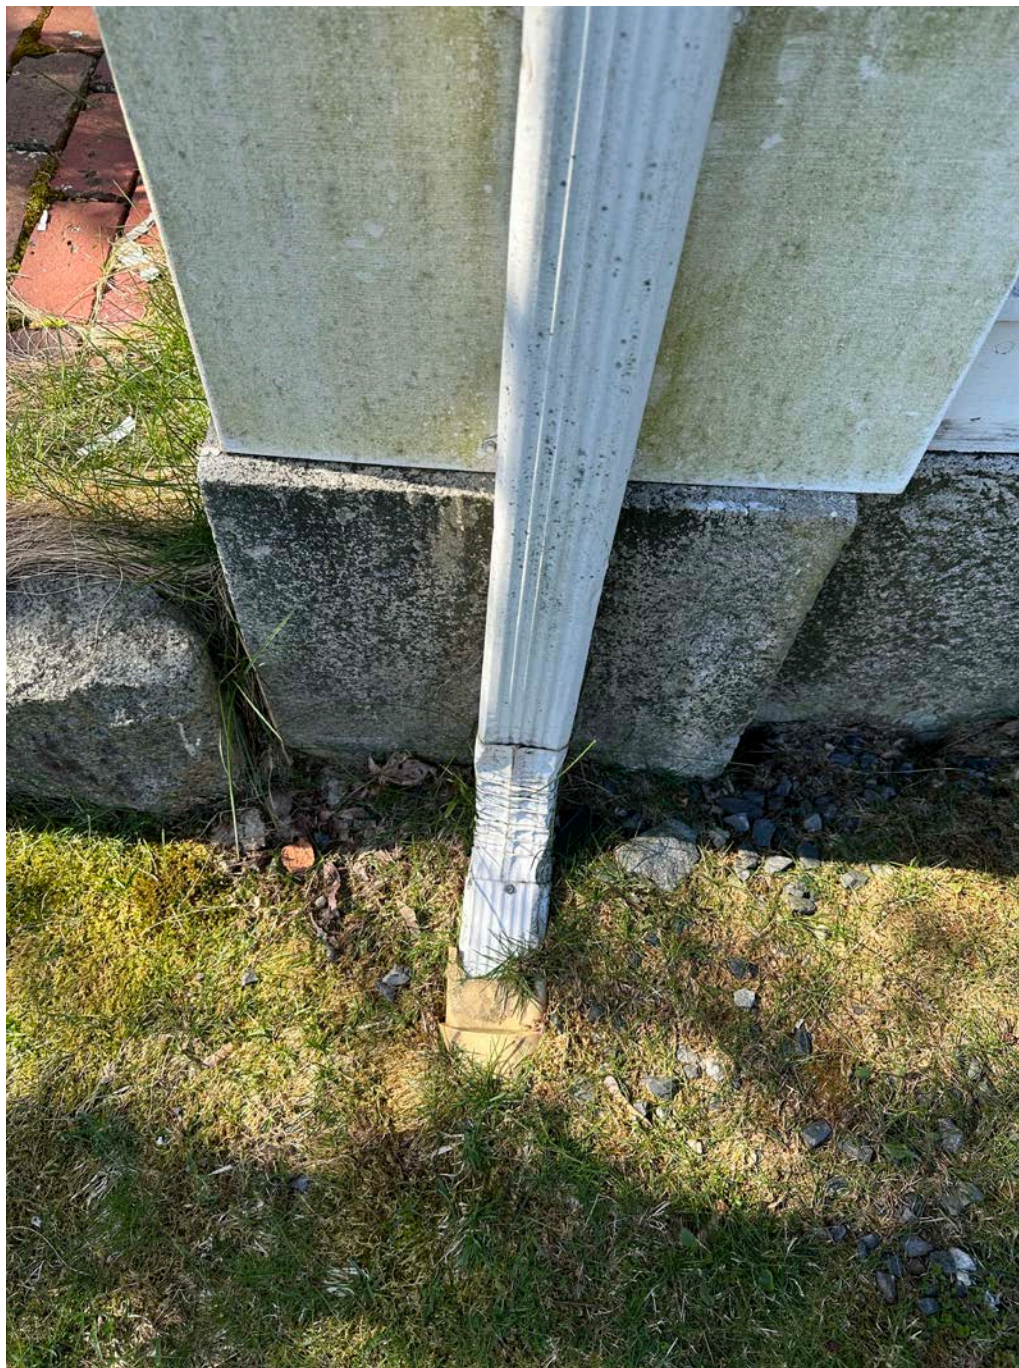
Figure 4.3-5
There is no evident base flashing between the wood pilaster and the granite foundation.

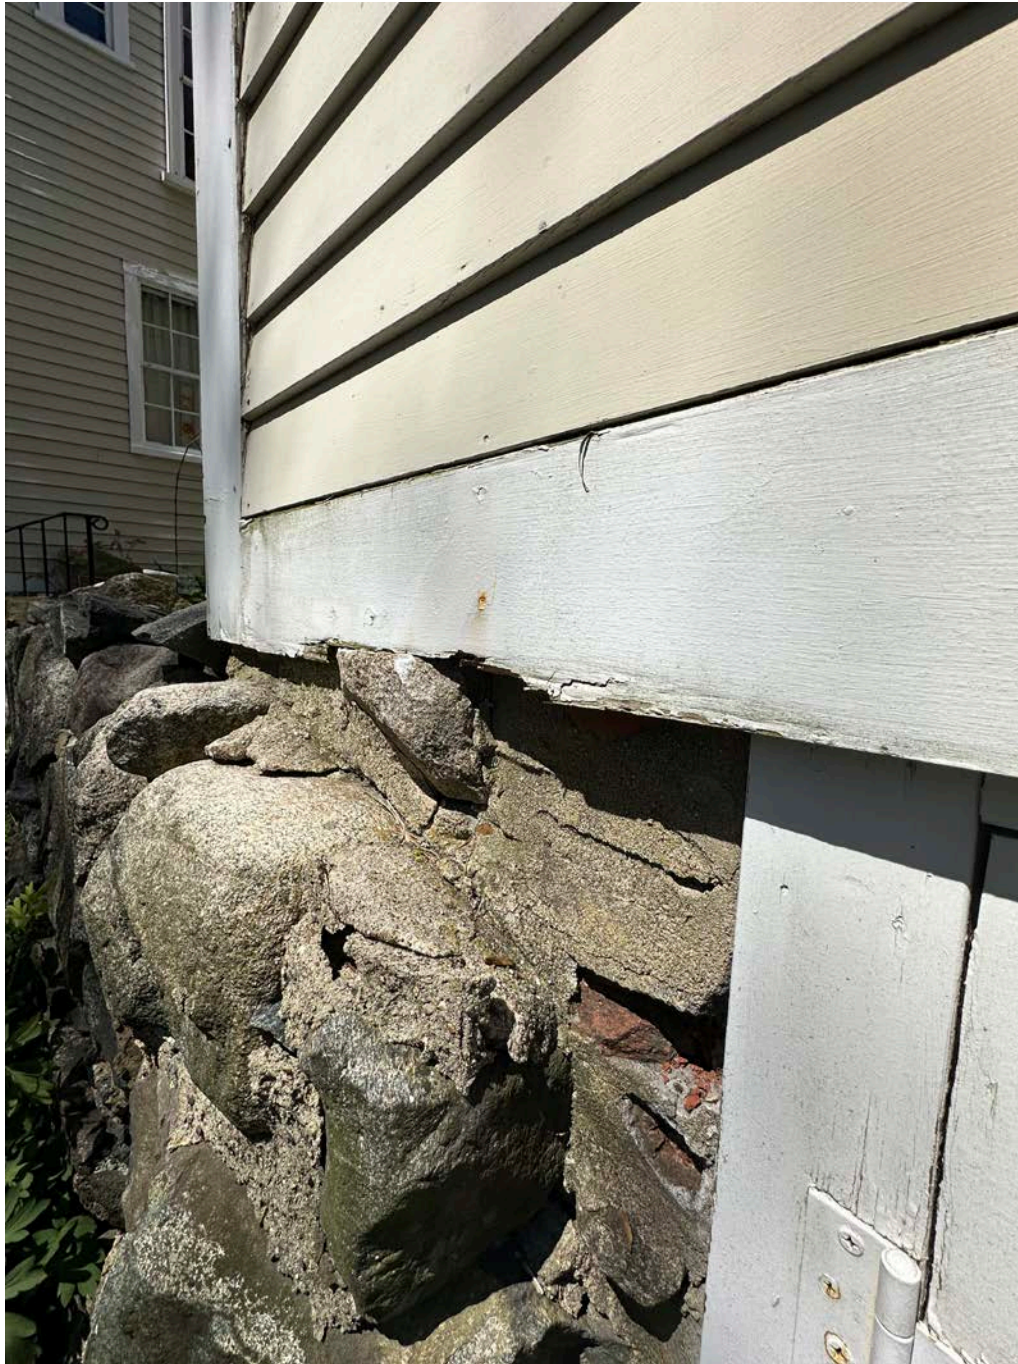
Figure 4.3-6
There is no evident base flashing between the cladding system and the ashlar stone foundation wall.

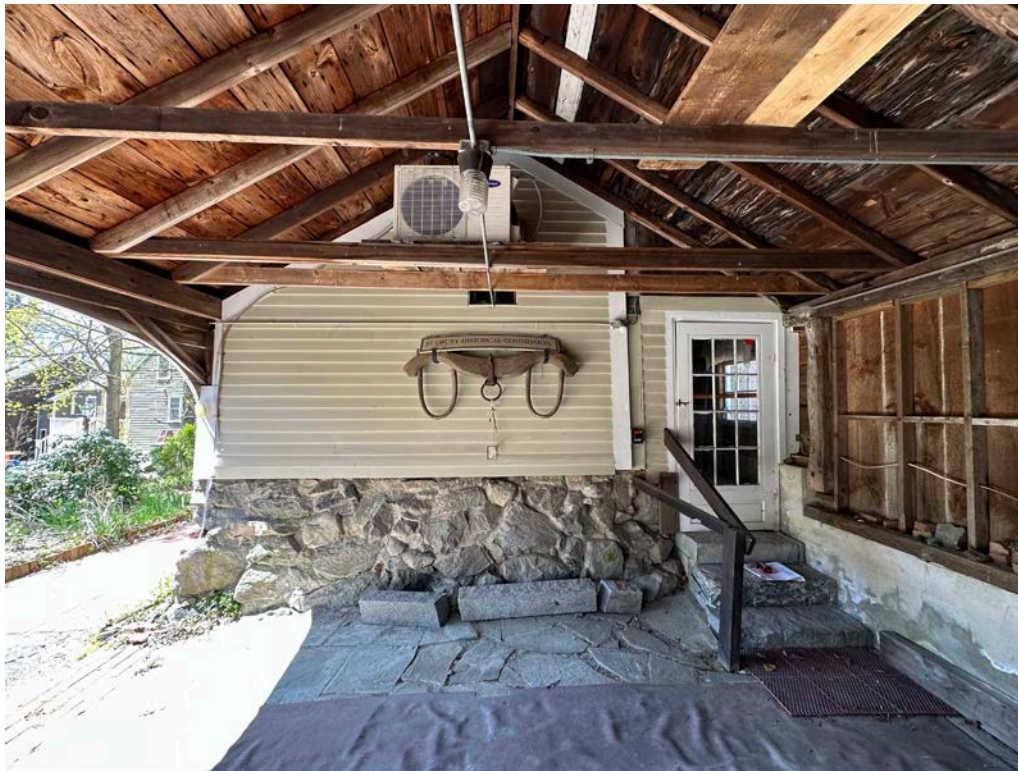
Figure 4.3-7
Ashlar foundation wall shared by the east wall of the southeast addition, and the carriage house.

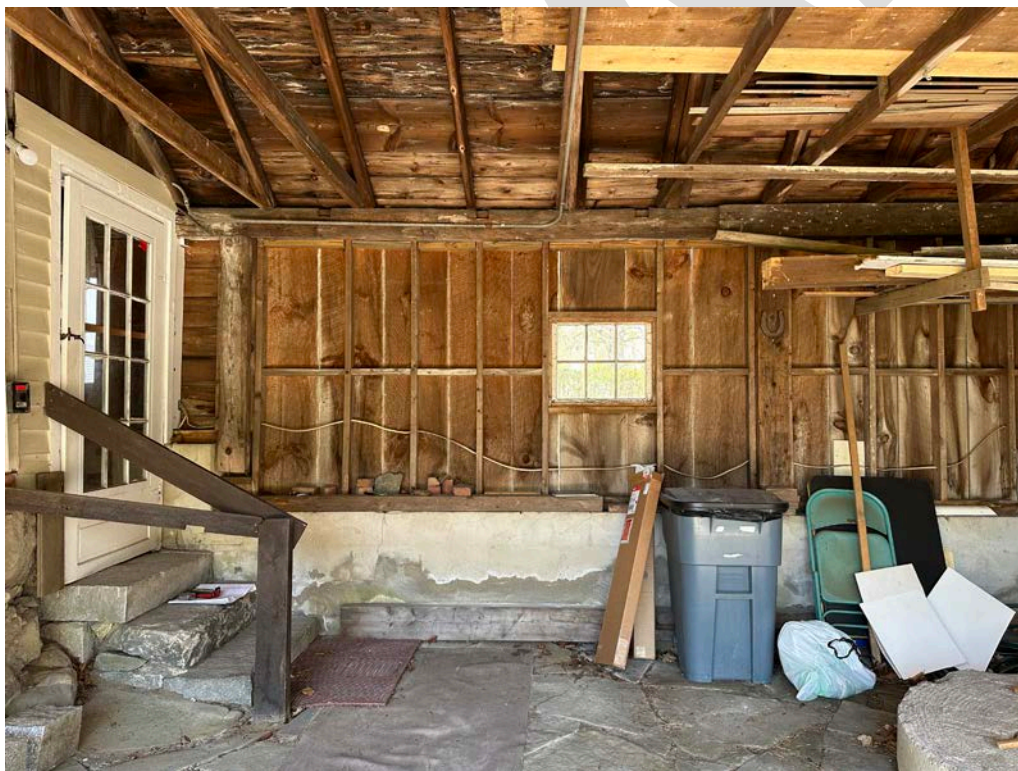
Figure 4.3-8
The foundation along the northern wall is constructed of concrete masonry units (CMU's) and timber. These foundations seem to have been restored in the recent past and are in good condition.

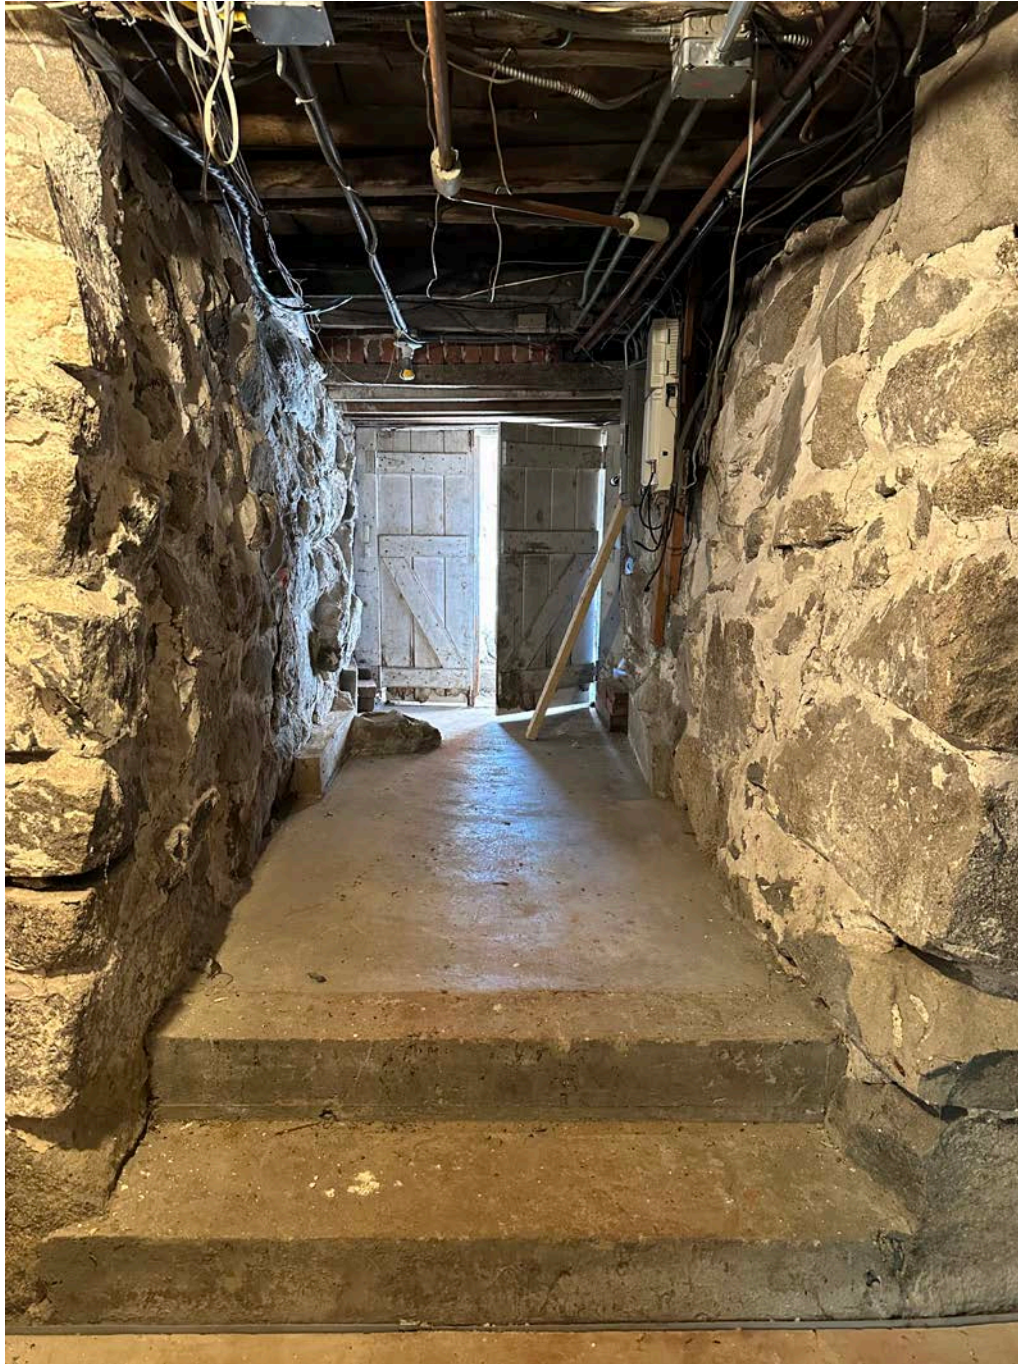
Figure 4.3-9
The basement is partially below-grade with an exterior access door along the south wall of the southwest addition. The foundation walls are constructed of ashlar masonry, which are also exposed in the basement.

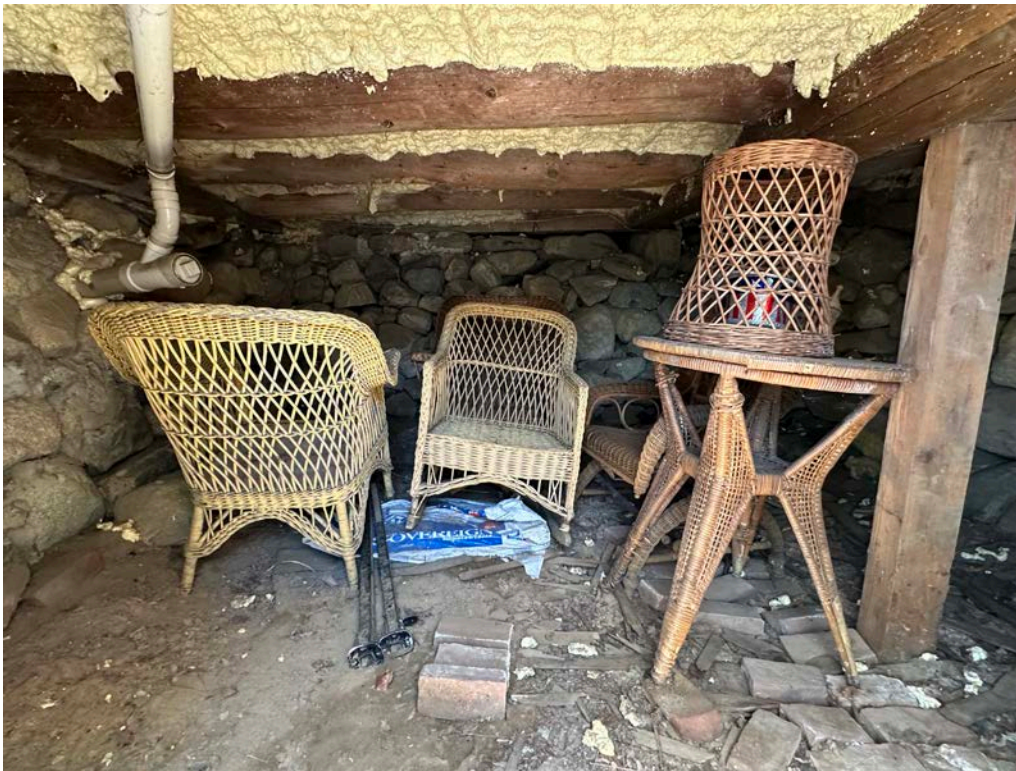
Figure 4.3-10
There is one crawl space (room B-02) directly below room F-05, which is accessed from outside with no access to the basement, and is also constructed of both ashlar and loose laid stone masonry.

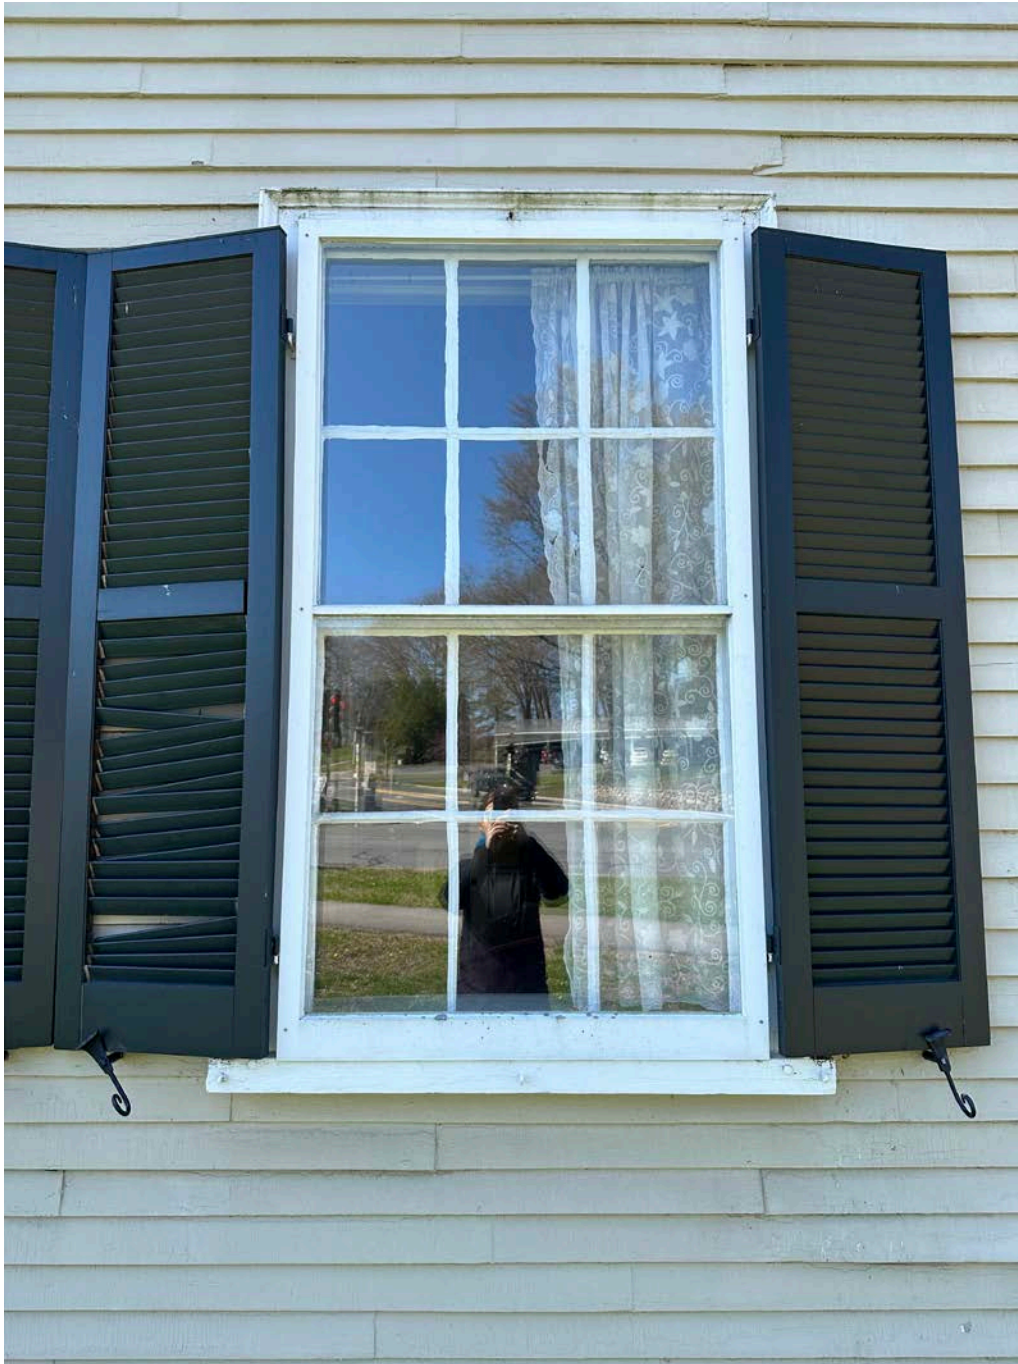
Figure 4.4-1
Double-hung six-over-six
lite window configuration
found typically on the
main house.

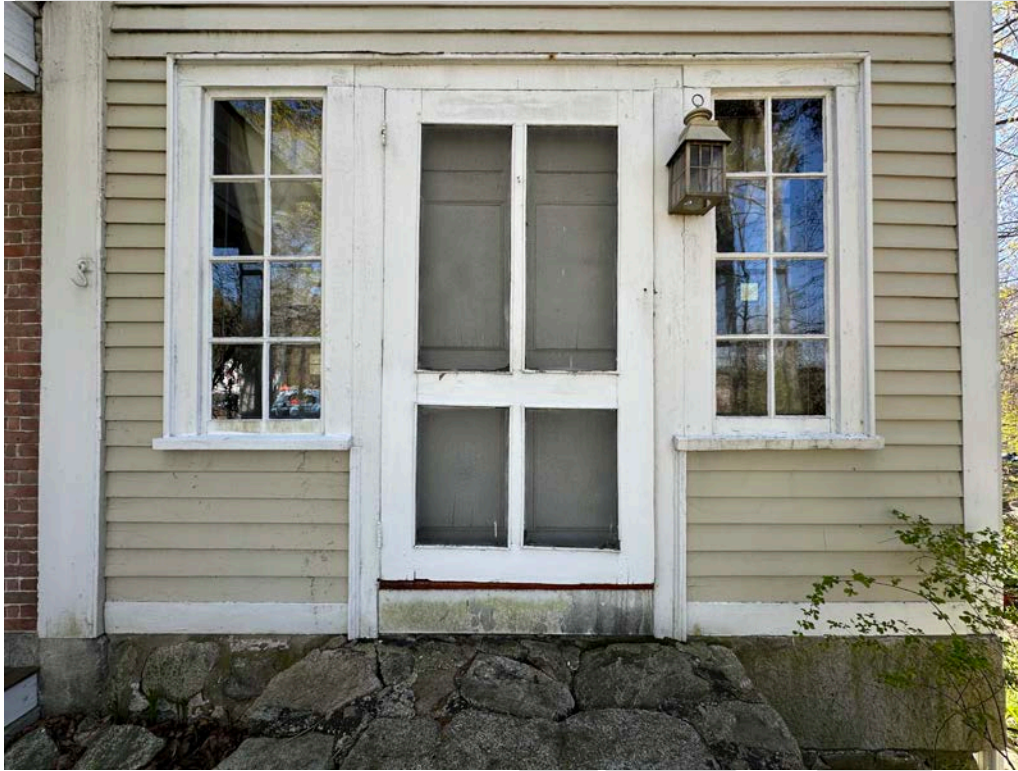
Figure 4.4-2
Two vertical fixed wood windows flanking the office entrance door (D-21). The screen door was found to be damaged and inappropriate in design.

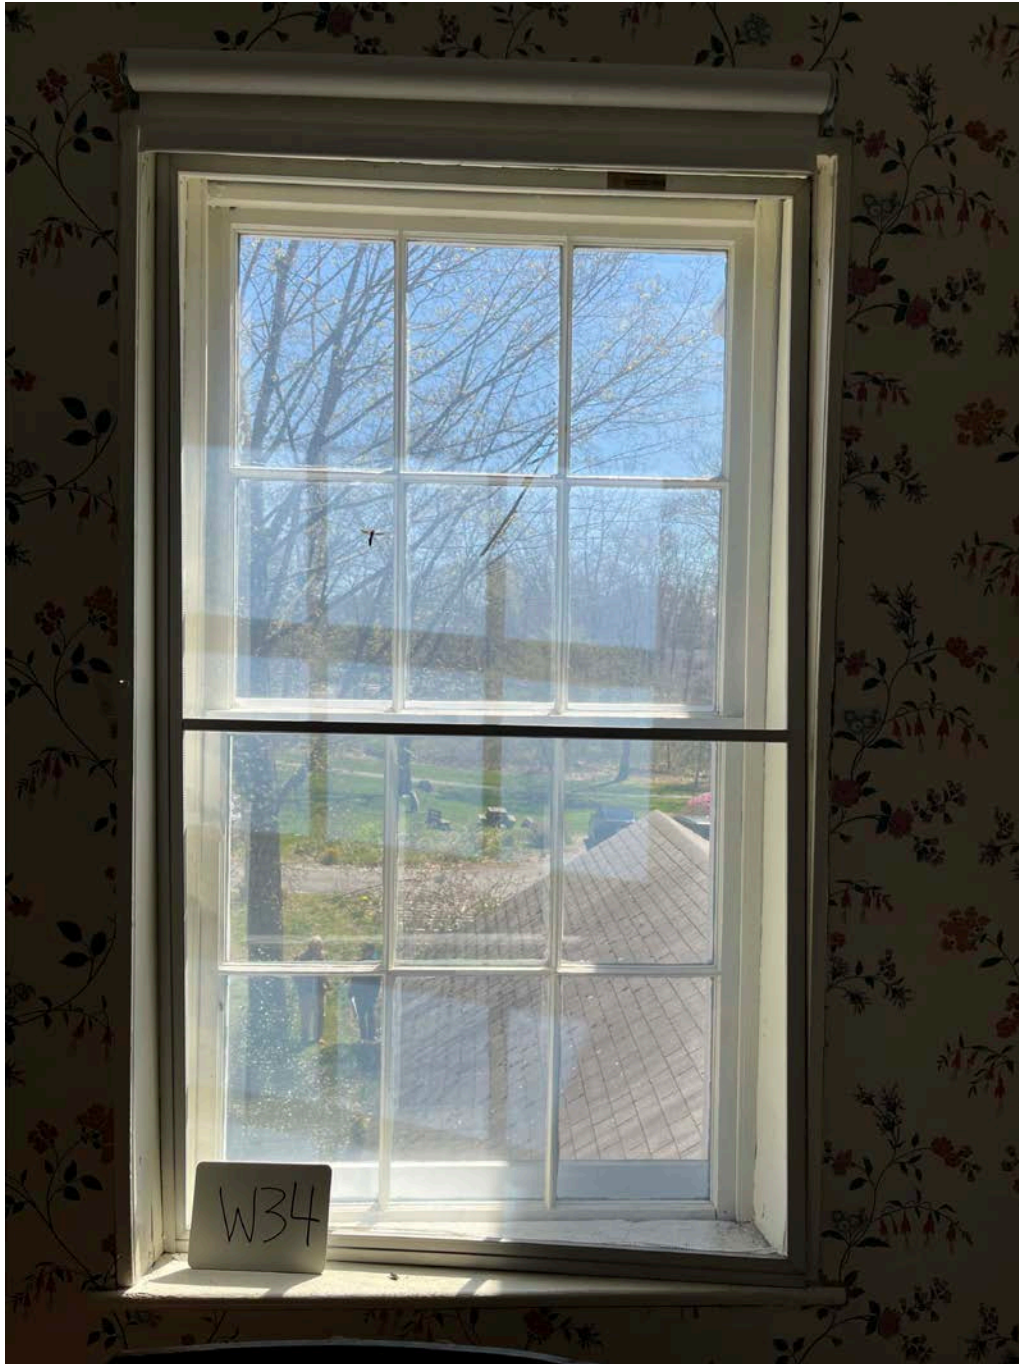
Figure 4.4-3
Window inserts painted
white and installed at the
interior of the windows.

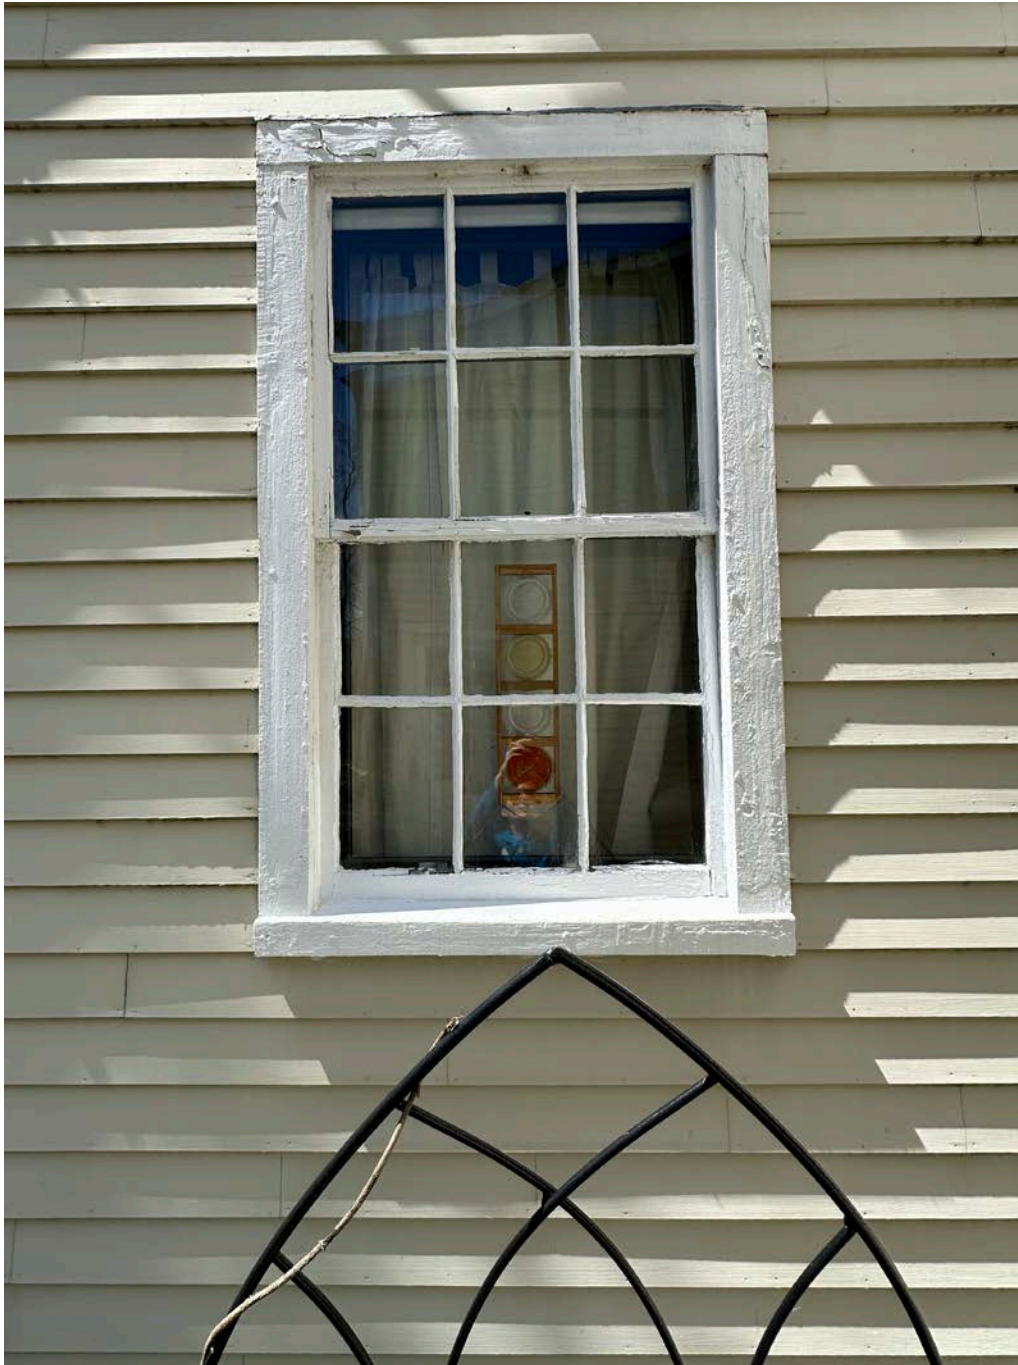
Figure 4.4-6
Minor wood damage and
peeling paint found
typically over all
elevations.

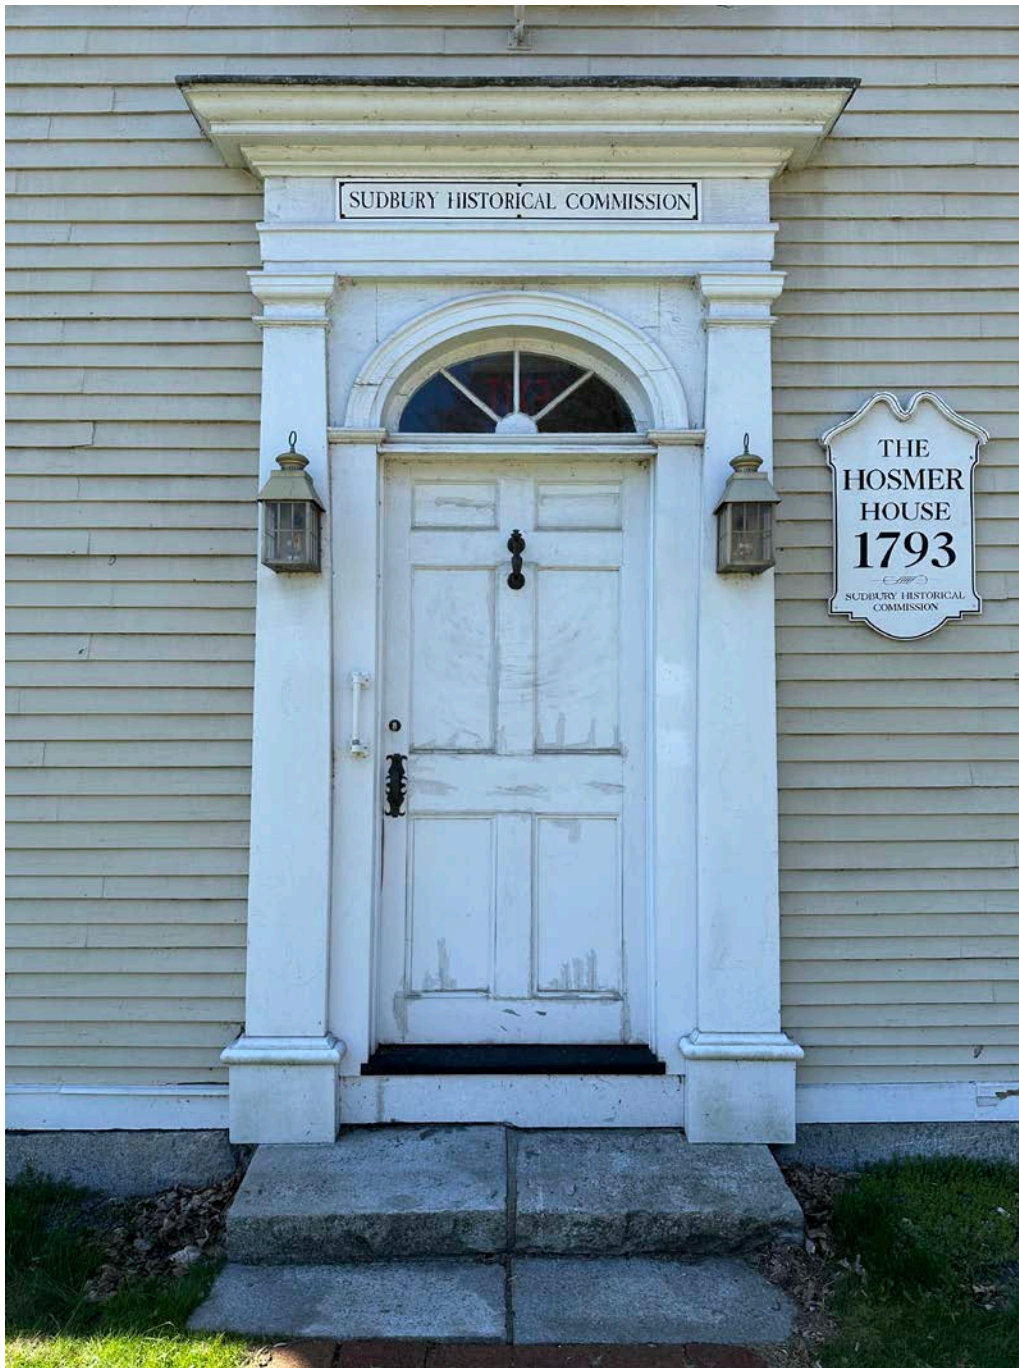
Figure 4.4-7
D-01 in poor-to-fair
condition, showing signs
of wood deterioration,
cracks, and previous
repairs.

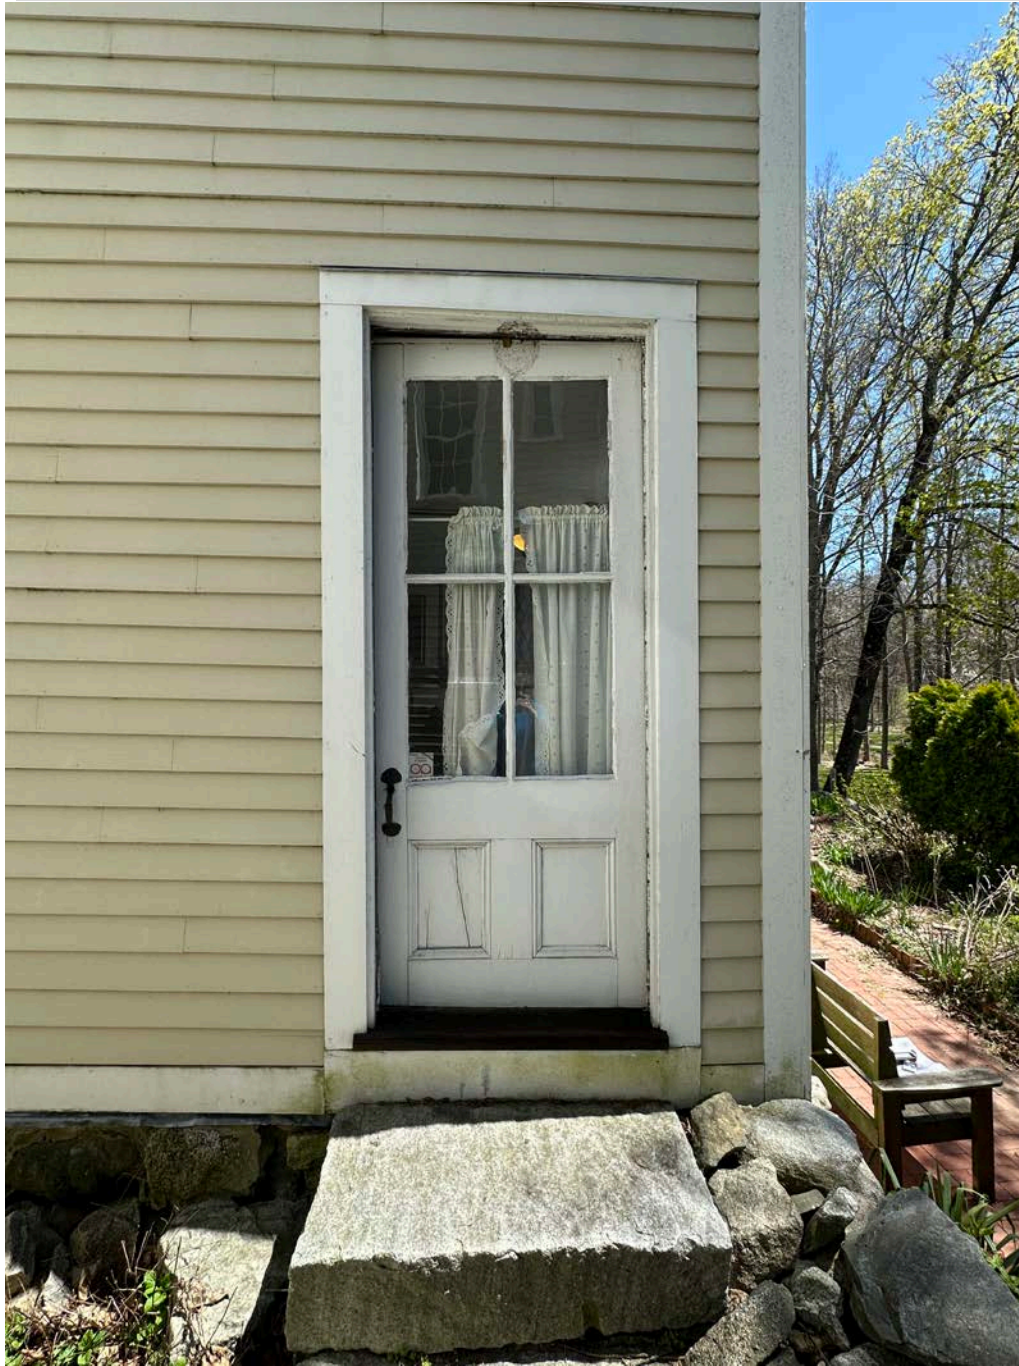
Figure 4.4-8
D-12 in poor-to-fair
condition, showing signs
of wood deterioration,
cracks, and previous
repairs.

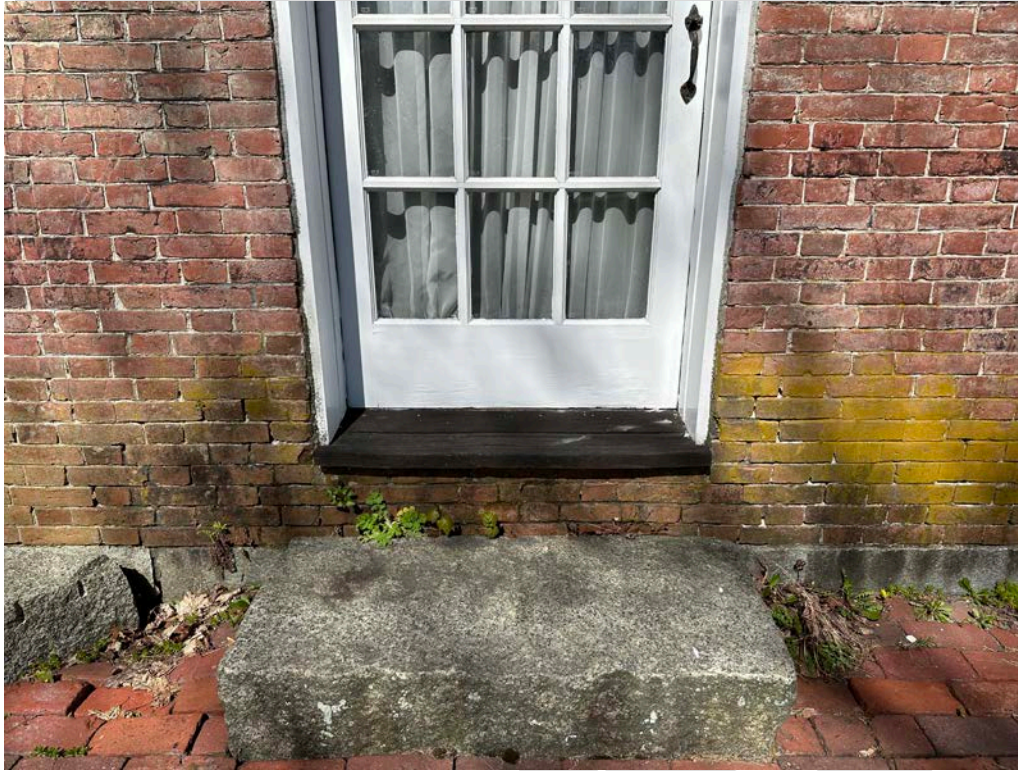
Figure 4.4-9
Door and sill on D-12
and D-06 were found to
be damaged, cupped,
and pitched backward.

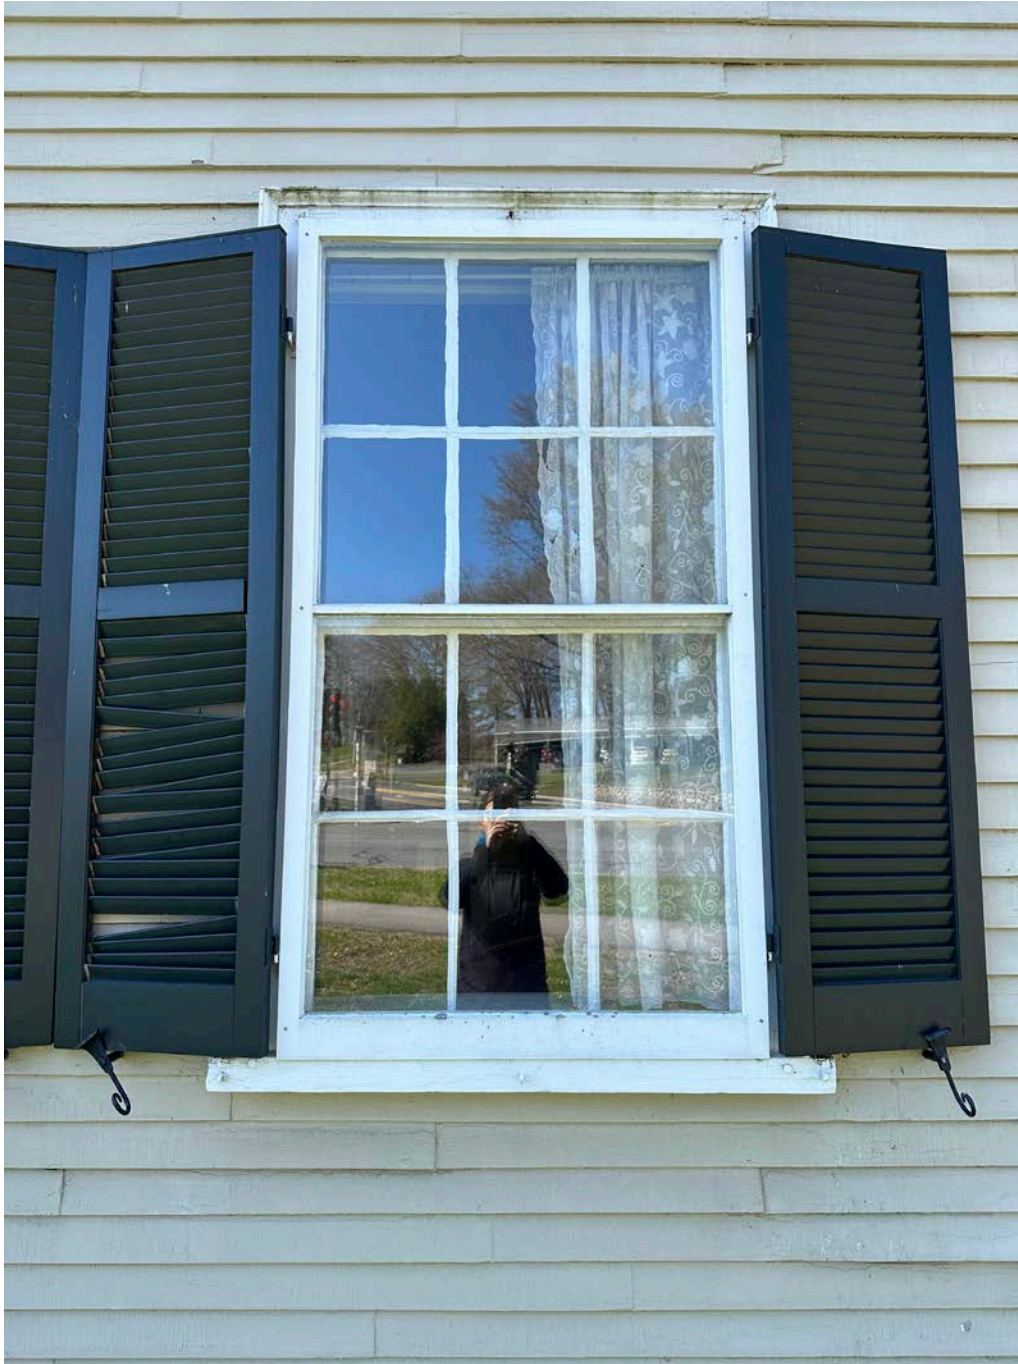
Figure 4.4-10
The storm windows are non-operable and are screwed to the wood casing. One storm window on the north façade (W-05) was installed upside down.

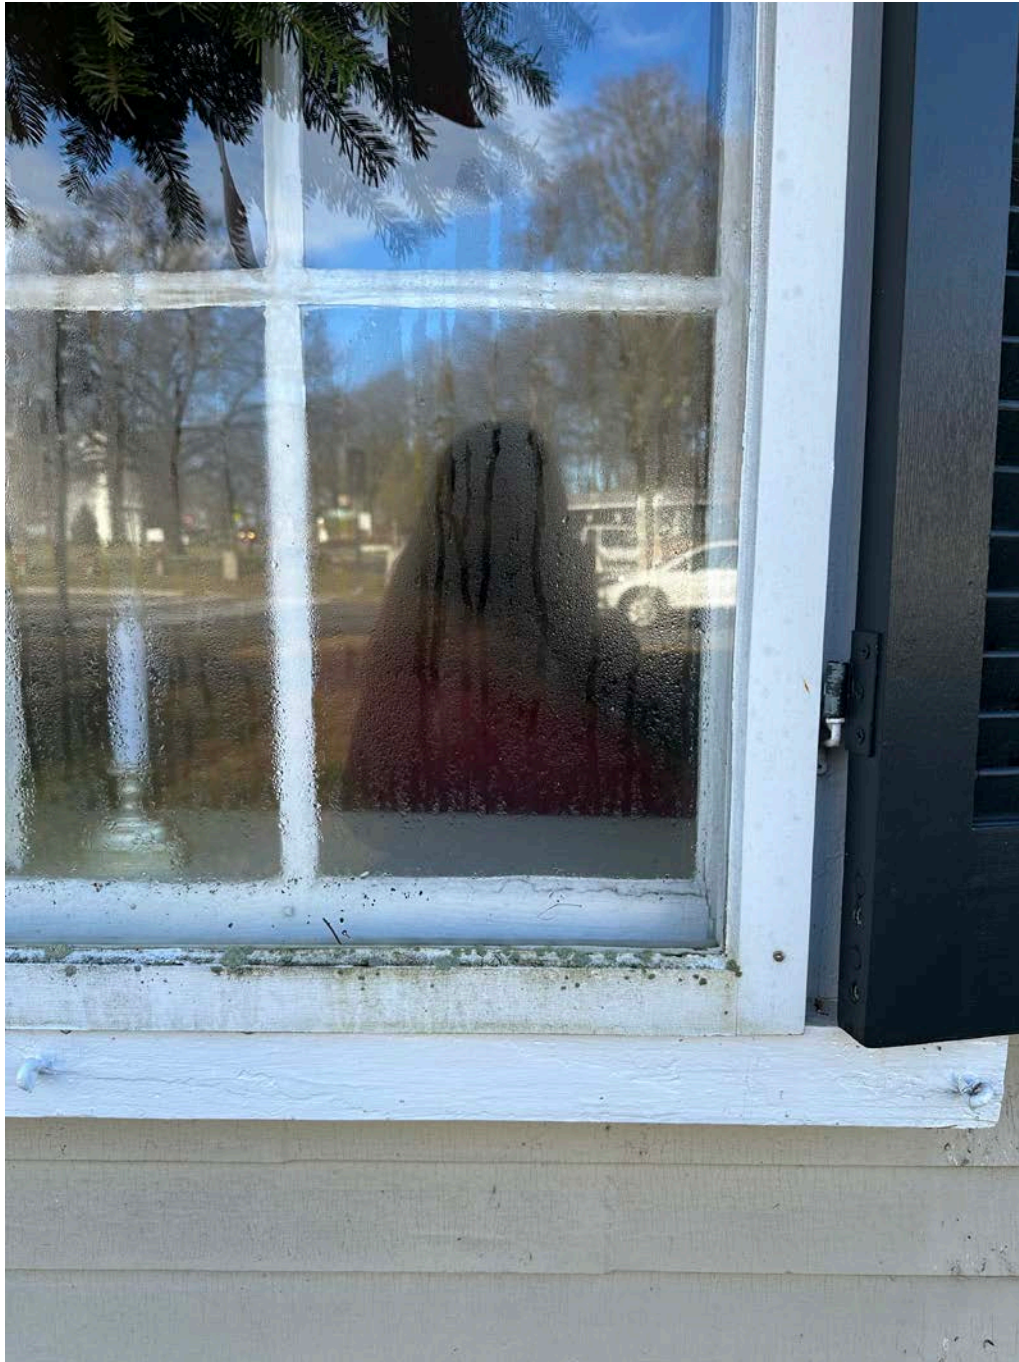
Figure 4.4-12
During the Request for
Proposal process in
December 2023,
condensation was
observed between the
window and storm
window.

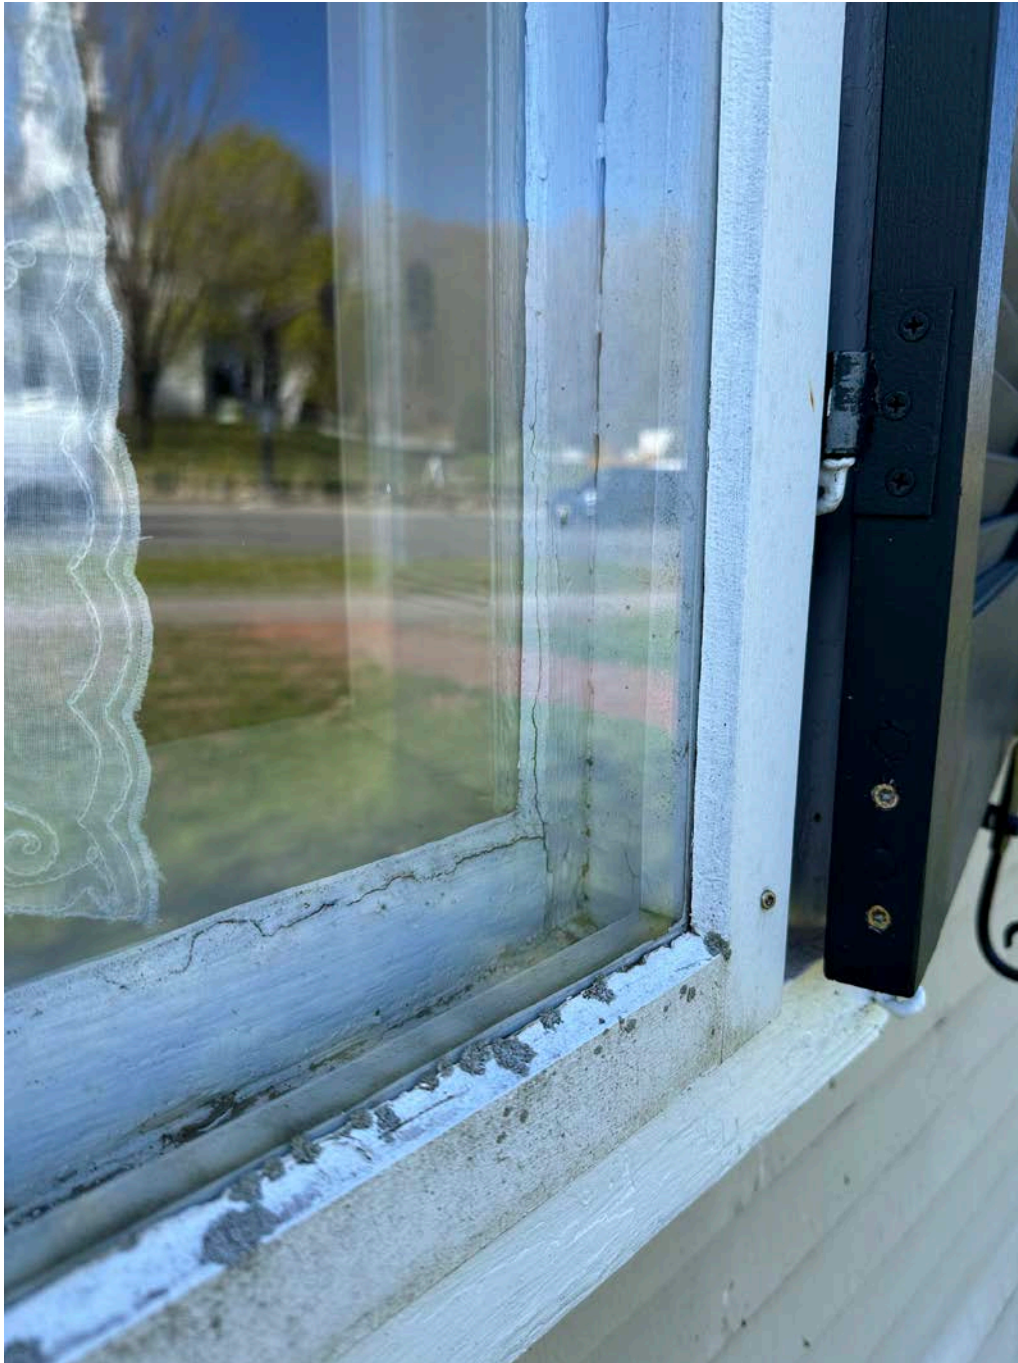
Figure 4.4-13
The perimeter sealant and glazing putty around the windows appear deteriorated, with cracks and gaps in some locations, leading to poor performance.

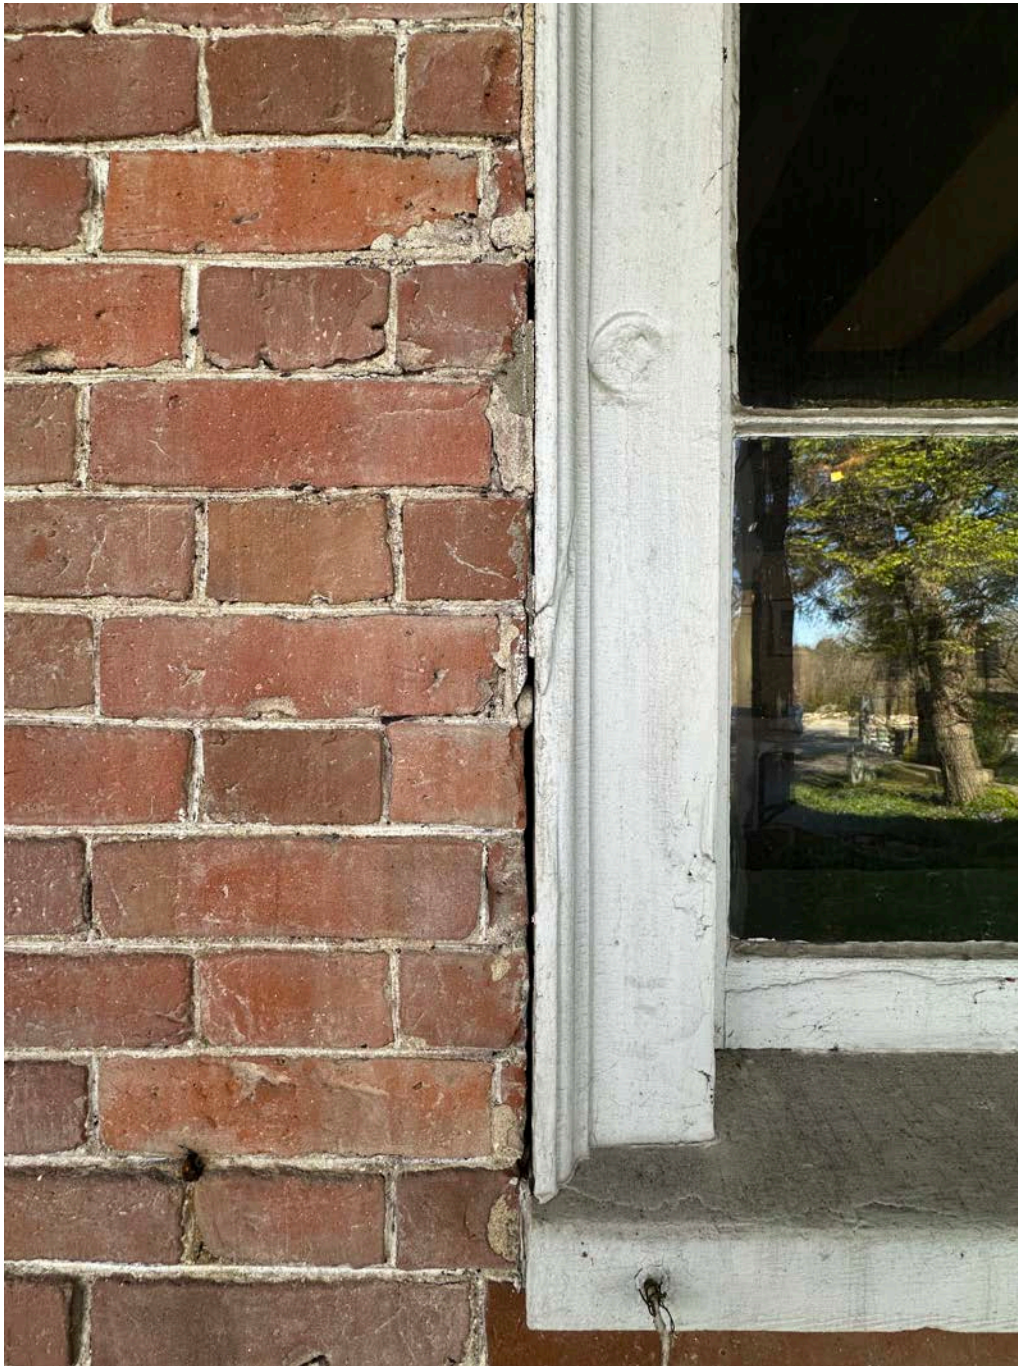
Figure 4.4-14
The perimeter sealant and glazing putty around the windows appear deteriorated, with cracks and gaps in some locations, leading to poor performance.
