RECEIVED
AUG 30 2024

BY: R. Poteat

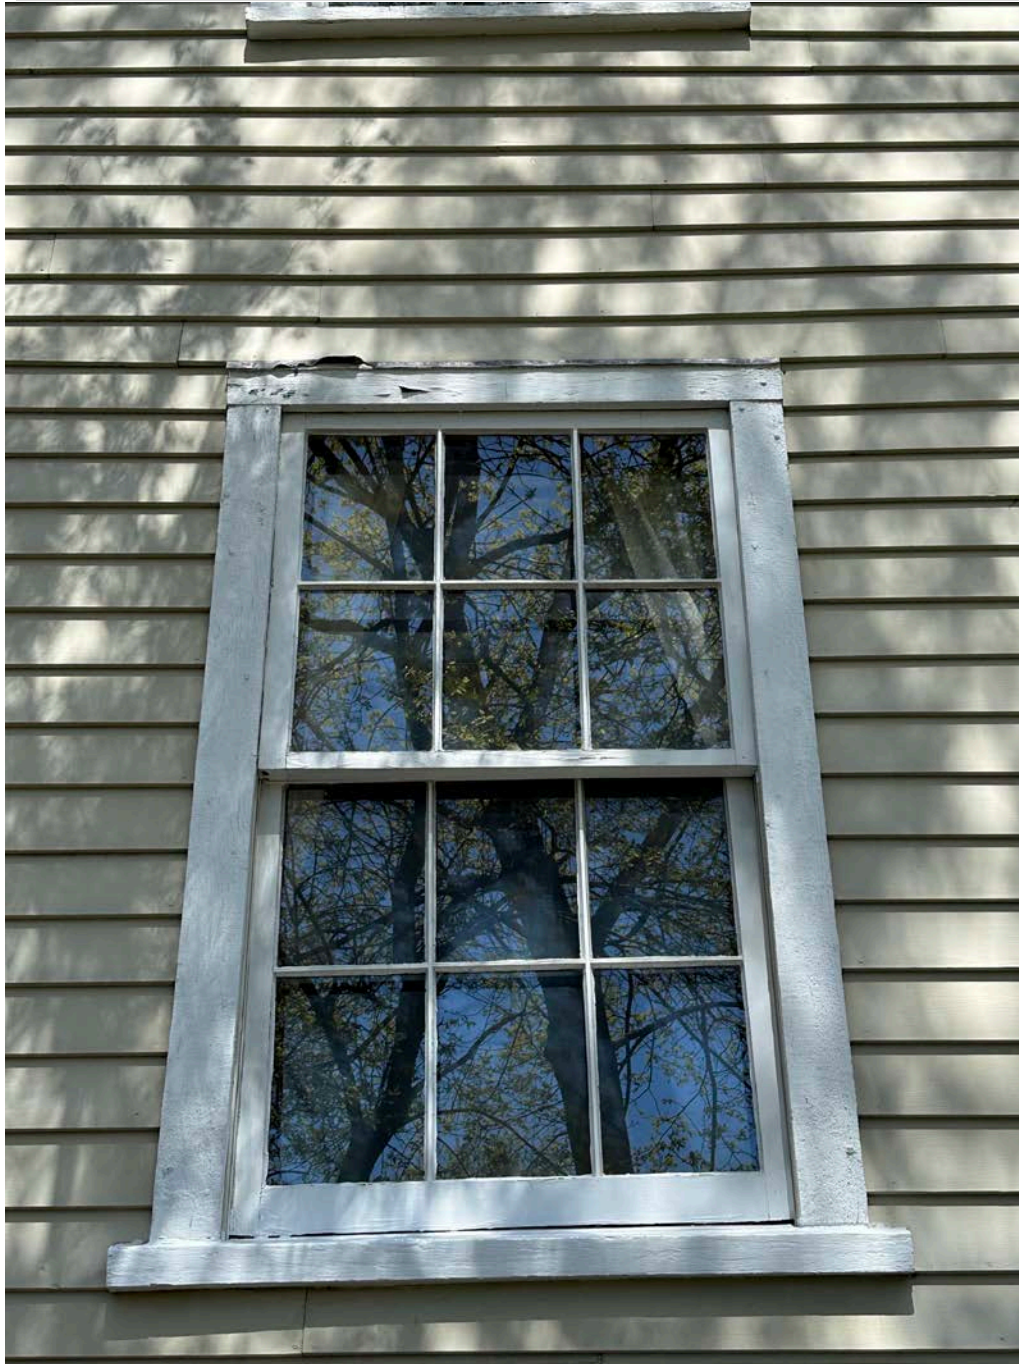
Figure 4.4-15
Metal window head
flashing was noted at
most windows but
appears bent or poorly
installed in some areas.

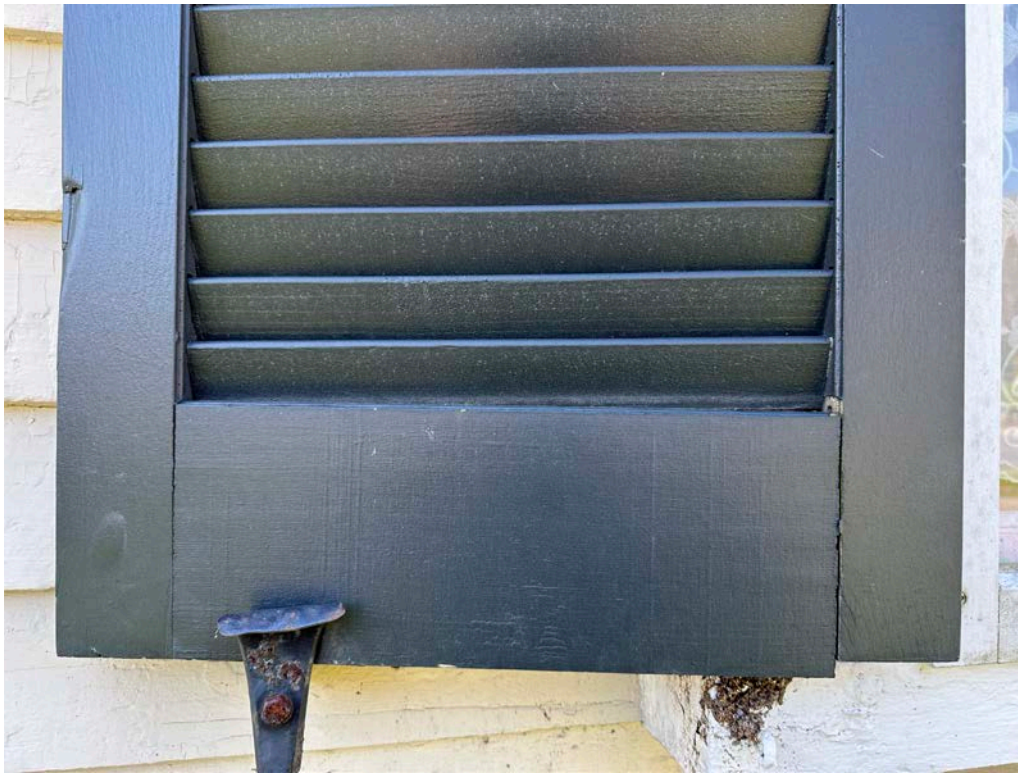
Figure 4.6-1
Loose bottom rail of
a shutter. Typical
conditions seen
throughout.

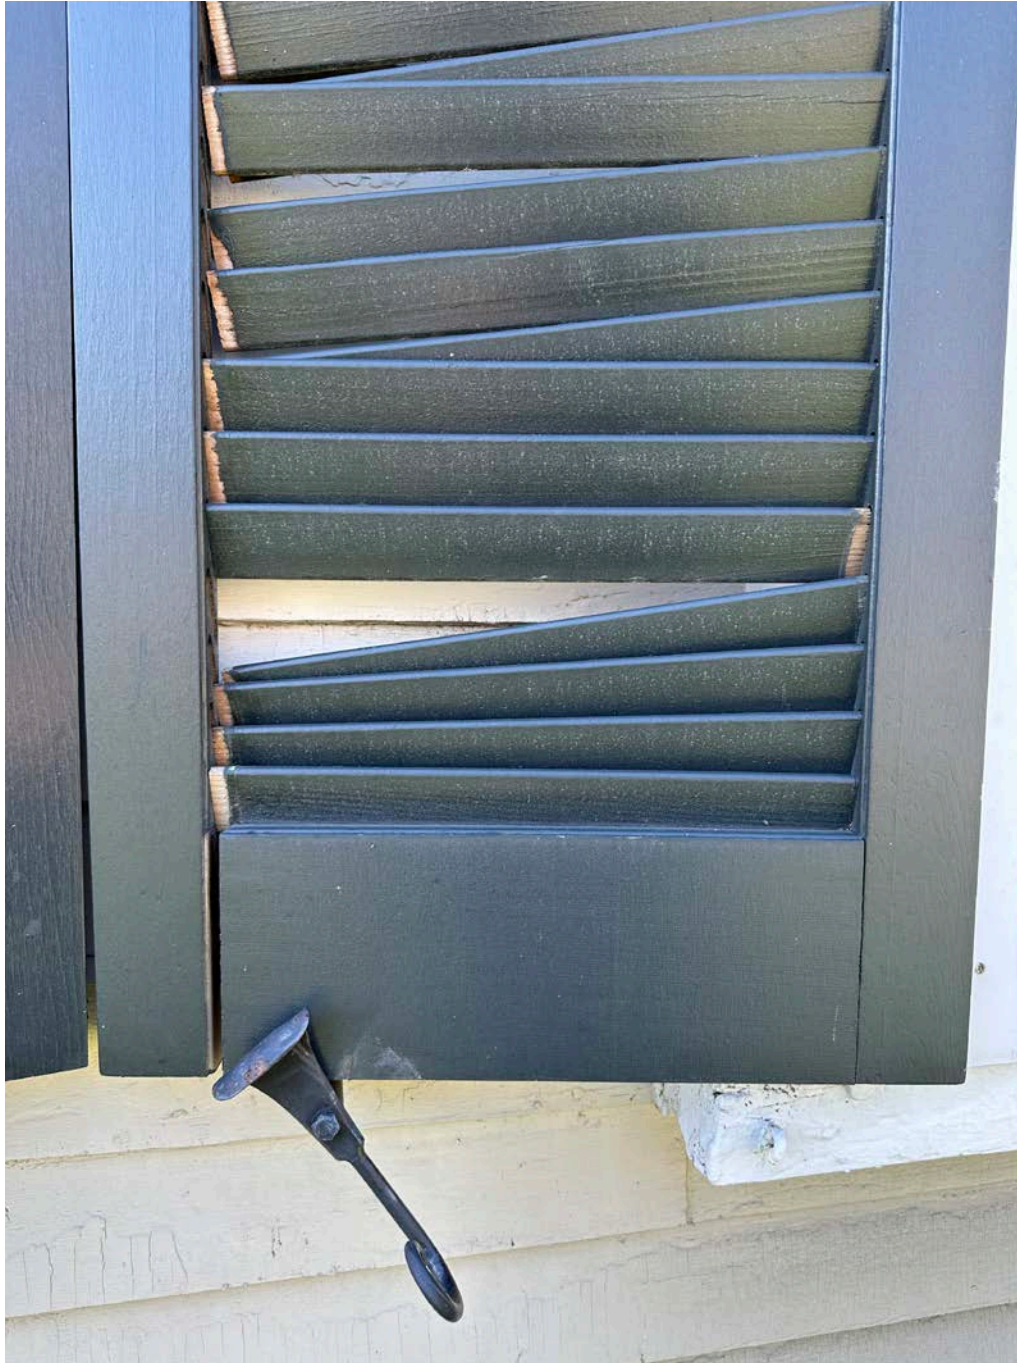
Figure 4.6-2
Louvers which
have fallen out of
place. Typical
condition seen
throughout.

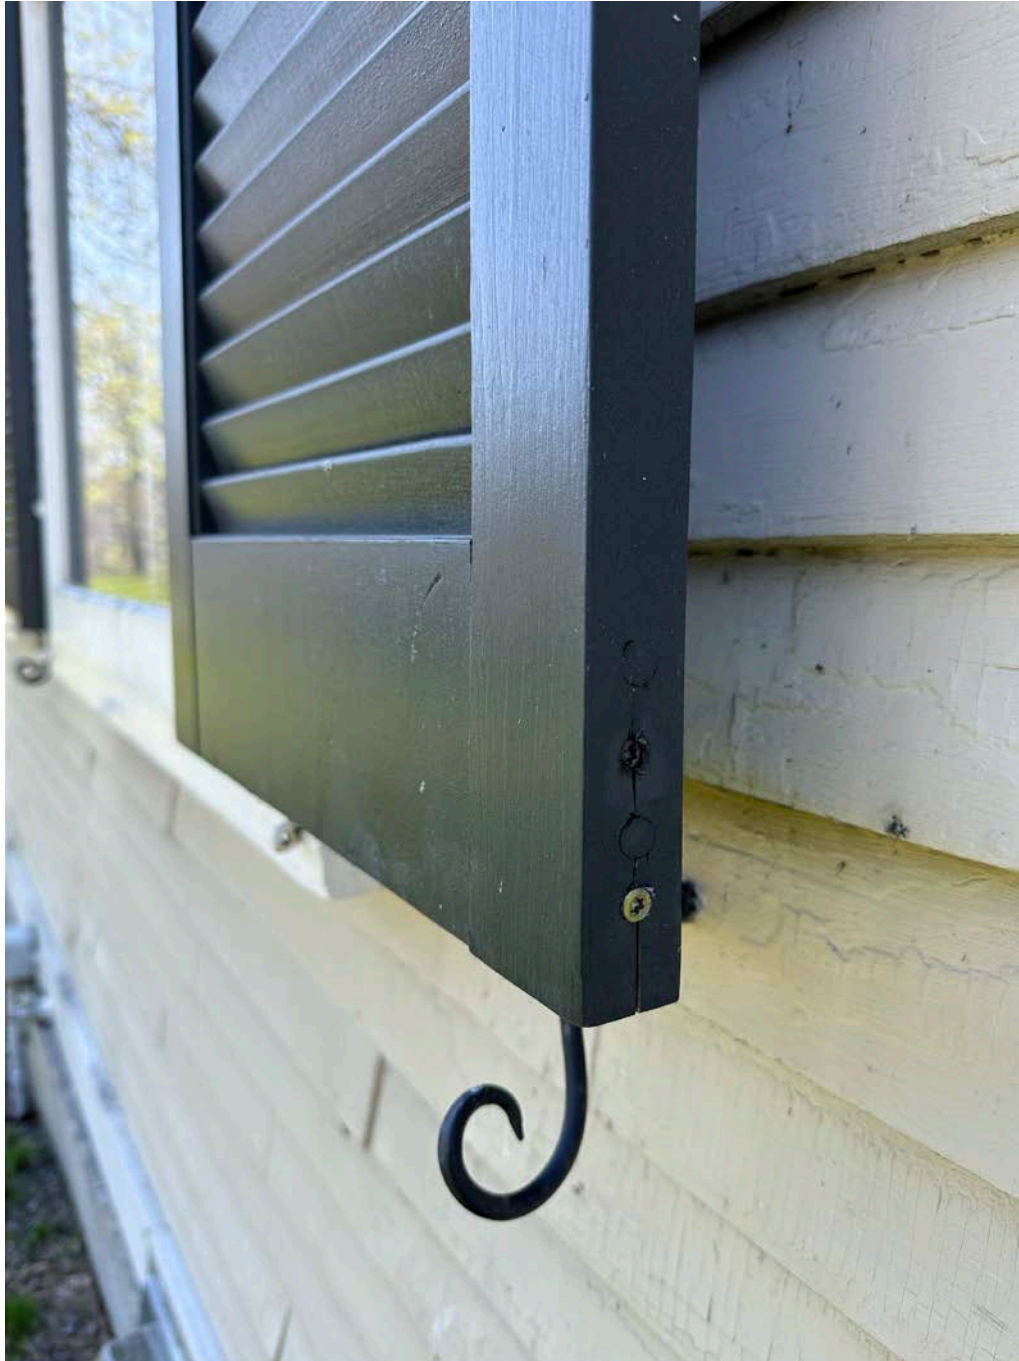
Figure 4.6-3
Instances where the bottom rail of the shutter has become loose. A repair had been made by inserting a screw into the side of the stiles, through to the bottom rail, however this seems to have failed as well, as the wood around the screw is now splitting.

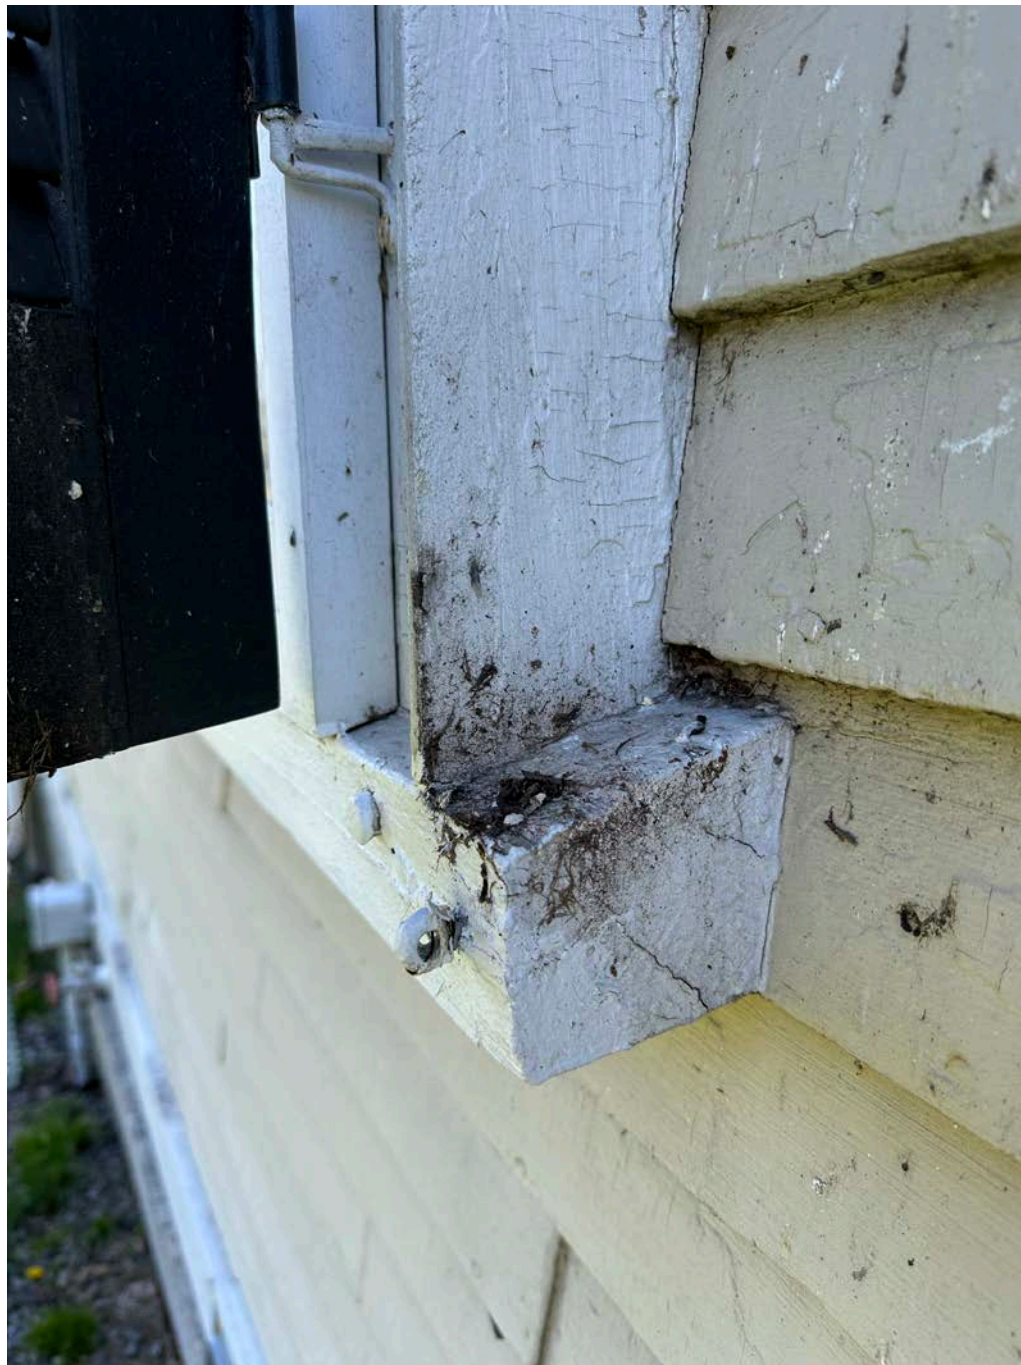
Figure 4.6-4
Evidence of
soiling such as
dust, dirt and
debris piling up.
Typical condition
seen throughout.

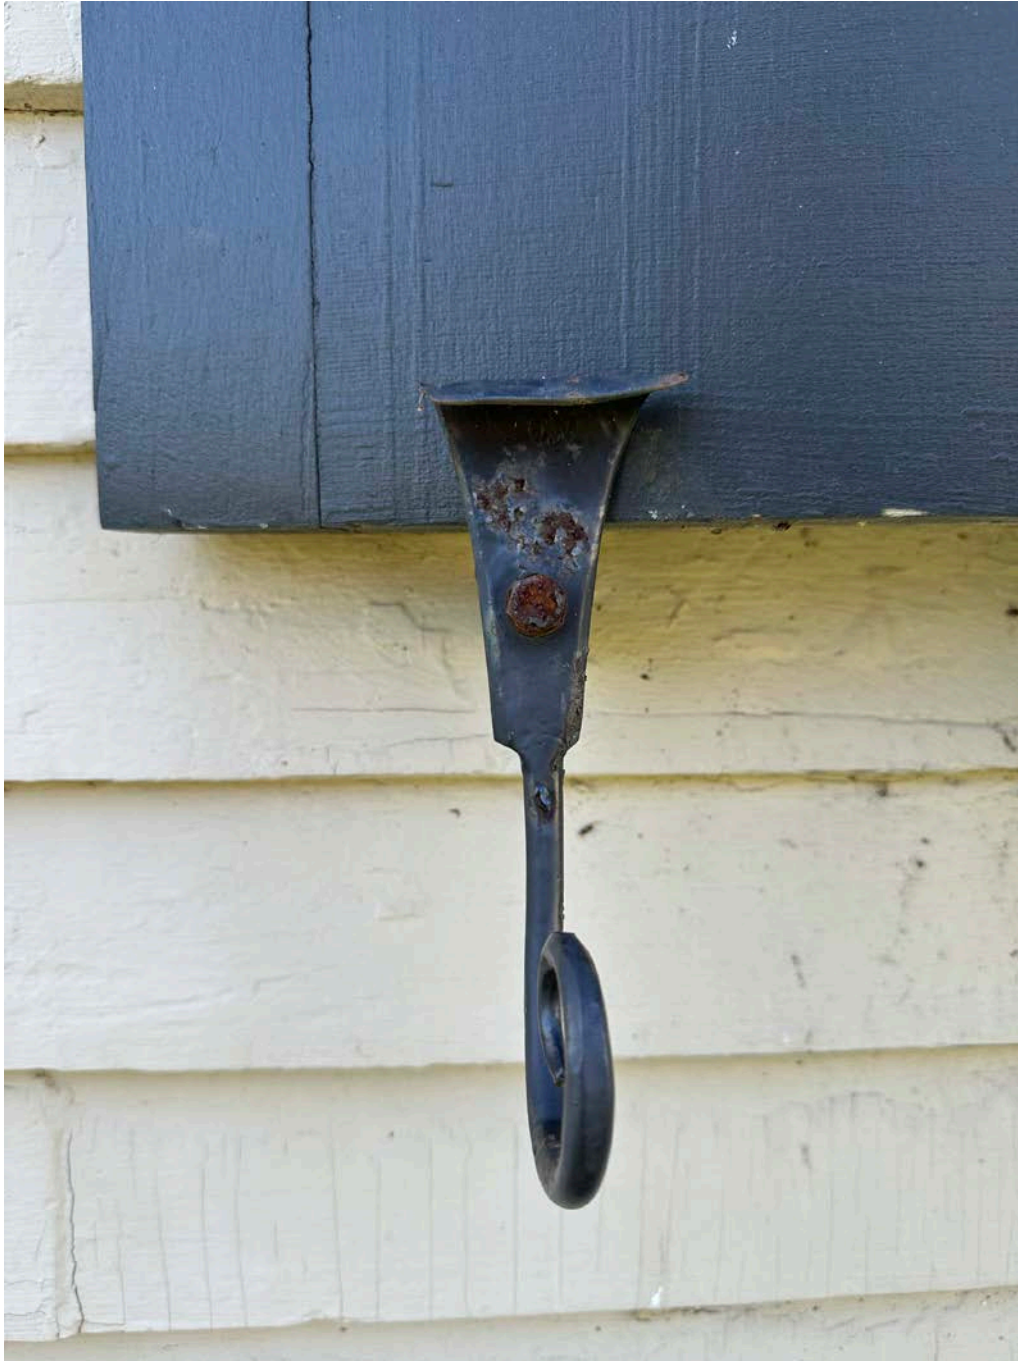
Figure 4.6-5
Less typical conditions found were that the shutters have been loosely anchored to the building, and many of the tiebacks are loosely installed and are rusting. Typical condition seen throughout.

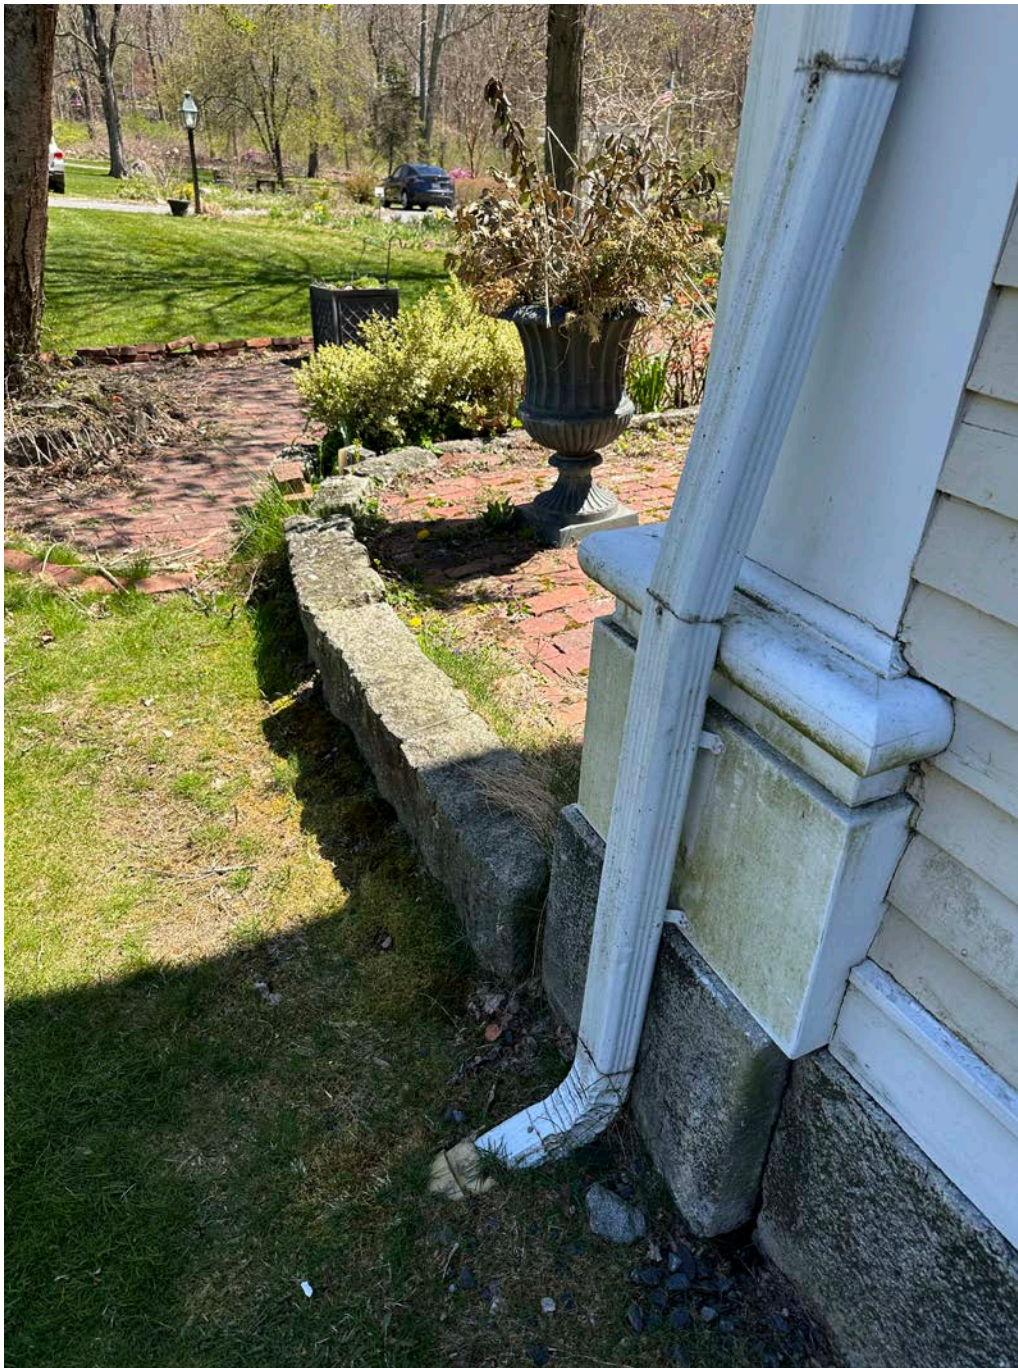
Figure 4.8-1
Located at the
northeast corner
of the house is a
downspout that
expels water
below grade.

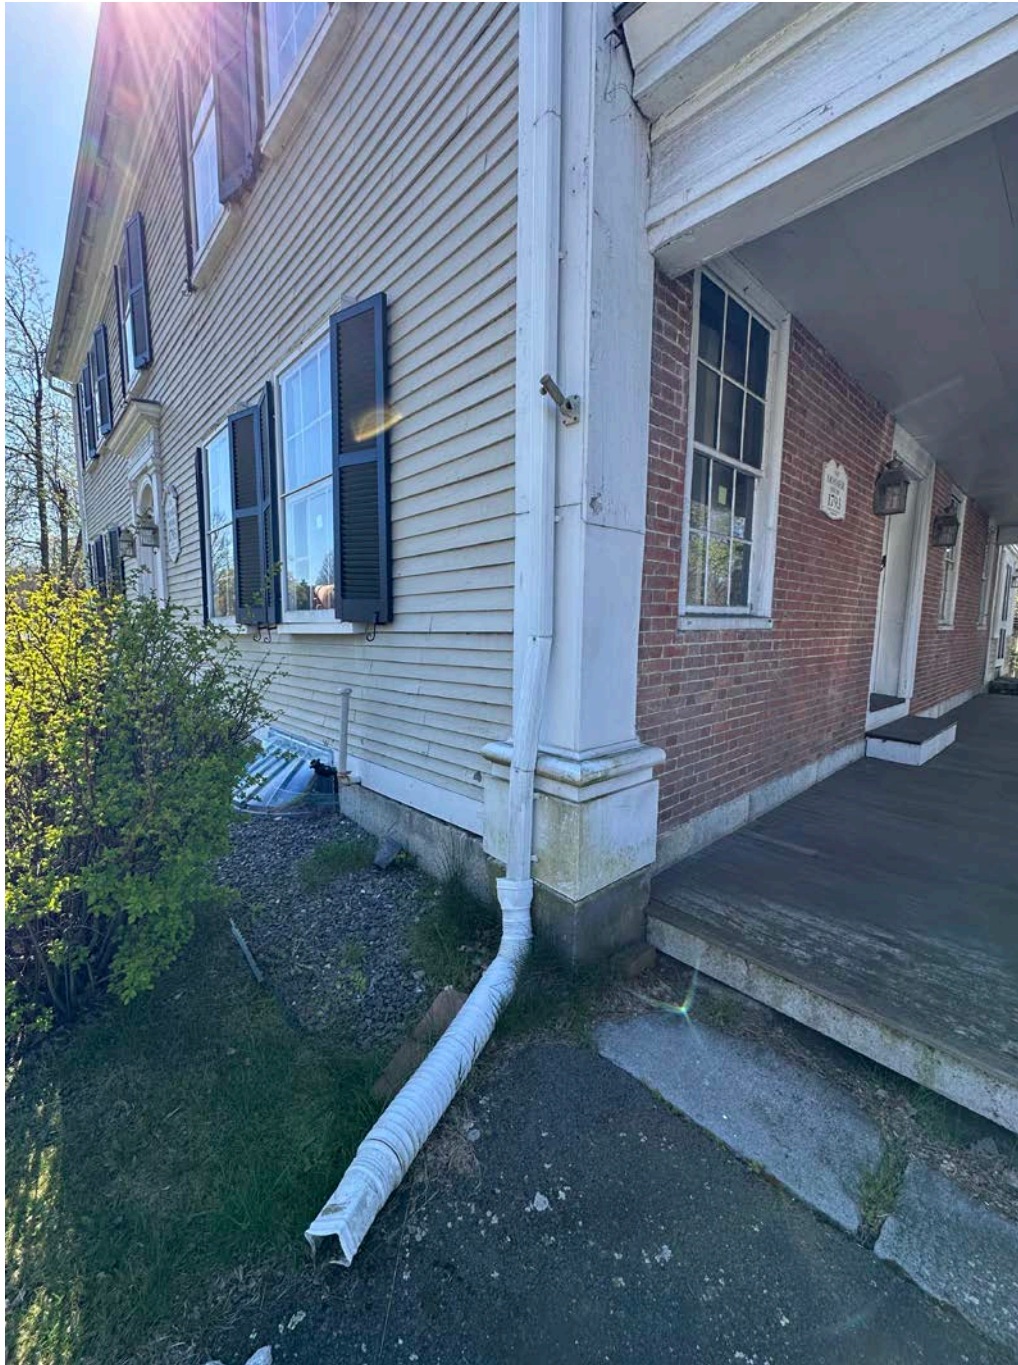
Figure 4.8-2
Located at the northwest corner of the house is a downspout that expels water through a downspout extension above grade, away from the house's foundation walls.

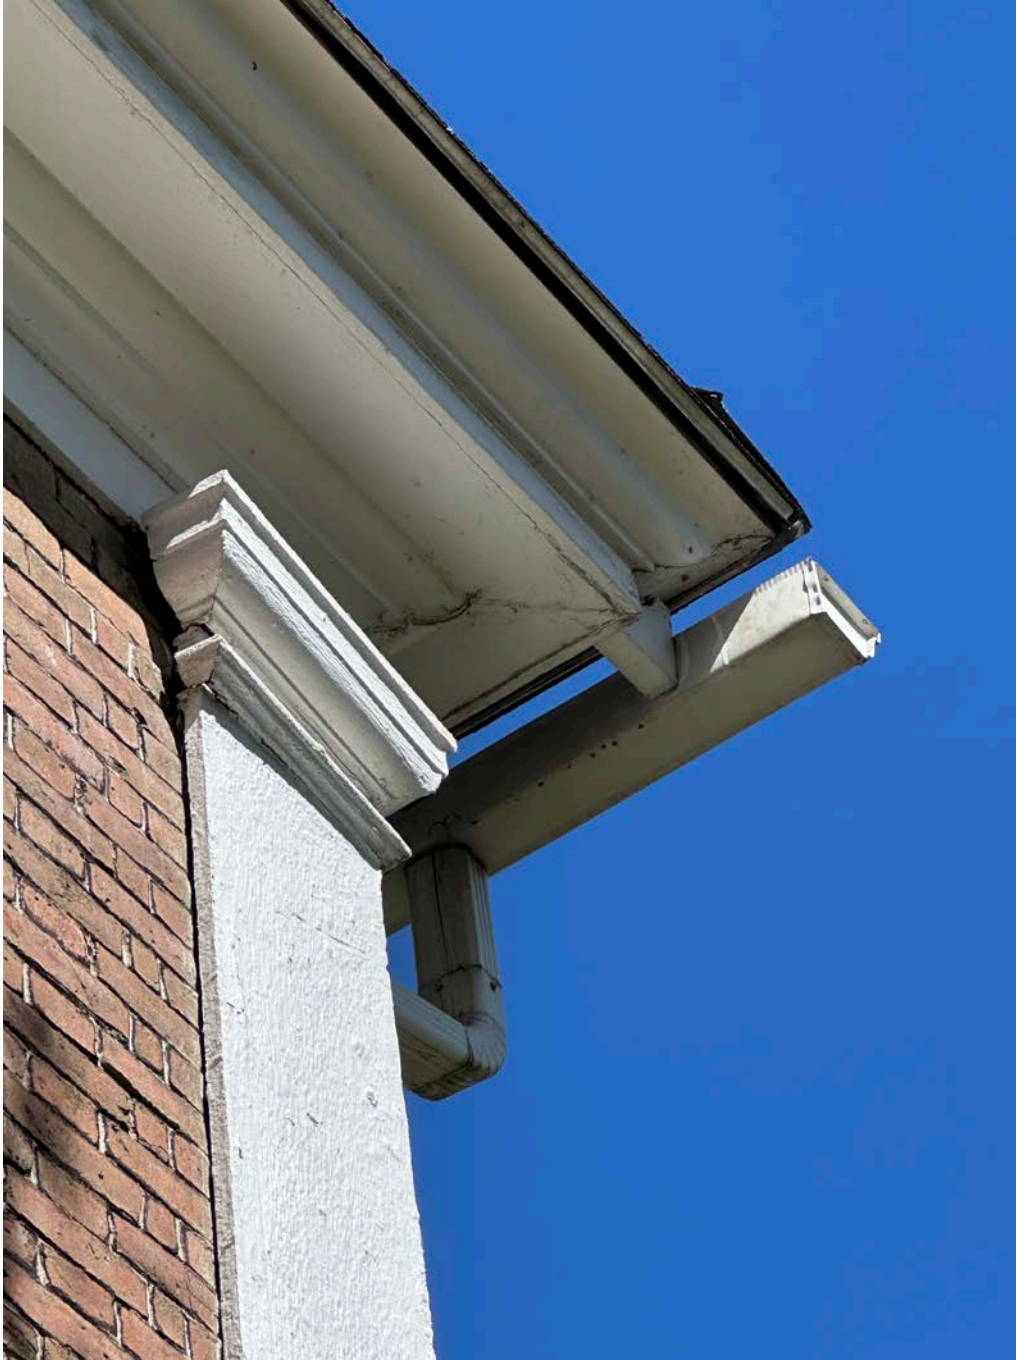
Figure 4.8-3
Along the north
elevation, a gutter
was installed
along the roofline,
supported by
wood blocking.

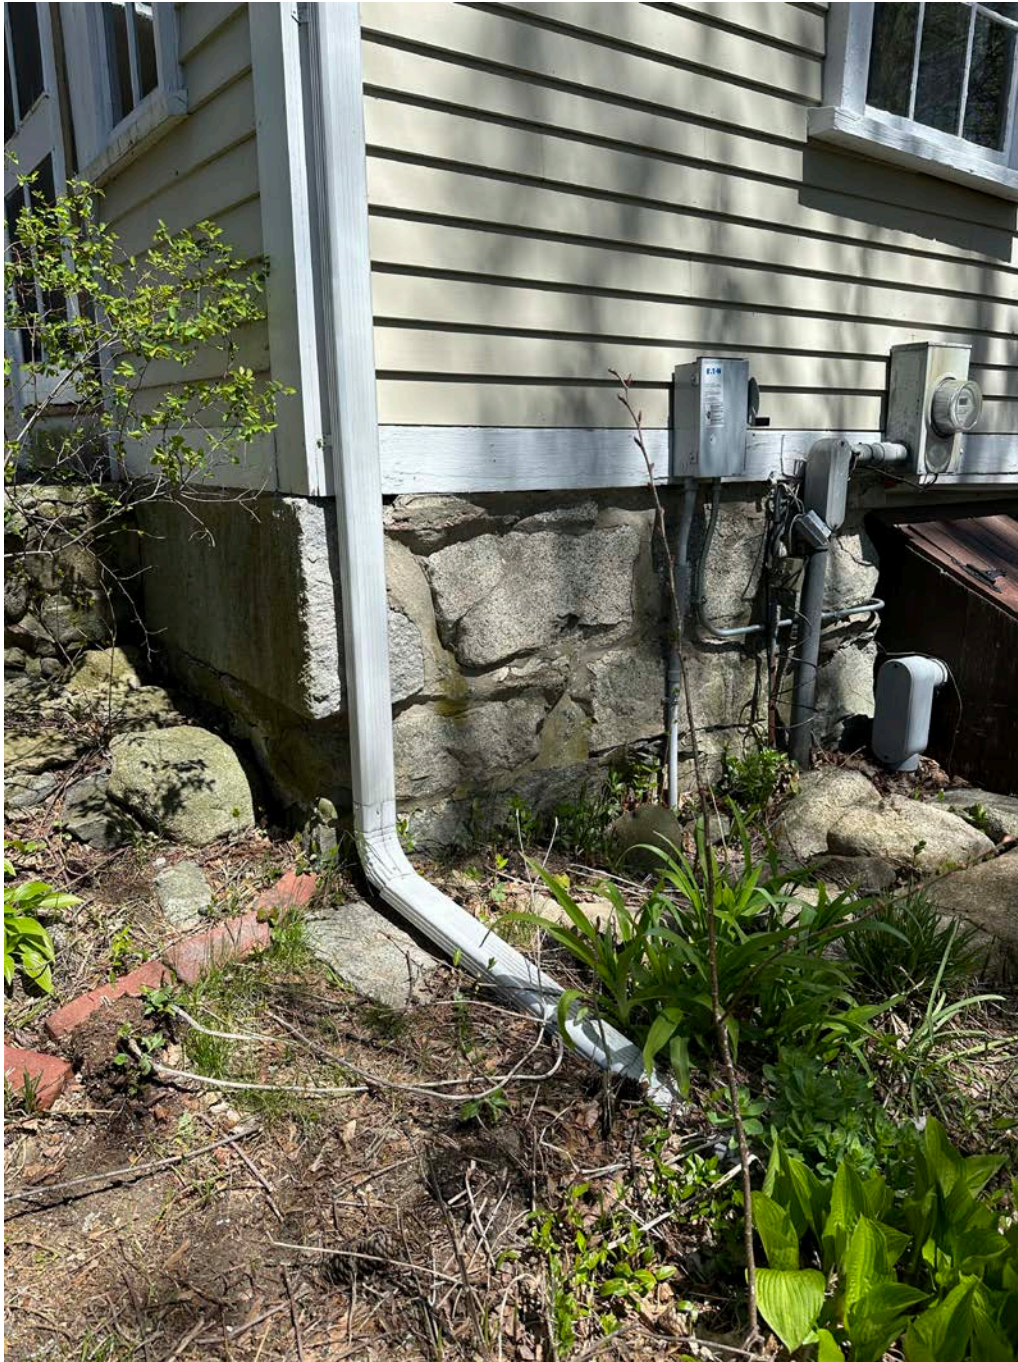
Figure 4.8-8
This downspout terminates an appropriate distance from the house's foundation, and expels water above grade.

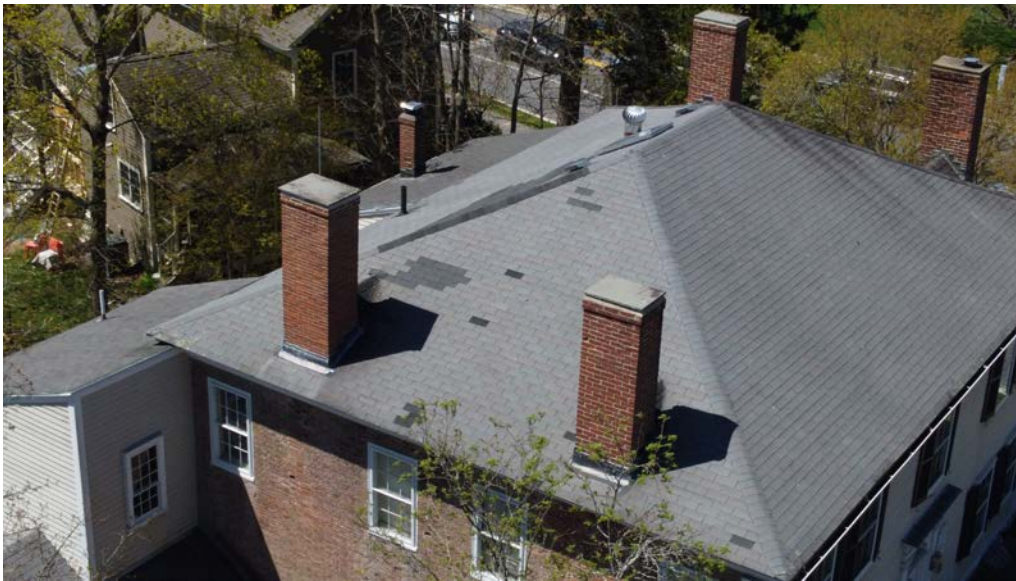
Figure 4.9-1
Four tall, brick-masonry chimneys are situated in pairs along the east and west elevations of the main house, slightly set back from the hipped roofline. The fifth chimney is located in the southwest addition.

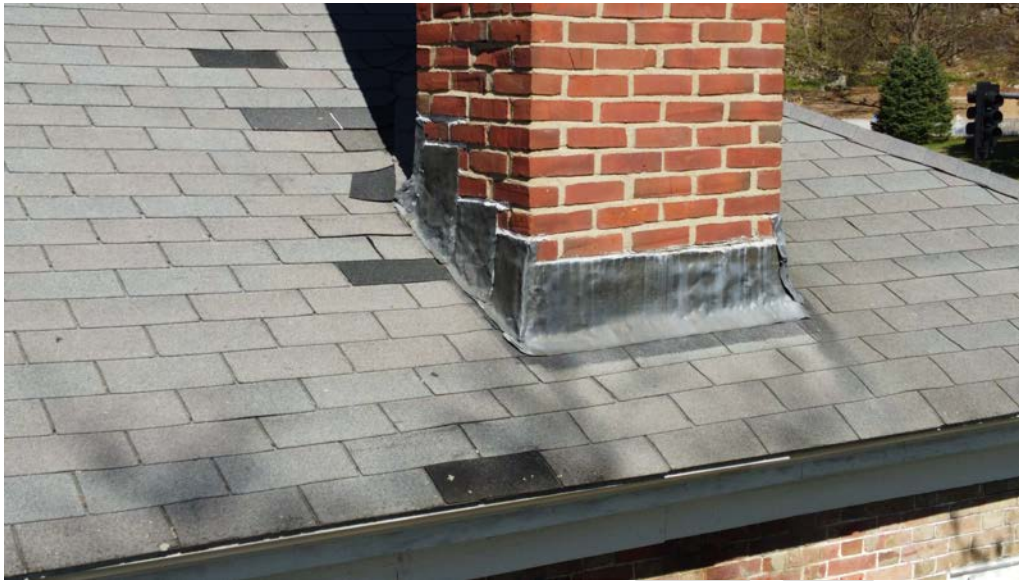
Figure 4.9-3
The step-flashing around the chimneystack s and crickets is in poor condition due to general end-of-life degradation as edges of the flashing are upturned and portions of the step-flashing are separating.

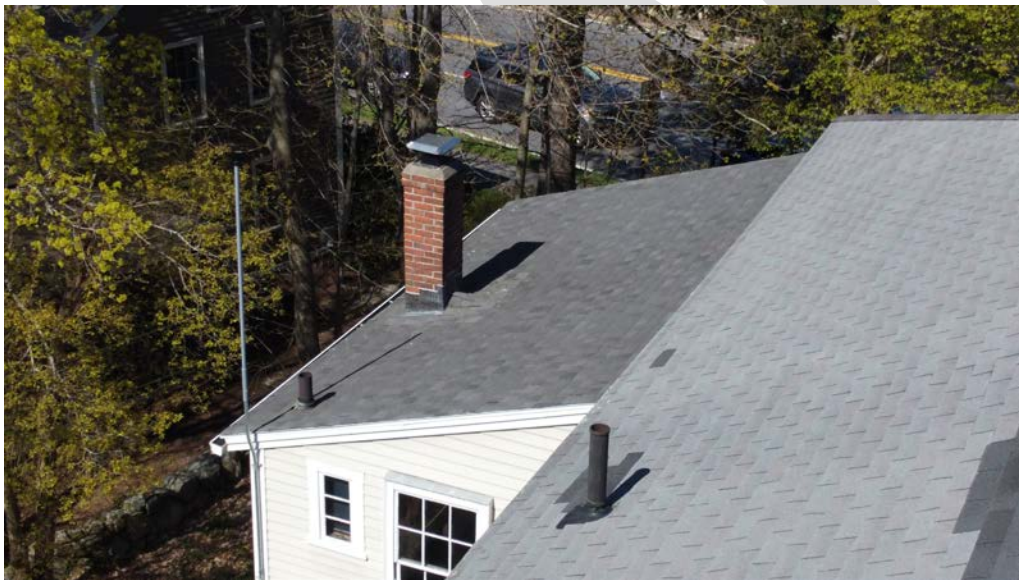
Figure 4.9-4
The fifth chimney, located in the southwest addition, is topped with a vent cap.

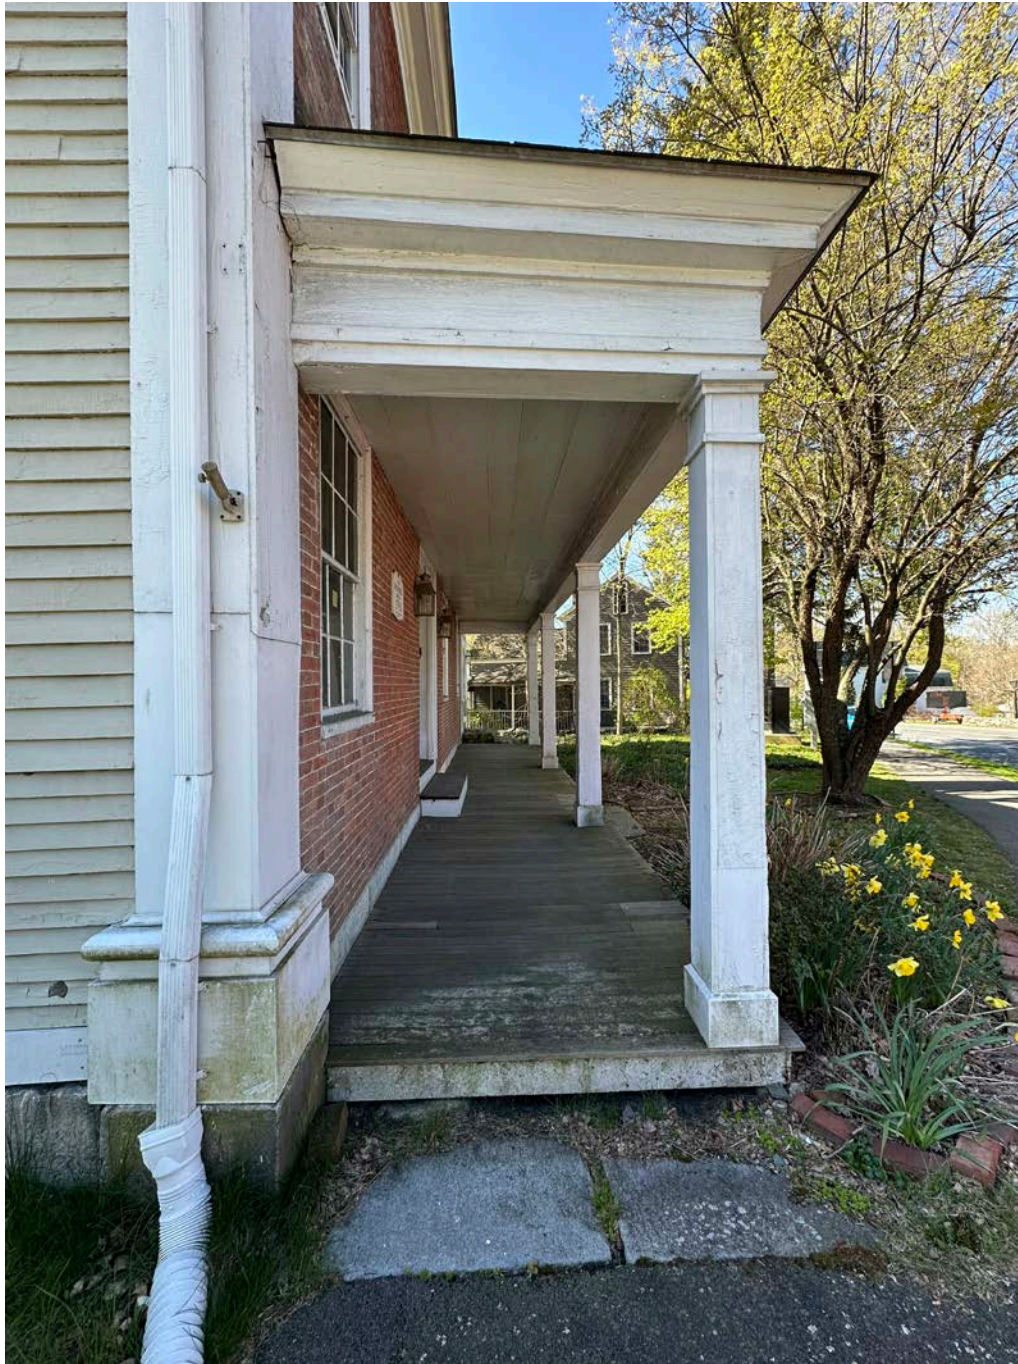
Figure 4.10-1
A single-story open porch extends along the entire length of the west elevation. It is constructed of a wood deck, wood columns and a shingled hip roof.

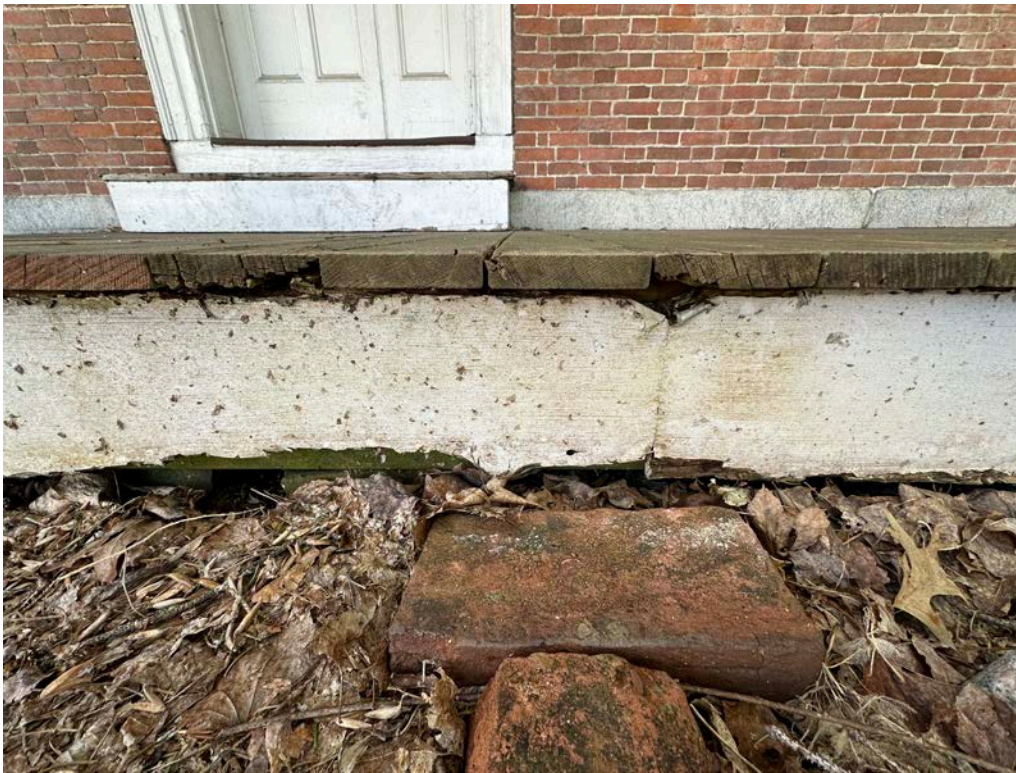
Figure 4.10-2
There is extensive mildew and mold on the deck fascia, most likely due to its proximity to the earth and surrounding vegetation and the section of fascia between the second and third columns is rotted through, the wood is cracked, and a portion of the fascia has fallen off.

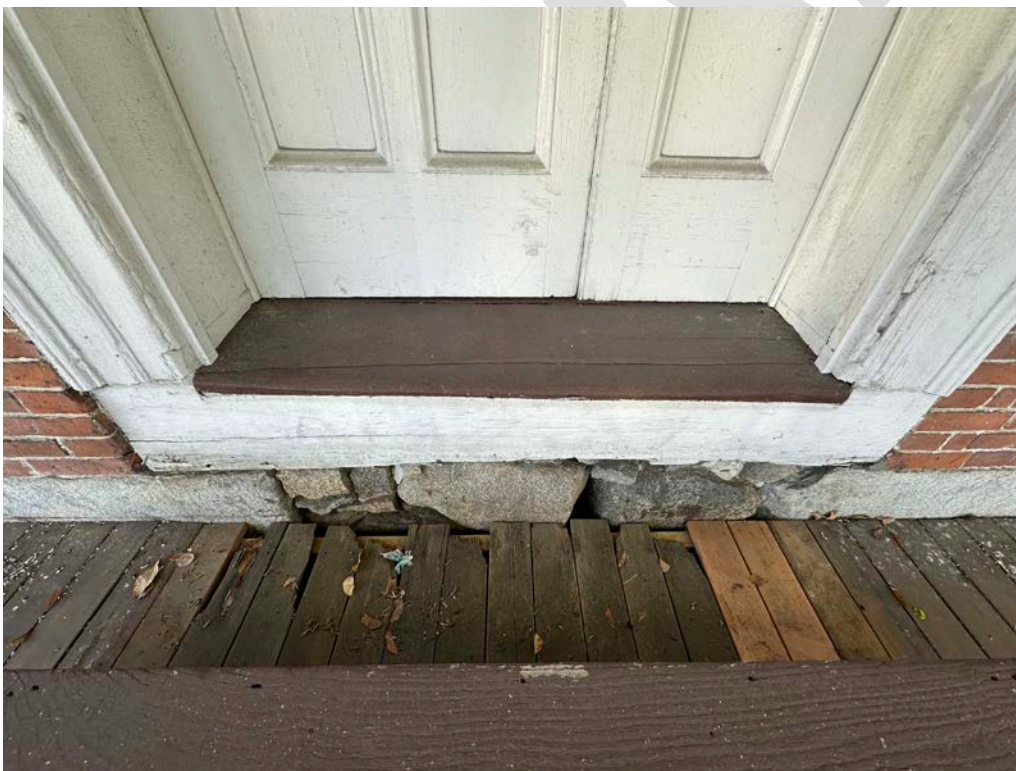
Figure 4.10-3
The decking planks directly below the door threshold are rotted, and are exhibit the most severe deteriorated of the deck.

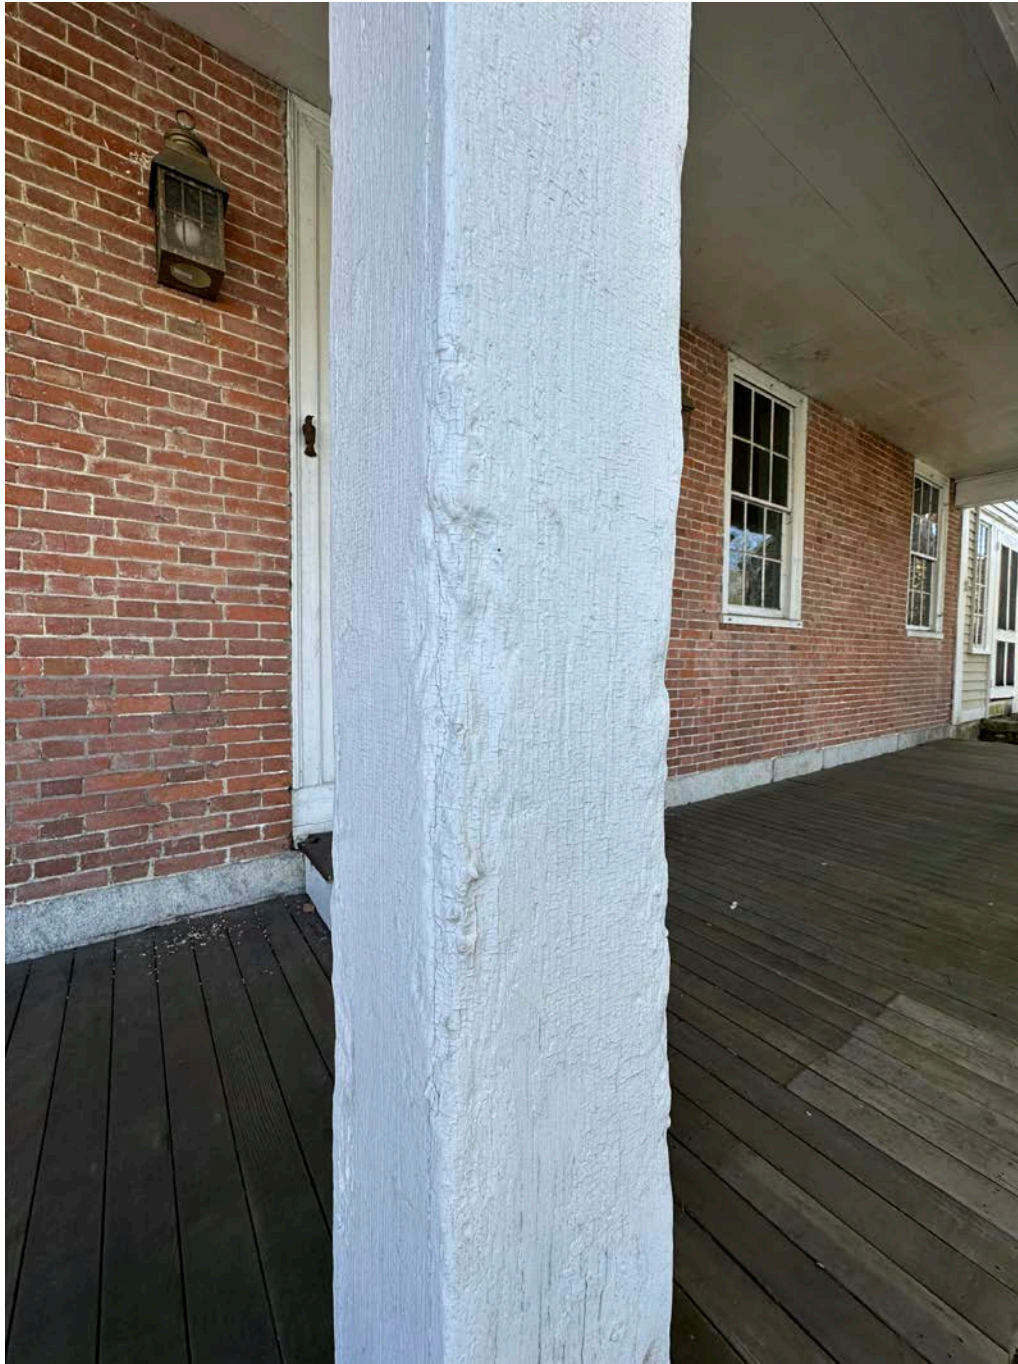
Figure 4.10-4
The 4 columns which support the porch roof are in poor-to-fair condition. The shaft of the columns have degraded over time, and have lost material mass at various locations.

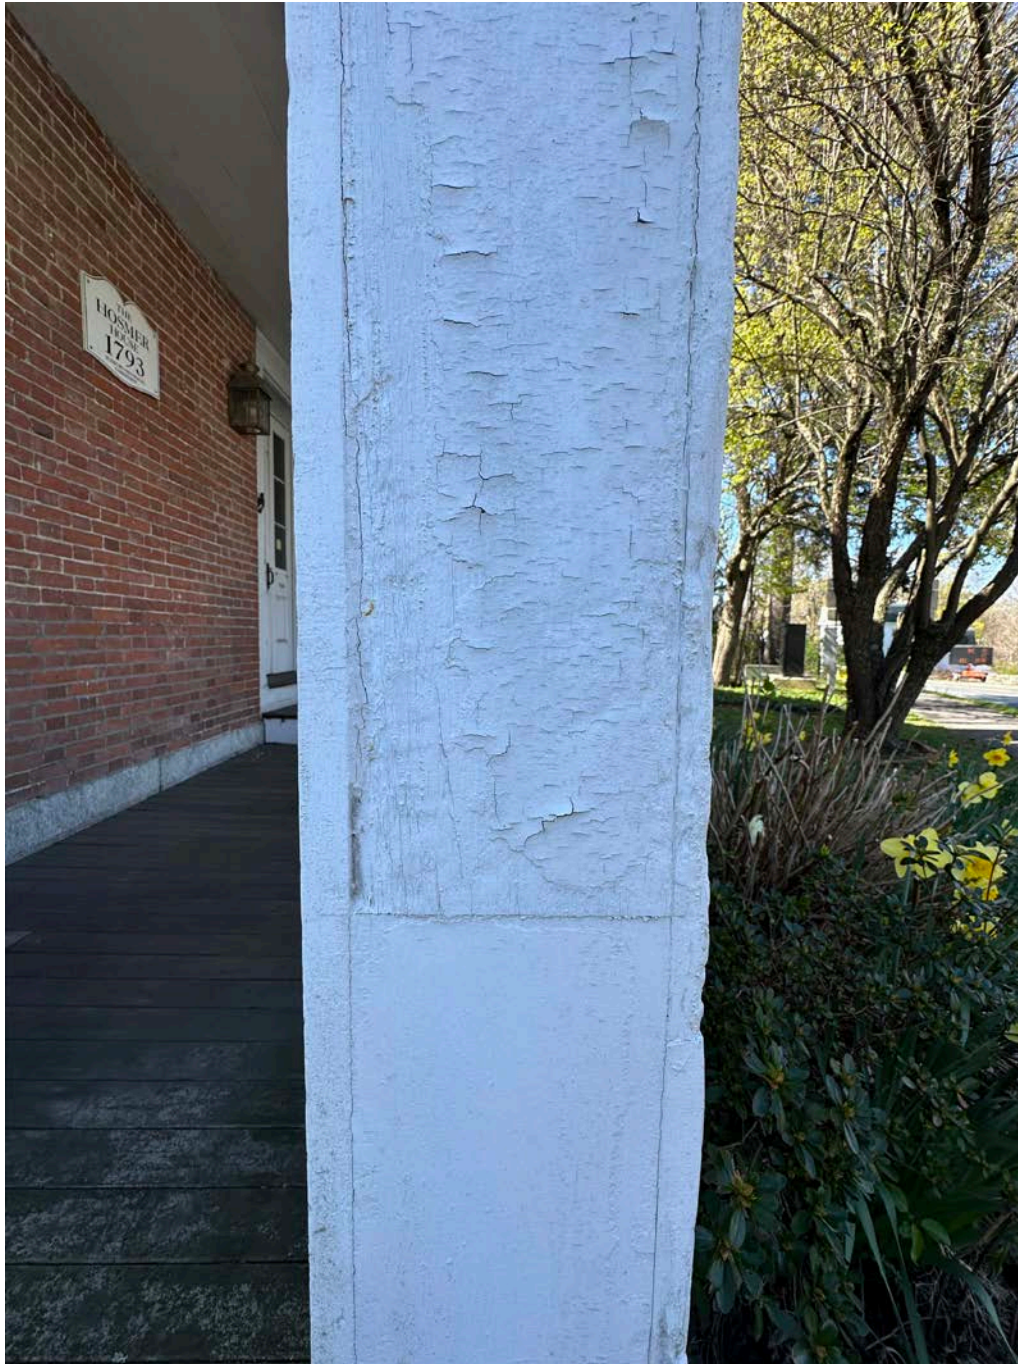
Figure 4.10-5
Between 12" to
14" of the shafts
of the two
columns at either
end of the porch
have been
replaced along
with all 4 column
capitals and
bases.

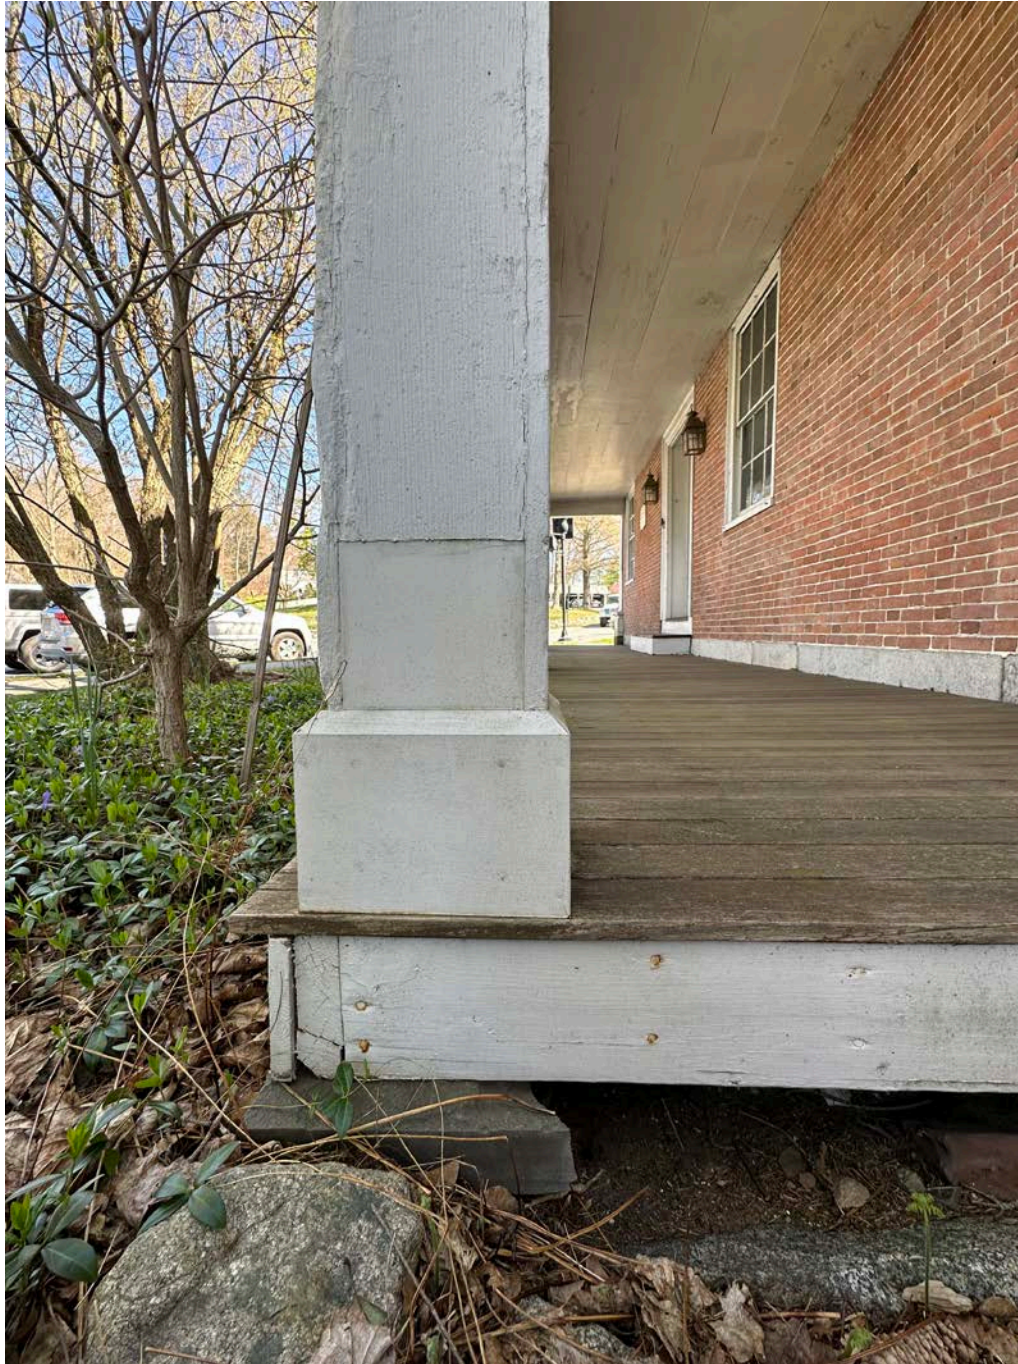
Figure 4.10-6
Between 12" to
14" of the shafts
of the two
columns at either
end of the porch
have been
replaced along
with all 4 column
capitals and
bases.
