RECEIVED
AUG 30 2024

BY: R. Poteat

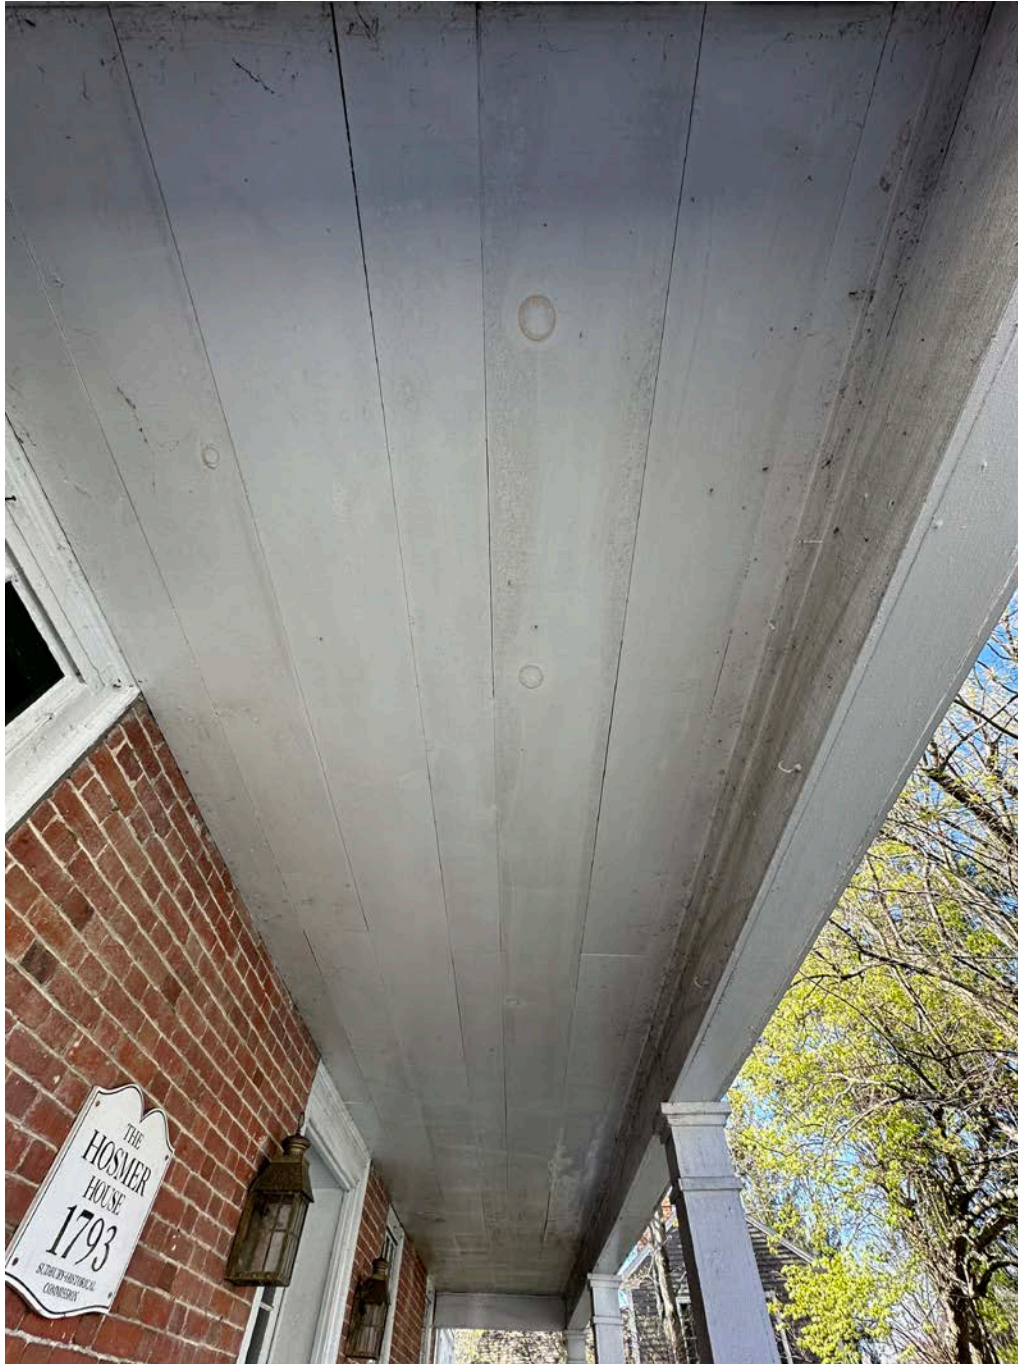
Figure 4.10-7
The porch ceiling is in good condition. The ceiling board at the underside of the roof is relatively new, however, oils are being drawn out from the knots in the wood, creating brown rings which telegraph through the white paint, typical throughout.

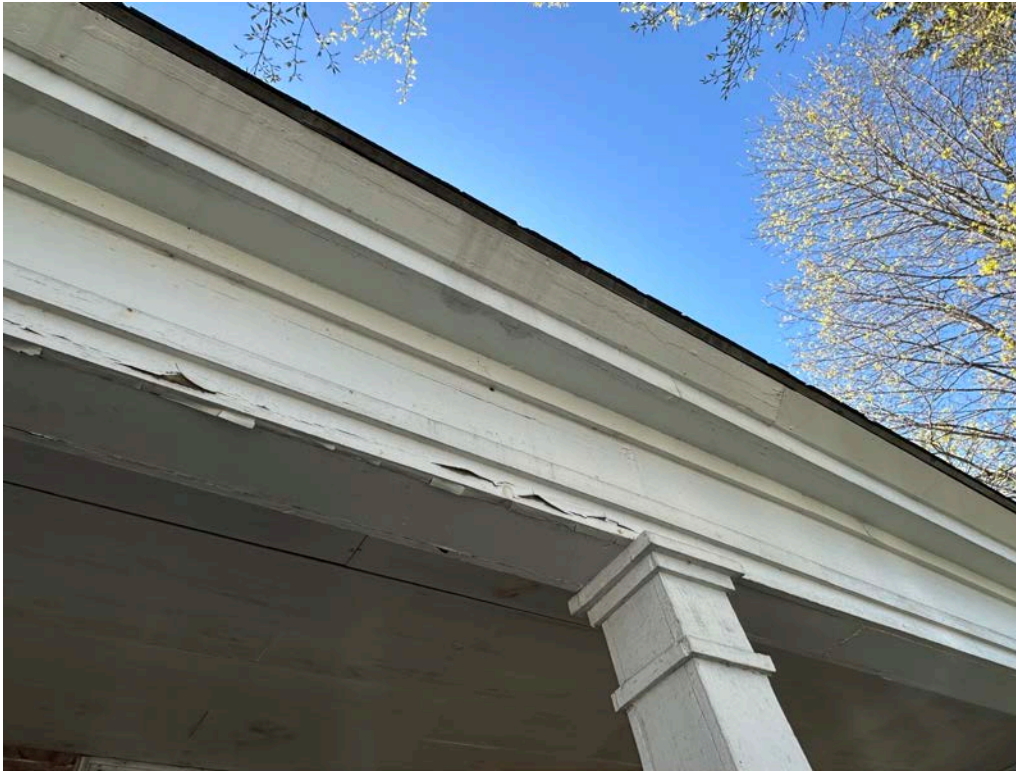
Figure 4.10-8
The frieze board and
fascia of the porch
roof have as well
been replaced.

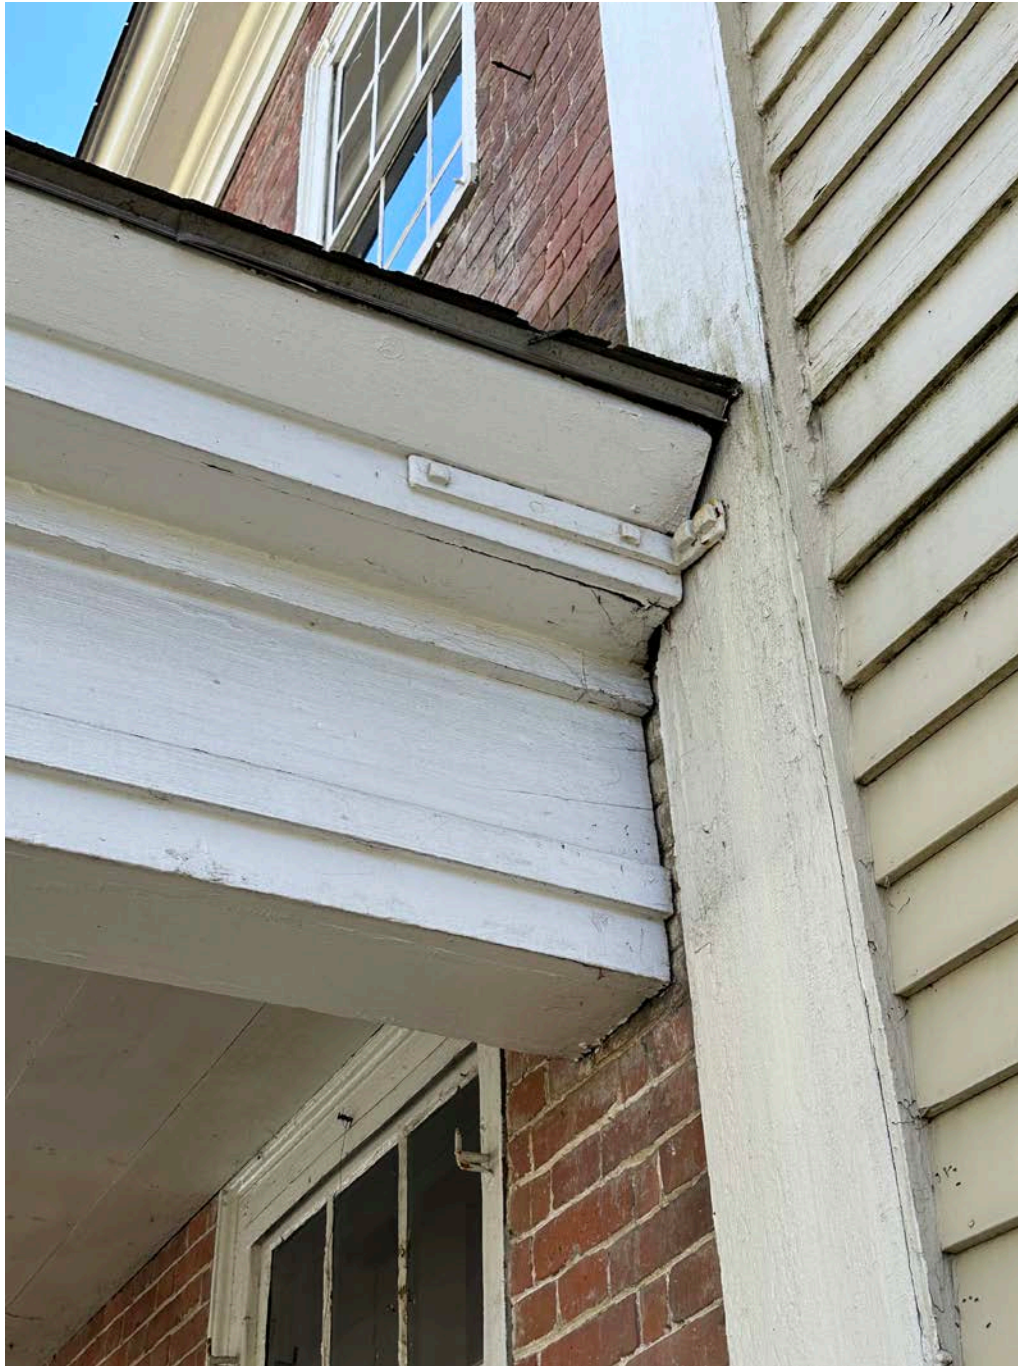
Figure 4.10-9
The portion of fascia and frieze along the south elevation of the porch has been reinforced with a metal 'L' bracket and bolts, which fastens into the trim of the clapboard siding on the west elevation.
