## DPW Offices and Garage

## Town of Sudbury ADA Transition Plan

October 2020

Institute for Human Centered Design

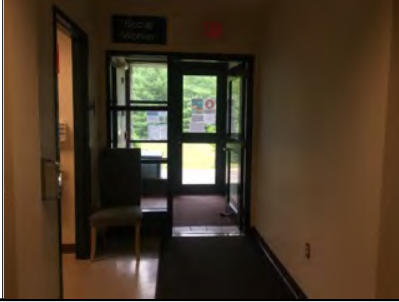
| ID | Location | Floor | Room | Element | Type | Photo | Issues | Current Measure | Recommendations | Quantity | Price | Cost Estimation |
|---|---|---|---|---|---|--|---|---|---|---|---|---|
| 5 | North Exit | 1 | | Emergency Exit | | | Tactile sign not provided at exit<br>Illuminated Int. Symbol of Acc. not provided (MAAB)<br>Mat not securely attached | -<br>-<br>- | Provide tactile exit signs with raised characters and braille at exit doors. Mount signs between 48"- 60" above the finished floor located on the latch side of the door.<br>Provide an illuminated sign with the International Symbol of Accessibility.<br>Secure the mat. | 1 | 432<br>Labor | \$432 |

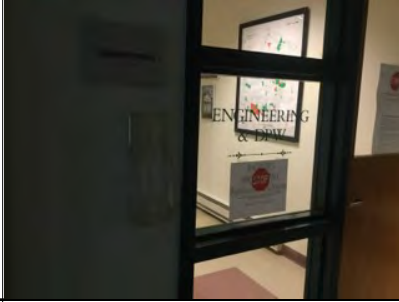
| ID | Location | Floor | Room | Element | Type | Photo | Issues | Current Measure | Recommendations | Quantity | Price | Cost Estimation |
|---|---|---|---|---|---|--|---|---|--|---|---|---|
| 15 | Engineering Near Main Entrance | 1 | | Signage | Designation | | Signage lacks clear floor space | - | Remove the plastic container to ensure that a clear floor space of 18" by 18" is centered on the tactile characters. | 1 | Labor | \$0 |

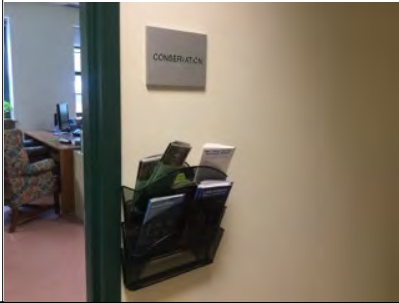
| ID | Location | Floor | Room | Element | Type | Photo | Issues | Current Measure | Recommendations | Quantity | Price | Cost Estimation |
|---|---|---|---|---|---|--|---|---|--|---|---|---|
| 16 | Conservation | 1 | | Signage | Designation | | Signage lacks clear floor space | - | Remove the file folder to ensure that a clear floor space of 18" by 18" is centered on the tactile characters. | 1 | Labor | \$0 |

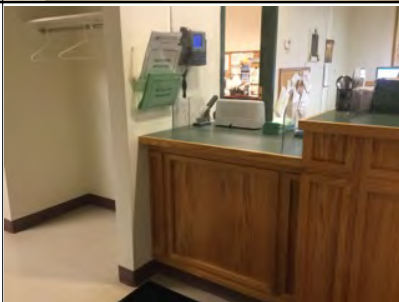
| ID | Location | Floor | Room | Element | Type | Photo | Issues | Current Measure | Recommendations | Quantity | Price | Cost Estimation |
|---|---|---|---|---|---|--|---|---|--|---|---|---|
| 19 | Transfer Station Cemetery Department | 1 | | Operable Parts | Other | | Reach < 15" or > 48"(forward/side approach) | 56" | Relocate one of each form to be located between 15"- 48" above the finished floor. | 1 | Labor | \$0 |

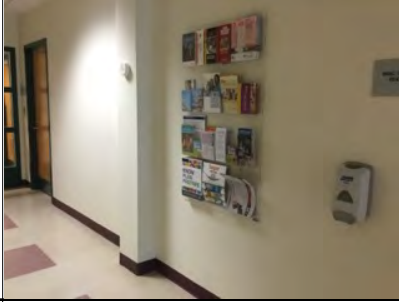
| ID | Location | Floor | Room | Element | Type | Photo | Issues | Current Measure | Recommendations | Quantity | Price | Cost Estimation |
|---|---|---|---|---|---|--|--|---|--|---|---|---|
| 20 | Corridor Near Mail/Copy Room | 1 | | Operable Parts | Other | | Reach < 15" or > 48"(forward/side approach) | 61", 73" | Relocate one of each form to be located between 15"- 48" above the finished floor. | 1 | Labor | \$0 |

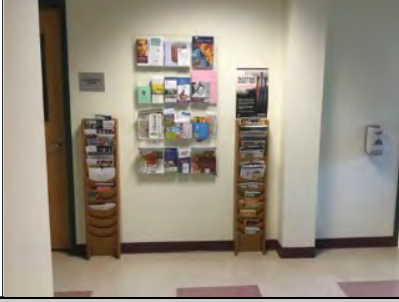
| ID | Location | Floor | Room | Element | Type | Photo | Issues | Current Measure | Recommendations | Quantity | Price | Cost Estimation |
|---|---|---|---|---|---|--|--|---|--|---|---|---|
| 21 | Corridor Near Mail/Copy Room | 1 | | Operable Parts | Other | | Reach < 15" or > 48"(forward/side approach) | 61", 73" | Relocate one of each form to be located between 15"- 48" above the finished floor. | 1 | Labor | \$0 |

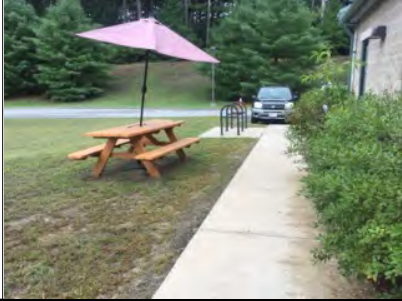
| ID | Location | Floor | Room | Element | Type | Photo | Issues | Current Measure | Recommendations | Quantity | Price | Cost Estimation |
|---|---|---|---|---|---|--|---|---|--|---|---|---|
| 25 | Picnic Table by North Exit | Ext. | | Picnic Tables | N/A | | Picnic table not on an accessible route | - | Ensure that the dining surface is connected to an accessible route. (Cost estimate for a 6' long 4' wide concrete route.) | 1 | 384 | \$384 |

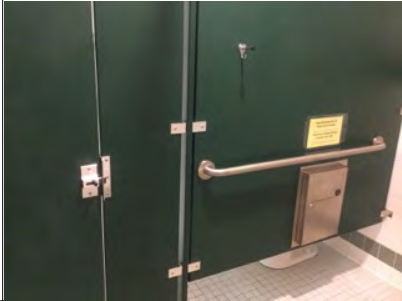
| ID | Location | Floor | Room | Element | Type | Photo | Issues | Current Measure | Recommendations | Quantity | Price | Cost Estimation |
|---|---|---|---|---|---|--|---|---|--|---|---|---|
| 27 | Women's Toilet Room | 1 | | Toilet Compartment | | | Door has non-compliant hardware | - | Provide hardware that can be operable with one hand and not require tight grasping, pinching, or twisting of the wrist. | 1 | 70 | \$70 |

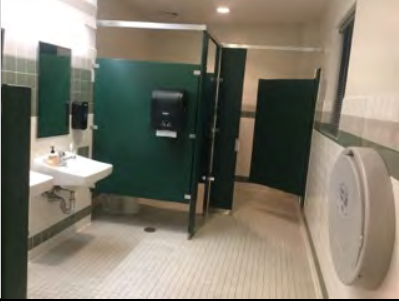
| ID | Location | Floor | Room | Element | Type | Photo | Issues | Current Measure | Recommendations | Quantity | Price | Cost Estimation |
|---|---|---|---|---|---|--|---|---|--|---|---|---|
| 29 | Women's Toilet Room | 1 | | Toilet Compartment | Accessible Compartment | | Door has malfunctioning self-closing hinge | - | Repair hinge. | 1 | Labor | \$0 |

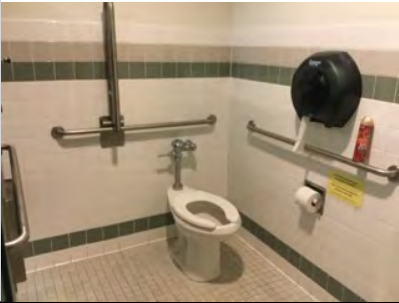
| ID | Location | Floor | Room | Element | Type | Photo | Issues | Current Measure | Recommendations | Quantity | Price | Cost Estimation |
|---|---|---|---|---|---|--|---|---|--|---|---|---|
| 30 | Women's Toilet Room | 1 | | Toilet Compartment | | | Non-compliant toilet paper dispenser | - | Remove toilet paper dispenser that is mounted above the grab bar. | 1 | 353 | \$353 |

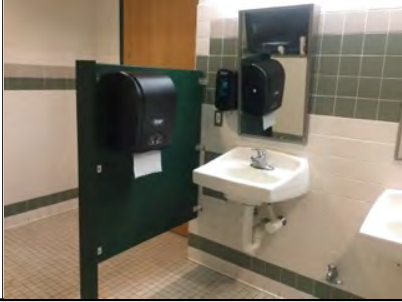
| ID | Location | Floor | Room | Element | Type | Photo | Issues | Current Measure | Recommendations | Quantity | Price | Cost Estimation |
|---|--|---|---|---|---|--|--|---|--|---|---|---|
| 34 | Men's Toilet Room | 1 | | Dispensers | Paper Towel Dispenser | | Dispenser acts as a protruding object | 9" | Relocate paper towel dispensers out of the circulation path. | 2 | 256 | \$512 |

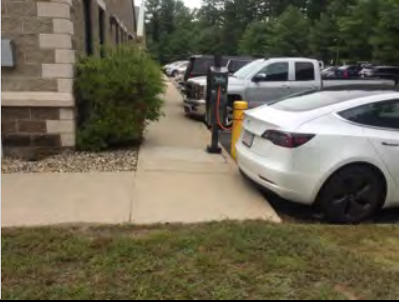
| ID | Location | Floor | Room | Element | Type | Photo | Issues | Current Measure | Recommendations | Quantity | Price | Cost Estimation |
|---|---|---|---|---|---|--|---|---|--|---|---|---|
| 40 | Front Walkway | Ext. | | | | | | | Recommend providing an accessible vehicle charging station with 3' min. access aisles on each side and a 10'-13' wide vehicle space. | 1 | - | \$0 |

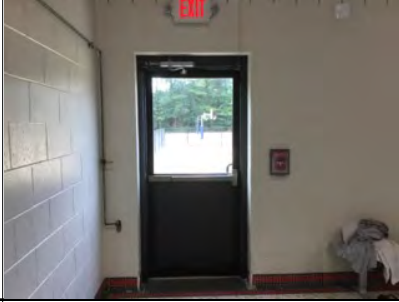
| ID | Location | Floor | Room | Element | Type | Photo | Issues | Current Measure | Recommendations | Quantity | Price | Cost Estimation |
|---|--|---|---|---|---|--|--|---|--|---|---|---|
| 10 | Diving Pool Egress to Picnic Table Area | 1 | | Emergency Exit | N/A | | Tactile sign not provided at exit<br>Illuminated Int. Symbol of Acc. not provided (MAAB) | -<br>- | Provide tactile exit signs with raised characters and braille at exit doors. Mount signs between 48"- 60" above the finished floor located on the latch side of the door.<br>Provide an illuminated sign with the International Symbol of Accessibility. | 1 | 432 | \$432 |

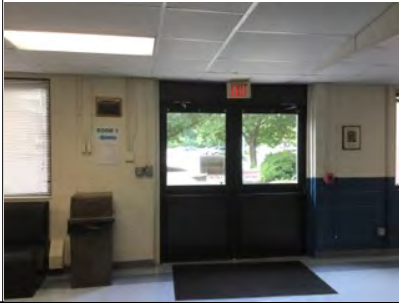
| ID | Location | Floor | Room | Element | Type | Photo | Issues | Current Measure | Recommendations | Quantity | Price | Cost Estimation |
|---|--|---|---|---|---|--|--|---|--|---|---|---|
| 11 | Egress Next to Gym/Stage | 1 | | Emergency Exit | N/A | | Tactile sign not provided at exit<br>Illuminated Int. Symbol of Acc. not provided (MAAB) | | Provide tactile exit signs with raised characters and braille at exit doors. Mount signs between 48"- 60" above the finished floor located on the latch side of the door.<br>Provide an illuminated sign with the International Symbol of Accessibility. | 1 | 432 | \$432 |

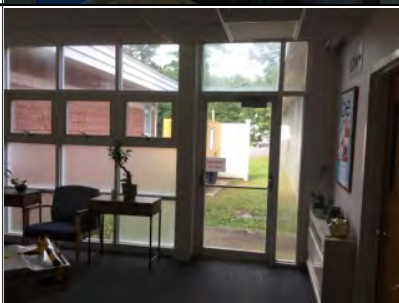
| ID | Location | Floor | Room | Element | Type | Photo | Issues | Current Measure | Recommendations | Quantity | Price | Cost Estimation |
|---|--|---|---|---|---|--|--|---|--|---|---|---|
| 14 | Egress Next to Toilet Rooms in the Senior Center | 1 | | Emergency Exit | N/A | | Tactile sign not provided at exit<br>Illuminated Int. Symbol of Acc. not provided (MAAB) | -<br>- | Provide tactile exit signs with raised characters and braille at exit doors. Mount signs between 48"- 60" above the finished floor located on the latch side of the door.<br>Provide an illuminated sign with the International Symbol of Accessibility. | 1 | 1116 | \$1116 |

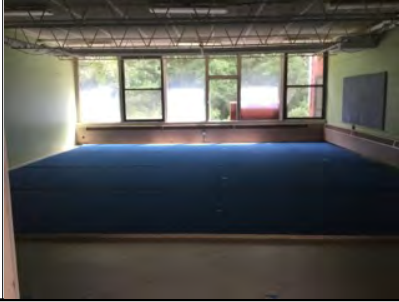
| ID | Location | Floor | Room | Element | Type | Photo | Issues | Current Measure | Recommendations | Quantity | Price | Cost Estimation |
|---|---|---|---|---|---|--|--|---|---|---|---|---|
| 20 | Pre-school Multipurpose Room | 1 | | Interior Access Route | N/A | | Accessible route not provided | 2" | Provide a portable ramp at 2" level change. | 1 | 500 | \$500 |

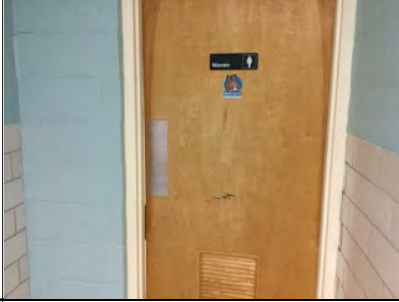
| ID | Location | Floor | Room | Element | Type | Photo | Issues | Current Measure | Recommendations | Quantity | Price | Cost Estimation |
|---|--|---|---|---|---|--|--|---|---|---|---|---|
| 35 | Women's/ Girls' Toilet Room by Human Resources | 1 | 30 | Doors, Doorways, & Gates | Toilet Room | | Door requires > 5 lbs. of force to open | 9 lbs | Adjust closers so doors do not require more than 5 pounds of force to open. | 1 | Labor | \$0 |

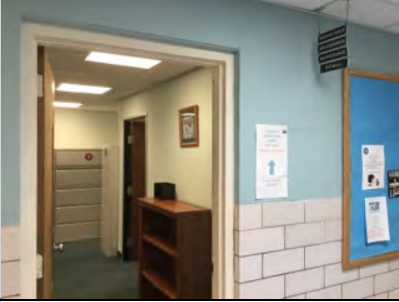
| ID | Location | Floor | Room | Element | Type | Photo | Issues | Current Measure | Recommendations | Quantity | Price | Cost Estimation |
|---|--|---|---|---|---|--|--|---|--|---|---|---|
| 45 | Business Office | 1 | | Signage | Designation | | Raised characters not provided on sign<br>Braille not provided on sign | -<br>- | Provide text with raised characters duplicated in braille on sign. | 1 | 232 | \$232 |

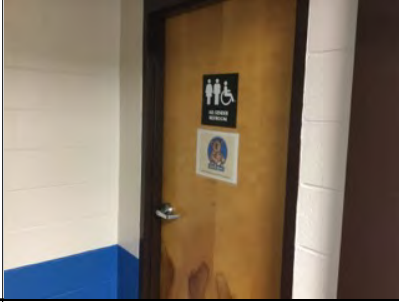
| ID | Location | Floor | Room | Element | Type | Photo | Issues | Current Measure | Recommendations | Quantity | Price | Cost Estimation |
|---|--|---|---|---|---|--|--|---|--|---|---|---|
| 55 | All Gender Toilet Room by Locker Rooms (West Side) | 1 | | Signage | Designation | | Sign not located on the latch side of the door | - | Locate sign at permanent rooms alongside the door on the latch side. | 1 | Labor | \$0 |

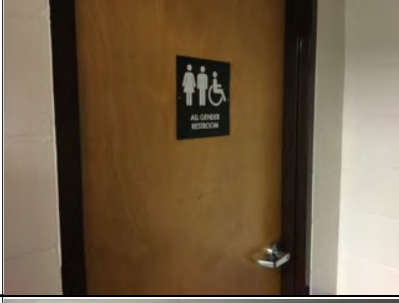
| ID | Location | Floor | Room | Element | Type | Photo | Issues | Current Measure | Recommendations | Quantity | Price | Cost Estimation |
|---|--|---|---|---|---|--|--|---|--|---|---|---|
| 56 | All Gender Toilet Room by Locker Rooms (East Side) | 1 | | Signage | Designation | | Sign not located on the latch side of the door | - | Locate sign at permanent rooms alongside the door on the latch side. | 1 | Labor | \$0 |

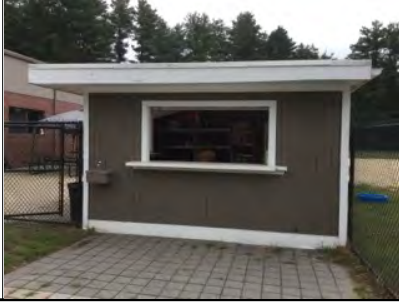
| ID | Location | Floor | Room | Element | Type | Photo | Issues | Current Measure | Recommendations | Quantity | Price | Cost Estimation |
|---|---|---|---|---|---|--|---|---|--|---|---|---|
| 60 | Concession Stand (Exterior of Fence) | Ext. | | Service Counter | N/A | | Counter > 36" high | 47" | Provide a counter that is 36" max. above the ground or finished floor. | 1 | 880 | \$880 |

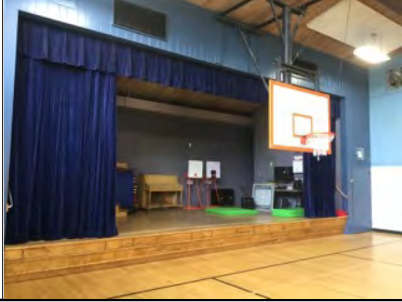
| ID | Location | Floor | Room | Element | Type | Photo | Issues | Current Measure | Recommendations | Quantity | Price | Cost Estimation |
|---|---|---|---|---|---|--|---|---|---|---|---|---|
| 65 | Gym/Stage | 1 | | Assembly Area | N/A | | Accessible route to stage not provided | - | Provide an interior lift to the stage. | 1 | 21660 | \$21660 |

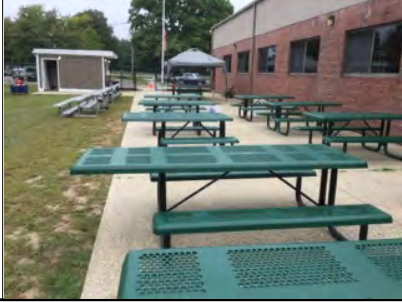
| ID | Location | Floor | Room | Element | Type | Photo | Issues | Current Measure | Recommendations | Quantity | Price | Cost Estimation |
|---|---|---|---|---|---|--|--|---|--|---|---|---|
| 75 | Picnic Area | Ext. | | Picnic Tables | N/A | | Picnic table not on an accessible route | - | Ensure that the accessible space at the picnic tables are connected to an accessible route. | 2 | Labor | \$0 |

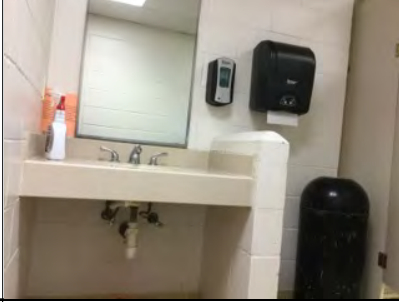
| ID | Location | Floor | Room | Element | Type | Photo | Issues | Current Measure | Recommendations | Quantity | Price | Cost Estimation |
|---|--|---|---|---|---|--|---|---|---|---|---|---|
| 84 | All Gender Toilet Room by Locker Rooms (West Side) | 1 | | Lavatory | N/A | | Plumbing underneath is exposed<br>Dispensers not within reach range | -<br>48.8" | Insulate or otherwise configure pipes to prevent contact at lavatory.<br>Lower paper towel dispenser to 42" max. above the floor. | 1 | 348 | \$348 |

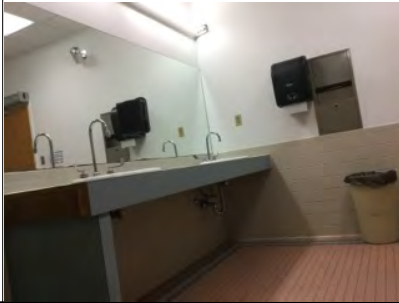
| ID | Location | Floor | Room | Element | Type | Photo | Issues | Current Measure | Recommendations | Quantity | Price | Cost Estimation |
|---|--|---|---|---|---|--|---|---|---|---|---|---|
| 85 | Senior Center, Women's Toilet Room | 1 | | Lavatory | N/A | | Plumbing underneath is exposed<br>Dispensers not within reach range | -<br>47.25" | Insulate or otherwise configure pipes to prevent contact for at least one lavatory.<br>Lower soap and paper towel dispensers to 42" max. above the floor. | 1 | 604 | \$604 |

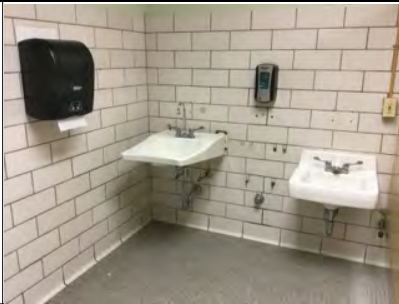
| ID | Location | Floor | Room | Element | Type | Photo | Issues | Current Measure | Recommendations | Quantity | Price | Cost Estimation |
|---|--|---|---|---|---|--|---|---|---|---|---|---|
| 86 | Men's/Boys' Toilet Room | 1 | | Lavatory | N/A | | Plumbing underneath is exposed<br>Dispensers not within reach range | -<br>46" | Insulate or otherwise configure pipes to prevent contact at lavatory with knee and toe clearance.<br>Lower soap dispenser to 42" max. above the floor. | 1 | 445 | \$445 |

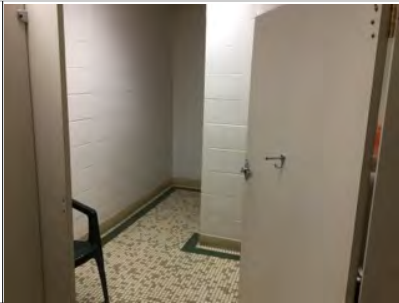
| ID | Location | Floor | Room | Element | Type | Photo | Issues | Current Measure | Recommendations | Quantity | Price | Cost Estimation |
|---|--|---|---|---|---|--|---|---|---|---|---|---|
| 87 | All Gender Toilet Room by Locker Rooms (West Side) | 1 | | Toilet Compartment | Accessible Compartment | | Door has non-compliant hardware<br>Door has malfunctioning self-closing hinge | -<br>- | Provide hardware that can be operable with one hand and not require tight grasping, pinching, or twisting of the wrist.<br>Repair hinge. | 1 | 70 Labor | \$70 |

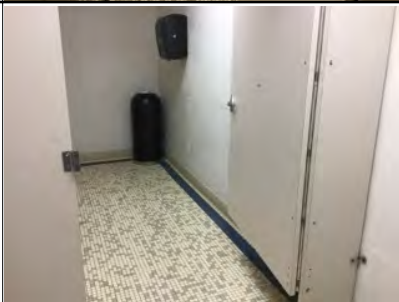
| ID | Location | Floor | Room | Element | Type | Photo | Issues | Current Measure | Recommendations | Quantity | Price | Cost Estimation |
|---|--|---|---|---|---|--|---|---|---|---|---|---|
| 88 | All Gender Toilet Room by Locker Rooms (East Side) | 1 | | Toilet Compartment | Accessible Compartment | | Door has non-compliant hardware<br>Door has malfunctioning self-closing hinge | -<br>- | Provide hardware that can be operable with one hand and not require tight grasping, pinching, or twisting of the wrist.<br>Repair hinge. | 1 | 70 Labor | \$70 |

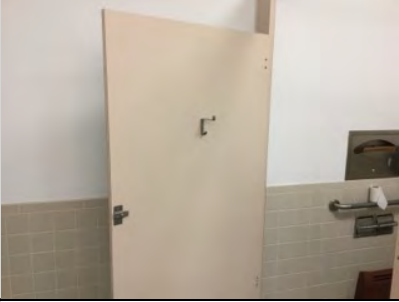
| ID | Location | Floor | Room | Element | Type | Photo | Issues | Current Measure | Recommendations | Quantity | Price | Cost Estimation |
|---|--|---|---|---|---|--|--|---|---|---|---|---|
| 89 | Senior Center, Men's Toilet Room | 1 | | Toilet Compartment | Accessible Compartment | | Door has non-compliant hardware<br>Door has malfunctioning self-closing hinge | -<br>-<br>54.5" | Provide hardware that can be operable with one hand and not require tight grasping, pinching, or twisting of the wrist.<br>Repair hinge. | 1 | 70<br>Labor | \$70 |

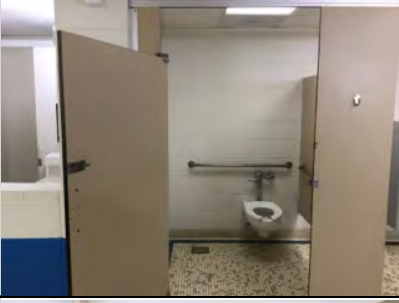
| ID | Location | Floor | Room | Element | Type | Photo | Issues | Current Measure | Recommendations | Quantity | Price | Cost Estimation |
|---|--|---|---|---|---|--|--|---|---|---|---|---|
| 90 | Pool - Men's Locker Room | 1 | | Toilet Compartment | Accessible Compartment | | Door has non-compliant hardware<br>Door has malfunctioning self-closing hinge<br>Coat hook > 48" | -<br>-<br>60.75" | Provide hardware that can be operable with one hand and not require tight grasping, pinching, or twisting of the wrist.<br>Repair hinge.<br>Lower coat hook so that it is no higher than 48". | 1 | 220<br>Labor | \$220 |

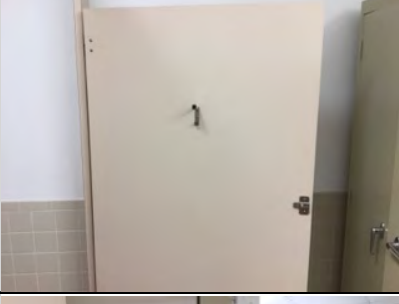
| ID | Location | Floor | Room | Element | Type | Photo | Issues | Current Measure | Recommendations | Quantity | Price | Cost Estimation |
|---|--|---|---|---|---|--|--|---|---|---|---|---|
| 91 | Senior Center, Women's Toilet Room | 1 | | Toilet Compartment | Accessible Compartment | | Door has non-compliant hardware<br>Door has malfunctioning self-closing hinge<br>Coat hook > 48" | -<br>-<br>55.25" | Provide hardware that can be operable with one hand and not require tight grasping, pinching, or twisting of the wrist.<br>Repair hinge.<br>Lower coat hook so that it is no higher than 48". | 1 | 220<br>Labor | \$220 |

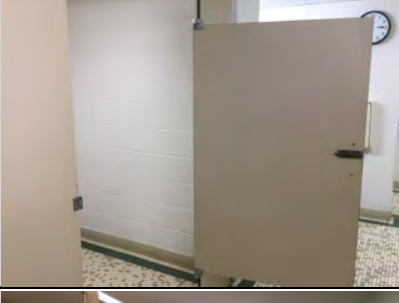
| ID | Location | Floor | Room | Element | Type | Photo | Issues | Current Measure | Recommendations | Quantity | Price | Cost Estimation |
|---|--|---|---|---|---|--|--|---|---|---|---|---|
| 92 | Pool - Women's Locker Room | 1 | | Toilet Compartment | Accessible Compartment | | Door has malfunctioning self-closing hinge | - | Repair hinge. | 1 | Labor | \$0 |

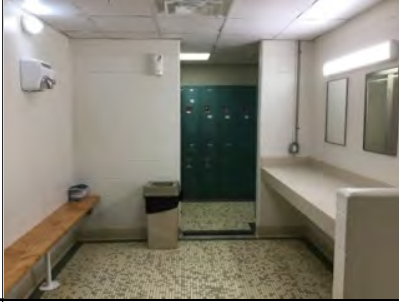
| ID | Location | Floor | Room | Element | Type | Photo | Issues | Current Measure | Recommendations | Quantity | Price | Cost Estimation |
|---|--|---|---|---|---|--|--|---|--|---|---|---|
| 104 | Pool - Women's Locker Room | 1 | | Dispensers | Hand Dryer | | Controls > 42" high<br>Clear floor space not provided at accessory | 70"<br>- | Relocate one hand dryer so the operable part is 42" max. above the finished floor and there is a 30" min. by 48" min. clear floor space. | 1 | 256 | \$256 |

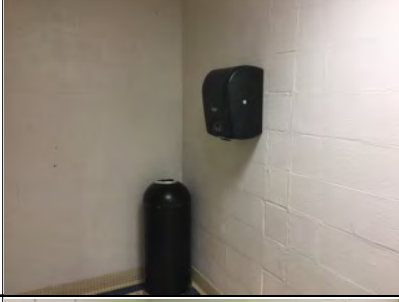
| ID | Location | Floor | Room | Element | Type | Photo | Issues | Current Measure | Recommendations | Quantity | Price | Cost Estimation |
|---|--|---|---|---|---|--|--|---|--|---|---|---|
| 105 | All Gender Toilet Room by Locker Rooms (East Side) | 1 | | Dispensers | Paper Towel Dispenser | | Controls > 42" high<br>Dispenser acts as a protruding object | 52.25"<br>9.5" | Relocate paper towel dispenser so the operable part is 42" max. above the finished floor, and out of the circulation path. | 1 | 256 | \$256 |

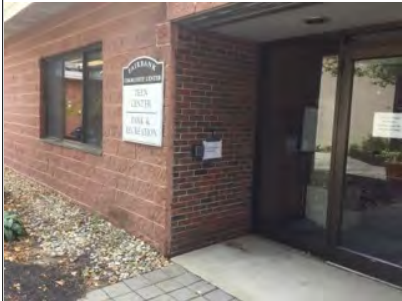
| ID | Location | Floor | Room | Element | Type | Photo | Issues | Current Measure | Recommendations | Quantity | Price | Cost Estimation |
|---|---|---|---|---|---|--|---|---|--|---|---|---|
| 124 | Pool - Main Entrance | Ext. | | | | | | | Recommend applying glass manifestation to large expanse of clear glass, in order to make the glass visible, preventing injury through collision. | 1 | - | \$0 |

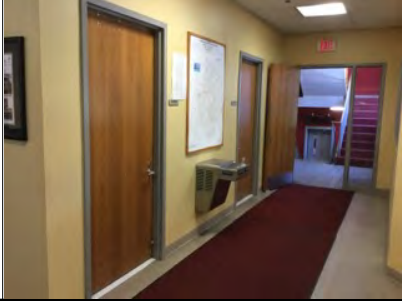
| ID | Location | Floor | Room | Element | Type | Photo | Issues | Current Measure | Recommendations | Quantity | Price | Cost Estimation |
|---|---|---|---|---|---|--|--|---|--|---|---|---|
| 19 | Corridor by Toilet Rooms | 1 | | Drinking Fountains | | | No drinking fountain provided for standing users | - | Install a Hi-Lo drinking fountain. | 1 | 4216 | \$4216 |

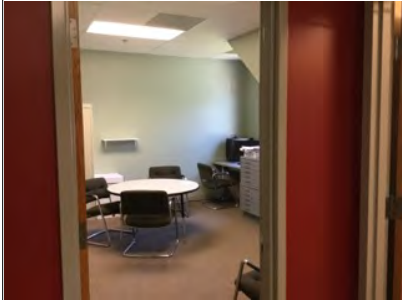
| ID | Location | Floor | Room | Element | Type | Photo | Issues | Current Measure | Recommendations | Quantity | Price | Cost Estimation |
|---|---|---|---|---|---|--|--|---|--|---|---|---|
| 20 | Conference Room | 1 | | | | | Signage is not provided | - | Recommend providing designation signage with raised characters and braille at all permanent rooms where signage is not provided. | 1 | - | \$0 |

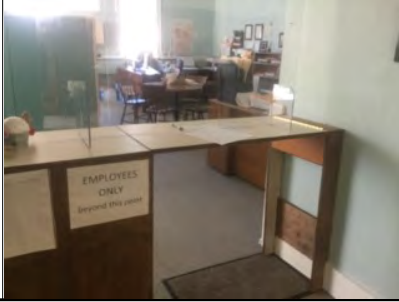
| ID | Location | Floor | Room | Element | Type | Photo | Issues | Current Measure | Recommendations | Quantity | Price | Cost Estimation |
|---|--|---|---|---|---|--|---|---|--|---|---|---|
| 10 | Selectmen's/<br>Town<br>Manager<br>Office<br>Counter | 2 | | Interior<br>Access<br>Route | N/A | | Surface not stable, firm, and slip-resistant | - | Secure the mat. | 1 | Labor | \$0 |

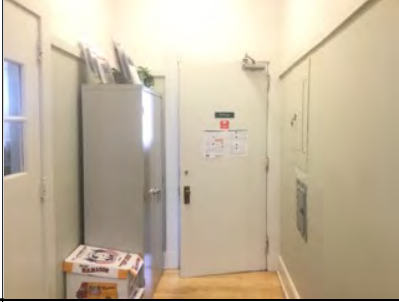
| ID | Location | Floor | Room | Element | Type | Photo | Issues | Current Measure | Recommendations | Quantity | Price | Cost Estimation |
|---|---|---|---|---|---|--|--|---|---|---|---|---|
| 15 | Access to Selectmen's and Town Manager's Office | 2 | | Doors, Doorways, & Gates | Office | | Maneuvering clearance(s) not provided<br>Hardware not operable with a closed fist<br>Door requires > 5 lbs. of force to open | 6"<br>-<br>15 lbs. | Relocate furniture out of the required 18" maneuvering clearance on the latch side of the door.<br>Provide hardware that can be operable with one hand and not require tight grasping, pinching, or twisting of the wrist.<br>Adjust closers so doors do not require more than 5 pounds of force to open. | 1 | 484<br>Labor | \$484 |

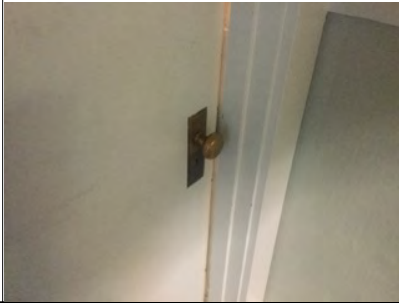
| ID | Location | Floor | Room | Element | Type | Photo | Issues | Current Measure | Recommendations | Quantity | Price | Cost Estimation |
|---|---|---|---|---|---|--|--|---|---|---|---|---|
| 16 | Women's Toilet Room | 1 | | Doors, Doorways, & Gates | Toilet Room | | Hardware not operable with a closed fist | - | Provide hardware that can be operable with one hand and not require tight grasping, pinching, or twisting of the wrist. | 1 | 484 | \$484 |

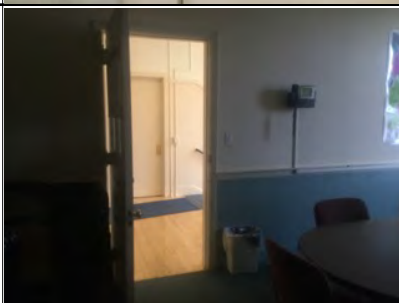
| ID | Location | Floor | Room | Element | Type | Photo | Issues | Current Measure | Recommendations | Quantity | Price | Cost Estimation |
|---|---|---|---|---|---|--|--|---|---|---|---|---|
| 19 | Small Meeting Room/<br>Thompson Conference Room | 2 | | Doors, Doorways, & Gates | Meeting Room | | Hardware not operable with a closed fist | - | Provide hardware that can be operable with one hand and not require tight grasping, pinching, or twisting of the wrist. | 1 | 484 | \$484 |

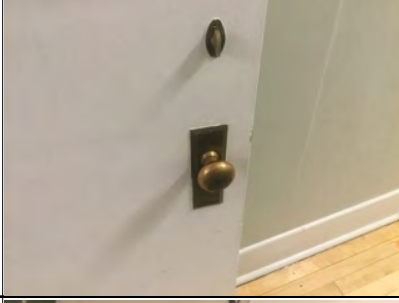
| ID | Location | Floor | Room | Element | Type | Photo | Issues | Current Measure | Recommendations | Quantity | Price | Cost Estimation |
|---|---|---|---|---|---|--|--|---|---|---|---|---|
| 21 | Large Meeting Room | 2 | | Doors, Doorways, & Gates | Meeting Room | | Hardware not operable with a closed fist | - | Provide hardware that can be operable with one hand and not require tight grasping, pinching, or twisting of the wrist. | 1 | 484 | \$484 |

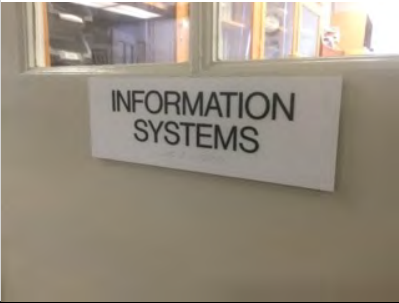
| ID | Location | Floor | Room | Element | Type | Photo | Issues | Current Measure | Recommendations | Quantity | Price | Cost Estimation |
|---|---|---|---|---|---|--|--|---|---|---|---|---|
| 41 | Information Systems | 1 | | Signage | Designation | | Sign not located on the latch side of the door | - | Locate sign at permanent rooms alongside the door on the latch side. | 1 | Labor | \$0 |

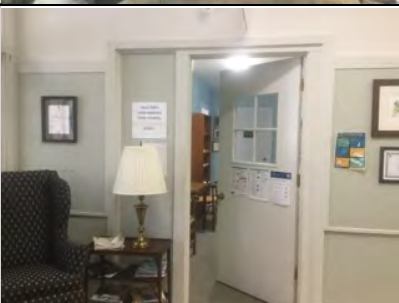
| ID | Location | Floor | Room | Element | Type | Photo | Issues | Current Measure | Recommendations | Quantity | Price | Cost Estimation |
|---|---|---|---|---|---|--|--|---|---|---|---|---|
| 44 | Selectmen, Town Manager, Town Counsel and Notary Office | 2 | | Signage | Designation | | Clear floor space not provided at sign | - | Relocate furniture so that there is a clear floor space of 18" min. by 18" min. centered on the tactile characters at the tactile sign. | 1 | Labor | \$0 |

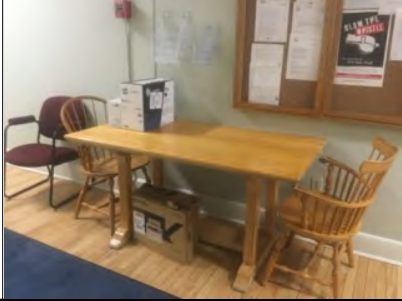
| ID | Location | Floor | Room | Element | Type | Photo | Issues | Current Measure | Recommendations | Quantity | Price | Cost Estimation |
|---|---|---|---|---|---|--|--|---|--|---|---|---|
| 50 | Corridor by Elevator | 1 | | Dining or Work Surfaces | Work Surface | | Knee or toe clearance not provided | - | Provide at least 1 work surface with 27" min. knee and toe clearance. | 1 | 700 | \$700 |

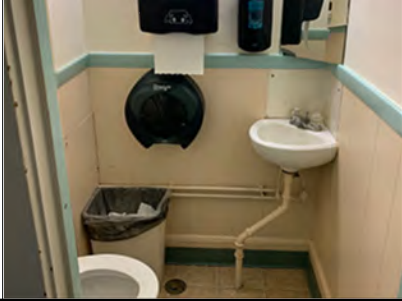
| ID | Location | Floor | Room | Element | Type | Photo | Issues | Current Measure | Recommendations | Quantity | Price | Cost Estimation |
|---|---|---|---|---|---|--|---|---|---|---|---|---|
| 55 | Single-User Toilet Room | 2 | | Overall Access | Toilet Room | | Turning space not provided<br>Accessible plumbing fixtures or stalls not provided<br>Grab bars not provided | 42" x 53"<br>-<br>- | Renovate and enlarge toilet room or add an accessible single-user toilet room on this floor. | 1 | 24604 | \$24604 |

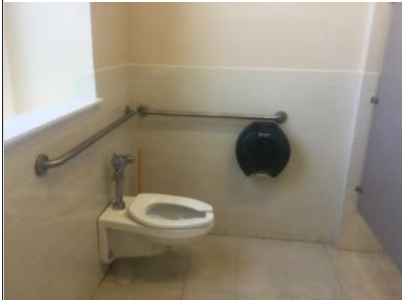
| ID | Location | Floor | Room | Element | Type | Photo | Issues | Current Measure | Recommendations | Quantity | Price | Cost Estimation |
|---|---|---|---|---|---|--|---|---|---|---|---|---|
| 57 | Men's Toilet Room | 1 | | Toilet Compartment | Accessible Compartment | | Side grab bar < 42" long<br>Clearance at toilet < 72" clear depth (MAAB)<br>Toilet lacks 42" min. clear in front of toilet (MAAB) | 36"<br>36.5"<br>61.5" | Provide a side wall grab bar that is 42" long min. located 12" max. from the rear wall.<br>Toilet compartment size complies with ADA but not 521 CMR (MAAB). If a variance was not sought during the time of construction, relocate toilet to adjacent wall to ensure that there is 72" min. deep at toilet and 42" min. clear in front of the toilet. (Cost is for grab bar only.) | 1 | 898 | \$898 |

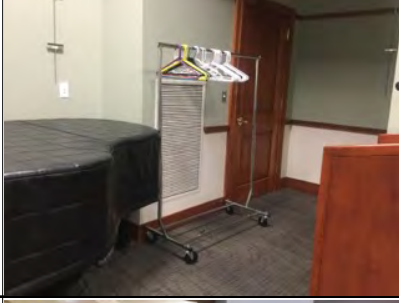
| ID | Location | Floor | Room | Element | Type | Photo | Issues | Current Measure | Recommendations | Quantity | Price | Cost Estimation |
|---|---|---|---|---|---|--|---|---|---|---|---|---|
| 21 | Community Meeting Room | 1 | | Operable Parts | Clothes Rod/Hooks | | Reach < 15" or > 48"(forward/side approach) | 62" | Provide a clothing rack that is located no higher than 48" above the finished floor. | 1 | 92 | \$92 |

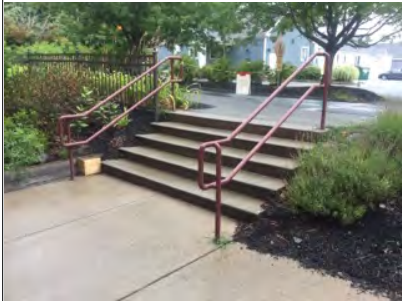
| ID | Location | Floor | Room | Element | Type | Photo | Issues | Current Measure | Recommendations | Quantity | Price | Cost Estimation |
|---|---|---|---|---|---|--|---|---|---|---|---|---|
| 54 | Stair by Front of Library on Southeast Side | Ext. | | | | | | | Recommend providing contrast strips on stair treads. | 1 | - | \$0 |

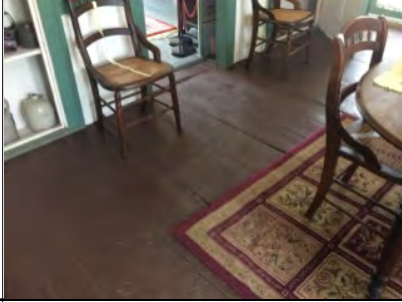
| ID | Location | Floor | Room | Element | Type | Photo | Issues | Current Measure | Recommendations | Quantity | Price | Cost Estimation |
|---|---|---|---|---|---|--|--|---|--|---|---|---|
| 11 | Dining Room | 1 | | Interior Access Route | N/A | | Route < 36" wide | 25.75" | Ensure that a clear width of 36" min. is maintained at the accessible route. Route is allowed to narrow to 32" wide min. for 24" of depth. | 1 | Labor | \$0 |

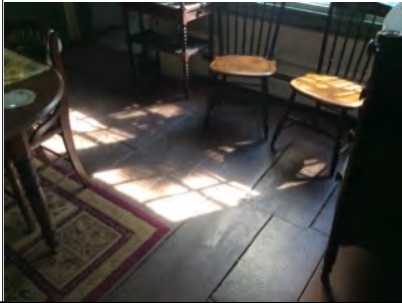
| ID | Location | Floor | Room | Element | Type | Photo | Issues | Current Measure | Recommendations | Quantity | Price | Cost Estimation |
|---|---|---|---|---|---|--|--|---|--|---|---|---|
| 12 | Dining Room - Route to Kitchen | 1 | | Interior Access Route | N/A | | Route < 36" wide | 28.75" | Ensure that a clear width of 36" min. is maintained at the accessible route. Route is allowed to narrow to 32" wide min. for 24" of depth. | 1 | Labor | \$0 |

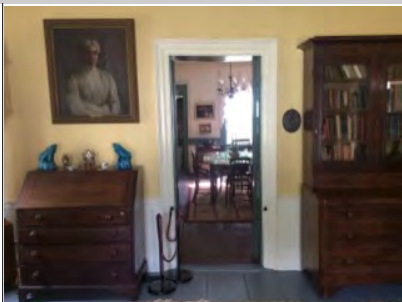
| ID | Location | Floor | Room | Element | Type | Photo | Issues | Current Measure | Recommendations | Quantity | Price | Cost Estimation |
|---|---|---|---|---|---|--|--|---|--|---|---|---|
| 15 | Doorway From Living Room to Dining Room | 1 | | Doors, Doorways, & Gates | Circulation | | Clear width at door < 32"<br>Threshold > 1/2" high | 30.5"<br>1" | Provide offset hinges at door to provide 32" min. clear width. The historic hinges of these doors could be retained in storage. Alteration to the threshold may not be feasible. Compliance with the requirements may threaten or destroy the historic significance of the building. Provide a video of the rooms or photographs to provide program accessibility. | 1 | 2232 | \$2232 |

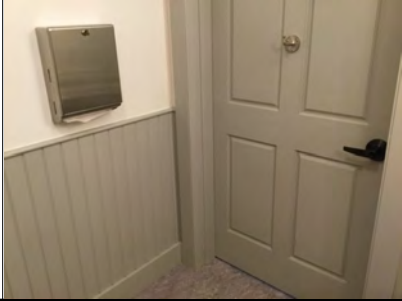
| ID | Location | Floor | Room | Element | Type | Photo | Issues | Current Measure | Recommendations | Quantity | Price | Cost Estimation |
|---|--|---|---|---|---|--|---|---|---|---|---|---|
| 14 | Toilet Room - North Side of Building | 1 | 103 | Single-User Toilet | N/A | | Hook located > 48" high | 53.5" | Locate hook no higher than 48" above the finished floor. | 1 | 150 | \$150 |

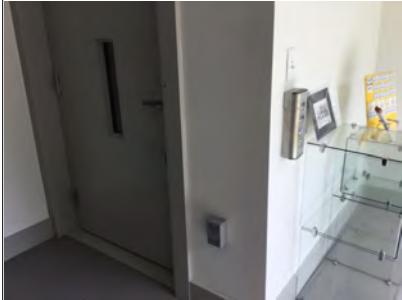
| ID | Location | Floor | Room | Element | Type | Photo | Issues | Current Measure | Recommendations | Quantity | Price | Cost Estimation |
|---|--|---|---|---|---|--|---|---|---|---|---|---|
| 15 | Platform Lift, East Side of Building | 1 | | | | | | - | Relocate shelves to provide easier access to and clearance at lift controls. | 1 | - | \$0 |

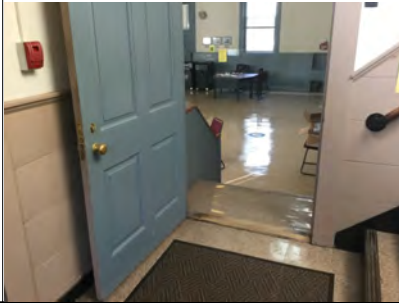
| ID | Location | Floor | Room | Element | Type | Photo | Issues | Current Measure | Recommendations | Quantity | Price | Cost Estimation |
|---|--|---|---|---|---|--|---|---|--|---|---|---|
| 21 | South Stairwell to Meeting Hall | 1 | | Doors, Doorways, & Gates | Circulation | | Hardware not operable with a closed fist | - | Provide hardware that can be operable with one hand and not require tight grasping, pinching, or twisting of the wrist. | 1 | 484 | \$484 |

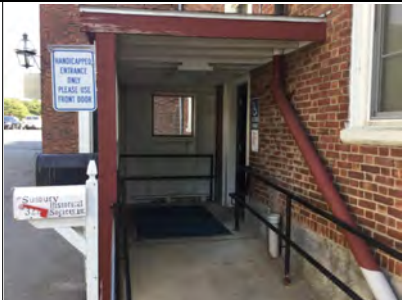
| ID | Location | Floor | Room | Element | Type | Photo | Issues | Current Measure | Recommendations | Quantity | Price | Cost Estimation |
|---|---|---|---|---|---|---|---|---|--|---|---|---|
| 40 | Accessible Entrance to Meeting Hall | Ext | | | | | | | Provide clear information about the locations of destination spaces at each entrance.<br>Avoid terms such as "handicapped" and use the term "accessible" instead. | 1 | - | \$0 |

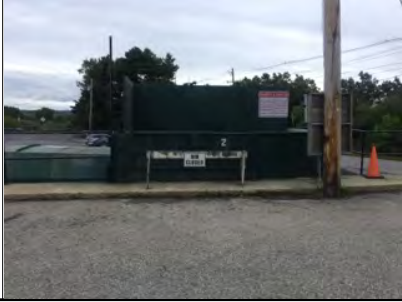
| ID | Location | Floor | Room | Element | Type | Photo | Issues | Current Measure | Recommendations | Quantity | Price | Cost Estimation |
|---|---|---|---|---|---|--|---|---|---|---|---|---|
| 11 | Compactor 2 | Ext. | | Exterior Access Route | Exterior | | Level changes > 1/4" | 5" | Have staff provide assistance accessing compactor 2 as needed. | 1 | Labor | \$0 |
