Roof Repair Project Report

**Fairbank Complex
40 Fairbank Road
Sudbury, Massachusetts**

February 14, 2014

RBA Project No. 2014007.00

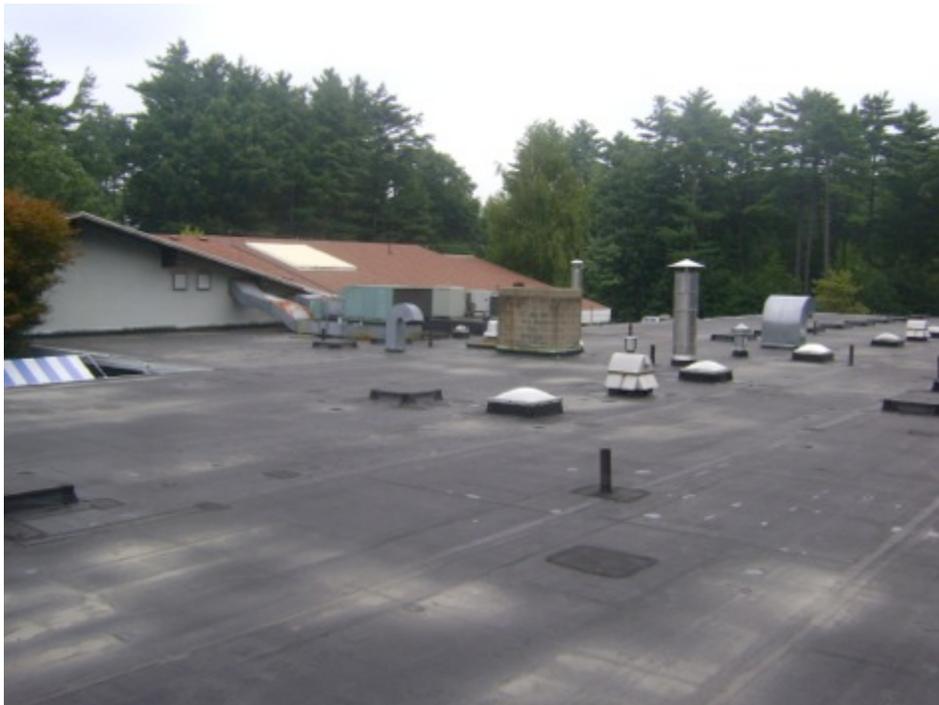
Photo No. 02

Description:
Overall view of Roof Area No. 3; the largest of the (3) older EPDM roofs.

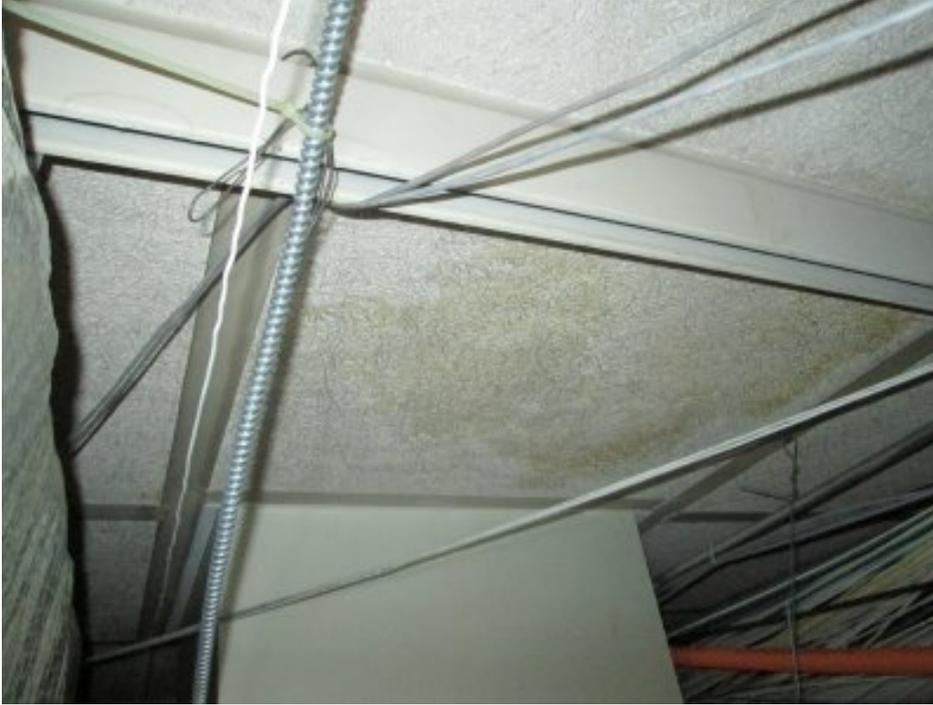
Photo No. 03

The existing cementitious wood fiber roof decking is deteriorated in many locations due to previous leaking (approximately 14 locations totaling 342 SF). These areas are also shown on the attached Roof Area Plan. Replacement of full roof deck panels is recommended. We must note however that the true extent of deteriorated roof deck conditions can only be determined when all roofing is removed and the entire roof deck is exposed.

Description:
Location of deteriorated cementitious wood fiber roof decking.

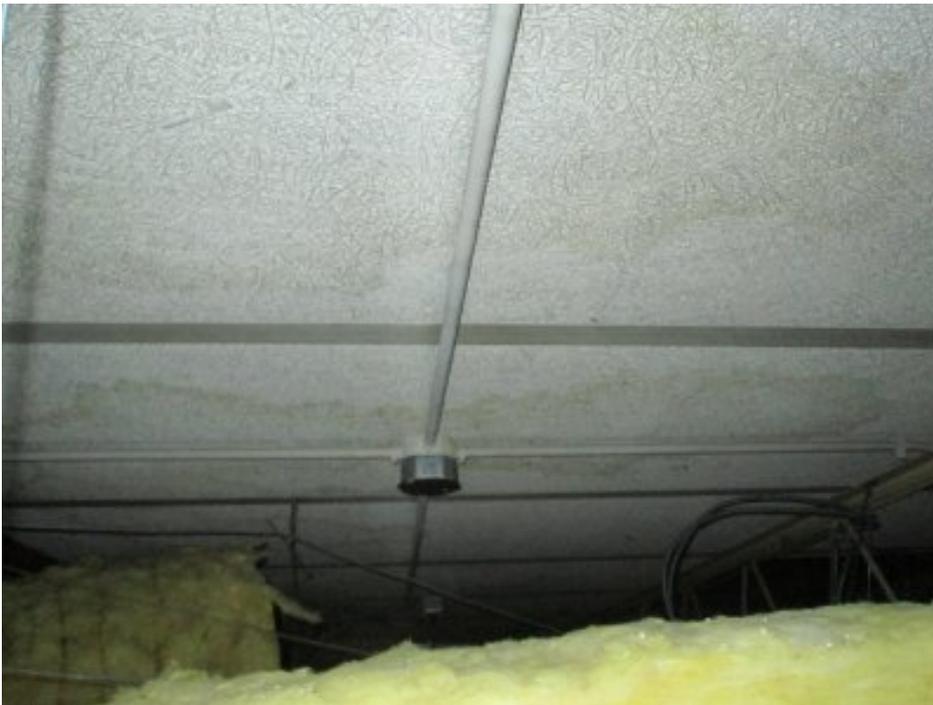
Photo No. 04

Description:
Location of deteriorated cementitious wood fiber roof decking.

Note:
Conduit and electric work box attached to underside of roof decking.

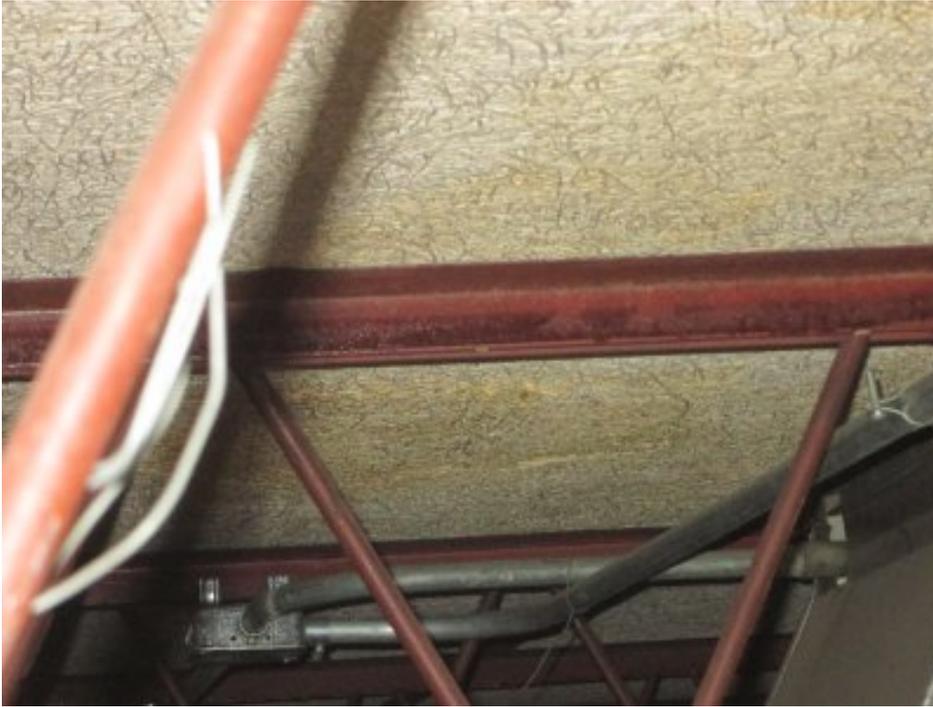
Photo No. 05

Description:
Location of
deteriorated
cementitious wood
fiber roof decking.

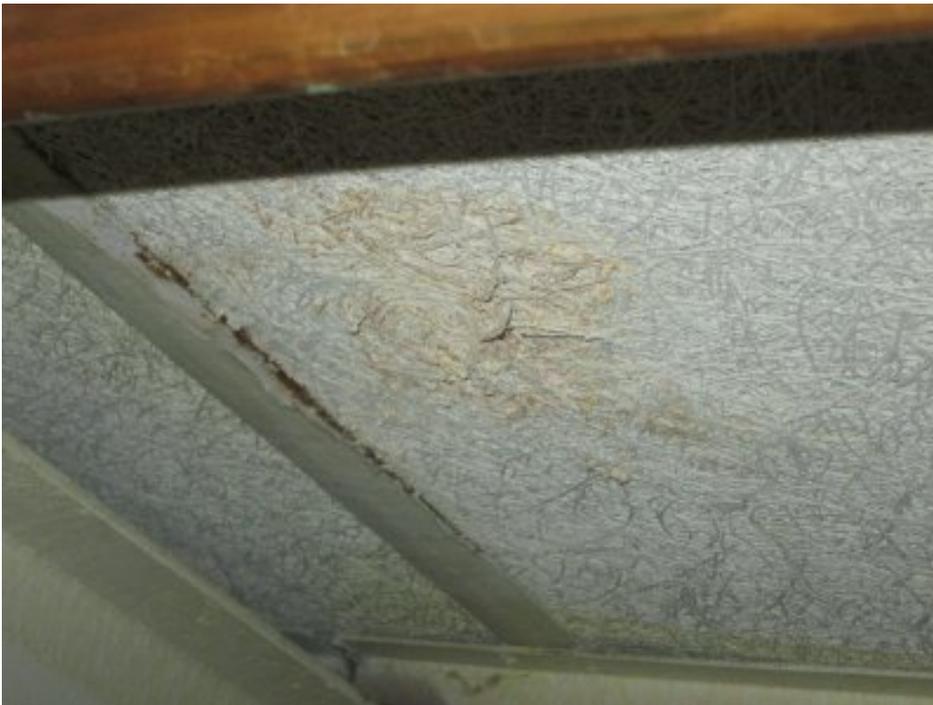
Photo No. 06

Description:
Location of
deteriorated
cementitious wood
fiber roof decking.

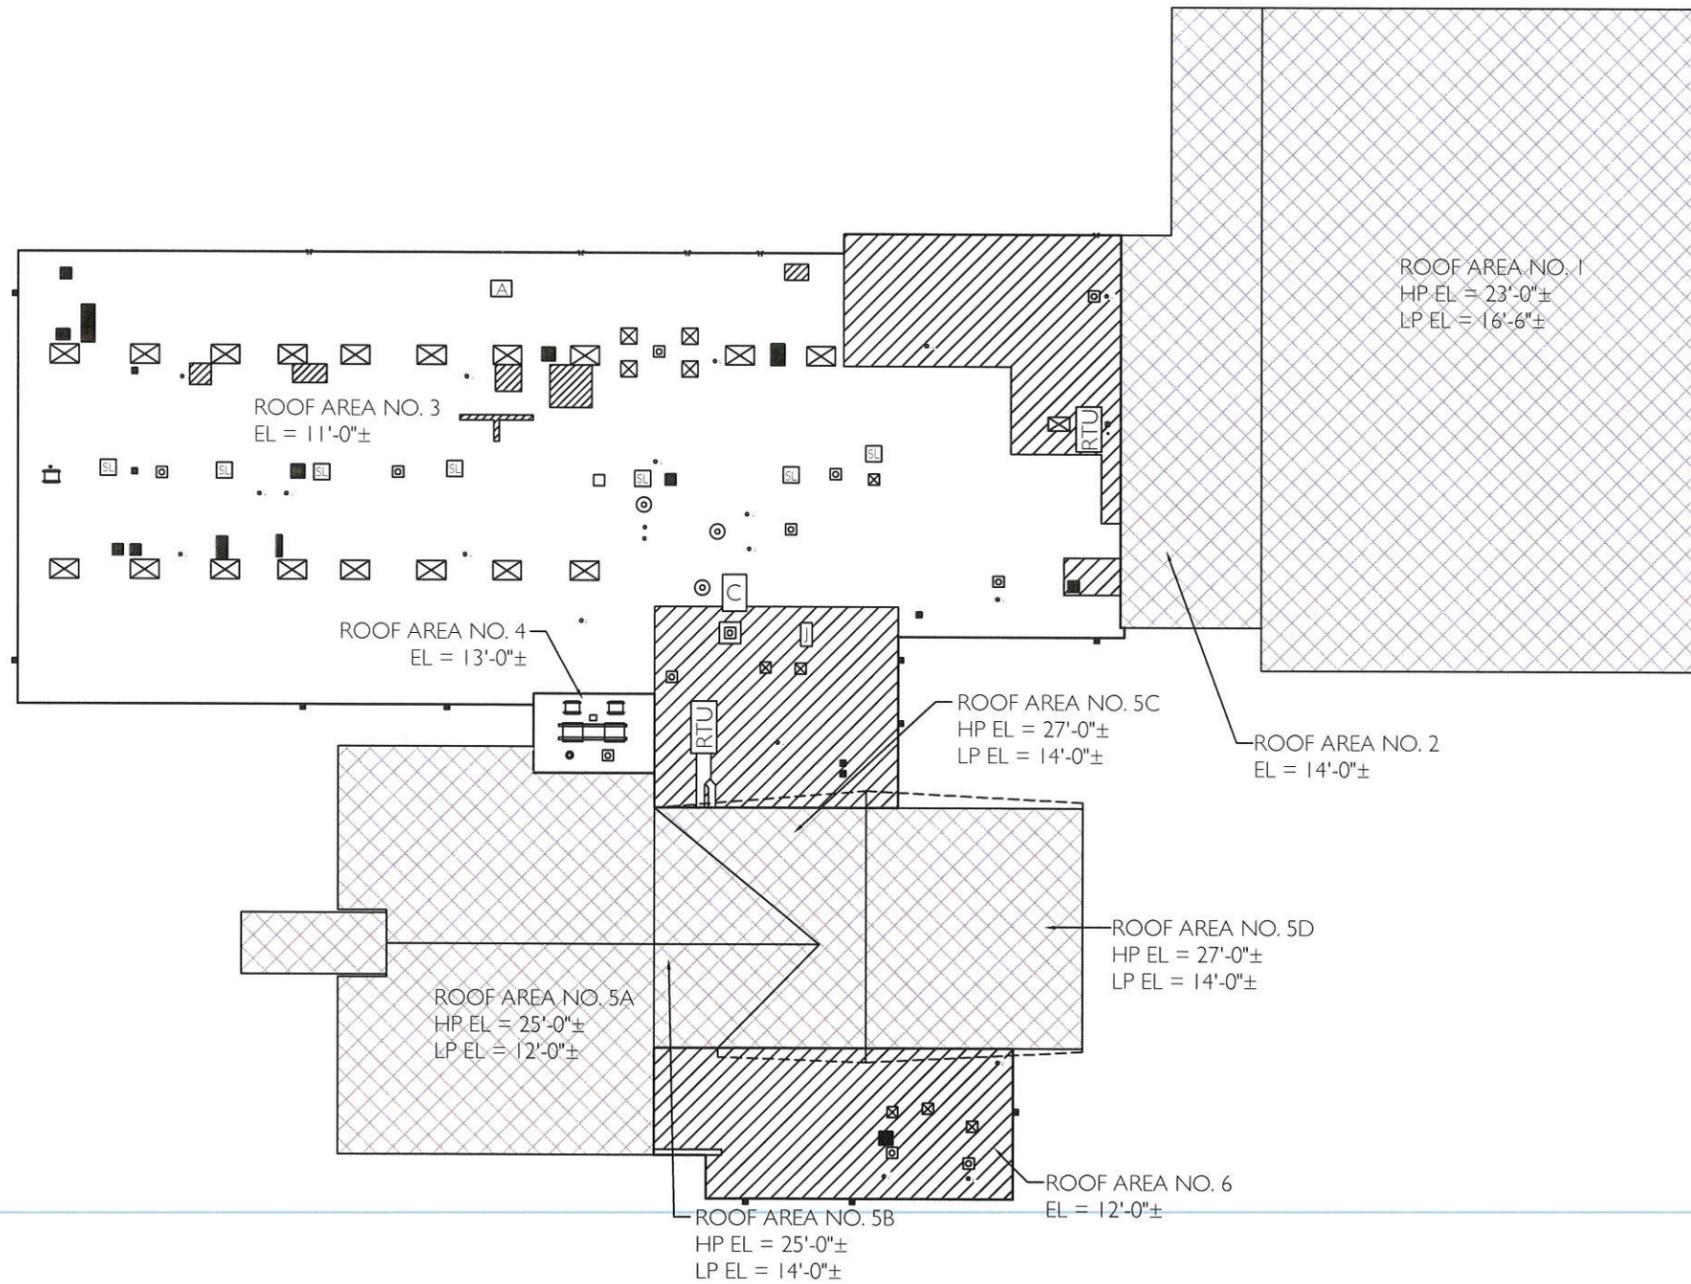
FAIRBANK COMPLEX - ROOF AREA PLAN
SCALE: 1/8"=1'-0"

Proscan Infrared Technologies performed an infrared survey on Roof Area 3 in April of 2013 and had found wet insulation in 4 general areas. This office performed an infrared survey of Roof Areas 3, 4 and 6 in February of 2012 and we found a greater number and greater area of moisture contaminated roof insulation materials. Suspected wet roof insulation areas are shown on the attached Roof Area Plan and total approximately 5,722 SF.
